Permit Fact Sheet

Permit Number:	WI-0066494-02-0
Permittee Name:	Horsens Homestead Farms, LLC
Address:	W1980 County Road C
City/State/Zip:	Cecil WI 54111
Discharge Location:	W1980 County Road C, Cecil, WI 54111 ; SW ¼ of SW ¼ Section 5, T27N, R18E
Receiving Water:	Unnamed tributaries of the Oconto River within the Oconto River Watershed, and groundwaters of the state
Discharge Type:	Existing

On Thursday June 29, 2023 Hanson & Arnoldi met with Horsens & Horsens at 10:00 at Horsens Homestead Farms LLC site to conduct a permit reissuance walkover inspection. The only site in the permit & inspected was the main farm. No liquid precipitation had fallen recently and the temperature was in the 80's and sunny. No permit violations were observed, and no water samples were collected. Hanson & Arnoldi departed at approximately 11:15.

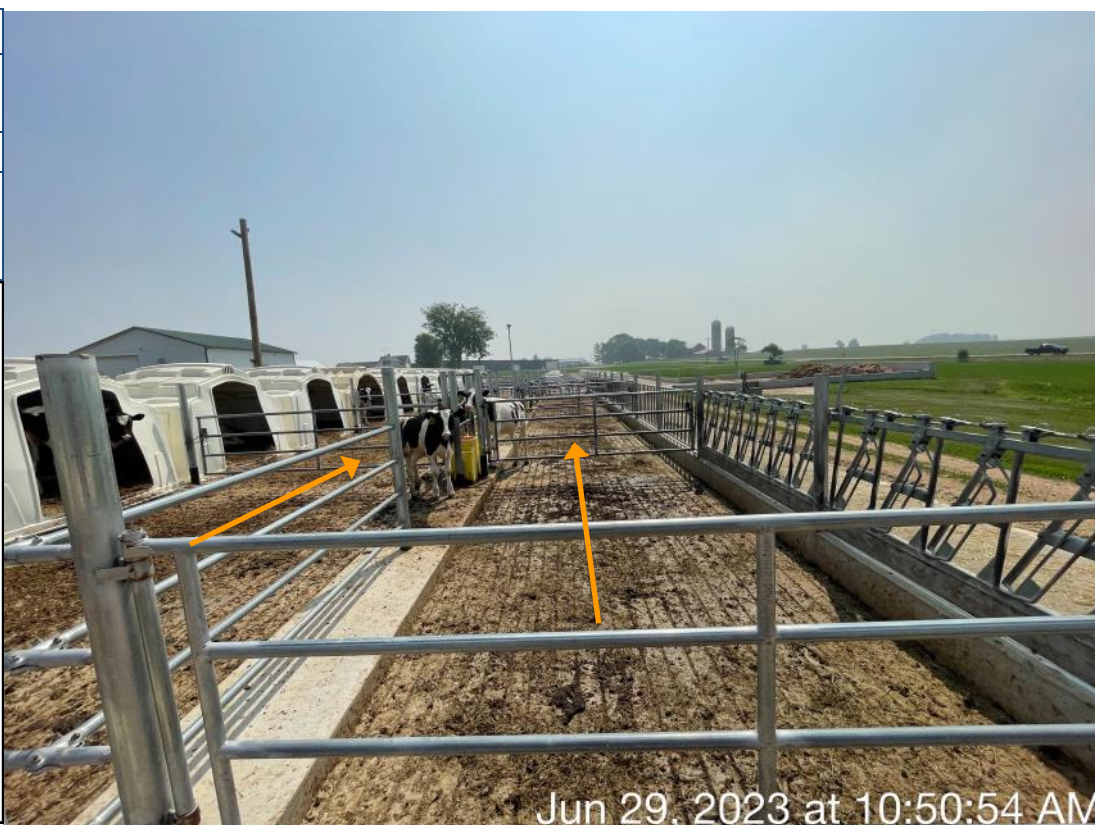
Photo #:	6807
Date/Time of Photo:	6/29/2023 10:50
Photo By:	Brian Hanson
Photo Location:	Calf Hutch Area

Photo Description:
Standing on the west side of calf hutch area looking east: View of calf hutches & drive by feeding area on western half of lot. Arrows indicate direction of flow.

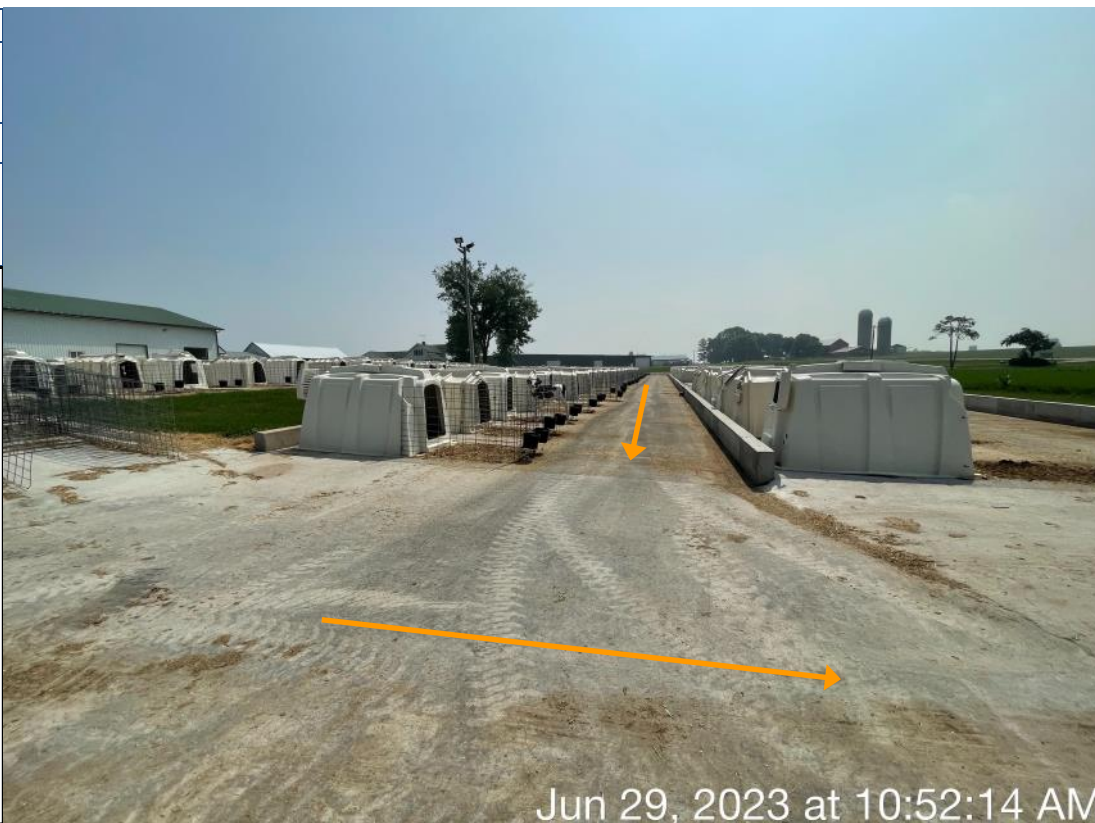
Photo #:	6816
Date/Time of Photo:	6/29/2023 10:52
Photo By:	Brian Hanson
Photo Location:	Calf Hutch Area

Photo Description:
Standing in the center of the calf hutch area looking east: View of the east half of the calf hutch area. Arrows indicate direction of runoff flow.

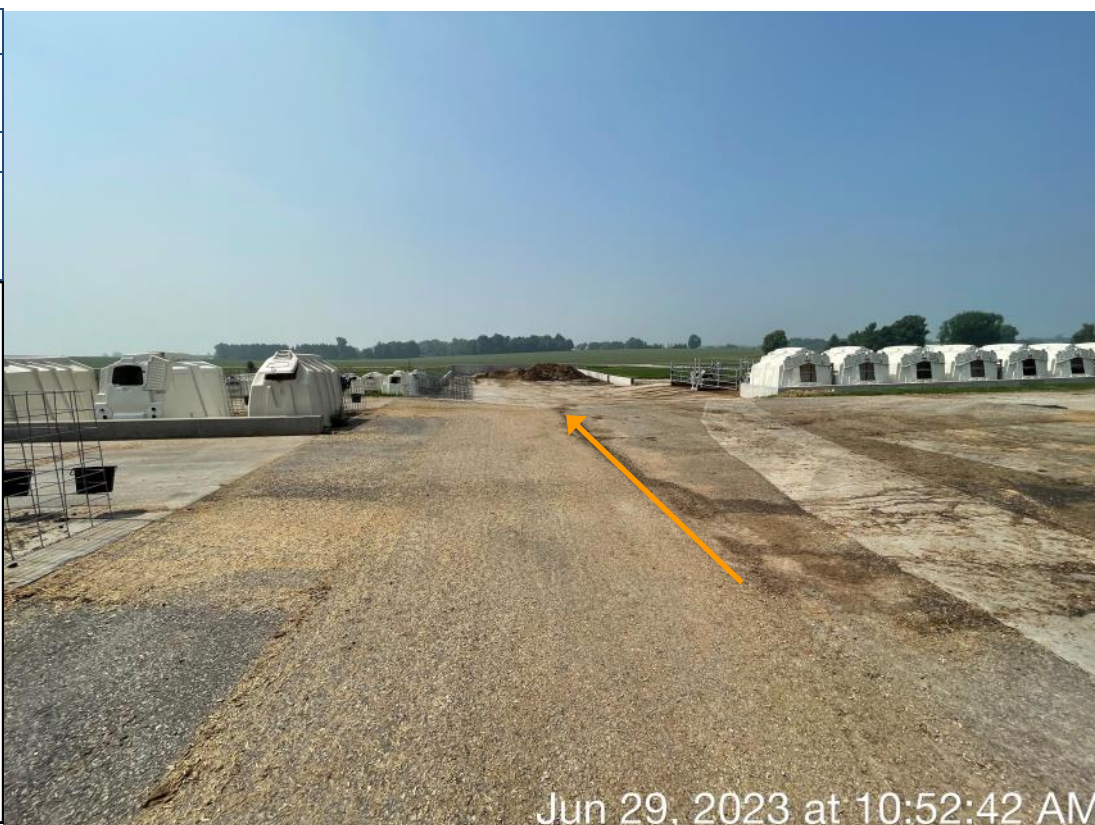
Photo #:	6825
Date/Time of Photo:	6/29/2023 10:52
Photo By:	Brian Hanson
Photo Location:	Calf Hutch Area

Photo Description:
Standing on the north side of calf hutch area looking south: View of center alley of calf hutch area used to convey runoff to collection system.

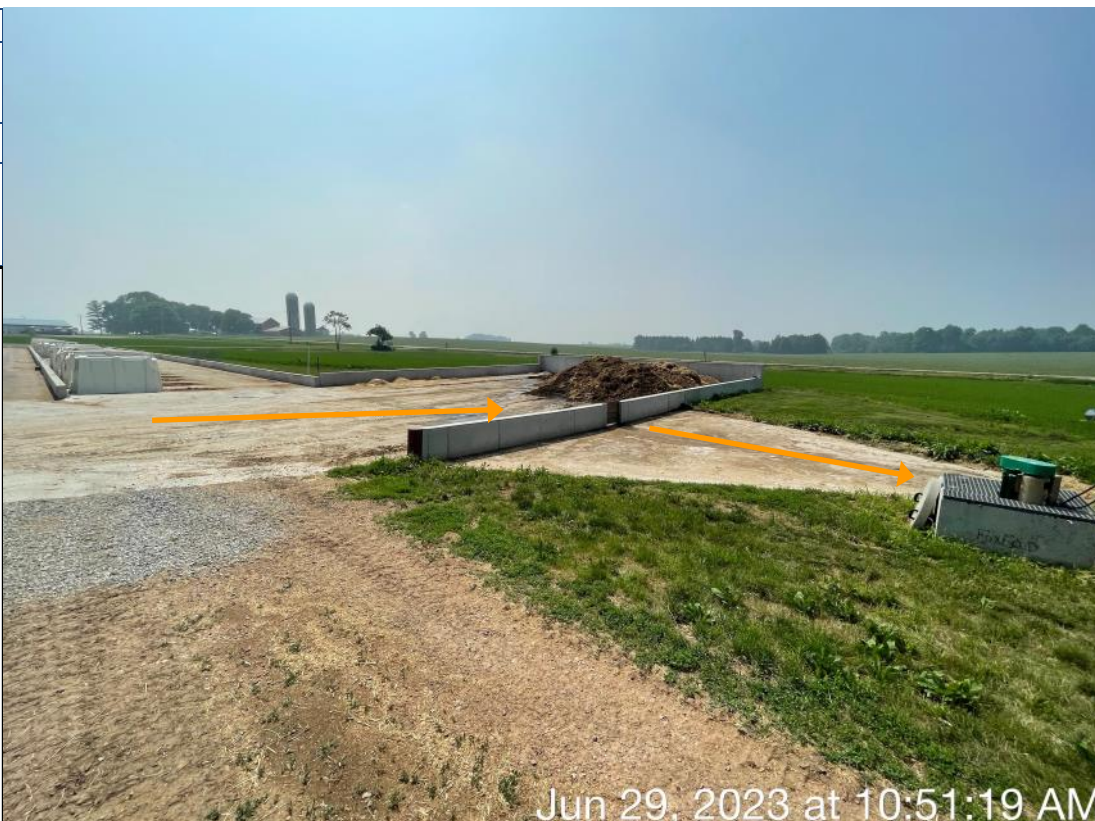
Photo #:	6808
Date/Time of Photo:	6/29/2023 10:51
Photo By:	Brian Hanson
Photo Location:	Calf Hutch Area

Photo Description:
Standing on the south side of calf hutch area looking southeast: View of solid stacking area at south end of calf hutch area near the runoff collection system. Arrows indicate direction of runoff flow.

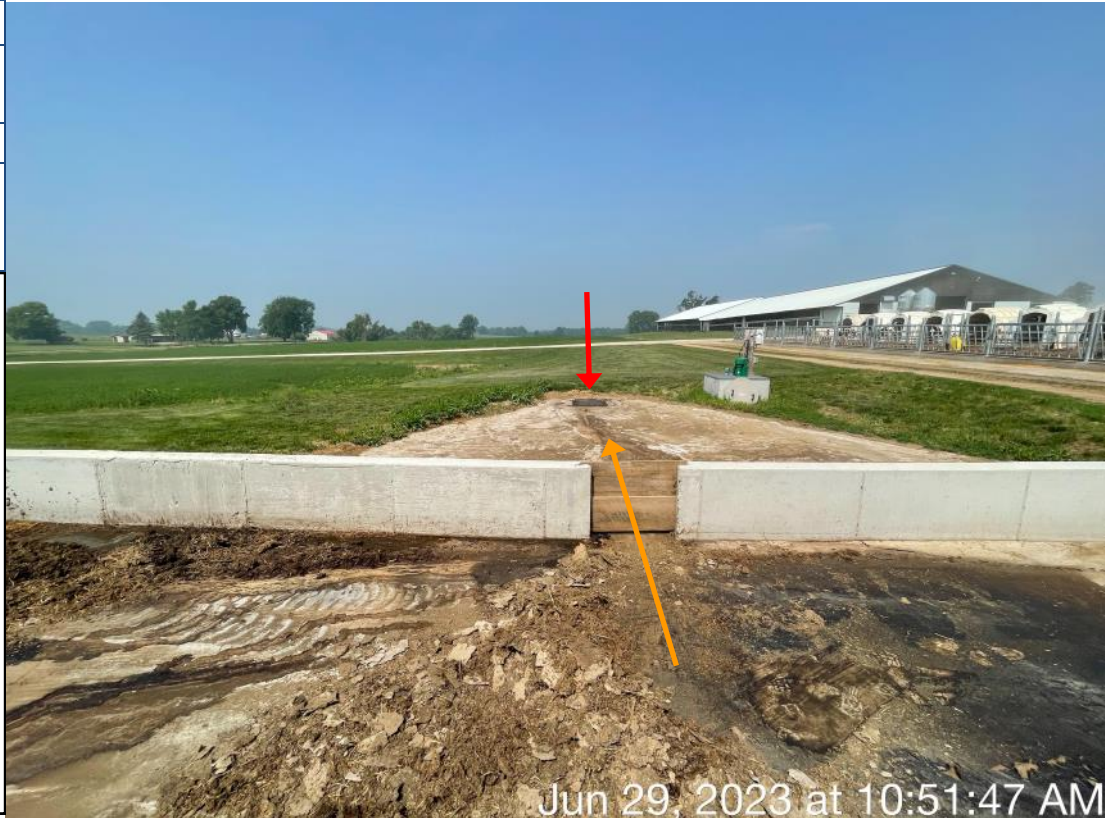
Photo #:	6814
Date/Time of Photo:	6/29/2023 10:51
Photo By:	Brian Hanson
Photo Location:	Calf Hutch Area

Photo Description:
 Standing on south side of calf hutch area looking west: View of runoff collection system for calf hutch area. Solids settle out on basin and runoff flows to underground tank, which is pumped to Heifer Pit.

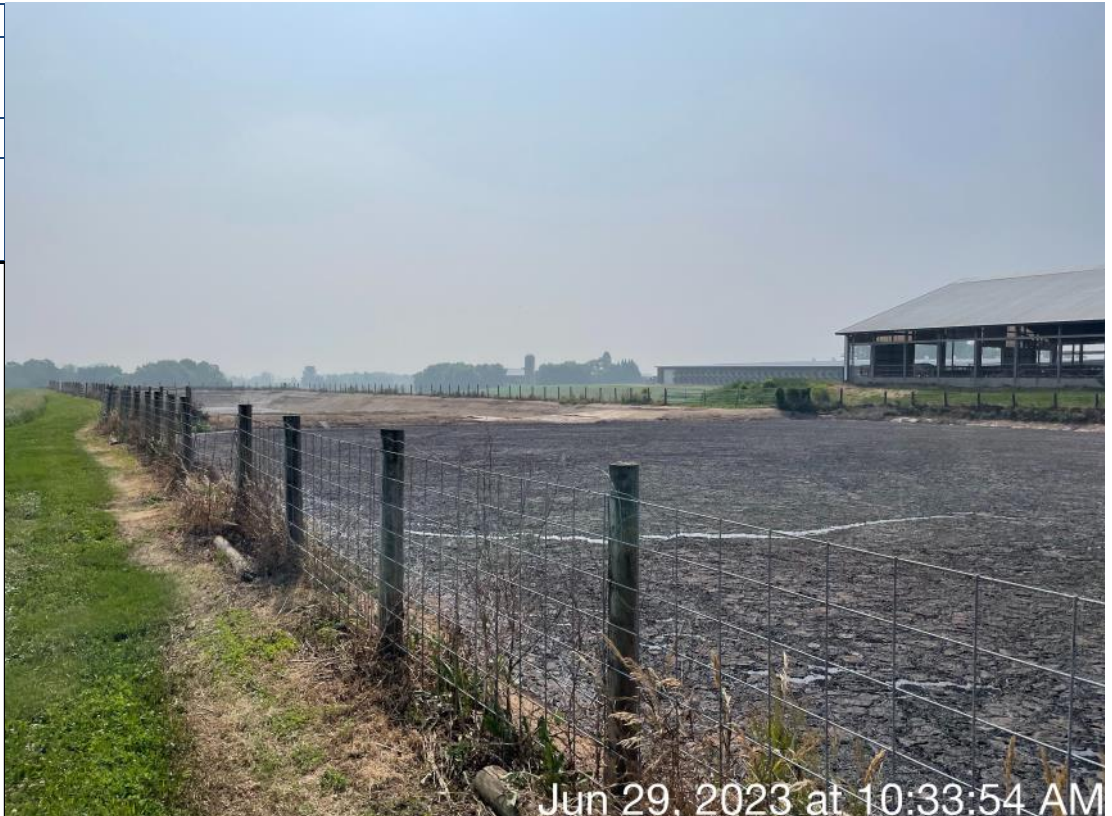
Photo #:	6739
Date/Time of Photo:	6/29/2023 10:33
Photo By:	Brian Hanson
Photo Location:	WSF #1

Photo Description:
 Standing on the north side of WSF #1 looking southeast: View of center section of WSF #1. WSF #1 normally operates near MOL as it is controlled by a gravity overflow channel into WSF #2.

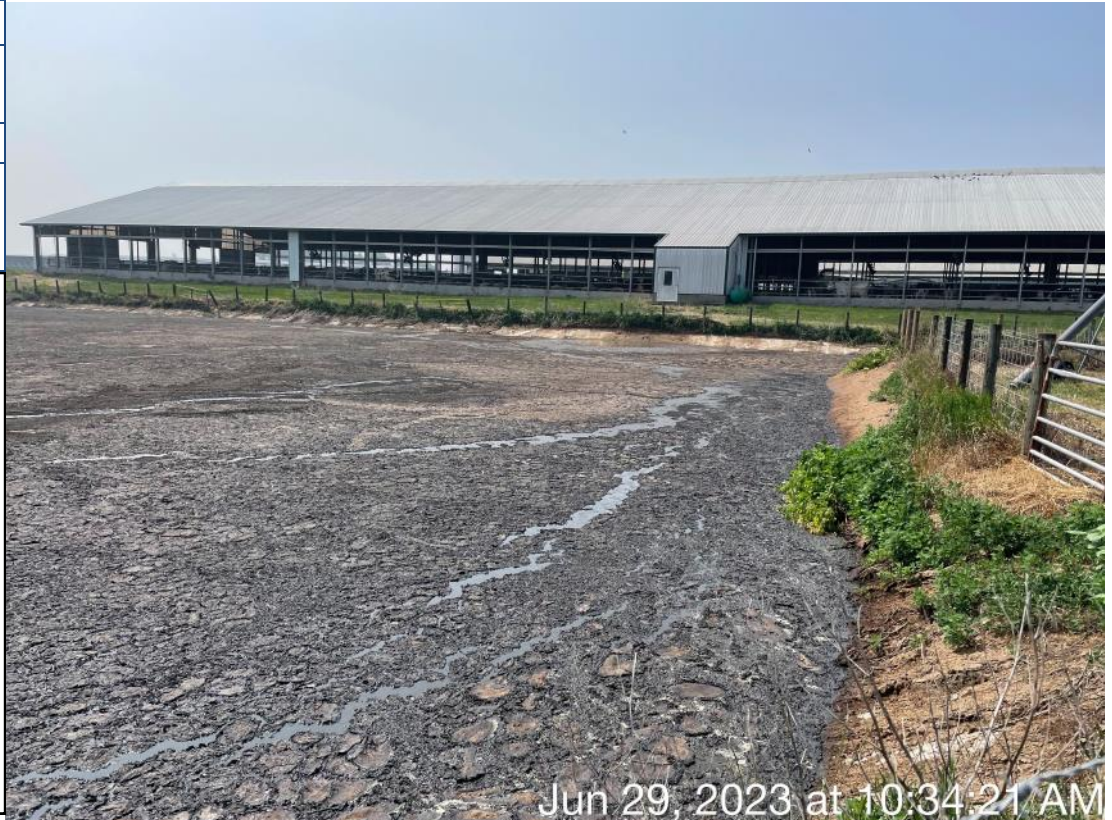
Photo #:	6742
Date/Time of Photo:	6/29/2023 10:34
Photo By:	Brian Hanson
Photo Location:	WSF #1
Photo Description:	Standing at the northwest corner of WSF #1 looking south: View of west edge of WSF #2.

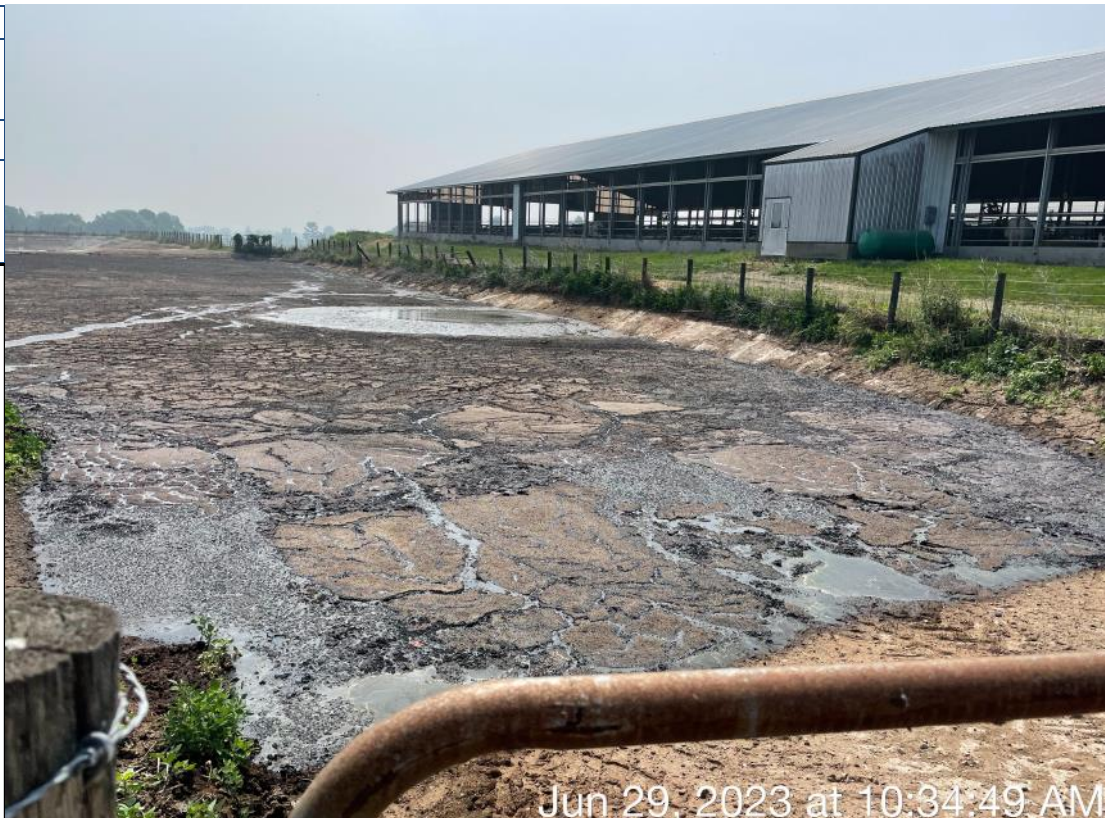
Photo #:	6744
Date/Time of Photo:	6/29/2023 10:34
Photo By:	Brian Hanson
Photo Location:	WSF #1
Photo Description:	Standing on the west side of WSF #1 looking east: View of southwest corner of WSF #1 at access ramp. Ramp used to aid in sand & solids removal.

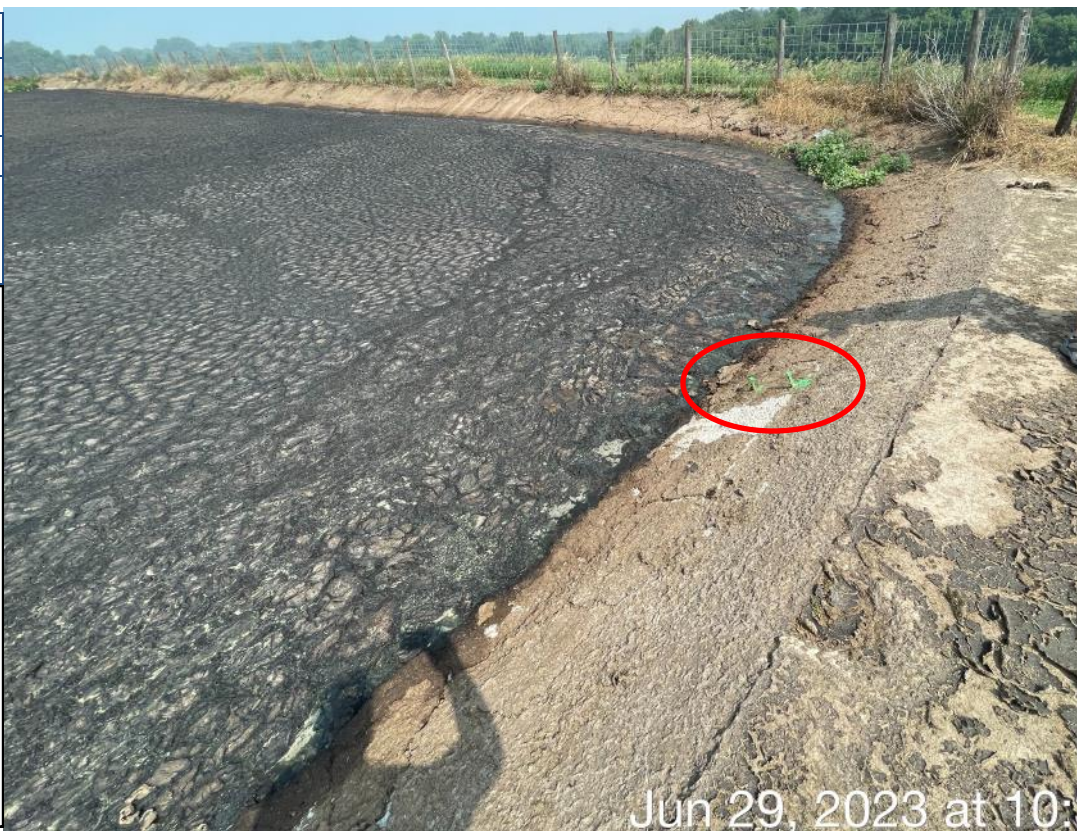
Photo #:	6734
Date/Time of Photo:	6/29/2023 10:32
Photo By:	Brian Hanson
Photo Location:	WSF #1

Photo Description:
Standing on east side of WSF #1 looking northwest: View of permanent markers in WSF #1. Metal rebar embedded in concrete & painted green.

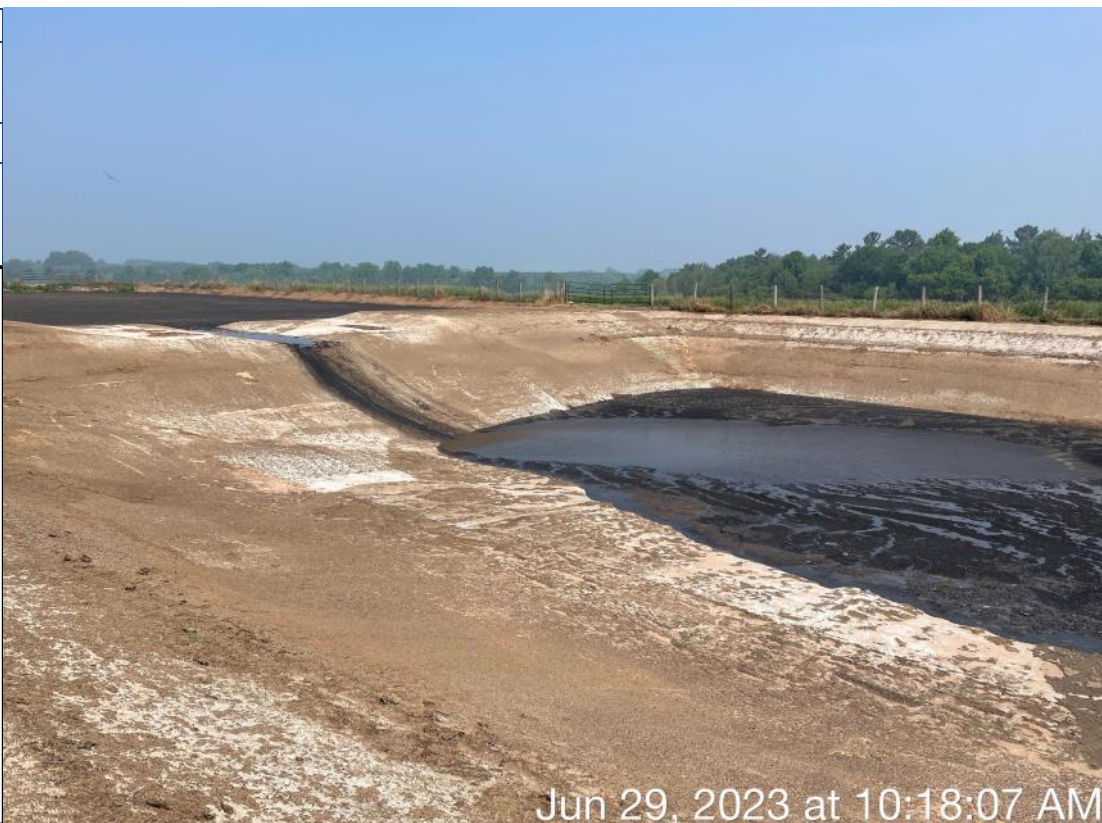
Photo #:	6702
Date/Time of Photo:	6/29/2023 10:18
Photo By:	Brian Hanson
Photo Location:	WSF #2

Photo Description:
Standing on the south side of WSF #2 looking northwest: View of western edge of WSF #2. Notice manure entering the facility via concrete overflow channel from WSF #1.

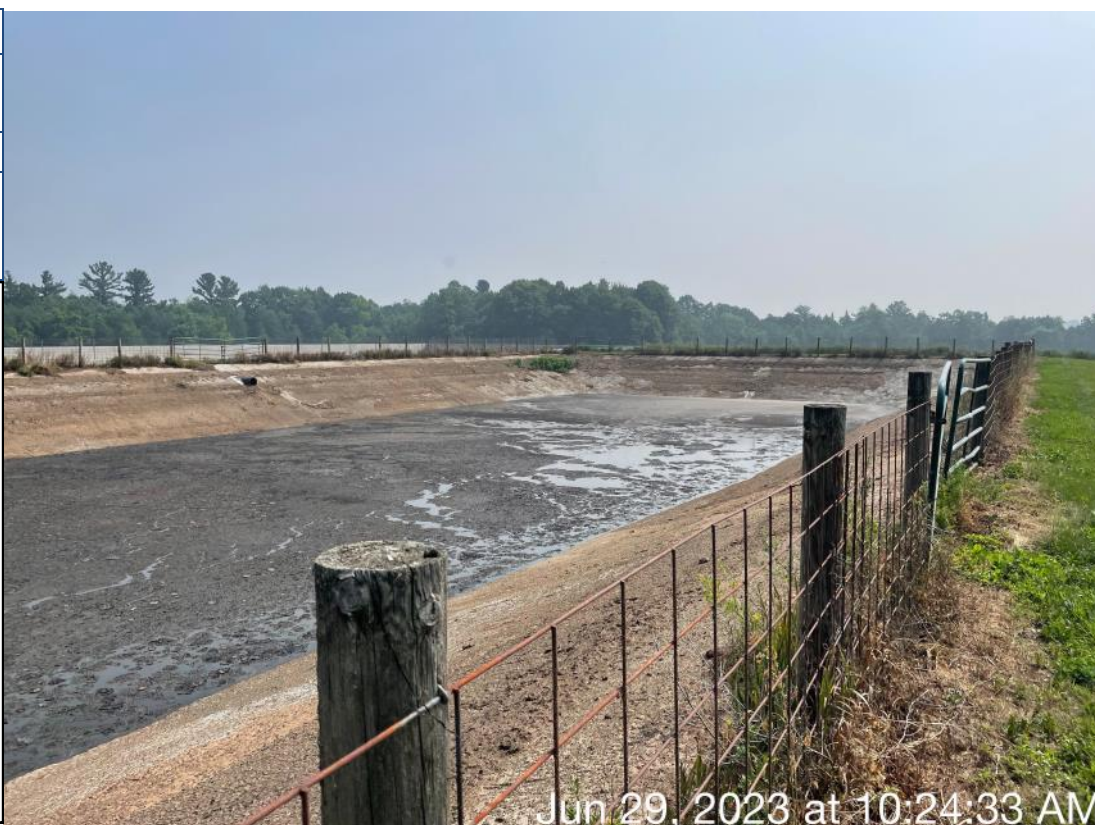
Photo #:	6705
Date/Time of Photo:	6/29/2023 10:24
Photo By:	Brian Hanson
Photo Location:	WSF #2

Photo Description:
Standing on the south side of WSF #2 looking northeast: View of east half of WSF #2.

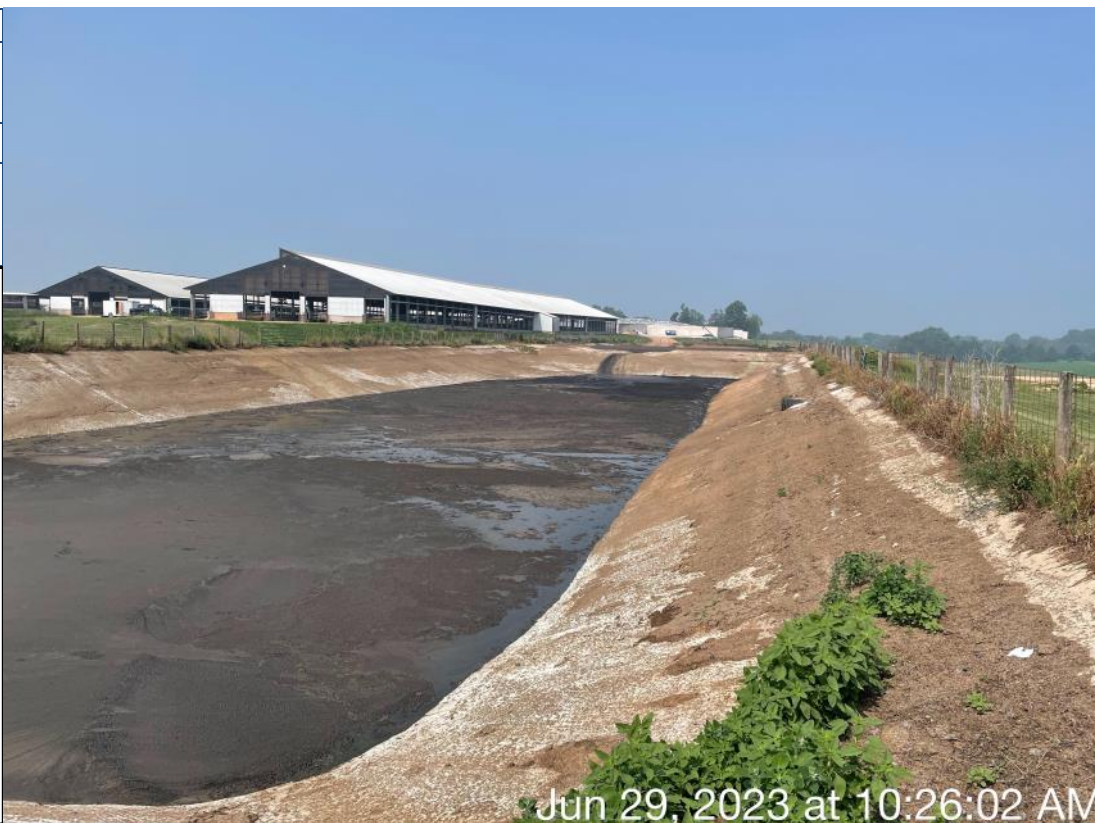
Photo #:	6711
Date/Time of Photo:	6/29/2023 10:26
Photo By:	Brian Hanson
Photo Location:	WSF #2

Photo Description:
Standing at the northeast corner of WSF #2 looking west: View of northeast corner of WSF #2.

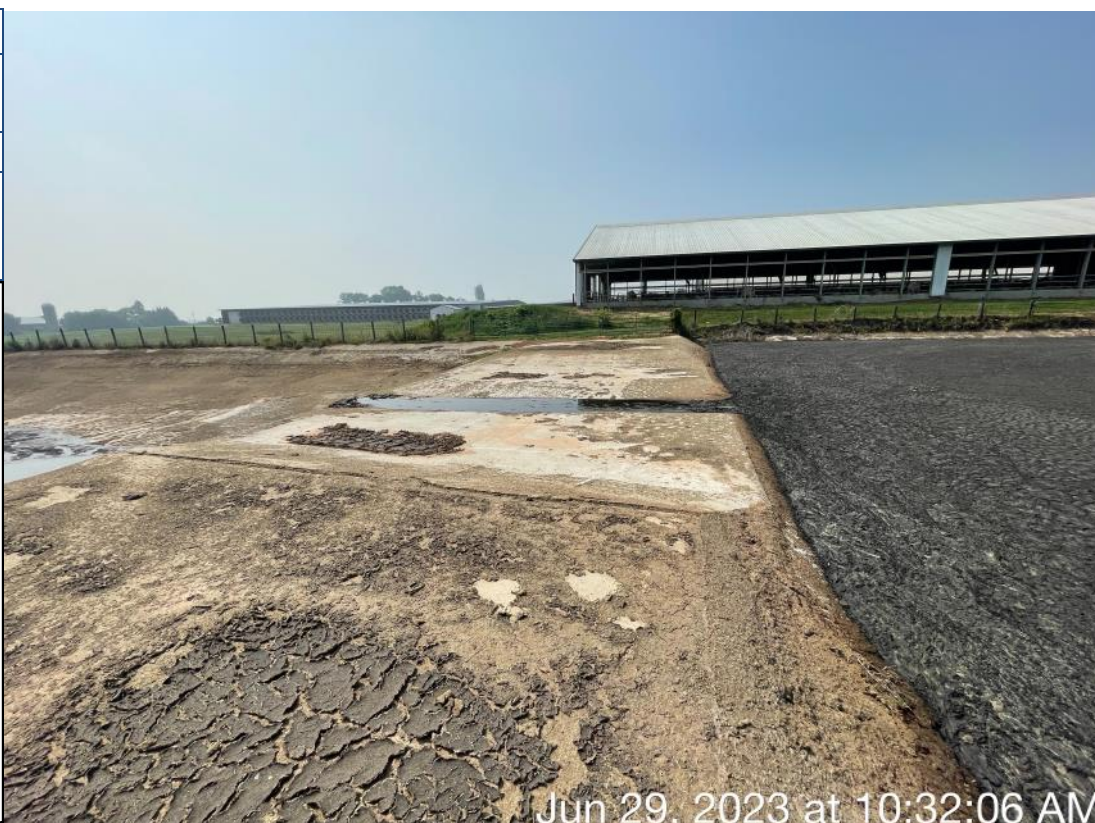
Photo #:	6732
Date/Time of Photo:	6/29/2023 10:32
Photo By:	Brian Hanson
Photo Location:	WSF #1 & WSF #2

Photo Description:
Standing on the concrete berm separating WSF #1 & WSF #2 looking south: View of concrete overflow channel used to connect the 2 facilities.

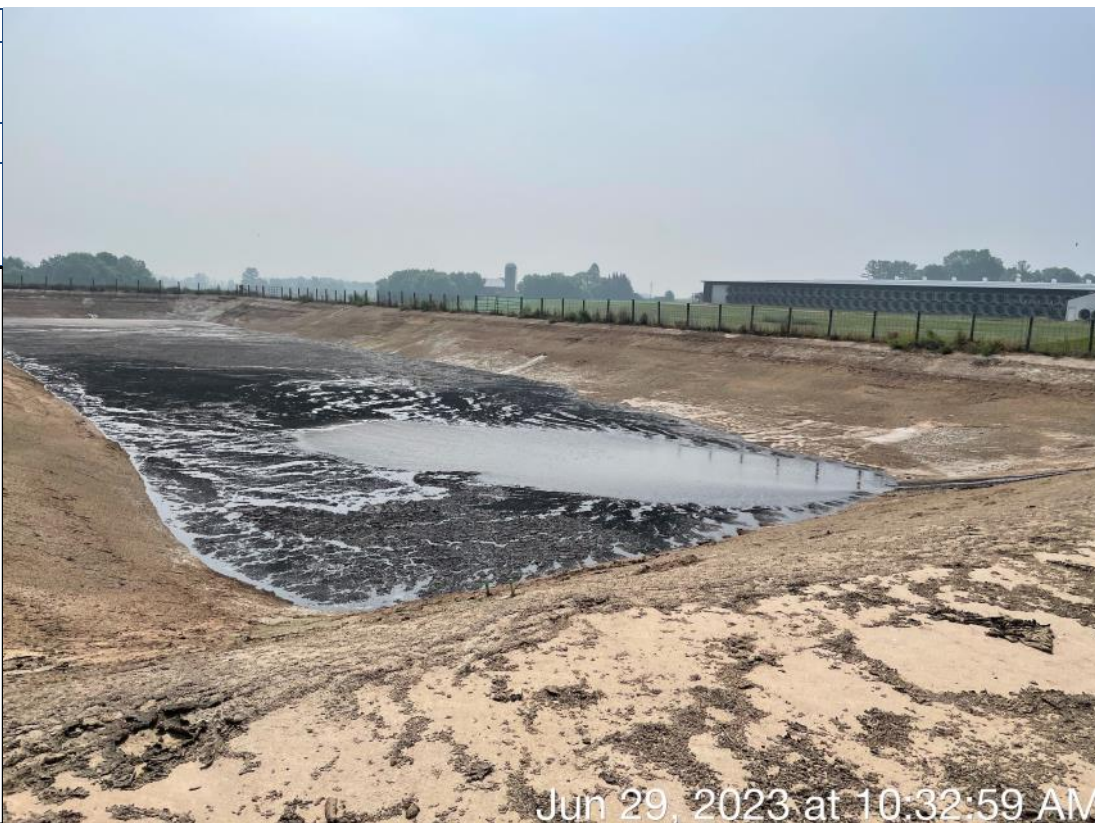
Photo #:	6738
Date/Time of Photo:	6/29/2023 10:32
Photo By:	Brian Hanson
Photo Location:	WSF #2

Photo Description:
Standing on the west side of WSF #2 looking southeast: View of west 1/2 of WSF #2.

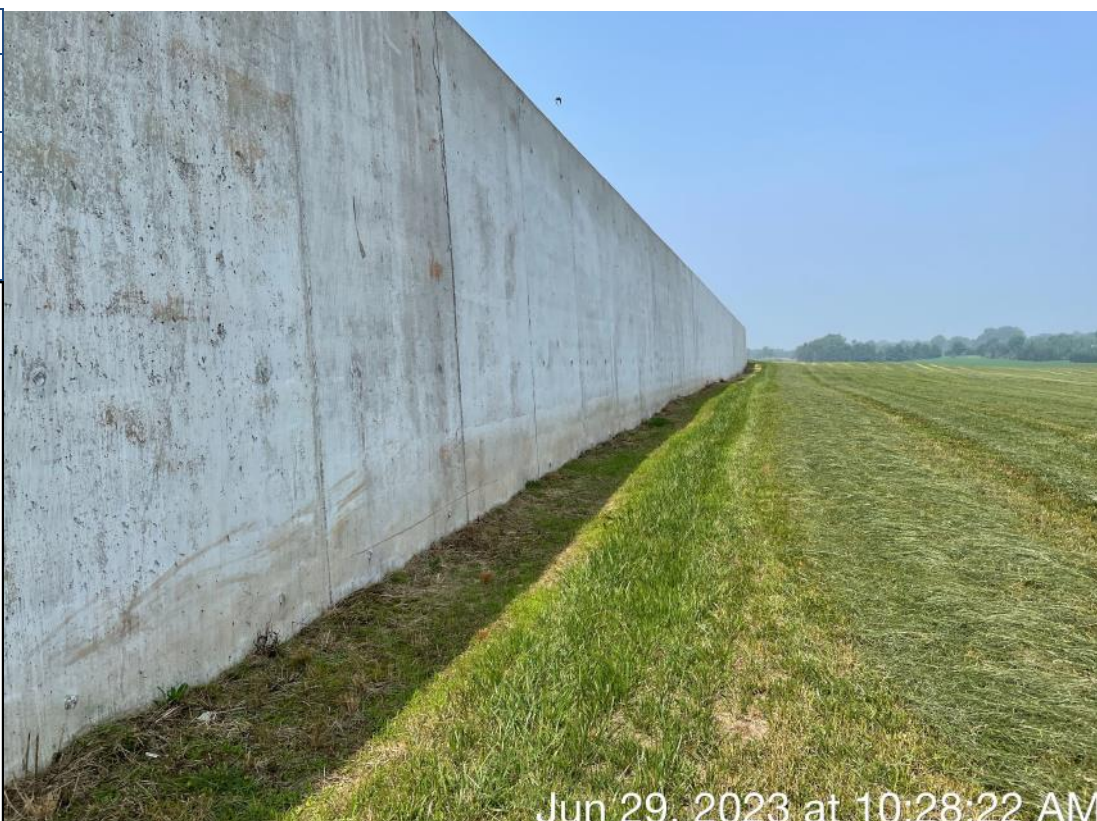
Photo #:	6719
Date/Time of Photo:	6/29/2023 10:28
Photo By:	Brian Hanson
Photo Location:	WSF #3
Photo Description:	Standing on the north side of WSF #3 looking west: View of wall exterior of WSF #3. A few minor hairline cracks visible, but no leaking of manure present.

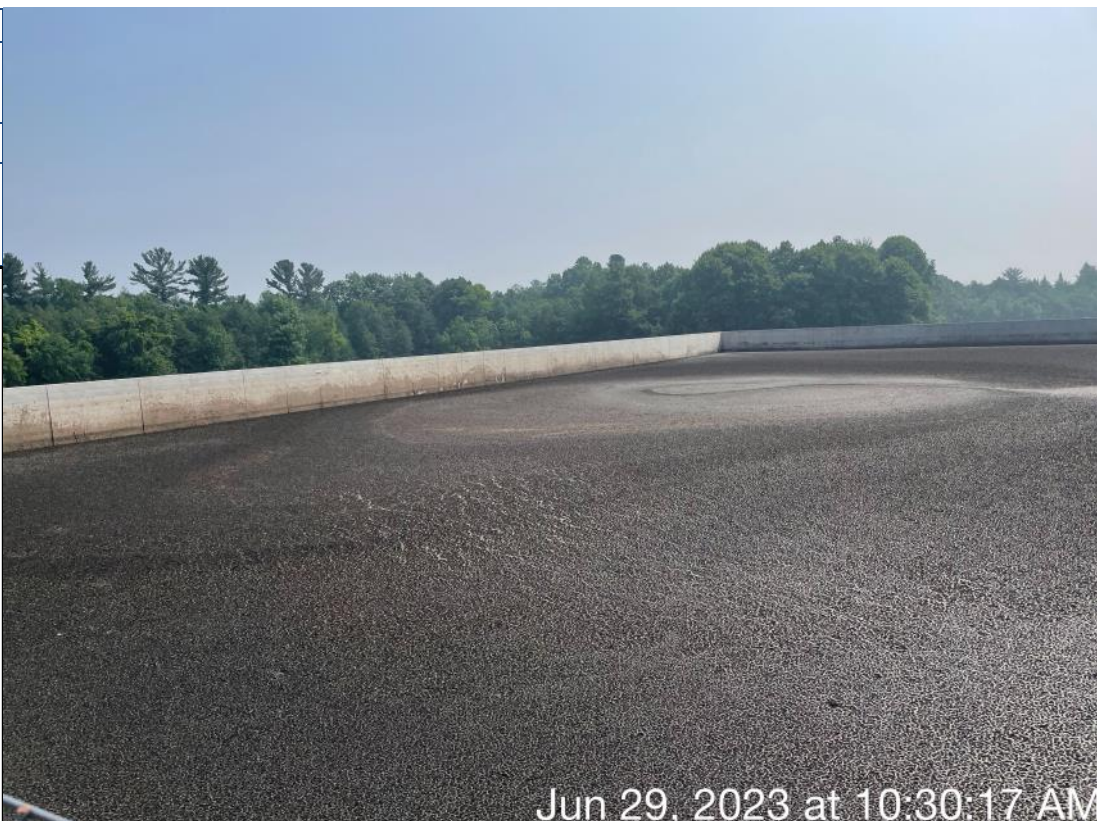
Photo #:	6721
Date/Time of Photo:	6/29/2023 10:30
Photo By:	Brian Hanson
Photo Location:	WSF #3
Photo Description:	Standing on the south side of WSF #3 looking northeast: View of center section of WSF #3.

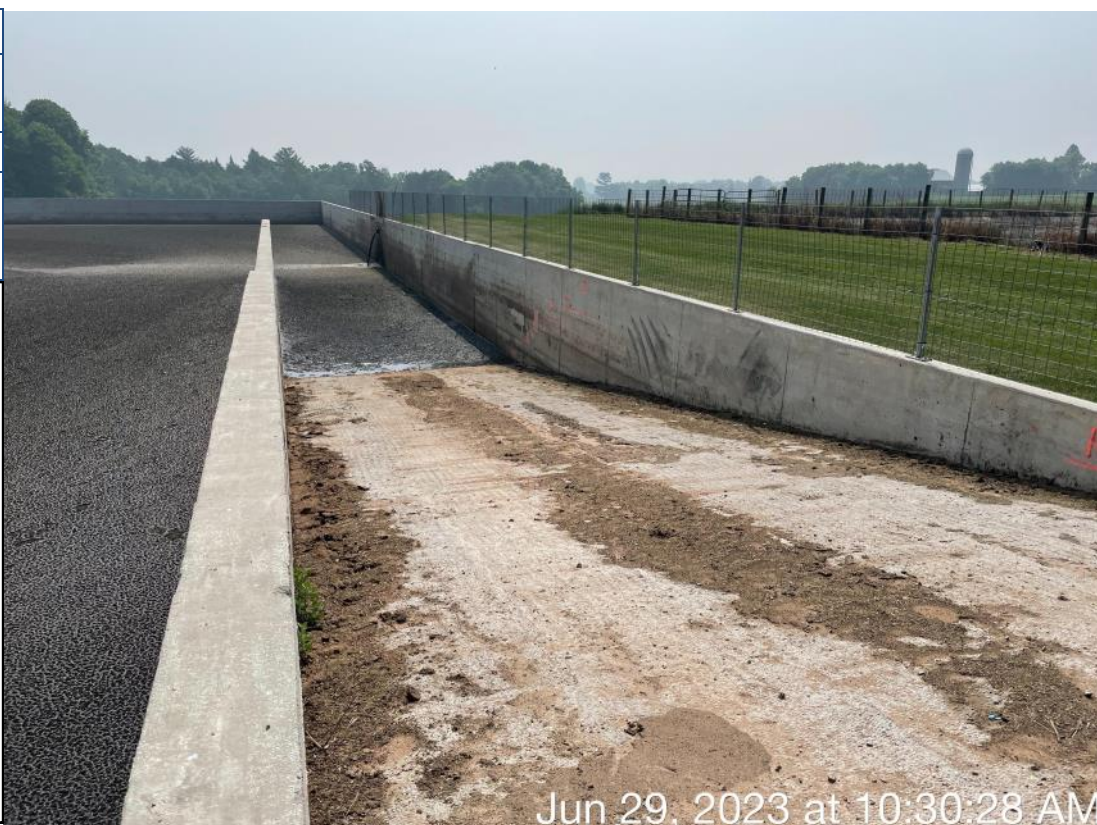
Photo #:	6724
Date/Time of Photo:	6/29/2023 10:30
Photo By:	Brian Hanson
Photo Location:	WSF #3
Photo Description:	Standin at the southwest corner of WSF #3 looking east: View of concrete access ramp in Southwest corner of WSF #3 used to aid in the removal of sand & other solids.

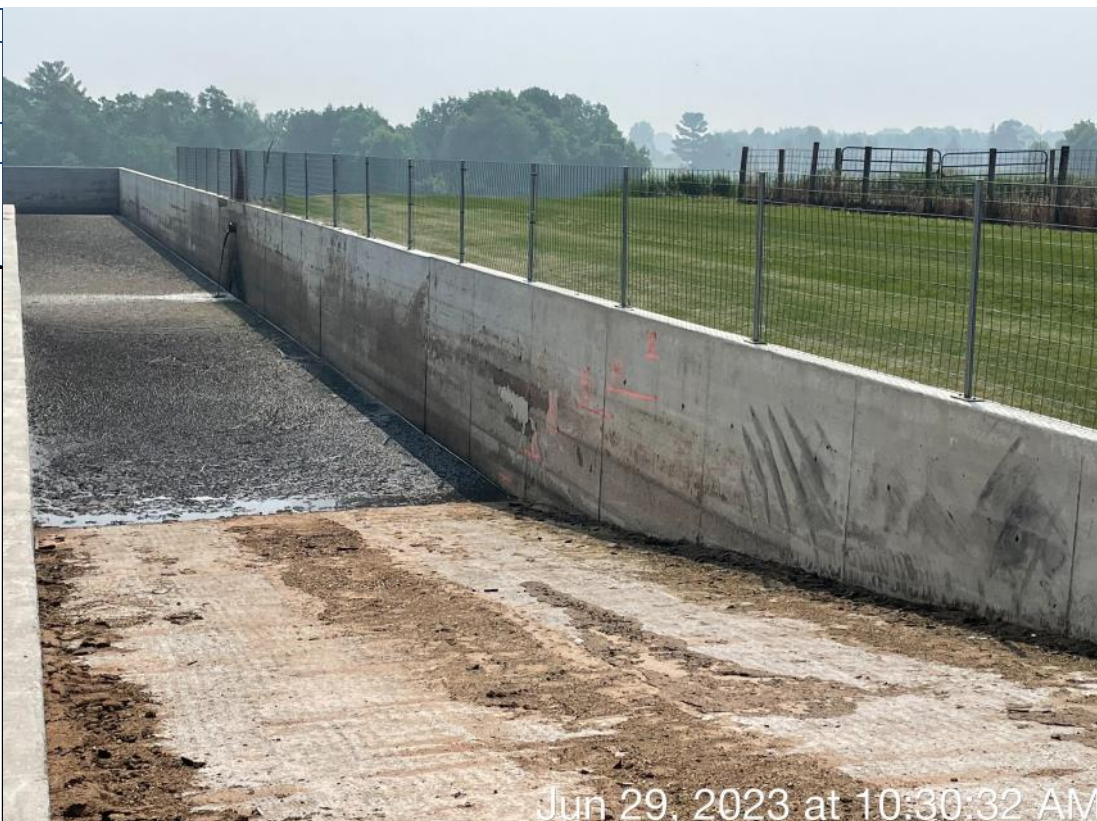
Photo #:	6726
Date/Time of Photo:	6/29/2023 10:30
Photo By:	Brian Hanson
Photo Location:	WSF #3
Photo Description:	Close up view of depth markers painted on access ramp wall used by farm to measure waste depth.

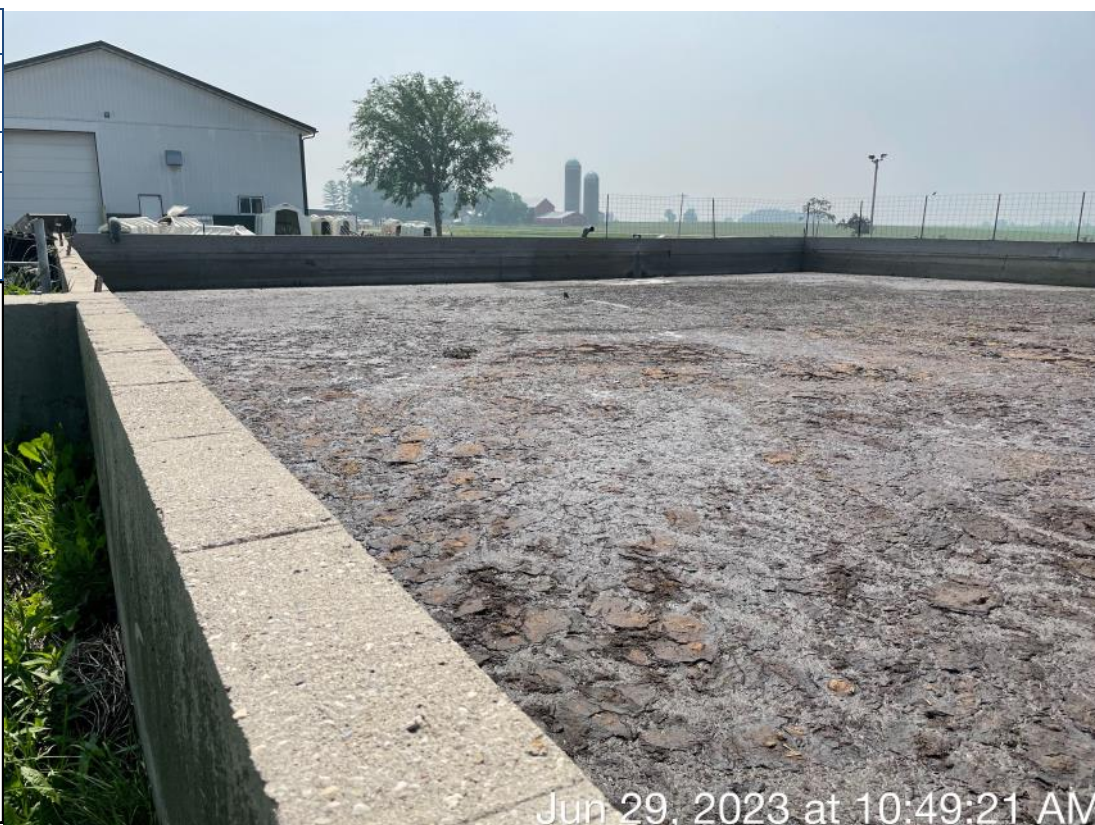
Photo #:	6798
Date/Time of Photo:	6/29/2023 10:49
Photo By:	Brian Hanson
Photo Location:	Heifer Pit

Standing on the north side of the Heifer Pit looking east: View of the north wall of the heifer pit. No visible signs of leakage.

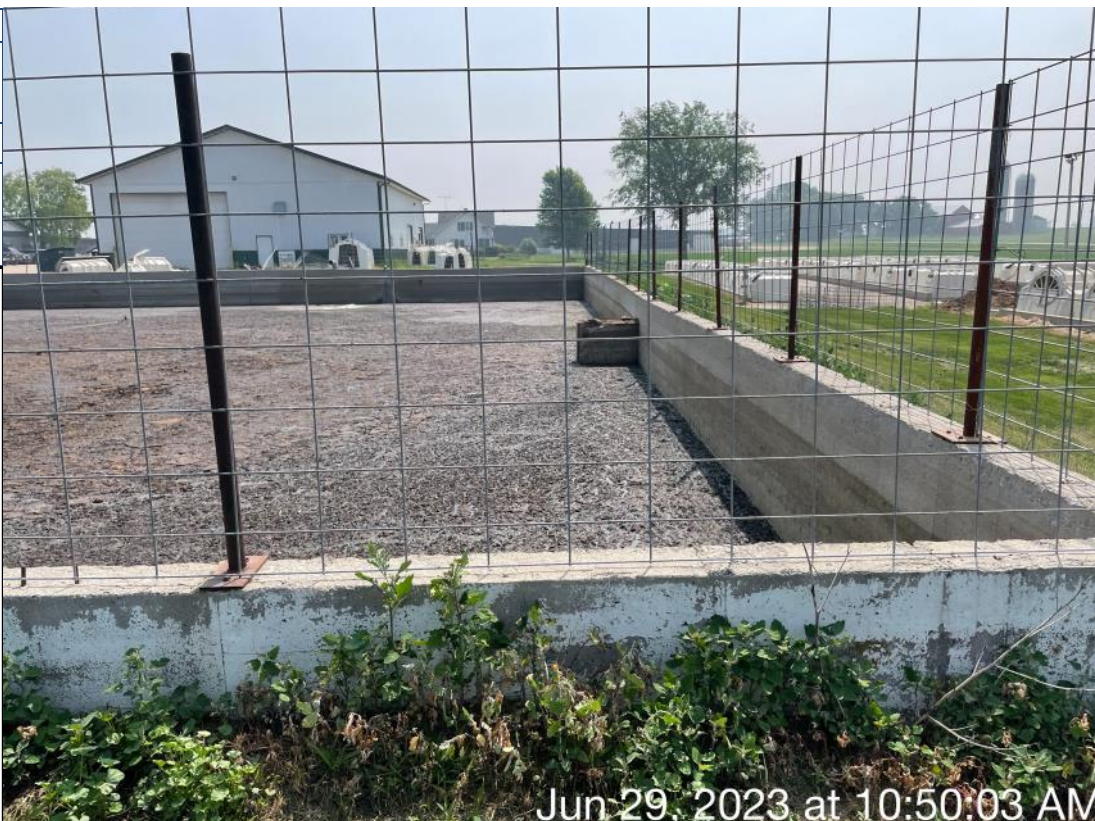
Photo #:	6801
Date/Time of Photo:	6/29/2023 10:50
Photo By:	Brian Hanson
Photo Location:	Heifer Pit

Standing on the west side of the Heifer Pit looking east: View of south wall of Heifer Pit.

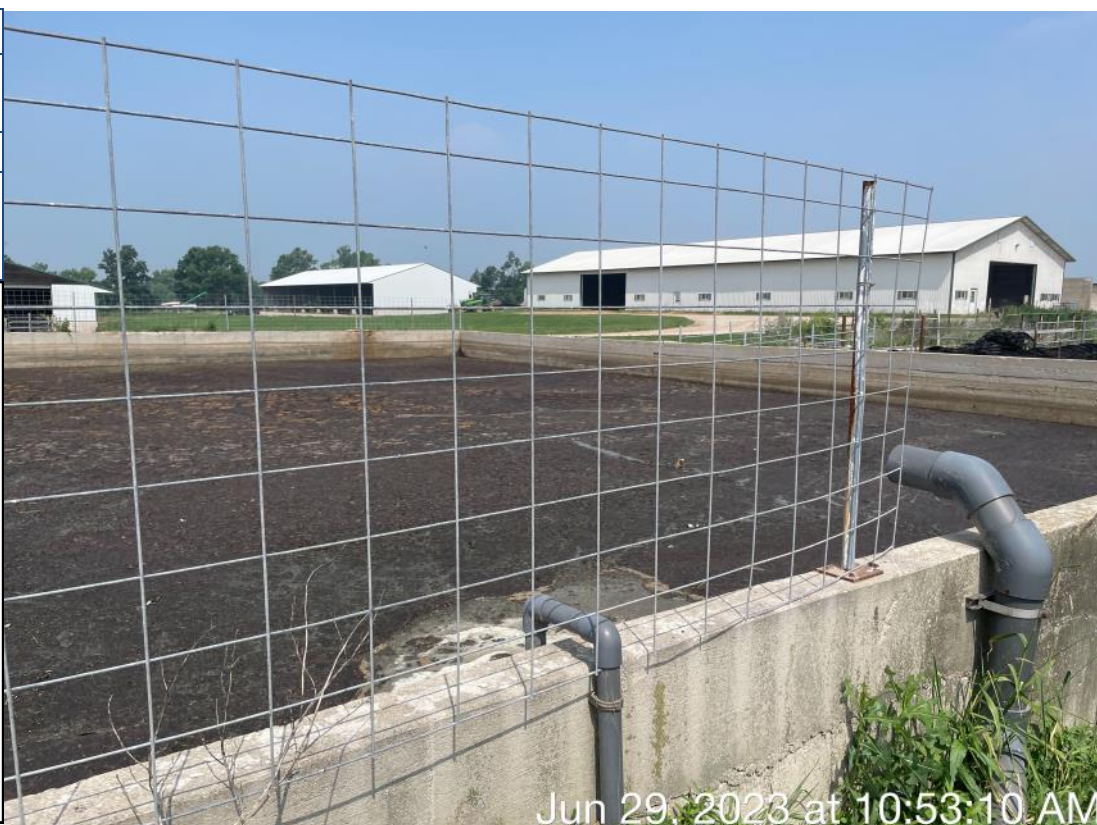
Photo #:	6828
Date/Time of Photo:	6/29/2023 10:53
Photo By:	Brian Hanson
Photo Location:	Heifer Pit
Photo Description:	Standing on the east side of Heifer Pit looking northwest: View of calf hutch area runoff control outlet pipe.

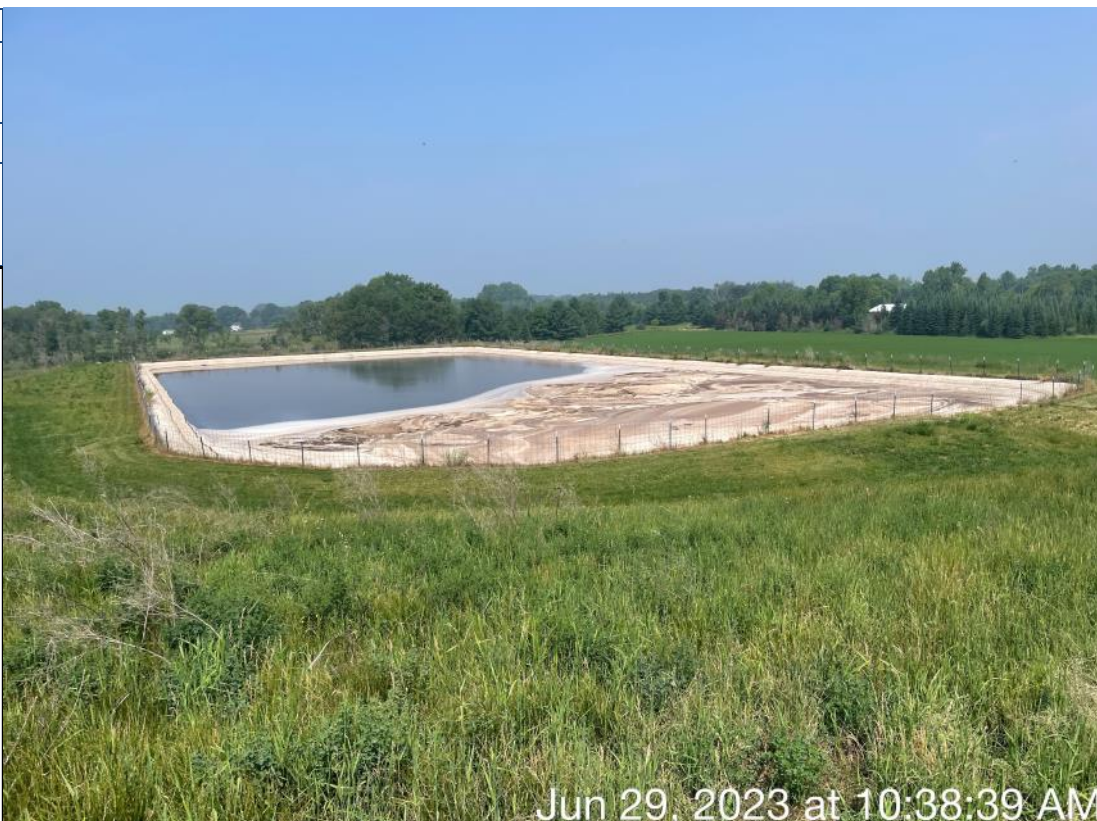
Photo #:	6759
Date/Time of Photo:	6/29/2023 10:38
Photo By:	Brian Hanson
Photo Location:	Leachate Pit
Photo Description:	Standing at the northwest corner of Feed Storage Area looking northwest: General view of Leachate Pit.

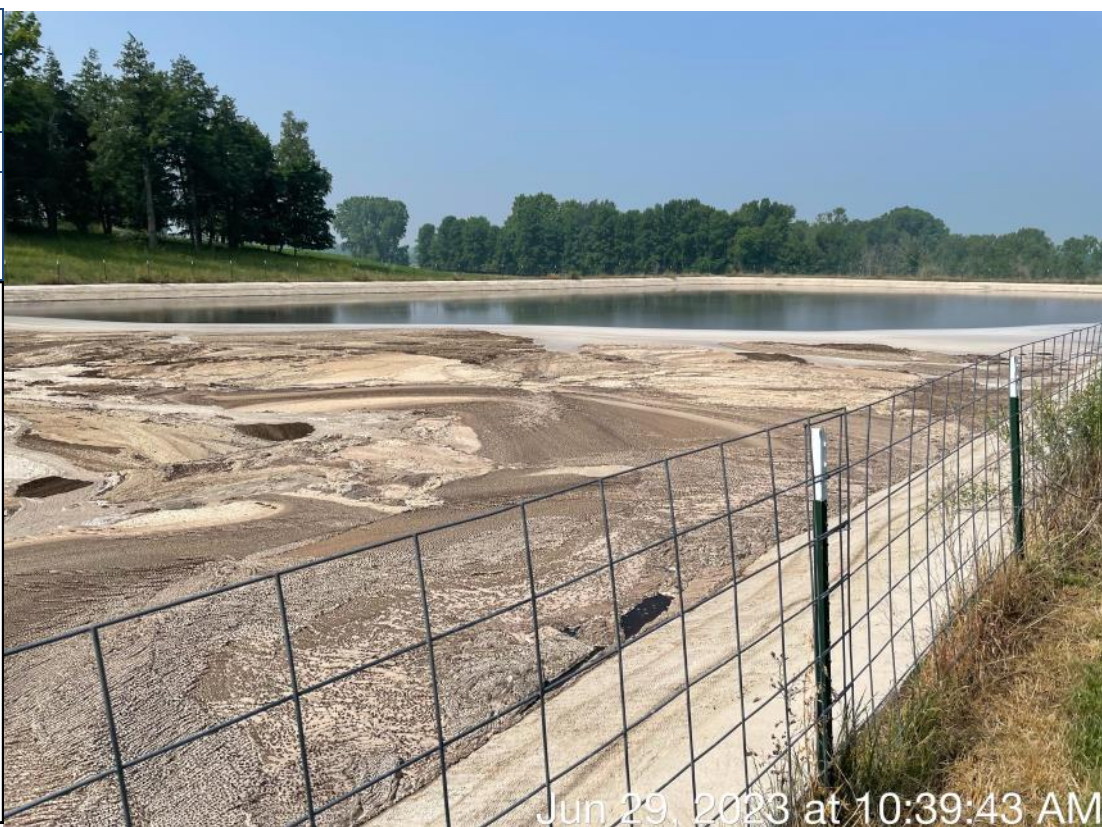
Photo #:	6764
Date/Time of Photo:	6/29/2023 10:39
Photo By:	Brian Hanson
Photo Location:	Leachate Pit
Photo Description:	Standin on the south side of Leachate Pit looking northeast: View of southwest corner of leachate pit. Water was dark brown in color and had a whitish brown film floating on top.
