Permit Fact Sheet

Permit Number:	WI-0066494-02-0
Permittee Name:	Horsens Homestead Farms, LLC
Address:	W1980 County Road C
City/State/Zip:	Cecil WI 54111
Discharge Location:	W1980 County Road C, Cecil, WI 54111 ; SW ¼ of SW ¼ Section 5, T27N, R18E
Receiving Water:	Unnamed tributaries of the Oconto River within the Oconto River Watershed, and groundwaters of the state
Discharge Type:	Existing

On Thursday June 29, 2023 Hanson & Arnoldi met with Horsens & Horsens at 10:00 at Horsens Homestead Farms LLC site to conduct a permit reissuance walkover inspection. The only site in the permit & inspected was the main farm. No liquid precipitation had fallen recently and the temperature was in the 80's and sunny. No permit violations were observed, and no water samples were collected. Hanson & Arnoldi departed at approximately 11:15.

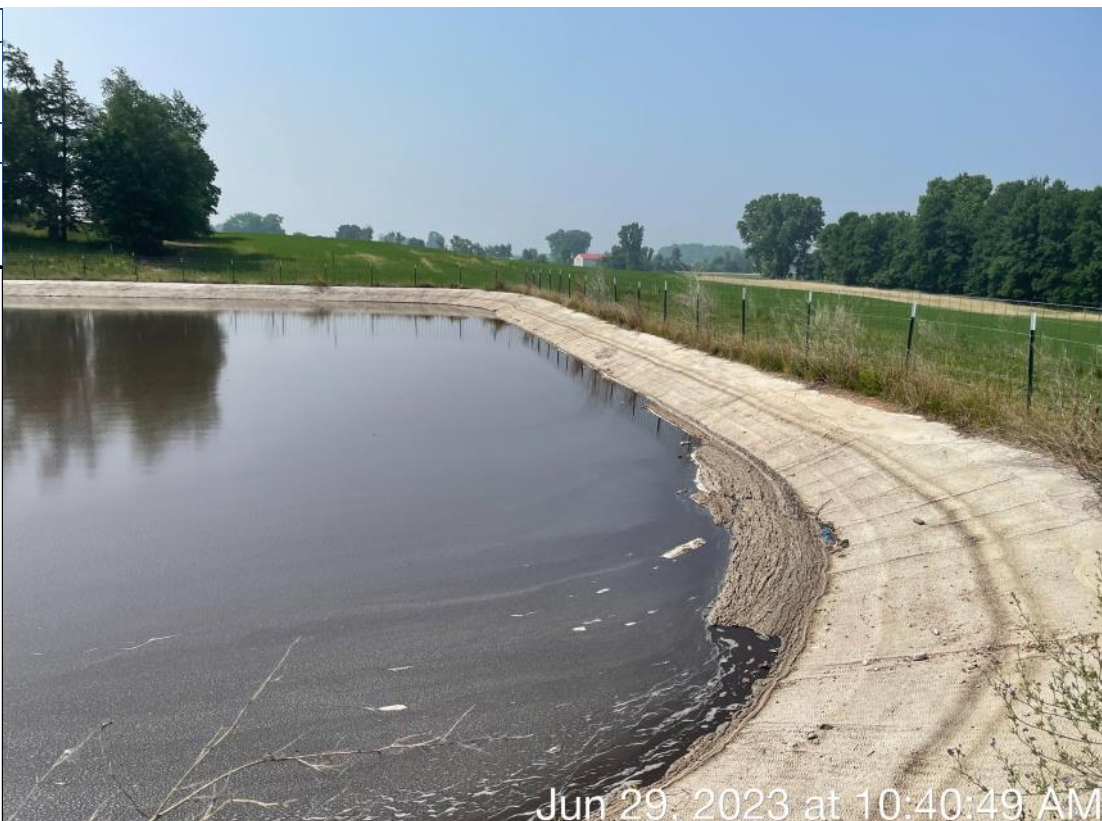
Photo #:	6767
Date/Time of Photo:	6/29/2023 10:40
Photo By:	Brian Hanson
Photo Location:	Leachate Pit
Photo Description:	Standing at northwest corner of Leachate Pit looking south: View of western edge of Leachate Pit.

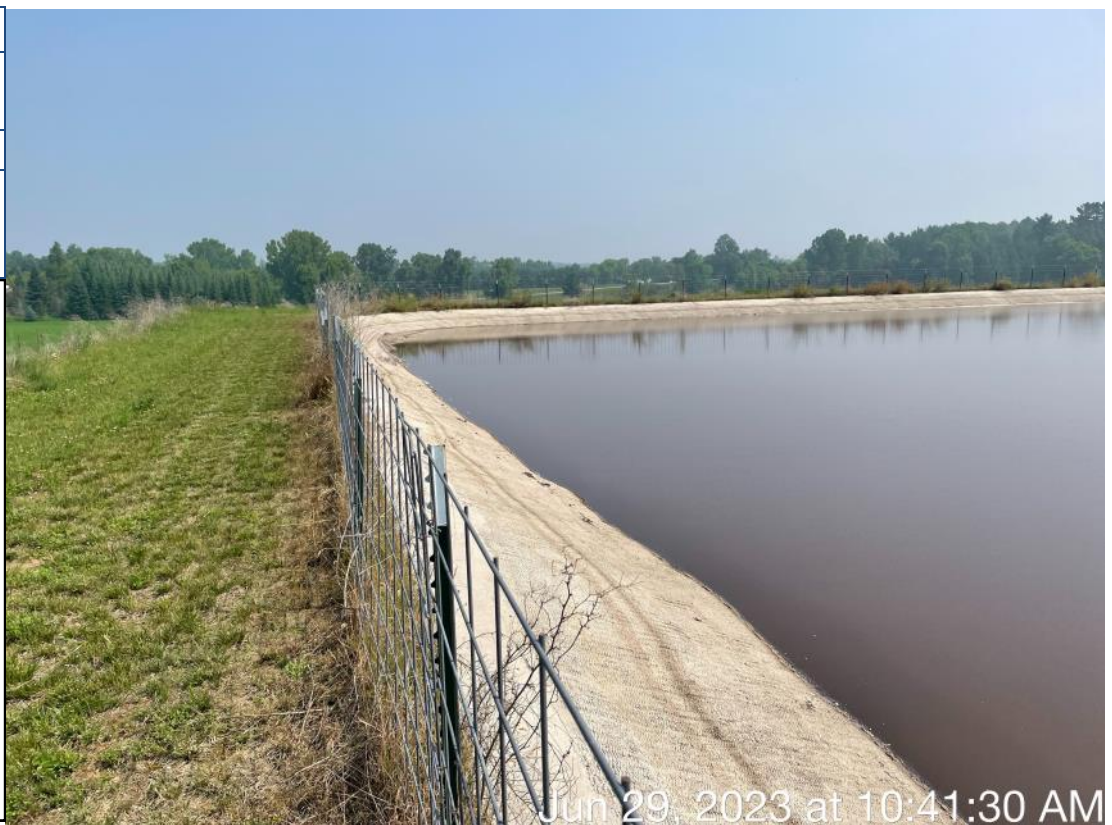
Photo #:	6771
Date/Time of Photo:	6/29/2023 10:41
Photo By:	Brian Hanson
Photo Location:	Leachate Pit
Photo Description:	
Standing on the south side of Leachate Pit looking west: View of southern edge of Leachate Pit.

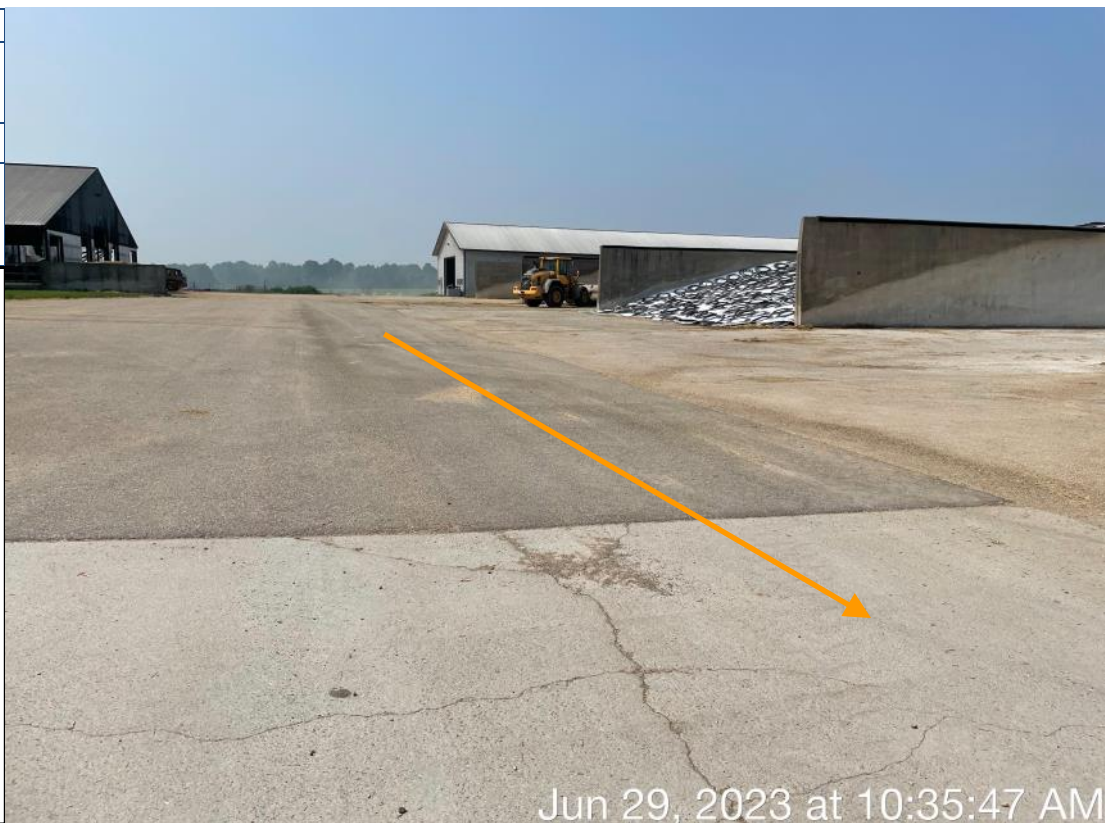
Photo #:	6746
Date/Time of Photo:	6/29/2023 10:35
Photo By:	Brian Hanson
Photo Location:	Feed Storage Area (FSA)
Photo Description:	
Standing on the east side of the FSA looking south: View of the east edge of the feed storage area. Arrow indicated direction of runoff flow.

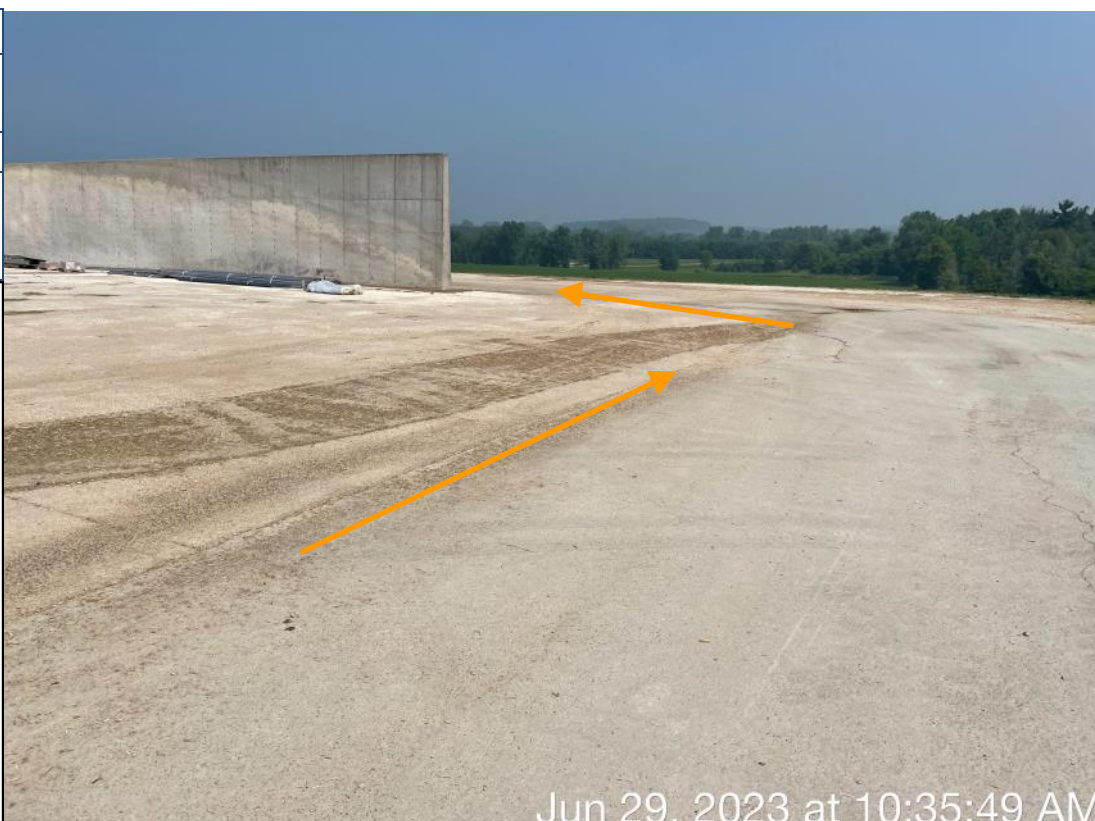
Photo #:	6747
Date/Time of Photo:	6/29/2023 10:35
Photo By:	Brian Hanson
Photo Location:	Feed Storage Area
Photo Description:	Standing on the east side of the FSA looking north: View of east side of FSA where runoff controls divert flow to the north side of the FSA. Arrows indicate direction of runoff flow.

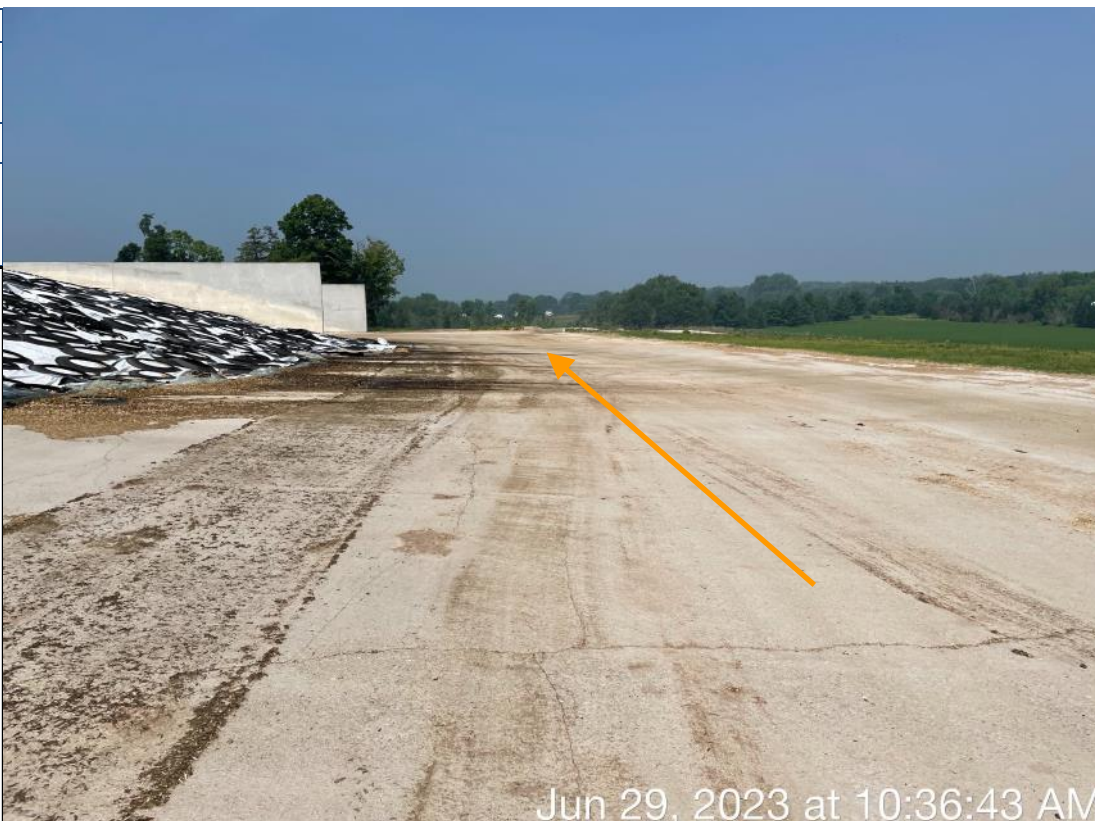
Photo #:	6750
Date/Time of Photo:	6/29/2023 10:36
Photo By:	Brian Hanson
Photo Location:	Feed Storage Area
Photo Description:	Standing on the north side of FSA looking west: View of north edge of FSA that acts as runoff collection channel.

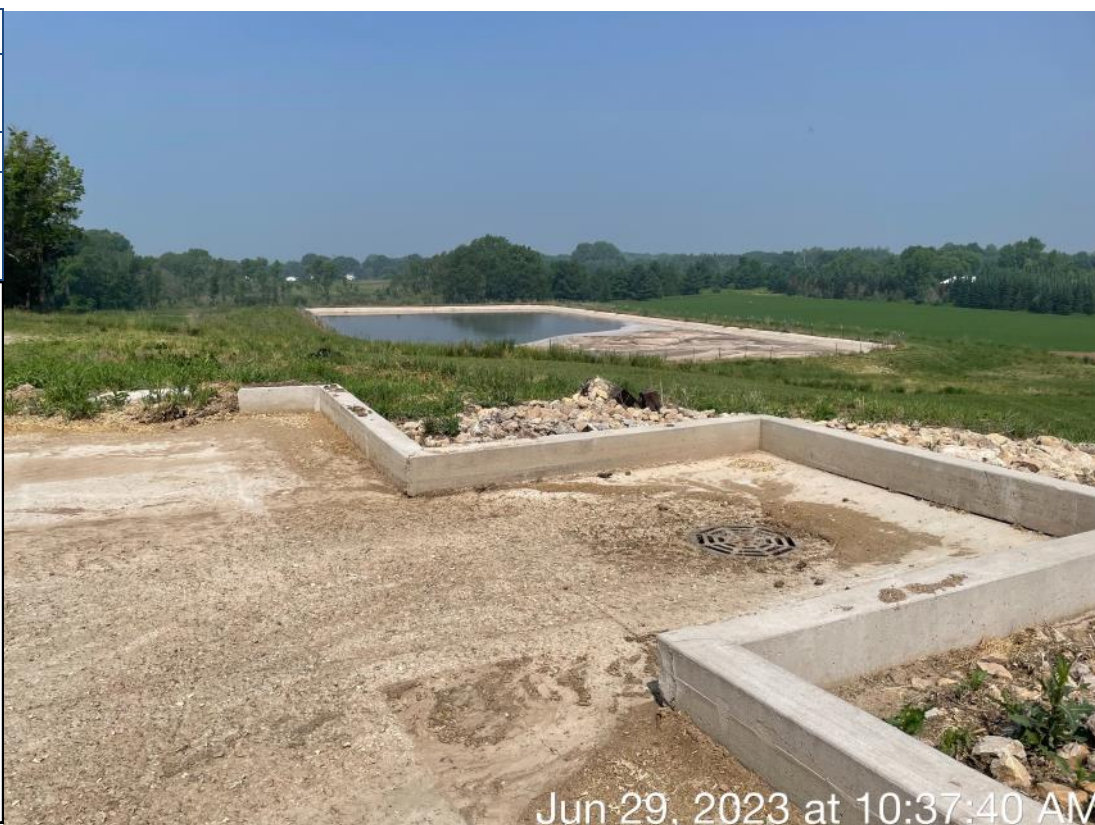
Photo #:	6756
Date/Time of Photo:	6/29/2023 10:37
Photo By:	Brian Hanson
Photo Location:	Feed Storage Area

Photo Description:
Standing at the northwest corner of FS looking northwest: View of runoff collection inlet grate located in northwest corner of FSA. Runoff enters this grate and gravity-flows to Leachate Pit located in the background.

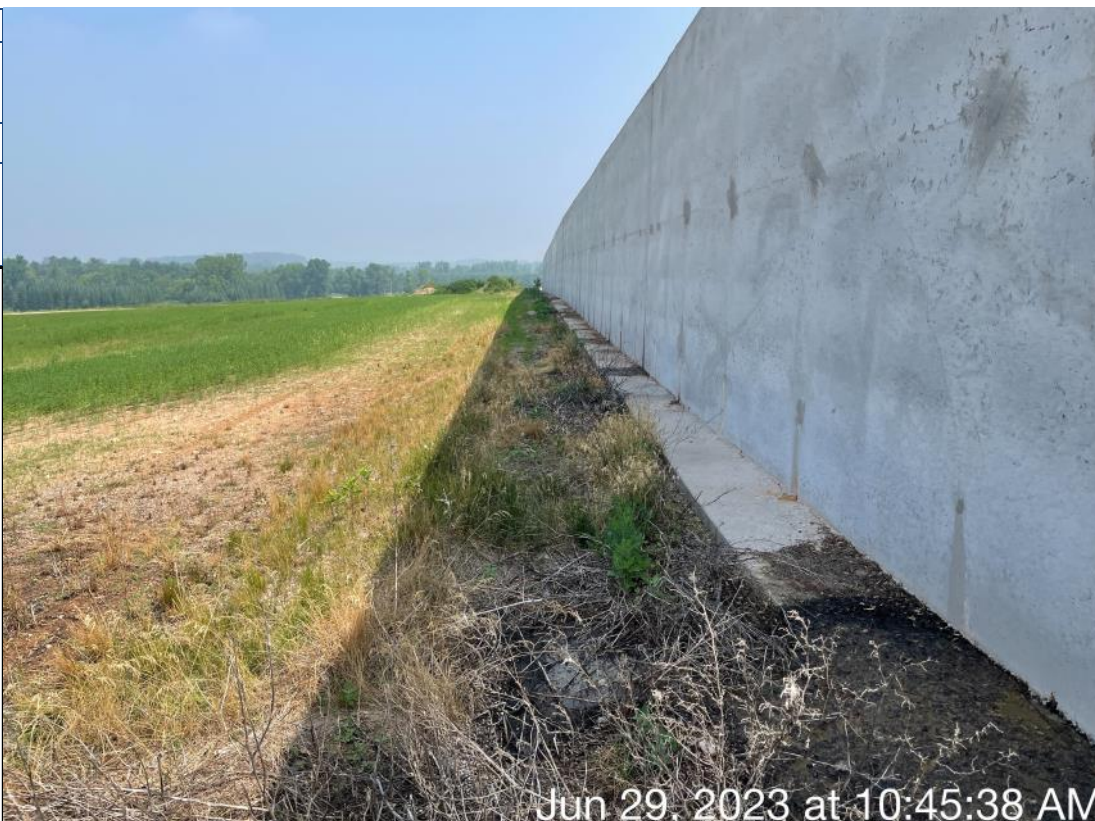
Photo #:	6786
Date/Time of Photo:	6/29/2023 10:45
Photo By:	Brian Hanson
Photo Location:	Feed Storage Area

All feed storage areas (FSA) and runoff controls are located at the Main Dairy and located in the northwest corner of the production area. Surface drainage of leachate and runoff is directed to a centralized collection point at the northwest corner of the FSA which gravity-flows to the Leachate Pond. There is also a perimeter drain system (gravel french drain) used to collect any leachate that seeps through the cracks of the bunker walls along the western wall. This system was evident on the west side of the FSA and appeared to be collecting all leachate. Operation and maintenance is required to make sure gravel drain continues to function as designed. At the time of the inspection there was evidence of leachate that had flowed through the south bunker wall/floor joint and had ponded up in the grass swale between the feed storage area & the shed. According to the farm, this was an older section of the bunker and did not have the perimeter drain which is why the leachate was able to pond up and kill the vegetation.

Photo Description:
Standing on the west side of FSA looking north: View of the exterior of the bunker wall. Notice a few areas of leachate seeping through the floor/wall joint. A gravel drain is installed next to the concrete footer with subsurface drain to collect this leachate. No signs of leachate getting past the gravel into the grassed area.

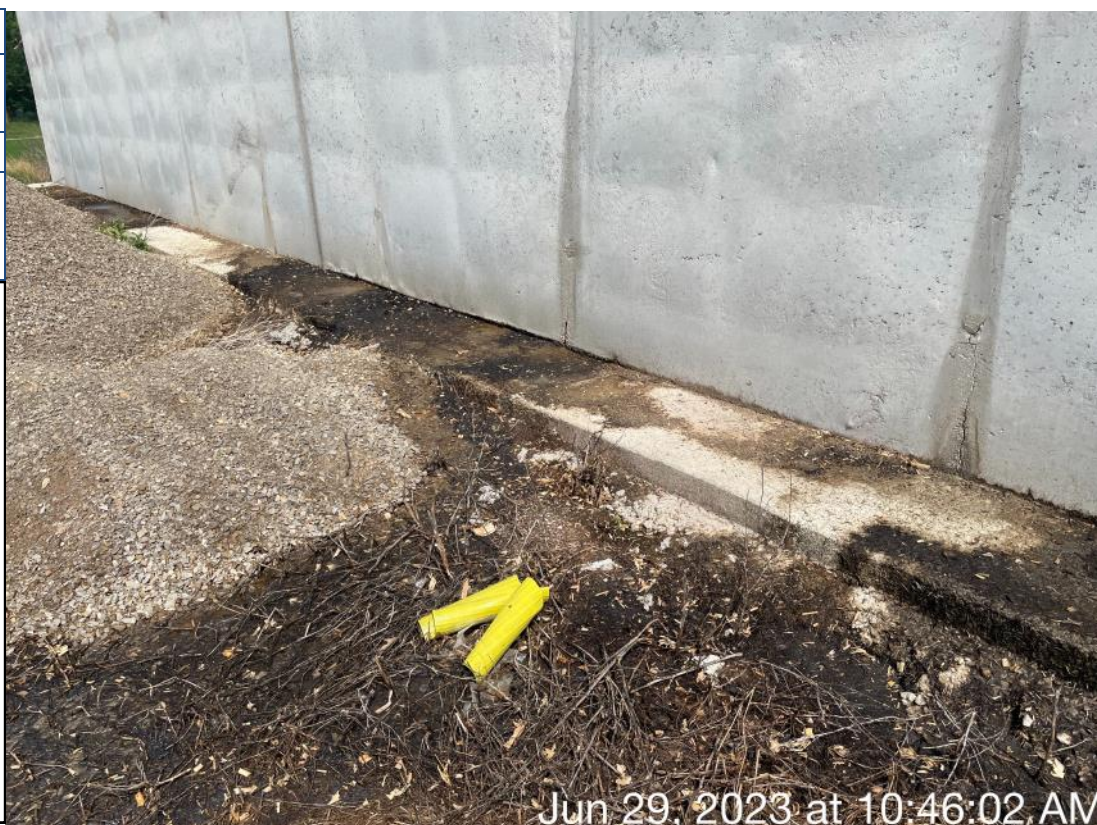
Photo #:	6789
Date/Time of Photo:	6/29/2023 10:46
Photo By:	Brian Hanson
Photo Location:	Feed Storage Area

Photo Description:
 Standing on the south side of FSA looking northwest: View of southwest corner of bunker walls. Leachate also seeping through floor/wall joint in this location. Gravel drain present to collect this leachate.

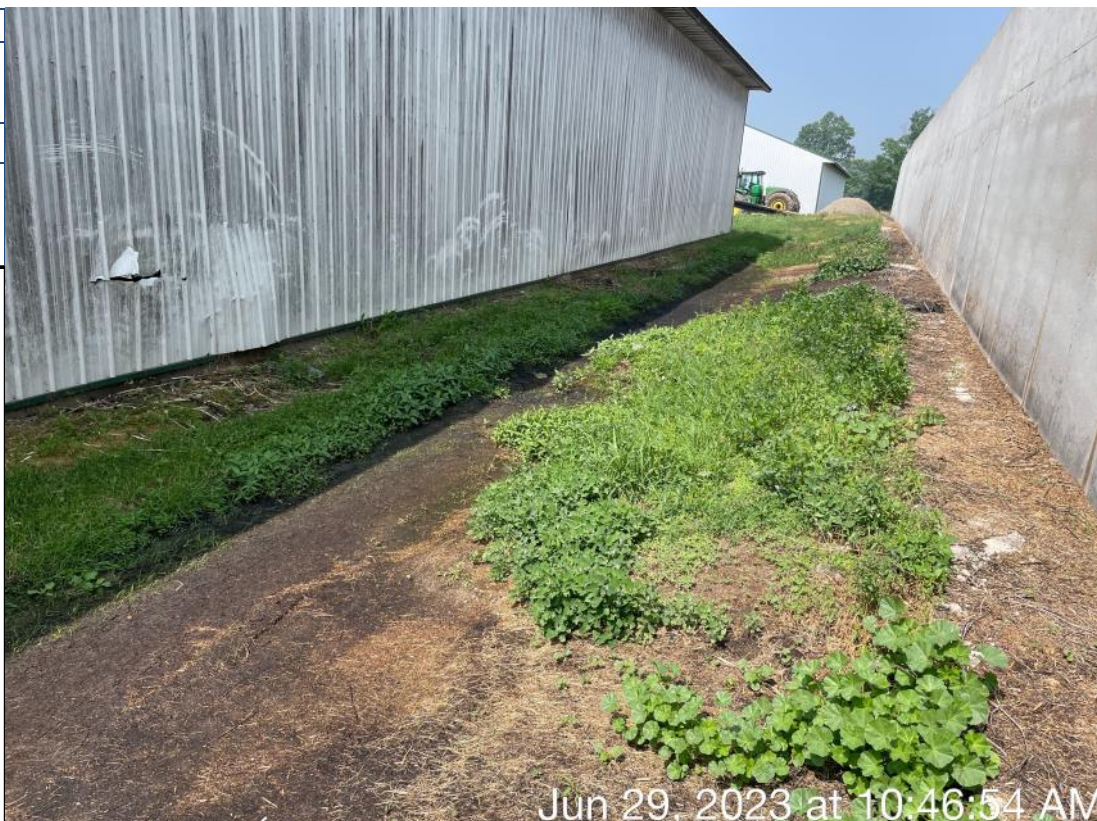
Photo #:	6790
Date/Time of Photo:	6/29/2023 10:46
Photo By:	Brian Hanson
Photo Location:	Feed Storage Area

Photo Description:
 Standing on the south side of FSA looking west: View of south side of FSA bunker wall. This is one of the older bunker and does not have a gravel drain to collect leachate. Notice leachate had ponded in stormwater channel and killed the vegetation. Not actively flowing due to bunker being empty.

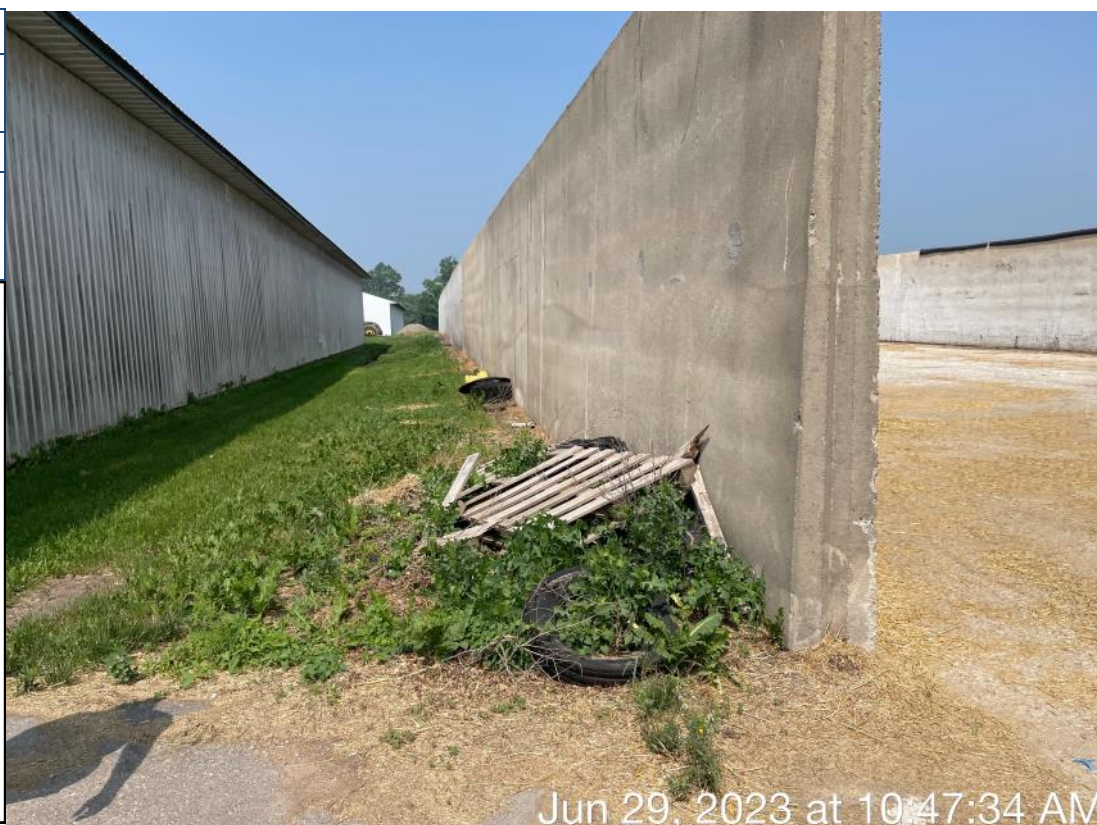
Photo #:	6791
Date/Time of Photo:	6/29/2023 10:47
Photo By:	Brian Hanson
Photo Location:	Feed Storage Area

Photo Description:
 Standing at the southeast corner of the FSA looking west: View of stormwater channel just east of previous picture. No sign of leachate or dead vegetation at this location.

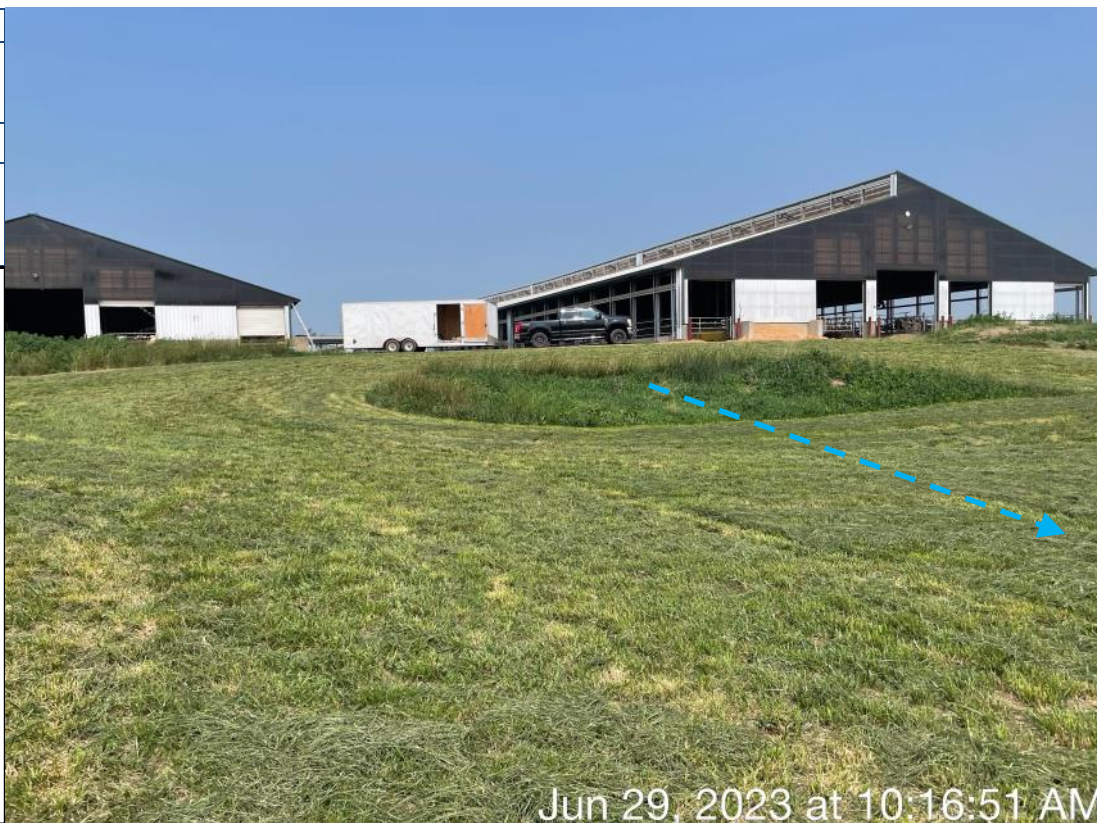
Photo #:	6697
Date/Time of Photo:	6/29/2023 10:16
Photo By:	Brian Hanson
Photo Location:	Storm Water

Photo Description:
 Standing north of the robot barn looking west" View of culvert outlets carrying stormwater from Freestall #1 & #2 out to crop field. Area is well-vegetated.

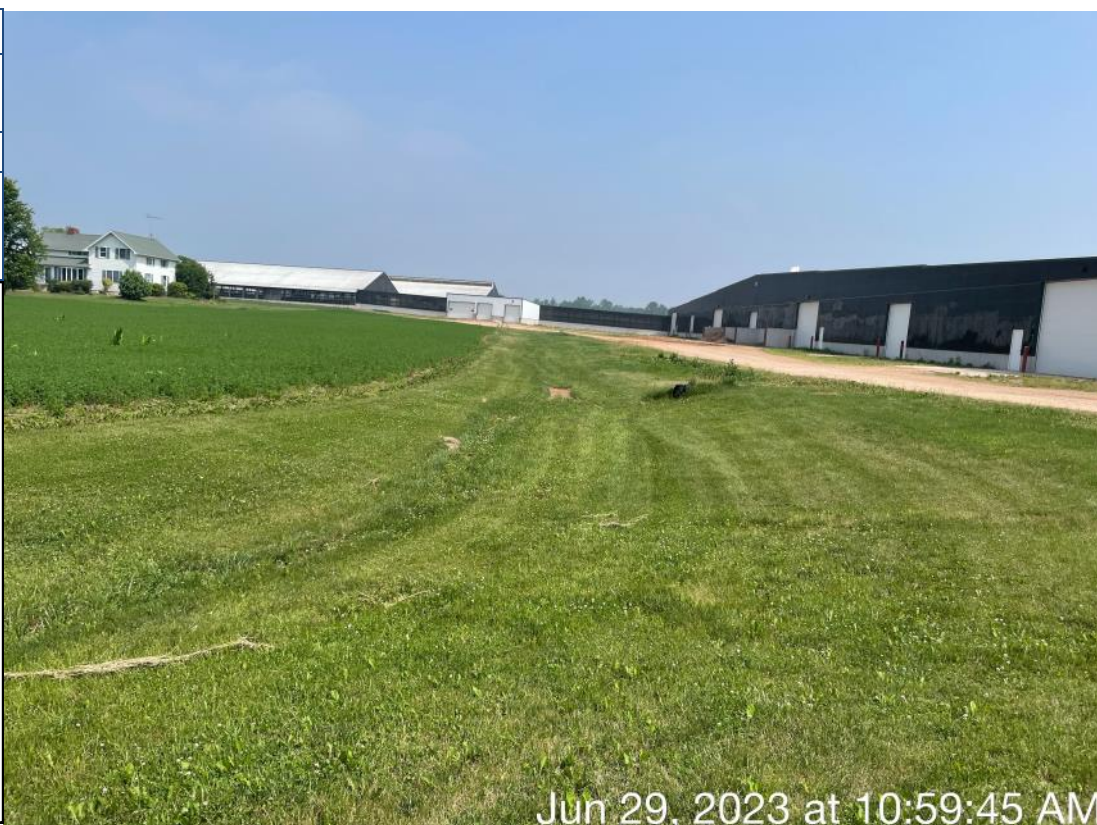
Photo #:	6837
Date/Time of Photo:	6/29/2023 10:59
Photo By:	Brian Hanson
Photo Location:	Stormwater
Photo Description:	Standing off the southwest corner of the robot barn: View of stormwater channel used to convey runoff from the farmstead and buildings towards the road ditch.

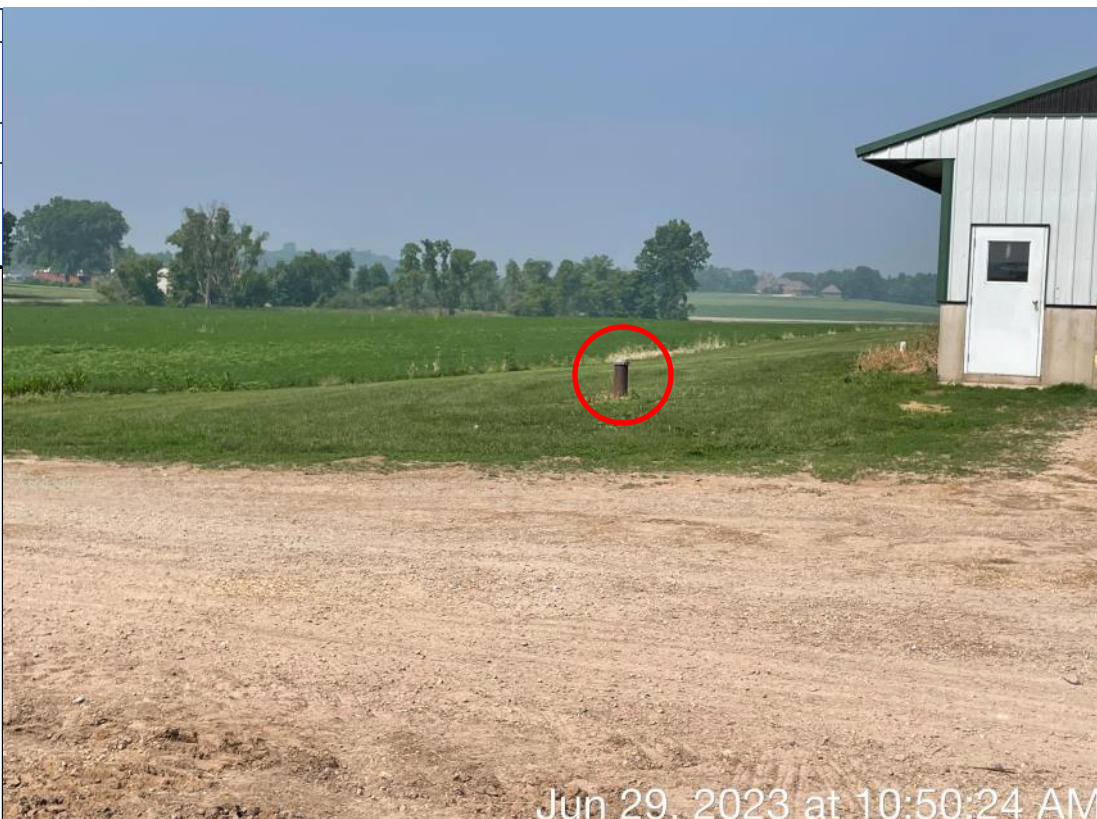
Photo #:	6803
Date/Time of Photo:	6/29/2023 10:50
Photo By:	Brian Hanson
Photo Location:	Well Locations
Photo Description:	Standing on the west side of calf hutch area looking west: View of well off southeast corner of heifer barn. Identified as Hi Cap well # 92584: Unique well ID T1729

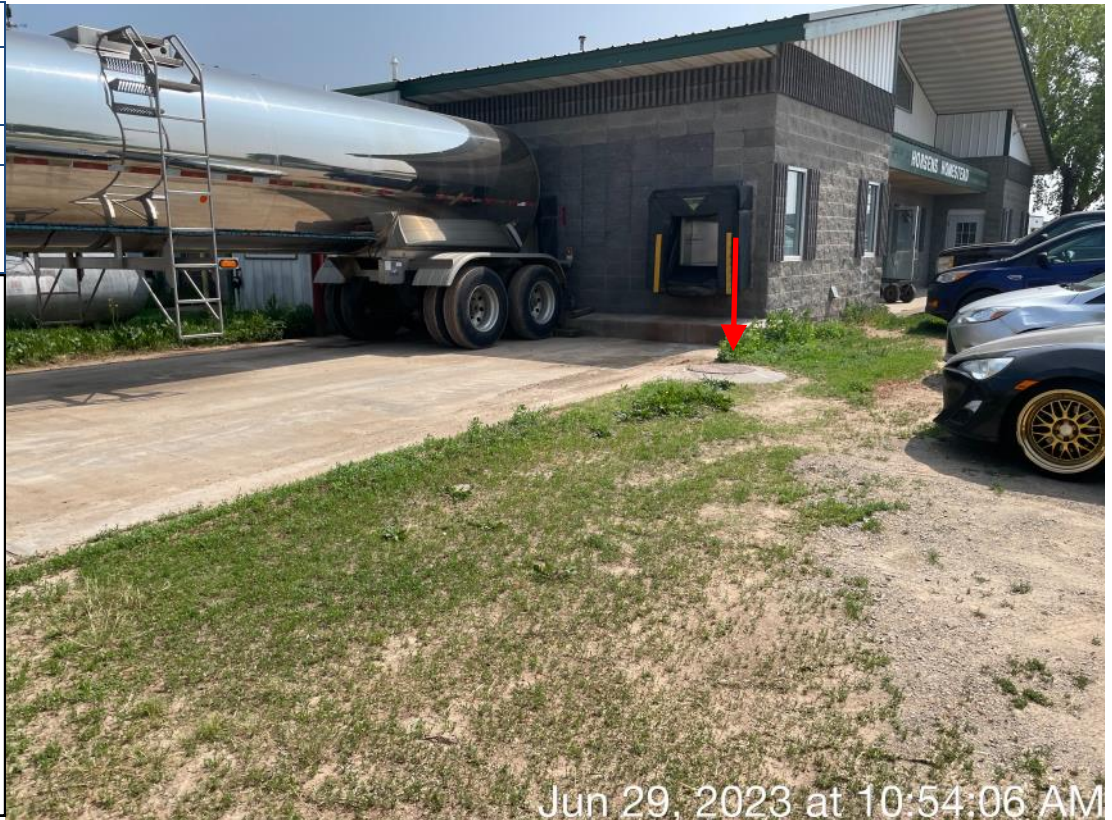
Photo #:	6830
Date/Time of Photo:	6/29/2023 10:54
Photo By:	Brian Hanson
Photo Location:	Well Locations
Photo Description:	
<p>Standing off the southeast corner of parlor looking northeast: View of well location. Well located in manhole below ground at red arrow. Identified as Hi Cap # 92583: Unique Well ID IJ829</p>

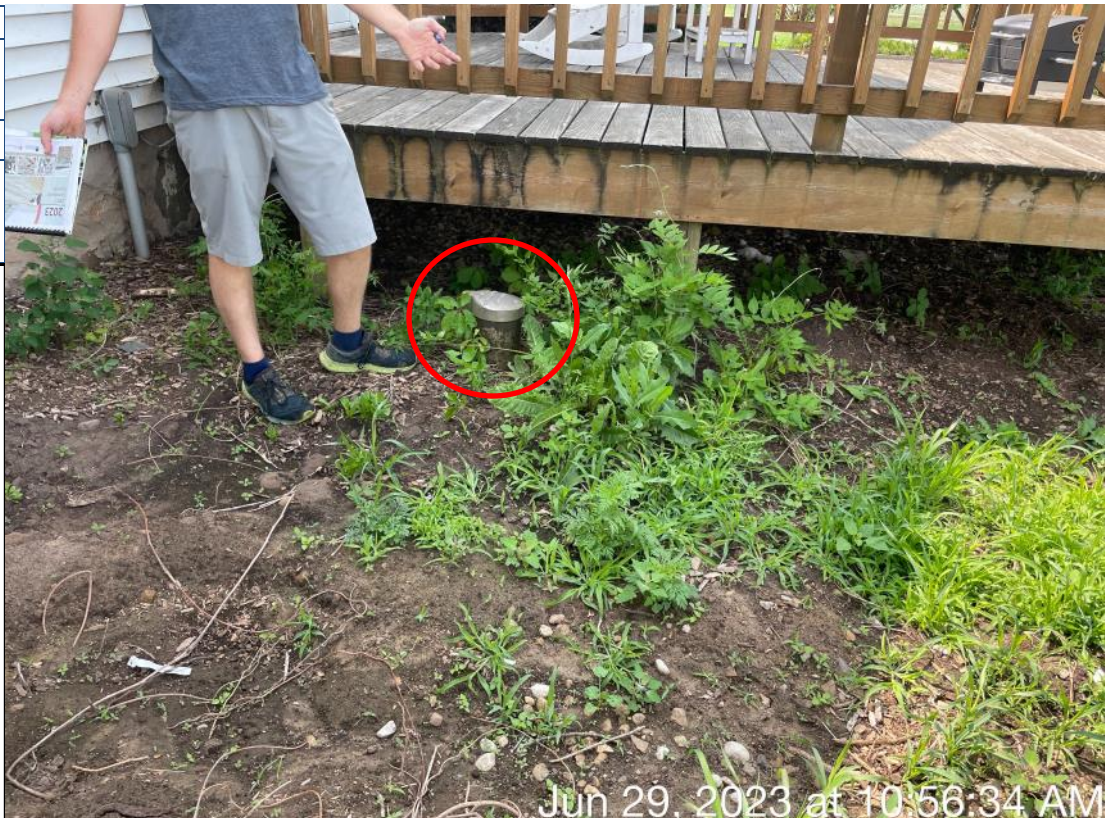
Photo #:	6831
Date/Time of Photo:	6/29/2023 10:56
Photo By:	Brian Hanson
Photo Location:	Well Locations
Photo Description:	
<p>Standing on the west side of the farm residence looking south: View of well location that only serves the house & shop. Does not appear to be connected with Hi Capacity application. No record of well construction report found. Well Cap shows B. Young Well Drilling, Gillet, WI.</p>

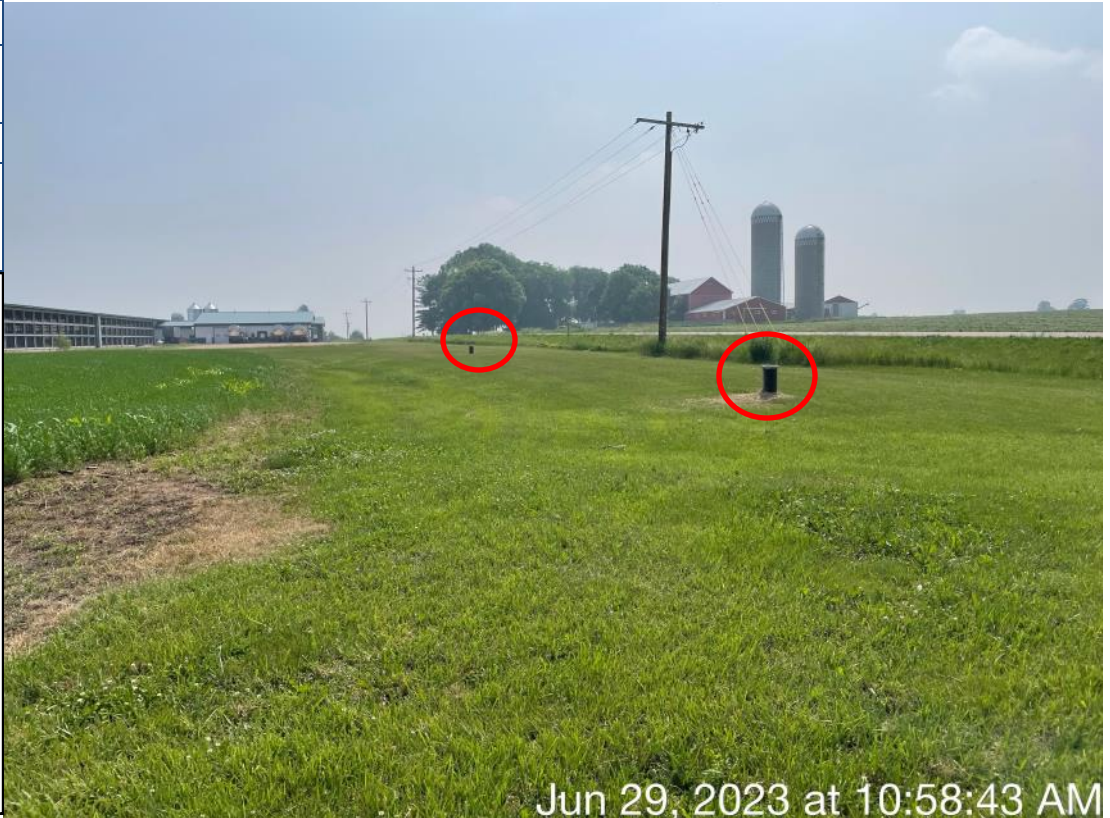
Photo #:	6835
Date/Time of Photo:	6/29/2023 10:58
Photo By:	Brian Hanson
Photo Location:	Well Locations
Photo Description:	<p>Standing on the driveway southeast of the calf hutch area looking east: View of 2 new Hi Cap wells drilled in 2019 along road ditch.</p> <p>Hi Cap # 92585 & 92586</p> <p>Unique Well ID: ZF640 & ZF643</p>
