# Permit Fact Sheet

Permit Number:	WI-0067385-01-0
Permittee Name:	Karcz Nation, LLC
Address:	N3035 Willow Road
City/State/Zip:	Pulaski WI 54162
Discharge Location:	Karcz Nation – N3035 Willow Road, Pulaski, WI 54162; E ½ of SE ¼ Section 28, T26N, R18E Heifer Nation – W1455 Town Hall Dr, Pulaski, WI 54162; NW ¼ of NE ¼ Section 28, T26N, R18E
Receiving Water:	unnamed tributary within the Pensaukee River Watershed, and groundwaters of the state
Stream Classification:	303(d) impaired by “total phosphorus”
Discharge Type:	Existing

## Site Overview Diagram (Karcz Nation LLC & Heifer Nation LLC)

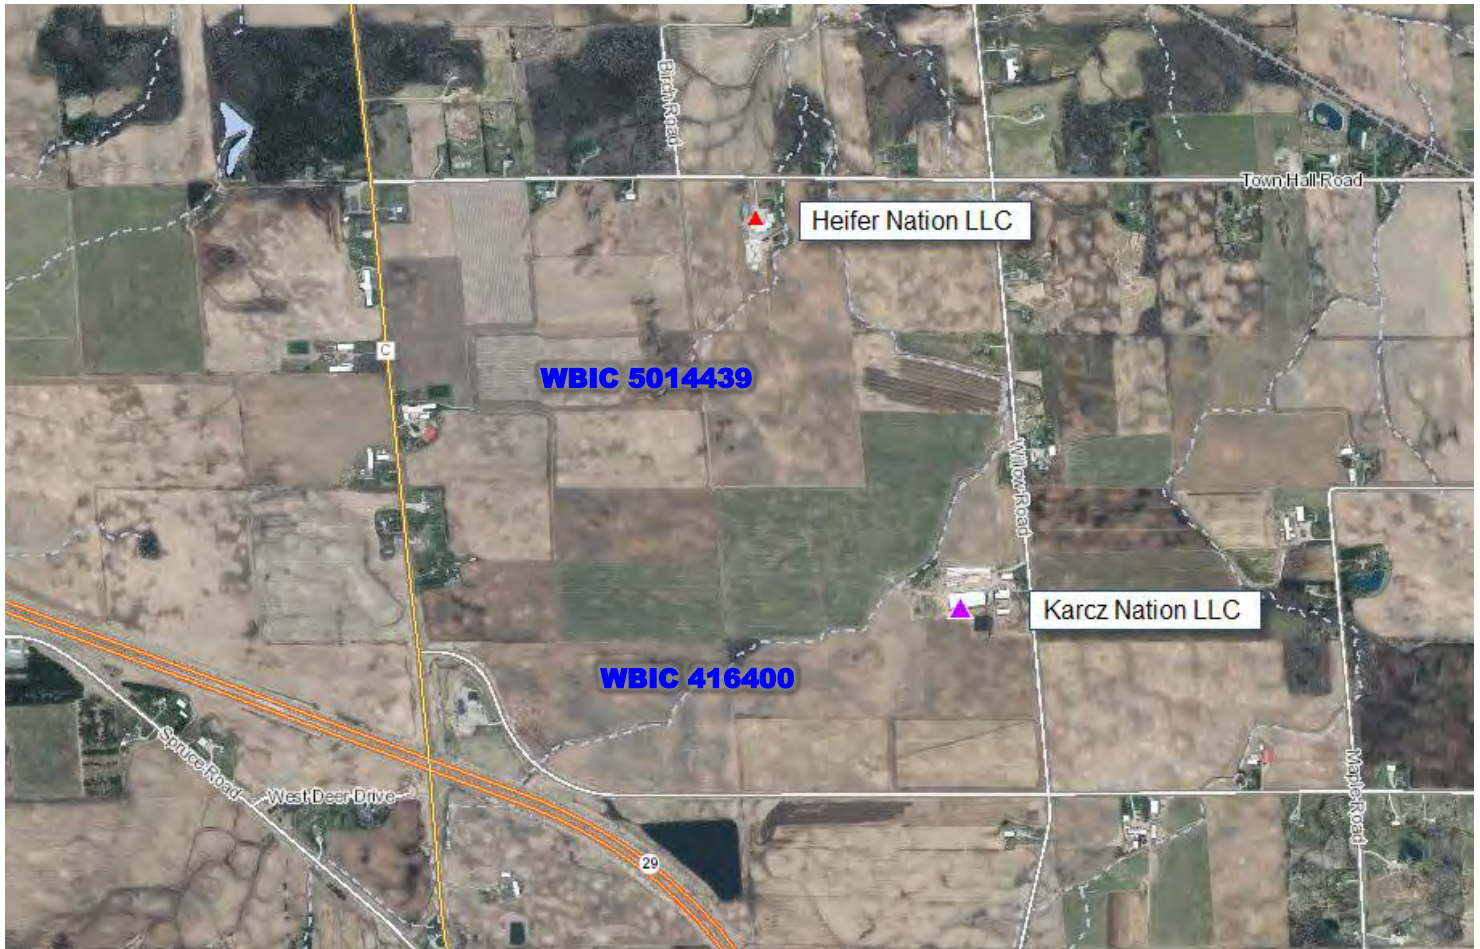
**Site Overview Diagram (Karcz Nation: orange lines =potential contaminated runoff, blue lines = stormwater flow, pink lines = waste transfer system , yellow circles = water supply well locations)**

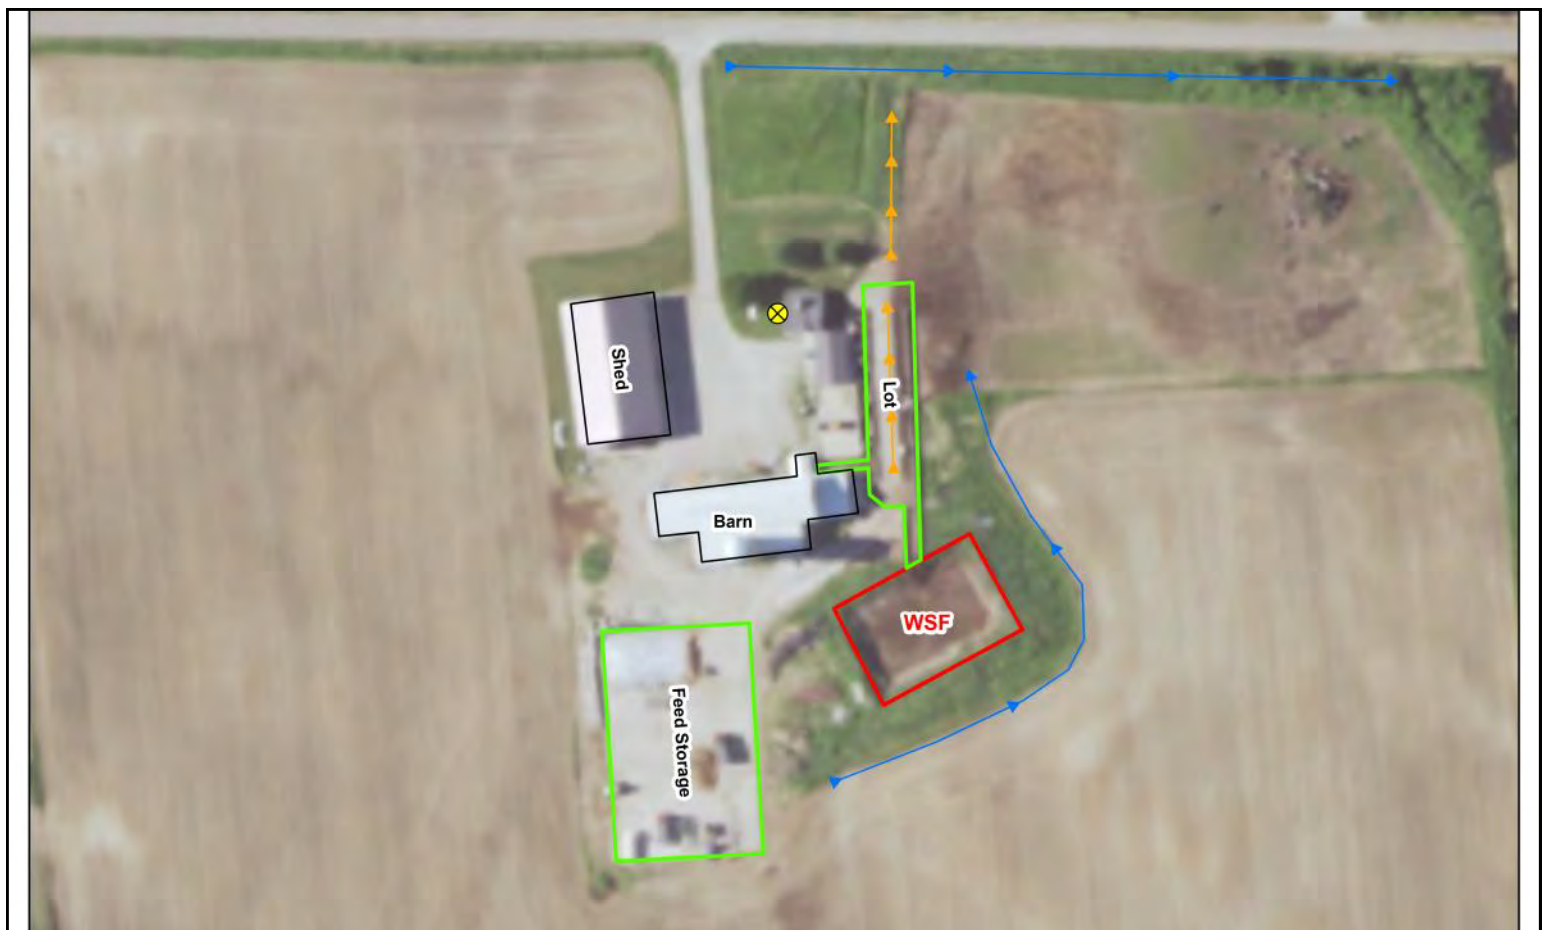
**Site Overview Diagram (Heifer Nation LLC: orange lines =potential contaminated runoff, blue lines= stormwater flow, pink lines= waste transfer system, yellow circles = water supply well locations)**

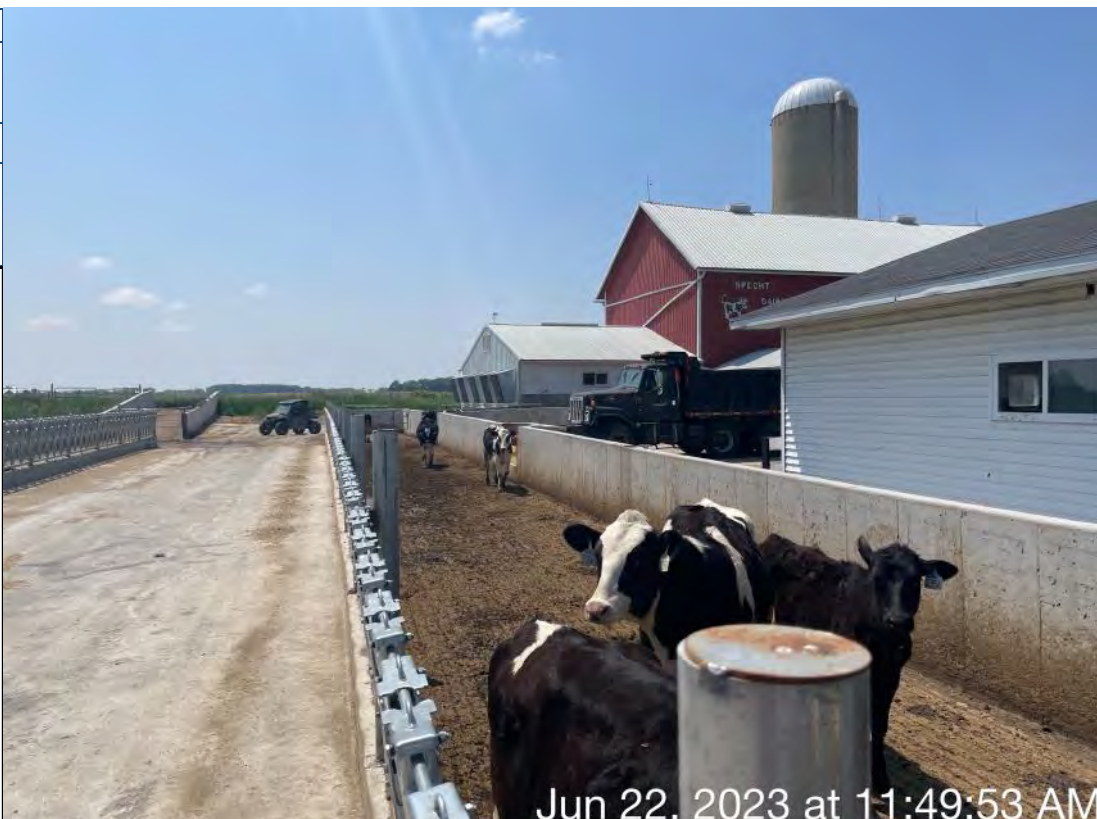
<b>Photo #:</b>	6519
<b>Date/Time of Photo:</b>	6/22/2023 11:49
<b>Photo By:</b>	Brian Hanson
<b>Photo Location:</b>	Heifer Nation Outdoor Lot

Standing at the northwest corner of lot looking south: View of west outdoor lot. 50-60 heifers have access to this lot from barn. North edge had a small curb to keep most runoff on lot.

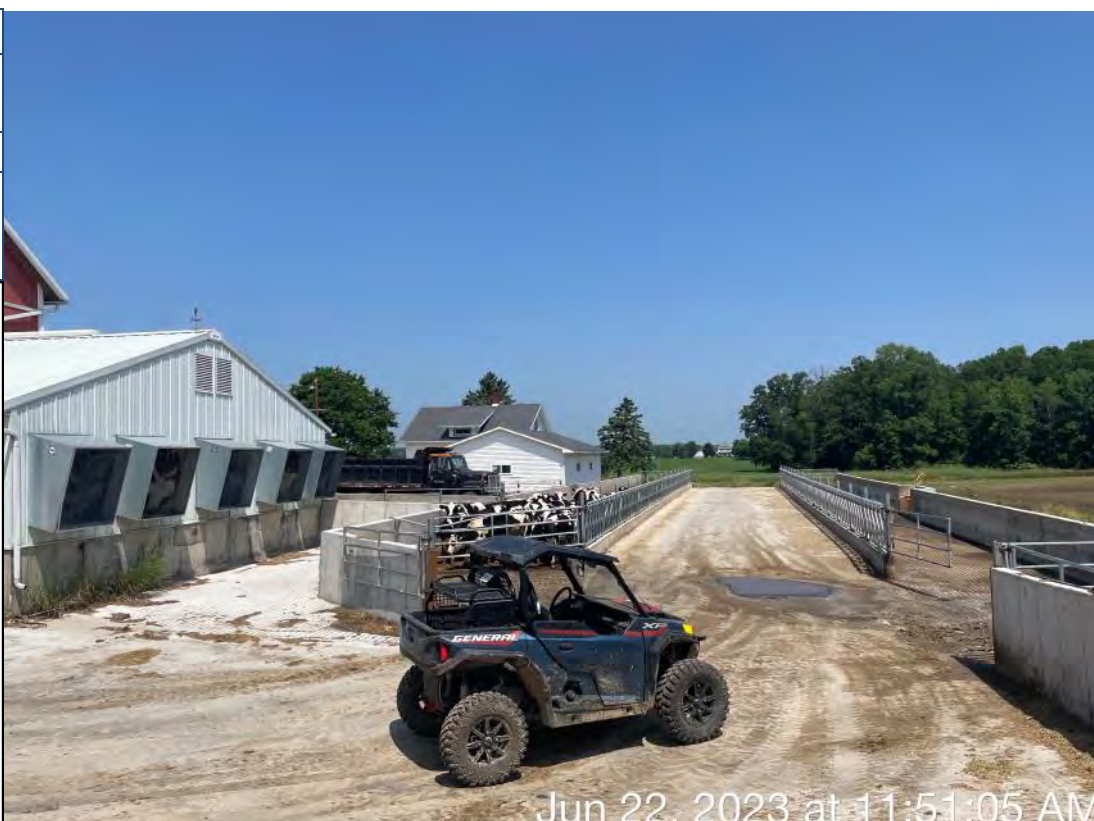
<b>Photo #:</b>	6525
<b>Date/Time of Photo:</b>	6/22/2023 11:51
<b>Photo By:</b>	Brian Hanson
<b>Photo Location:</b>	Heifer Nation Outdoor Lot

**Photo Description:**  
Standing on the south side of lot looking north: View of entire lot & drive by feeding area.

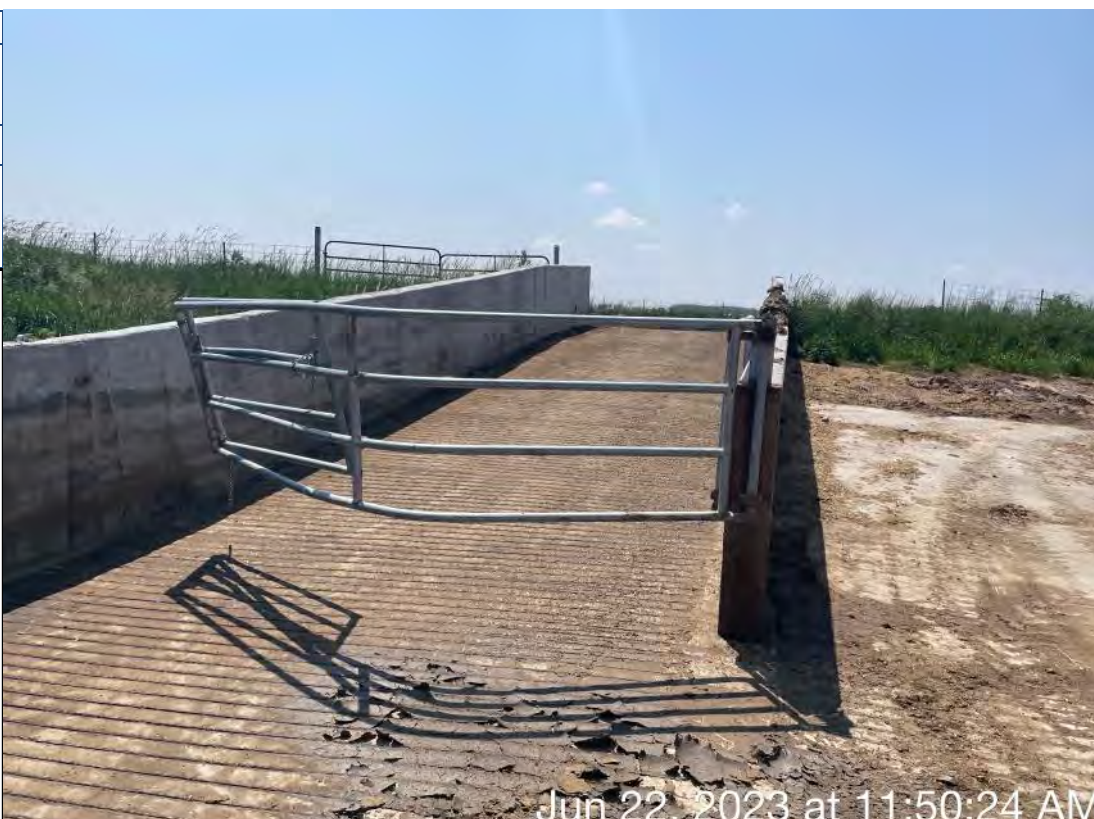
<b>Photo #:</b>	6520
<b>Date/Time of Photo:</b>	6/22/2023 11:50
<b>Photo By:</b>	Brian Hanson
<b>Photo Location:</b>	Heifer Nation Outdoor Lot

**Photo Description:**  
Standing at southeast corner of lot looking south: View of concrete ramp used to push manure from outdoor lots into WSF #2.

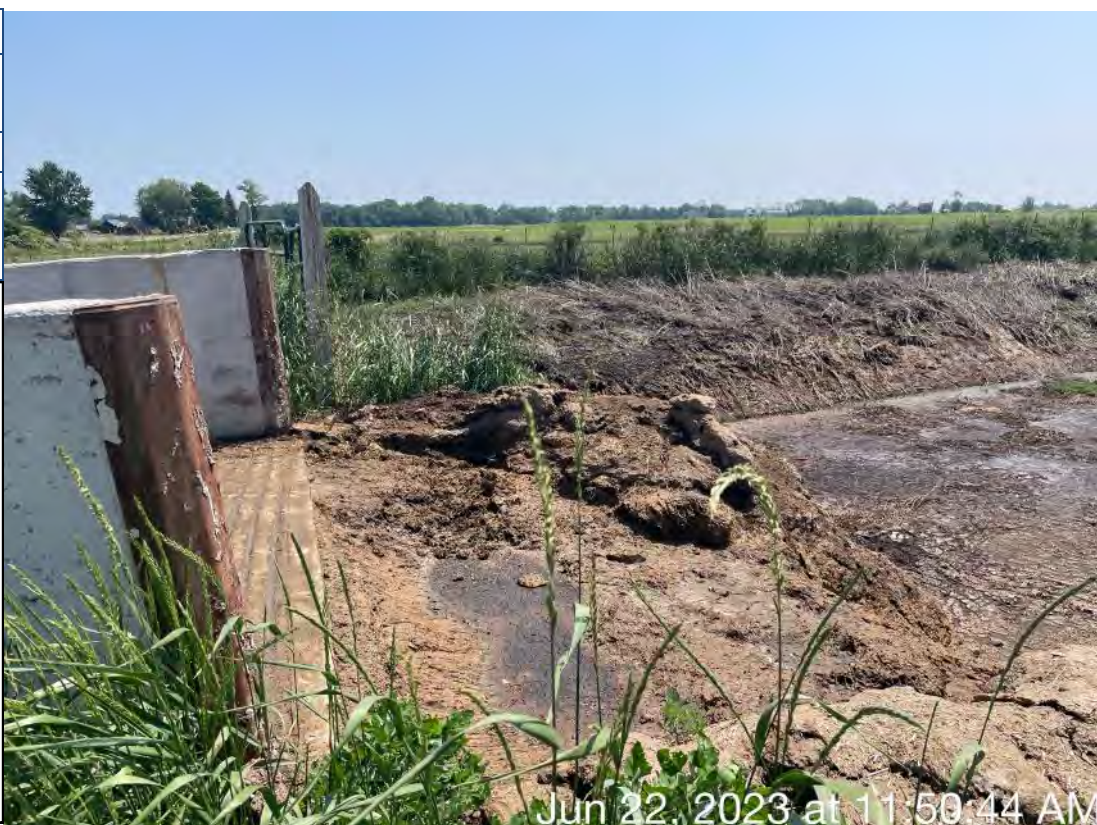
<b>Photo #:</b>	6521
<b>Date/Time of Photo:</b>	6/22/2023 11:50
<b>Photo By:</b>	Brian Hanson
<b>Photo Location:</b>	Heifer Nation Outdoor Lot
<b>Photo Description:</b>	Standing at northeast corner of WSF #2 looking east: View of south end of concrete ramp used to push manure into WSF #2. No scour protection visible off end of ramp

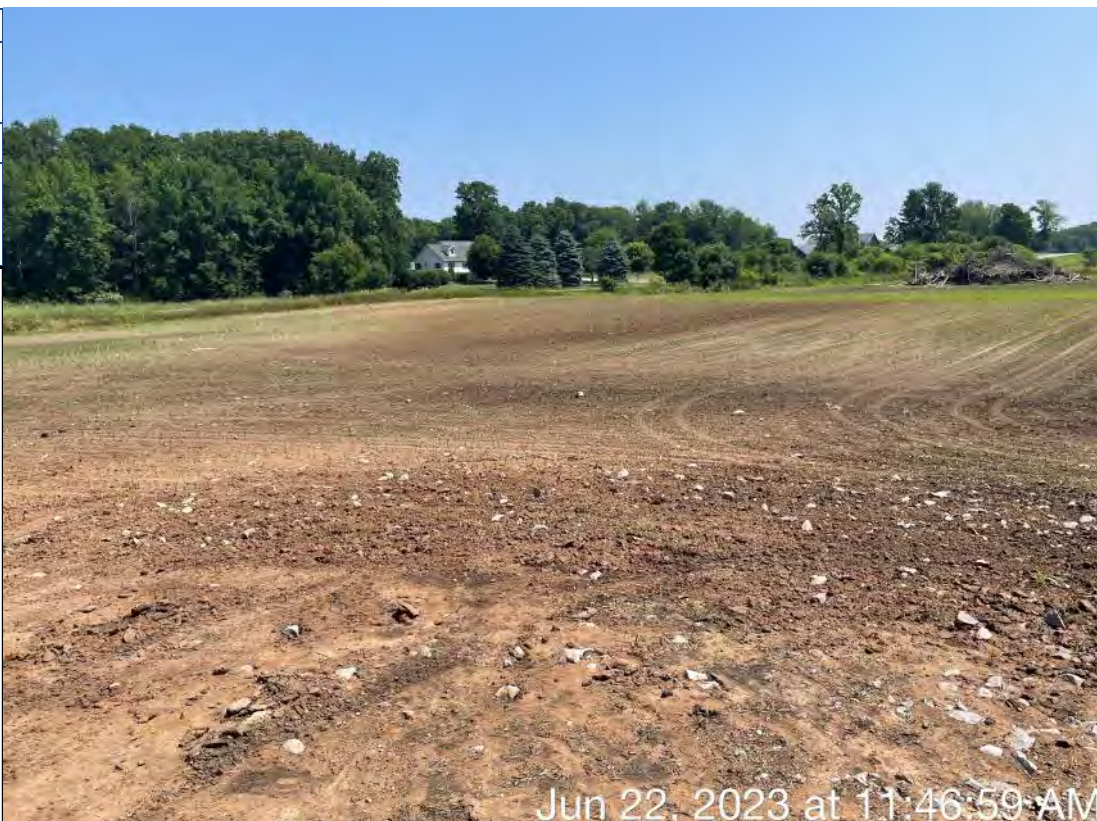
<b>Photo #:</b>	6512
<b>Date/Time of Photo:</b>	6/22/2023 11:46
<b>Photo By:</b>	Brian Hanson
<b>Photo Location:</b>	Heifer Nation Outdoor Lot
<b>Photo Description:</b>	Standing at north end of lot looking east: View of area northeast of outdoor lot. Area was previously used as a pasture/earthen lot, but has now been converted to crop production.

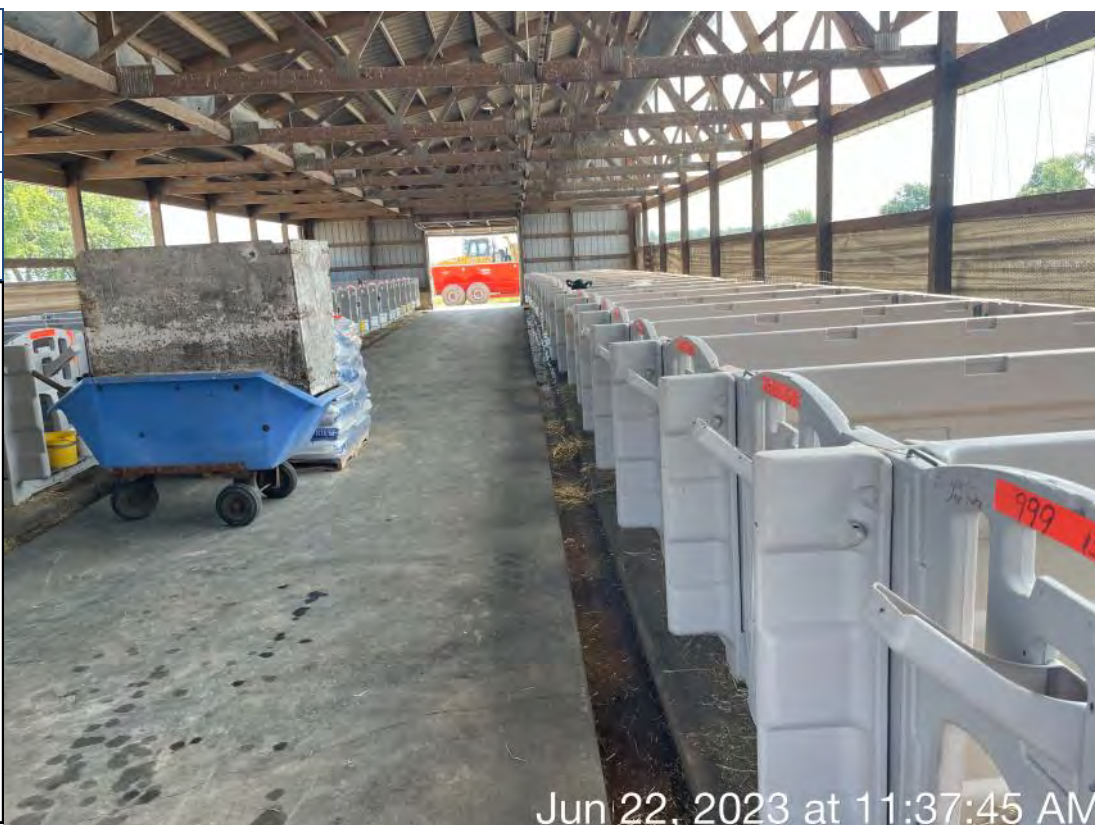
<b>Photo #:</b>	6507
<b>Date/Time of Photo:</b>	6/22/2023 11:37
<b>Photo By:</b>	Brian Hanson
<b>Photo Location:</b>	Karcz Nation Calf Barn

Standing on the west side of the calf barn looking east: View of calf hutches housed inside of calf barn. Notice gutter in front of hutches. Gutter flows west out of barn door.

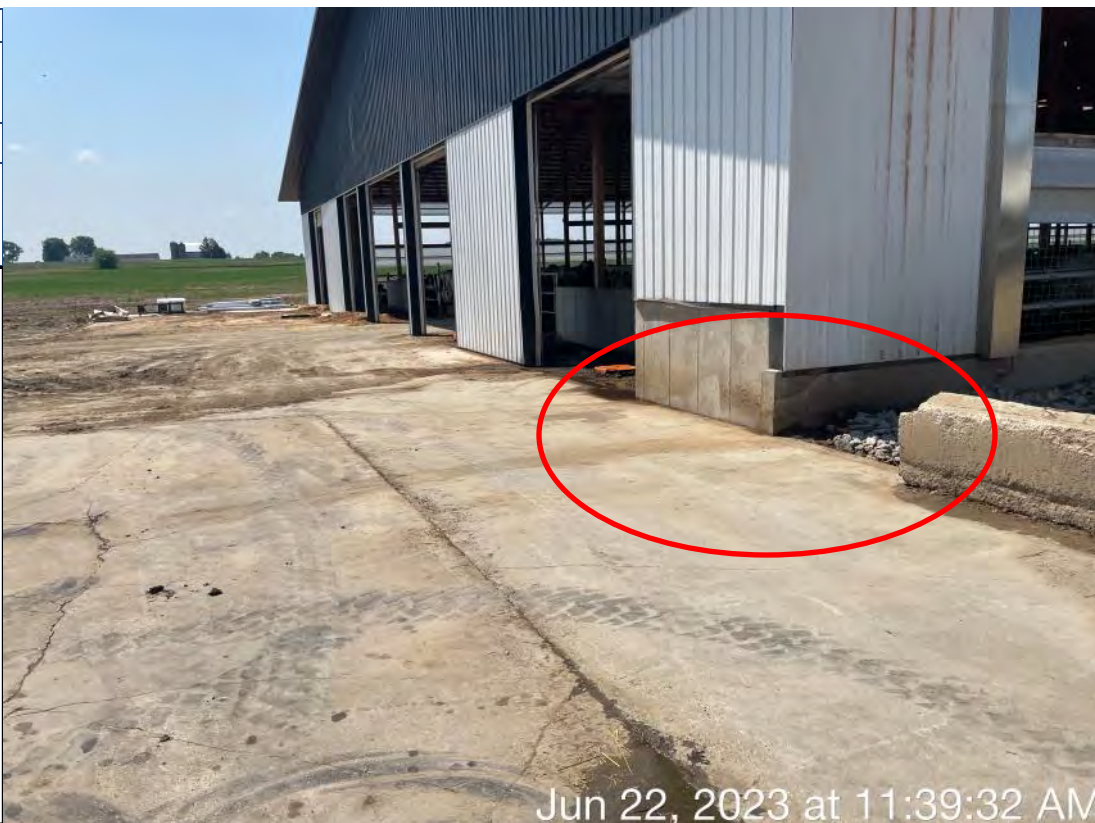
<b>Photo #:</b>	6508
<b>Date/Time of Photo:</b>	6/22/2023 11:39
<b>Photo By:</b>	Brian Hanson
<b>Photo Location:</b>	Karcz Nation Calf Barn

Standing on the west side of calf barn looking south: View of concrete area between calf barn at freestall barn. Runoff from calf barn flows west towards corner of freestall. Staining on concrete appears to show runoff entering gravel along north wall of freestall barn which is also a French drain for roof water.

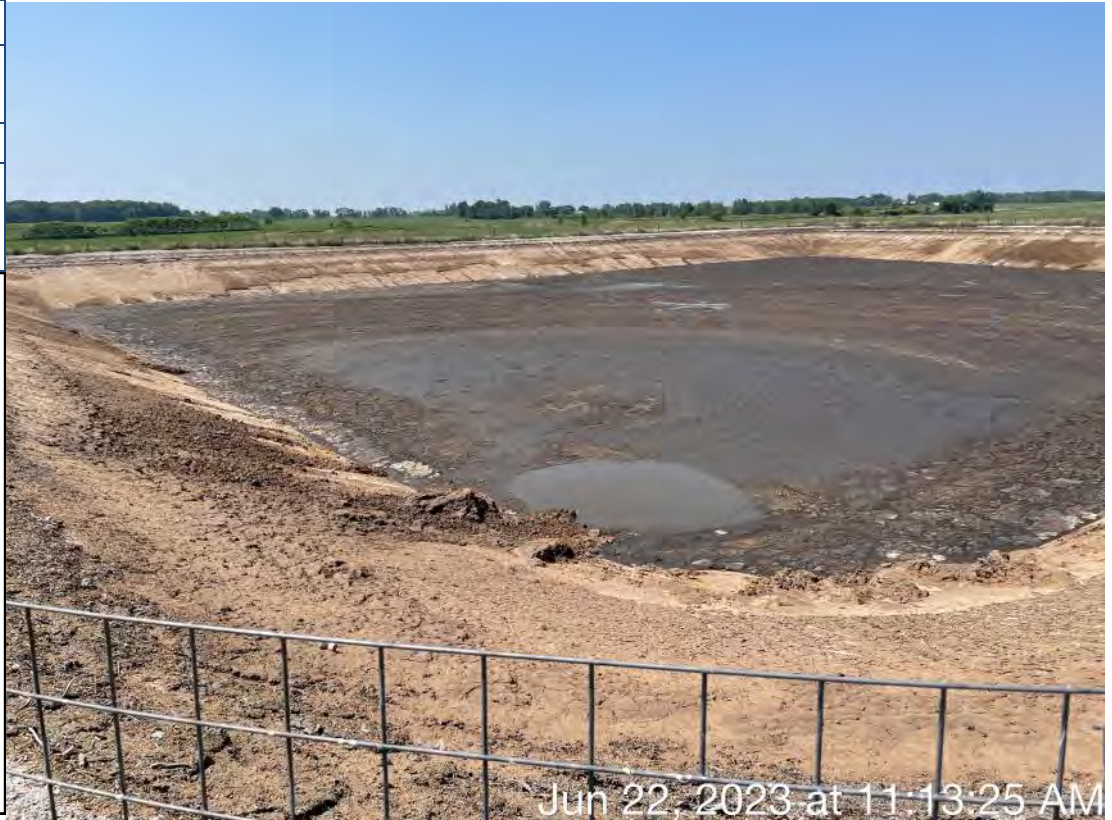
<b>Photo #:</b>	6474
<b>Date/Time of Photo:</b>	6/22/2023 11:13
<b>Photo By:</b>	Brian Hanson
<b>Photo Location:</b>	Karcz Nation WSF #1
<b>Photo Description:</b>	Standing at the northeast corner of WSF #1 looking southwest: View o of the northeast corner of WSF #1.

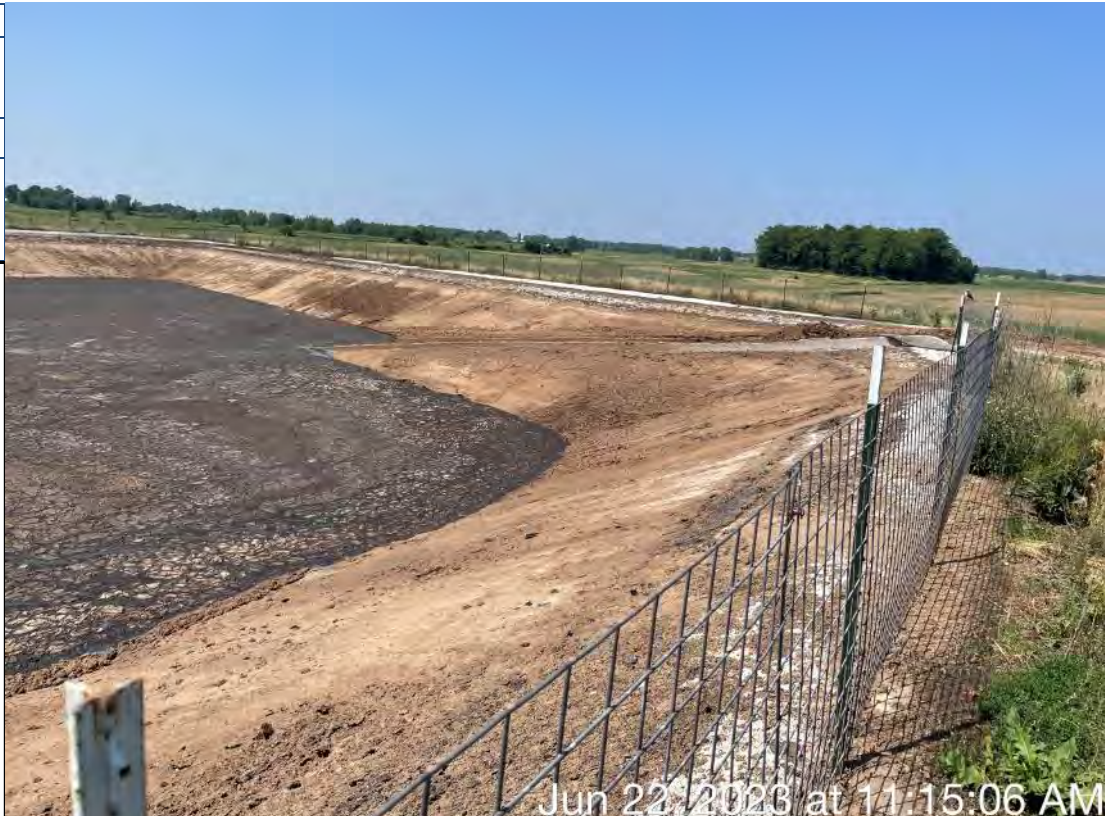
<b>Photo #:</b>	6476
<b>Date/Time of Photo:</b>	6/22/2023 11:15
<b>Photo By:</b>	Brian Hanson
<b>Photo Location:</b>	Karcz Nation WSF #1
<b>Photo Description:</b>	Standing on the north side of WSF #1 looking west: View of north edge of WSF #1. Notice access ramp in northwest corner.

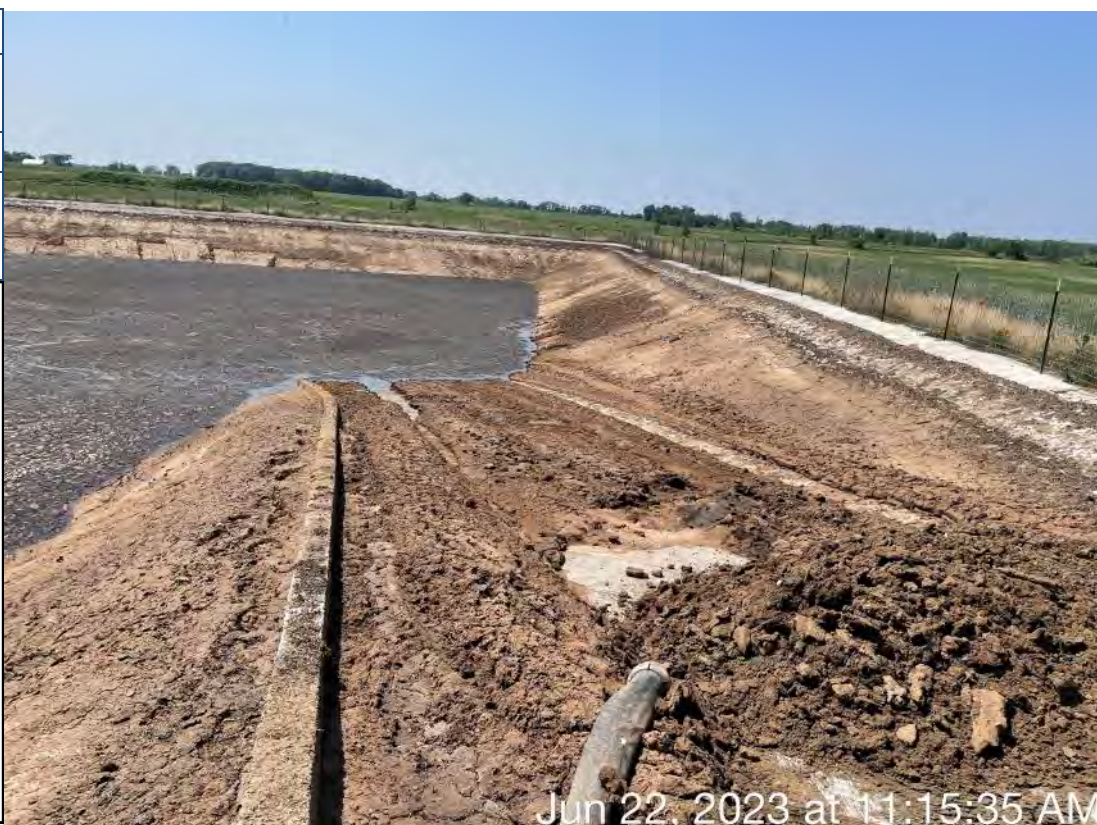
<b>Photo #:</b>	6481
<b>Date/Time of Photo:</b>	6/22/2023 11:15
<b>Photo By:</b>	Brian Hanson
<b>Photo Location:</b>	Karcz Nation WSF #1
<b>Photo Description:</b>	Standing at the northwest corner of WSF #1 looking south" View of northwest corner of WSF #1 at access ramp location.

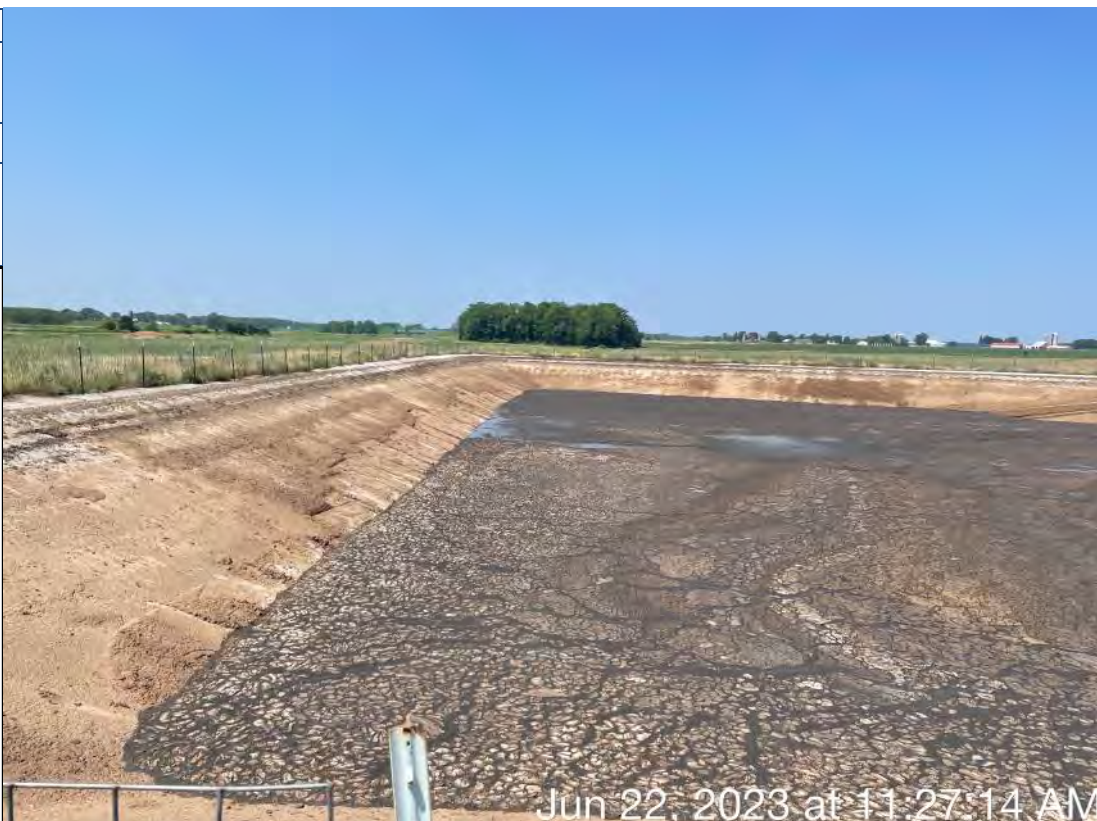
<b>Photo #:</b>	6495
<b>Date/Time of Photo:</b>	6/22/2023 11:27
<b>Photo By:</b>	Brian Hanson
<b>Photo Location:</b>	Karcz Nation WSF #1
<b>Photo Description:</b>	Standing at southeast corner of WSF #1 looking west: View of south edge of WSF #1.

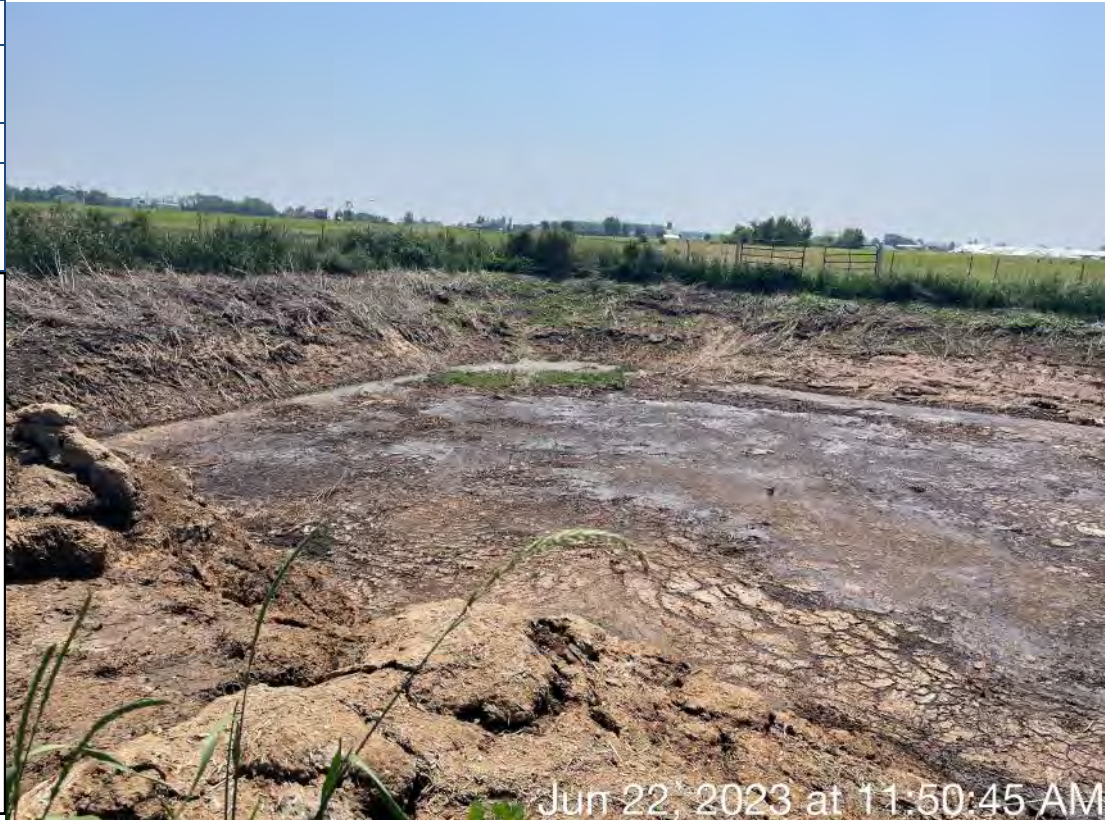
<b>Photo #:</b>	6522
<b>Date/Time of Photo:</b>	6/22/2023 11:50
<b>Photo By:</b>	Brian Hanson
<b>Photo Location:</b>	Heifer Nation WSF #2

**Photo Description:**  
Standing on north side of WSF #2 looking southeast: View of east half of WSF #2.

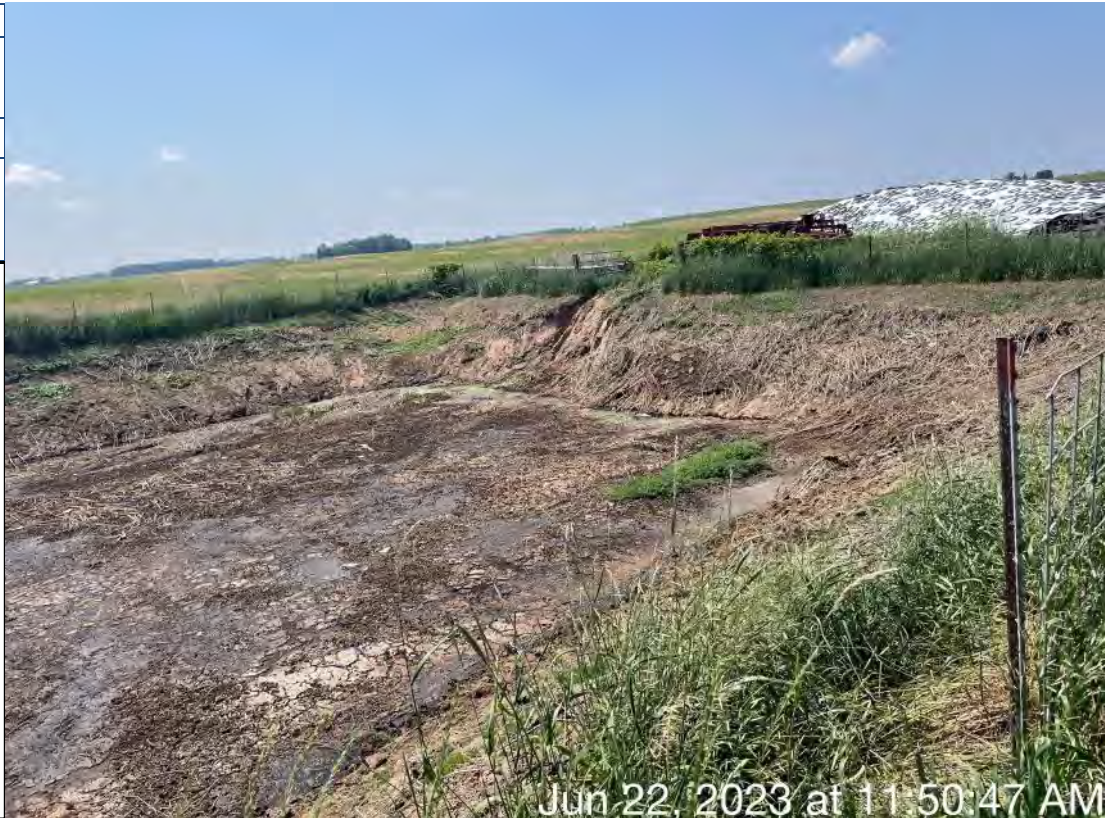
<b>Photo #:</b>	6523
<b>Date/Time of Photo:</b>	6/22/2023 11:50
<b>Photo By:</b>	Brian Hanson
<b>Photo Location:</b>	Heifer Nation WSF #2

**Photo Description:**  
Standing on north side of WSF #2 looking southwest: View of west half of WSF #2.

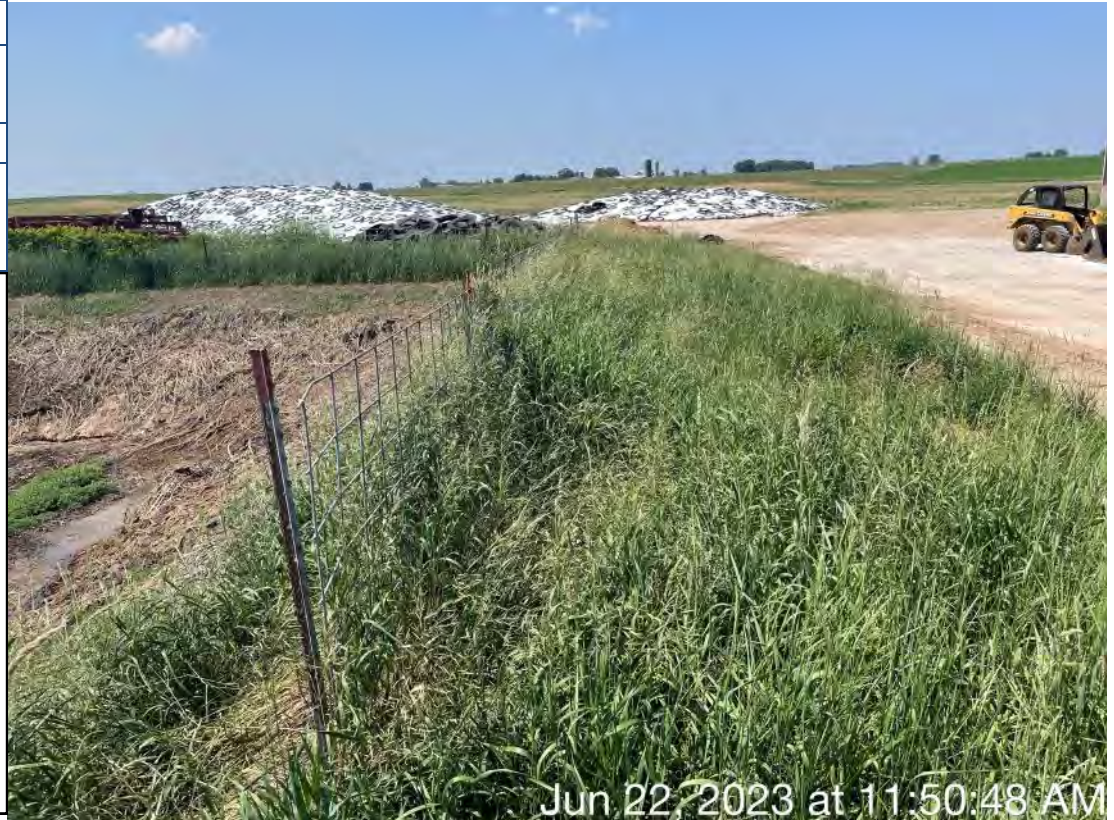
<b>Photo #:</b>	6524
<b>Date/Time of Photo:</b>	6/22/2023 11:50
<b>Photo By:</b>	Brian Hanson
<b>Photo Location:</b>	Heifer Nation WSF #2
<b>Photo Description:</b>	Standing on the west side of WSF #2 looking south: View of the west berm of WSF #2.

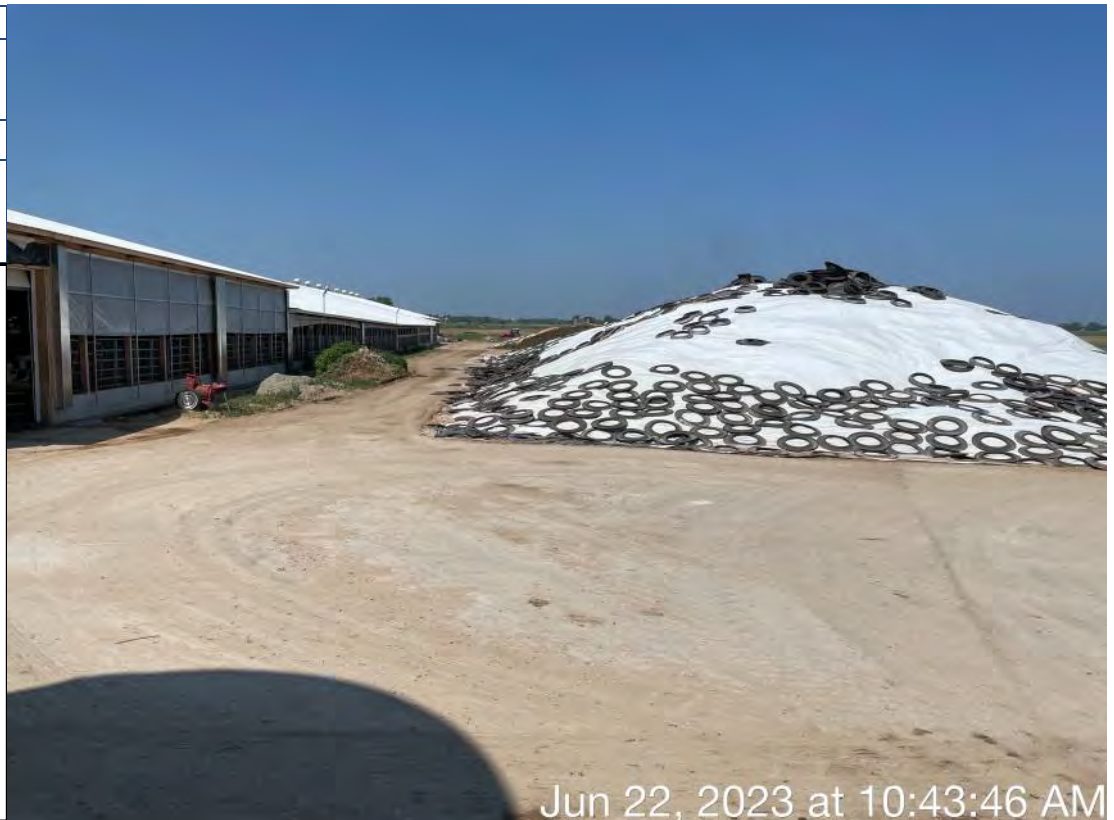
<b>Photo #:</b>	6413
<b>Date/Time of Photo:</b>	6/22/2023 10:43
<b>Photo By:</b>	Brian Hanson
<b>Photo Location:</b>	Karcz Nation Feed Storage
<b>Photo Description:</b>	Standing on the east side of FSA looking west: View of the southeast corner of FSA.

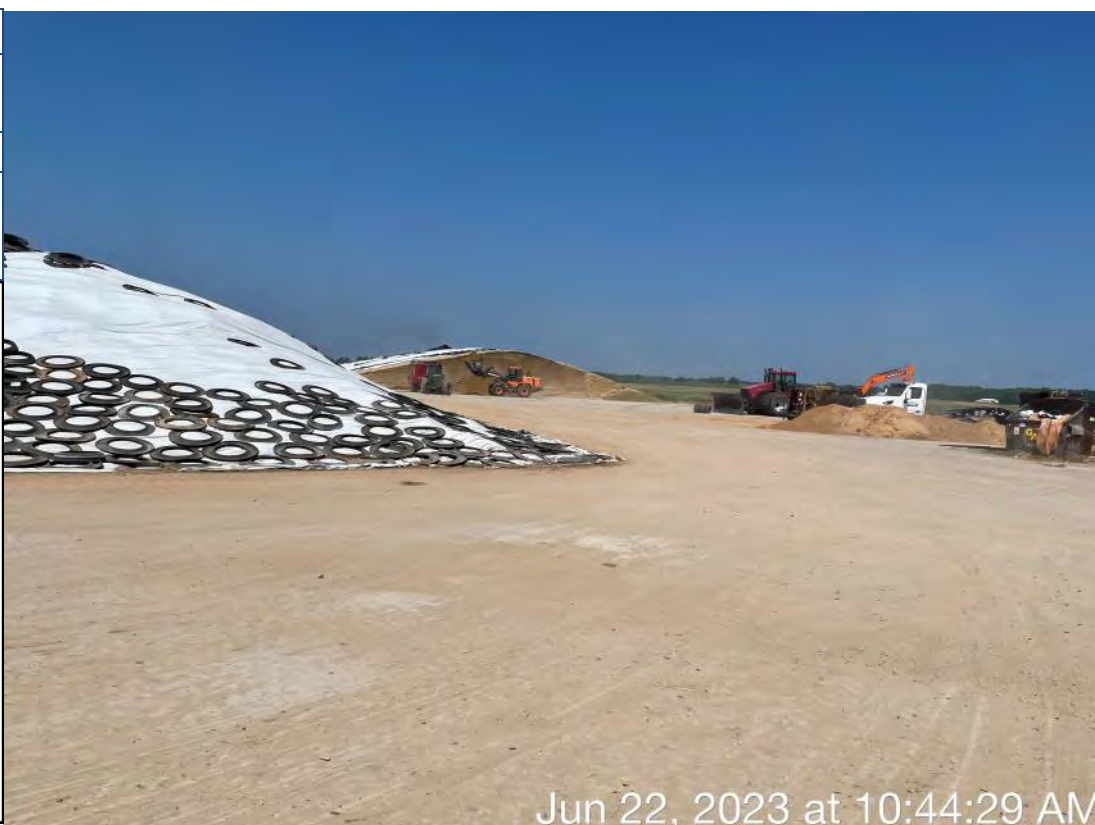
<b>Photo #:</b>	6417
<b>Date/Time of Photo:</b>	6/22/2023 10:44
<b>Photo By:</b>	Brian Hanson
<b>Photo Location:</b>	Karcz Nation Feed Storage

**Photo Description:**  
Standing on the east side of FSA looking northwest: View of the east end of FSA.

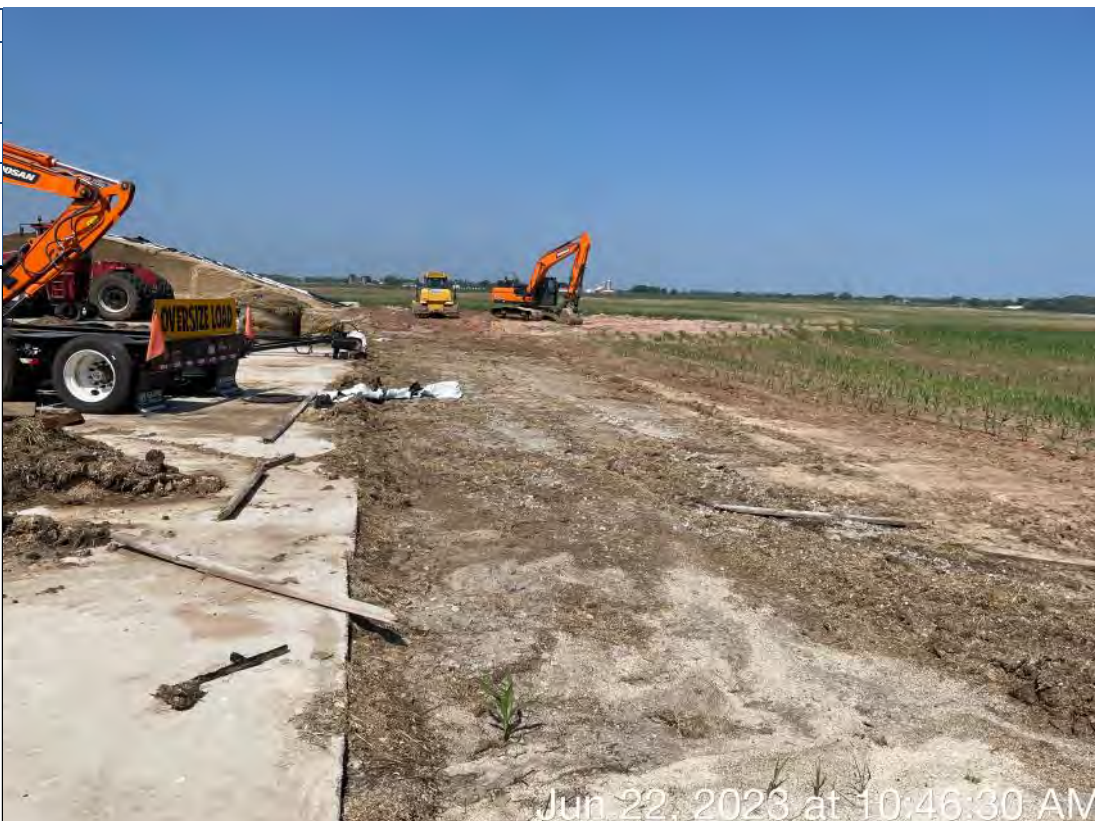
<b>Photo #:</b>	6423
<b>Date/Time of Photo:</b>	6/22/2023 10:46
<b>Photo By:</b>	Brian Hanson
<b>Photo Location:</b>	Karcz Nation Feed Storage

The feed storage areas are well-maintained & in good repair. However, there are no engineered runoff control system on either feed storage area.

**Photo Description:**  
Standing on the north side of FSA looking west: View of north edge of FSA. Notice lack of containment berm at edge of concrete. Also notice & evidence of runoff & feed solids have left the concrete pad.

Required Action	Due Date
Written Description of Existing System: Submit an engineering evaluation that includes a written description of the existing feed storage area and its adequacy to meet the conditions found in the Production Area Discharge Limitations subsection and NR 243.15, Wis. Adm. Code.	05/15/2025
Plans and Specifications: Submit plans and specifications for Department review and approval to permanently correct any adverse conditions identified as part of the engineering evaluation for the feed storage area in accordance with Chapter 281.41, Wis. Stats., and Chapter NR 243, Wis. Adm. Code.	12/31/2026
Corrections and Post Construction Documentation: Complete construction of improvements to permanently correct any adverse conditions in concurrence with and approval by the Department, by the specified Date Due. Submit post construction documentation within 60 days of completion of the project.	10/31/2027

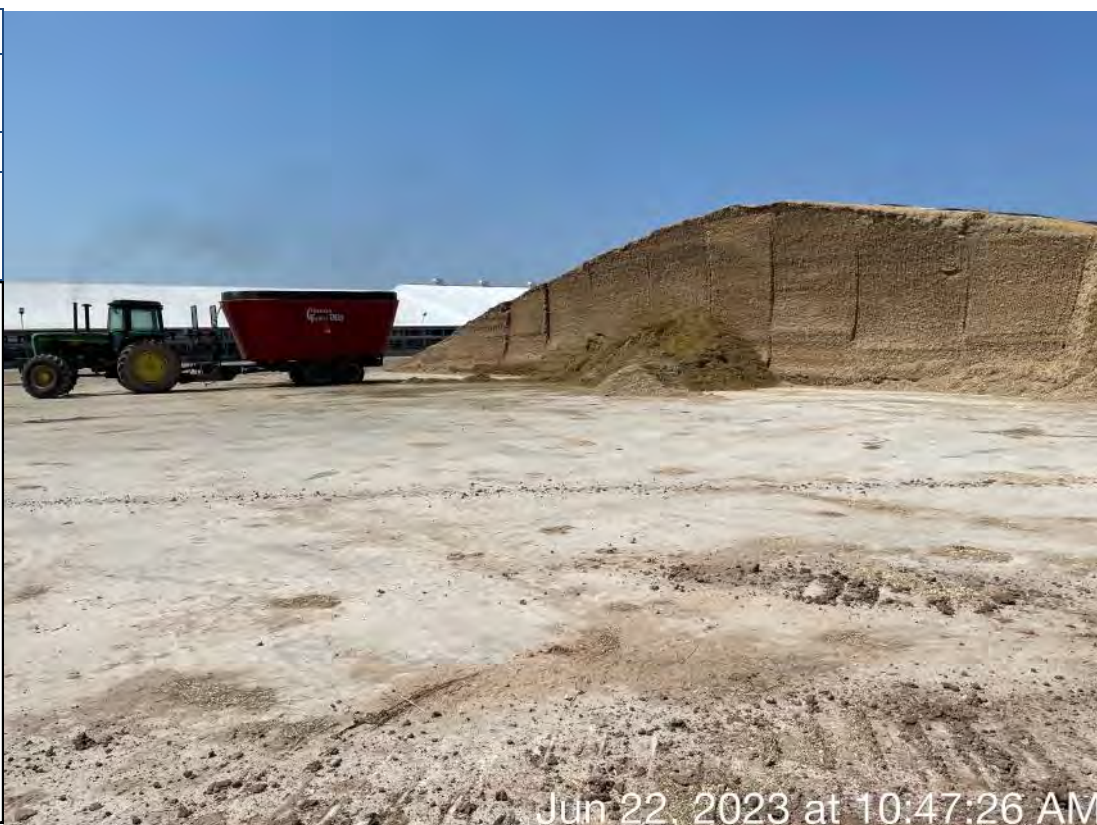
<b>Photo #:</b>	6426
<b>Date/Time of Photo:</b>	6/22/2023 10:47
<b>Photo By:</b>	Brian Hanson
<b>Photo Location:</b>	Karcz Nation Feed Storage
<b>Photo Description:</b>	Standing in the middle of FSA looking south: View of center of FSA.

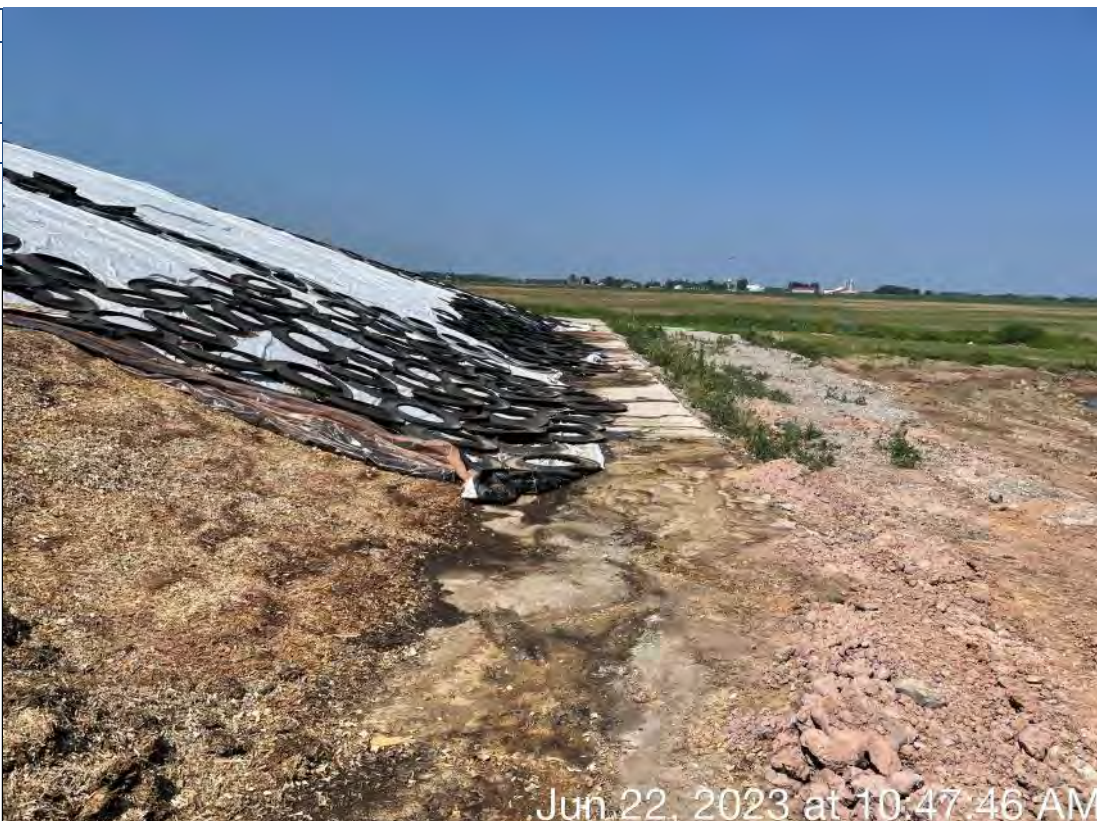
<b>Photo #:</b>	6428
<b>Date/Time of Photo:</b>	6/22/2023 10:47
<b>Photo By:</b>	Brian Hanson
<b>Photo Location:</b>	Karcz Nation Feed Storage
<b>Photo Description:</b>	Standing on north side of FSA looking west: View of northwest corner of FSA. Notice an earthen berm has been installed along a portion of FSA. Also notice leachate stains flowing off of concrete.

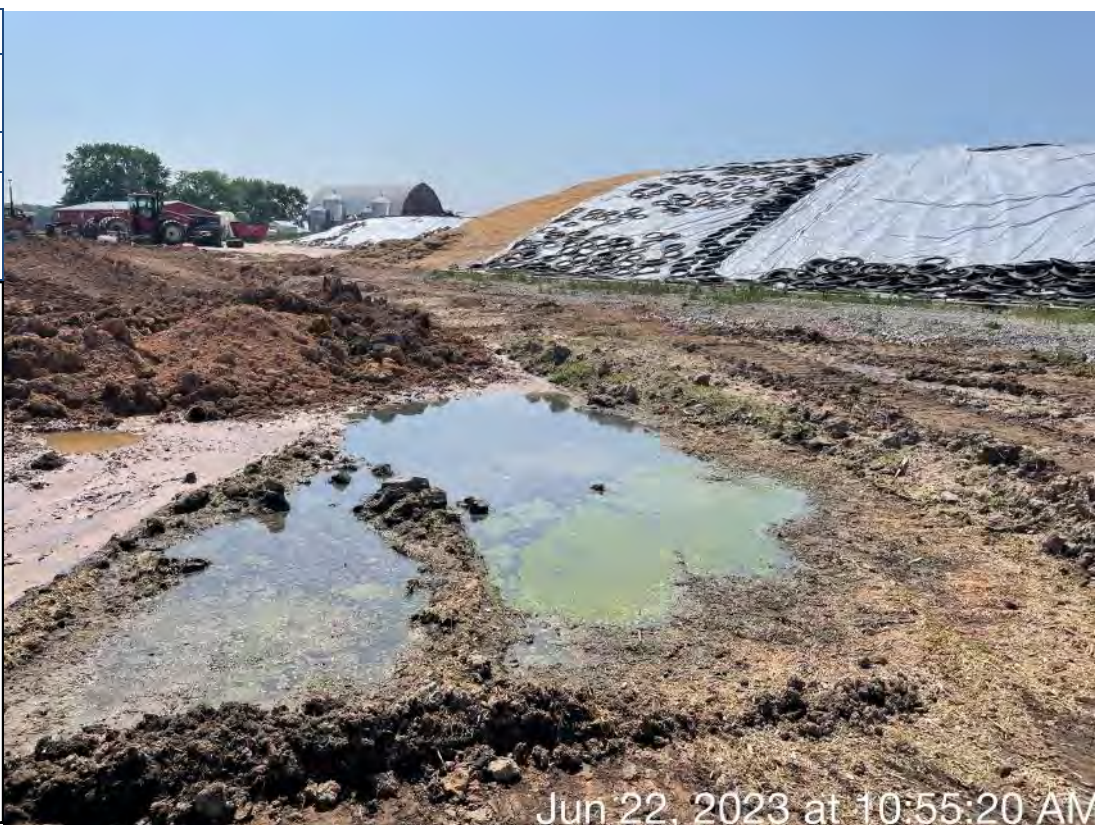
<b>Photo #:</b>	6434
<b>Date/Time of Photo:</b>	6/22/2023 10:55
<b>Photo By:</b>	Brian Hanson
<b>Photo Location:</b>	Karcz Nation Feed Storage

Standing off the north side of FSA looking southeast: View of ponded runoff on north side of FSA. Water was opaque, blackish in color, and had an odor consistent with feed leachate.
