# Permit Fact Sheet

Permit Number:	WI-0067385-01-0
Permittee Name:	Karcz Nation, LLC
Address:	N3035 Willow Road
City/State/Zip:	Pulaski WI 54162
Discharge Location:	Karcz Nation – N3035 Willow Road, Pulaski, WI 54162; E ½ of SE ¼ Section 28, T26N, R18E Heifer Nation – W1455 Town Hall Dr, Pulaski, WI 54162; NW ¼ of NE ¼ Section 28, T26N, R18E
Receiving Water:	unnamed tributary within the Pensaukee River Watershed, and groundwaters of the state
Stream Classification:	303(d) impaired by “total phosphorus”
Discharge Type:	Existing

## Site Overview Diagram (Karcz Nation LLC & Heifer Nation LLC)

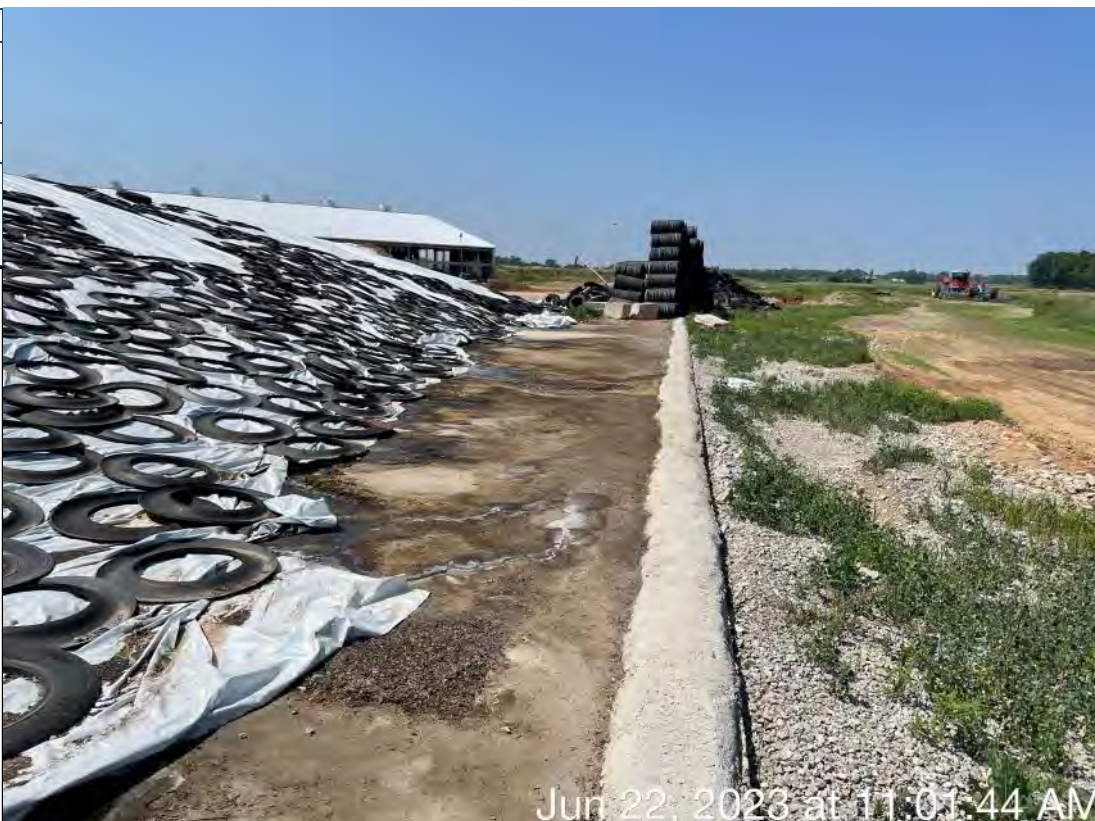
<b>Photo #:</b>	6442
<b>Date/Time of Photo:</b>	6/22/2023 11:01
<b>Photo By:</b>	Brian Hanson
<b>Photo Location:</b>	Karcz Nation Feed Storage

Standing on the west side of FSA looking southwest: View of west edge of FSA. Notice concrete berm installed along west side of FSA.

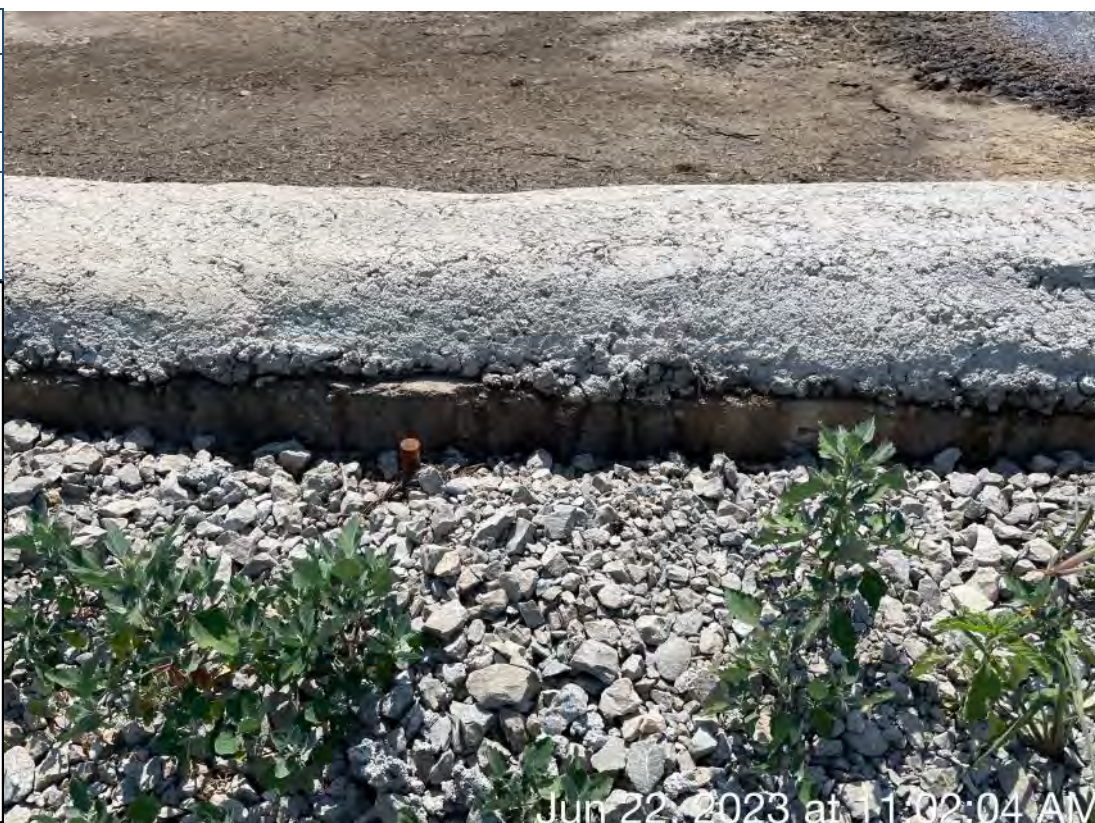
**Photo Description:**  
Standing on the west side of FSA looking east & down:  
Close up view of concrete berm installed along west side of FSA. Notice concrete berm is not a monolithic pour with concrete slab. Evidence of leachate flowing under the berm present.

Required Action	Due Date
Written Description of Existing System: Submit an engineering evaluation that includes a written description of the existing feed storage area and its adequacy to meet the conditions found in the Production Area Discharge Limitations subsection and NR 243.15, Wis. Adm. Code.	05/15/2025
Plans and Specifications: Submit plans and specifications for Department review and approval to permanently correct any adverse conditions identified as part of the engineering evaluation for the feed storage area in accordance with Chapter 281.41, Wis. Stats., and Chapter NR 243, Wis. Adm. Code.	12/31/2026
Corrections and Post Construction Documentation: Complete construction of improvements to permanently correct any adverse conditions in concurrence with and approval by the Department, by the specified Date Due. Submit post construction documentation within 60 days of completion of the project.	10/31/2027

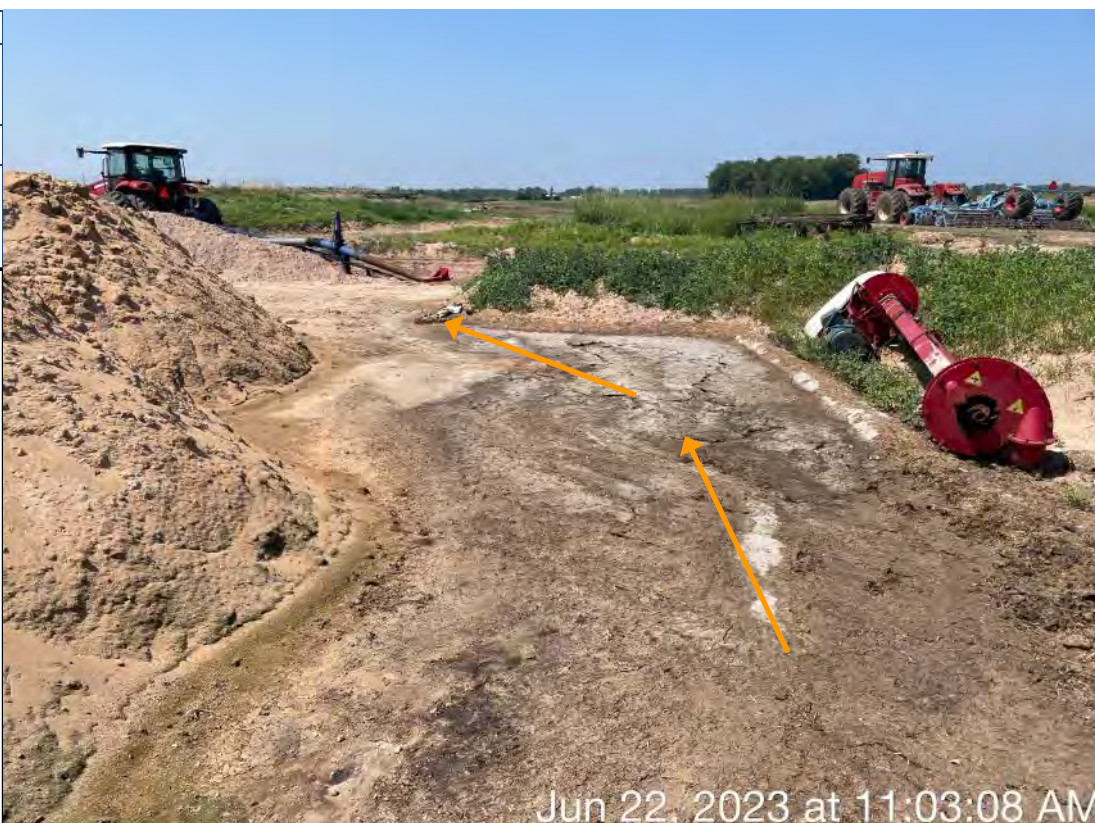
**Photo Description:**  
Standing on the west side of FSA looking south: View of southwest corner of FSA. Arrows indicate direction of runoff flow.

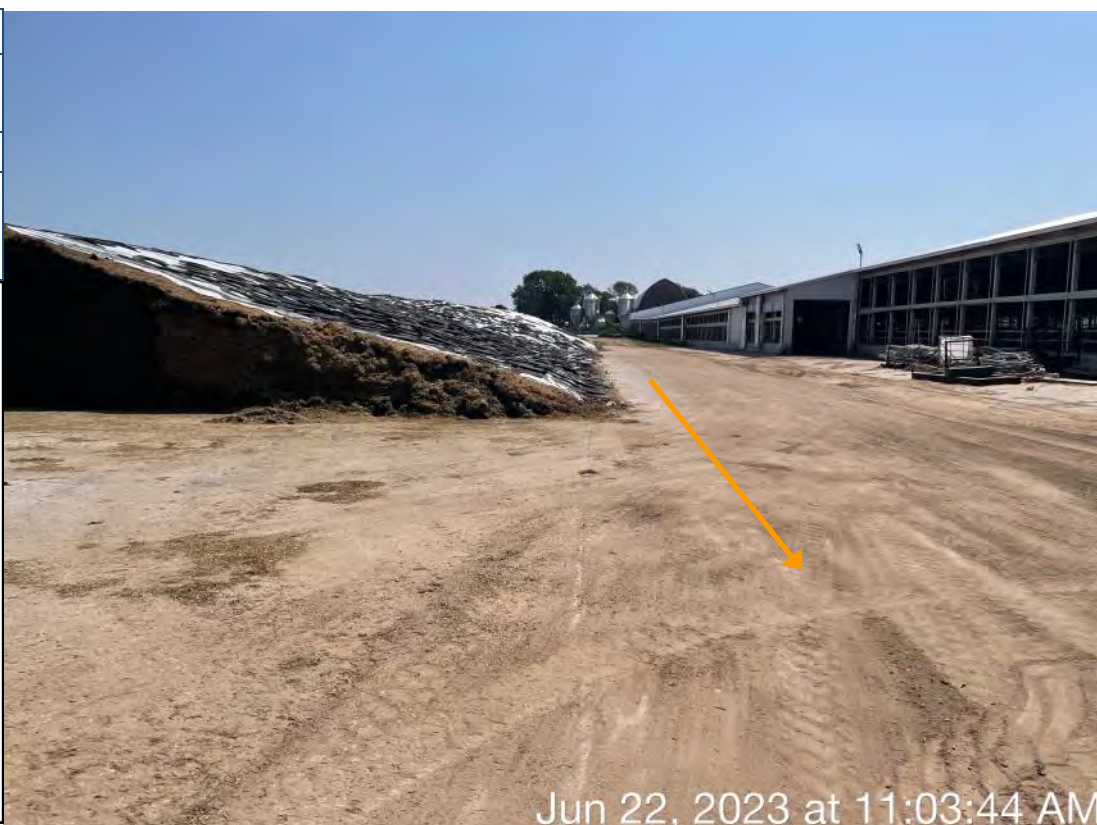
<b>Photo #:</b>	6453
<b>Date/Time of Photo:</b>	6/22/2023 11:03
<b>Photo By:</b>	Brian Hanson
<b>Photo Location:</b>	Karcz Nation Feed Storage
<b>Photo Description:</b>	
<p>Standing at southwest corner of FSA looking east: View of southwest corner of FSA. Arrow indicates direction of runoff flow.</p>

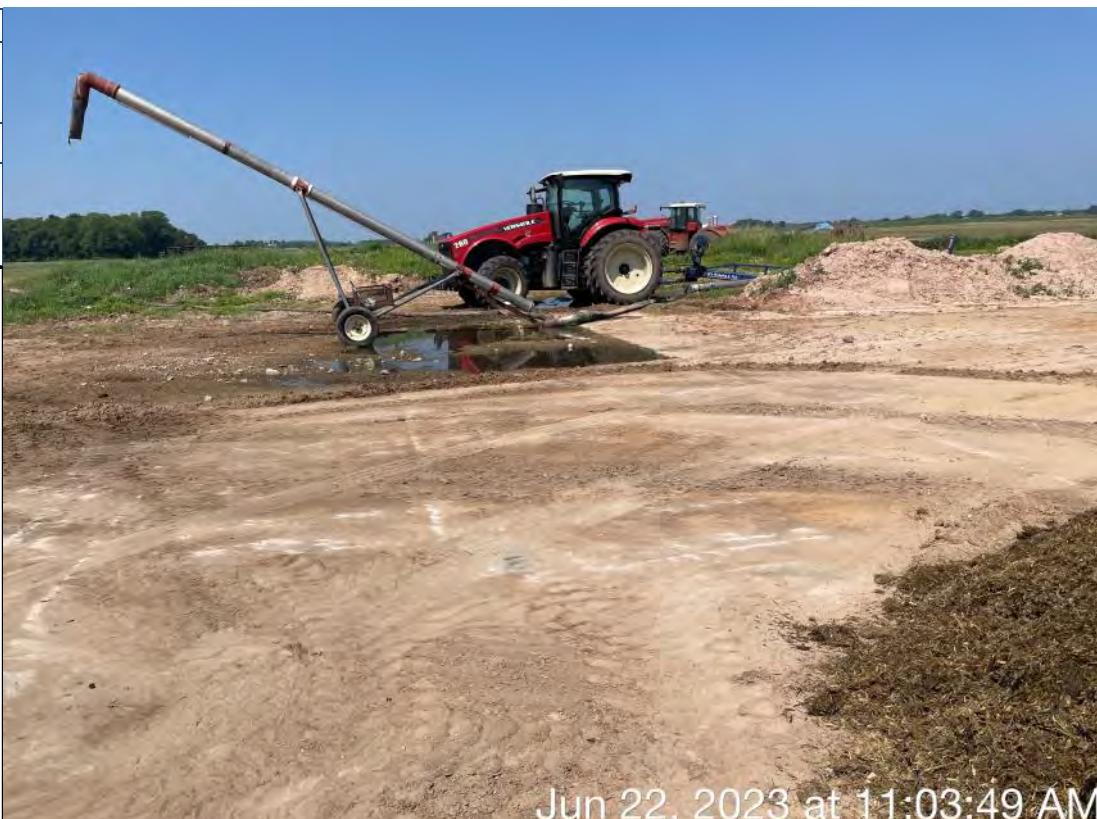
<b>Photo #:</b>	6454
<b>Date/Time of Photo:</b>	6/22/2023 11:03
<b>Photo By:</b>	Brian Hanson
<b>Photo Location:</b>	Karcz Nation Feed Storage
<b>Photo Description:</b>	
<p>Standing at southwest corner of FS looking west. View of southwest corner of FSA. Notice ponded runoff in front of tractor. Water was opaque, blackish in color, and had an odor consistent with feed leachate.</p>

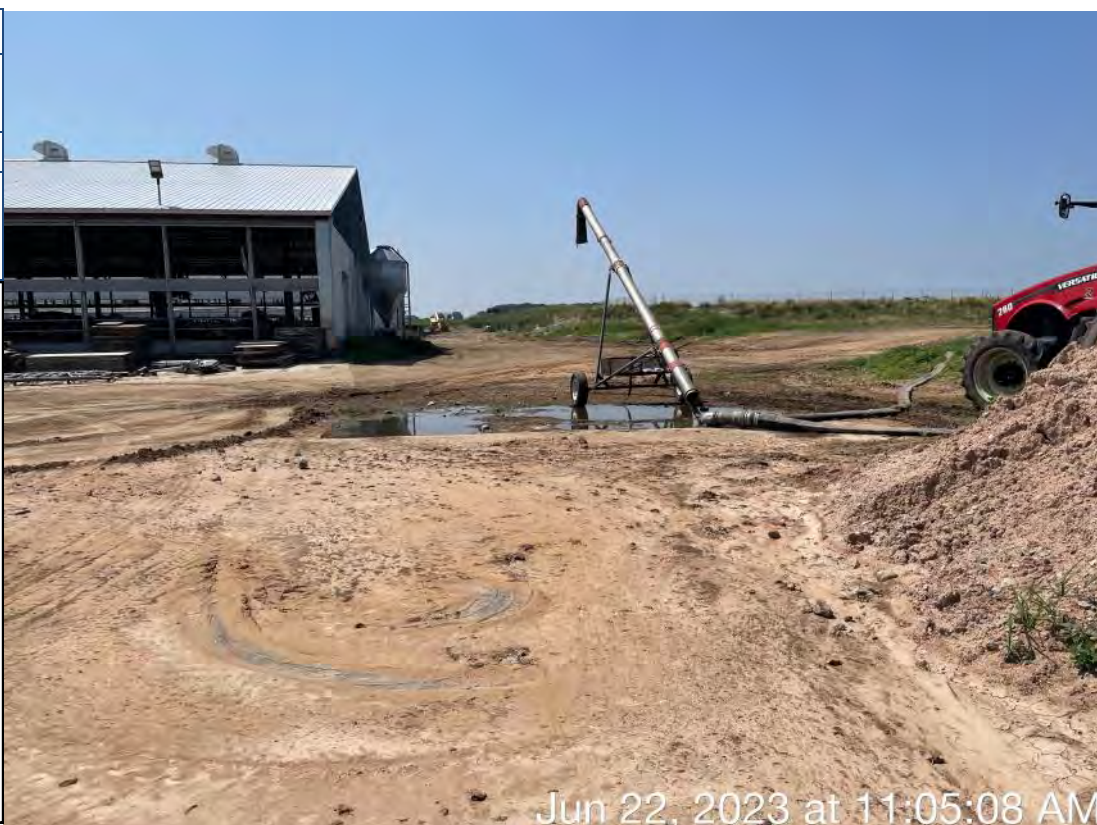
<b>Photo #:</b>	6456
<b>Date/Time of Photo:</b>	6/22/2023 11:05
<b>Photo By:</b>	Brian Hanson
<b>Photo Location:</b>	Karcz Nation Feed Storage
<b>Photo Description:</b>	
Standing on west edge of FSA looking south: Alternate view of ponded runoff off the southwest corner of FSA.

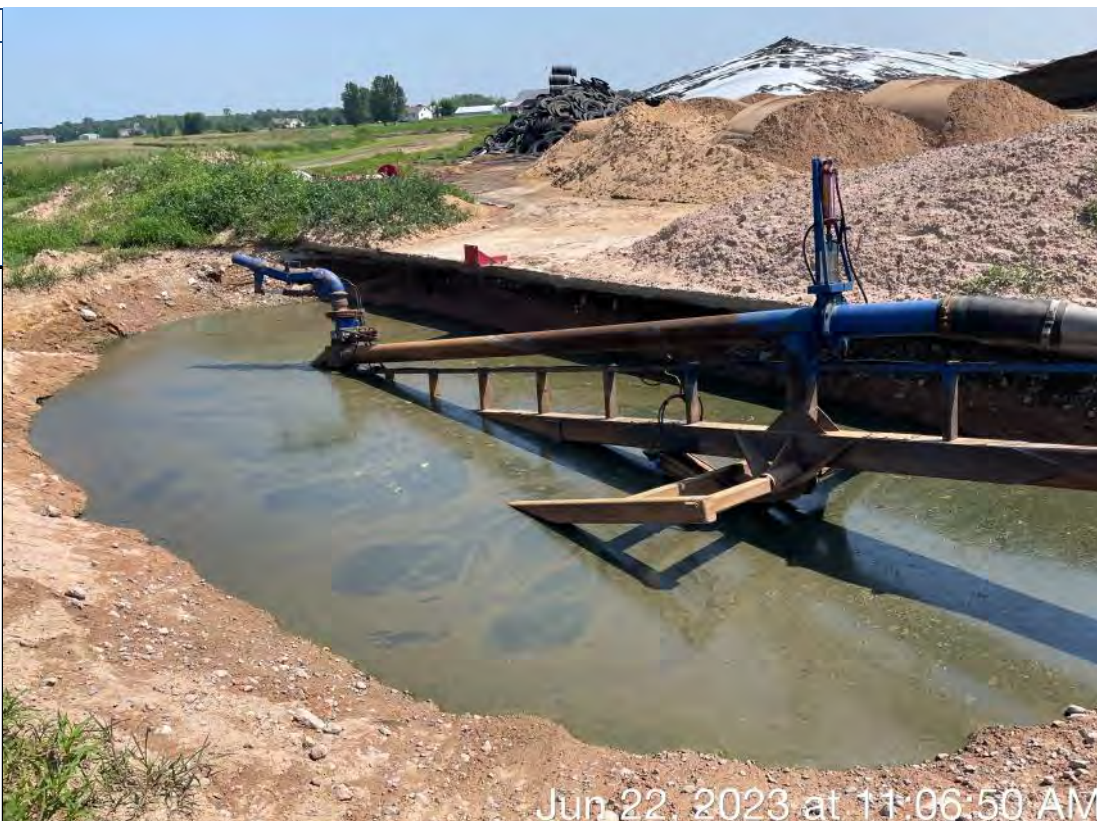
<b>Photo #:</b>	6465
<b>Date/Time of Photo:</b>	6/22/2023 11:06
<b>Photo By:</b>	Brian Hanson
<b>Photo Location:</b>	Karcz Nation Feed Storage
<b>Photo Description:</b>	
Standing on the west side of FSA looking north: View of interim collection basin used to collect runoff from FSA. Lagoon pump is used to transfer runoff to WSF #1 or load into tankers. Water was opaque, black in color, and had an odor consistent with feed leachate.

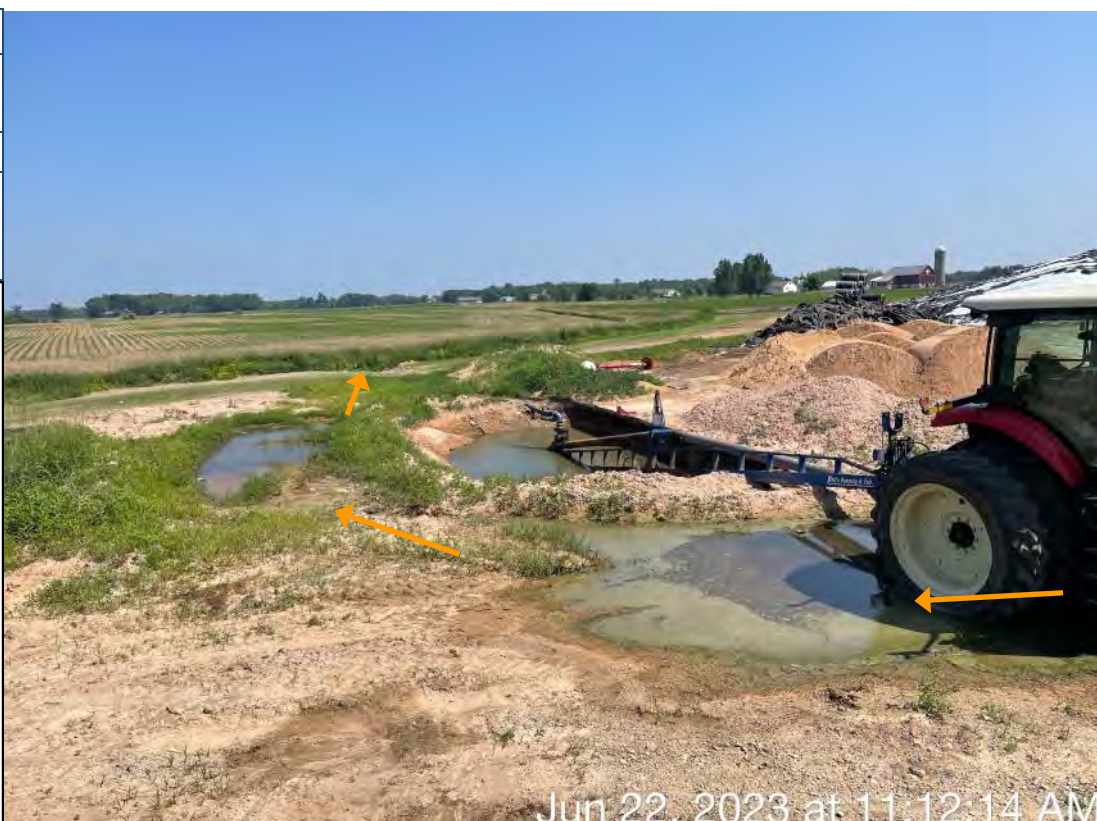
Standing southwest of feed storage area looking north: View of interim runoff collection pond. Notice ponded runoff on south & west sides that is not being collected. This runoff flows northwest straight into stream. Arrows indicate direction of runoff flow.

- Feed storage area does not have engineered runoff controls installed. Interim controls were partially installed, but there was evidence of feed solids & contaminated runoff leaving the feedpad and not being collected by interim measures.
- A pipe outlet was found in the stream located northwest of the feed storage area that had algae growth consistent with water discharging high nutrient loads. The farm did not know the location or origin of this pipe.
- Unconfined manure and straw were located on the adjacent to and in the channel of the stream. The farm explained that they were unaware of this unconfined manure pile.

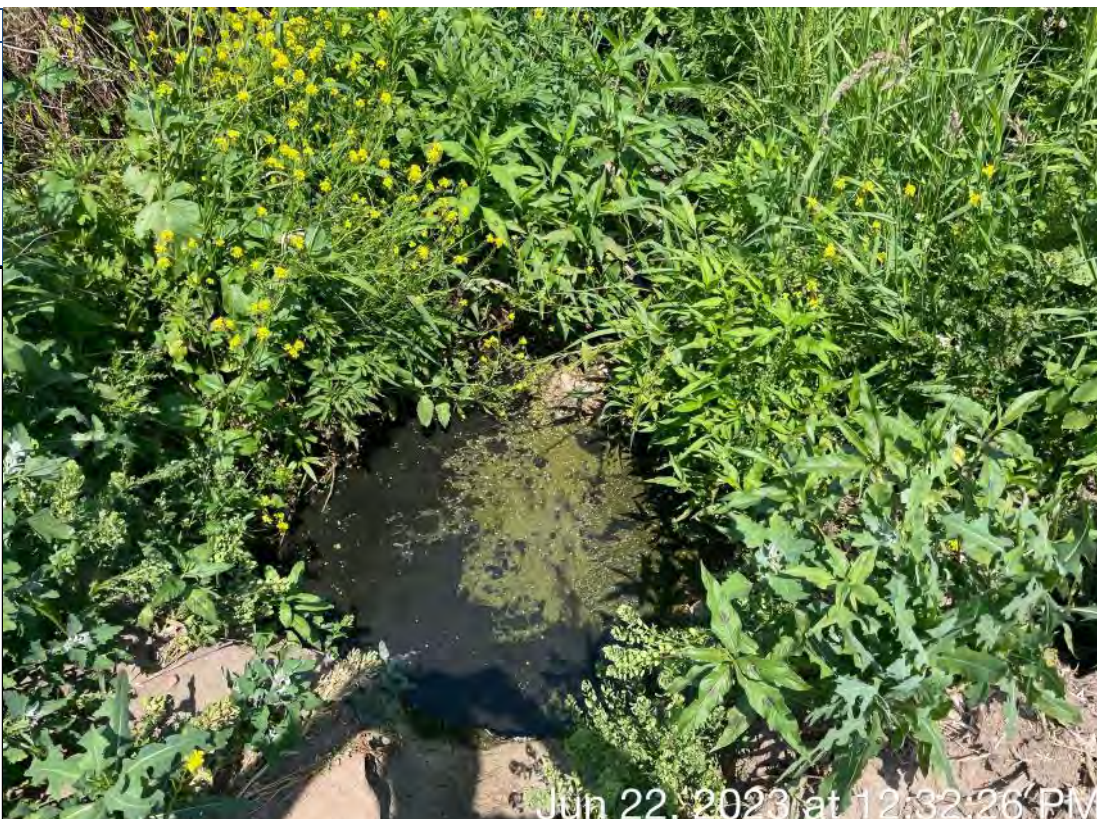
<b>Photo #:</b>	6539
<b>Date/Time of Photo:</b>	6/22/2023 12:32
<b>Photo By:</b>	Brian Hanson
<b>Photo Location:</b>	Karcz Nation Feed Storage

Standing in stream directly downstream of ponded runoff in photo 6469, looking down: View of ponded runoff in bottom of stream adjacent to main flow channel. Water was opaque, blackish in color, and had an odor consistent with feed leachate.

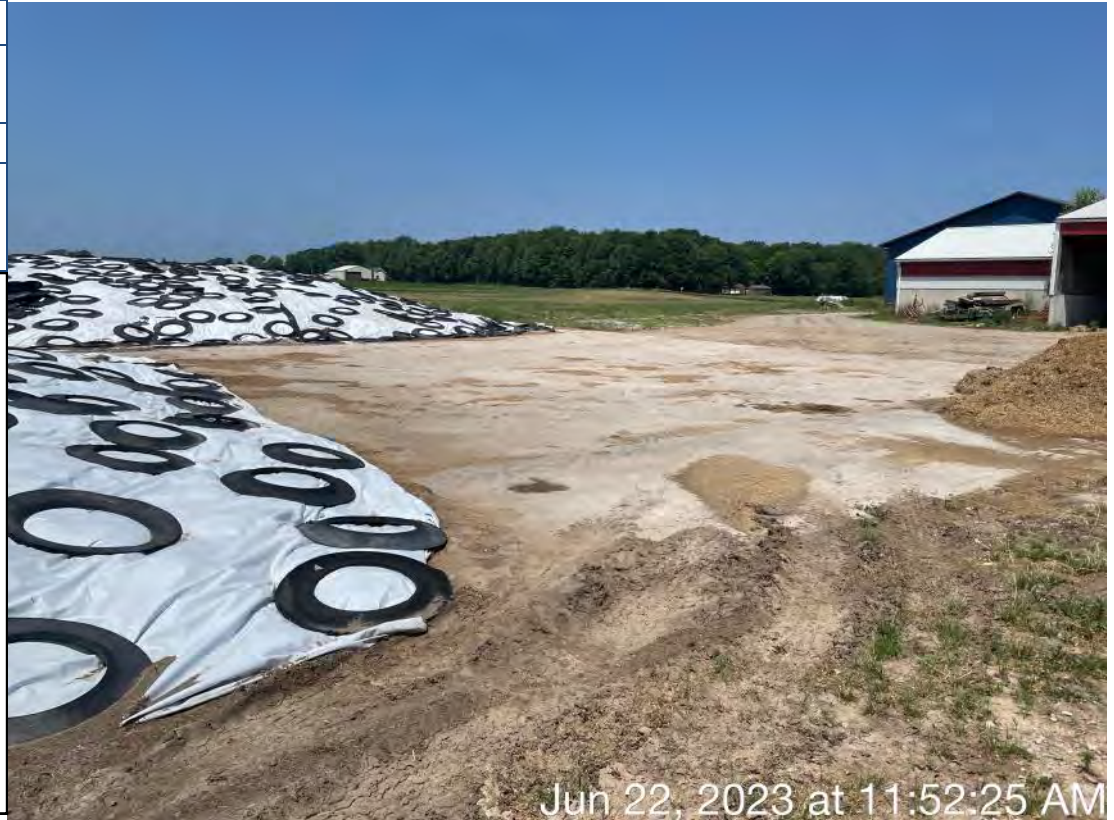
<b>Photo #:</b>	6527
<b>Date/Time of Photo:</b>	6/22/2023 11:52
<b>Photo By:</b>	Brian Hanson
<b>Photo Location:</b>	Heifer Nation Feed Storage
<b>Photo Description:</b>	Standing on east side of FSA looking northwest: View of northeast corner of FSA.

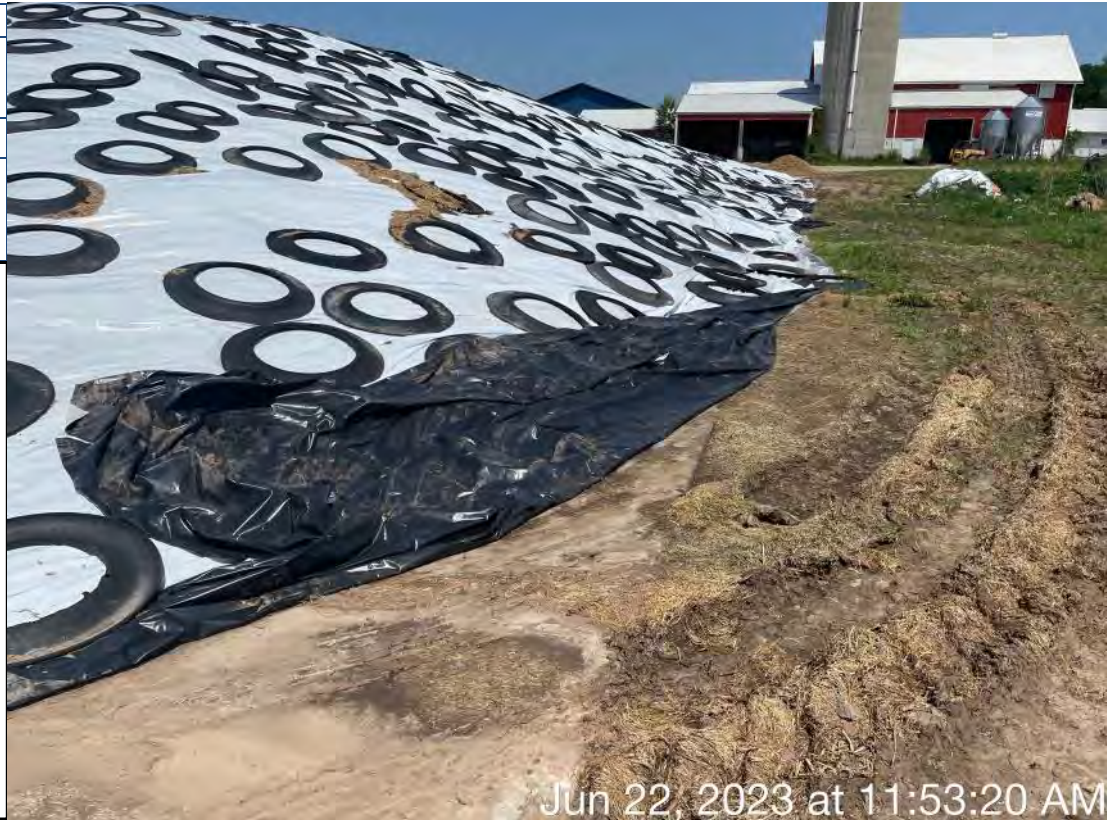
<b>Photo #:</b>	6530
<b>Date/Time of Photo:</b>	6/22/2023 11:53
<b>Photo By:</b>	Brian Hanson
<b>Photo Location:</b>	Heifer Nation Feed Storage
<b>Photo Description:</b>	Standing at southeast corner of FSA looking north: View of east edge of FSA.

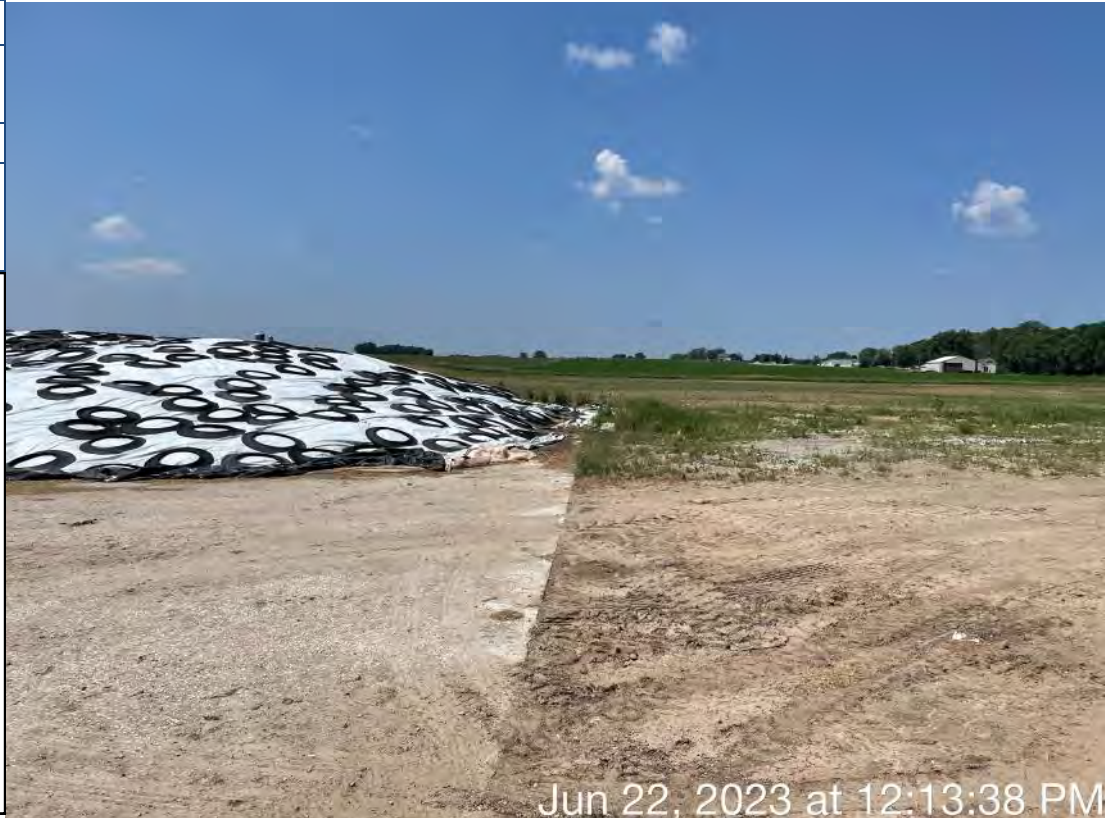
<b>Photo #:</b>	6533
<b>Date/Time of Photo:</b>	6/22/2023 12:13
<b>Photo By:</b>	Brian Hanson
<b>Photo Location:</b>	Heifer Nation Feed Storage

**Photo Description:**  
Standing on the north side of FSA looking west: View of north edge of FSA.

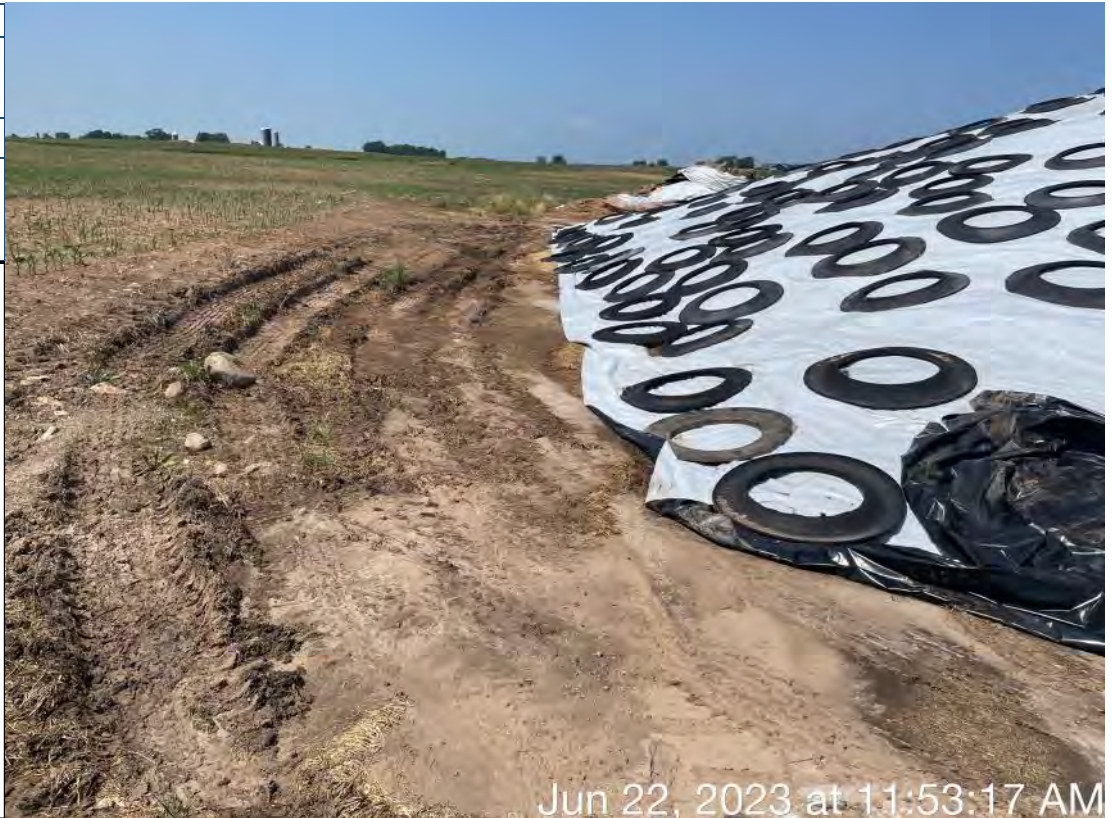
**Photo Description:**  
Standing at southwest corner of FSA looking north: View of west edge of FSA.

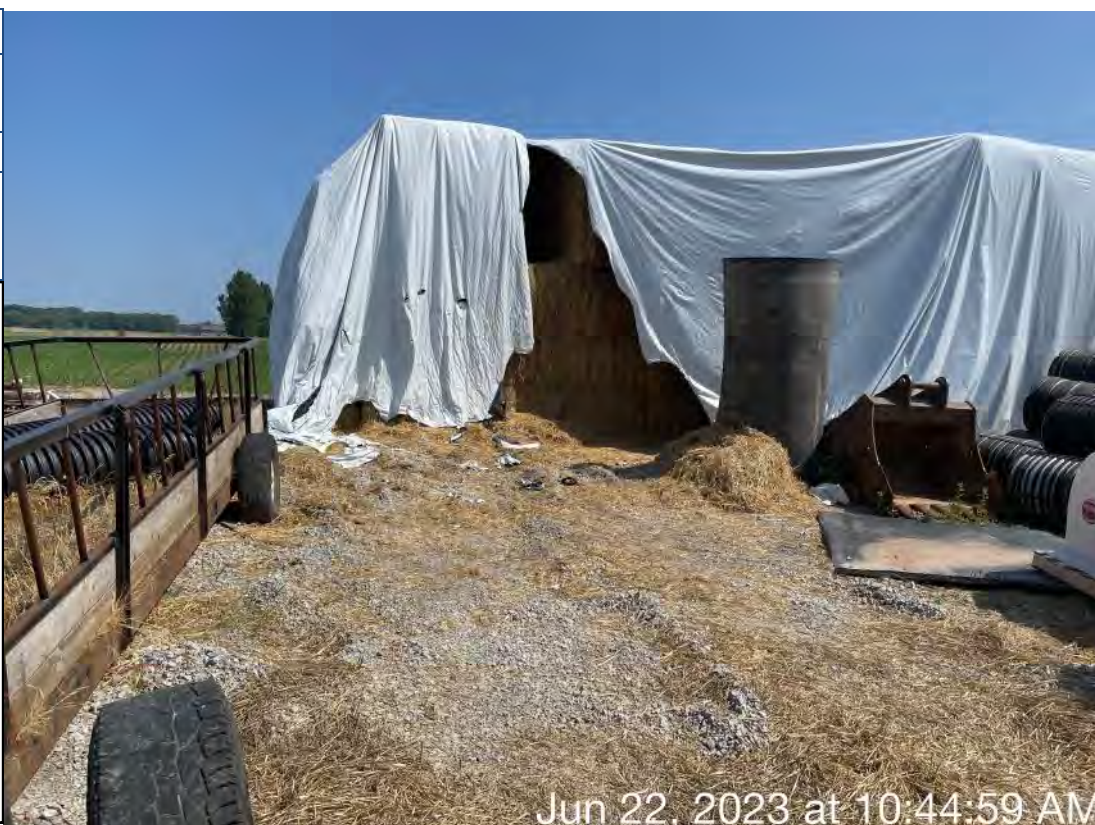
**Photo Description:**  
Standing on north side of shop looking north: View of straw & hay storage area. Bales are placed on a gravel pad & covered with plastic tarp.

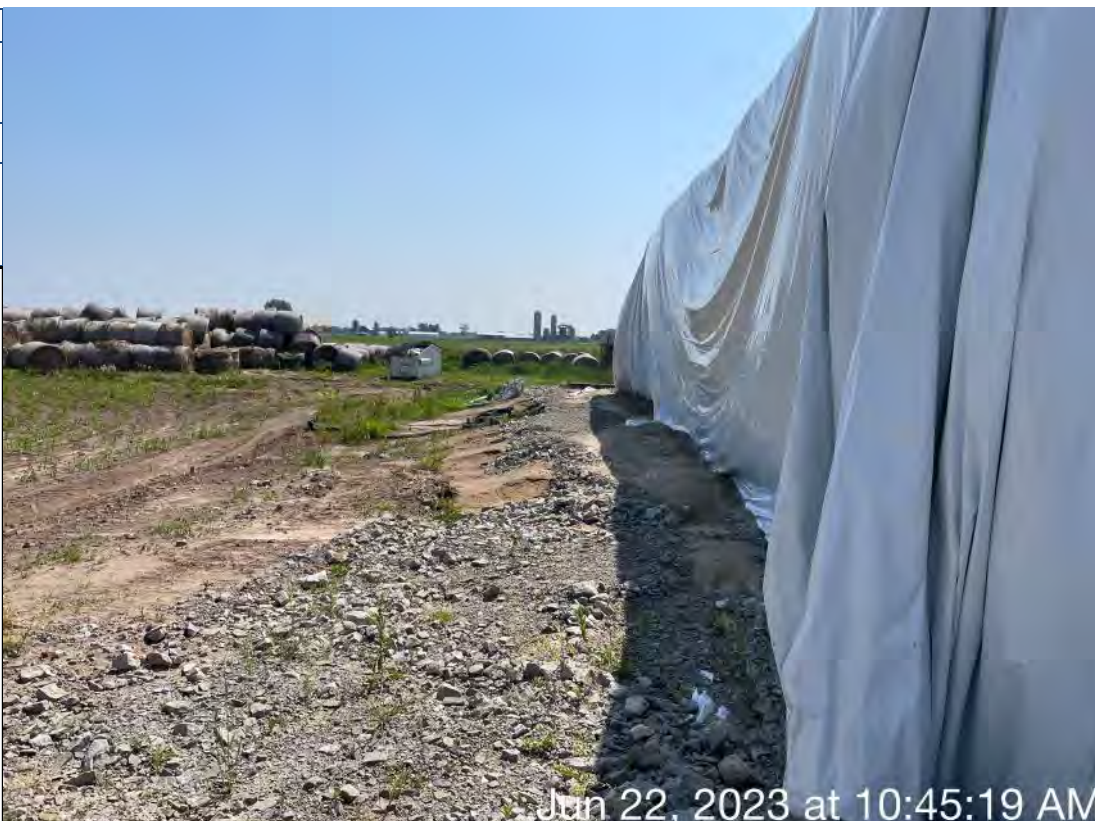
**Photo Description:**  
Standing on north side of bale storage area looking east: View of area adjacent to baled feed. No signs of current or past discharges from this area.

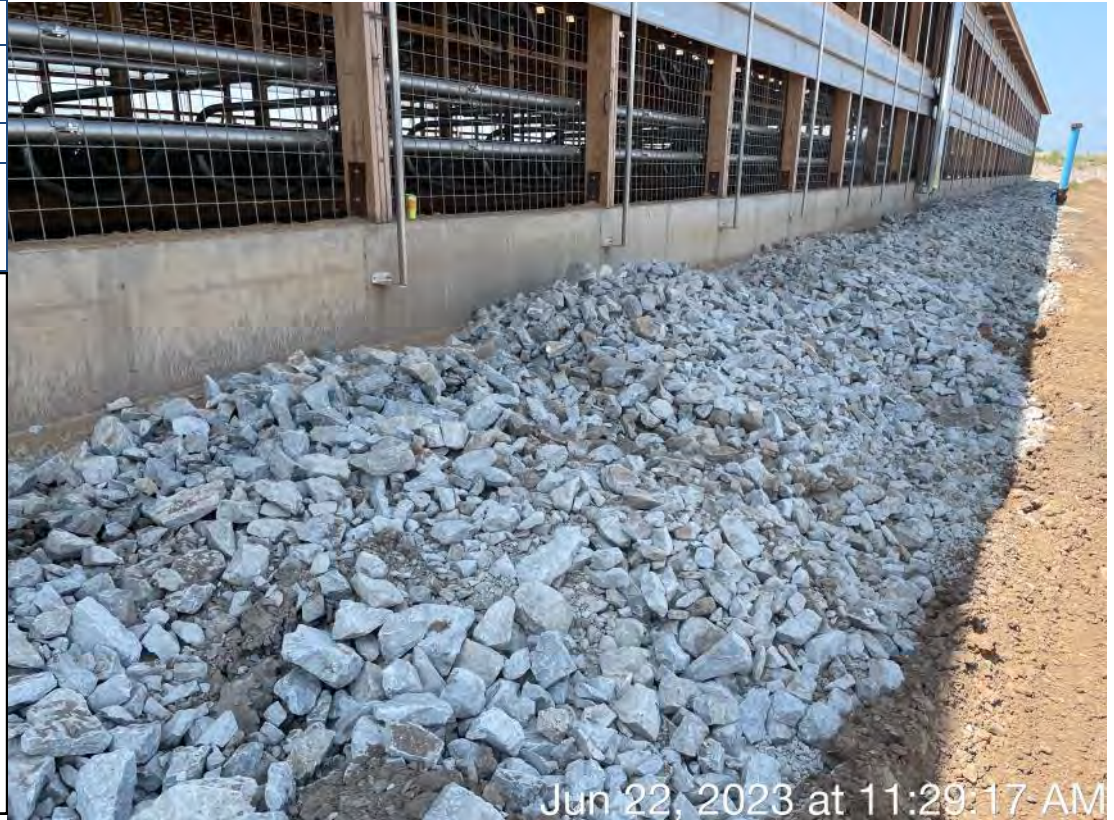
<b>Photo #:</b>	6501
<b>Date/Time of Photo:</b>	6/22/2023 11:29
<b>Photo By:</b>	Brian Hanson
<b>Photo Location:</b>	Karcz Nation Stormwater

Standing in between the freestall barns looking east: View of gravel stormwater drain along south freestall barn. Gravel drain contains tile line to take clean stormwater away from area.

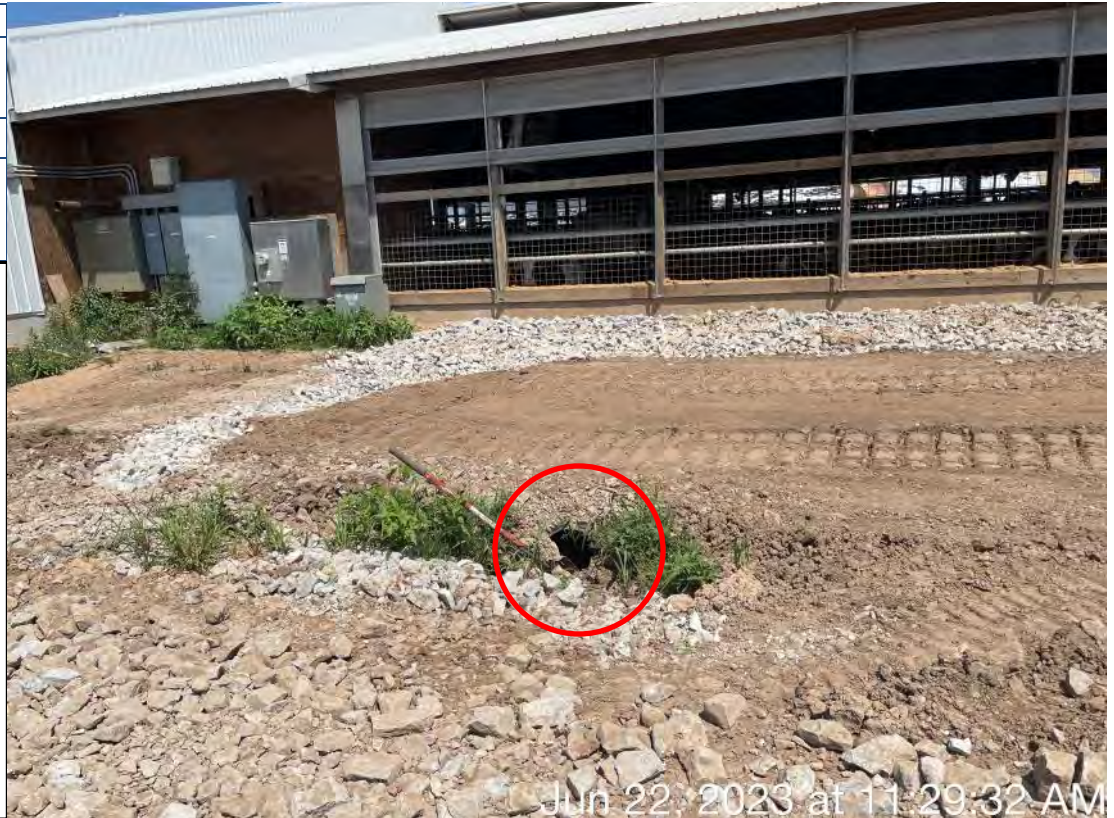
<b>Photo #:</b>	6503
<b>Date/Time of Photo:</b>	6/22/2023 11:29
<b>Photo By:</b>	Brian Hanson
<b>Photo Location:</b>	Karcz Nation Stormwater

Standing in between the freestall barns looking north: View of surface inlet for stormwater.

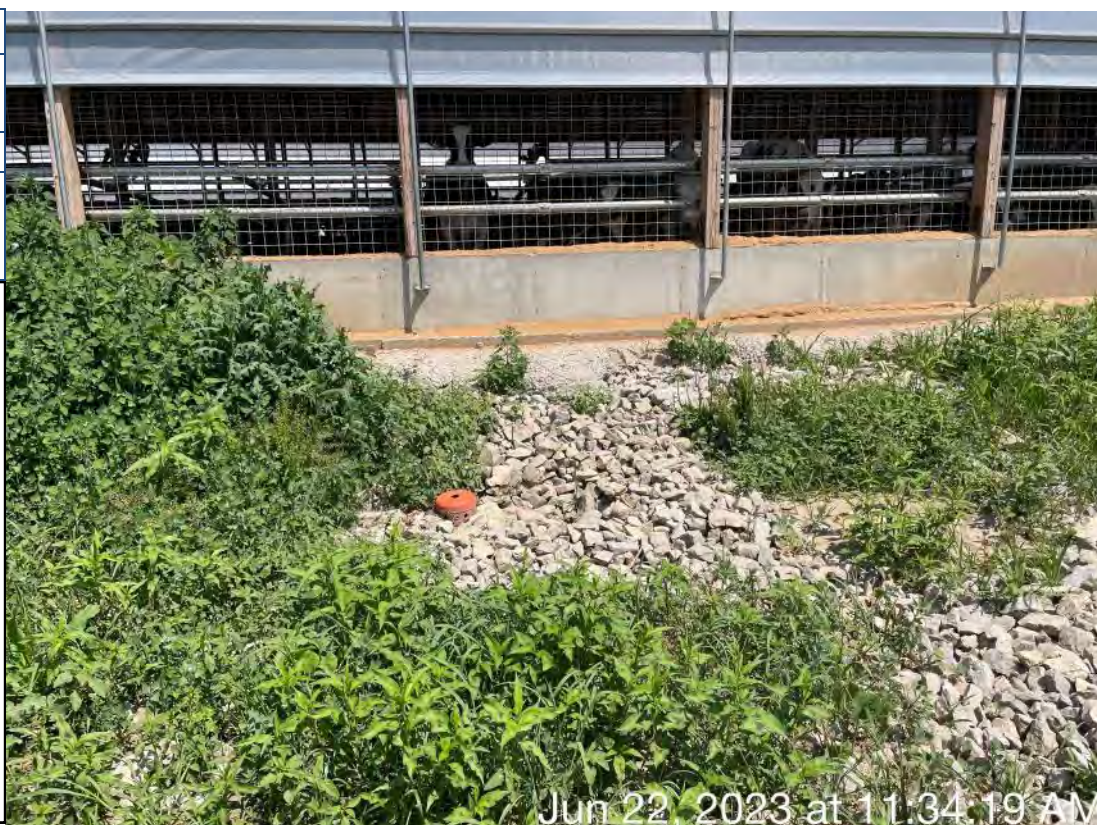
**Photo Description:**  
 Standing on the south side of freestall barns looking north: View of stormwater inlet on south side of south barn.

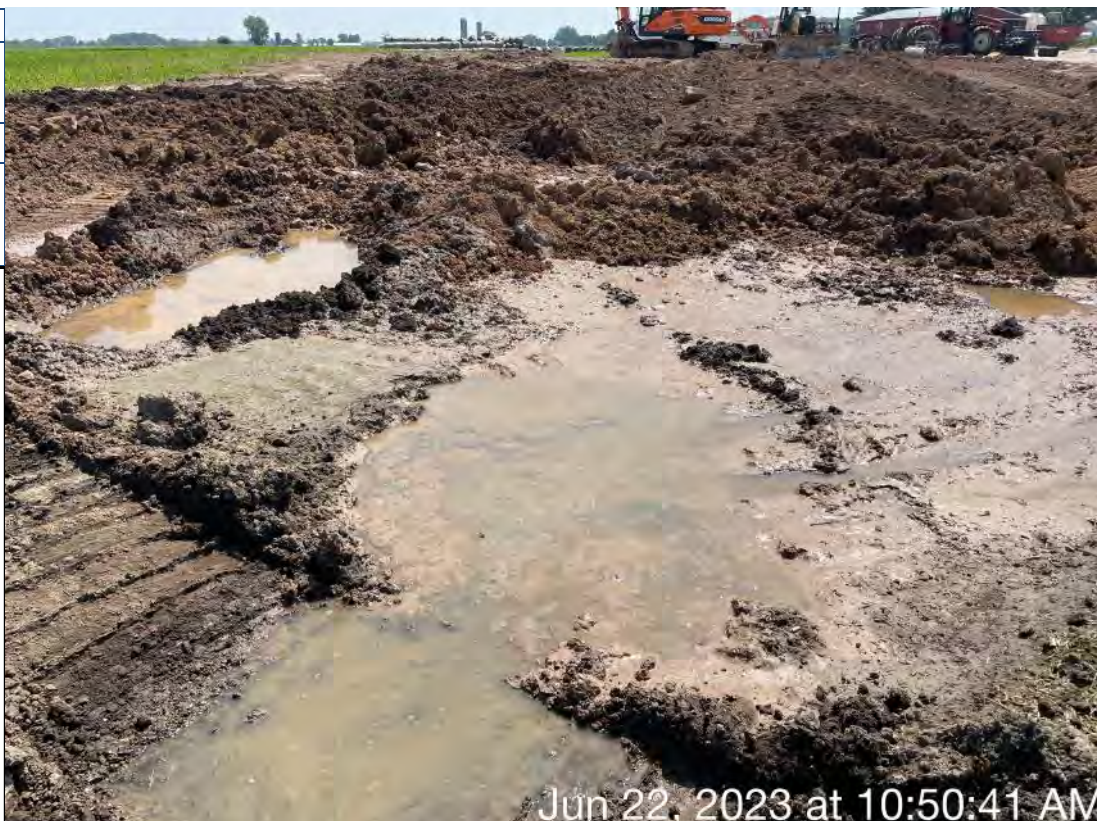
**Photo Description:**  
 Standing north of Feedpad looking east: View of recently fixed tile blowout area in filed north of FSA. Ponded water in this area was clear and showed no signs of pollutants.

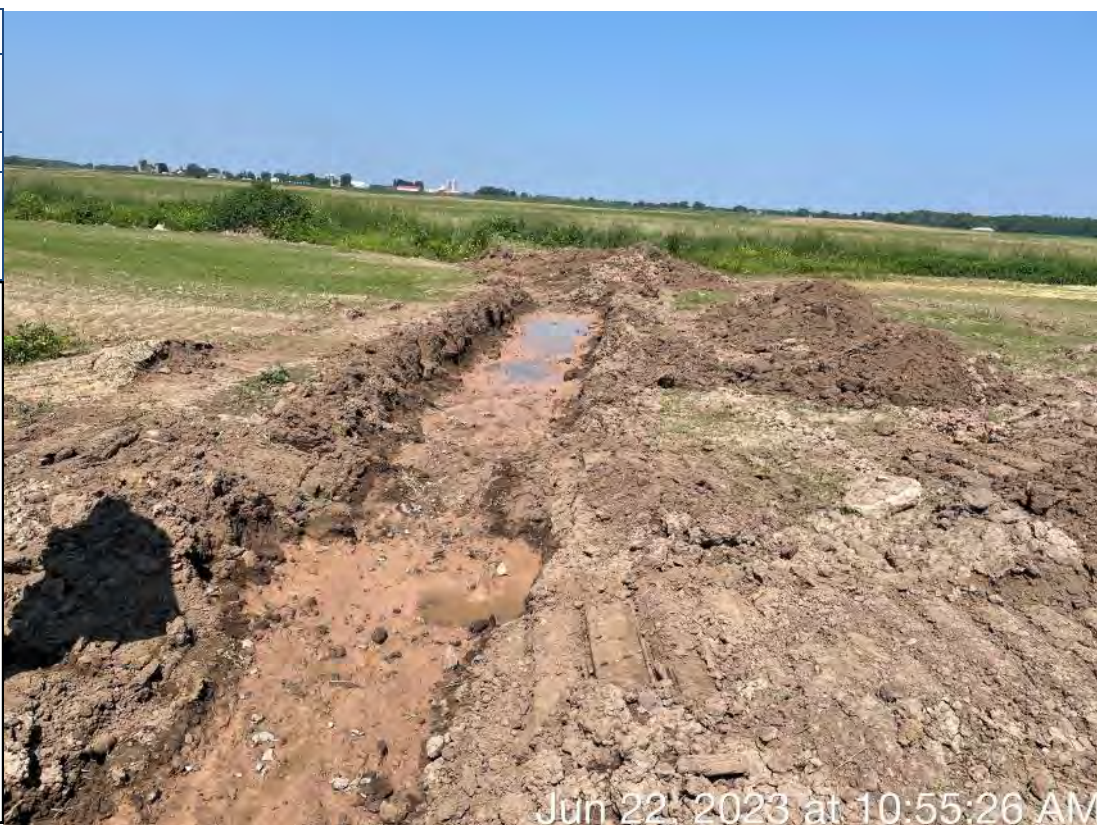
<b>Photo #:</b>	6435
<b>Date/Time of Photo:</b>	6/22/2023 10:55
<b>Photo By:</b>	Brian Hanson
<b>Photo Location:</b>	Karcz Nation Stormwater
<b>Photo Description:</b>	Standing north of FSA near tile blowout area looking west: View of trench dug by farm to drain the water from the tile blowout area to the stream.

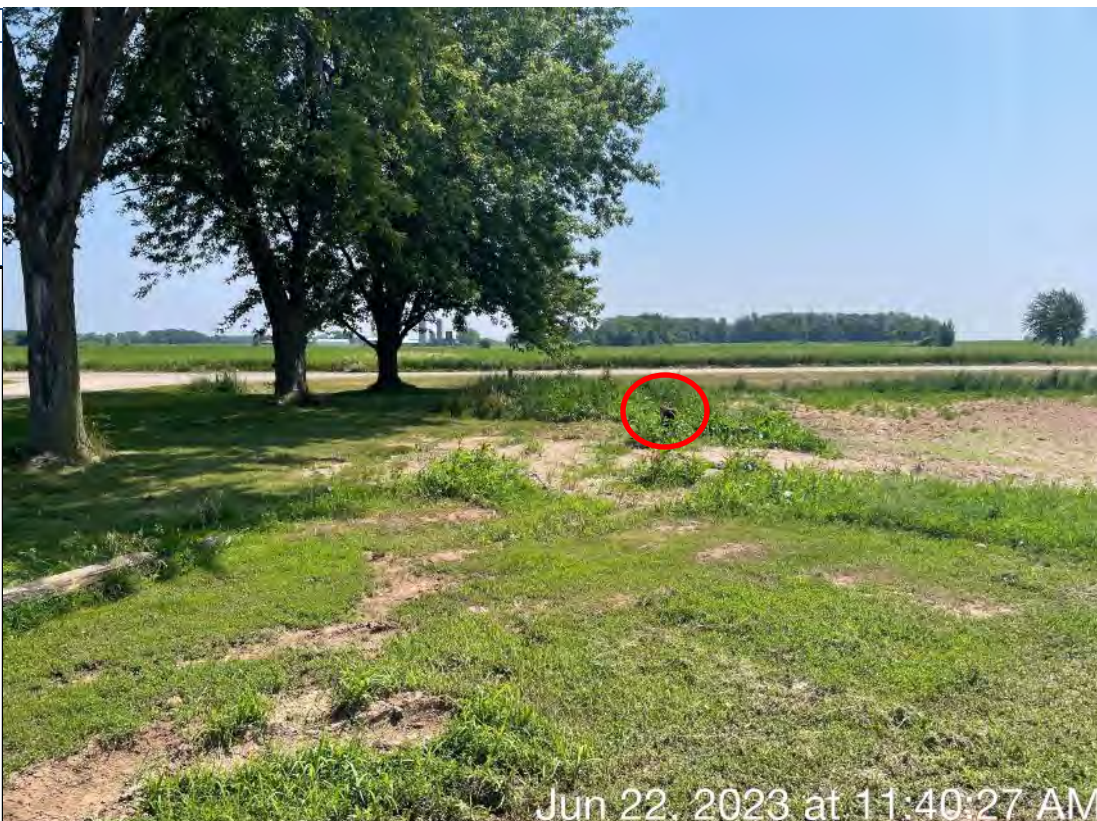
<b>Photo #:</b>	6509
<b>Date/Time of Photo:</b>	6/22/2023 11:40
<b>Photo By:</b>	Brian Hanson
<b>Photo Location:</b>	Karcz Nation Well Locations
<b>Photo Description:</b>	Standing east of the parlor looking east: View of water supply well location just south of the driveway. Identified as:  Hi Cap #93841  Unique Well Id: ZL844

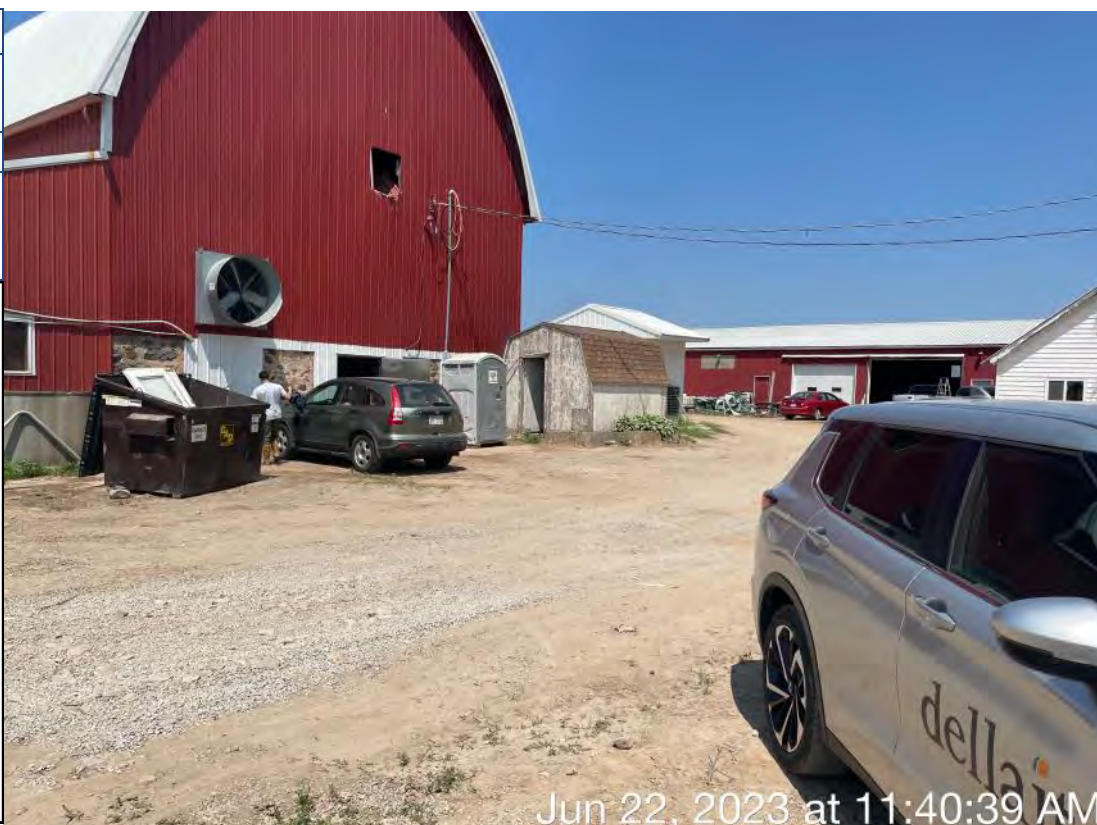
<b>Photo #:</b>	6510
<b>Date/Time of Photo:</b>	6/22/2023 11:40
<b>Photo By:</b>	Brian Hanson
<b>Photo Location:</b>	Karcz Nation Well Locations
<b>Photo Description:</b>	Standing on the east side of the parlor looking northwest: View of water supply well location. According to farm, well is located inside white shed on east end of parlor. Identified as:  Hi Cap # 93840

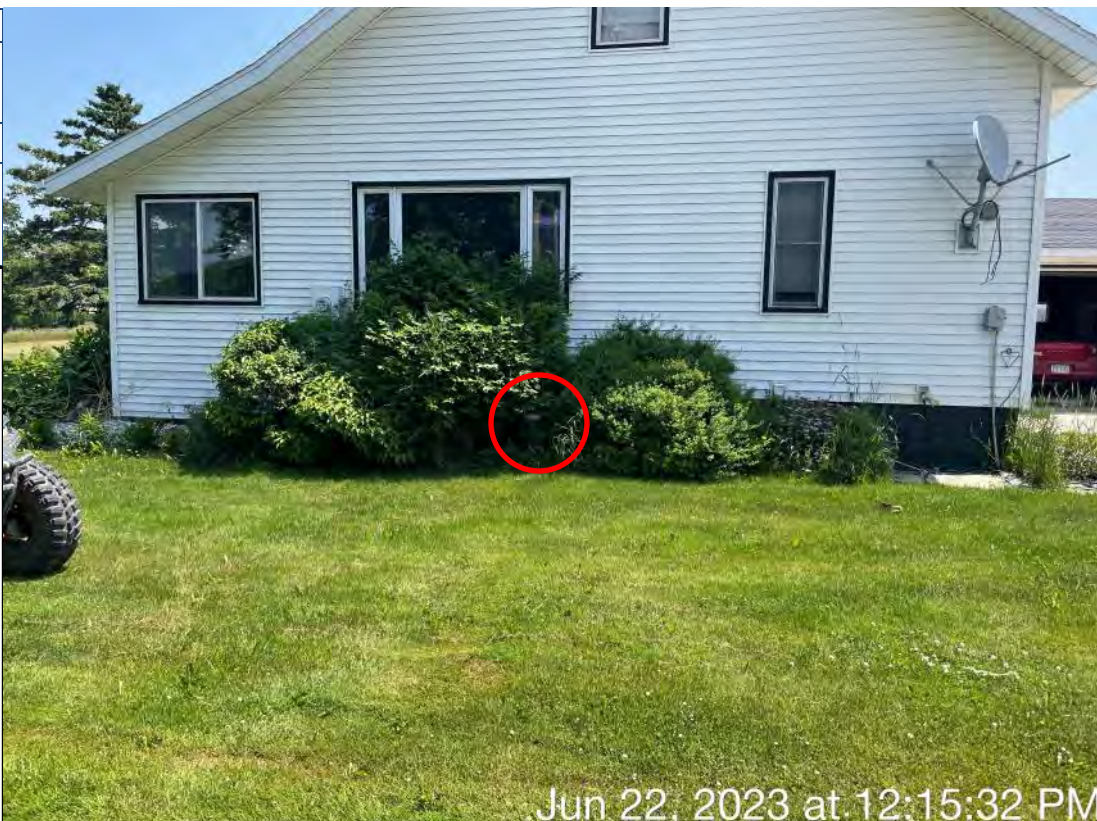
<b>Photo #:</b>	6535
<b>Date/Time of Photo:</b>	6/22/2023 12:15
<b>Photo By:</b>	Brian Hanson
<b>Photo Location:</b>	Heifer Nation Well Locations
<b>Photo Description:</b>	Standing east of shed looking east: View of water supply well location at heifer farm. Well located on west side of house in bushes. Believed to be Unique well ID: GW265
