# Permit Fact Sheet

Permit Number:	WI-0067385-01-0
Permittee Name:	Karcz Nation, LLC
Address:	N3035 Willow Road
City/State/Zip:	Pulaski WI 54162
Discharge Location:	Karcz Nation – N3035 Willow Road, Pulaski, WI 54162; E ½ of SE ¼ Section 28, T26N, R18E Heifer Nation – W1455 Town Hall Dr, Pulaski, WI 54162; NW ¼ of NE ¼ Section 28, T26N, R18E
Receiving Water:	unnamed tributary within the Pensaukee River Watershed, and groundwaters of the state
Stream Classification:	303(d) impaired by “total phosphorus”
Discharge Type:	Existing

## Site Overview Diagram (Karcz Nation LLC & Heifer Nation LLC)

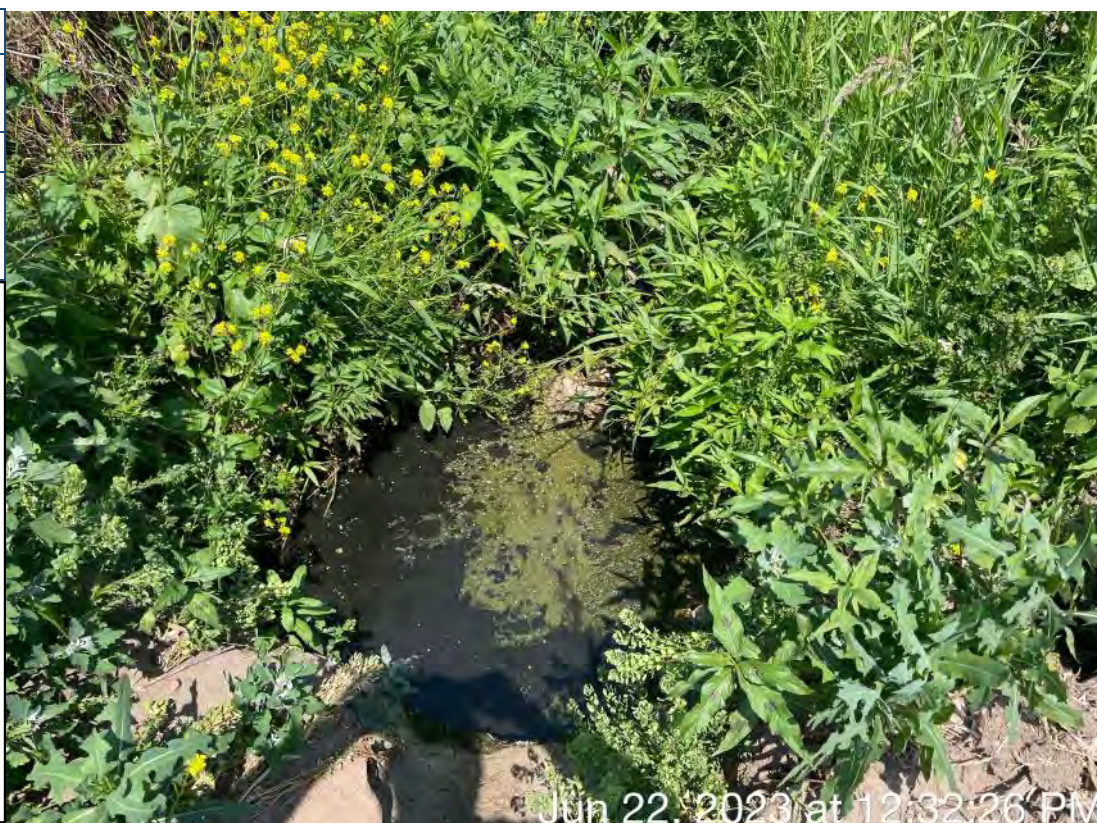
<b>Photo #:</b>	6539
<b>Date/Time of Photo:</b>	6/22/2023 12:32
<b>Photo By:</b>	Brian Hanson
<b>Photo Location:</b>	Karcz Nation Stream

**Photo Description:**  
 Standing on bank of stream west of Feed Storage area looking west & down: View of ponded runoff in bottom of ditch adjacent to active flow channel. Water was opaque, blackish in color, and had an odor consistent with feed leachate.

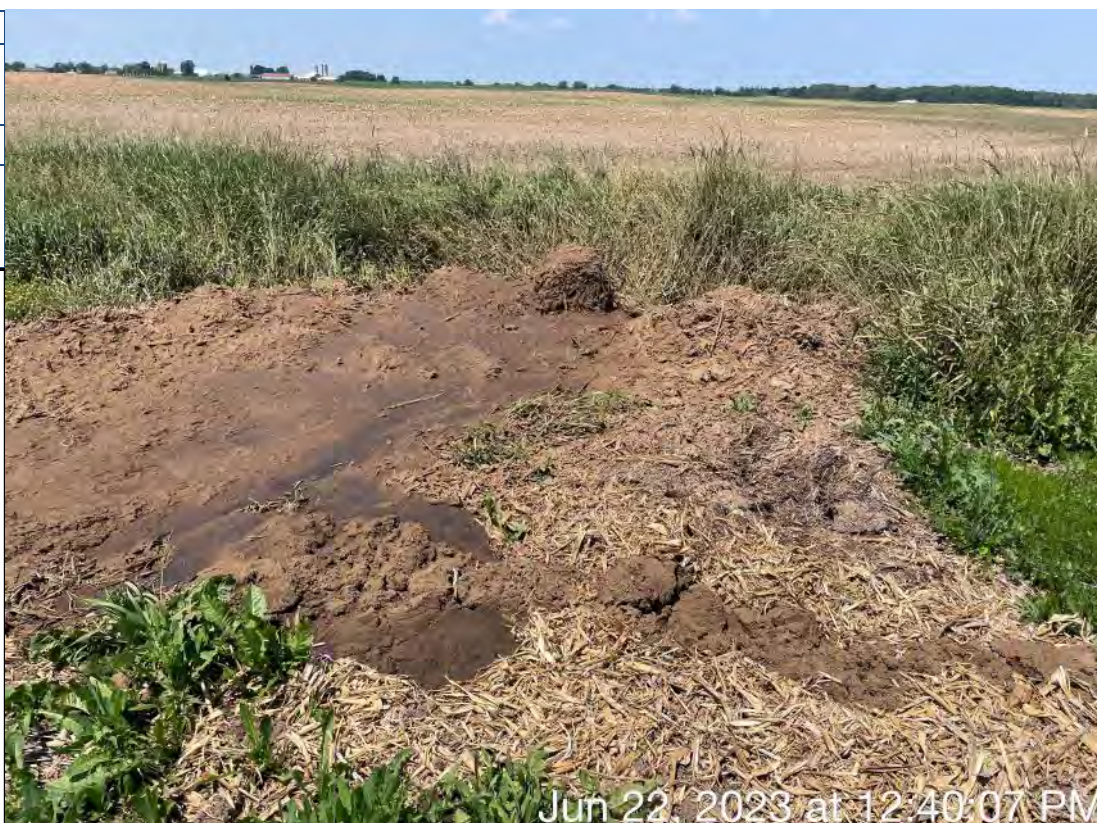
**Photo Description:**  
 Standing northwest of WSF #1 looking west: View of manure & straw pile located on top of stream ditch bank. Straw appeared to be placed as a dam which was then covered in manure.

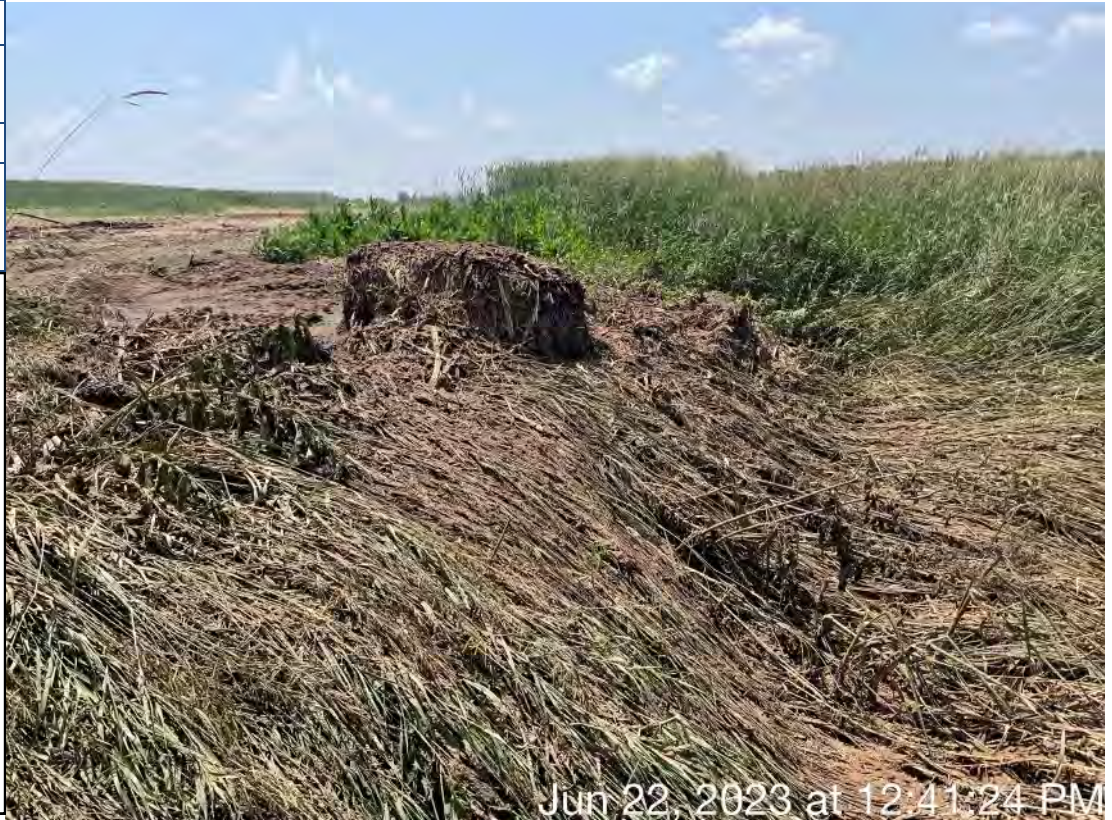
**Photo Description:**  
Standing in stream northwest of WSF #1 looking south: View of manure flow path entering stream. Notice tall vegetation matted down in direction of channel indicating large volume or high velocity. Manure solids apparent all the way to bottom of channel

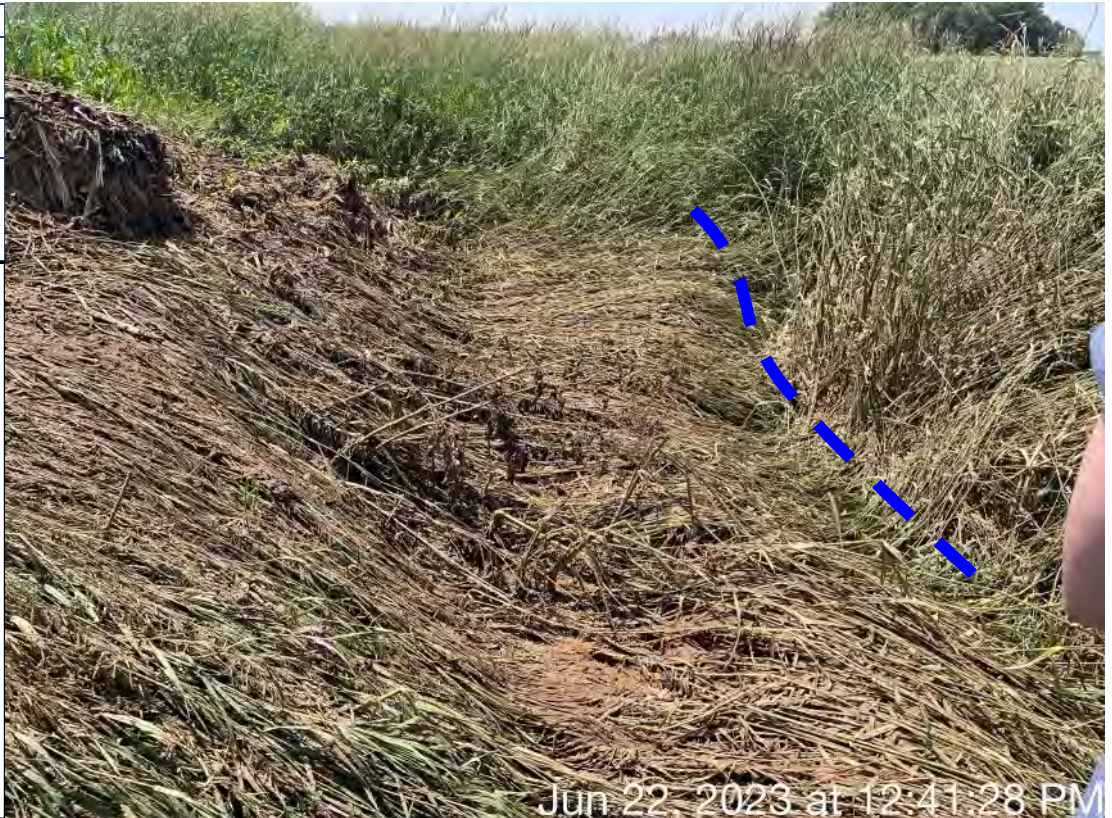
**Photo Description:**  
Standing in stream northwest of WSF #1 looking south: Alternate view of stream near manure flow path. Dashed line indicated location of actively flow water channel.

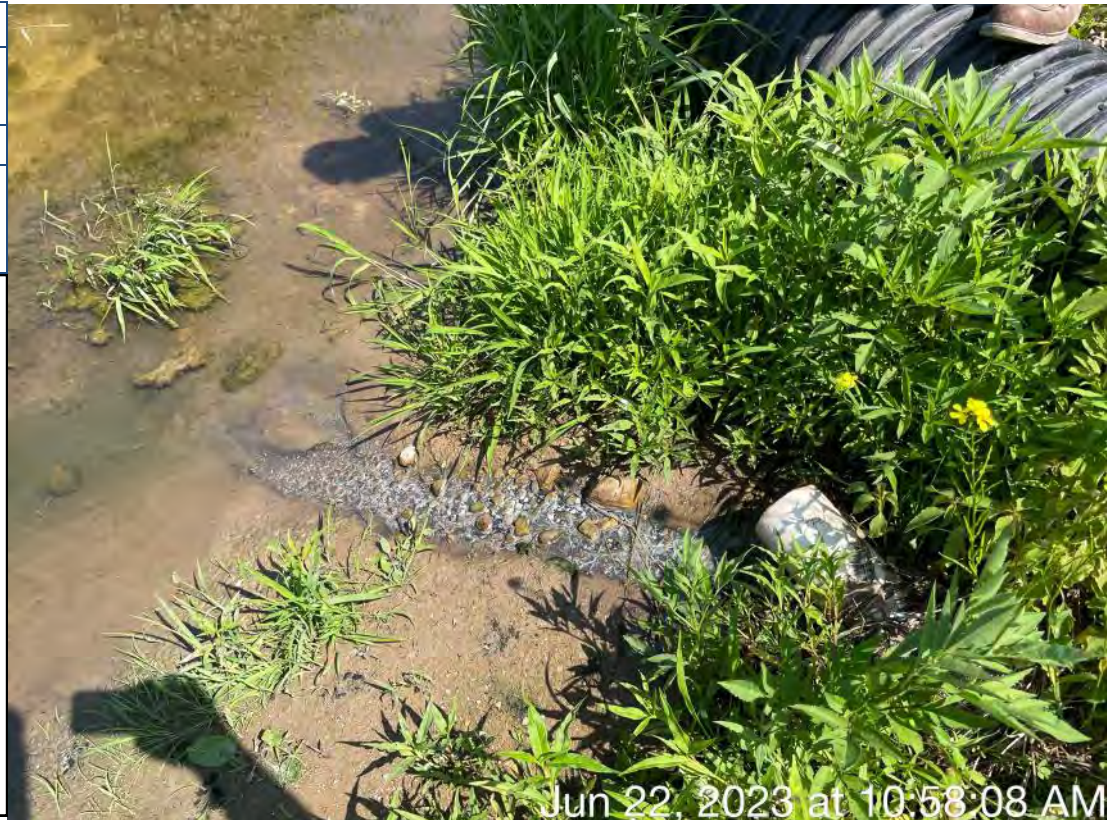
Standing on bank of stream northwest of Feed Storage area looking west & down: View of pipe outlet discharging into stream. Water appeared clear, but algal growth directly below pipe indicates some type of nutrient loading. Farm did not know where this pipe leads to or what it is connected to.

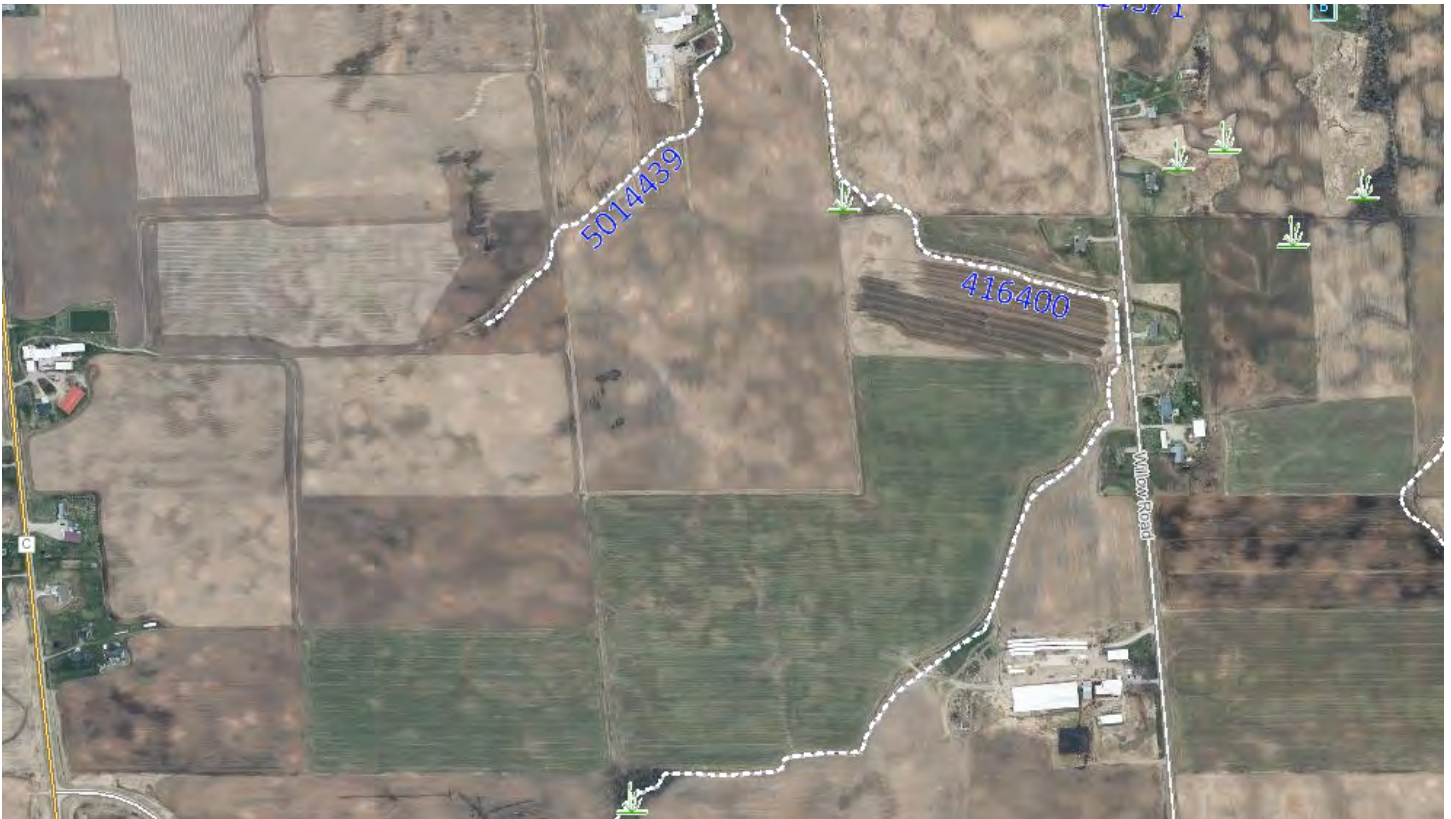
Site overview showing waterbodies in vicinity of farm. Intermittent streams with WBIC Code & wetlands mapped. From DNR Surface Water Data Viewer.

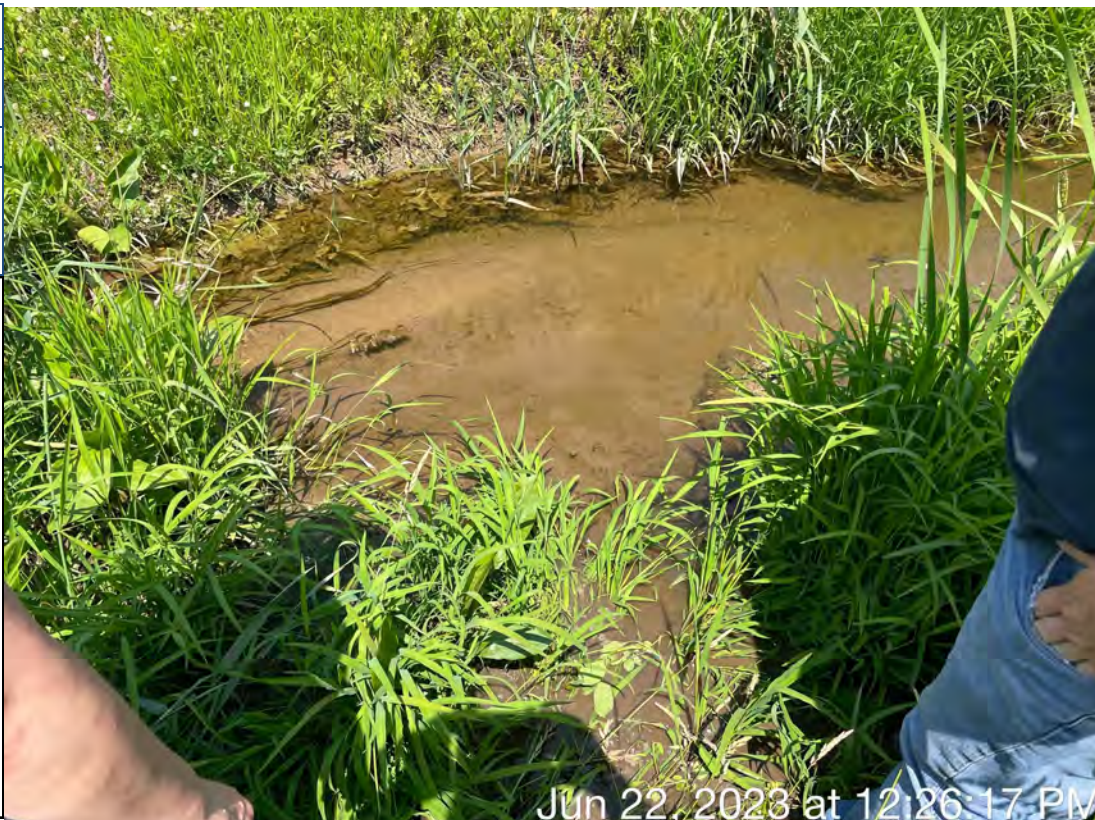
Standing on east side of stream looking west & down: View of stream location at water sample ID: Down. Flowing water was clear with no visible signs impairment.

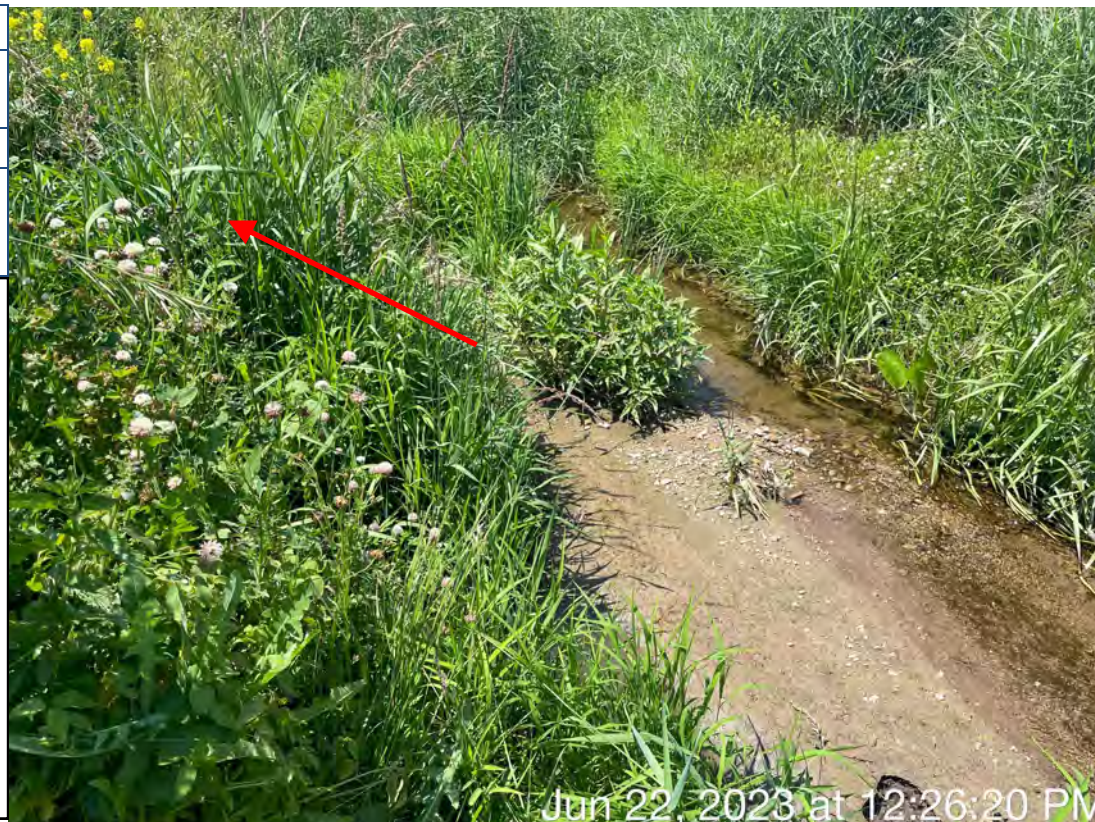
Standing on east side of stream looking south & down: View of stream location at sample ID: Swale. Flowing water was clear with no visible signs impairment. Arrow points to location of next photo, #6539.

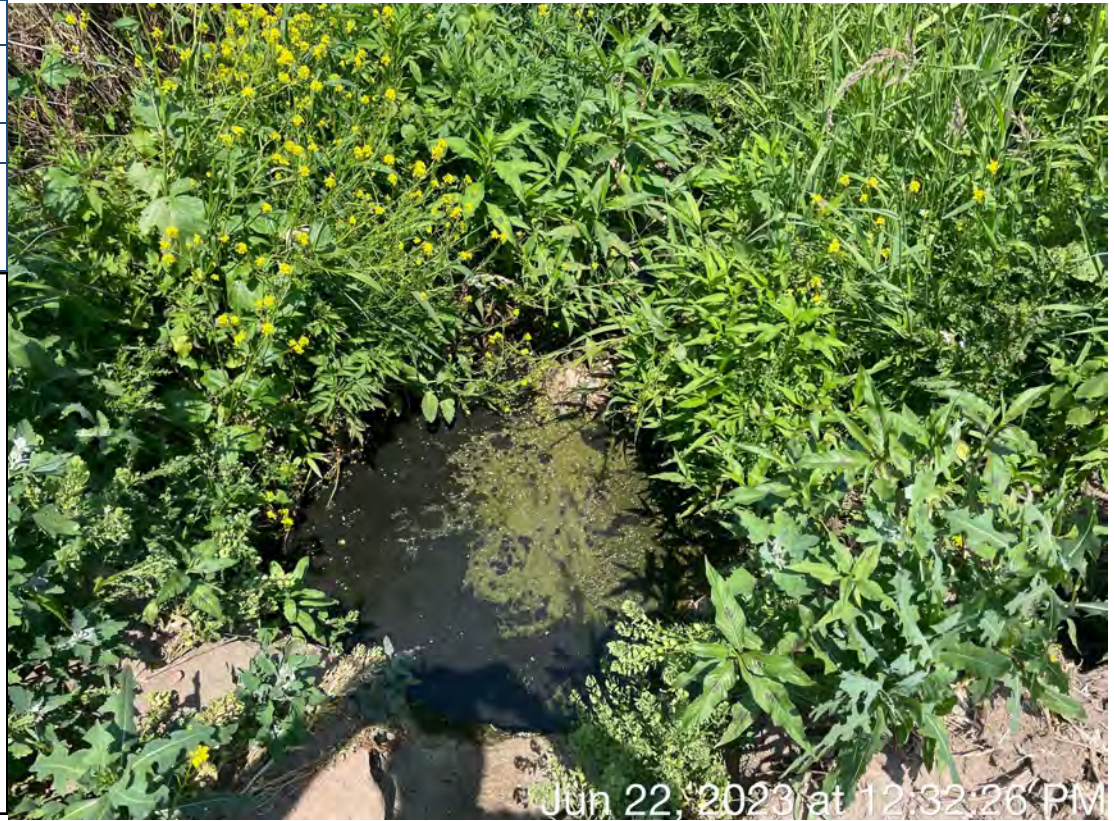
<b>Photo #:</b>	6539
<b>Date/Time of Photo:</b>	6/22/2023 12:32
<b>Photo By:</b>	Brian Hanson
<b>Photo Location:</b>	Karcz Nation Water Samples

Standing on east side of stream looking west & down: View of ponded feed storage area runoff in bottom of stream channel adjacent to water sample ID: Swale. Water is opaque, blackish in color, and had an odor consistent with feed leachate.

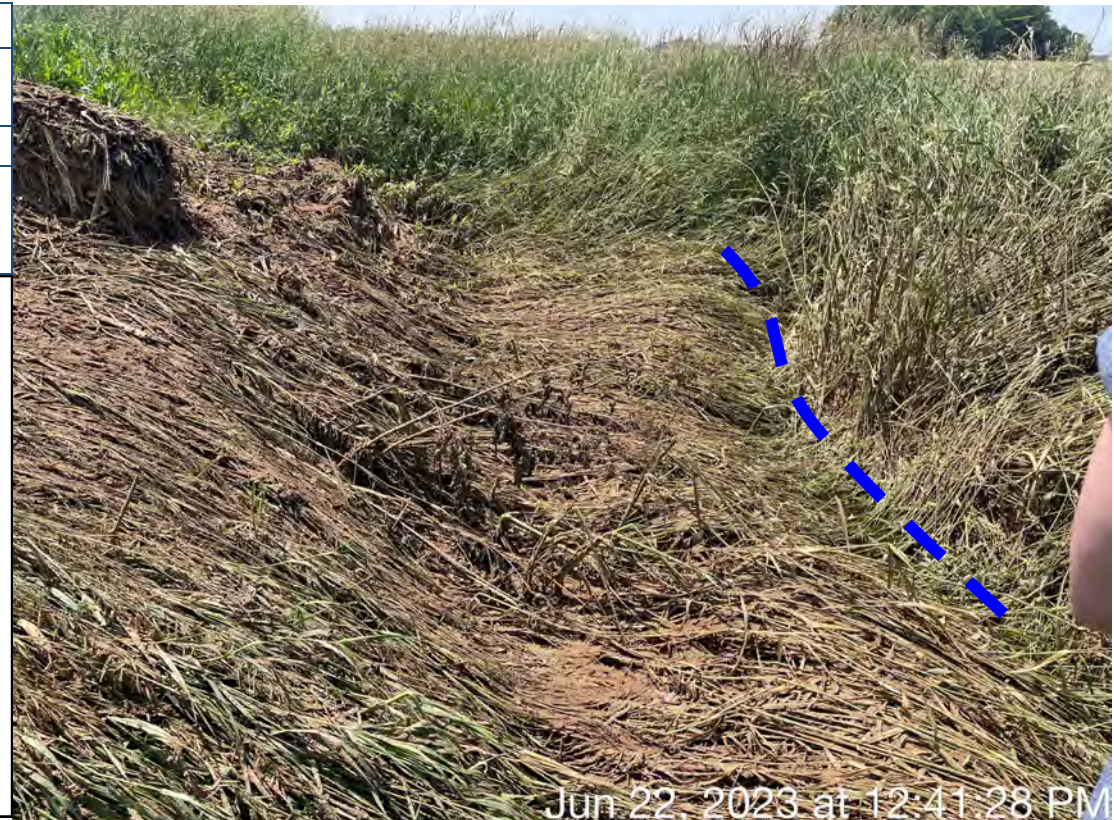
<b>Photo #:</b>	6545
<b>Date/Time of Photo:</b>	6/22/2023 12:41
<b>Photo By:</b>	Brian Hanson
<b>Photo Location:</b>	Karcz Nation Water Samples

Standing in stream channel northwest of WSF #1 looking south: View of stream near manure flow path at water sample location ID: MS. Dashed line indicated location of actively flow water channel.

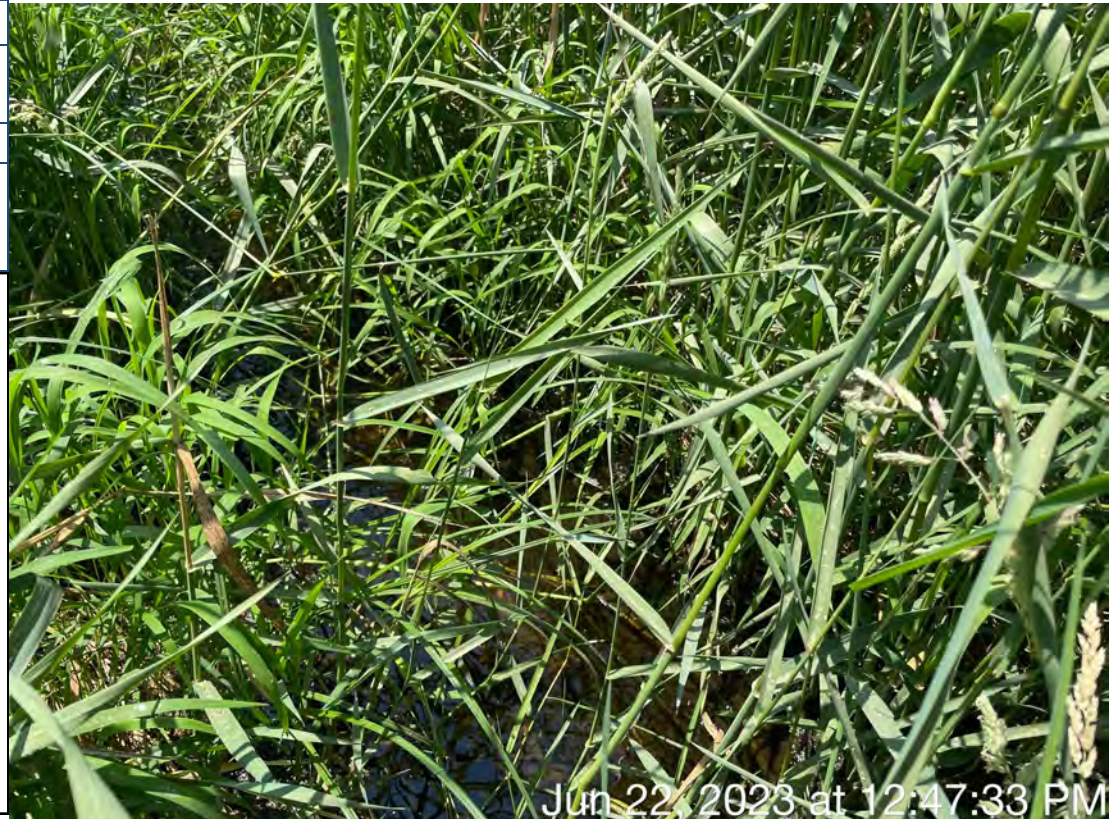
<b>Photo #:</b>	6547
<b>Date/Time of Photo:</b>	6/22/2023 12:47
<b>Photo By:</b>	Brian Hanson
<b>Photo Location:</b>	Karcz Nation Water Samples

Standing on east side of stream looking west & down: Close up view of stream location at water sample ID: MS. Flowing water was clear with no visible signs impairment.

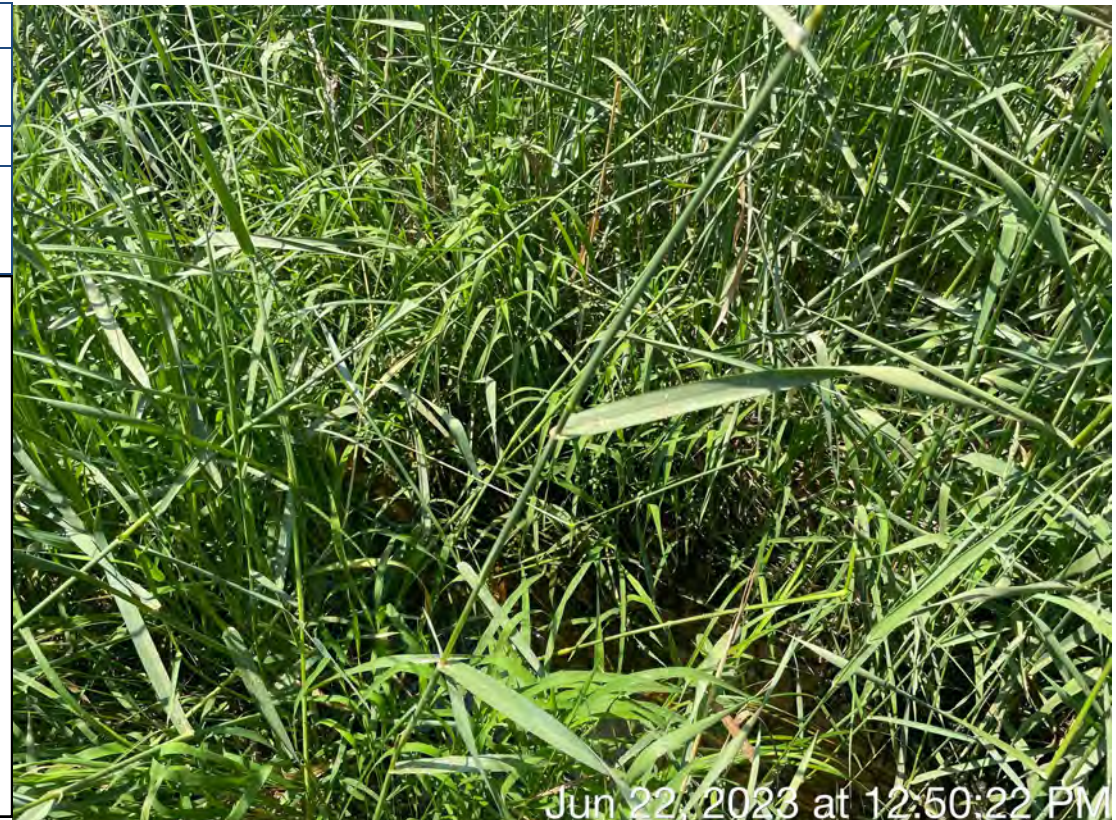
<b>Photo #:</b>	6549
<b>Date/Time of Photo:</b>	6/22/2023 12:50
<b>Photo By:</b>	Brian Hanson
<b>Photo Location:</b>	Karcz Nation Water Samples

Standing on east side of stream looking west & down: Close up view of stream location at water sample ID: UP. Flowing water was clear with no visible signs impairment.
