# Permit Fact Sheet

Permit Number:	WI-0065421-02-0
Permittee Name:	Ledgeview Farms LLC
Address:	3870 Dickinson Rd
City/State/Zip:	De Pere WI 54115
Discharge Location:	Unnamed tributaries within the Bower Creek Watershed, East River Watershed, and groundwaters of the state

DNR Staff / Report Writer: Holly Stegemann, Agricultural Runoff Management Specialist

On August 1, 2023 Stegemann met with Pansier to conduct a WPDES reissuance inspection of Ledgeview Farms and follow up on the completed abandonment of the heifer feed storage area and runoff controls. All facilities currently covered under Ledgeview Farms' WPDES permit were inspected, including the main site, heifer site, and Glenmore site. No liquid precipitation had fallen 24 hours prior to the inspection. Follow up items are requested on page 5.

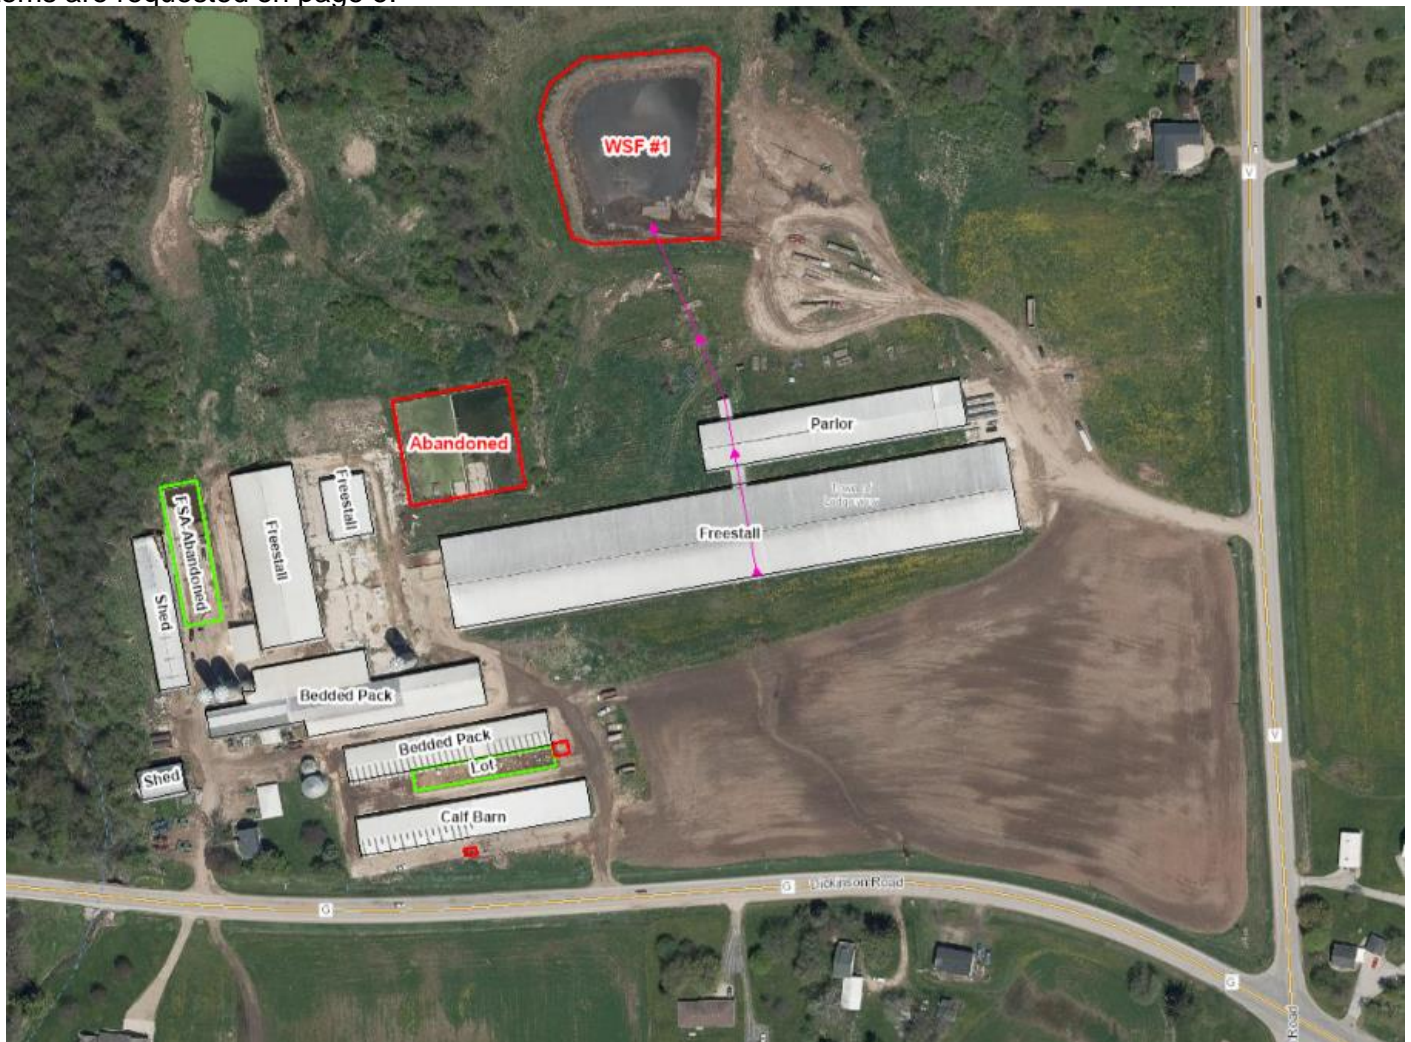
Figure 1. Aerial overview of Ledgeview Farms main site. Approximate contaminated flow paths are indicated with orange arrows. Blue arrows indicate stormwater flow paths. Pink arrows indicate manure transfer lines.

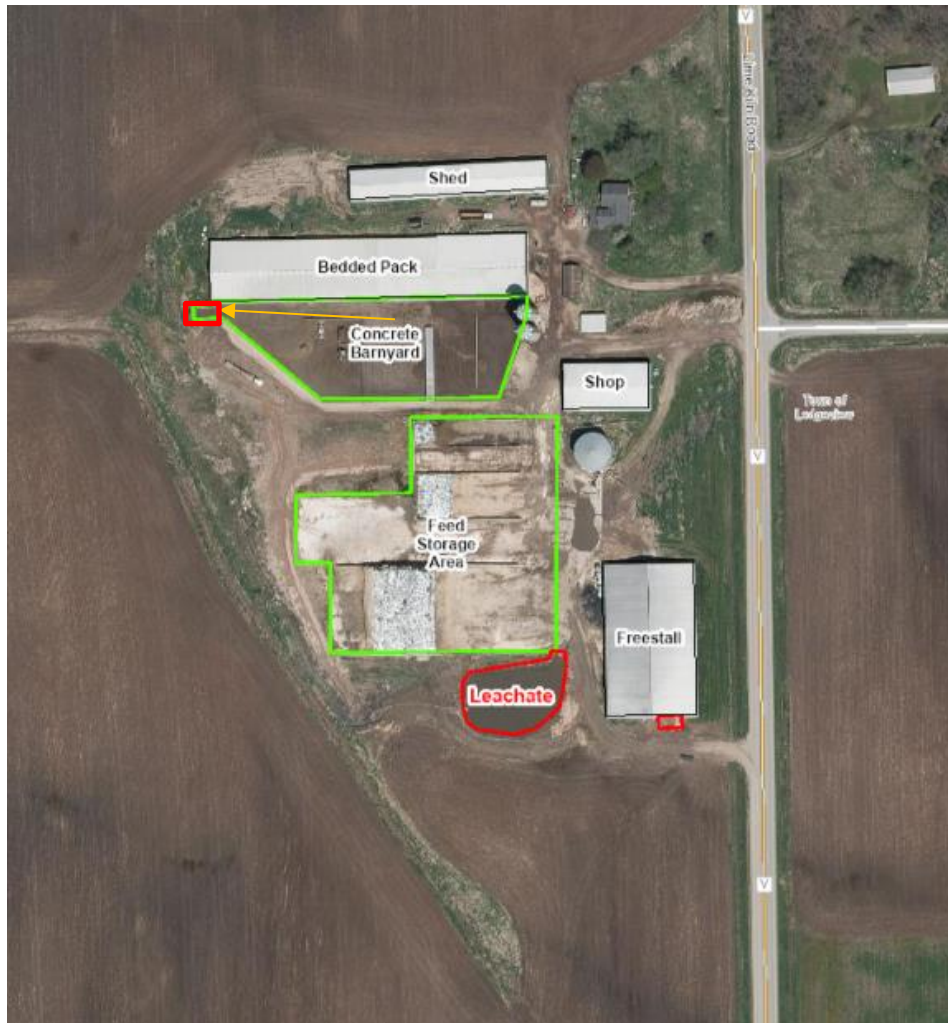
Figure 2. Aerial overview of Ledgerview Farms heifer site. Feed storage area and leachate basin have been abandoned.

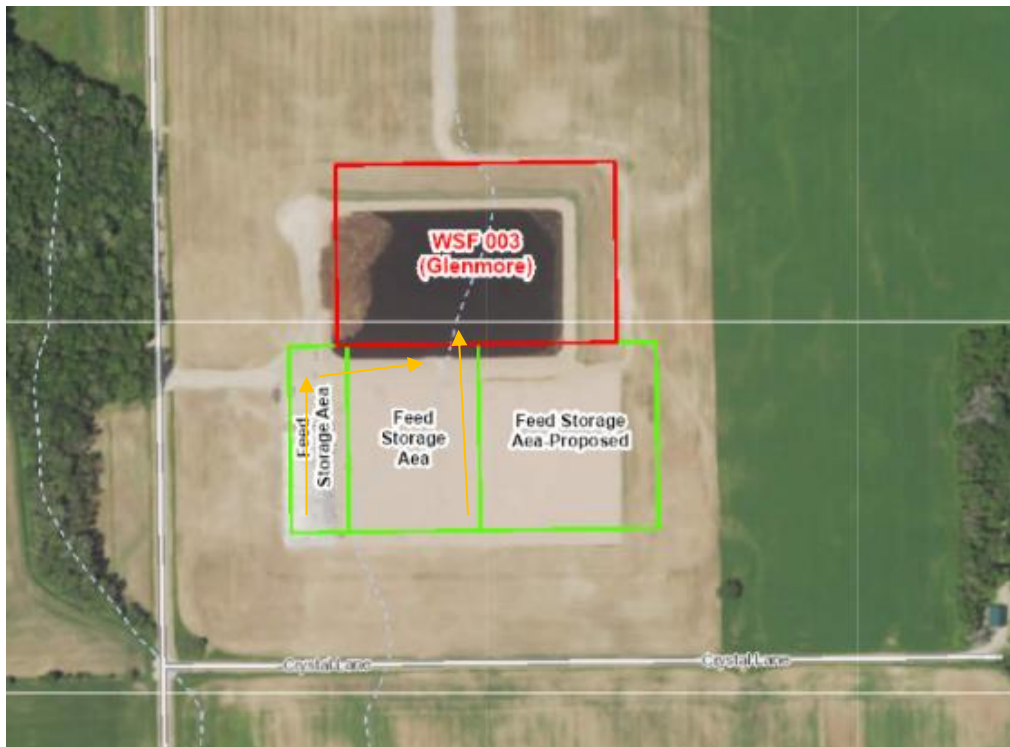
Figure 3. Aerial overview of Ledgerview Farms Glenmore site. Approximate contaminated flow paths are indicated with orange arrows.

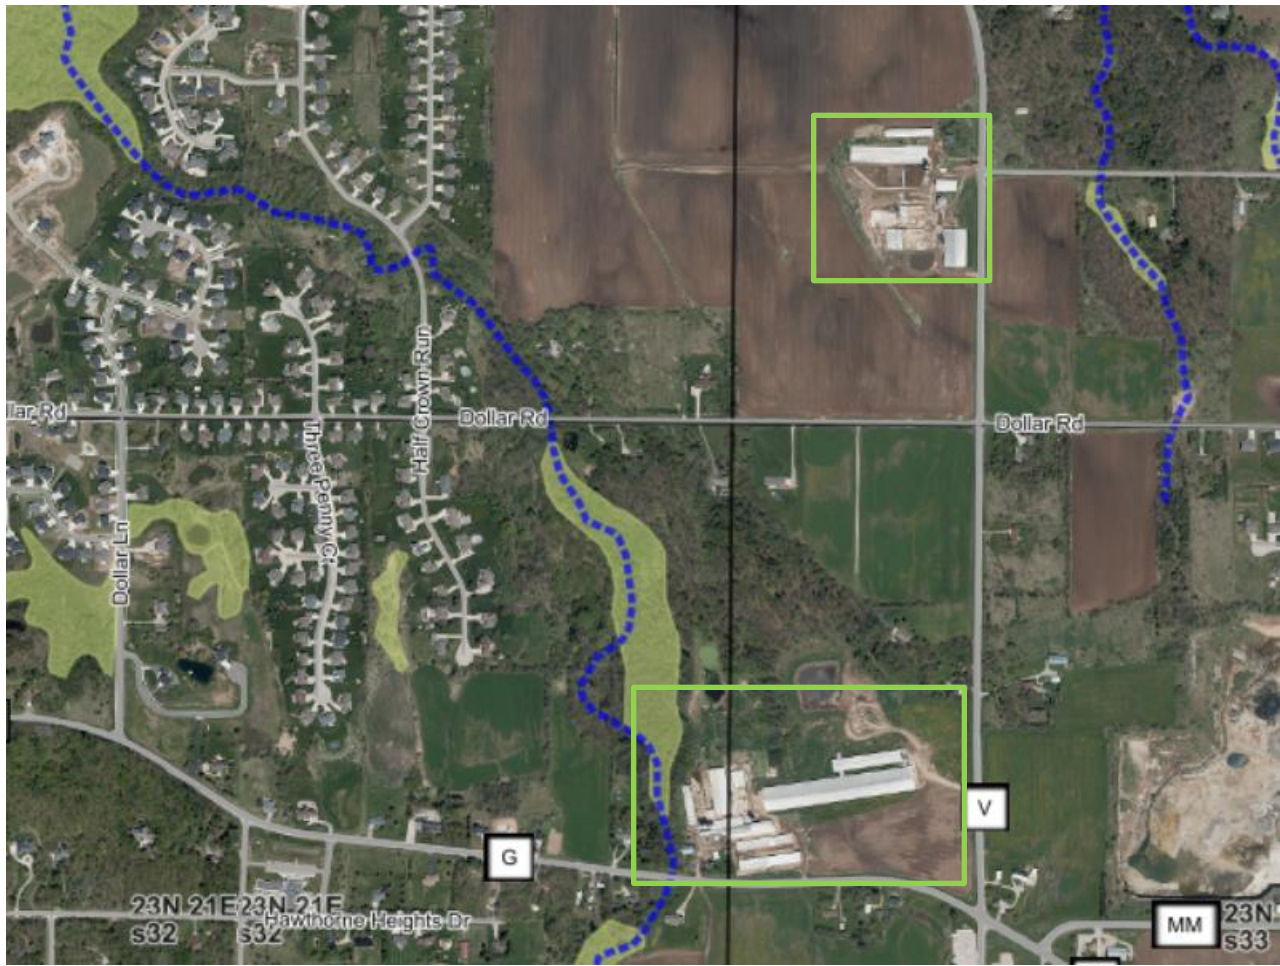
Figure 4. Aerial overview of Ledgeview Farms main and heifer sites in relation to surface water features. Green areas represent designated wetlands.

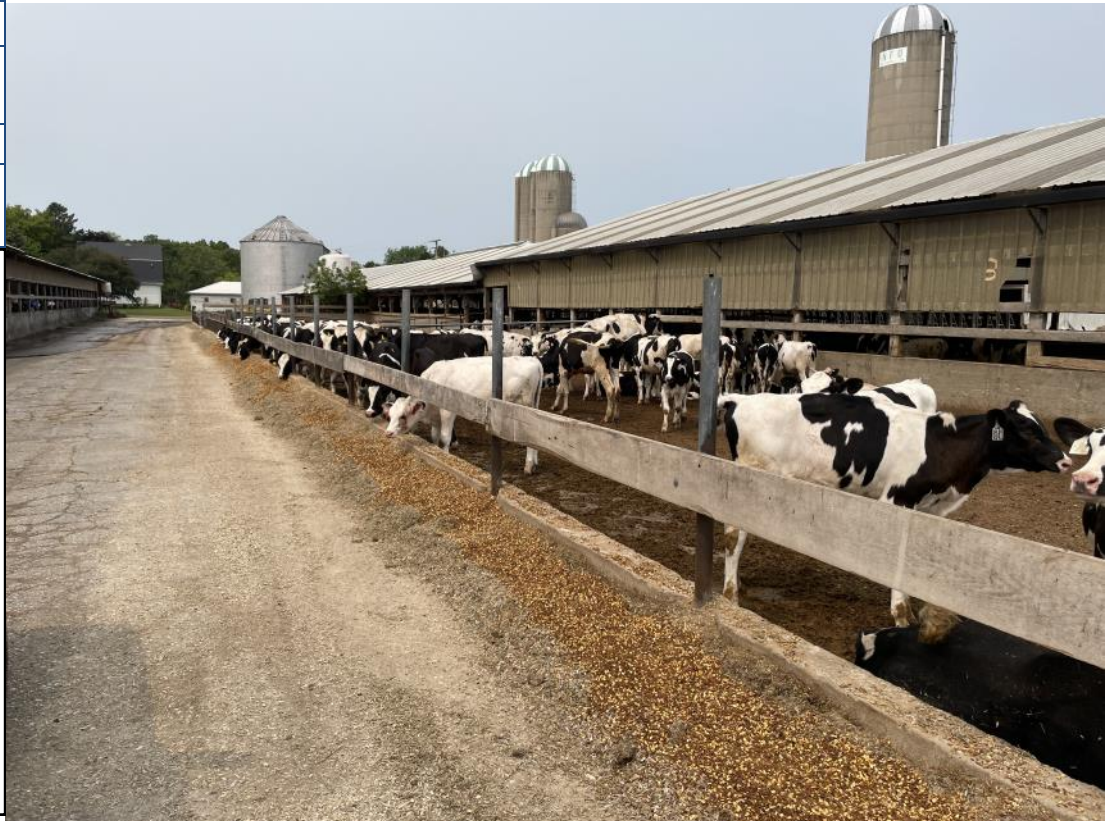
<b>Photo #:</b>	1695
<b>Date/Time of Photo:</b>	08/01/2023 11:37
<b>Photo By:</b>	Stegemann
<b>Photo Location:</b>	Main Site Outdoor Lot
<b>Photo Description: View of main site outdoor heifer lot, looking west.</b>

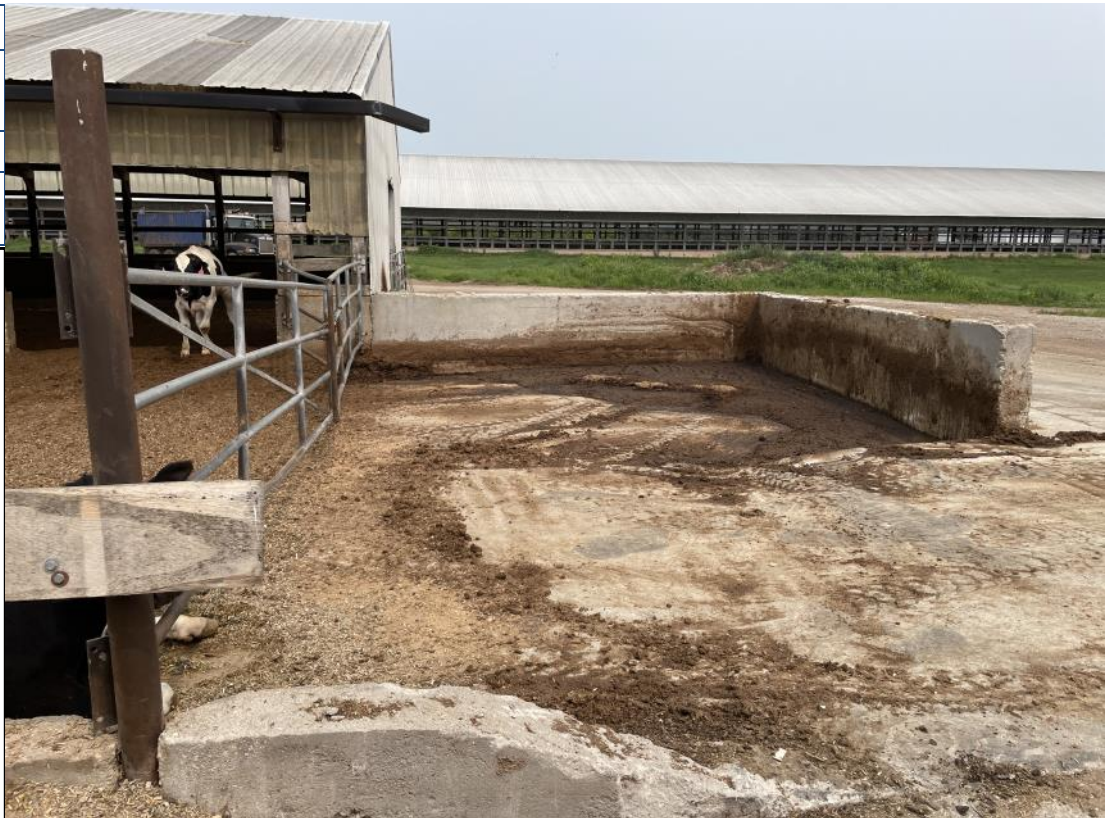
<b>Photo #:</b>	1693
<b>Date/Time of Photo:</b>	08/01/2023 11:37
<b>Photo By:</b>	Stegemann
<b>Photo Location:</b>	Main Site Outdoor Lot
<b>Photo Description: View of loadout area on west side of outdoor lot, looking north.</b>

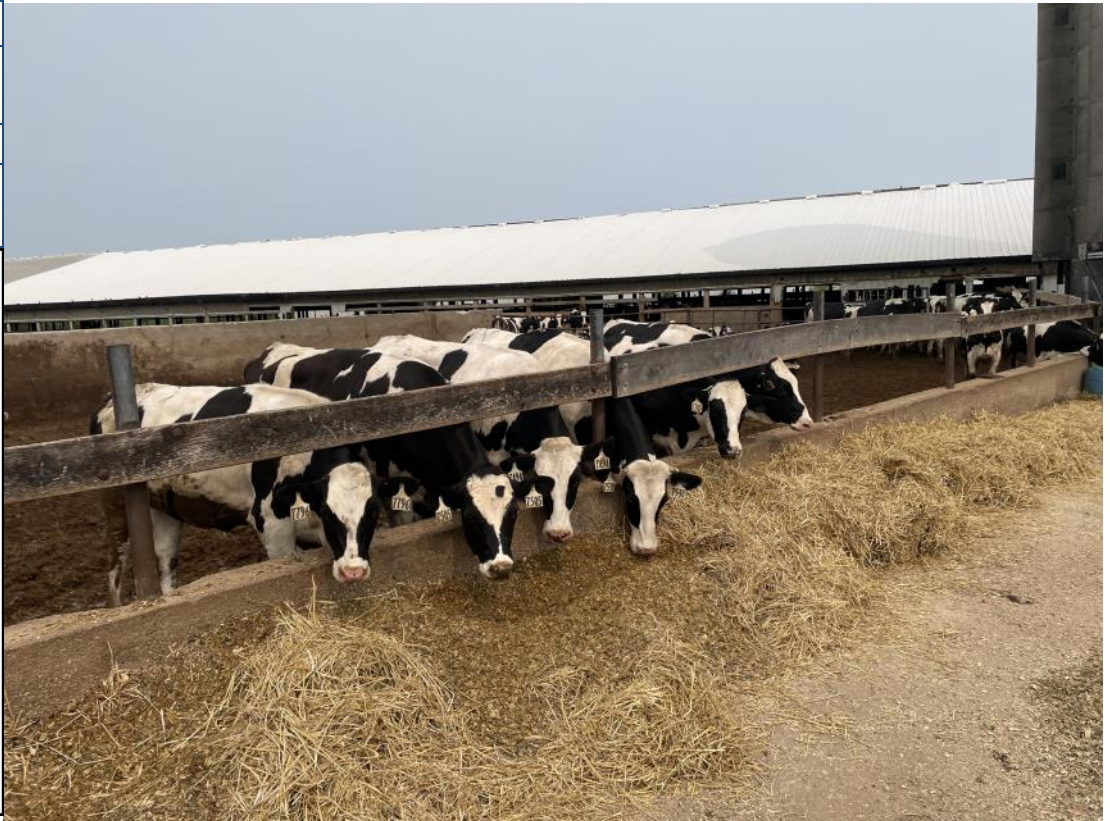
<b>Photo #:</b>	1641
<b>Date/Time of Photo:</b>	08/01/2023 11:10
<b>Photo By:</b>	Stegemann
<b>Photo Location:</b>	Heifer Site Outdoor Lot
<b>Photo Description:</b> View of outdoor lot at the heifer site, looking northwest.

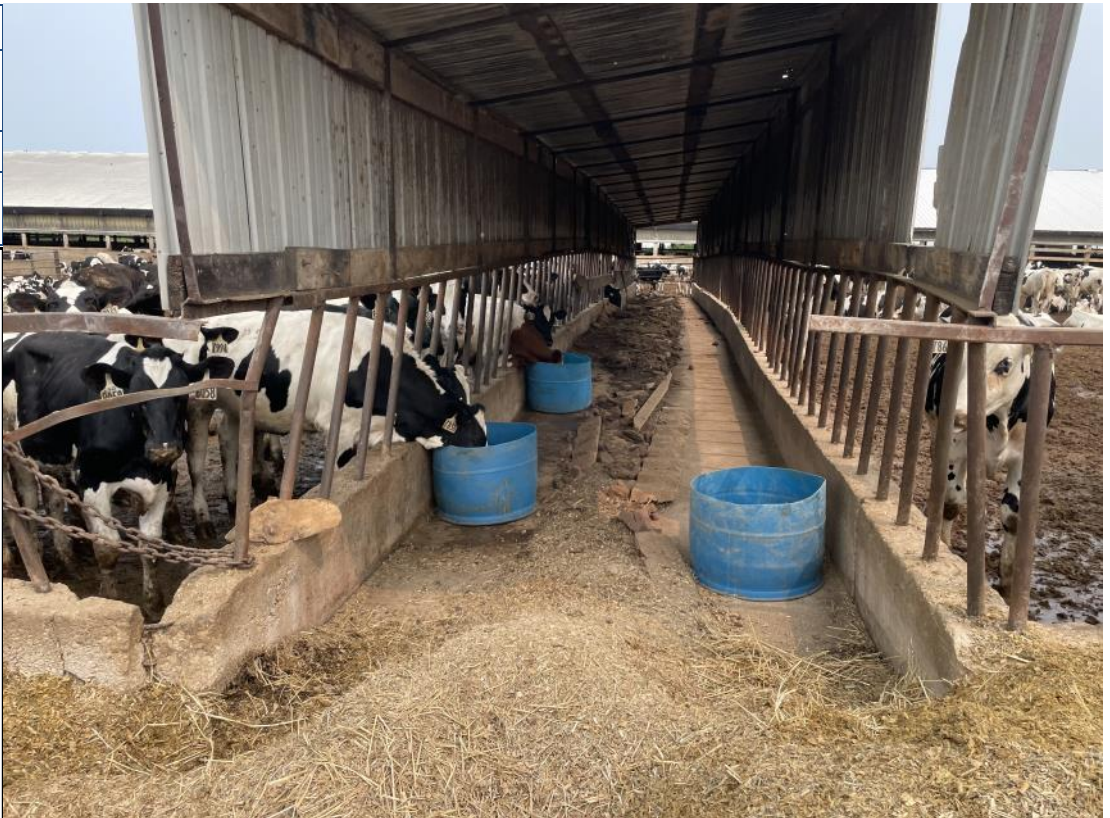
<b>Photo #:</b>	1643
<b>Date/Time of Photo:</b>	08/01/2023 11:11
<b>Photo By:</b>	Stegemann
<b>Photo Location:</b>	Heifer Site Outdoor Lot
<b>Photo Description:</b> View of outdoor lot at the heifer site looking north.

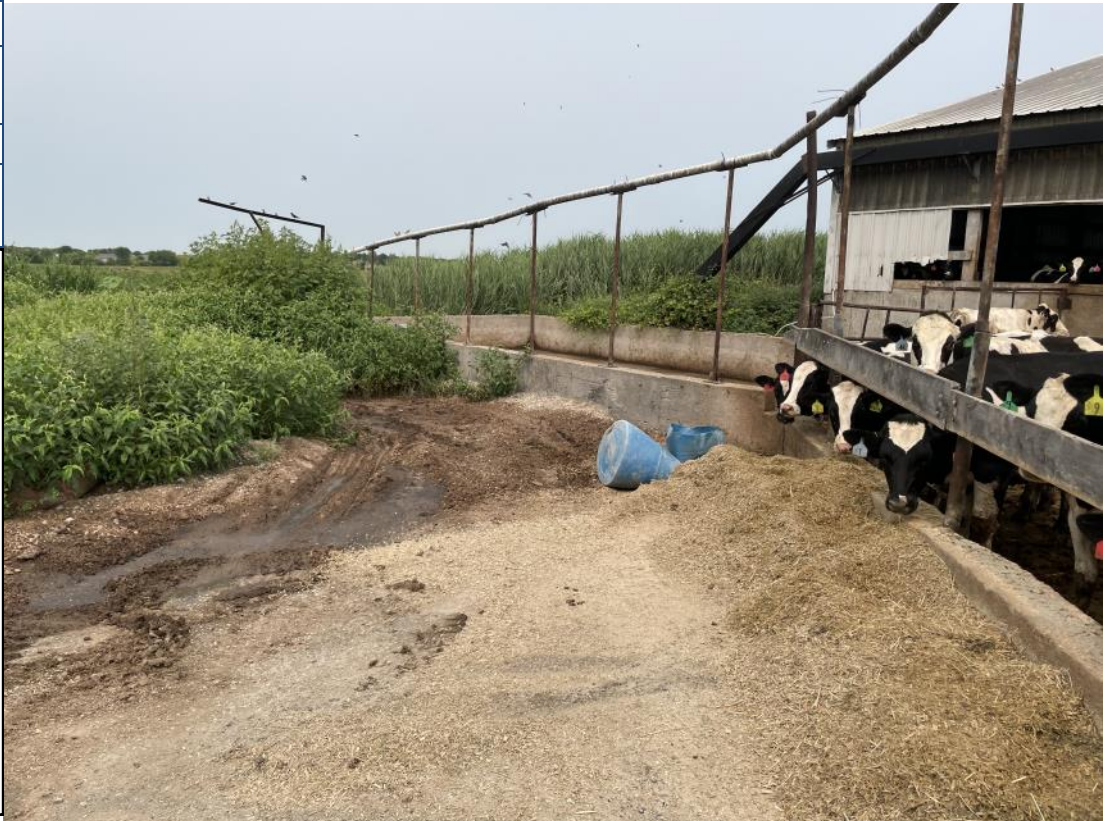
<b>Photo #:</b>	1647
<b>Date/Time of Photo:</b>	08/01/2023 11:12
<b>Photo By:</b>	Stegemann
<b>Photo Location:</b>	Heifer Site Outdoor Lot
<b>Photo Description: View of loadout area for outdoor lot at the heifer site, looking northwest.</b>

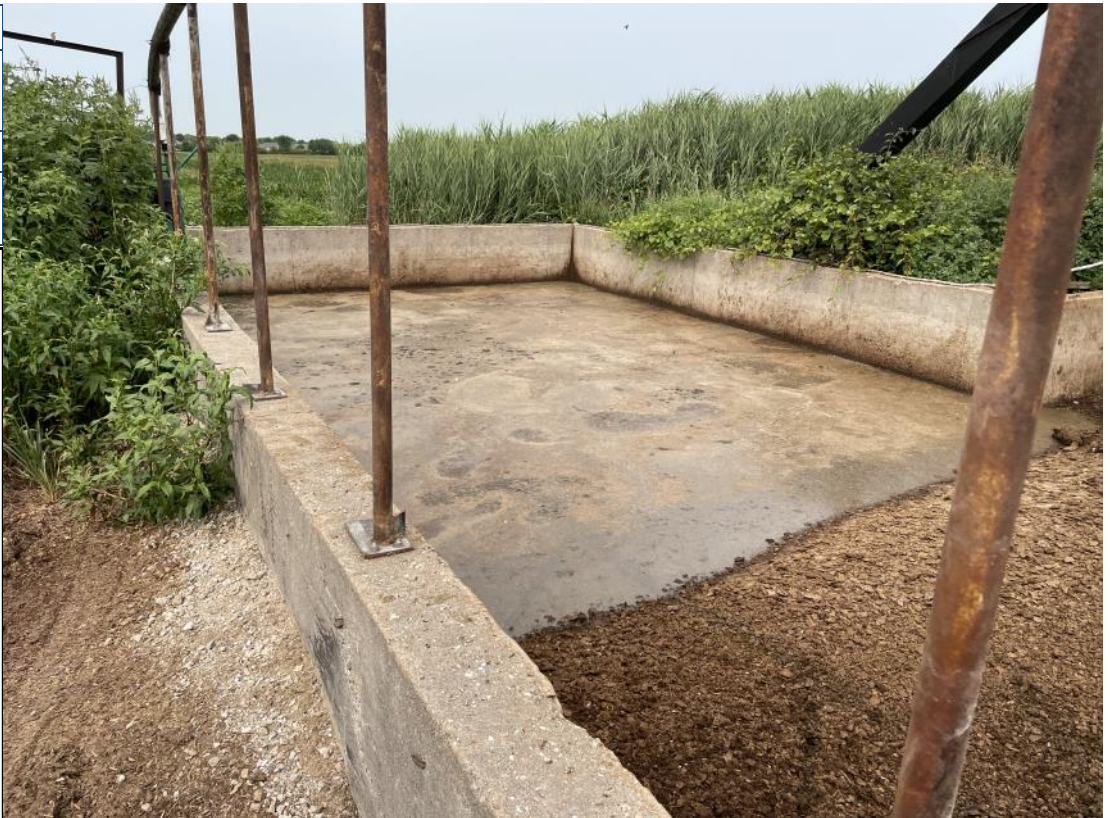
<b>Photo #:</b>	1649
<b>Date/Time of Photo:</b>	08/01/2023 11:12
<b>Photo By:</b>	Stegemann
<b>Photo Location:</b>	Heifer Site Outdoor Lot
<b>Photo Description: View of loadout area for outdoor lot at the heifer site, looking northwest.</b>

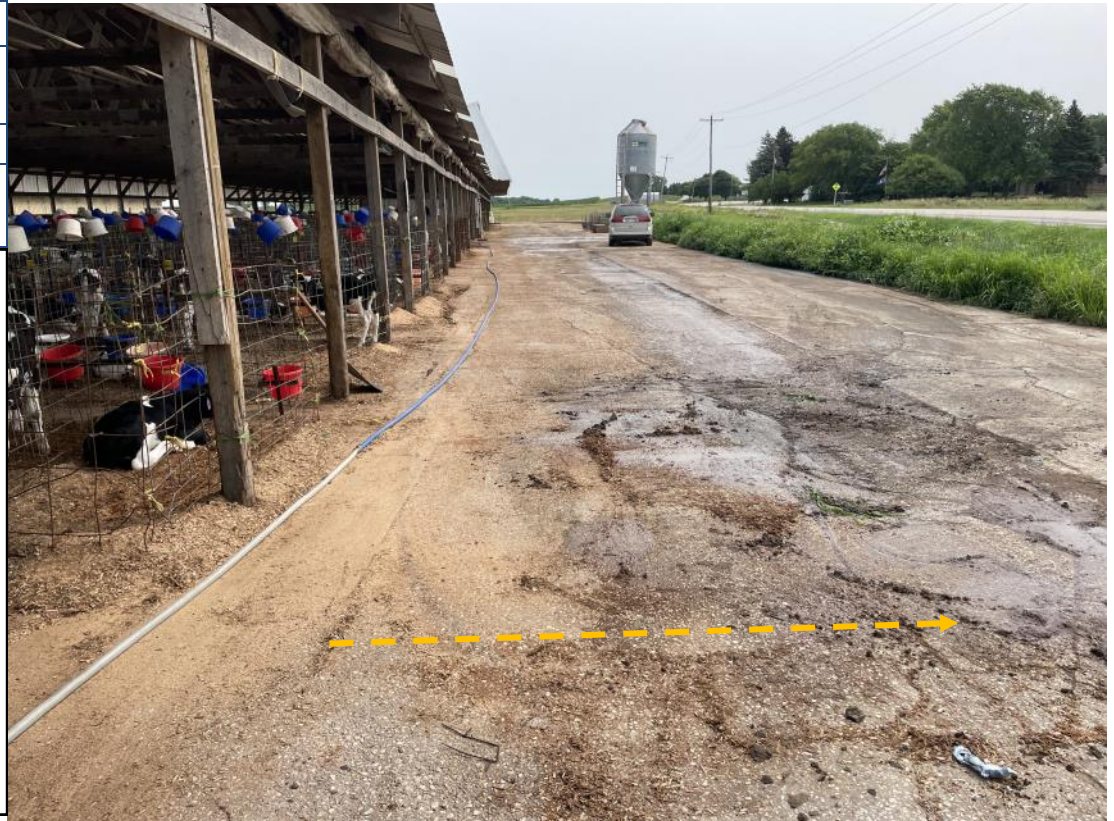
<b>Photo #:</b>	1703
<b>Date/Time of Photo:</b>	08/01/2023 11:40
<b>Photo By:</b>	Stegemann
<b>Photo Location:</b>	Calf Barn Main Site
<b>Photo Description: View of calf barn, looking east. Arrows indicate approximate contaminated runoff flow paths.</b>

Calf barn runoff collection system evaluation and/or submittal of plans and specifications

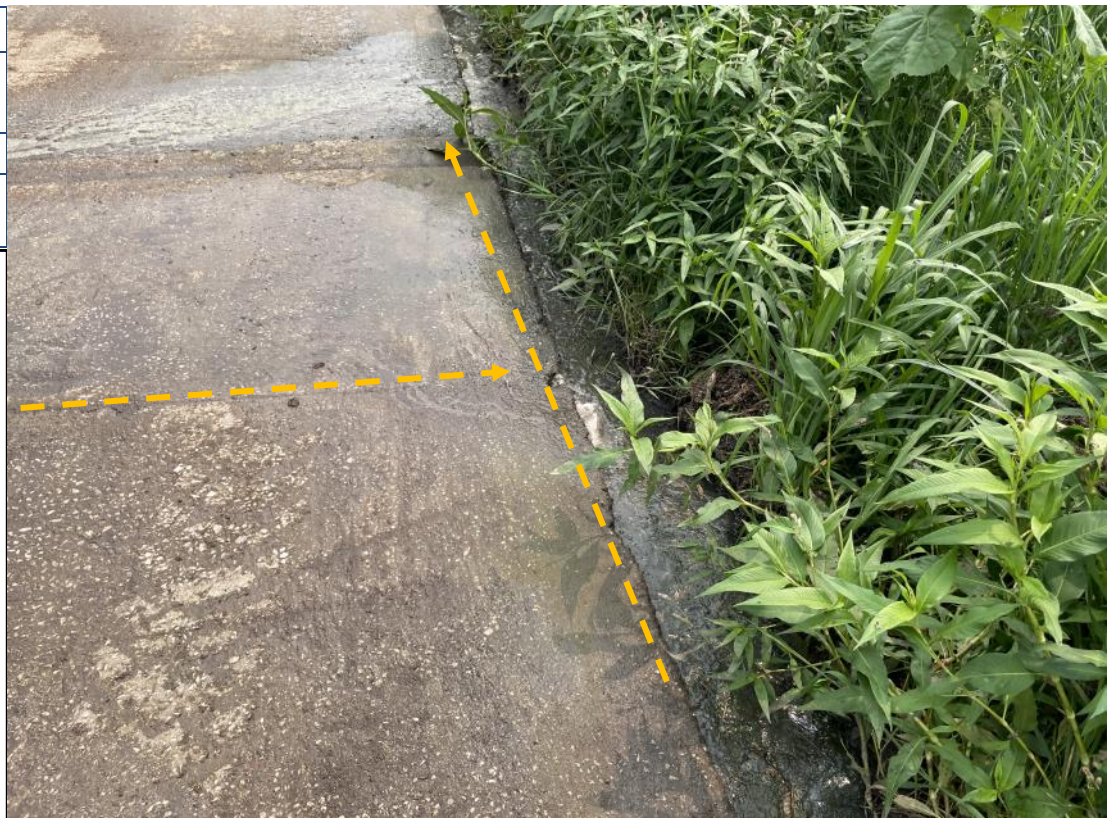
<b>Photo #:</b>	1707
<b>Date/Time of Photo:</b>	08/01/2023 11:41
<b>Photo By:</b>	Stegemann
<b>Photo Location:</b>	Calf Barn Main Site
<b>Photo Description: View of runoff from the calf barn crossing the concrete to the vegetated ditch. Runoff hits a small channel dug in the ditch along the concrete and is collected in a dug out collection basin. Arrows indicate approximate contaminated runoff flow paths.</b>

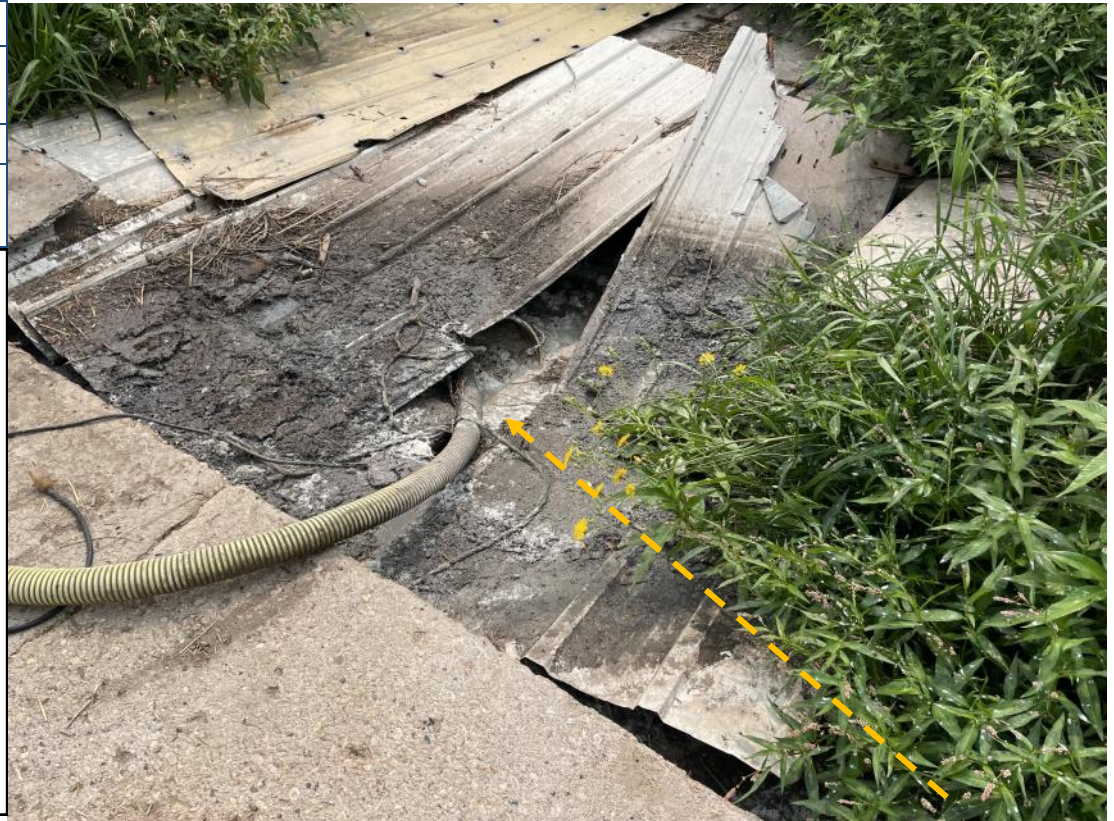
<b>Photo #:</b>	1708
<b>Date/Time of Photo:</b>	08/01/2023 11:41
<b>Photo By:</b>	Stegemann
<b>Photo Location:</b>	Calf Barn Main Site

**Photo Description:** View of calf barn collection basin. Arrows indicate approximate contaminated runoff flow paths.

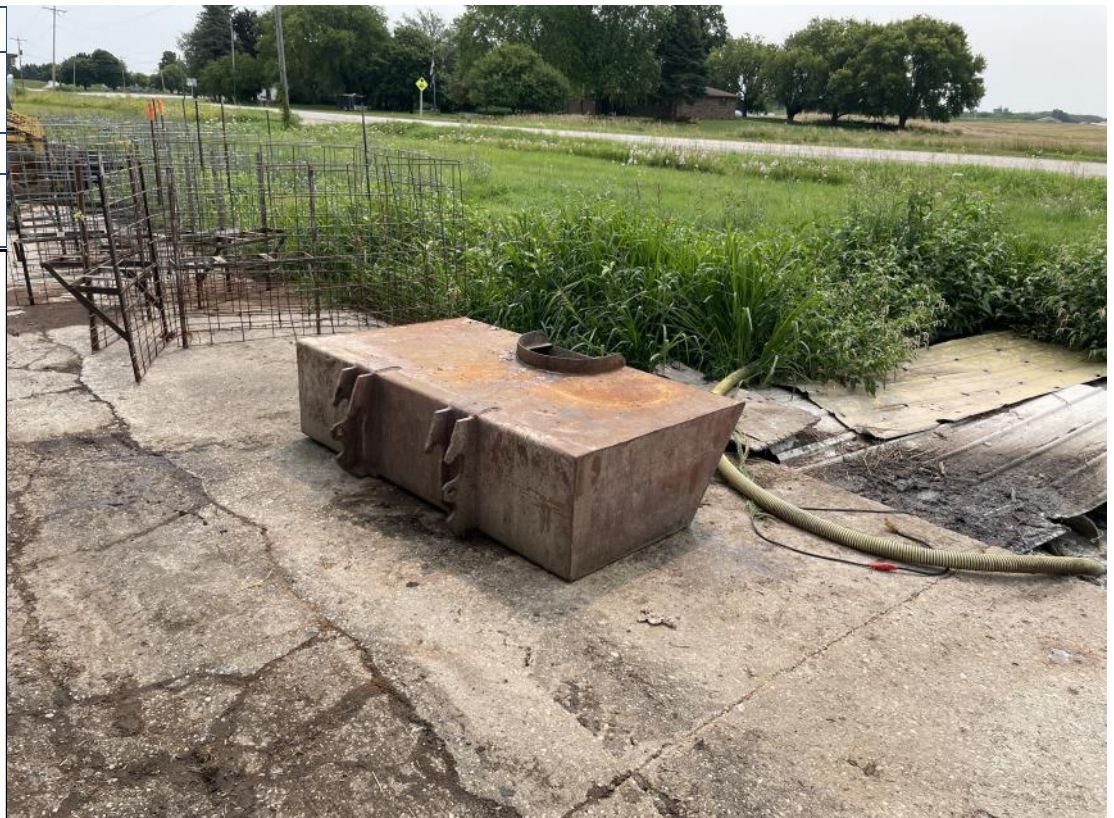
<b>Photo #:</b>	1709
<b>Date/Time of Photo:</b>	08/01/2023 11:42
<b>Photo By:</b>	Stegemann
<b>Photo Location:</b>	Calf Barn Main Site

**Photo Description:** View of calf barn collection tank. Runoff is pumped from basin to the tank that is emptied into the manure transfer system in the large freestall barn. Photo direction, southeast.

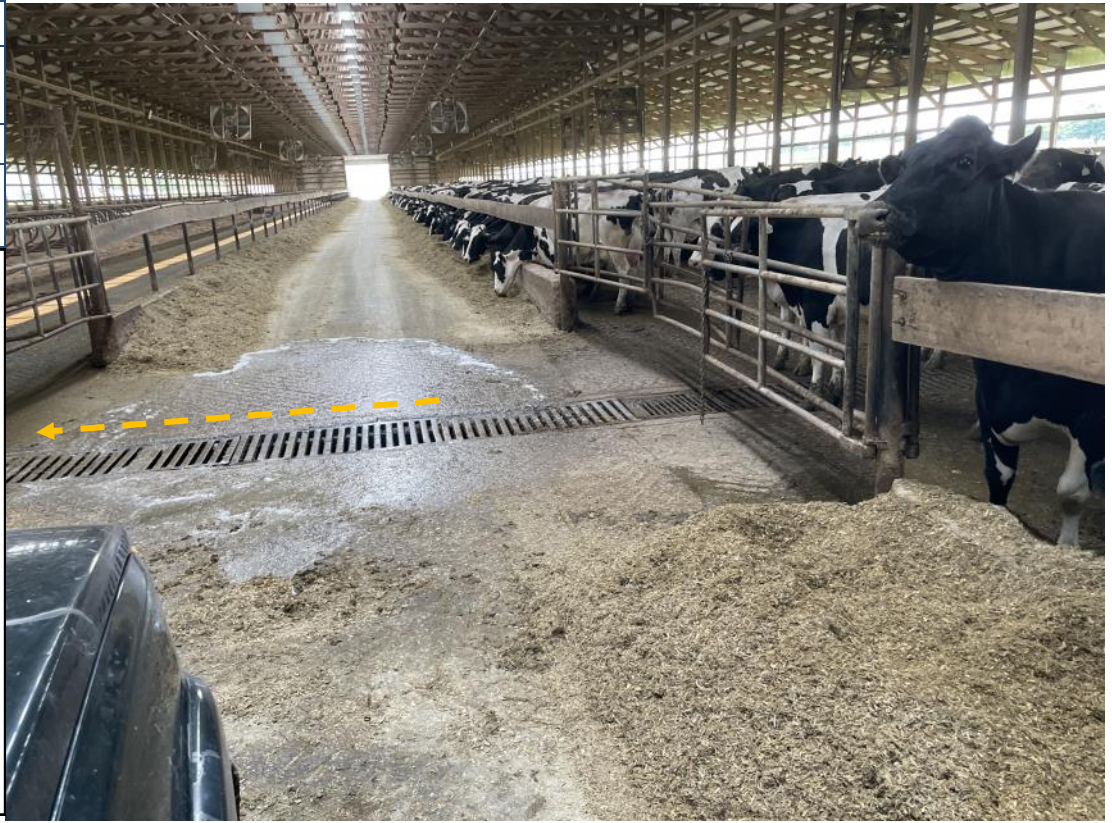
<b>Photo #:</b>	1710
<b>Date/Time of Photo:</b>	08/01/2023 11:43
<b>Photo By:</b>	Stegemann
<b>Photo Location:</b>	Main Site Freestall

**Photo Description:** View of where calf barn runoff is dumped into the manure transfer system that flows to WSF 1. Arrows indicate approximate contaminated runoff flow paths.

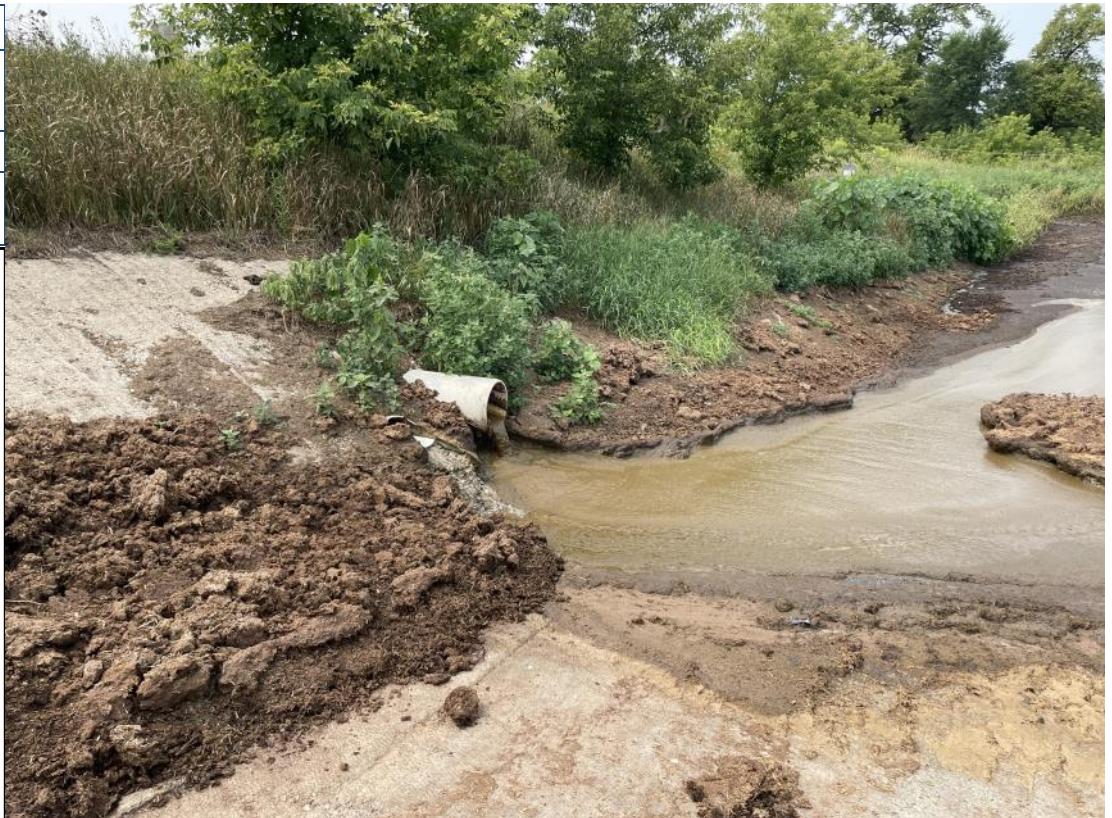
<b>Photo #:</b>	1711
<b>Date/Time of Photo:</b>	08/01/2023 11:45
<b>Photo By:</b>	Stegemann
<b>Photo Location:</b>	WSF 1

**Photo Description:** View of WSF 1 outlet from freestall barn, looking west.

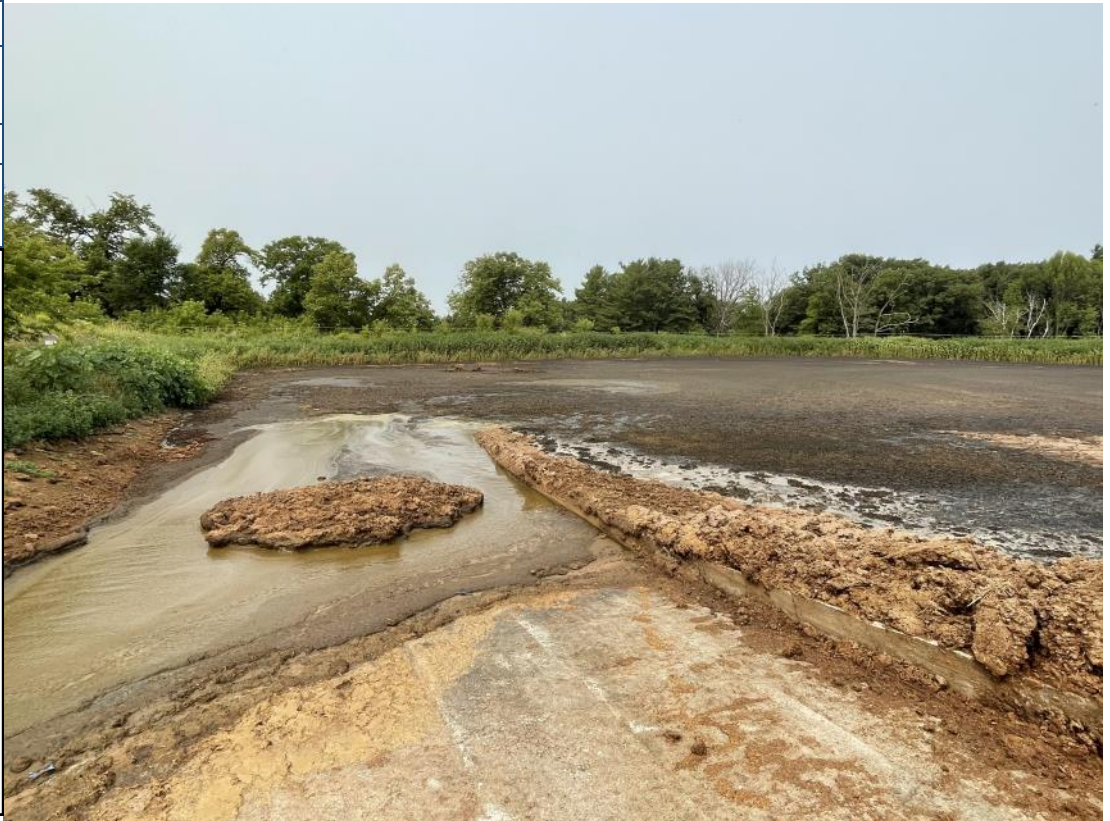
<b>Photo #:</b>	1713
<b>Date/Time of Photo:</b>	08/01/2023 11:45
<b>Photo By:</b>	Stegemann
<b>Photo Location:</b>	WSF 1

**Photo Description:** View of concrete ramp of WSF 1, looking northwest.

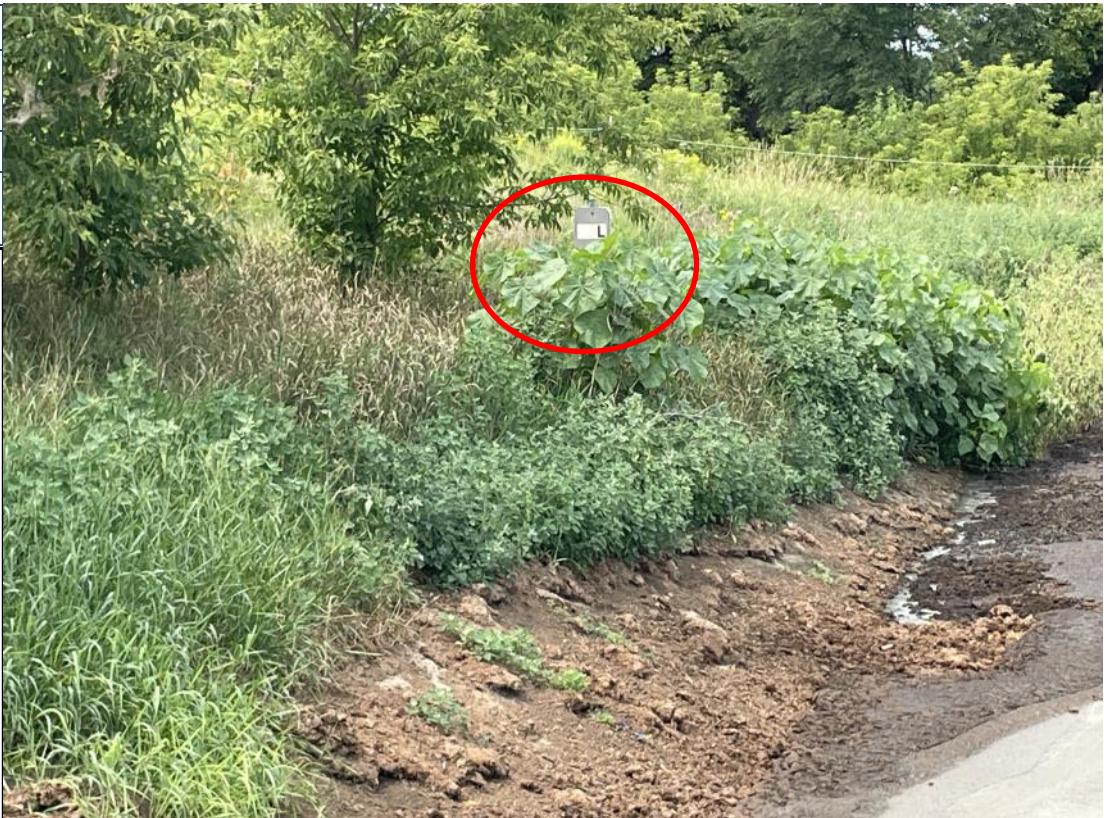
<b>Photo #:</b>	1712
<b>Date/Time of Photo:</b>	08/01/2023 11:45
<b>Photo By:</b>	Stegemann
<b>Photo Location:</b>	WSF 1

**Photo Description:** View of WSF 1 permanent marker circled in red.

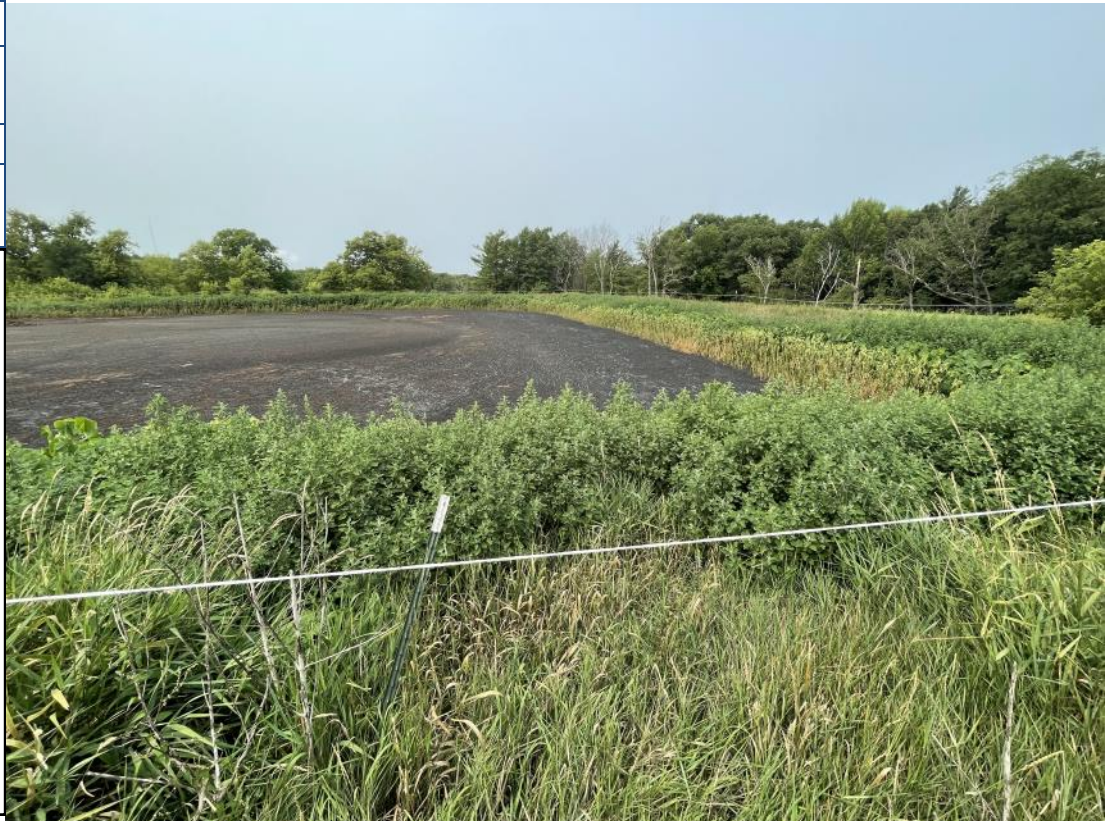
<b>Photo #:</b>	1718
<b>Date/Time of Photo:</b>	08/01/2023 11:47
<b>Photo By:</b>	Stegemann
<b>Photo Location:</b>	WSF 1
<b>Photo Description: View of WSF 1 looking west.</b>

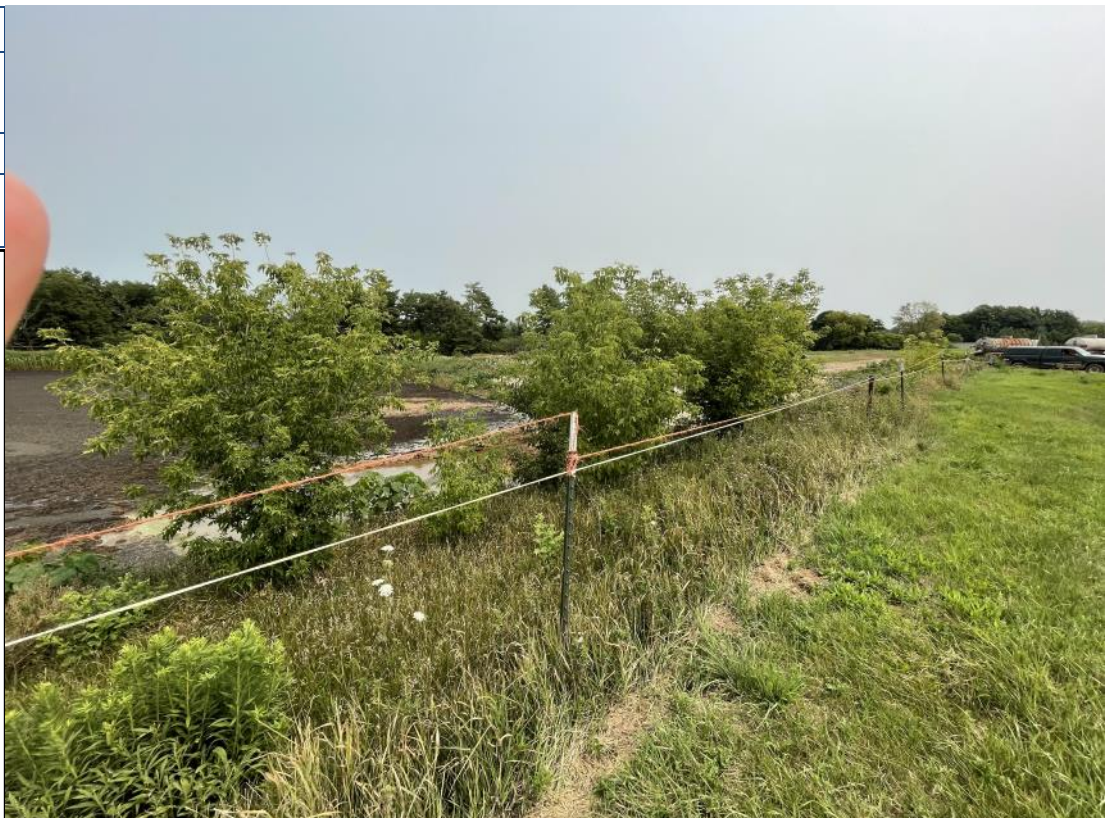
<b>Photo #:</b>	1724
<b>Date/Time of Photo:</b>	08/01/2023 11:49
<b>Photo By:</b>	Stegemann
<b>Photo Location:</b>	WSF 1
<b>Photo Description: View of woody vegetation along WSF 1, looking northeast.</b>

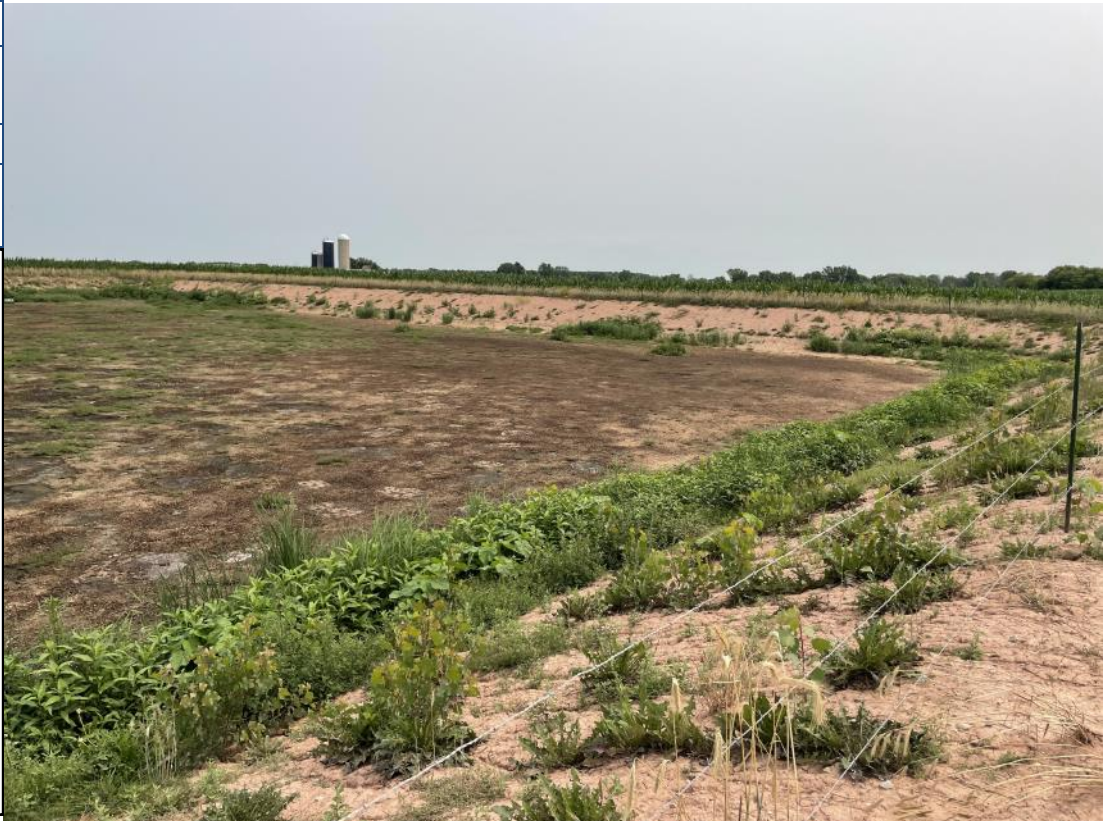
<b>Photo #:</b>	1676
<b>Date/Time of Photo:</b>	08/01/2023 11:24
<b>Photo By:</b>	Stegemann
<b>Photo Location:</b>	WSF 2

**Photo Description: View of WSF, looking northeast.**

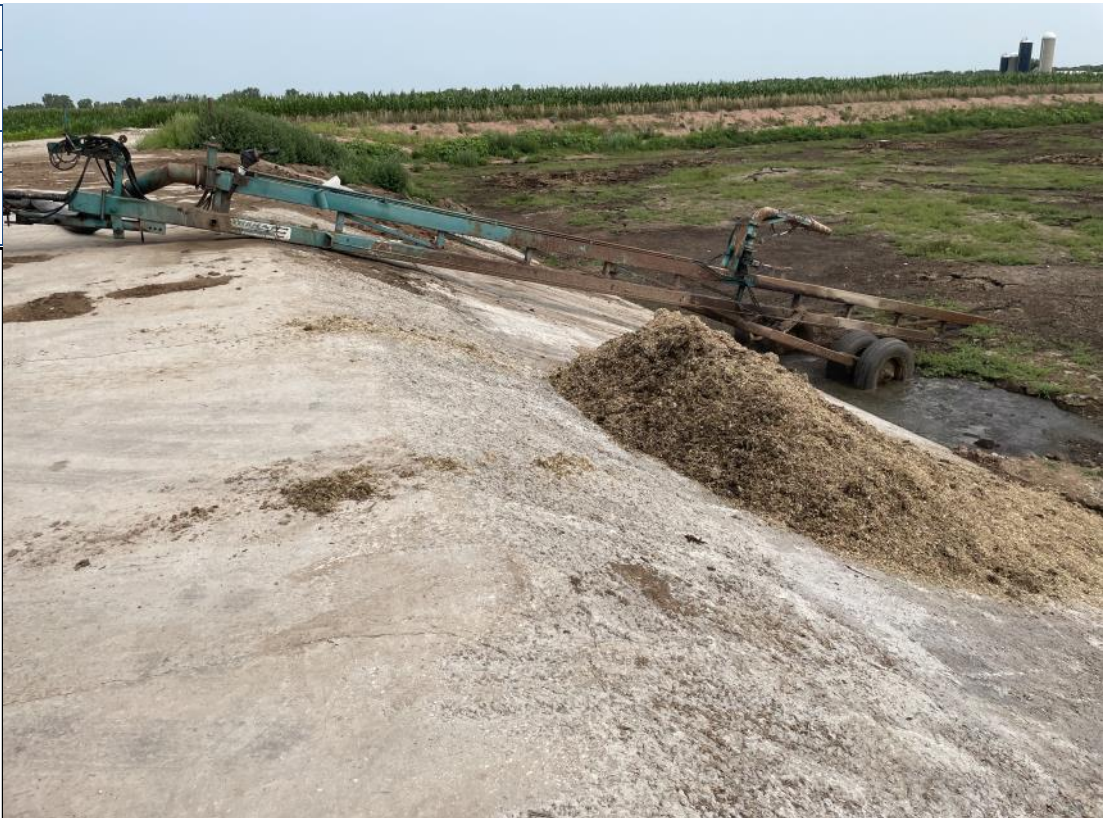
<b>Photo #:</b>	1687
<b>Date/Time of Photo:</b>	08/01/2023 11:30
<b>Photo By:</b>	Stegemann
<b>Photo Location:</b>	WSF 2

WSF 2 is an earthen lined facility with a concrete side and bottom, located at the Glenmore site. Construction of WSF 2 was completed in 2022 and has a maximum operating level of 16,870,140 gallons. WSF 2 accepts process wastewater from the adjacent feed storage area. At the time of inspection, permanent markers and safety fencing were present. Notable erosion channels were observed on the south side of the storage due to the amount of stormwater that flows across the bare ground to the east of the feed pad where feed pad where pad expansions are planned.

**Photo Description: View of concrete side of WSF 2, looking north.**
