# Permit Fact Sheet

Permit Number:	WI-0065421-02-0
Permittee Name:	Ledgeview Farms LLC
Address:	3870 Dickinson Rd
City/State/Zip:	De Pere WI 54115
Discharge Location:	Unnamed tributaries within the Bower Creek Watershed, East River Watershed, and groundwaters of the state

DNR Staff / Report Writer: Holly Stegemann, Agricultural Runoff Management Specialist

On August 1, 2023 Stegemann met with Pansier to conduct a WPDES reissuance inspection of Ledgeview Farms and follow up on the completed abandonment of the heifer feed storage area and runoff controls. All facilities currently covered under Ledgeview Farms' WPDES permit were inspected, including the main site, heifer site, and Glenmore site. No liquid precipitation had fallen 24 hours prior to the inspection. Follow up items are requested on page 5.

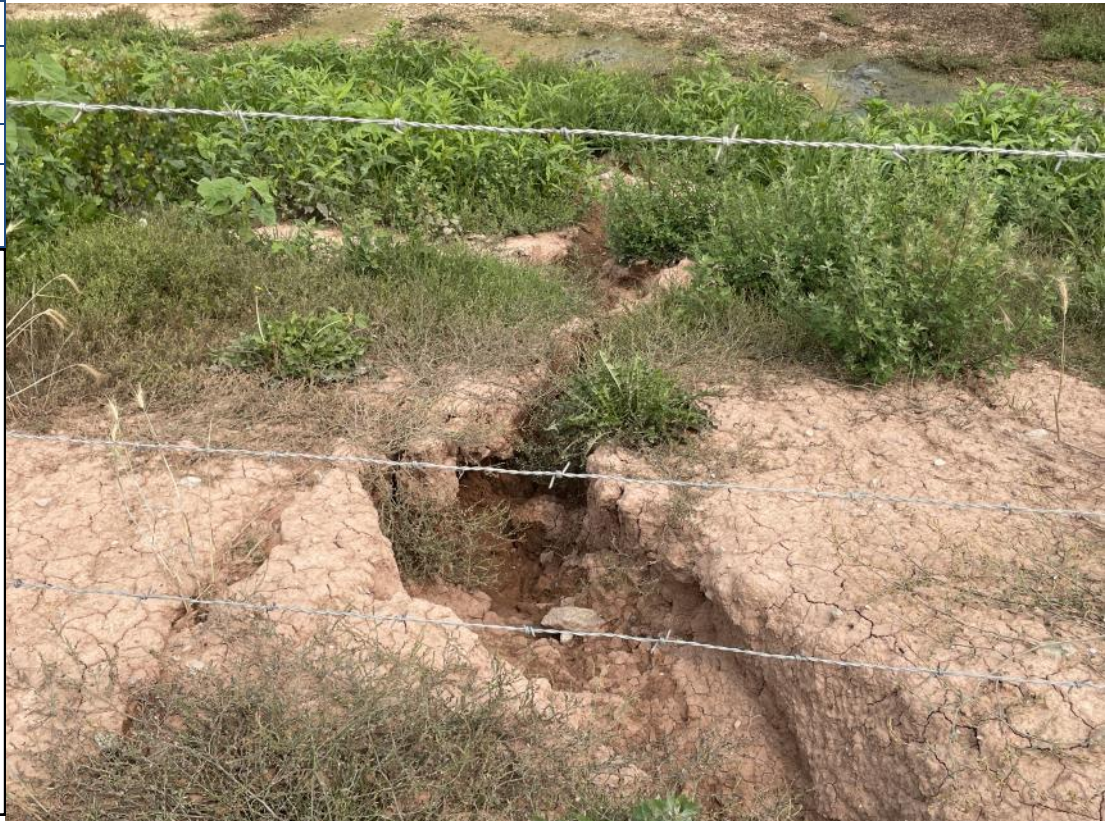
<b>Photo #:</b>	1680
<b>Date/Time of Photo:</b>	08/01/2023 11:25
<b>Photo By:</b>	Stegemann
<b>Photo Location:</b>	WSF 2

**Photo Description: View of erosion channel on south berm of WSF 2.**

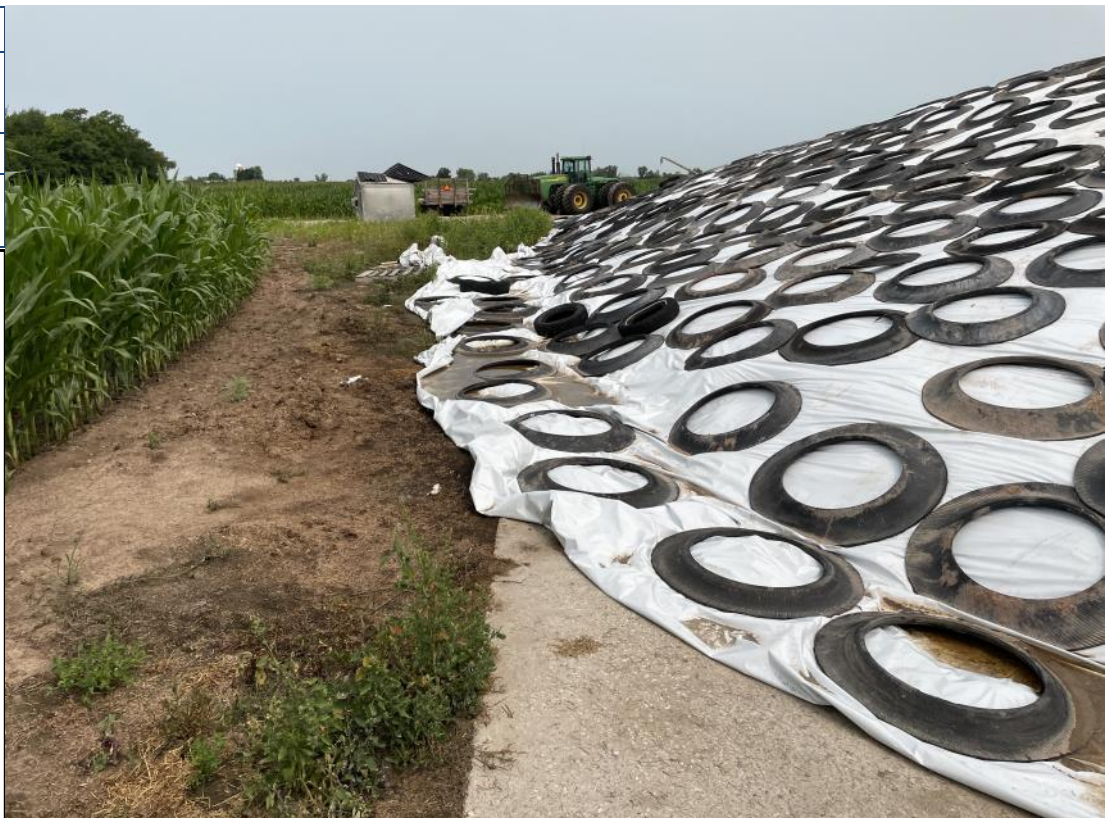
<b>Photo #:</b>	1655
<b>Date/Time of Photo:</b>	08/01/2023 11:20
<b>Photo By:</b>	Stegemann
<b>Photo Location:</b>	Glenmore FSA

Ledgeview Farms utilizes one feed storage area located at the Glenmore site. Feed is stored under plastic on a concrete pad is pitched to convey leachate and runoff to WSF 2. At the time of inspection, only about half of the planned feed pad was constructed (R-2020-0180). Observations of leachate pooled around the edges of the pad were noted. Stegemann spoke to Pansier about housekeeping practices which included keeping plastic on the pad with some space around the edge to allow the runoff controls to operate as designed. The area to the east of the pad had not been constructed and was cleared of vegetation with multiple large erosion channels. One channel flowed next to the concrete pad, conveying stormwater runoff to WSF 2. Stegemann showed Pansier the erosion occurring in the berm of WSF 2 due to the amount of water being conveyed from the open area and discussed options for correcting the damage.

**Photo Description: View of plastic over the edge of the concrete pad, looking north.**

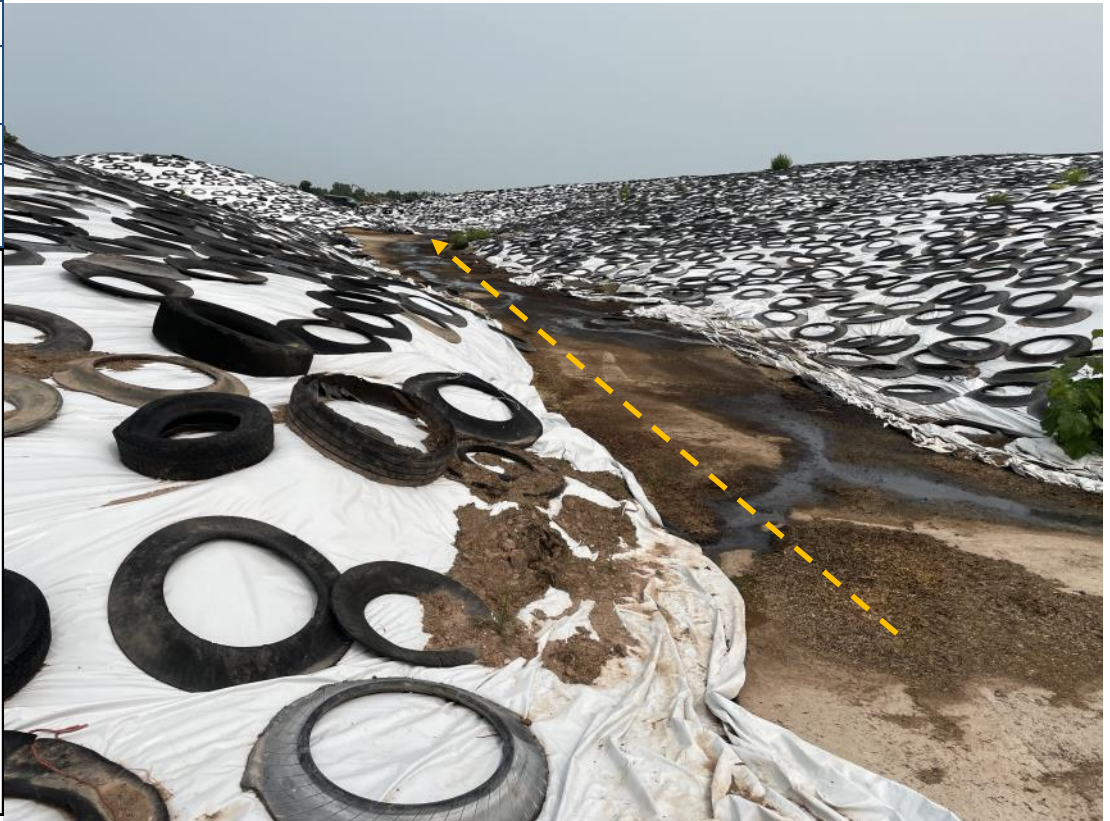
<b>Photo #:</b>	1663
<b>Date/Time of Photo:</b>	08/01/2023 11:21
<b>Photo By:</b>	Stegemann
<b>Photo Location:</b>	Glenmore FSA

**Photo Description:** View of feed under plastic. Arrows indicate approximate runoff flow paths. Photo direction, north.

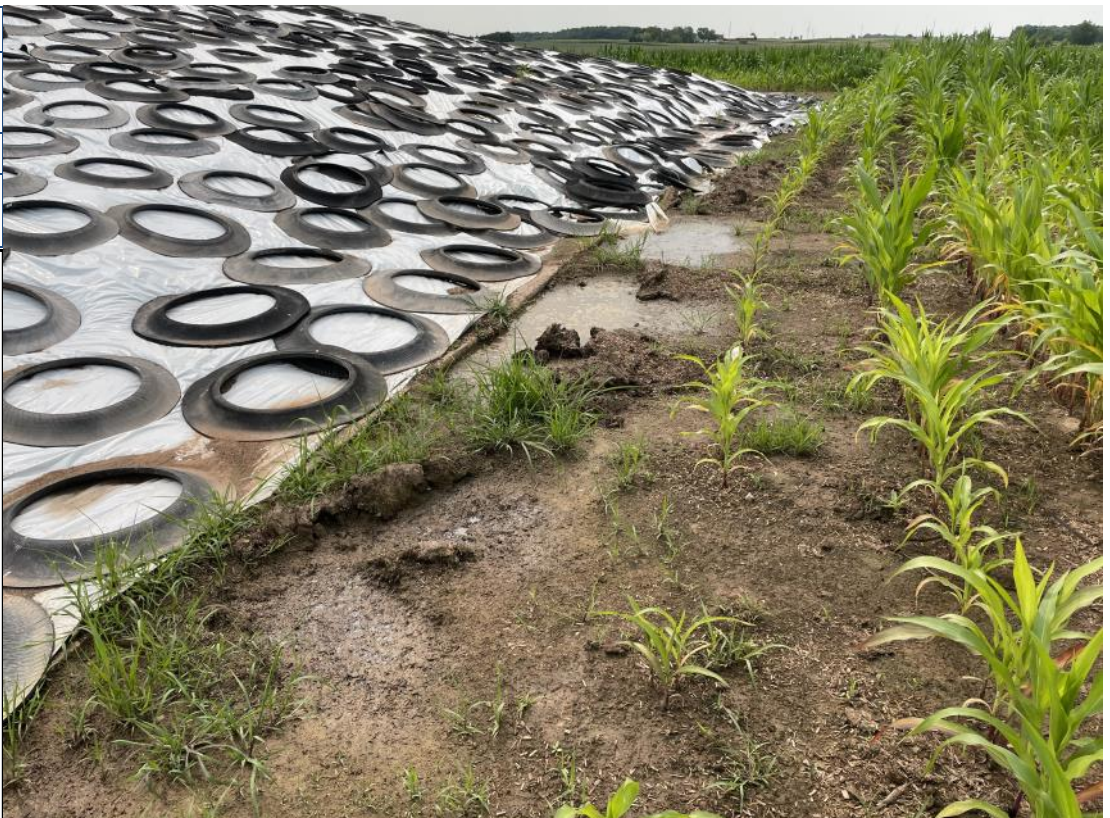
<b>Photo #:</b>	1659
<b>Date/Time of Photo:</b>	08/01/2023 11:20
<b>Photo By:</b>	Stegemann
<b>Photo Location:</b>	Glenmore FSA

**Photo Description:** View of feed and plastic right on edge of feedpad with leachate on base soil. Photo direction, south.

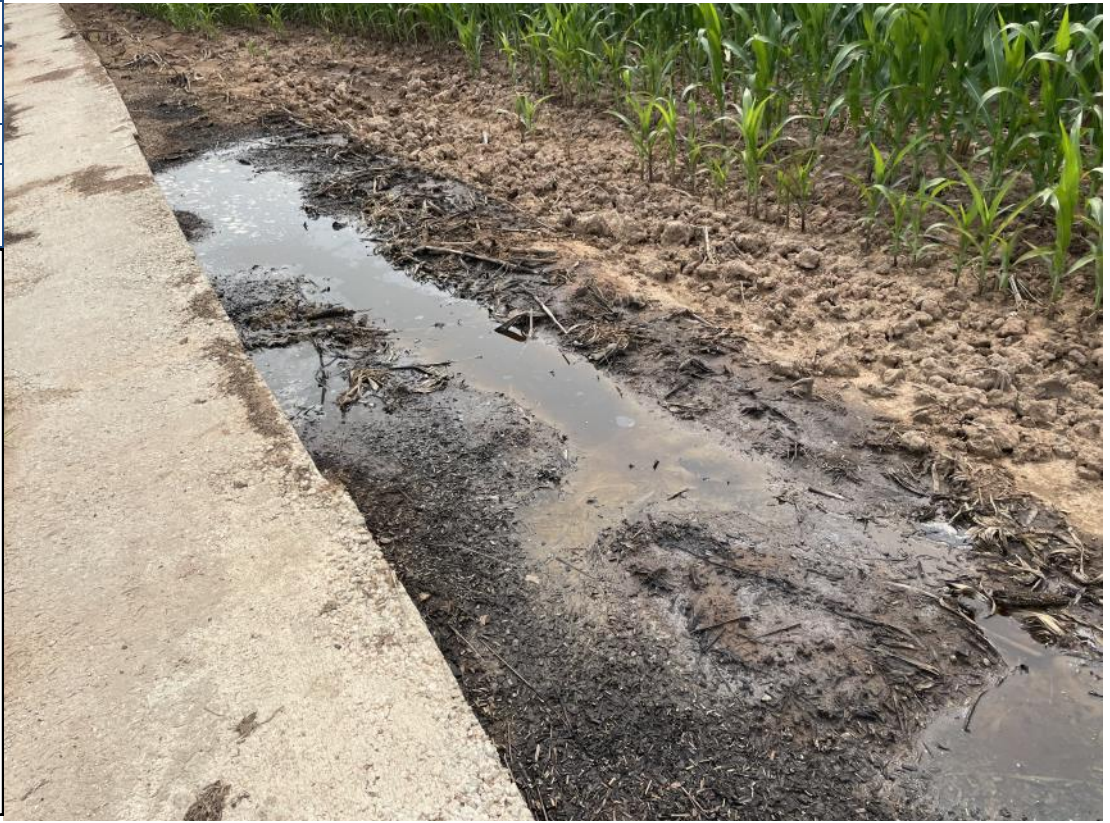
<b>Photo #:</b>	1664
<b>Date/Time of Photo:</b>	08/01/2023 11:22
<b>Photo By:</b>	Stegemann
<b>Photo Location:</b>	Glenmore FSA
<b>Photo Description: View of leachate on base ground on south end of feedpad.</b>

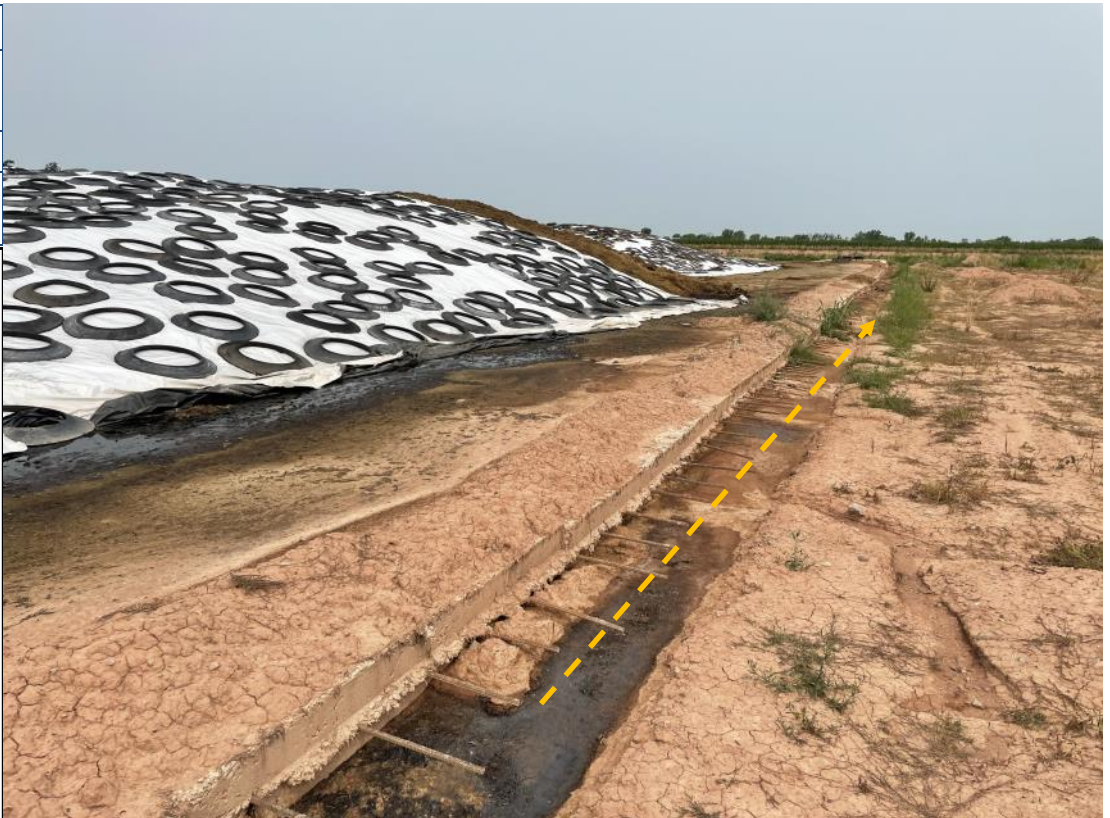
<b>Photo #:</b>	1673
<b>Date/Time of Photo:</b>	08/01/2023 11:23
<b>Photo By:</b>	Stegemann
<b>Photo Location:</b>	Glenmore FSA
<b>Photo Description: View of clay placed on unfinished east side of concrete pad. Photo taken standing on southeast corner, looking north. Arrows indicate approximate contaminated runoff flow paths.</b>

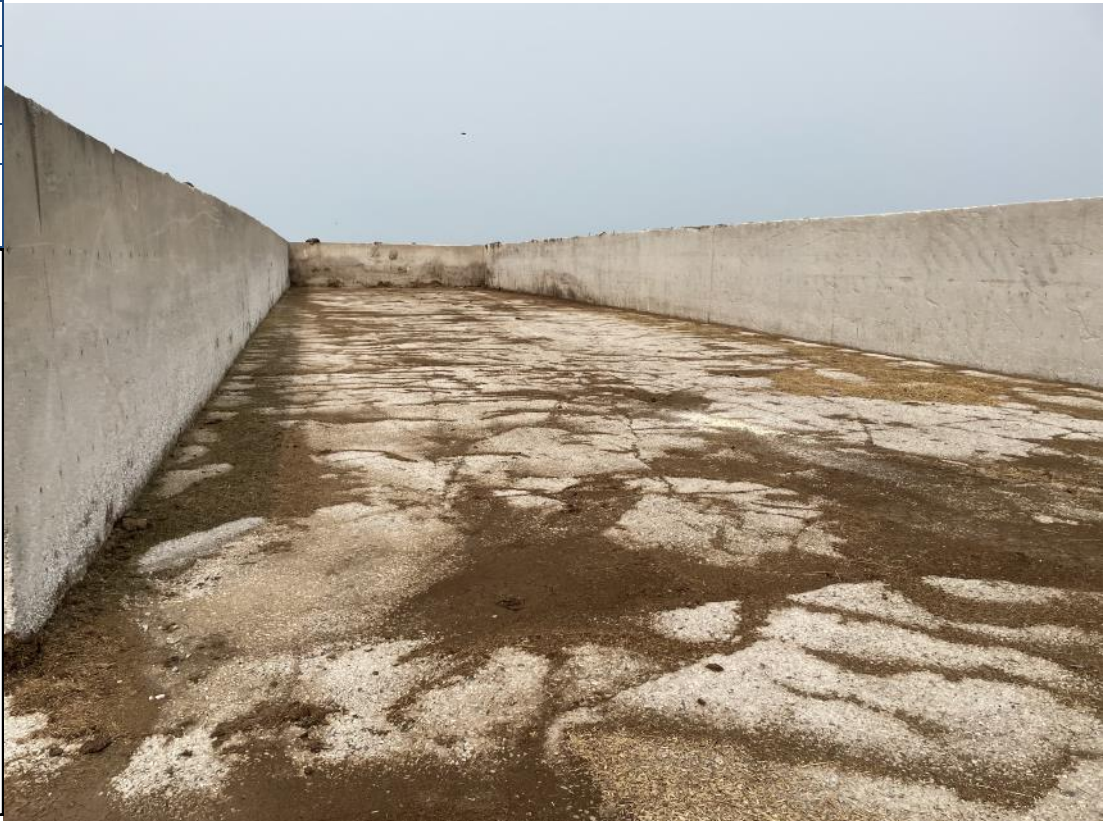
<b>Photo #:</b>	1636
<b>Date/Time of Photo:</b>	08/01/2023 10:24
<b>Photo By:</b>	Stegemann
<b>Photo Location:</b>	Heifer FSA

**Photo Description:** View of feed removed from feed storage area at the heifer site, looking west.

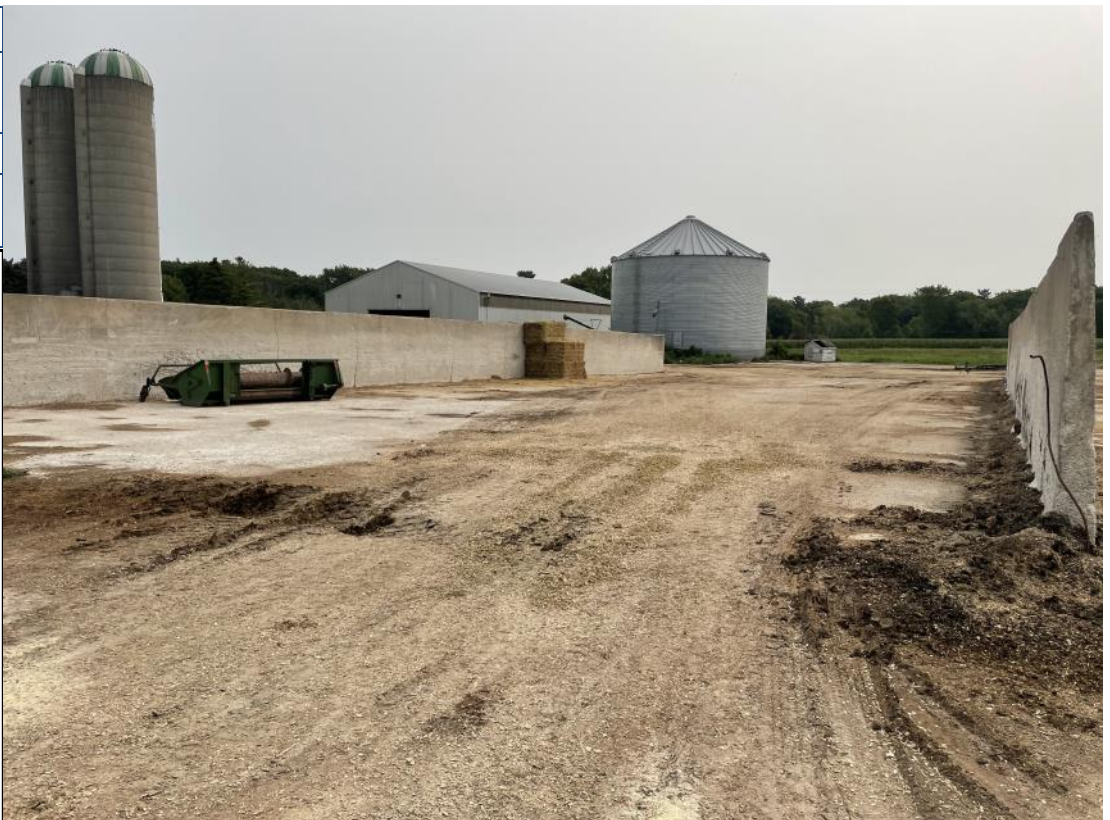
<b>Photo #:</b>	1635
<b>Date/Time of Photo:</b>	08/01/2023 10:24
<b>Photo By:</b>	Stegemann
<b>Photo Location:</b>	Heifer FSA

**Photo Description:** View of feed removed from the feed storage area at the heifer site, looking west.

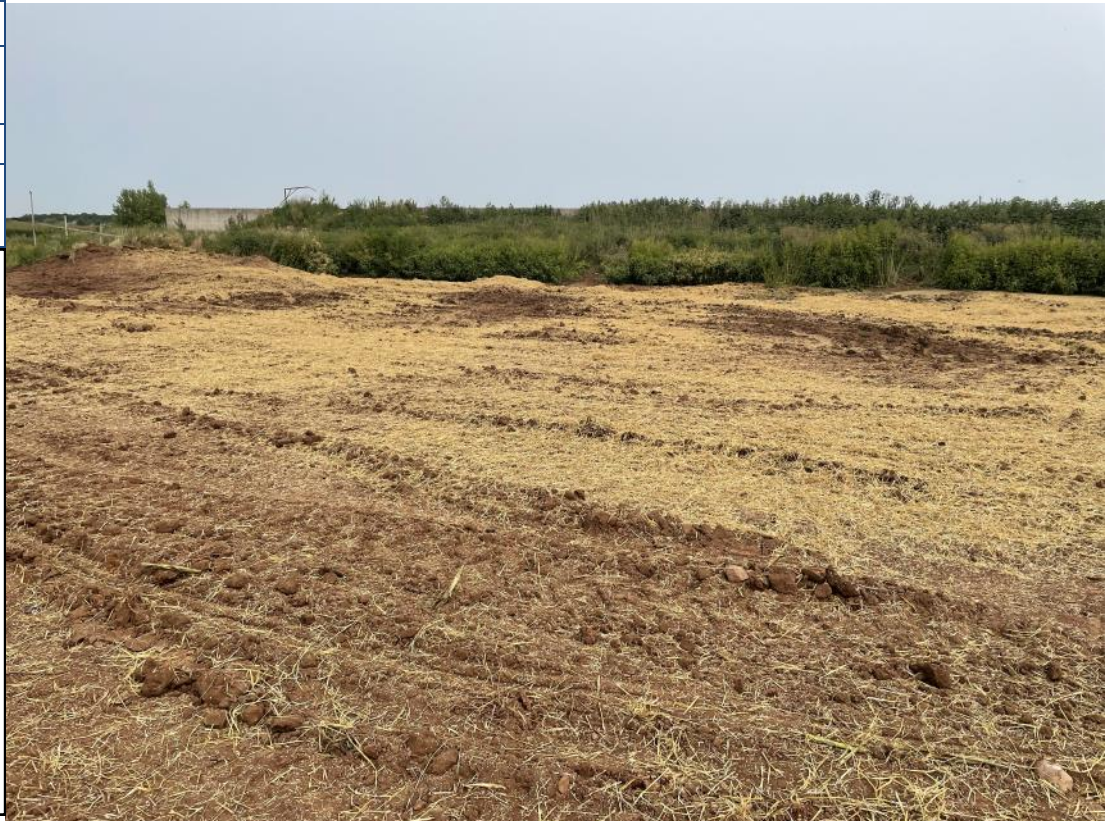
<b>Photo #:</b>	1622
<b>Date/Time of Photo:</b>	08/01/2023 10:21
<b>Photo By:</b>	Stegemann
<b>Photo Location:</b>	Heifer Leachate Basin

**Photo Description:** View of the leachate basin, filled in and reseeded. Photo direction, northwest.

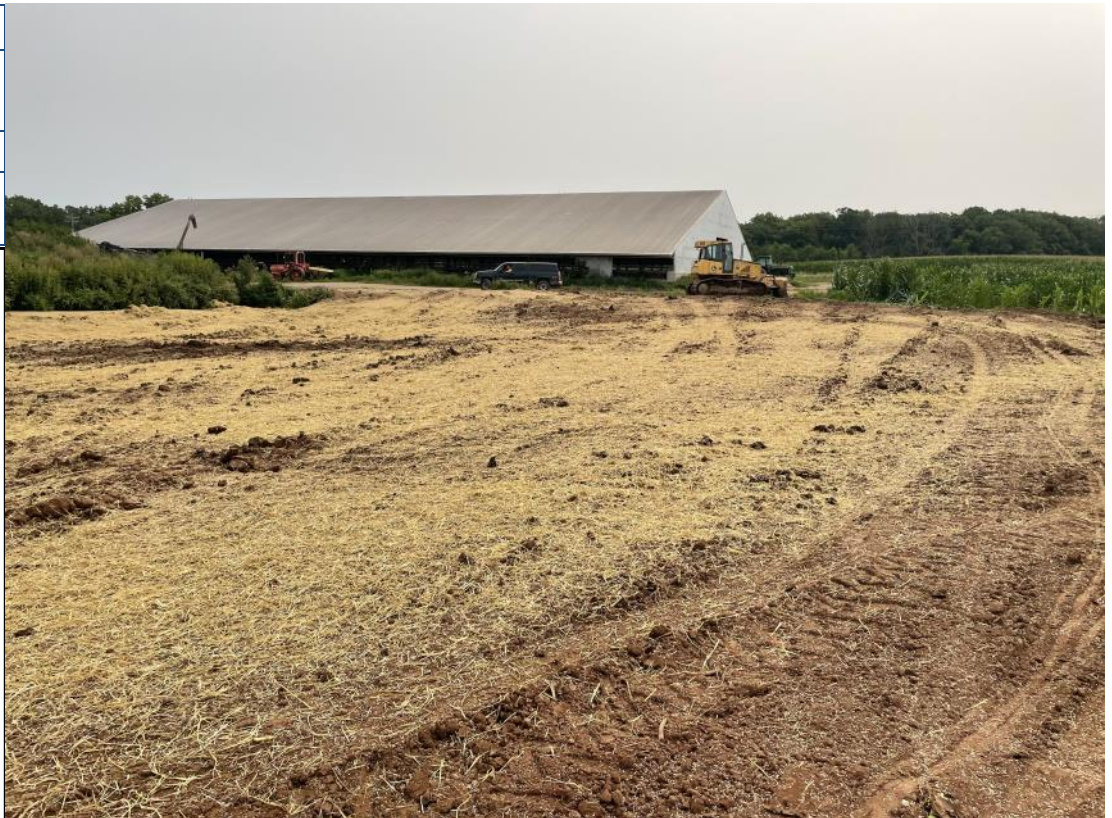
<b>Photo #:</b>	1625
<b>Date/Time of Photo:</b>	08/01/2023 10:21
<b>Photo By:</b>	Stegemann
<b>Photo Location:</b>	Heifer Leachate Basin

**Photo Description:** View of the leachate basin, filled in and reseeded. Photo direction, east.

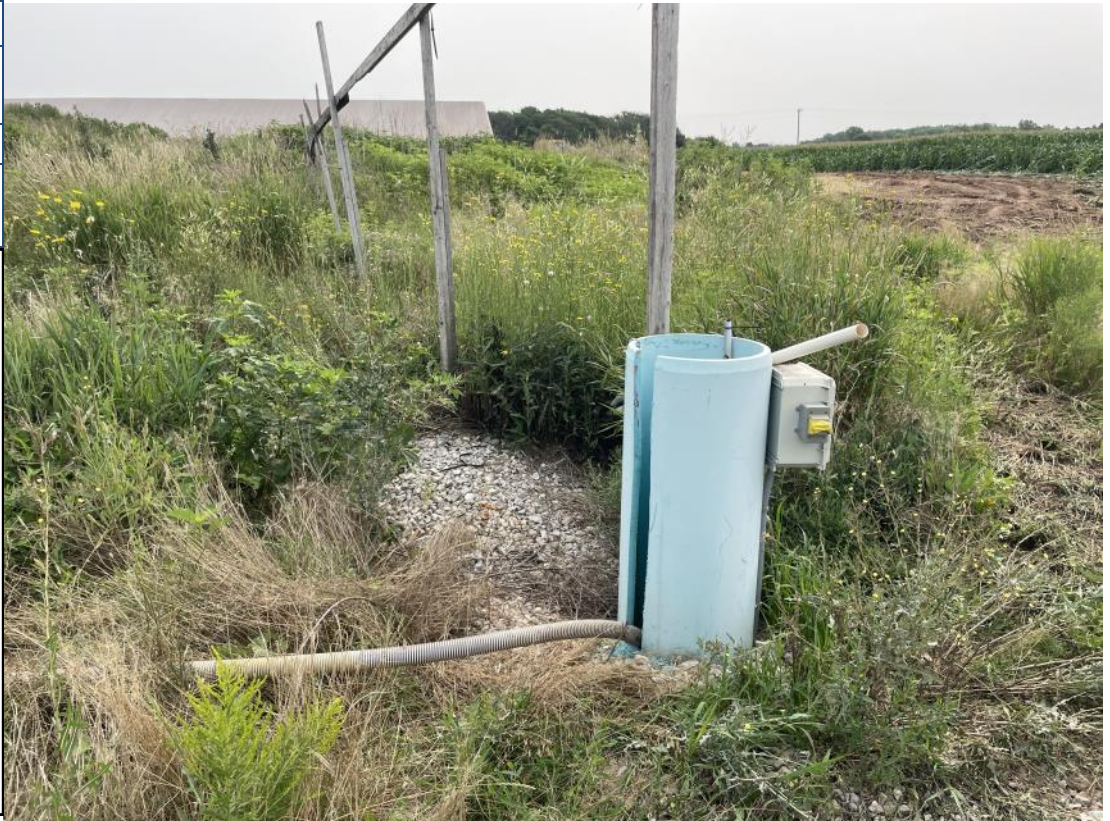
<b>Photo #:</b>	1631
<b>Date/Time of Photo:</b>	08/01/2023 10:22
<b>Photo By:</b>	Stegemann
<b>Photo Location:</b>	Heifer FSA

**Photo Description: View of pump for abandoned feed storage area at the heifer site.**

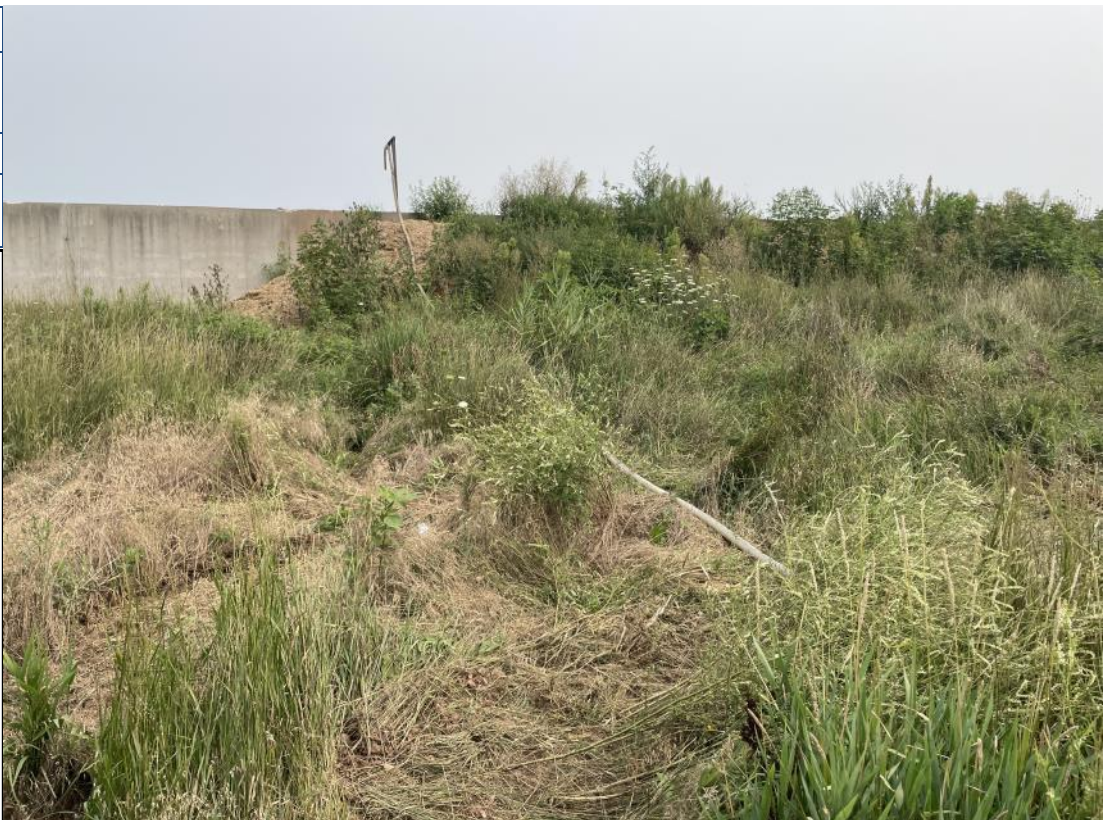
<b>Photo #:</b>	1632
<b>Date/Time of Photo:</b>	08/01/2023 10:22
<b>Photo By:</b>	Stegemann
<b>Photo Location:</b>	Heifer FSA

**Photo Description: View of pump for abandoned feed storage area at the heifer site.**
