## Permit Fact Sheet

| Permit Number | WI-0062367-05-0 |
| Permittee Name and Address | Ostrowski Farms, Inc.<br>218040 Black Cherry Drive, Eland, WI 54427 |

On Monday August 18th, 2025, at 09:00 Hanson met with Ostrowski at Ostrowski Farms Inc site to conduct a permit reissuance walkover inspection. The main dairy site was the only facility inspected. No significant rain had occurred previous to the inspection and the temperature was in the 70's, cloudy, with light rain falling. No active discharges were observed, and no water samples were collected. Hanson departed at approximately 11:30.

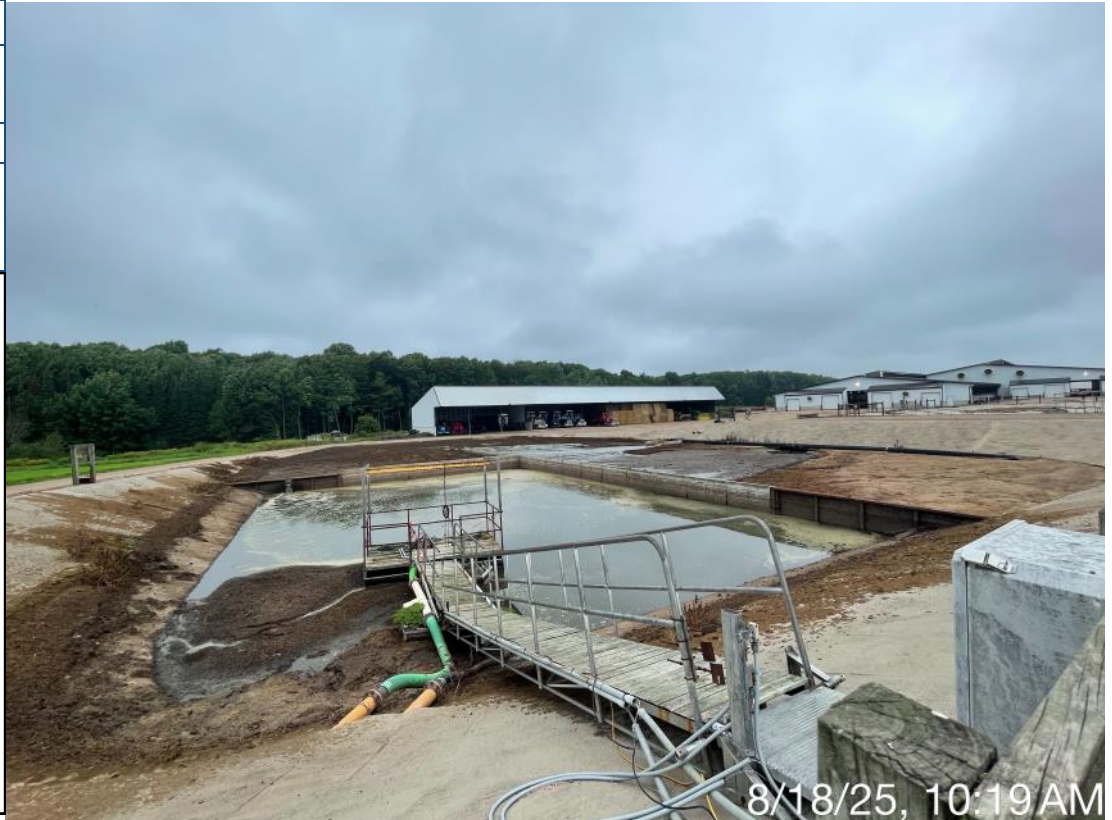
| <b>Photo Location:</b> | Sand Pit |

| <b>Photo Description:</b><br><br>Standing on the east side of the Sand Pit looking west: View of southeast corner of Sand Pit. Notice floating intake used to pump manure to 6 Million Pit. | |

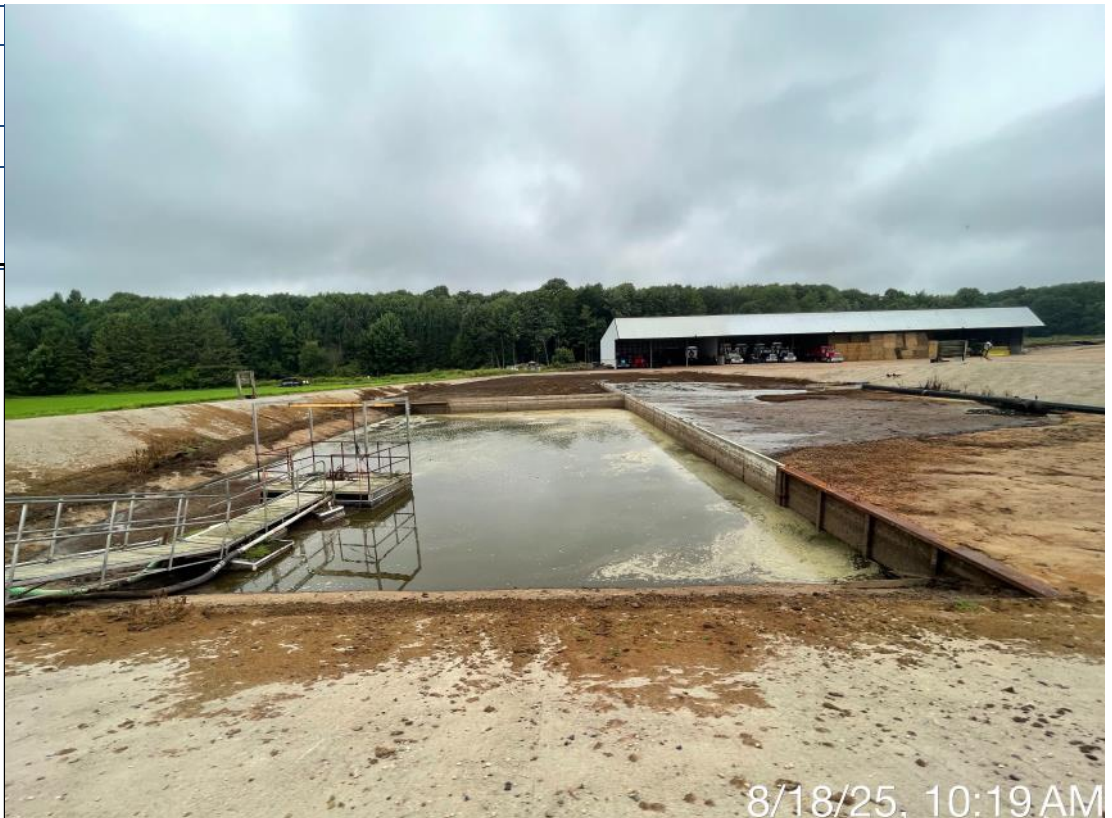
| <b>Photo #:</b> | 2 |

| <b>Photo Description:</b><br><br>Standing on the east end of Sand Pit looking west: View of east end of Sand Pit. Notice vertical walls used to separate sand from liquids. Notice no safety fence is installed. | |

- Install all missing safety fences and MOL/MOS markers for all waste storage facilities which currently do not have one.
- Submit permit reissuance application by 12/1/2025.

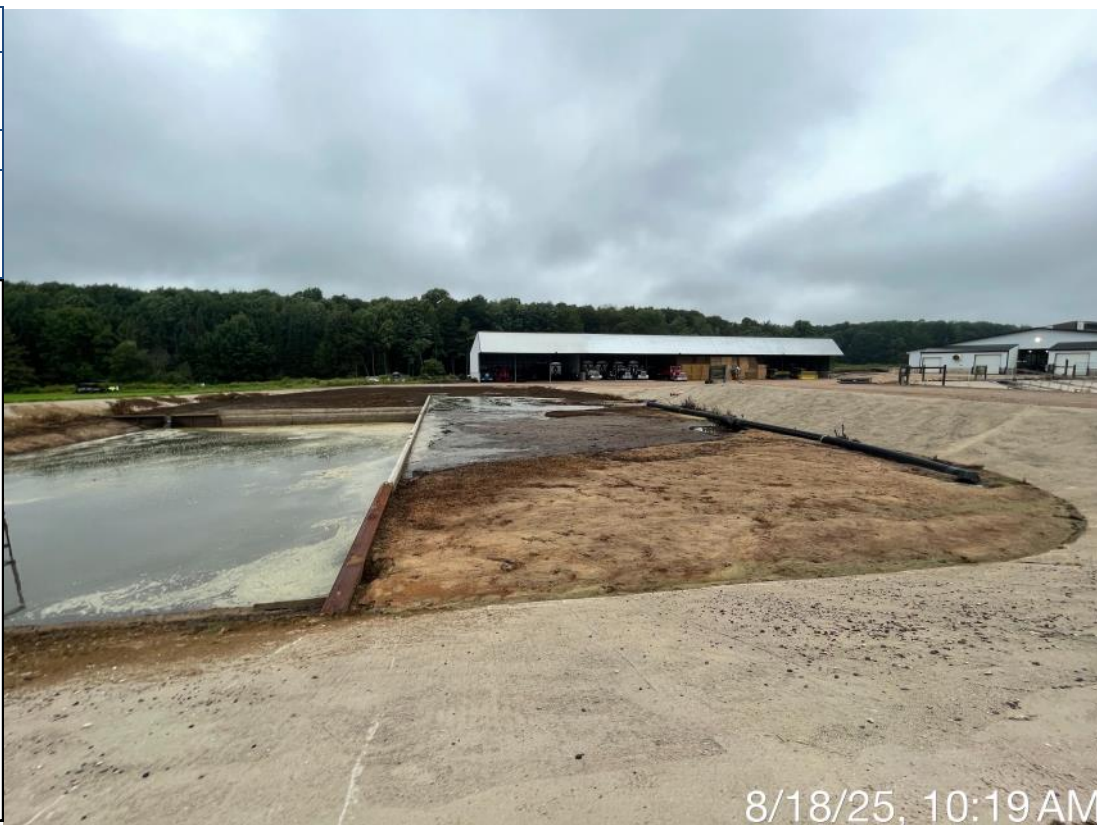
| <b>Photo #:</b> | 3 |

| <p>Standing on east side of Sand Pit looking west: View of northeast corner of Sand Pit. Notice vertical wall used to separate settled sand from liquid portion of pit.</p> | |

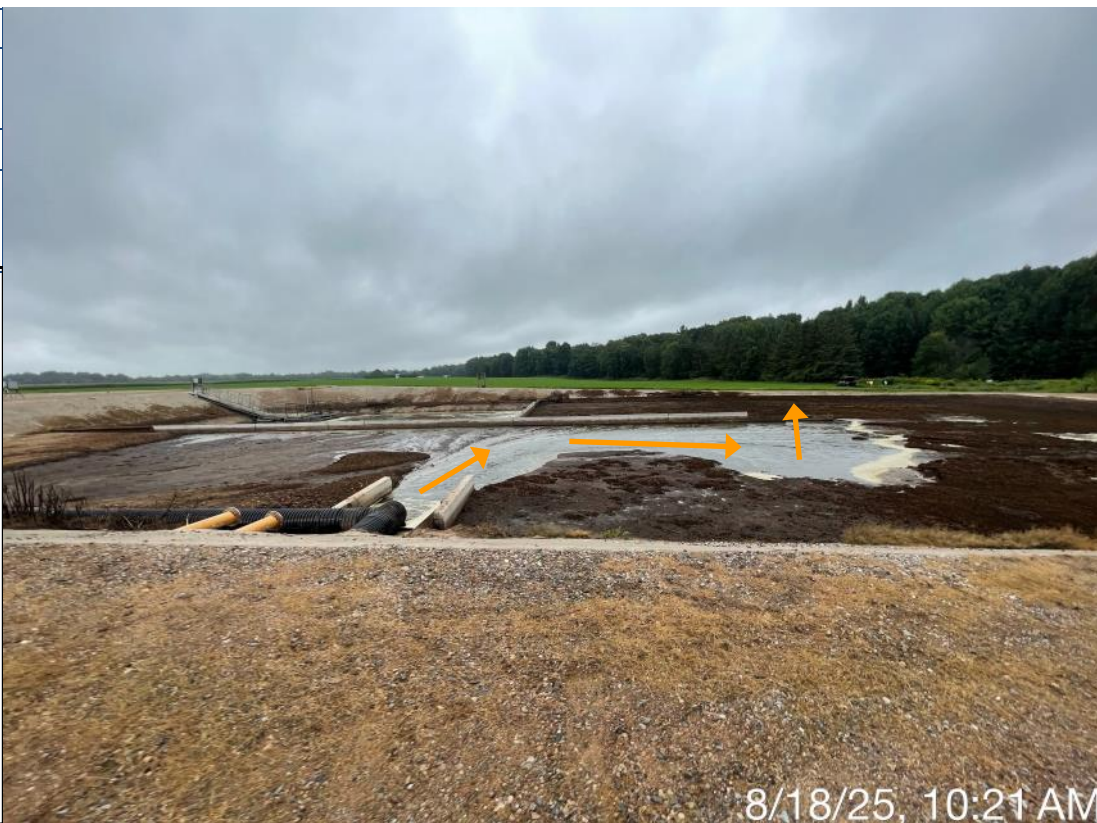
| <b>Photo #:</b> | 4 |

| <p>Standing on north side of Sand Pit looking south: View of outlet pipe from freestall barn that supplies manure to the basin. Arrows indicate direction of manure flow.</p> | |

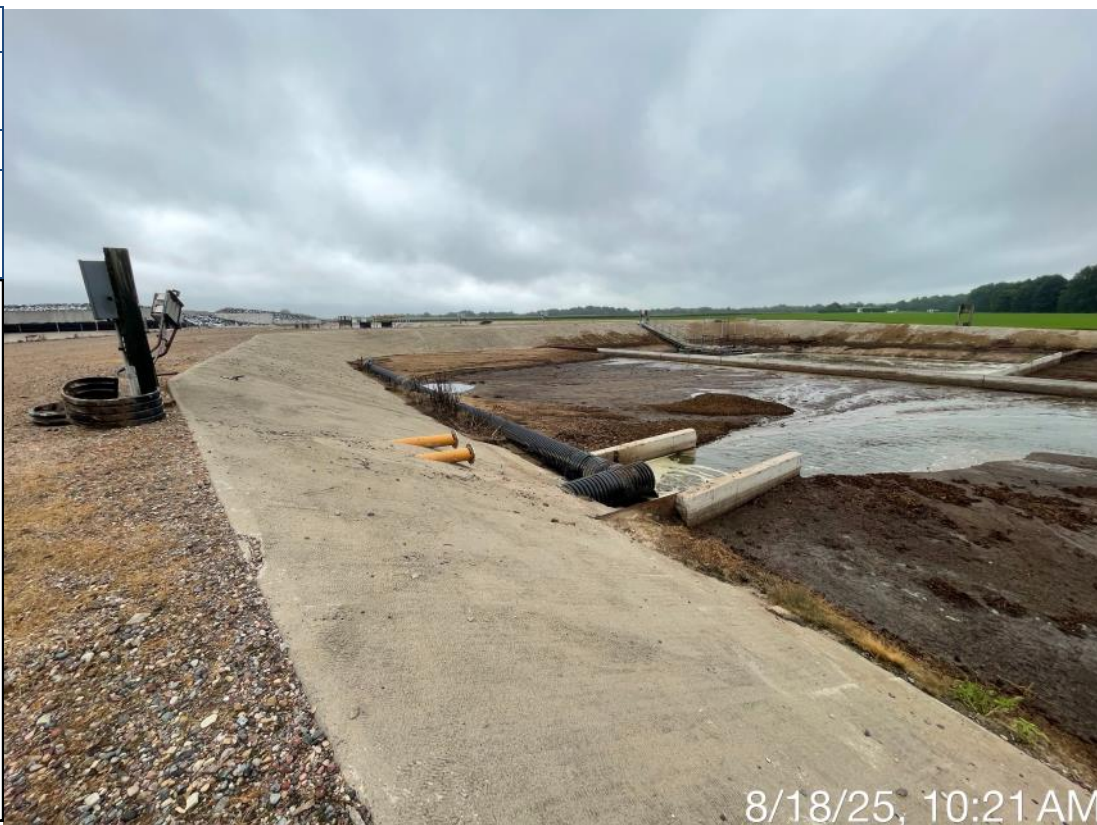
| <b>Photo #:</b> | 5 |

| <b>Photo Description:</b><br><br>Standing on the north side of Sand Pit looking east: View of additional pipes used to convey sand laden manure to east end of pit. | |

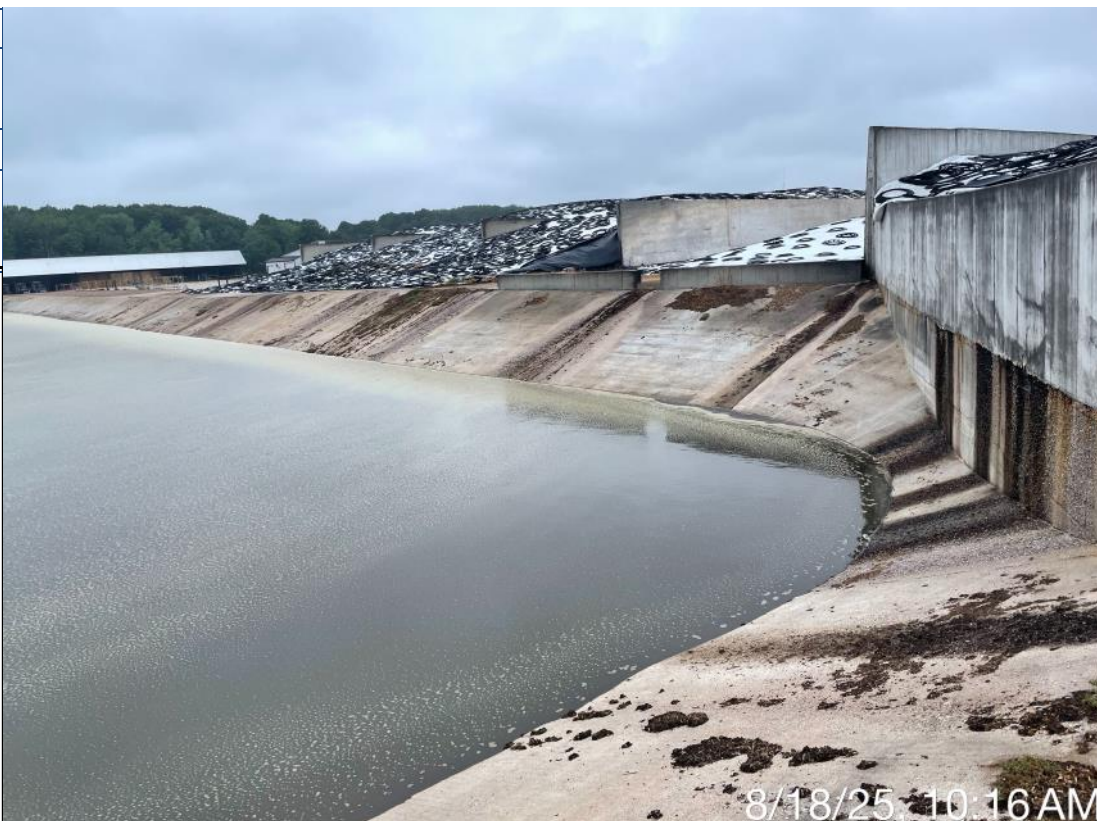
| <b>Photo #:</b> | 6 |

| <b>Photo Description:</b><br><br>Standing on east side of 6 Million Pit looking northwest: View of northeast corner of 6 Million Pit. Notice black staining of feed leachate flowing into the facility along north edge. | |

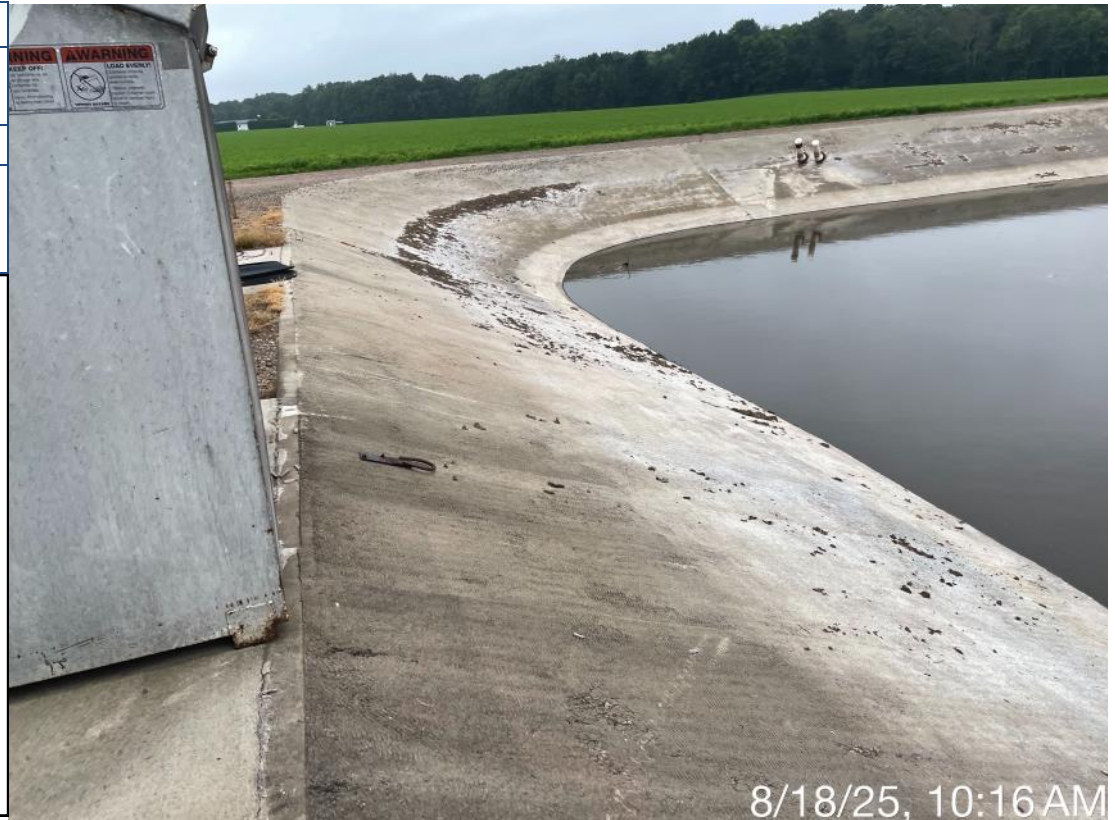
| <b>Photo Description:</b><br><br>Standing on east end of 6 Million Pit looking south: View of southeast corner of pit. | |

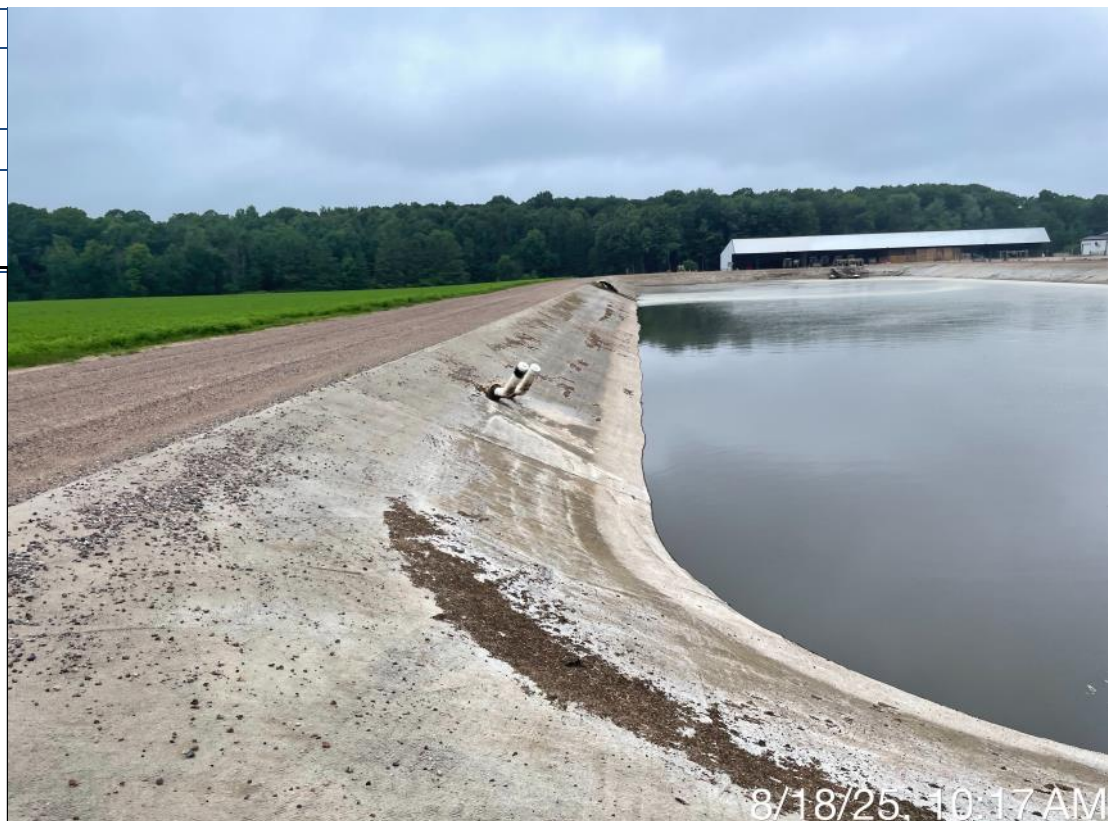
| <b>Photo #:</b> | 8 |

| <b>Photo Description:</b><br><br>Standing at southeast corner of pit looking west: View of south edge of pit. Notice no safety fence is installed. Pipes sticking through liner were stubbed and are not in use. | |

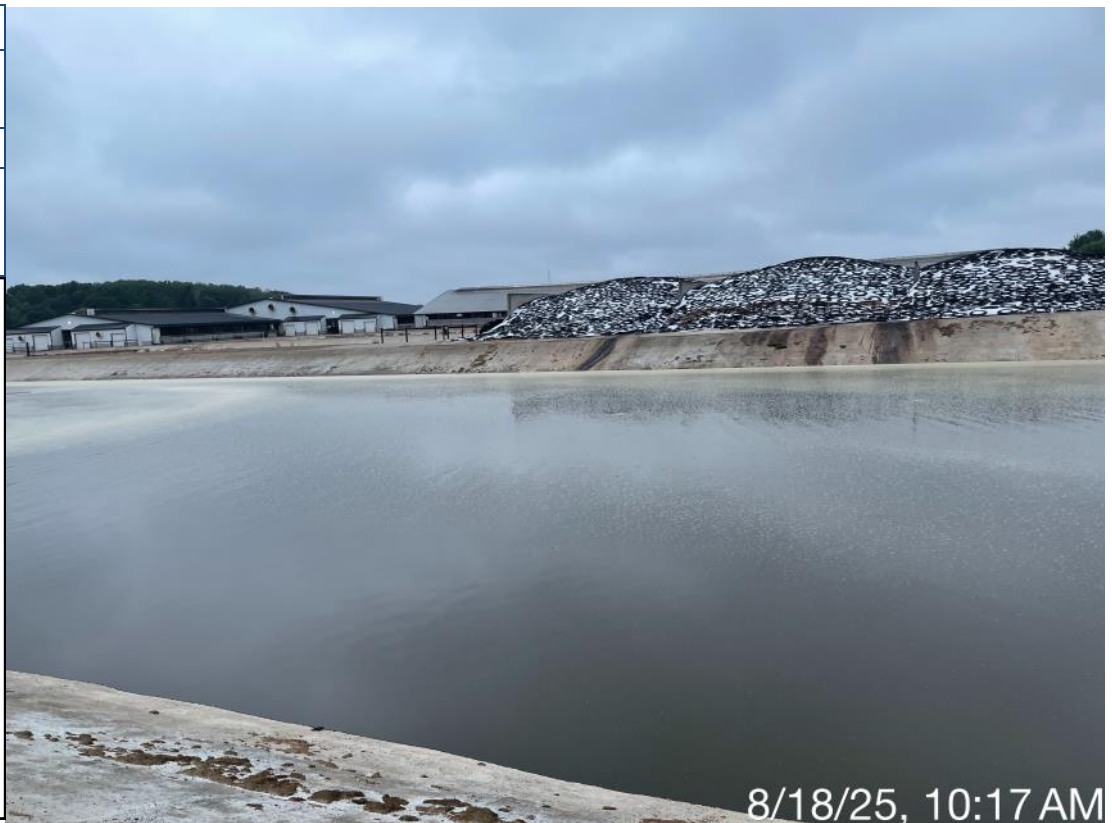
| <b>Photo #:</b> | 9 |

| <b>Photo Description:</b><br><br>Standing on the south side of pit looking north: View of center of pit. Notice leachate stains on north side concrete liner. | |

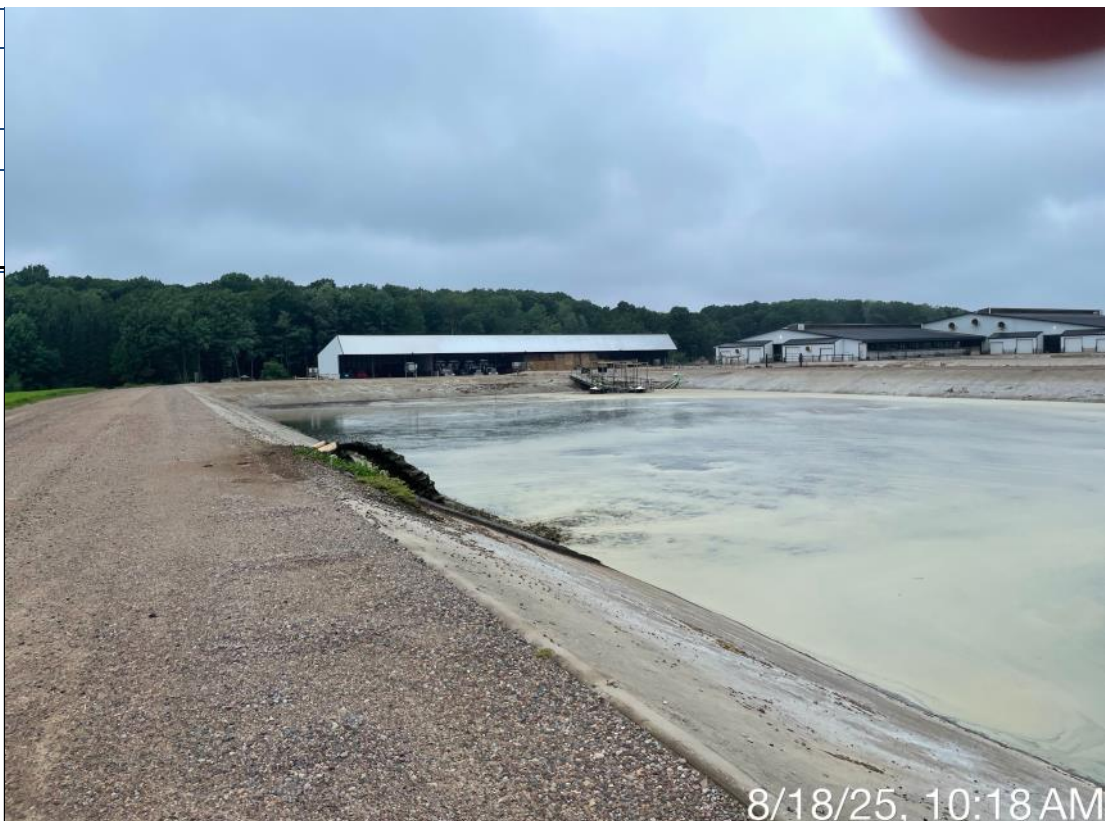
| <b>Photo #:</b> | 10 |

| <b>Photo Description:</b><br><br>Standing on south side of pit looking west: View of south edge of pit. Notice outlet pipes flowing from Sand Pit. Also notice no safety fence present. | |

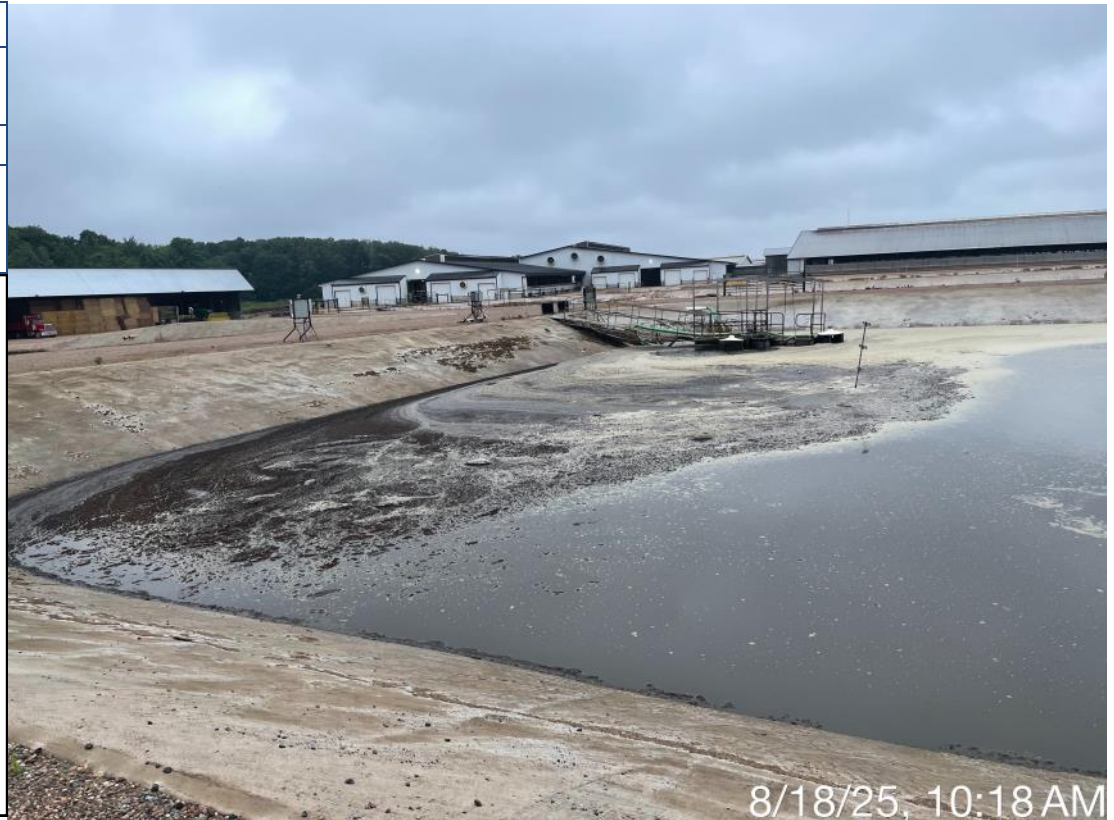
| <b>Photo Description:</b><br><br>Standing on the south side of pit looking north: View of west end of pit. | |

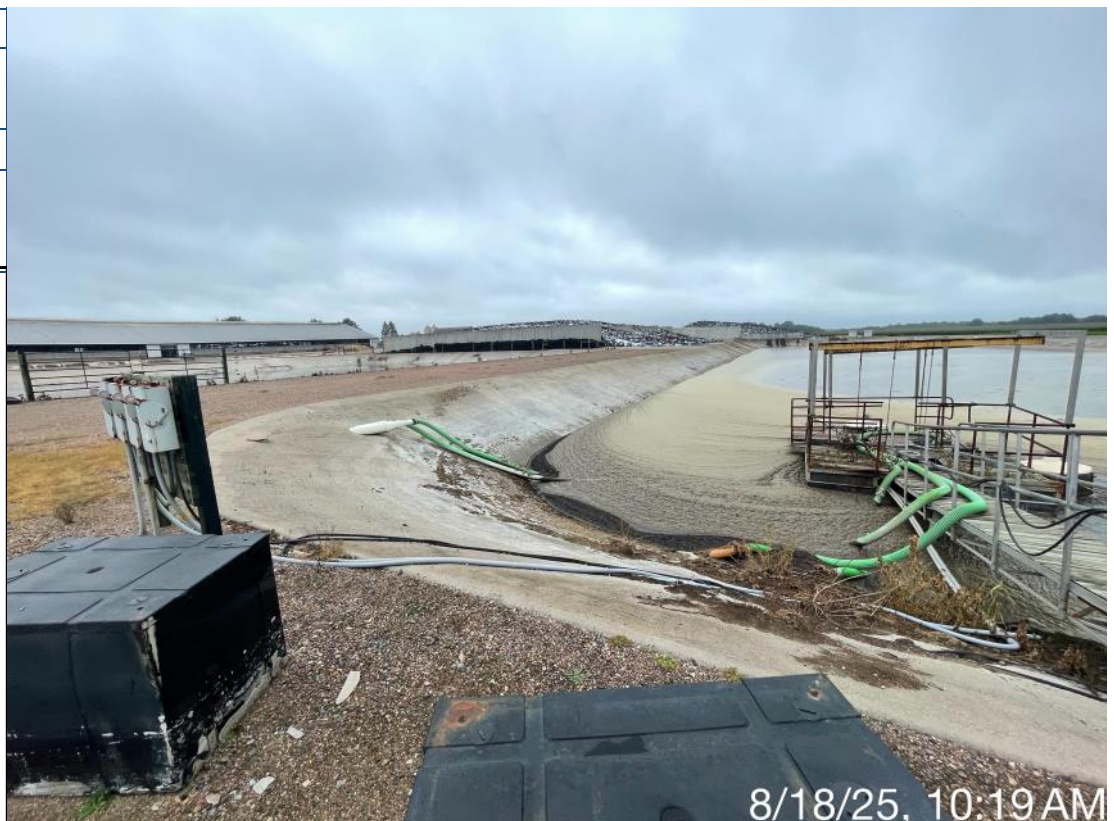
| <b>Photo #:</b> | 12 |

| <b>Photo Description:</b><br><br>Standing on west end of pit looking east: View of northwest corner of pit. Notice floating pump used to recirculate manure to the flush system in the 2010 freestall barn. | |

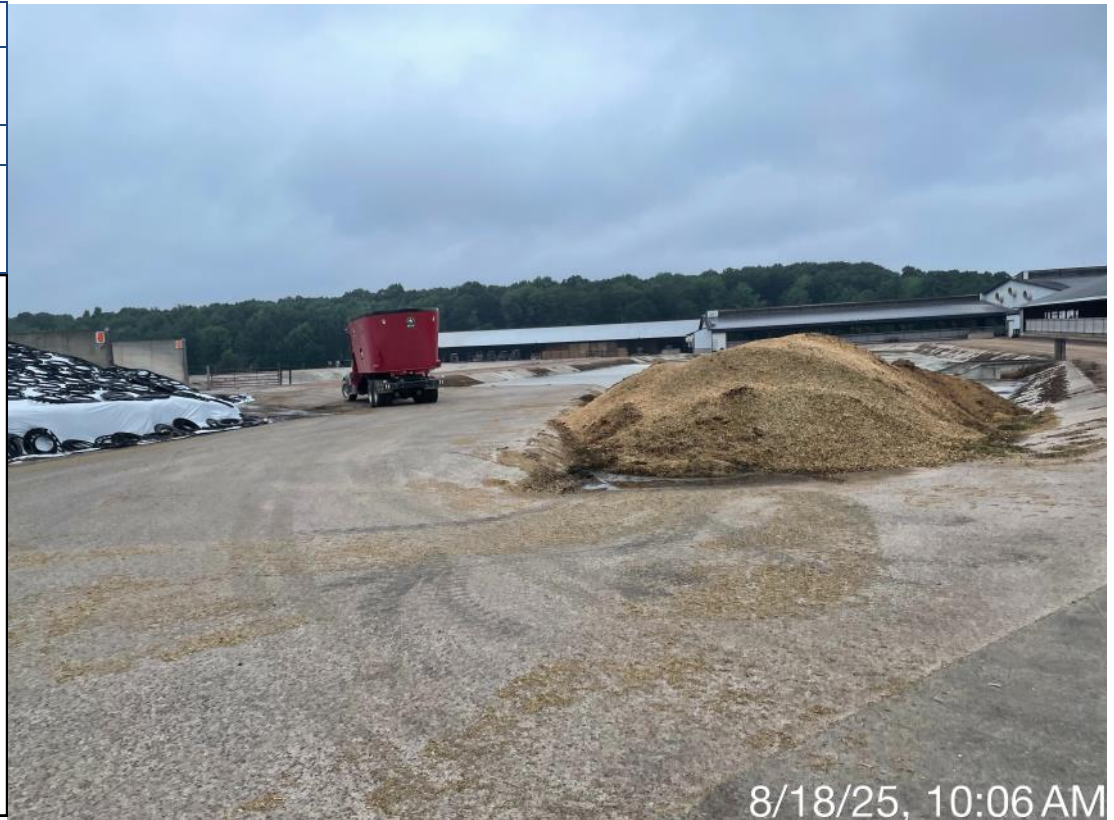
| <b>Photo #:</b> | 13 |

| <b>Photo Description:</b><br><br>Standing on east side of Main Pit looking west: View of access ramp into Main Pit. Notice solids stacked on ramp above the MOL level. | |

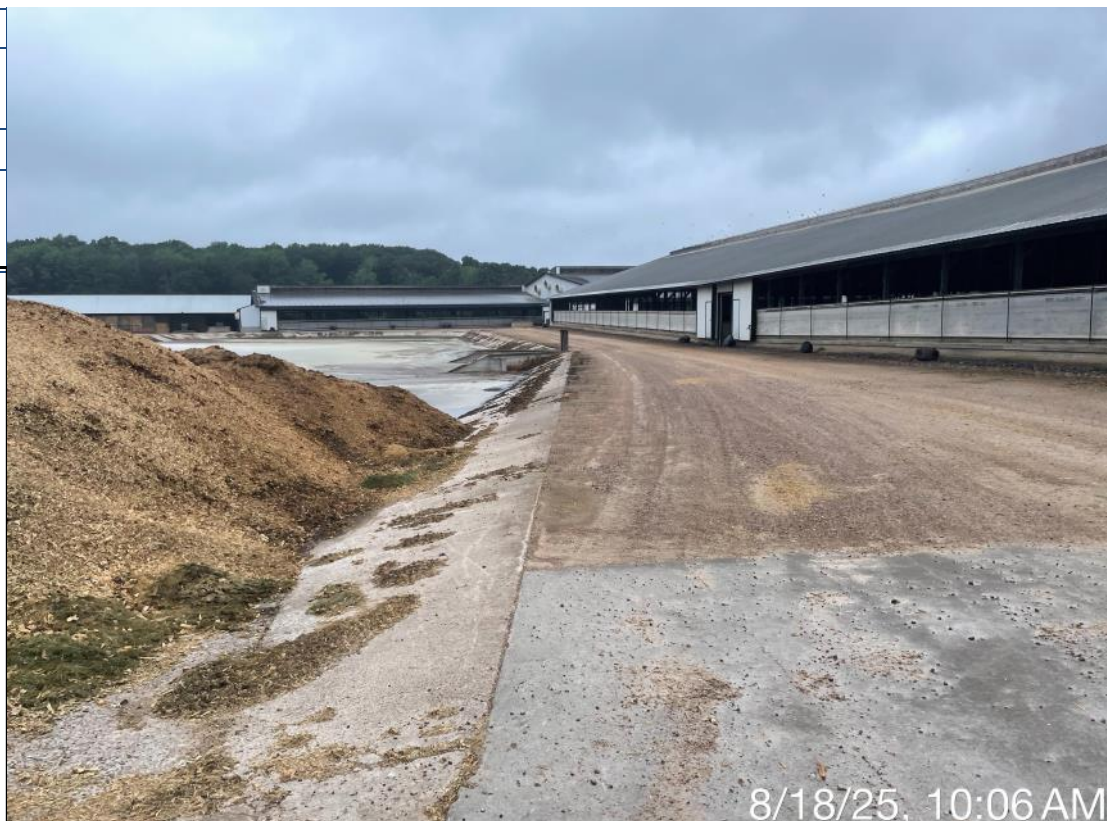
| <b>Photo #:</b> | 14 |

| <b>Photo Description:</b><br><br>Standing on the north side of Main Pit looking west: View of north edge of Main Pit. Notice solids stacked on access ramp and lack of safety fence. | |

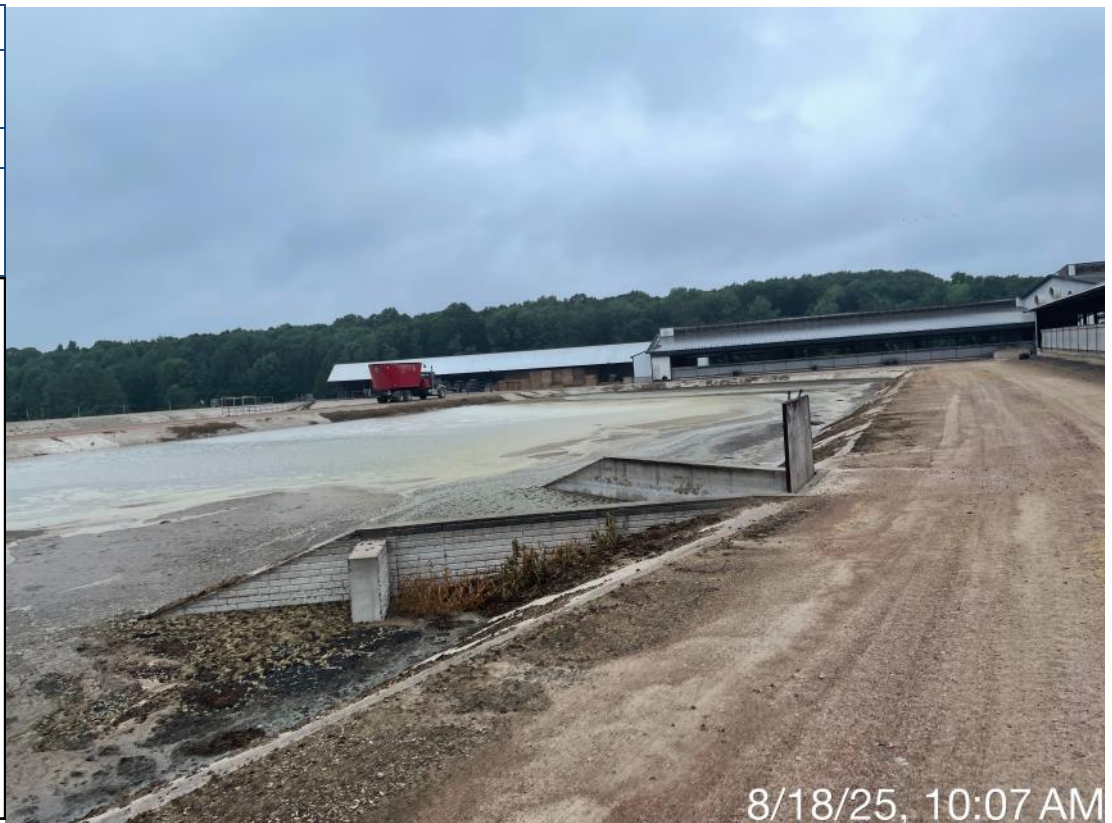
| <b>Photo #:</b> | 15 |

| <b>Photo Description:</b><br><br>Standing on the north side of Main Pit looking southwest:<br>View of manure transfer channel entering Main Pit.<br>Notice lack of safety fence. | |

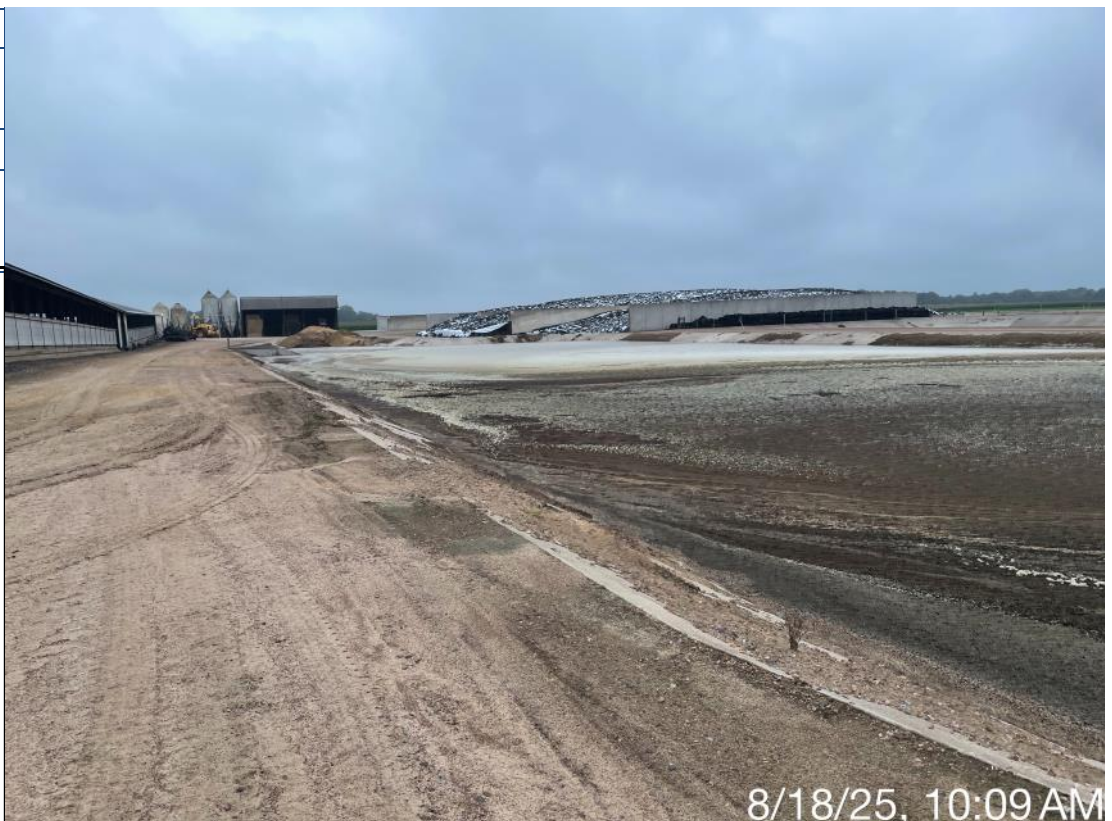
| <b>Photo Description:</b><br><br>Standing on the north side of Main Pit looking east: View of north edge of Main Pit. | |

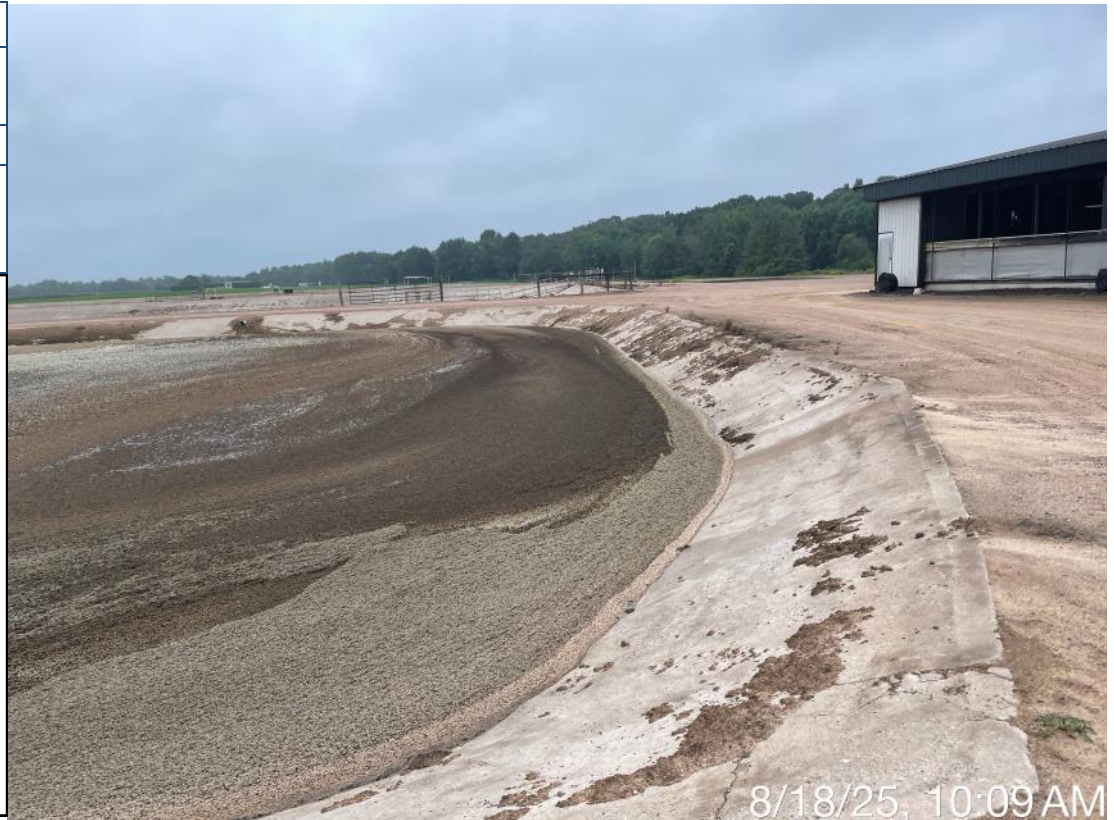
| <b>Photo Description:</b><br><br>Standing on the north side of Main Pit looking south: View of west end of Main Pit. | |

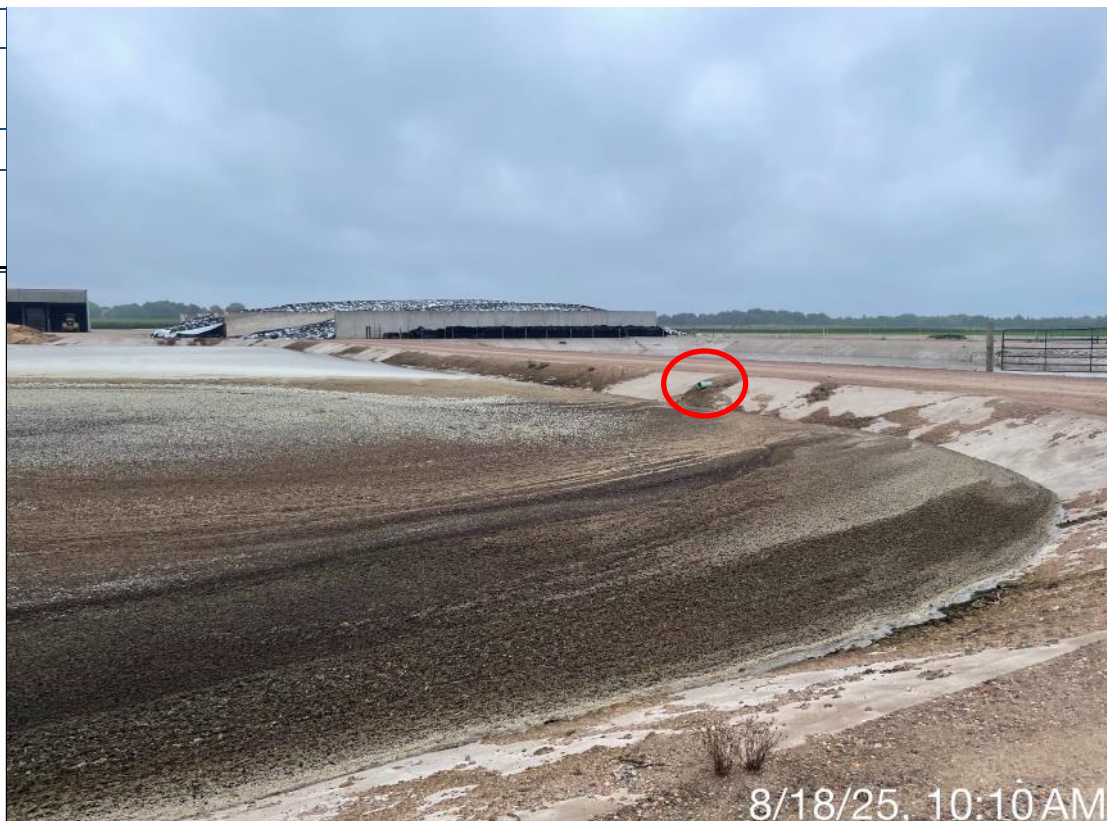
| <b>Photo #:</b> | 18 |

| <b>Photo Description:</b><br><br>Standing on west end of Main Pit: View of southwest corner of Main Pit. Overflow pipe to middle pit highlighted. | |

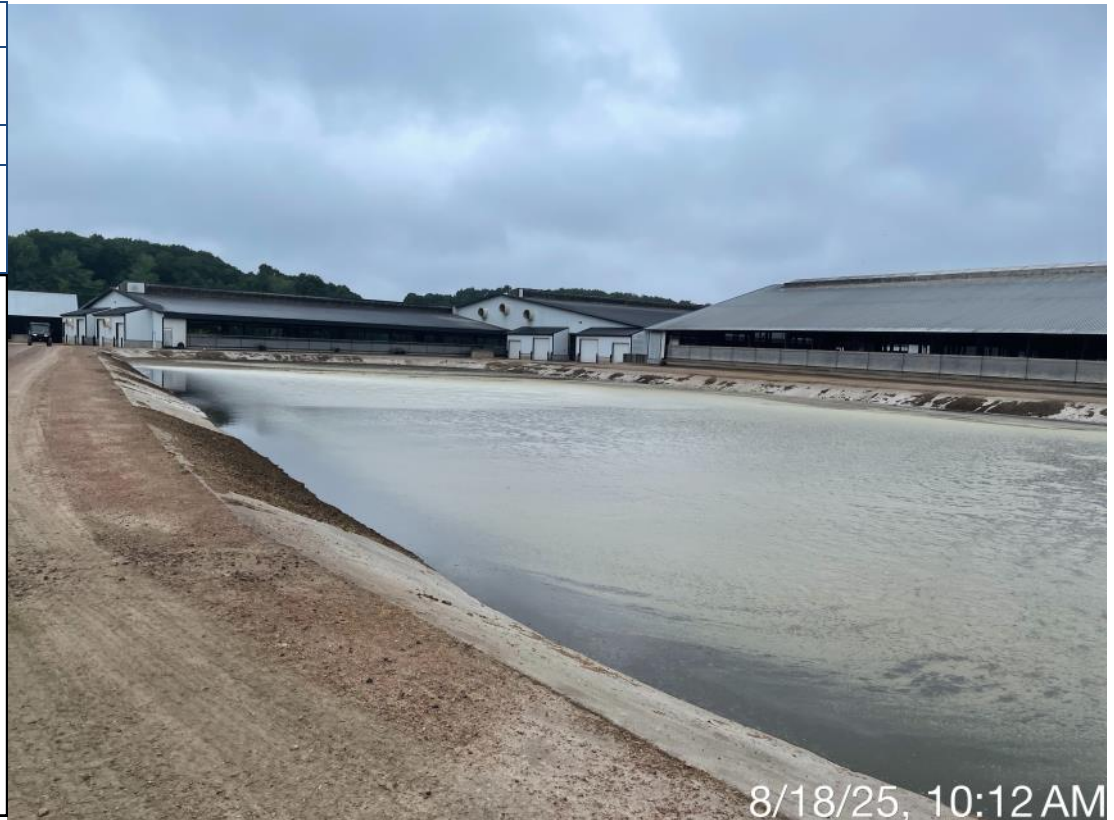
| <b>Photo Description:</b><br><br>Standing on the south side of Main Pit looking west: View of south edge of Main pit. | |

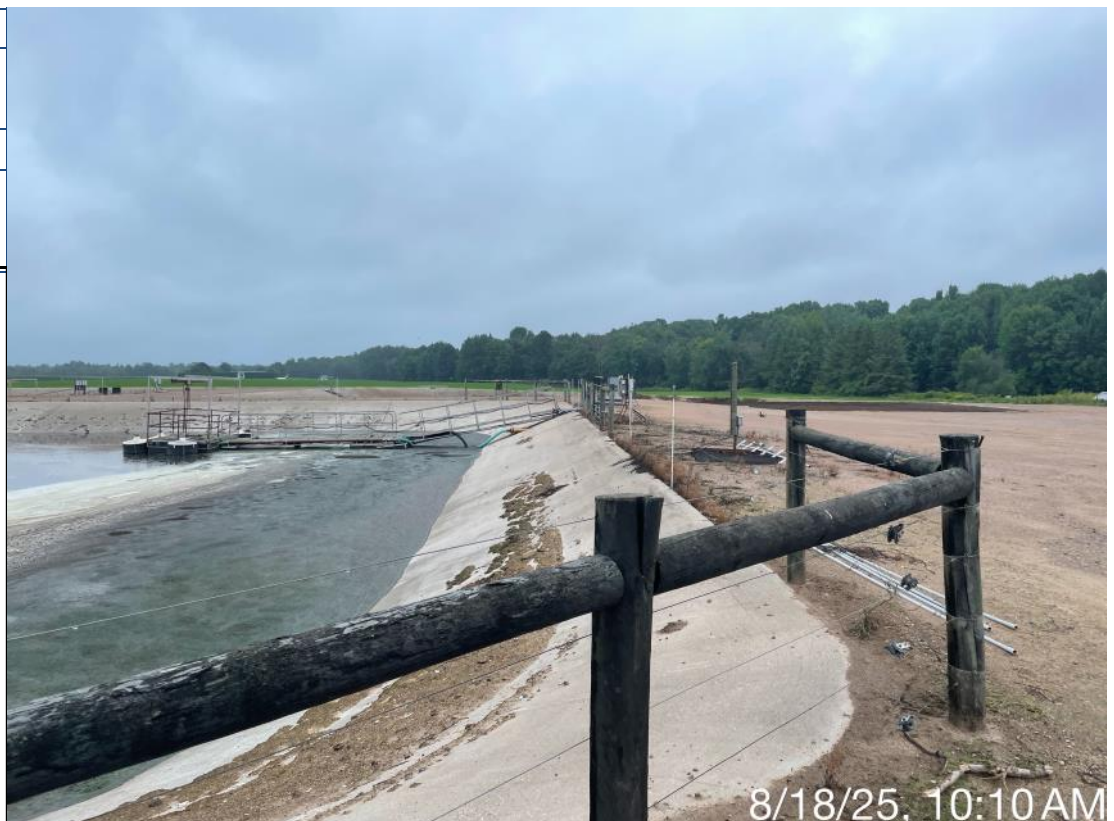
| <b>Photo Description:</b><br><br>Standing on the north side of Middle Pit looking south: View of west edge of middle Pit | |

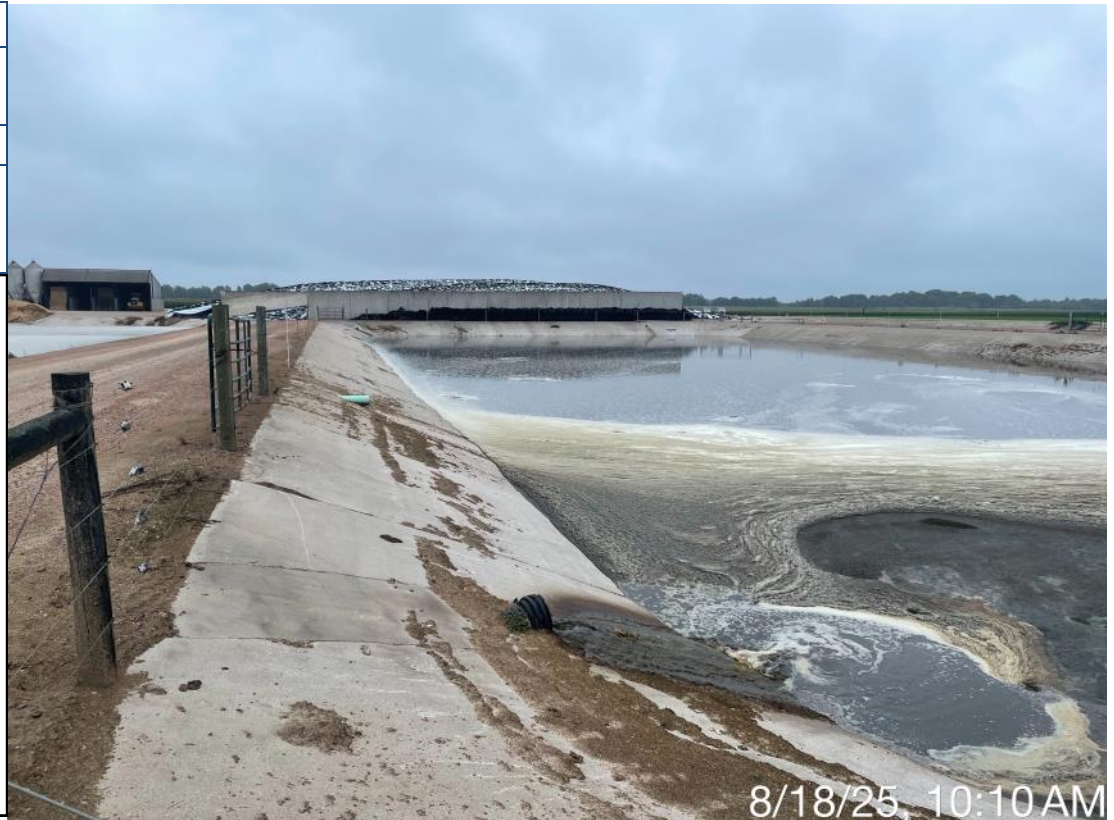
| <b>Photo #:</b> | 21 |

| <b>Photo Description:</b><br><br>Standing at the northwest corner of Middle Pit looking east: View of north edge of Middle Pit. Notice outlet pipe from parlor transfer and Main Pit overflow pipe visible | |

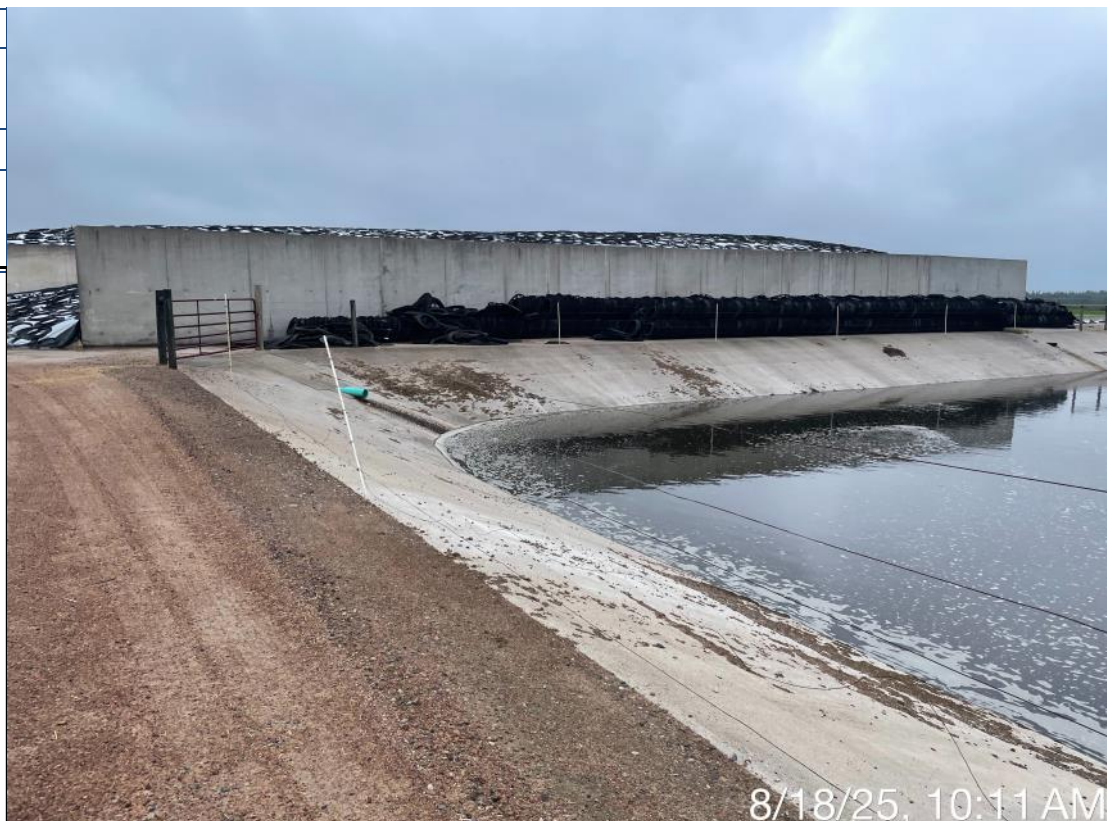
| <b>Photo Description:</b><br><br>Standing on north side of Middle Pit looking east: View of northeast corner Middle Pit. | |

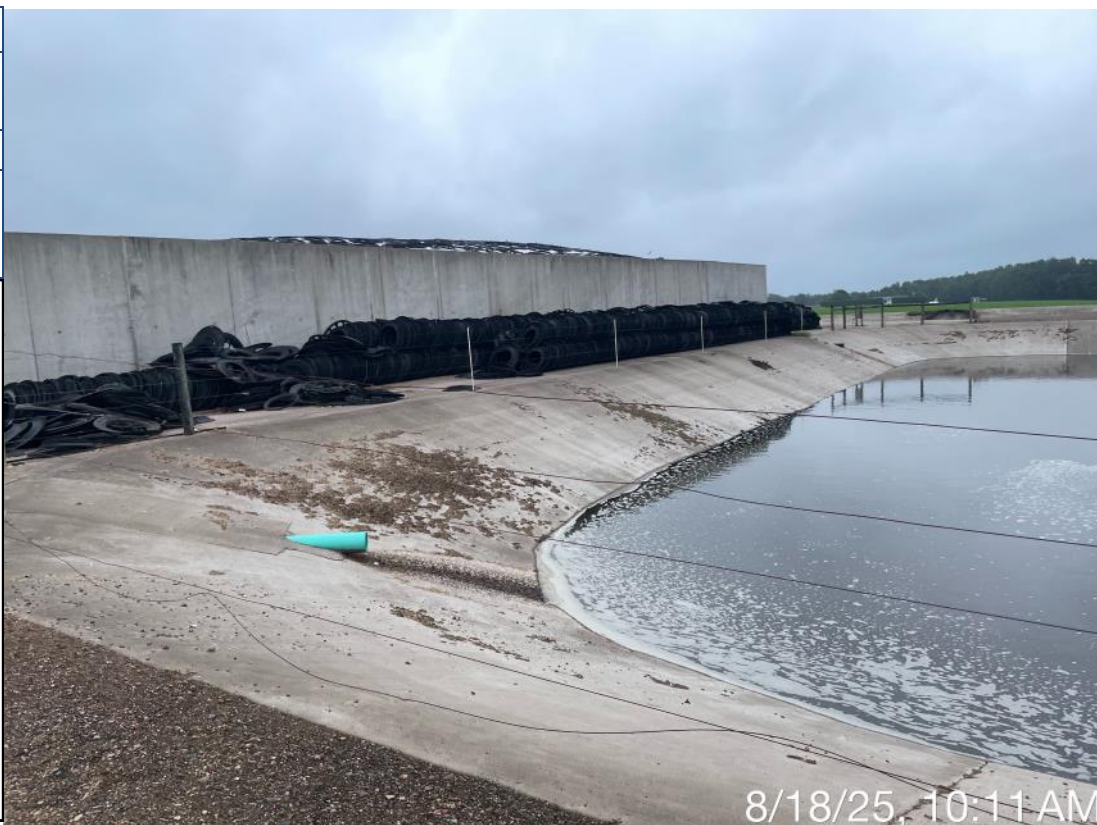
| <b>Photo #:</b> | 23 |

| <b>Photo Description:</b><br><br>Standing on the north side of Middle Pit looking south: View of east end of Middle Pit. Notice green pipe outlet coming from FSA runoff collection system. | |

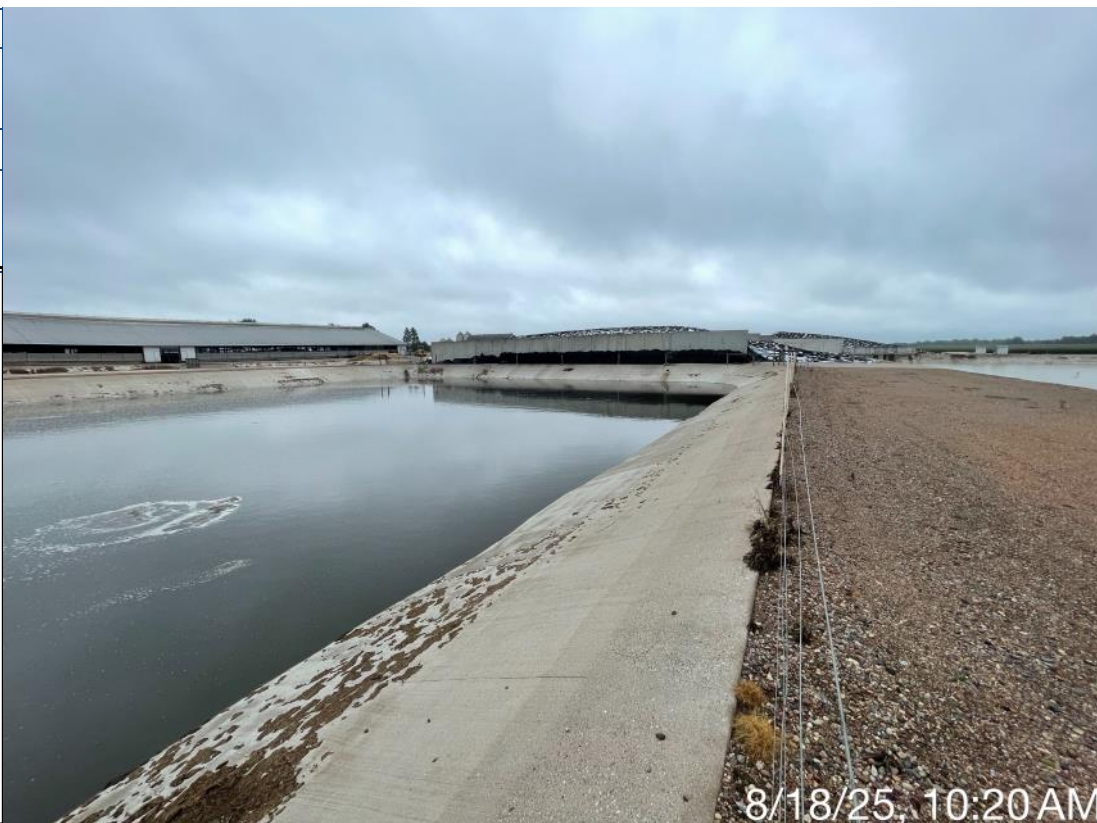
| <b>Photo Description:</b><br><br>Standing on south side of Middle Pit looking east: View of south edge of Middle Pit. | |
