## Permit Fact Sheet

| Permit Number | WI-0062367-05-0 |
| Permittee Name and Address | Ostrowski Farms, Inc.<br>218040 Black Cherry Drive, Eland, WI 54427 |

On Monday August 18th, 2025, at 09:00 Hanson met with Ostrowski at Ostrowski Farms Inc site to conduct a permit reissuance walkover inspection. The main dairy site was the only facility inspected. No significant rain had occurred previous to the inspection and the temperature was in the 70's, cloudy, with light rain falling. No active discharges were observed, and no water samples were collected. Hanson departed at approximately 11:30.

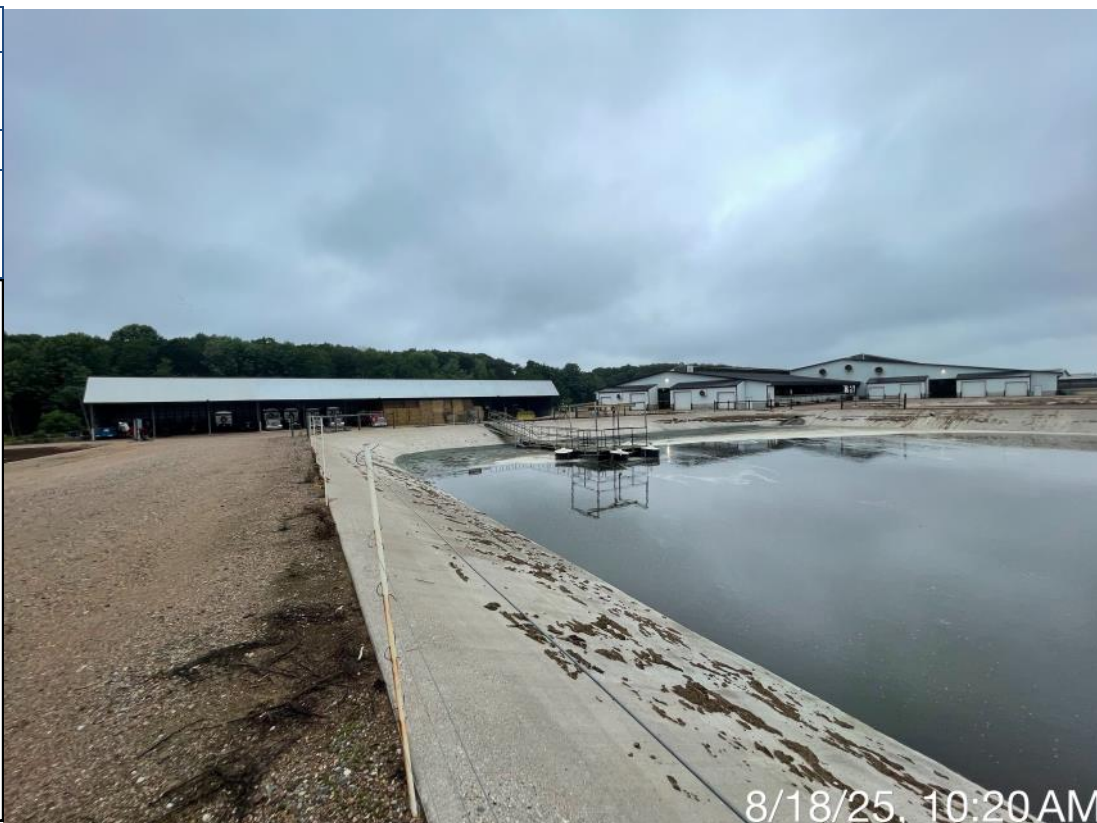
| <b>Photo #:</b> | 25 |

| <b>Photo Description:</b><br><br>Standing on the south side of Middle Pit looking west: View of south west corner of Middle pit. Notice floating pump used to supply water for flush system. | |

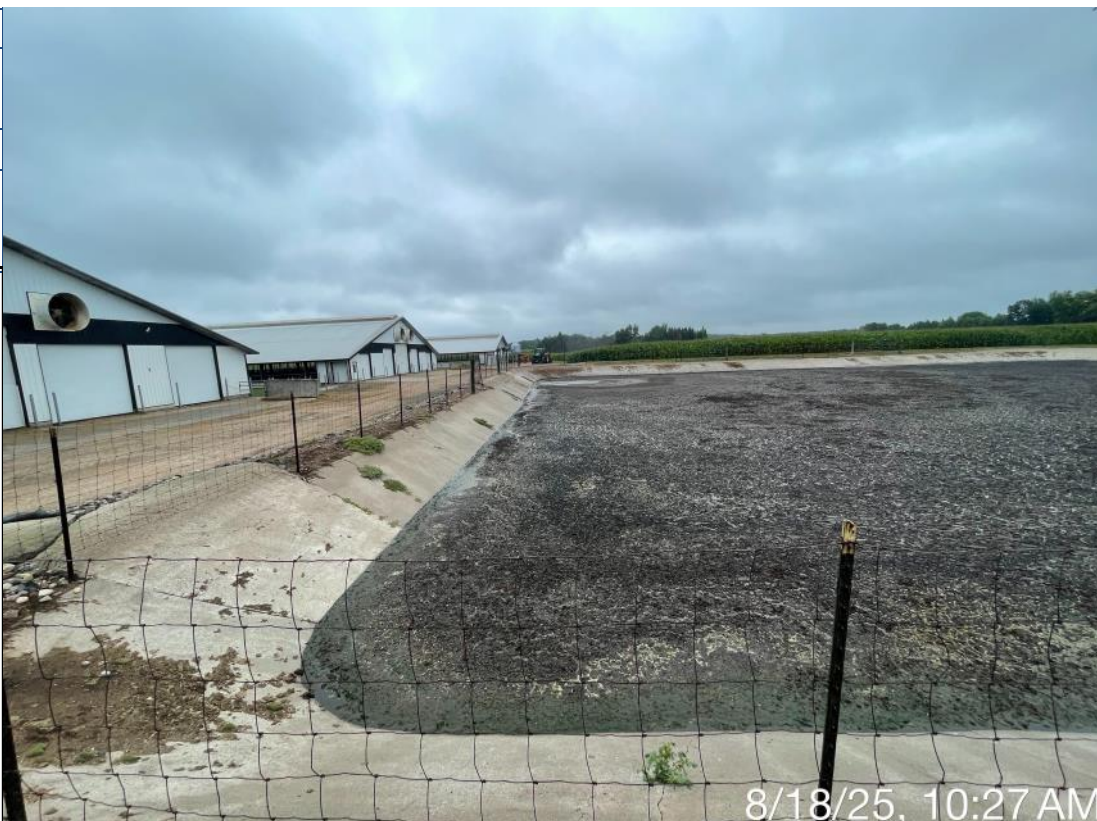
| <b>Photo Description:</b><br><br>Standing at the southwest corner of Heifer Pit looking north: View of the west edge of Heifer Pit. | |

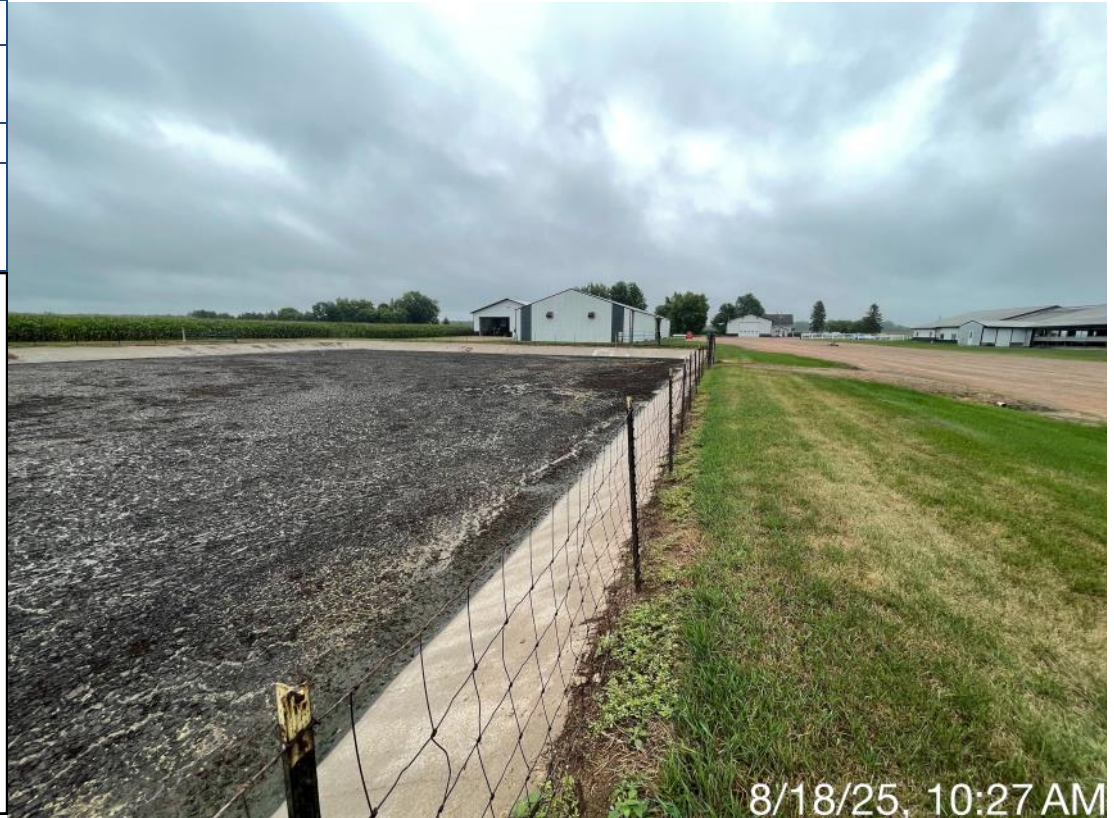
| <b>Photo Description:</b><br><br>Standing on the south side of Heifer Pit looking east: View of south edge of Heifer Pit. | |

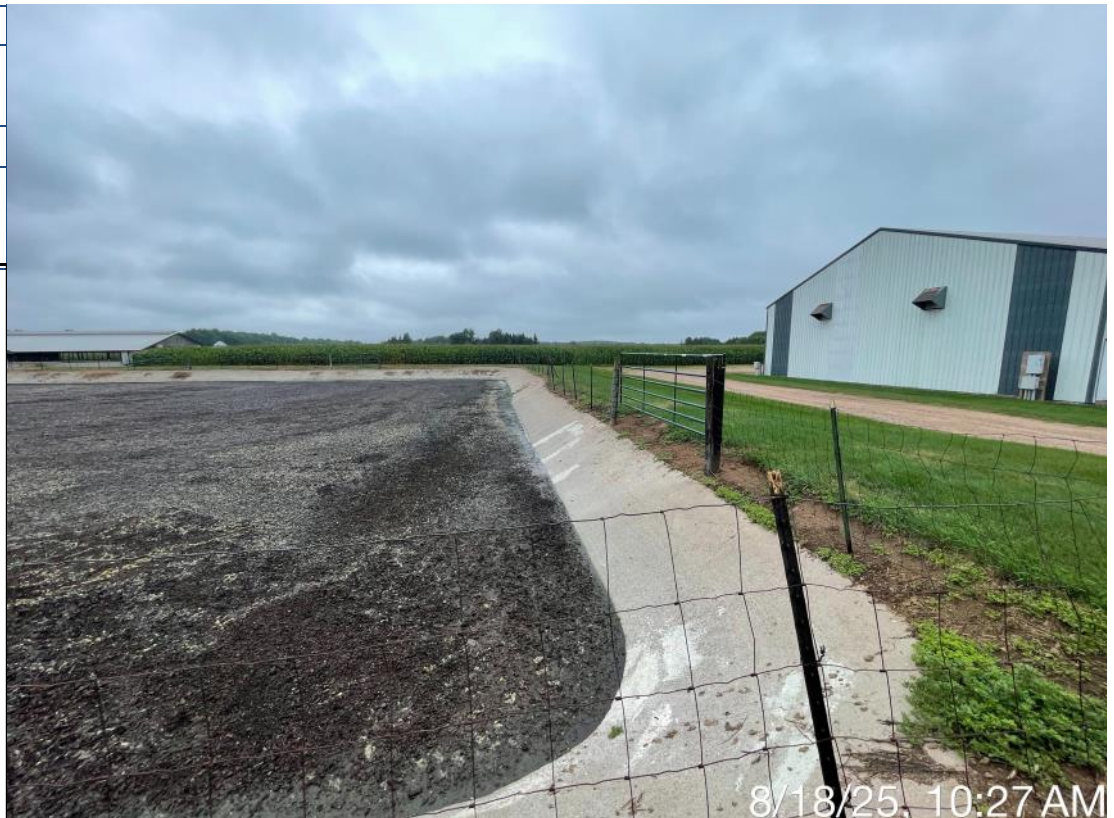
| <b>Photo Description:</b><br><br>Standing at the southeast corner of Heifer Pit looking north: View of east edge of Heifer Pit. | |

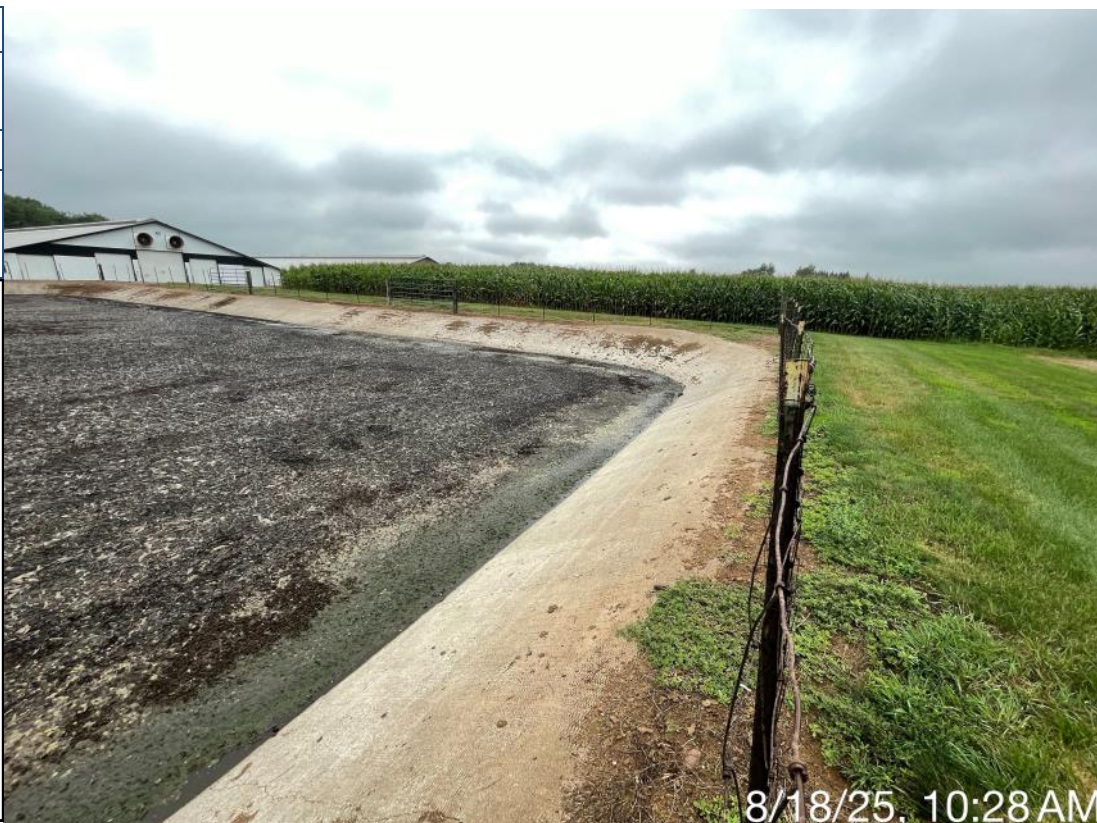
| <b>Photo Description:</b><br><br>Standing on the east side of Heifer Pit looking northwest: View of northeast corner of Heifer Pit. | |

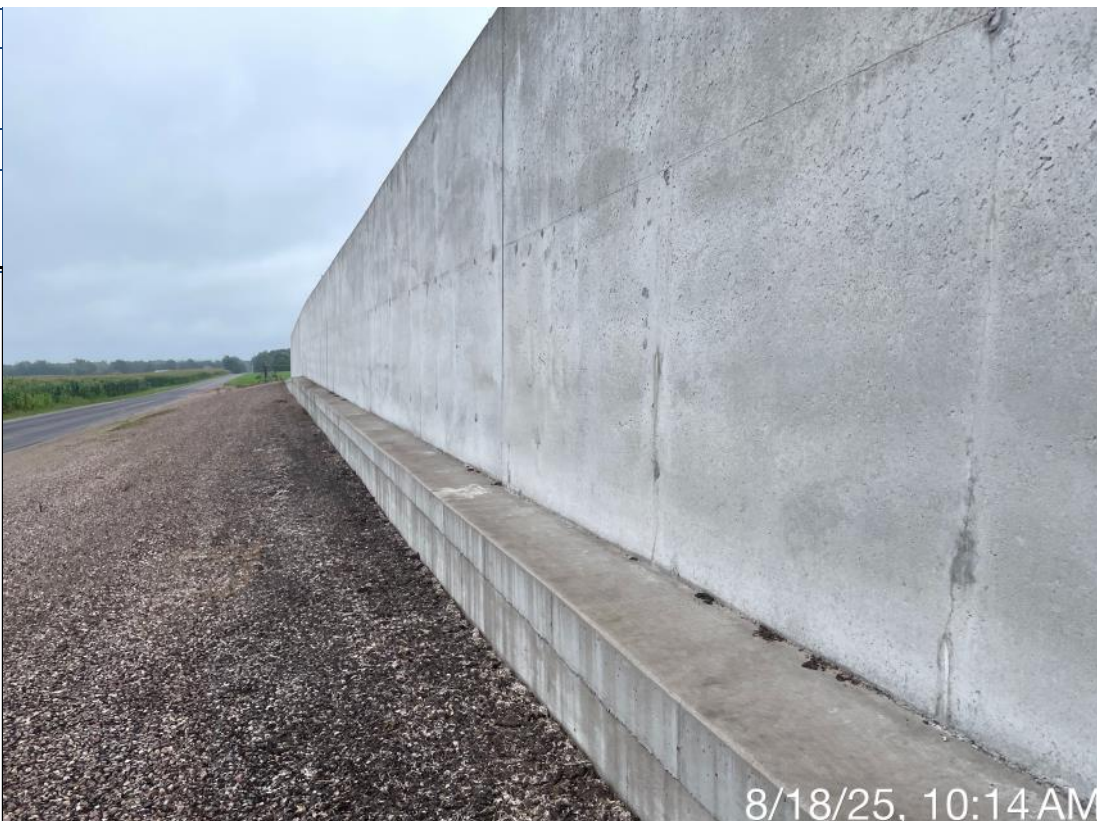
| <b>Photo Description:</b><br><br>Standing on the east side of FSA looking south: View of east edge of bunkers. | |

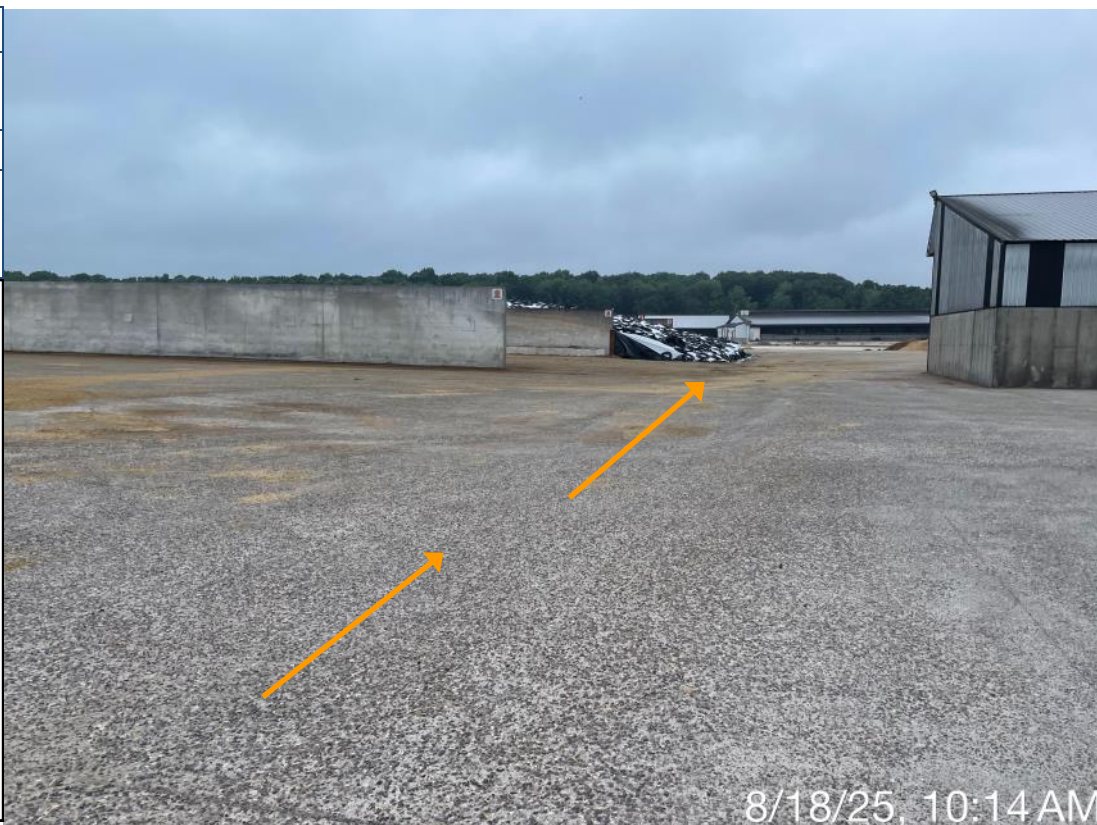
| <b>Photo Description:</b><br><br>Standing on the north side of FSA looking west: View of north edge of FSA. | |

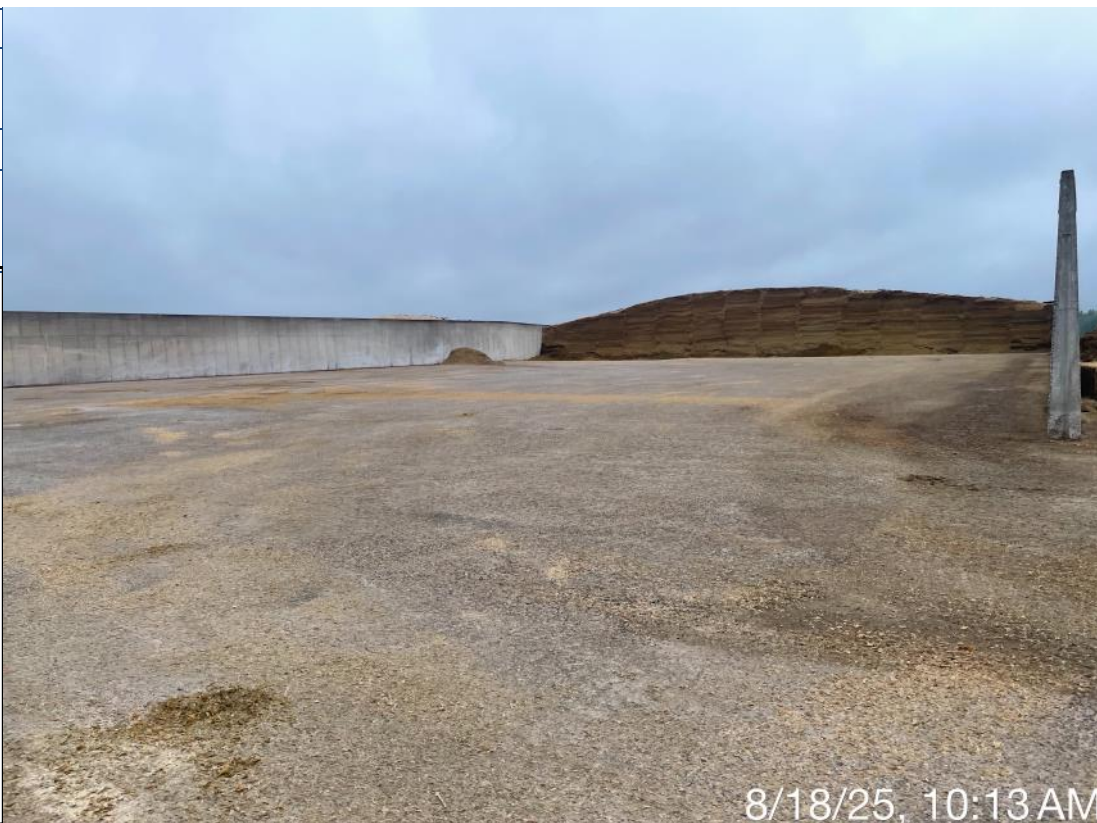
| <b>Photo Description:</b><br><br>Standing on the north side of FSA looking south: View of interior of eastern bunker. | |

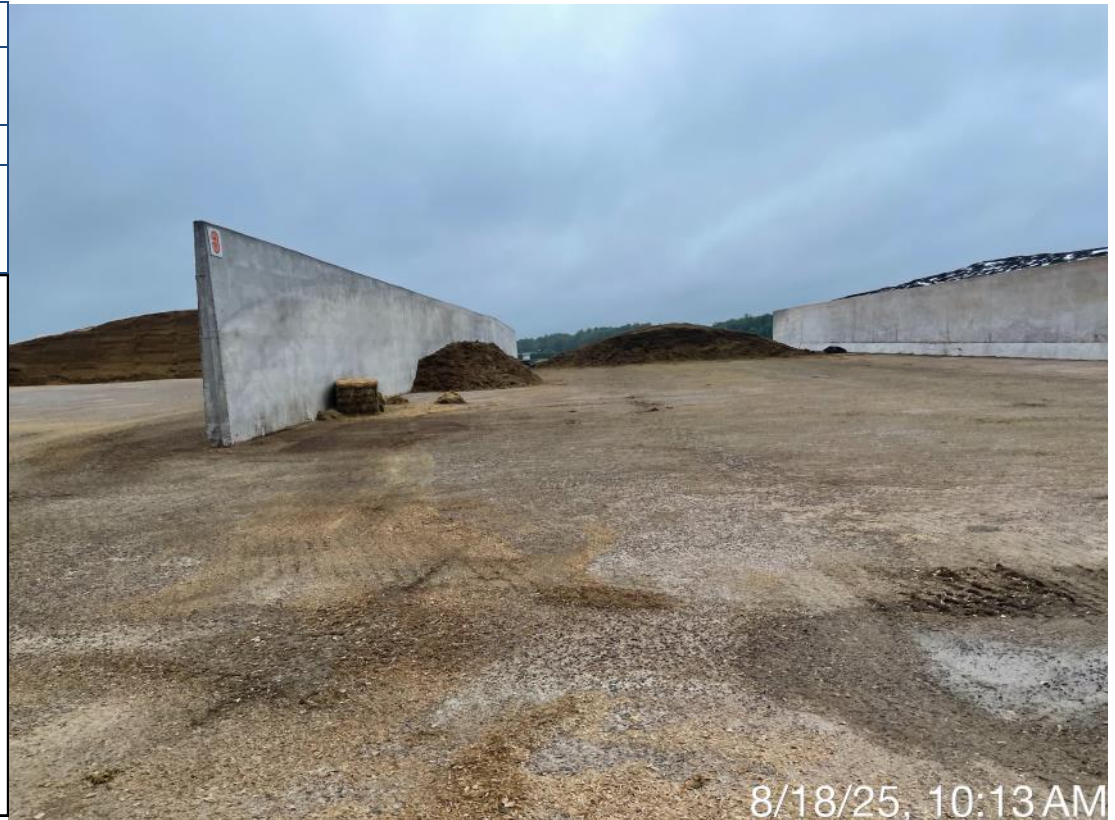
| <b>Photo Description:</b><br><br>Standing on north side of FSA looking south: View of a nearly empty bunker. | |

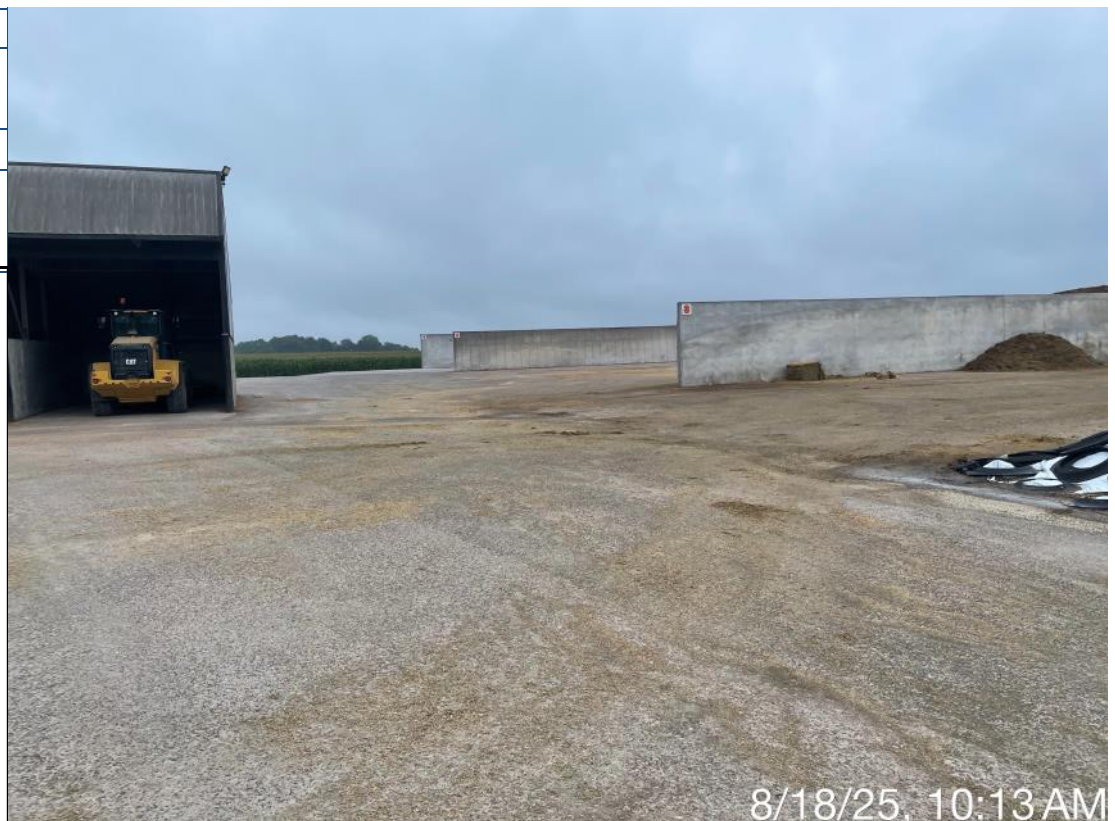
| <b>Photo #:</b> | 34 |

| <b>Photo Description:</b><br><br>Standing on north side of FSA looking east: View of north edge of FSA used to collect runoff. Arrows indicate direction of runoff flow. Notice commodity shed on left side of photo. | |

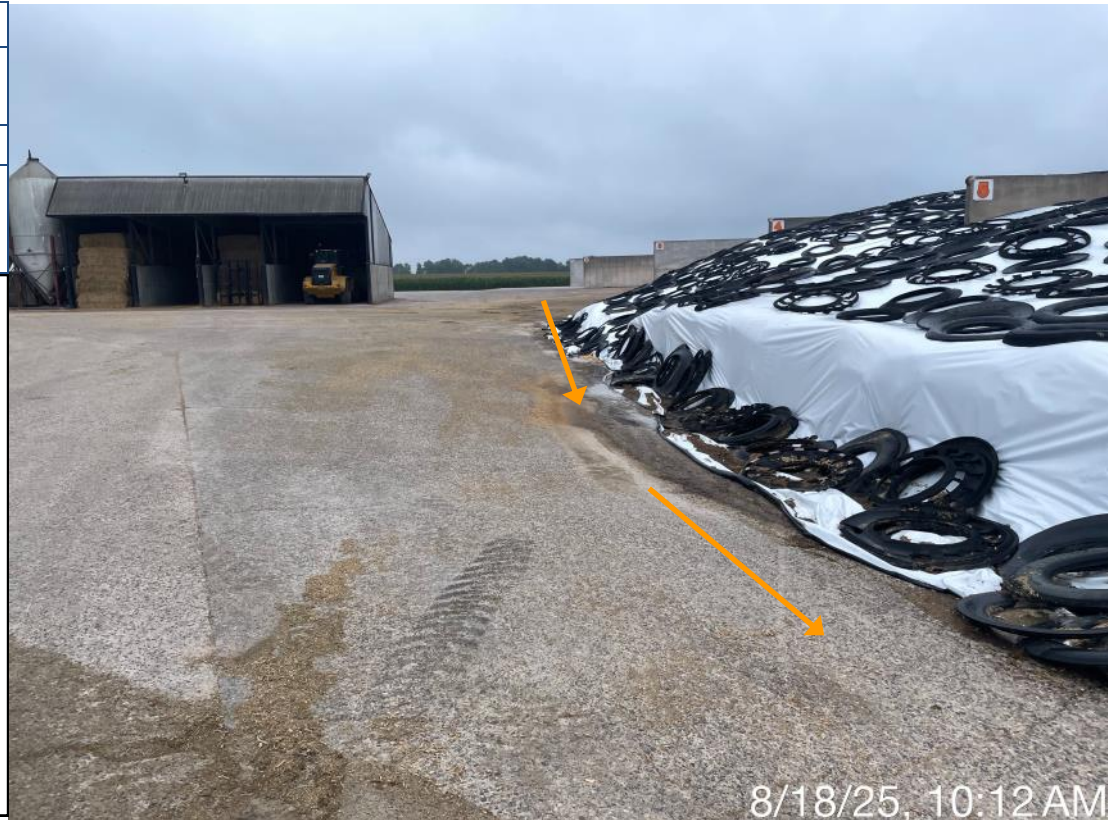
| <b>Photo #:</b> | 35 |

| Standing on north side of FSA looking east: View of north edge of FSA. Arrows indicate direction of runoff flow. | |

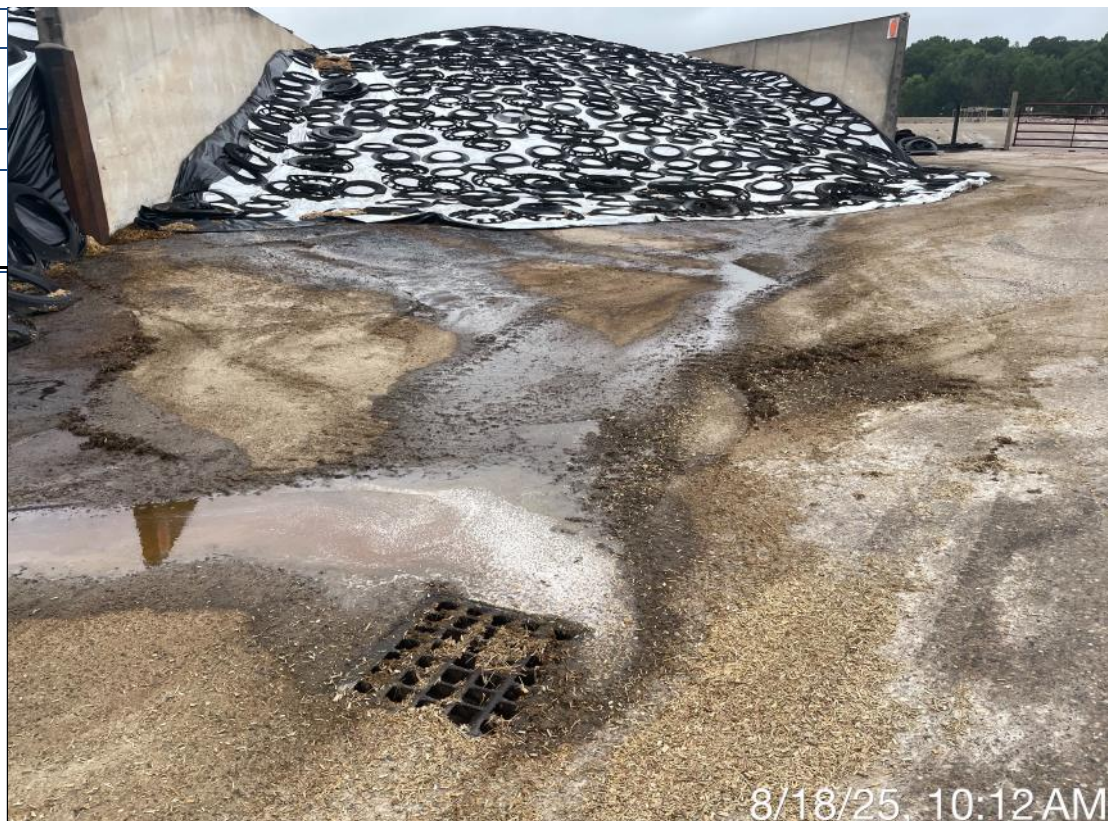
| <b>Photo #:</b> | 36 |

| Standing on the north side of FSA looking southwest: View of runoff collection inlet at northwest corner of FSA. Gravity flows to northeast corner of Middle Pit. | |

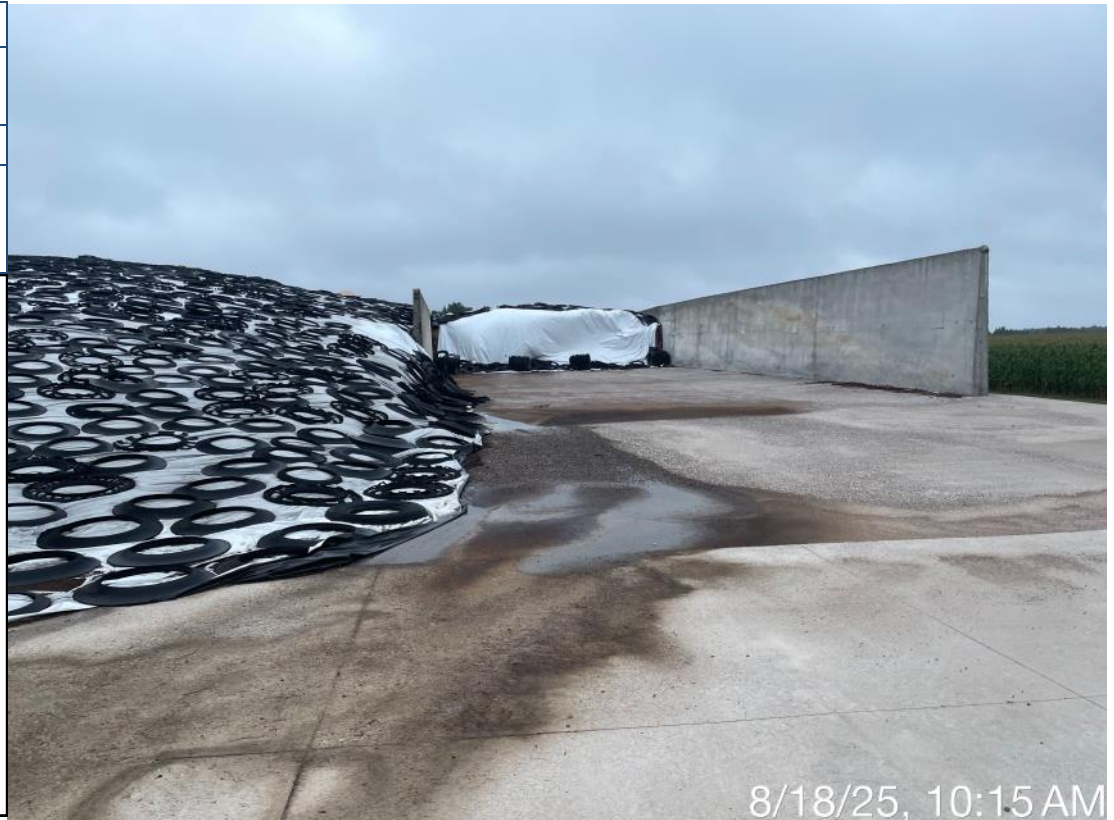
| <b>Photo Description:</b><br><br>Standing on the southside of FSA looking north: View of southeast corner of FSA. | |

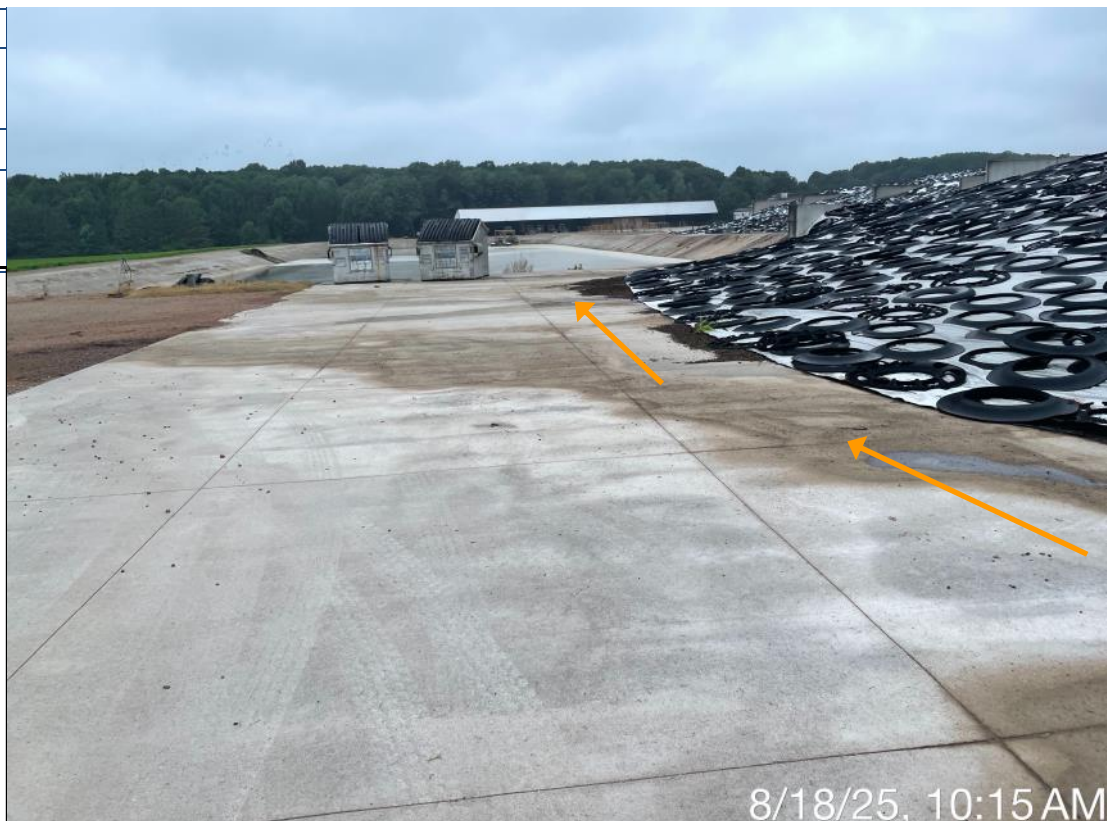
| <b>Photo #:</b> | 38 |

| <b>Photo Description:</b><br><br>Standing on the south side of FSA looking west: View of south edge of FSA used to collect runoff. Arrows indicate direction of runoff flow. | |

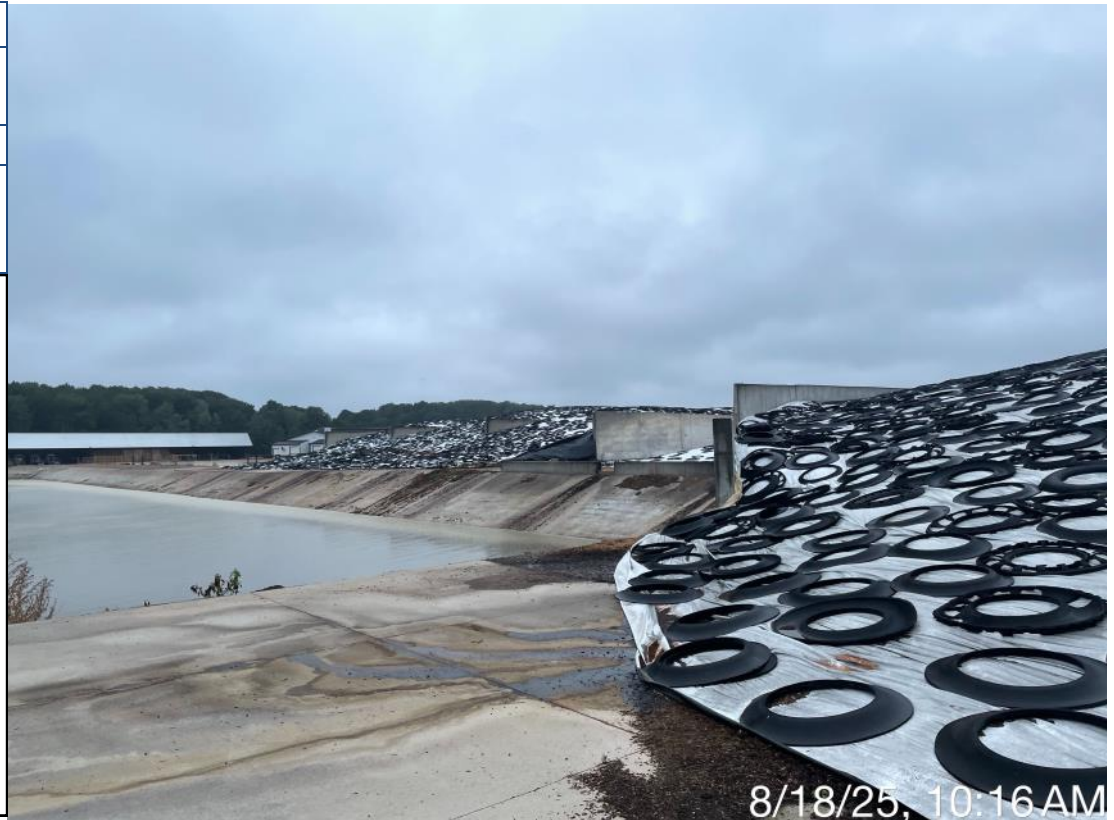
| <b>Photo #:</b> | 39 |

| Standing on the south side of FSA looking northwest: View of southwest edge of FSA where runoff flows directly in 6 Million Pit | |

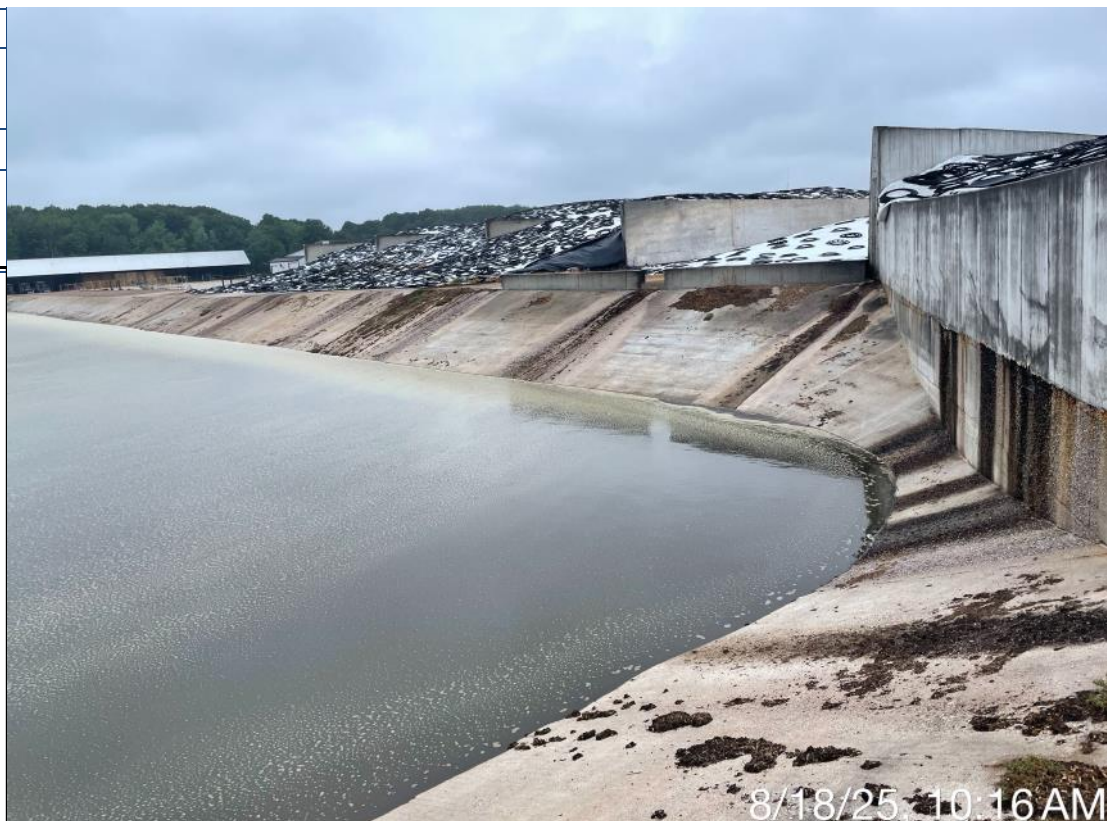
| <b>Photo #:</b> | 40 |

| Standing on the south side of FSA looking northwest: View of south edge of FSA along 6 Million Pit. Notice leachate staining on concrete liner of 6 Million Pit. | |

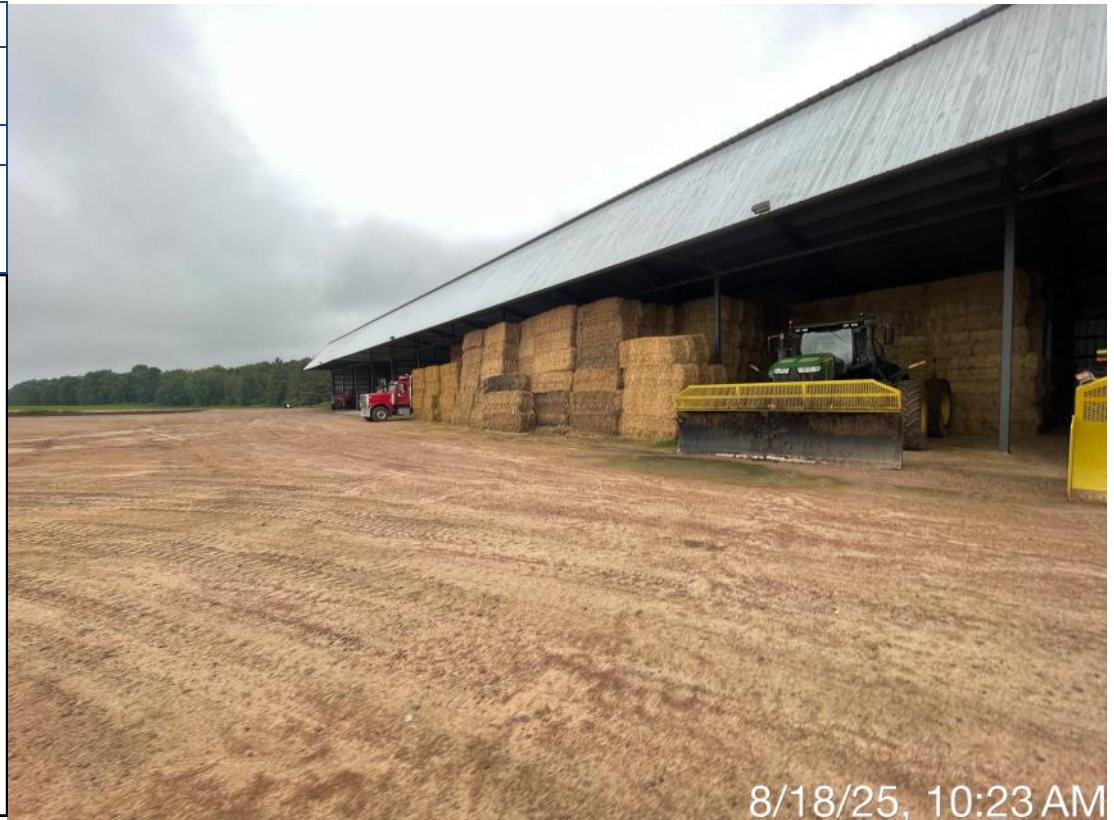
| Standing on the west side of Middle Pit looking southwest: View of shed at southwest corner of production area used to store equipment & dry hay. | |

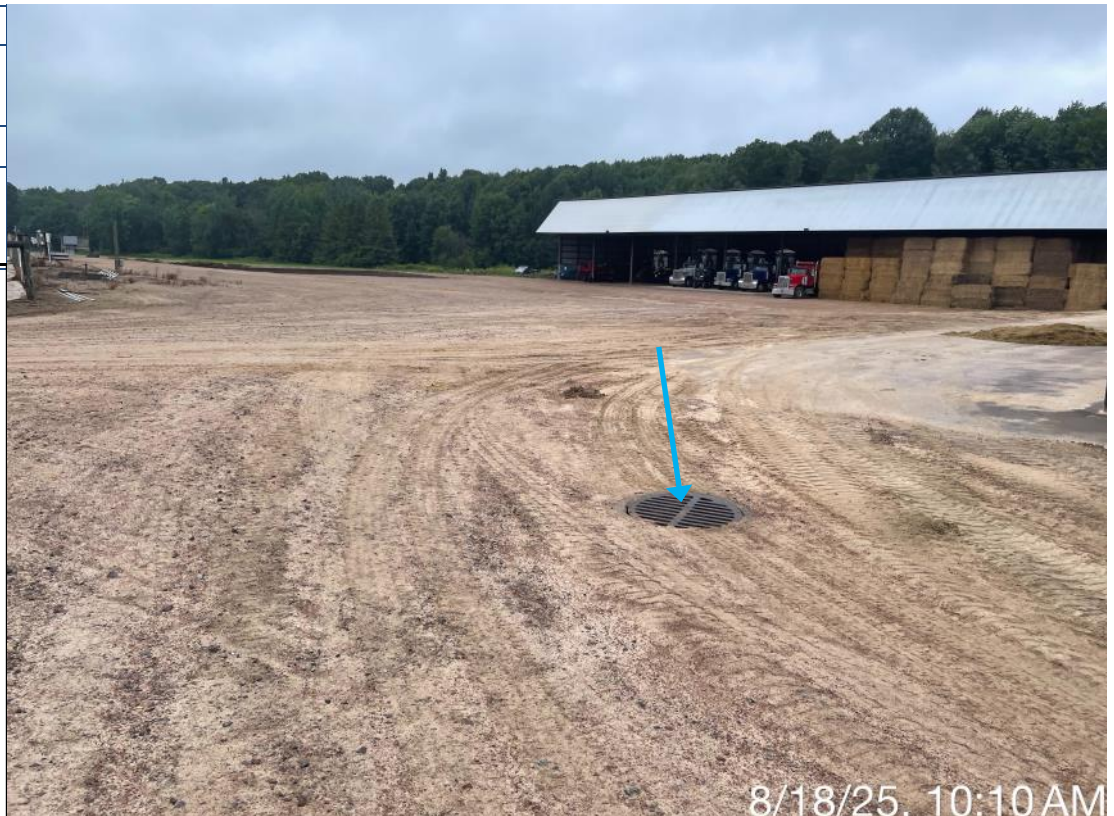
| <b>Photo #:</b> | 42 |

| Standing at the northwest corner of Main pit looking southwest: View of stormwater collection inlet on west side of Main Pit | |

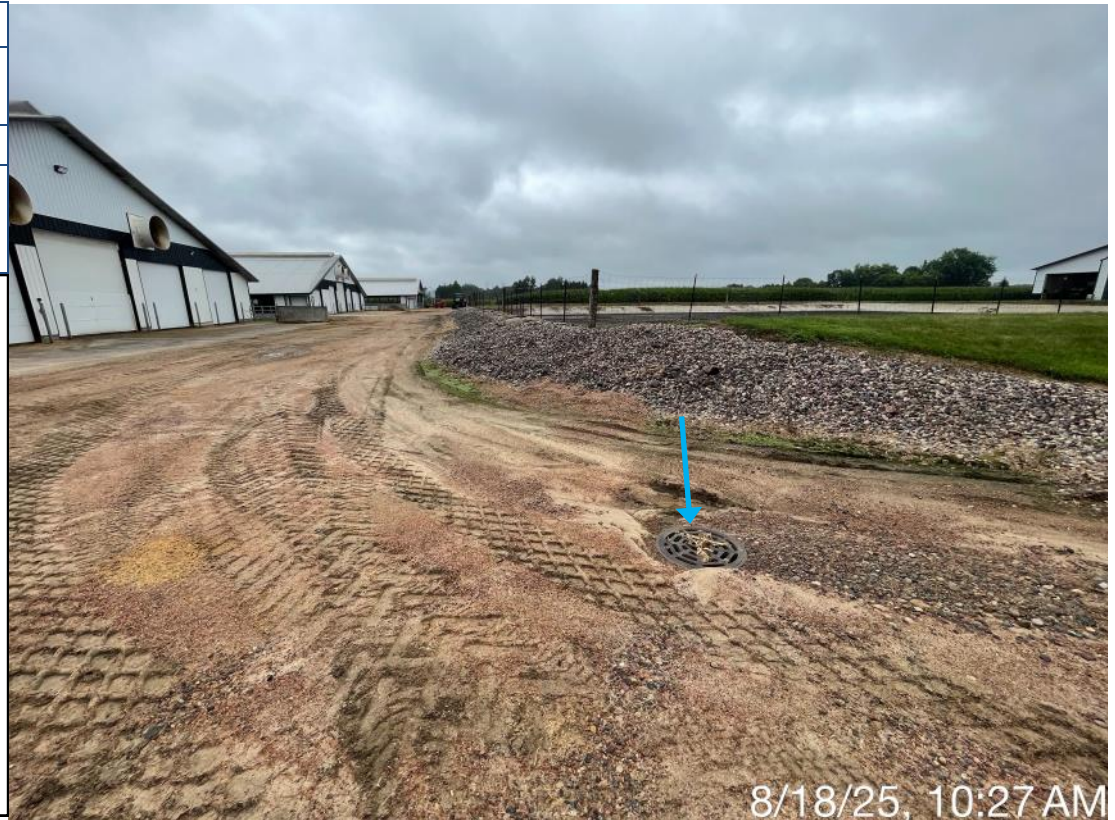
| <b>Photo #:</b> | 43 |

| Standing on southwest corner of Heifer Pit looking north: View of stormwater collection inlet at southwest corner of Heifer Pit. | |

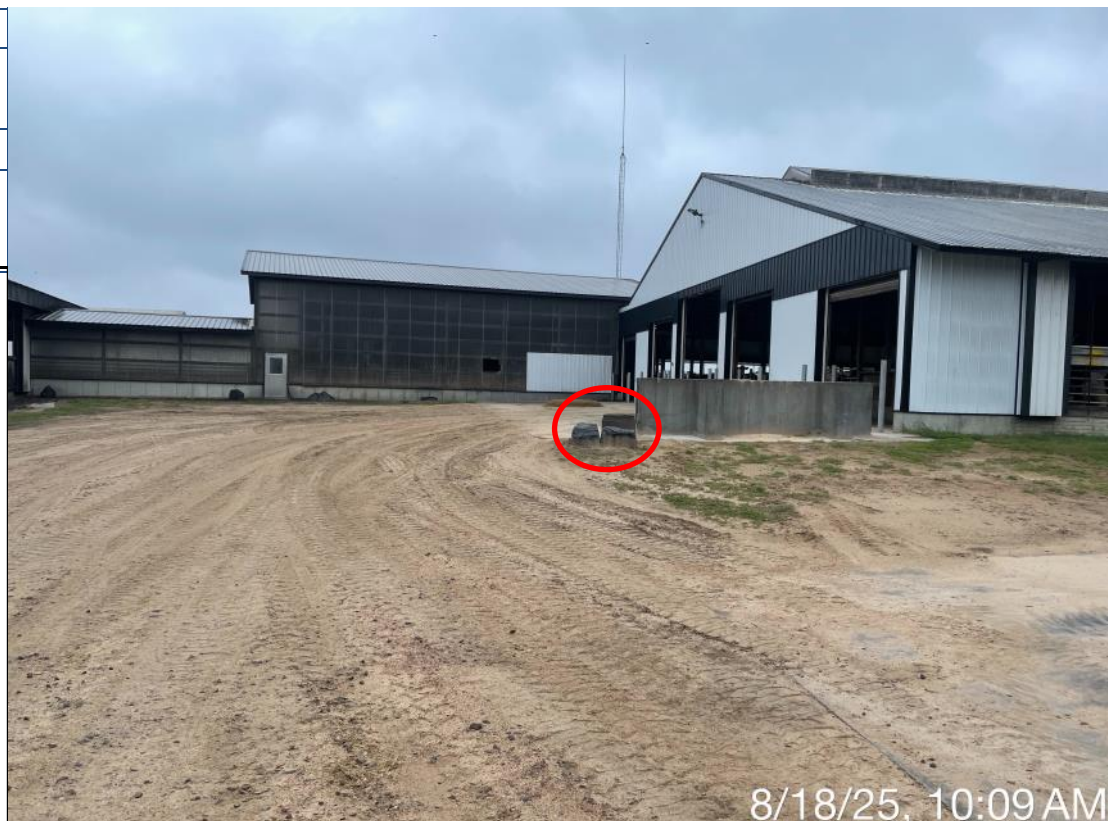
| <b>Photo #:</b> | 44 |

| Standing on north side of Main Pit looking north: View of water supply well location on west end of freestall barn | |

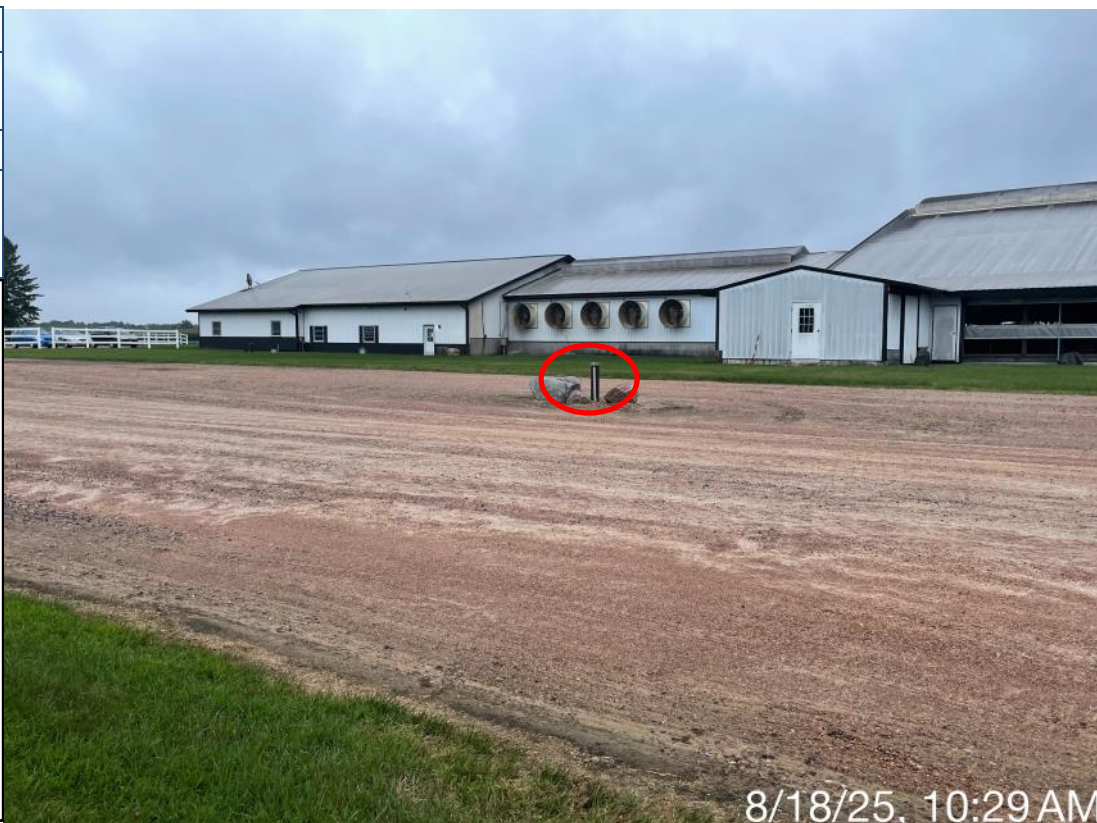
| <b>Photo #:</b> | 45 |

| Standing at southeast corner of Heifer Pit looking southeast: View of well located in driveway. | |

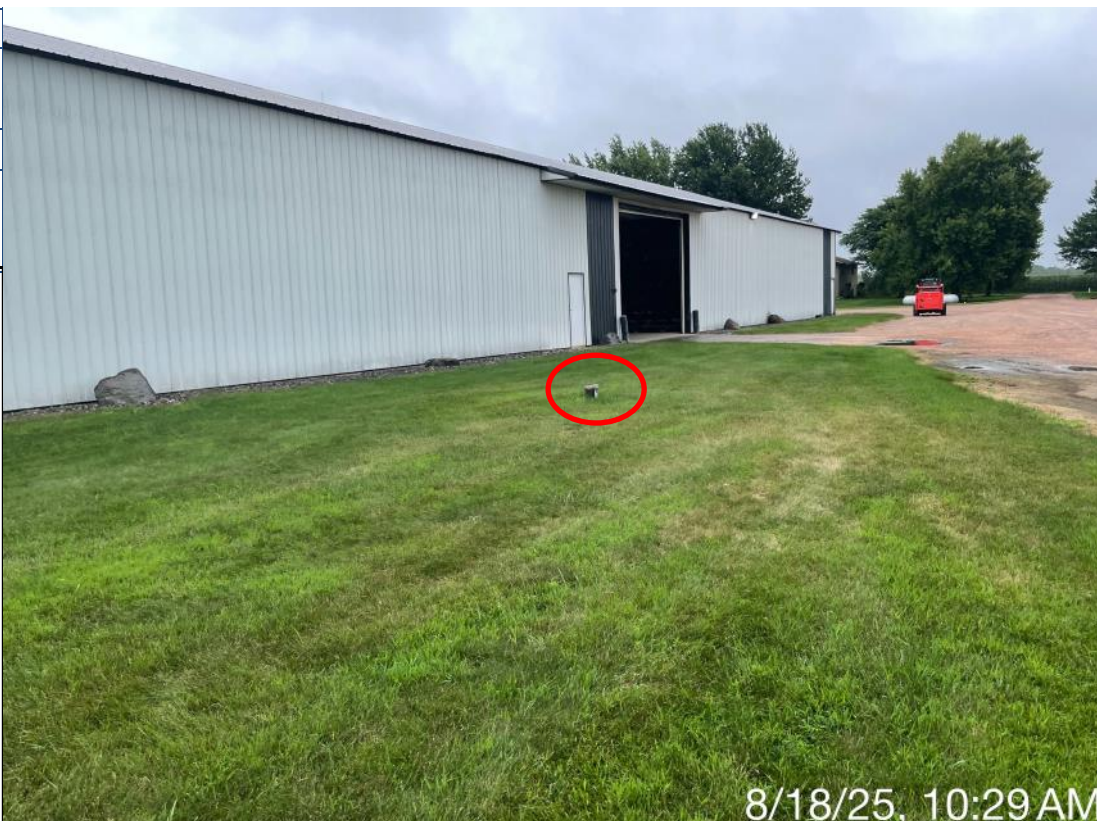
| <b>Photo #:</b> | 46 |

| Standing at southeast corner of Heifer Pit looking east: View of well location on south side of shed, just north of well shown in photo #45. | |
