Permit Fact Sheet

Permit Number:	WI-0059374-05-0
Permittee Name:	Pagels Ponderosa Dairy, LLC
Address:	N4893 Hwy C
City/State/Zip:	Kewaunee WI 54216
Discharge Location:	N4893 County Road C, Kewaunee, WI 54216 N ½ NW ¼ S4 T23N R24E, Township of West Kewaunee N5318 County Road E, Kewaunee, WI 54216 SE ¼ SW ¼ S27 T24N R24E, Township of Casco E3470 County Rd F, Kewaunee, WI 54216 SE ¼ SW ¼ S16 T23N R24E, Township of West Kewaunee
Receiving Water:	Unnamed tributaries within the Kewaunee River Watershed, Lake Michigan Drainage Basin, and groundwaters of the State

On Tuesday, July 7, 2020, James Salscheider and Brian Hanson, Agricultural Runoff Management Specialists WDNR (Department) met with John J Pagel, Bryan Pagel, and Susan LaCrosse to conduct a WPDES permit reissuance inspection at Pagel's Ponderosa Dairy, LLC (PPD). The Main Site is located at the NW ¼ Sec 4 T23N R24E in the Town of West Kewaunee. The Clyde Hill Farm Site is located at SE ¼ SW ¼ Sec 27 T24N R24E in the Town of Casco. The weather conditions during the inspection were sunny and dry. The farm did receive approximately 0.33" of rain the day before. Follow up items are requested on Page 7. All photos taken during the

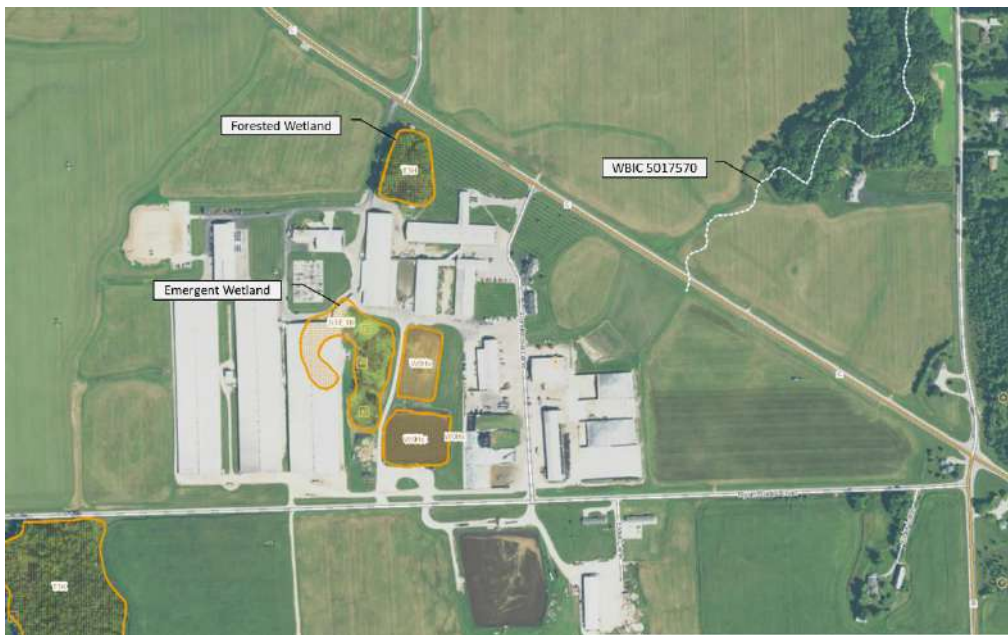
Figure 2. An aerial photograph depicting surface water and wetlands near the production site at the Main Site. There is one mapped intermittent stream and several mapped wetlands near the production site. This photo was obtained from WDNR Surface Water Data Viewer.

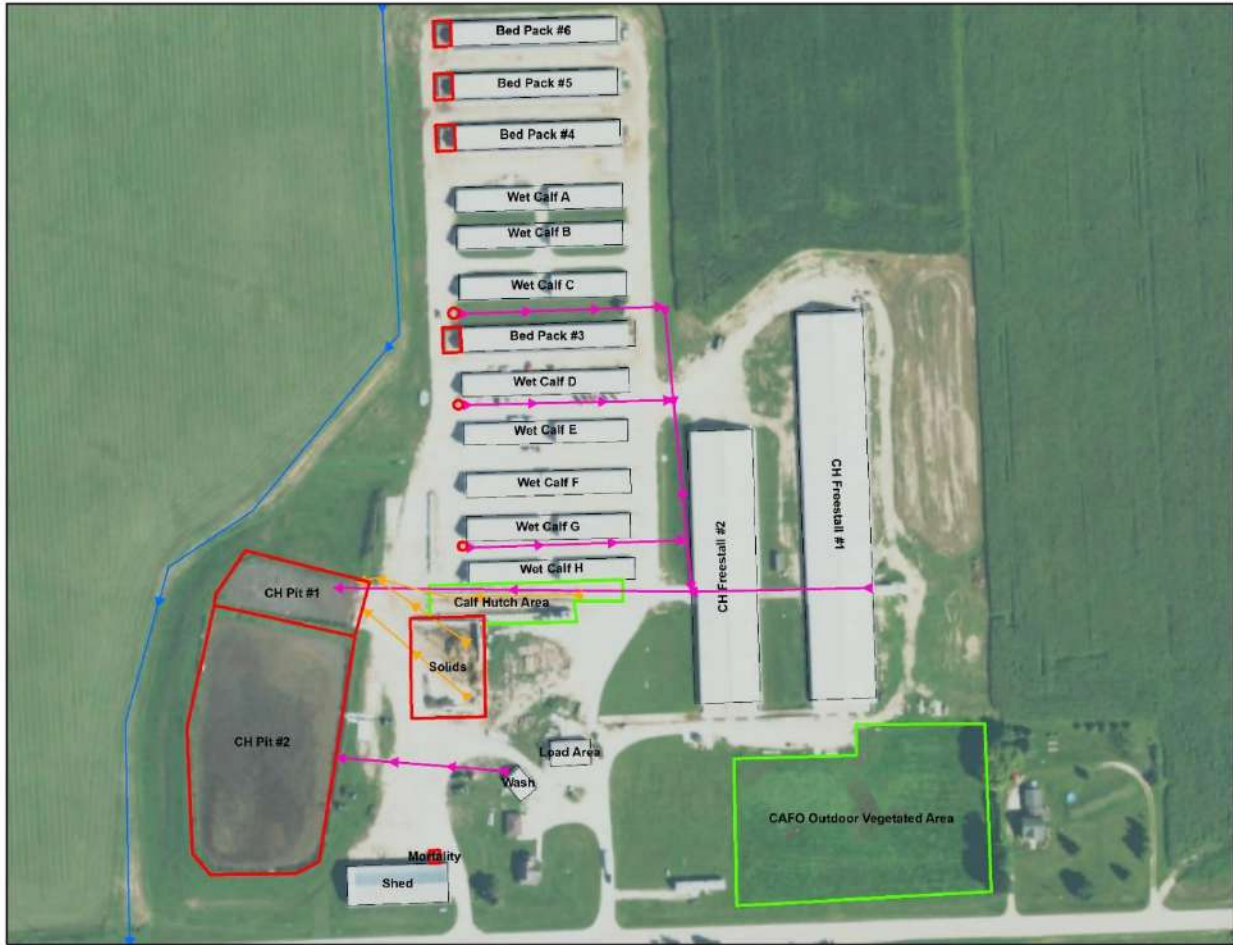
Figure 3. An aerial photograph depicting the buildings, storages, and waste transfer lines/flow paths at the Heifer Site. The Heifer Site consists of 14 animal housing buildings, three manure storage structures, several machine/commodity sheds, and a CAFO Outdoor Vegetated Area. The pink lines represent manure transfer lines. The yellow lines represent the flow paths of runoff from the feed storage area. The blue lines represent flow paths of surface water around the production site.

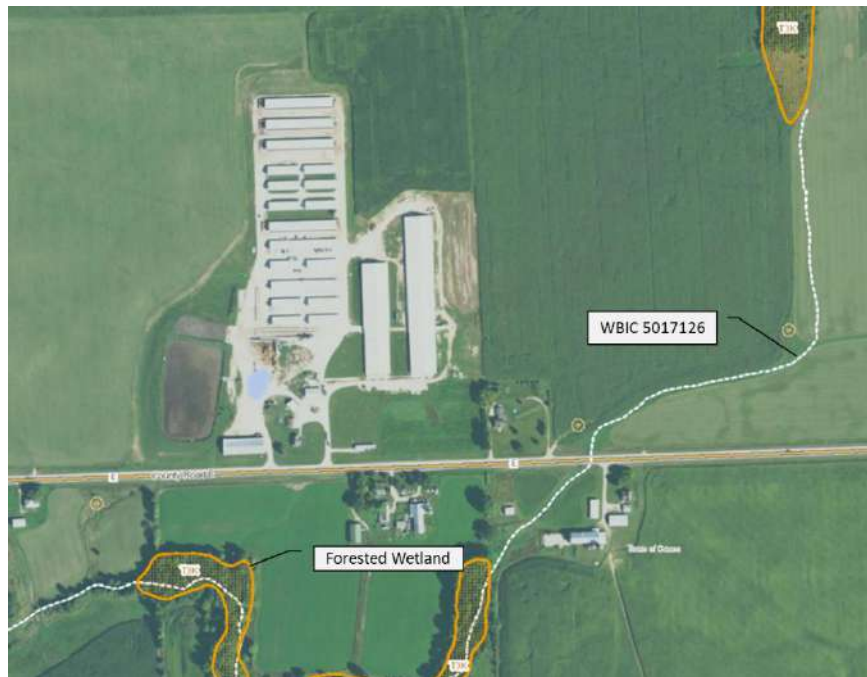
Figure 4. An aerial photograph depicting surface water and wetlands near the production site at the Heifer Site. There is one mapped intermittent stream and several mapped wetlands near the production site. This photo was obtained from WDNR Surface Water Data Viewer.

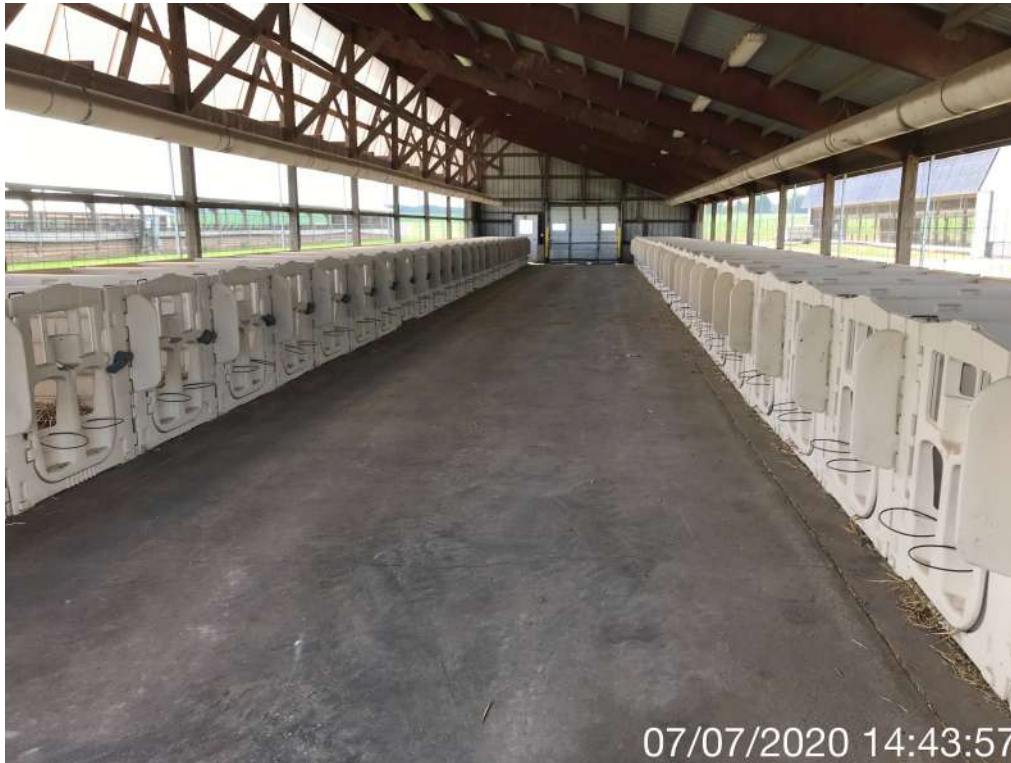
Photo #:	1
Date/Time of Photo:	07/07/2020 14:43
Photo Location:	Heifer Site
Photo By:	Brian Hanson

Photo Description: Calves being kept under adequate roof in a calf barn located at the Heifer Site. Separated manure and straw are used for bedding. All wastewater drains to a reception basin where it is then combined with the manure transfer system.

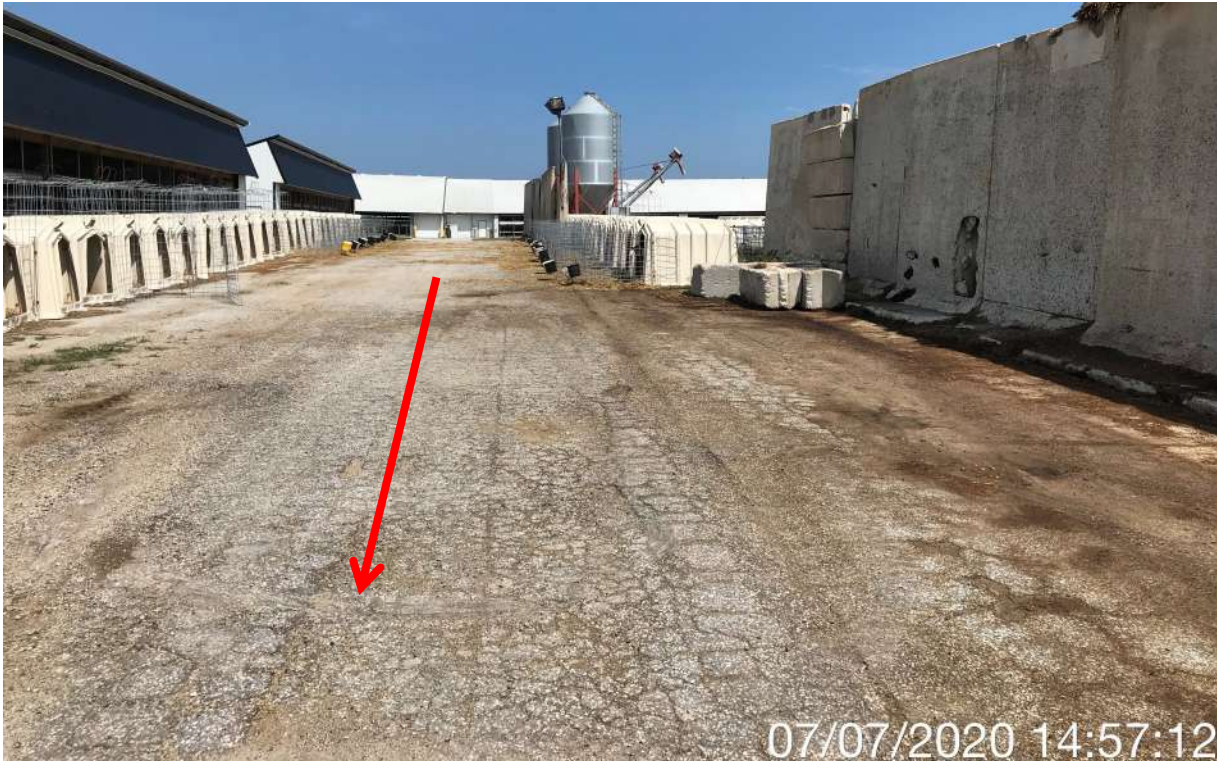
Photo #:	3	Photo Description: Calf hutches that are stored outside, between the solid manure stacking pad and the southernmost calf barn. All runoff from the calf hutches is directed to surface flow into the existing WSFs on-site. This photo was taken facing east.
Date/Time of Photo:	07/07/2020 14:57	
Photo Location:	Heifer Site	
Photo By:	Brian Hanson

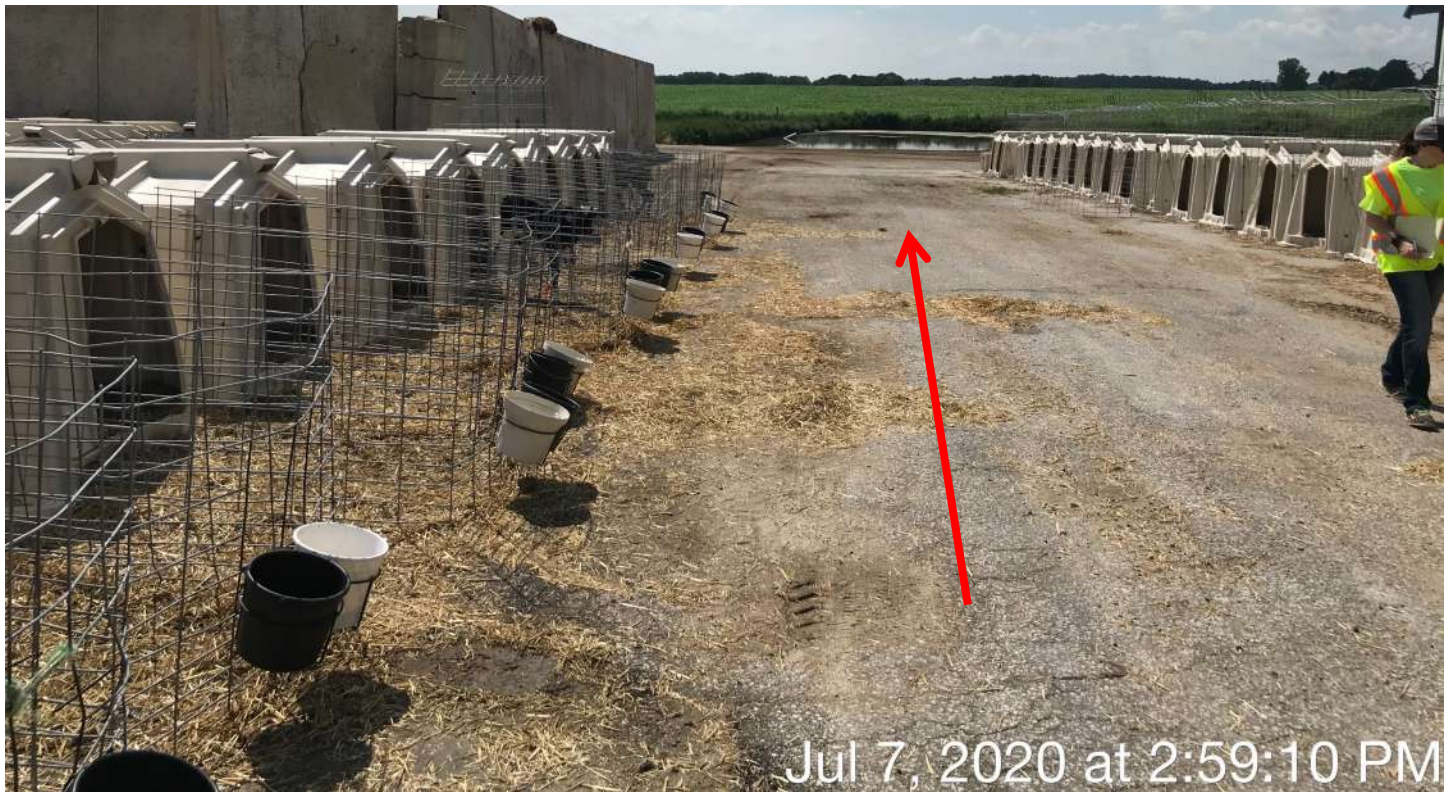
Photo #:	4	Photo Description: Calf hutches that are stored outside, between the solid manure stacking pad and the southernmost calf barn. All runoff from the calf hutches is directed to surface flow into the existing WSFs on-site. This photo was taken facing west.
Date/Time of Photo:	07/07/2020 14:59	
Photo Location:	Heifer Site	
Photo By:	James Salscheider

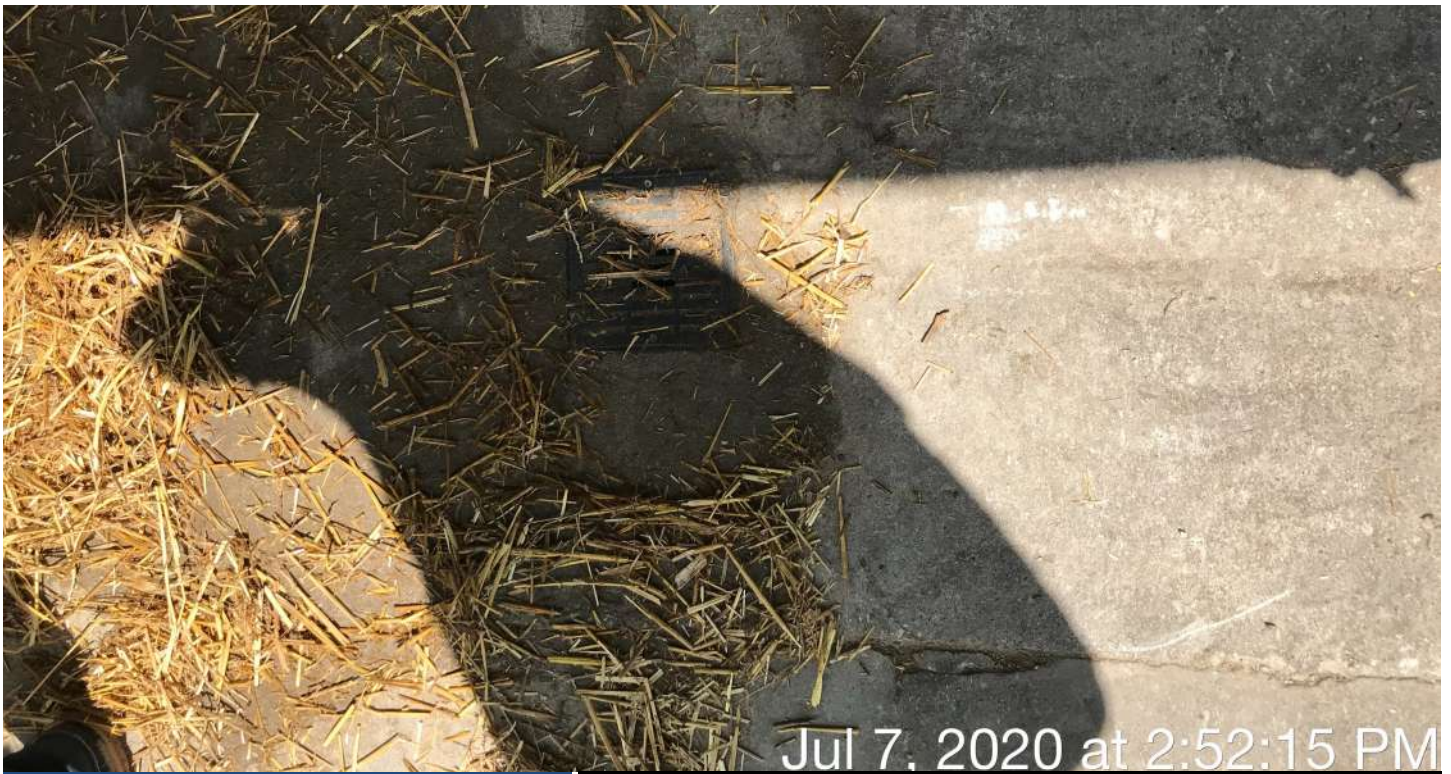
Photo #:	5	Photo Description: One of the drains that are in the wet calf barns that collects all process wastewater and transfers it to a reception basin, where it is pumped to the solid separator and the manure transfer system.
Date/Time of Photo:	07/07/2020 14:52	
Photo Location:	Heifer Site	
Photo By:	James Salscheider

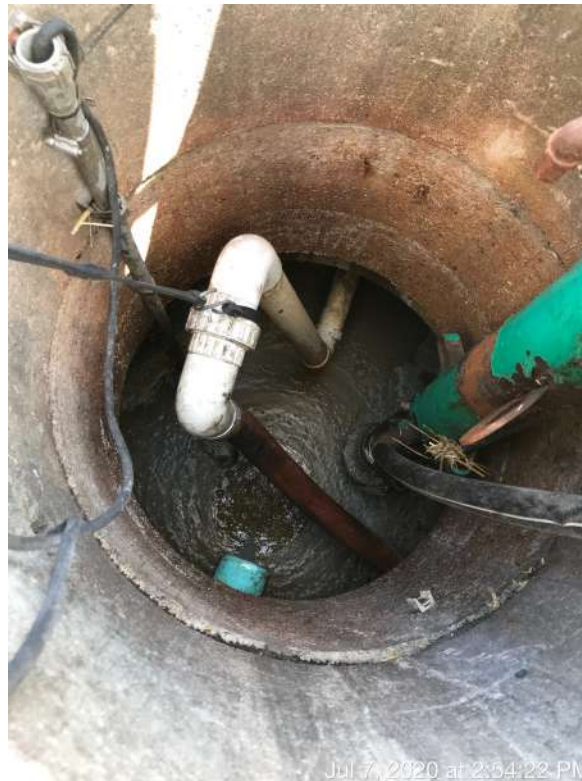
Photo #:	6	Photo Description: One of the reception tanks for the wet calf barns. Wastewater from the barns gravity flows to the reception basin, where it is then pumped to the solid separator and manure transfer system.
Date/Time of Photo:	07/07/2020 14:54	
Photo Location:	Heifer Site	
Photo By:	James Salscheider

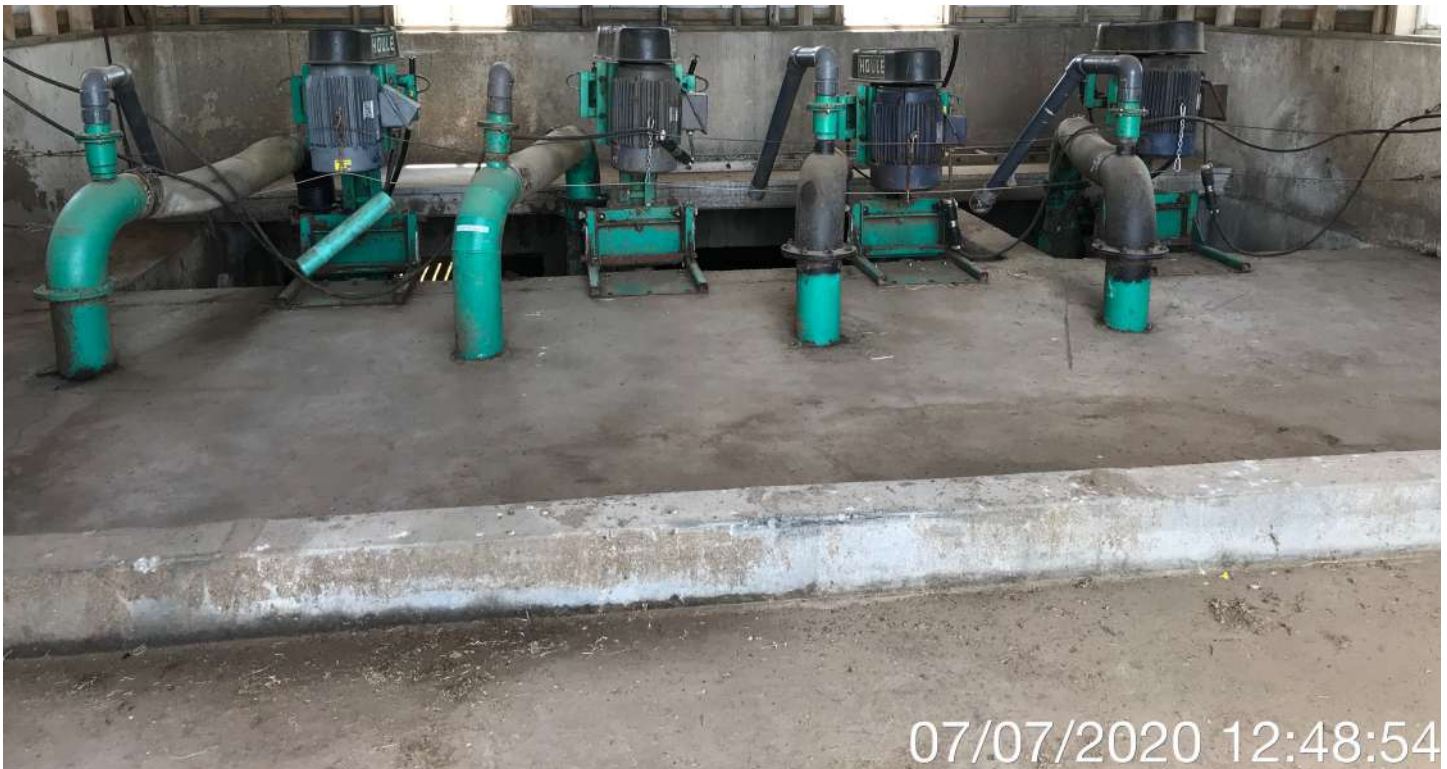
Photo #:	7	Photo Description: The manure transfer pumps located in the manure handling building located between free stall barns 5 and 6.
Date/Time of Photo:	07/07/2020 12:48	
Photo Location:	Main Site	
Photo By:	Brian Hanson

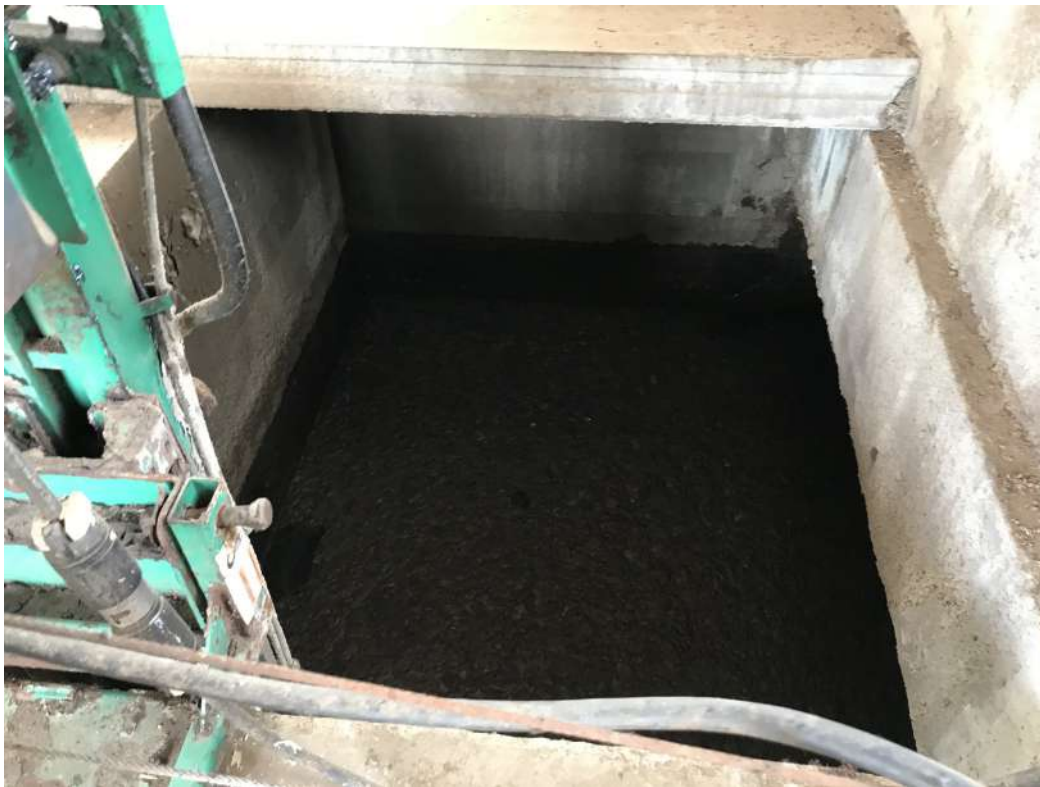
Photo #:	8	Photo Description: The reception basin at the manure handling building located between Free Stall barns 5 and 6. The reception basin has a capacity of 134,340 gallons.
Date/Time of Photo:	07/07/2020 12:49	
Photo Location:	Main Site	
Photo By:	James Salscheider

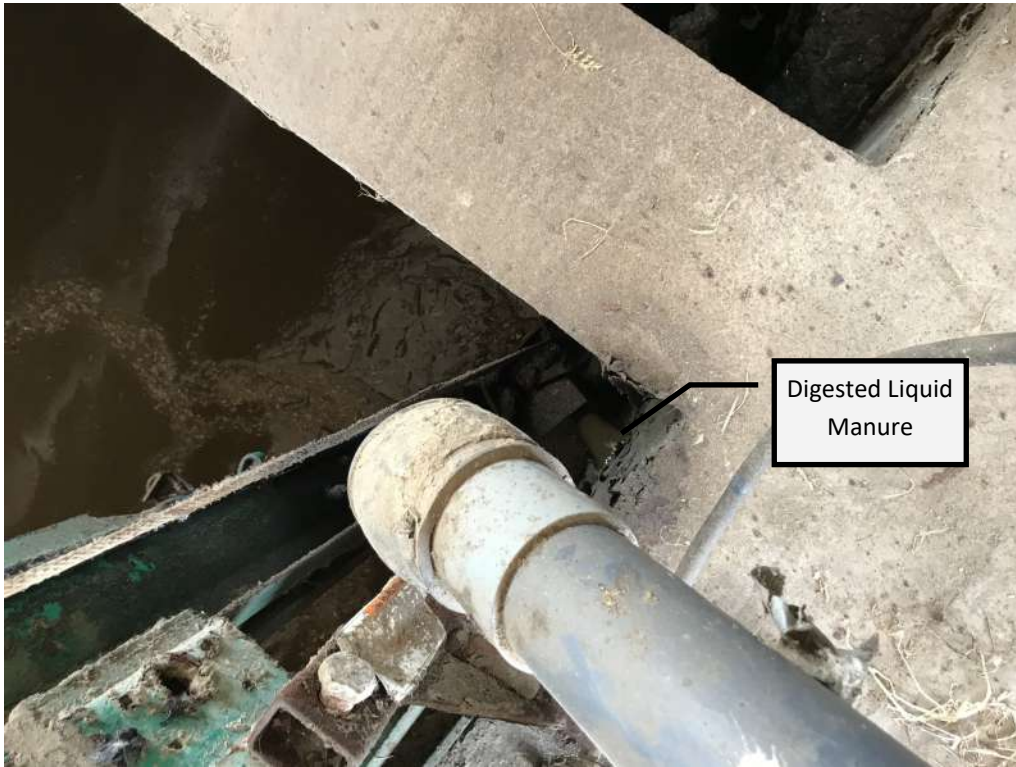
Photo #:	9	Photo Description: The reception basin located at the manure handling building located between Free Stall Barns 5 and 6. The inlet identified in the photo is digested liquid from the digester coming back into the system to allow the system to run smoothly.
Date/Time of Photo:	07/07/2020 12:50	
Photo Location:	Main Site	
Photo By:	James Salscheider

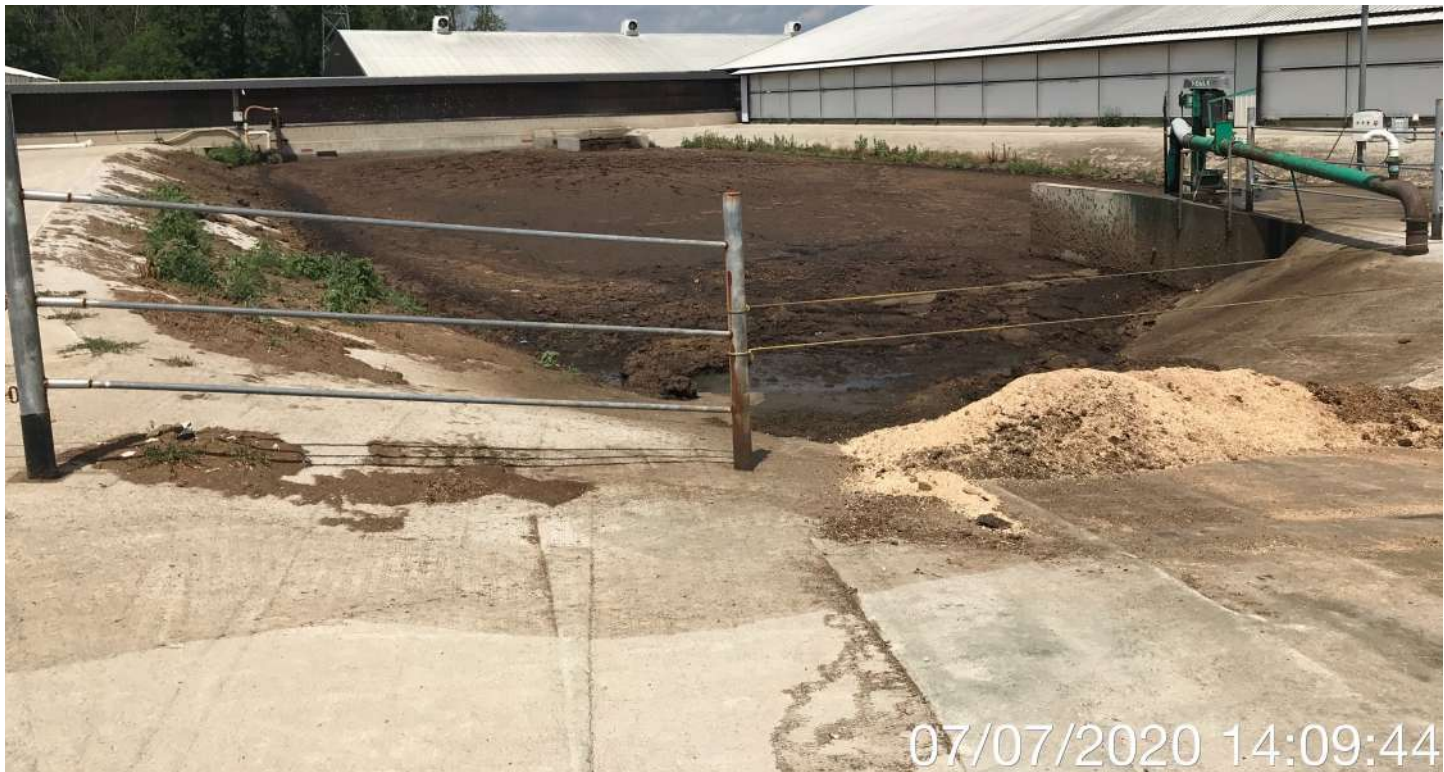
Photo #:	10	Photo Description: Waste Storage Facility 1 located at the Main Site between Free Stall Barns 3 and 4. Manure first enters WSF 1 before being transferred to other WSFs. WSF 1 has a capacity of 1,087,487 gallons.
Date/Time of Photo:	07/07/2020 14:09	
Photo Location:	Main Site	
Photo By:	Brian Hanson

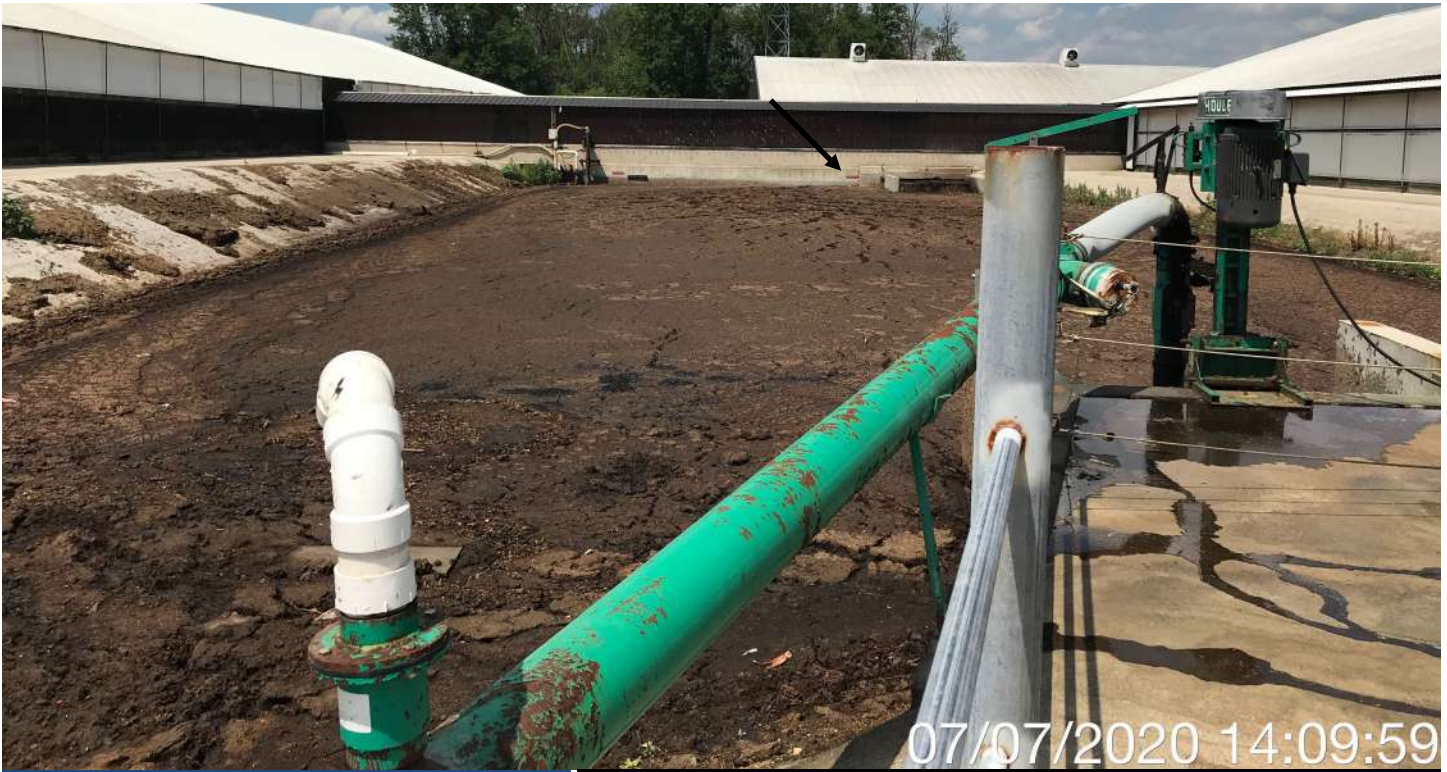
Photo #:	11	Photo Description: Waste Storage Facility 1 located at the Main Site between Free Stall Barns 3 and 4. Manure first enters WSF 1 before being transferred to other WSFs. There was only one maker present and it identified in the photo by the black arrow.
Date/Time of Photo:	07/07/2020 14:09	
Photo Location:	Main Site	
Photo By:	Brian Hanson

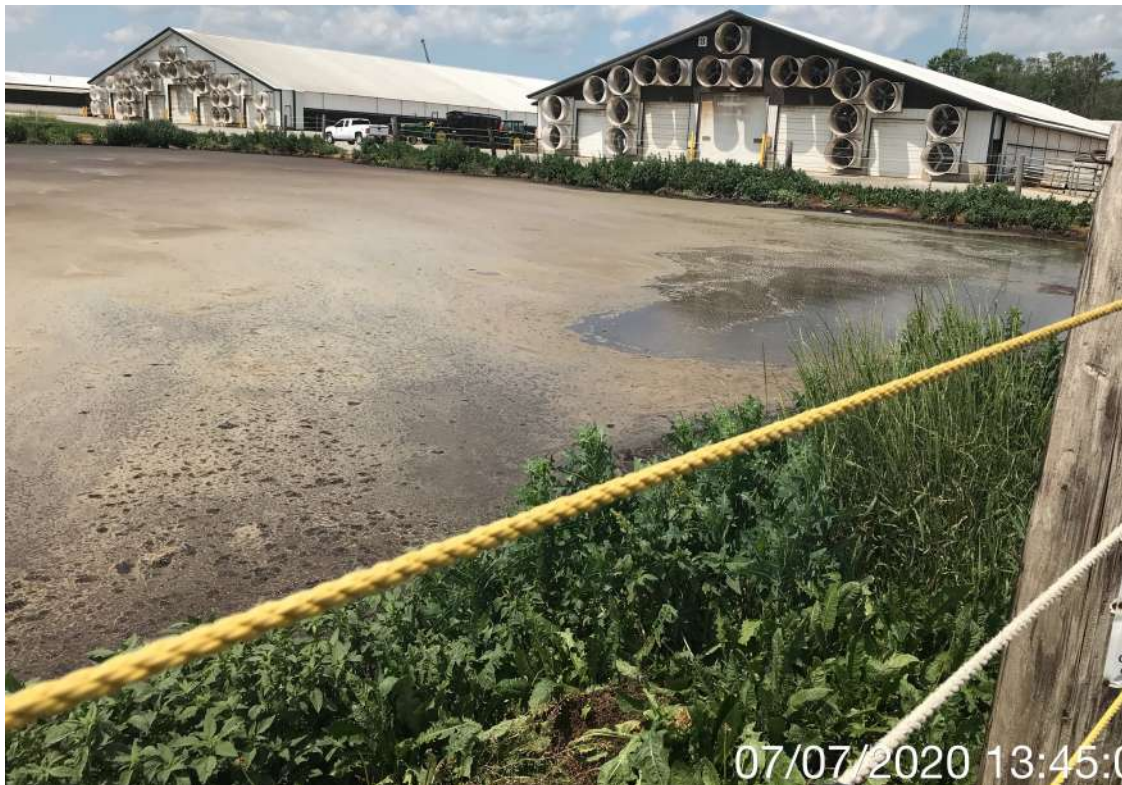
Photo #:	12	Photo Description: Waste Storage Facility 2 located at the Main Site, south of WSF 1. WSF 2 has a capacity of 5,917,996 gallons and is the first cell in a two-cell system.
Date/Time of Photo:	07/07/2020 13:45	
Photo Location:	Main Site	
Photo By:	Brian Hanson

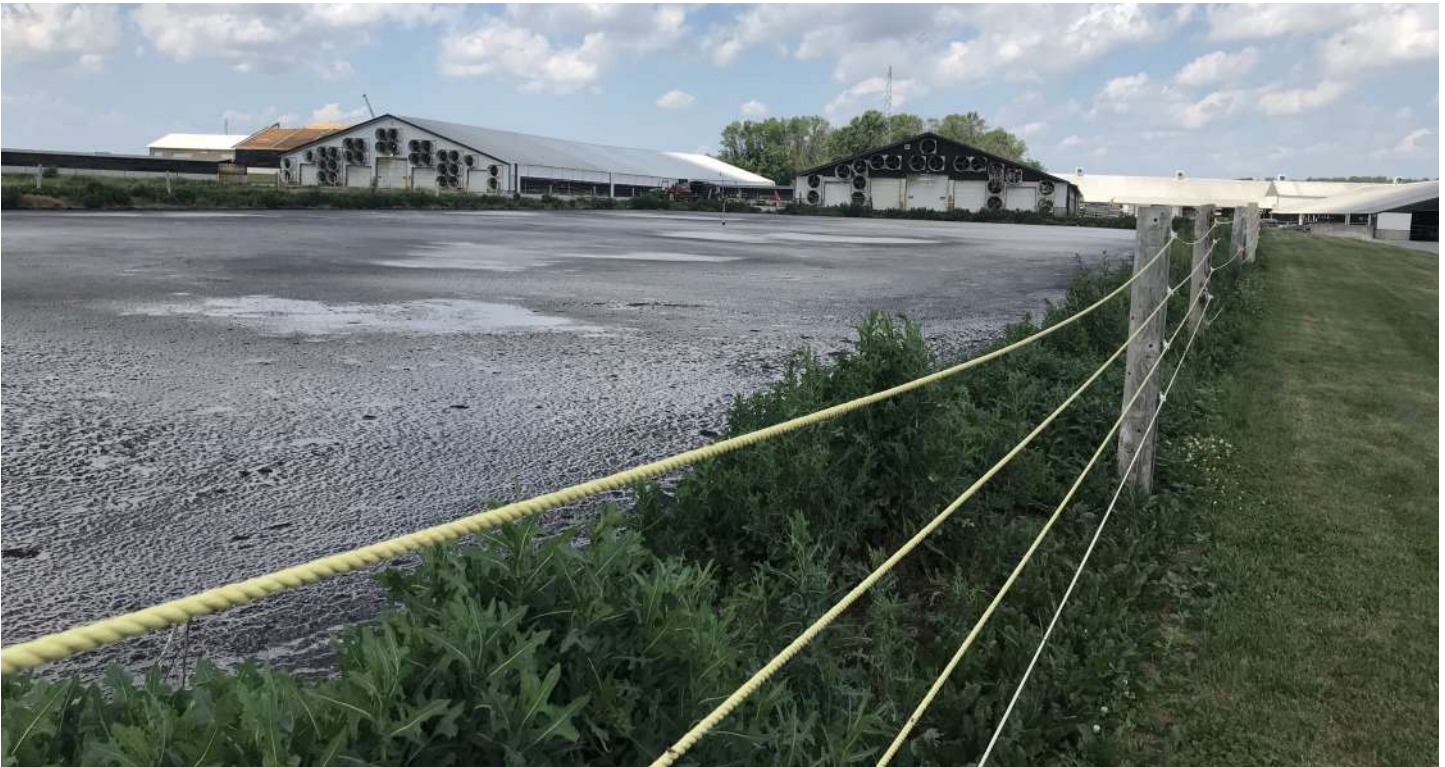
Photo #:	13	Photo Description: Waste Storage Facility 2 located at the Main Site, south of WSF 1. WSF 2 has a useable capacity of 5,917,996 gallons and is the first cell in a two-cell system.
Date/Time of Photo:	07/07/2020 13:47	
Photo Location:	Main Site	
Photo By:	James Salscheider

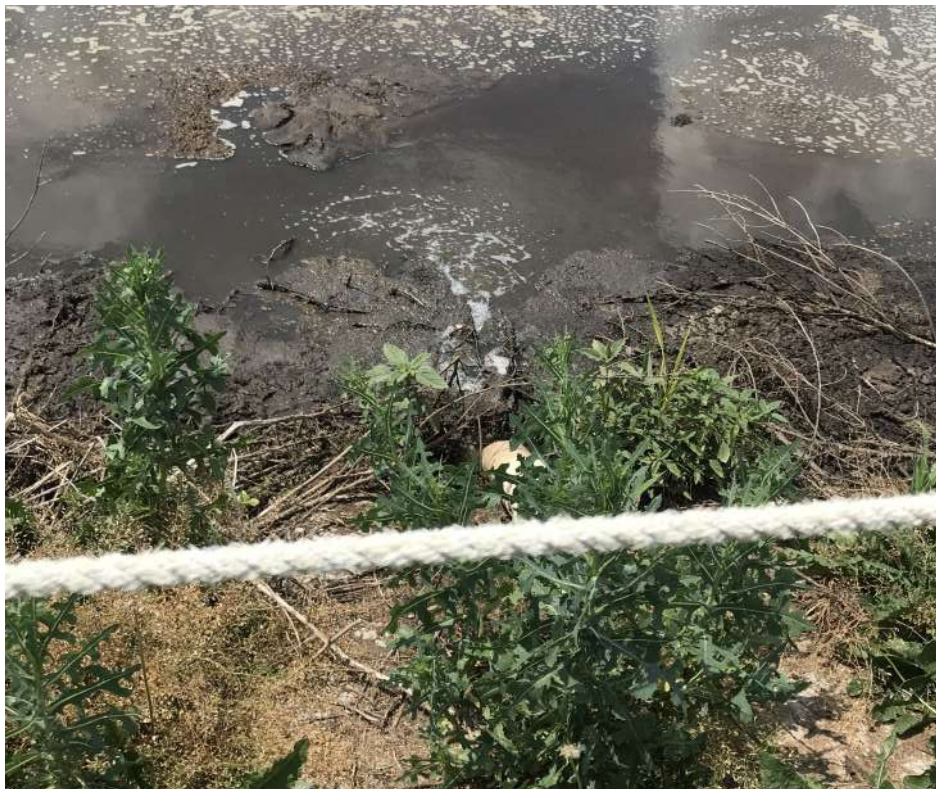
Photo #:	14	Photo Description: The inlet for feed storage runoff into WSF 2 from the runoff collection system.
Date/Time of Photo:	07/07/2020 13:45	
Photo Location:	Main Site	
Photo By:	James Salscheider

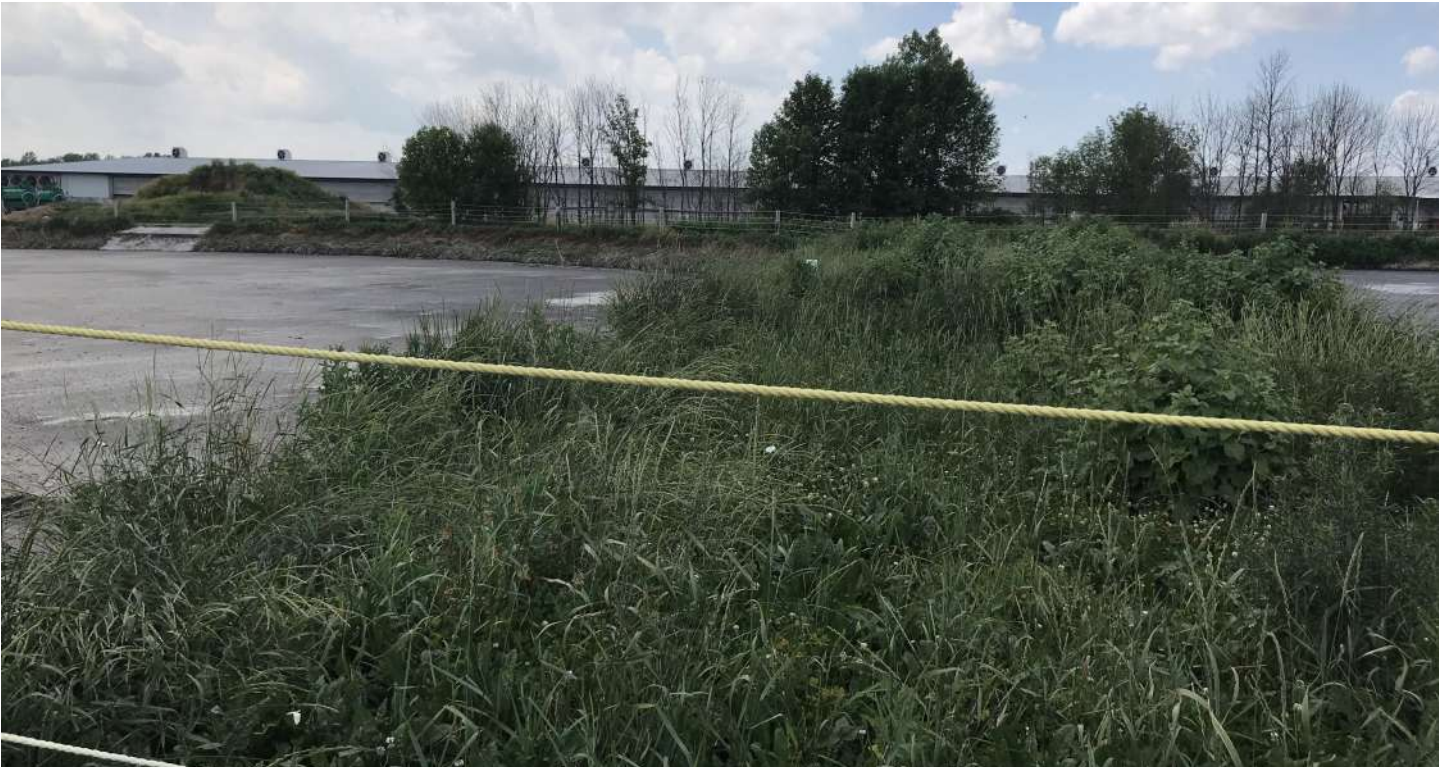
Photo #:	15	Photo Description: The berm separating WSF 2 and WSF 3. A concrete weir is located in the middle of the berm to allow waste to transfer from WSF 2 to WSF 3. This photo was taken facing west.
Date/Time of Photo:	07/07/2020 13:47	
Photo Location:	Main Site	
Photo By:	James Salscheider

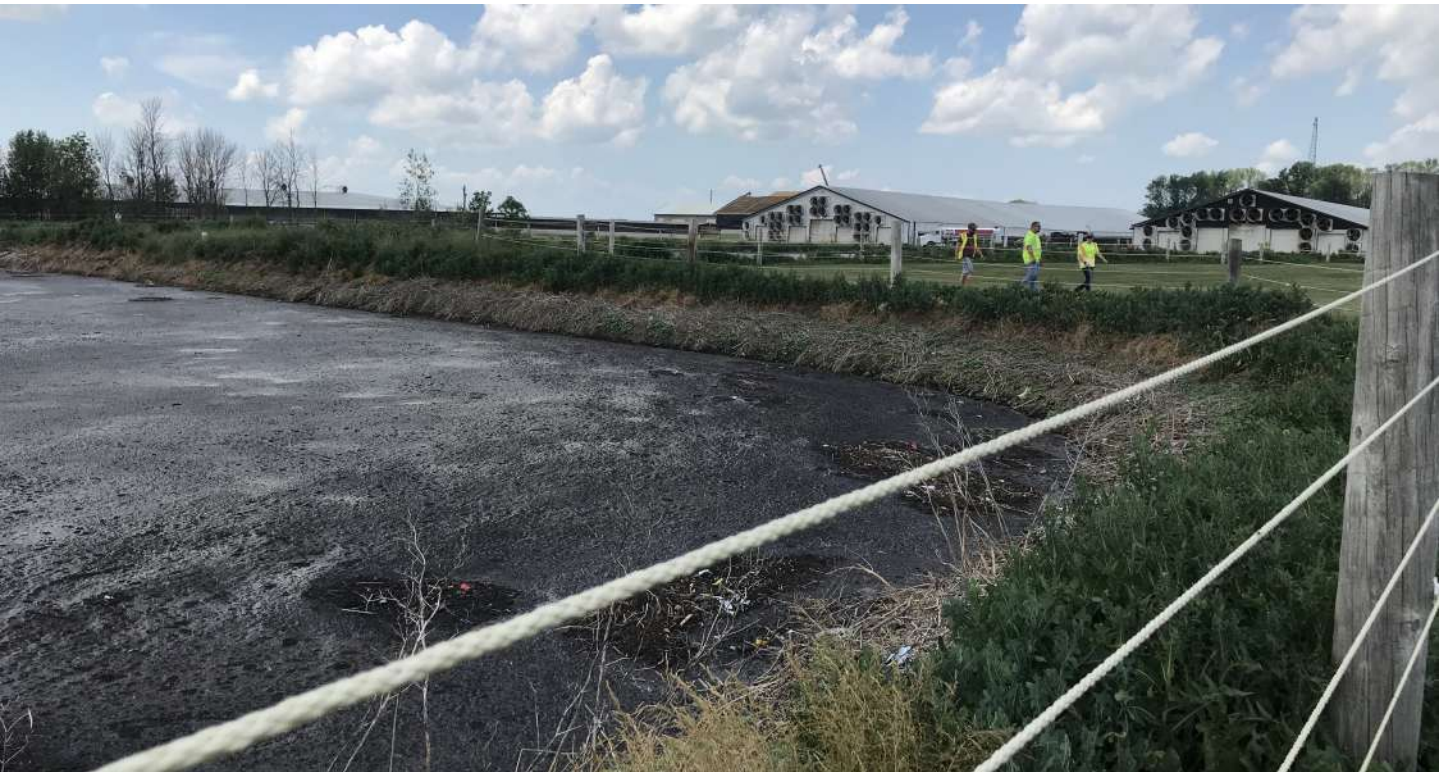
Photo #:	16	Photo Description: Waste Storage Facility 3, located south of WSF 2 at the Main Site. WSF 3 has a capacity of 10,063,816 gallons and is the second stage of a two-cell system. This photo was taken facing northwest.
Date/Time of Photo:	07/07/2020 13:48	
Photo Location:	Main Site	
Photo By:	James Salscheider

Required Action	Due Date
Retain Expert: Retain a qualified expert to complete an engineering evaluation for WSF 3 at the Main Site and report the name of the expert to the Department.	08/01/2024
Written Report: Submit a written report evaluating the existing manure storage facility's ability to meet the conditions in the Production Area Discharge Limitations and Manure and Process Wastewater Storage subsections and s. NR 243.15, Wis. Adm. Code. (See Standard Requirements for report details.)	04/01/2025
Plans and Specifications: Submit plans and specifications for Department review and approval in accordance with Chapter 281.41, Wis. Stats., and Chapter NR 243, Wis. Adm. Code, to permanently correct any adverse manure storage conditions.	12/31/2025
Corrections and Post Construction Documentation: Complete construction on the manure storage facility that permanently corrects any adverse conditions in concurrence with and approval by the Department, by the specified Date Due. Submit post construction documentation within 60 days of completion of the project.	12/31/2026

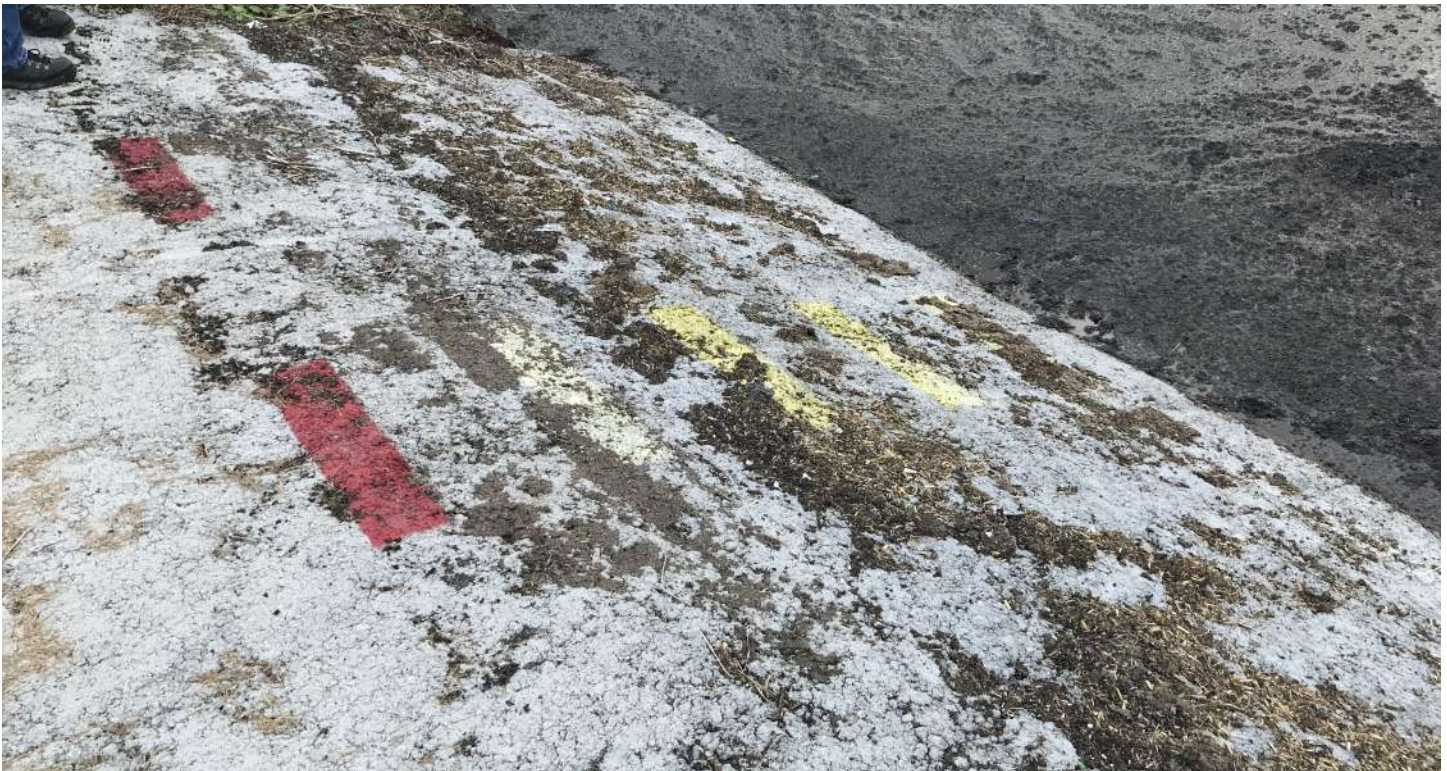
Photo #:	17	Photo Description: Permanent markers within WSF 3. The red line represents the Margin of Safety and the Maximum Operating Level is 2 1/2 feet below the red line.
Date/Time of Photo:	07/07/2020 13:48	
Photo Location:	Main Site	
Photo By:	James Salscheider

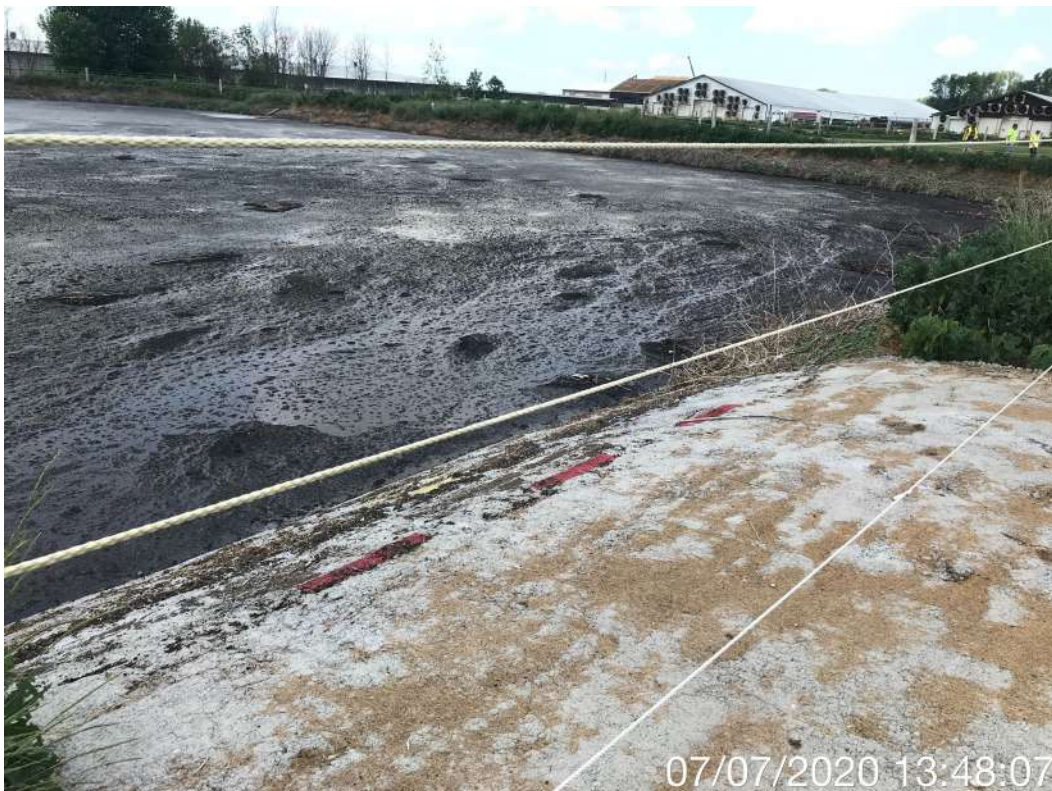
Photo #:	18	Photo Description: Waste Storage Facility 3, located south of WSF 2 at the Main Site. WSF 3 has a usable capacity of 10,063,816 gallons and is the second stage of a two-cell system. The permanent markers can be seen in the foreground of the photo. This photo was taken facing northwest.
Date/Time of Photo:	07/07/2020 13:48	
Photo Location:	Main Site	
Photo By:	Brian Hanson

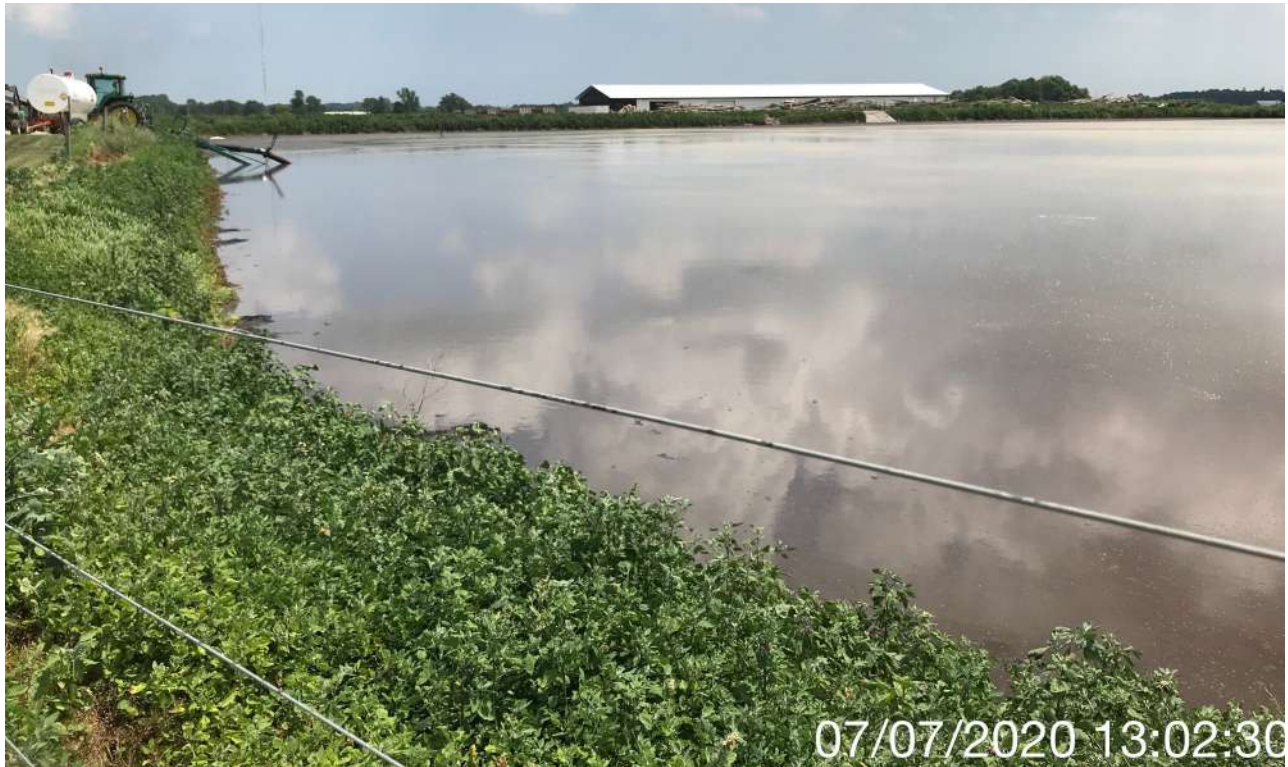
Photo #:	19	Photo Description: Waste Storage Facility 4 located south of Ryan Radio Rd at the Main Site. WSF 4 has a usable capacity of 23,320,788 gallons. This photo was taken facing east.
Date/Time of Photo:	07/07/2020 13:02	
Photo Location:	Main Site	
Photo By:	Brian Hanson

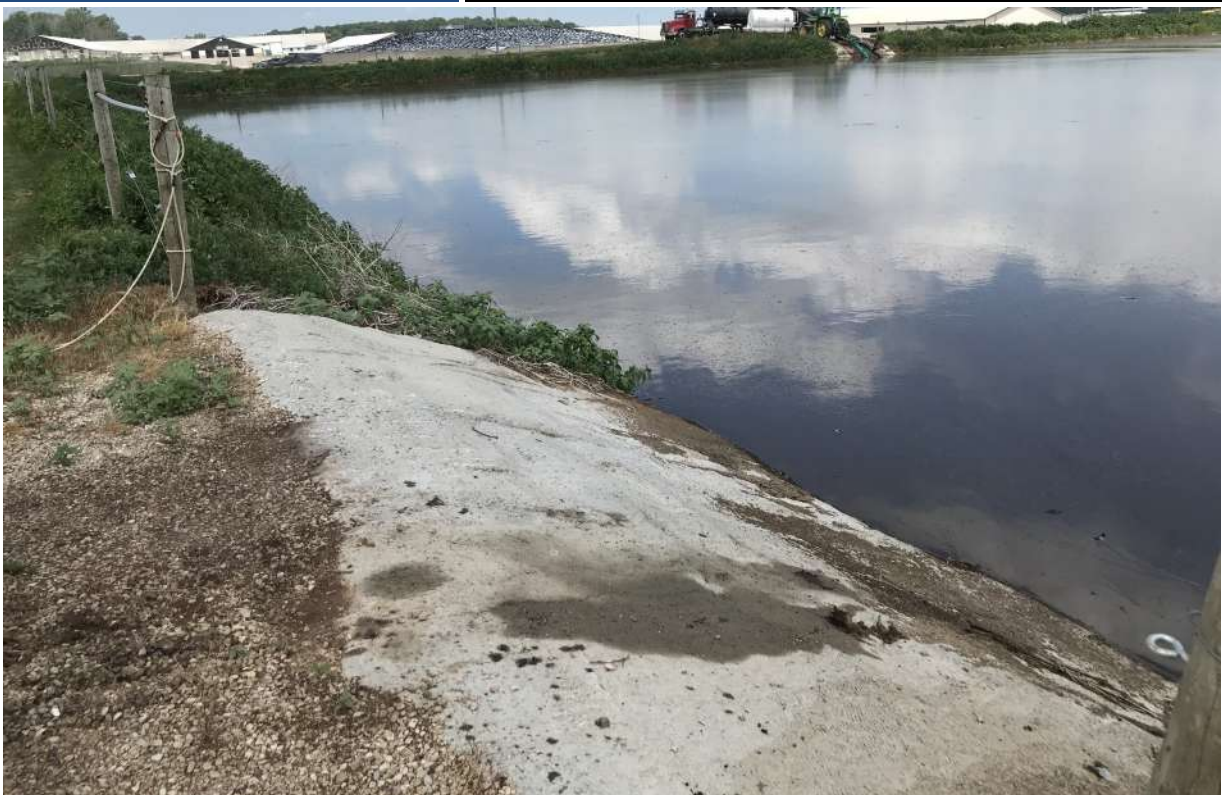
Photo #:	20	Photo Description: Waste Storage Facility 4 located south of Ryan Radio Rd at the Main Site. WSF 4 has a usable capacity of 23,320,788 gallons. This photo was taken facing north.
Date/Time of Photo:	07/07/2020 13:03	
Photo Location:	Main Site	
Photo By:	James Salscheider
