Permit Fact Sheet

Permit Number:	WI-0059374-05-0
Permittee Name:	Pagels Ponderosa Dairy, LLC
Address:	N4893 Hwy C
City/State/Zip:	Kewaunee WI 54216
Discharge Location:	N4893 County Road C, Kewaunee, WI 54216 N ½ NW ¼ S4 T23N R24E, Township of West Kewaunee N5318 County Road E, Kewaunee, WI 54216 SE ¼ SW ¼ S27 T24N R24E, Township of Casco E3470 County Rd F, Kewaunee, WI 54216 SE ¼ SW ¼ S16 T23N R24E, Township of West Kewaunee
Receiving Water:	Unnamed tributaries within the Kewaunee River Watershed, Lake Michigan Drainage Basin, and groundwaters of the State

On Tuesday, July 7, 2020, James Salscheider and Brian Hanson, Agricultural Runoff Management Specialists WDNR (Department) met with John J Pagel, Bryan Pagel, and Susan LaCrosse to conduct a WPDES permit reissuance inspection at Pagel's Ponderosa Dairy, LLC (PPD). The Main Site is located at the NW ¼ Sec 4 T23N R24E in the Town of West Kewaunee. The Clyde Hill Farm Site is located at SE ¼ SW ¼ Sec 27 T24N R24E in the Town of Casco. The weather conditions during the inspection were sunny and dry. The farm did receive approximately 0.33" of rain the day before. Follow up items are requested on Page 7. All photos taken during the

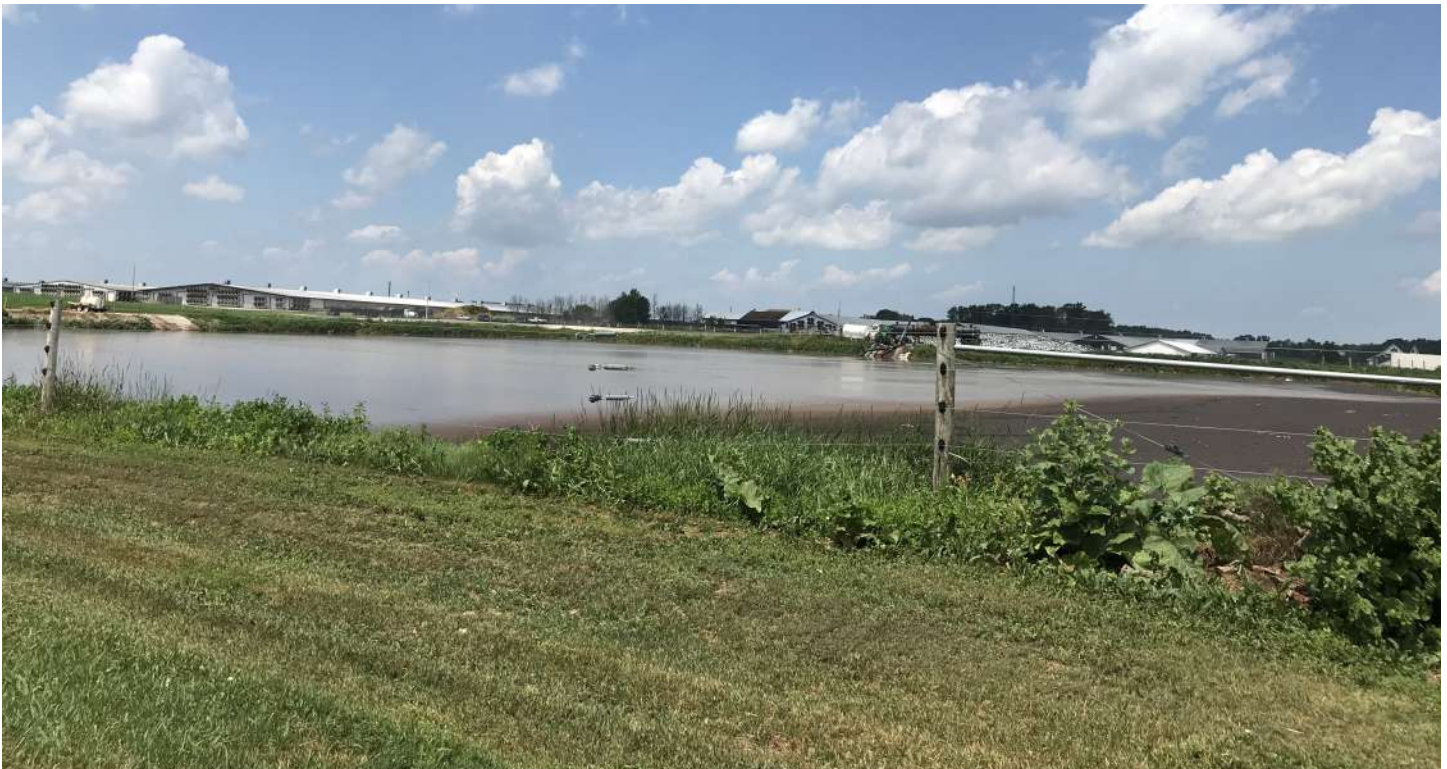
Photo #:	21	Photo Description: Waste Storage Facility 4 located south of Ryan Radio Rd at the Main Site. WSF 4 has a usable capacity of 23,320,788 gallons. This photo was taken facing north.
Date/Time of Photo:	07/07/2020 13:07	
Photo Location:	Main Site	
Photo By:	James Salscheider

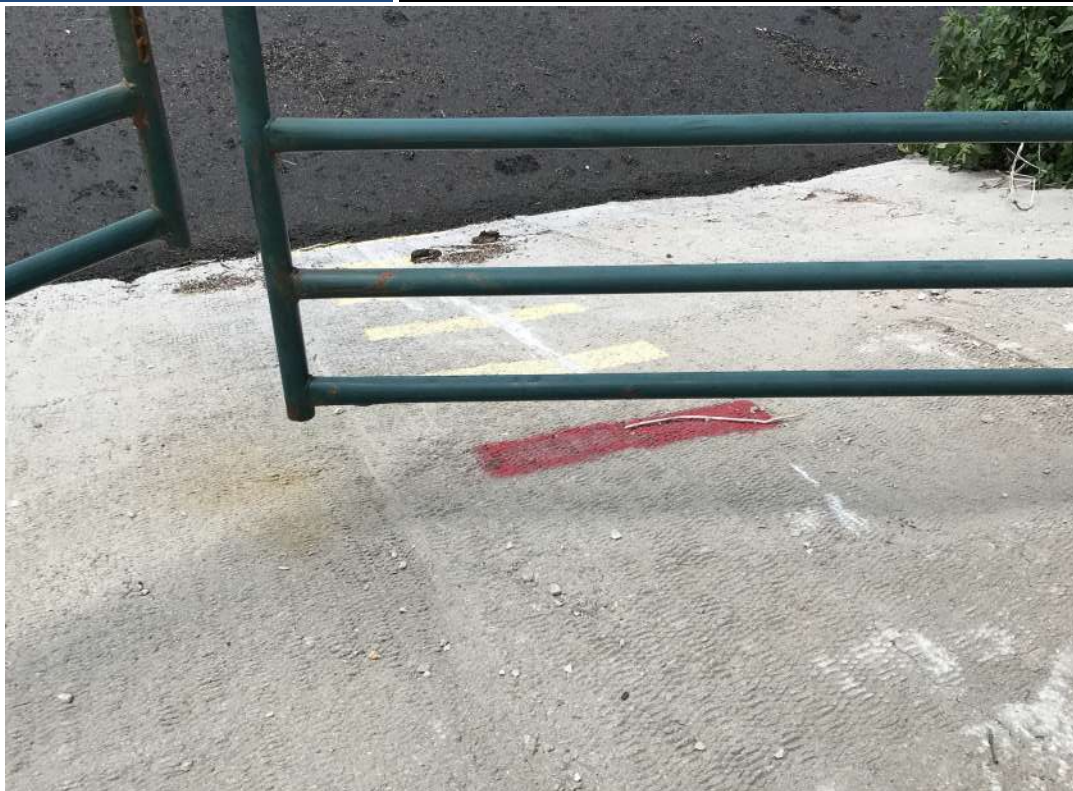
Photo #:	22	Photo Description: The permanent markers within WSF 4. The red line represents the Margin of Safety and the Maximum Operating Level. The markers are located on a scour pad on the east side of the structure.
Date/Time of Photo:	07/07/2020 13:11	
Photo Location:	Main Site	
Photo By:	James Salscheider

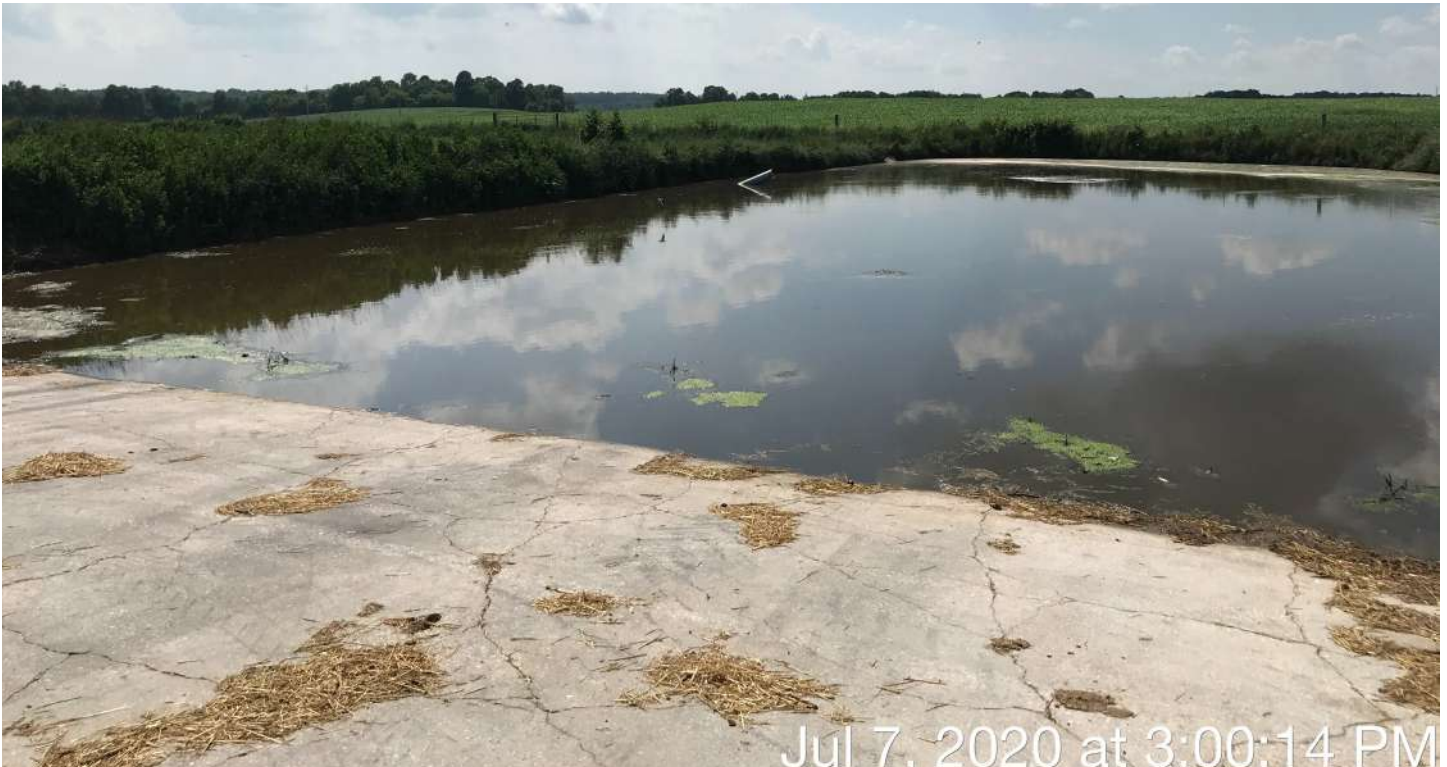
Photo #:	23
Date/Time of Photo:	07/07/2020 15:00
Photo Location:	Heifer Site
Photo By:	James Salscheider

Photo Description: Waste Storage Facility 1 located on the west side of the Heifer Site. WSF 1 is the first stage in a two-cell system. WSF 1 has a usable capacity of 1,500,000 gallons. This photo was taken facing west

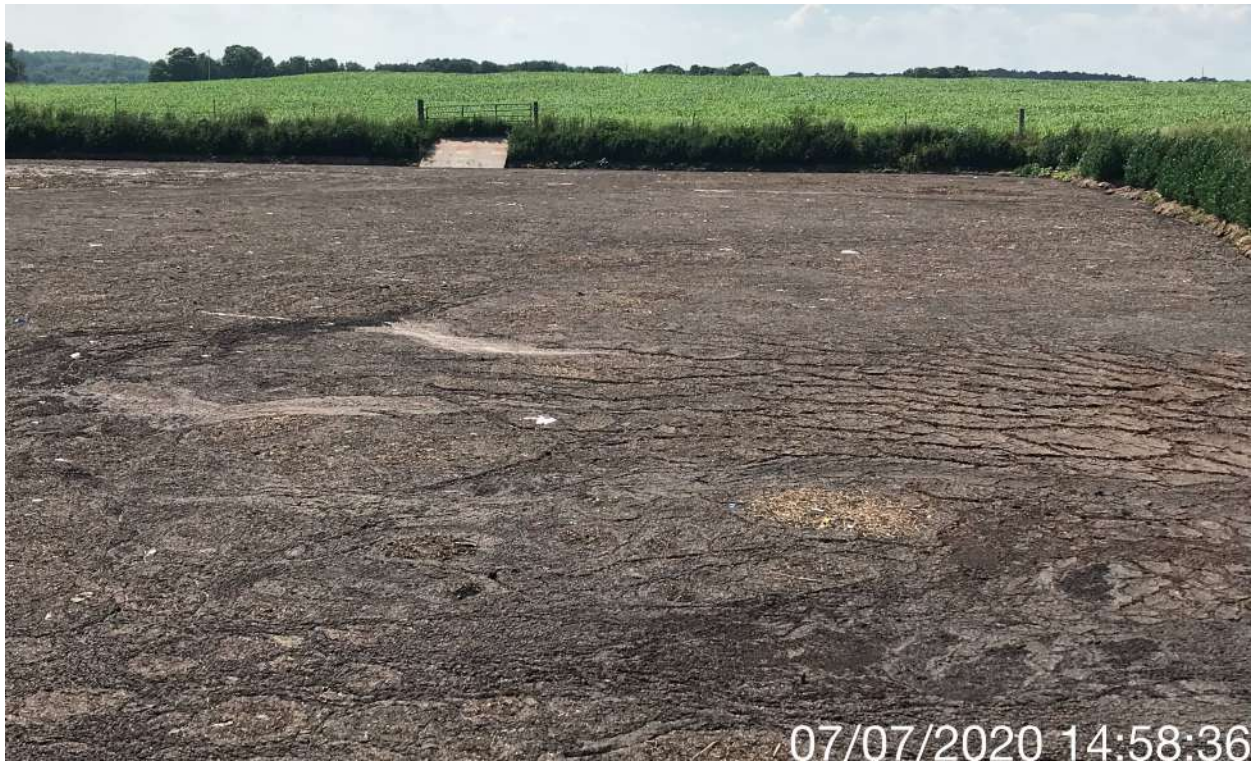
Photo #:	25	Photo Description: Waste Storage Facility 2 located on the west side of the Heifer Site. WSF 2 is the second stage in a two-cell system. WSF 2 has a usable capacity of 7,000,000 gallons. This photo was taken facing west.
Date/Time of Photo:	07/07/2020 14:58	
Photo Location:	Heifer Site	
Photo By:	James Salscheider

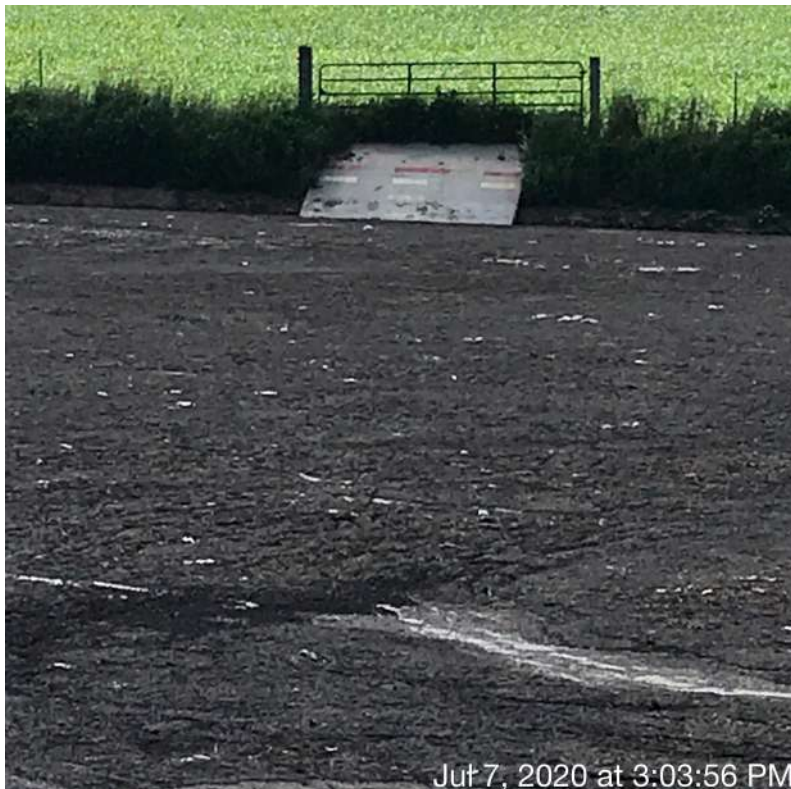
Photo #:	26	Photo Description: Permanent markers present within WSF 2 at the Heifer Site. The red line represents the Margin of Safety and the Maximum Operating Level is approximately 2 1/2 feet below the MOS. This photo was taken facing west.
Date/Time of Photo:	07/07/2020 15:03	
Photo Location:	Heifer Site	
Photo By:	James Salscheider

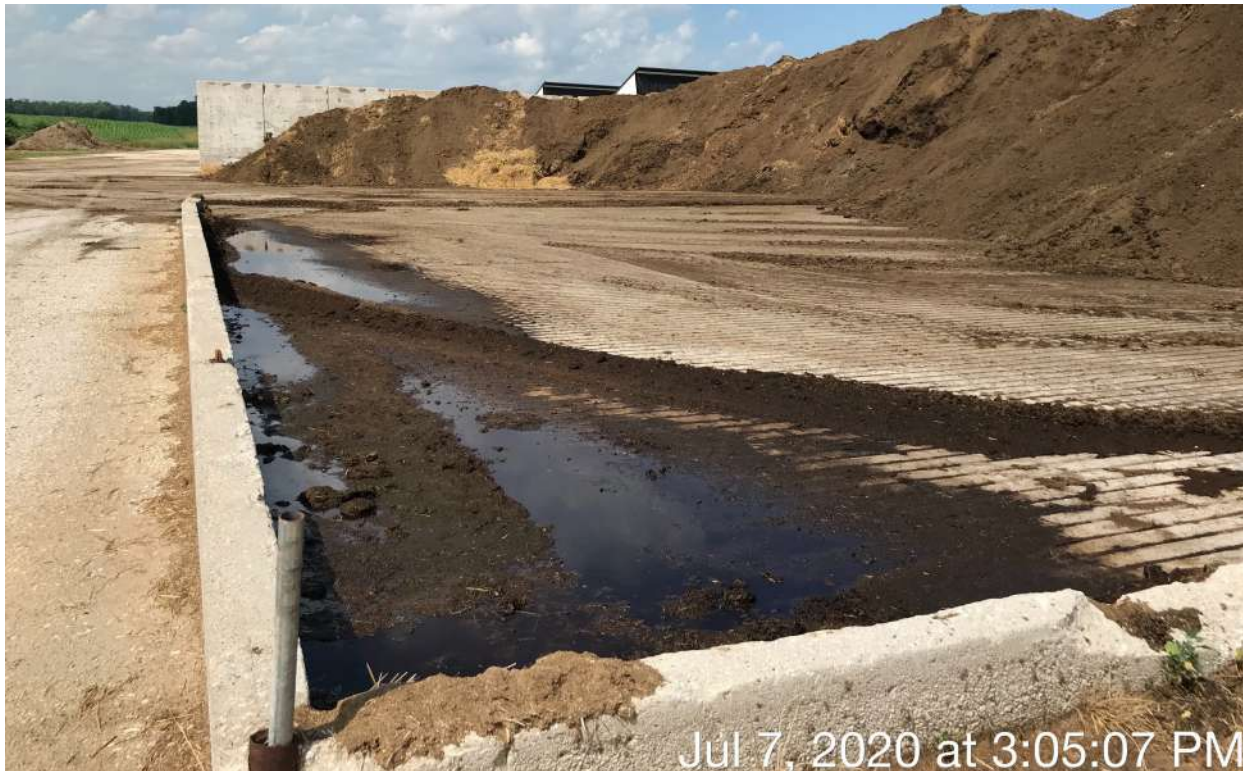
Photo #:	27
Date/Time of Photo:	07/07/2020 15:05
Photo Location:	Heifer Site
Photo By:	James Salscheider

Photo Description: The solid manure stacking pad located east of the liquid waste storage facilities at the Heifer Site. All liquid runoff is diverted to WSF 1. This photo was taken facing north.

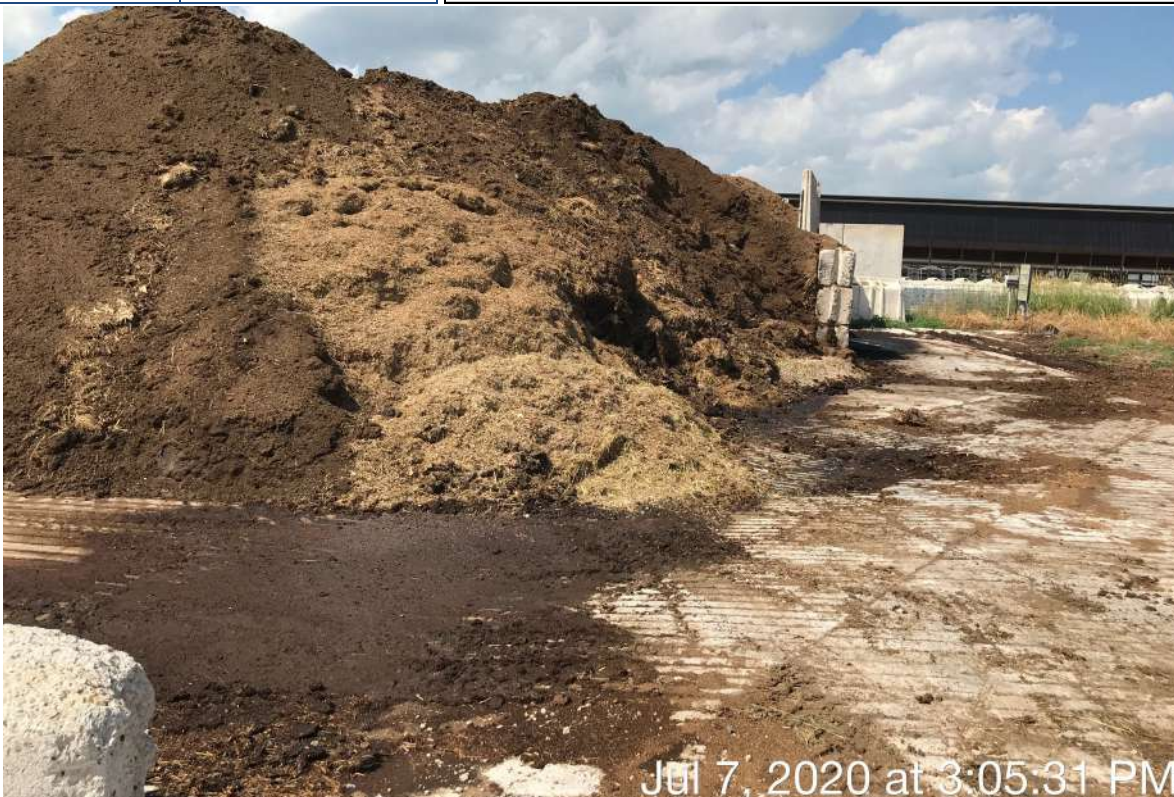
Photo #:	28
Date/Time of Photo:	07/07/2020 15:05
Photo Location:	Heifer Site
Photo By:	James Salscheider

Photo Description: The solid manure stacking pad located east of the liquid waste storage facilities. All liquid runoff is diverted to WSF 1. This photo was taken facing north.

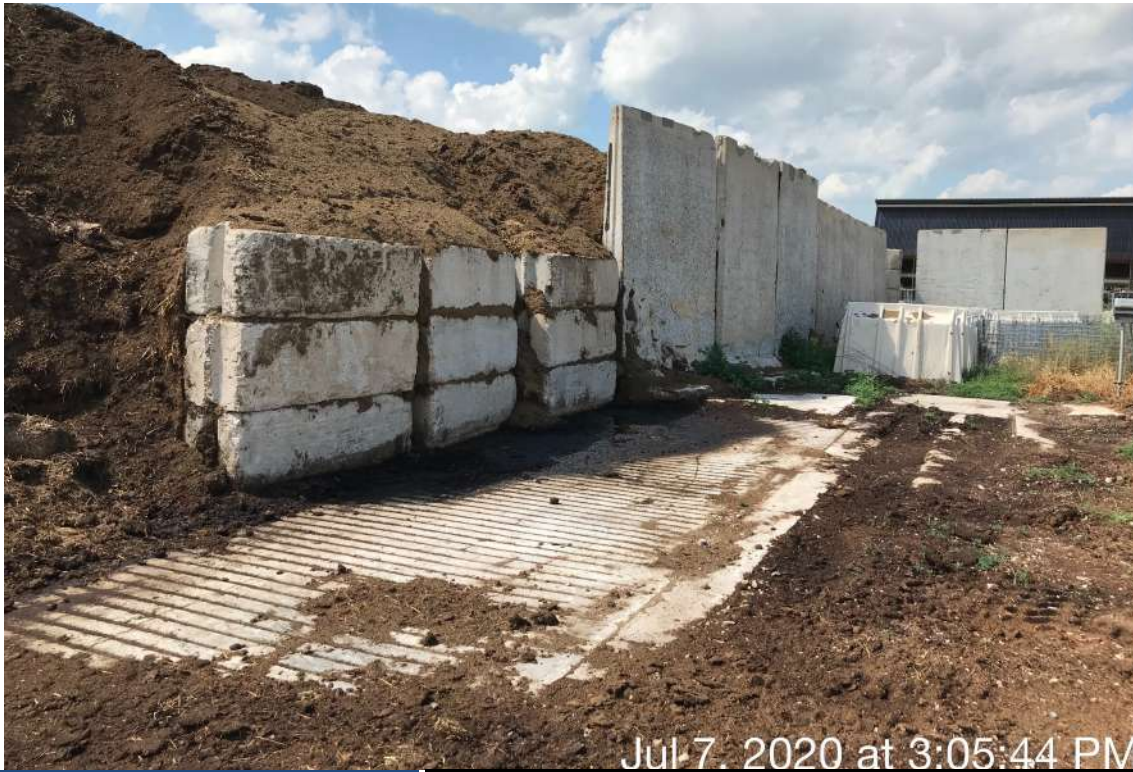
Photo #:	29	Photo Description: The solid manure stacking pad located east of the liquid waste storage facilities. All liquid runoff is diverted to WSF 1. This photo was taken facing northwest.
Date/Time of Photo:	07/07/2020 15:05	
Photo Location:	Heifer Site	
Photo By:	James Salscheider

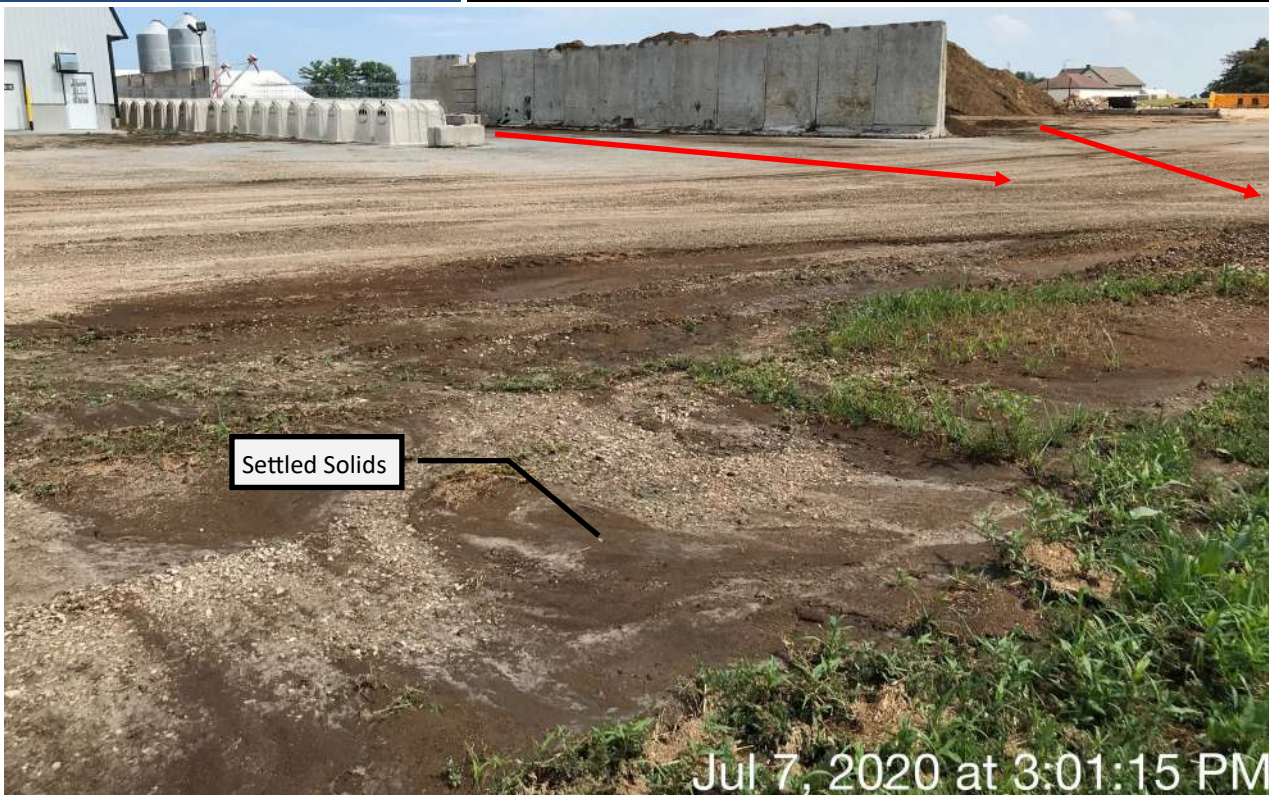
Calf hutch areas are managed to not have current or past indicators of discharges. Runoff control systems are not well-maintained, in good repair and in compliance with permit requirements.

Photo #:	30	Photo Description: Runoff from the solid manure stacking pad and calf hutch area is represented by the red arrows and is diverted to WSF 1. Settled manure solids are present in the foreground of the photo, indicating that runoff is ponding outside of the WSF.
Date/Time of Photo:	07/07/2020 15:01	
Photo Location:	Heifer Site	
Photo By:	James Salscheider

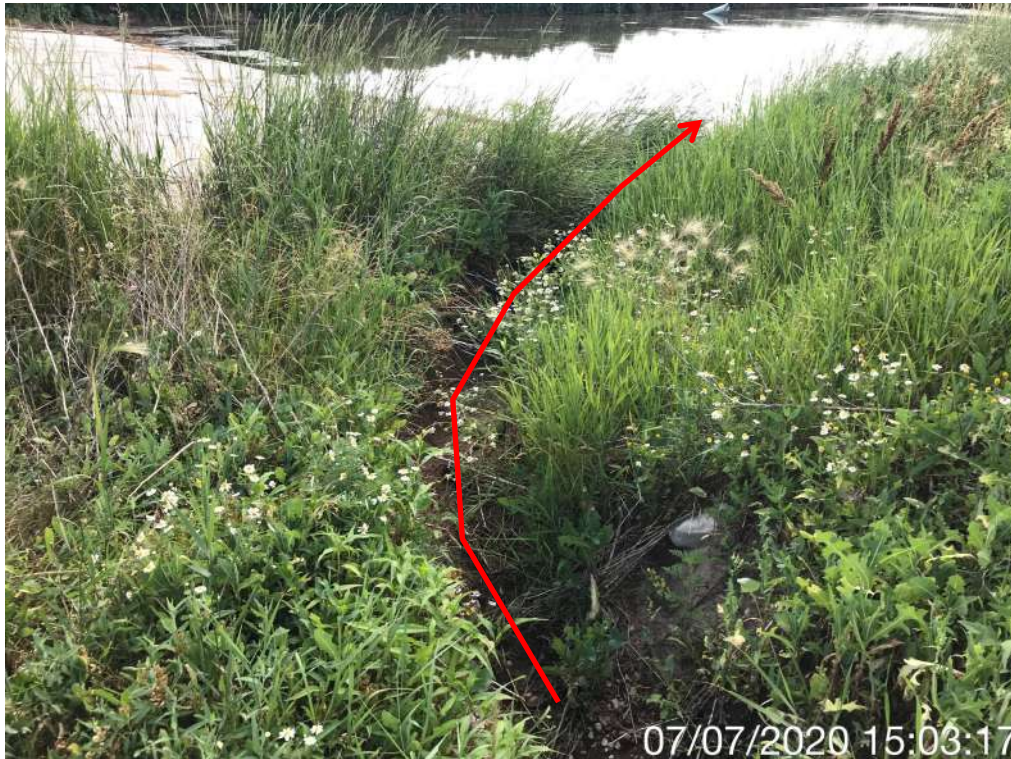
Photo #:	31	Photo Description: Gully erosion adjacent to the concrete ramp, indicating that runoff from the solid manure stacking pad and calf hutch area is flowing next to the ramp instead of on the ramp. The red arrow represents the flow path of runoff into WSF 1.
Date/Time of Photo:	07/07/2020 15:03	
Photo Location:	Heifer Site	
Photo By:	Brian Hanson

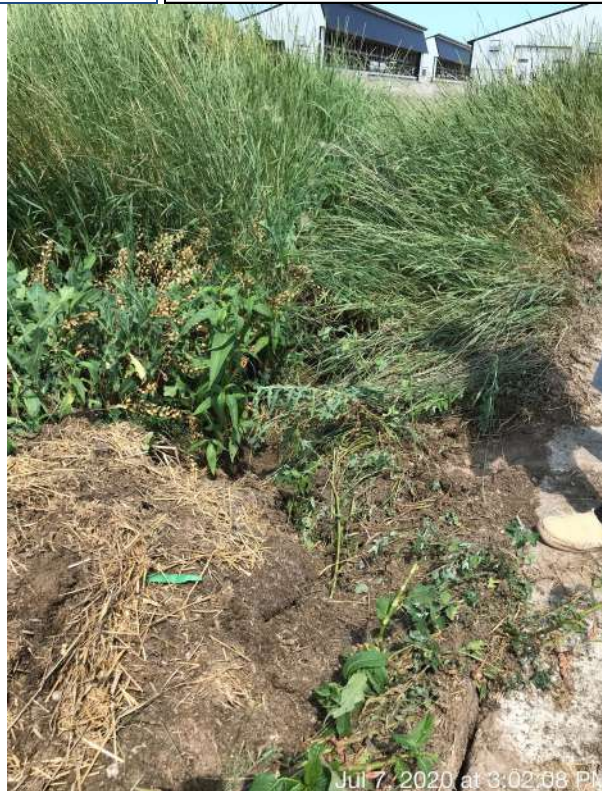
Photo #:	32	Photo Description: Gully erosion adjacent to the concrete ramp, indicating that runoff from the solid manure stacking pad and calf hutch area is flowing next to the ramp instead of on the ramp.
Date/Time of Photo:	07/07/2020 15:02	
Photo Location:	Heifer Site	
Photo By:	James Salscheider

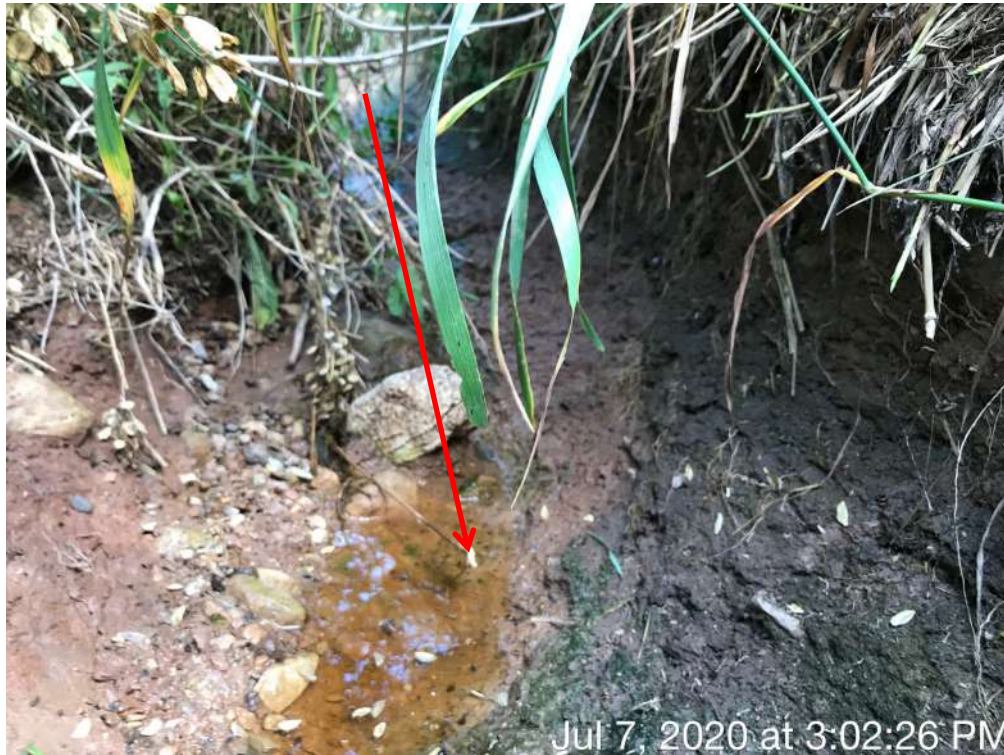
Photo #:	33	Photo Description: Gully erosion adjacent to the concrete ramp, indicating that runoff from the solid manure stacking pad and calf hutch area is flowing next to the ramp instead of on the ramp. The red arrow represents the flow path of runoff into WSF 1.
Date/Time of Photo:	07/07/2020 15:02	
Photo Location:	Heifer Site	
Photo By:	James Salscheider

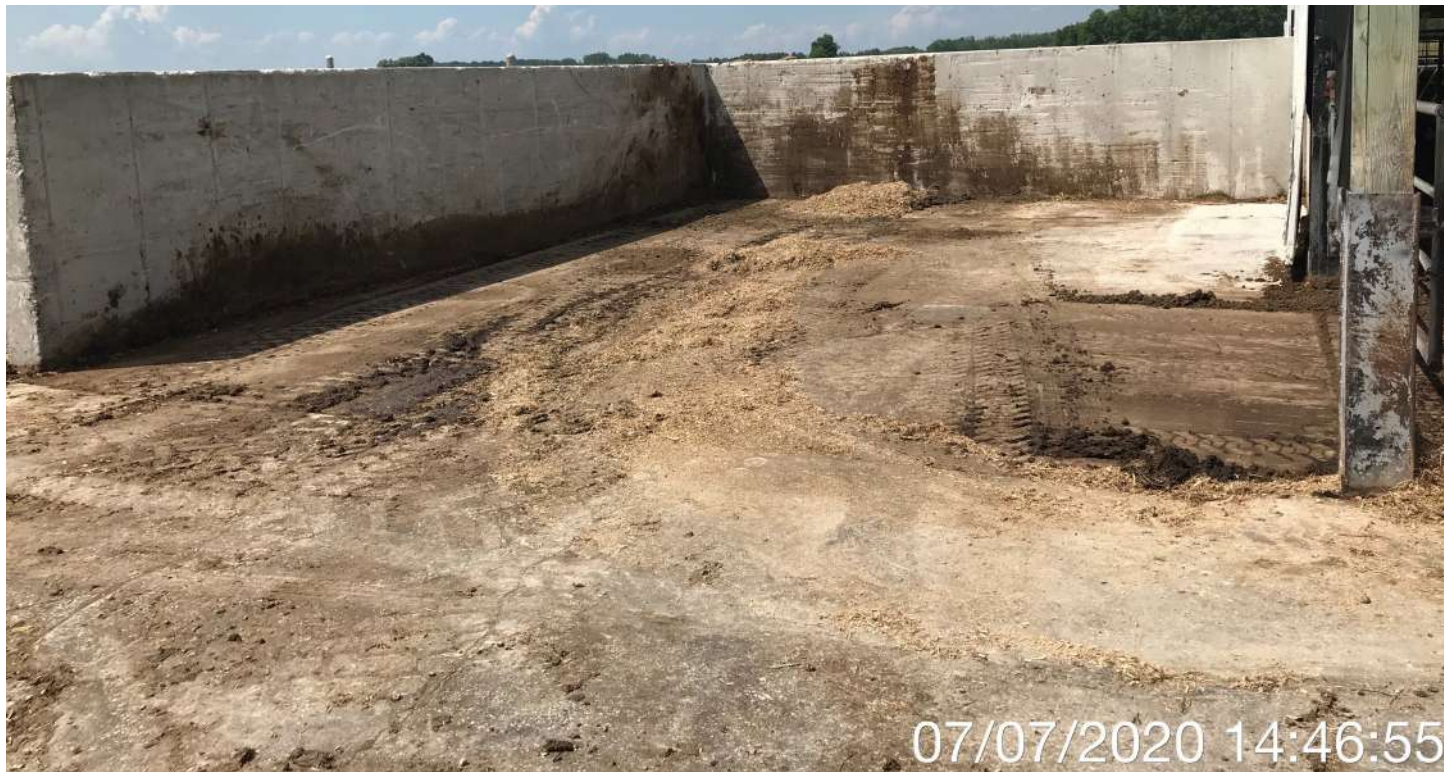
Photo #:	34	Photo Description: The pushout area for the dry calf barns located at the heifer site. When the barns are scrapped, the bed pack and solid manure are pushed to this area and then transferred to the solid manure stacking pad.
Date/Time of Photo:	07/07/2020 11:46	
Photo Location:	Heifer Site	
Photo By:	Brian Hanson

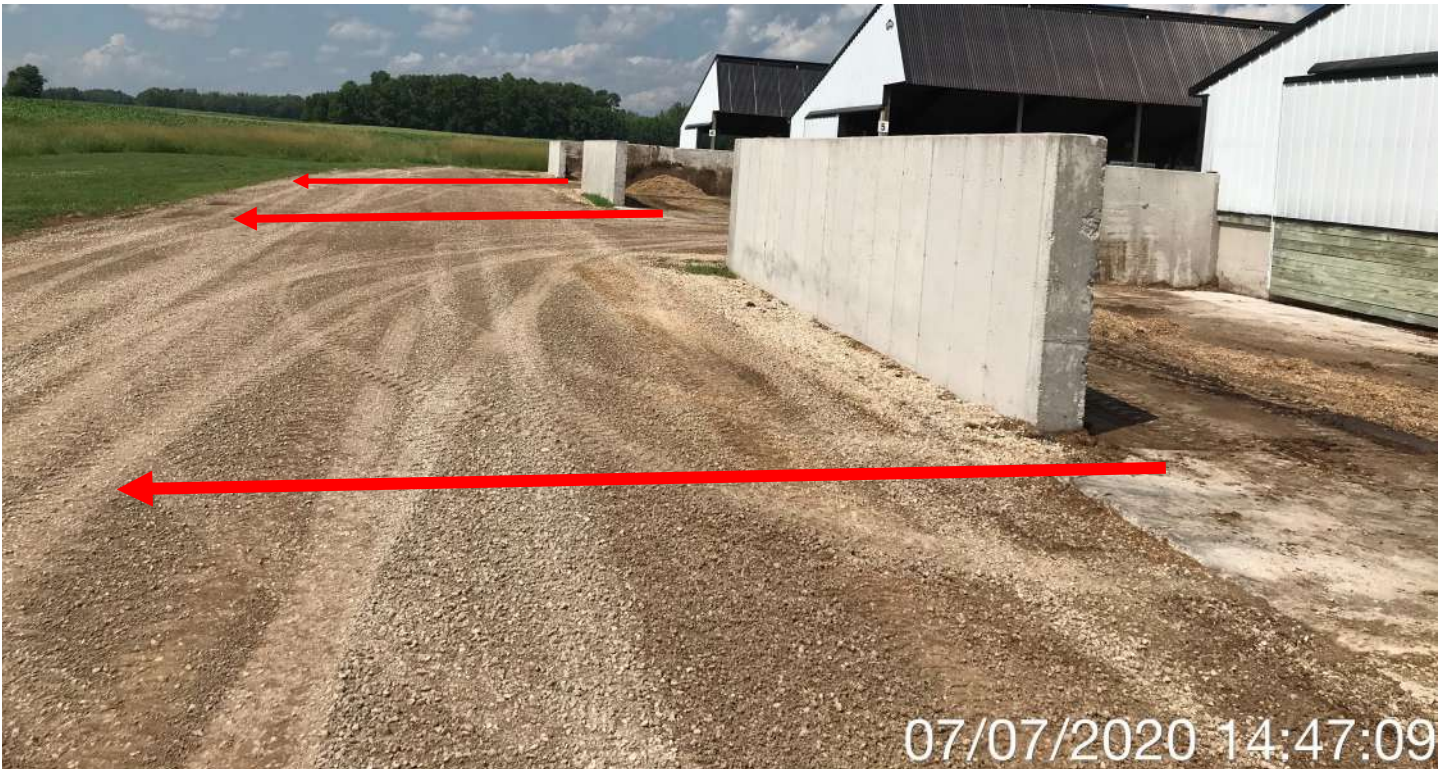
Photo #:	35
Date/Time of Photo:	07/07/2020 14:47
Photo Location:	Heifer Site
Photo By:	Brian Hanson

Photo Description: The pushout areas for the dry calf barns located at the heifer site. When the barns are scrapped, the bed pack and solid manure are pushed to this area and then transferred to the solid manure stacking pad. The red arrows represent the flow path of contaminated water away from the pushout areas.

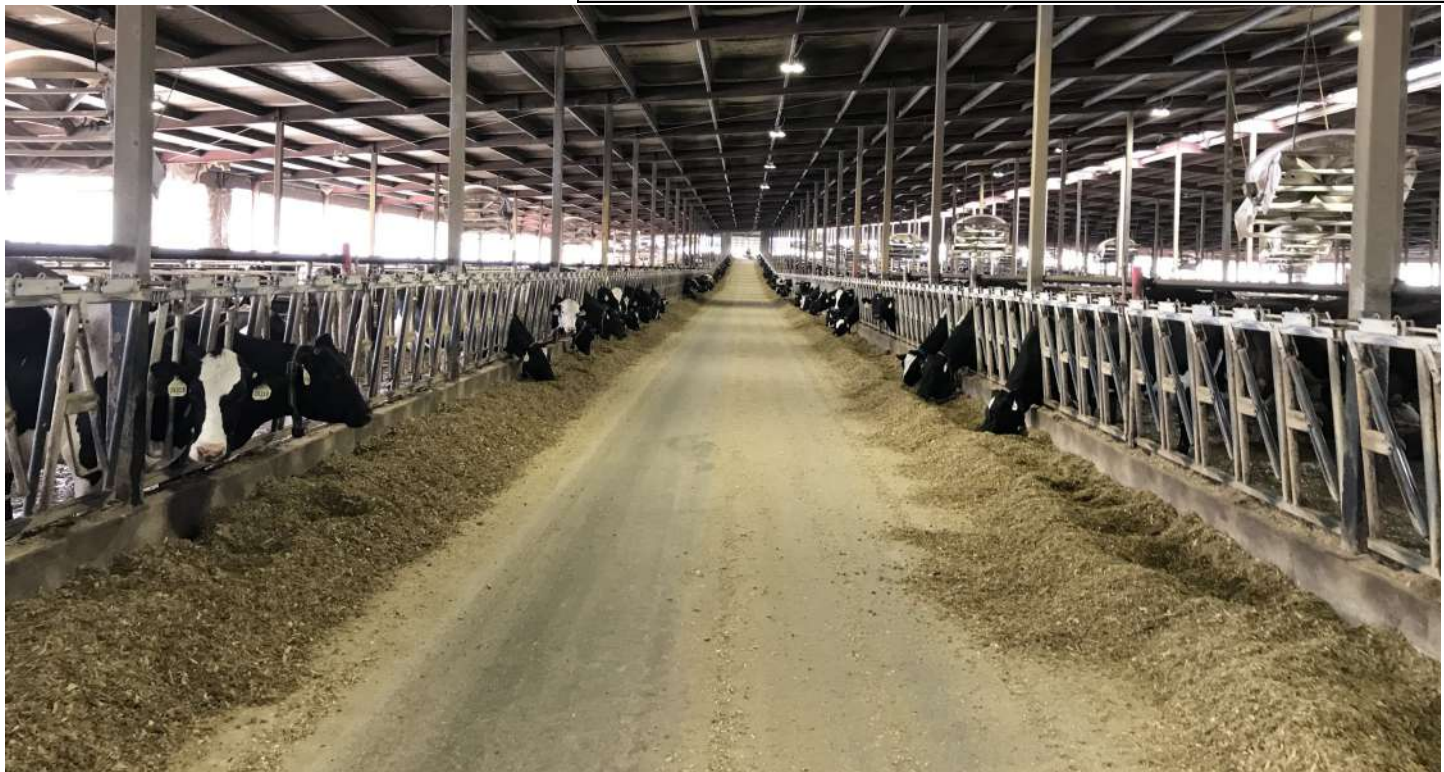
Photo #:	36
Date/Time of Photo:	07/07/2020 12:44
Photo Location:	Main Site
Photo By:	James Salscheider

Photo Description: Free Stall Barn 6 at the Main Site. The barn floors are pitched to the middle where a trench collected manure and transfers the manure to the manure handling building located between barns 5 and 6.

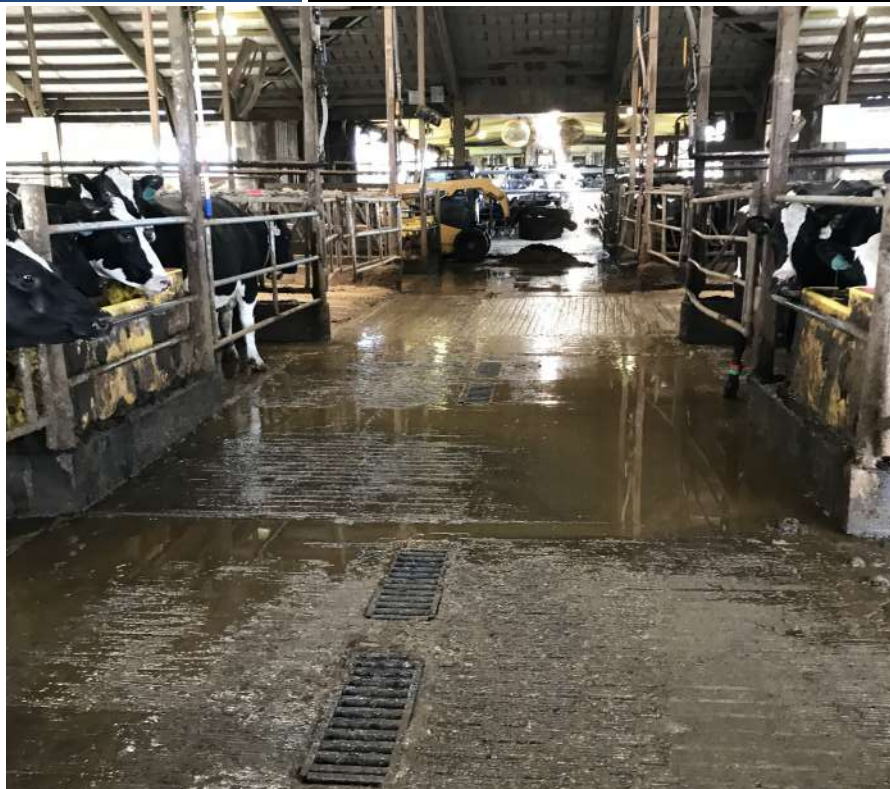
Photo #:	38	Photo Description: One of the milking parlors at the Main Site can be seen in the background of the photo. All process wastewater from the milking parlors are collected and comingled with manure, digested, and stored in the existing WSFs.
Date/Time of Photo:	07/07/2020 14:02	
Photo Location:	Main Site	
Photo By:	James Salscheider

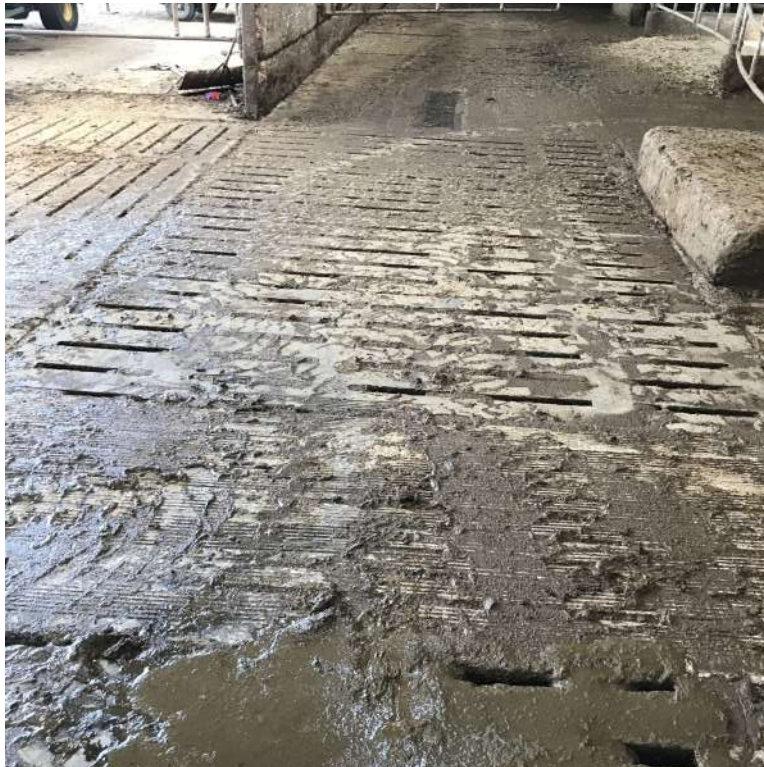
Photo #:	39	Photo Description: The reception basin located at the north end of Free Stall Barn 2. The reception basin has a capacity of 265,091 gallons.
Date/Time of Photo:	07/07/2020 14:01	
Photo Location:	Main Site	
Photo By:	James Salscheider

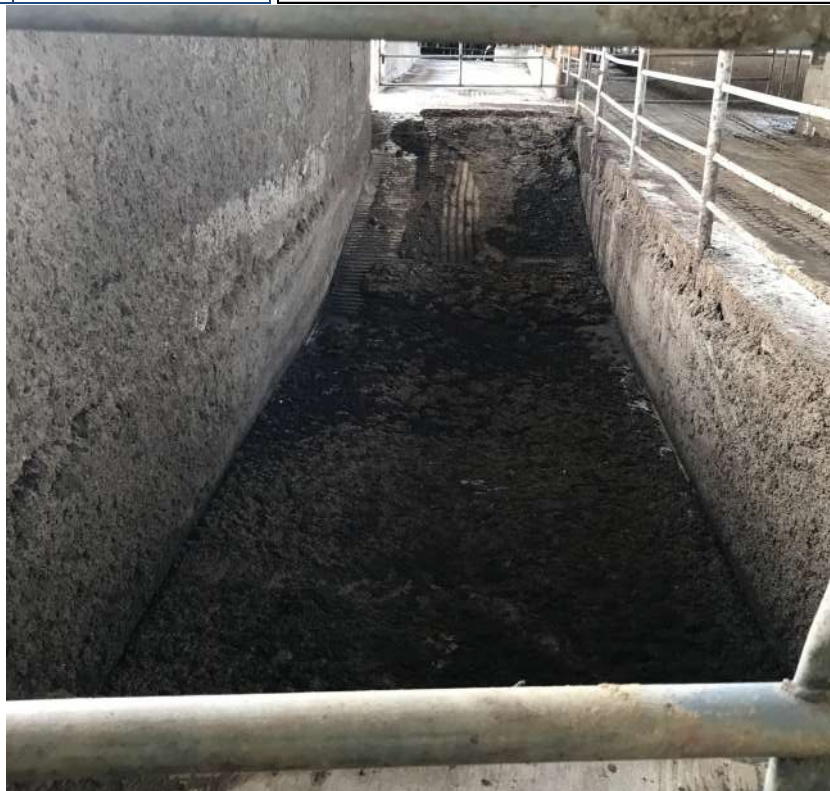
Photo #:	40	Photo Description: The reception basin located at the north end of Free Stall Barn 2. The reception basin has a capacity of 265,091 gallons.
Date/Time of Photo:	07/07/2020 14:01	
Photo Location:	Main Site	
Photo By:	James Salscheider

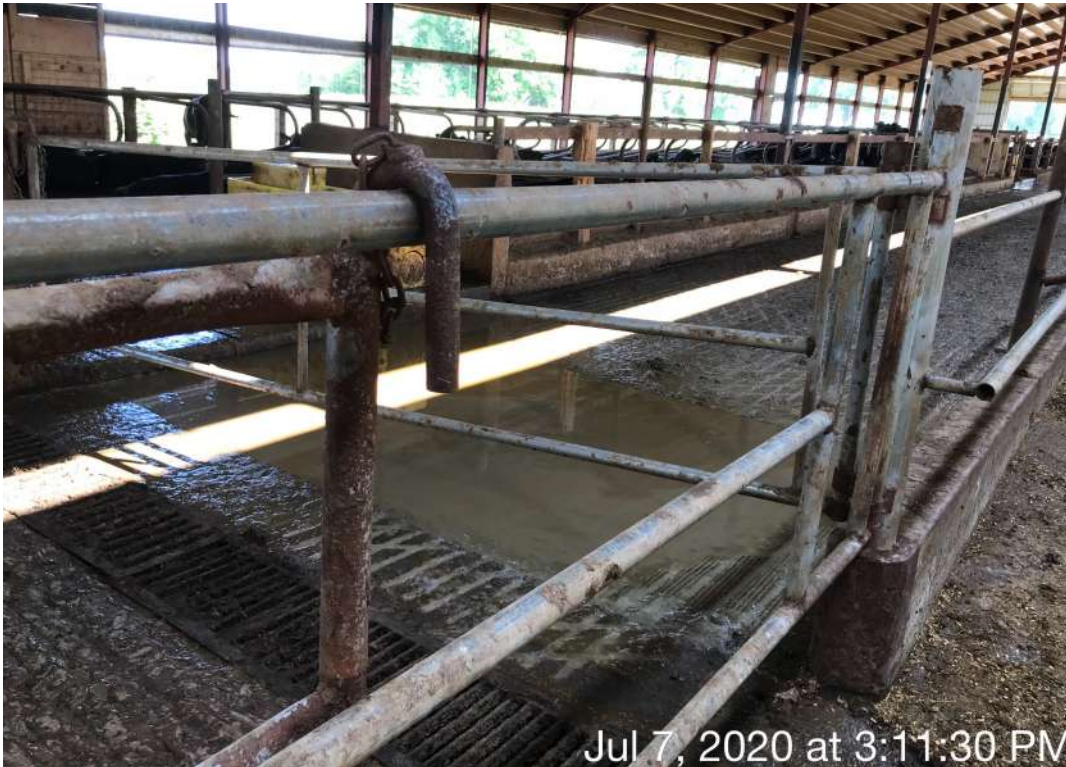
Photo #:	41	Photo Description: Flumes within the heifer barns at the Heifer Site that capture manure and transfer manure to the reception basin and solid separator located in Heifer Barn 2. Similar to the Main Site, the free stall barns are pitched to the middle.
Date/Time of Photo:	07/07/2020 15:11	
Photo Location:	Heifer Site	
Photo By:	James Salscheider

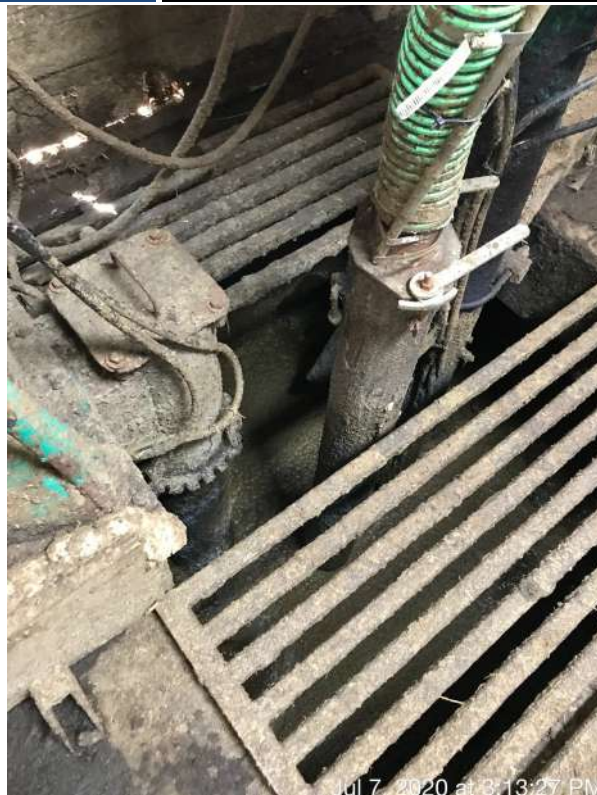
Photo #:	42	Photo Description: The reception basin located in Heifer Barn 2 at the Heifer Site. All liquid waste generated in the animal housing units at the Heifer Site are transferred to this basin, where the solids are then separated and liquids are transferred to the existing WSFs that are on-site.
Date/Time of Photo:	07/07/2020 15:13	
Photo Location:	Heifer Site	
Photo By:	James Salscheider

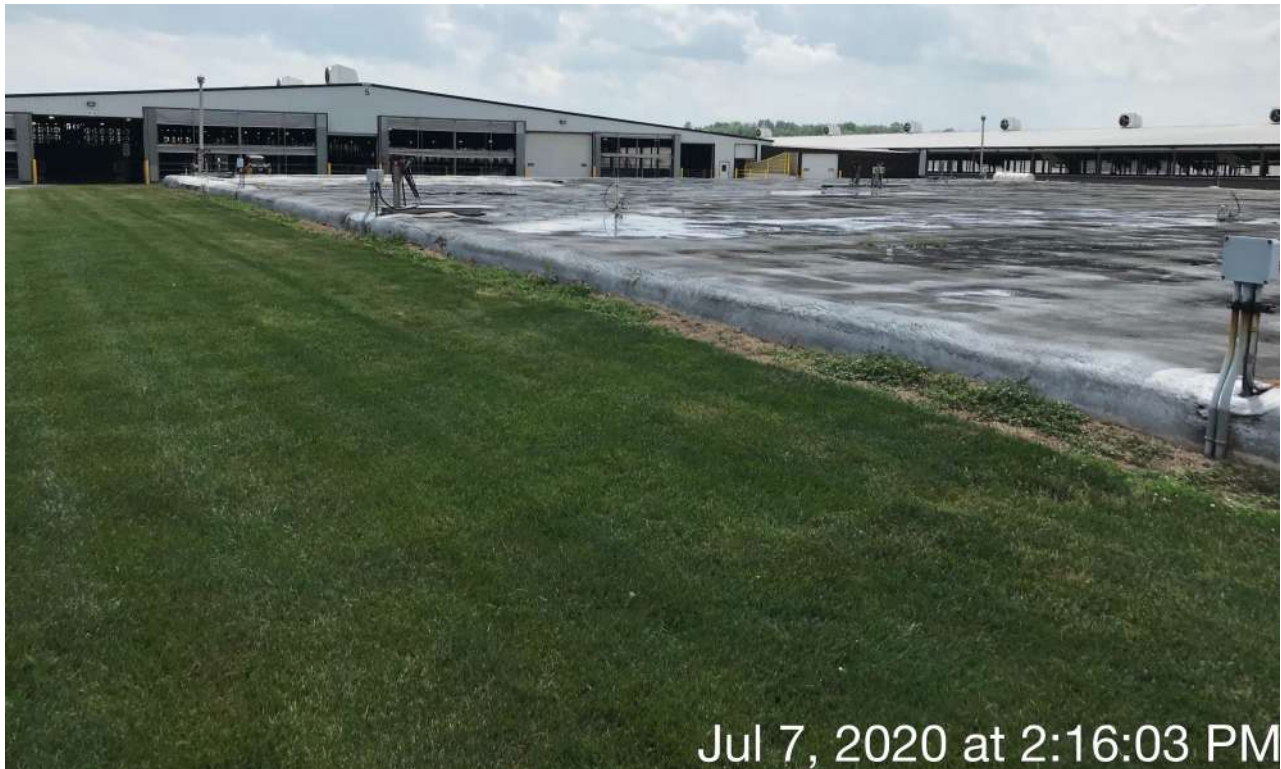
Photo #:	43	Photo Description: The manure digester located north of the Dry Cow Barn at the Main Site. The digester is a plug-flow digester and digests manure and process wastewater from the Main Site.
Date/Time of Photo:	07/07/2020 14:16	
Photo Location:	Main Site	
Photo By:	James Salscheider

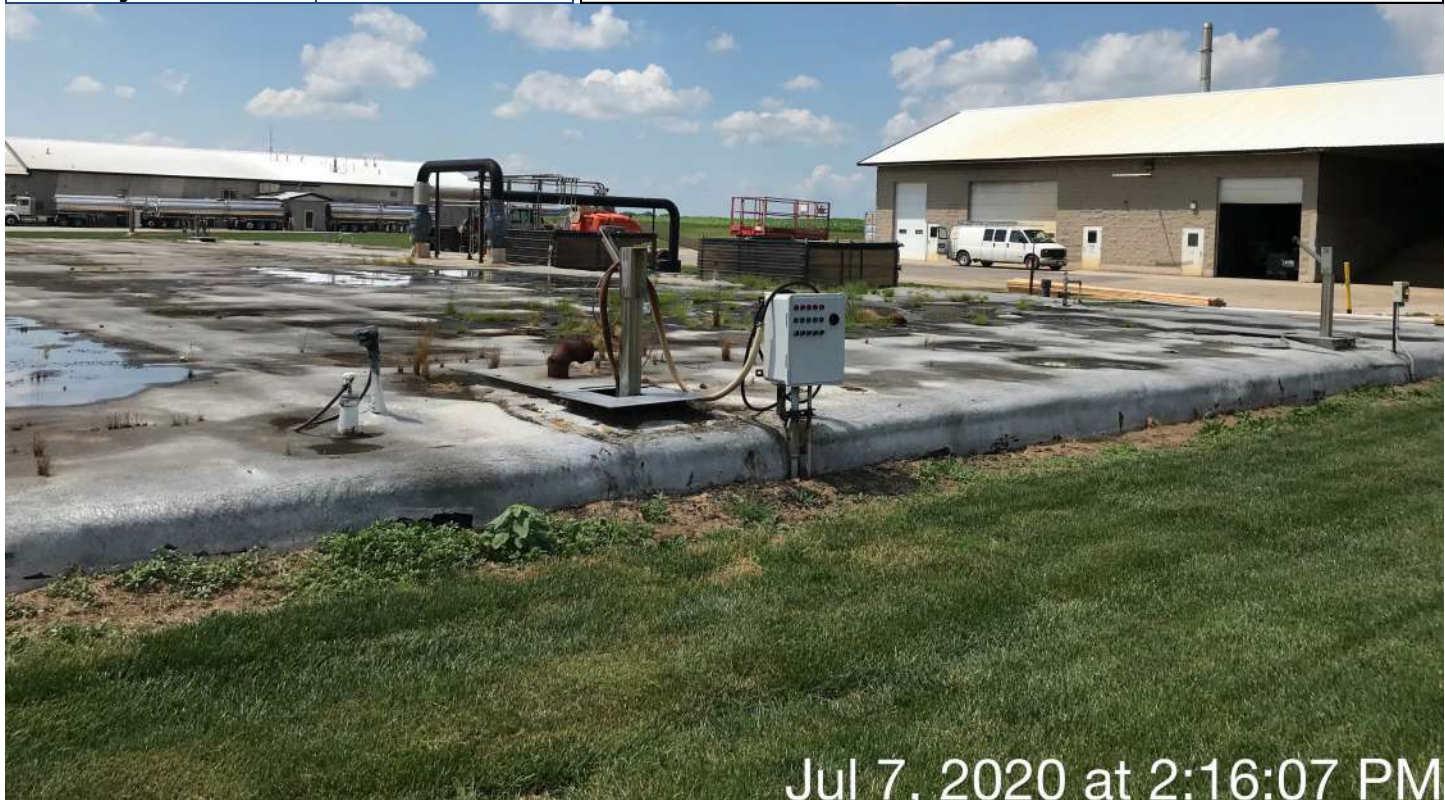
Photo #:	44	Photo Description: The manure digester located north of the Dry Cow Barn at the Main Site. The digester is a plug-flow digester and digests manure and process wastewater from the Main Site.
Date/Time of Photo:	07/07/2020 14:16	
Photo Location:	Main Site	
Photo By:	James Salscheider

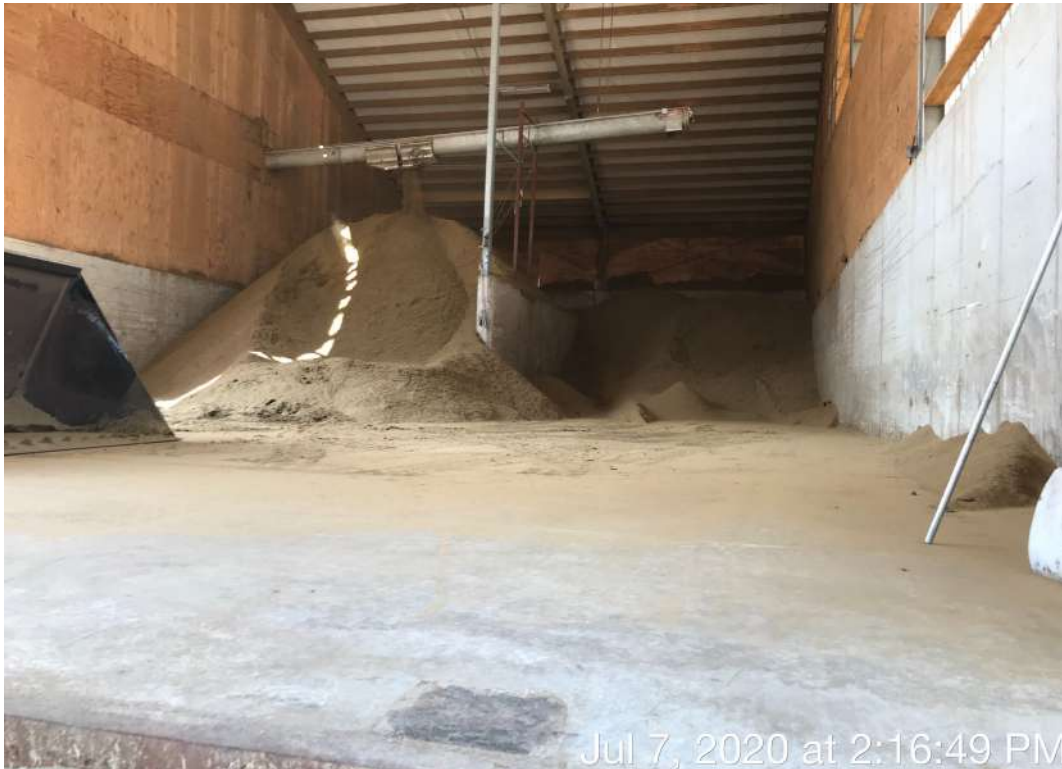
Photo #:	45	Photo Description: The dry bedding bay located at the east end of the solid separating building. Solids are separated from the manure and are dried and stored in this bay and used for bedding in the free stall barns.
Date/Time of Photo:	07/07/2020 14:16	
Photo Location:	Main Site	
Photo By:	James Salscheider
