Permit Fact Sheet

Permit Number:	WI-0059374-05-0
Permittee Name:	Pagels Ponderosa Dairy, LLC
Address:	N4893 Hwy C
City/State/Zip:	Kewaunee WI 54216
Discharge Location:	N4893 County Road C, Kewaunee, WI 54216 N ½ NW ¼ S4 T23N R24E, Township of West Kewaunee N5318 County Road E, Kewaunee, WI 54216 SE ¼ SW ¼ S27 T24N R24E, Township of Casco E3470 County Rd F, Kewaunee, WI 54216 SE ¼ SW ¼ S16 T23N R24E, Township of West Kewaunee
Receiving Water:	Unnamed tributaries within the Kewaunee River Watershed, Lake Michigan Drainage Basin, and groundwaters of the State

On Tuesday, July 7, 2020, James Salscheider and Brian Hanson, Agricultural Runoff Management Specialists WDNR (Department) met with John J Pagel, Bryan Pagel, and Susan LaCrosse to conduct a WPDES permit reissuance inspection at Pagel's Ponderosa Dairy, LLC (PPD). The Main Site is located at the NW ¼ Sec 4 T23N R24E in the Town of West Kewaunee. The Clyde Hill Farm Site is located at SE ¼ SW ¼ Sec 27 T24N R24E in the Town of Casco. The weather conditions during the inspection were sunny and dry. The farm did receive approximately 0.33" of rain the day before. Follow up items are requested on Page 7. All photos taken during the

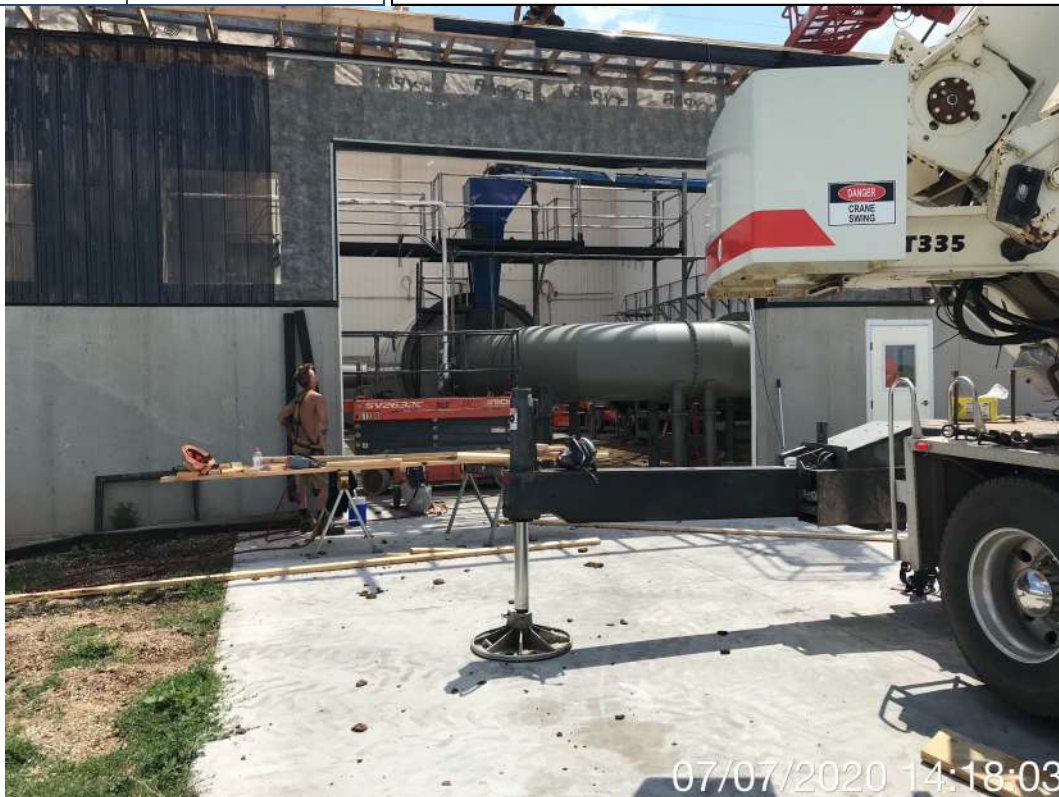
Photo #:	46	Photo Description: The manure drying equipment located in the solid separating building. Wet manure solids are conveyed from the solid separator into the dryer.
Date/Time of Photo:	07/07/2020 14:18	
Photo Location:	Main Site	
Photo By:	Brian Hanson

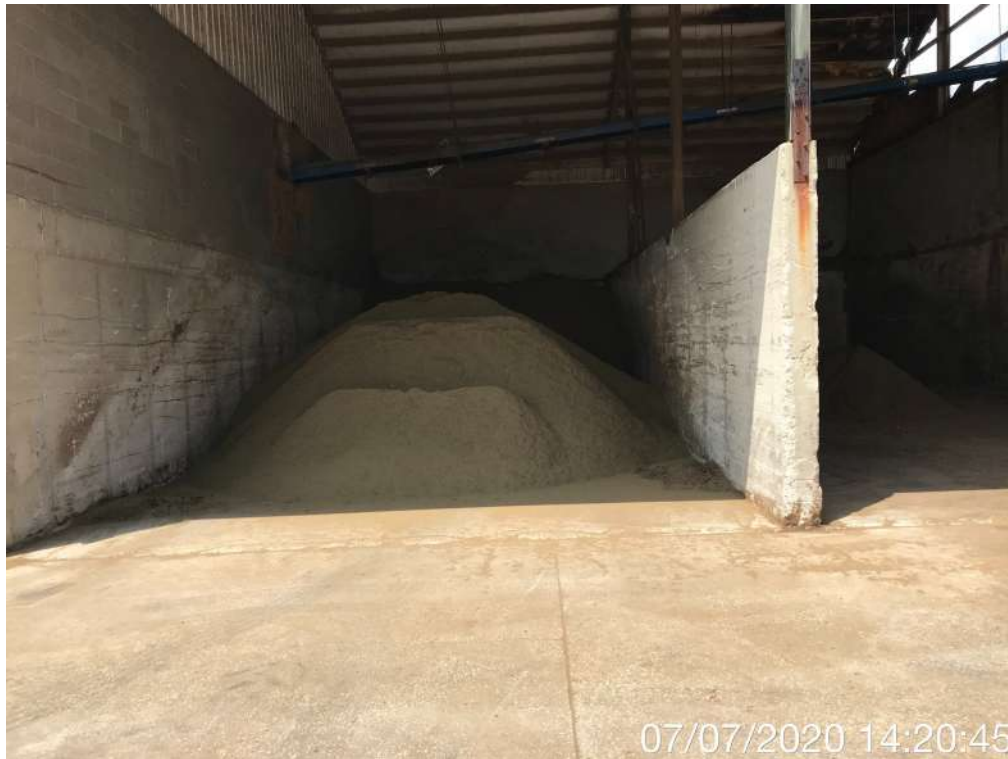
Photo #:	47
Date/Time of Photo:	07/07/2020 14:20
Photo Location:	Main Site
Photo By:	Brian Hanson

Photo Description: Another bay used to stored dried manure solids to be used for bedding. Typically, these bays are used for wet bedding but due to construction after a building fire, these bays are being used for dry bedding.

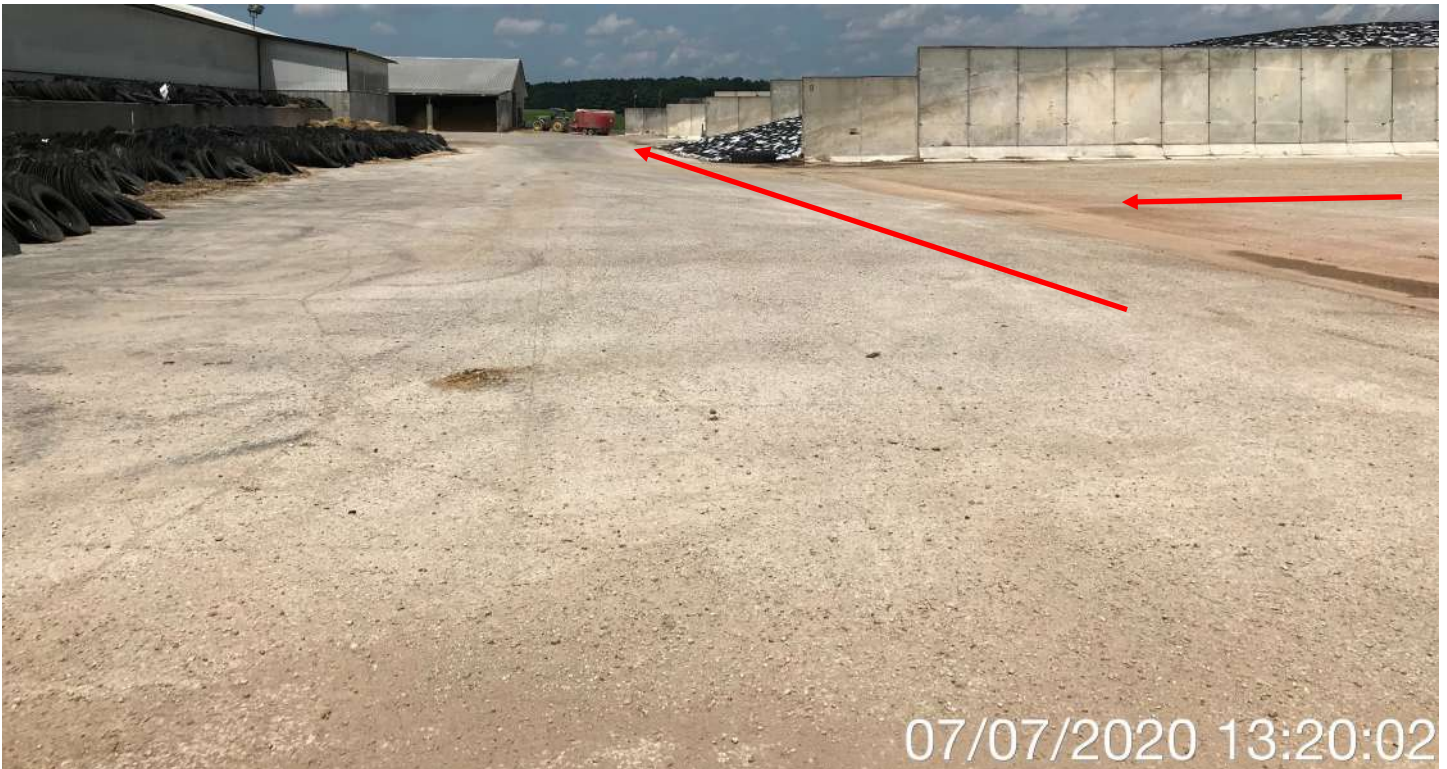
Photo #:	49	Photo Description: The east feed side of the feed storage area, where the majority of the corn silage is stored. This side of the FSA pitches east to west and then north towards the runoff control system. The red arrows represent the flow path.
Date/Time of Photo:	07/07/2020 13:20	
Photo Location:	Main Site	
Photo By:	Brian Hanson

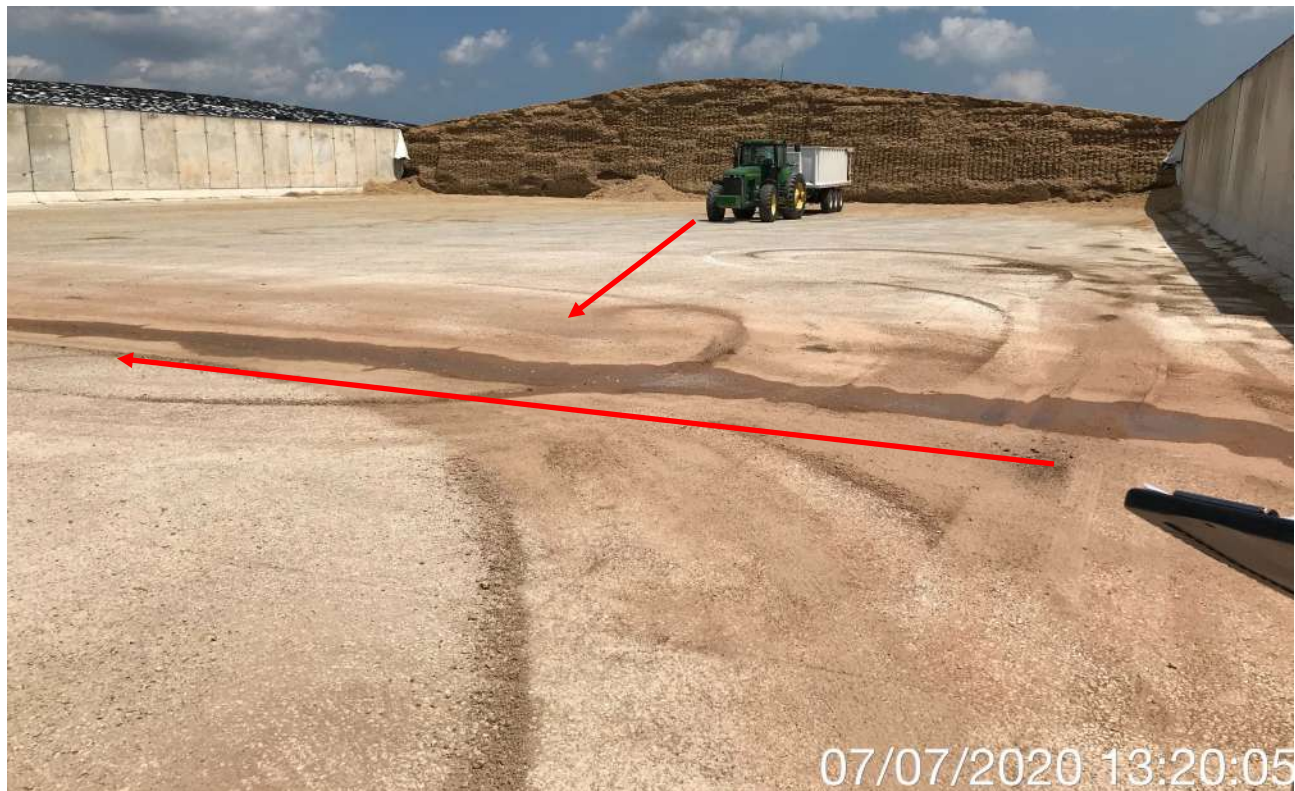
Photo #:	50	Photo Description: The east feed side of the feed storage area, where the majority of the corn silage is stored. This side of the FSA pitches east to west and then north towards the runoff control system. The red arrows represent the flow path.
Date/Time of Photo:	07/07/2020 13:20	
Photo Location:	Main Site	
Photo By:	James Salscheider

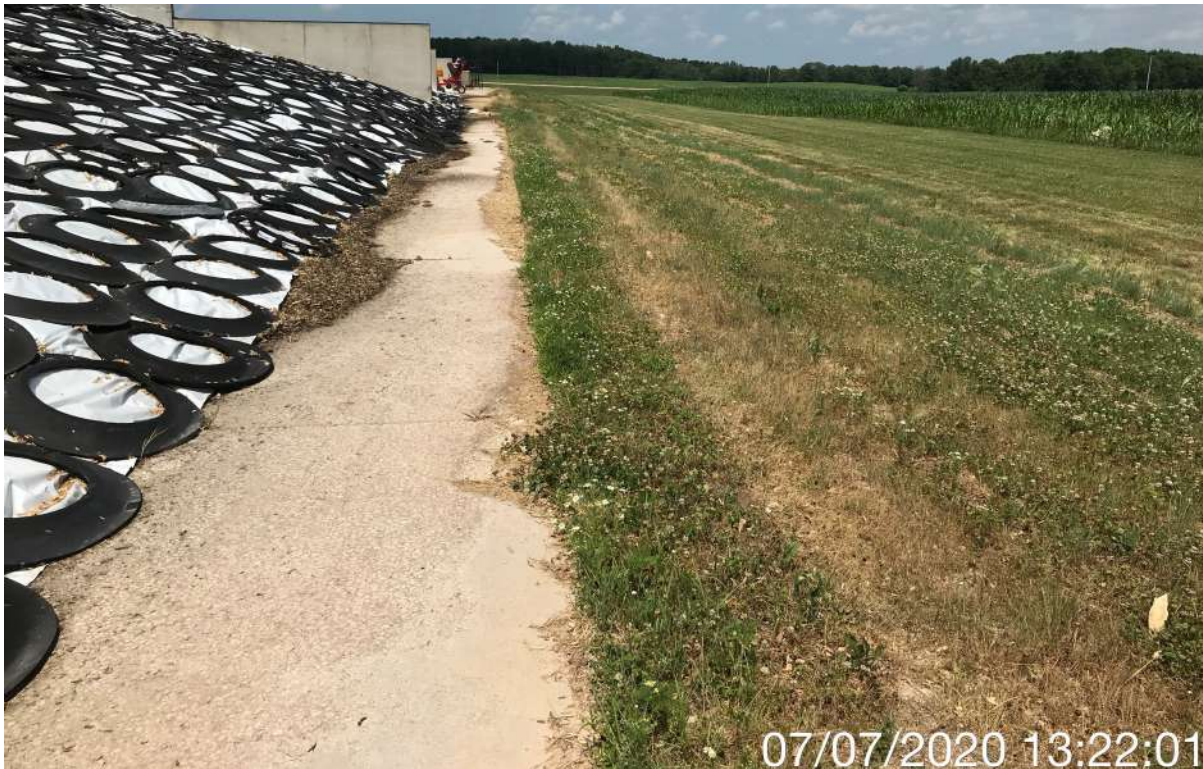
Photo #:	51	Photo Description: The backside of the east FSA. There was no evidence of feed solids or leachate off the backside of the feed pad.
Date/Time of Photo:	07/07/2020 13:22	
Photo Location:	Main Site	
Photo By:	Brian Hanson

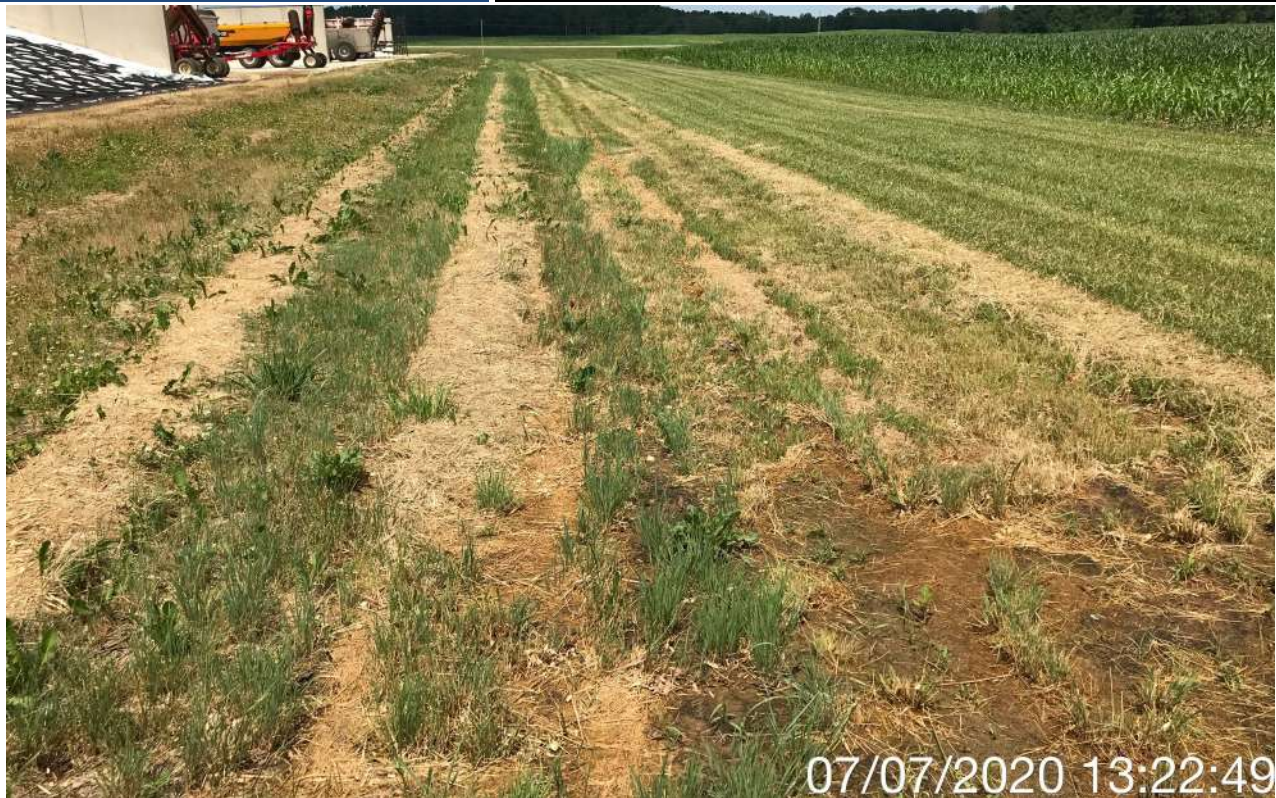
Photo #:	52	Photo Description: The backside of the east FSA. There was no evidence of feed solids or leachate off the backside of the feed pad.
Date/Time of Photo:	07/07/2020 13:22	
Photo Location:	Main Site	
Photo By:	Brian Hanson

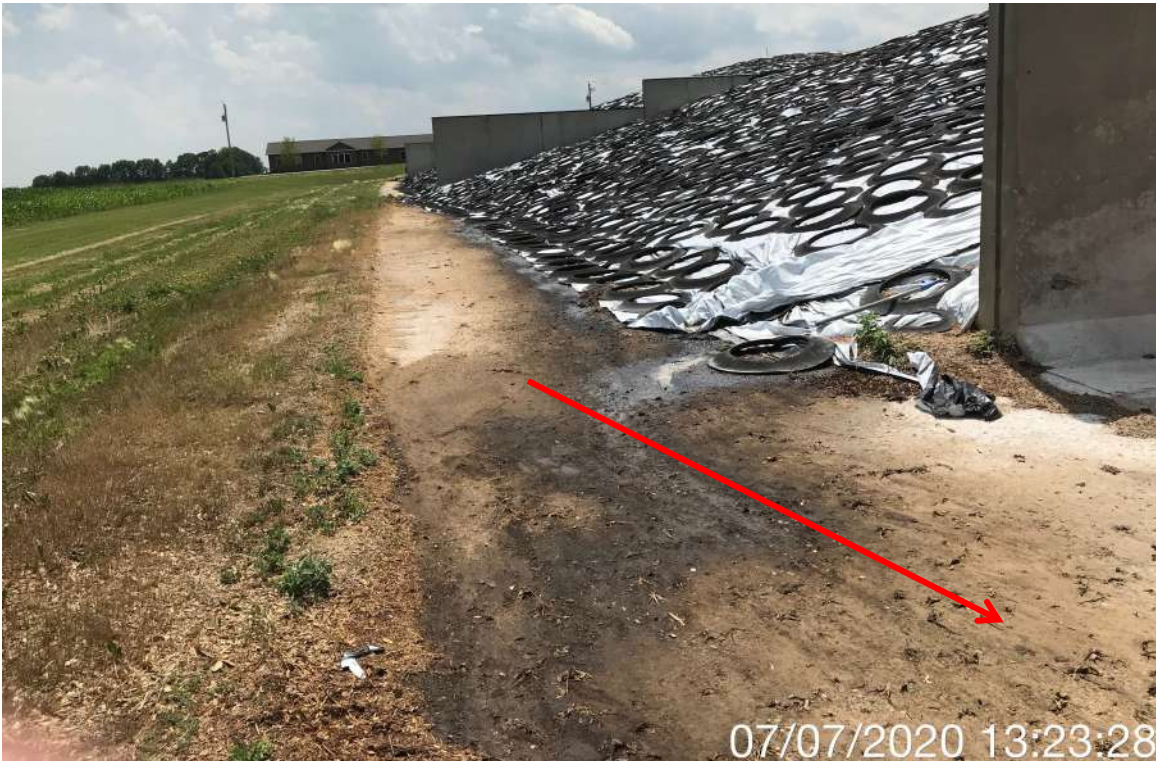
Photo #:	53	Photo Description: The backside of the east FSA. There was no evidence of feed solids or leachate off the backside of the feed pad. The red arrows represent the flow path of runoff.
Date/Time of Photo:	07/07/2020 13:23	
Photo Location:	Main Site	
Photo By:	Brian Hanson

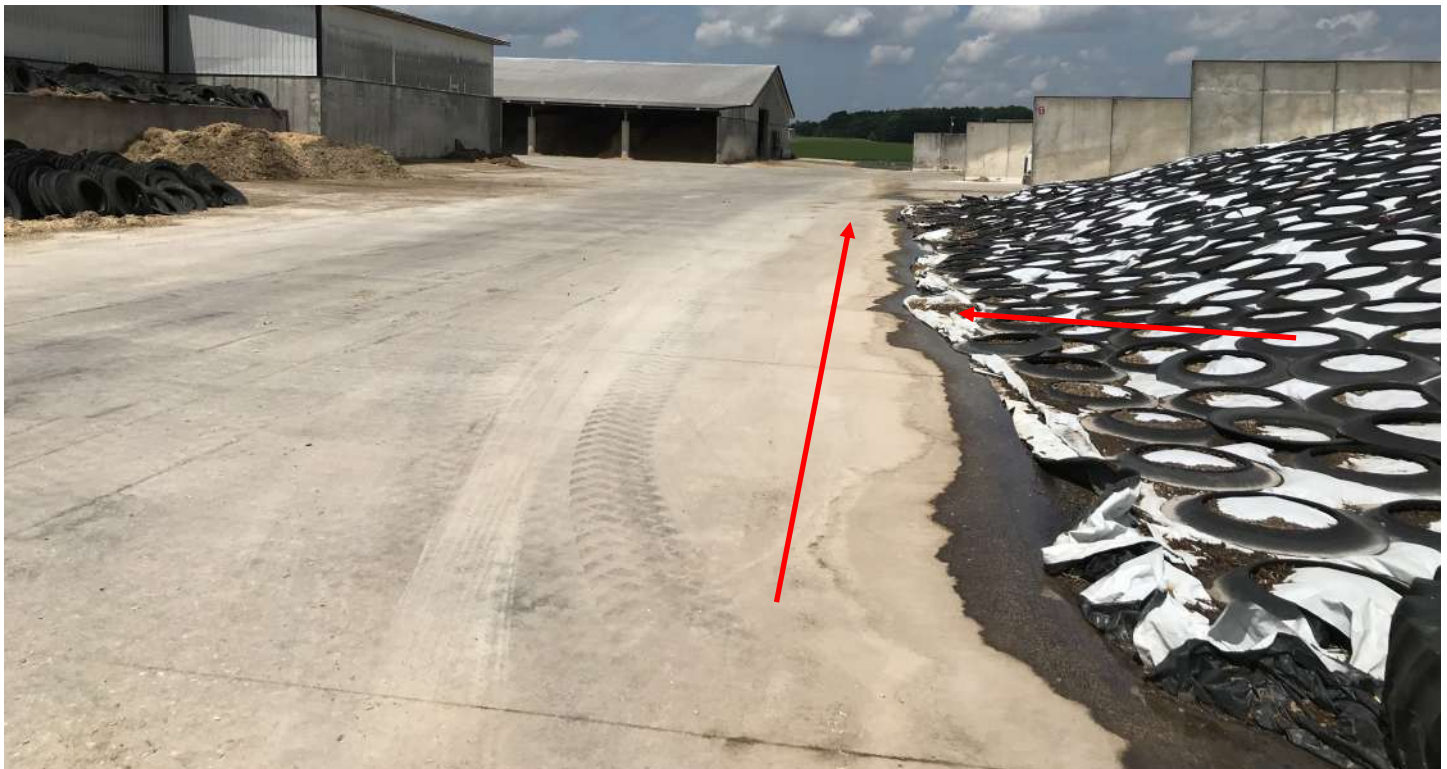
Photo #:	54	Photo Description: The east feed side of the feed storage area, where the majority of the corn silage is stored. This side of the FSA pitches east to west and then north towards the runoff control system. The red arrows represent the flow path.
Date/Time of Photo:	07/07/2020 13:21	
Photo Location:	Main Site	
Photo By:	James Salscheider

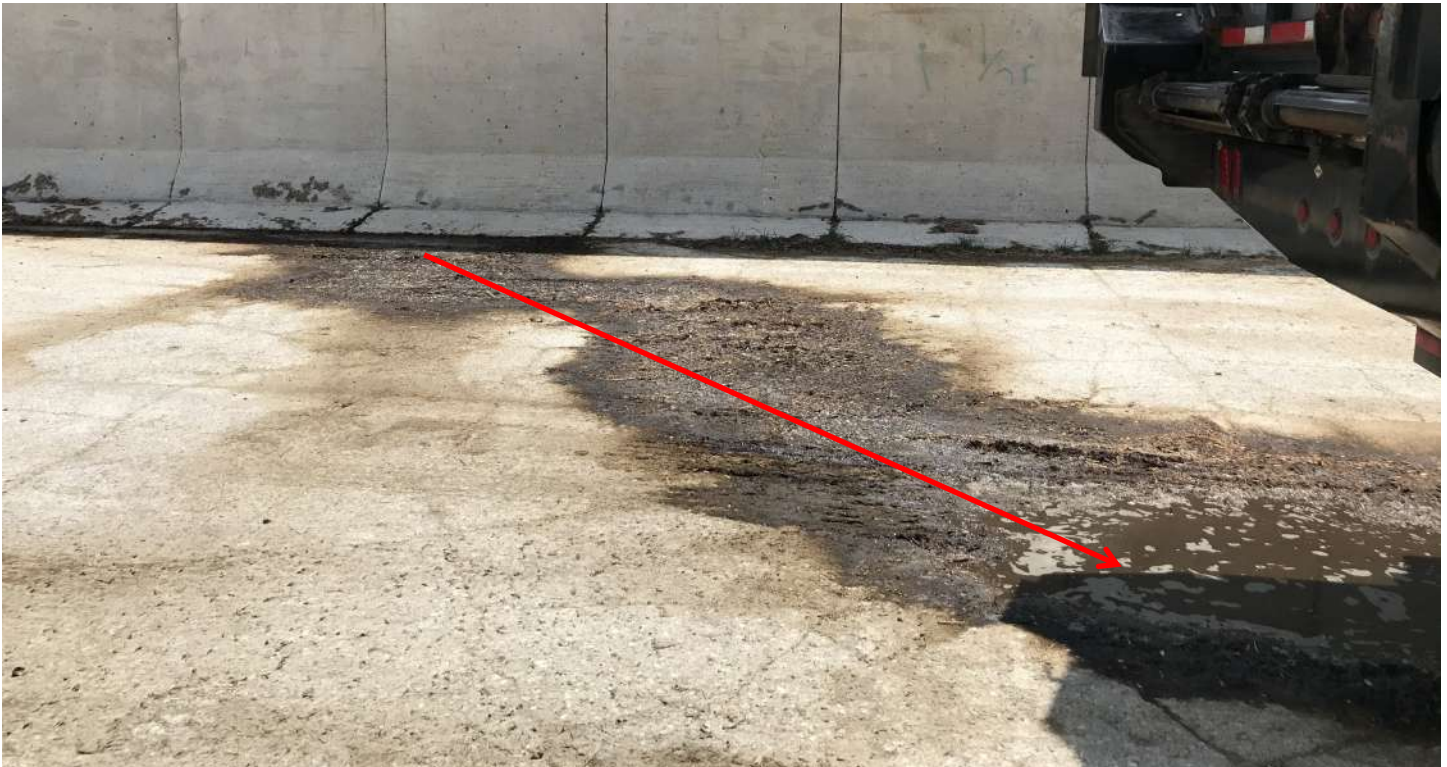
Photo #:	55	Photo Description: Leachate seeping under the wall in the middle of the east FSA. All runoff is still contained and captured by the runoff control system. The red arrow represents the flow path of runoff.
Date/Time of Photo:	07/07/2020 13:23	
Photo Location:	Main Dairy	
Photo By:	James Salscheider

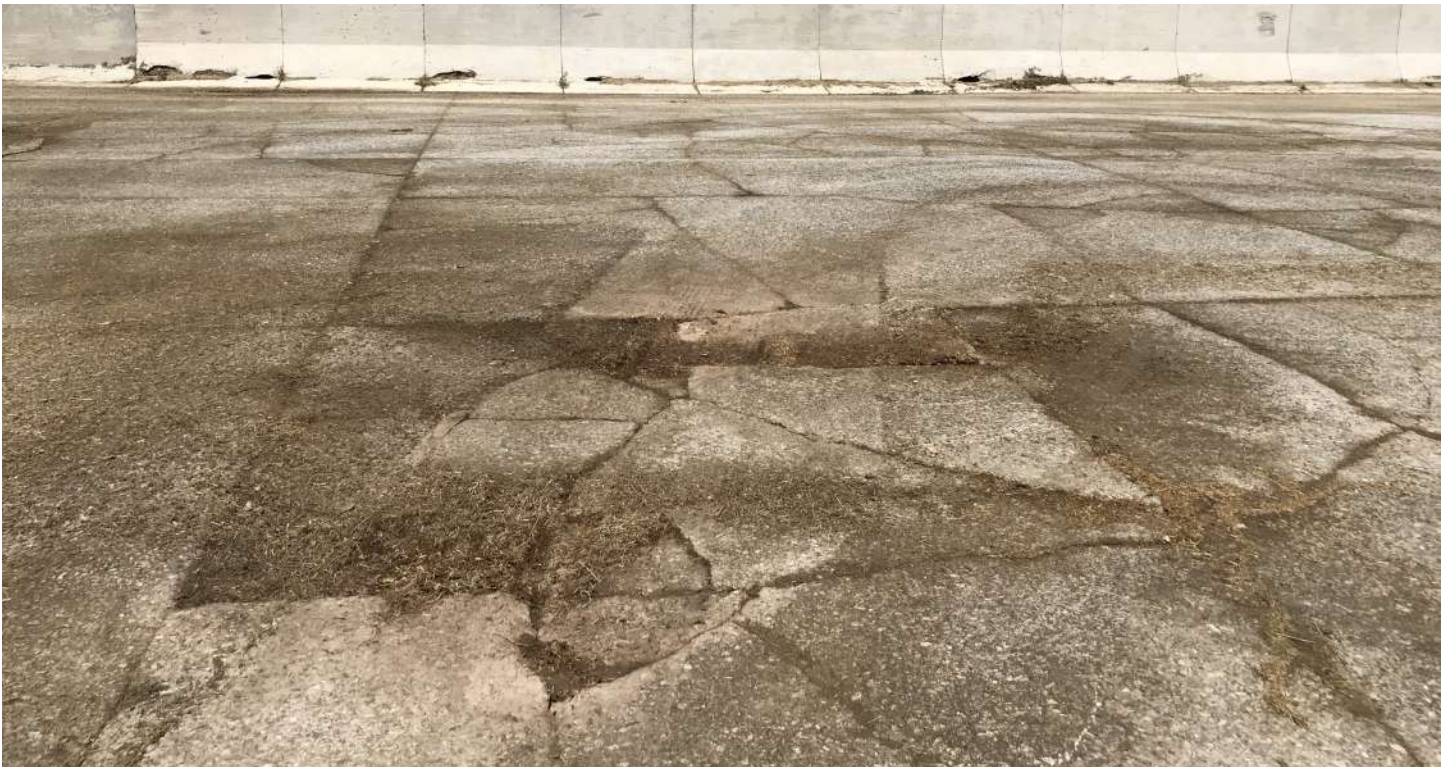
Photo #:	56	Photo Description: Cracks and seeps in the floor of the feed storage area. PPD has a plan in place to repair these areas.
Date/Time of Photo:	07/07/2020 13:24	
Photo Location:	Main Site	
Photo By:	James Salscheider

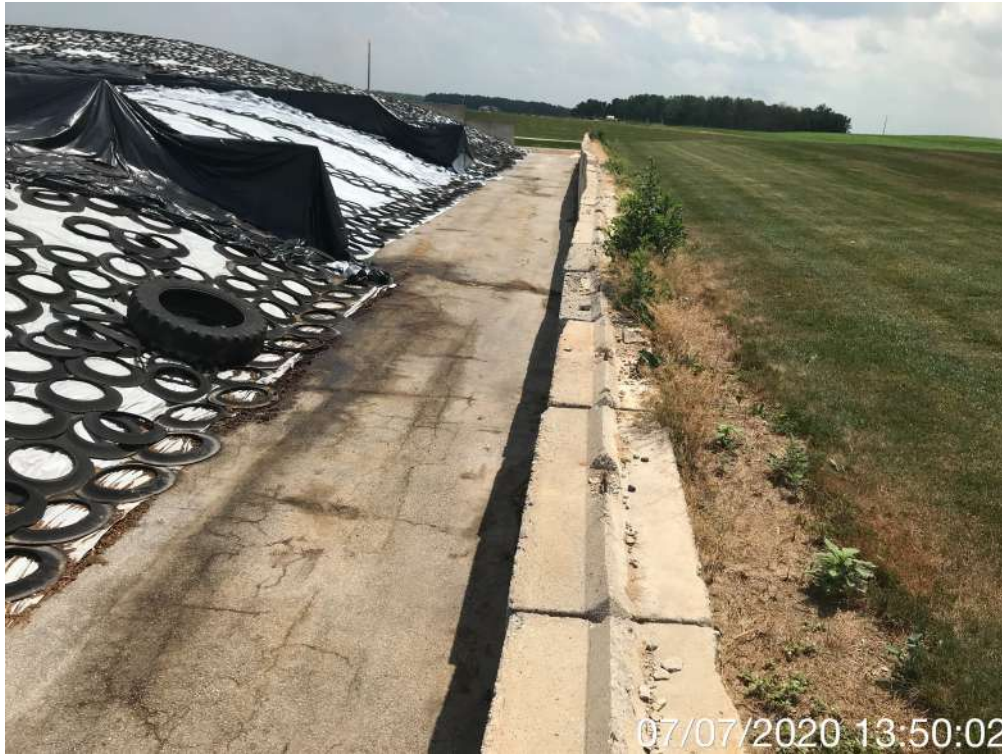
Photo #:	57	Photo Description: The backside of the west feed storage area located at the Main Site. Concrete blocks are used for the back wall. The west feed storage is pitched from west to east and then north where it flows into a man-hole that transfers the runoff to the runoff control system.
Date/Time of Photo:	07/07/2020 13:50	
Photo Location:	Main Site	
Photo By:	Brian Hanson

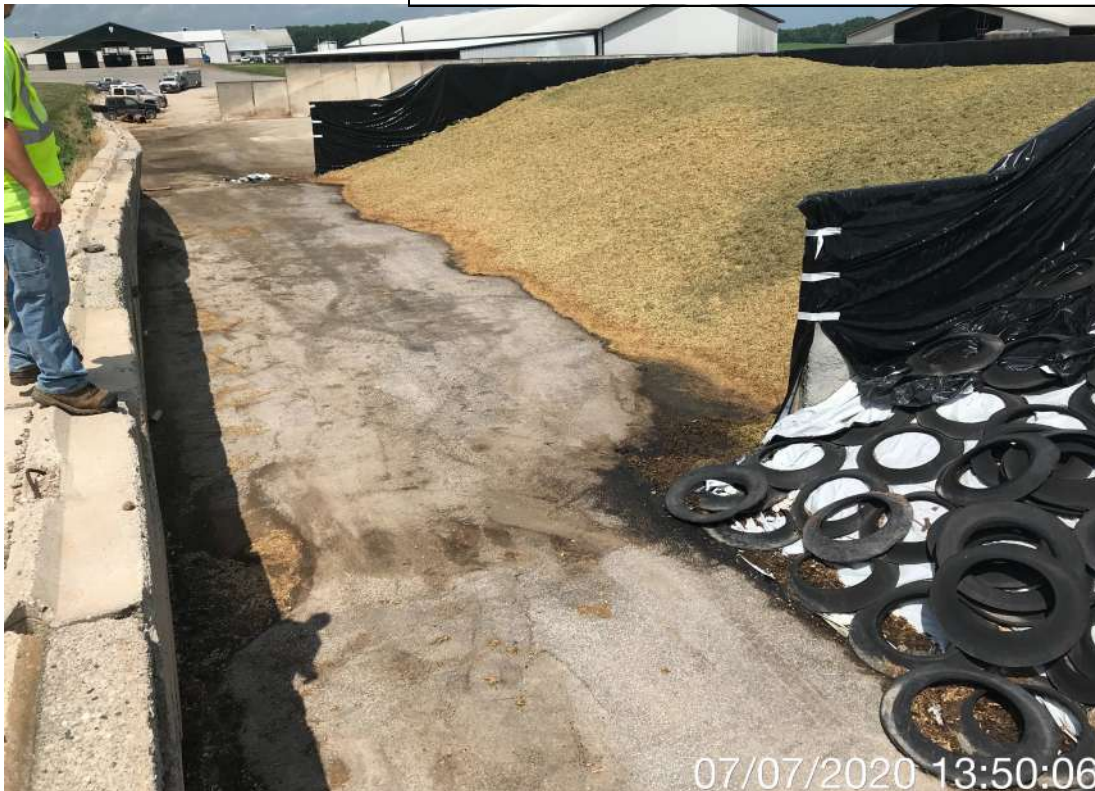
Photo #:	58	Photo Description: The backside of the west feed storage area located at the Main Site. Concrete blocks are used for the back wall. The west feed storage is pitched from west to east and then north where it flows into a man-hole that transfers the runoff to the runoff control system.
Date/Time of Photo:	07/07/2020 13:50	
Photo Location:	Main Site	
Photo By:	Brian Hanson

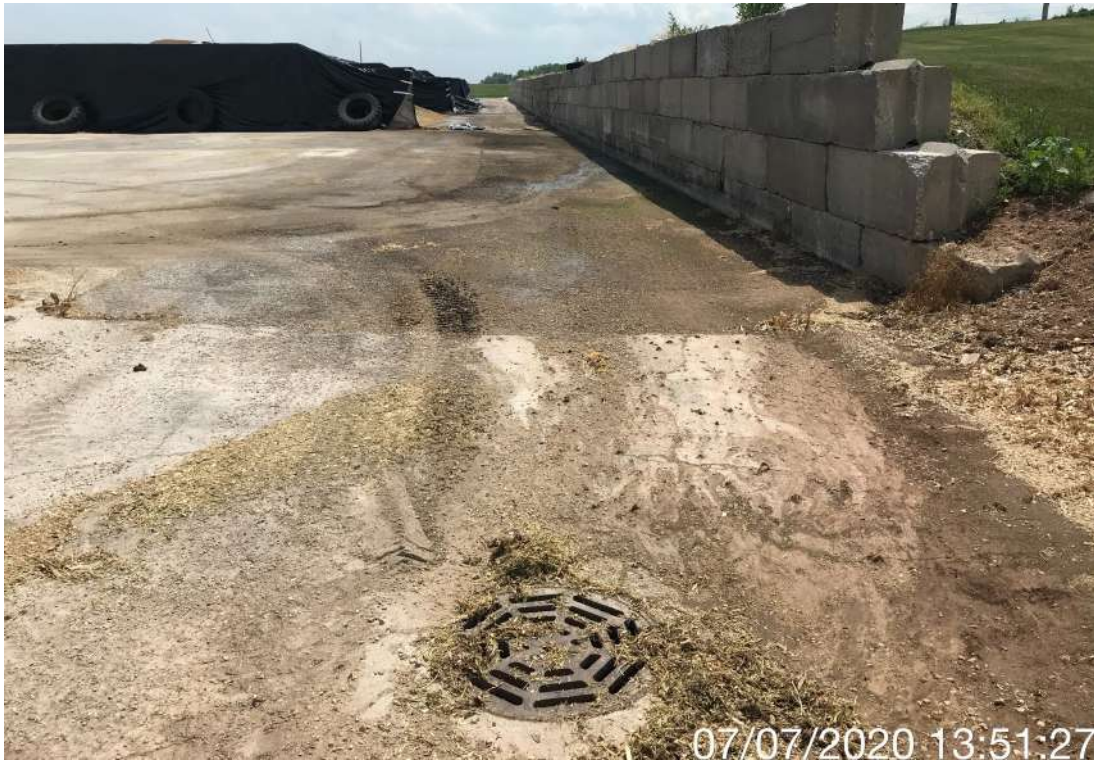
Photo #:	59	Photo Description: A man-hole associated with the feed storage runoff collection system. Feed solids were present around the man-hole. This photo was taken facing south towards the west feed storage area.
Date/Time of Photo:	07/07/2020 13:51	
Photo Location:	Main Site	
Photo By:	Brian Hanson

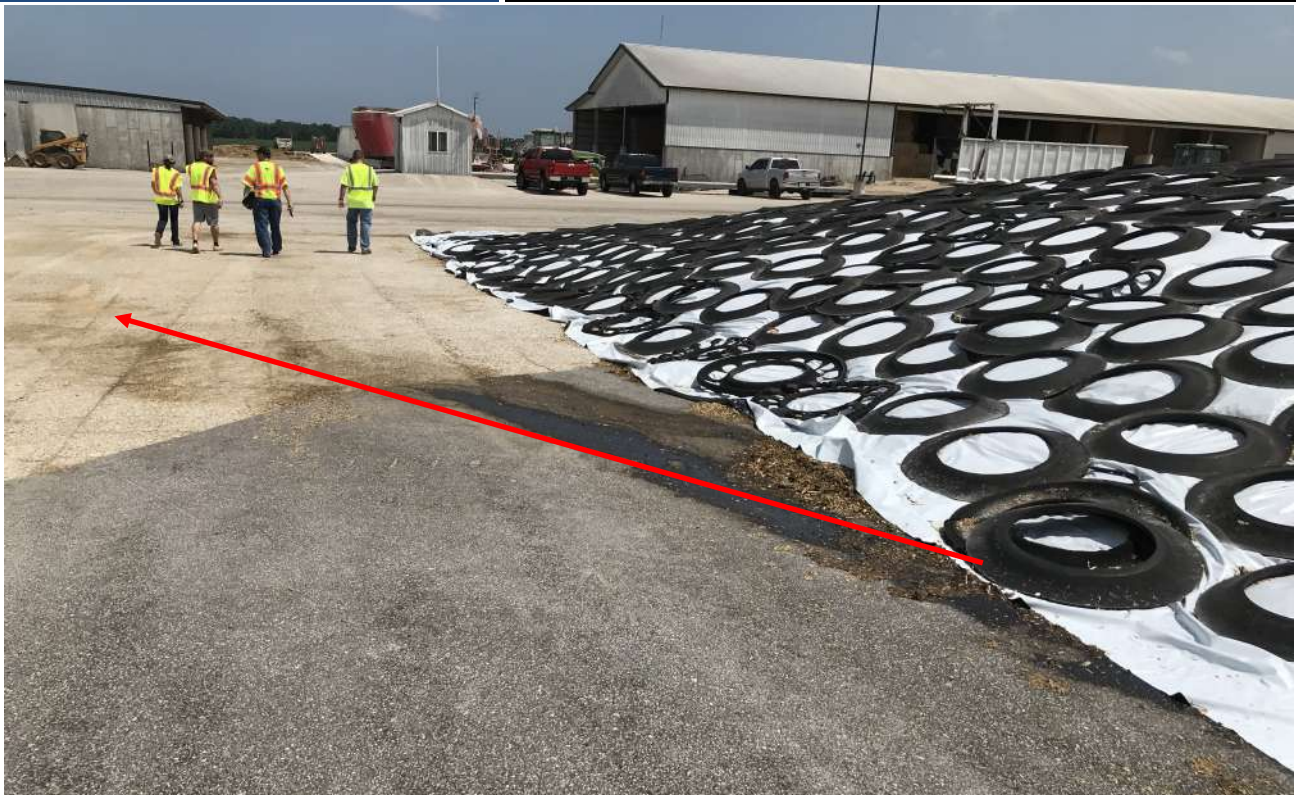
Photo #:	60	Photo Description: The west feed storage located at the Main Site, east of WSF 3. The west feed storage is pitched from west to east and then north where it flows into a man-hole that transfers the runoff to the runoff control system. The red arrows represent the runoff flow path.
Date/Time of Photo:	07/07/2020 13:52	
Photo Location:	Main Site	
Photo By:	James Salscheider

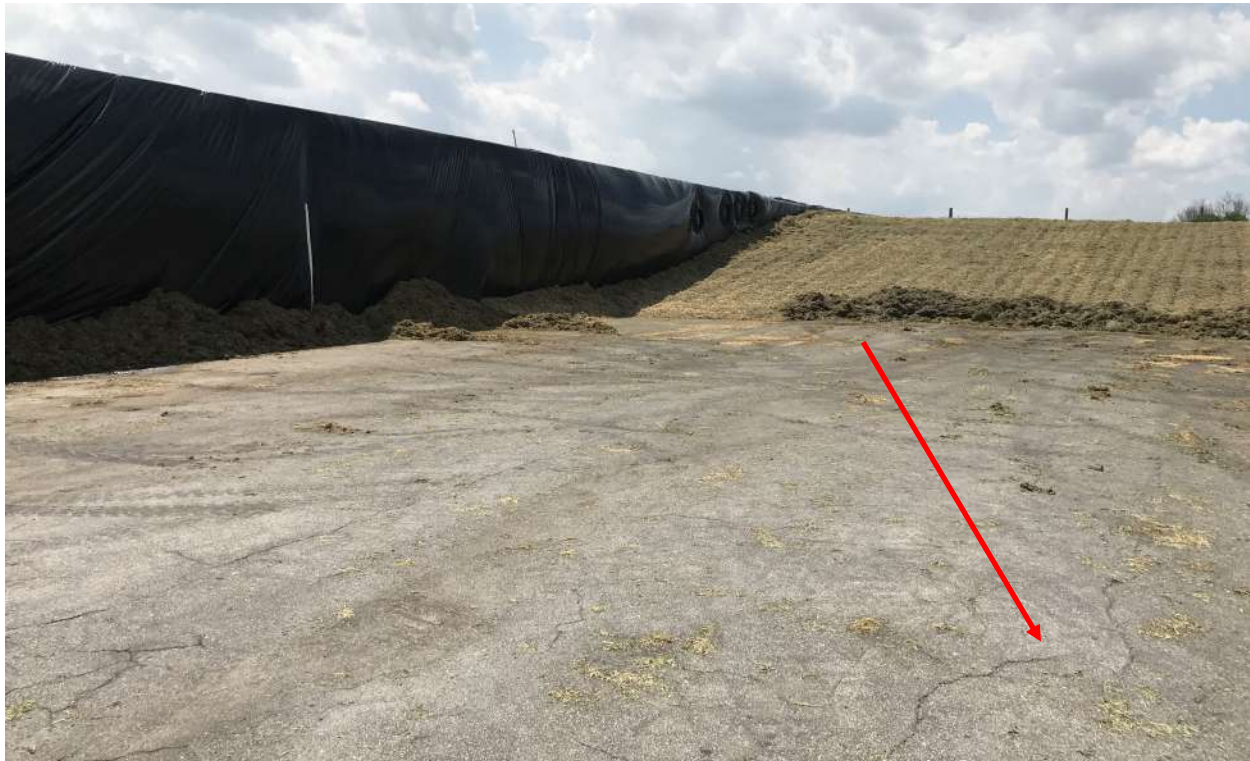
Photo #:	61	Photo Description: Haylage storage on the west FSA located at the Main Site. Black plastic is used to wrap the feed storage walls to prevent leakage from bay to bay. The red arrows represent the runoff flow path.
Date/Time of Photo:	07/07/2020 13:53	
Photo Location:	Main Site	
Photo By:	James Salscheider

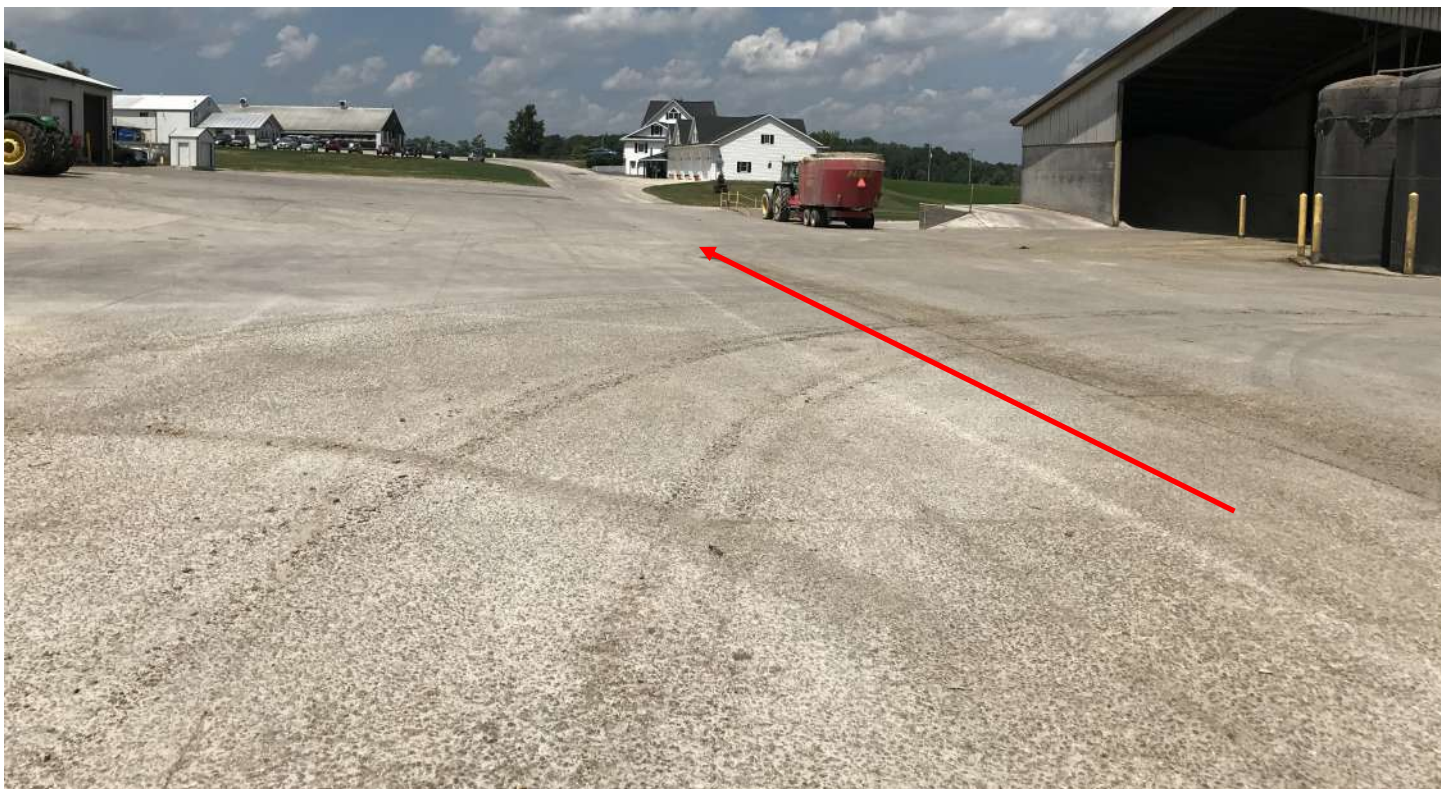
Photo #:	62	Photo Description: The concrete driveway between the commodity shed and the machine shed. Feed storage runoff flows between the two buildings before entering the runoff collection system. The red arrow represents the flow path that runoff takes.
Date/Time of Photo:	07/07/2020 13:53	
Photo Location:	Main Site	
Photo By:	James Salscheider

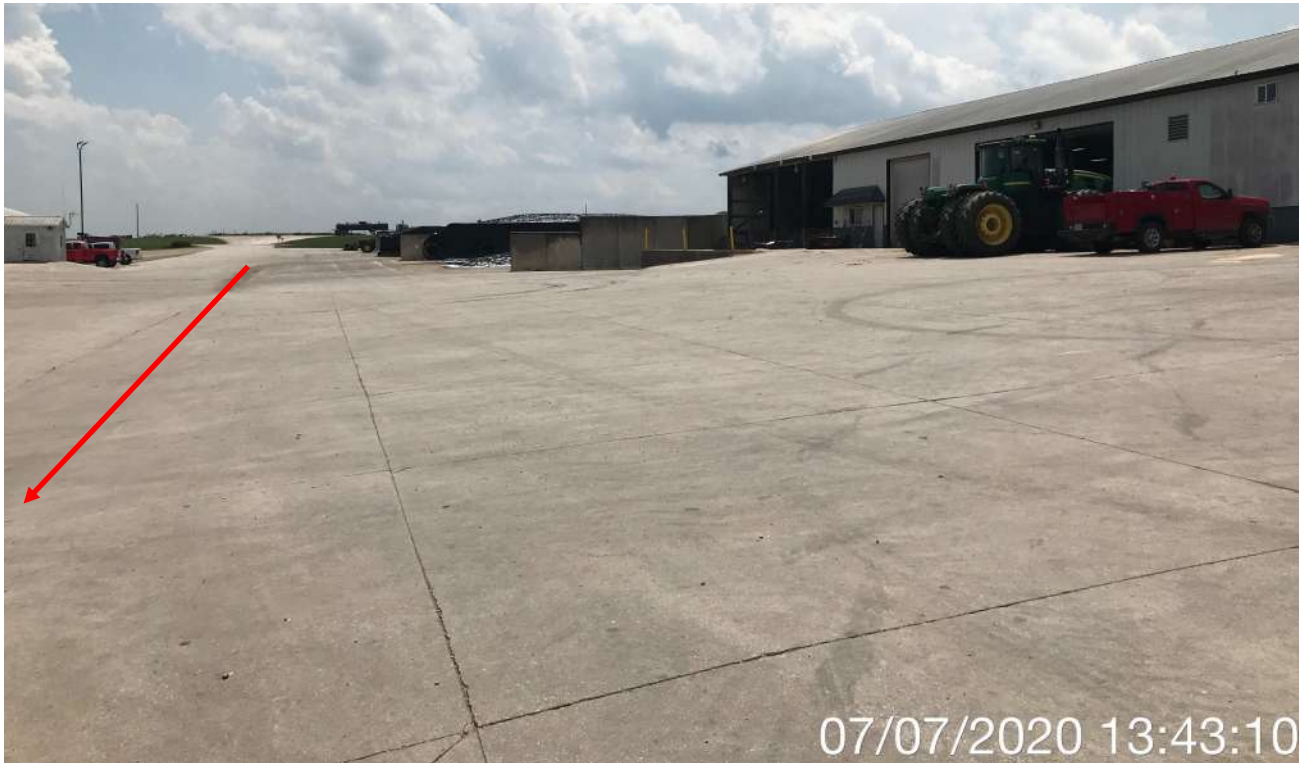
Photo #:	63	Photo Description: The concrete driveway between the commodity shed and the machine shed. Feed storage runoff flows between the two buildings before entering the runoff collection system. The red arrow represents the flow path that runoff takes.
Date/Time of Photo:	07/07/2020 13:43	
Photo Location:	Main Site	
Photo By:	Brian Hanson

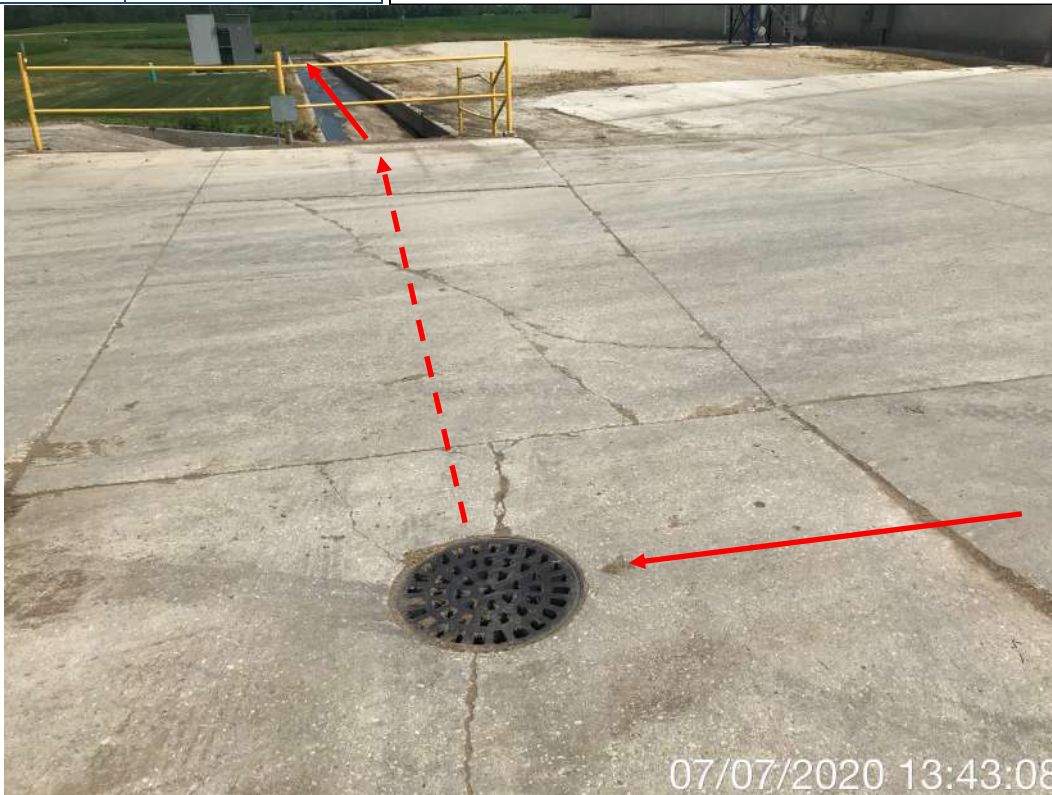
Photo #:	64	Photo Description: A man-hole associated with the runoff collection system. Feed storage runoff from the west FSA flows into this man-hole and gets transferred to the runoff control system. The red arrows represents the flow path.
Date/Time of Photo:	07/07/2020 13:43	
Photo Location:	Main Site	
Photo By:	Brian Hanson

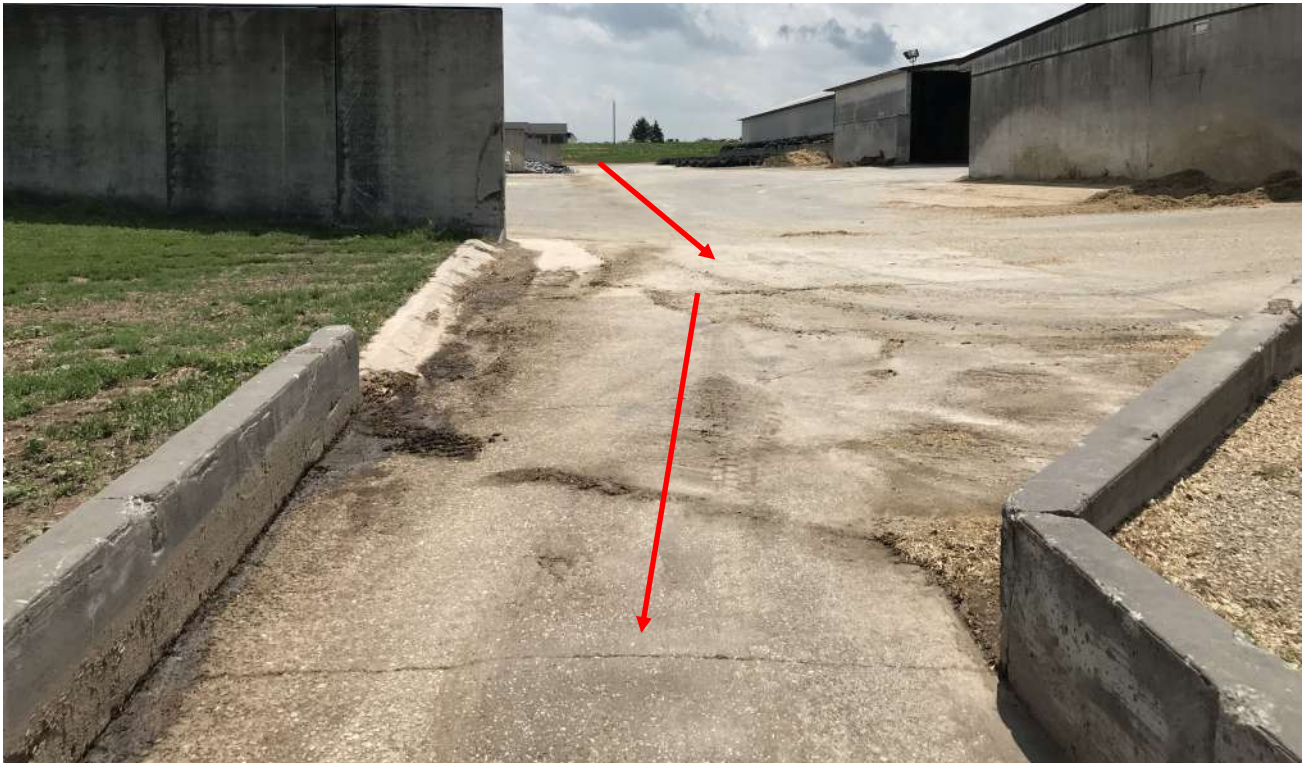
Photo #:	65	Photo Description: The runoff collection system for the east feed storage area. Runoff from the FSA is directed north and into this concrete swale. The red arrows represent the flow path.
Date/Time of Photo:	07/07/2020 13:28	
Photo Location:	Main Site	
Photo By:	James Salscheider

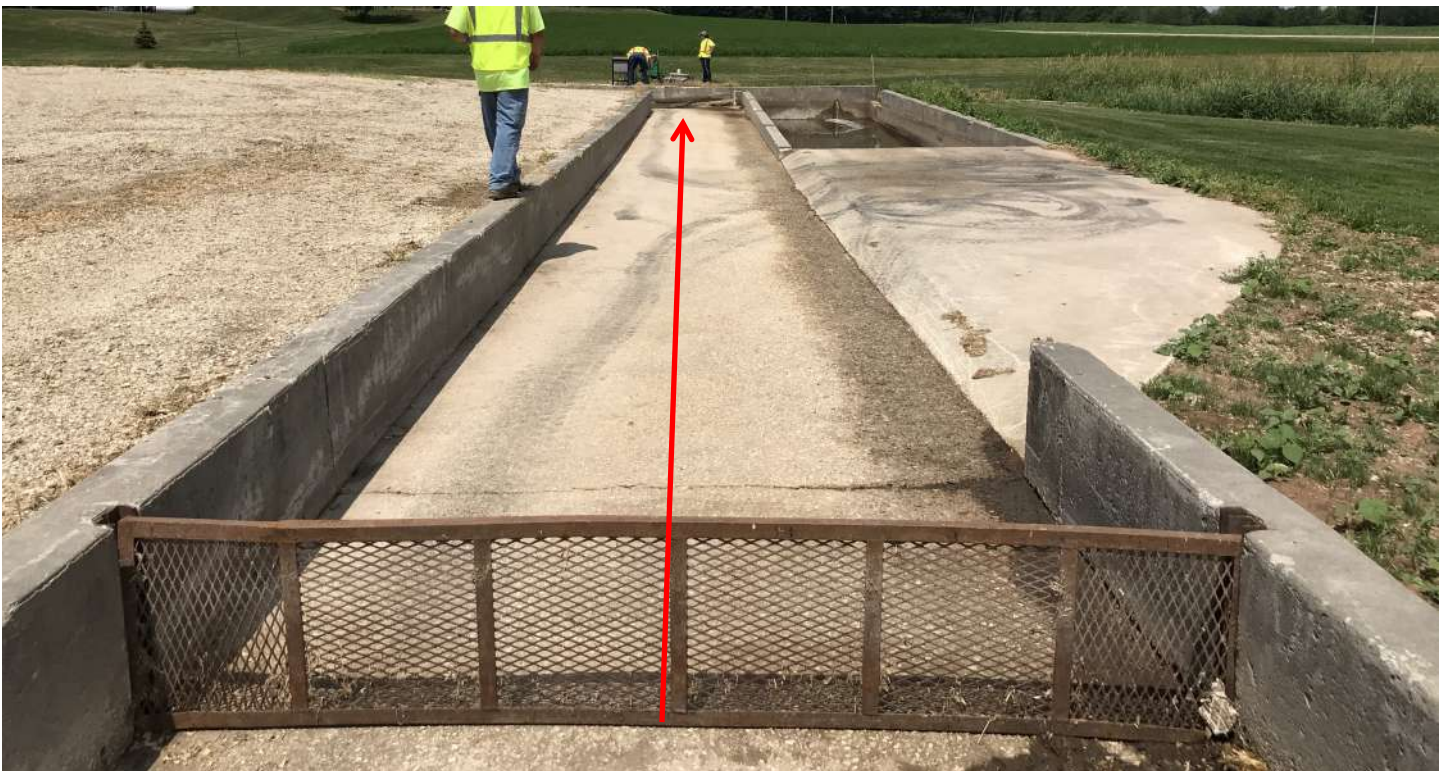
Photo #:	66	Photo Description: The runoff collection system for the east feed storage area. Runoff from the FSA is directed north and into this concrete swale. The red arrow represents the flow path.
Date/Time of Photo:	07/07/2020 13:28	
Photo Location:	Main Site	
Photo By:	James Salscheider

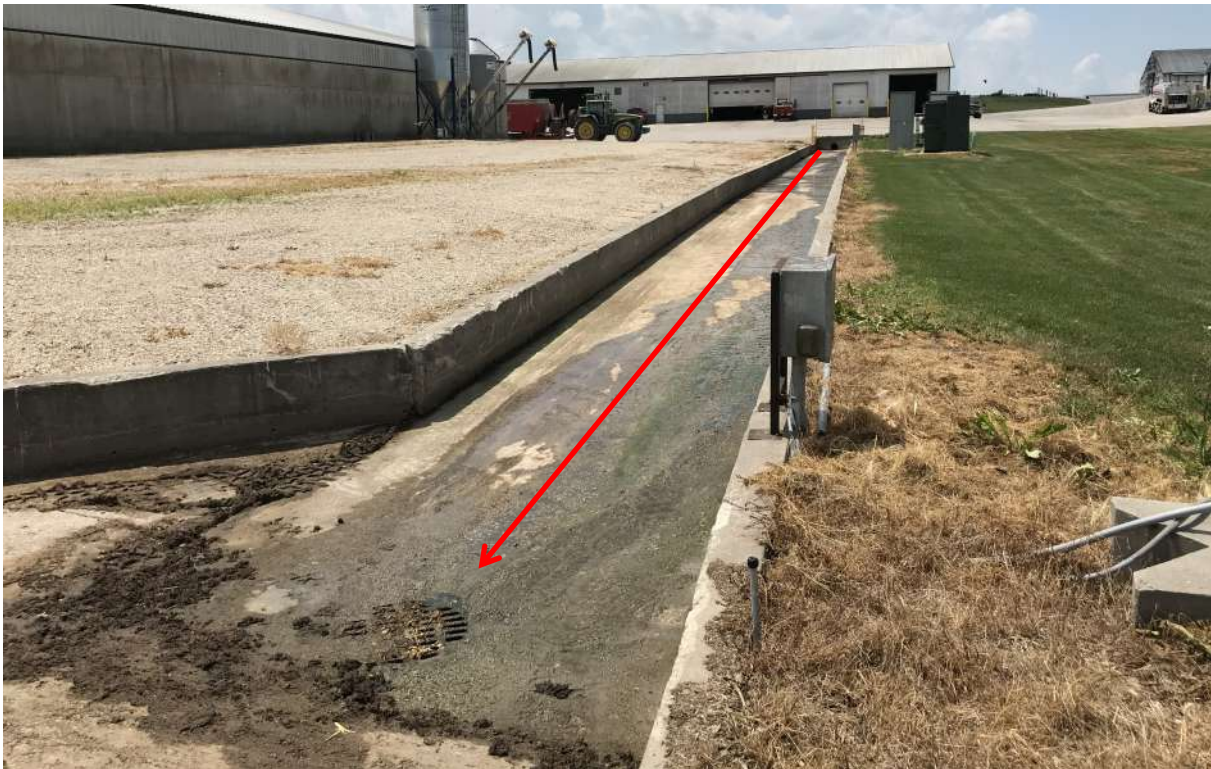
Photo #:	67	Photo Description: The concrete swale that runoff from the west FSA flows through. The red arrow represents the flow path of the runoff.
Date/Time of Photo:	07/07/2020 13:29	
Photo Location:	Main Site	
Photo By:	James Salscheider
