Permit Fact Sheet

Permit Number:	WI-0059374-05-0
Permittee Name:	Pagels Ponderosa Dairy, LLC
Address:	N4893 Hwy C
City/State/Zip:	Kewaunee WI 54216
Discharge Location:	N4893 County Road C, Kewaunee, WI 54216 N ½ NW ¼ S4 T23N R24E, Township of West Kewaunee N5318 County Road E, Kewaunee, WI 54216 SE ¼ SW ¼ S27 T24N R24E, Township of Casco E3470 County Rd F, Kewaunee, WI 54216 SE ¼ SW ¼ S16 T23N R24E, Township of West Kewaunee
Receiving Water:	Unnamed tributaries within the Kewaunee River Watershed, Lake Michigan Drainage Basin, and groundwaters of the State

On Tuesday, July 7, 2020, James Salscheider and Brian Hanson, Agricultural Runoff Management Specialists WDNR (Department) met with John J Pagel, Bryan Pagel, and Susan LaCrosse to conduct a WPDES permit reissuance inspection at Pagel's Ponderosa Dairy, LLC (PPD). The Main Site is located at the NW ¼ Sec 4 T23N R24E in the Town of West Kewaunee. The Clyde Hill Farm Site is located at SE ¼ SW ¼ Sec 27 T24N R24E in the Town of Casco. The weather conditions during the inspection were sunny and dry. The farm did receive approximately 0.33" of rain the day before. Follow up items are requested on Page 7. All photos taken during the

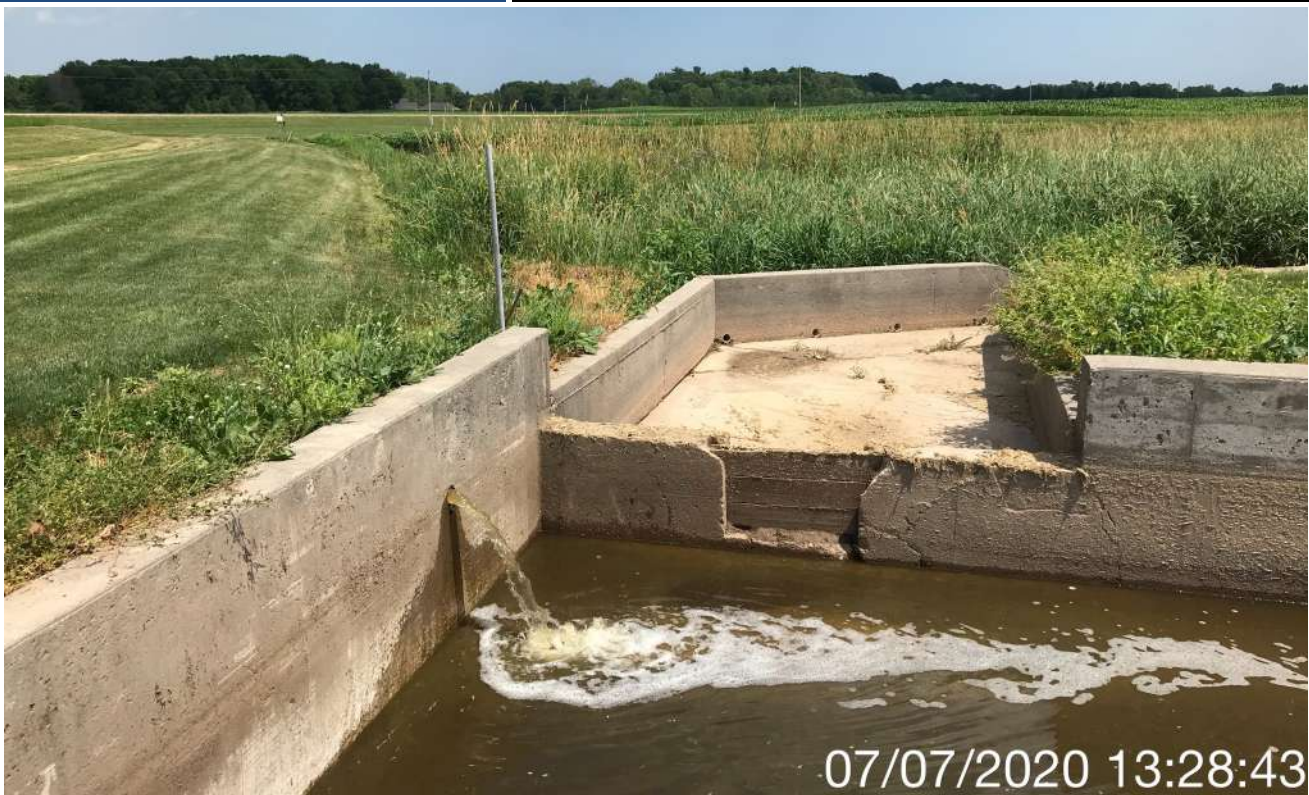
Photo #:	68	Photo Description: The reception basin for the FSA runoff collection system. Runoff from the concrete swale is transferred to this basin and then onto the spreader bar where it then flows through the VTA.
Date/Time of Photo:	07/07/2020 13:28	
Photo Location:	Main Site	
Photo By:	Brian Hanson

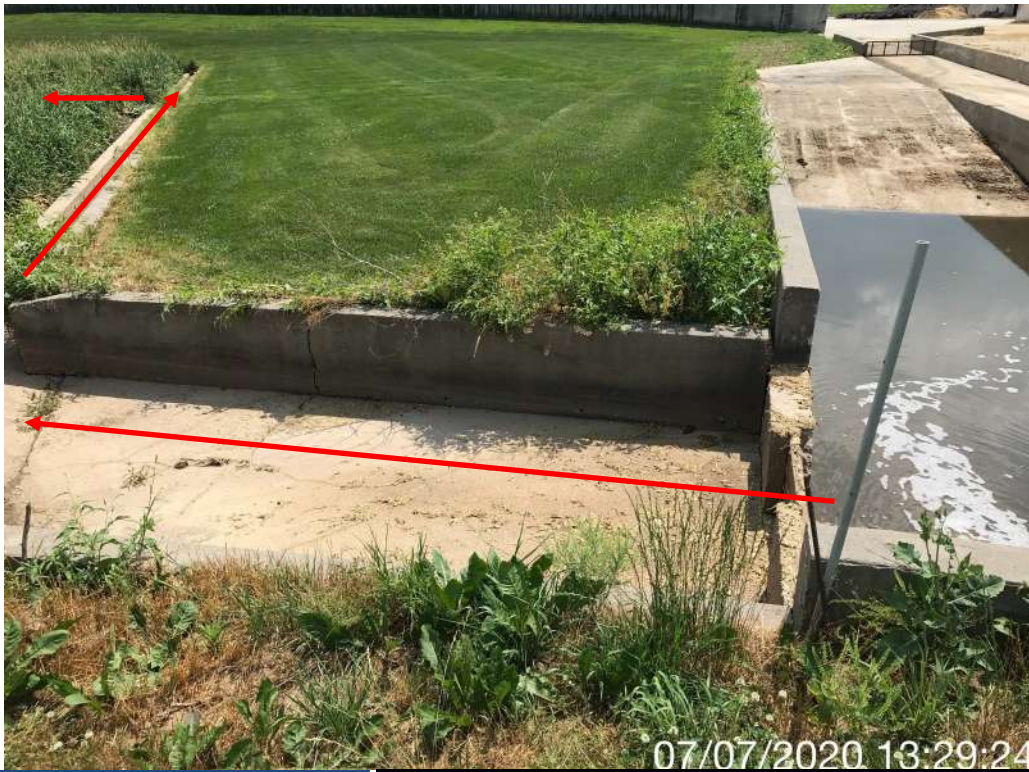
Photo #:	69	Photo Description: The reception basin for the FSA runoff collection system. Runoff from the concrete swale is transferred to this basin and then onto the spreader bar where it then flows through the VTA. The red arrows represent the flow path of runoff.
Date/Time of Photo:	07/07/2020 13:29	
Photo Location:	Main Site	
Photo By:	Brian Hanson

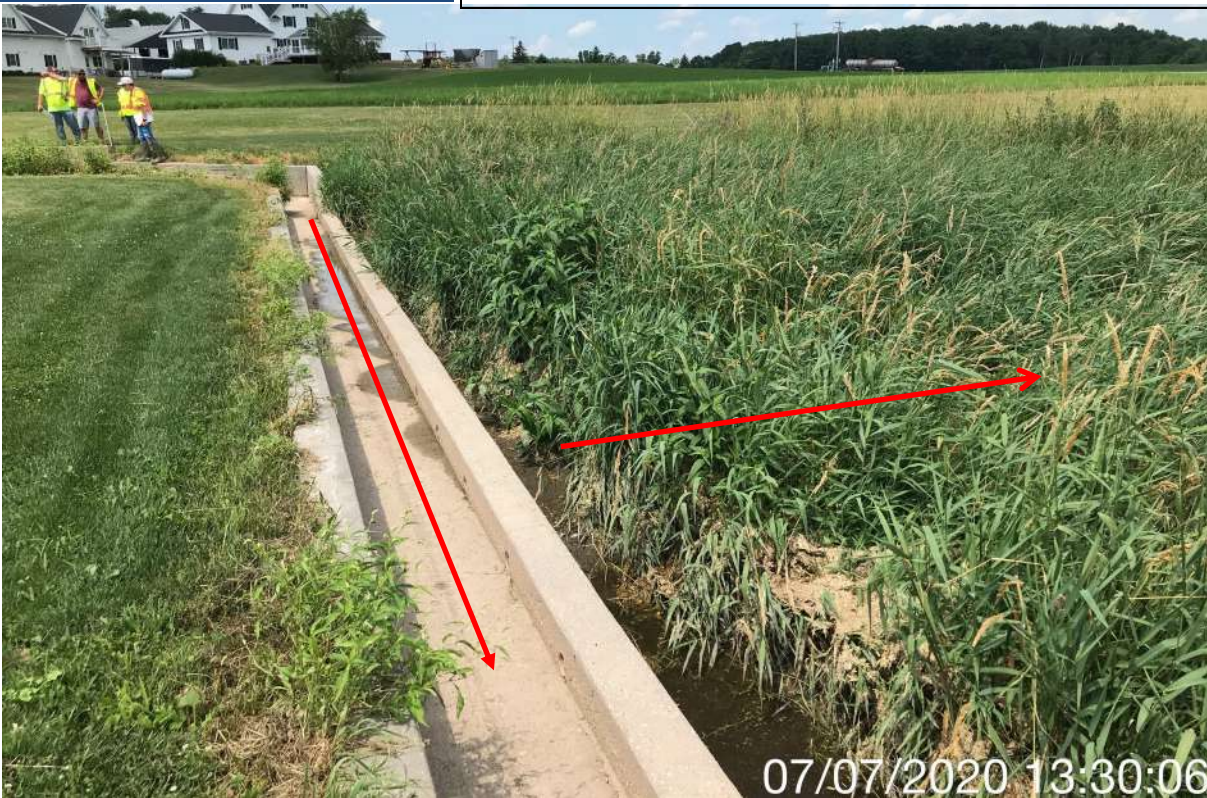
Approximately 185 feet downslope of the spreader bar, there is a berm present to collect any runoff that would flow through the end of the VTA. This creates a large ponded area of leachate, approximately 0.5 acres in size. PPD installed a hickenbottom drain & pump station at the northwest corner of the VTA to capture any liquid that is ponded within the VTA. This transfers the liquid to a reception basin located west of the VTA and where the liquid gets pumped to WSF 2. The Department observed approximately 2 feet of liquid within the VTA based on the amount of the hickenbottom drain that was exposed. The VTA is currently not functioning as designed and an evaluation will be required in the next permit term to return the VTA into working order.

Photo #:	70	Photo Description: The spreader bar and beginning of the vegetated treatment area. The vegetation was not mowed and ponding of contaminated runoff was present. The red arrows represent the flow path of runoff.
Date/Time of Photo:	07/07/2020 13:30	
Photo Location:	Main Site	
Photo By:	Brian Hanson

- During the inspection, the Department observed the runoff controls for the feed storage area at the Main Dairy not being operated in accordance with the "Proper Operations and Maintenance" section. Liquid was heavily ponded within the VTA and concentrated flow channels were present. An evaluation of the runoff controls is required to be submitted in the "Action Items" below.

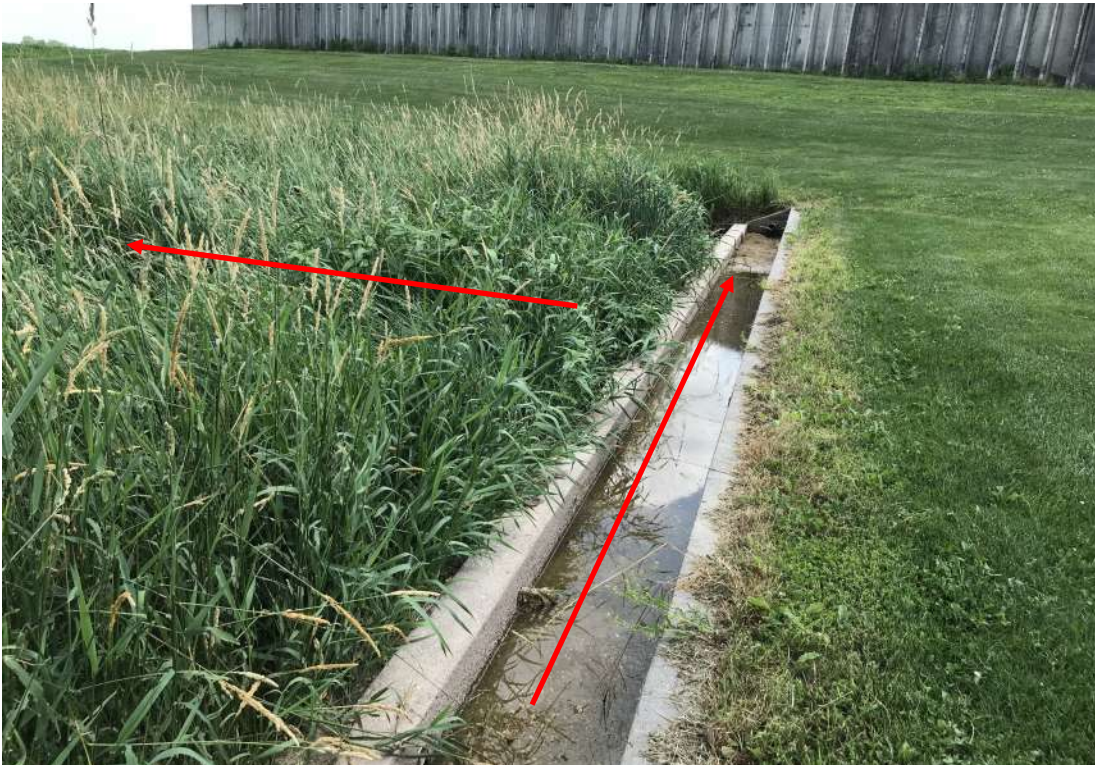
Photo #:	71
Date/Time of Photo:	07/07/2020 13:31
Photo Location:	Main Site
Photo By:	James Salscheider

Photo Description: The spreader bar and beginning of the vegetated treatment area. The vegetation was not mowed and ponding of contaminated runoff was present. The red arrows represent the flow path of runoff.

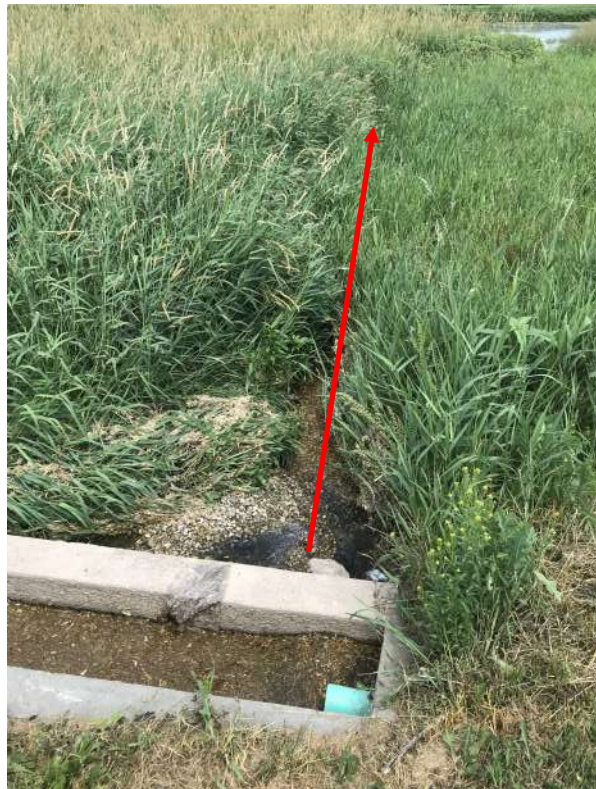
Photo #:	72
Date/Time of Photo:	07/07/2020 13:31
Photo Location:	Main Site
Photo By:	James Salscheider

Photo Description: The spreader bar and beginning of the vegetated treatment area. The vegetation was not mowed and ponding of contaminated runoff and concentrated flow channels were present. The red arrows represent the flow path of runoff.

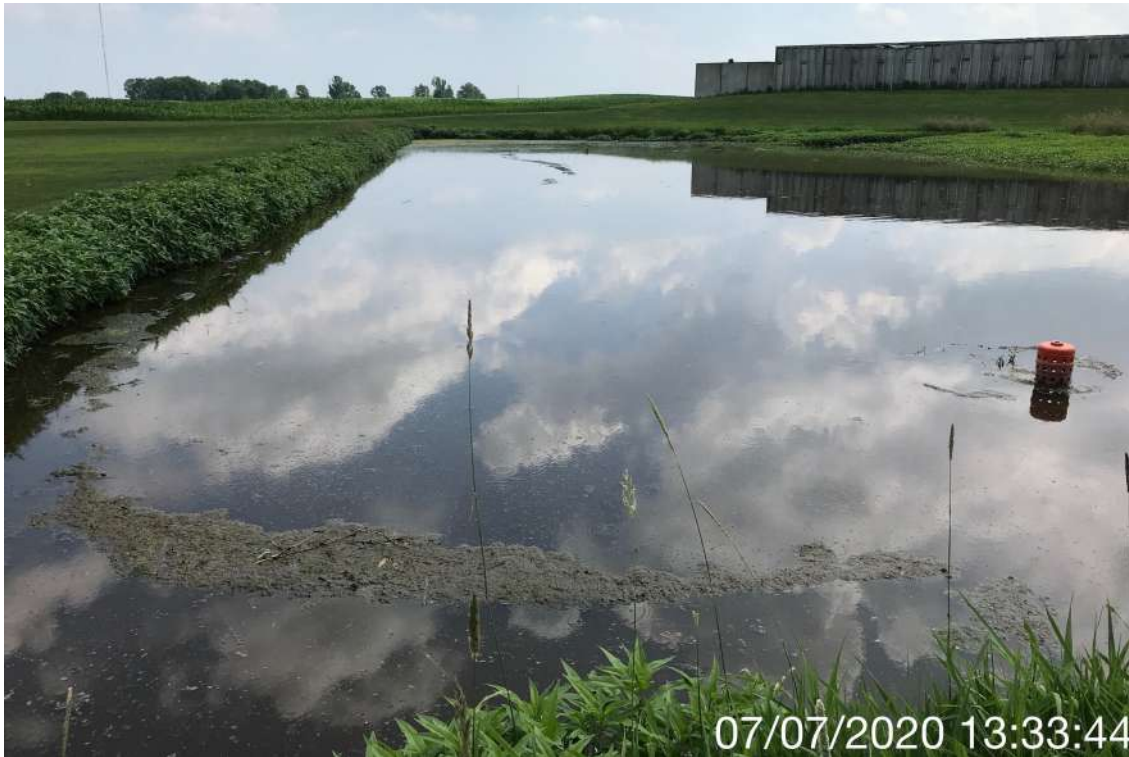
Photo #:	73	Photo Description: The south end of the VTA, where contaminated runoff collects and ponds. A hickenbottom inlet collects the ponded runoff and transfers it to a reception basin where it is pumped to WSF 2 at the Main Site.
Date/Time of Photo:	07/07/2020 13:33	
Photo Location:	Main Site	
Photo By:	Brian Hanson

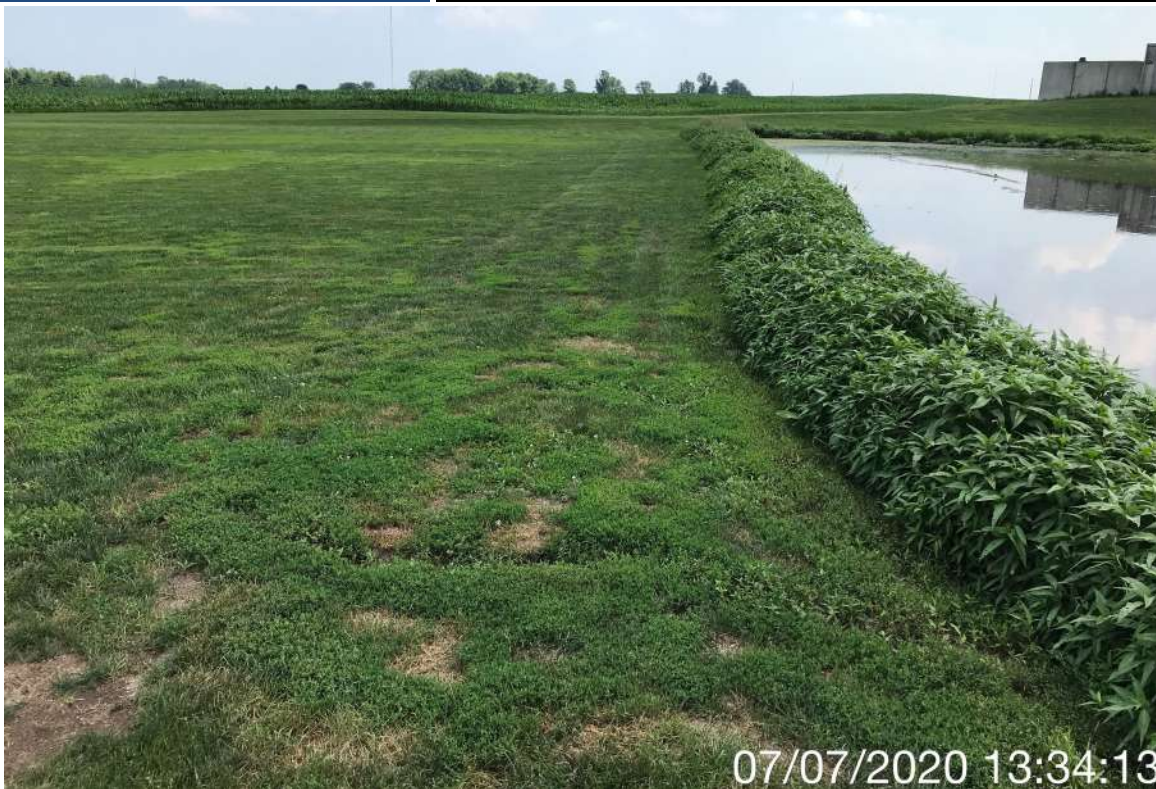
Photo #:	74	Photo Description: The berm at the south end of the VTA area that prevents runoff from continuing down the grassed area south of the VTA. The berm collects and ponds the runoff at the south end of the VTA.
Date/Time of Photo:	07/07/2020 13:34	
Photo Location:	Main Site	
Photo By:	Brian Hanson

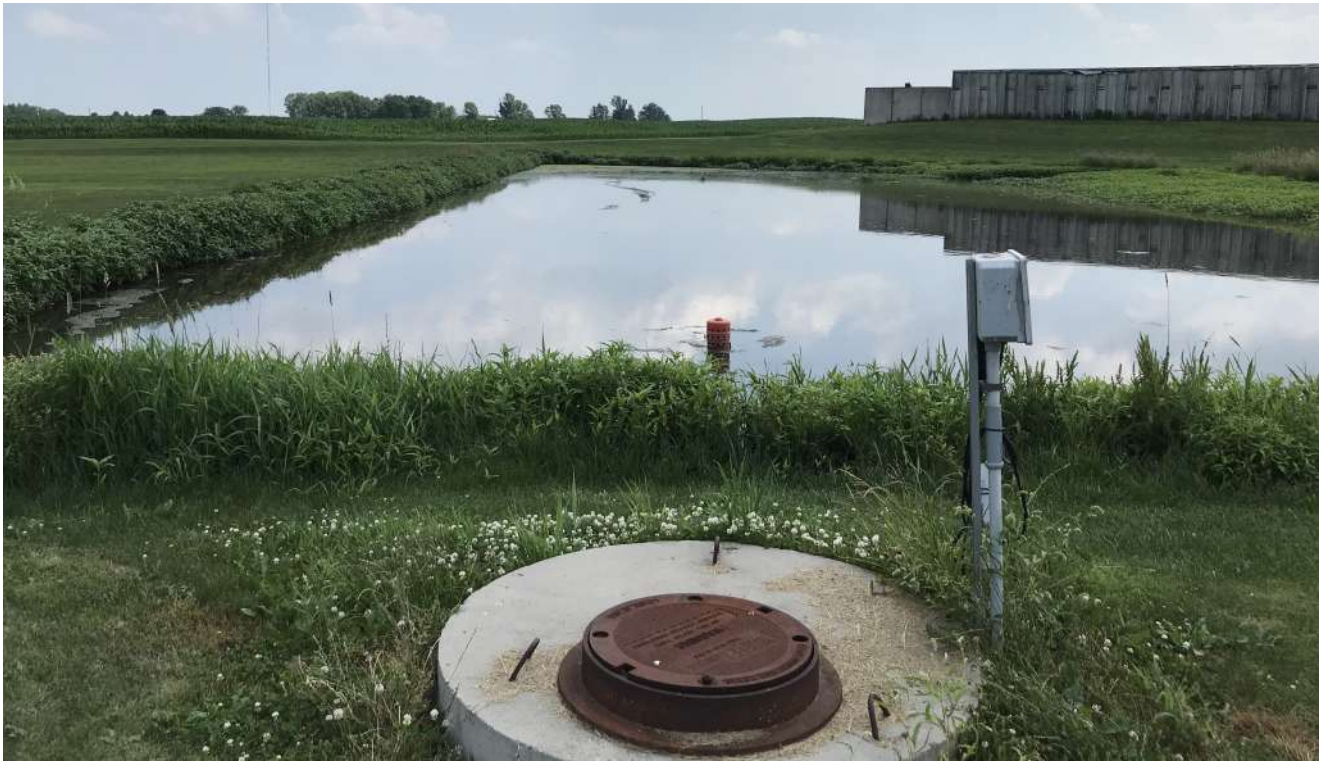
Photo #:	75	Photo Description: The hickenbottom inlet and the reception basin, adjacent to the VTA. Runoff enters the hickenbottom and flows into the reception basin, where it is pumped to the reception basin adjacent to the concrete swales and then to WSF 2.
Date/Time of Photo:	07/07/2020 13:34	
Photo Location:	Main Site	
Photo By:	James Salscheider

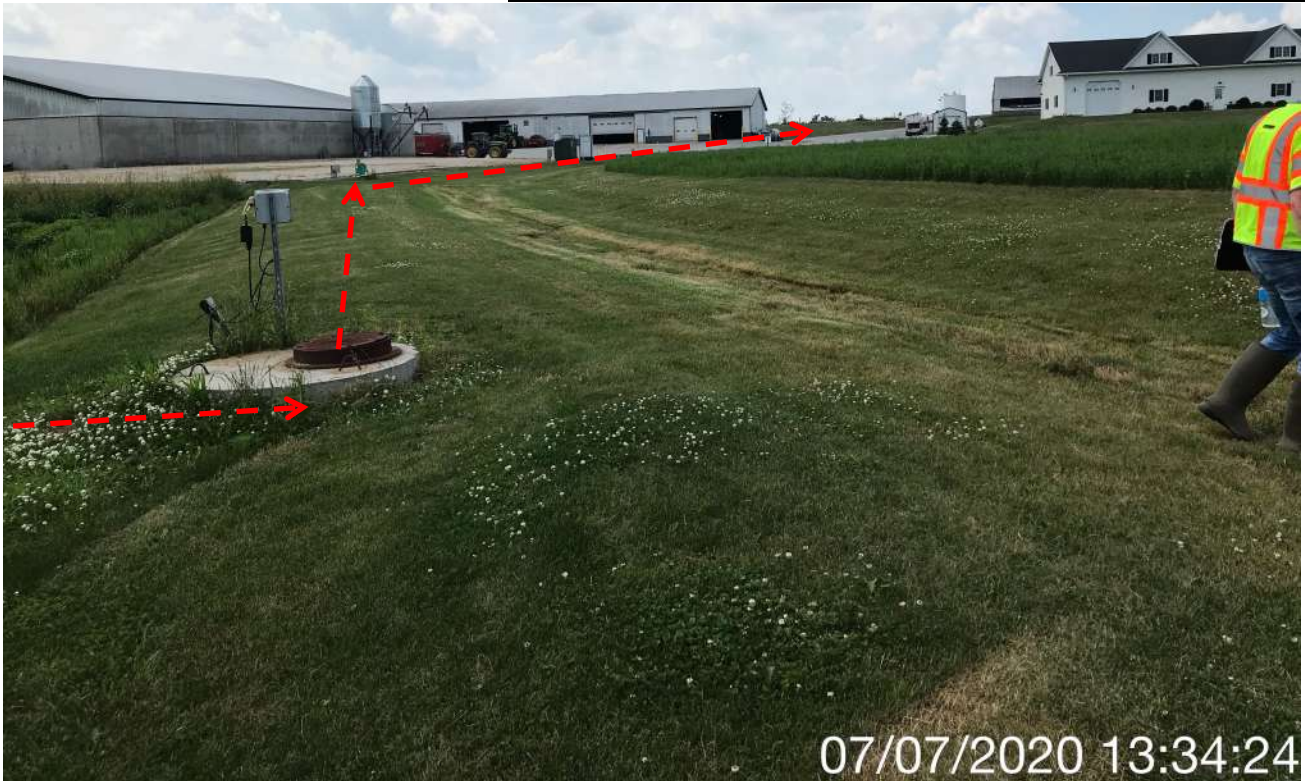
Photo #:	76	Photo Description: The reception basin adjacent to the VTA, which pumps runoff back to the reception basin adjacent to the concrete swale and then to WSF 2. The dashed red arrows represent the transfer lines.
Date/Time of Photo:	07/07/2020 13:34	
Photo Location:	Main Site	
Photo By:	Brian Hanson

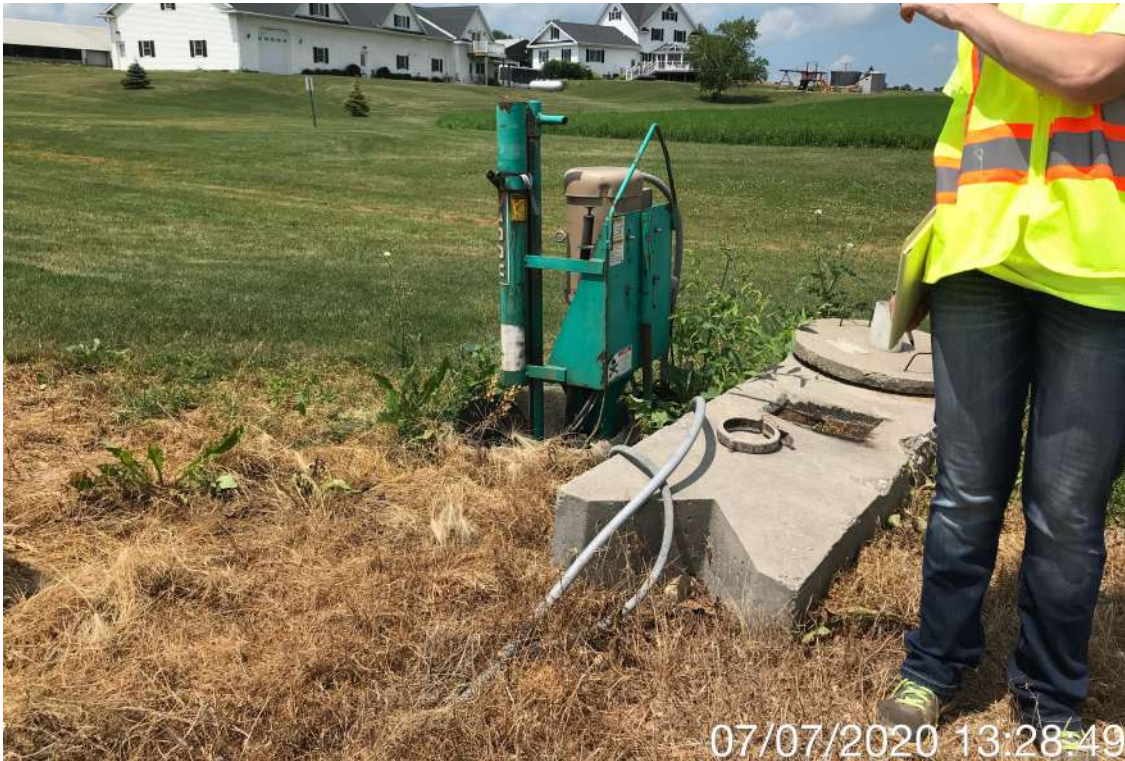
Photo #:	77	Photo Description: The reception basin and pump adjacent to the concrete swales. Runoff is pumped from this reception basin to WSF 2 at the Main Site.
Date/Time of Photo:	07/07/2020 13:28	
Photo Location:	Main Site	
Photo By:	Brian Hanson

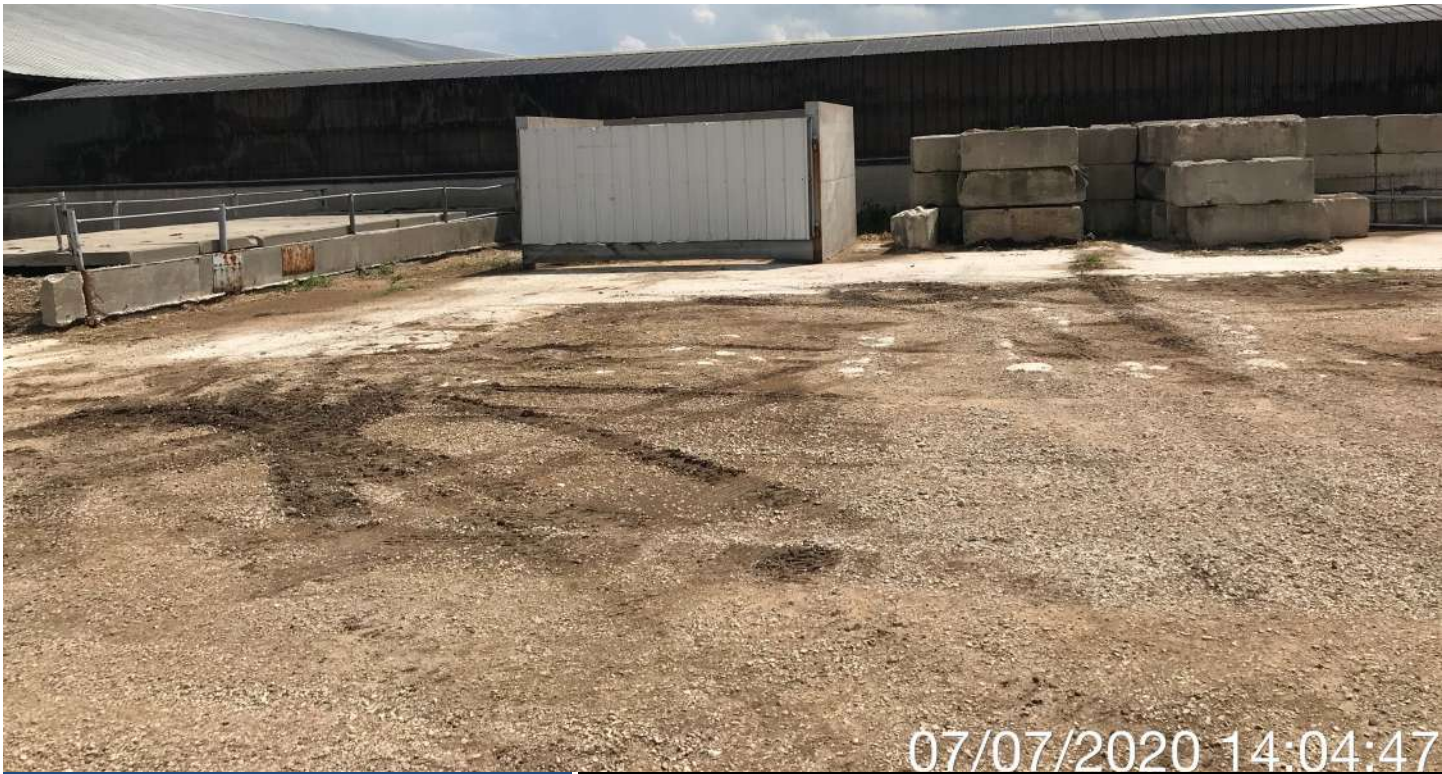
Photo #:	78	Photo Description: The animal mortality shed located at the Main Site, north of WSF 1. Animals are stored here until they are picked up by Sandy Bay Mink Ranch.
Date/Time of Photo:	07/07/2020 14:04	
Photo Location:	Main Site	
Photo By:	Brian Hanson

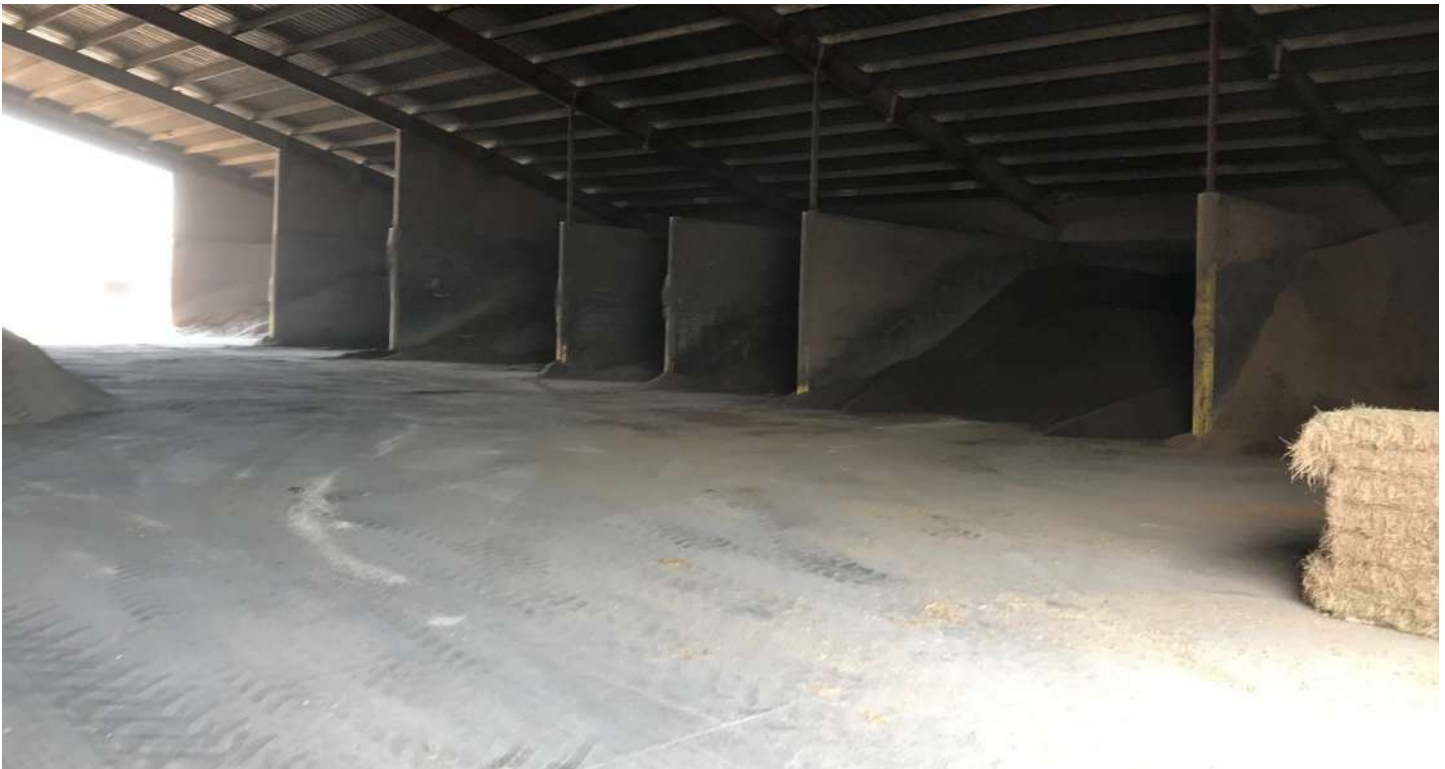
Photo #:	79	Photo Description: The commodity shed located at the home site, between the west FSA and the east FSA.
Date/Time of Photo:	07/07/2020 13:28	
Photo Location:	Main Site	
Photo By:	James Salscheider

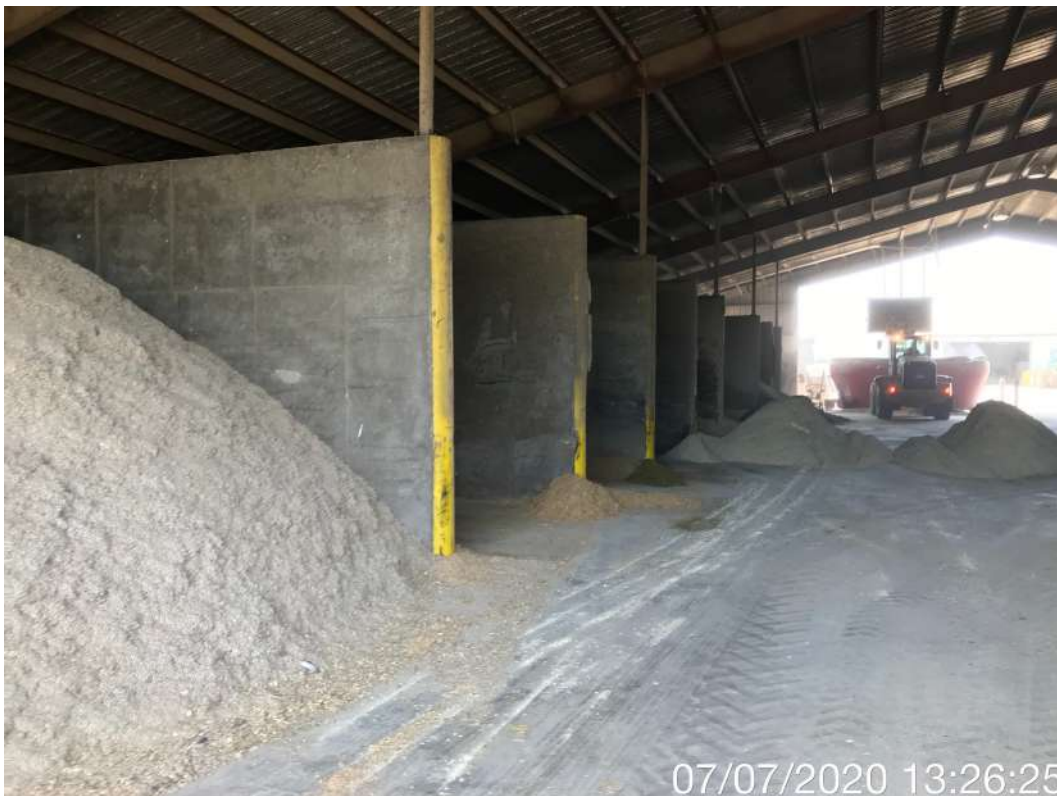
Photo #:	80	Photo Description: The commodity shed located at the home site, between the west FSA and the east FSA.
Date/Time of Photo:	07/07/2020 13:26	
Photo Location:	Main Site	
Photo By:	Brian Hanson

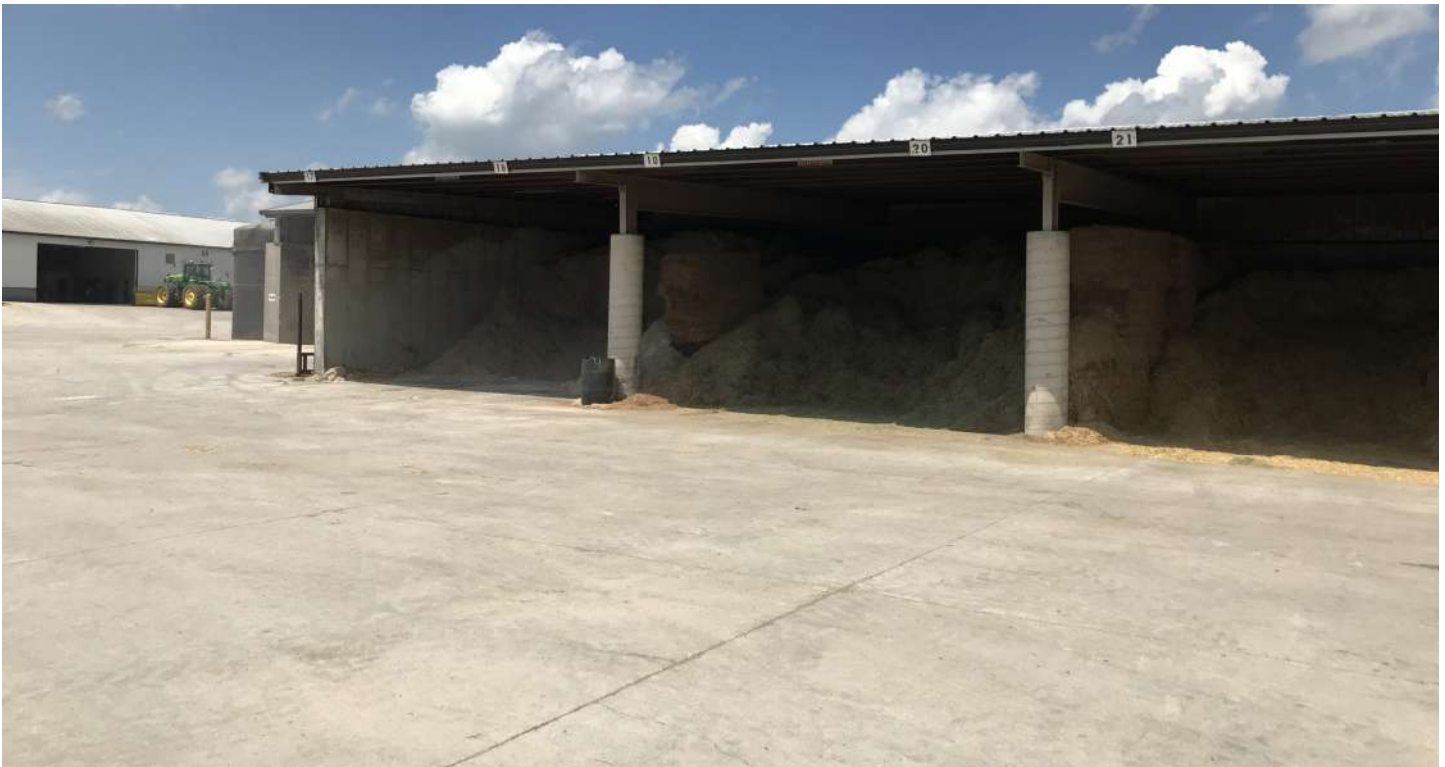
Photo #:	82	Photo Description: Bedding storage bays located on the south end of the main commodity shed.
Date/Time of Photo:	07/07/2020 13:26	
Photo Location:	Main Site	
Photo By:	James Salscheider

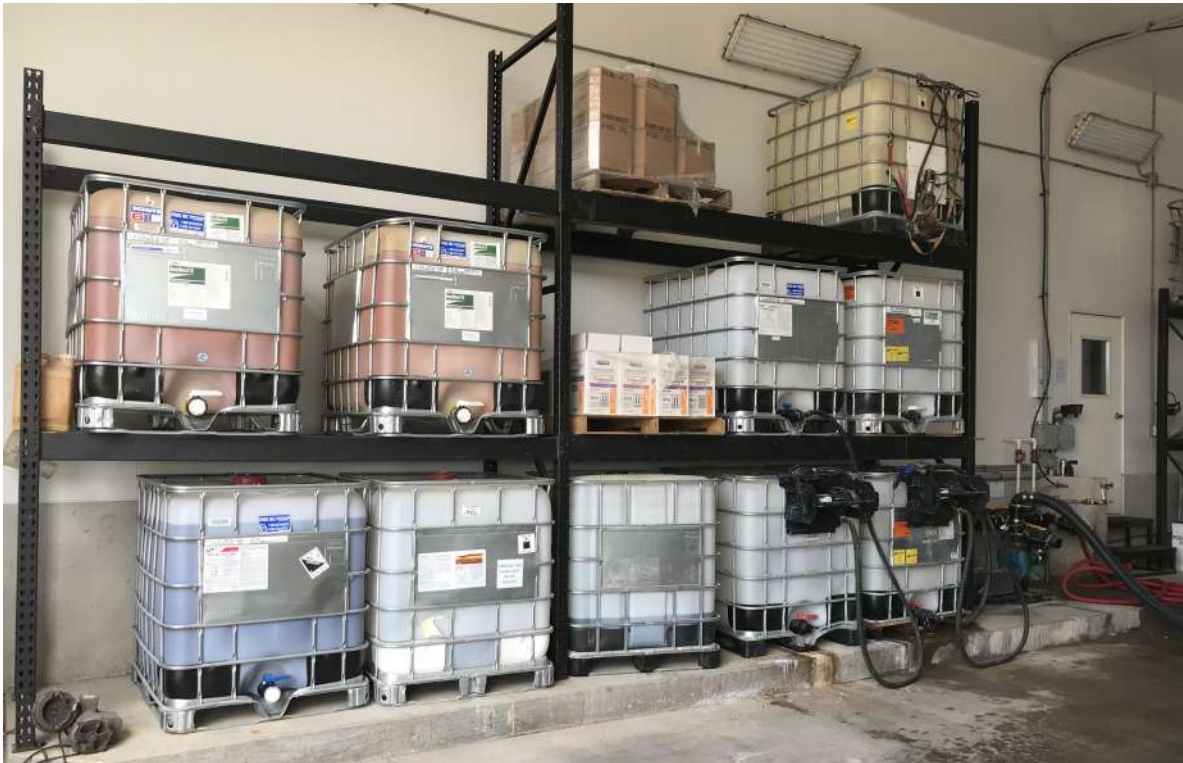
Fertilizer and other chemicals are stored in the shed located east of WSF 4. Controls are in place to collect and prevent discharges of hazardous chemicals. A concrete trench is located adjacent to the storage tanks to collect any leaks and a concrete underground storage basin is located adjacent to the building to hold any spilled chemicals.

Photo #:	83	Photo Description: Chemical storage located in the building east of WSF 4 at the Main Site. Runoff controls are in place to prevent discharges from the building.
Date/Time of Photo:	07/07/2020 13:13	
Photo Location:	Main Site	
Photo By:	James Salscheider

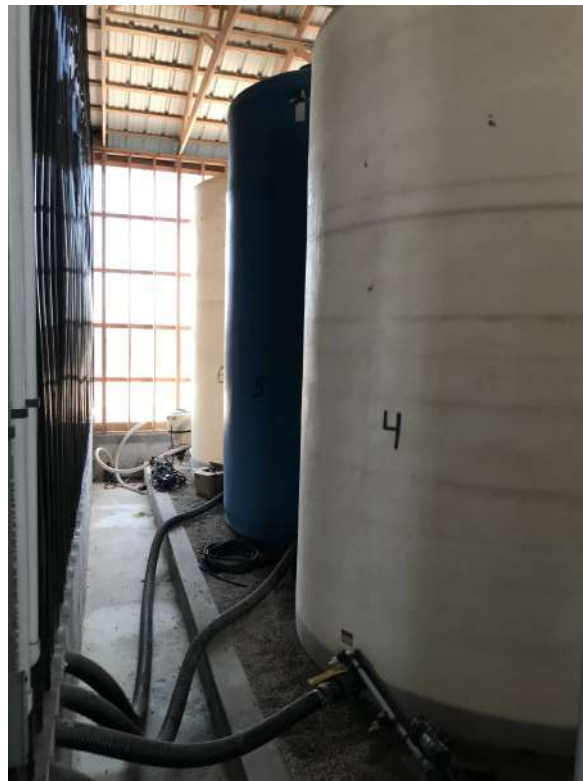
Photo #:	84	Photo Description: Chemical storage located in the building east of WSF 4 at the Main Site. Runoff controls are in place to prevent discharges from the building, including the concrete gully that will capture any discharges of chemicals.
Date/Time of Photo:	07/07/2020 13:13	
Photo Location:	Main Site	
Photo By:	James Salscheider

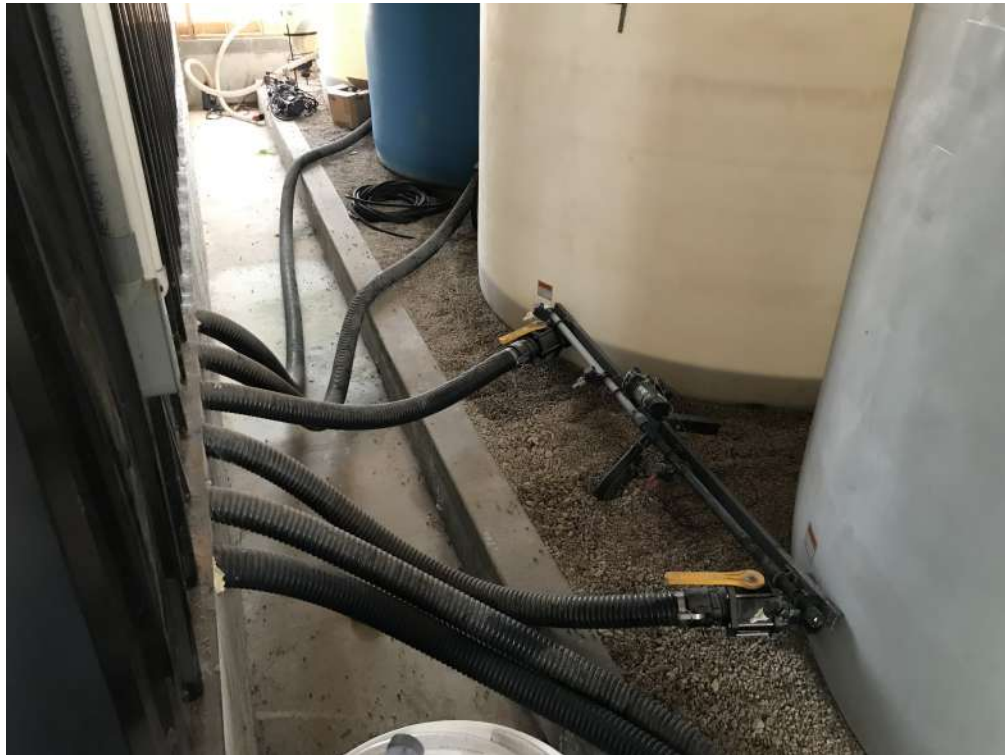
Photo #:	85	Photo Description: The concrete trench that is in-place to capture any discharges of chemicals from the large storage tanks.
Date/Time of Photo:	07/07/2020 13:13	
Photo Location:	Main Site	
Photo By:	James Salscheider

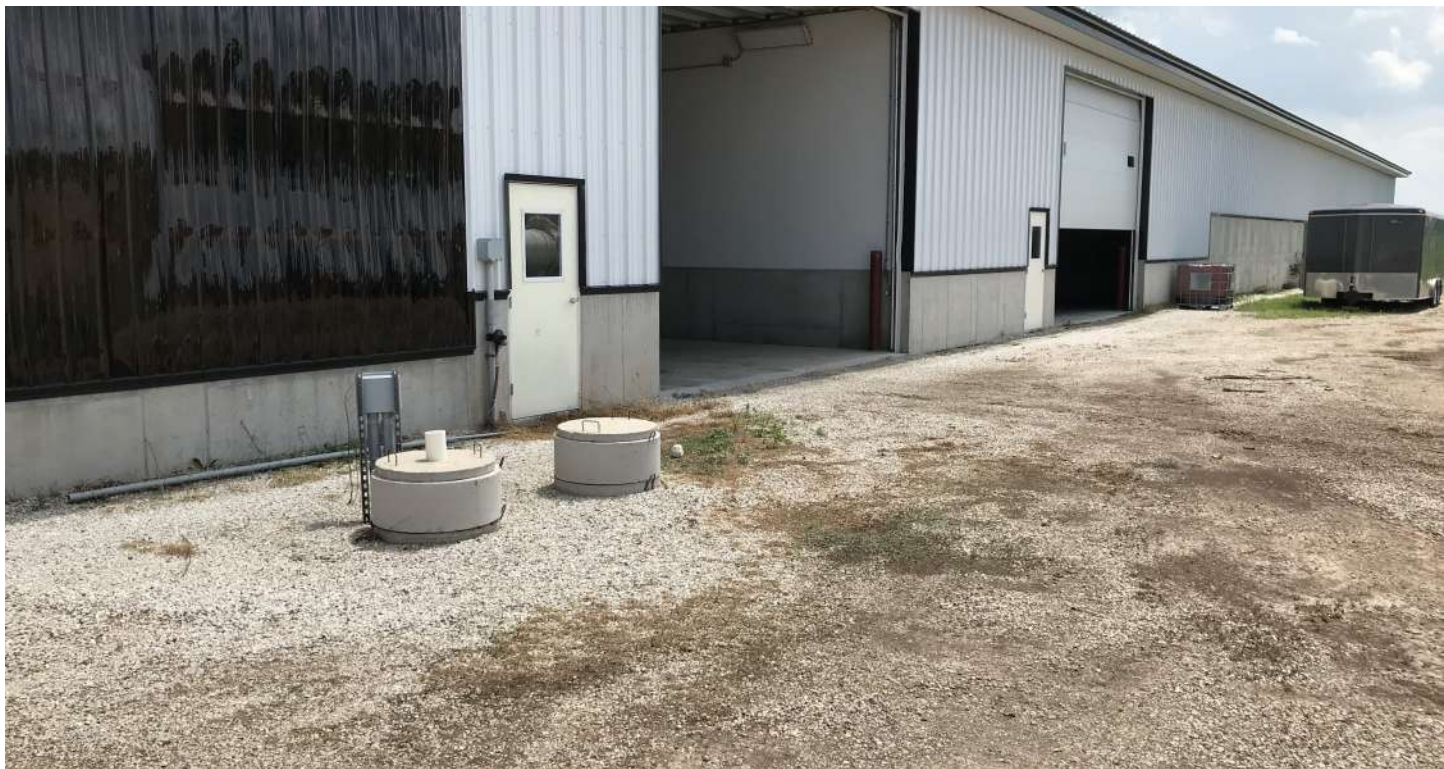
Photo #:	86	Photo Description: The reception tank outside of the chemical storage building that is in-place to temporarily store any chemicals that are spilled and recovered. The storage capacity is approx. 2,000 gallons.
Date/Time of Photo:	07/07/2020 13:12	
Photo Location:	Main Site	
Photo By:	James Salscheider

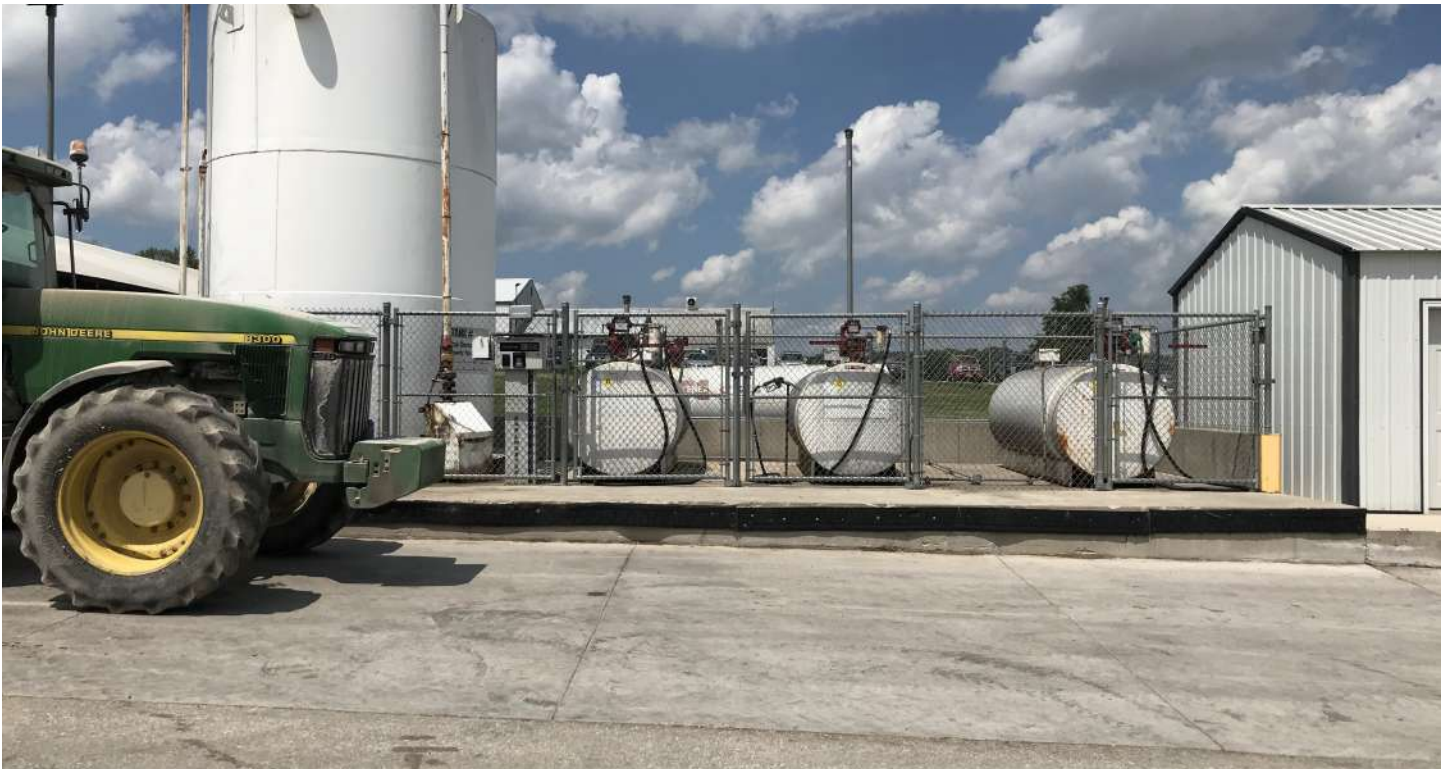
PPD stores fuel north of the shop building in large above ground storage tanks. There were no observed discharges from the fuel tanks during the inspection.

Photo #:	87	Photo Description: The fuel storage area located at the Main Site, north of the machine shop.
Date/Time of Photo:	07/07/2020 13:58	
Photo Location:	Main Site	
Photo By:	James Salscheider

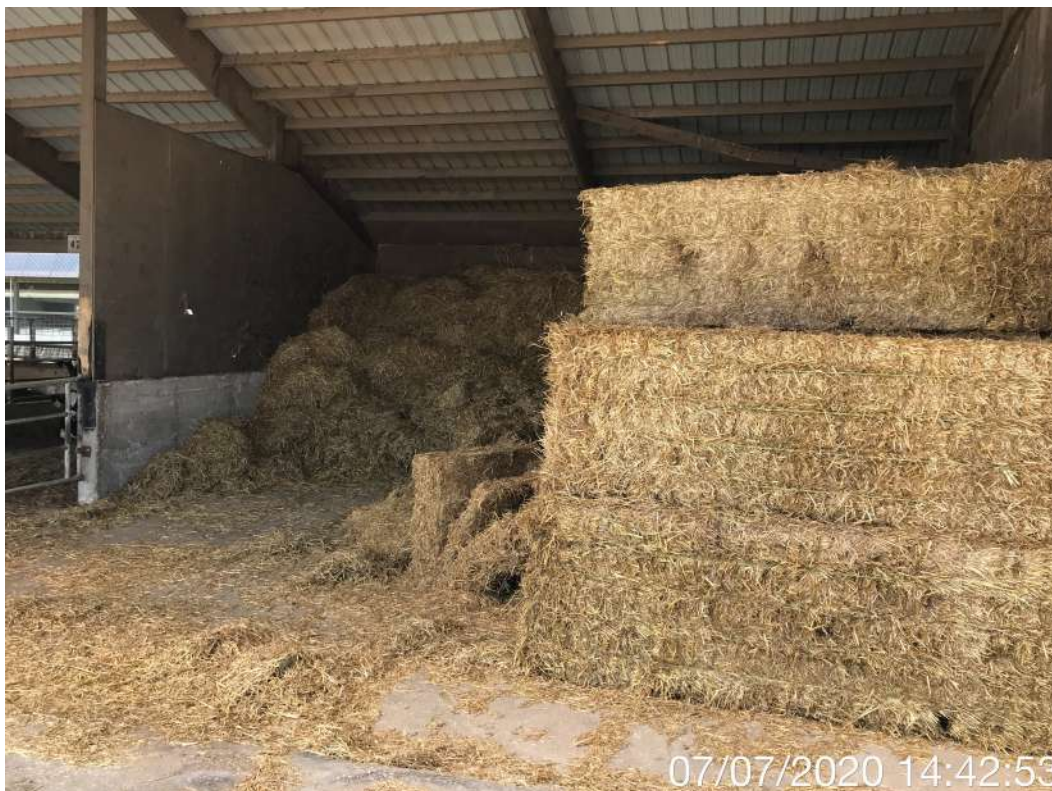
Photo #:	89	Photo Description: Separated solids storage bay located at the end of a small heifer barn. Separated solids and straw are used for bedding the calf and small heifer barns.
Date/Time of Photo:	07/07/2020 14:45	
Photo Location:	Heifer Site	
Photo By:	James Salscheider
