# Permit Fact Sheet

| Permit Number | WI-0066991-02-0 |
| Permittee Name and Address | Paiser Family Dairy LLC<br>51 Highview Road, Gresham, WI 54128 |

On Thursday October 16th, 2025 Hanson met with Paiser & Schuebel at 9:00 at Paiser Family Dairy LLC site to conduct a mid permit compliance inspection. 2 sites were inspected. The Kroenke farm only has a few personal animals left as the outdoor lots & feed storage area has been abandoned. No significant precipitation had fallen & temperatures were in the 60's and sunny. No permit violations were observed, and no water samples were collected. Hanson departed at approximately 10:30.

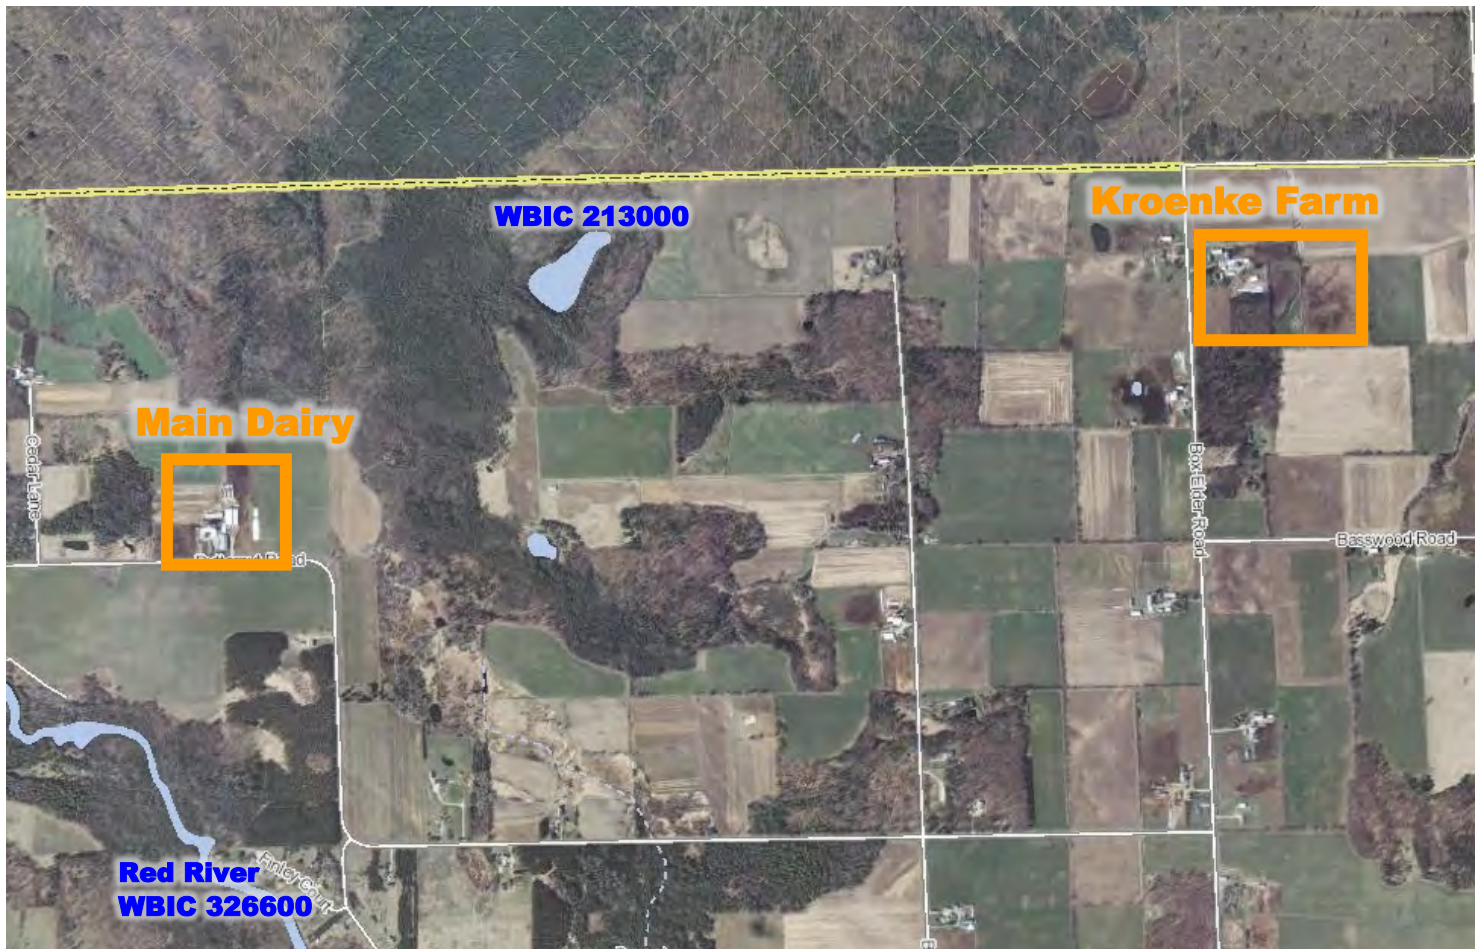
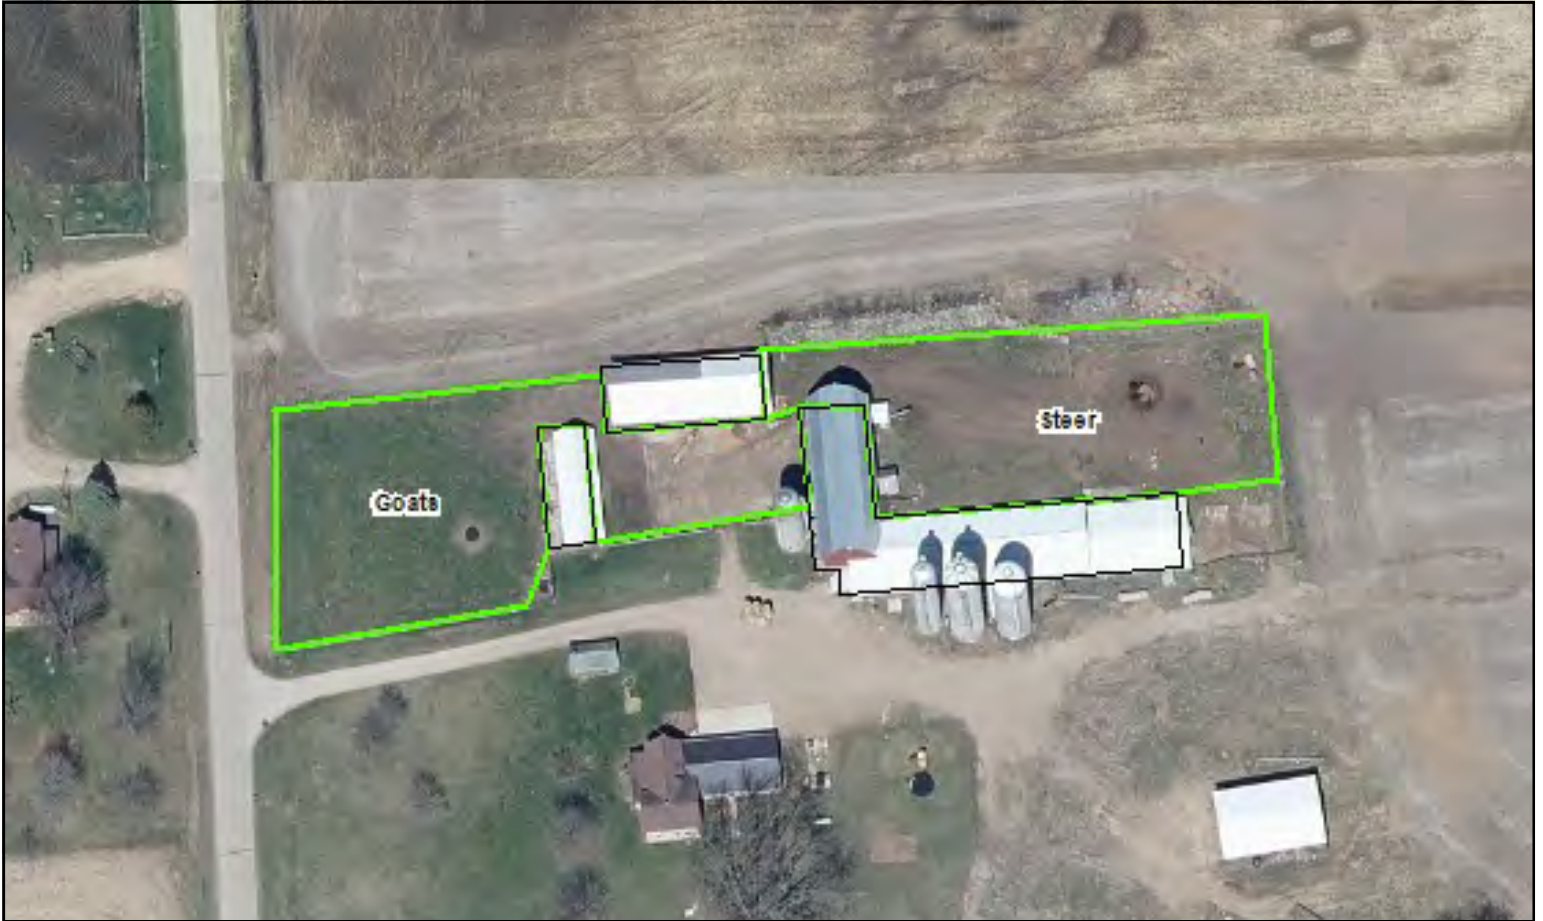
## Site Overview Diagram (Main Dairy & Kroenke Farm)

**Site Overview Diagram** (Main Dairy: orange lines = potential contaminated runoff, blue lines = stormwater flow, pink lines = waste transfer system, yellow circles = wells)

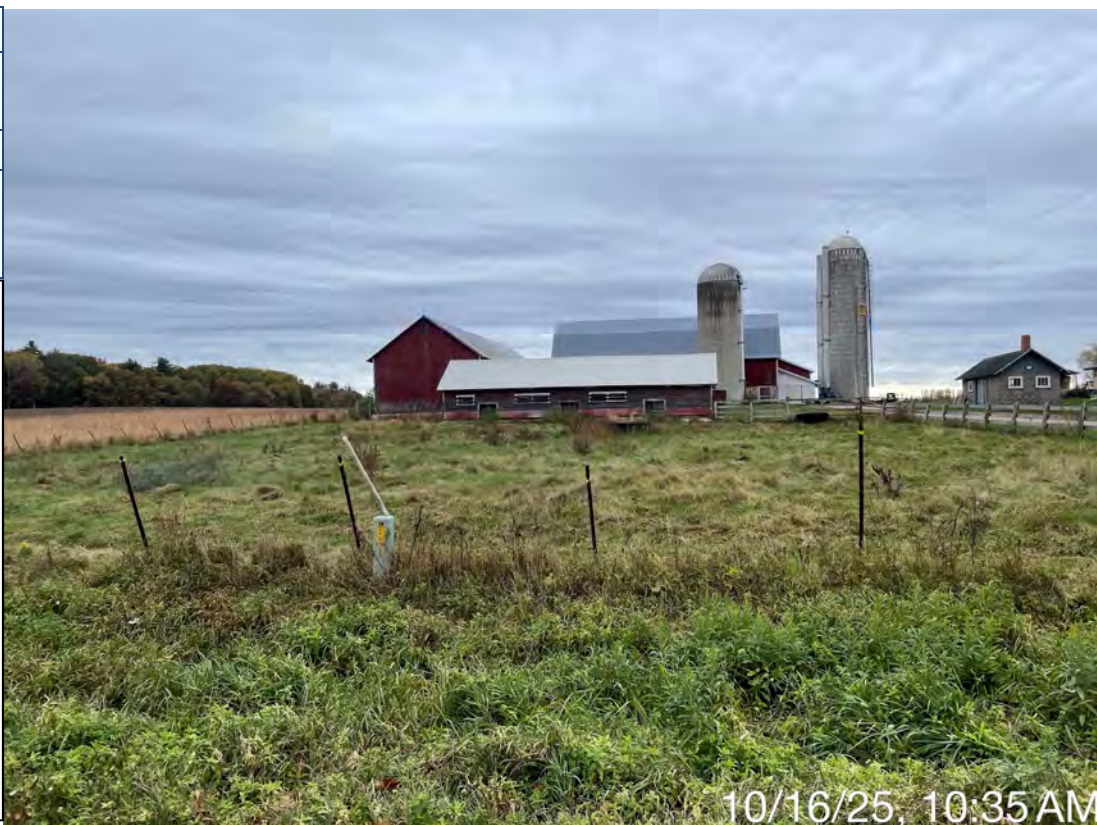
| <b>Photo #:</b> | 2 |

| <b>Photo Location:</b> | Kroenke Farm<br>Outdoor Lot |
| <b>Photo Description:</b><br><br>Standing on the road looking east: View of outdoor lot on west side of barn. Lot only houses a few pet animals now and is well vegetated. | |

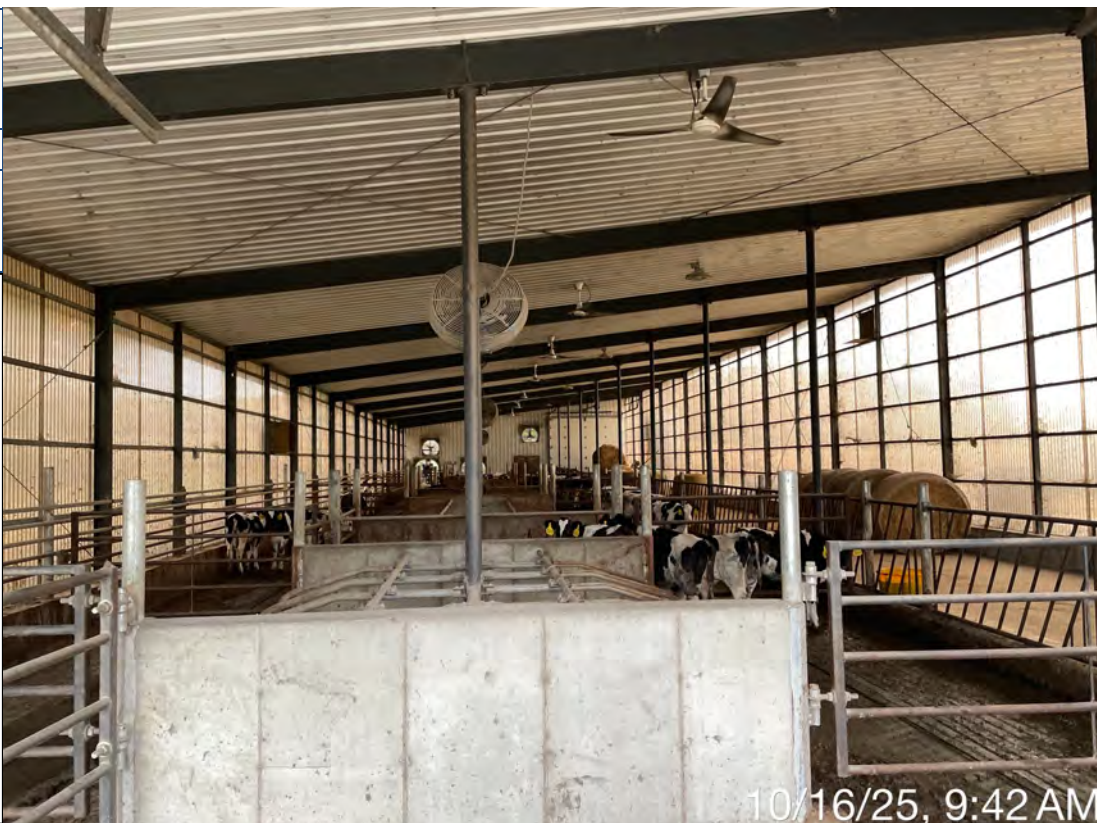
| <b>Photo #:</b> | 3 |

| <b>Photo Location:</b> | Main Dairy<br>Calf Barn |
| <b>Photo Description:</b><br><br>Standing on the south side of calf barn looking north: View of interior of calf barn. | |

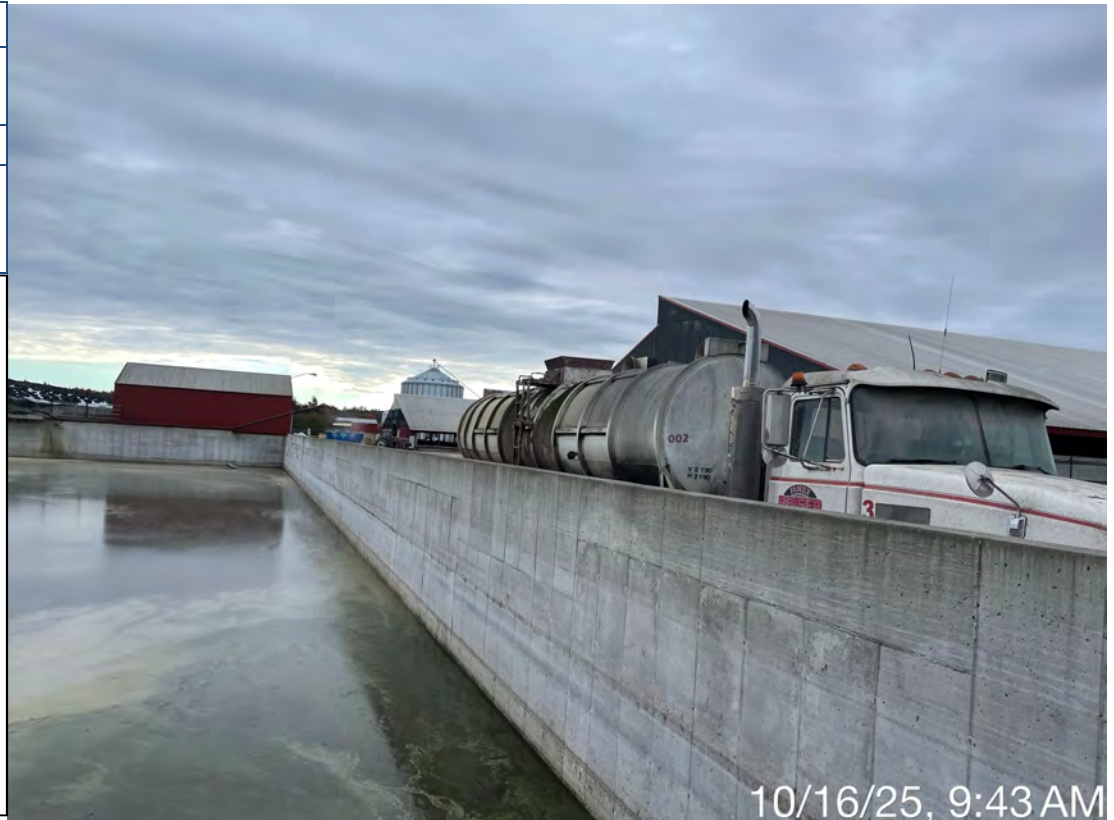
| <b>Photo #:</b> | 4 |

| <b>Photo Location:</b> | Main Dairy<br>WSF #1 |
| <b>Photo Description:</b><br><br>Standing on the west side of WSF #1 looking east: View of south wall of WSF #1. | |

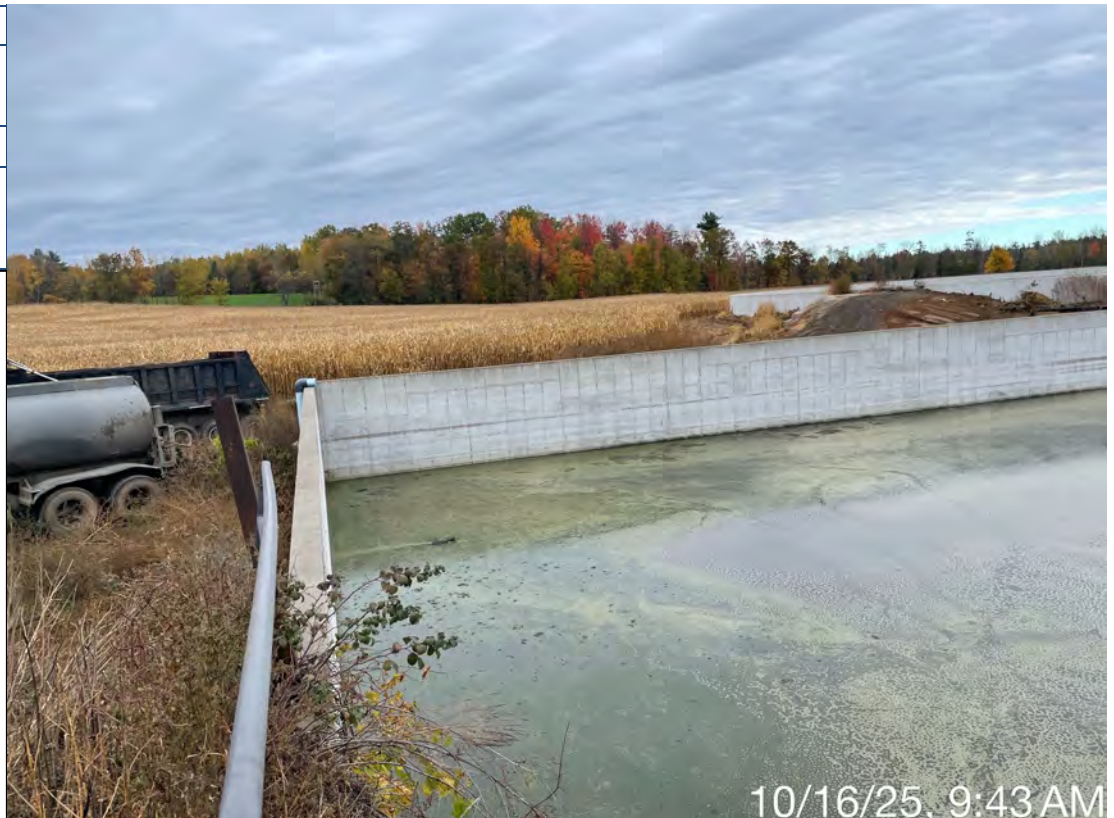
| <b>Photo #:</b> | 5 |

| <b>Photo Location:</b> | Main Dairy<br>WFS #1 |
| <b>Photo Description:</b><br><br>Standing on the west side of WSF #1 looking north: View of northwest corner of WSF #1. | |

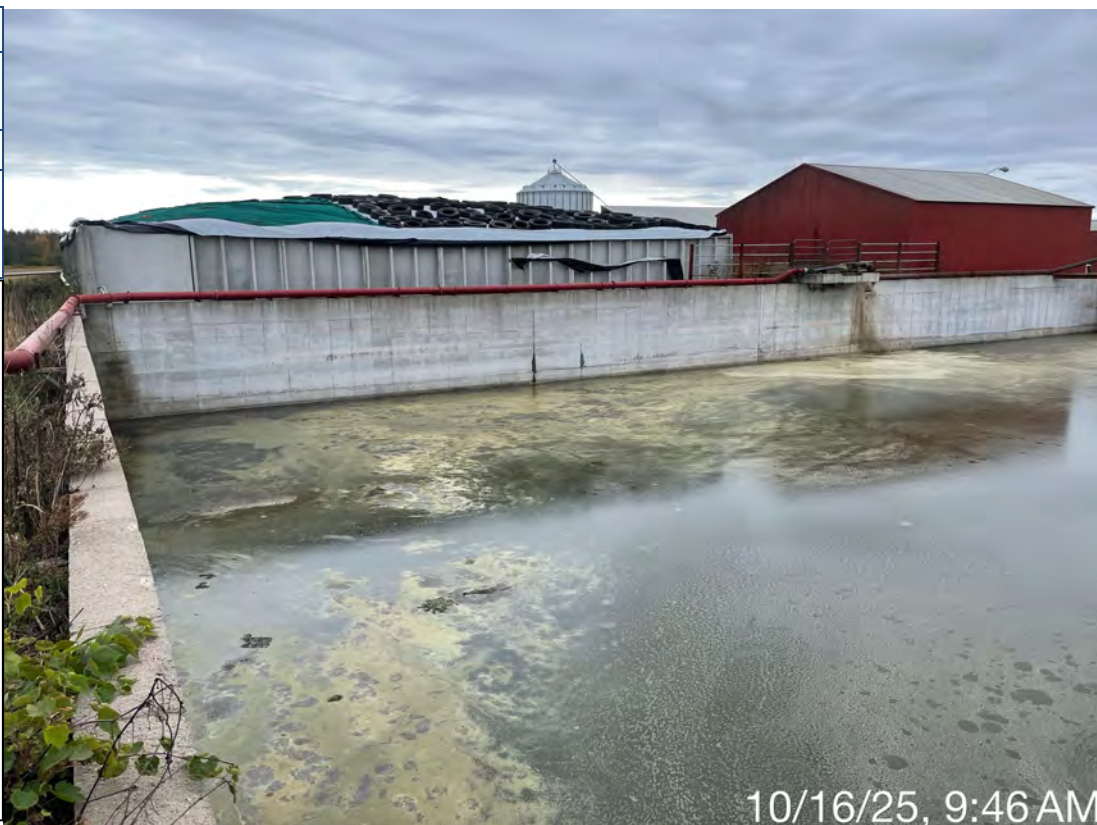
| <b>Photo #:</b> | 6 |

Standing on north side of WSF #1 looking east: View of northeast corner of WSF #1. Red Pipe on top of wall is load out line for WSF #2.

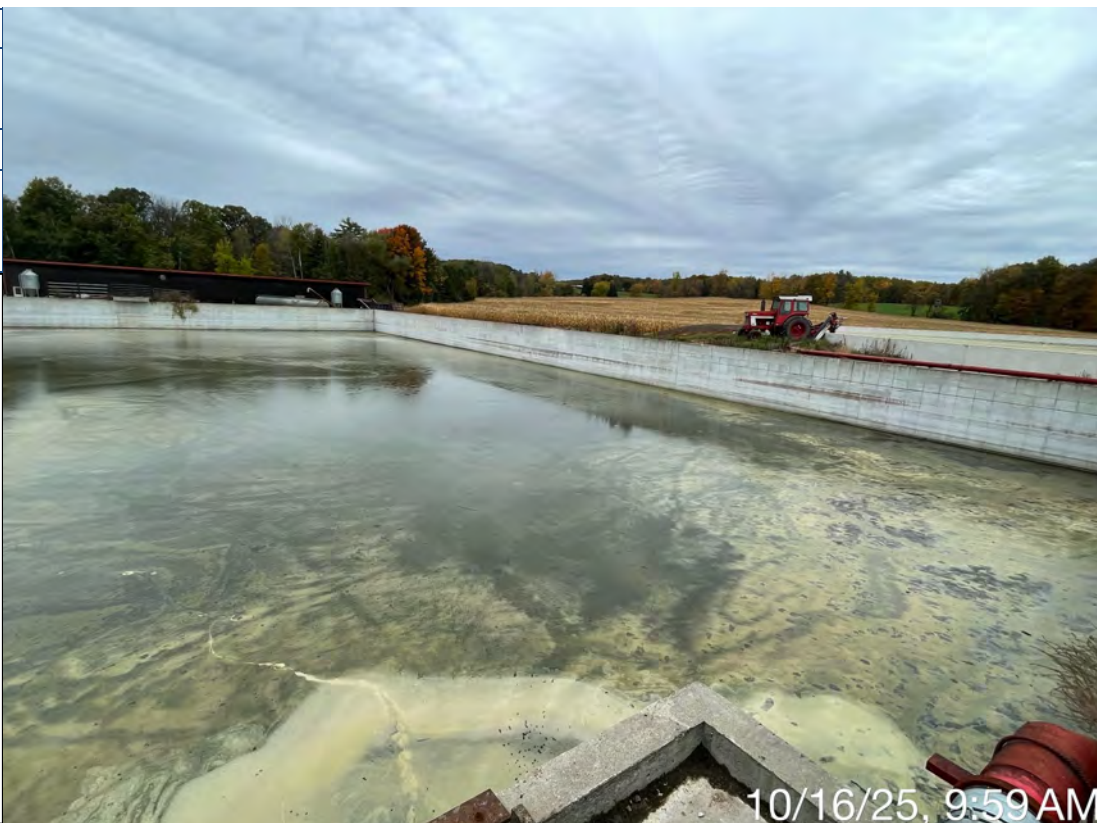
| Photo #: | 7 |

Standing on east side of WSF #1 looking northwest: View of north 1/2 of WSF #1.

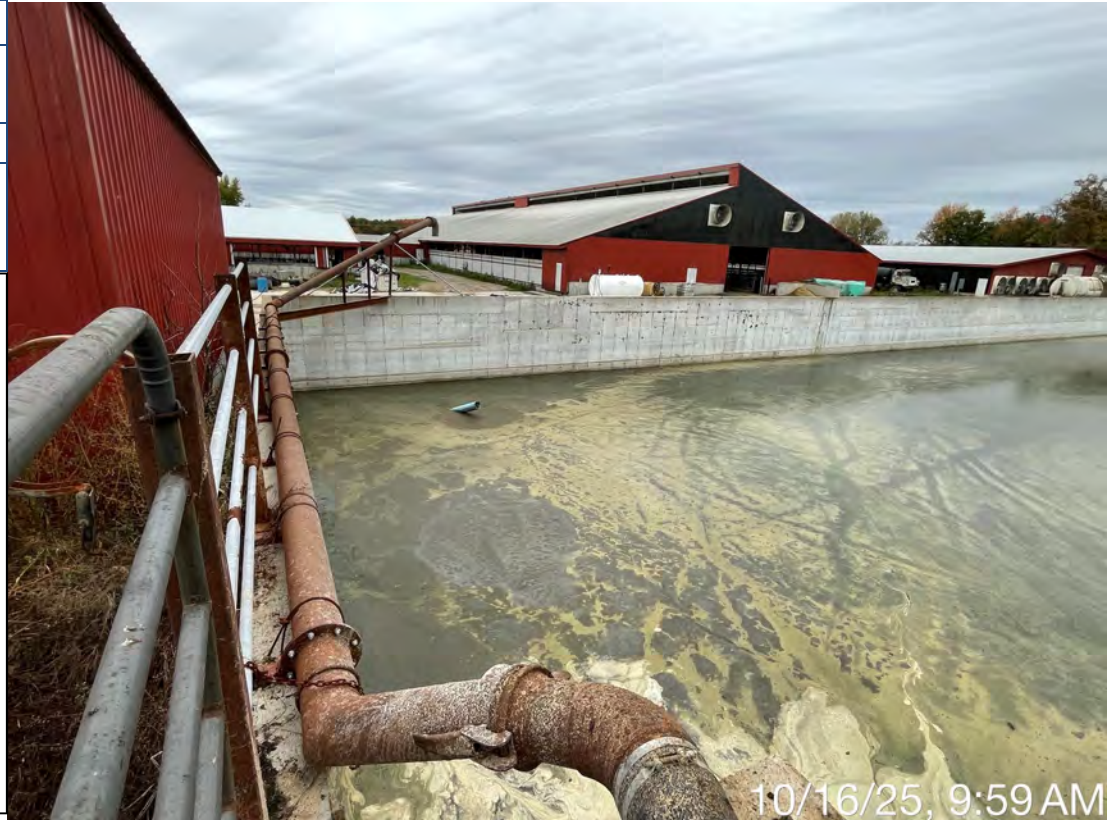
| Photo #: | 8 |

Standing on east side of WSF #1 looking south: View of southeast corner of WSF #1. Pipe on top of wall is load out line for both pits.

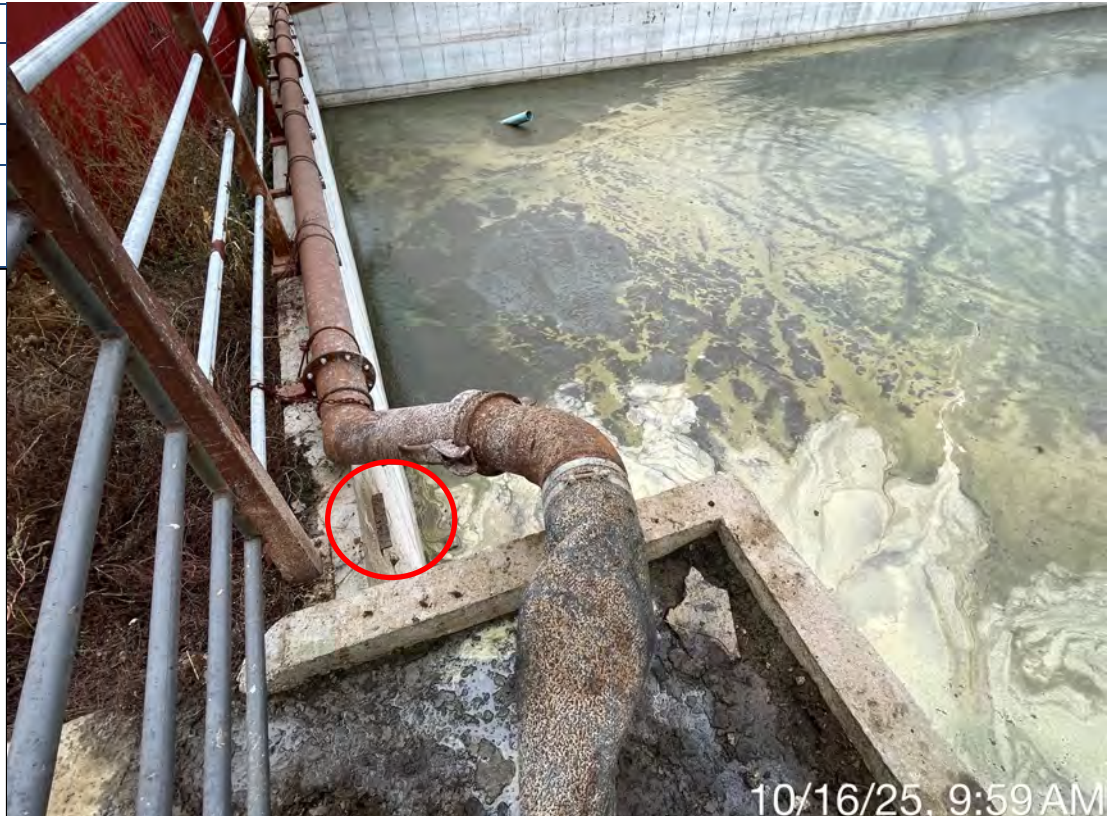
| <b>Photo #:</b> | 9 |

Standing on east side of WSF #1 looking south & down: View of permanent markers in east wall of pit.

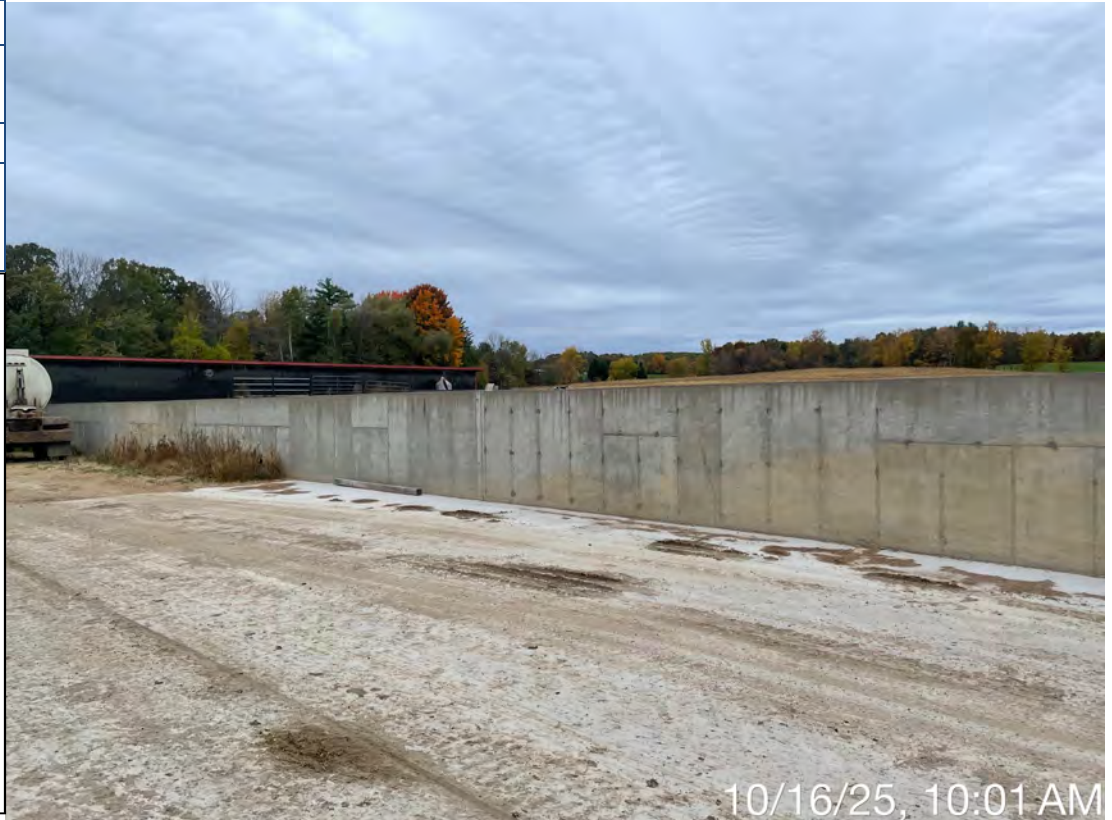
| <b>Photo #:</b> | 10 |

| <b>Photo Location:</b> | Main Dairy<br>WSF #1 |
| <b>Photo Description:</b><br><br>Standing on south side of WSF #1 looking northwest: View of exterior side of concrete wall of WSF #1. | |

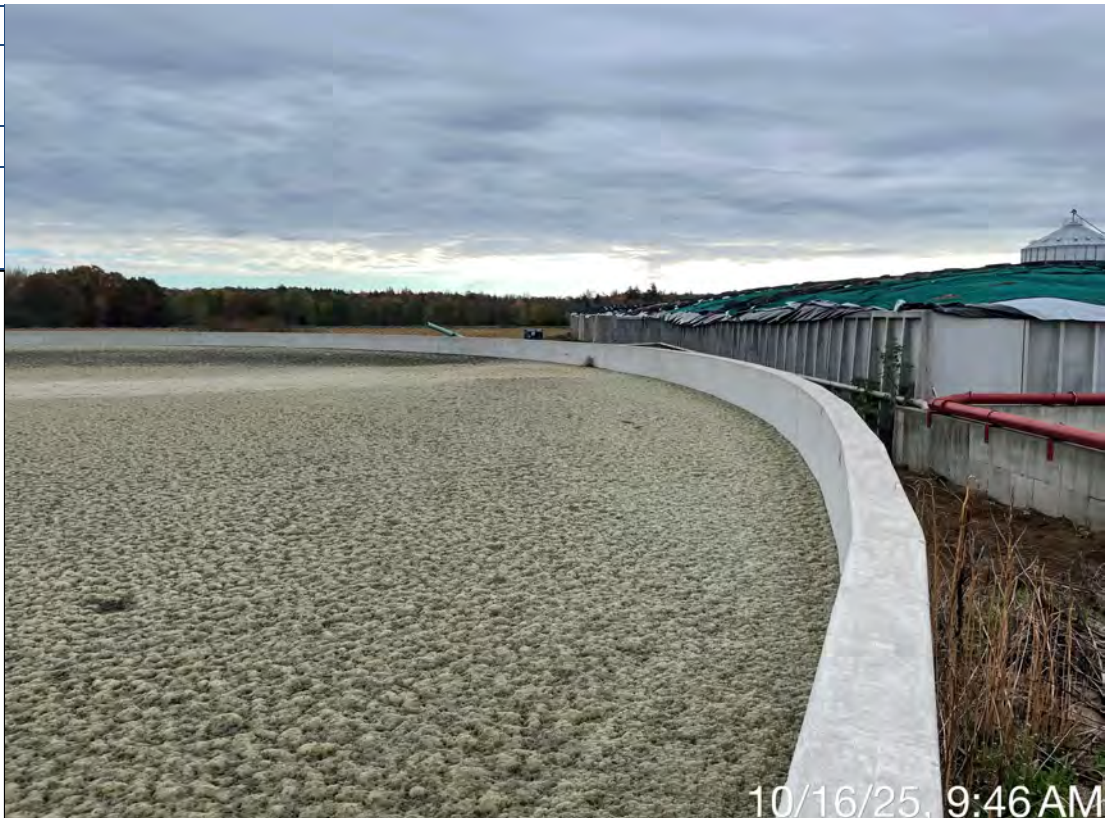
| <b>Photo #:</b> | 11 |

| <b>Photo Location:</b> | Main Dairy<br>WSF #2 |
| <b>Photo Description:</b><br><br>Standing on the southwest side of WSF #2 looking east: View of south side of WSF #2 | |

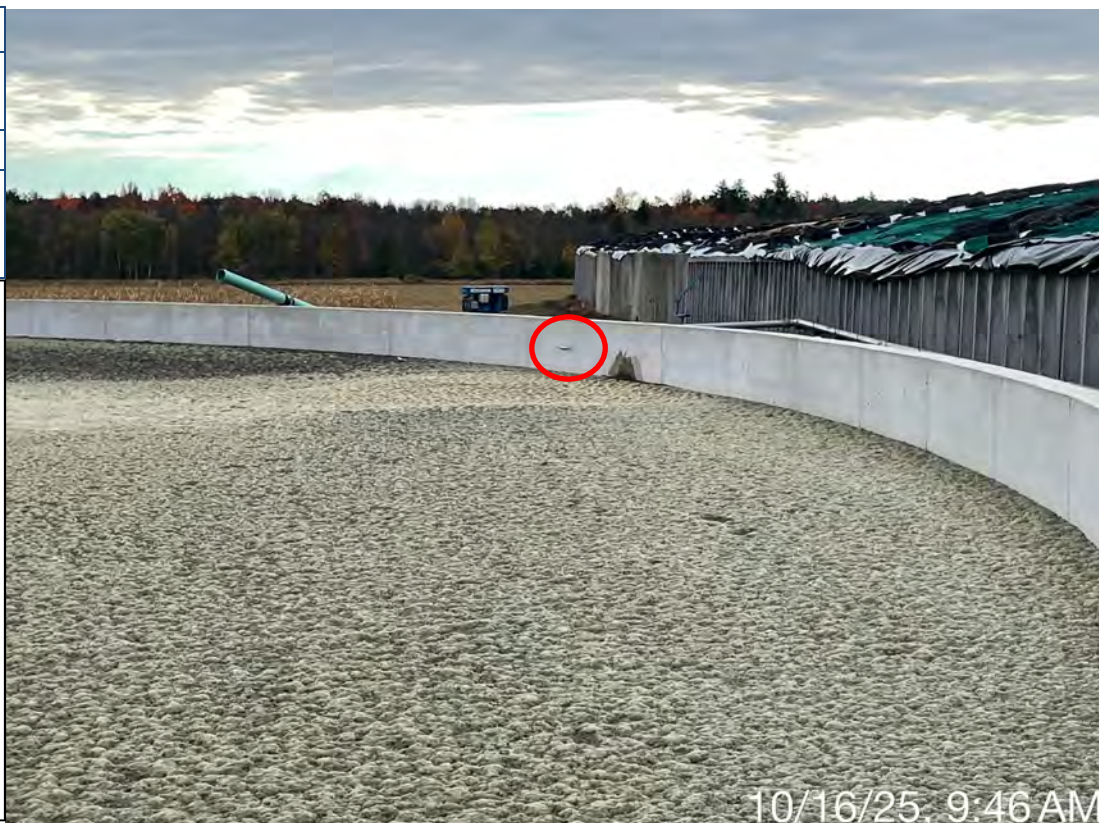
| <b>Photo #:</b> | 12 |

Standing on the west side of WSF #2 looking southeast: View of permanent markers in south wall of WSF #2.

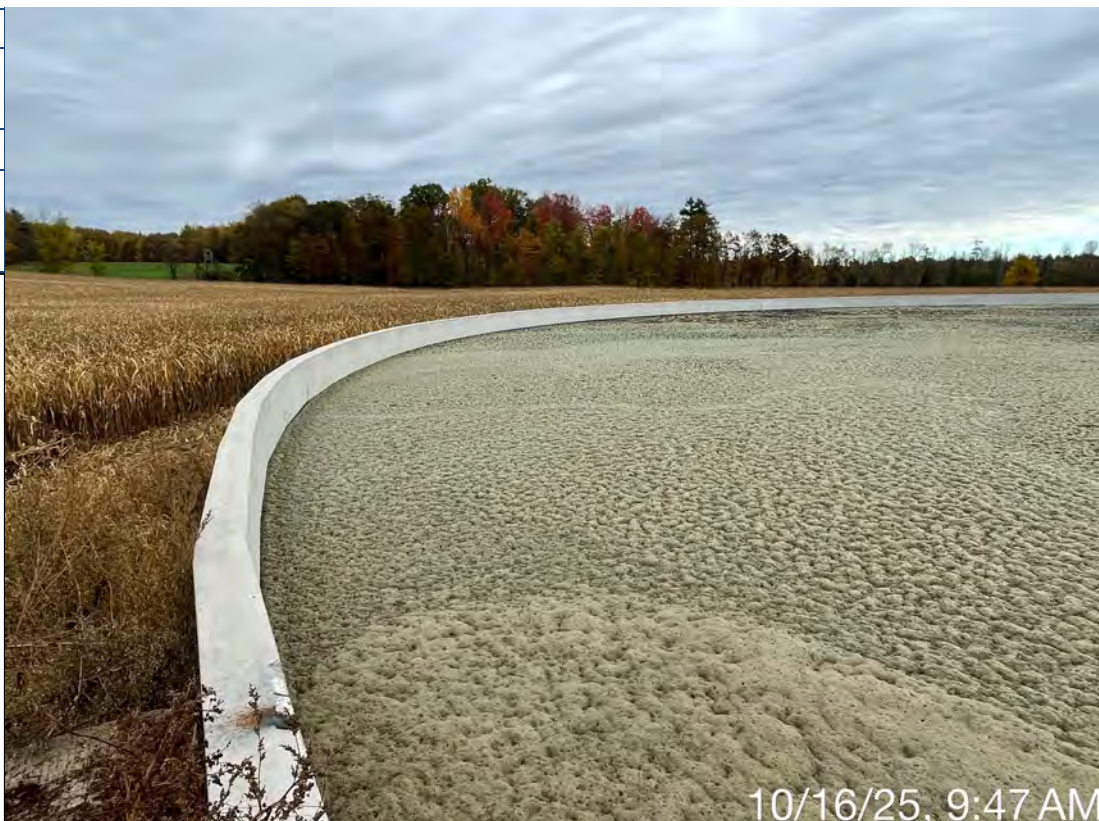
| <b>Photo #:</b> | 13 |

Standing on the west side of WSF #2 looking northeast: View of north side of WSF #2.

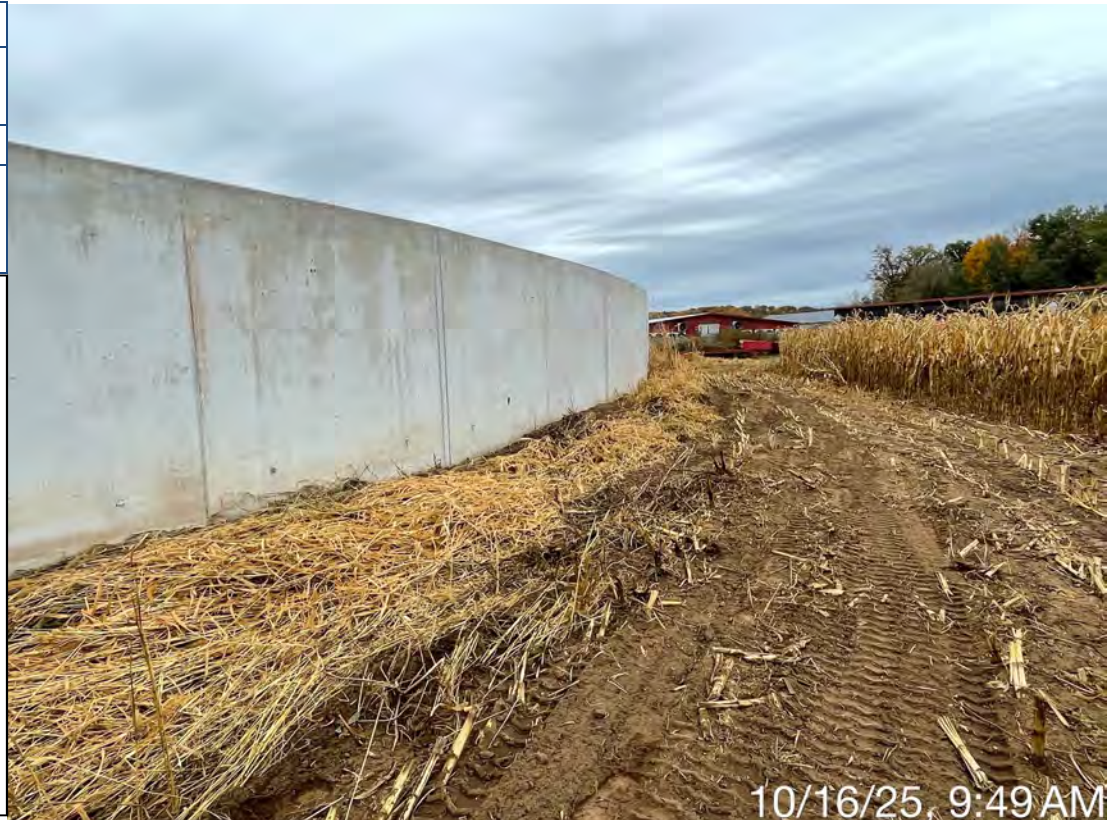
| <b>Photo #:</b> | 14 |

| <b>Photo Location:</b> | Main Dairy<br>WSF #2 |
| <b>Photo Description:</b><br><br>Standing on the north side of WSF #2 looking southwest:<br>View of the exterior of wall on northwest side of WSF #2. | |

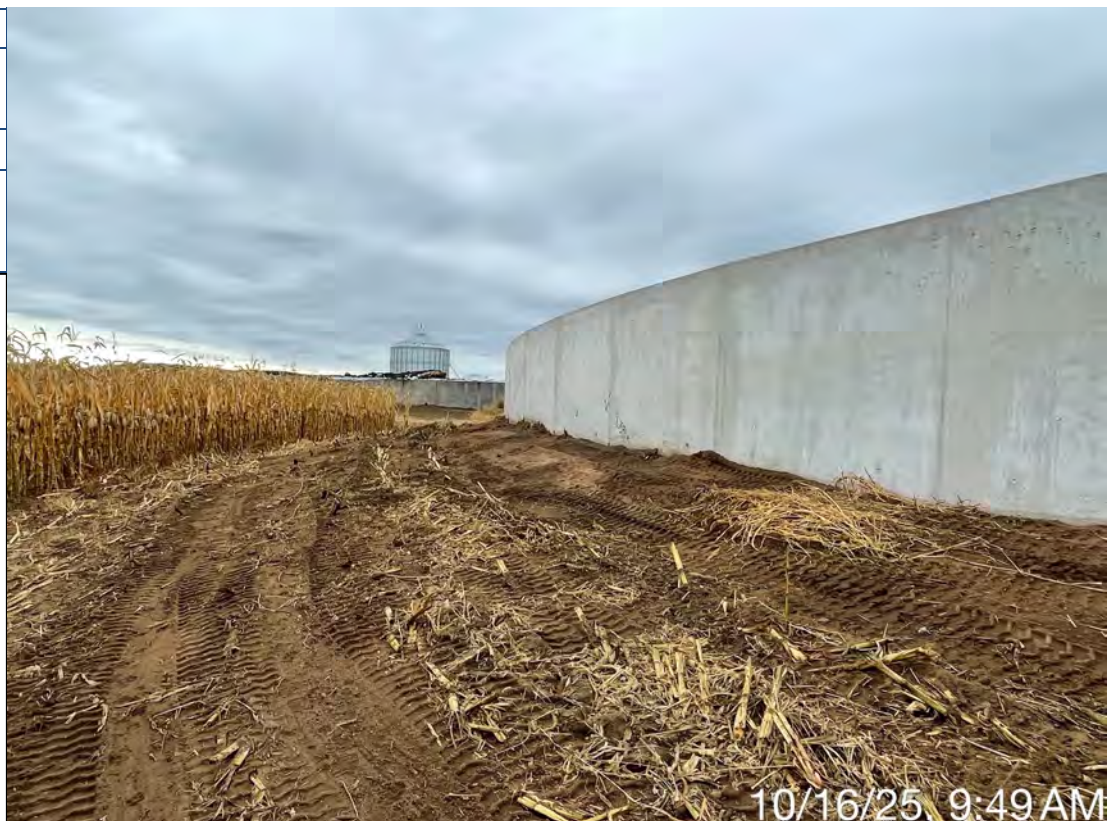
| <b>Photo #:</b> | 15 |

| <b>Photo Location:</b> | Main Dairy<br>WSF #2 |
| <b>Photo Description:</b><br><br>Standing on the north side of WSF #2 looking southeast:<br>View of the exterior of wall on northeast side of WSF #2. | |

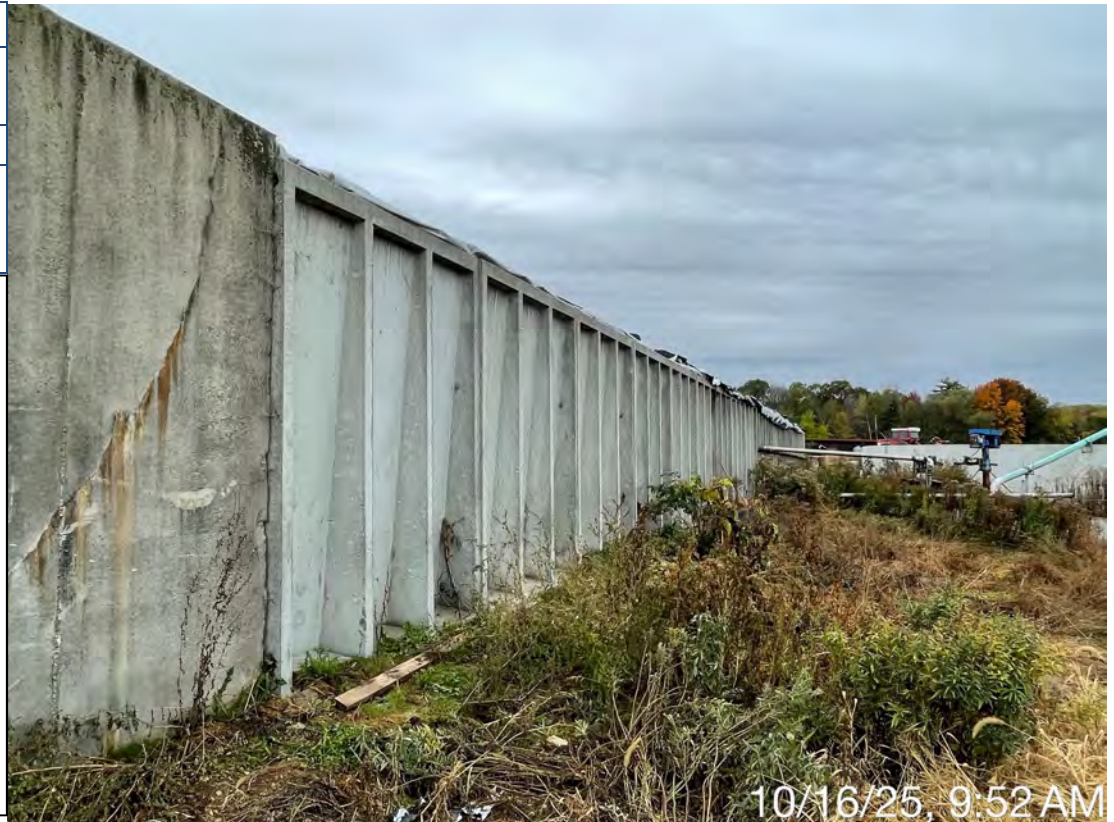
| <b>Photo #:</b> | 16 |

Standing on north side of FSA looking west: View of north wall of FSA on the west end.

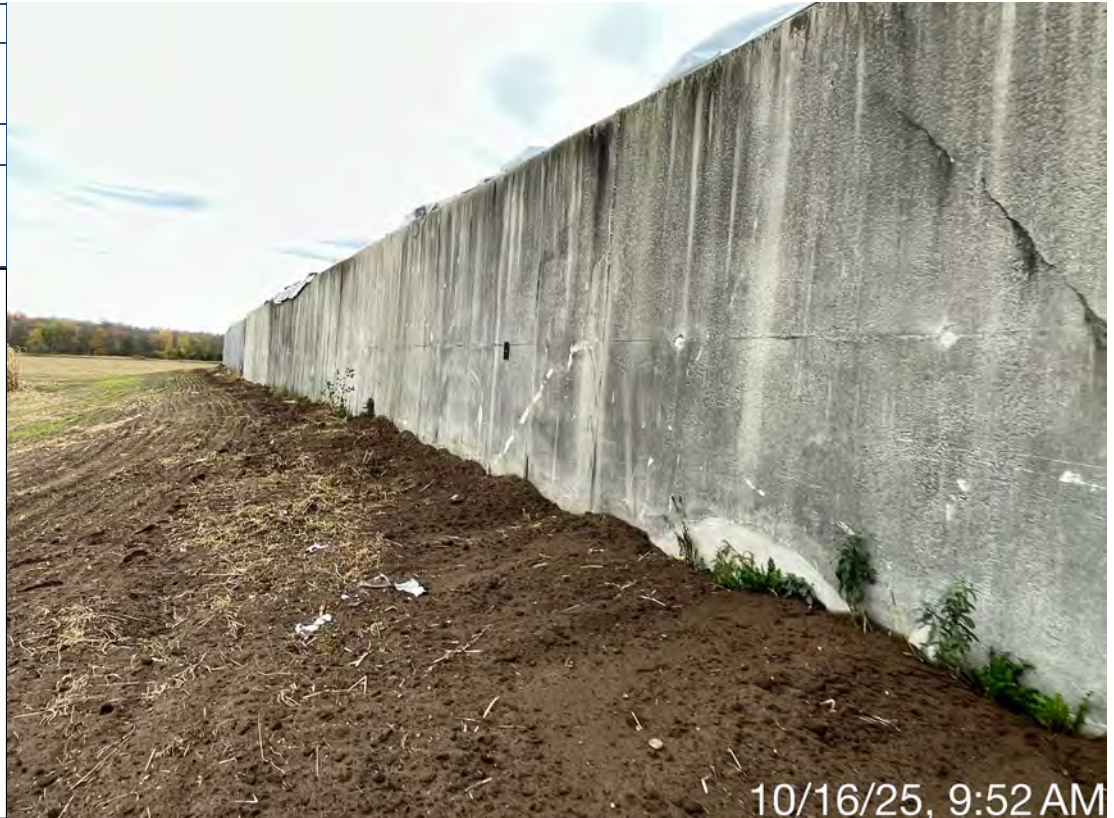
| <b>Photo #:</b> | 17 |

Standing on the north side of FSA looking east: View of original bunker wall in center section of north wall.

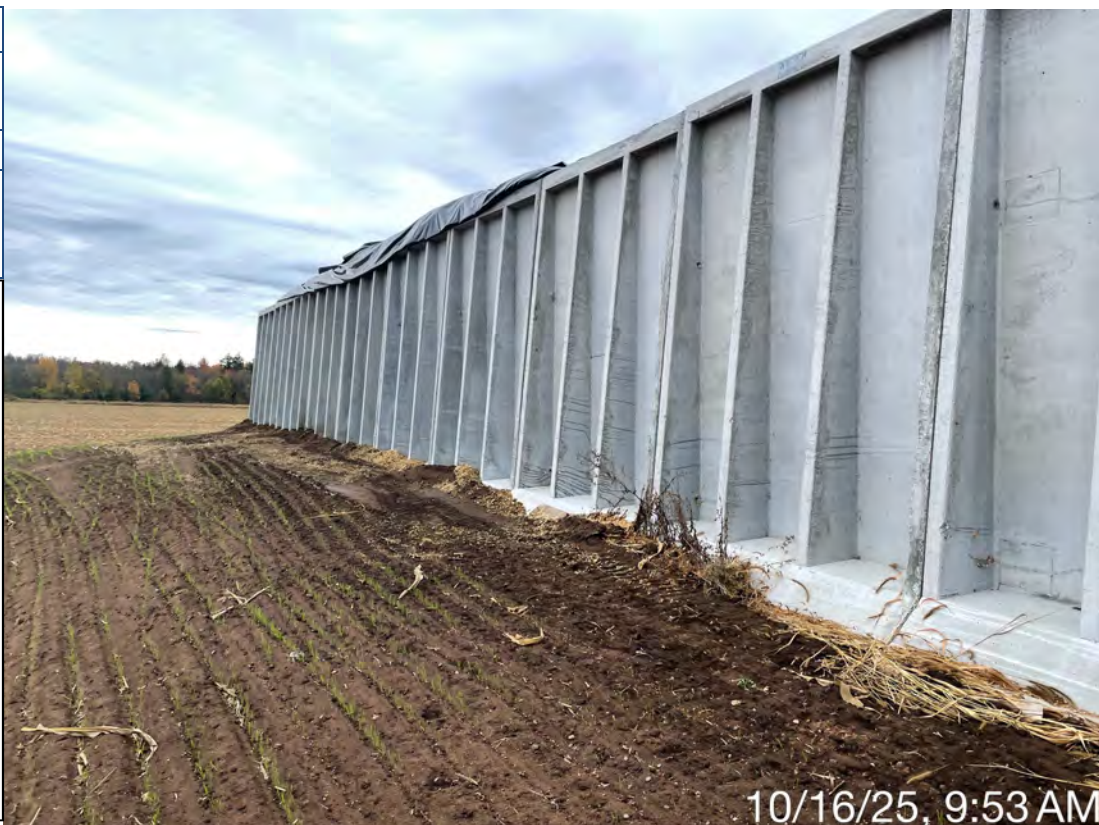
| <b>Photo #:</b> | 18 |

| <b>Photo Location:</b> | Main Dairy<br>Feed Storage |
| <b>Photo Description:</b><br><br>Standing on the north side of FSA looking east: View of newly installed bunker wall on east end of north wall. | |

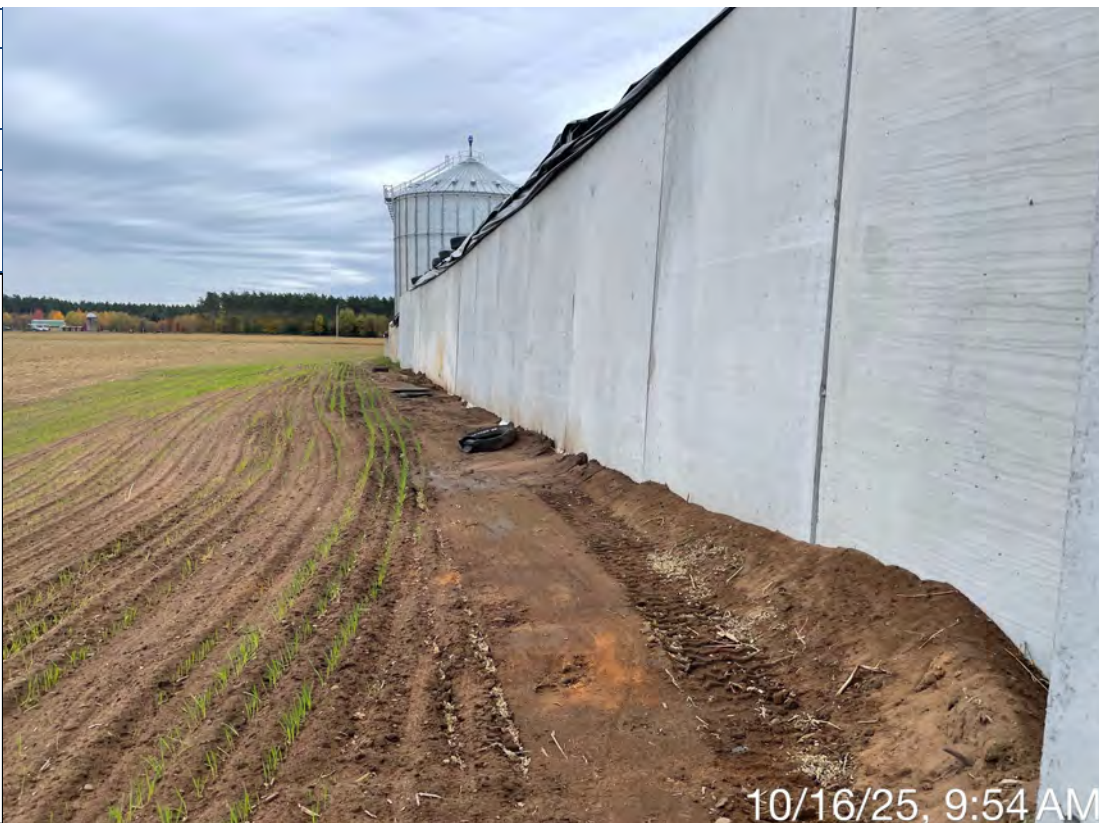
| <b>Photo #:</b> | 19 |

| <b>Photo Location:</b> | Main Dairy<br>Feed Storage |
| <b>Photo Description:</b><br><br>Standing on the east side of FSA looking south: View of newly installed bunker wall on east edge of FSA. | |

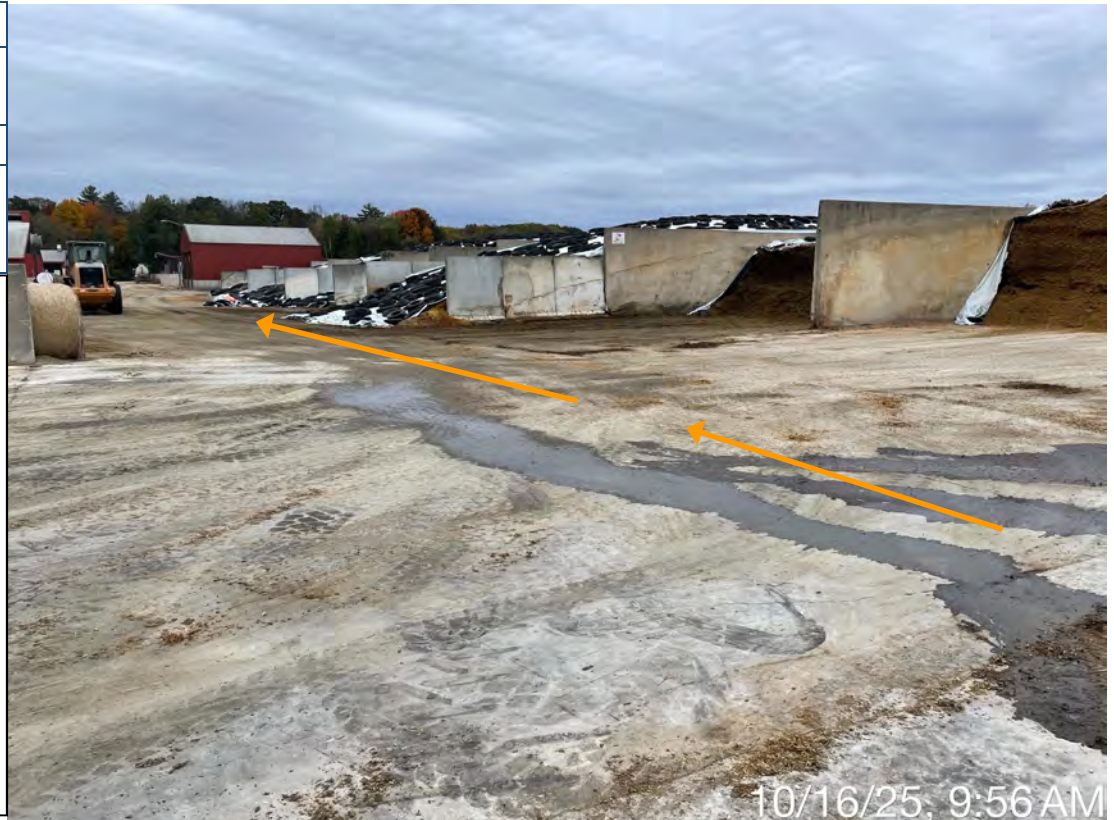
| <b>Photo #:</b> | 20 |

| <b>Photo Location:</b> | Main Dairy<br>Feed Storage |
| <b>Photo Description:</b><br><br>Standing at the southeast corner of FSA looking west:<br>View of south edge of FSA which acts as a runoff collection channel. Arrows indicate direction of runoff flow. | |

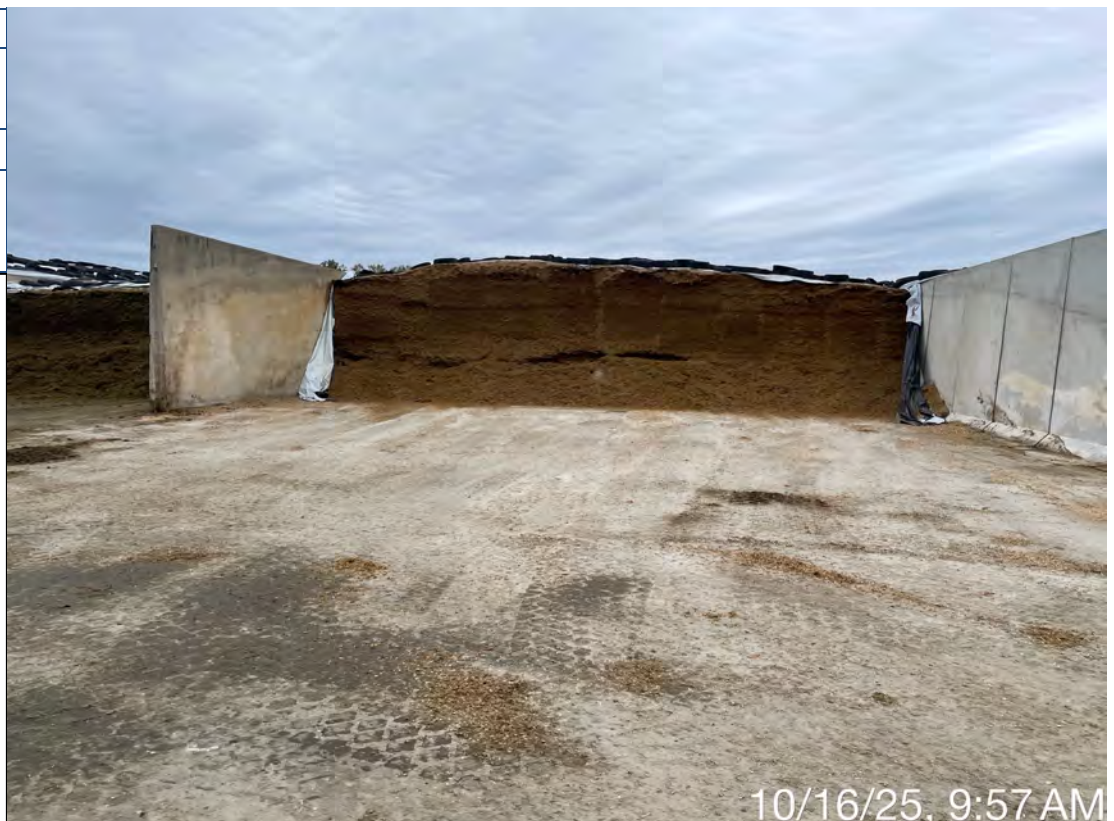
| <b>Photo #:</b> | 21 |

| <b>Photo Location:</b> | Main Dairy<br>Feed Storage |
| <b>Photo Description:</b><br><br>Standing on the south side of FSA looking north: View of an interior bunker. Floor appears to be in good condition. | |

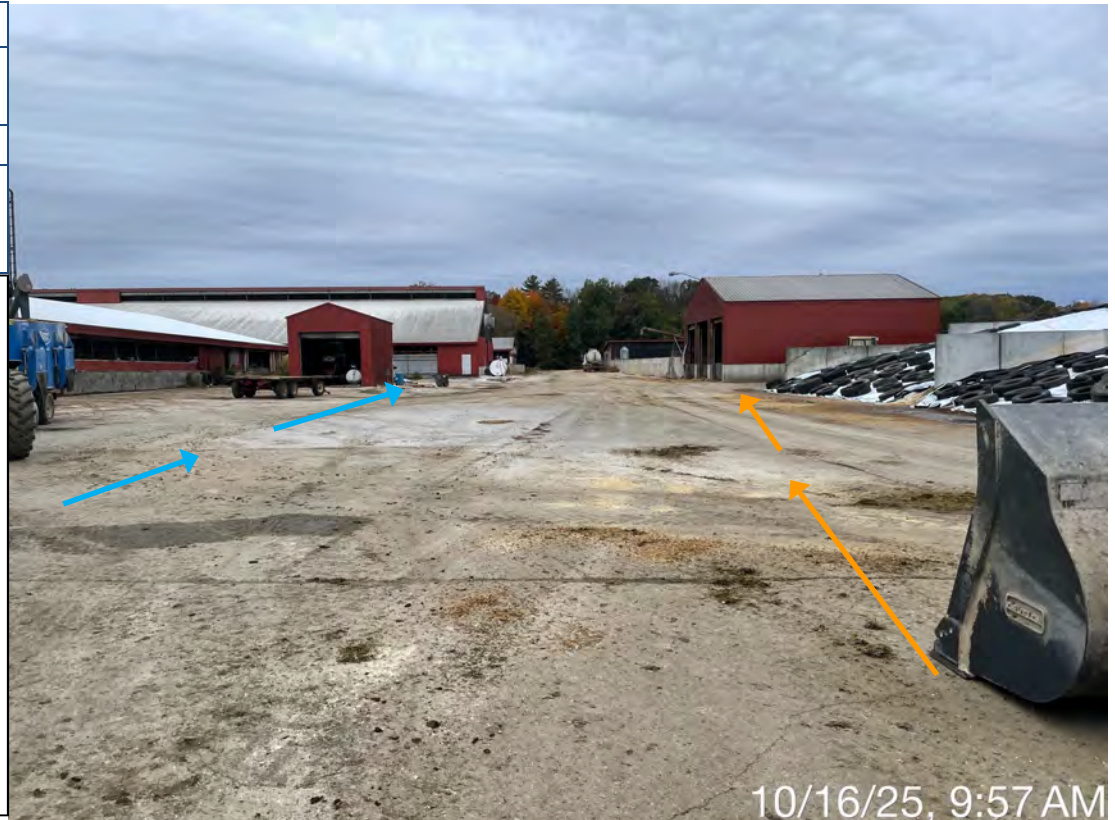
| <b>Photo #:</b> | 22 |

| <b>Photo Location:</b> | Main Dairy<br>Feed Storage |
| <b>Photo Description:</b><br><br>Standing on the south side of FSA looking west: View of south edge of FSA. Orange arrows indicate FSA runoff & blue indicate stormwater runoff. | |
