# Permit Fact Sheet

| Permit Number | WI-0066991-02-0 |
| Permittee Name and Address | Paiser Family Dairy LLC<br>51 Highview Road, Gresham, WI 54128 |

On Thursday October 16th, 2025 Hanson met with Paiser & Schuebel at 9:00 at Paiser Family Dairy LLC site to conduct a mid permit compliance inspection. 2 sites were inspected. The Kroenke farm only has a few personal animals left as the outdoor lots & feed storage area has been abandoned. No significant precipitation had fallen & temperatures were in the 60's and sunny. No permit violations were observed, and no water samples were collected. Hanson departed at approximately 10:30.

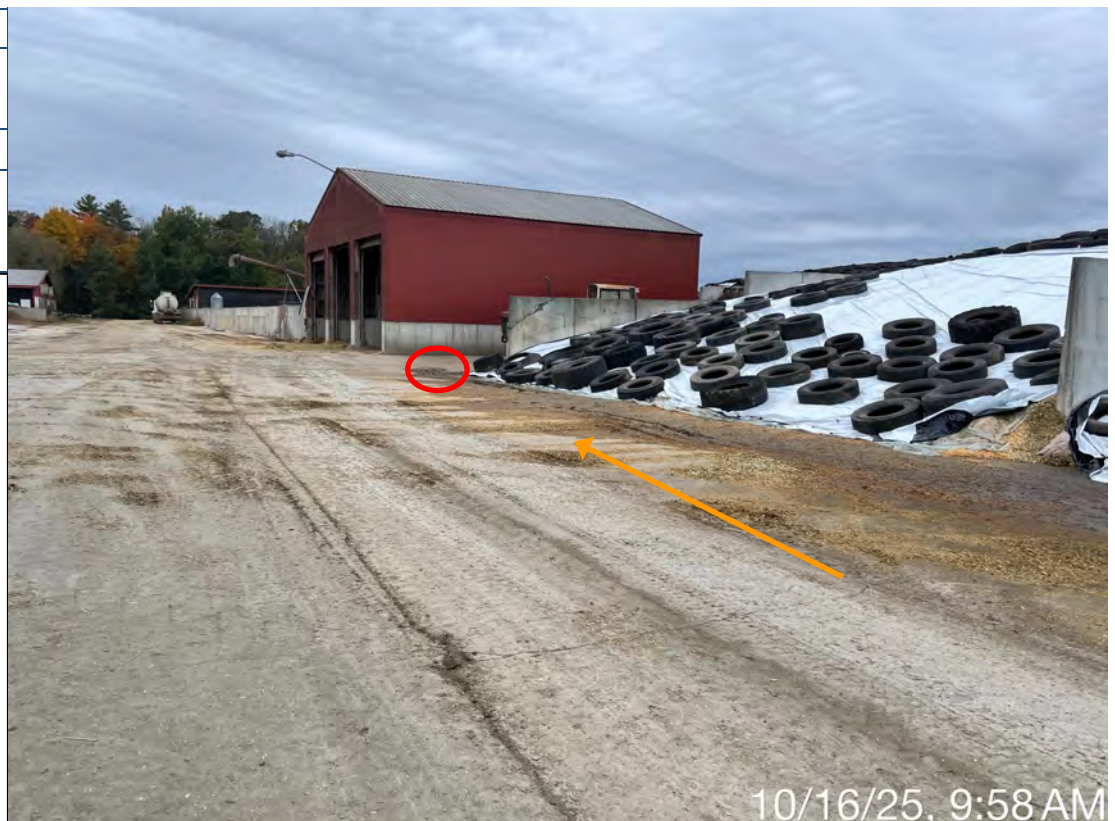
| <b>Photo #:</b> | 23 |

| <b>Photo Location:</b> | Main Dairy<br>Feed Storage |
| <b>Photo Description:</b><br><br>Standing on the south side of FSA looking west: View of west end of FSA. Runoff controls inlet location highlighted. | |

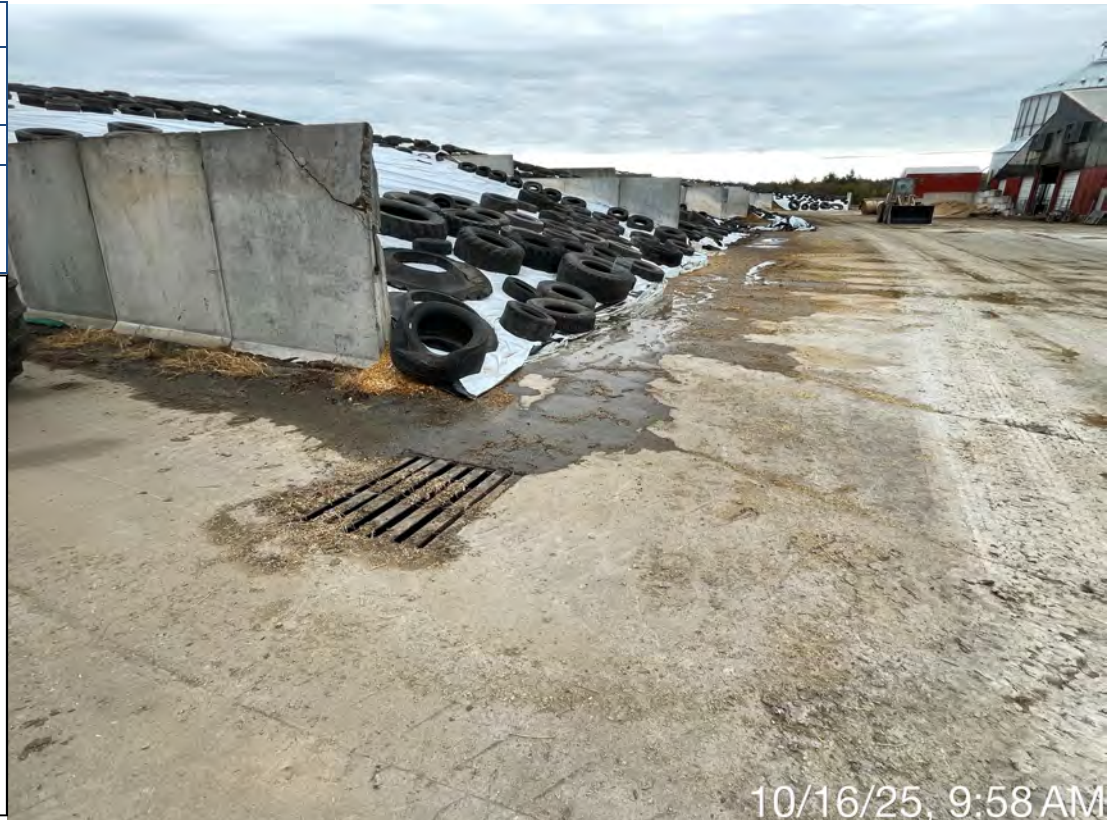
| <b>Photo #:</b> | 24 |

| <b>Photo Location:</b> | Main Dairy<br>Feed Storage |
| <b>Photo Description:</b><br><br>Standing at the southwest corner of FSA looking east:<br>View of runoff control inlet at southwest corner of FSA. | |

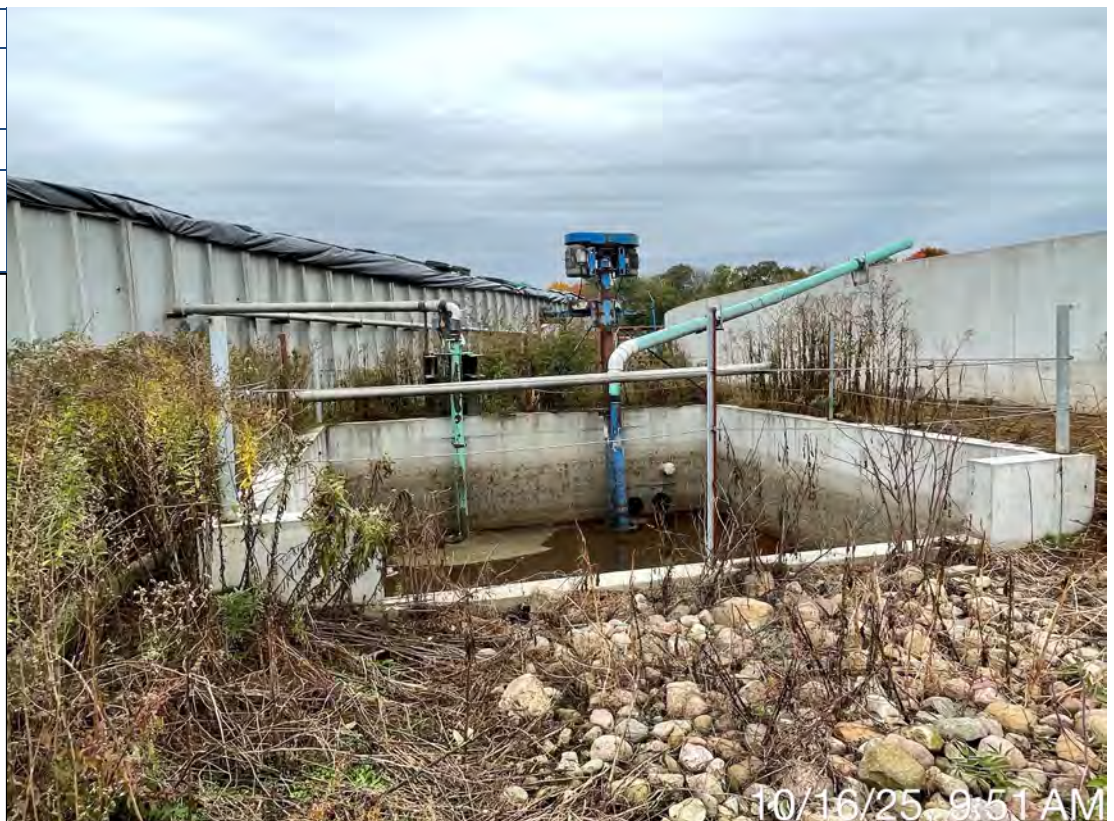
| <b>Photo #:</b> | 25 |

| <b>Photo Location:</b> | Main Dairy<br>Feed Storage |
| <b>Photo Description:</b><br><br>Standing on the north side of FSA looking west: View of runoff collection tank in between FSA & WSF #2. | |

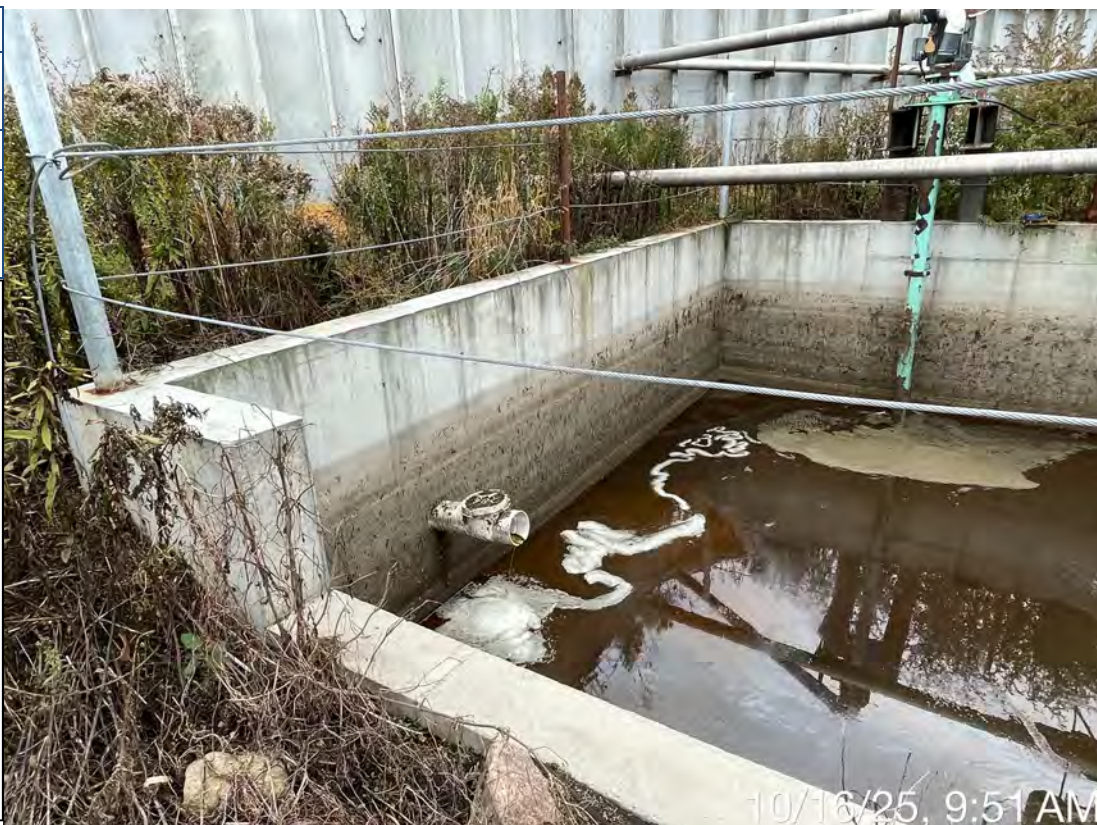
| <b>Photo #:</b> | 26 |

Standing on the east side of runoff collection tank looking southwest & down: View of south wall of runoff collection tank. Notice white pipe in south wall. This is outlet of tile drainage system around FSA.

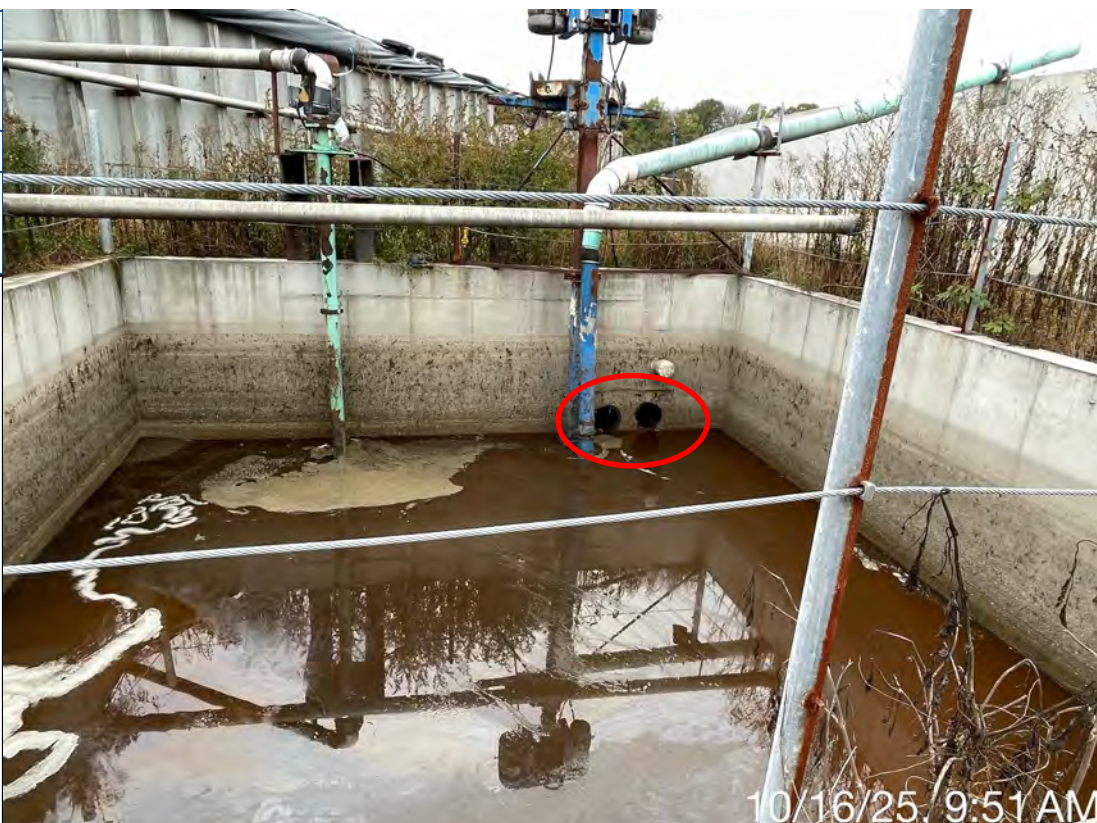
| <b>Photo #:</b> | 27 |

Standing on east side of runoff collection tank looking west: View of west wall of runoff collection tank. Notice 2 black pipe outlets by the north pump. These are outlet pipes from collection inlet in southwest corner of FSA.

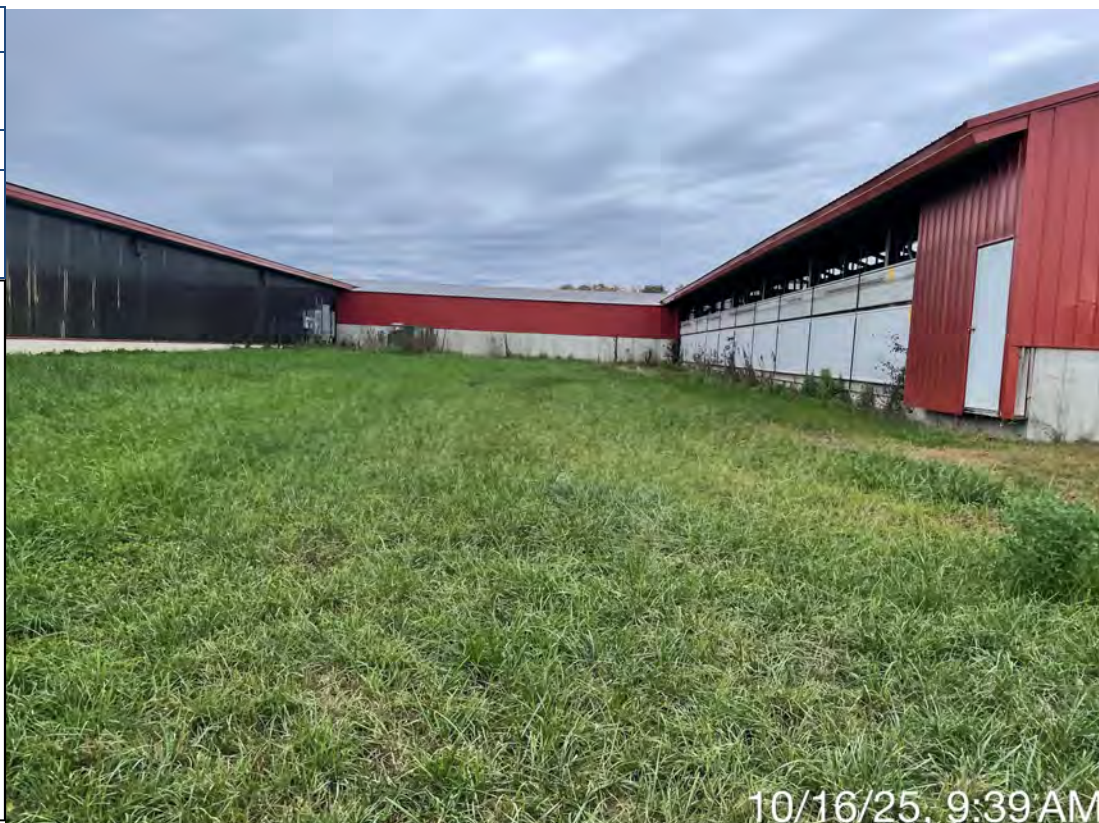
| <b>Photo #:</b> | 28 |

Standing on the south side of freestall barns looking north: View of grassed area in between freestall barns.

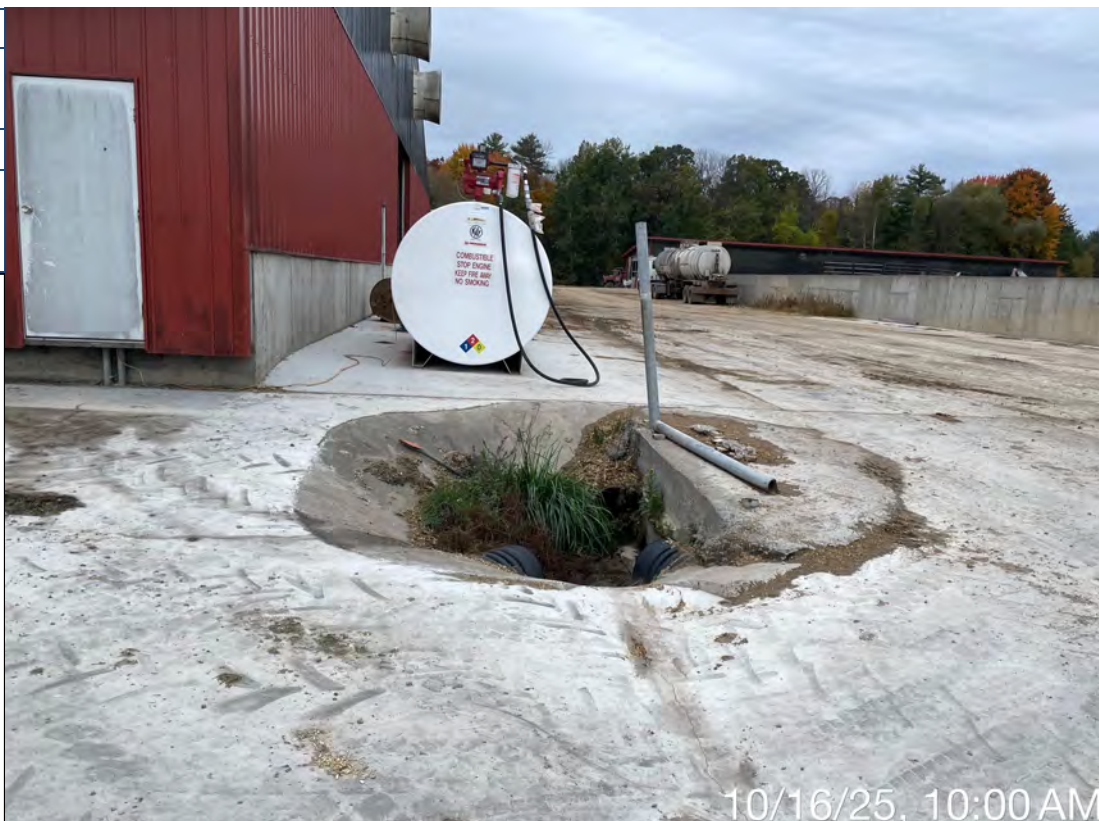
| <b>Photo #:</b> | 29 |

Standing on the north side of heifer barn looking west: View of stormwater inlet on north side of freestall barns. Stormwater that enters this inlet flows west of the production site.

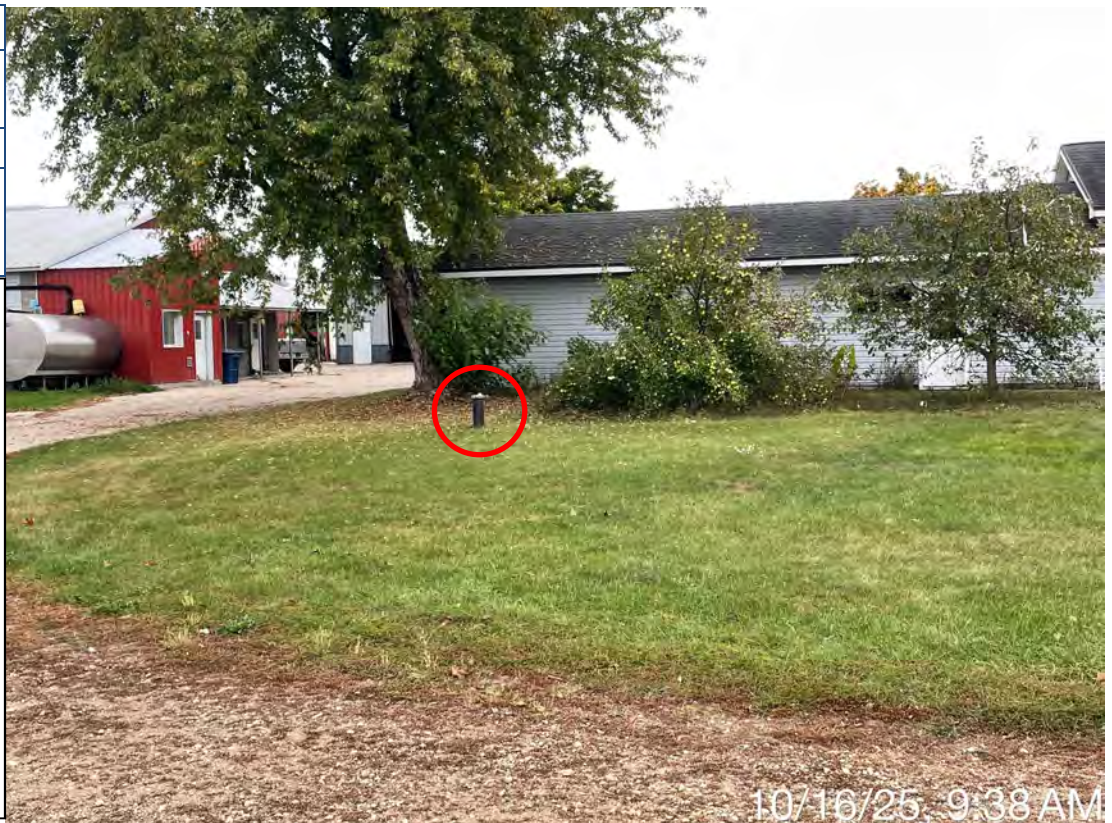
| <b>Photo #:</b> | 30 |

| <b>Photo Location:</b> | Main Dairy<br>Well Location |
| <b>Photo Description:</b><br><br>Standing on the south side of freestall barn looking east: View of water supply well location northwest of house in lawn. | |

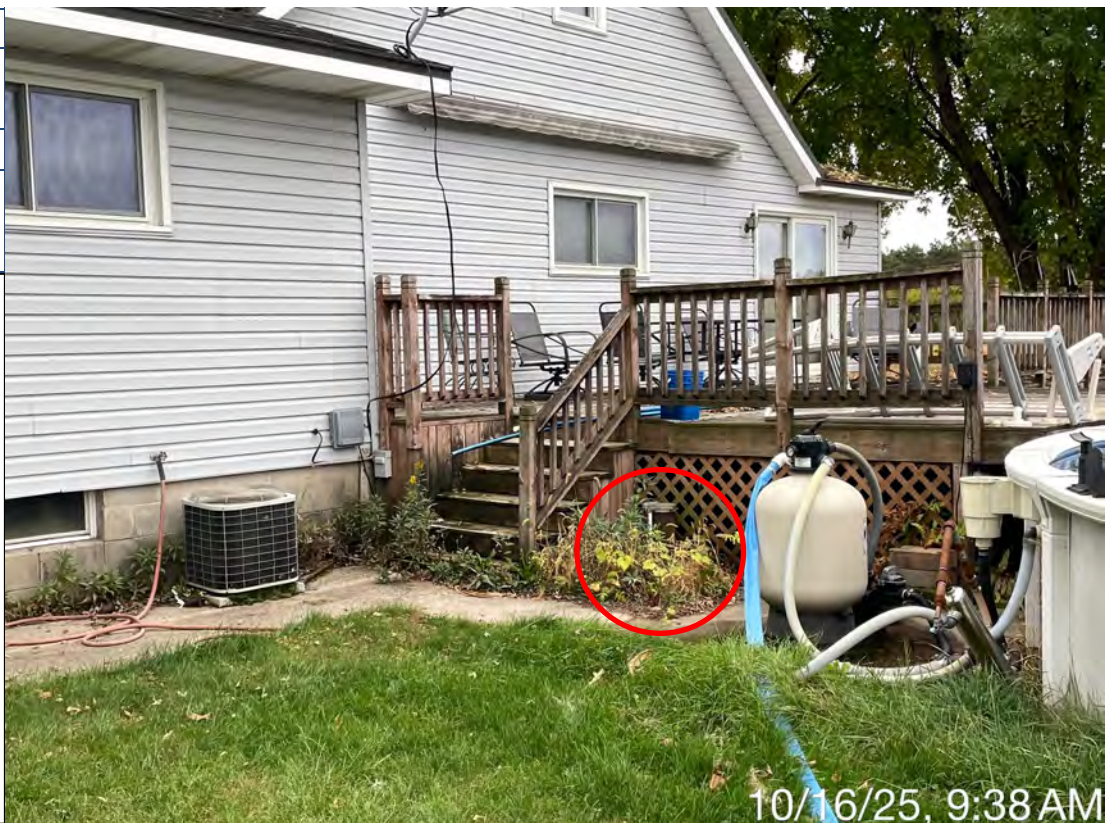
| <b>Photo Location:</b> | Main Dairy<br>Well Location |
| <b>Photo Description:</b><br><br>Standing on west side of house looking southeast: View of water supply well location on west edge of house. | |
