# Permit Fact Sheet

Permit Number	WI-0064521-04-0
Permittee Name and Address	Rohan Dairy Farms LLC N7832 Village Rd, Bear Creek, WI 54922
Permitted Facility Name and Address	Rohan Dairy Farms LLC Main Dairy - N7832 Village Rd Bear Creek WI – NW ¼ SW ¼ Section 30 Township 24N Range 15E Heifer Hill – N7899 Village Rd Bear Creek, WI – NE ¼ SE ¼ Section 25 Township 24N Range 14E
Permit Term	August 01, 2026 to July 31, 2031
Receiving Water	Unnamed tributaries within the Bear Creek – Embarrass River Watershed, and groundwaters of the state
Discharge Type	Existing source CAFO per NR 243.03(23) as the facility has been permitted since 2010.

On Tuesday August 12th, 2025, at 09:00 Hanson met with Rohan & Much at Rohan Dairy Farms LLC site to conduct a permit reissuance walkover inspection. The main dairy site & the Heifer site were inspected. No significant rain had occurred previous to the inspection and the temperature was in the 70's & cloudy. No active discharges were observed, and no water samples were collected. Hanson departed at approximately 11:30.

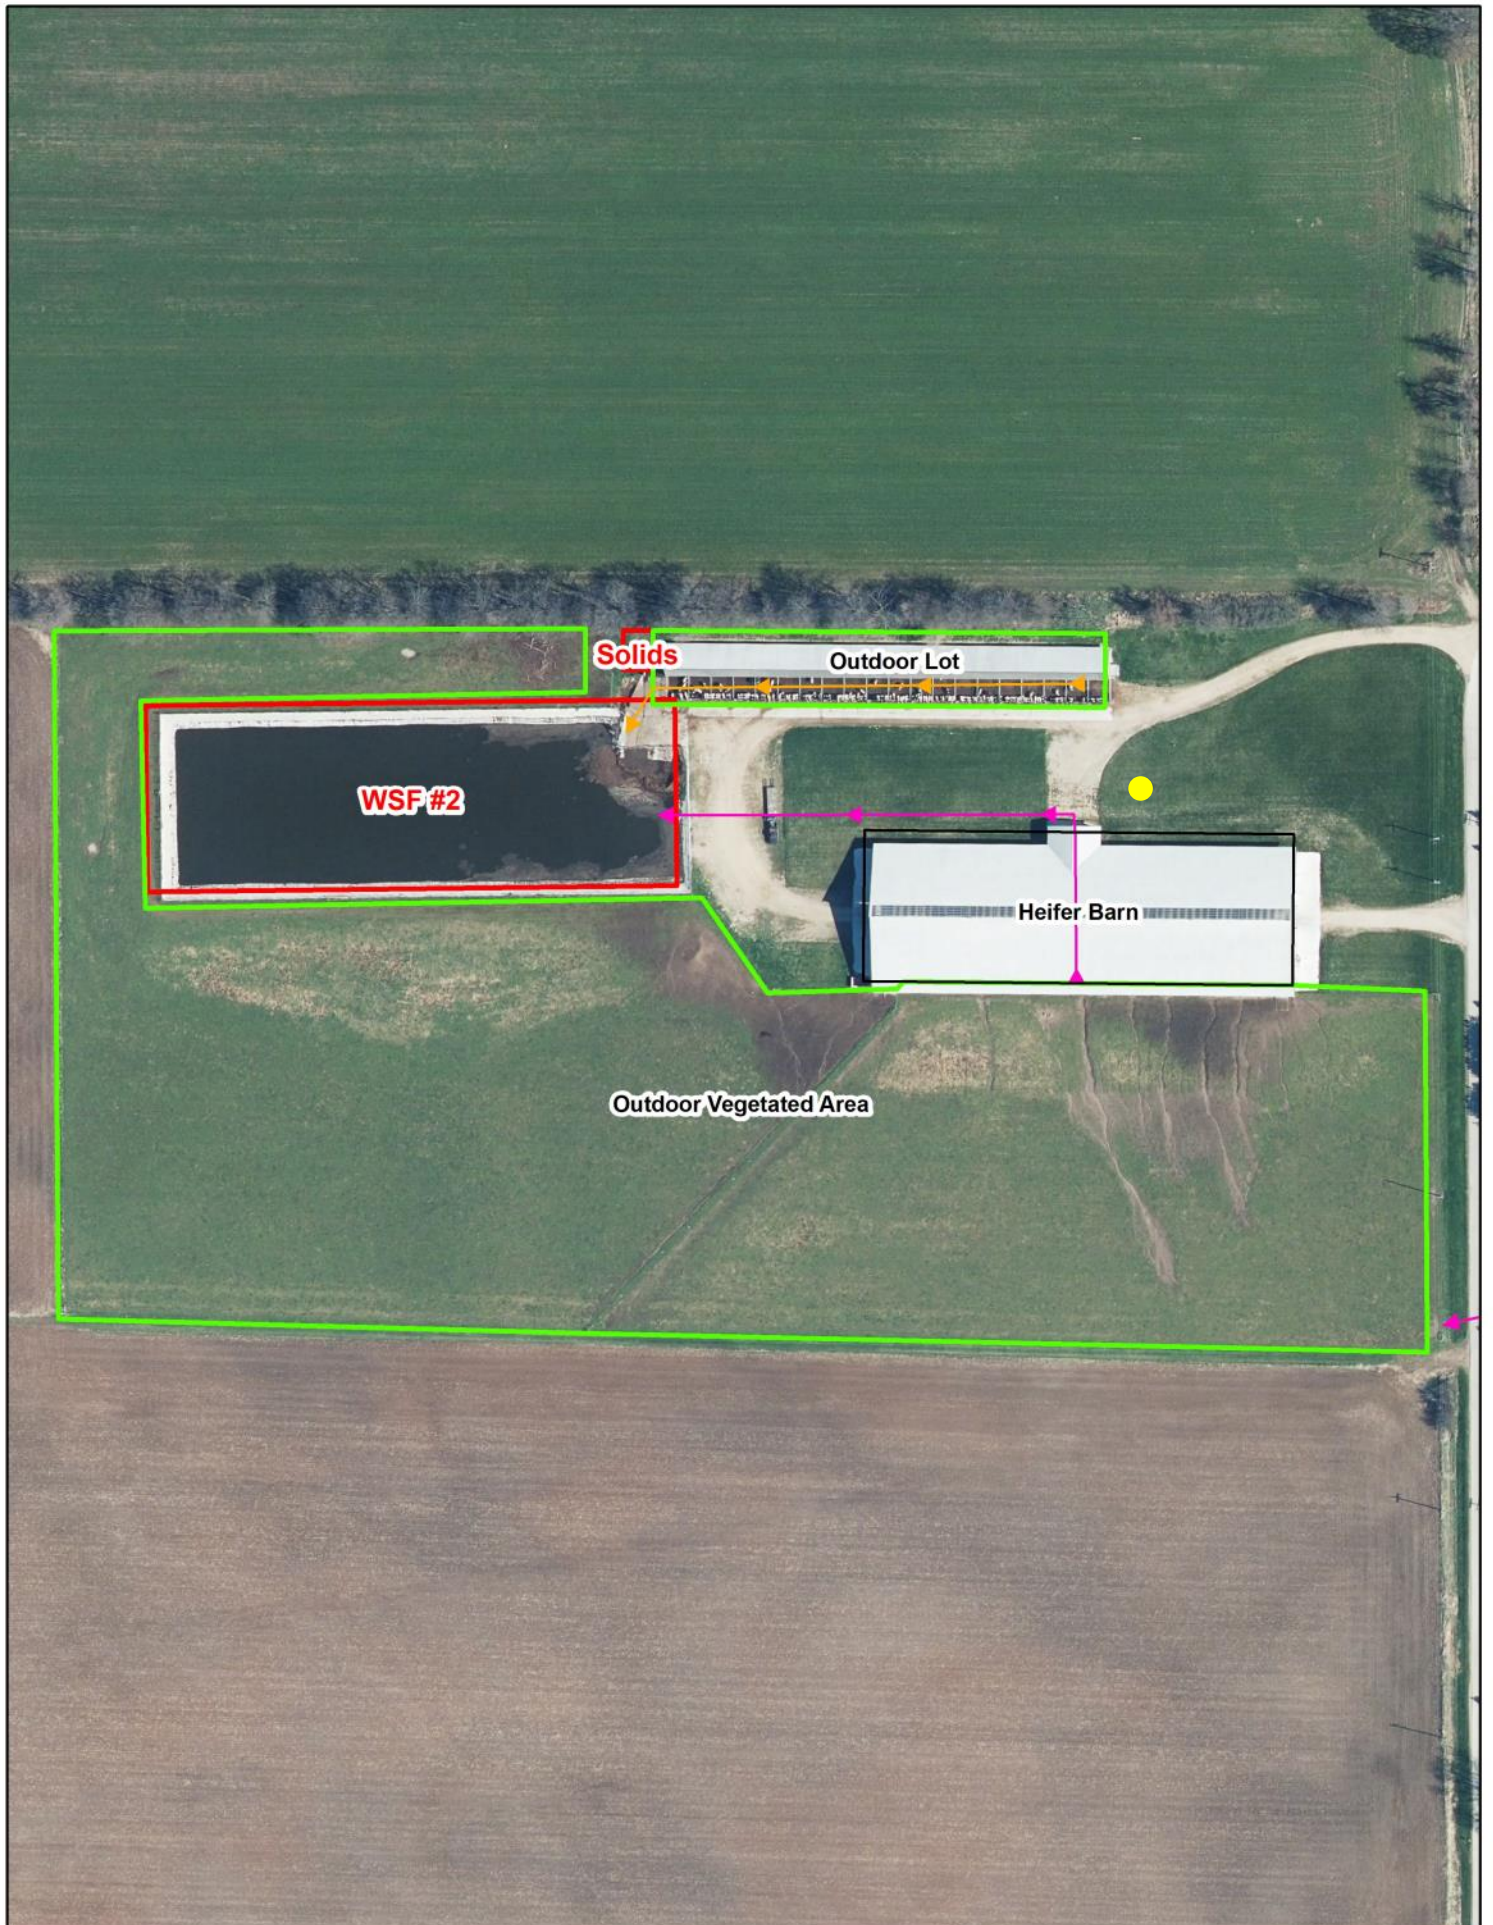
**Site Overview Diagram** (Heifer Hill Farm: orange lines =potential contaminated runoff, blue lines = stormwater flow, pink lines = waste transfer system, Yellow circles = well locations)

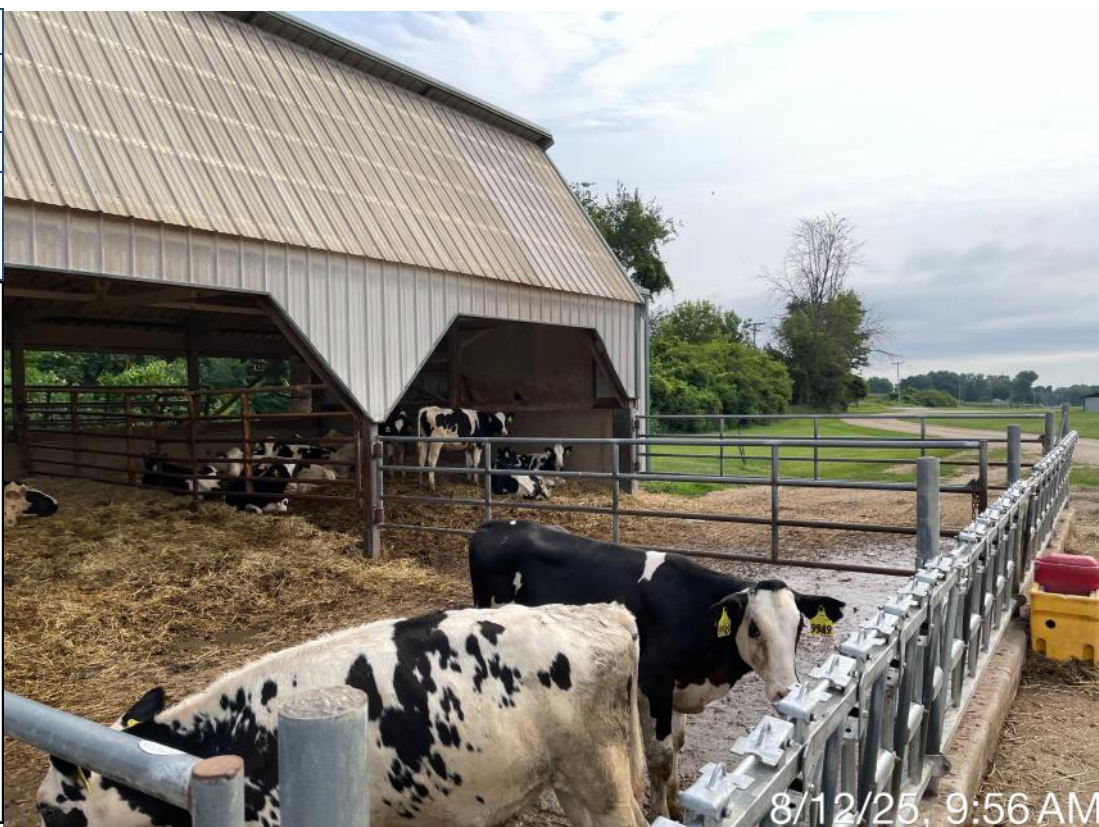
<b>Photo #:</b>	1
<b>Date/Time of Photo:</b>	8/12/2025 09:56
<b>Photo By:</b>	Brian Hanson
<b>Photo Location:</b>	Heifer Hill Outdoor Lot

**Photo Description:**  
Standing on the south side of outdoor concrete lot looking northeast: View of east end of outdoor lot.

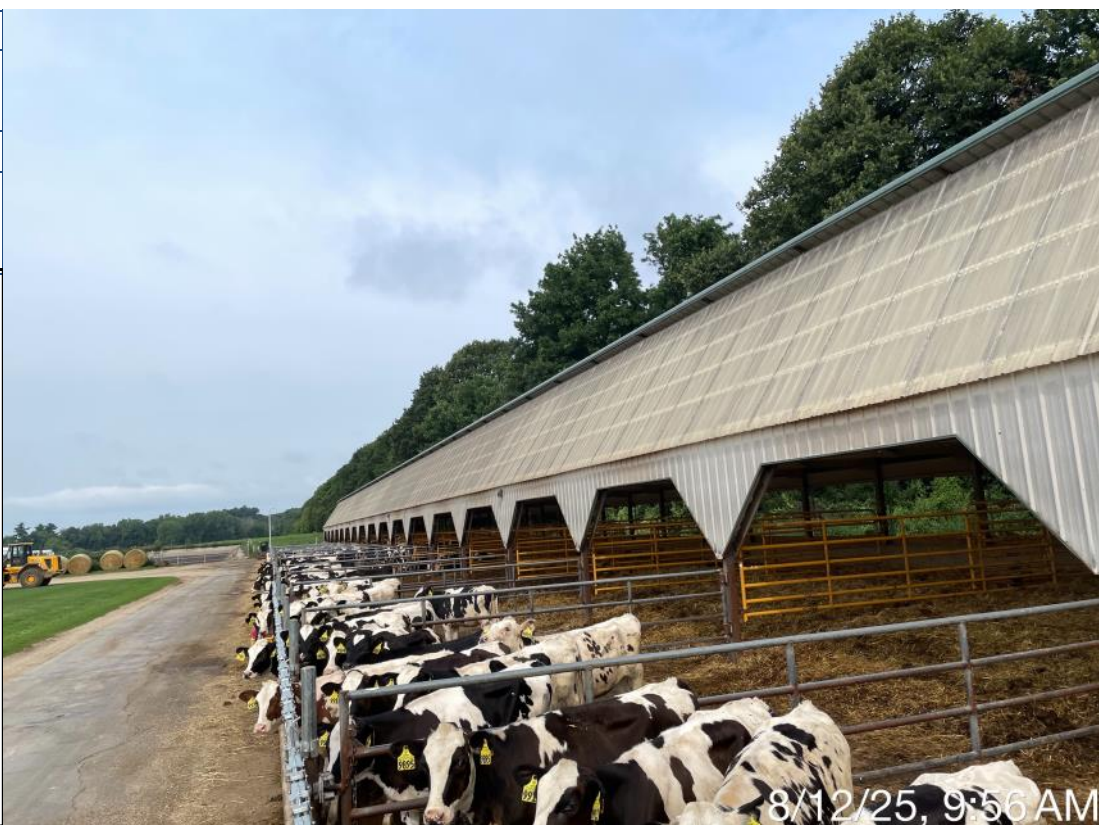
<b>Photo #:</b>	2
<b>Date/Time of Photo:</b>	8/12/2025 09:56
<b>Photo By:</b>	Brian Hanson
<b>Photo Location:</b>	Heifer Hill Outdoor Lot

**Photo Description:**  
Standing on the south side of outdoor concrete lot looking west: View of bedded pack pens, litter alley & drive by feeding rail.

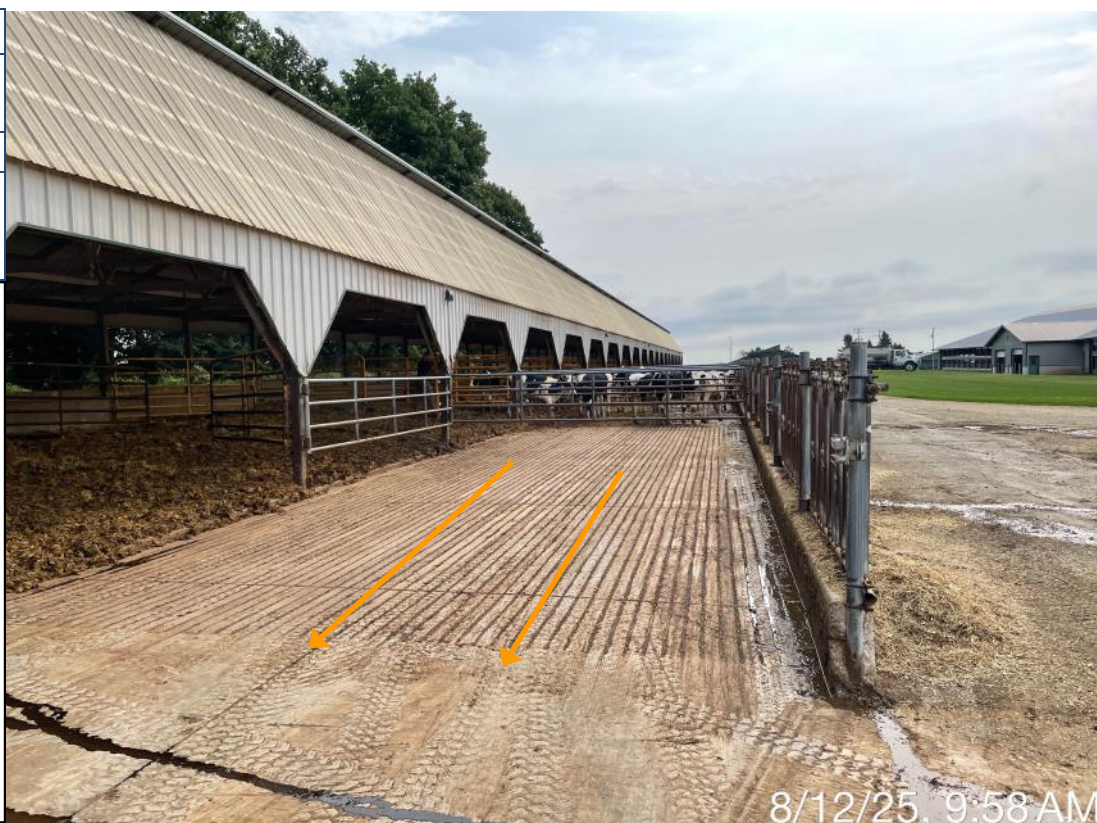
<b>Photo #:</b>	3
<b>Date/Time of Photo:</b>	8/12/2025 09:58
<b>Photo By:</b>	Brian Hanson
<b>Photo Location:</b>	Heifer Hill Outdoor Lot

**Photo Description:**  
Standing on west end of outdoor lot looking east: View of western end of litter alley. Arrows indicate direction of runoff flow.

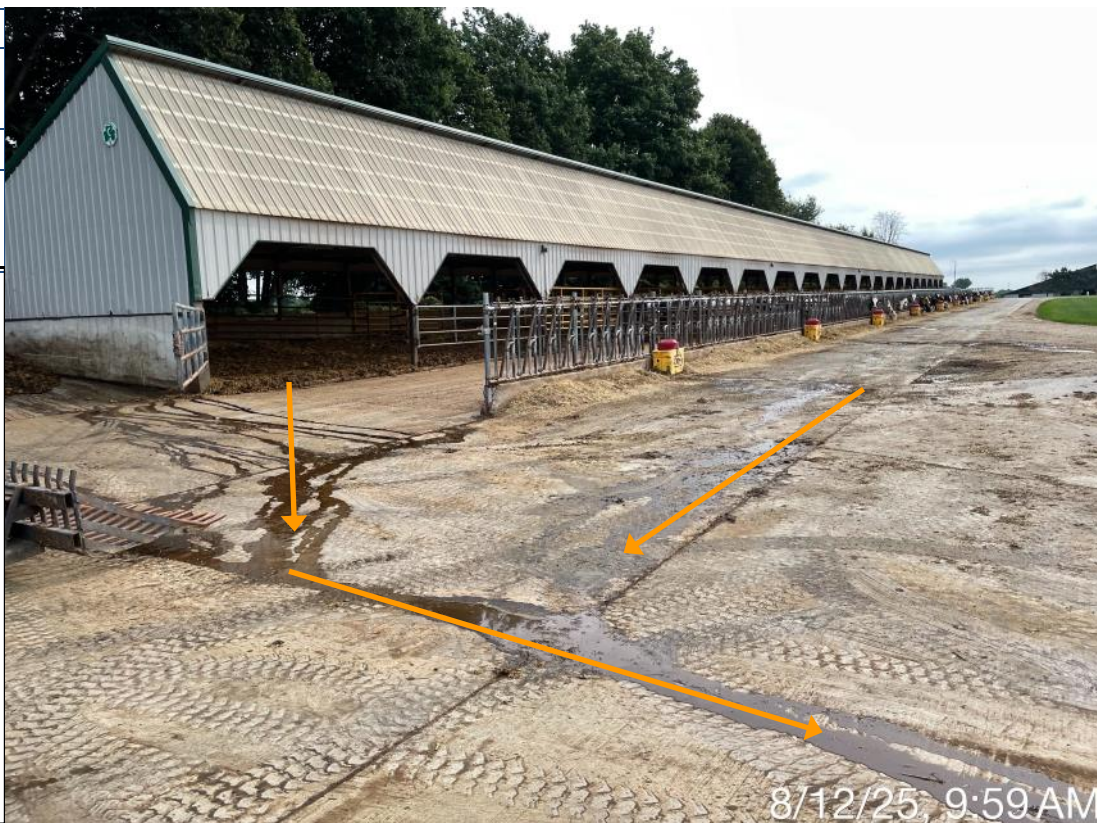
<b>Photo #:</b>	4
<b>Date/Time of Photo:</b>	8/12/2025 09:59
<b>Photo By:</b>	Brian Hanson
<b>Photo Location:</b>	Heifer Hill Outdoor Lot

**Photo Description:**  
Standing on the southwest corner of outdoor lot looking northeast: View of west end of concrete lot. Arrows indicate direction of runoff flow.

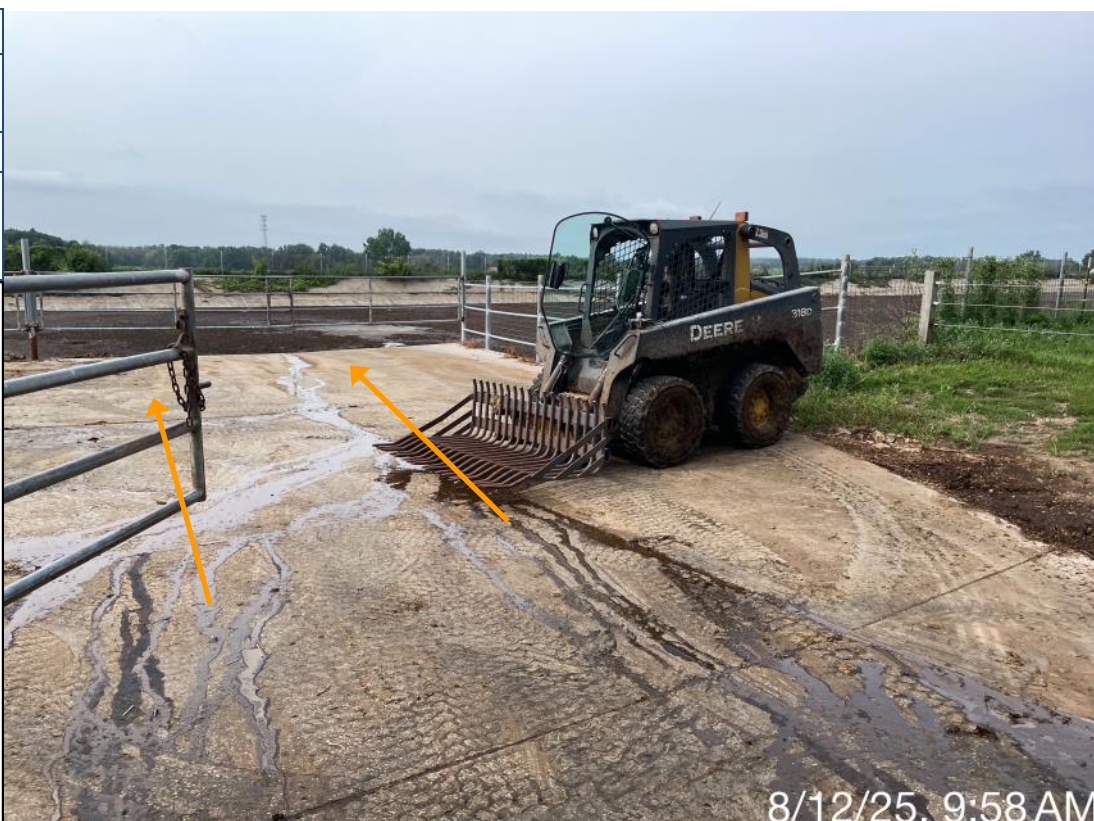
**Photo Description:**  
Standing on the west end of outdoor lot looking south: View of west end of outdoor lot where runoff flows directly into WSF #2.

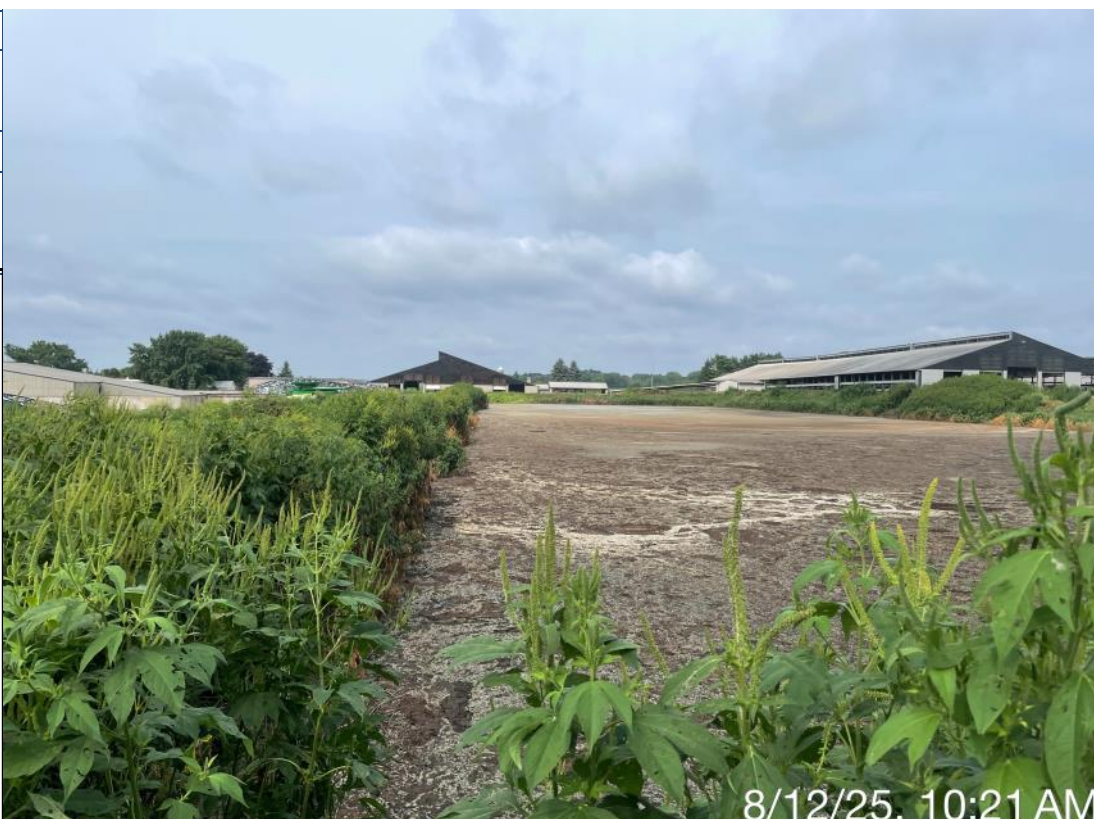
<b>Photo #:</b>	6
<b>Date/Time of Photo:</b>	8/12/2025 10:21
<b>Photo By:</b>	Brian Hanson
<b>Photo Location:</b>	Main Dairy WSF #1

At the time of inspection, a safety fence was visible, but difficult to see its condition due the berm and interior sides slopes being covered in tall dense vegetation. Markers were not visible due to vegetation, but Rohan pointed out where they were.

Except as noted above, solid and liquid waste storage structures are well-maintained, in good repair, and appear to be in compliance with permit requirements. Maintenance of WSF #1 is needed to ensure liner integrity is not being compromised. See photo log for details.

**Photo Description:**  
Standing on the east side of WSF #1 looking west: View of southeast corner of WSF #1. Notice abundant vegetation.

- WSF #1 has excessive vegetation growth along the top of the berm and the interior side slopes. Failure to control this vegetation may have a negative effect on the integrity of the earthen liner. Perform maintenance activities to control this vegetation.

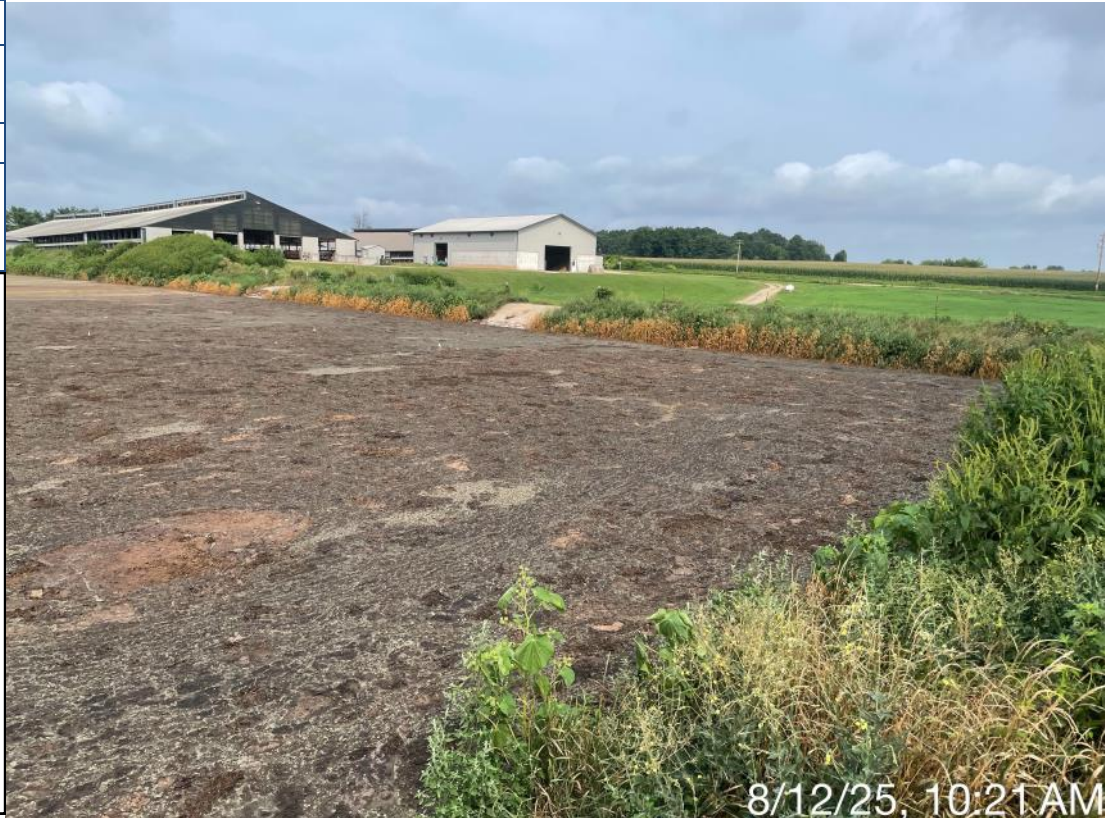
<b>Photo #:</b>	7
<b>Date/Time of Photo:</b>	8/12/2025 10:21
<b>Photo By:</b>	Brian Hanson
<b>Photo Location:</b>	Main Dairy WSF #1
<b>Photo Description:</b>	Standing on the east side of WSF #1 looking northwest: View of northeast corner of WSF #1.

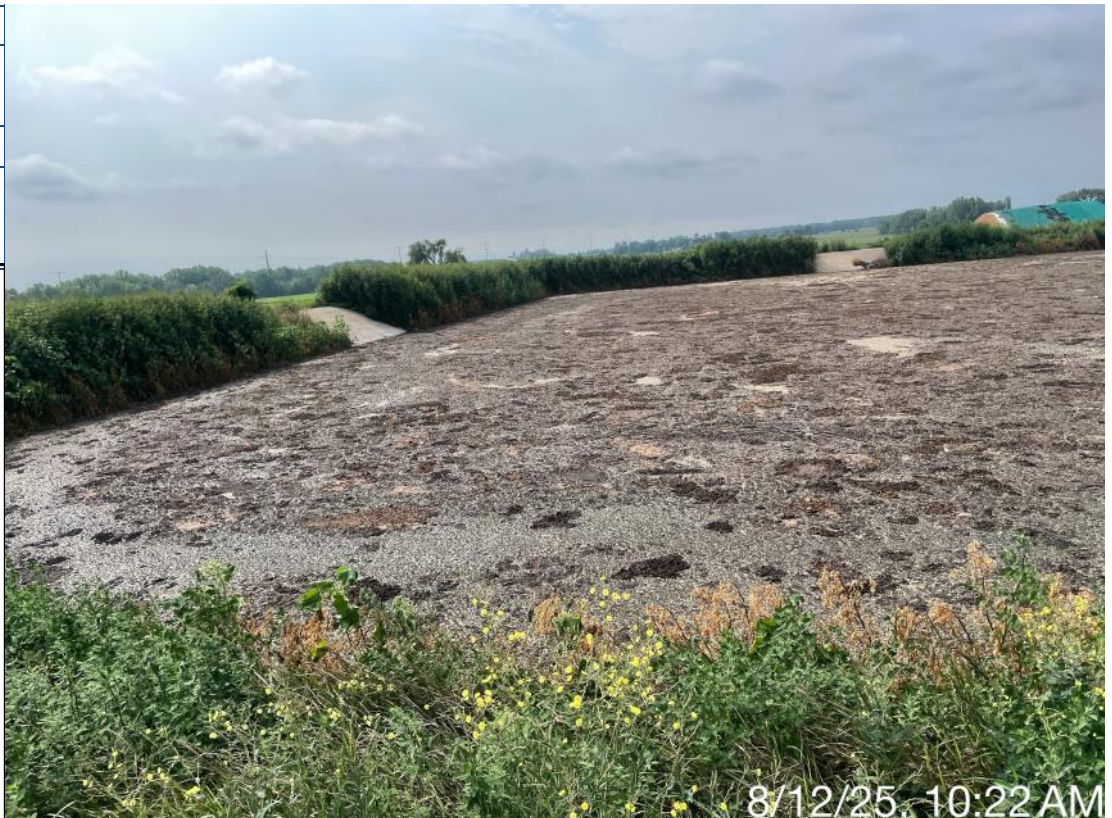
<b>Photo #:</b>	8
<b>Date/Time of Photo:</b>	8/12/2025 10:22
<b>Photo By:</b>	Brian Hanson
<b>Photo Location:</b>	Main Dairy WSF #1
<b>Photo Description:</b>	Standing on north side of WSF #1 looking south: View of east end of WSF #1.

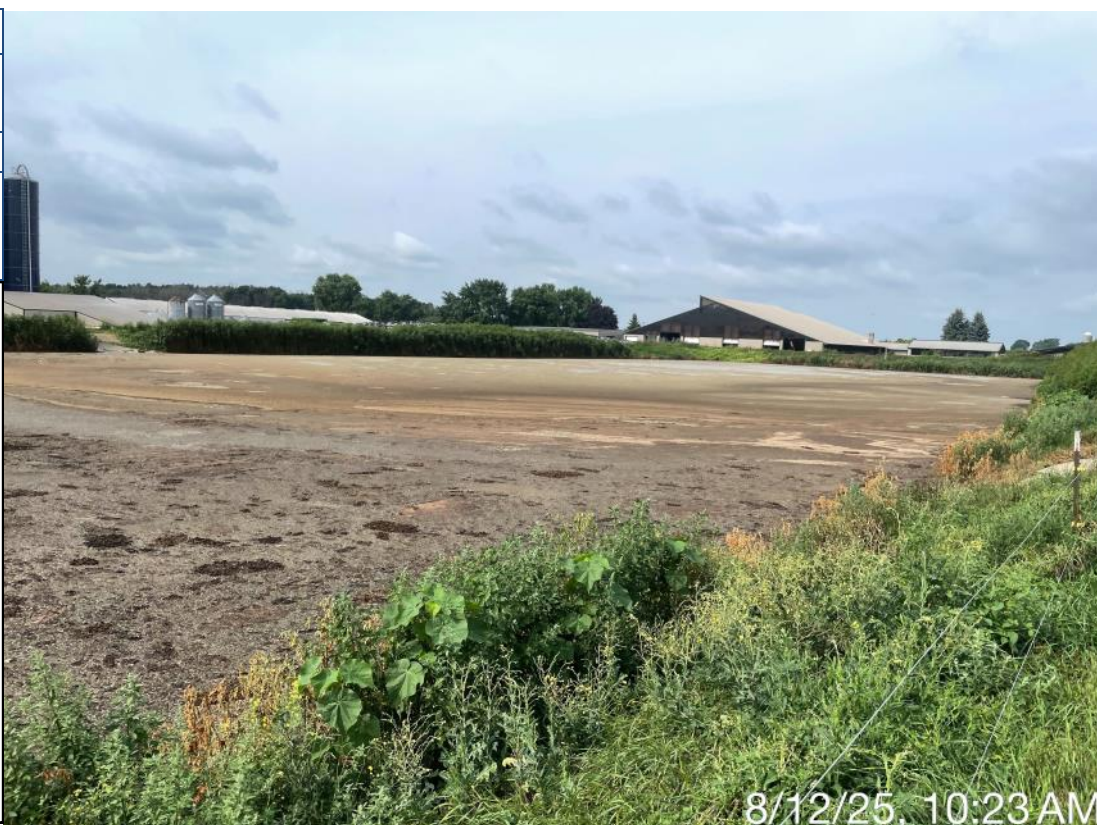
<b>Photo #:</b>	9
<b>Date/Time of Photo:</b>	8/12/2025 10:23
<b>Photo By:</b>	Brian Hanson
<b>Photo Location:</b>	Main Dairy WSF #1
<b>Photo Description:</b>	Standing on the north side of WSF #1 looking west: View of western 1/2 of WSF #1.

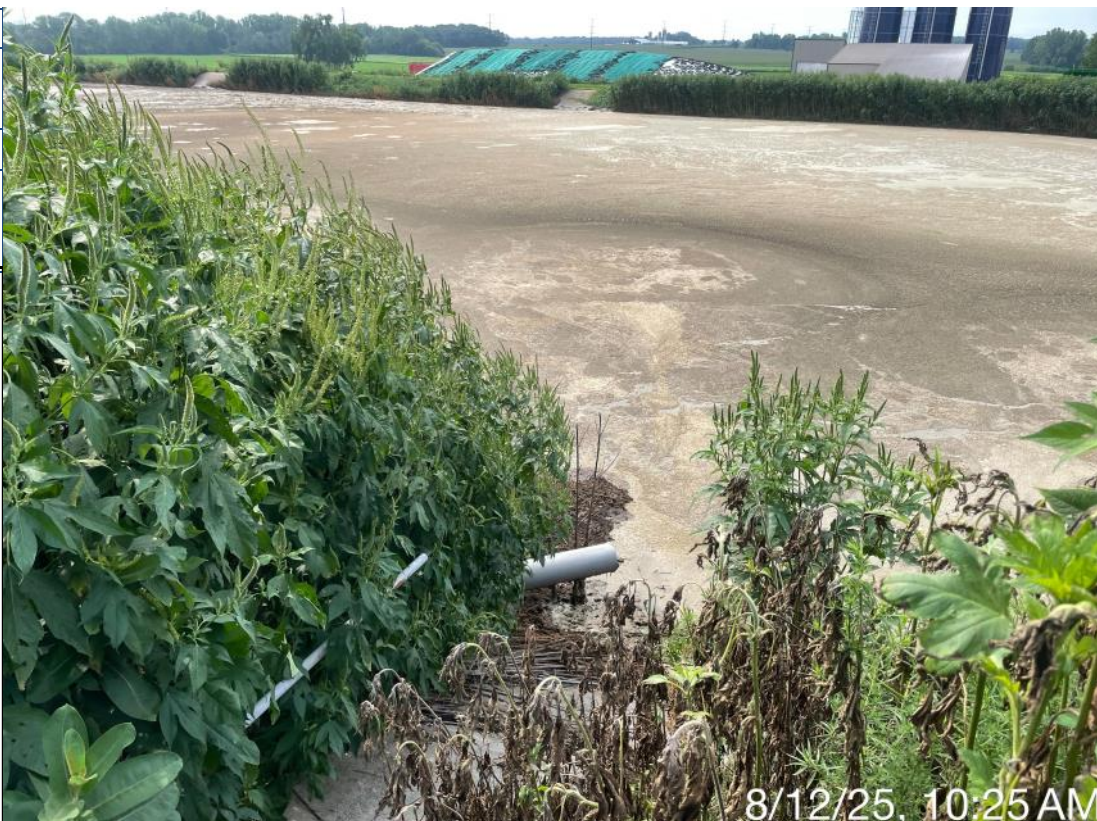
<b>Photo #:</b>	10
<b>Date/Time of Photo:</b>	8/12/2025 10:25
<b>Photo By:</b>	Brian Hanson
<b>Photo Location:</b>	Main Dairy WSF #1
<b>Photo Description:</b>	.Standing on the north side of WSF #1 looking southeast & down. View of sand separation building outlet pipe as it enters WSF #1. Permanent markers are concrete ledges built into the agitation pad just west of this, but are covered by vegetation.

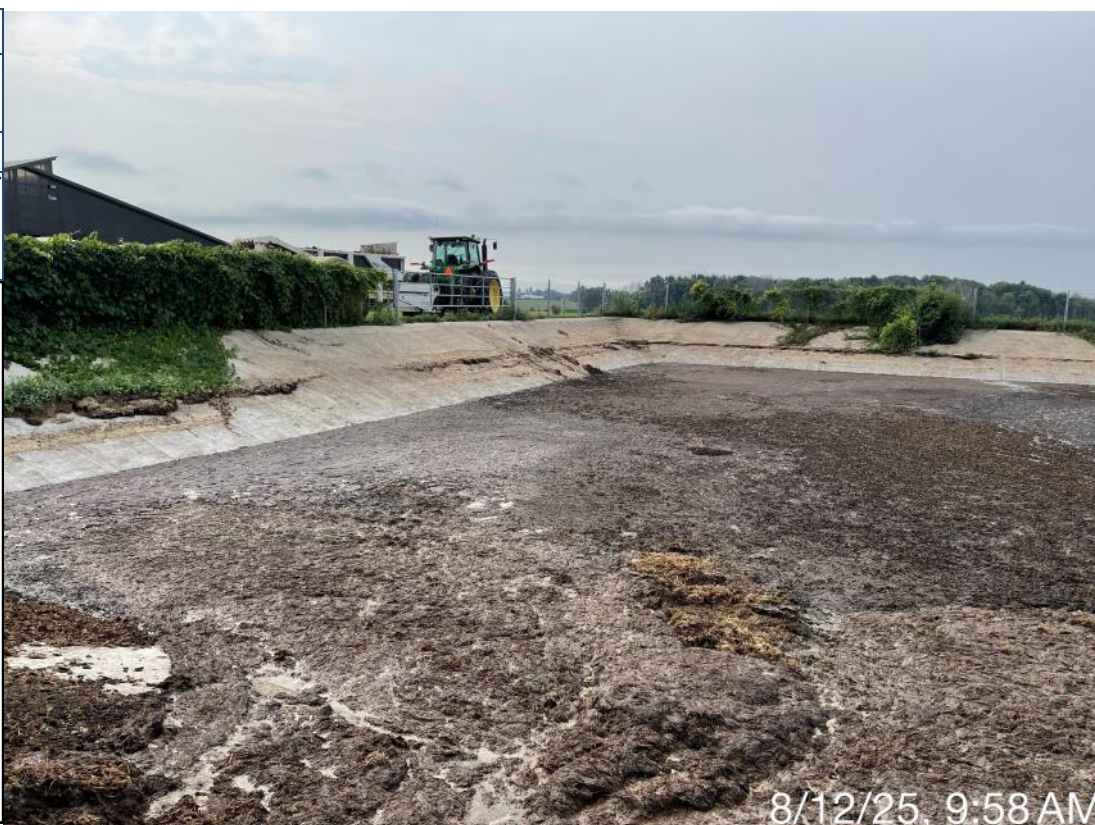
<b>Photo #:</b>	11
<b>Date/Time of Photo:</b>	8/12/2025 09:58
<b>Photo By:</b>	Brian Hanson
<b>Photo Location:</b>	Heifer Hill WSF #2

**Photo Description:**  
Standing on the north side of WSF #2 looking southeast: View of southeast corner of WSF #2.

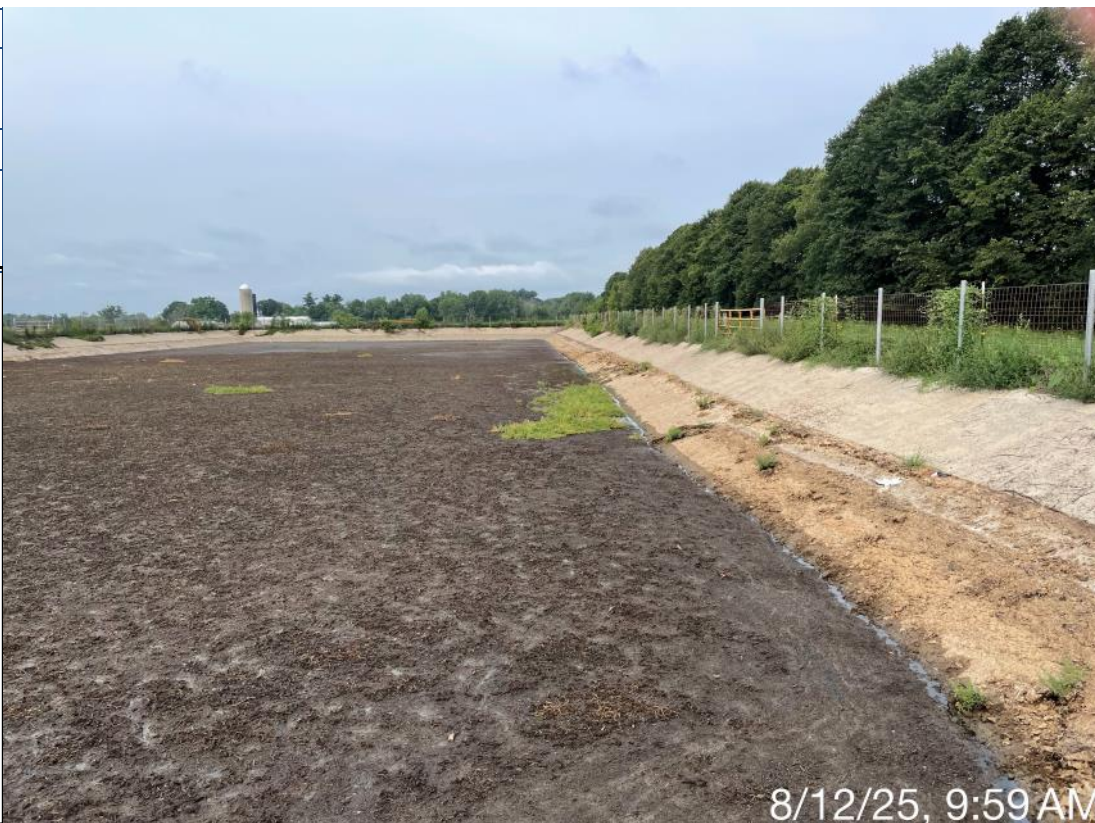
<b>Photo #:</b>	12
<b>Date/Time of Photo:</b>	8/12/2025 09:59
<b>Photo By:</b>	Brian Hanson
<b>Photo Location:</b>	Heifer Hill WSF #2

**Photo Description:**  
.Standing on east side of WSF #2 looking west: View of north side of WSF #2.

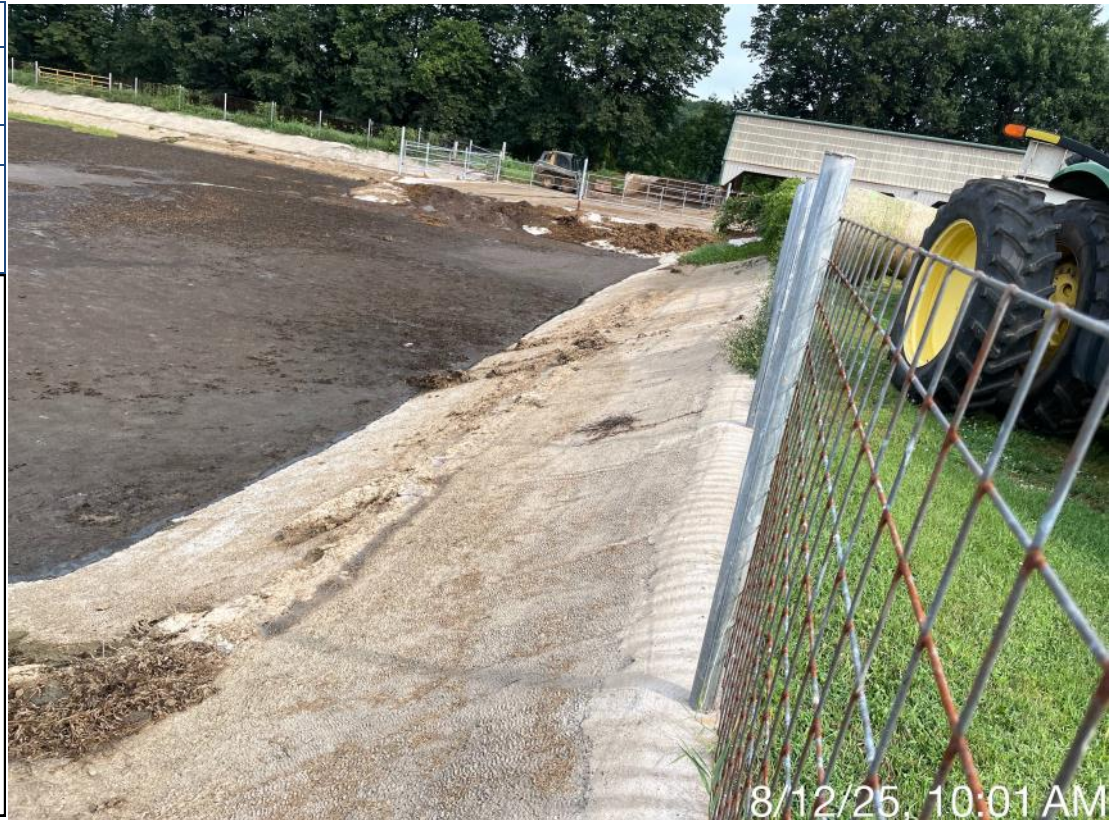
**Photo Description:**  
Standing on the east side of WSF #2 looking north: View of east edge of WSF #2.

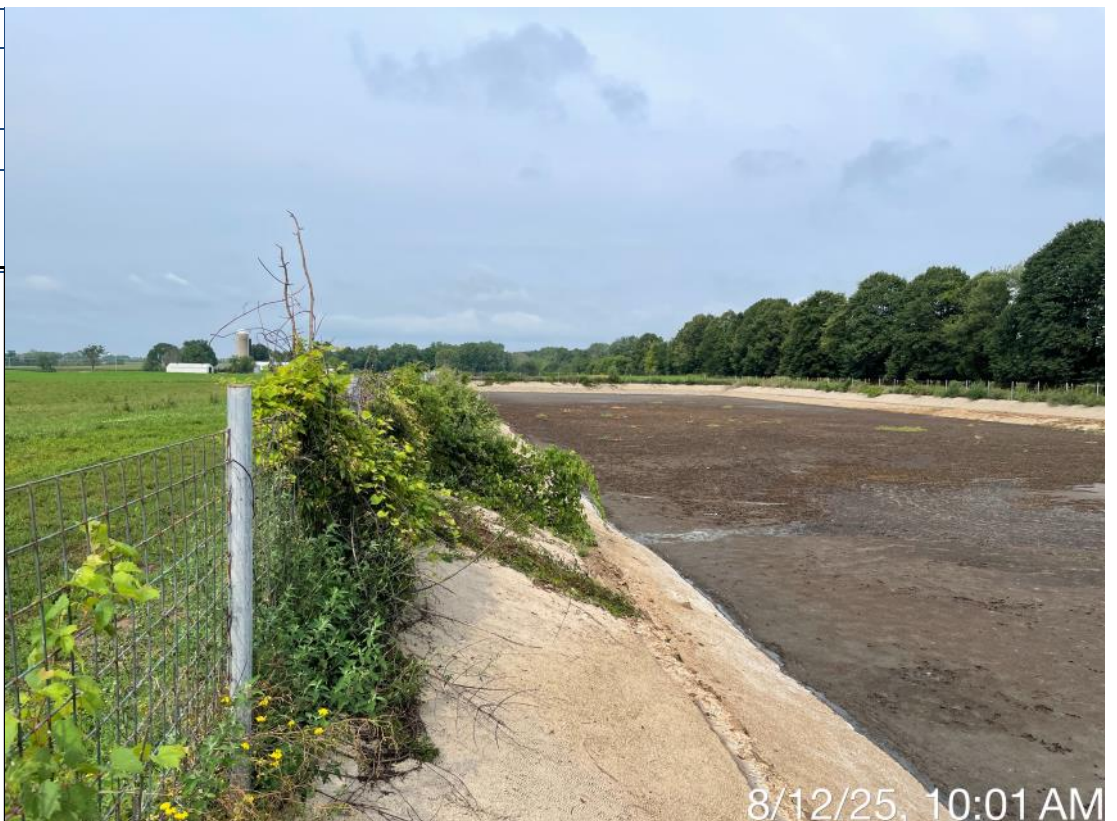
<b>Photo #:</b>	14
<b>Date/Time of Photo:</b>	8/12/2025 10:01
<b>Photo By:</b>	Brian Hanson
<b>Photo Location:</b>	Heifer Hill WSF #2

**Photo Description:**  
Standing on the south side of WSF #2 looking west: View of south edge of WSF #2.

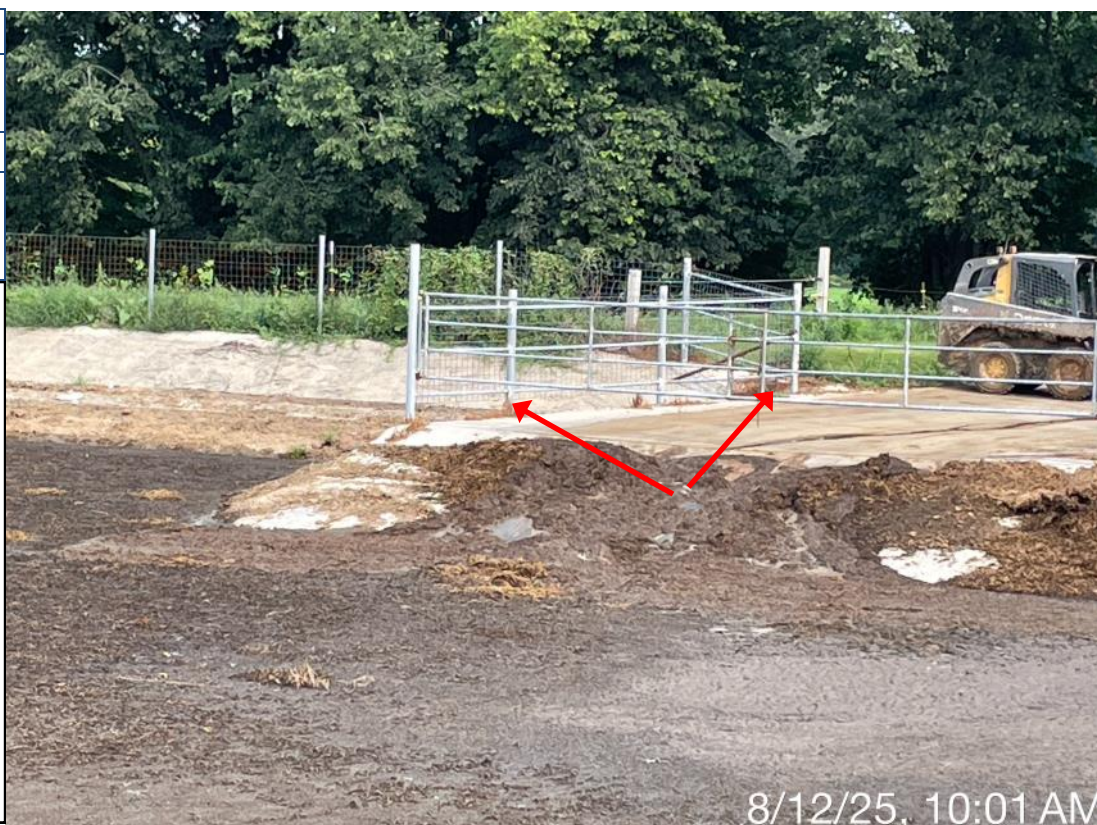
<b>Photo #:</b>	15
<b>Date/Time of Photo:</b>	8/12/2025 10:01
<b>Photo By:</b>	Brian Hanson
<b>Photo Location:</b>	Heifer Hill WSF #2

**Photo Description:**  
Standing on the south side of WSF #2 looking north: View of permanent markers for WSF #2. Marker elevations are at or near the bottom of the indicated posts.

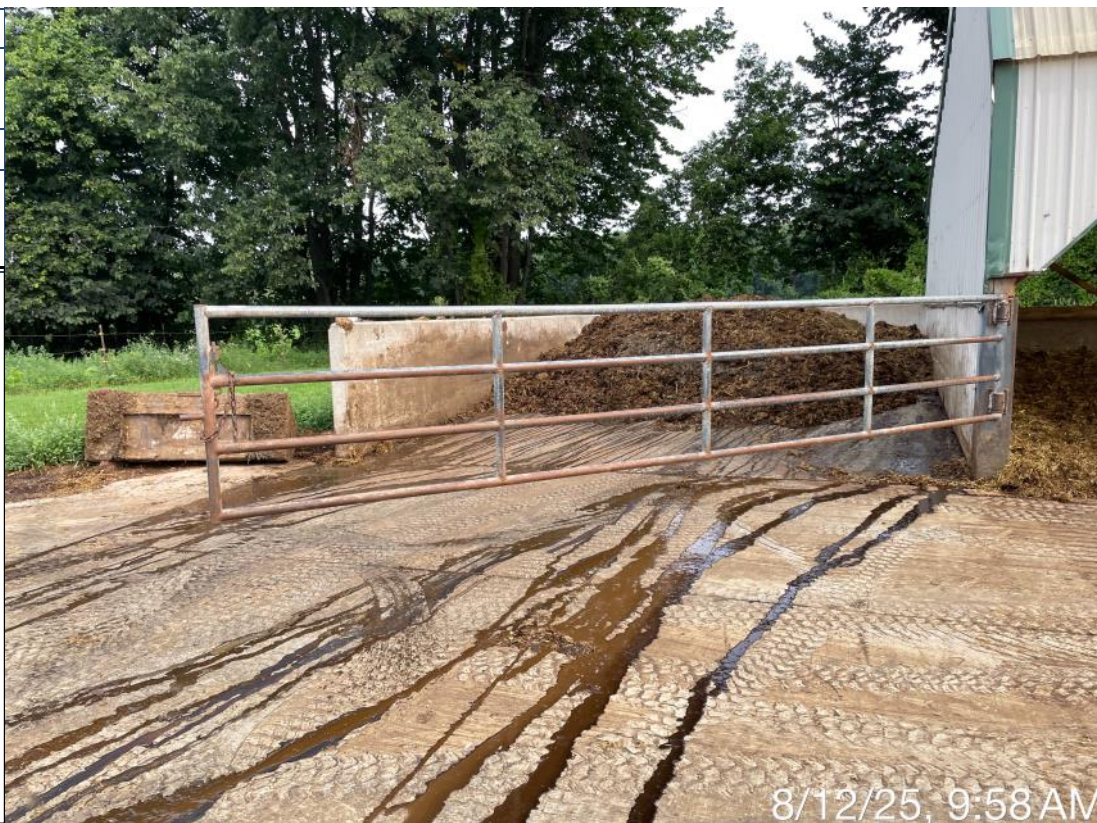
<b>Photo #:</b>	16
<b>Date/Time of Photo:</b>	8/12/2025 09:58
<b>Photo By:</b>	Brian Hanson
<b>Photo Location:</b>	Heifer Hill Solids Stacking

**Photo Description:**  
Standing on the west end of the outdoor lot looking north: View of solid manure stacking area on west end of outdoor lot. Notice runoff flowing directly towards WSF #2.

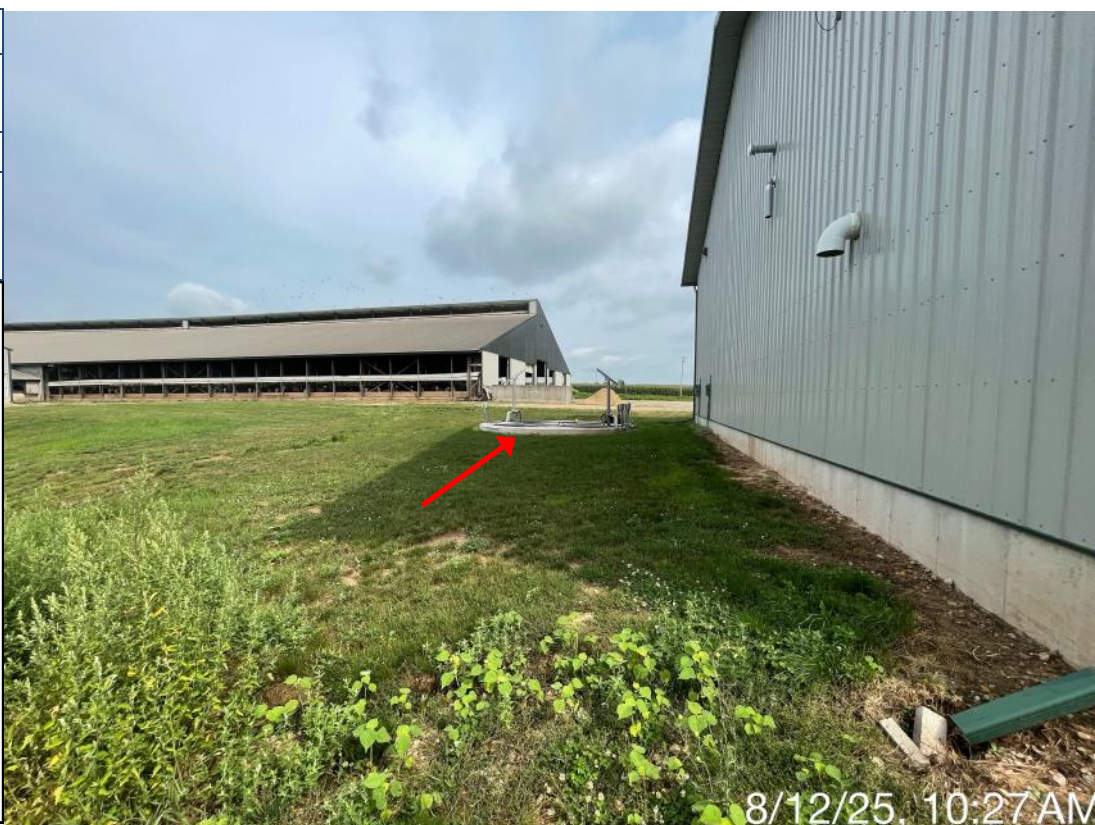
<b>Photo #:</b>	17
<b>Date/Time of Photo:</b>	8/12/2025 10:27
<b>Photo By:</b>	Brian Hanson
<b>Photo Location:</b>	Main Dairy Sand Building

**Photo Description:**  
Standing on the west side of sand separation building looking north: View of reception tank used to join and mix all manure sources prior to sand separation system.

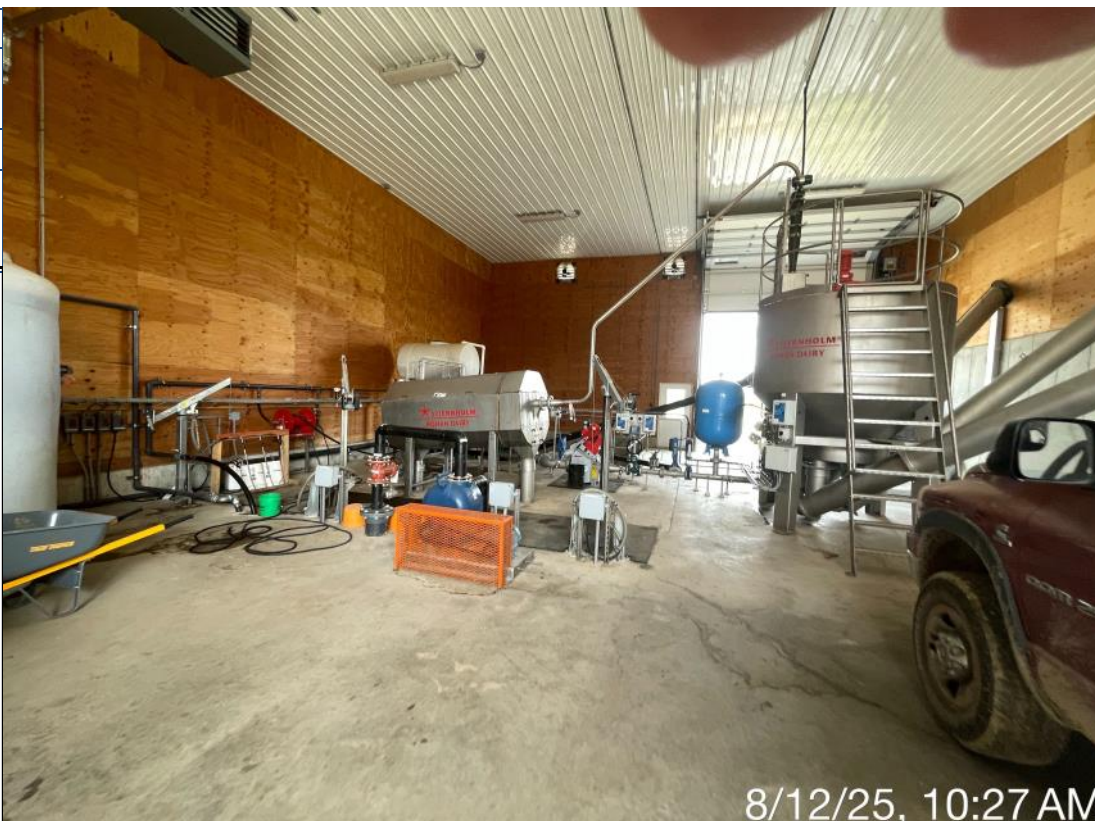
<b>Photo #:</b>	18
<b>Date/Time of Photo:</b>	8/12/2025 10:27
<b>Photo By:</b>	Brian Hanson
<b>Photo Location:</b>	Main Dairy Sand Building

**Photo Description:**  
Standing inside sand separation building looking north: View of Stjernholm sand separator.

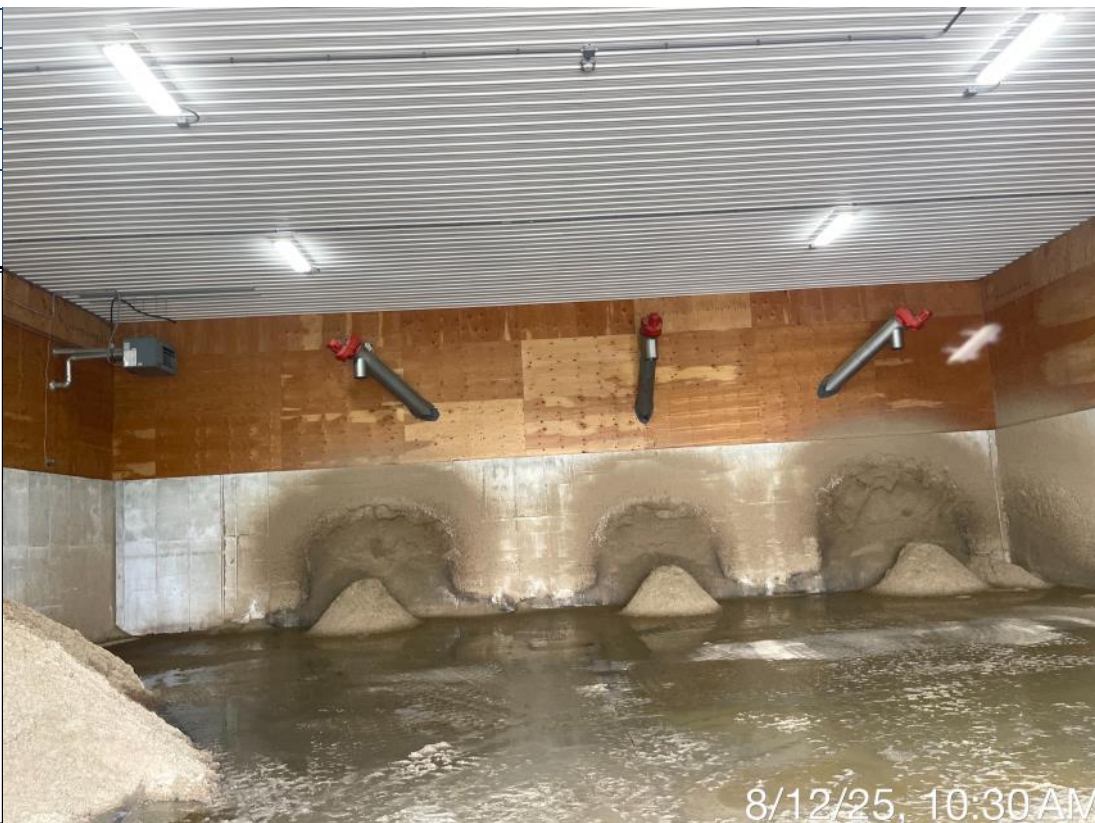
<b>Photo #:</b>	20
<b>Date/Time of Photo:</b>	8/12/2025 10:30
<b>Photo By:</b>	Brian Hanson
<b>Photo Location:</b>	Main Dairy Sand Building

Standing inside the sand storage building looking west: View of the interior of the sand storage building. Notice the 3 augers used to convey recycled sand from the Stjernholm system to the storage building.

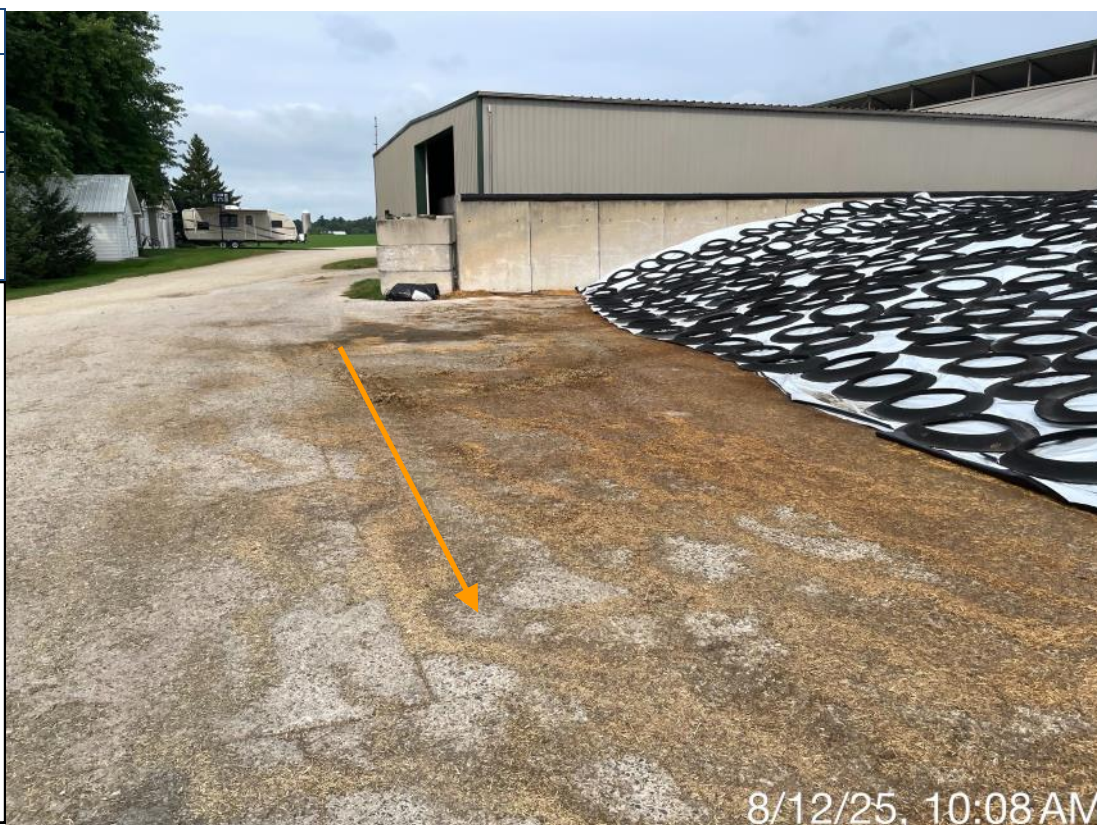
<b>Photo #:</b>	21
<b>Date/Time of Photo:</b>	8/12/2025 10:08
<b>Photo By:</b>	Brian Hanson
<b>Photo Location:</b>	Main Dairy Feed Storage S

**Photo Description:**  
Standing on the south side of FSA looking west: View of southwest corner of FSA. Arrow indicated direction of runoff flow.
