# Permit Fact Sheet

Permit Number	WI-0064521-04-0
Permittee Name and Address	Rohan Dairy Farms LLC N7832 Village Rd, Bear Creek, WI 54922
Permitted Facility Name and Address	Rohan Dairy Farms LLC Main Dairy - N7832 Village Rd Bear Creek WI – NW ¼ SW ¼ Section 30 Township 24N Range 15E Heifer Hill – N7899 Village Rd Bear Creek, WI – NE ¼ SE ¼ Section 25 Township 24N Range 14E
Permit Term	August 01, 2026 to July 31, 2031
Receiving Water	Unnamed tributaries within the Bear Creek – Embarrass River Watershed, and groundwaters of the state
Discharge Type	Existing source CAFO per NR 243.03(23) as the facility has been permitted since 2010.

On Tuesday August 12th, 2025, at 09:00 Hanson met with Rohan & Much at Rohan Dairy Farms LLC site to conduct a permit reissuance walkover inspection. The main dairy site & the Heifer site were inspected. No significant rain had occurred previous to the inspection and the temperature was in the 70's & cloudy. No active discharges were observed, and no water samples were collected. Hanson departed at approximately 11:30.

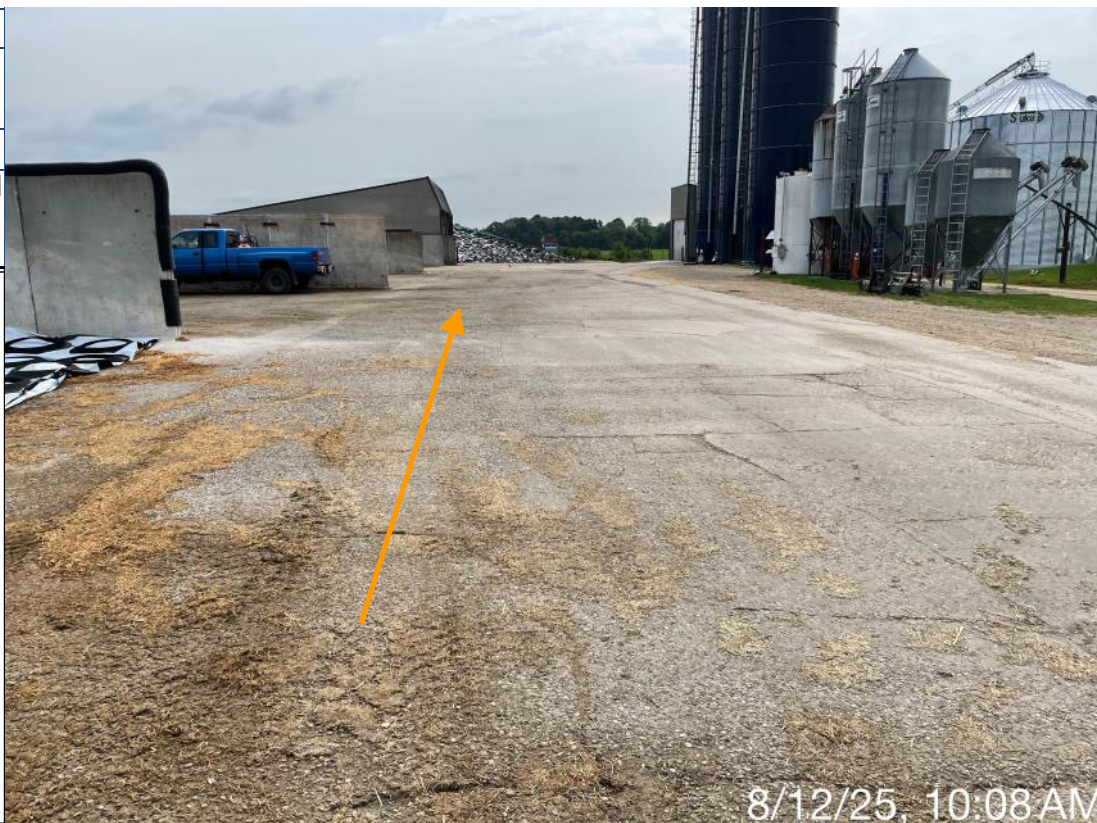
<b>Photo #:</b>	22
<b>Date/Time of Photo:</b>	8/12/2025 10:08
<b>Photo By:</b>	Brian Hanson
<b>Photo Location:</b>	Main Dairy Feed Storage S

**Photo Description:**  
Standing on the south side of FSA looking east: View of south edge of FSA in front of bunkers. Arrow indicated direction of runoff flow.

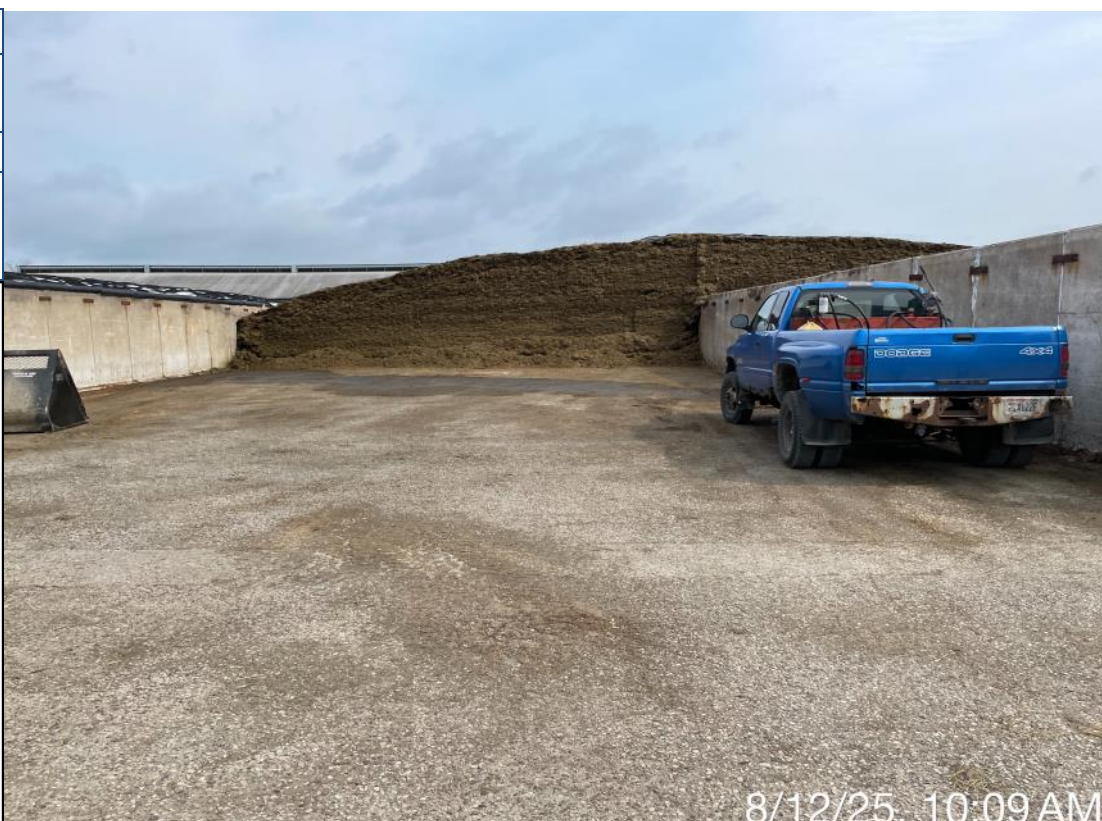
**Photo Description:**  
Standing on the south side of FSA looking north: View of a bunker. Notice floor is pitted, but no major cracking.

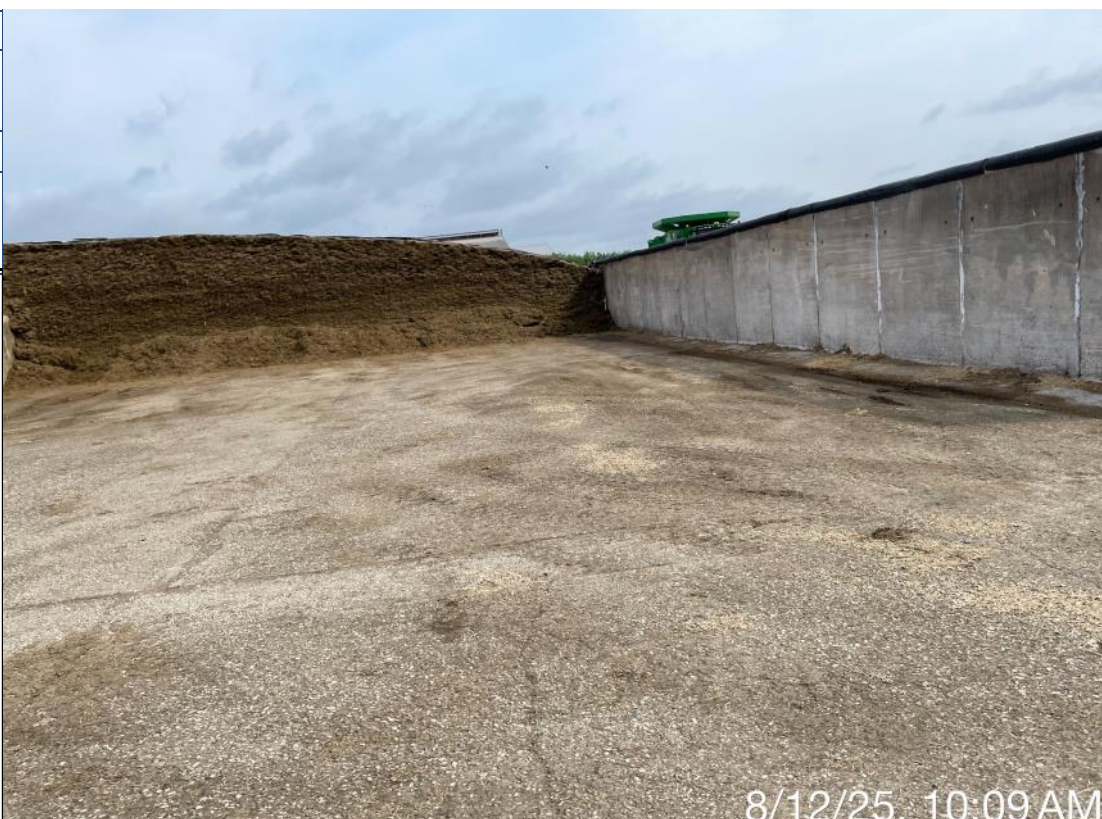
<b>Photo #:</b>	24
<b>Date/Time of Photo:</b>	8/12/2025 10:09
<b>Photo By:</b>	Brian Hanson
<b>Photo Location:</b>	Main Dairy Feed Storage S

**Photo Description:**  
Standing on the south side of the FSA looking north: View of another bunker east of photo #23. Again notice floor is pitted but no major cracking.

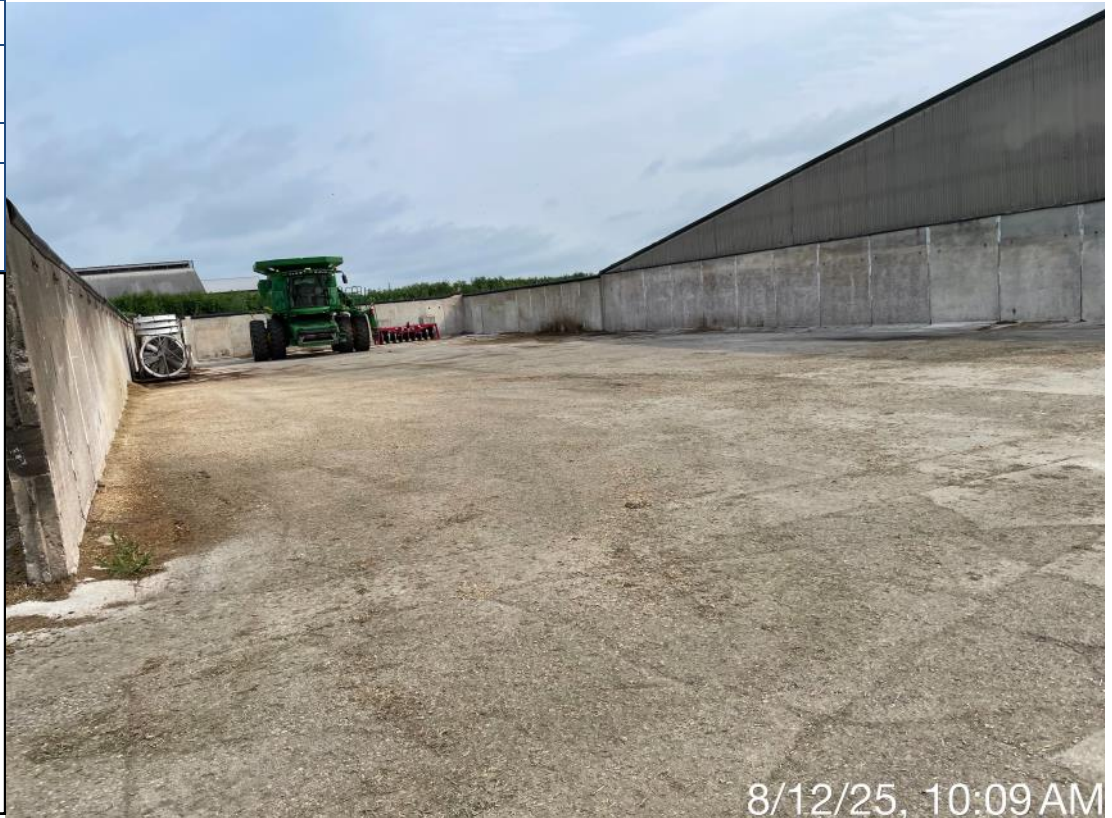
<b>Photo #:</b>	25
<b>Date/Time of Photo:</b>	8/12/2025 10:09
<b>Photo By:</b>	Brian Hanson
<b>Photo Location:</b>	Main Dairy Feed Storage S

**Photo Description:**  
Standing on the south side of FSA looking north: View of eastern most bunker.

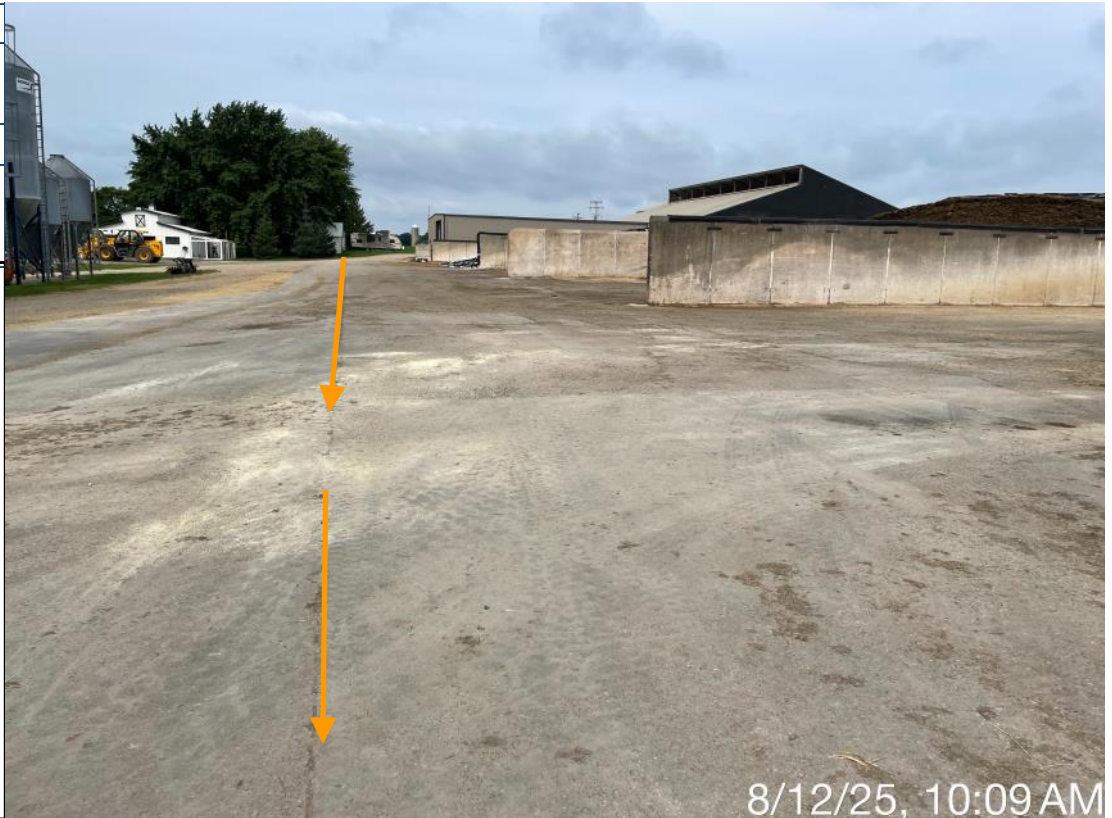
<b>Photo #:</b>	26
<b>Date/Time of Photo:</b>	8/12/2025 10:09
<b>Photo By:</b>	Brian Hanson
<b>Photo Location:</b>	Main Dairy Feed Storage S

**Photo Description:**  
Standing on the south side of the FSA looking west: View of south edge of FSA used as runoff collection channel. Arrows indicate direction of runoff flow.

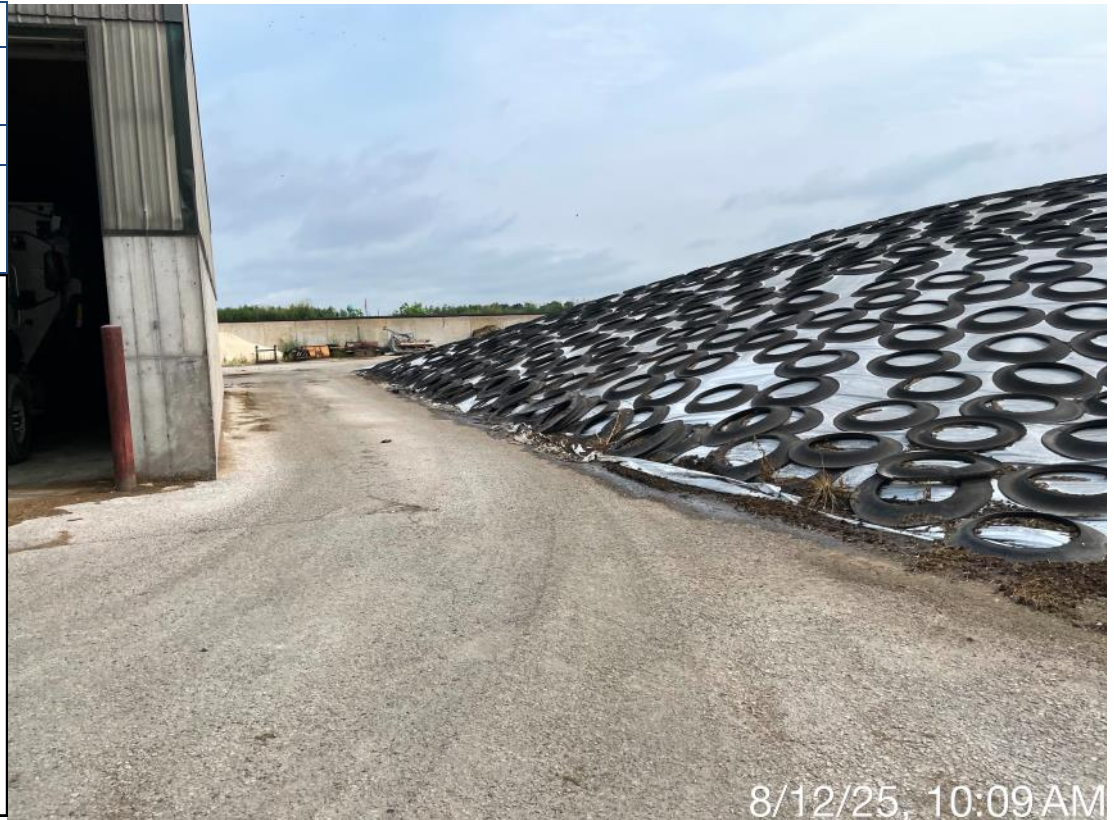
Standing on the south side of FSA looking north: View of the west edge of the feedpad east of the commodity shed.

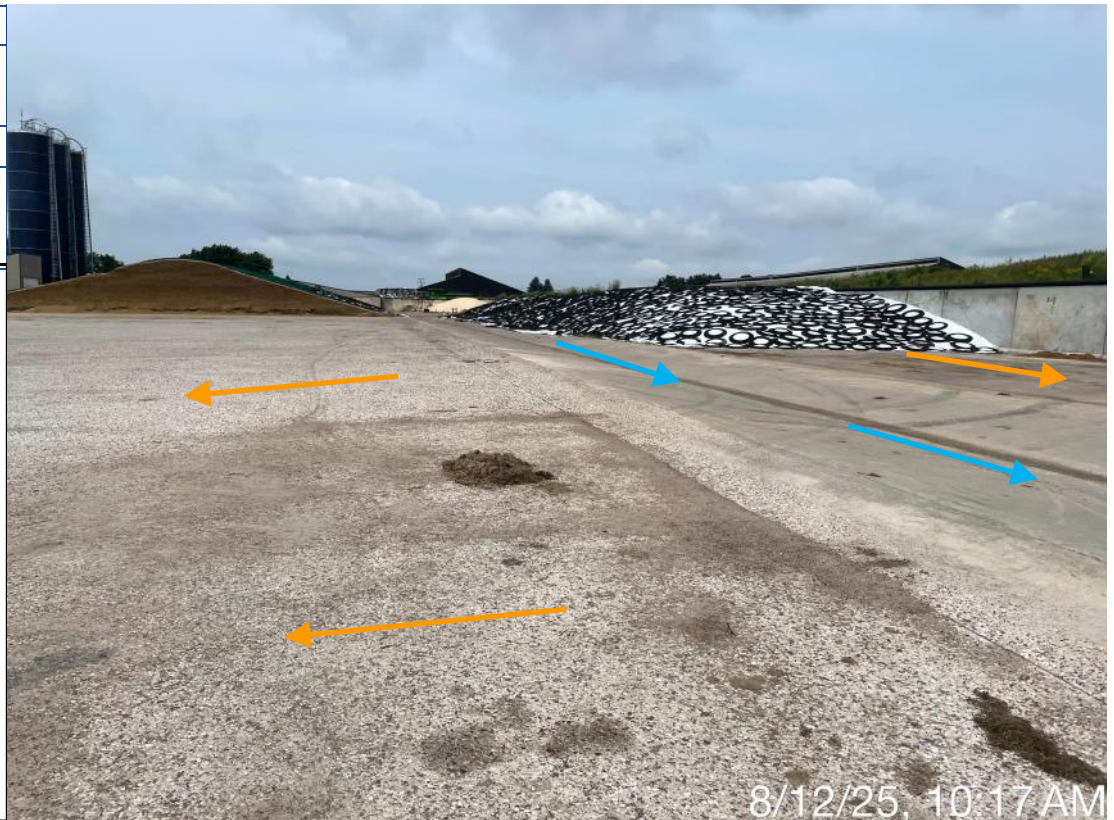
<b>Photo #:</b>	28
<b>Date/Time of Photo:</b>	8/12/2025 10:17
<b>Photo By:</b>	Brian Hanson
<b>Photo Location:</b>	Main Dairy Feed Storage S

.Standing on the east side of the FSA looking west: View of the north edge of the feedpad. Blue arrows represents clean water diversion in between the 2 pads.

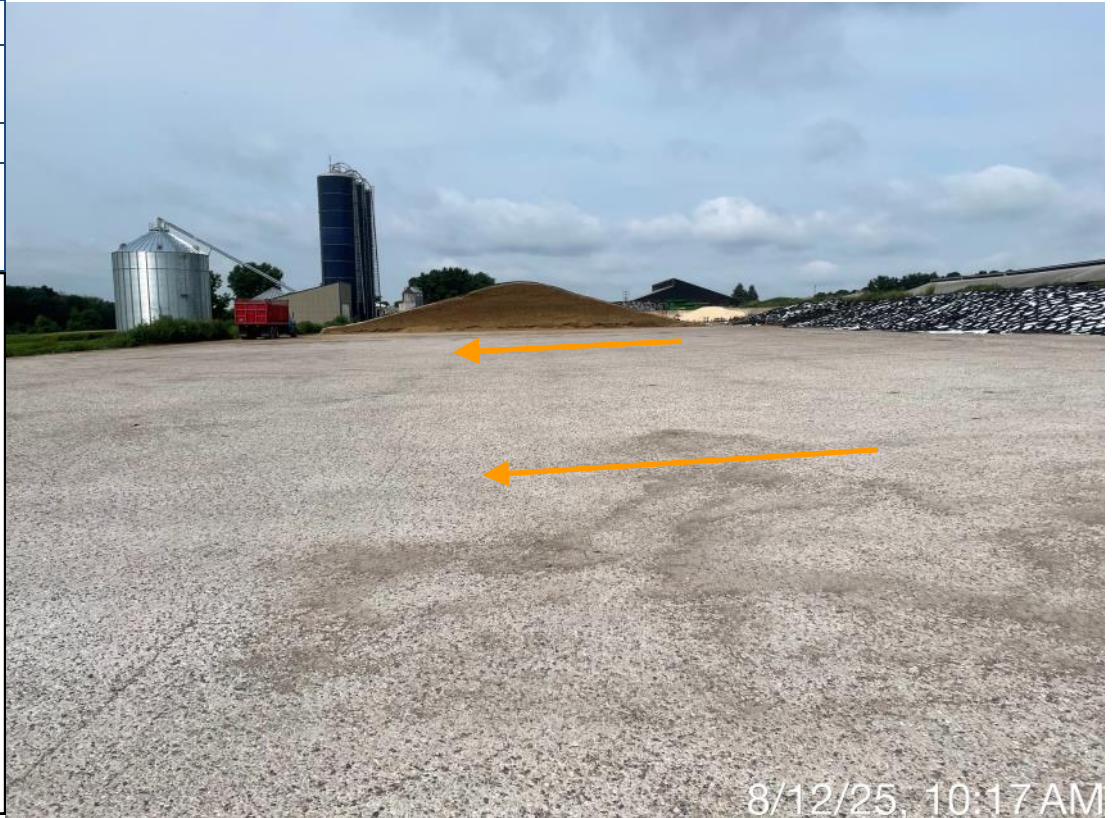
<b>Photo #:</b>	29
<b>Date/Time of Photo:</b>	8/12/2025 10:17
<b>Photo By:</b>	Brian Hanson
<b>Photo Location:</b>	Main Dairy Feed Storage S
<b>Photo Description:</b>	Standing on the east end of FSA looking west: View of east end of feedpad.

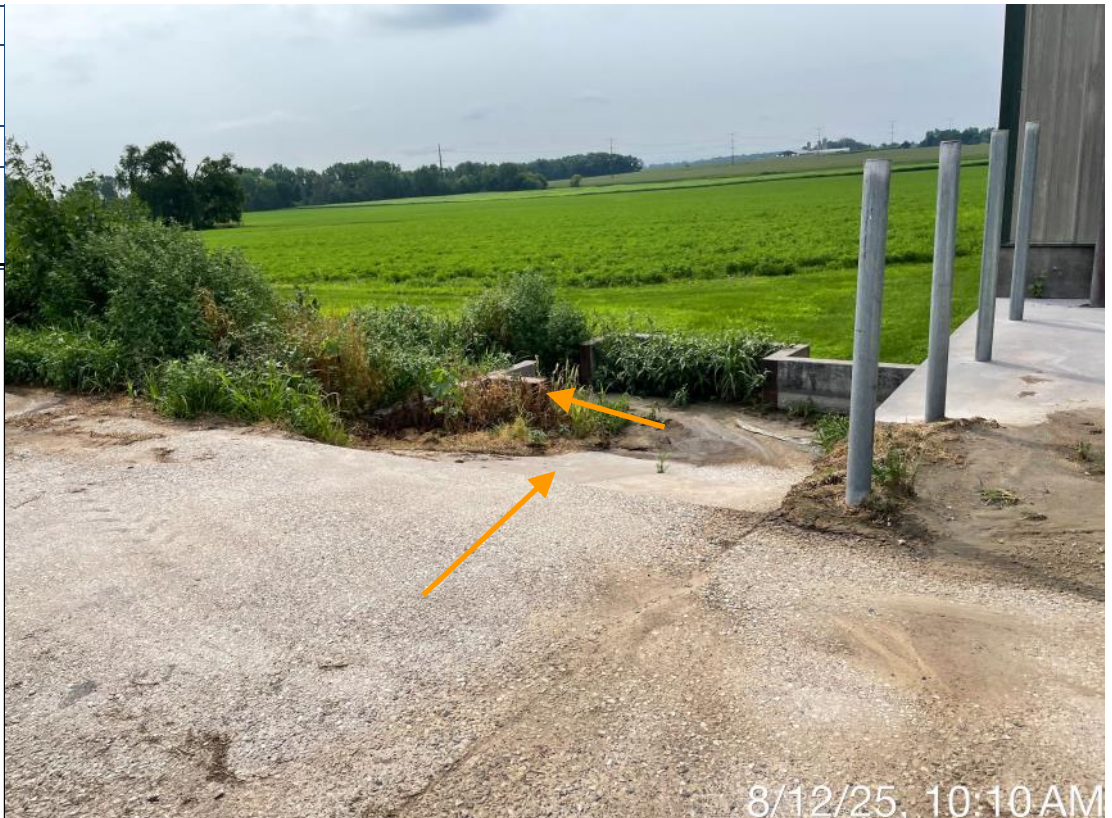
<b>Photo #:</b>	30
<b>Date/Time of Photo:</b>	8/12/2025 10:10
<b>Photo By:</b>	Brian Hanson
<b>Photo Location:</b>	Main Dairy Feed Storage S
<b>Photo Description:</b>	.Standing on the south side of FSA looking southeast: View of south edge of FSA where runoff flows off pad into runoff collection system.

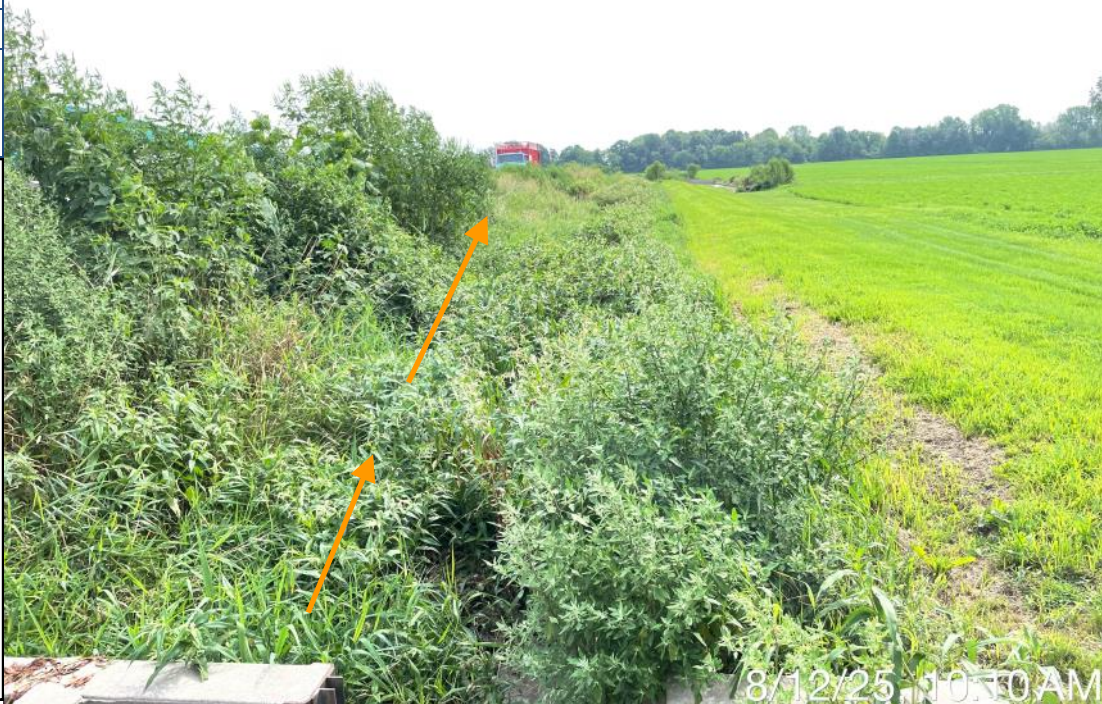
<b>Photo #:</b>	31
<b>Date/Time of Photo:</b>	8/12/2025 10:10
<b>Photo By:</b>	Brian Hanson
<b>Photo Location:</b>	Main Dairy Feed Storage S

**Photo Description:**  
Standing at the west end of the runoff collection channel shown in photo #30 looking east: View of vegetated runoff channel on south side of FSA.

At the time of inspection the FSA was in good working condition and the runoff collection system appeared to be functional, although it was in need of maintenance. The earthen channel was overgrown with vegetation and ponded runoff was observed on the concrete spreader. Overgrown vegetation was observed on the downstream edge of the spreader bar likely causing the runoff to remain ponded on the spreader bar.

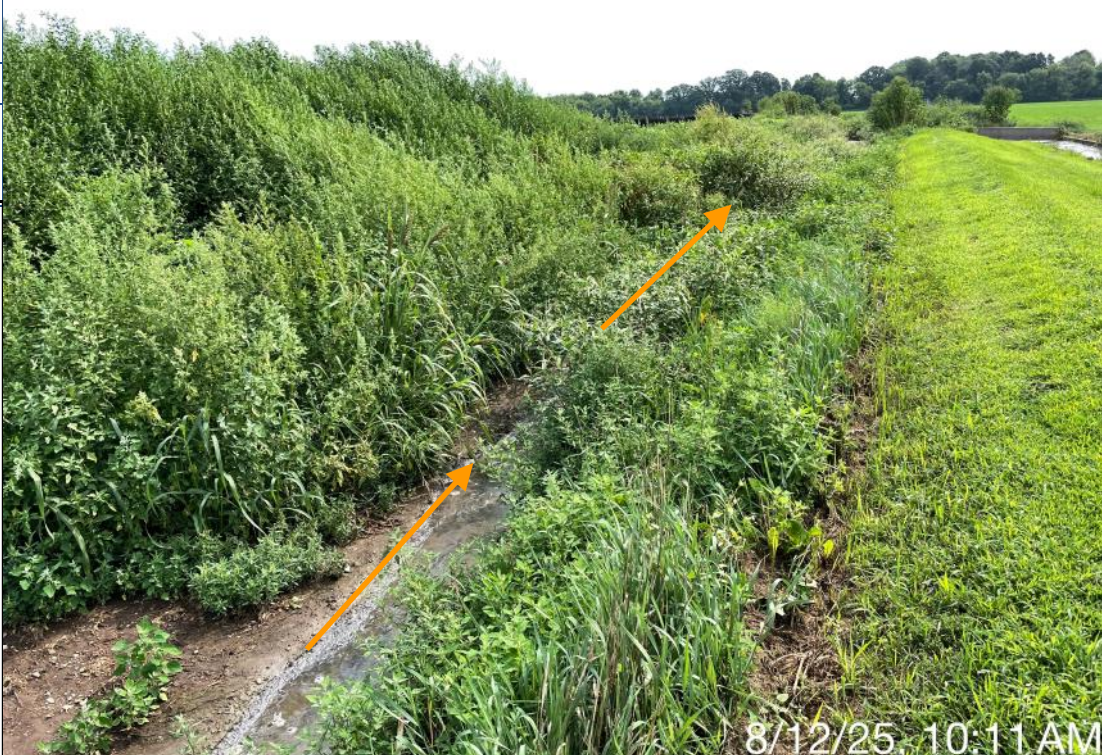
<b>Photo #:</b>	32
<b>Date/Time of Photo:</b>	8/12/2025 10:11
<b>Photo By:</b>	Brian Hanson
<b>Photo Location:</b>	Main Dairy Feed Storage S

**Photo Description:**  
Alternate view of runoff collection channel shown in photo #31 a little further east.

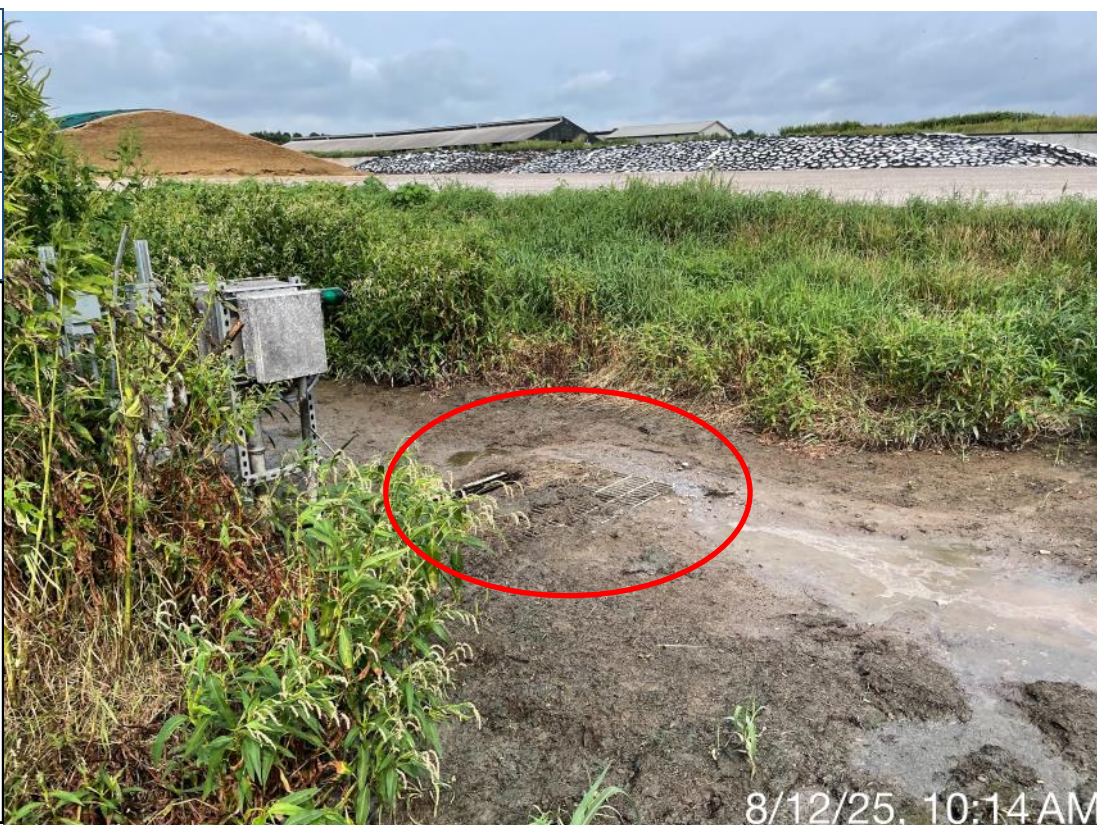
<b>Photo #:</b>	33
<b>Date/Time of Photo:</b>	8/12/2025 10:14
<b>Photo By:</b>	Brian Hanson
<b>Photo Location:</b>	Main Dairy Feed Storage S

Standing at the east end of runoff collection channel looking northwest: View of first flush collection system. Notice grate for collection system is partially plugged.

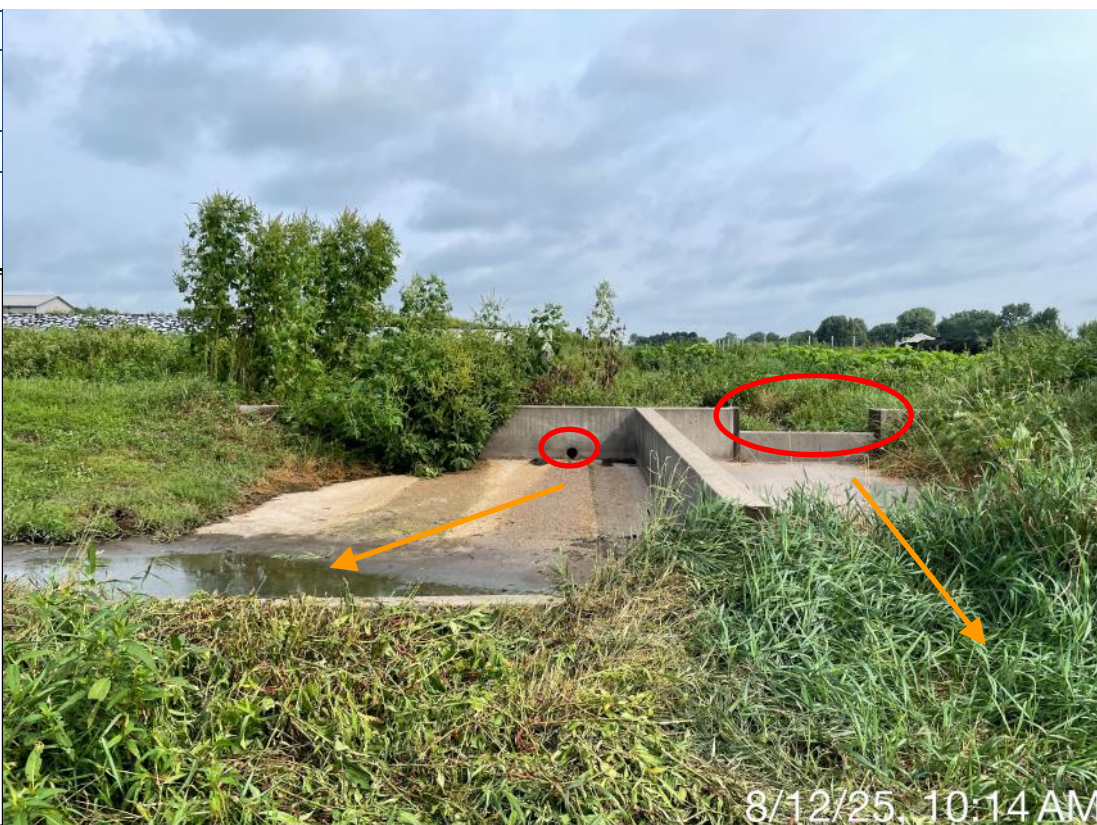
<b>Photo #:</b>	34
<b>Date/Time of Photo:</b>	8/12/2025 10:14
<b>Photo By:</b>	Brian Hanson
<b>Photo Location:</b>	Main Dairy Feed Storage S

Standing at southeast corner of concrete spreader pad looking north: View of spreader pad control box directly south of first flush system shown in photo #33. Spreader pad outlet pipe & emergency overflow weir highlighted.

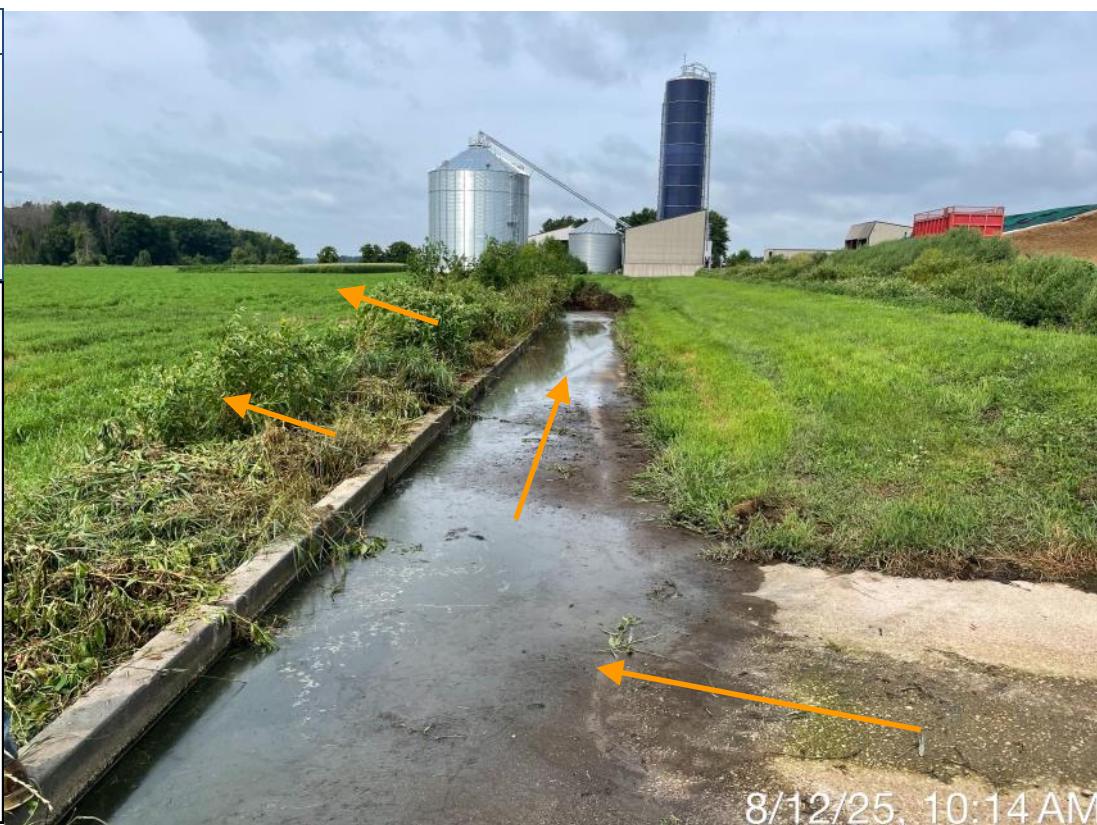
<b>Photo #:</b>	35
<b>Date/Time of Photo:</b>	8/12/2025 10:14
<b>Photo By:</b>	Brian Hanson
<b>Photo Location:</b>	Main Dairy FSA VTA
<b>Photo Description:</b>	Standing at the east end of concrete spreader pad looking west: View of east end of spreader pad and notched distribution wall. Notice built up vegetation on back side of wall is ponding runoff on the pad.

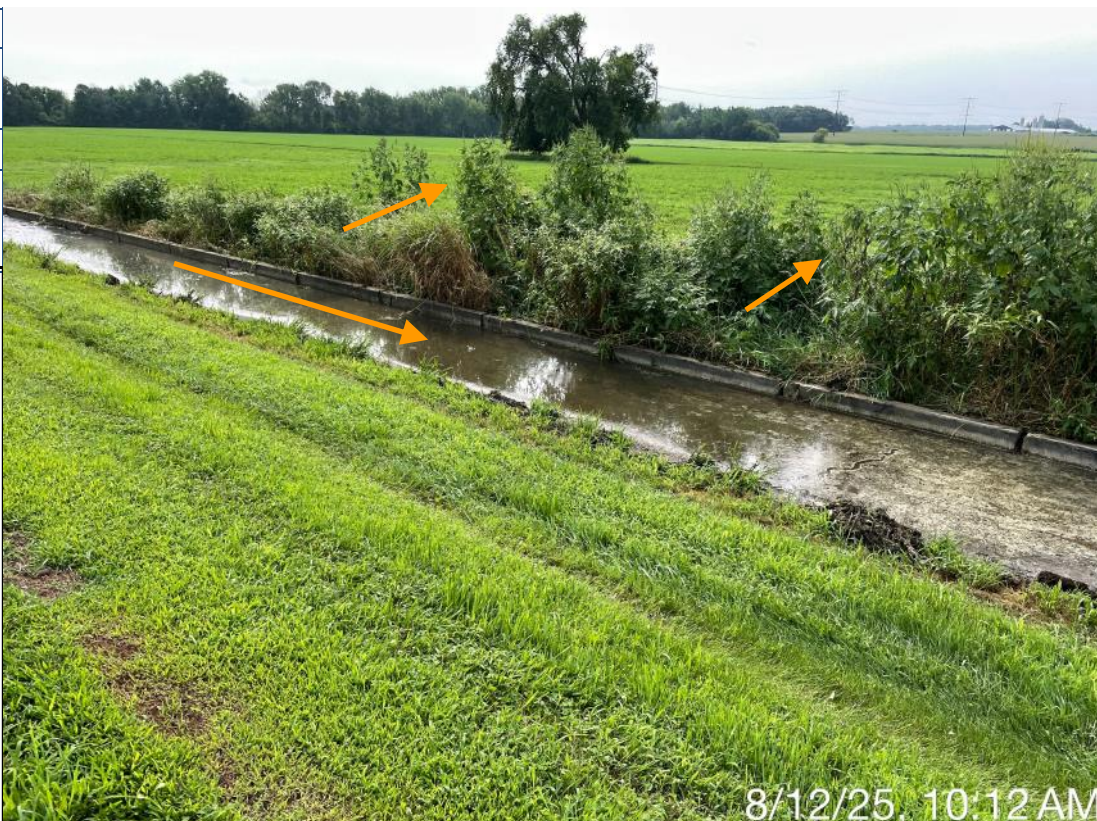
<b>Photo #:</b>	36
<b>Date/Time of Photo:</b>	8/12/2025 10:12
<b>Photo By:</b>	Brian Hanson
<b>Photo Location:</b>	Main Dairy FSA VTA
<b>Photo Description:</b>	Standing on the west end of concrete spreader pad looking southeast: View of west end of spreader pad. Notice built up vegetation on back side of wall is ponding runoff on the pad.

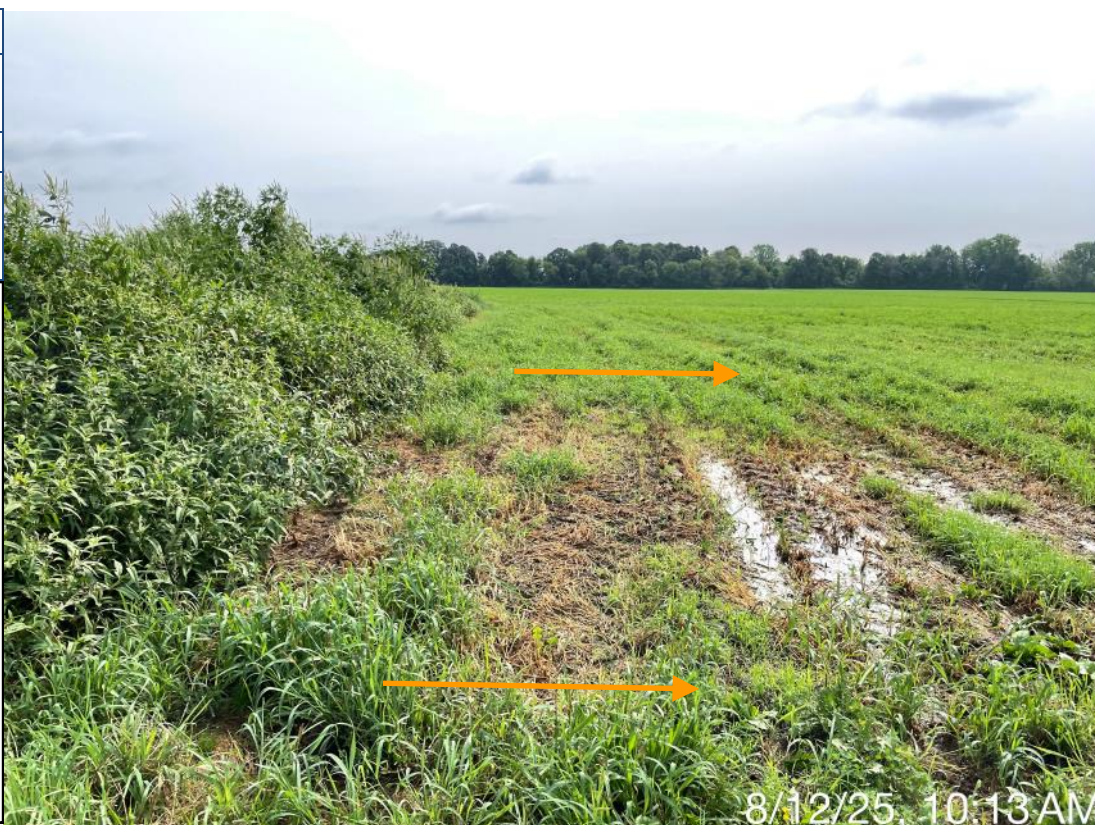
<b>Photo #:</b>	37
<b>Date/Time of Photo:</b>	8/12/2025 10:13
<b>Photo By:</b>	Brian Hanson
<b>Photo Location:</b>	Main Dairy FSA VTA

Standing on the south side of spreader bar looking east: View of area directly downstream of spreader bar. Notice small area of ponding and burnt out vegetation.

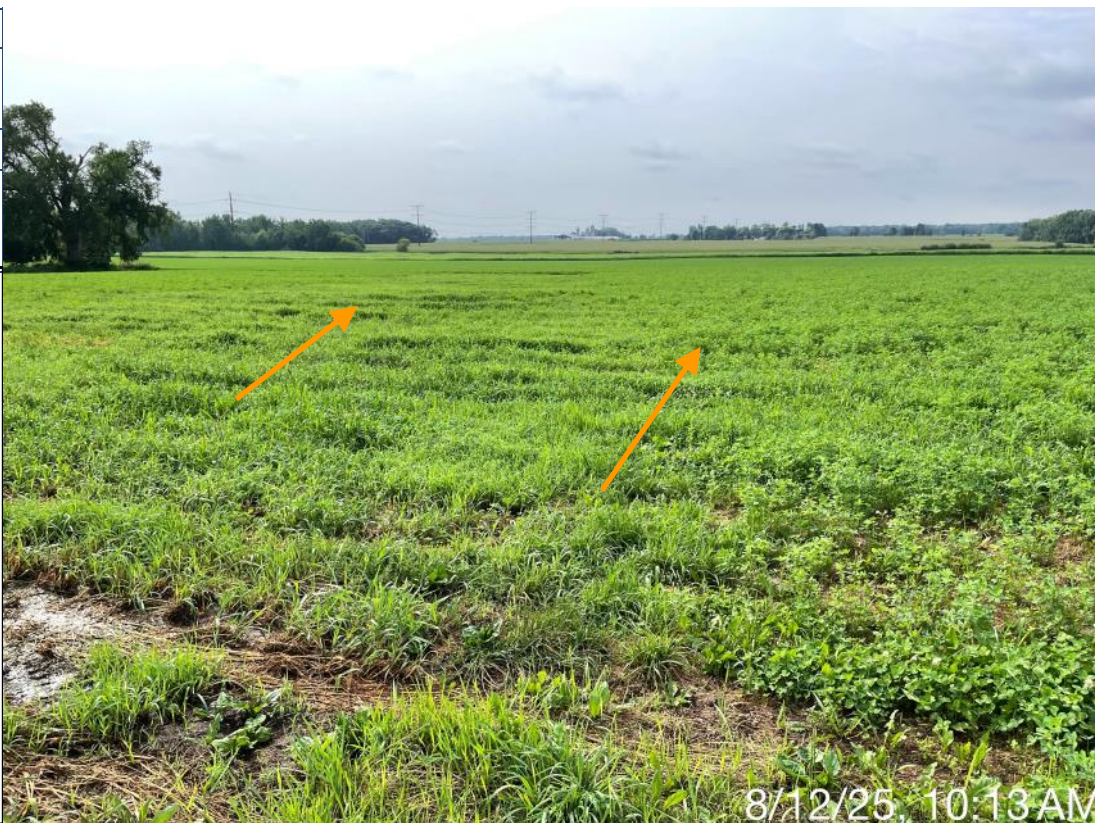
<b>Photo #:</b>	38
<b>Date/Time of Photo:</b>	8/12/2025 10:13
<b>Photo By:</b>	Brian Hanson
<b>Photo Location:</b>	Main Dairy FSA VTA

Standing on the south side of spreader bar looking south: View of vegetated treatment area. Notice majority of VTA is well vegetated with no sign of current or past discharge.

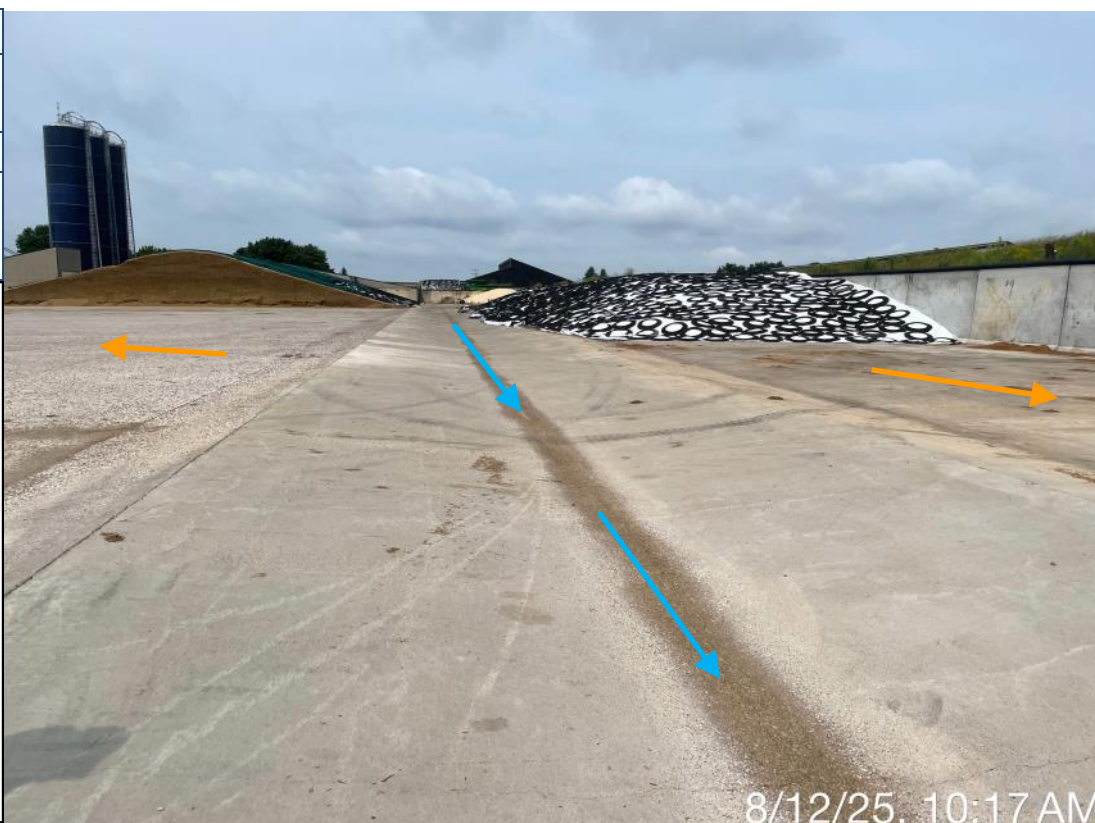
<b>Photo #:</b>	39
<b>Date/Time of Photo:</b>	8/12/2025 10:17
<b>Photo By:</b>	Brian Hanson
<b>Photo Location:</b>	Main Dairy Feed Storage

Standing at east end of FSA looking west: View of clean water diversion channel in between the 2 feedpads. Water from on top of the plastic is routed to this channel.

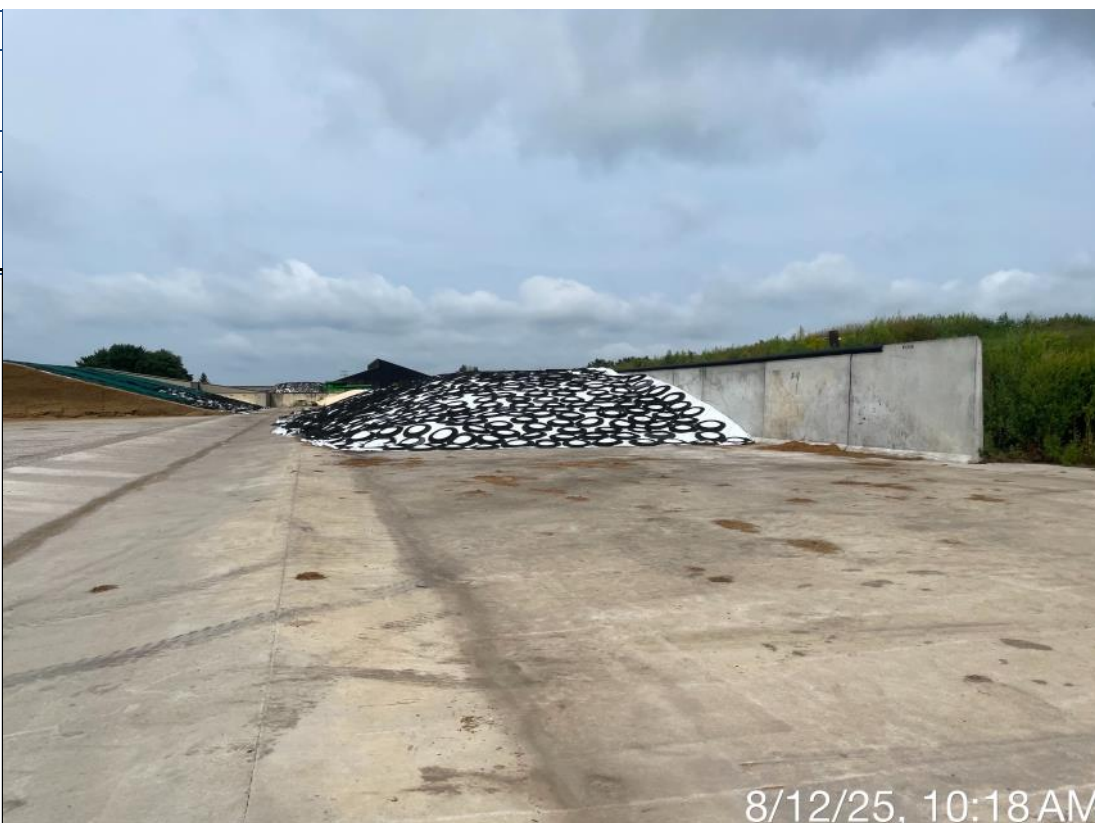
<b>Photo #:</b>	40
<b>Date/Time of Photo:</b>	8/12/2025 10:18
<b>Photo By:</b>	Brian Hanson
<b>Photo Location:</b>	Main Dairy Feed Storage N

Standing on the east end of FSA looking west: View of 2022 FSA expansion on north edge of FSA. This part of FSA has a separate runoff collection system and does not flow to VTA.

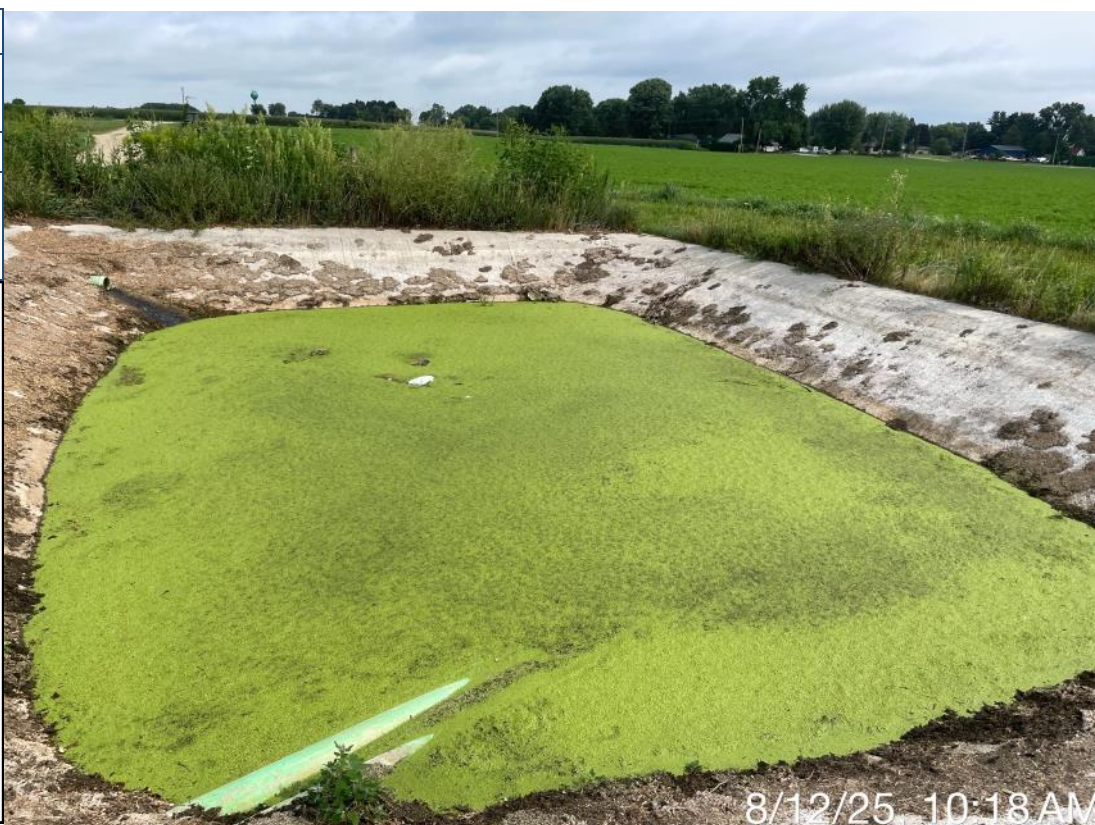
WSF #3: WSF #3 is a small concrete lined impoundment located at the main dairy on the east side of the feed storage area. Leachate & runoff from the 2022 FSA expansion are stored in this facility. At the time of inspection no safety fence or permanent markers were observed.

**Photo Description:**  
Standing at the east edge of FSA looking north: View of runoff collection basin for 2022 FS expansion. No markers present.

- A safety fence and MOL/MOS markers were not observed in WSF #3—Leachate Basin. Install missing items.

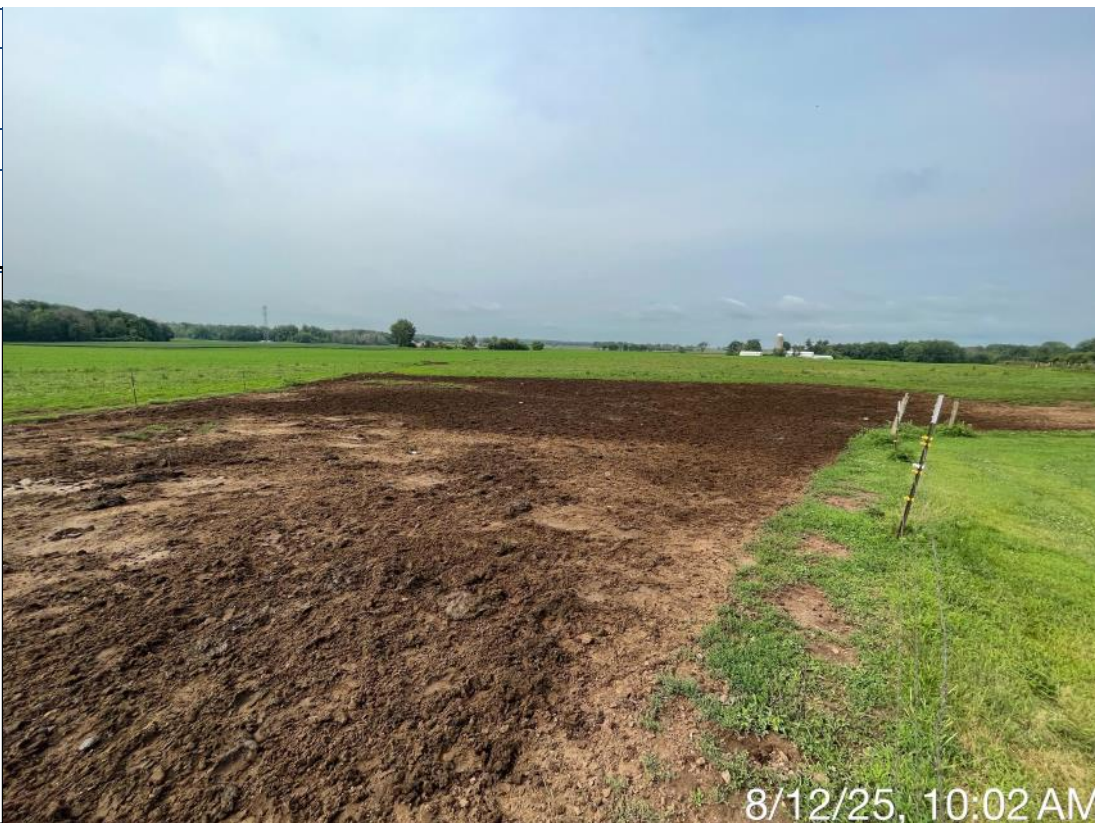
**Photo Description:**  
Standing on the west side of heifer barn looking west: View of earthen lane used to convey animals out to remainder of outdoor vegetated area.

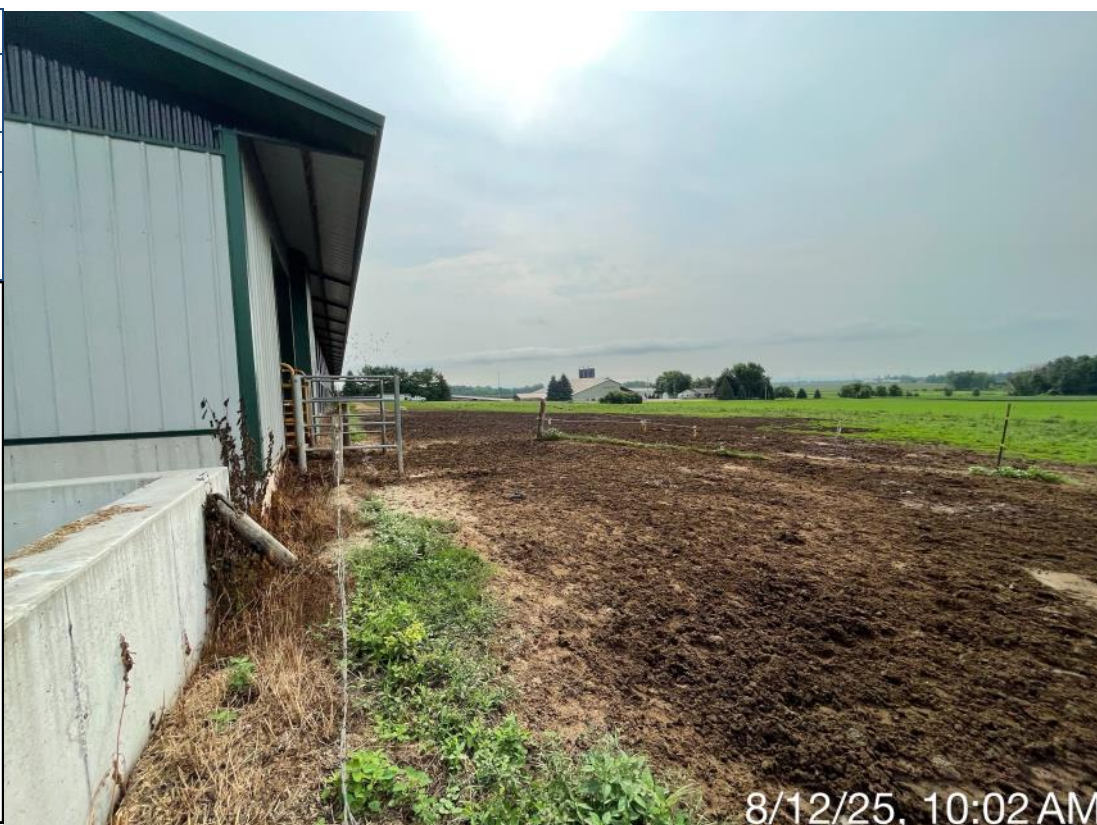
**Photo Description:**  
Standing on west side of heifer barn looking east: View of earthen lane along south edge of barn used by cattle to access outlying portions of outdoor CAFO vegetated area

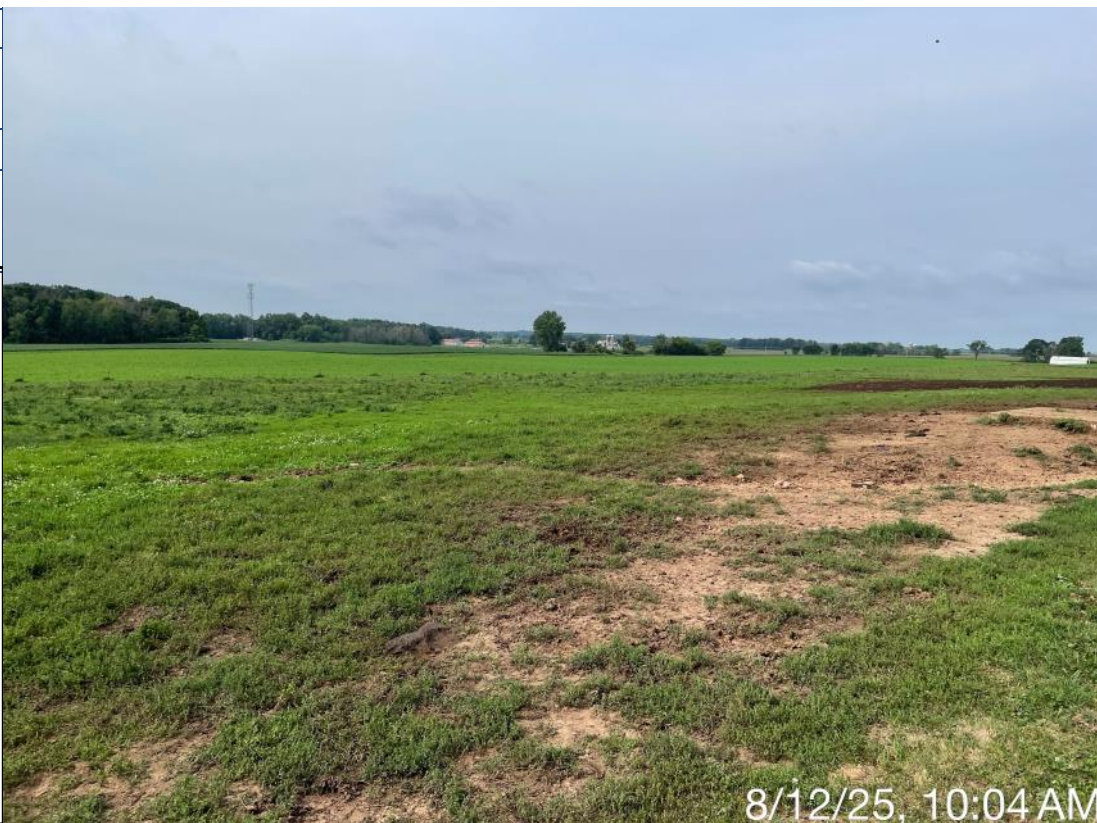
**Photo Description:**  
Standing on the east side of heifer barn looking southwest: view of outdoor vegetated area south of heifer barn. Notice most of the area is well vegetated.
