# Permit Fact Sheet

Permit Number	WI-0064521-04-0
Permittee Name and Address	Rohan Dairy Farms LLC N7832 Village Rd, Bear Creek, WI 54922
Permitted Facility Name and Address	Rohan Dairy Farms LLC Main Dairy - N7832 Village Rd Bear Creek WI – NW ¼ SW ¼ Section 30 Township 24N Range 15E Heifer Hill – N7899 Village Rd Bear Creek, WI – NE ¼ SE ¼ Section 25 Township 24N Range 14E
Permit Term	August 01, 2026 to July 31, 2031
Receiving Water	Unnamed tributaries within the Bear Creek – Embarrass River Watershed, and groundwaters of the state
Discharge Type	Existing source CAFO per NR 243.03(23) as the facility has been permitted since 2010.

On Tuesday August 12th, 2025, at 09:00 Hanson met with Rohan & Much at Rohan Dairy Farms LLC site to conduct a permit reissuance walkover inspection. The main dairy site & the Heifer site were inspected. No significant rain had occurred previous to the inspection and the temperature was in the 70's & cloudy. No active discharges were observed, and no water samples were collected. Hanson departed at approximately 11:30.

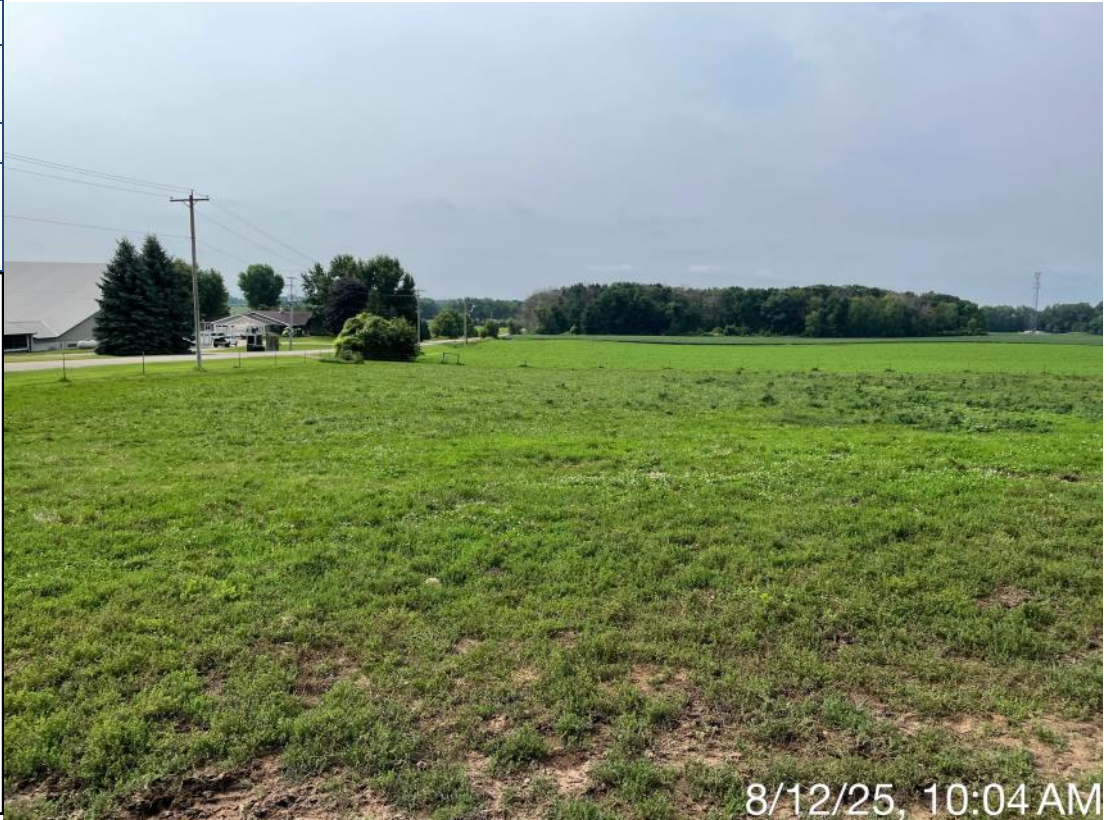
<b>Photo #:</b>	45
<b>Date/Time of Photo:</b>	8/12/2025 10:04
<b>Photo By:</b>	Brian Hanson
<b>Photo Location:</b>	Heifer Hill Pasture
<b>Photo Description:</b>  Standing east of the heifer barn looking south: View of outdoor vegetated area southeast of heifer barn along Village Road.

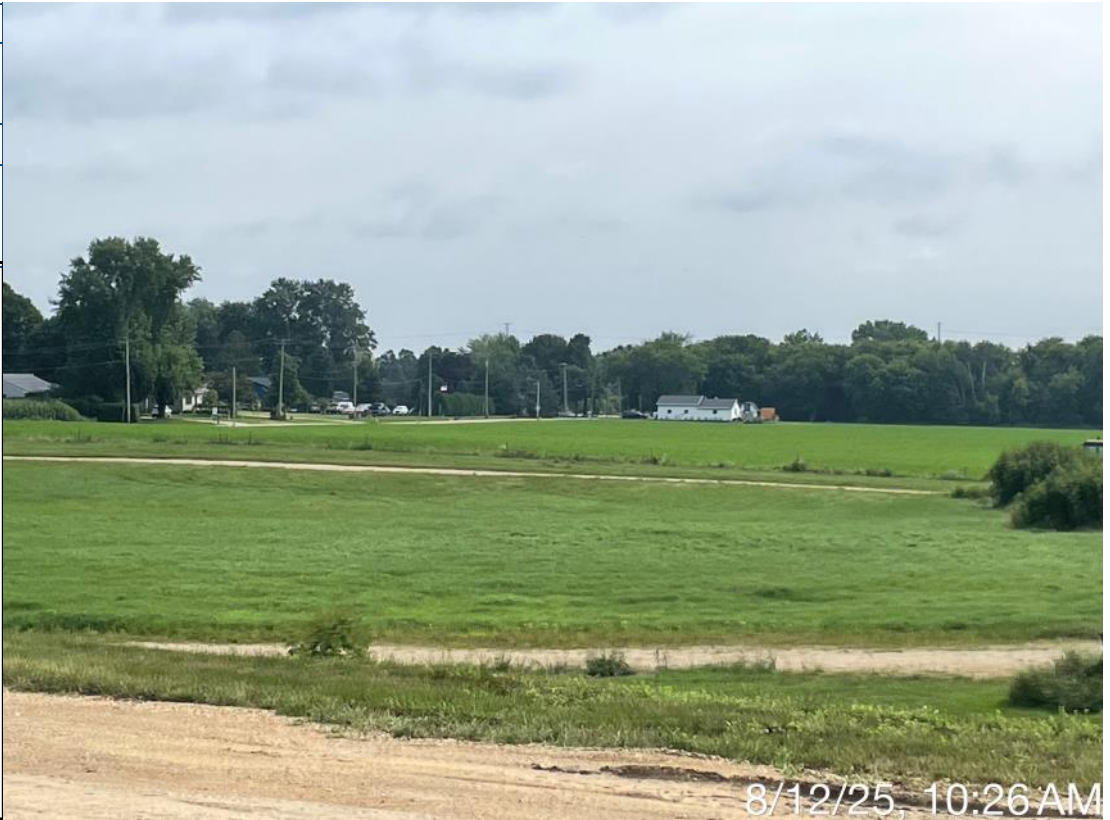
<b>Photo #:</b>	46
<b>Date/Time of Photo:</b>	8/12/2025 10:26
<b>Photo By:</b>	Brian Hanson
<b>Photo Location:</b>	Main Dairy Pasture
<b>Photo Description:</b>  Standing on east side of freestall barns looking east: View of inactive pasture east of barns & north of WSF #1. Area is well vegetated.

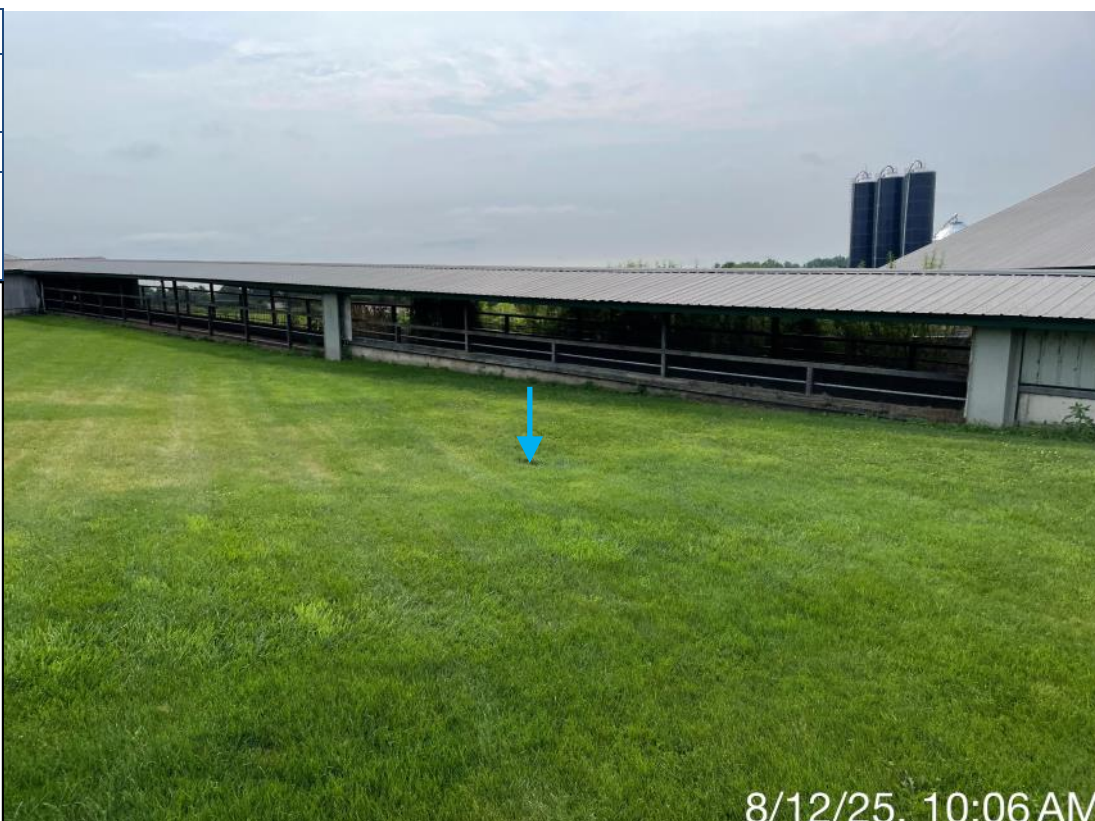
<b>Photo #:</b>	47
<b>Date/Time of Photo:</b>	8/12/2025 10:06
<b>Photo By:</b>	Brian Hanson
<b>Photo Location:</b>	Main Dairy Stormwater
<b>Photo Description:</b>  Standing on south side of freestall barns looking southeast: View of stormwater collection area along breezeway to dry cow barn. Stormwater surface inlet highlighted.

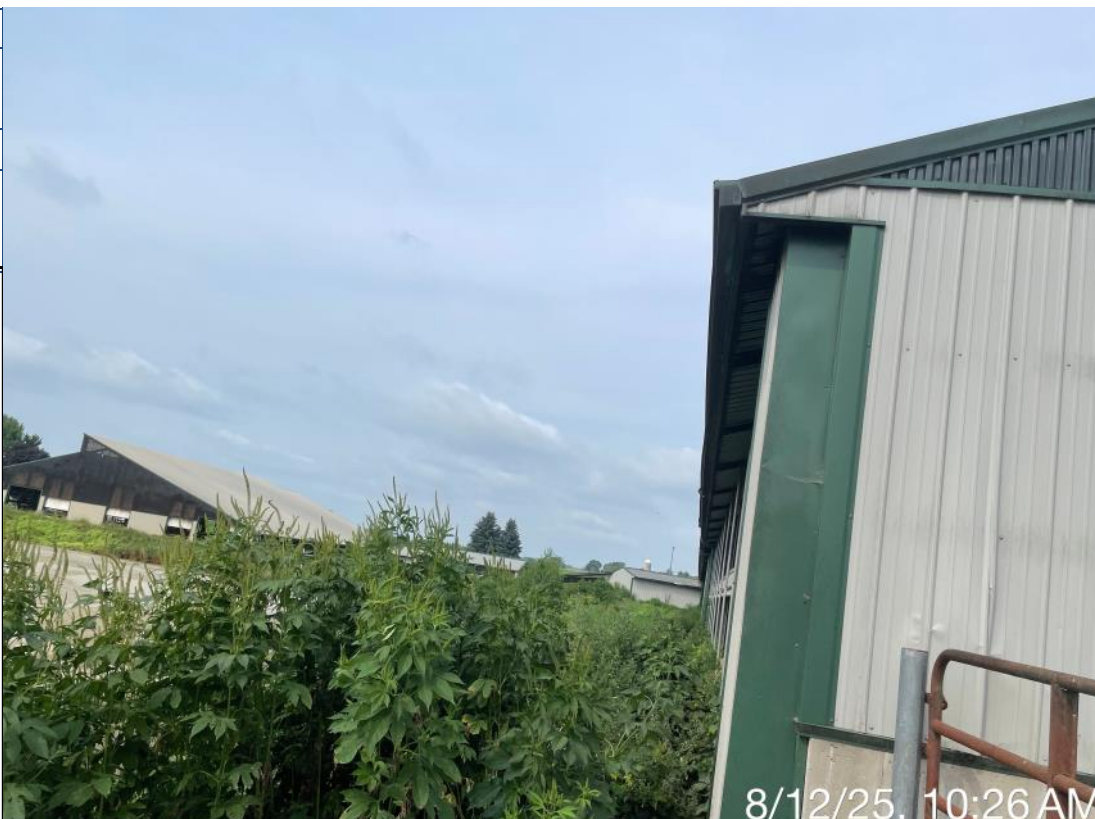
<b>Photo #:</b>	48
<b>Date/Time of Photo:</b>	8/12/2025 10:26
<b>Photo By:</b>	Brian Hanson
<b>Photo Location:</b>	Main Dairy Stormwater
<b>Photo Description:</b>  Standing on north side of WSF #1 looking west & up: View of gutters on south side of south freestall barn used to keep stormwater from flowing into WSF #1.

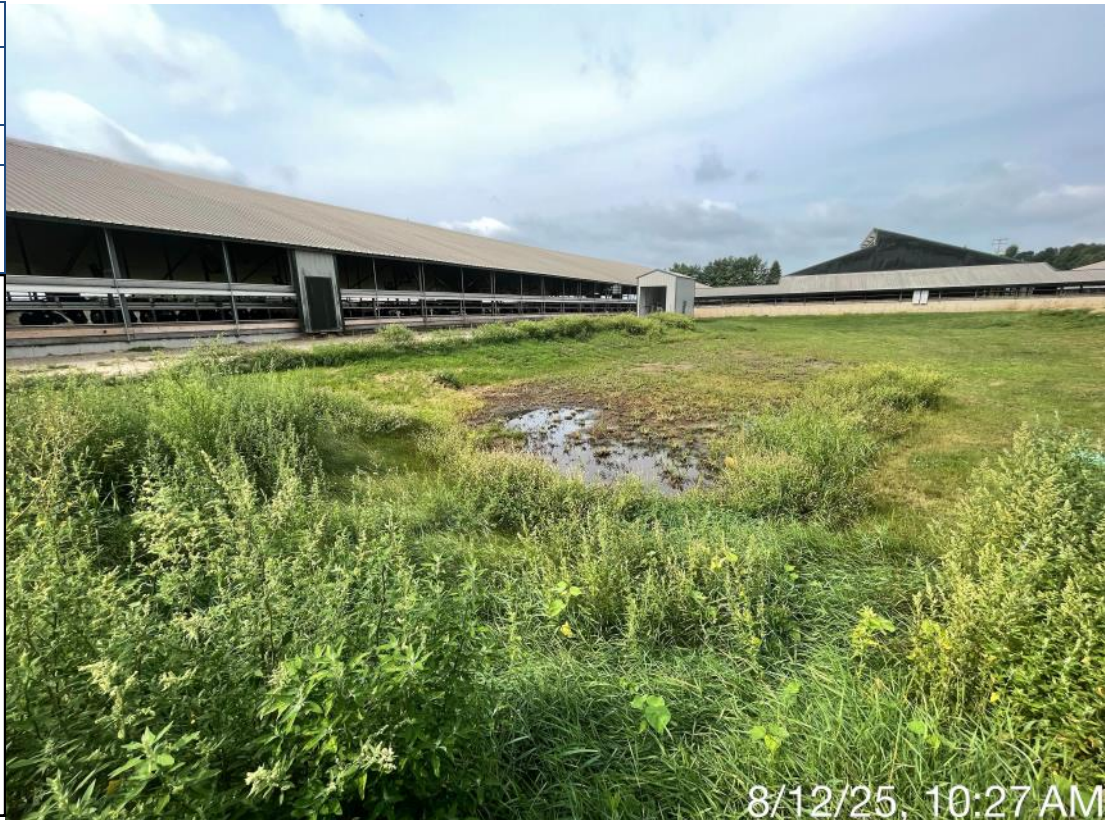
<b>Photo #:</b>	49
<b>Date/Time of Photo:</b>	8/12/2025 10:27
<b>Photo By:</b>	Brian Hanson
<b>Photo Location:</b>	Main Dairy Stormwater
<b>Photo Description:</b>	
Standing on south side of sand building looking west: View of stormwater detention basin on between freestall barns & sand building.

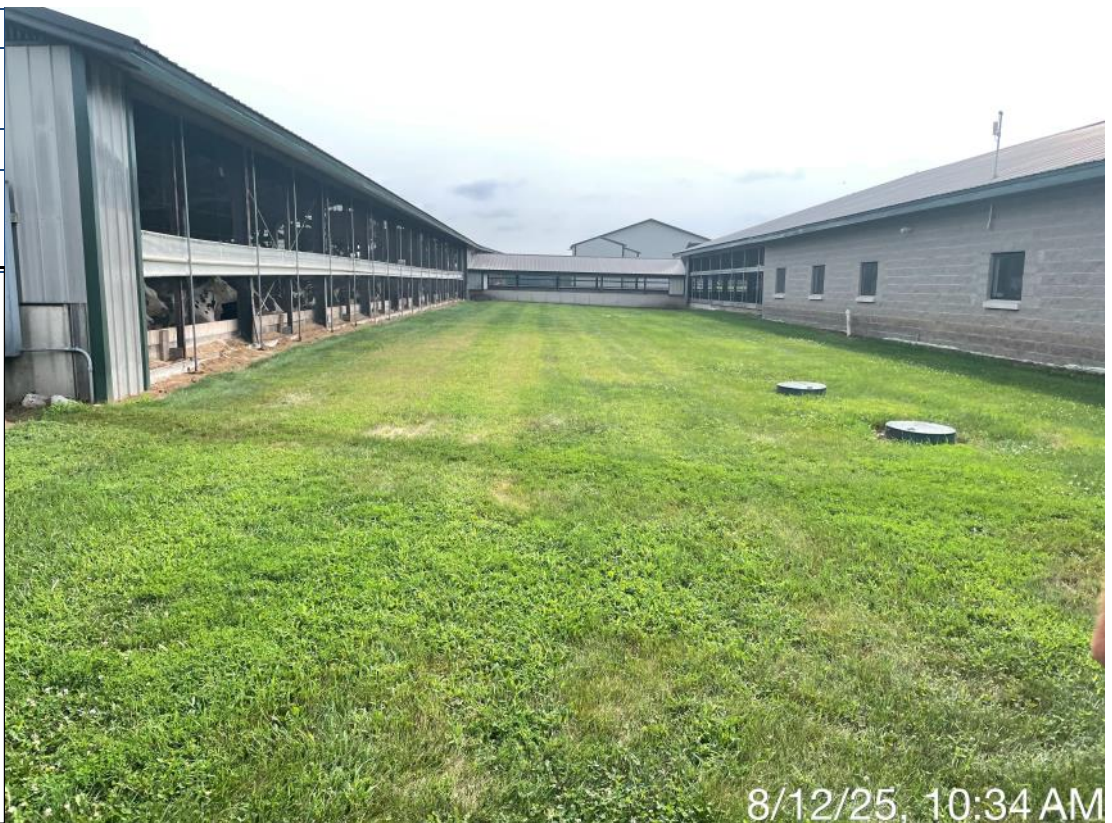
<b>Photo #:</b>	50
<b>Date/Time of Photo:</b>	8/12/2025 10:34
<b>Photo By:</b>	Brian Hanson
<b>Photo Location:</b>	Main Dairy Stormwater
<b>Photo Description:</b>	
Standing on west side of freestall barns looking east: View of stormwater collection area between barn & parlor.

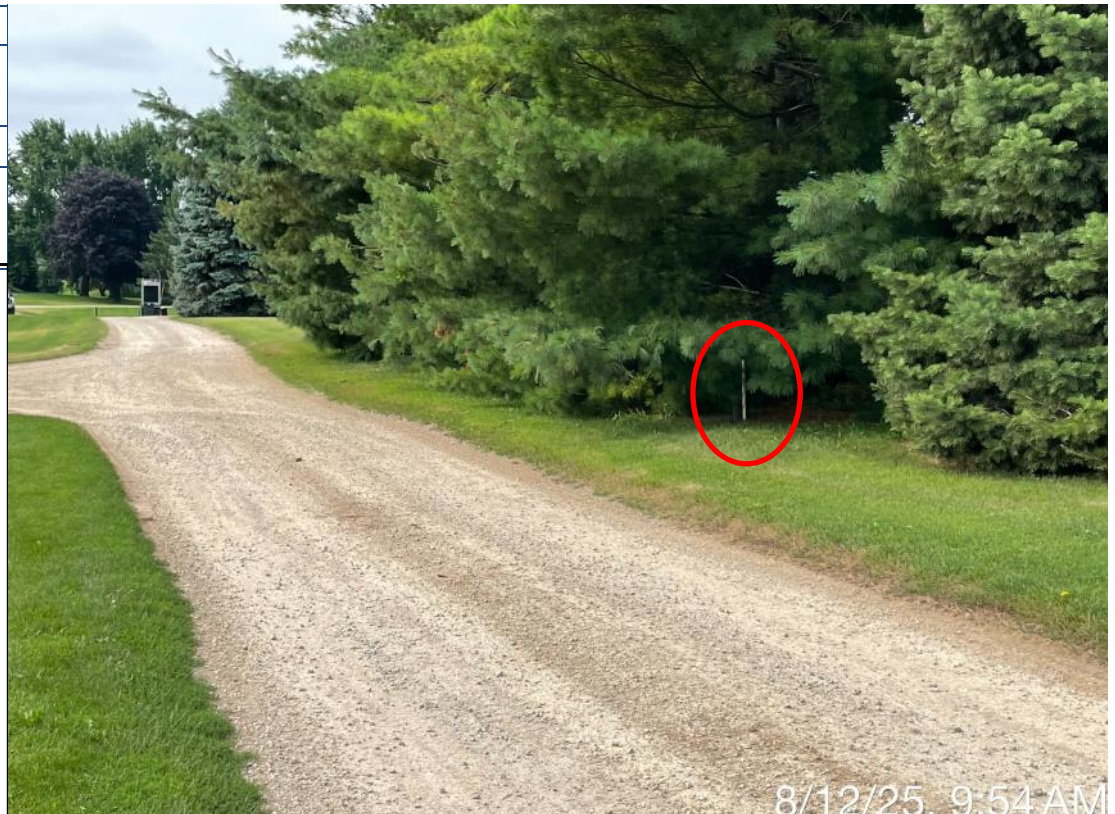
<b>Photo #:</b>	52
<b>Date/Time of Photo:</b>	8/12/2025 09:54
<b>Photo By:</b>	Brian Hanson
<b>Photo Location:</b>	Main Dairy Well Location

**Photo Description:**  
Standing on west side of parlor looking southwest: View of water supply well located in trees.

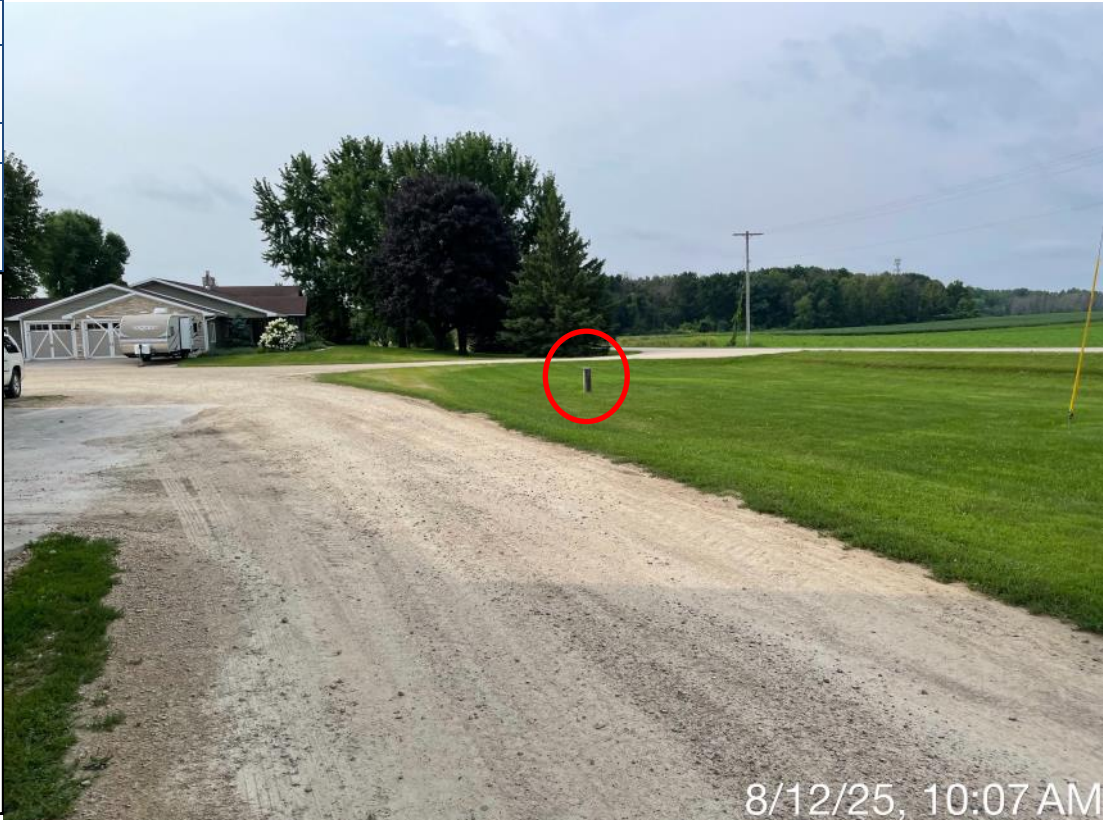
<b>Photo #:</b>	53
<b>Date/Time of Photo:</b>	8/12/2025 10:07
<b>Photo By:</b>	Brian Hanson
<b>Photo Location:</b>	Main Dairy Well Location
<b>Photo Description:</b>  Standing on the west side of dry cow barn looking southwest: View of water supply well near driveway.

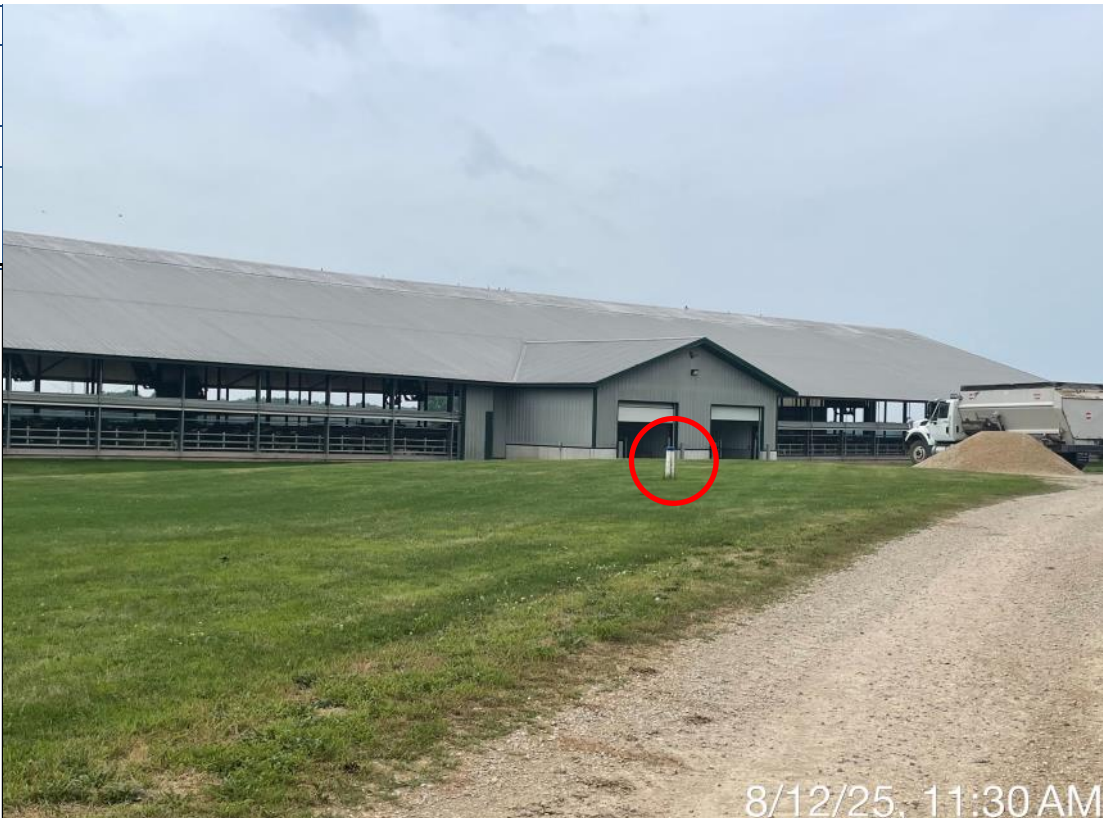
<b>Photo #:</b>	54
<b>Date/Time of Photo:</b>	8/12/2025 11:30
<b>Photo By:</b>	Brian Hanson
<b>Photo Location:</b>	Heifer Hill Well Location
<b>Photo Description:</b>  Standing on north side of heifer barn looking southwest: View of water supply well location on north side of heifer barn.
