Permit Fact Sheet

Permit Number	WI-0059391-06-0
Permittee Name and Address	Tauchen Harmony Valley Inc N3397 S Broadway Rd, Bonduel, WI 54107
Permitted Facility Name and Address	Tauchen Harmony Valley Inc N3399 Broadway Rd Bonduel
Permit Term	August 01, 2025 to July 31, 2030
Discharge Location	Main Farm: N3397 S Broadway Rd Bonduel, WI ; E ½ of the SE ¼ Section 23 T 26N R17E Klosterman Pit: N3745 N. Broadway Rd Bonduel, WI ; SE ¼ of the SE ¼ Section 14 T26N R17E
Discharge Type	Existing

SUBJECT: Conditional Approval of Tauchen Harmony Valley Inc Nutrient Management Plan,
WPDES Permit No. 0059391-06-0

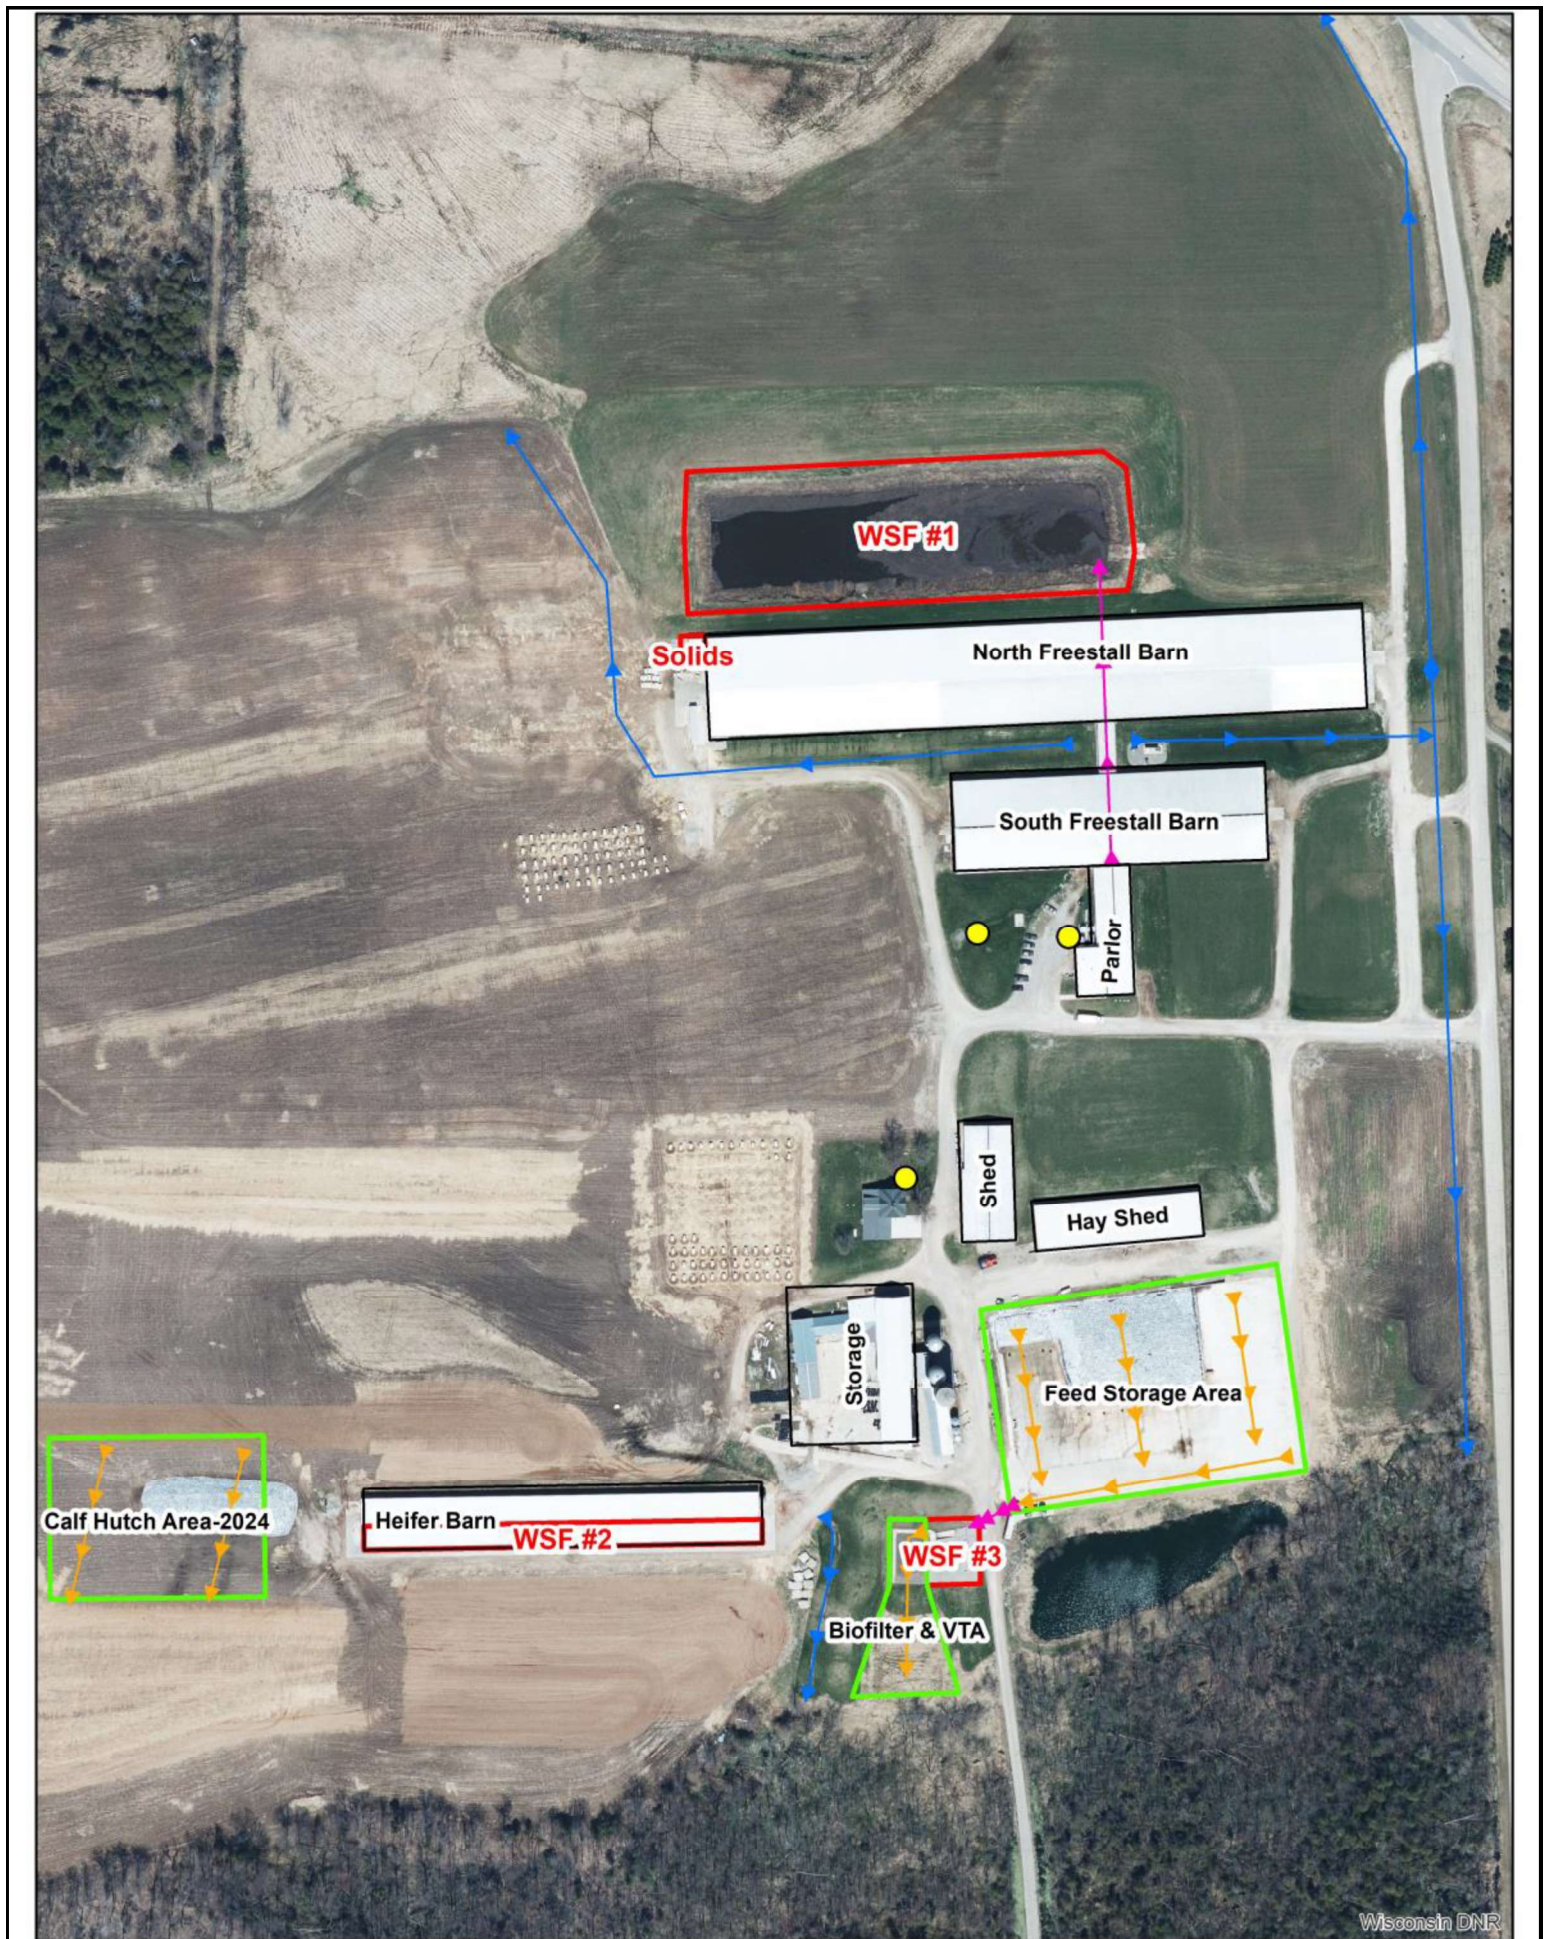
Site Overview Diagram (Tauchen Harmony Valley: orange lines = potential contaminated runoff, blue lines = stormwater flow, pink lines = waste transfer system, yellow circles = well locations)

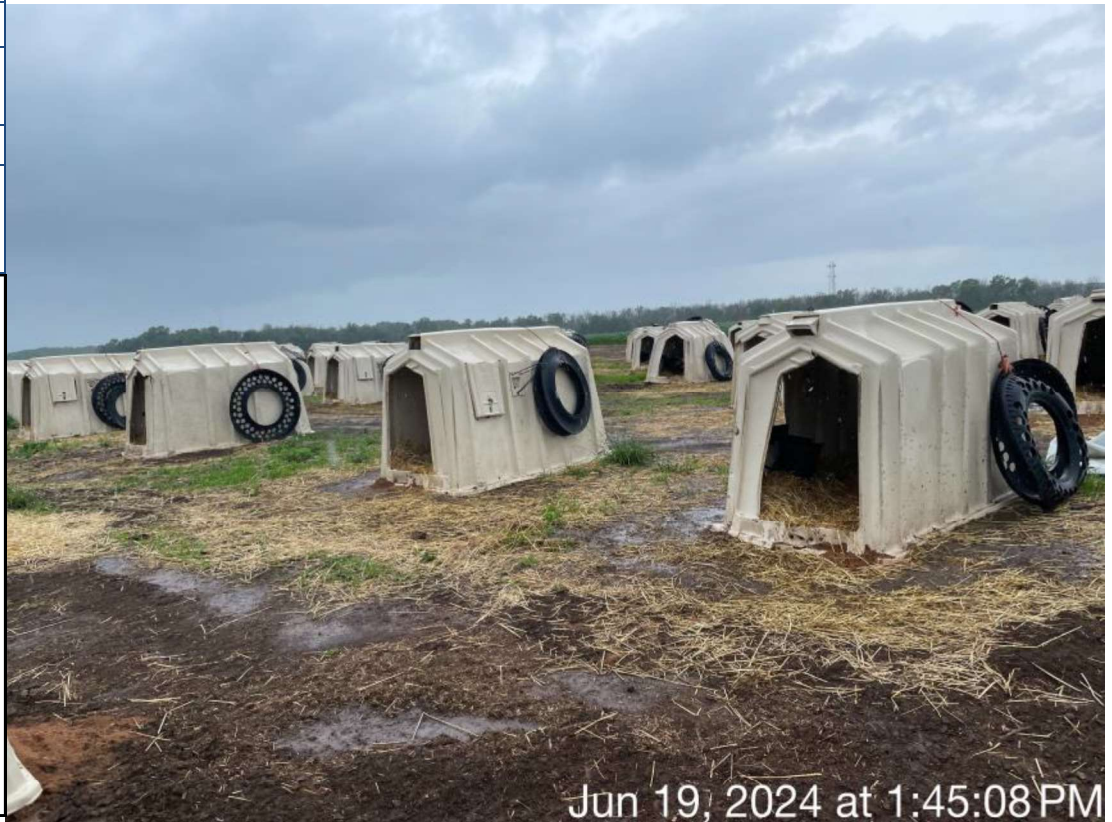
Photo #:	1
Date/Time of Photo:	6/19/2024 13:45
Photo By:	Brian Hanson
Photo Location:	Calf Hutch Area
Photo Description: Standing in the center of the calf hutch area looking northwest: View of center section of calf hutch area. Notice some bedding located outside of the hutches.

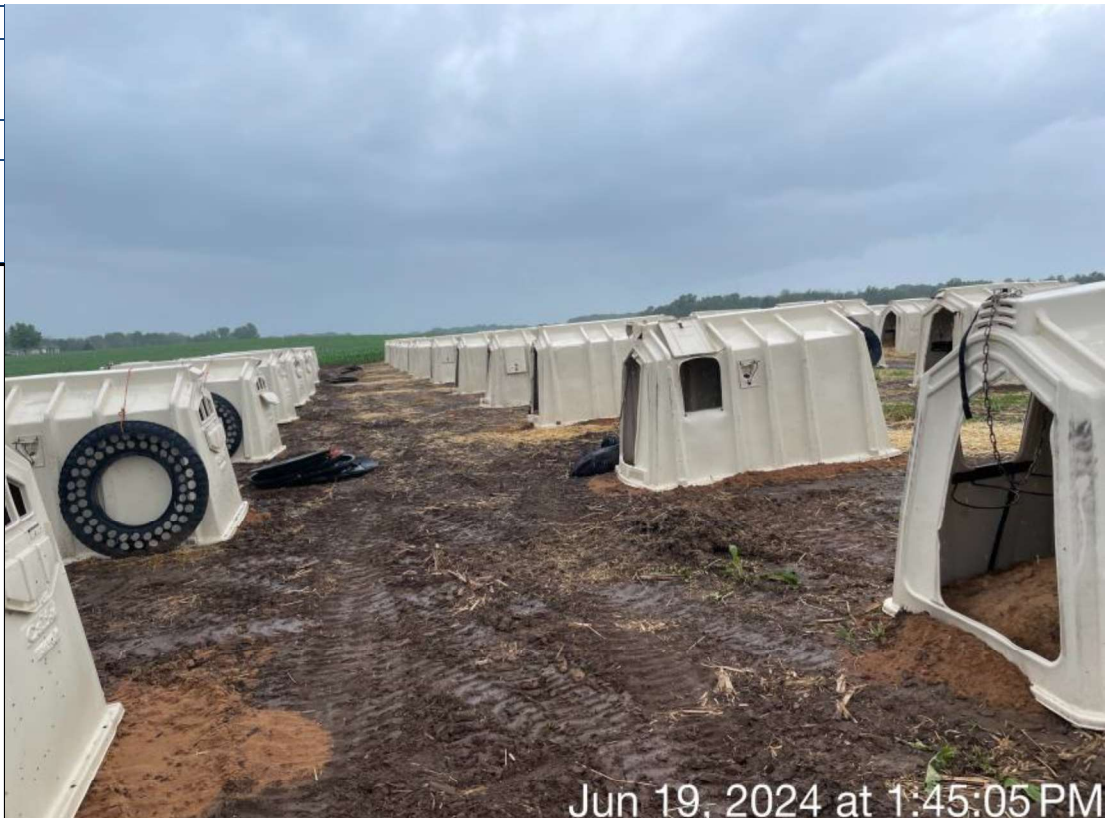
Photo #:	2
Date/Time of Photo:	6/19/2024 13:45
Photo By:	Brian Hanson
Photo Location:	Calf Hutch Area
Photo Description: Standing on the east side of the calf hutch area looking west: View of center section of calf hutch area.

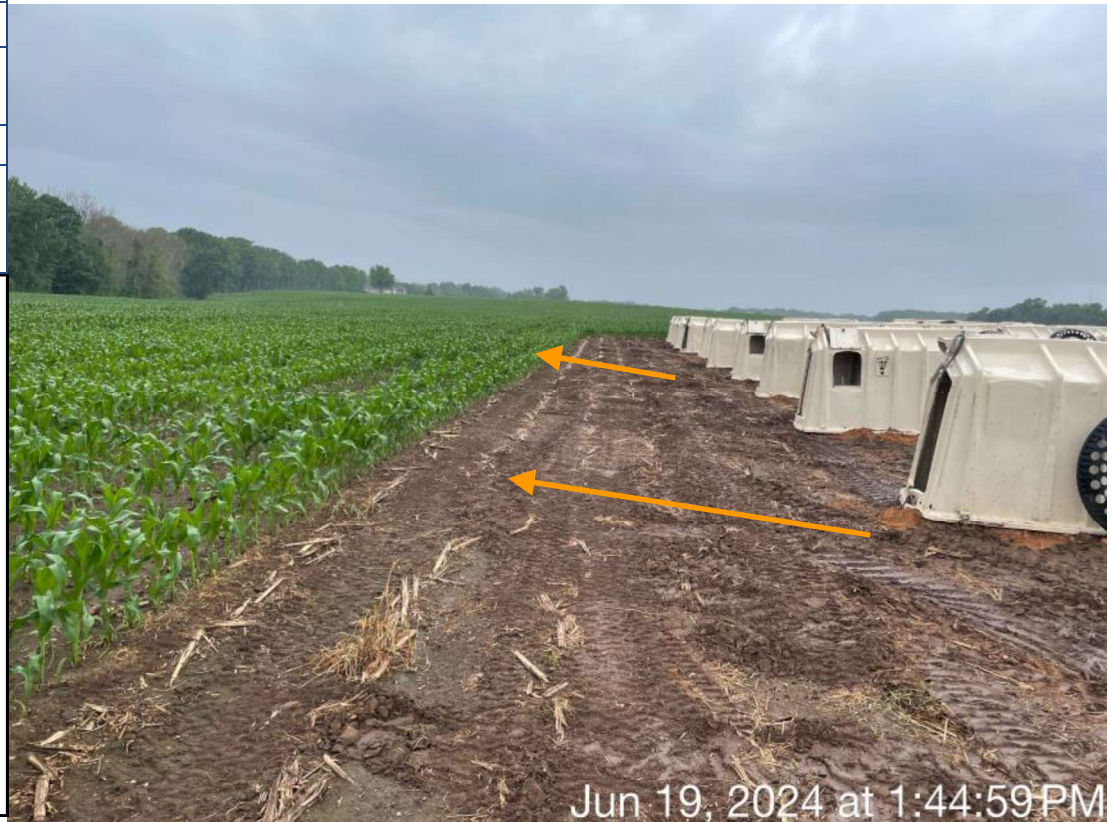
Photo #:	3
Date/Time of Photo:	6/19/2024 13:44
Photo By:	Brian Hanson
Photo Location:	Calf Hutch Area
Photo Description: Standing on the south side of the calf hutch area looking west: View of the south edge of calf hutch area. Notice runoff flow path is into existing corn field. No sign of past or current discharges.

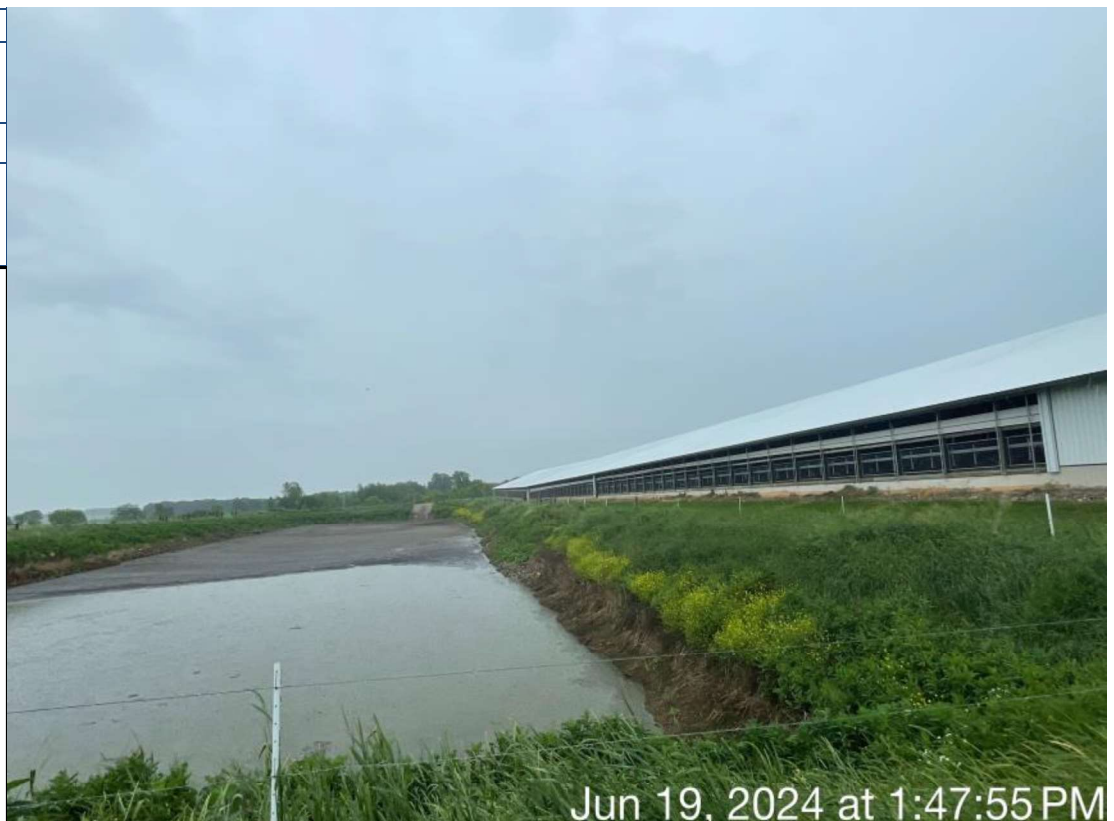
Photo #:	4
Date/Time of Photo:	6/19/2024 13:47
Photo By:	Brian Hanson
Photo Location:	WSF #1
Photo Description: Standing on the west side of WSF #1 looking east: View of southwest corner of WSF #1.

- WSF #1 was last constructed in 2001. Evidence of minor erosion of the earthen liner was visible & the farm should continue to monitor the liner integrity to prevent any discharge or liner failure. Vegetation had also started to establish itself along the interior berm of the facility. Excessive root growth from grasses or woody vegetation can negatively impact the integrity of earthen liners. This vegetation should be removed via mechanical or chemical methods.

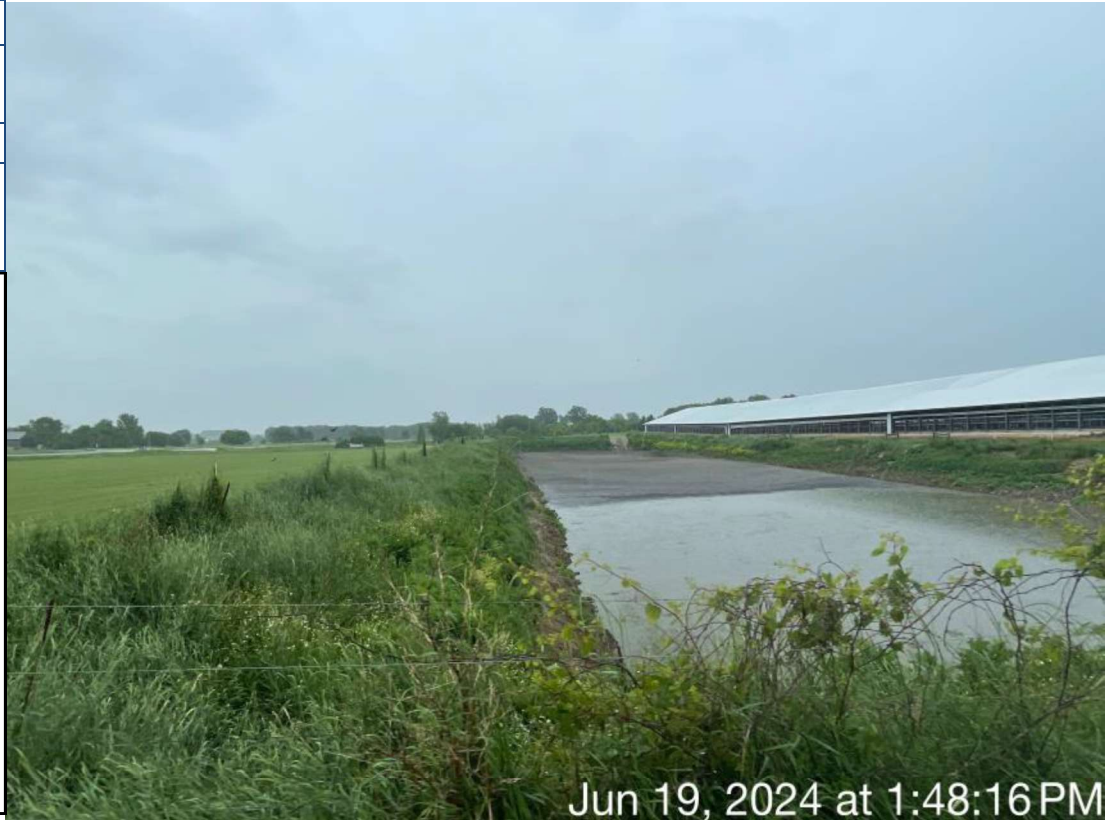
Photo #:	5
Date/Time of Photo:	6/19/2024 13:48
Photo By:	Brian Hanson
Photo Location:	WSF #1
Photo Description: Standing on the west side of WSF #1 looking east: View of northwest corner of WSF #1.

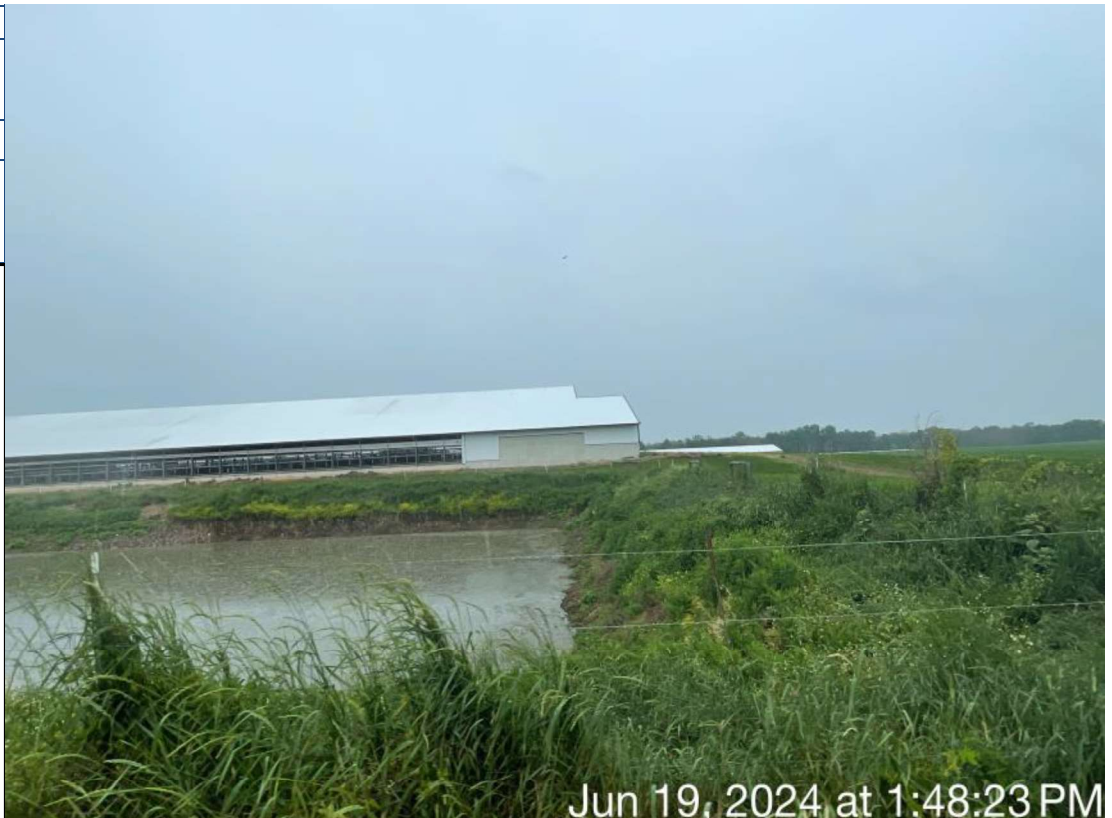
Photo #:	6
Date/Time of Photo:	6/19/2024 13:48
Photo By:	Brian Hanson
Photo Location:	WSF #1
Photo Description: Standing on the north side of WSF #1 looking south: View of west end of WSF #1.

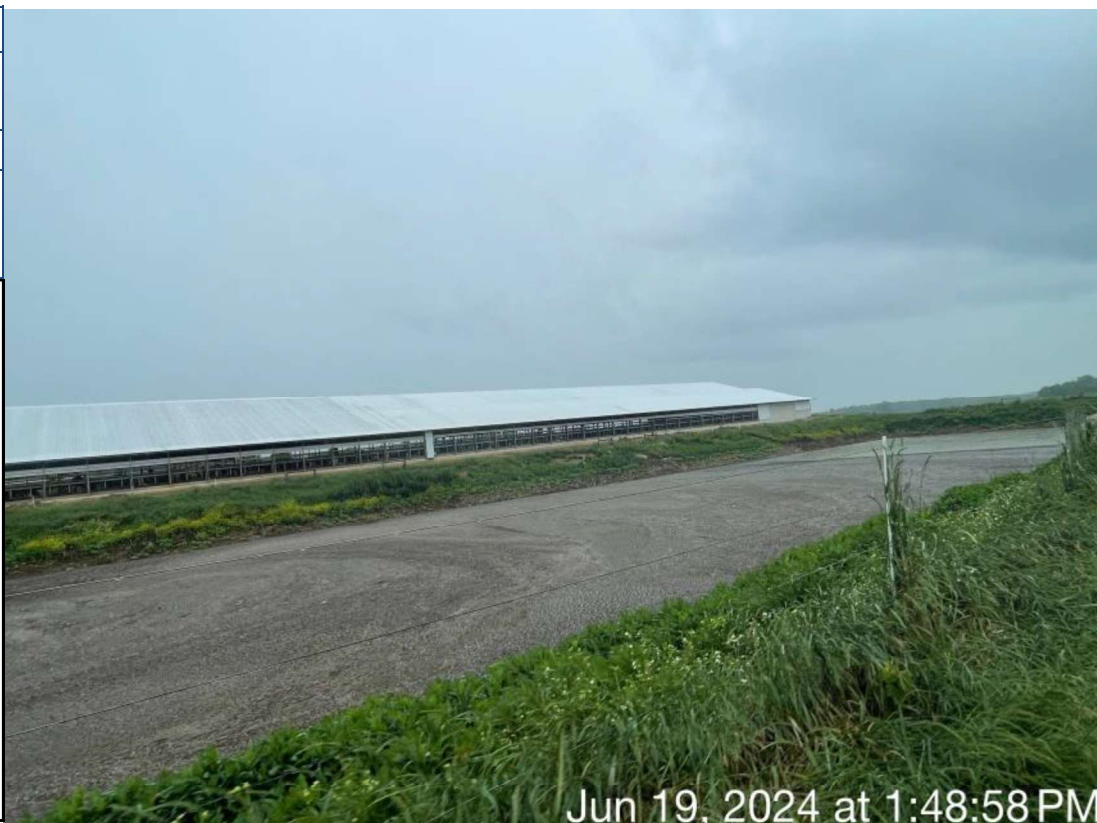
Photo #:	7
Date/Time of Photo:	6/19/2024 13:48
Photo By:	Brian Hanson
Photo Location:	WSF #1

Standing on the north side of WSF #1 looking southwest: View of center section of WSF #1.

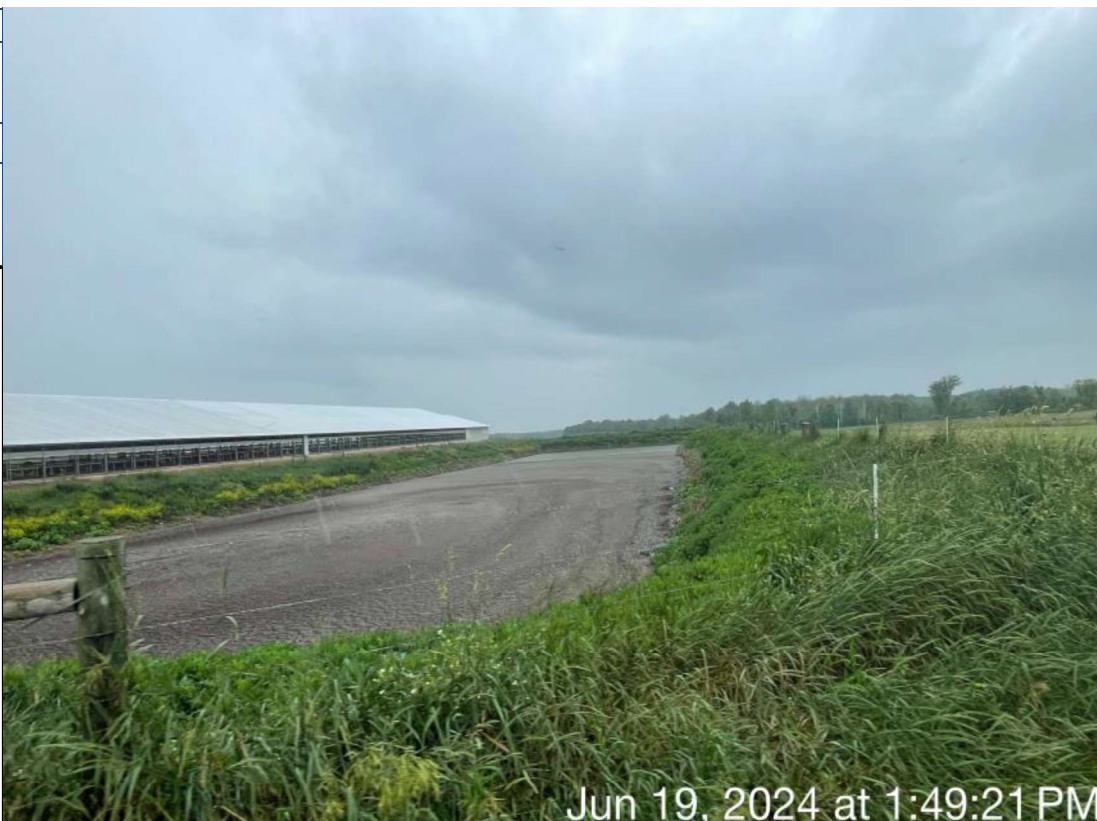
Photo #:	8
Date/Time of Photo:	6/19/2024 13:49
Photo By:	Brian Hanson
Photo Location:	WSF #1

Standing on the east side of WSF #1 looking west: View of northeast corner of WSF #1.

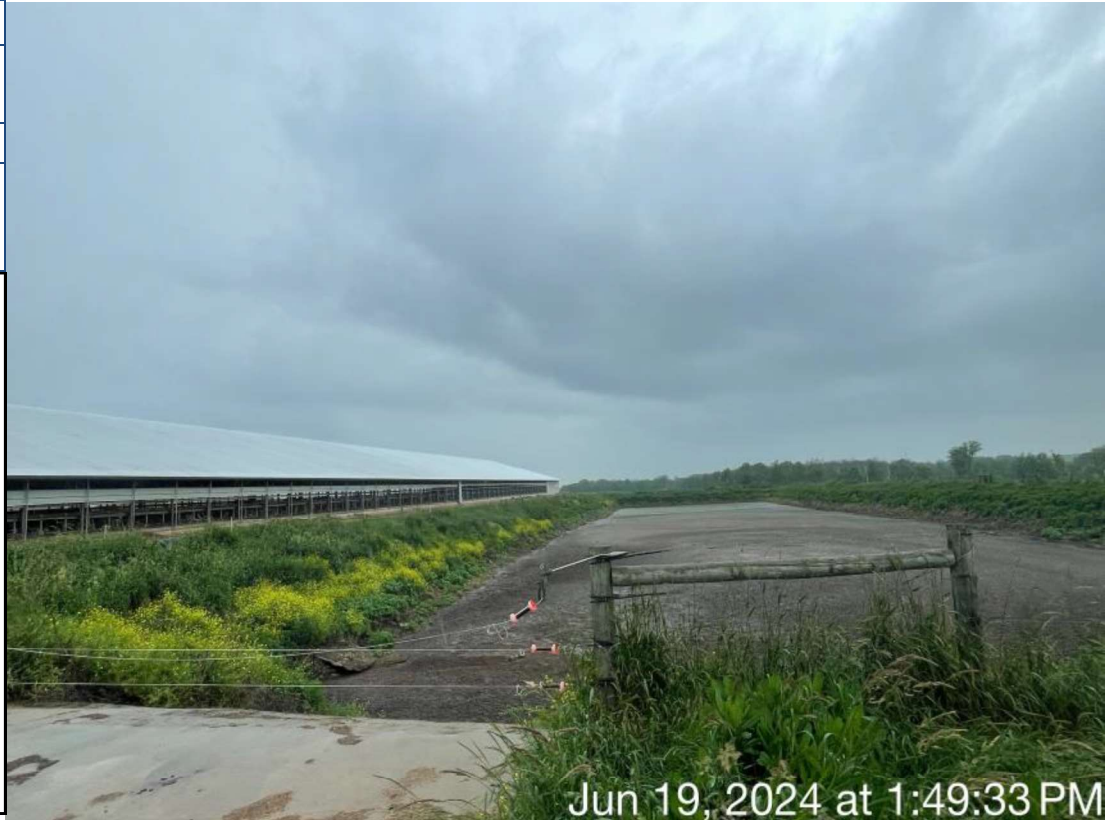
Photo #:	9
Date/Time of Photo:	6/19/2024 13:49
Photo By:	Brian Hanson
Photo Location:	WSF #1
Photo Description: Standing on the east side of WSF #1 looking west: View of southeast corner of WSF #1.

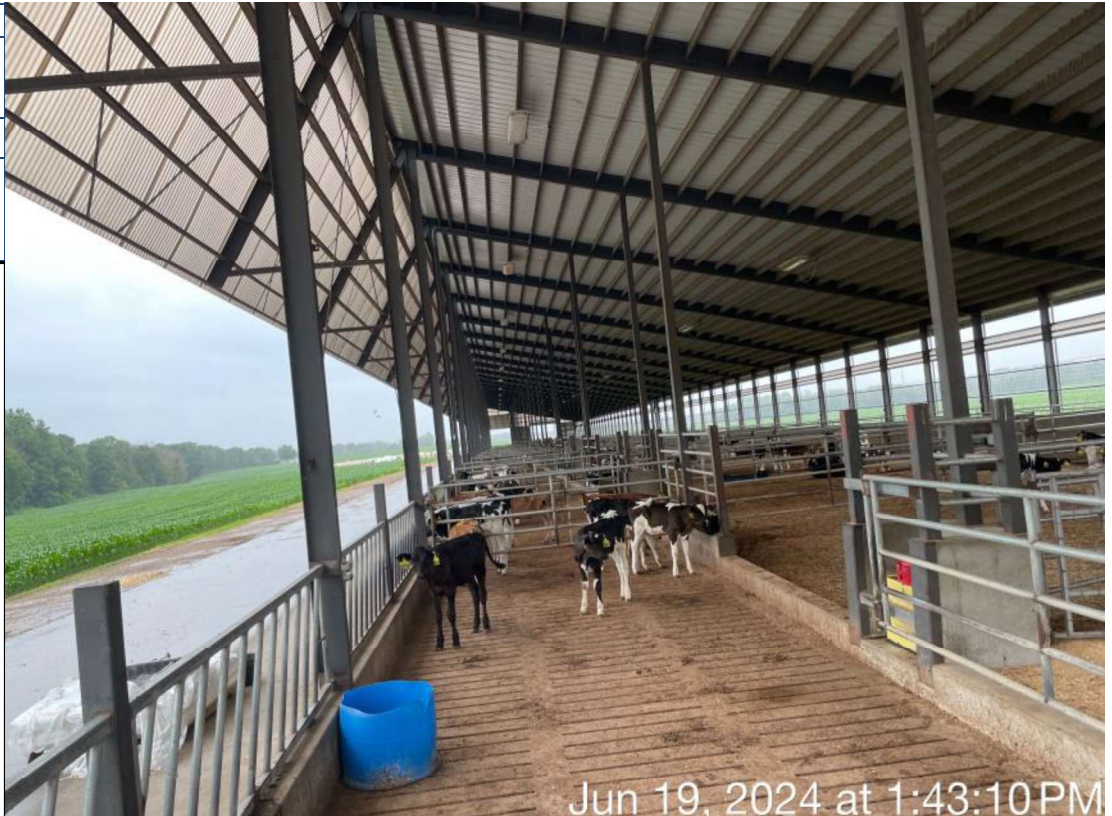
Photo #:	10
Date/Time of Photo:	6/19/2024 13:43
Photo By:	Brian Hanson
Photo Location:	WSF #2
Photo Description: Standing on the east side of heifer barn looking west: View of slatted floor in litter alley that acts as a cover for WSF #2.

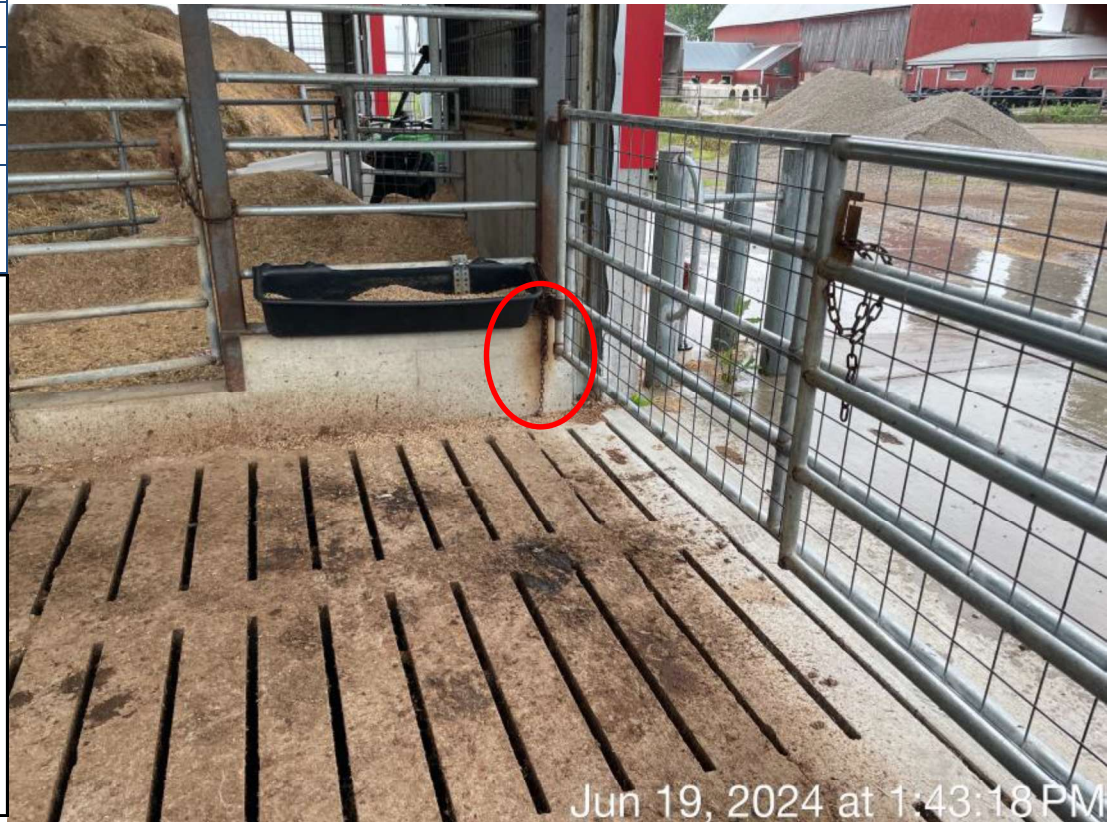
Photo #:	11
Date/Time of Photo:	6/19/2024 13:43
Photo By:	Brian Hanson
Photo Location:	WSF #2
Photo Description:	
Standing on the east side of WSF #2 looking north: View of east end of WSF #2. Chain used to measure depth highlighted.

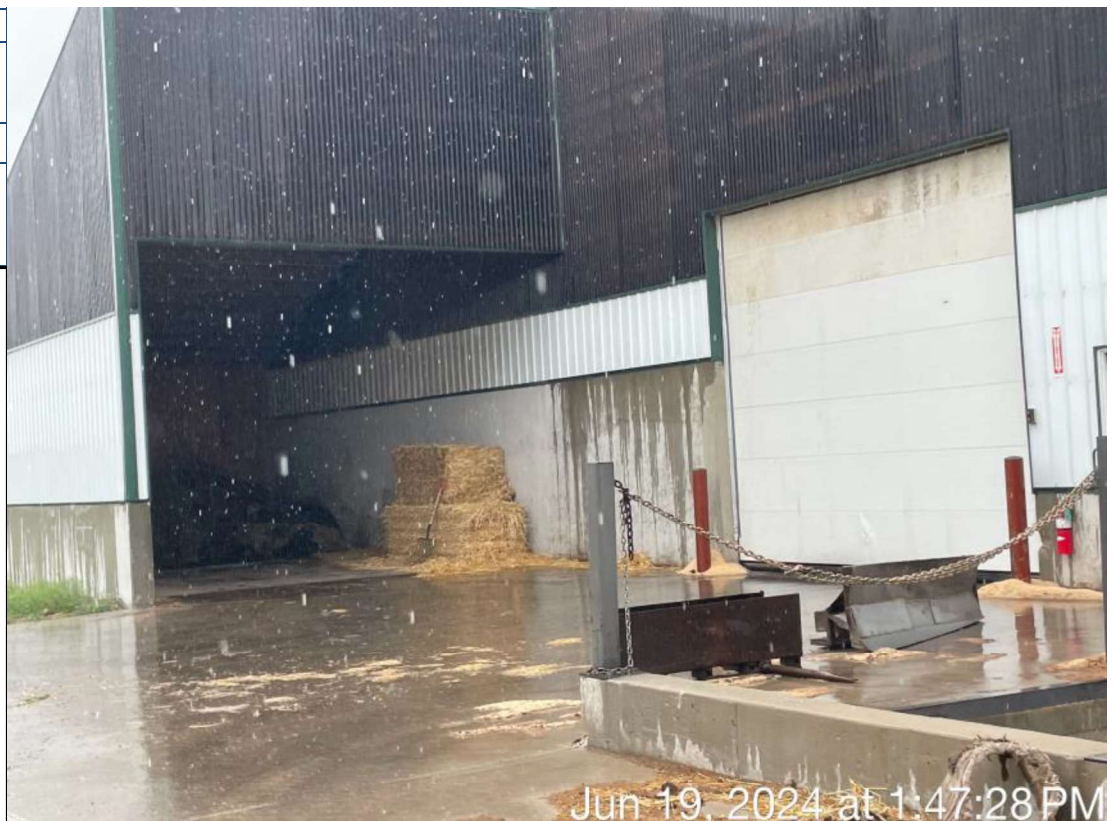
Photo #:	12
Date/Time of Photo:	6/19/2024 13:47
Photo By:	Brian Hanson
Photo Location:	Solids Stacking Area
Photo Description:	
Standing on the west side of the north freestall barn looking north: View of roofed solids stacking area used to temporarily store solid manure & bedded pack from the maternity area.

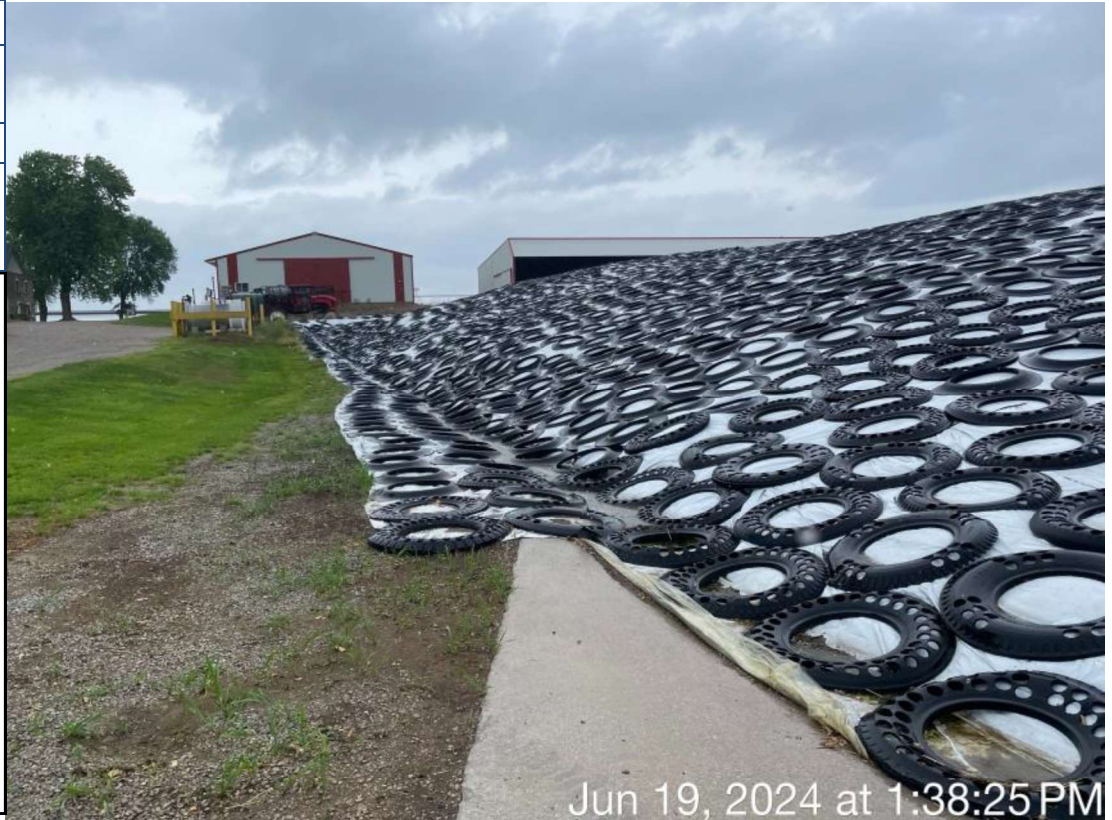
Photo #:	13
Date/Time of Photo:	6/19/2024 13:38
Photo By:	Brian Hanson
Photo Location:	Feed Storage Area
Photo Description: Standing on the west side of the FSA looking north: View of the west edge of FSA.

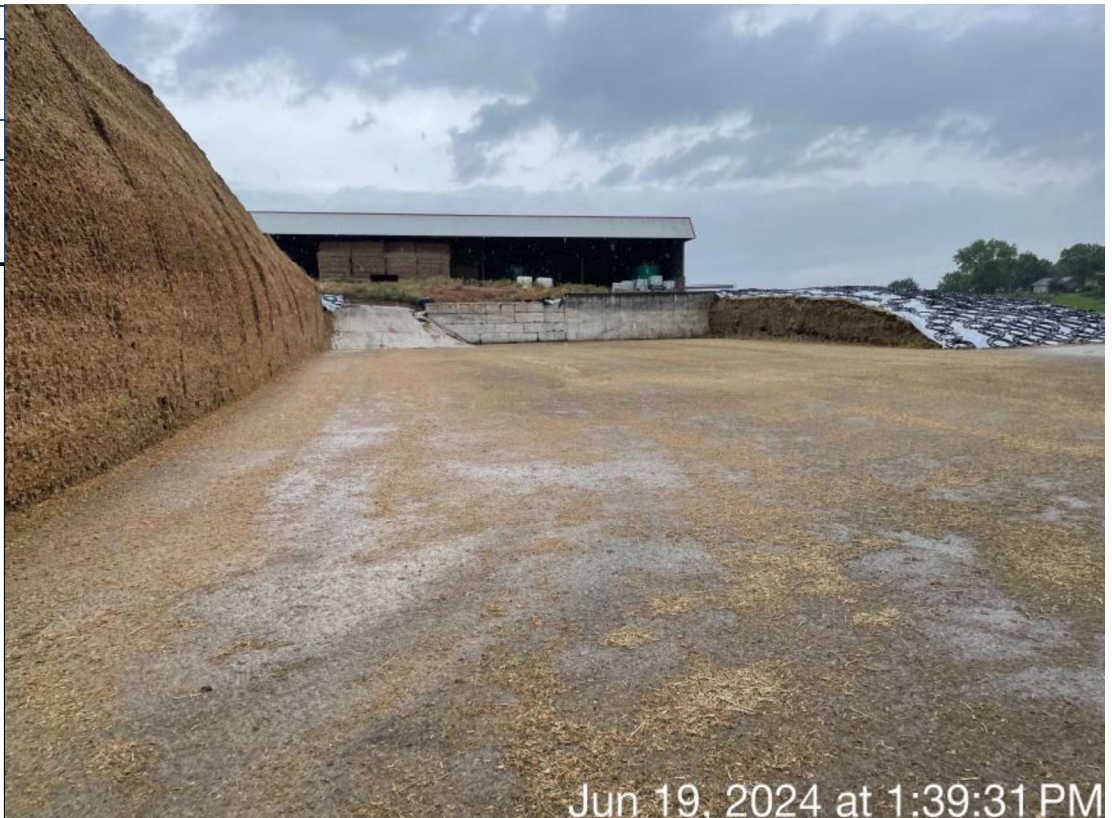
Photo #:	14
Date/Time of Photo:	6/19/2024 13:39
Photo By:	Brian Hanson
Photo Location:	Feed Storage Area
Photo Description: Standing in the center of the FSA looking north: View of center section of FSA. Floor is free of major cracks and appears to be in good working order.

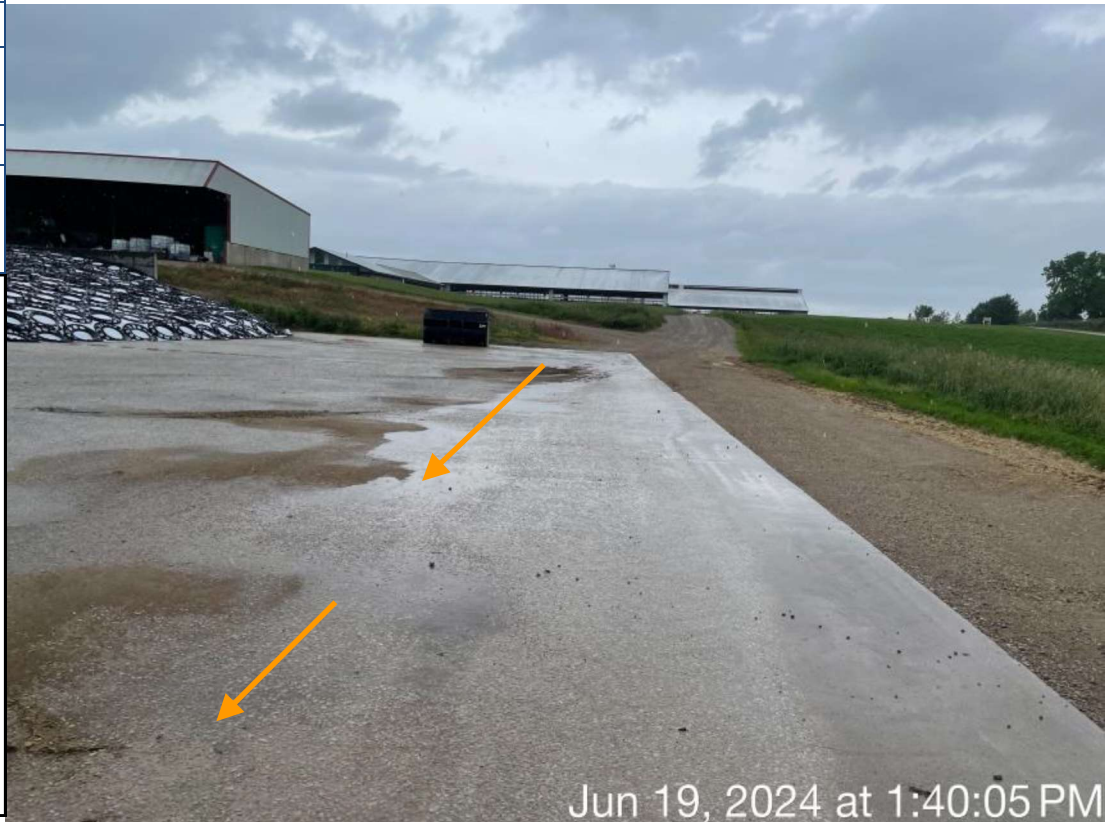
Photo #:	15
Date/Time of Photo:	6/19/2024 13:40
Photo By:	Brian Hanson
Photo Location:	Feed Storage Area
Photo Description: Standing on the east side of FSA looking north: View of east edge of FSA. Arrows indicate direction of runoff flow.

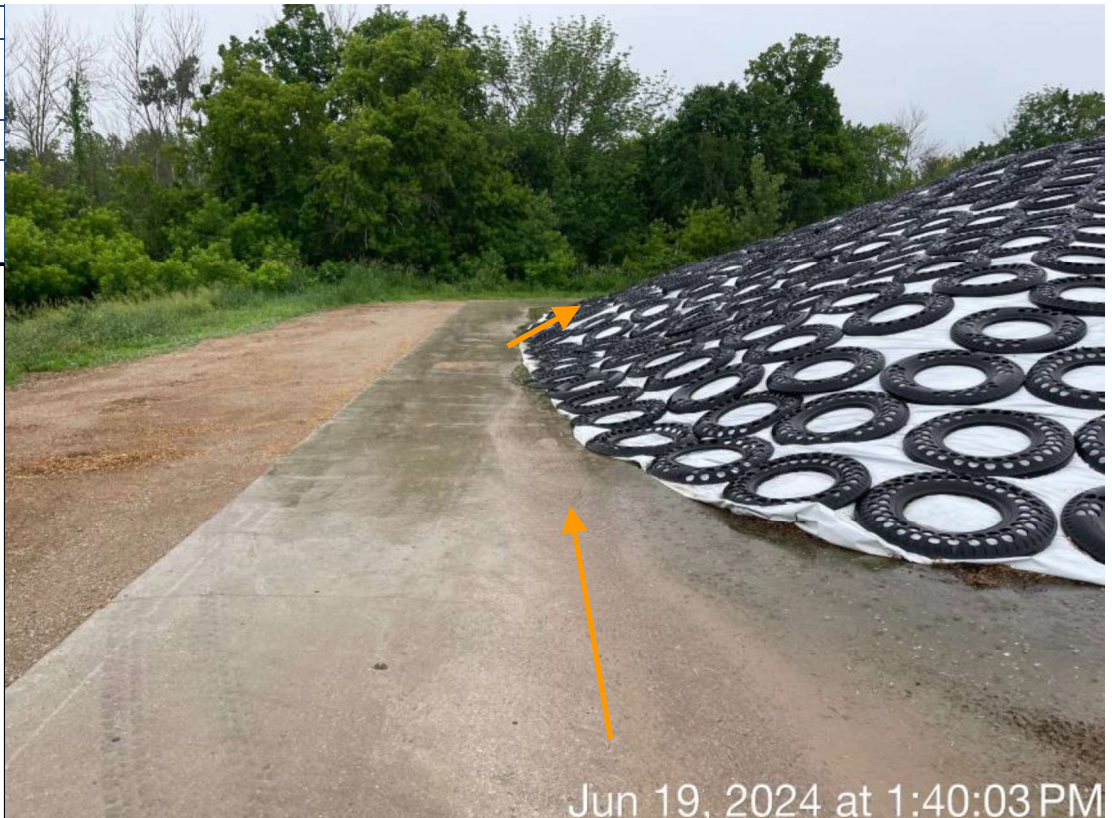
Photo #:	16
Date/Time of Photo:	6/19/2024 13:40
Photo By:	Brian Hanson
Photo Location:	Feed Storage Area
Photo Description: Standing on the east side of FSA looking south: View of southeast corner of FSA. Arrows indicate direction of runoff flow.

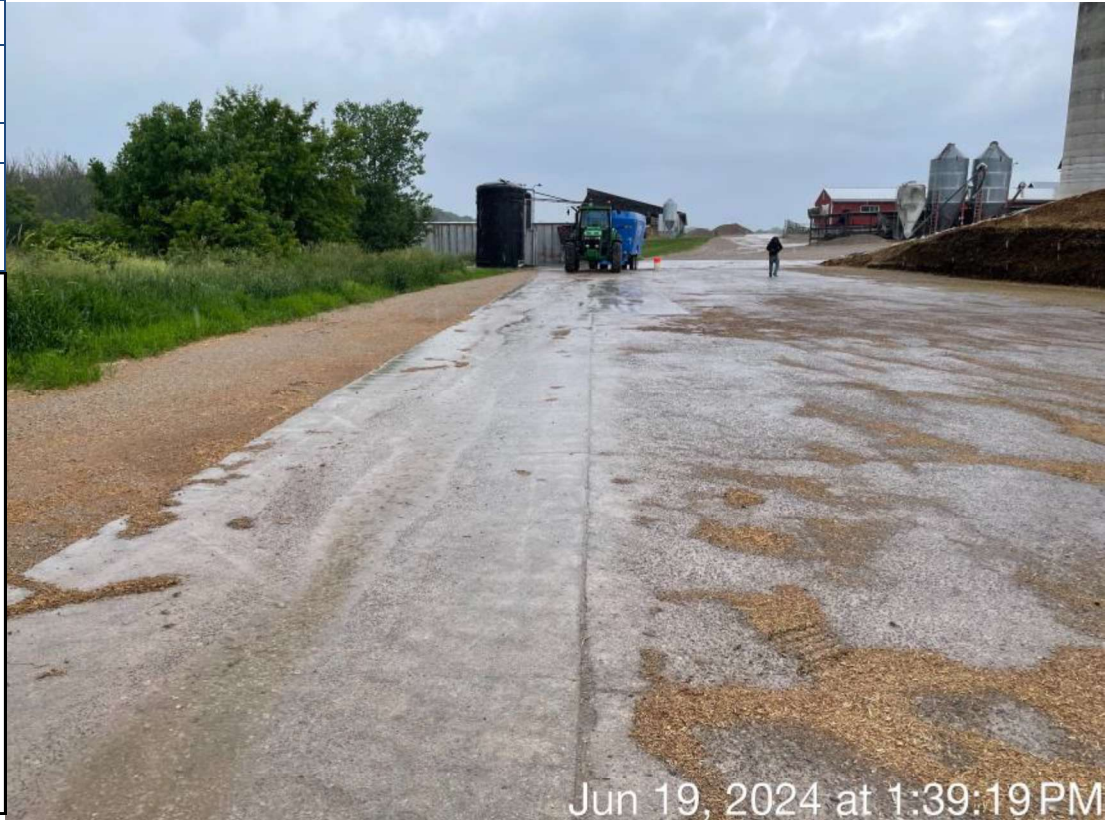
Photo #:	17
Date/Time of Photo:	6/19/2024 13:39
Photo By:	Brian Hanson
Photo Location:	Feed Storage Area
Photo Description: Standing on south side of FSA looking west: View of south edge of FSA. Arrows indicate direction of runoff flow.

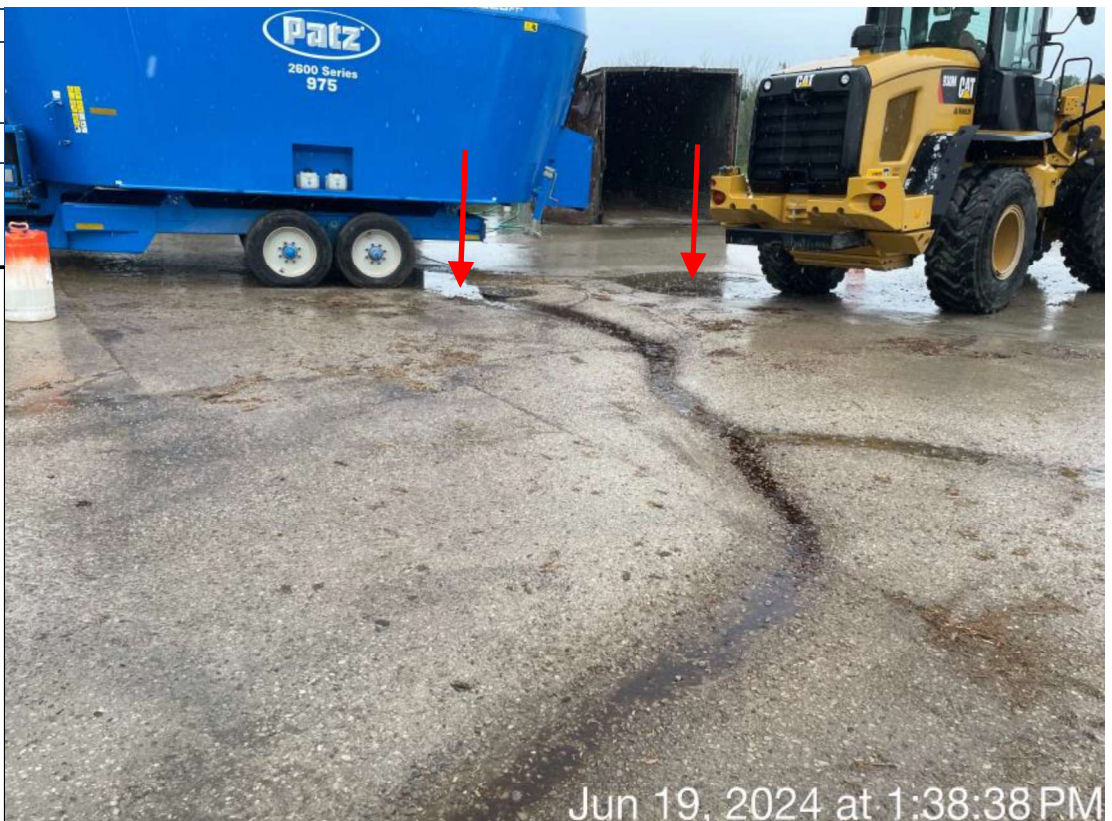
Photo #:	18
Date/Time of Photo:	6/19/2024 13:38
Photo By:	Brian Hanson
Photo Location:	Feed Storage Area
Photo Description: Standing in the southwest corner of FSA looking southwest: View of southwest corner of FSA where runoff enter one of 2 surface inlets highlighted by red arrows.

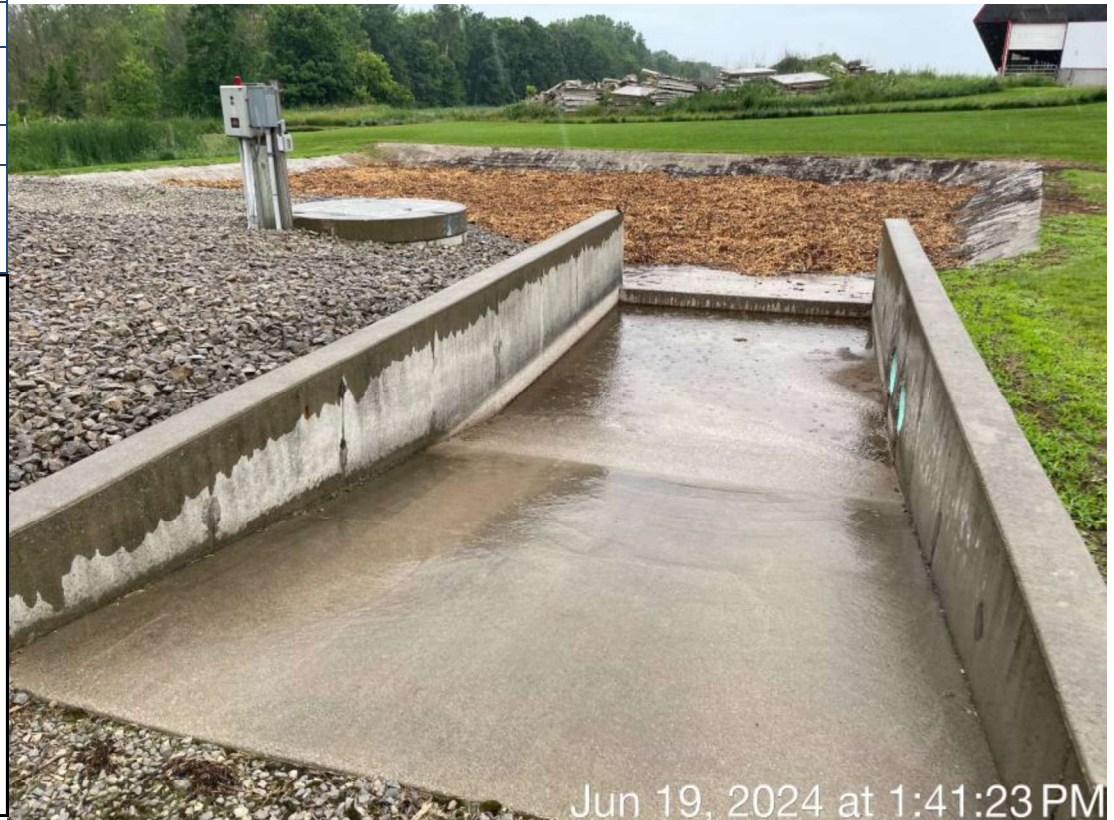
Photo #:	19
Date/Time of Photo:	6/19/2024 13:41
Photo By:	Brian Hanson
Photo Location:	FSA Runoff Controls

Standing at the northeast corner of the reception tanks & biofilter looking west: View of outlet basin for FSA runoff controls. Notice biofilter in background.

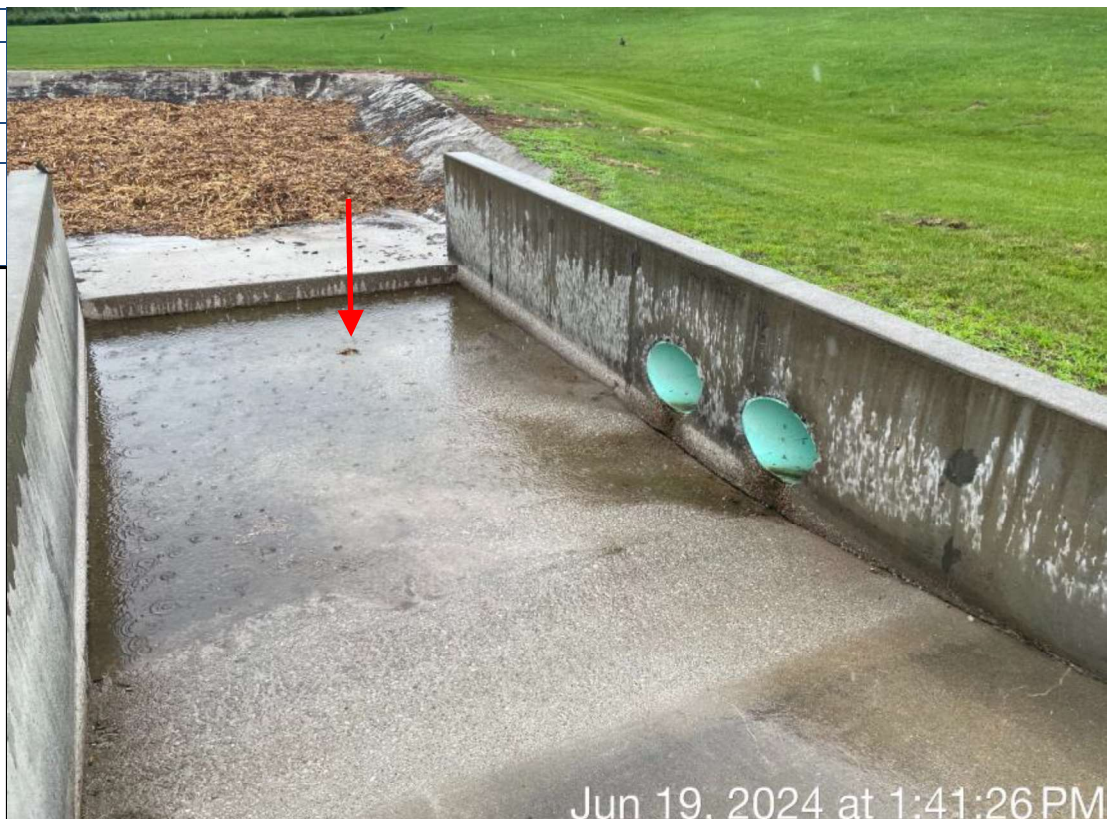
Photo #:	20
Date/Time of Photo:	6/19/2024 13:41
Photo By:	Brian Hanson
Photo Location:	FSA Runoff Controls

Standing at the northeast corner of the reception tanks & biofilter looking west: View of outlet basin for FSA runoff controls. Notice 2 green outlet pipe that convey runoff from the feedpad to this basin. Inlet at red arrows directs first flush into reception tanks to be stored. Remaining runoff overflows to biofilter.
