Permit Fact Sheet

Permit Number	WI-0059391-06-0
Permittee Name and Address	Tauchen Harmony Valley Inc N3397 S Broadway Rd, Bonduel, WI 54107
Permitted Facility Name and Address	Tauchen Harmony Valley Inc N3399 Broadway Rd Bonduel
Permit Term	August 01, 2025 to July 31, 2030
Discharge Location	Main Farm: N3397 S Broadway Rd Bonduel, WI ; E ½ of the SE ¼ Section 23 T 26N R17E Klosterman Pit: N3745 N. Broadway Rd Bonduel, WI ; SE ¼ of the SE ¼ Section 14 T26N R17E
Discharge Type	Existing

SUBJECT: Conditional Approval of Tauchen Harmony Valley Inc Nutrient Management Plan,
WPDES Permit No. 0059391-06-0

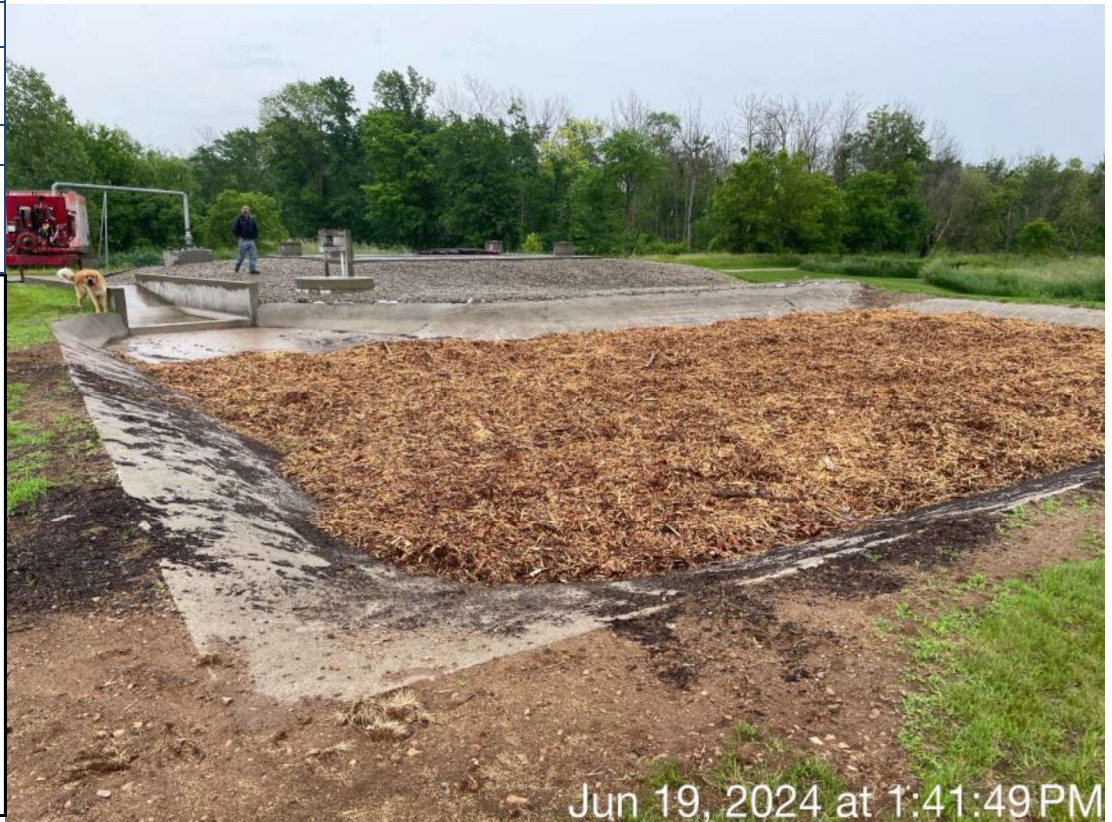
At the time of the inspection the runoff controls on the FSA were functioning as intended. The concrete basin was clear of debris and water was flowing into the manhole. The biofilter looked to have recently had the woodchip layer replaced with new material and appeared to be in good working order. The vegetated treatment area was well vegetated and the gravel spreader did not show any signs of concentrated flow channels. Vegetation in the VTA was quite tall and should be cut and harvested as soon as the soil conditions allow.

Photo #:	21
Date/Time of Photo:	6/19/2024 13:41
Photo By:	Brian Hanson
Photo Location:	FSA Runoff Controls
Photo Description: Standing on the west side of the biofilter looking east: View of concrete basin used as a biofilter for FSA runoff. Notice wood biofilter had recently been changed.

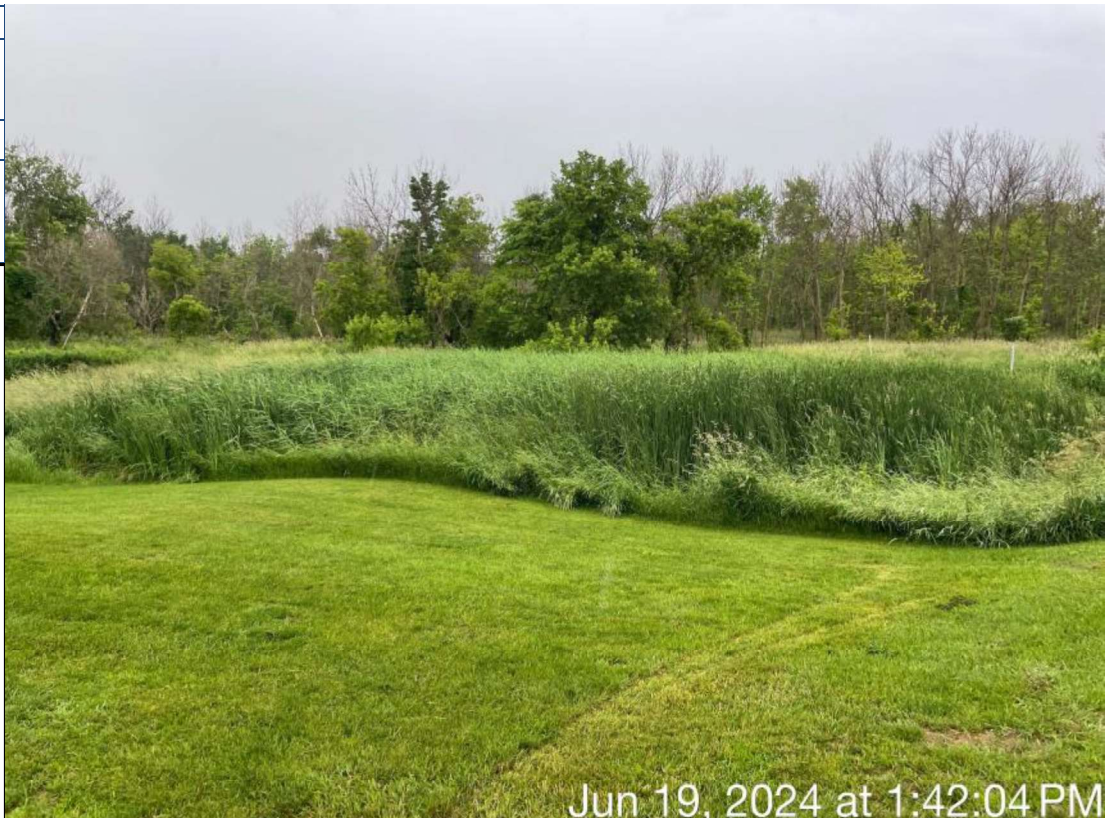
Photo #:	22
Date/Time of Photo:	6/19/2024 13:42
Photo By:	Brian Hanson
Photo Location:	FSA Runoff Controls
Photo Description: Standing on the south side of biofilter looking south: View of vegetated treatment area (VTA) on south side of biofilter. After runoff passes through the biofilter, it is directed to this VTA via gravity outlet pipes.

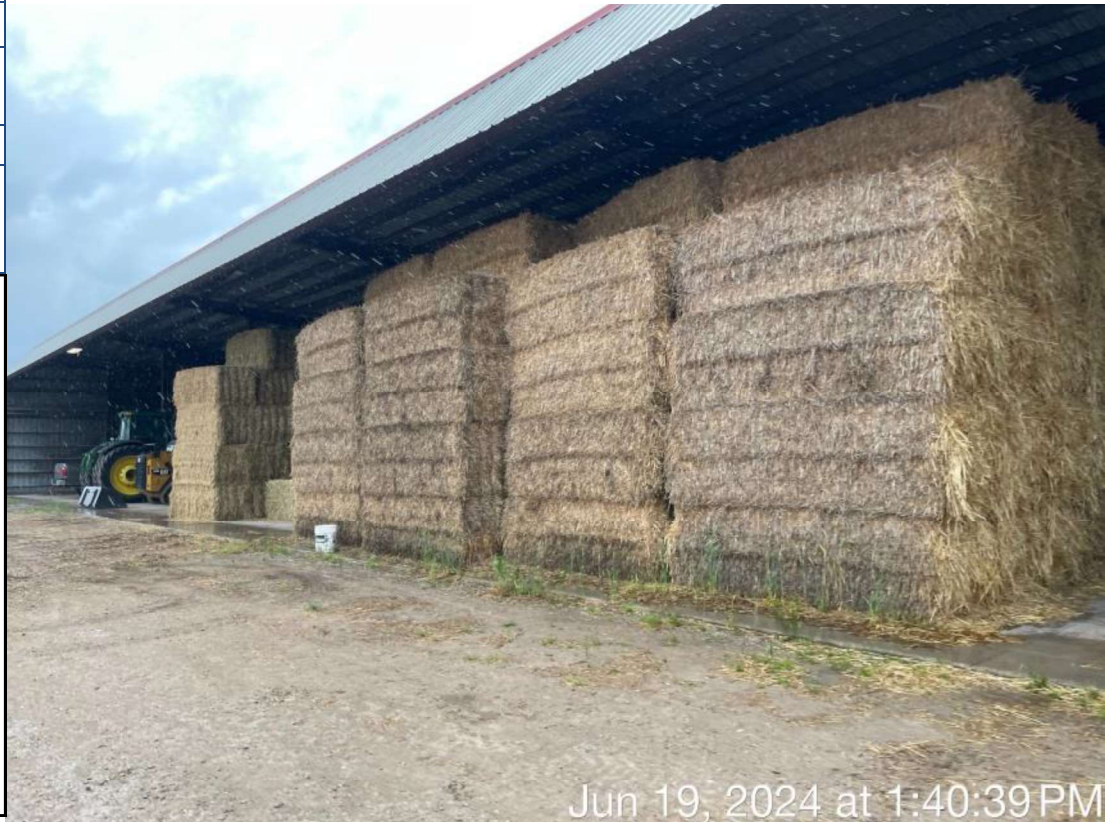
Photo #:	23
Date/Time of Photo:	6/19/2024 13:40
Photo By:	Brian Hanson
Photo Location:	Hay Storage Shed
Photo Description:	
Standing on the north side of FSA looking northwest: View of storage shed on north side of Feed Storage used to store dry hay and equipment.

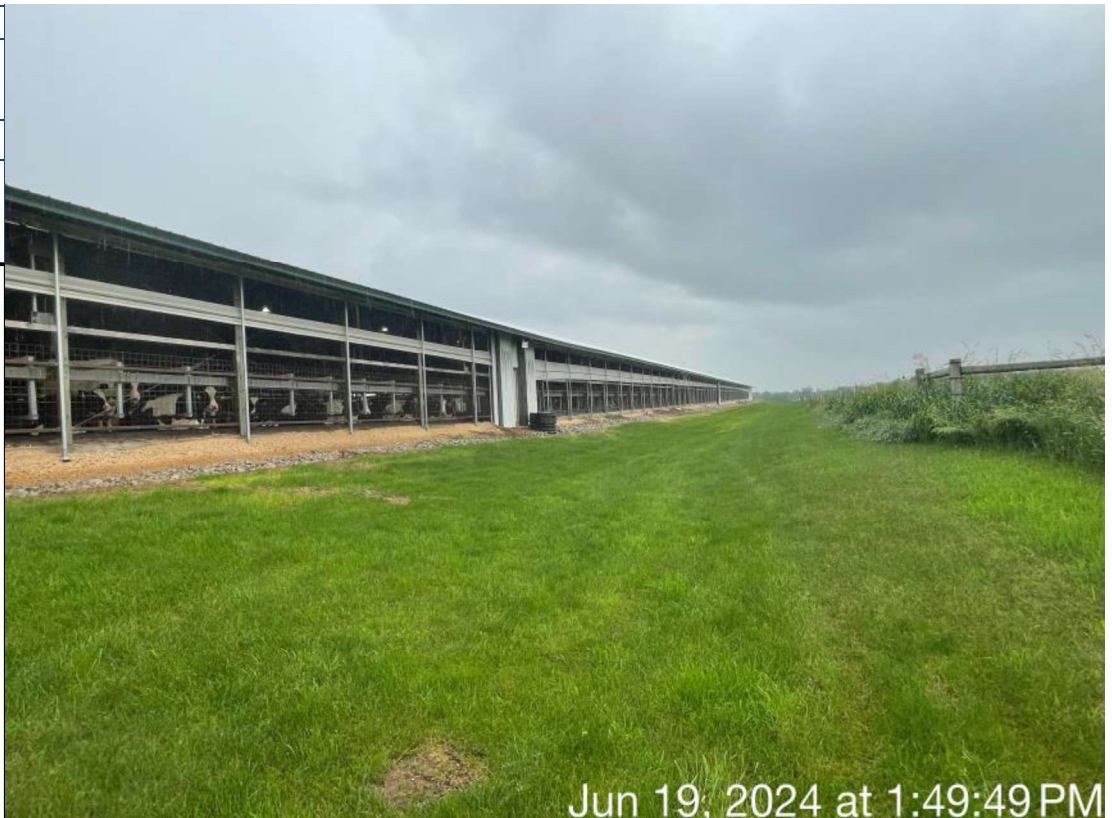
Photo #:	24
Date/Time of Photo:	6/19/2024 13:49
Photo By:	Brian Hanson
Photo Location:	Stormwater
Photo Description:	
Standing at the southeast corner of WSF #1 looking west: View of stormwater channel between the freestall barn & WSF #1. Area is well vegetated & shows no sign of erosion or discharges.

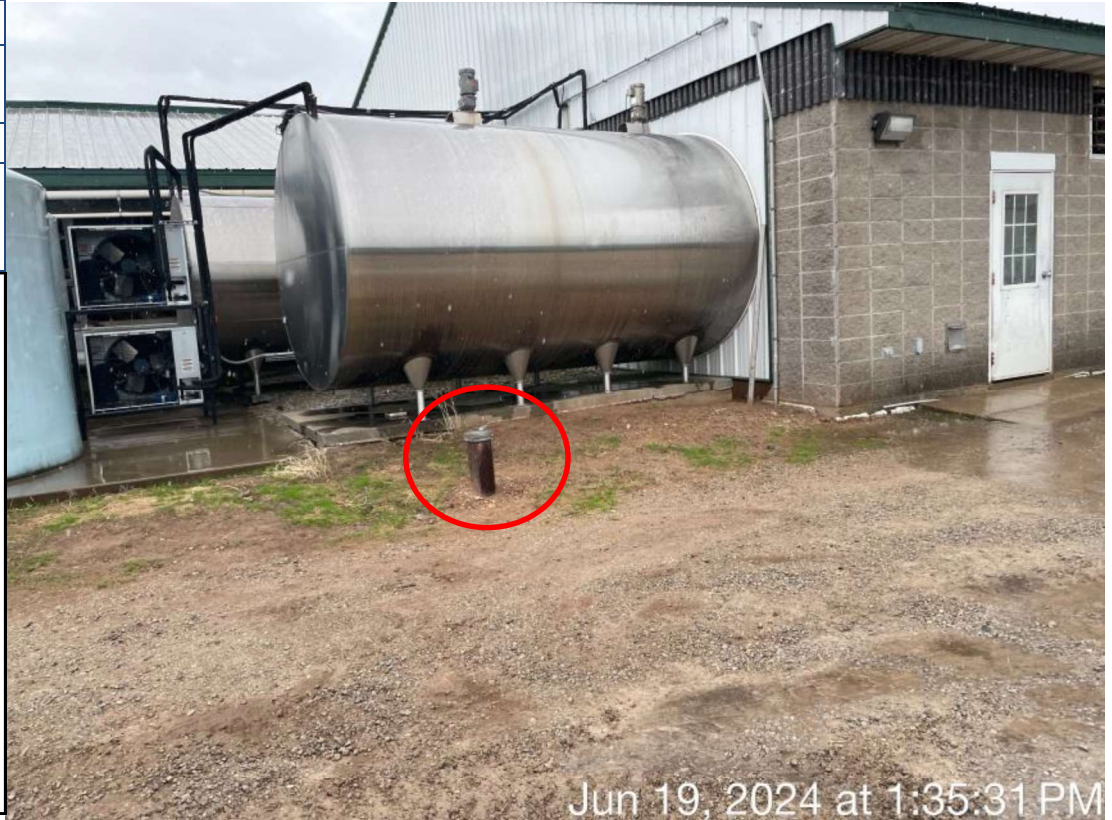
Photo #:	27
Date/Time of Photo:	6/19/2024 13:35
Photo By:	Brian Hanson
Photo Location:	Well Locations
Photo Description: Standing on the west side of the parlor looking east: View of well KV188 located next to the bulk tanks of the parlor.

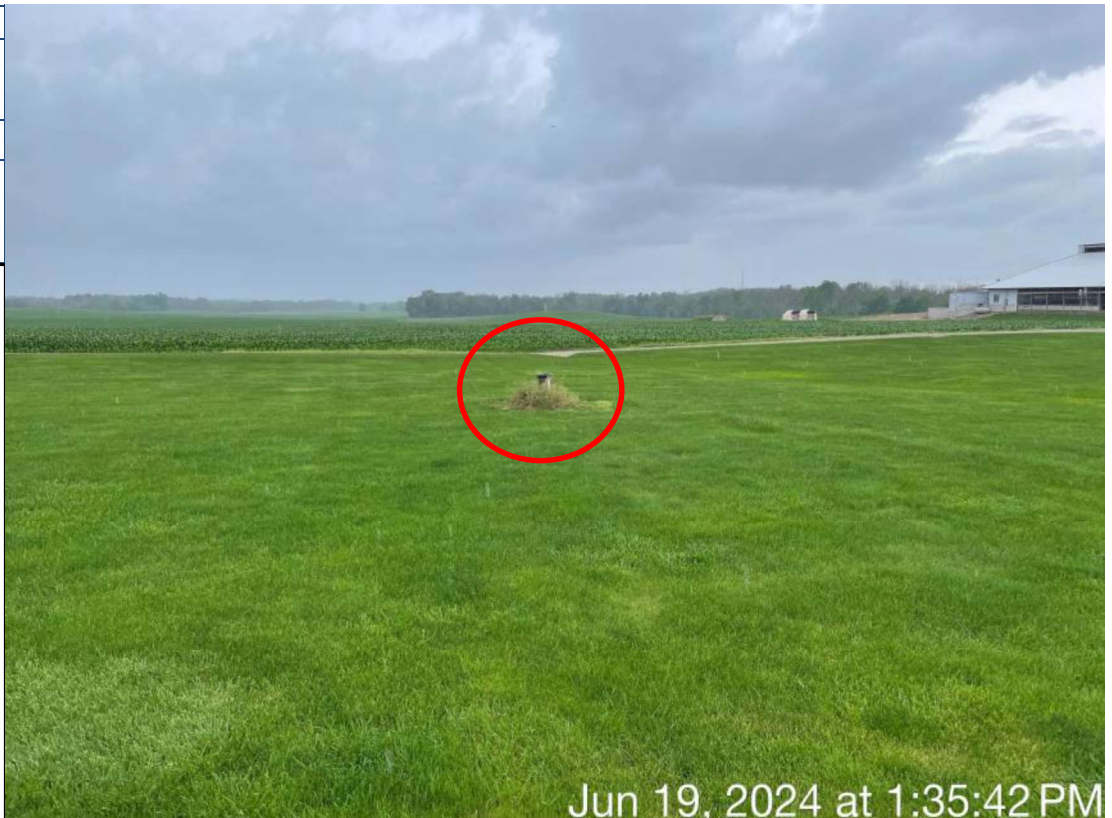
Photo #:	28
Date/Time of Photo:	6/19/2024 13:35
Photo By:	Brian Hanson
Photo Location:	Well Locations
Photo Description: Standing on the west side of the parlor looking west: View of well QO850 located in the grassy area west of the parlor.

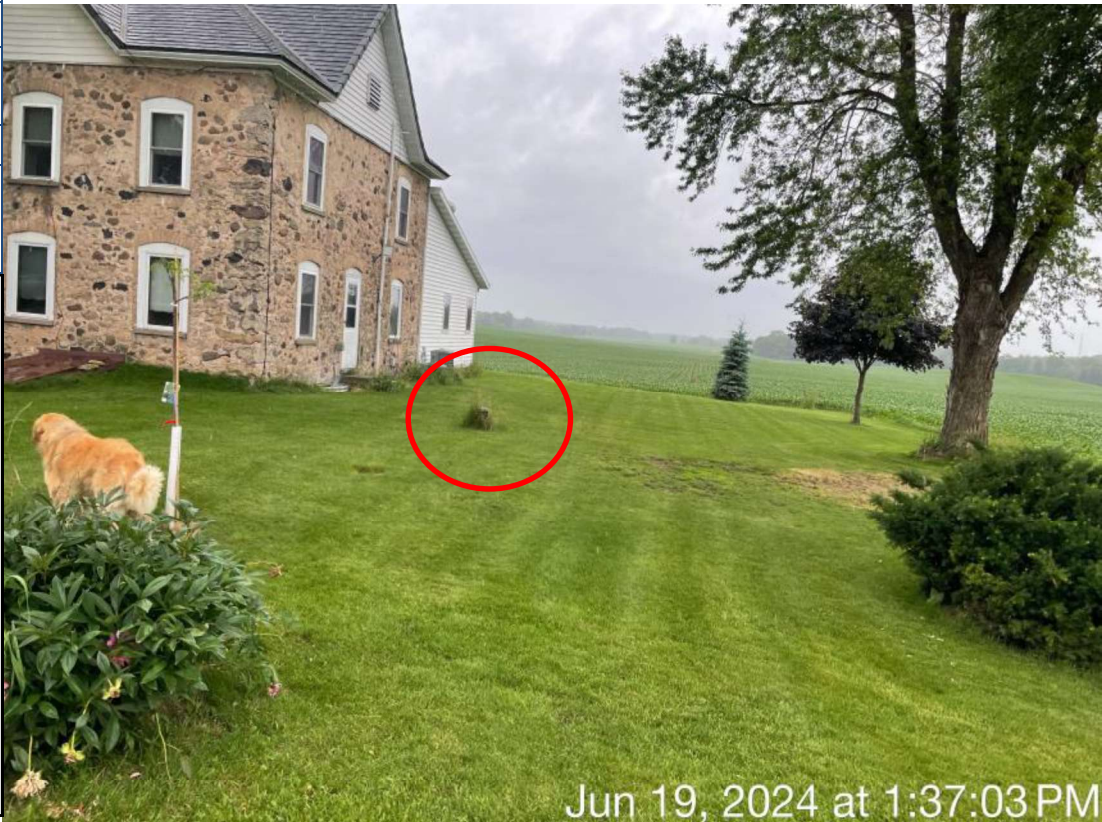
Photo #:	29
Date/Time of Photo:	6/19/2024 13:37
Photo By:	Brian Hanson
Photo Location:	Well Locations

Standing on the east side of the house looking west: View of well 8EC692 off the northeast corner of house. This may also be the same well as an inventoried well GW453 that has the same depth, 85'.
