Village of Readstown Public Noticed Permit Fact Sheet

WATER QUALITY TRADING PLAN

Village of Readstown
Wastewater Treatment Facility
WPDES Permit No. WI-0021661-10-0
623 West South Street
Readstown, Wisconsin 54652

Village of Readstown
Readstown Streambank Stabilization
Project #: 20230956
January 25, 2024

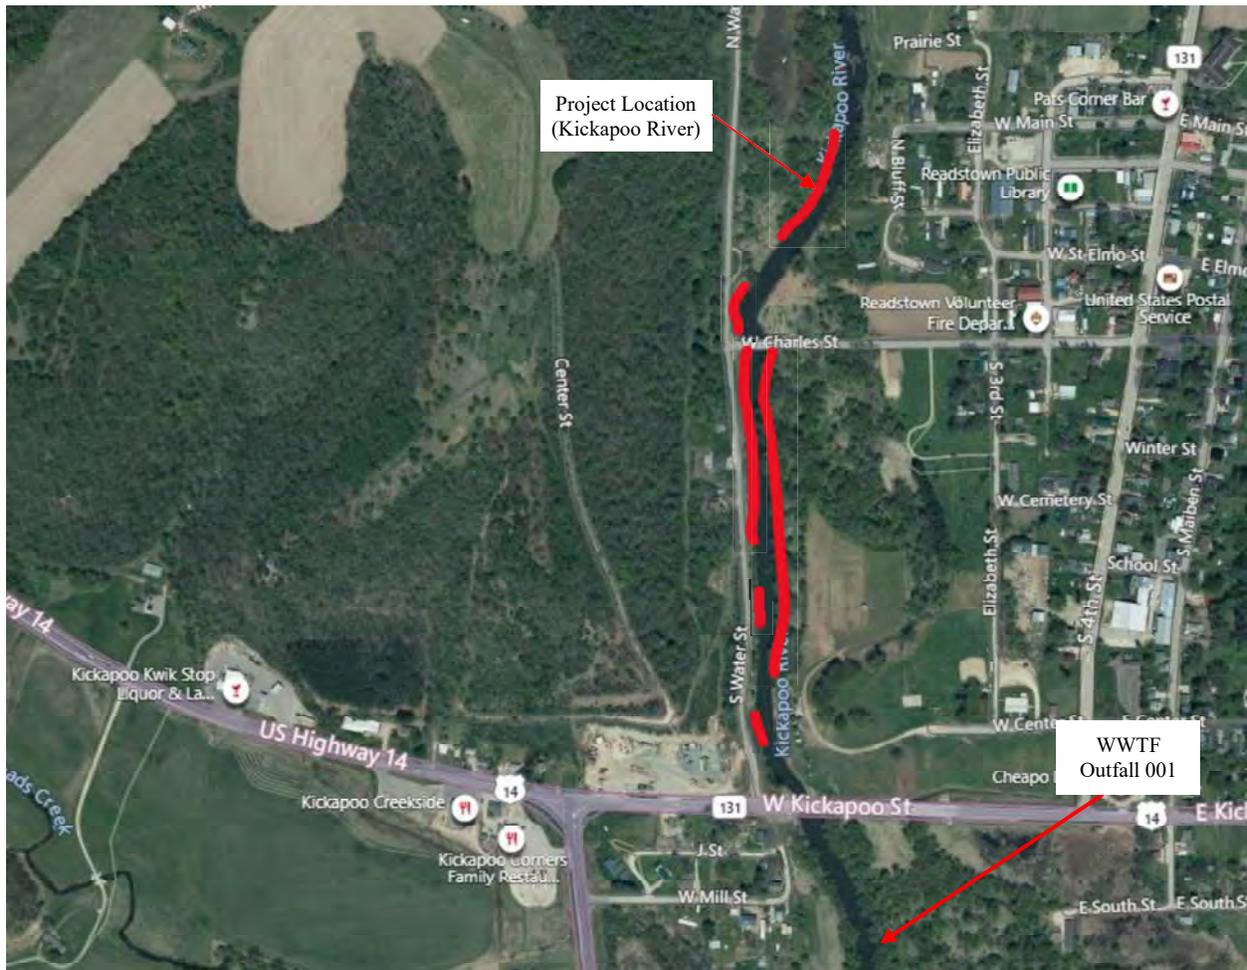
Figure 3.1 – Project location in relation to Outfall 001

The Village discharges to the Kickapoo River (Reads and Tainter Creek Watershed, Lower Wisconsin River Basin) at Outfall 001. As mentioned previously, the Village intends to perform WQT projects within the Village's HUC-12 #070700060402. The Village plans to perform streambank stabilization which will utilize grading and/or riprap to prevent the erosion of sediment from the streambanks. Projects will occur on Village-owned property. Streambank stabilization will not only prevent sediment from entering the stream, but will also prevent phosphorus, nitrogen, and other pollutants from discharging to the Kickapoo River. See Figure 3.1 for additional project location information.

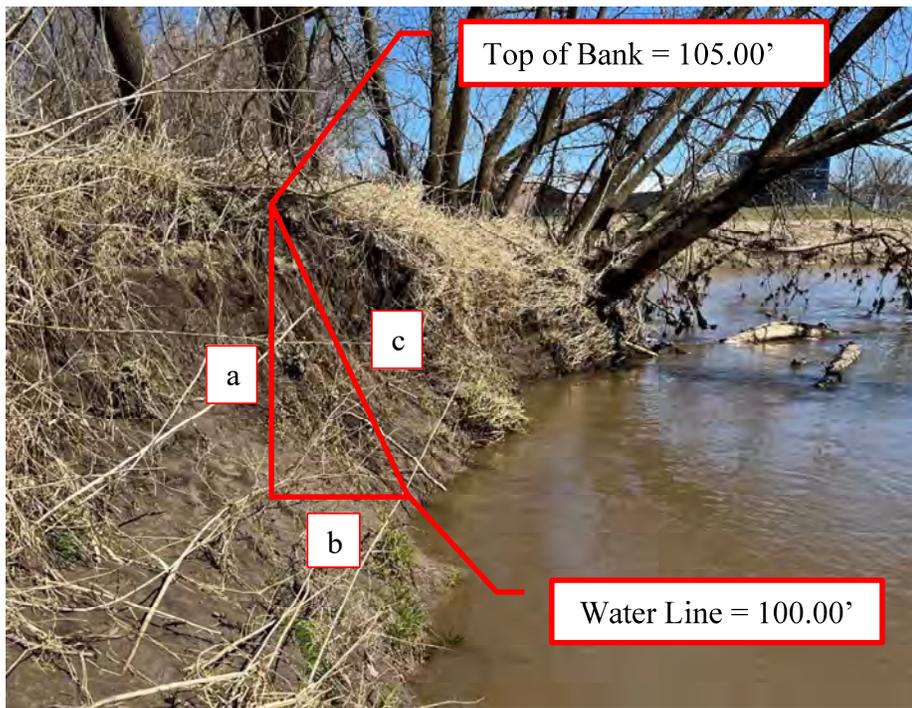
Figure 4.1 – Bank Hight Calculation Example

$b = 2.50'$ (horizontal difference from AutoCAD Civil3D)

$$c = \sqrt{5.00^2 + 2.50^2} = 5.59'$$

With the collected data, the NRCS Streambank Erosion Estimator was used to calculate TP loss from each reach of the eroding streambank. The modeling data for the NRCS Streambank Erosion Estimator is available in Attachment #11. The streambank grading and riprap design will eliminate streambank recession thus eliminating TP inputs within the Project areas.

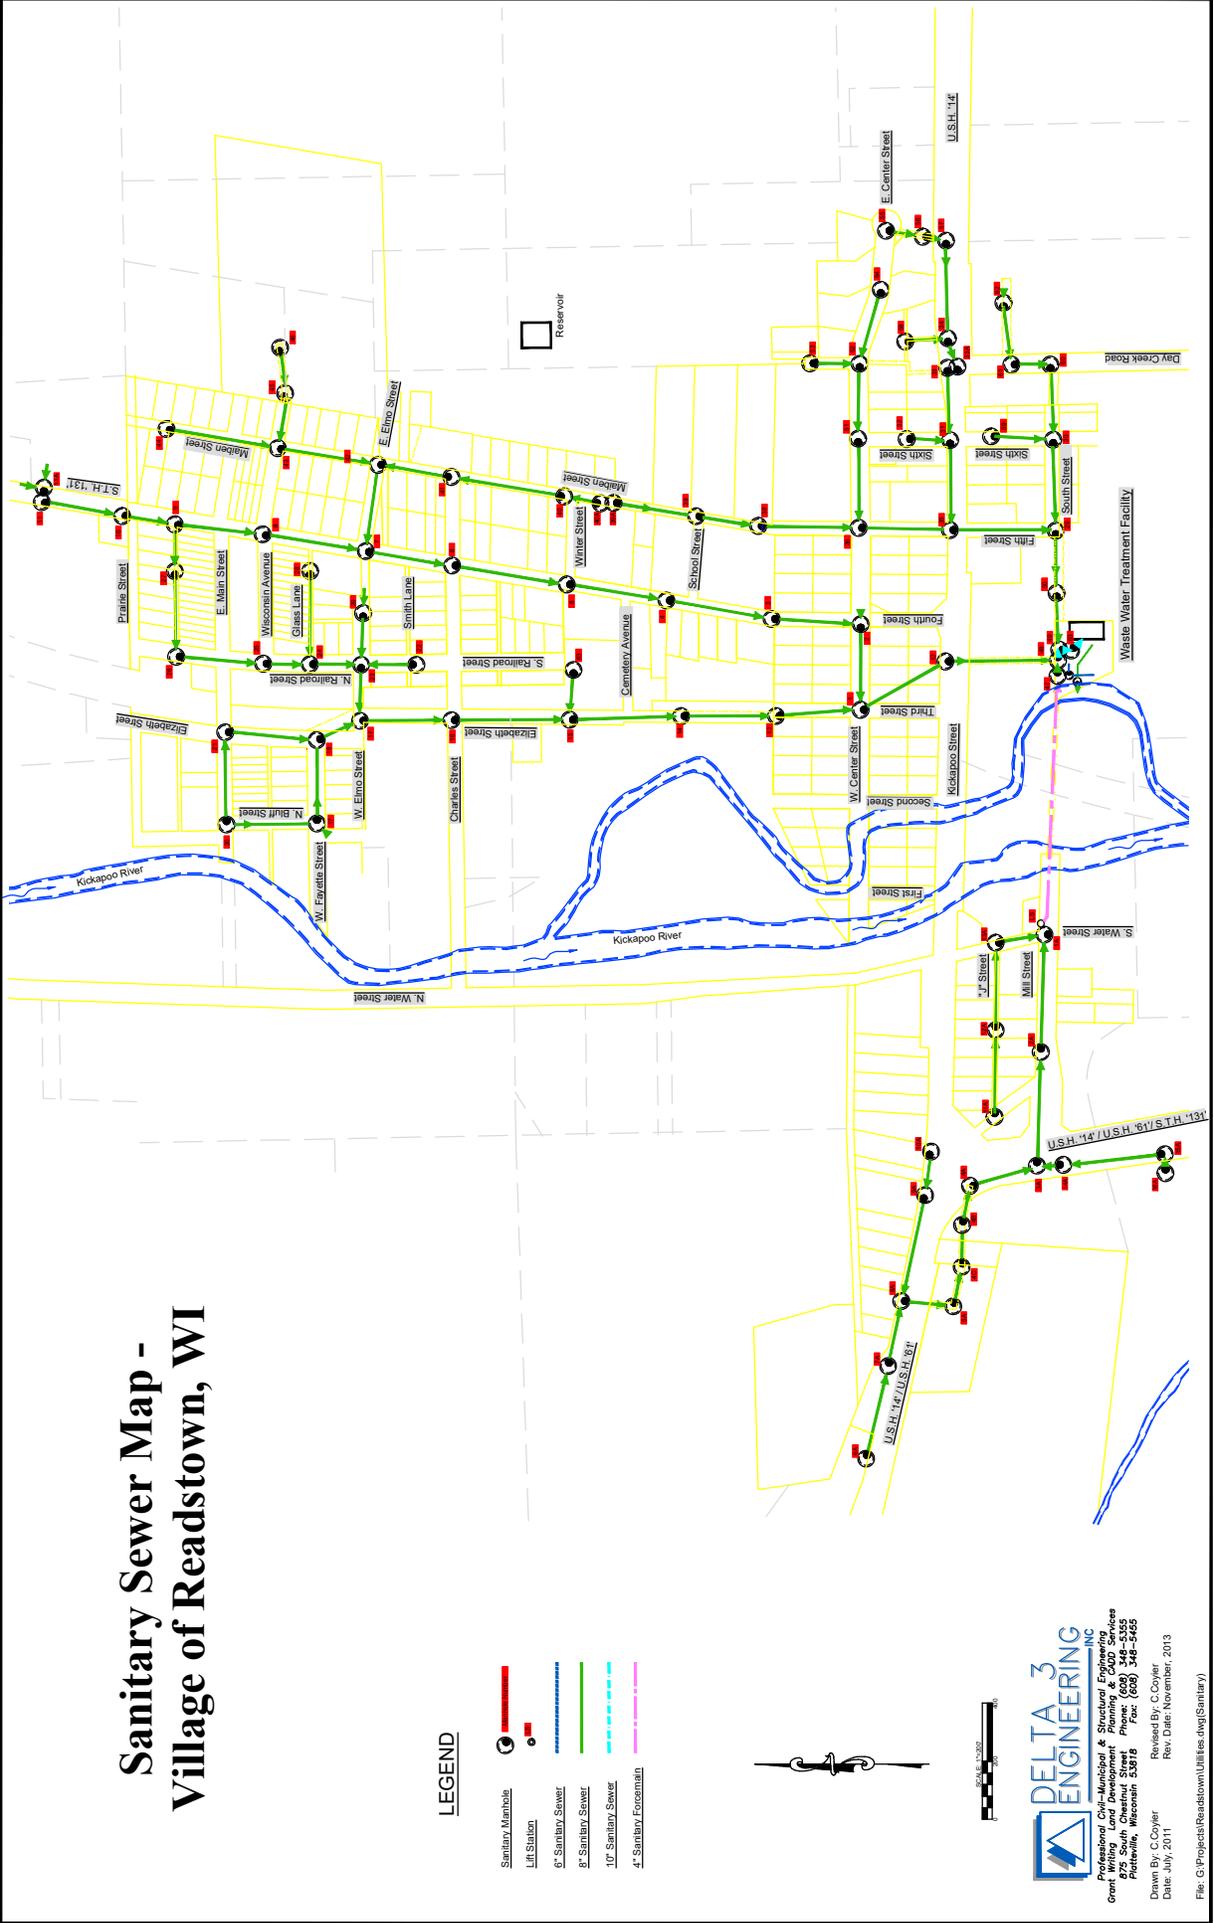
Sanitary Sewer Map - Village of Readstown, WI

- Sanitary Manhole
- Lift Station
- 6" Sanitary Sewer
- 8" Sanitary Sewer
- 10" Sanitary Sewer
- 4" Sanitary Foremain

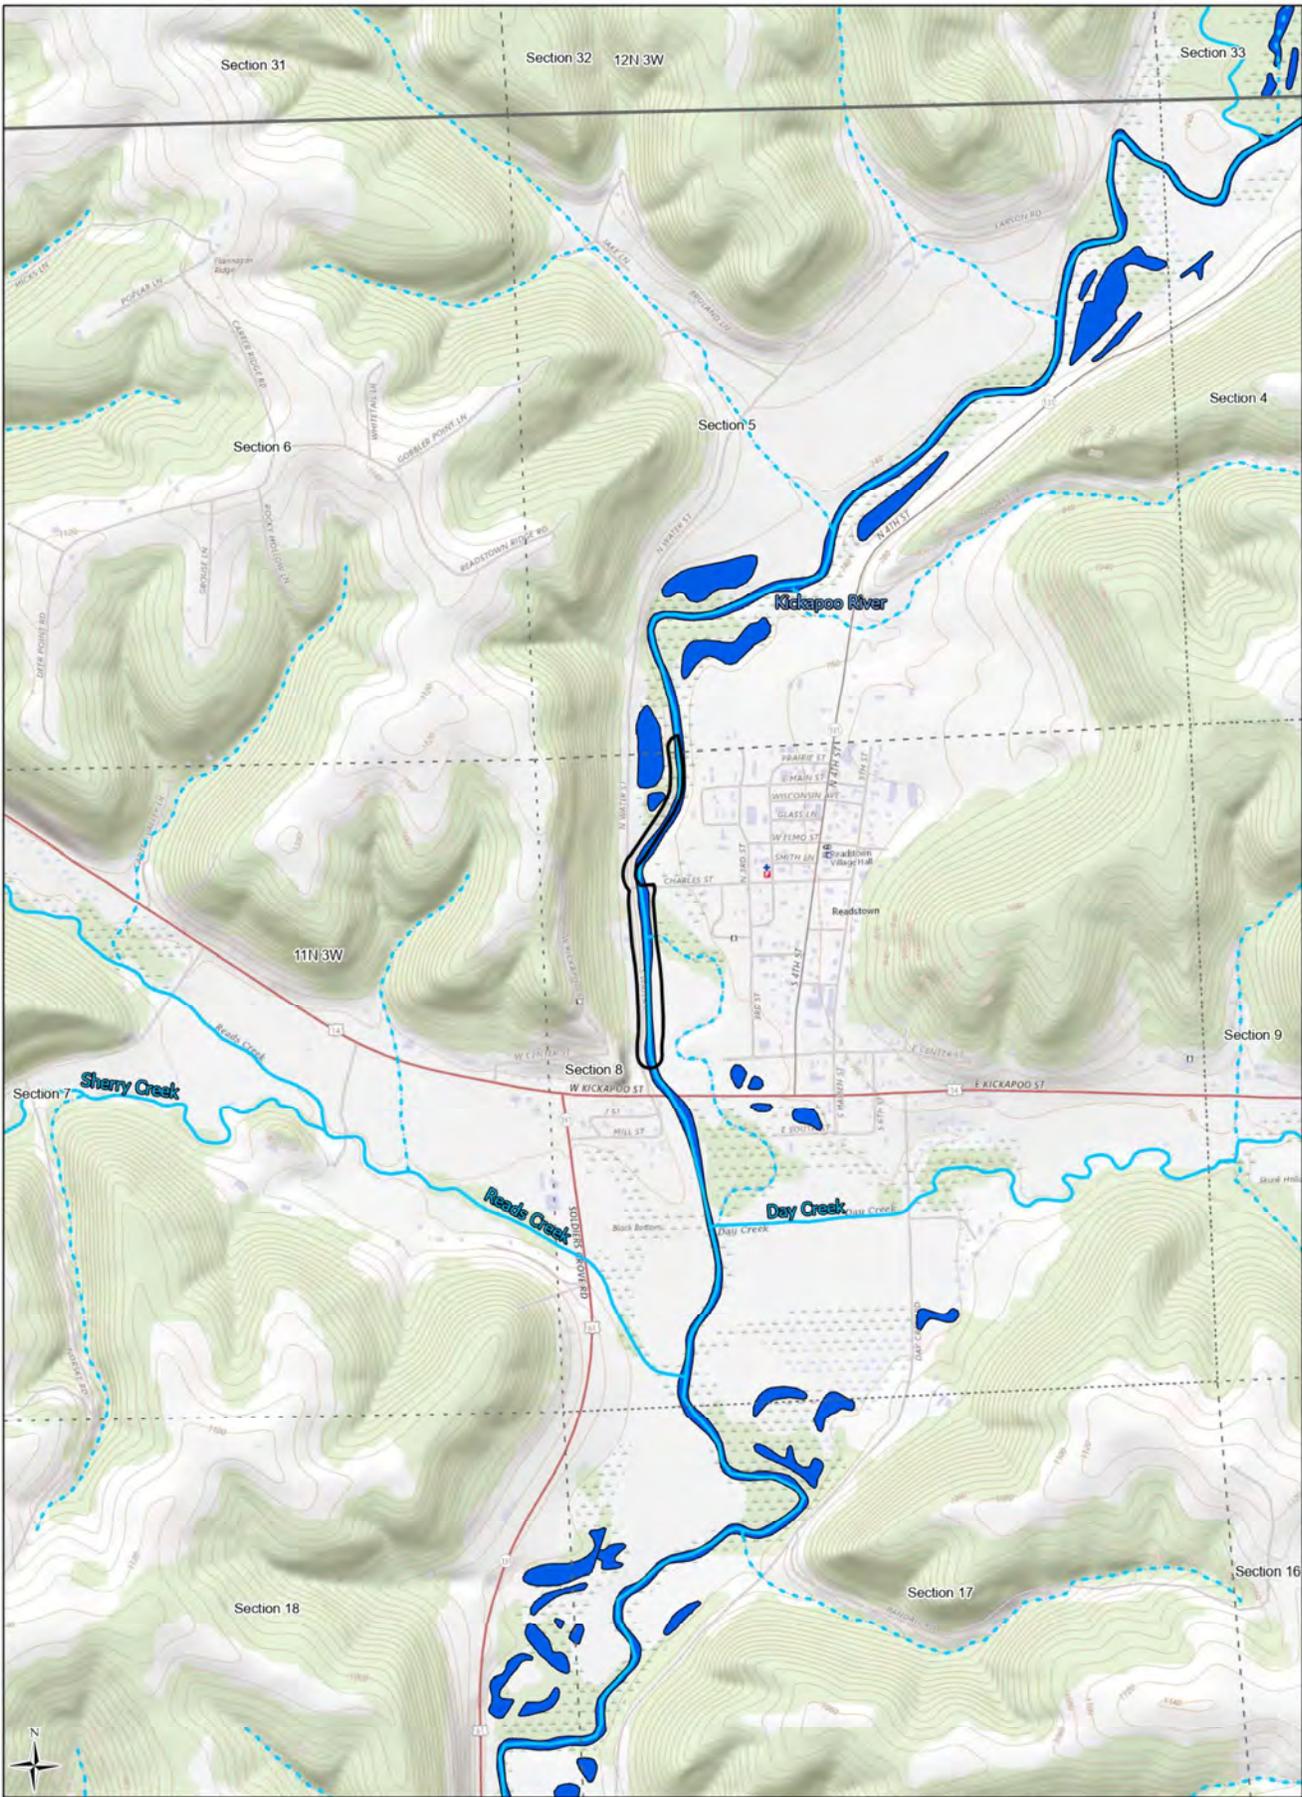
Figure 2. USGS
 Topography
 Readstown Streambank
 Project #20230956
 T11N, R3W, S05 & 08
 V Readstown, Vernon Co

- Study Area (9.71 ac)
- Township
- Section
- Perennial Streams
- Intermittent Streams
- Waterbodies

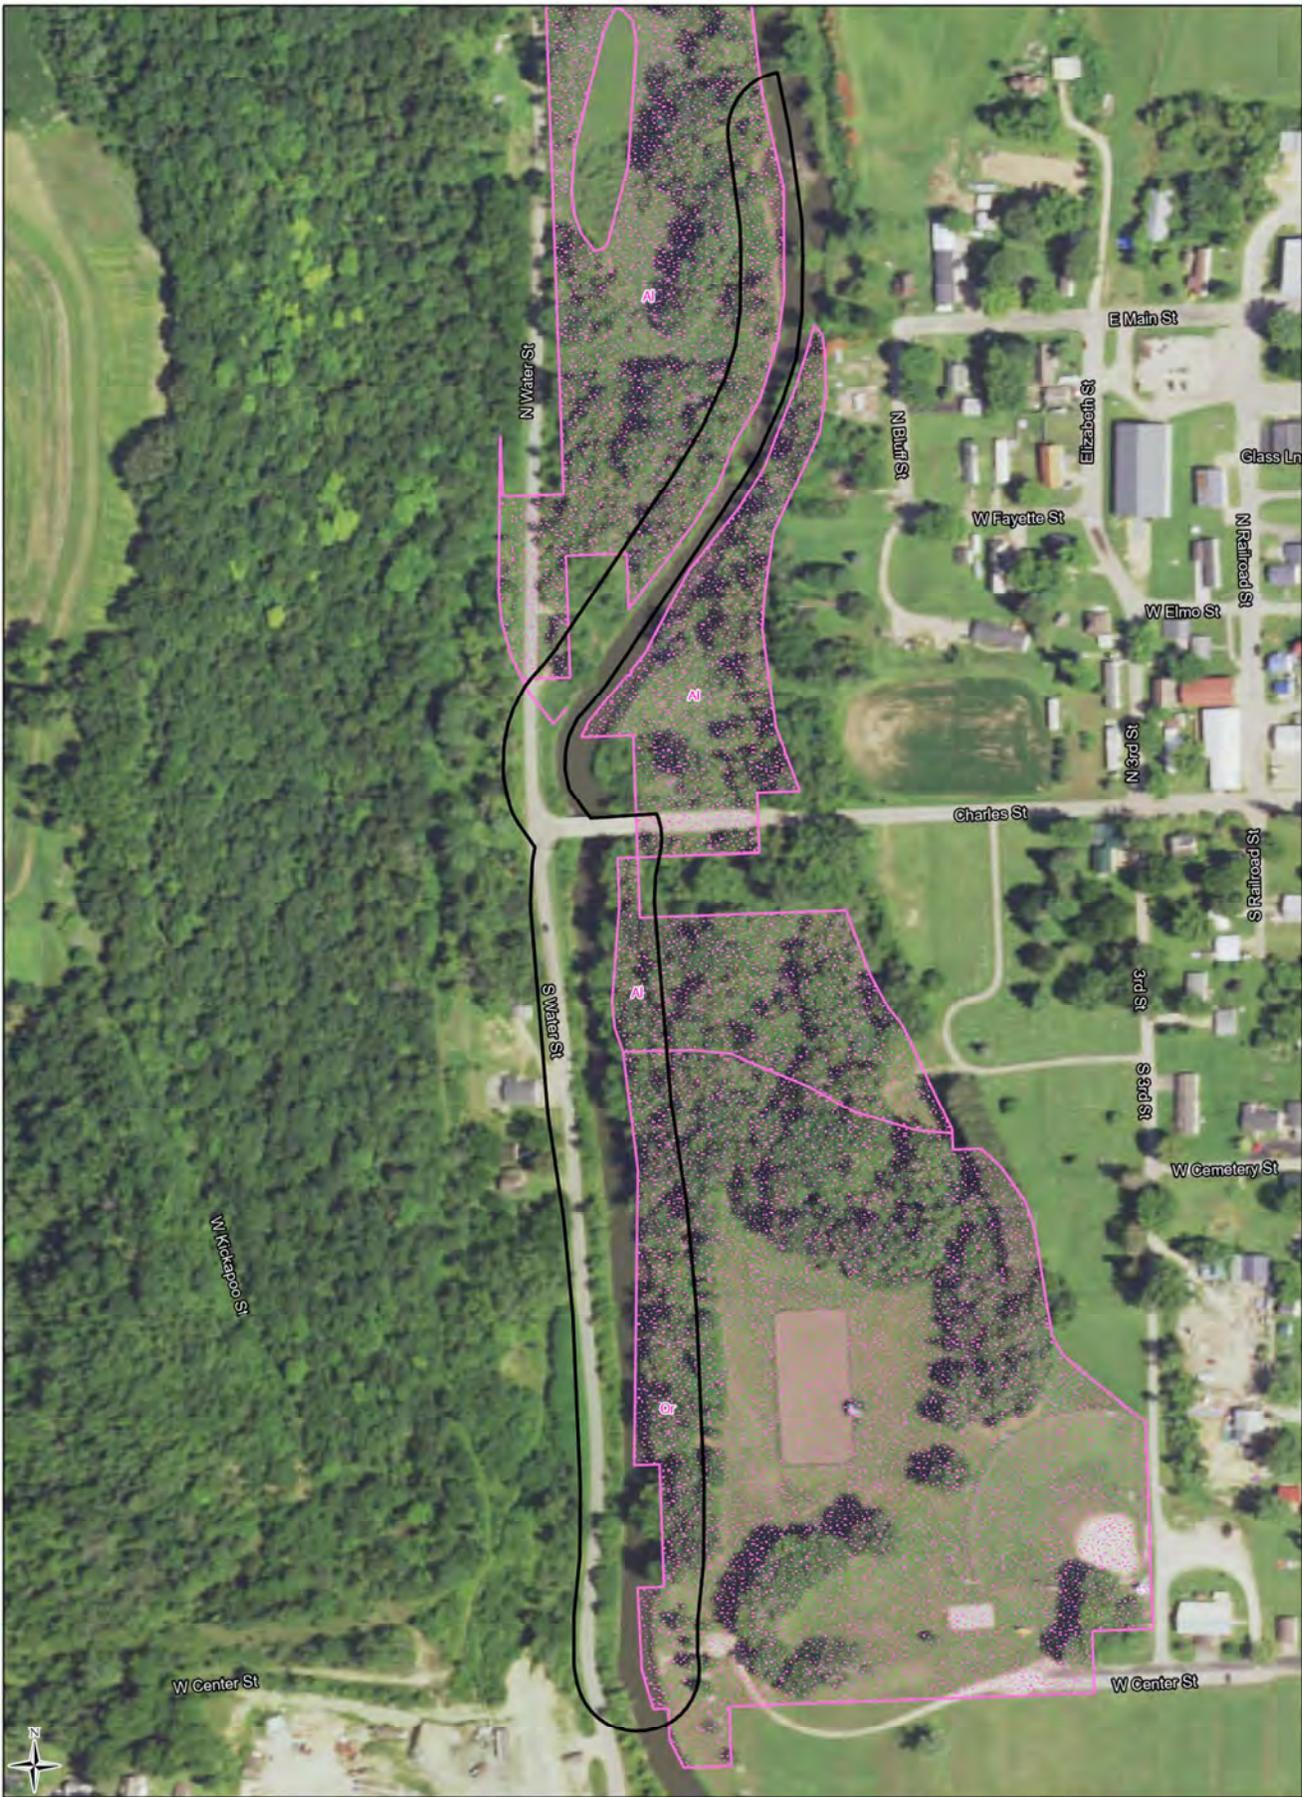
Figure 4. SWDV
Wetland Indicators
Readstown Streambank
Project #20230956
T11N, R3W, S05 & 08
V Readstown, Vernon Co

- Study Area (9.71 ac)
- SWDV Wetland Indicators

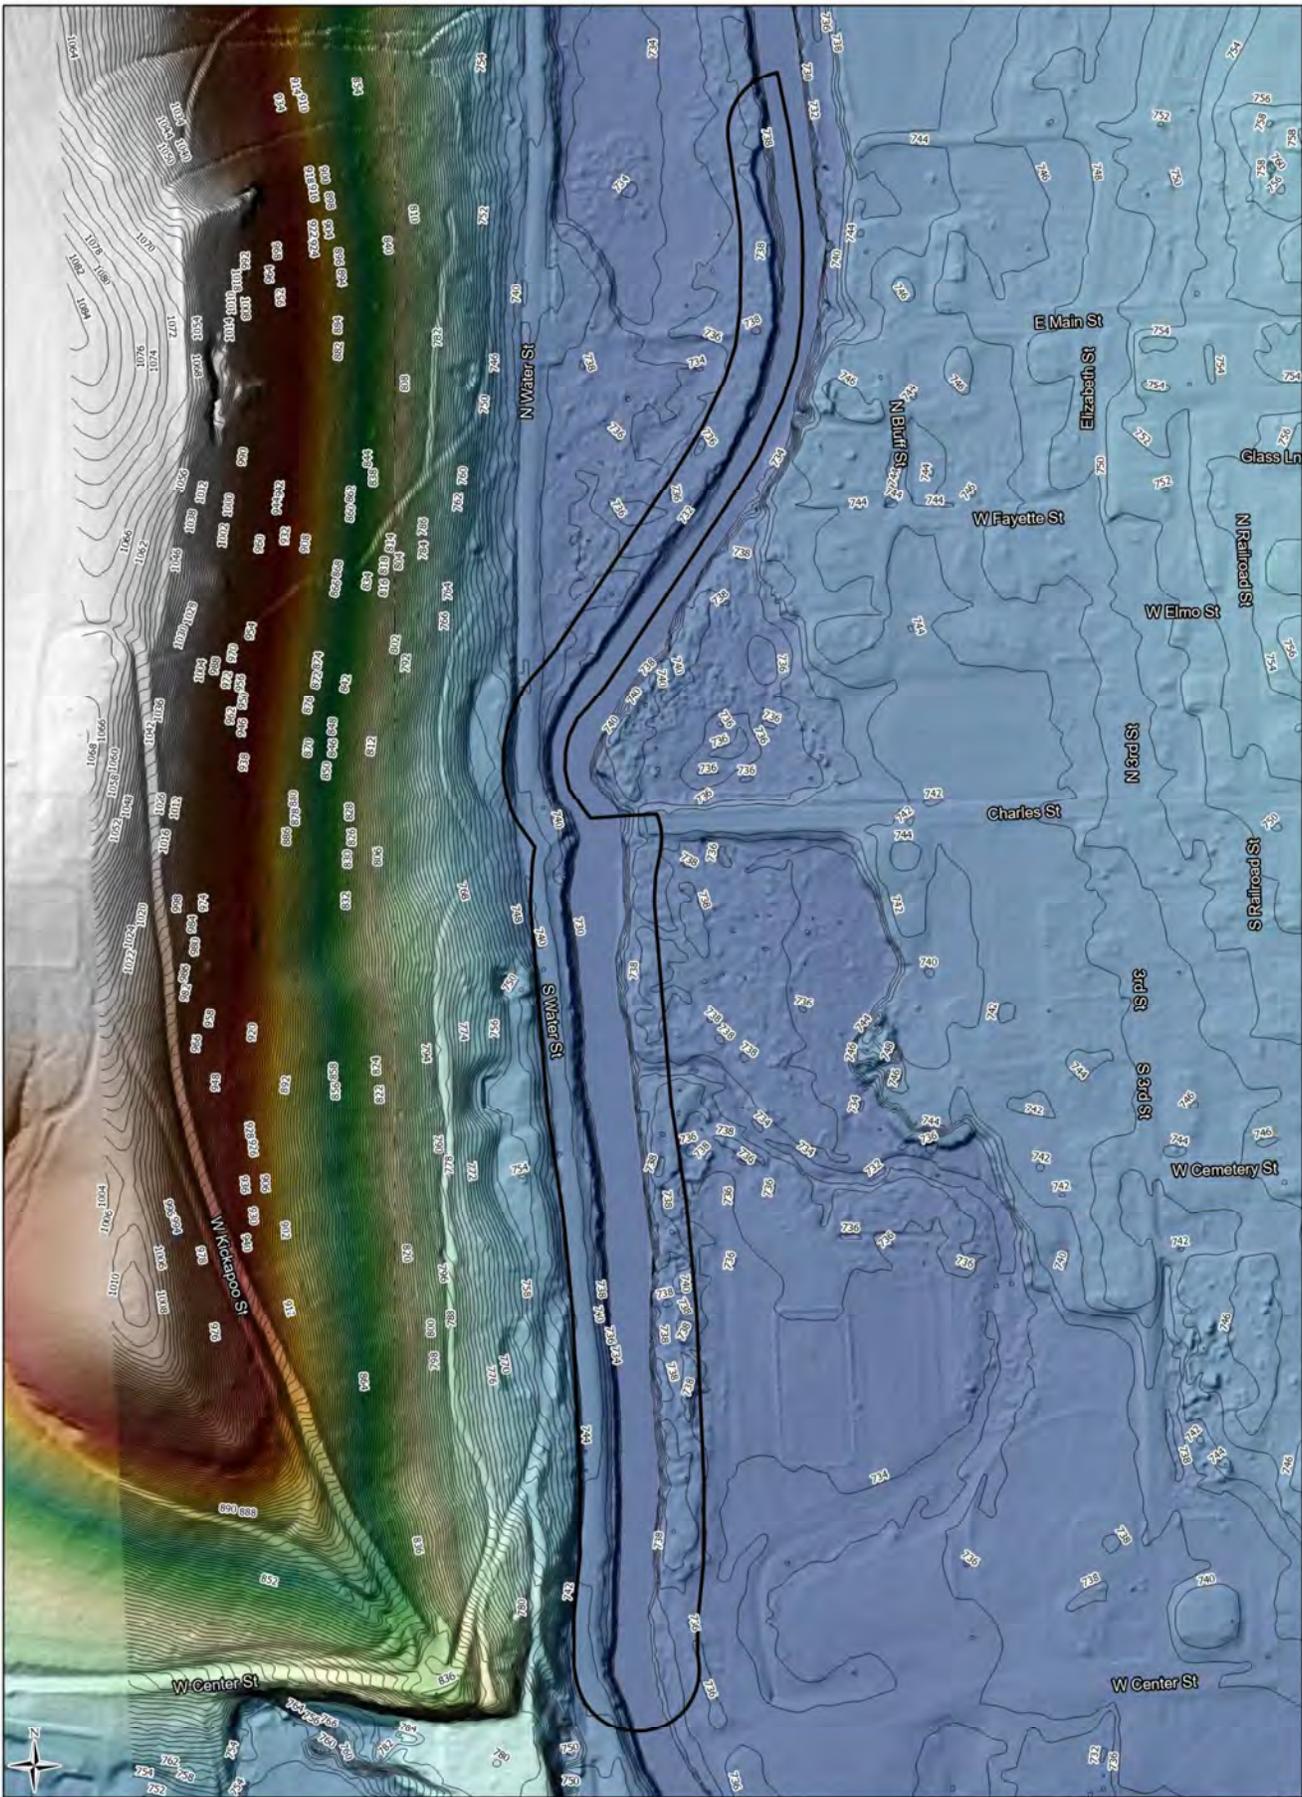
Heartland
 ECOLOGICAL GROUP INC
 Figure 6. Color-Stretch
 Digital Elevation Model
 Readstown Streambank
 Project #20230956
 T11N, R3W, S05 & 08
 V Readstown, Vernon Co
 2020 NAIP
 County Co, HEG
 LRR: MW
Figure Created: 9/20/2023

Study Area (9.71 ac)
 Vernon Co 2' Contours

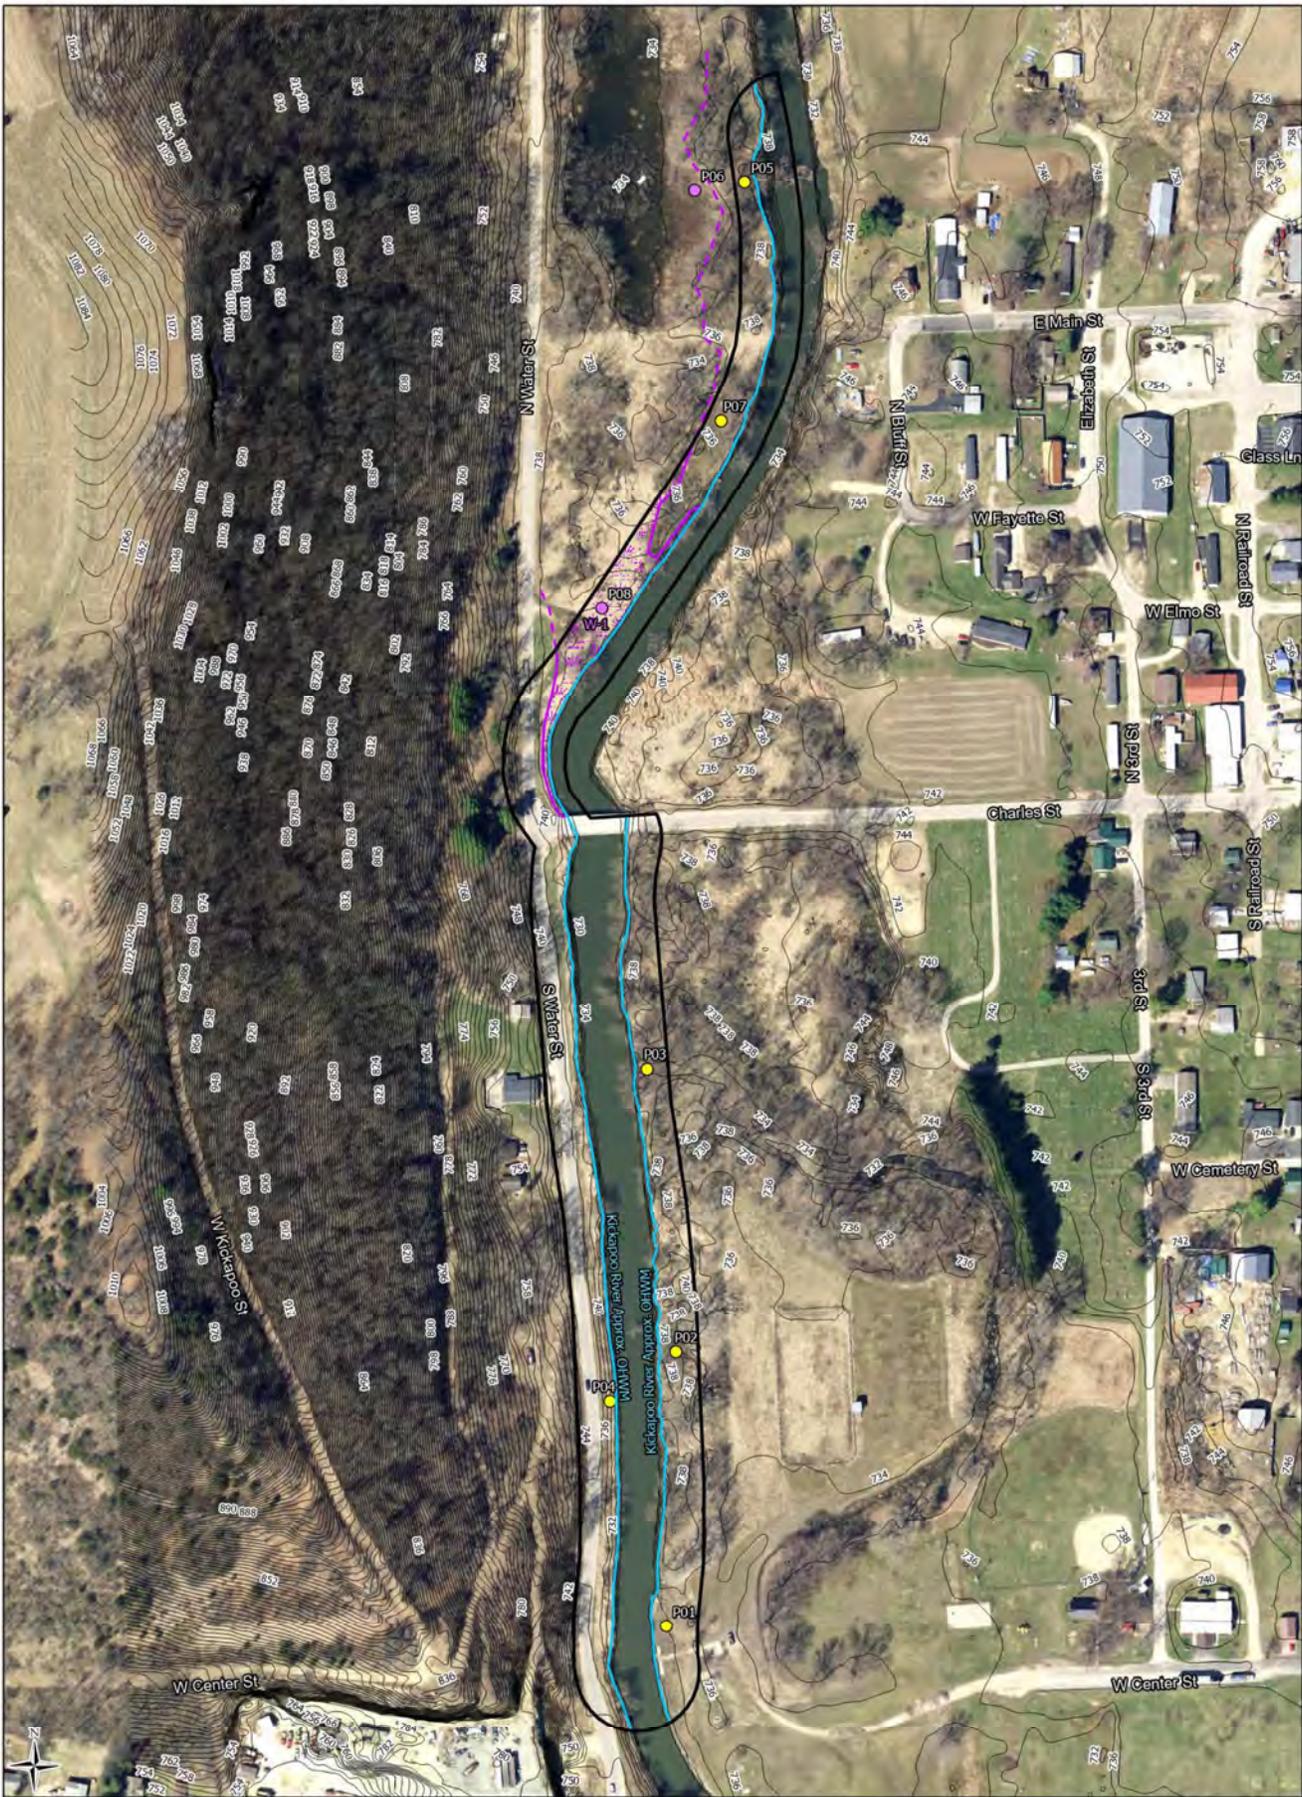
- Study Area (9.71 ac)
 - Vernon Co 2' Contours
 - Kickapoo River Approx. OHWM
 - Offsite Wetland Boundaries
 - Field Delineated Wetlands (0.50 ac)
- Sample Points**
- Upland
 - Wetland

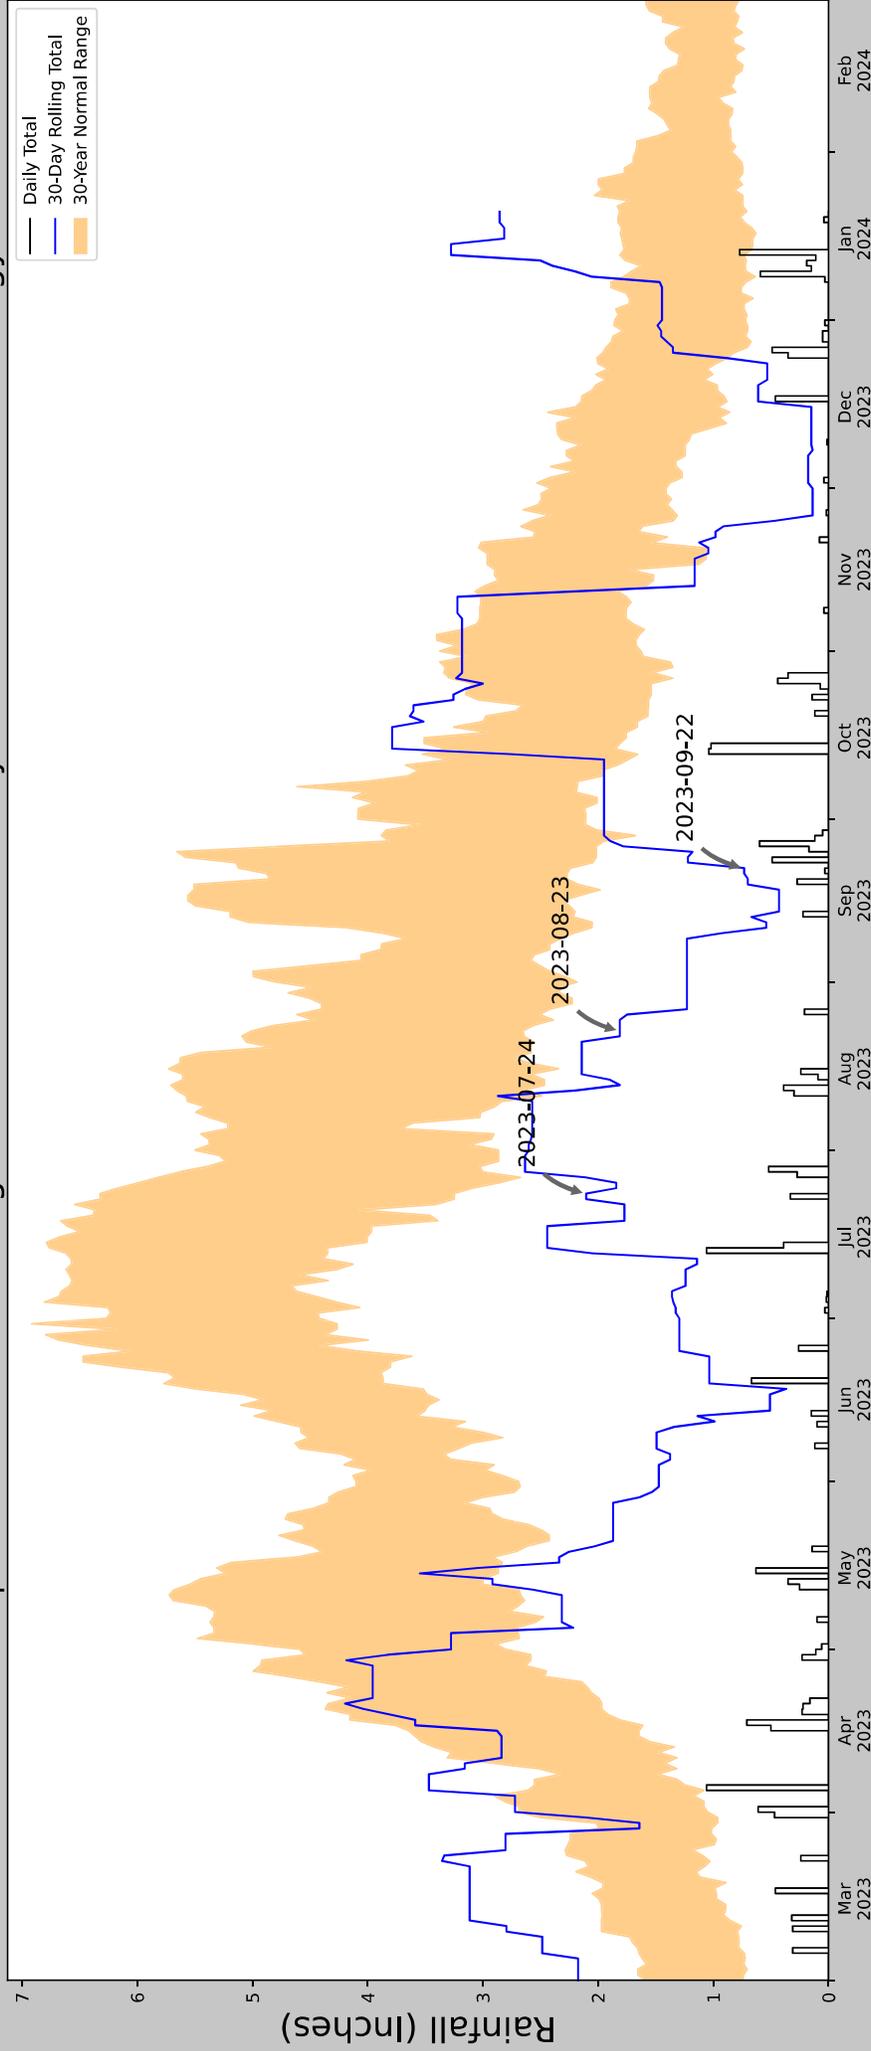
Antecedent Precipitation vs Normal Range based on NOAA's Daily Global Historical Climatology Network

— Daily Total
— 30-Day Rolling Total
 30-Year Normal Range

Coordinates	43.44822, -90.76478
Observation Date	2023-09-22
Elevation (ft)	731.113
Drought Index (PDSI)	Moderate drought
WebWIMP H ₂ O Balance	Wet Season

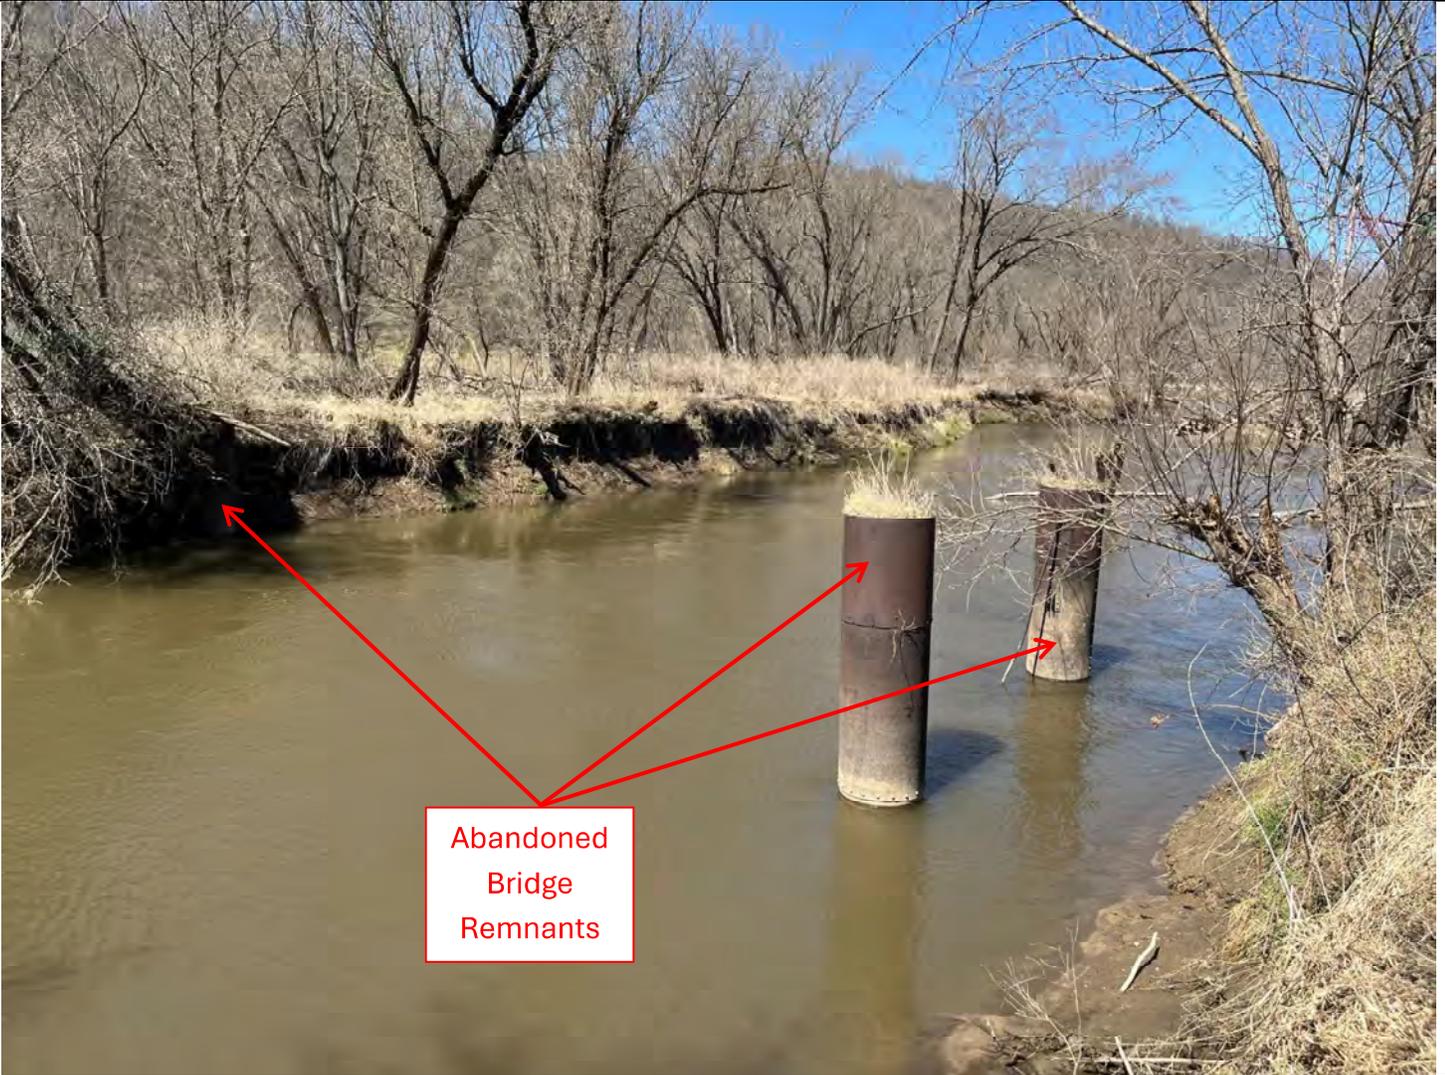
Photo #22

Abandoned
Bridge
Remnants

ID: A - STA 107+00

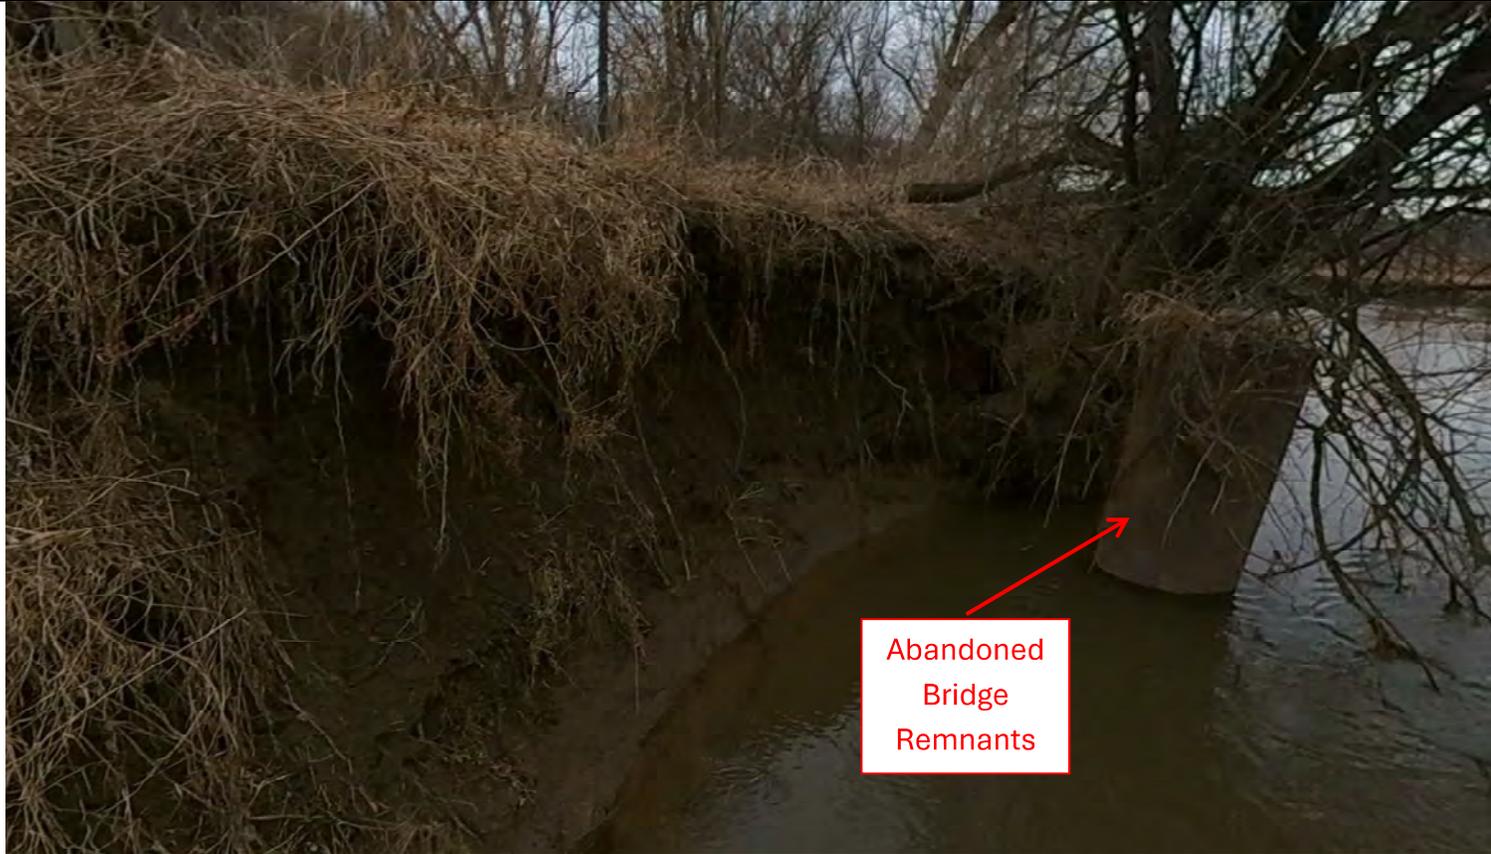
Photo #23

Abandoned
Bridge
Remnants

ID: A - STA 107+00

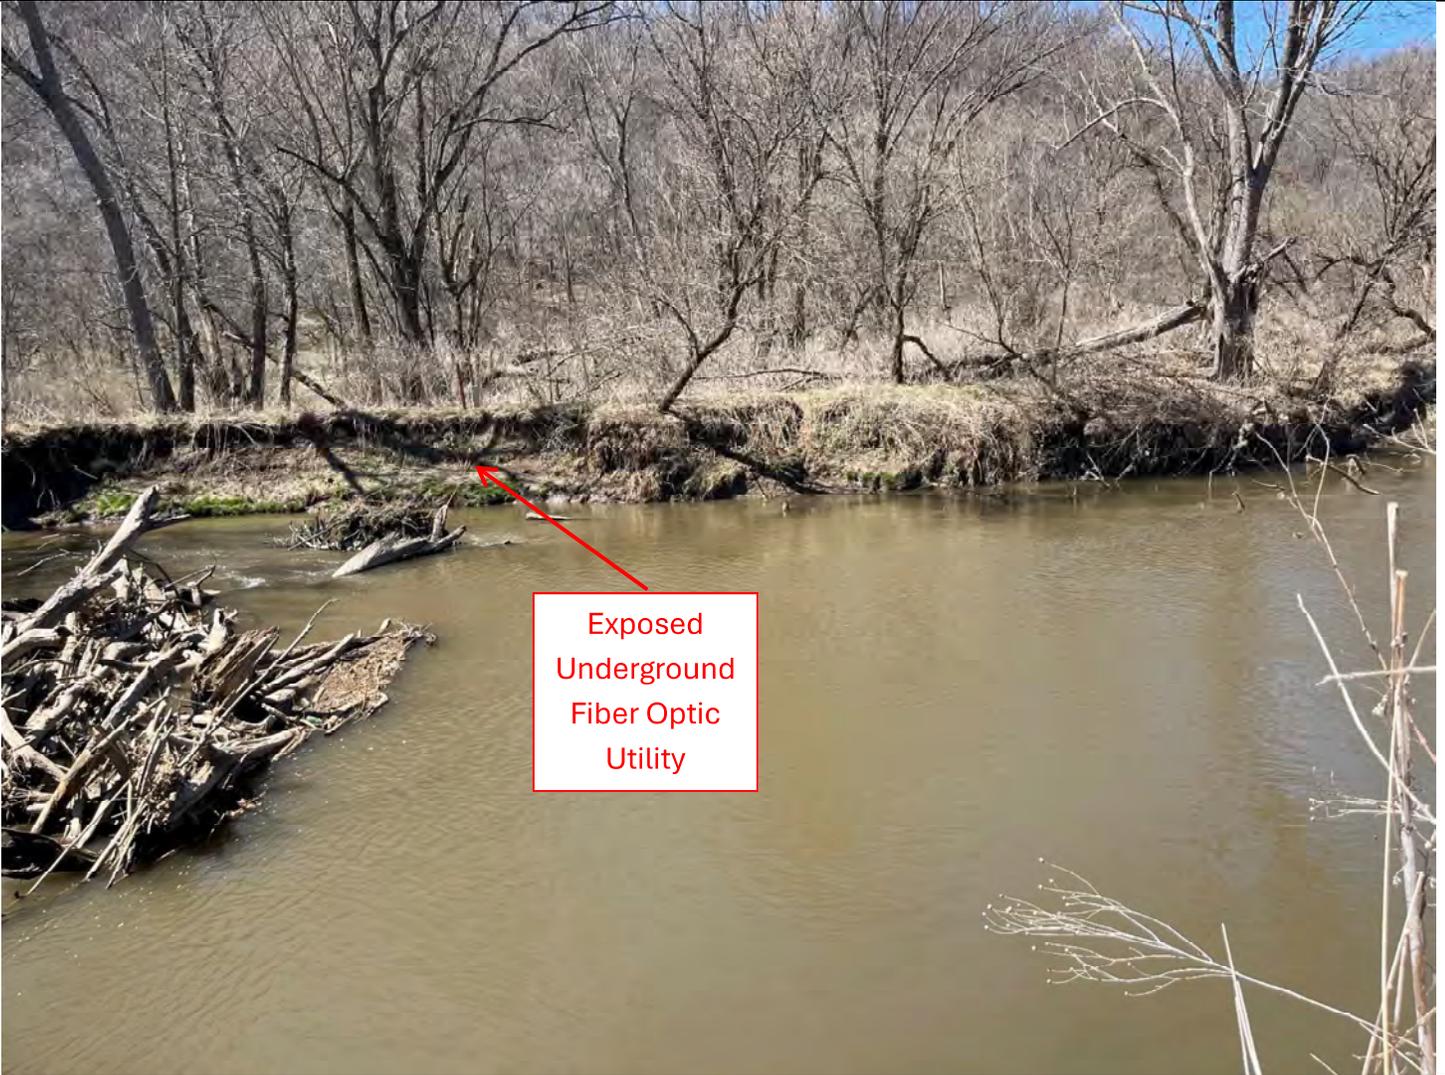
Photo #26

Exposed
Underground
Fiber Optic
Utility

ID: A - STA 104+00
