## Permit Fact Sheet

| Permit Number | WI-0066958-02-0 |
| Permittee Name and Address | Wagner Farms Inc<br>N6928 County Road BB, Oconto Falls, WI 54154 |

On Wednesday November 12th, 2025 Hanson met with Wagner & Wagner at 13:00 at Wagner Farms Inc site to conduct a permit reissuance compliance inspection. Only 1 site was inspected. No significant liquid precipitation had fallen over the previous 24 hours and the temperature was in the 50's and sunny. No permit violations were observed, and no water samples were collected. Hanson departed at approximately 14:15.

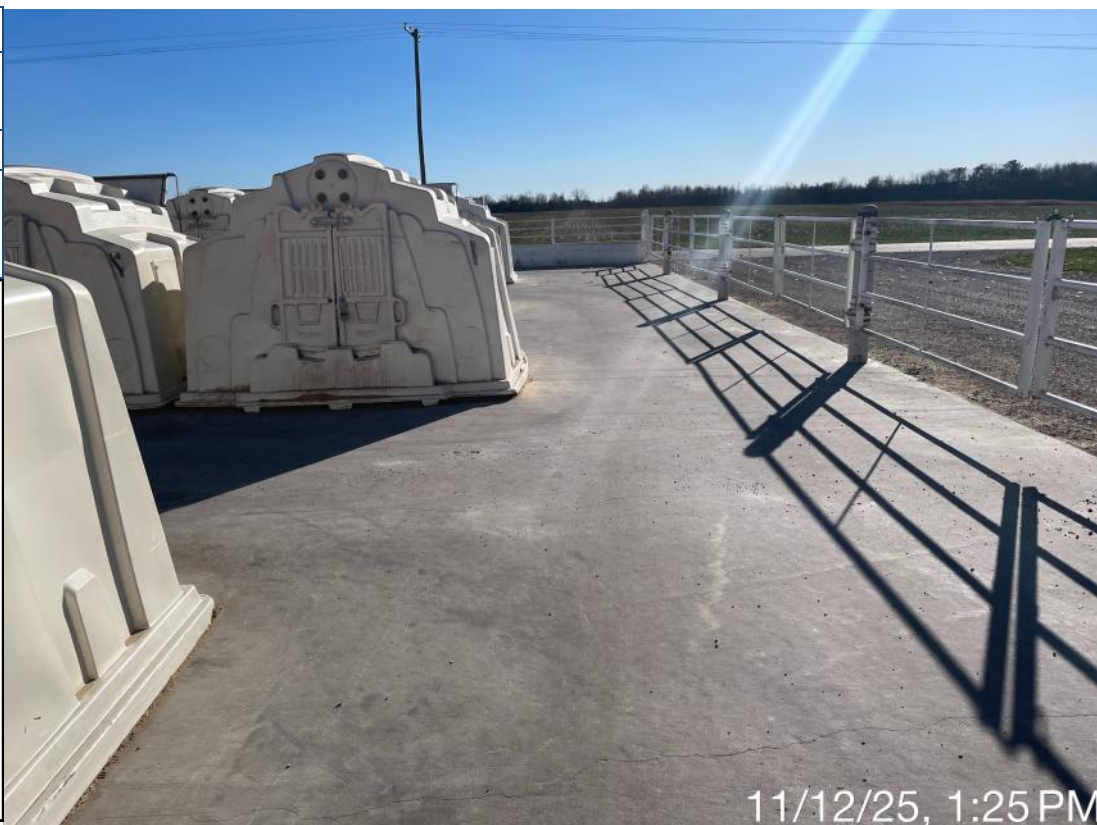
| <b>Photo #:</b> | 2 |

| <b>Photo Description:</b><br><br>Standing on the west side of calf hutch area looking south:<br>View of west edge of calf hutch area. | |

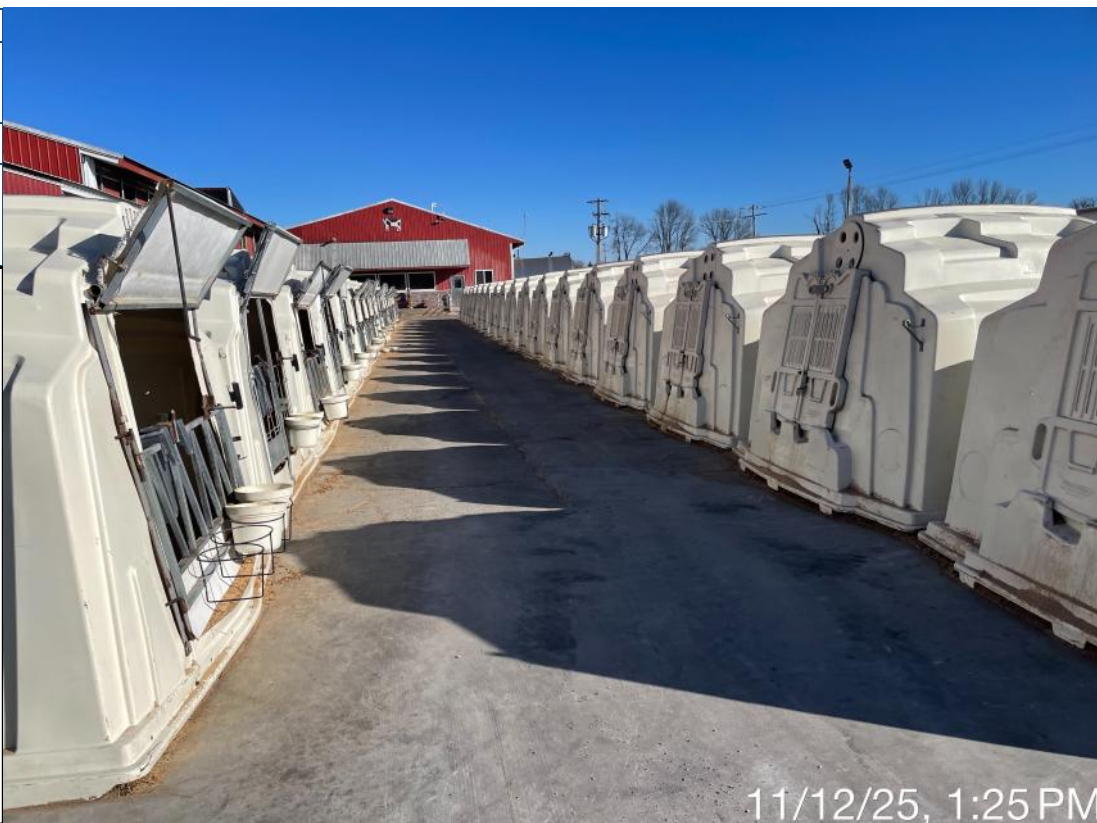
| <b>Photo #:</b> | 3 |

| <b>Photo Description:</b><br><br>Standing on the west side of calf hutches looking east: View of an internal alley of the calf hutches | |

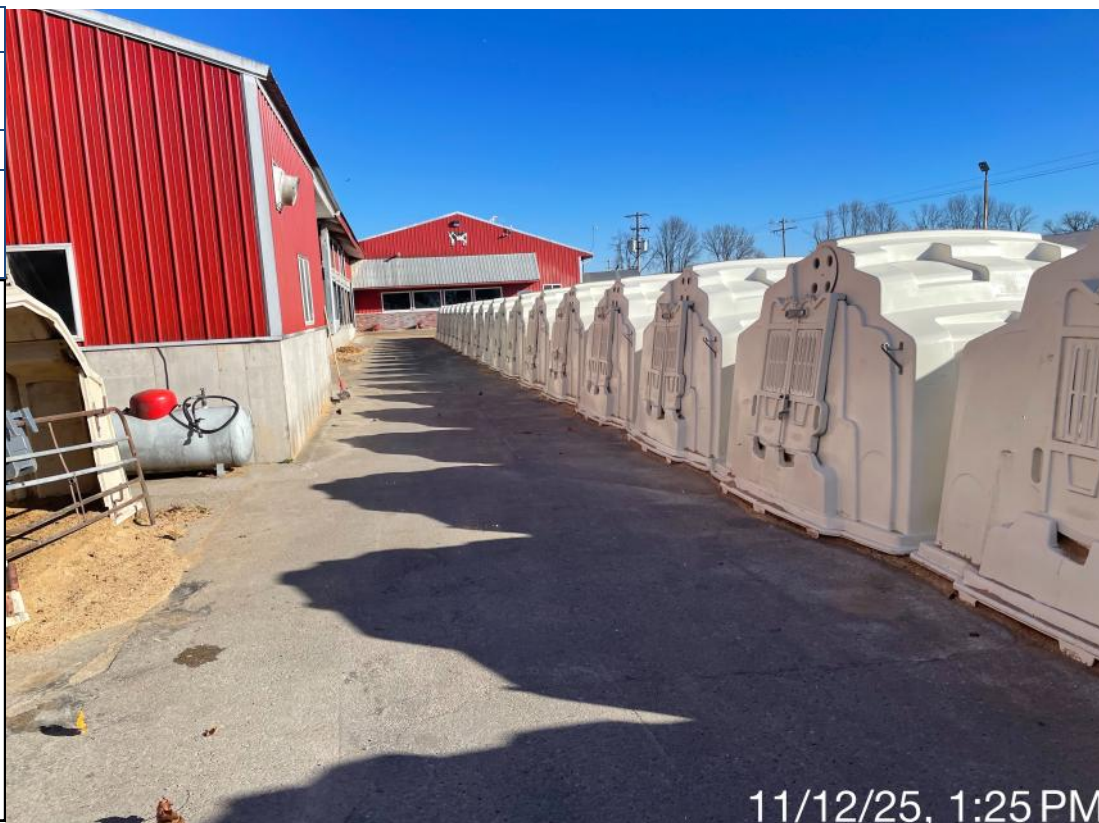
| <b>Photo #:</b> | 4 |

| <b>Photo Description:</b><br><br>Standing on the west side of calf hutch area looking east:<br>View of north edge of calf hutch area. | |

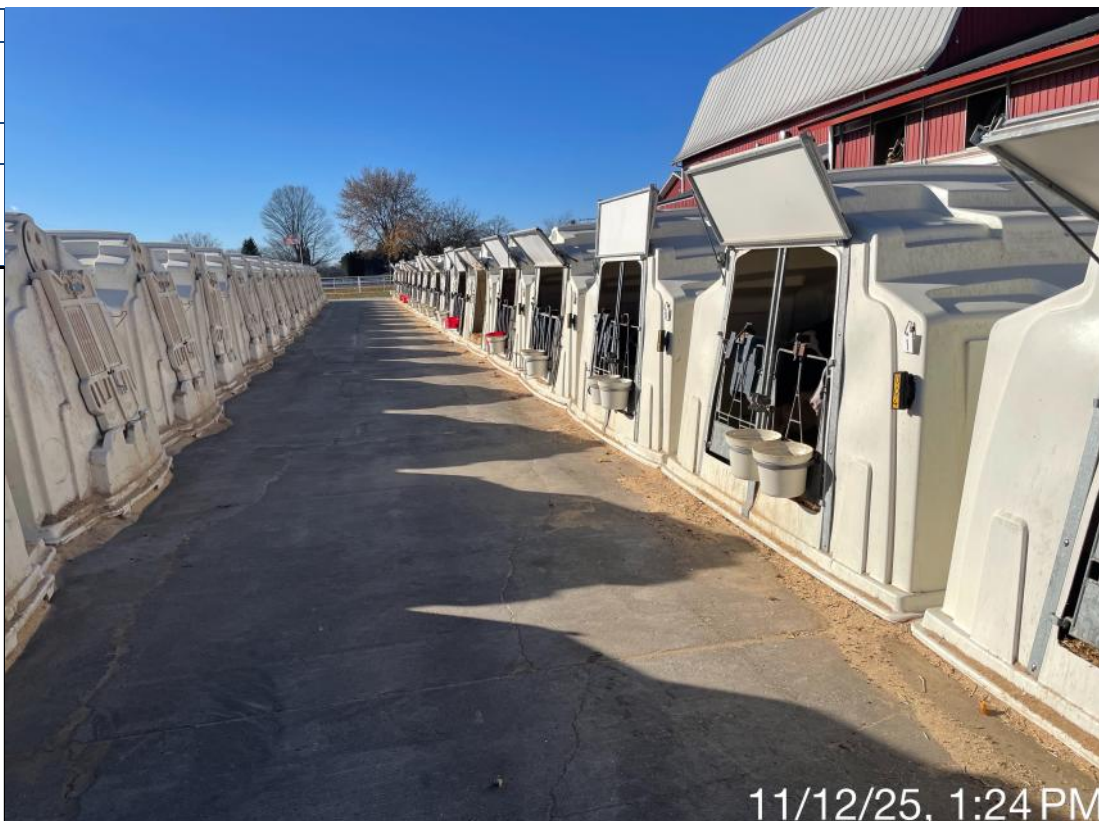
| <b>Photo #:</b> | 5 |

| <b>Photo Description:</b><br><br>Standing on the east end of calf hutch area looking west: View of interior drive alle between hutches. | |

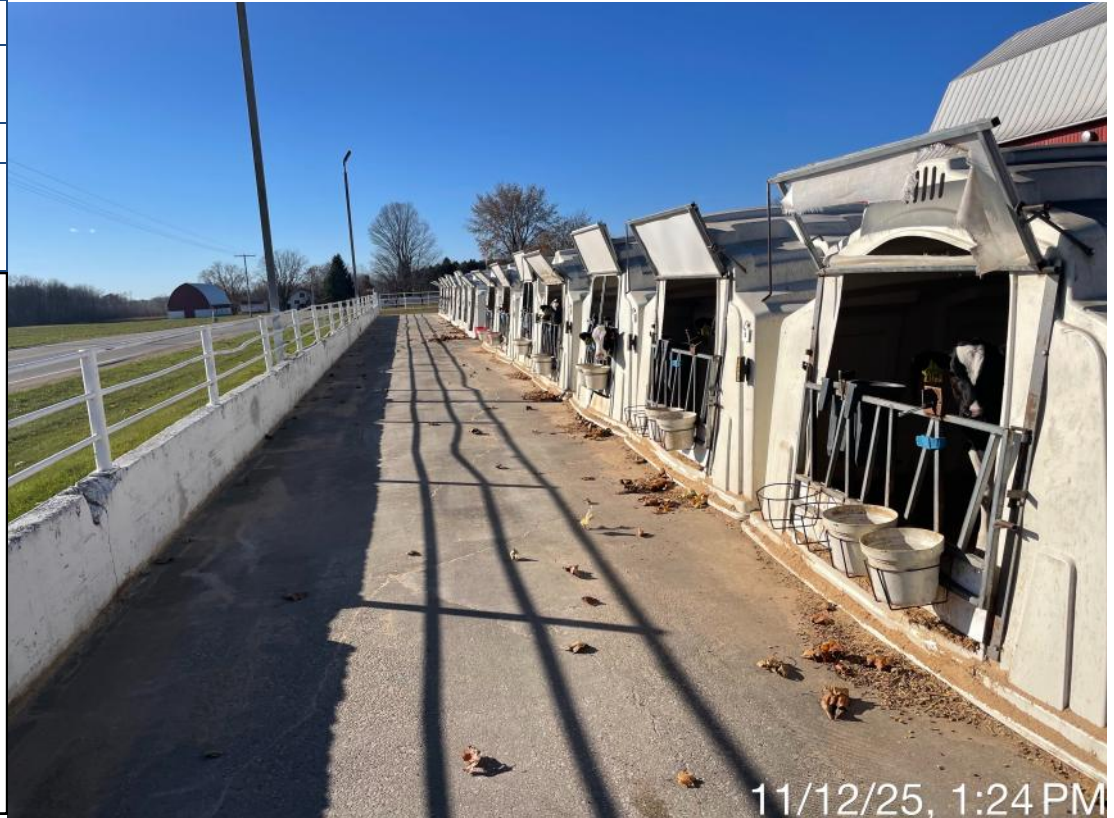
| <b>Photo #:</b> | 6 |

| Standing on the south side of calf hutches looking west: View of south edge of calf hutch area. Notice concrete wall along south edge. | |

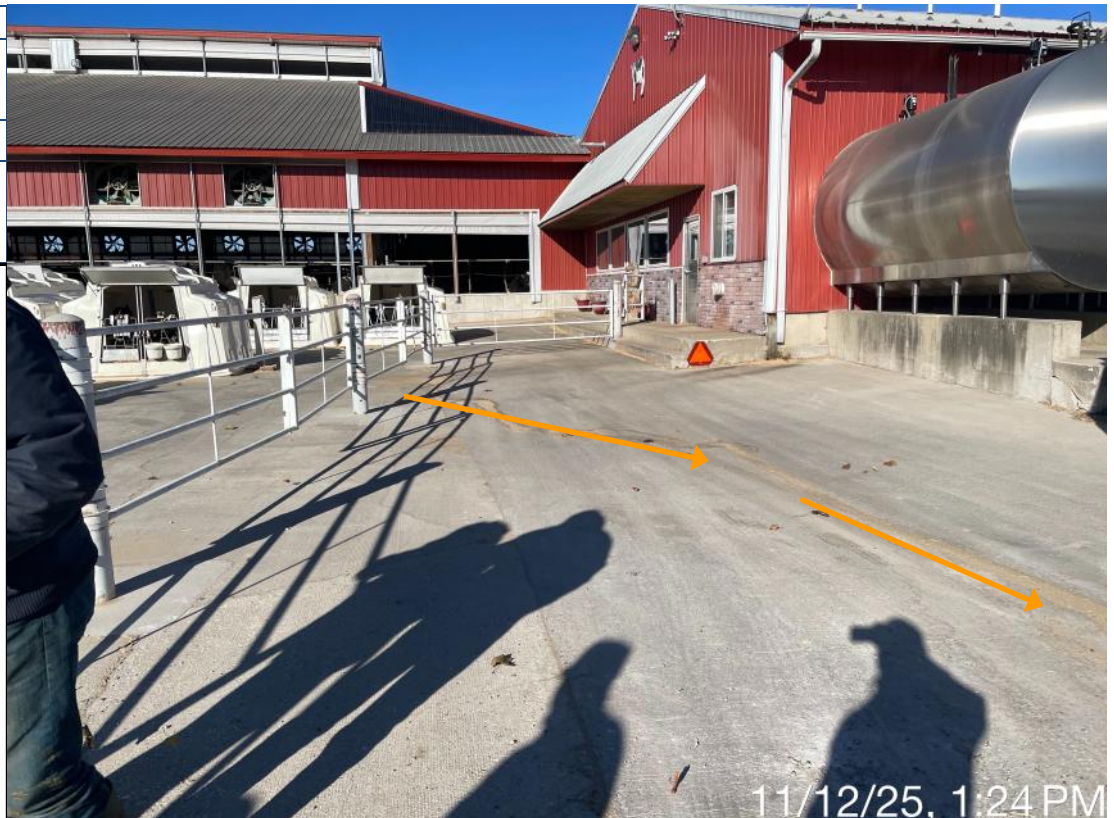
| <b>Photo #:</b> | 7 |

| Standing on the east side of calf hutch area looking north: View of east end of calf hutch area where runoff leaves the lot. Arrows indicate direction of runoff flow. | |

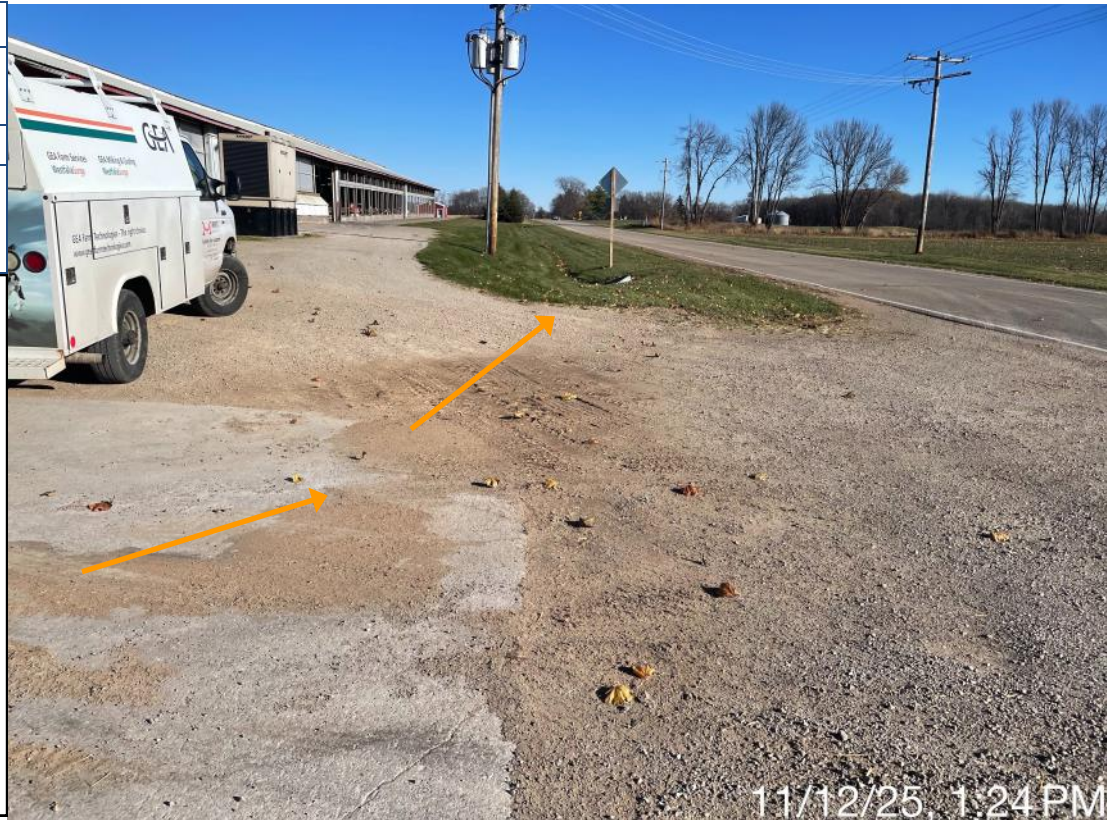
| <b>Photo #:</b> | 8 |

| <b>Photo Description:</b><br><br>Standing on east side of calf hutch area looking east: View of southeast corner of calf hutch area where runoff leaves lot & enters road ditch. | |

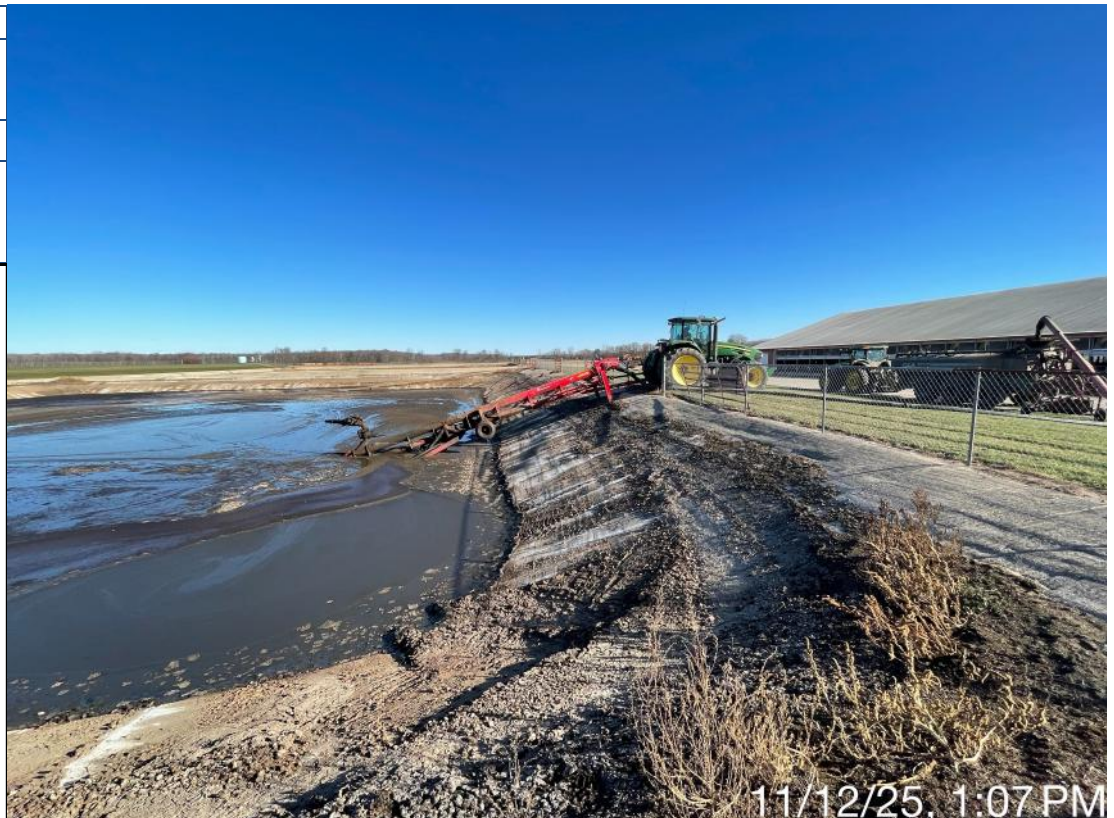
| <b>Photo #:</b> | 9 |

| <b>Photo Description:</b><br><br>Standing on the west side of WSF #1 looking east: View of the southwest corner of WSF #1. | |

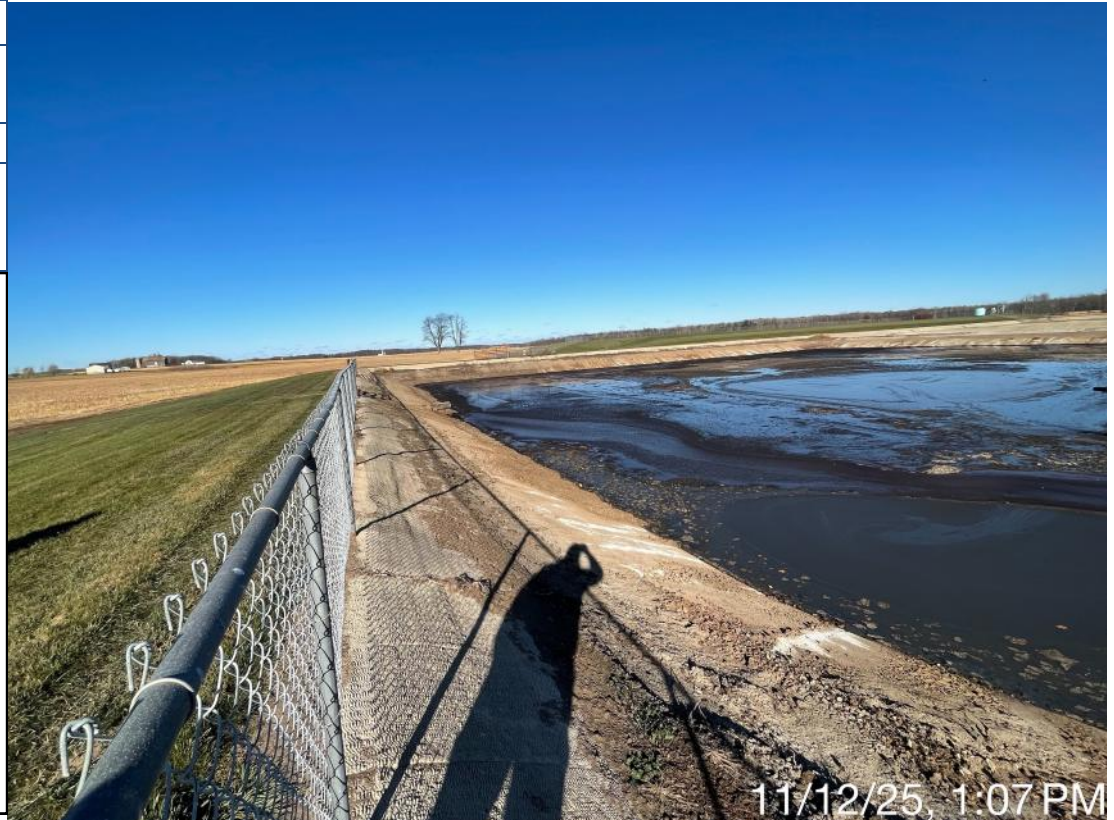
| <b>Photo #:</b> | 10 |

| <b>Photo Description:</b><br><br>Standing on west side of WSF #1 looking north: View of west edge of WSF #1. | |

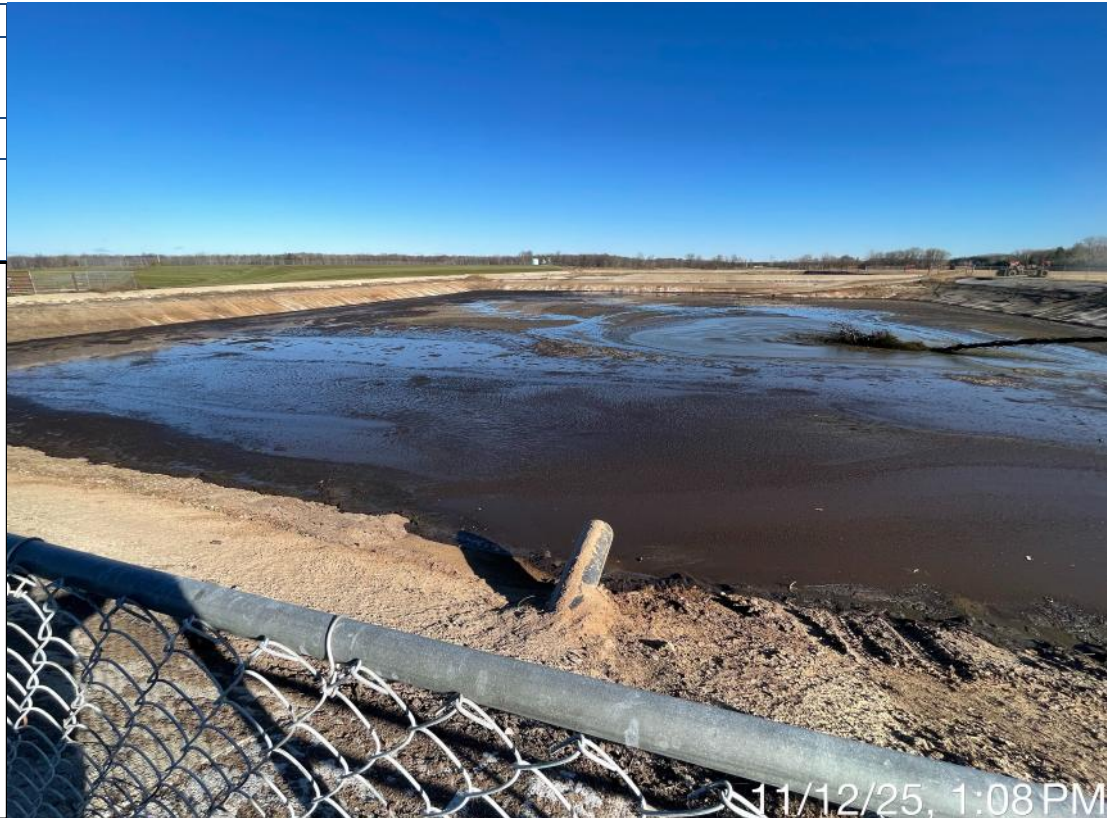
| <b>Photo #:</b> | 11 |

| <b>Photo Description:</b><br><br>Standing on west side of WSF #1 looking east: View of outlet pipe from heifer barn. | |

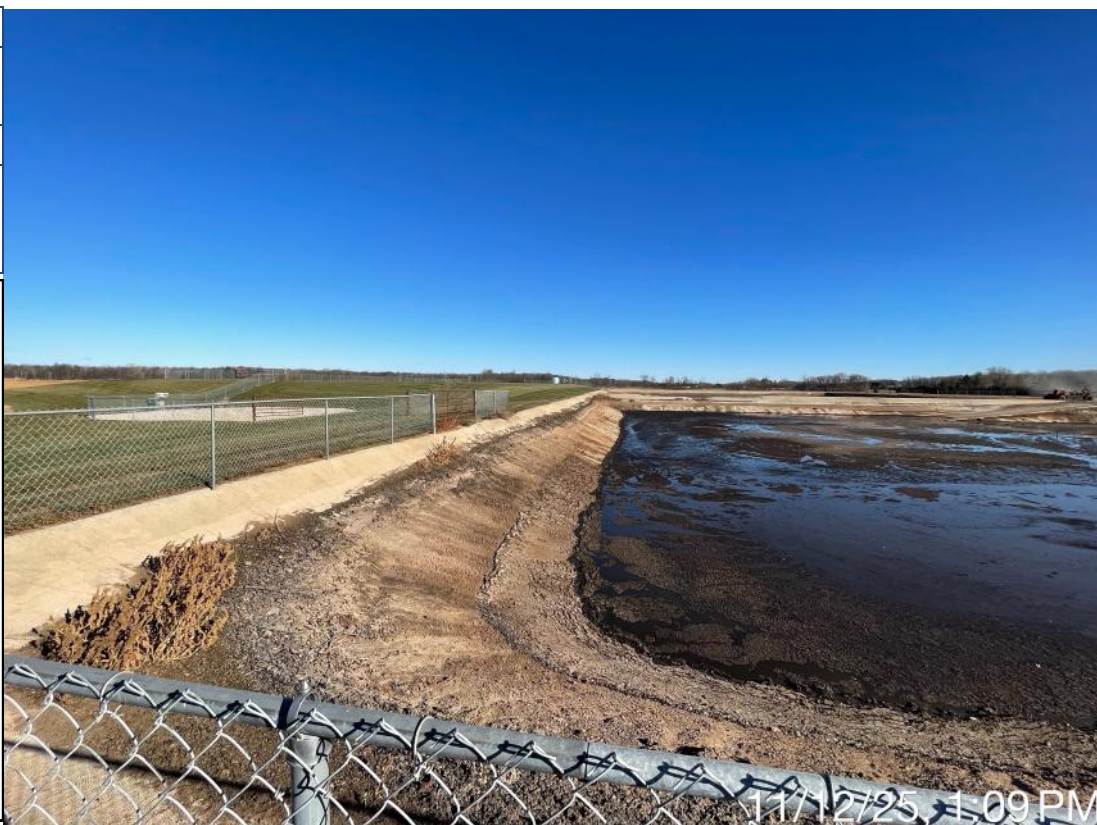
| <b>Photo #:</b> | 12 |

Standing on the west side of WSF #1 looking east: View of northwest corner of WSF #1.

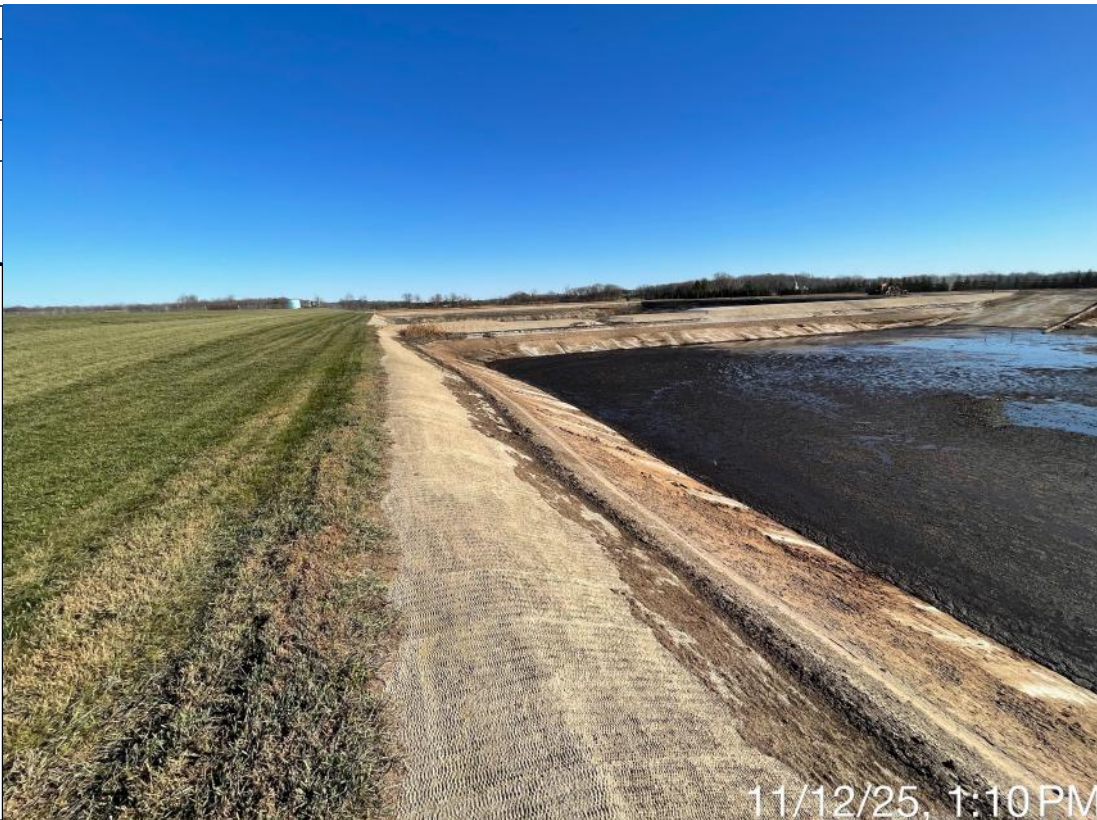
| <b>Photo #:</b> | 13 |

Standing on the north side of WSF #1 looking east: View of north edge of WSF #1.

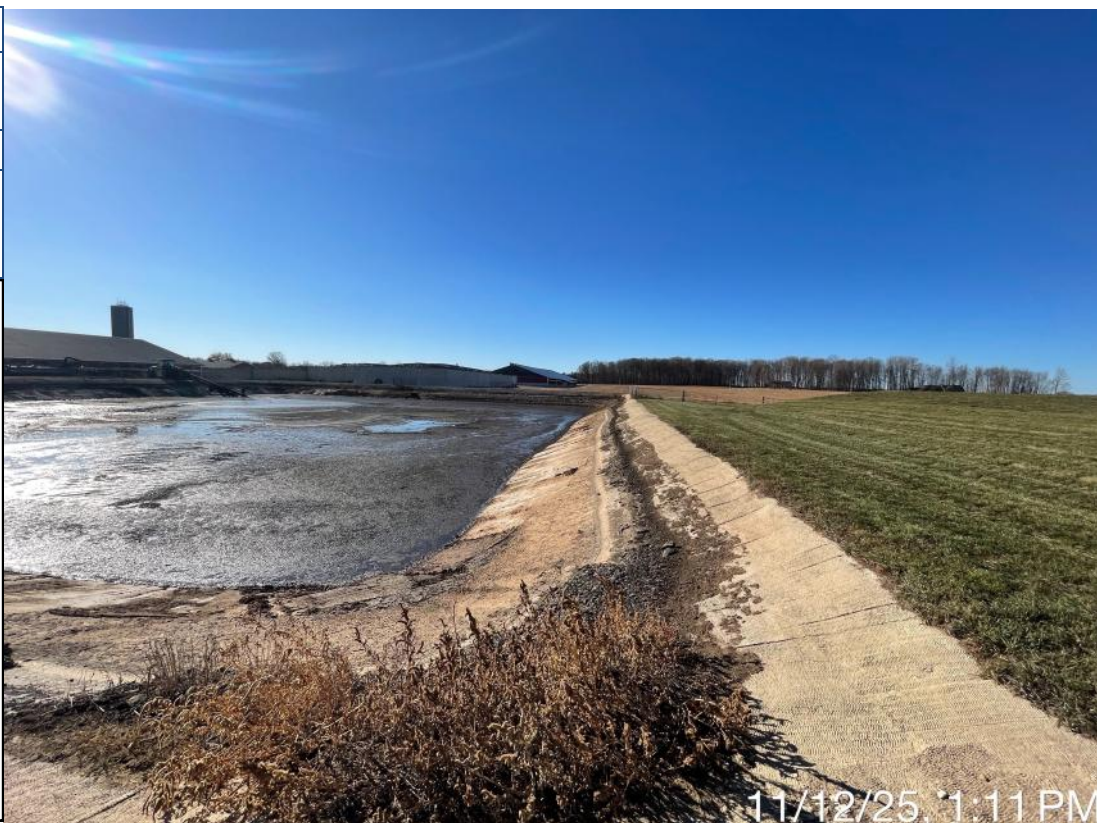
| <b>Photo #:</b> | 14 |

| <b>Photo Description:</b><br><br>Standing on the north side of WSF #1 looking west: View of northeast corner of WSF #1. | |

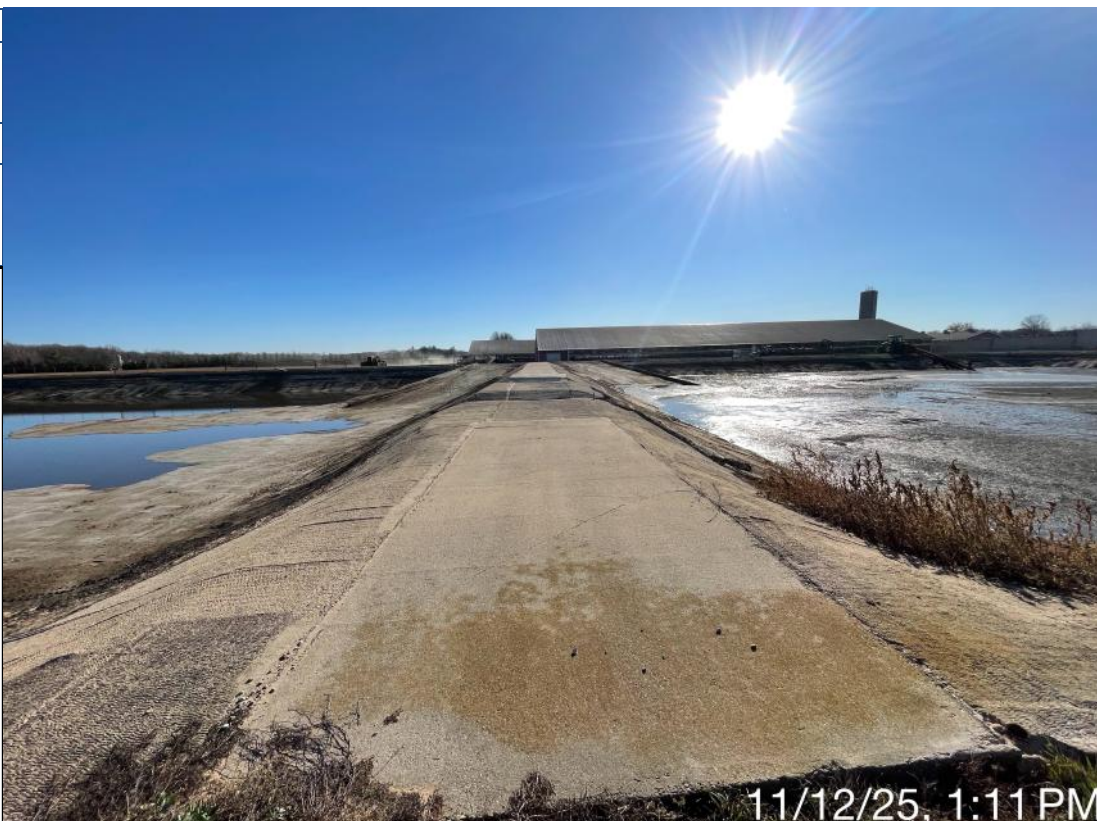
| <b>Photo #:</b> | 15 |

| <b>Photo Description:</b><br><br>Standing on north side of WSF #1 looking south: View of dividing berm that connects WSF #1 & WSF #2. | |

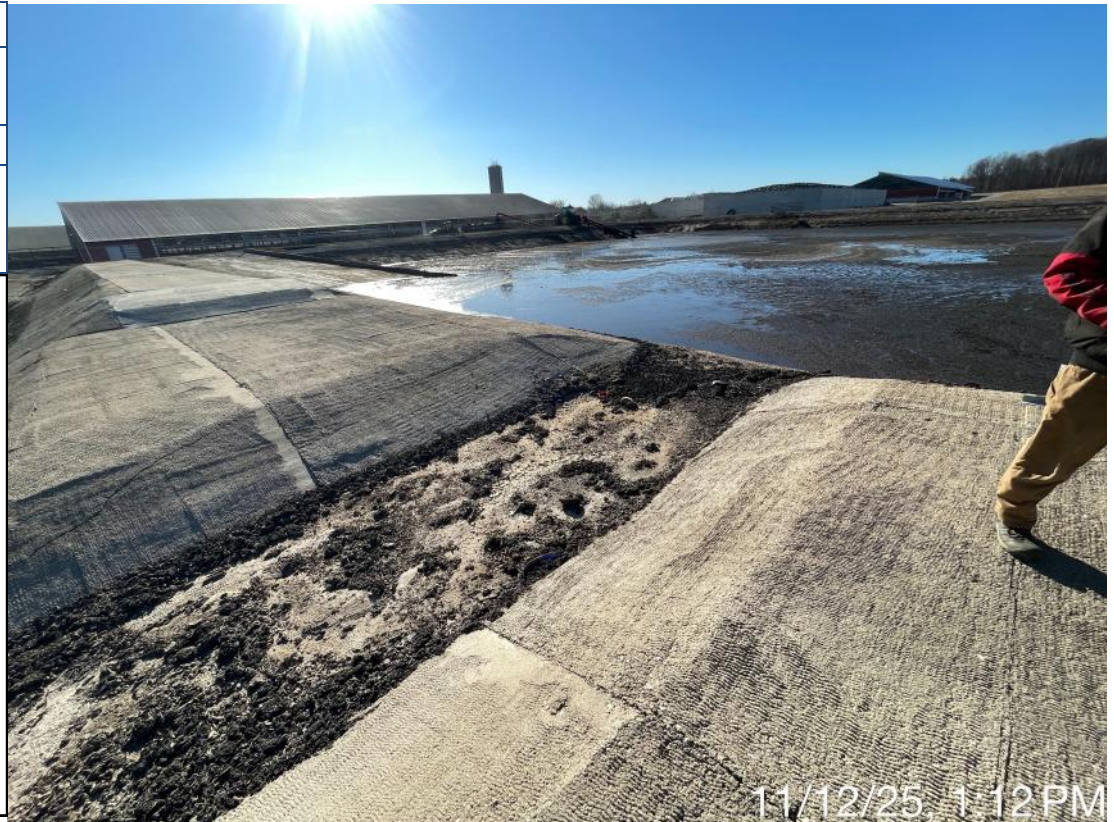
| <b>Photo #:</b> | 16 |

| <b>Photo Description:</b><br><br>Standing on the east side of WSF #1 looking southwest:<br>View of concrete overflow channel connecting WSF #1 & WSF #2. | |

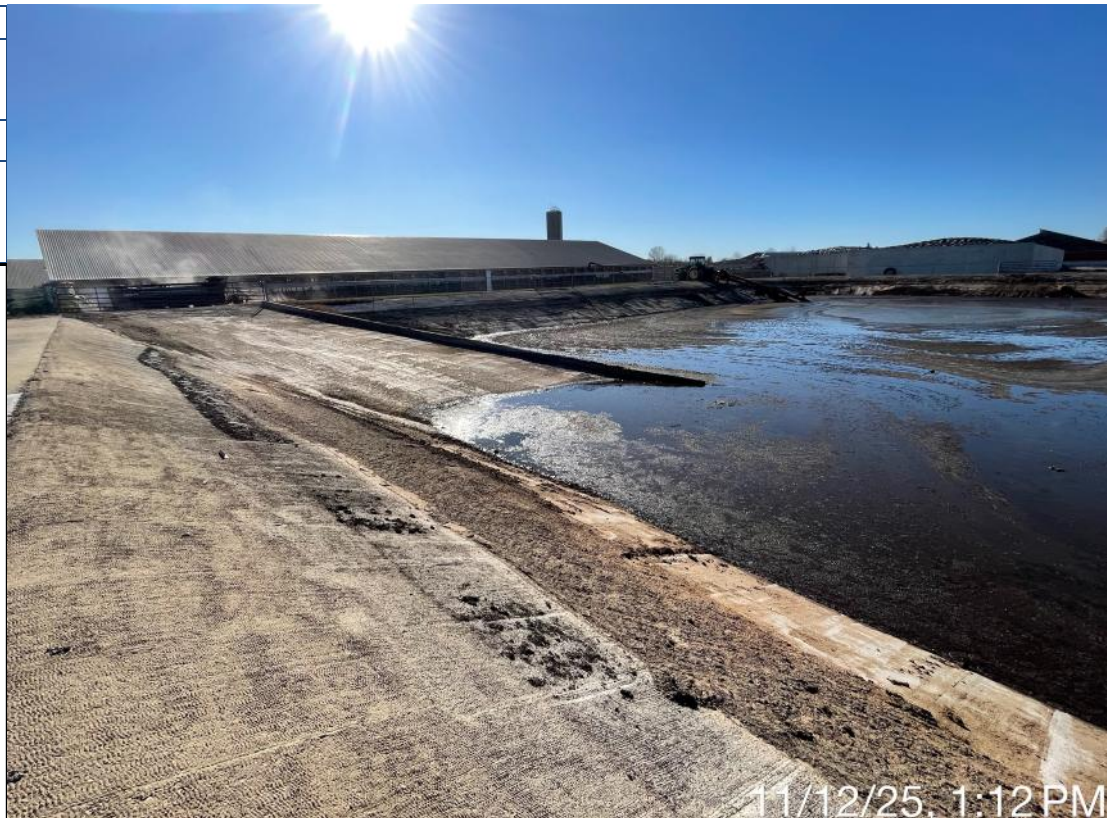
| <b>Photo #:</b> | 17 |

| <b>Photo Description:</b><br><br>Standing on east side of WSF #1 looking south: View of southeast corner of WSF #1.<br>Notice access ramp in southeast corner. | |

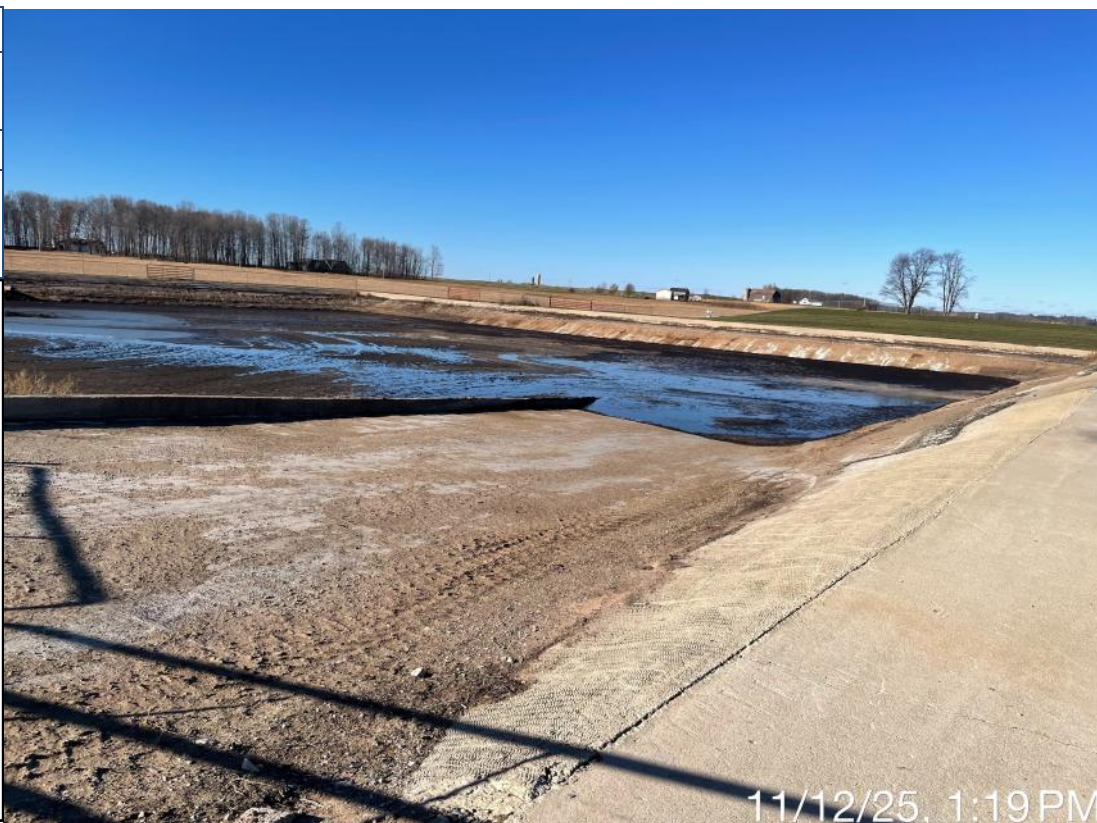
| <b>Photo #:</b> | 18 |

| <b>Photo Description:</b><br><br>Standing on east side of WSF #1 looking north: Alternate view of access ramp in southeast corner looking north. | |

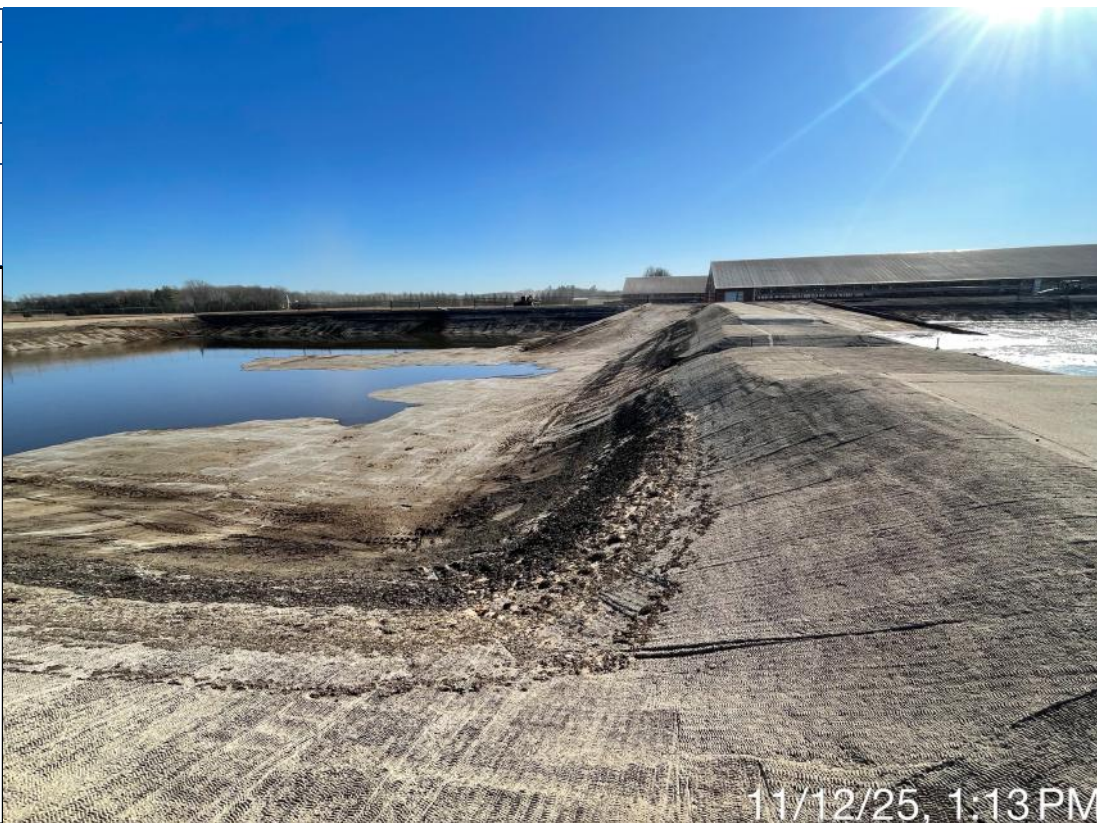
| <b>Photo #:</b> | 19 |

| <b>Photo Description:</b><br><br>Standing on the north side of WSF #2 looking south: View of northwest corner of WSF #2. Notice floor in NW corner is higher and slopes SE. | |

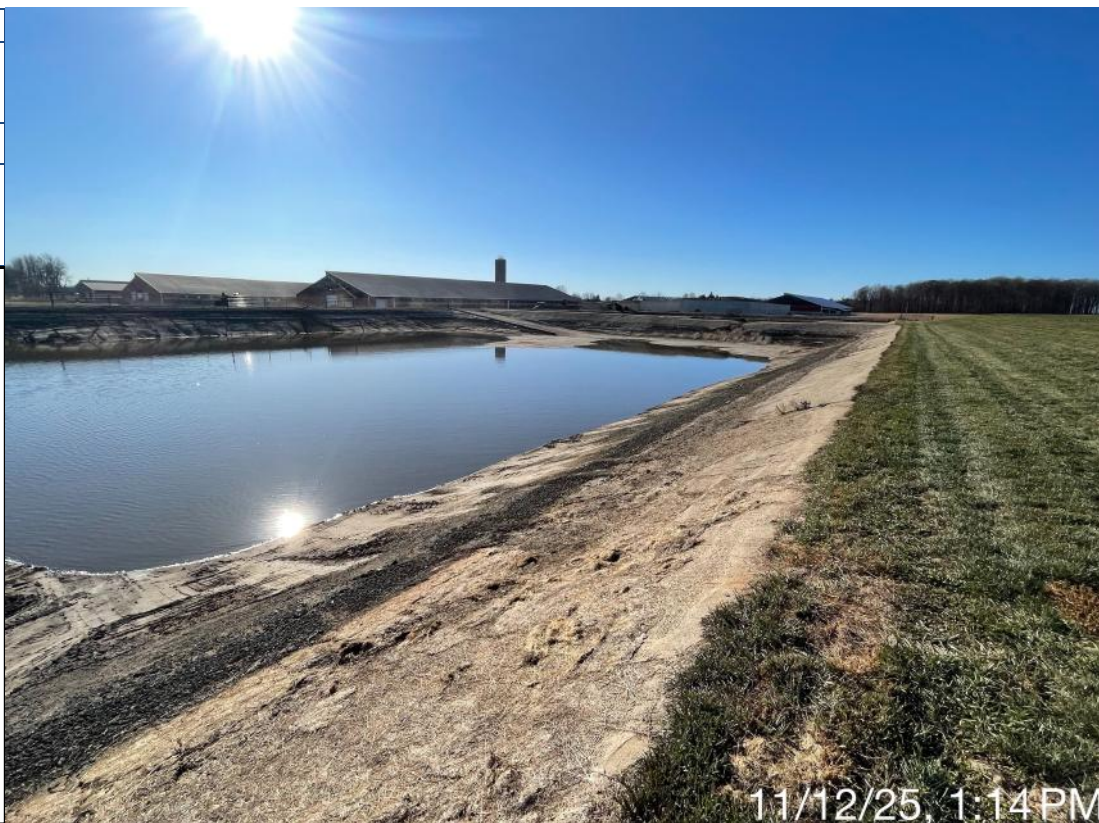
| <b>Photo #:</b> | 21 |

Standing on north side of WSF #2 looking west: View of north  
edge of WSF #2.

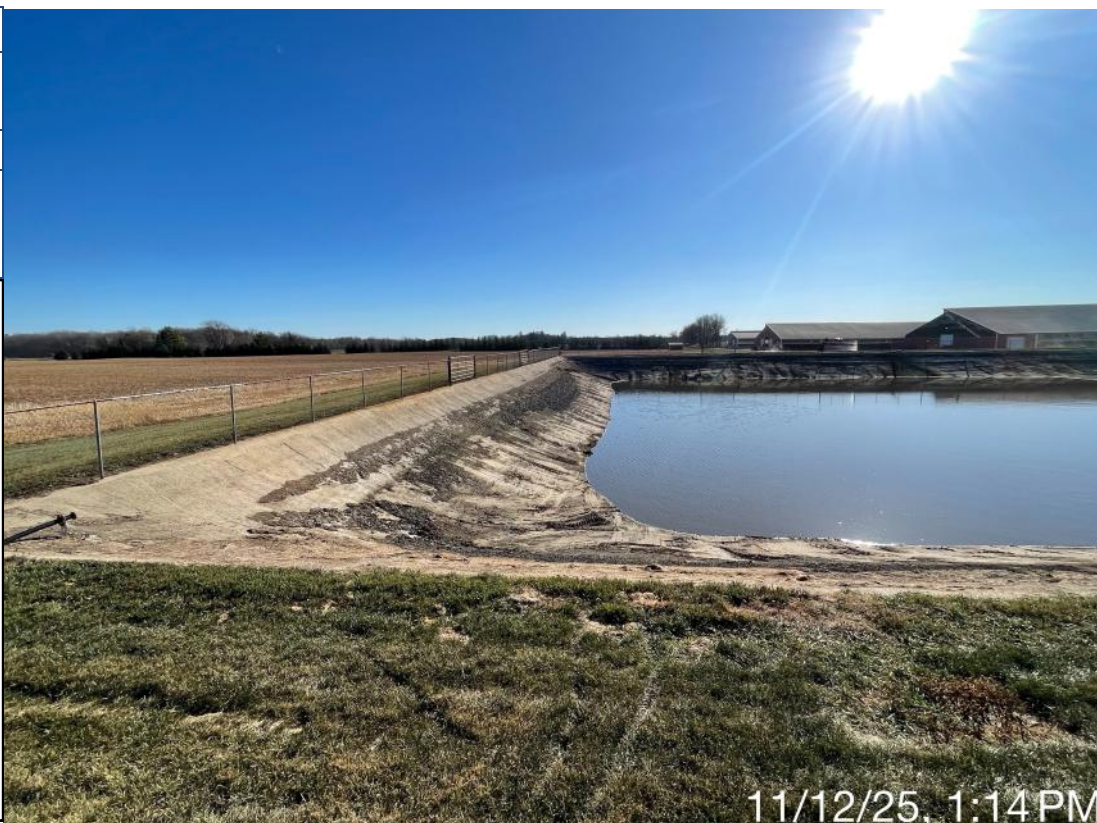
| <b>Photo #:</b> | 22 |

Standing on north side of WSF #2 looking south: View of northeast corner of WSF #2.

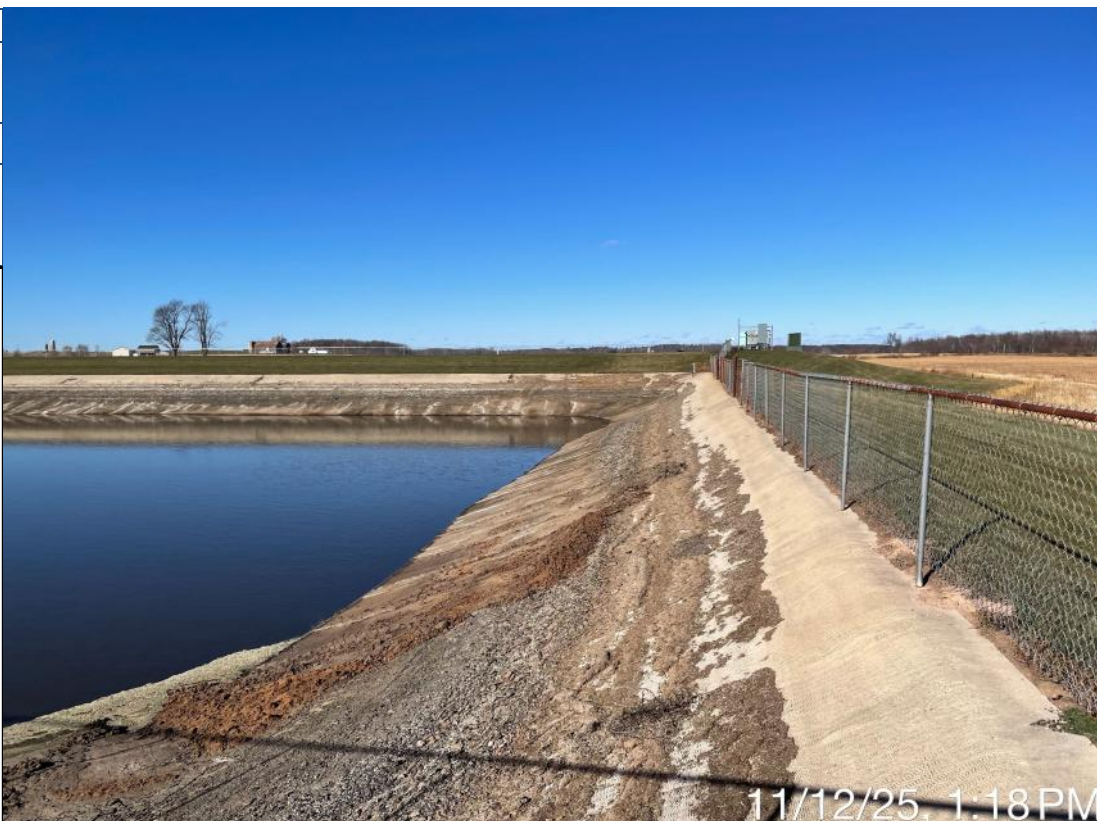
| <b>Photo #:</b> | 23 |

Standing on south side of WSF #2 looking north: View of east edge of WSF #2.

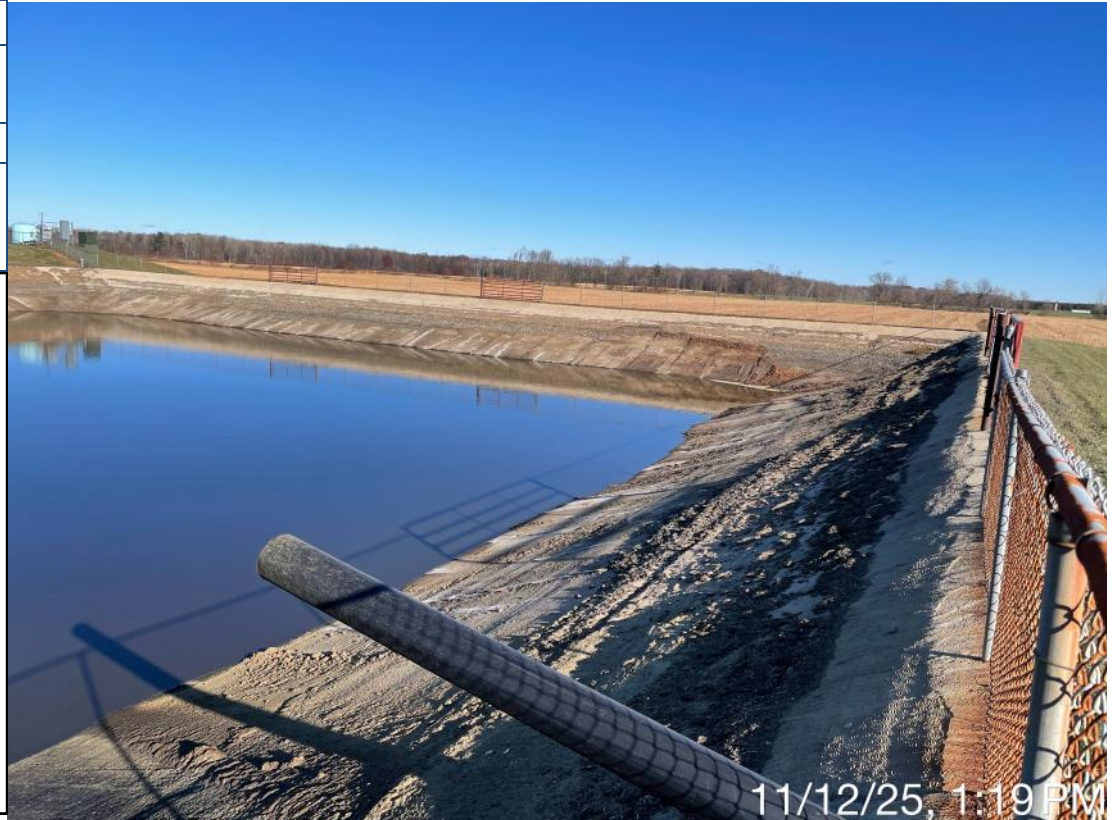
| <b>Photo #:</b> | 24 |

| <b>Photo Description:</b><br><br>Standing on south side of WSF #2 looking east: View of south edge of WSF #2. Notice optional outlet pipe for manure transfer system | |

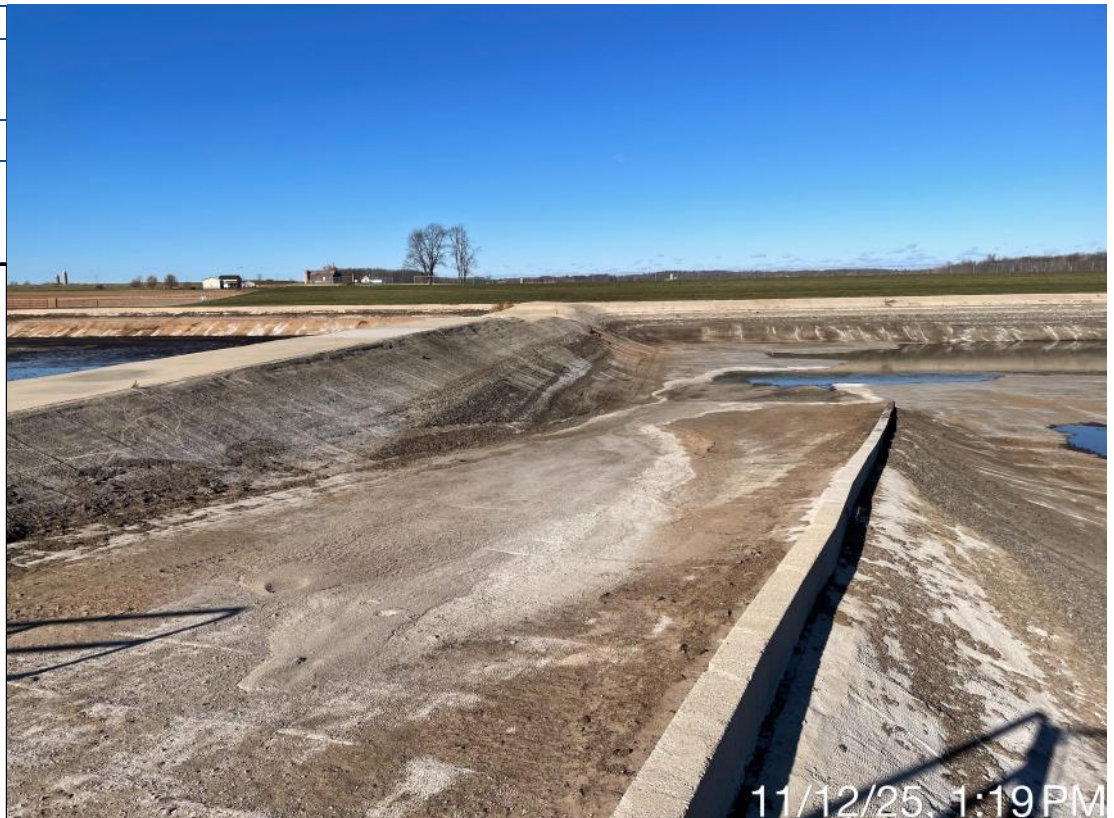
| <b>Photo #:</b> | 25 |

| <b>Photo Description:</b><br><br>Standing on south side of WSF #2 looking north: View of southwest corner of WSF #2. Notice access ramp in southwest corner. | |

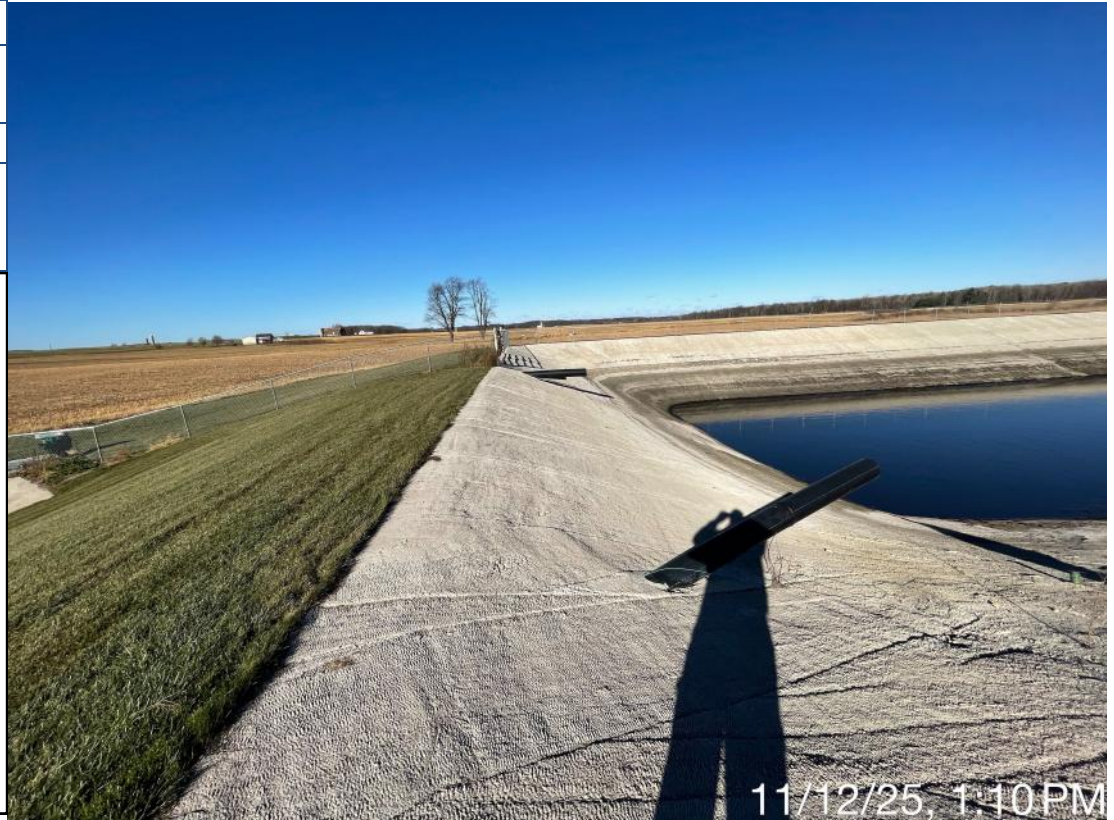
| <b>Photo #:</b> | 26 |

| <b>Photo Description:</b><br><br>Standing on the south side of WSF #3 looking north: View of west edge of WSF #3. | |
