## Permit Fact Sheet

| Permit Number | WI-0066958-02-0 |
| Permittee Name and Address | Wagner Farms Inc<br>N6928 County Road BB, Oconto Falls, WI 54154 |

On Wednesday November 12th, 2025 Hanson met with Wagner & Wagner at 13:00 at Wagner Farms Inc site to conduct a permit reissuance compliance inspection. Only 1 site was inspected. No significant liquid precipitation had fallen over the previous 24 hours and the temperature was in the 50's and sunny. No permit violations were observed, and no water samples were collected. Hanson departed at approximately 14:15.

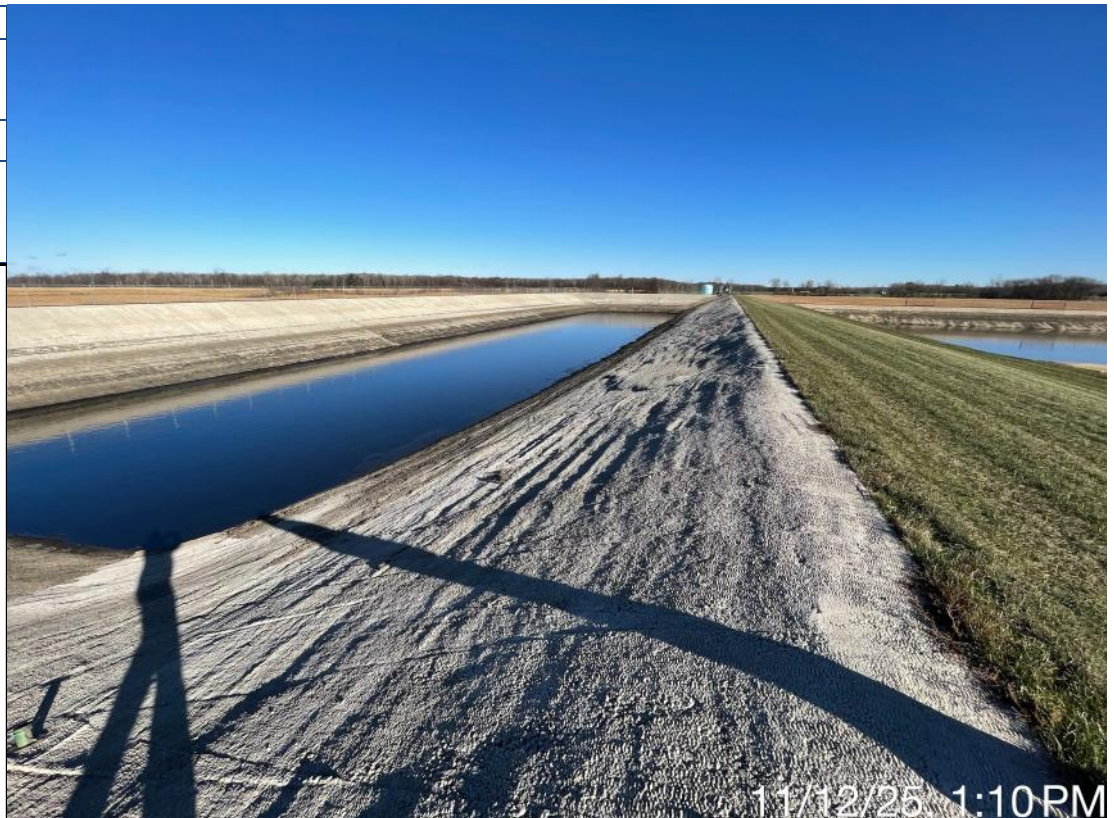
| <b>Photo #:</b> | 27 |

| <b>Photo Description:</b><br><br>Standing on the south side of WSF #3 looking east: View of south edge of WSF #3. | |

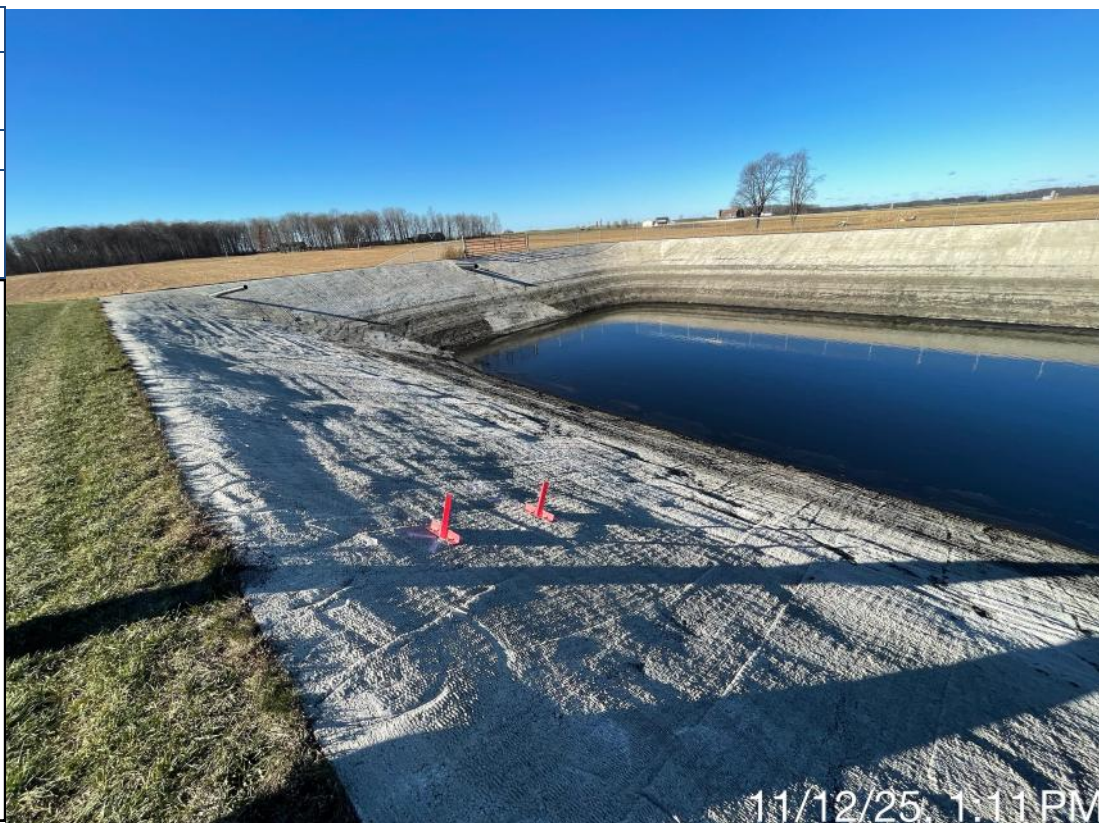
| <b>Photo #:</b> | 28 |

| <b>Photo Description:</b><br><br>Standing on the south side of WSF #3 looking west: View of permanent markers attached to concrete liner. | |

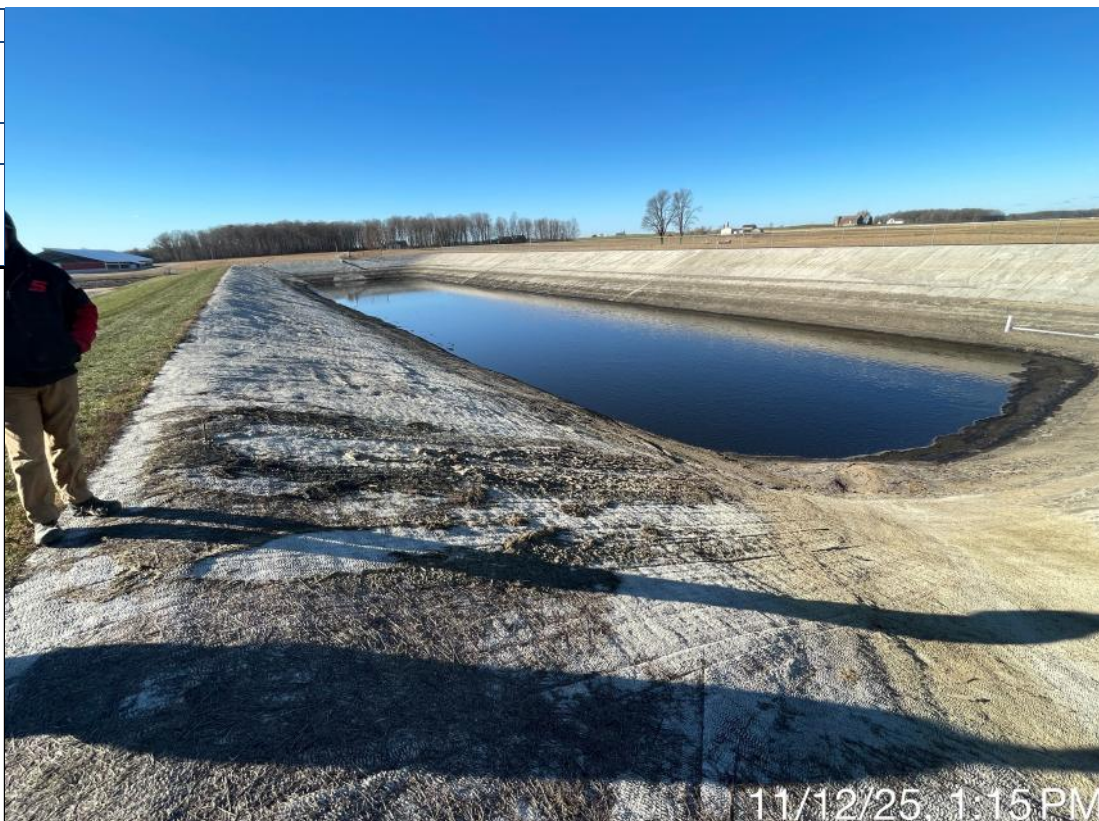
| <b>Photo #:</b> | 29 |

| <b>Photo Description:</b><br><br>Standing on the east side of WSF #3 looking west: View of southeast corner of WSF #3. | |

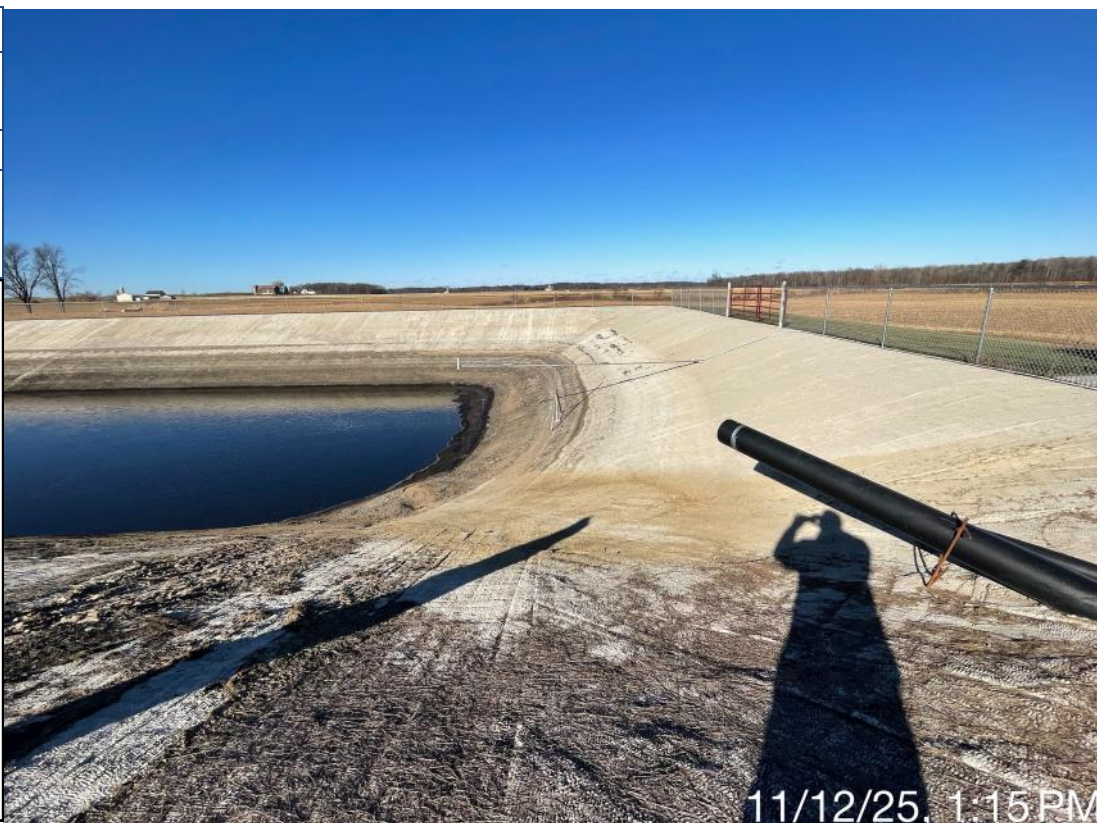
| <b>Photo #:</b> | 30 |

Standing on the east side of WSF #3 looking north: View of east edge of WSF #3. Notice black outlet pipes from parlor transfer system.

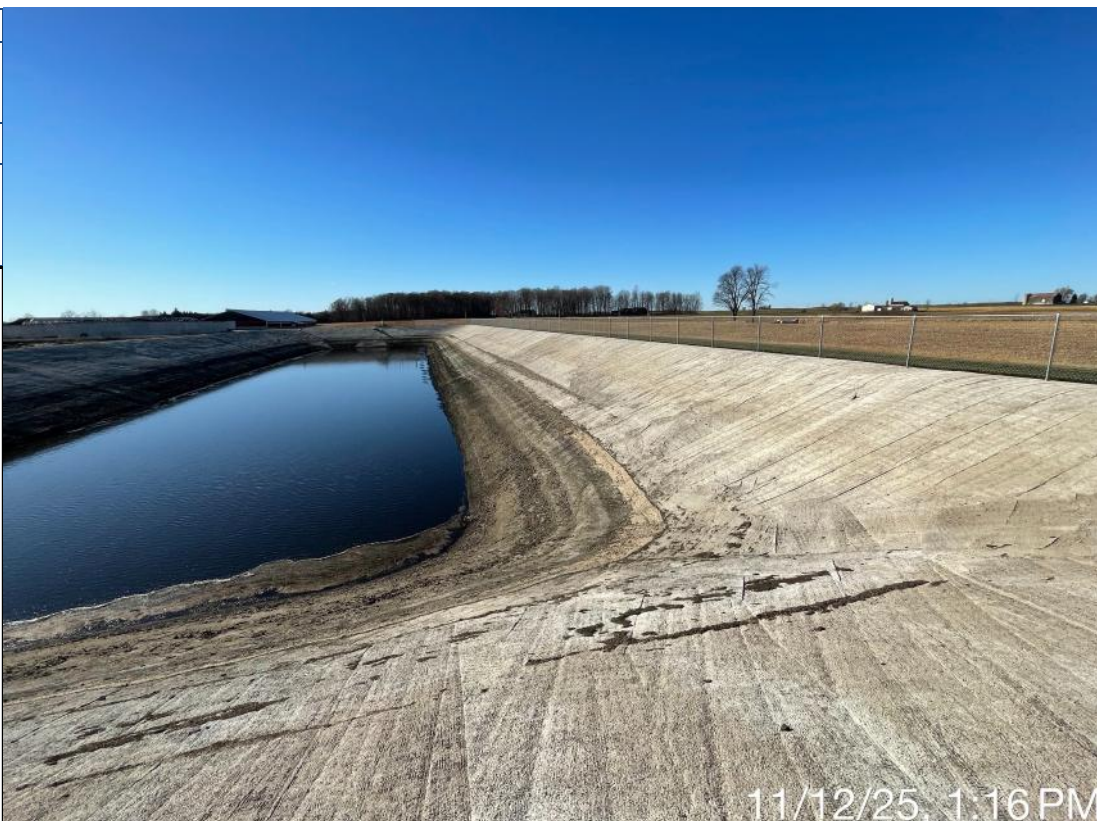
| <b>Photo #:</b> | 31 |

Standing on the east side of WSF #3 looking west: View of northeast corner of WSF #3.

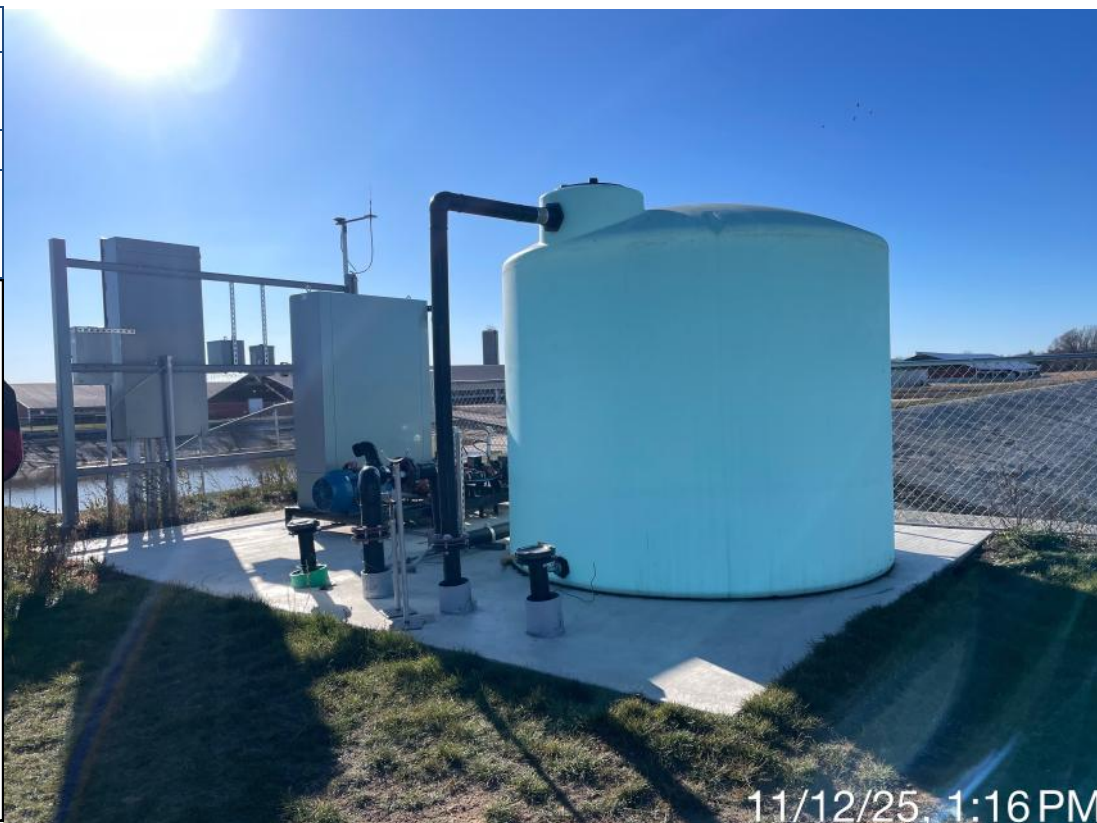
| <b>Photo Description:</b><br><br>Standing on the east side of WSF #3 looking southwest:<br>View of Rain 360 control unit, mixing manifold & auxiliary liquid fertilizer tank. | |

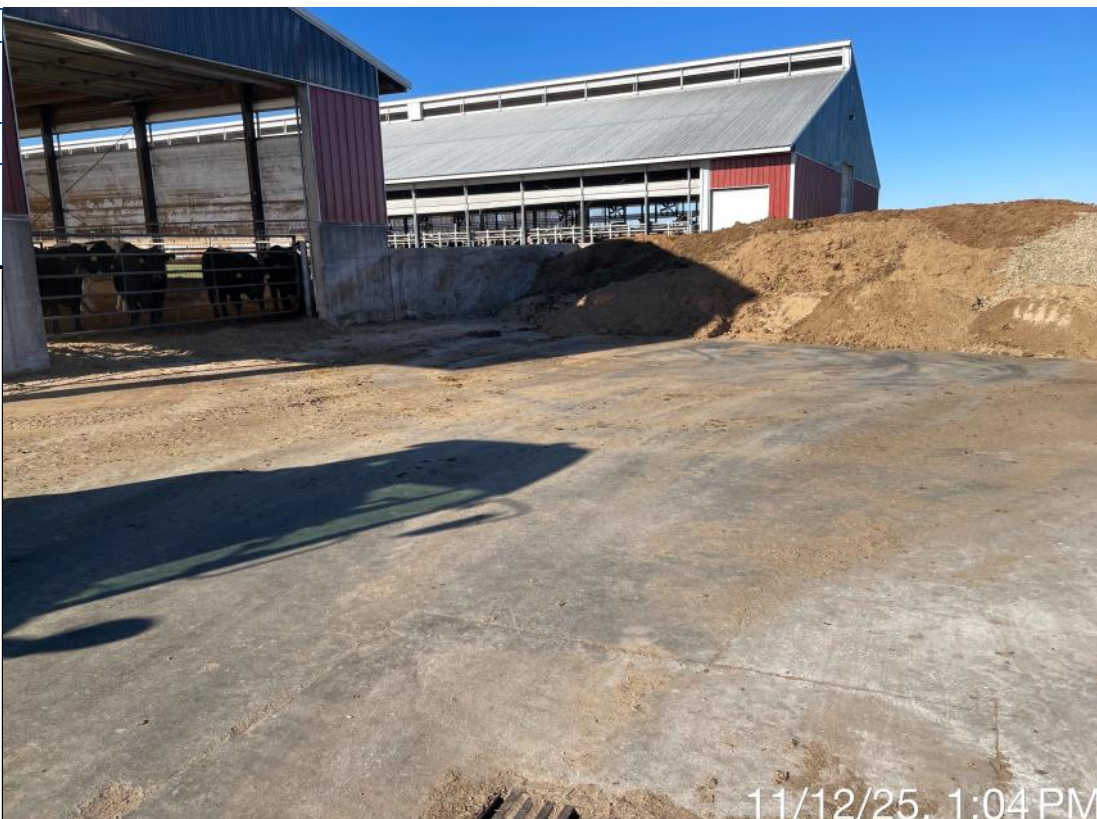
| <b>Photo Description:</b><br><br>Standing on the east side of the calf barn looking northwest:<br>View of solid stacking pad on the east side of the calf barn. | |

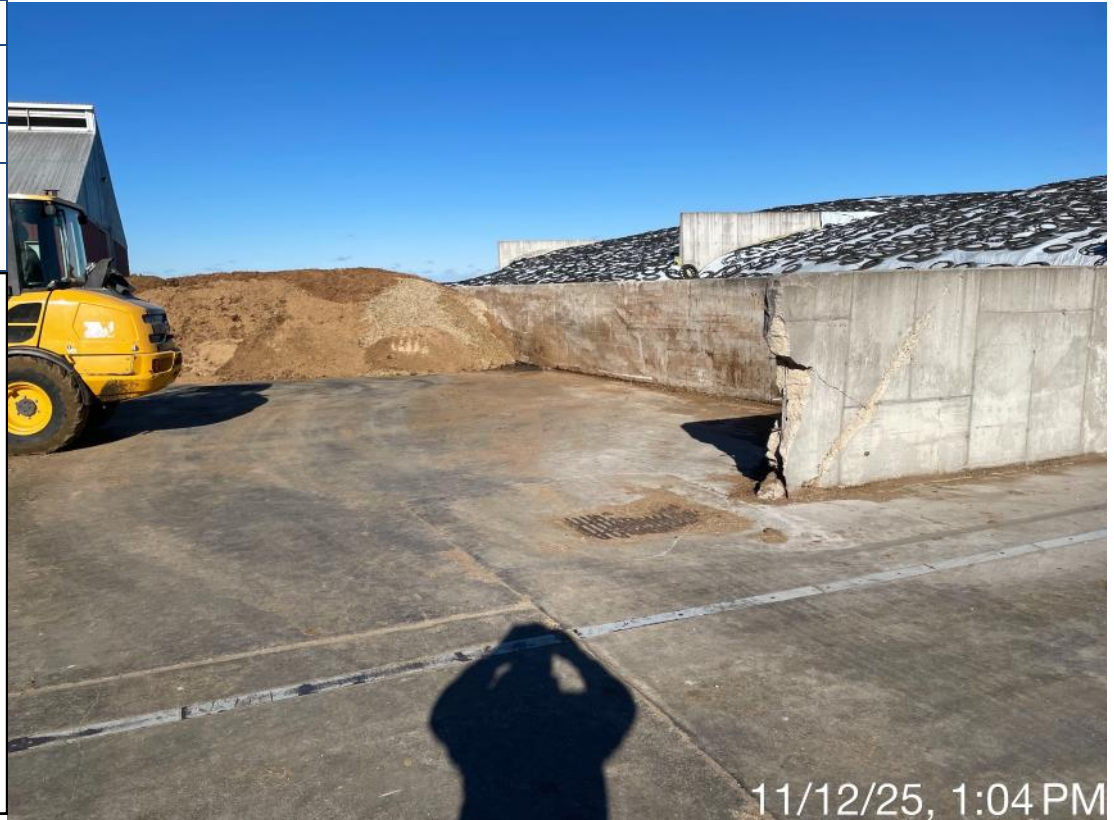
| <b>Photo #:</b> | 34 |

| Standing on the east side of calf barn looking northeast: View of solid stacking pad on east side of calf barn. Notice U-Drain trench along south side of pad used to collect runoff. | |

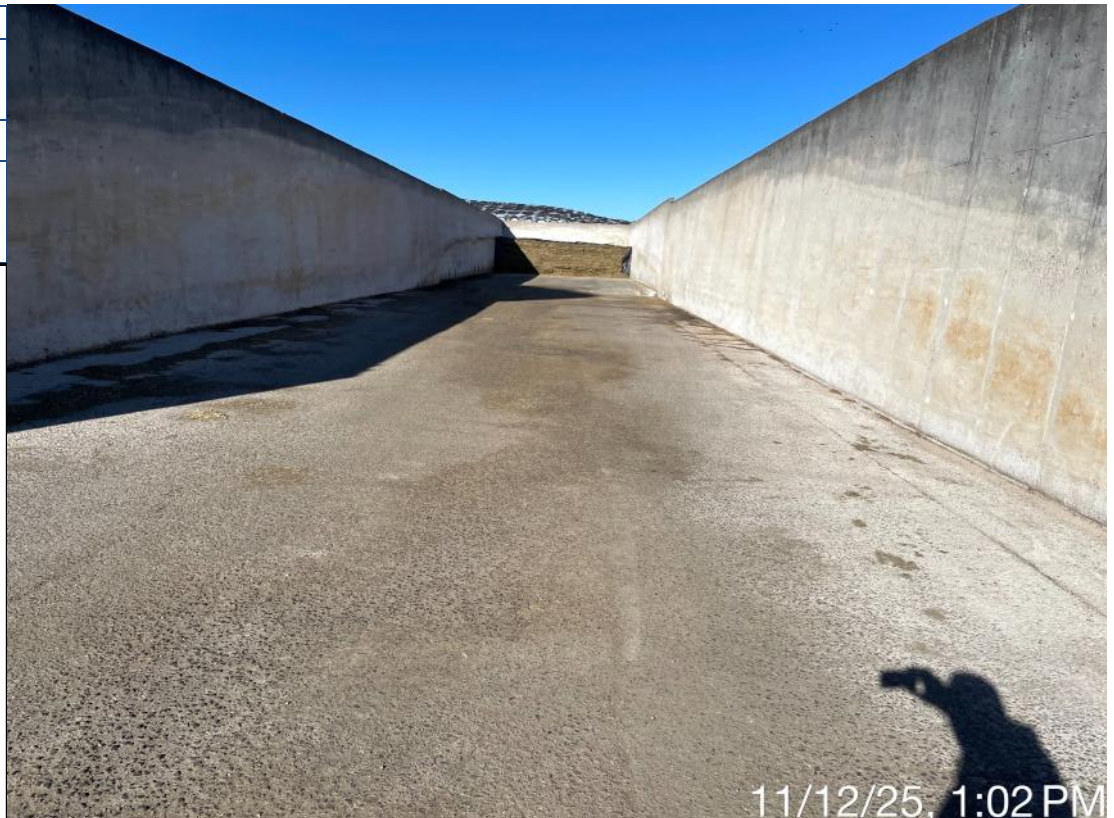
| <b>Photo #:</b> | 35 |

| Standing on the south side of FSA looking north: View of empty bunker. Notice floor is pitted, but free of cracking. | |

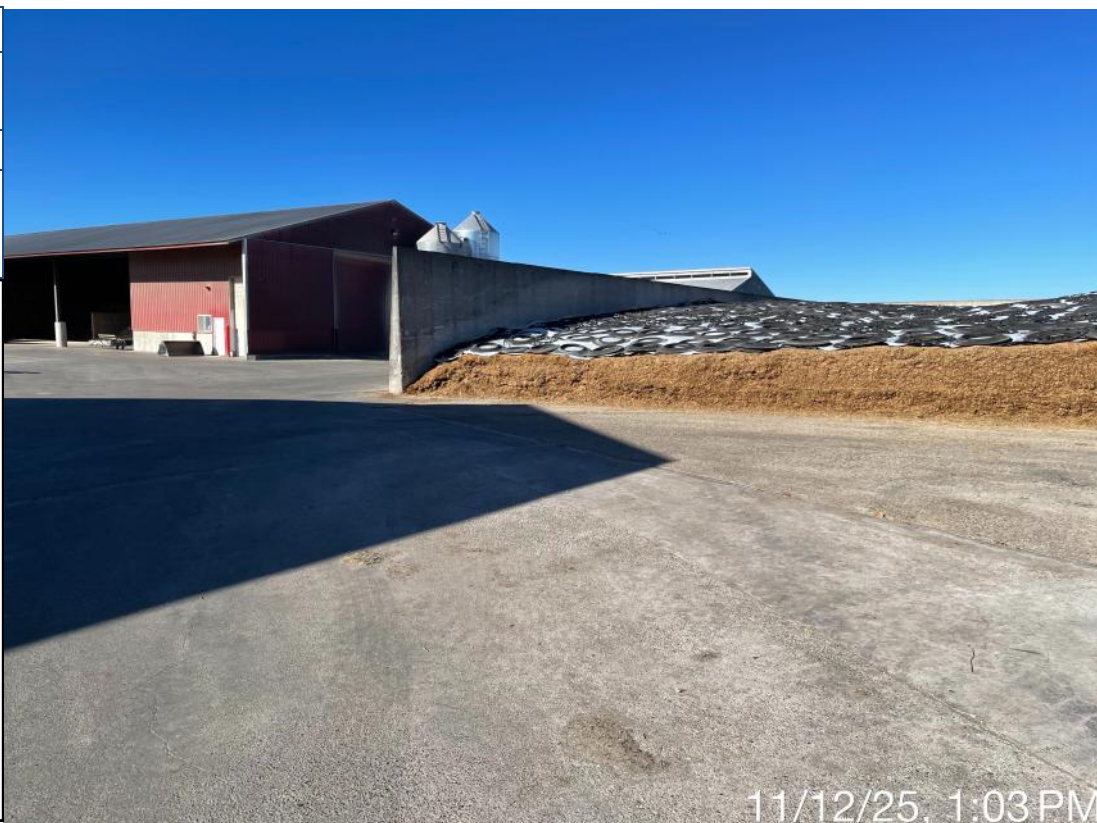
| <b>Photo #:</b> | 36 |

| <b>Photo Description:</b><br><br>Standing on the south side of FSA looking northwest: View of southwest corner of FSA. | |

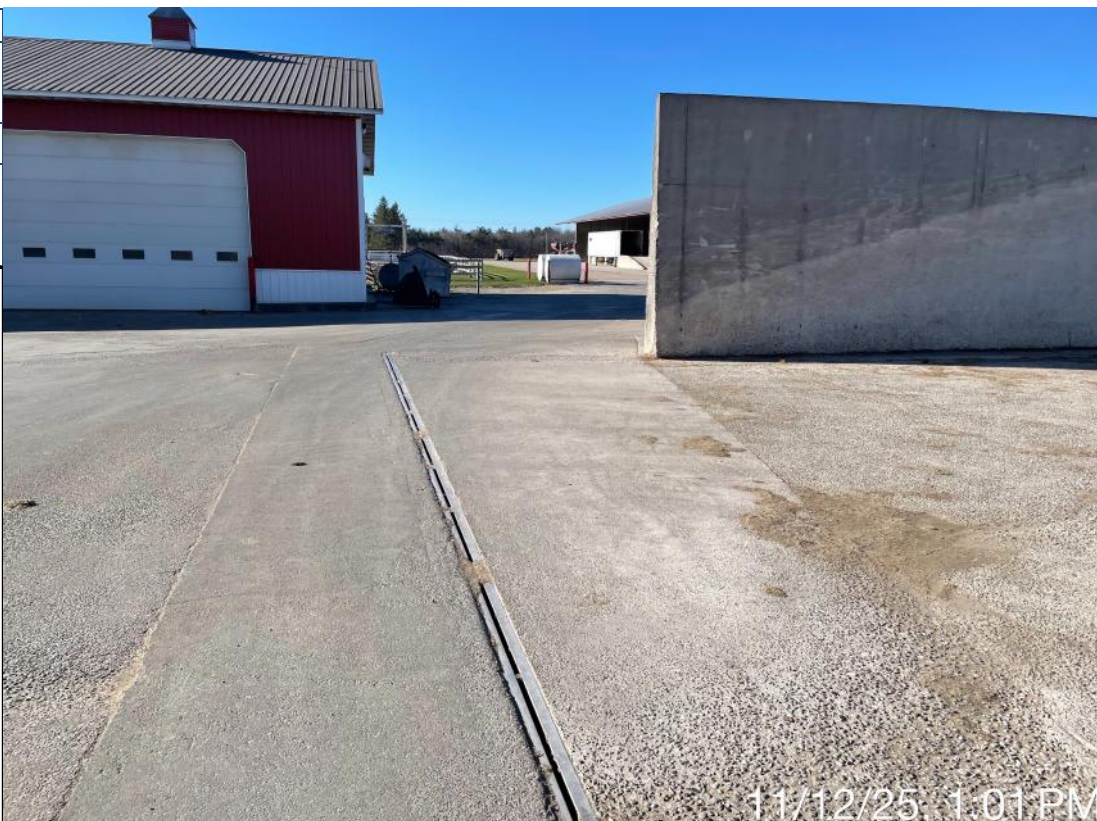
| <b>Photo #:</b> | 37 |

| <b>Photo Description:</b><br><br>Standing on the south side of FSA looking west: View of south edge of FSA. Notice U-Drain trench used to collect runoff. | |

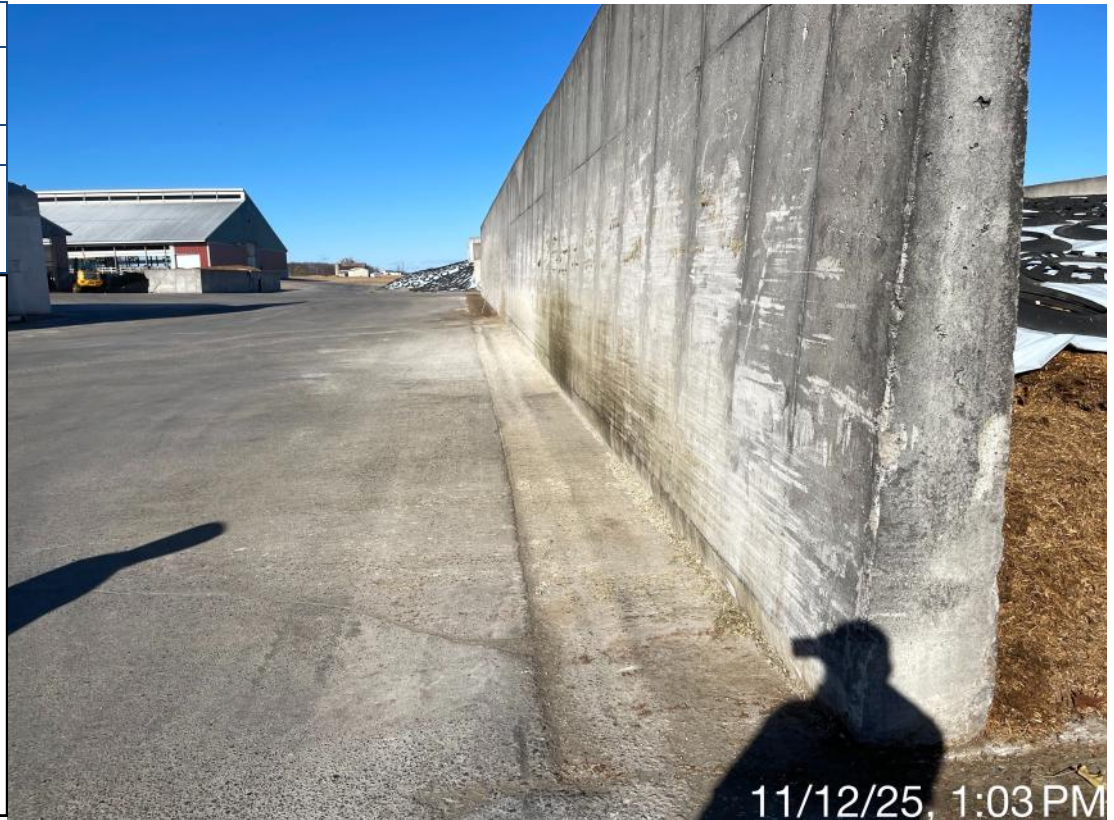
| <b>Photo #:</b> | 38 |

| <b>Photo Description:</b><br><br>Standing on the west side of FSA looking north: View of west edge of FSA. | |

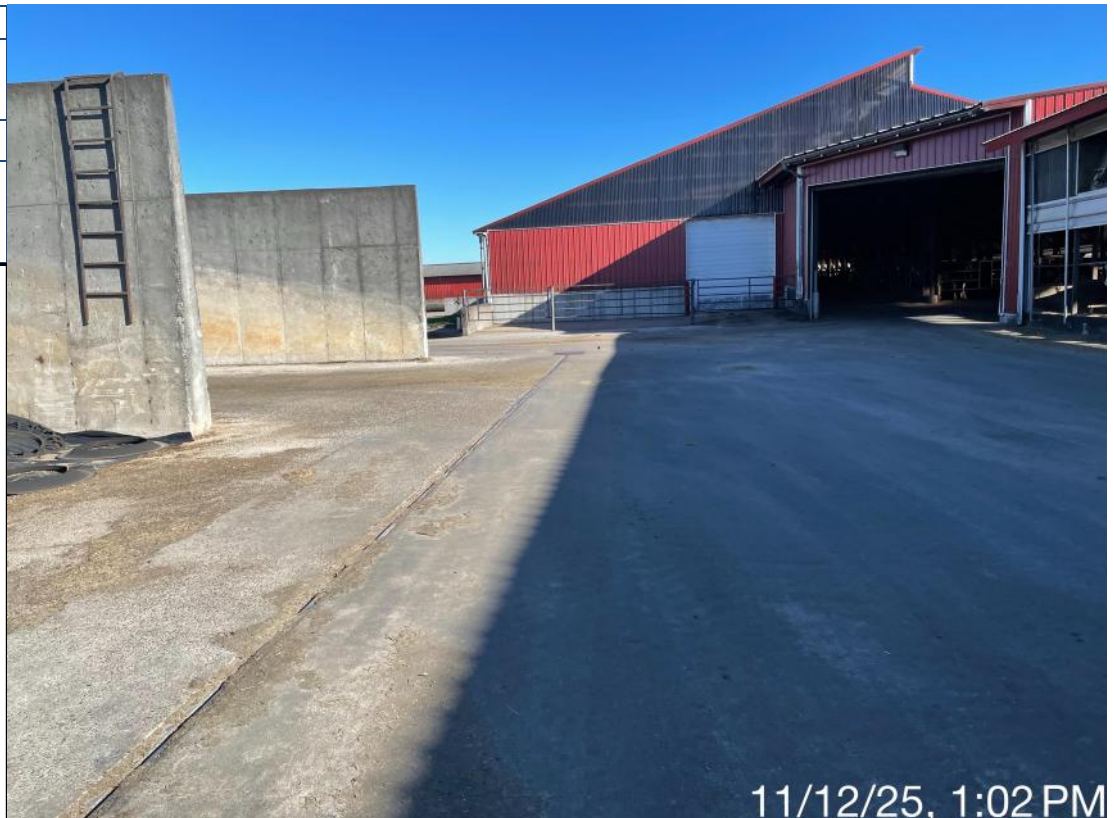
| <b>Photo #:</b> | 39 |

| <b>Photo Description:</b><br><br>Standing on the south side of FSA looking east: View of south edge of FSA. Notice U-Drain trench used to collect runoff. | |

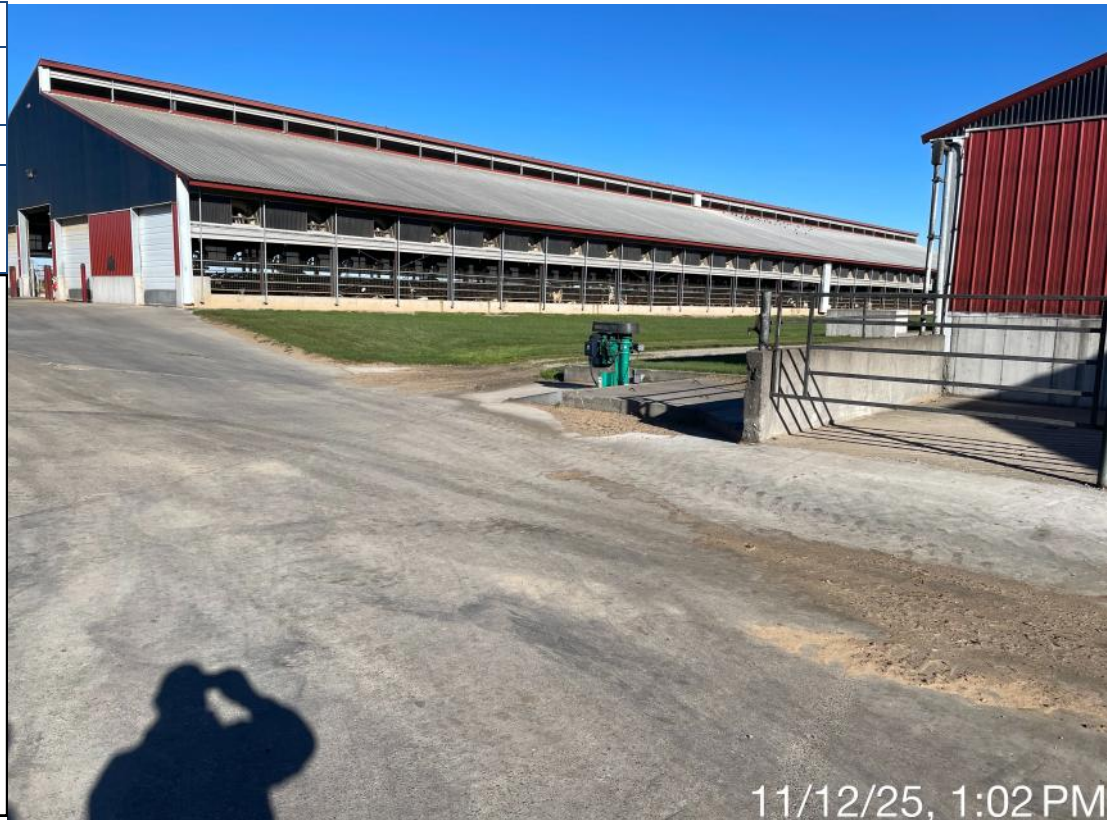
| <b>Photo #:</b> | 40 |

| <b>Photo Description:</b><br><br>Standing on the east side of FSA looking northeast: View of runoff collection tank on the east side of FSA. Tank pumps runoff to WSF #3. | |

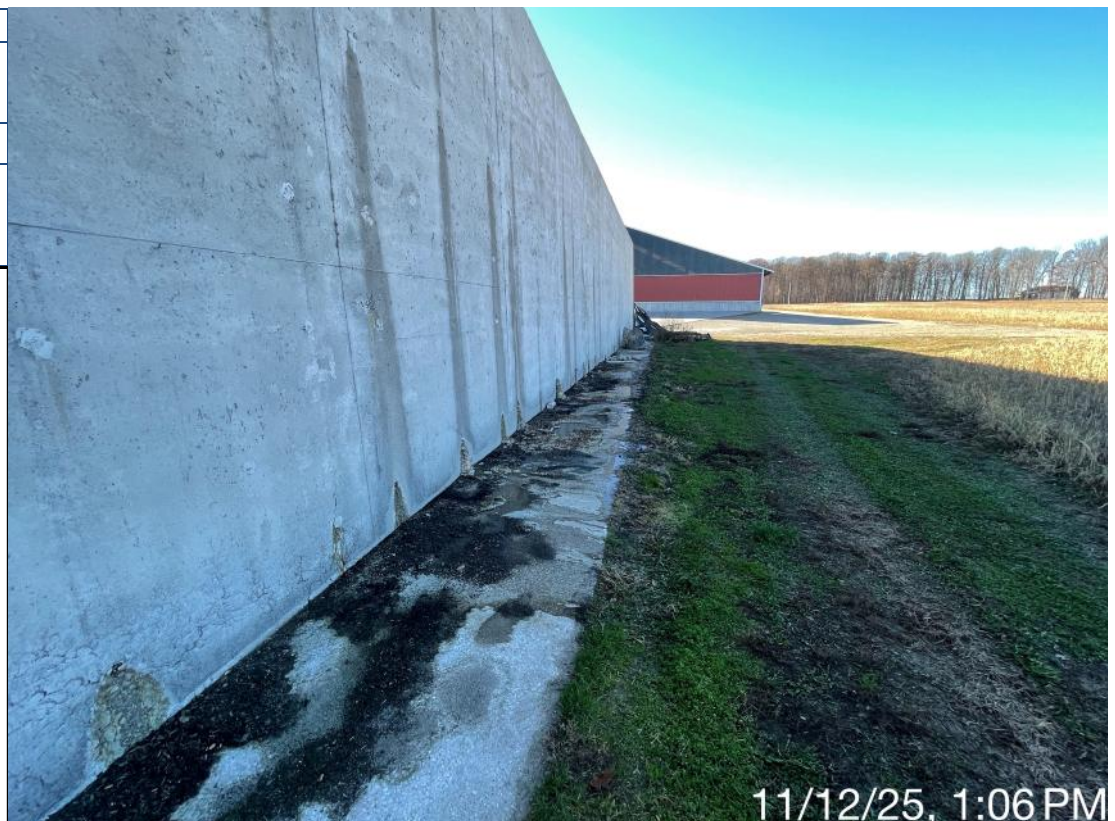
| <b>Photo #:</b> | 43 |

| <b>Photo Description:</b><br><br>Standing on the north side of FSA looking west: View of north edge of FSA. Notice leachate seeping through wall. Gravel drain at edge of concrete floor used to collect this leachate. | |

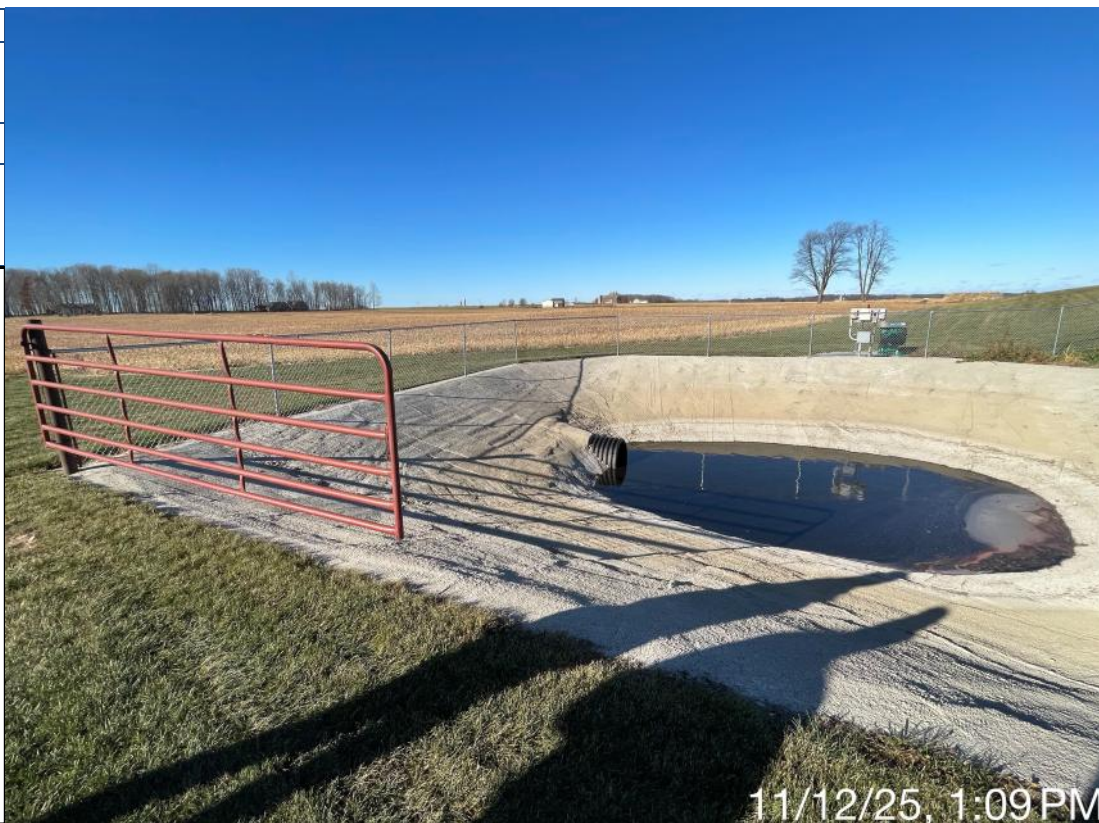
| <b>Photo #:</b> | 45 |

Standing on the north side of WSF #1 looking North: View of runoff collection basin on west side of WSF #3. Runoff from the West FSA gravity flows to this basin and is then pumped to WSF #3.

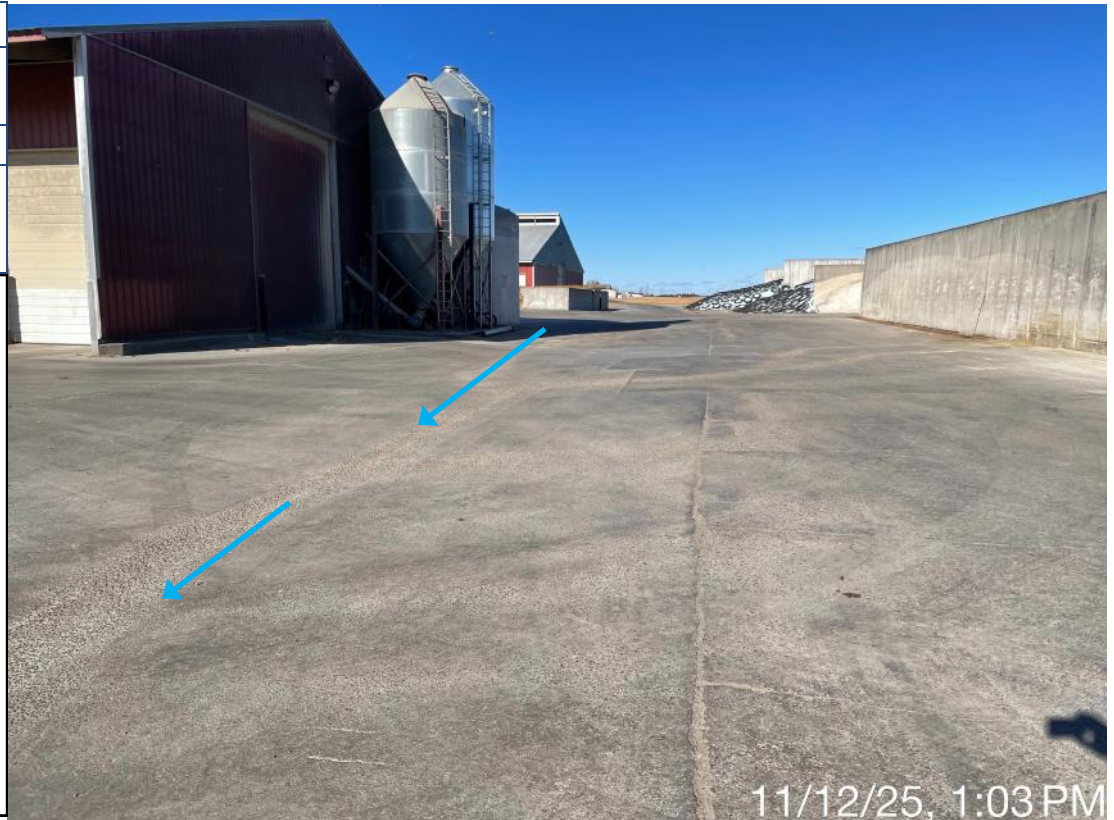
| <b>Photo #:</b> | 46 |

| <b>Photo Description:</b><br><br>Standing on the west side of FSA looking north: View of stormwater channel on west side of FSA: Arrows indicate direction of runoff flow. | |

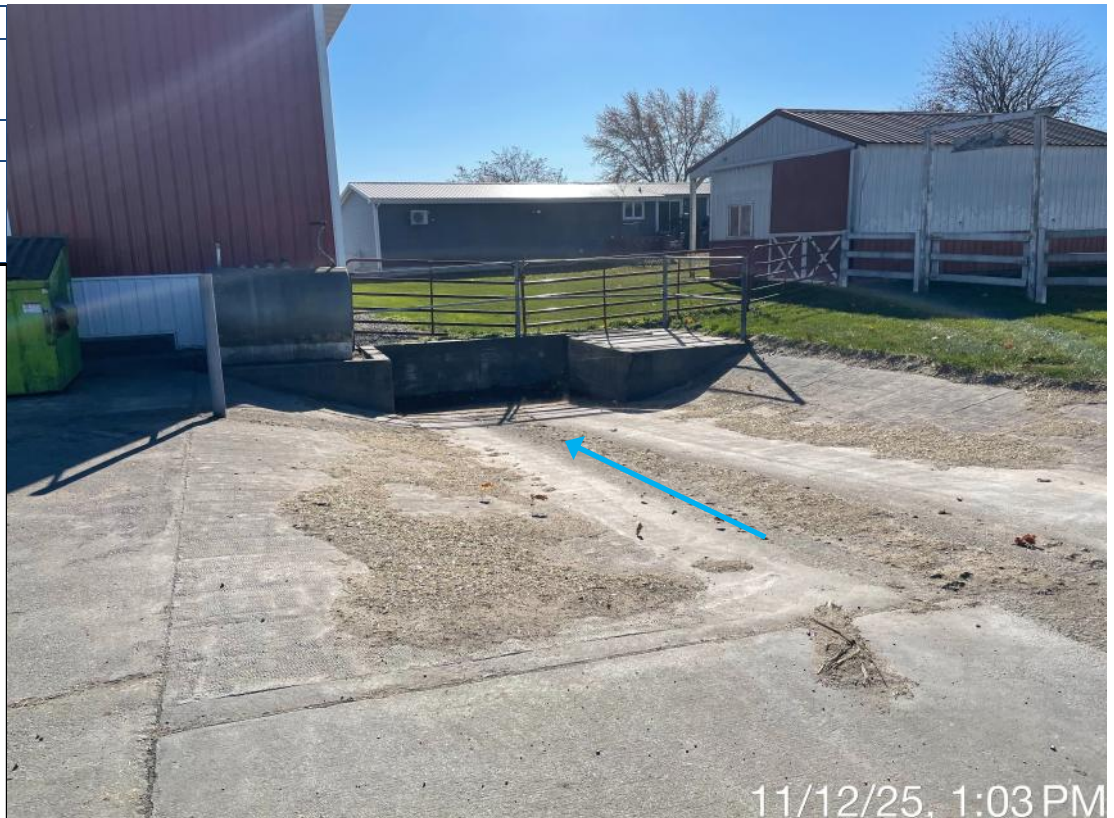
| <b>Photo #:</b> | 47 |

| <b>Photo Description:</b><br><br>Standing on west side of FSA looking south: View of stormwater collection area west of FSA. Stormwater flows to this collection point and then flows underground to road ditch. | |

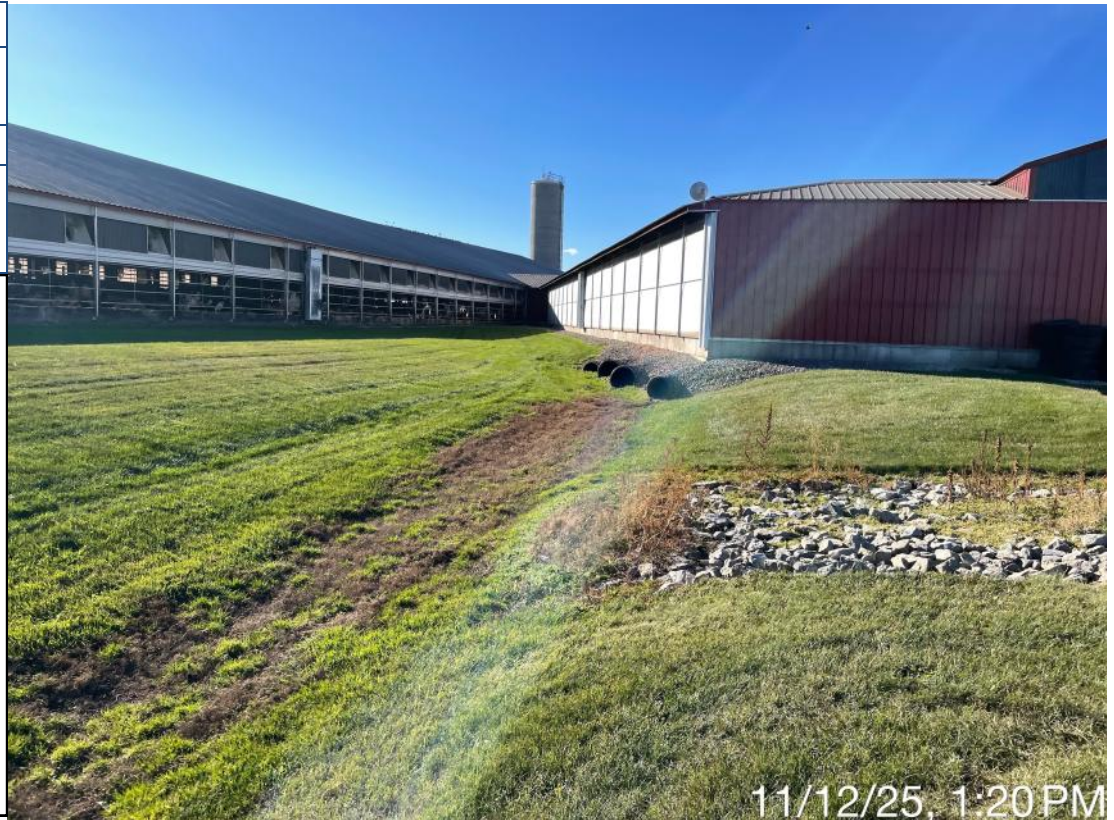
| <b>Photo #:</b> | 48 |

| <b>Photo Description:</b><br><br>Standing on north side of freestall barn looking west:<br>View of stormwater channel in between the 2 northern barns. | |

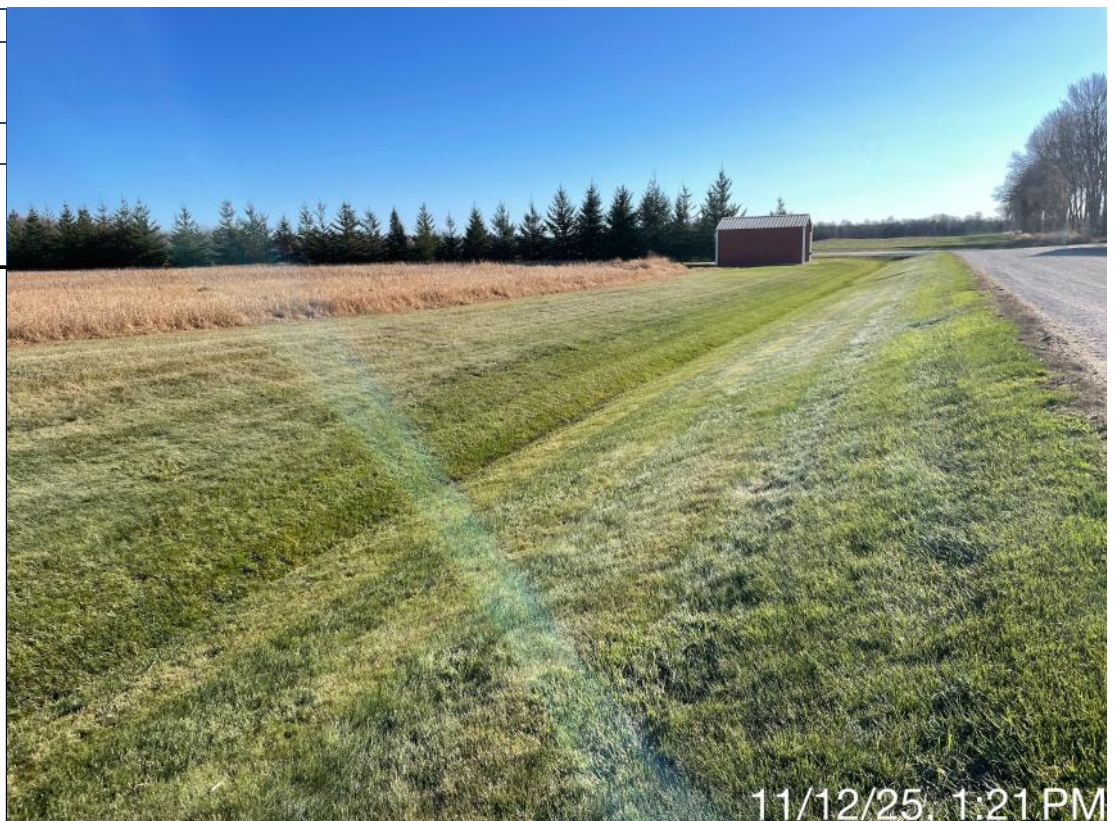
| <b>Photo #:</b> | 49 |

| <b>Photo Description:</b><br><br>Standing on east side of freestall barns looking south:<br>View of stormwater channel on east side of barns. | |

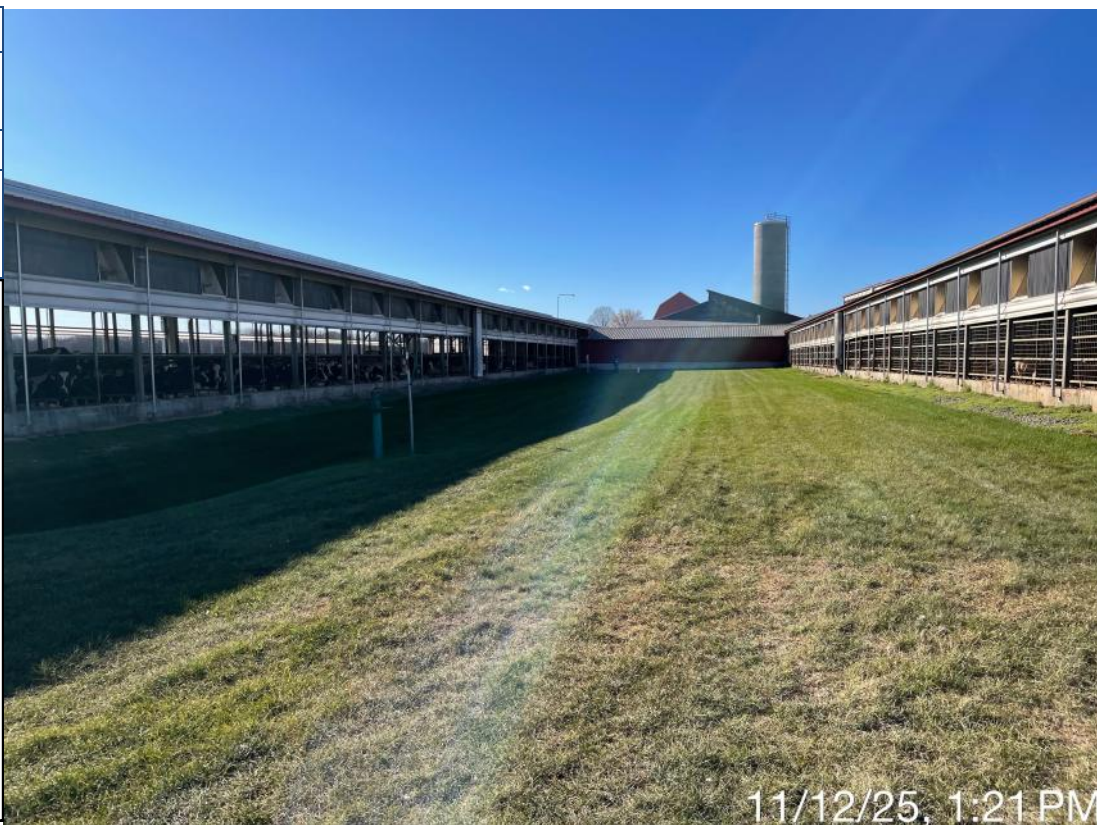
| <b>Photo #:</b> | 50 |

| <b>Photo Description:</b><br><br>Standing on the east side of the freestall barns looking west:<br>View of stormwater area in between the southern 2 barns. | |

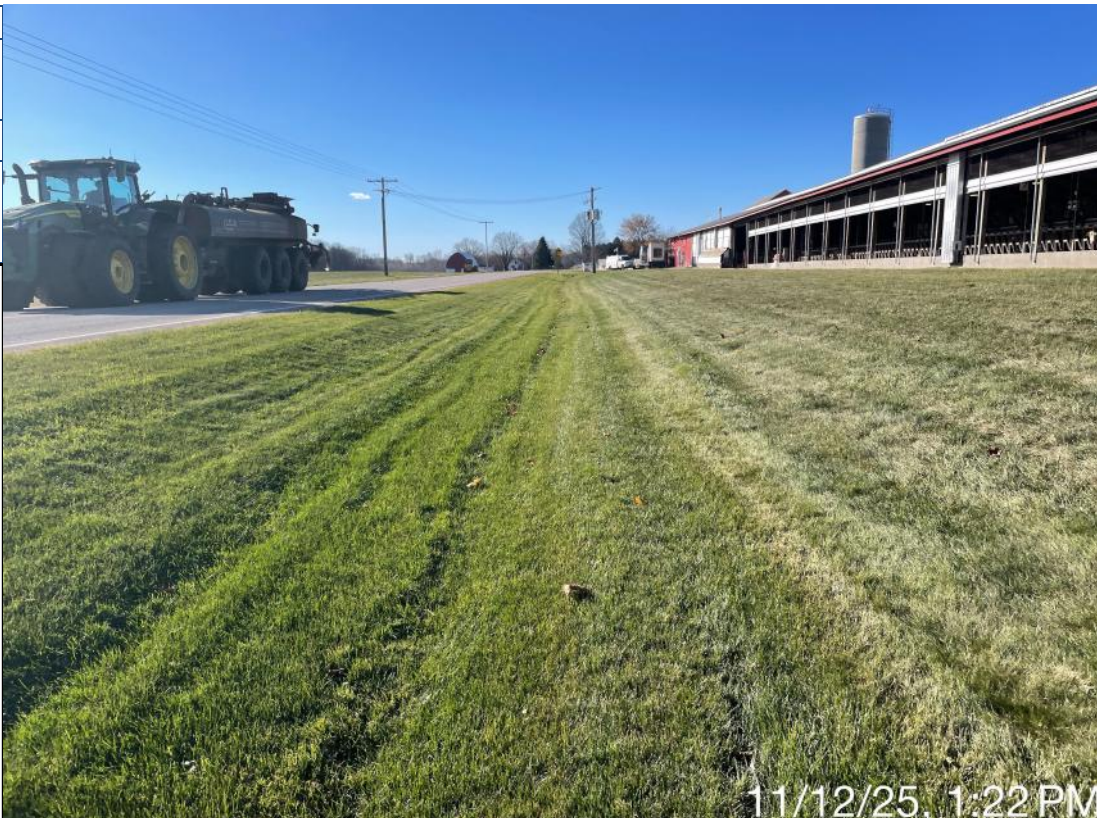
| <b>Photo #:</b> | 51 |

| <b>Photo Description:</b><br><br>Standing on the southside of the freestall barns looking west:<br>View of road ditch used to convey stormwater from the production site. Area is well vegetated. | |

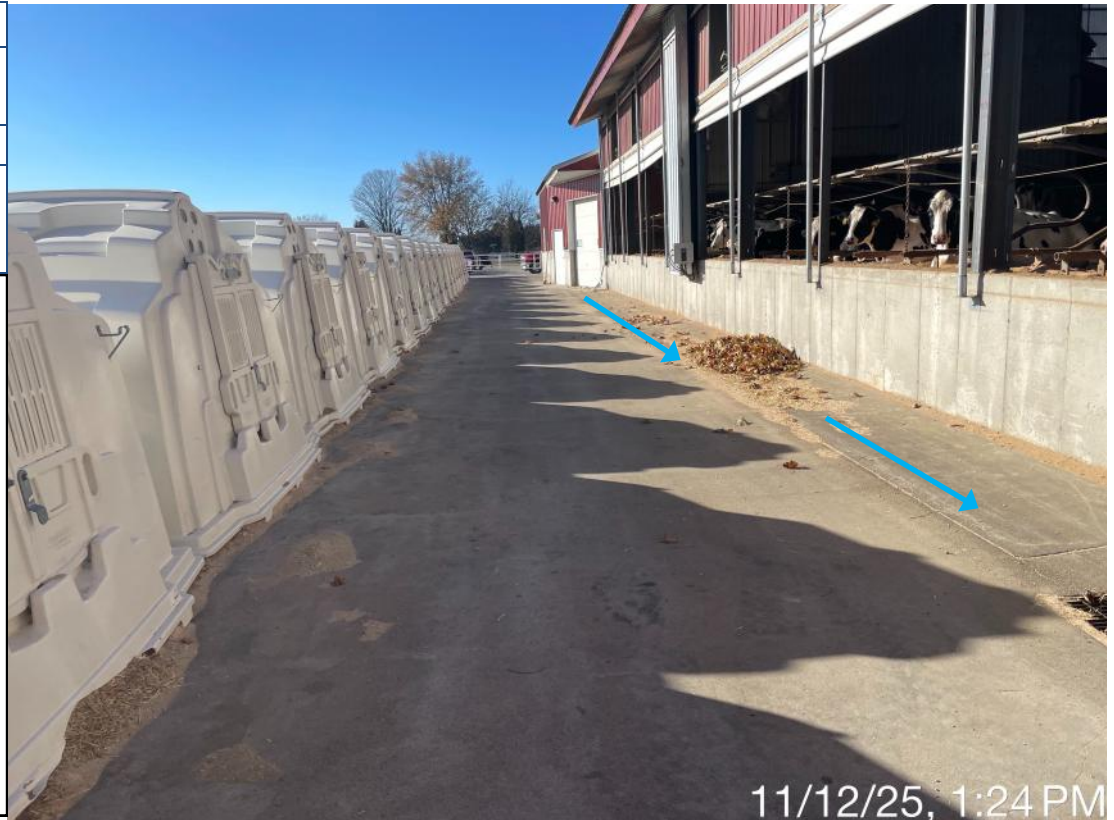
| <b>Photo #:</b> | 52 |

| Standing on the north edge of calf hutch area looking west: View of stormwater collection channel under roof line used to collect roof runoff. Arrows indicate direction of runoff flow. | |

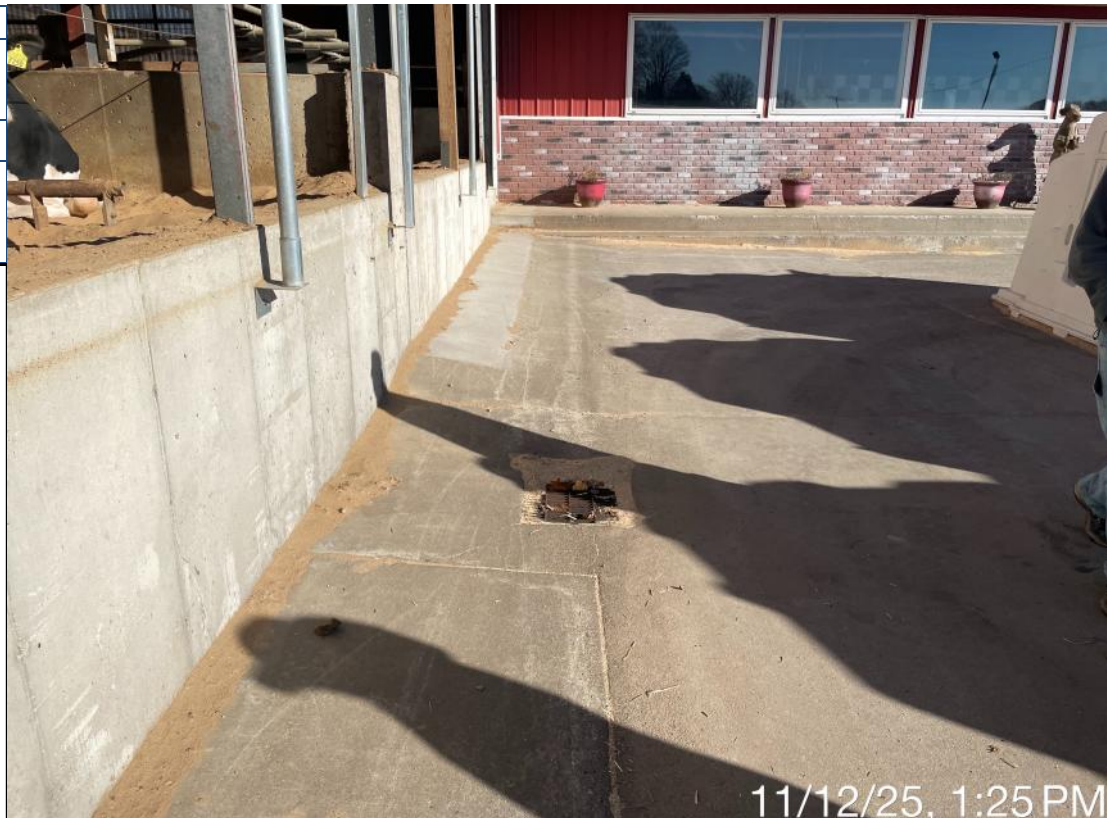
| <b>Photo #:</b> | 53 |

| Standing at same location as photo #51 looking east: View of surface inlet used to collect roof runoff. System outlets in road ditch. | |
