## Permit Fact Sheet

| Permit Number | WI-0066958-02-0 |
| Permittee Name and Address | Wagner Farms Inc<br>N6928 County Road BB, Oconto Falls, WI 54154 |

On Wednesday November 12th, 2025 Hanson met with Wagner & Wagner at 13:00 at Wagner Farms Inc site to conduct a permit reissuance compliance inspection. Only 1 site was inspected. No significant liquid precipitation had fallen over the previous 24 hours and the temperature was in the 50's and sunny. No permit violations were observed, and no water samples were collected. Hanson departed at approximately 14:15.

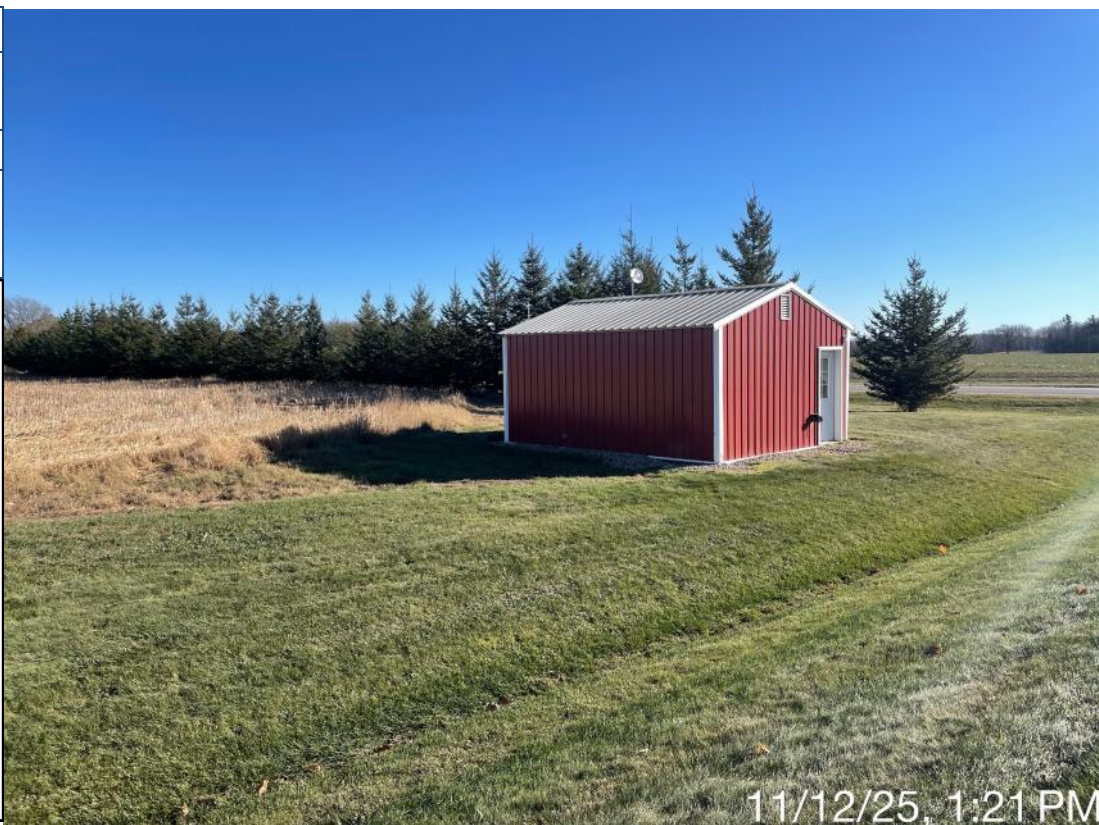
| <b>Photo #:</b> | 54 |

| <b>Photo Description:</b><br><br>Standing on the east side of freestall barns looking southeast: View of building housing a water supply well near the freestall barns. | |

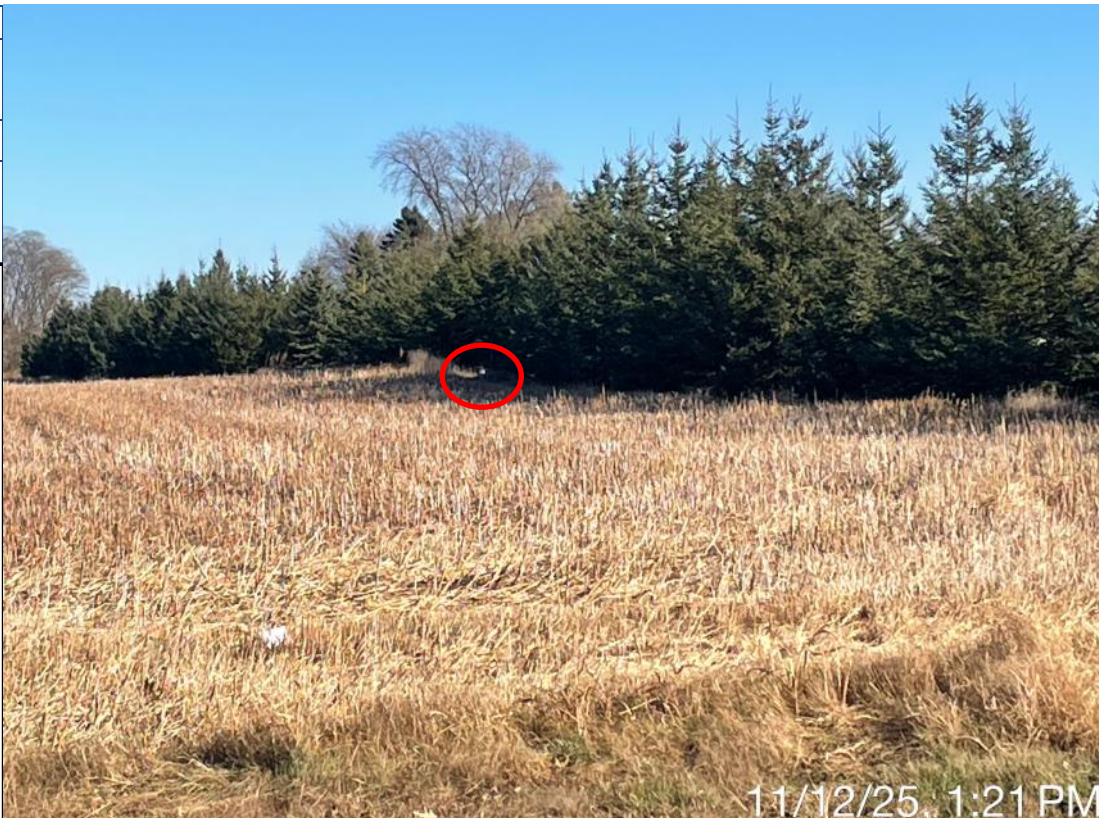
| <b>Photo Description:</b><br><br>Standing at same location as photo #53 looking east: View of 2nd well location further east along road right of way. | |
