Permit Fact Sheet

Permit Number	WI-0063673-04-0
Permittee Name and Address	Wakker Dairy Farm LLC N2348 Hwy 42, Kewaunee, WI 54216
Permitted Facility Name and Address	Main Site: N2348 Highway 42, Kewaunee, WI 54216 S ½ NW ¼ S1 T22N R24E, Township of Carlton, Kewaunee County Paplham Site: N1685 Woodside Rd, Kewaunee, WI 54216 NE ¼ NE ¼ S15 T22N R24E, Township of Carlton, Kewaunee County
Permit Term	August 01, 2026 to July 31, 2031
Receiving Water	Unnamed tributaries within the East Twin River Watershed and Lake Michigan Drainage Basin, and groundwaters of the state
Discharge Type	Existing source CAFO per NR 243.03(23) as the facility has been permitted since 2007

Facility Description

Wakker Dairy Farm, LLC is an existing Concentrated Animal Feeding Operation (CAFO) located in the Township of Carlton in Kewaunee County. Wakker Dairy Farm, LLC is owned and operated by Johannes Wakker. Wakker Dairy Farm, LLC consists of a main production area located at N2348 Highway 42, Kewaunee, WI 54216 and a satellite site (Paplham Site) located at N1685 Woodside Rd, Kewaunee, WI 54216. At the main production site there two liquid waste storage facilities, one feed storage area, one digester and

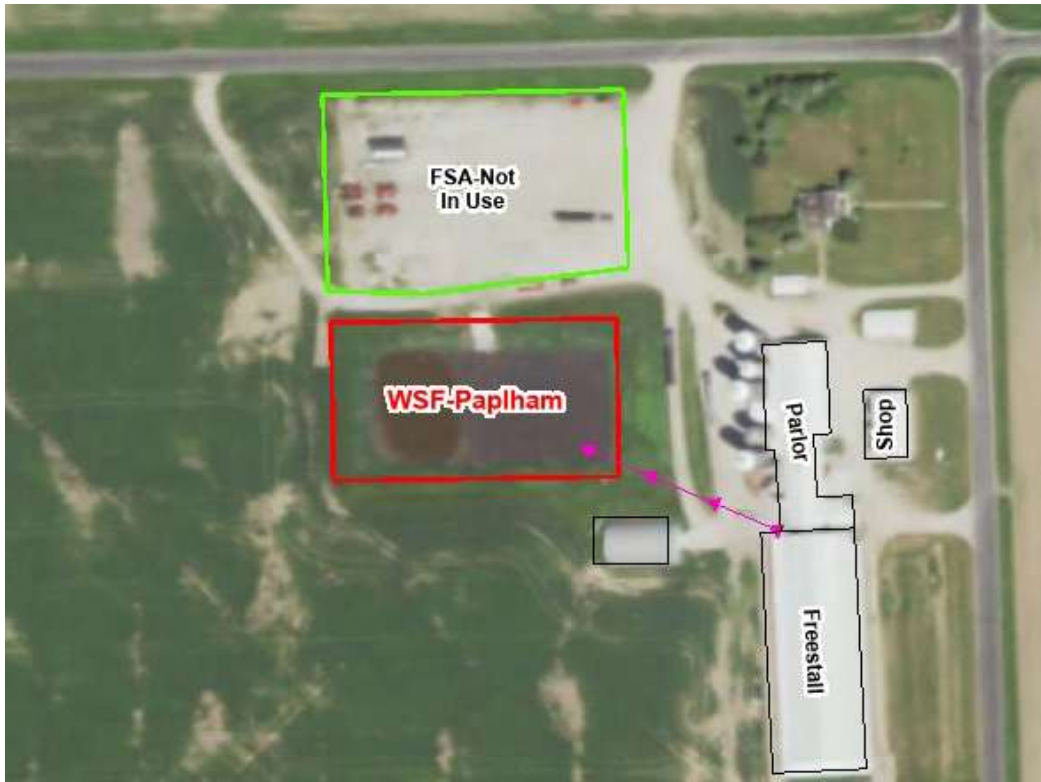
Aerial Map 2. The figure above illustrates the aerial view of Wakker Dairy Farm Inc.'s Paplham Site. The Paplham Site consists of one freestall barn, one liquid waste storage facility. The feed storage area and milking parlor are not being utilized. The purple lines represent manure and process wastewater transfer lines. The yellow arrows represent surface flow of runoff from the feed storage area. The aerial photo was obtained from WDNR AgViewer.

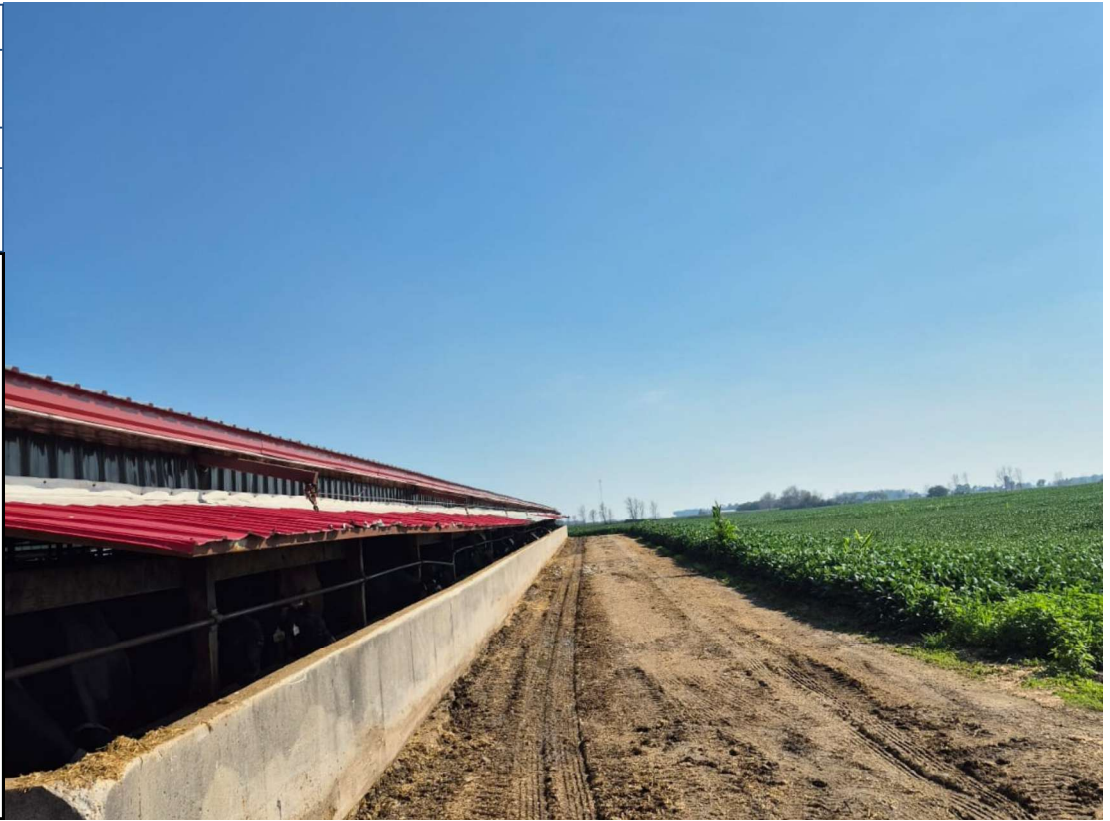
Photo #:	2393
Date/Time of Photo:	August 14, 2025
Photo By:	Jose Ruiz
Photo Location:	Paplhham Site

View of the Feed Spilt Outside the Mangers Cleaned Up on the East Side of the Paplhham Site.

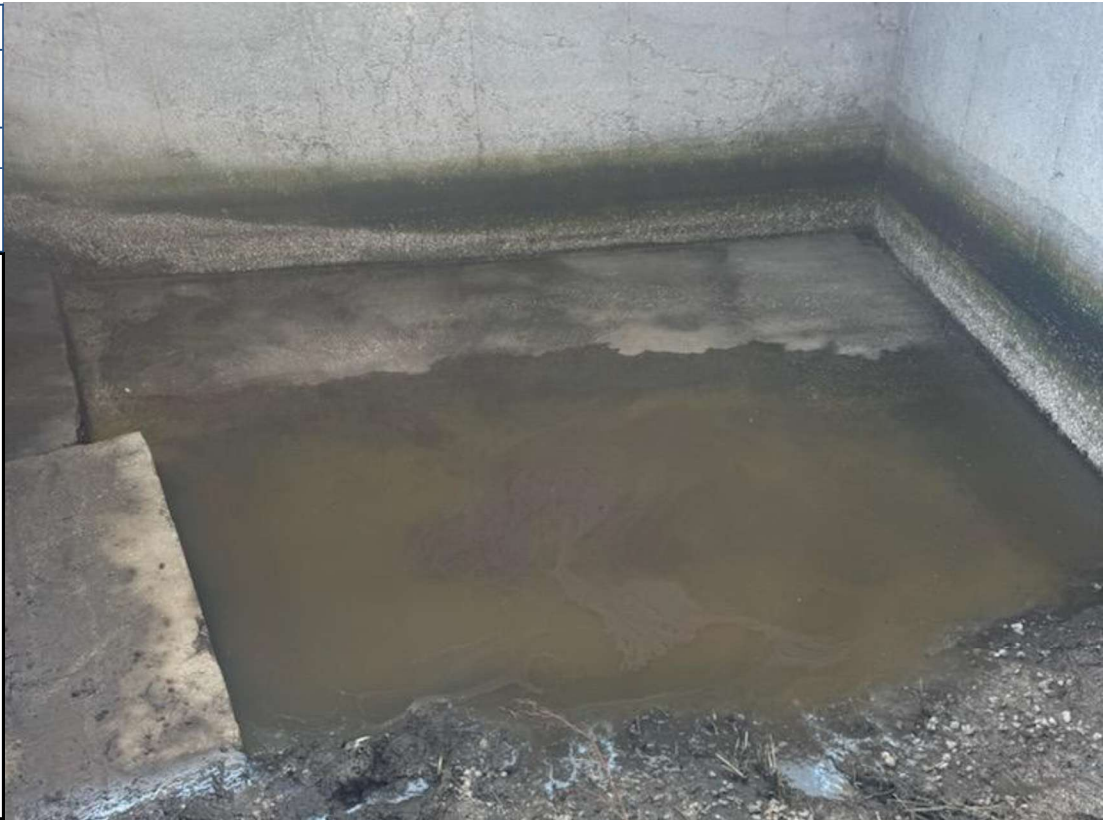
Photo #:	7277
Date/Time of Photo:	August 14, 2025
Photo By:	Jose Ruiz
Photo Location:	Main Site

Photo Description:
View of the Accumulated Water on the West Corner of a Feed Storage Bunker Cleaned Up Located on the West Side of the Main Site.

Wakker Dairy utilizes one feed storage area at the Main Site. The feed storage area is located on the south side of the production site, where corn silage and haylage is stored in bunkers and covered with plastic. In the west corner of a feed storage bunker, there was observed accumulation of water. **This area of concern has since been addressed and completed. See Appendix A.**

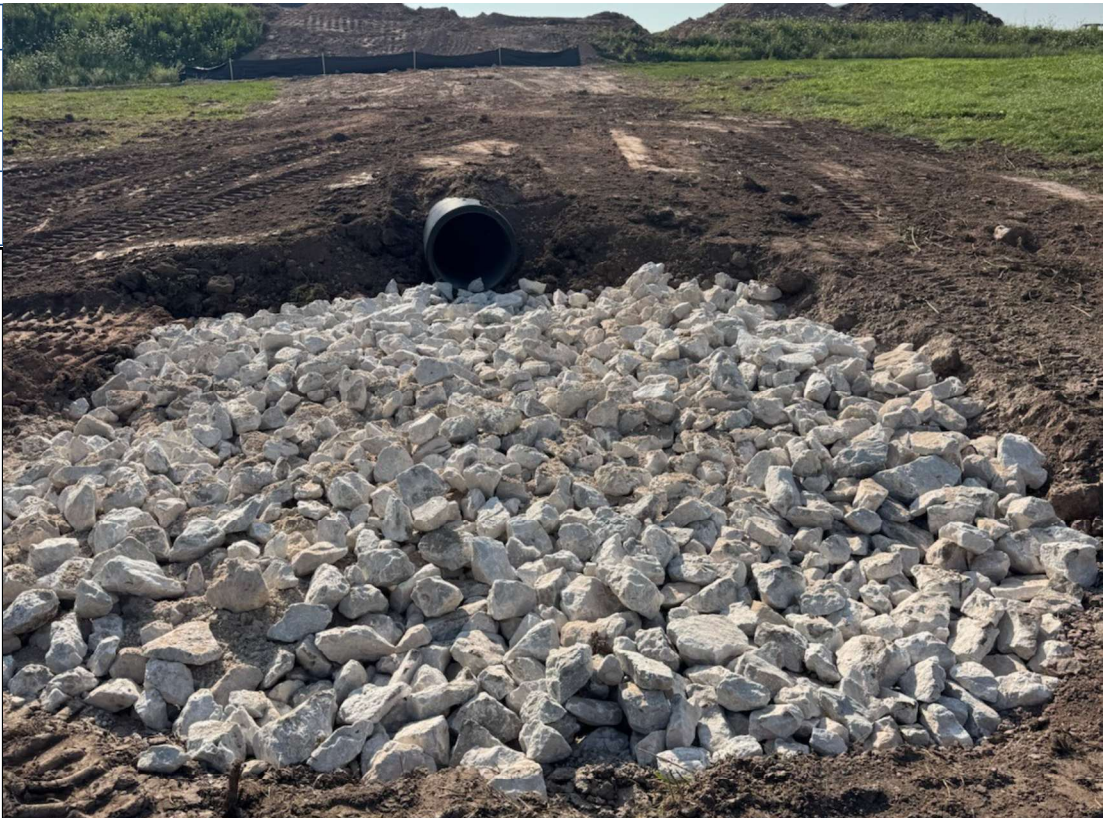
Photo #:	4411
Date/Time of Photo:	August 15, 2025
Photo By:	Jose Ruiz
Photo Location:	Main Site

Photo Description:
View of Erosion Measures Put in Place for the New Storm Water Culvert Pipe Located South of the Digester.

Wakker Dairy utilizes a series of surface inlets, culverts, and tile lines to capture stormwater and convey the clean water off-site. One surface inlet is located near the calf hutches, but there was no sign of runoff entering the inlet. A new stormwater culvert pipe was installed from the east side of the freestall barns east to the creek; however, no erosion mitigation measures were observed. ***This area of concern has since been addressed and completed. See Appendix A.***

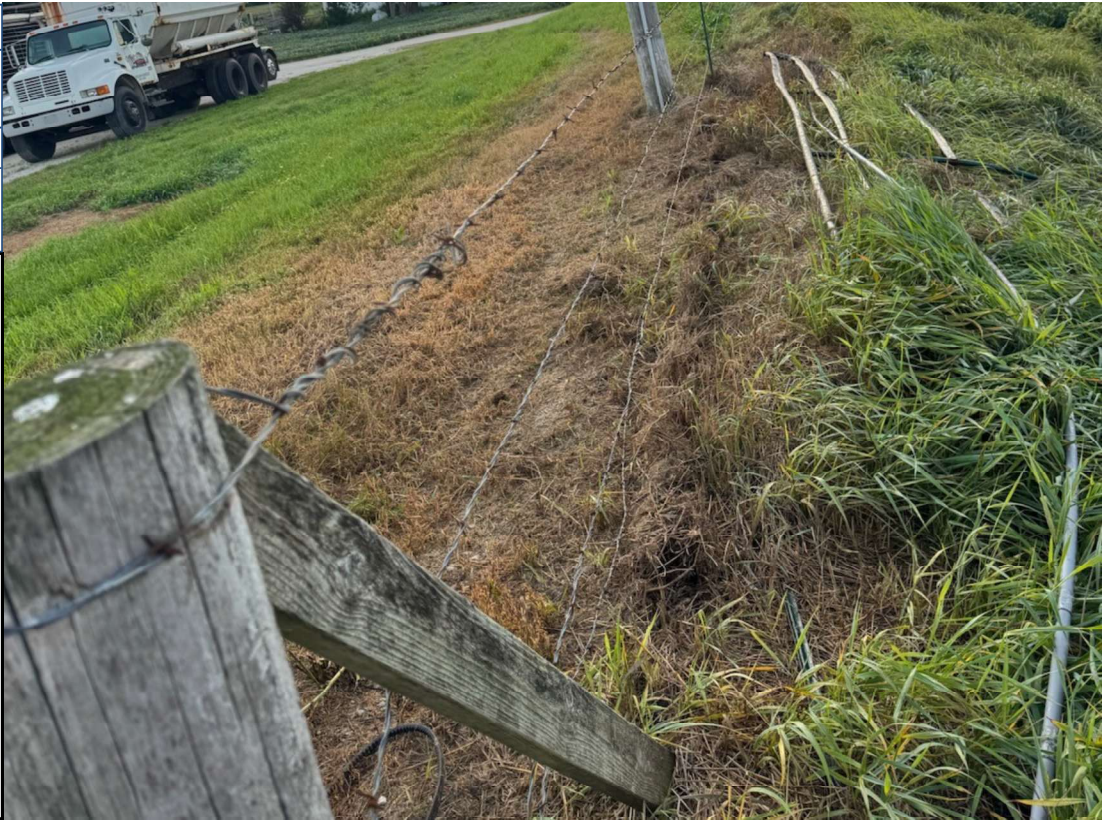
Photo #:	4455
Date/Time of Photo:	August 22, 2025
Photo By:	Jose Ruiz
Photo Location:	Paplham Site

Photo Description:
View of the Repaired Fence Around WSF Paplham Located on the Northwest Side of the Paplham Site.

- Clean out accumulated water in the Northwest corner of the feed storage area.
- Better housekeeping with feed coming out of the mangers at the Paplham Site.
- Remove vegetation around WSF Paplham.
- Repair the fence around WSF Paplham.
- Add erosion mitigation measures on the new culvert pipe at the Main Site.

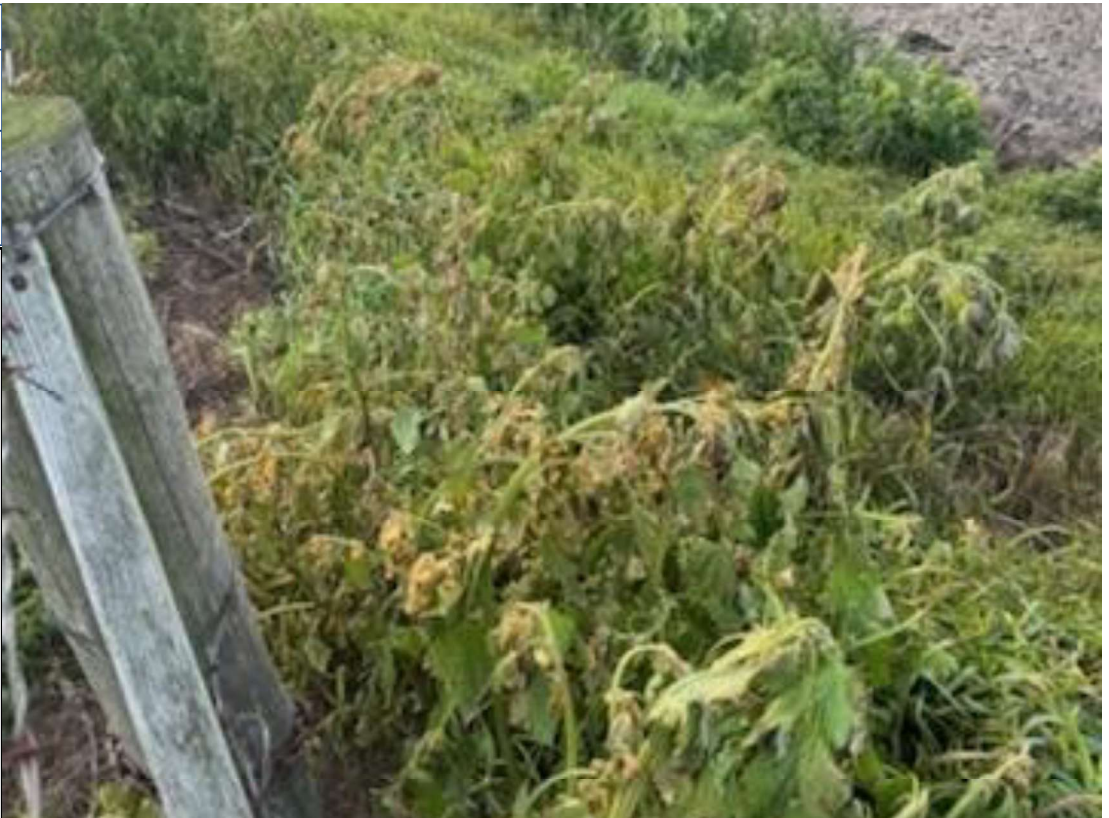
Photo #:	7809
Date/Time of Photo:	August 22, 2025
Photo By:	Jose Ruiz
Photo Location:	Paplham Site

Photo Description:
View of After the Vegetation Around WSF Paplham was Sprayed.

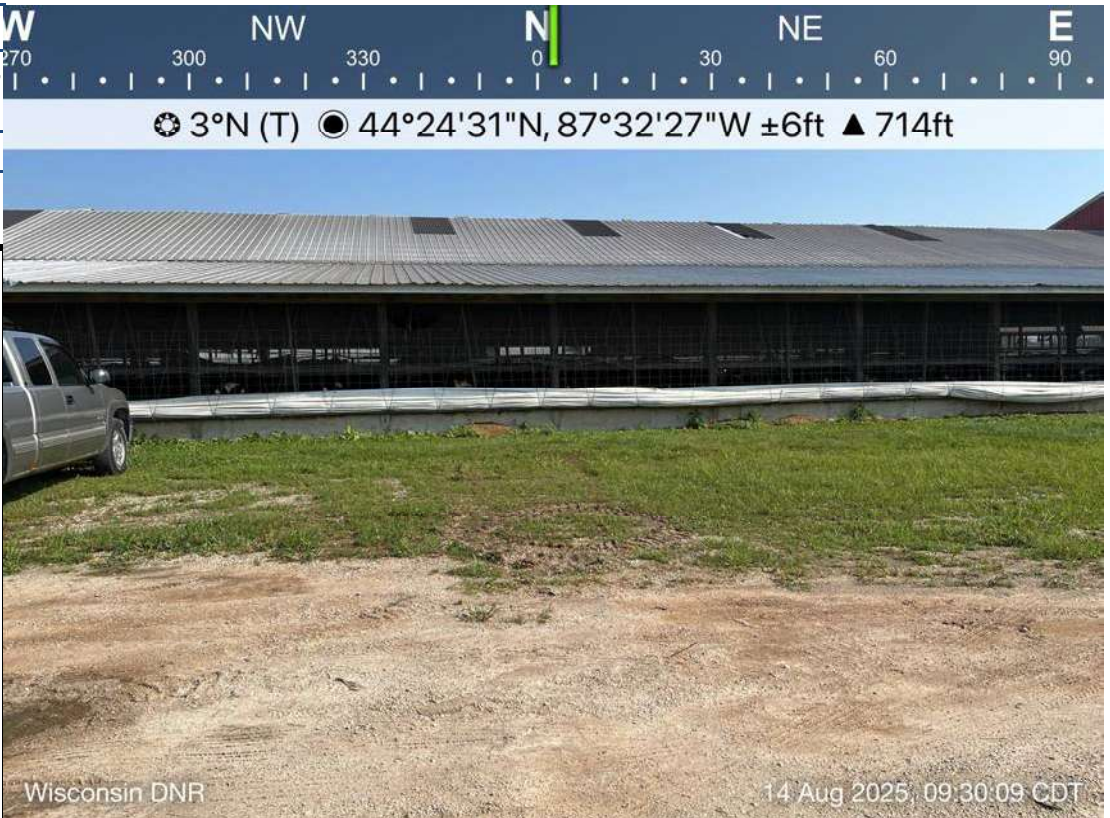
Photo #:	1759
Date/Time of Photo:	August 14, 2025 9:30 am
Photo By:	Mueller
Photo Location:	Main Site

View of the Furthest South Freestall Barn Located on the West Side of the Production Site. Minimal Bedding Leaving Barns Observed. This Photo was Taken Facing North.

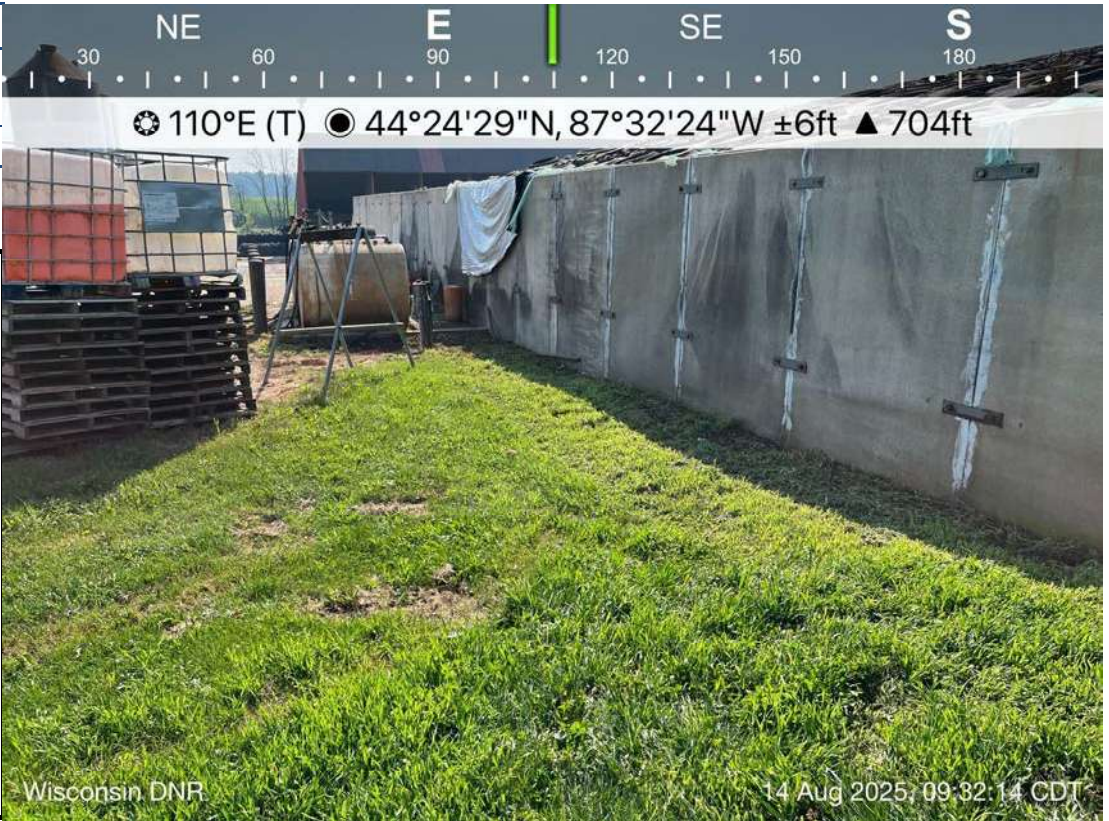
Photo #:	1766
Date/Time of Photo:	August 14, 2025 9:32 am
Photo By:	Mueller
Photo Location:	Main Site Feed Storage

View of the North Side of the Feed Storage Area and Fuel Storage Located Southeast of the Freestall Barns on the Southwest Side of the Production Site. This Photo was Taken Facing East.

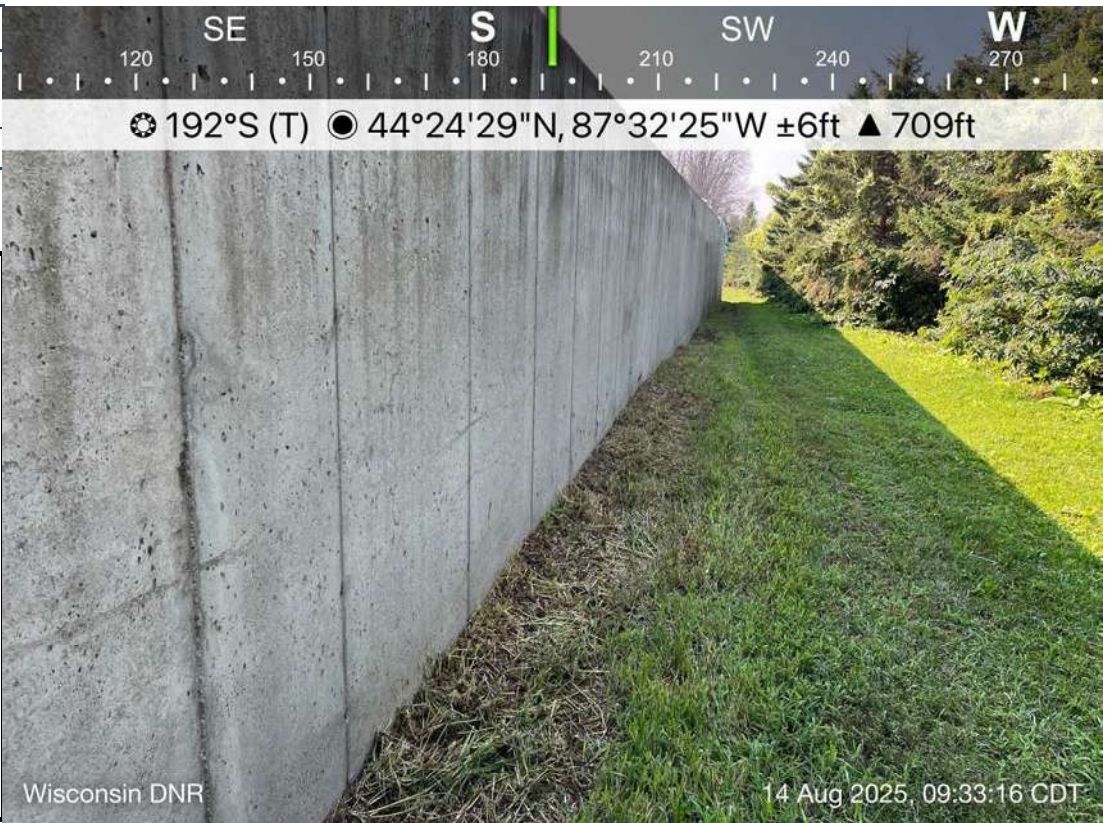
Photo #:	1769
Date/Time of Photo:	August 14, 2025 9:33 am
Photo By:	Mueller
Photo Location:	Main Site Feed Storage

Photo Description:
View of West Side of the Feed Storage Area Located Northwest of the VTA on the Southwest Side of the Production Site. This Photo was Taken Facing South.

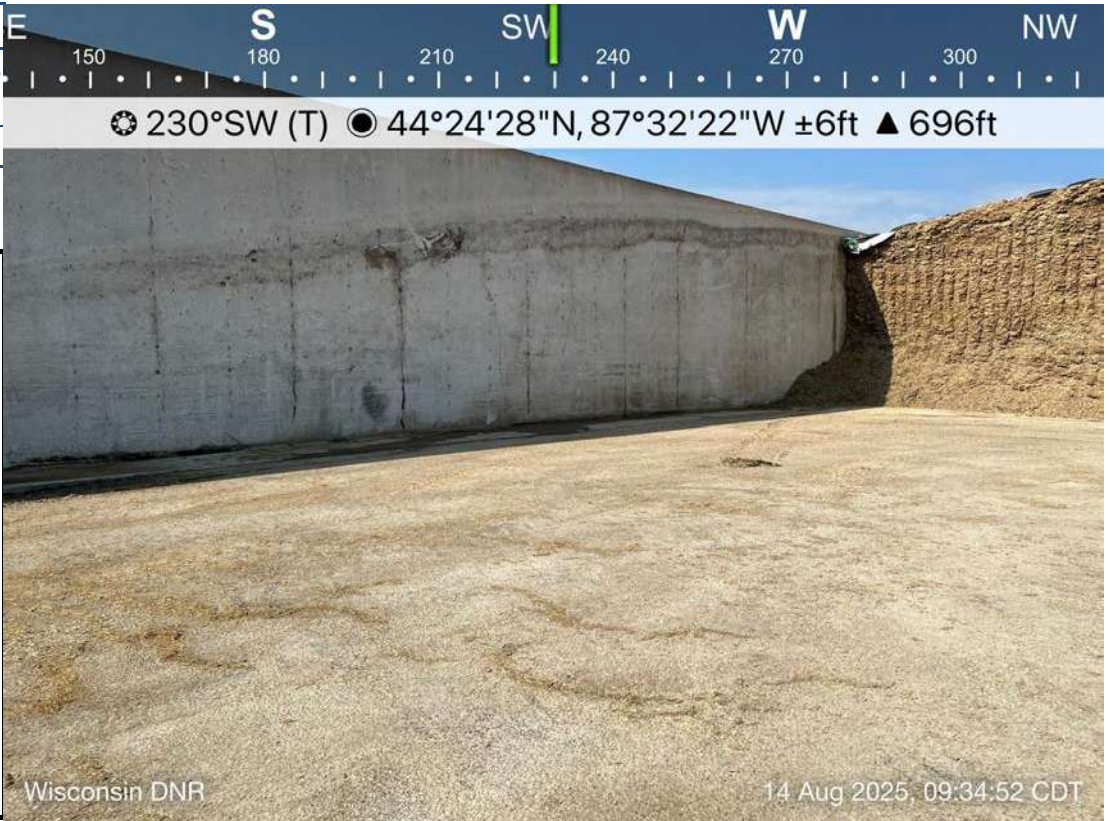
Photo #:	1777
Date/Time of Photo:	August 14, 2025 9:34 am
Photo By:	Mueller
Photo Location:	Main Site Feed Storage

View of South Side of the Feed Storage Area Located North of the VTA on the Southwest Side of the Production Site. This Photo was Taken Facing Southwest.

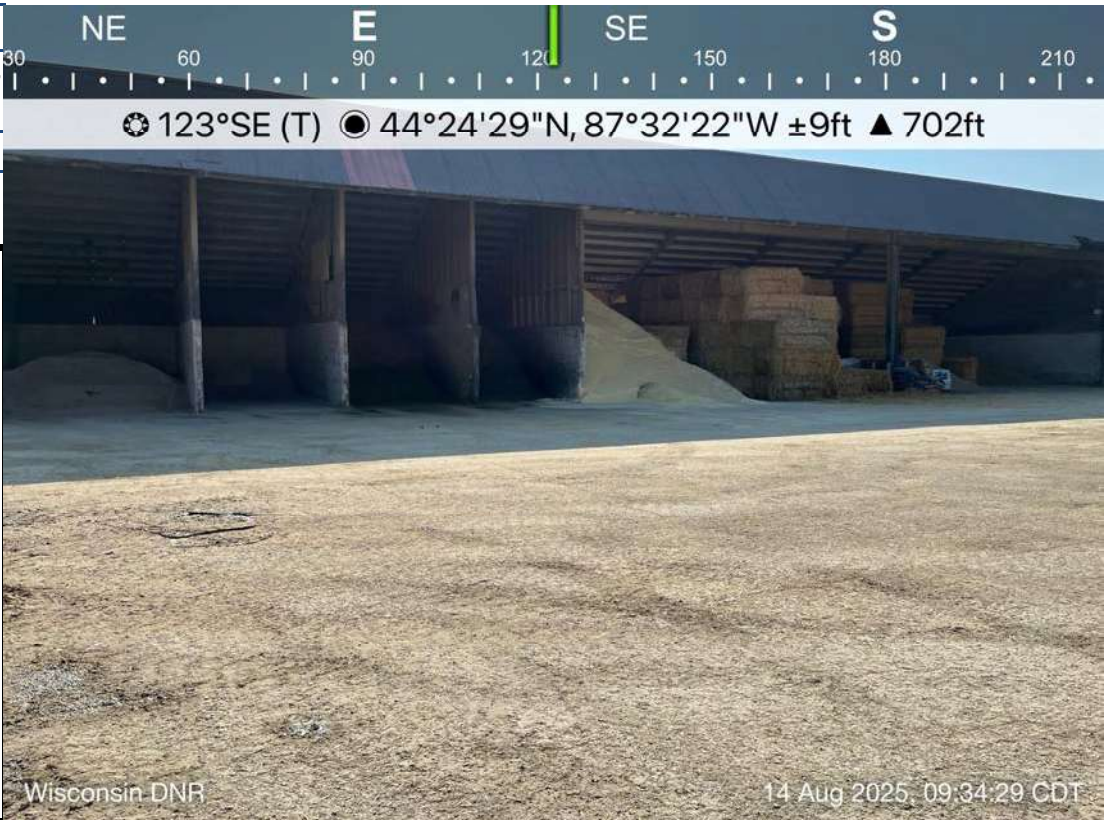
Photo #:	1776
Date/Time of Photo:	August 14, 2025 9:34 am
Photo By:	Mueller
Photo Location:	Main Site Feed Storage

View of Commodity Shed Located Southeast of the Feed Storage Area on the South Side of the Production Site. This Photo was Taken Facing Southeast.

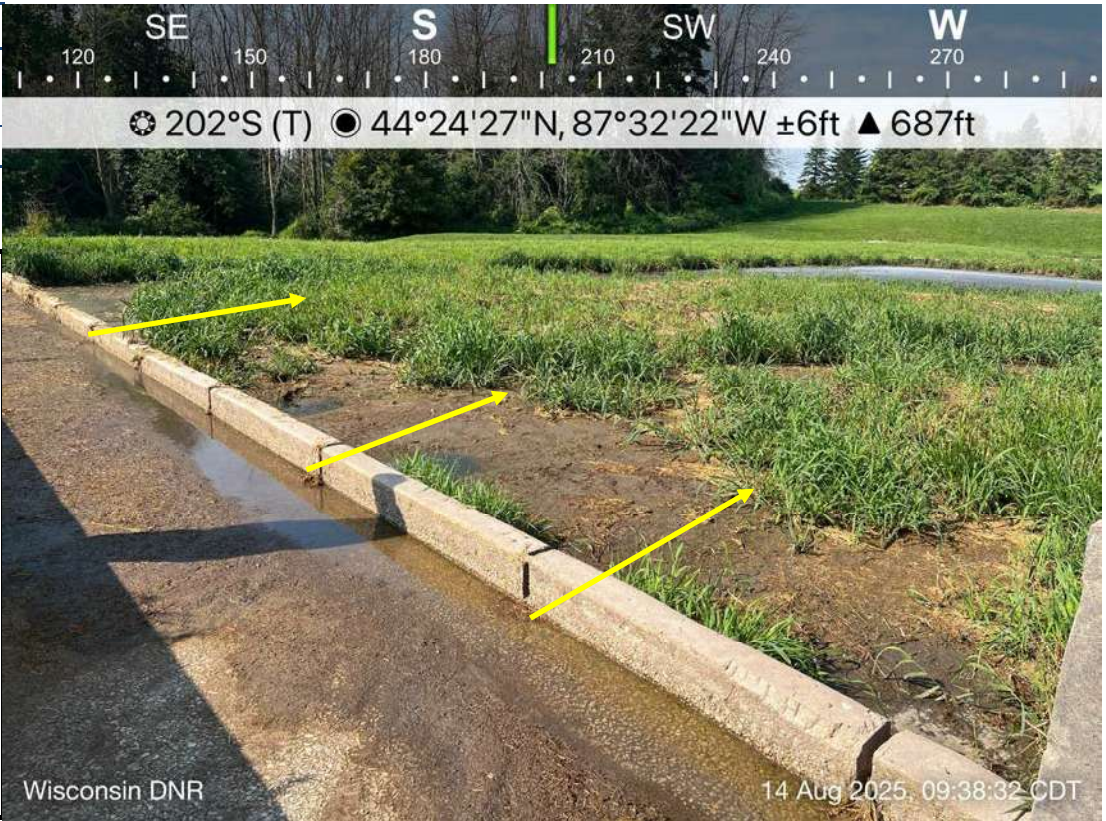
Photo #:	1797
Date/Time of Photo:	August 14, 2025 9:38 am
Photo By:	Mueller
Photo Location:	Main Site VTA

View of the Vegetated Treatment Area (VTA) Spreader Bar Located on the South Side of the Production Site. Concentrated Flow, Solids Within the Spreader Bar, and Ponding within the VTA Observed. The Yellow Arrows Represent the Flow Path of Leachate. This Photo was Taken Facing South.

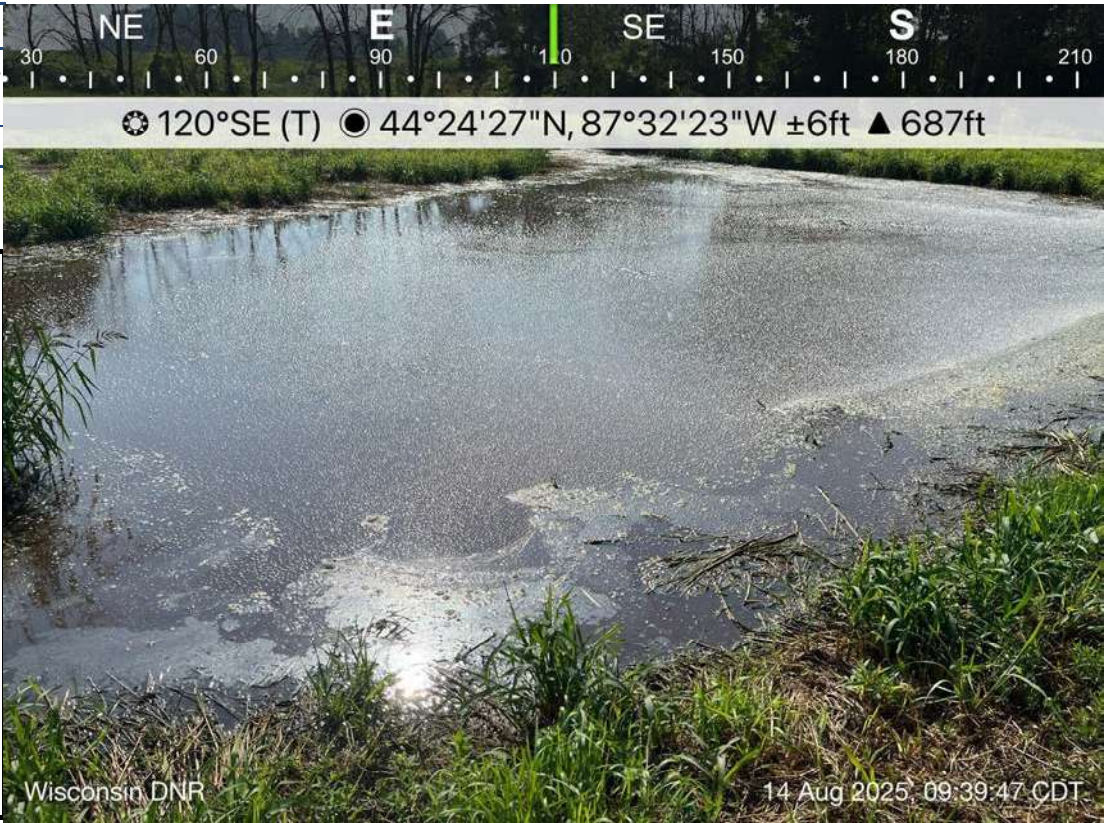
Photo #:	1808
Date/Time of Photo:	August 14, 2025 9:39 am
Photo By:	Mueller
Photo Location:	Main Site VTA

View of the East Side of the VTA Located on the South Side of the Production Site. Concentrated Flow, Solids Within the Spreader Bar, and Ponding within the VTA Observed. This Photo was Taken Facing Southeast.

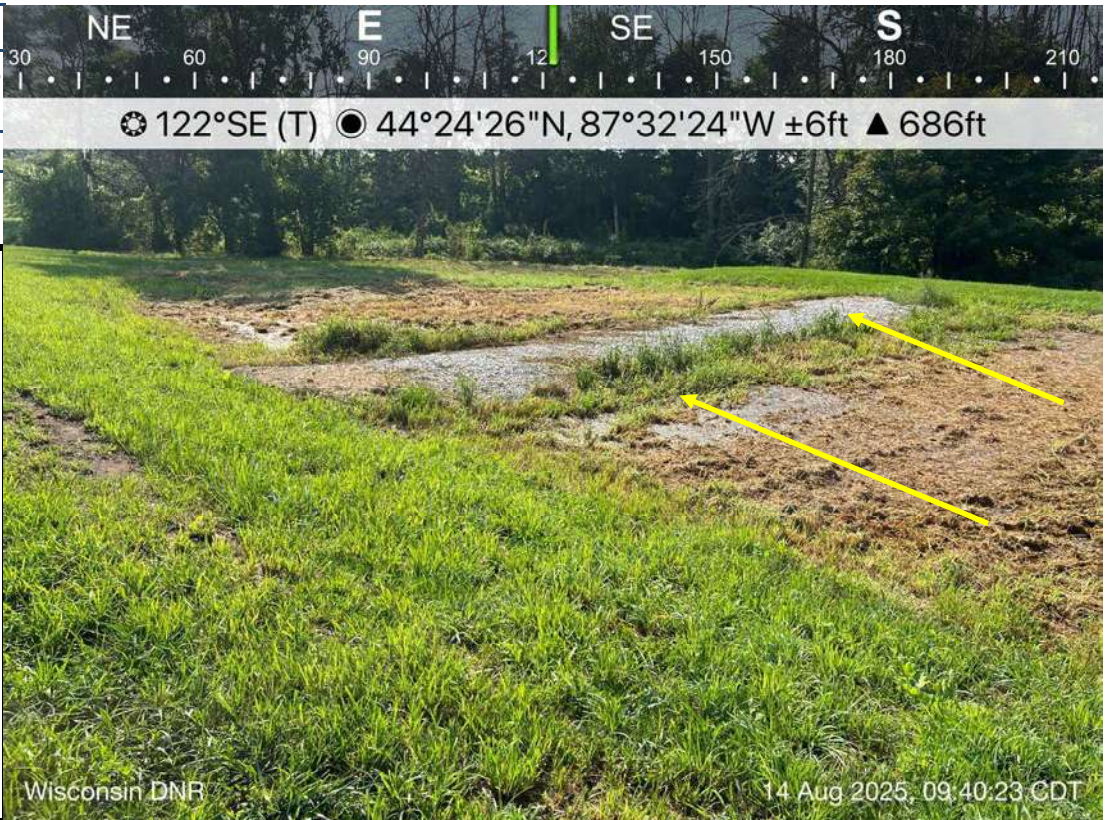
Photo #:	1812
Date/Time of Photo:	August 14, 2025 9:40 am
Photo By:	Mueller
Photo Location:	Main Site VTA

View of the Southeast Side of the VTA Located on the South Side of the Production Site. Concentrated Flow, Solids Within the Spreader Bar, and Ponding within the VTA Observed. The Yellow Arrows Represent the Flow Path of Leachate. This Photo was Taken Facing Southeast.

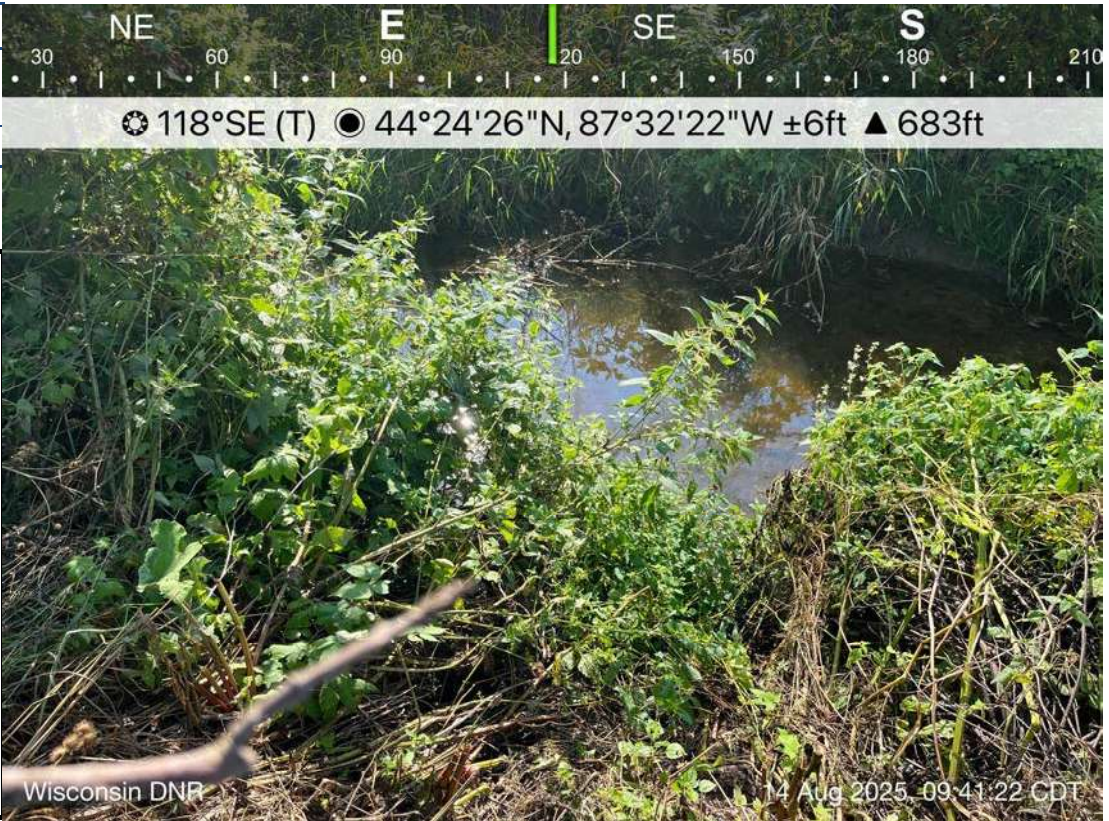
Photo #:	1818
Date/Time of Photo:	August 14, 2025 9:41 am
Photo By:	Mueller
Photo Location:	Main Site

View of the Stream Down Flow (East) of the VTA. No Impairment Within the Stream was Observed. A Tile Outlet with an Unknown Location of the Inlet was Observed. This Photo was Taken Facing Southeast.

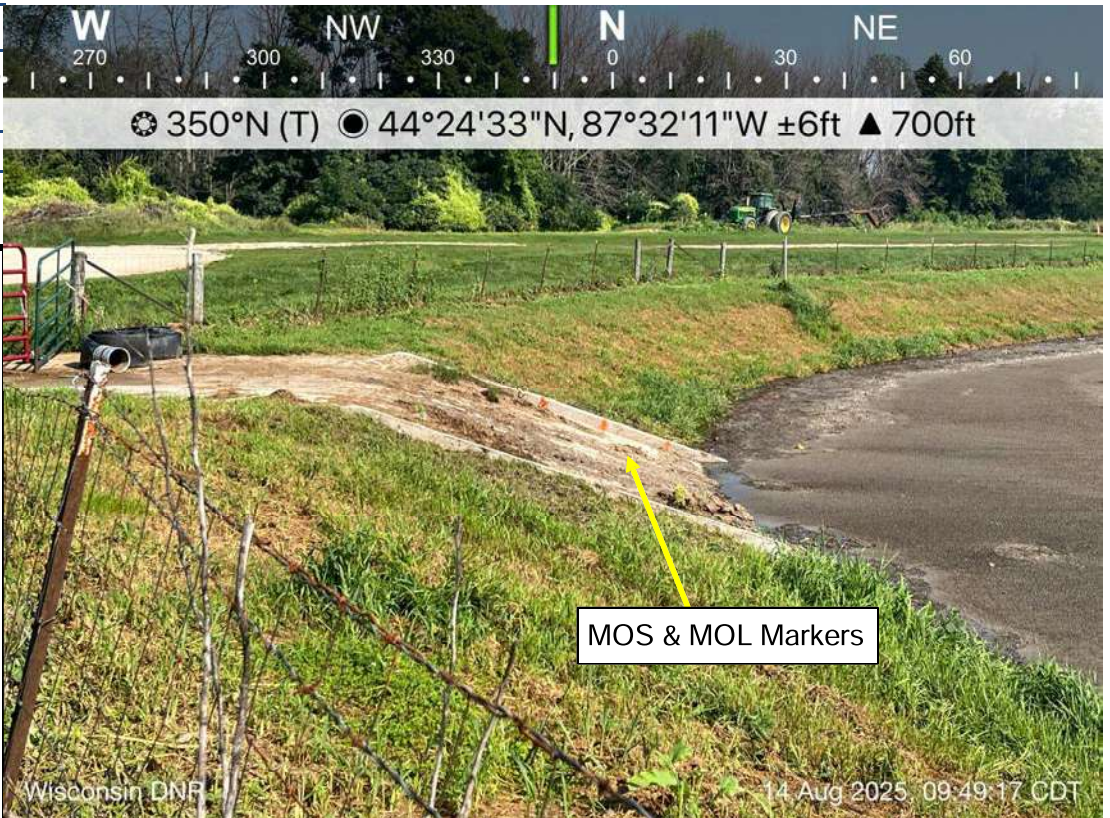
Photo #:	1842
Date/Time of Photo:	August 14, 2025 9:49 am
Photo By:	Mueller
Photo Location:	Main Site WSF 4

Photo Description:
View of the West Side of WSF 4 Located West of WSF 3 and on the East Side of the Production Site. The Yellow Arrow Represents the MOS & MOL Markers. This Photo was Taken Facing North.

Waste storage facilities do not have current or past indicators of discharges. Liquid waste storage WSF 3 and WSF 4 are well-maintained, in good repair, and in compliance with permit requirements. The Maximum Operating Level (MOL) markers and Margin of Safety (MOS) markers were present on all three WSFs. WSF Paplham required a portion of the fencing to be repaired, and vegetation management was necessary. **Both areas of concerns have since been addressed and completed. See Appendix A.**

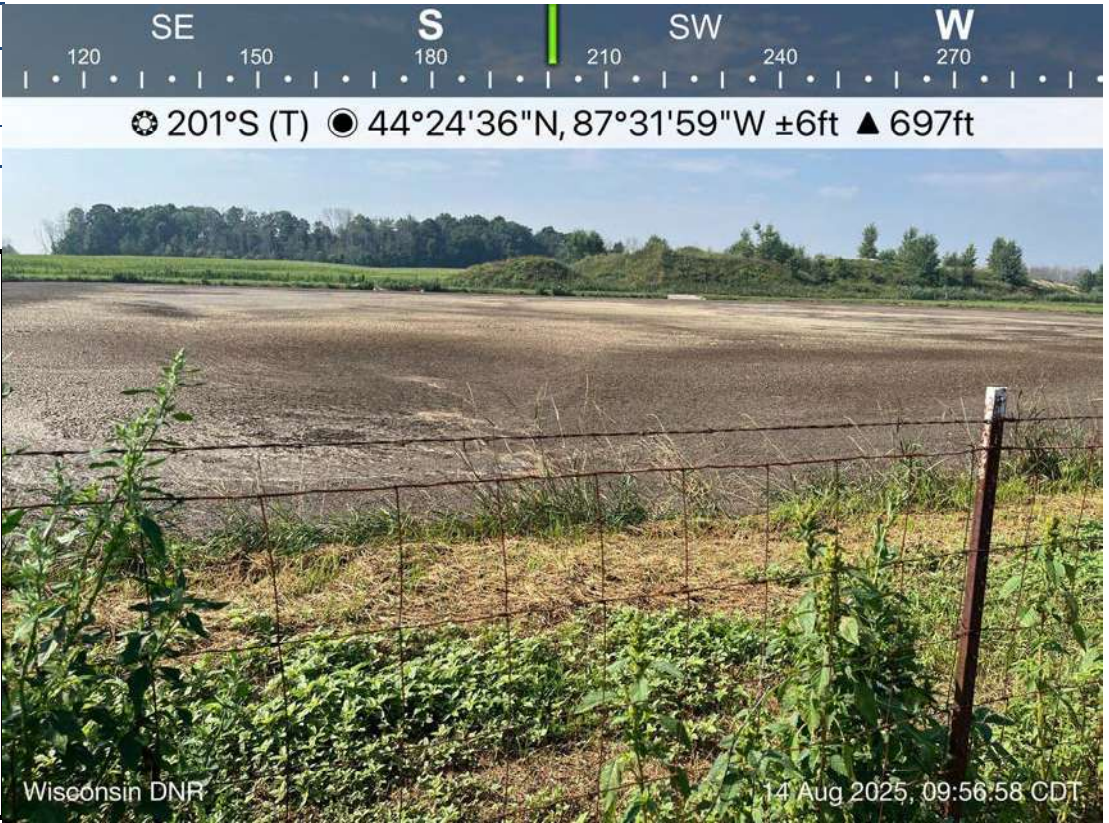
Photo #:	1882
Date/Time of Photo:	August 14, 2025 9:56 am
Photo By:	Mueller
Photo Location:	Main Site WSF 3

View of the North Side of WSF 3 Located East of WSF 4 on the East Side of the Production Site. This Photo was Taken Facing South.

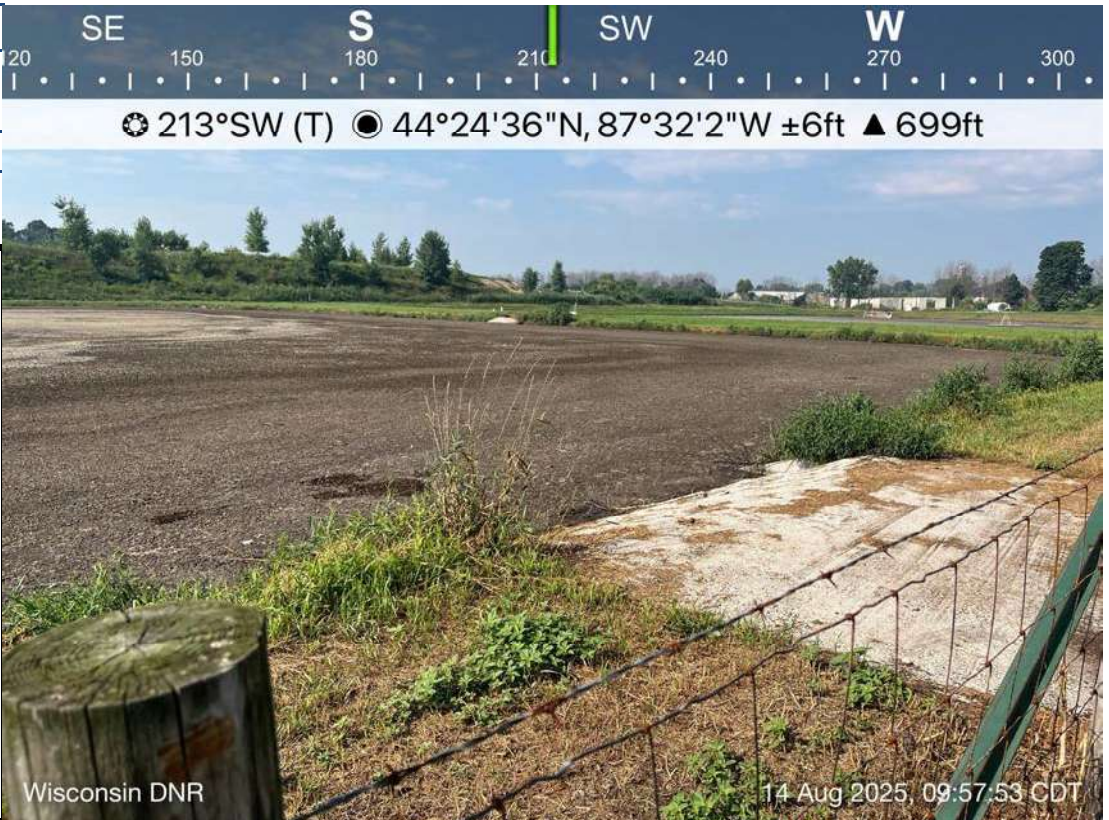
Photo #:	1888
Date/Time of Photo:	August 14, 2025 9:57 am
Photo By:	Mueller
Photo Location:	Main Site WSF 3

View of the Northwest Side of WSF 3 Located East of WSF 4 on the East Side of the Production Site. This Photo was Taken Facing Southwest.

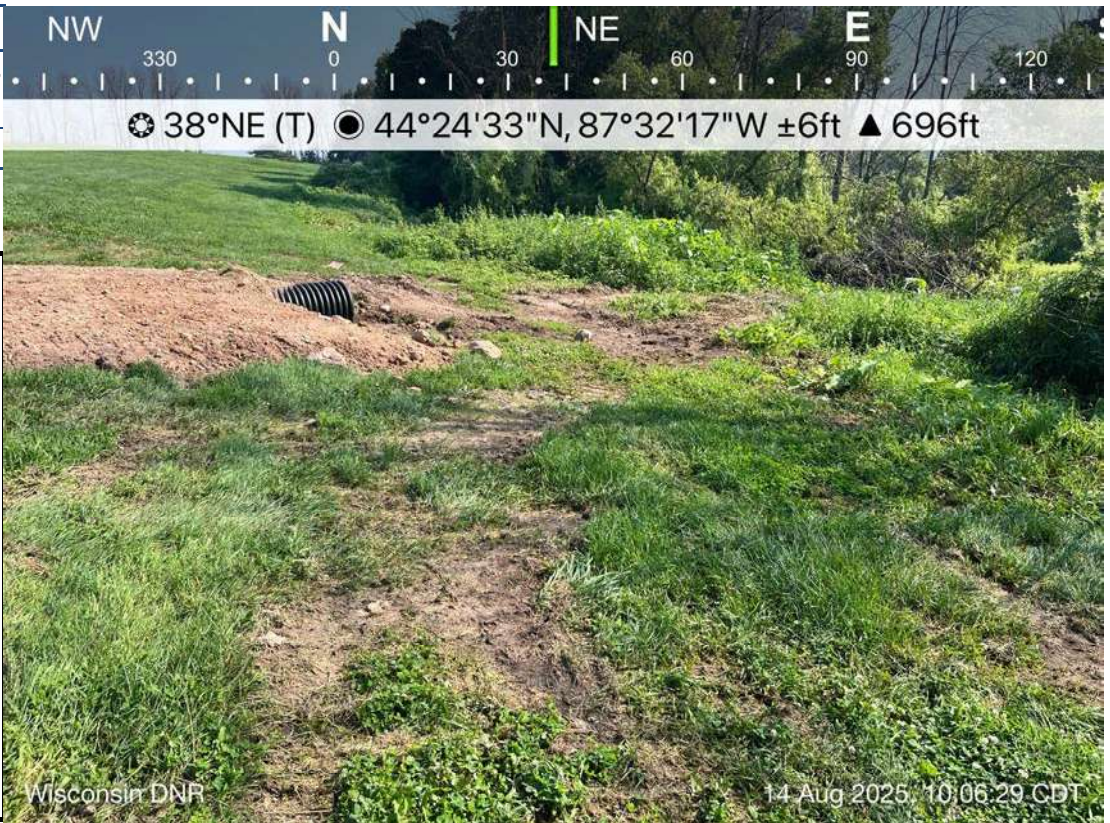
Photo #:	1911
Date/Time of Photo:	August 14, 2025 10:06 am
Photo By:	Mueller
Photo Location:	Main Site

View of a New Storm Water Culvert Pipe Located East of the Freestall Barns, South of the Digester. No Erosion Mitigation Manures Were Observed. This Photo was Taken Facing Northeast.

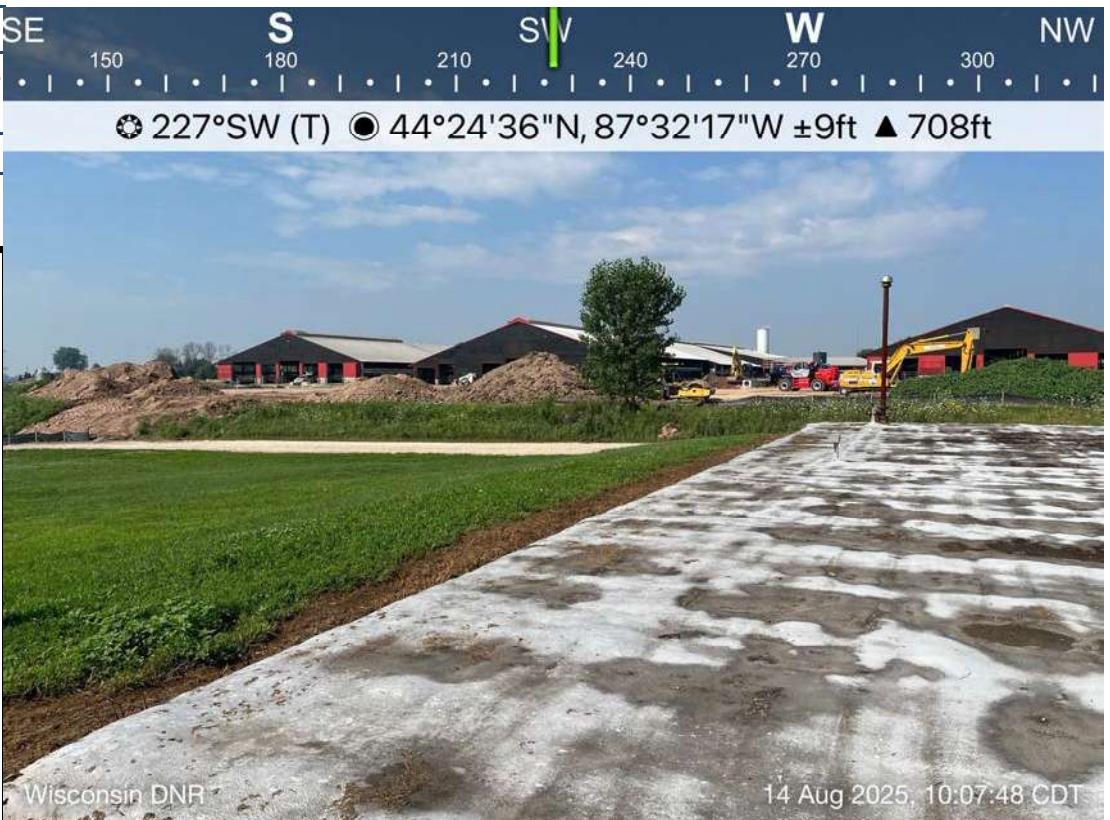
Photo #:	1920
Date/Time of Photo:	August 14, 2025 10:07 am
Photo By:	Mueller
Photo Location:	Main Site

View of Construction for the New Barn Located North of the Feed Storage Area. This Photo was Taken Facing Southwest.

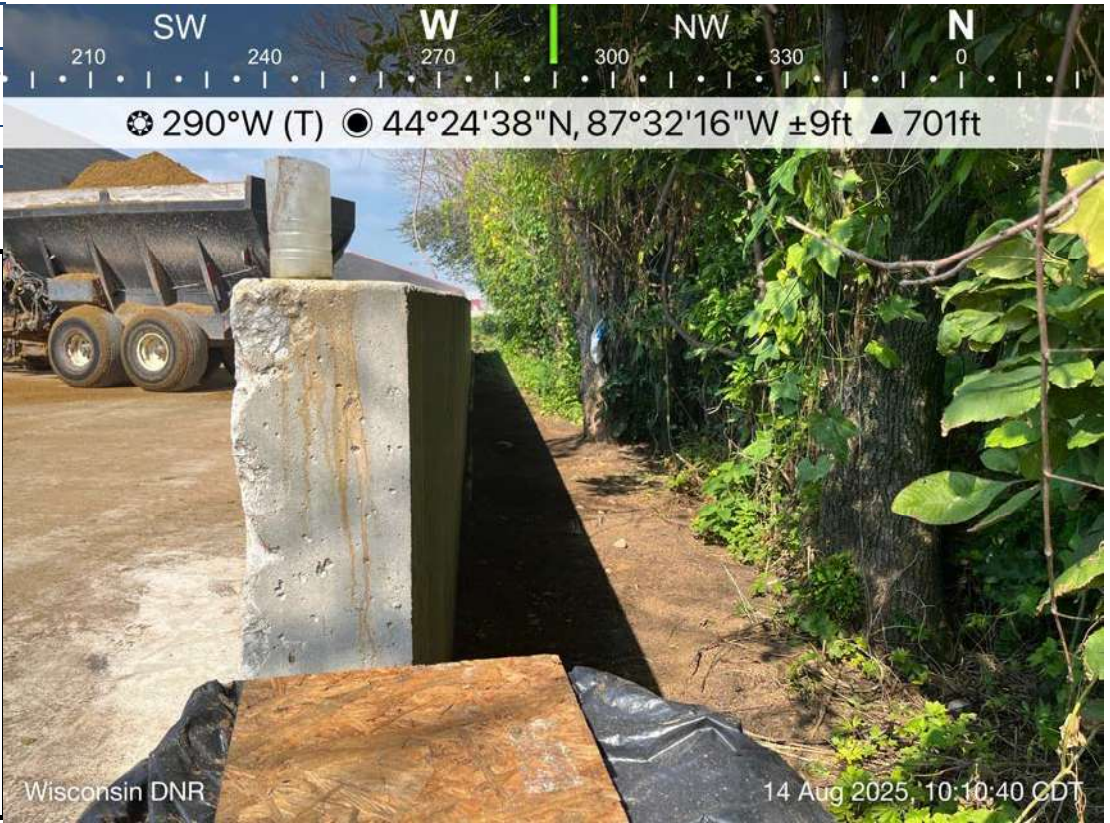
Photo #:	1931
Date/Time of Photo:	August 14, 2025 10:10 am
Photo By:	Mueller
Photo Location:	Main Site

View of Solid Stacking Area Next to the Digester Located on the Northeast Side of the Production Site. This Photo was Taken Facing West.

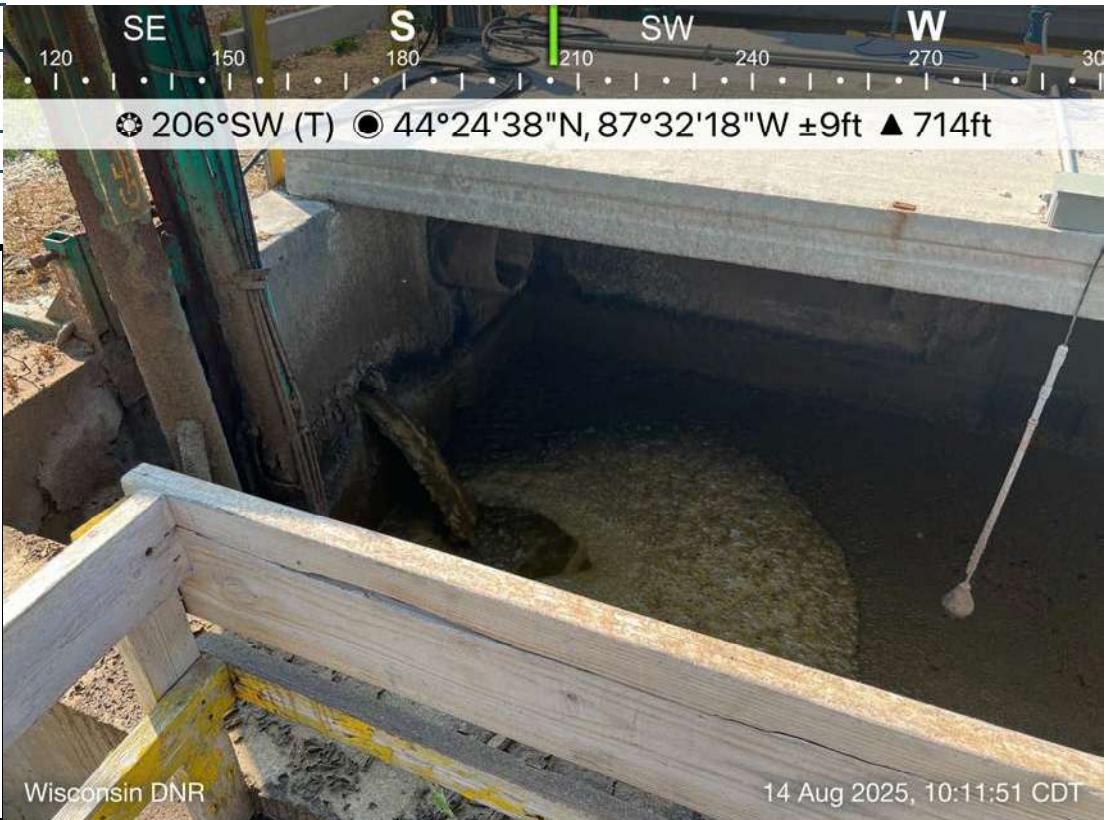
Photo #:	1938
Date/Time of Photo:	August 14, 2025 10:11 am
Photo By:	Mueller
Photo Location:	Main Site

View of the Reception Basin for the Digester Located on the Northeast Side of the Production Site. This Photo was Taken Facing Southwest.
