Permit Fact Sheet

Permit Number	WI-0063673-04-0
Permittee Name and Address	Wakker Dairy Farm LLC N2348 Hwy 42, Kewaunee, WI 54216
Permitted Facility Name and Address	Main Site: N2348 Highway 42, Kewaunee, WI 54216 S ½ NW ¼ S1 T22N R24E, Township of Carlton, Kewaunee County Paplham Site: N1685 Woodside Rd, Kewaunee, WI 54216 NE ¼ NE ¼ S15 T22N R24E, Township of Carlton, Kewaunee County
Permit Term	August 01, 2026 to July 31, 2031
Receiving Water	Unnamed tributaries within the East Twin River Watershed and Lake Michigan Drainage Basin, and groundwaters of the state
Discharge Type	Existing source CAFO per NR 243.03(23) as the facility has been permitted since 2007

Facility Description

Wakker Dairy Farm, LLC is an existing Concentrated Animal Feeding Operation (CAFO) located in the Township of Carlton in Kewaunee County. Wakker Dairy Farm, LLC is owned and operated by Johannes Wakker. Wakker Dairy Farm, LLC consists of a main production area located at N2348 Highway 42, Kewaunee, WI 54216 and a satellite site (Paplham Site) located at N1685 Woodside Rd, Kewaunee, WI 54216. At the main production site there two liquid waste storage facilities, one feed storage area, one digester and

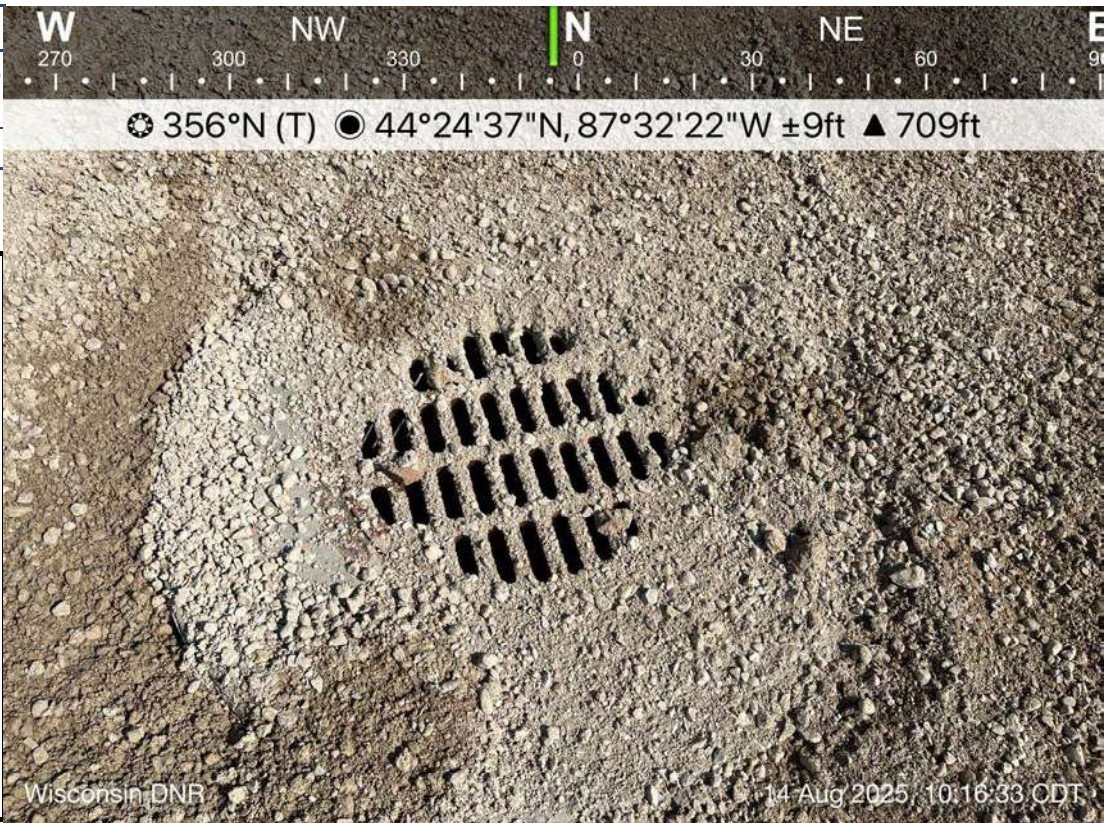
Photo #:	1950
Date/Time of Photo:	August 14, 2025 10:16 am
Photo By:	Mueller
Photo Location:	Main Site

View of a Storm Water Inlet Located on the East Side of the Freestall Barns. This Photo was Taken Facing North.

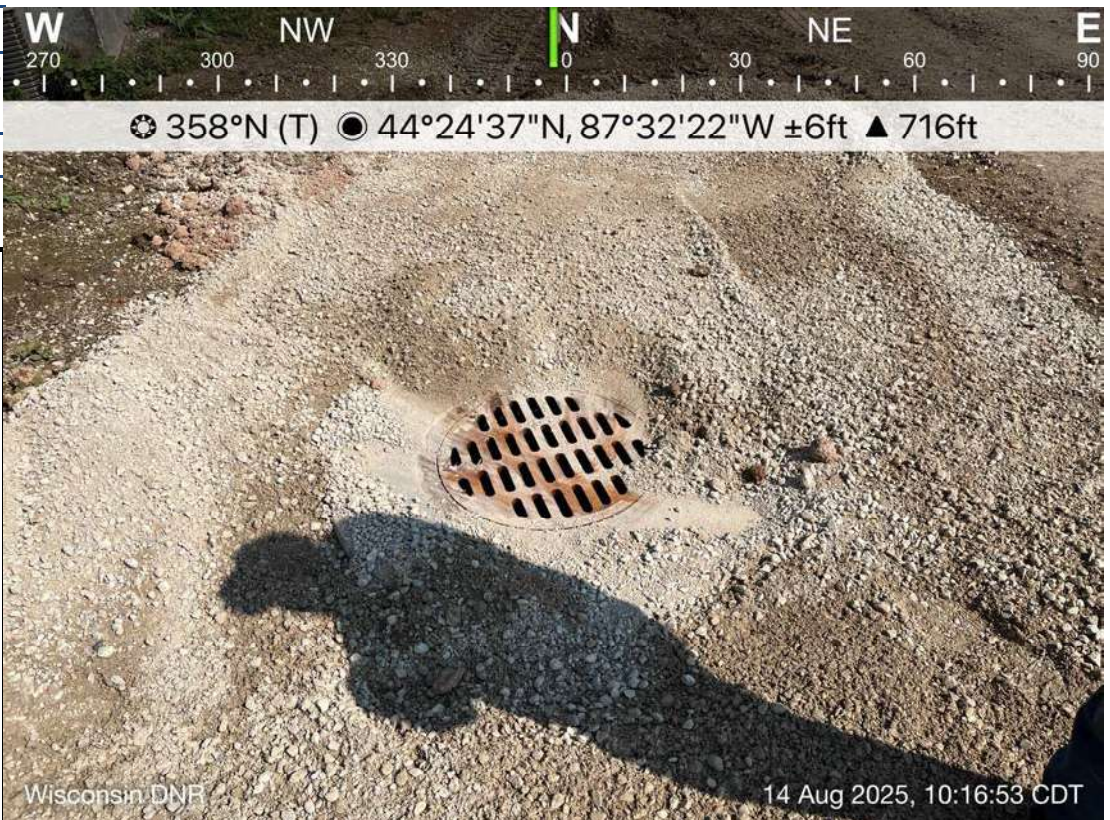
Photo #:	1951
Date/Time of Photo:	August 14, 2025 10:16 am
Photo By:	Mueller
Photo Location:	Main Site

View of a Storm Water Inlet Located on the East Side of the Freestall Barns. This Photo was Taken Facing North.

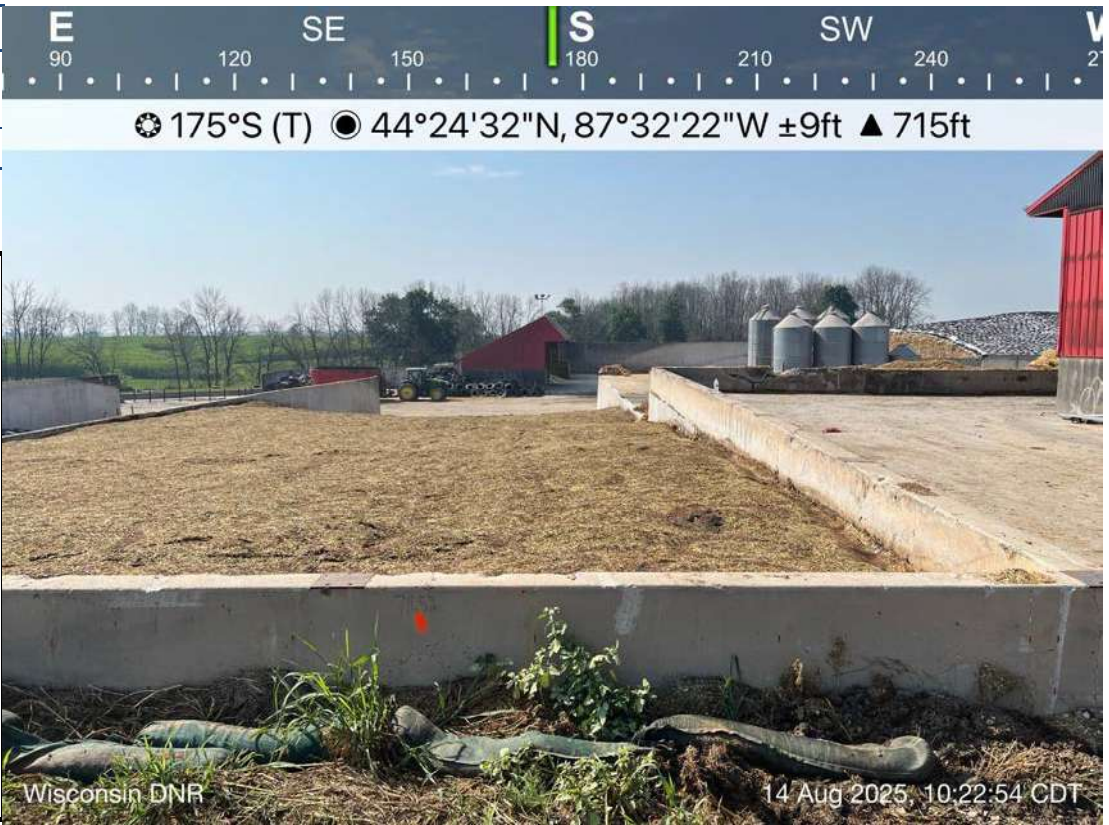
Photo #:	1974
Date/Time of Photo:	August 14, 2025 10:22 am
Photo By:	Mueller
Photo Location:	Main Site Feed Storage

View of North Side of the Feed Storage Area Located on the South Side of the Production Site. This Photo was Taken Facing South.

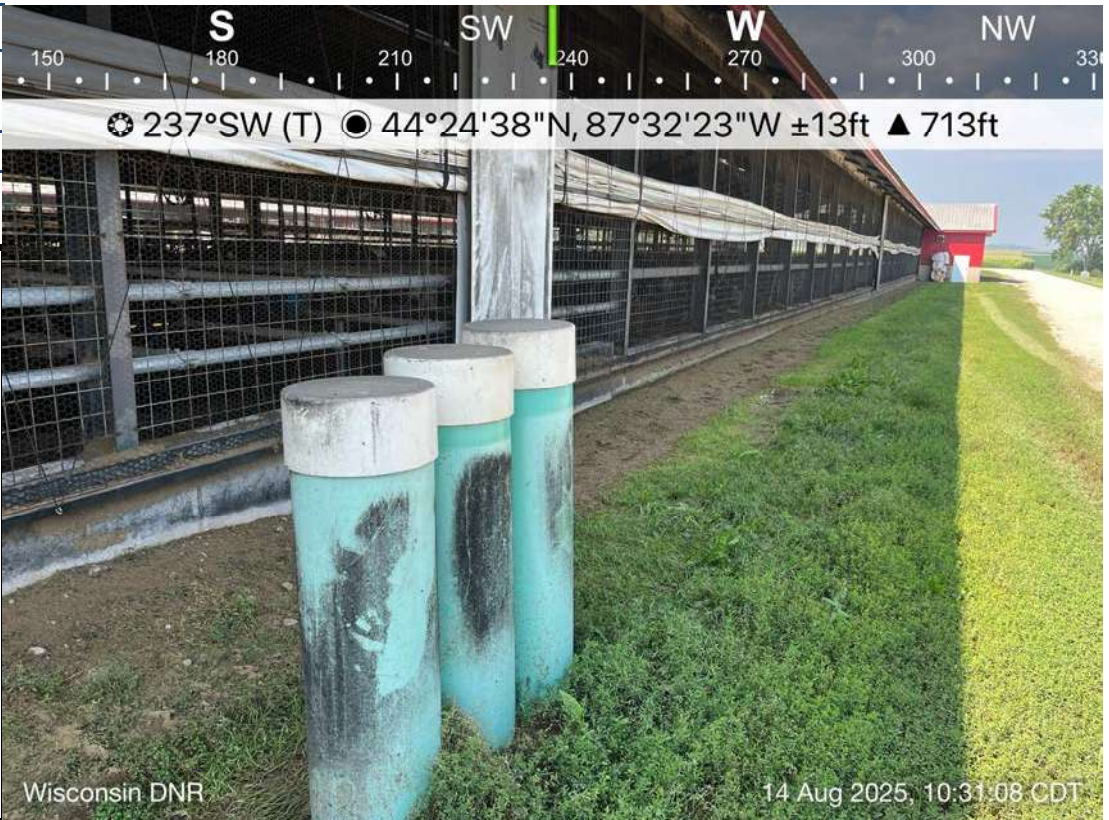
Photo #:	1978
Date/Time of Photo:	August 14, 2025 10:31 am
Photo By:	Mueller
Photo Location:	Main Site

View of the North Side of the North Freestall Barn Located on the Northwest Side of the Production Site. Minimal Bedding Leaving Barns Observed. This Photo was Taken Facing Southwest.

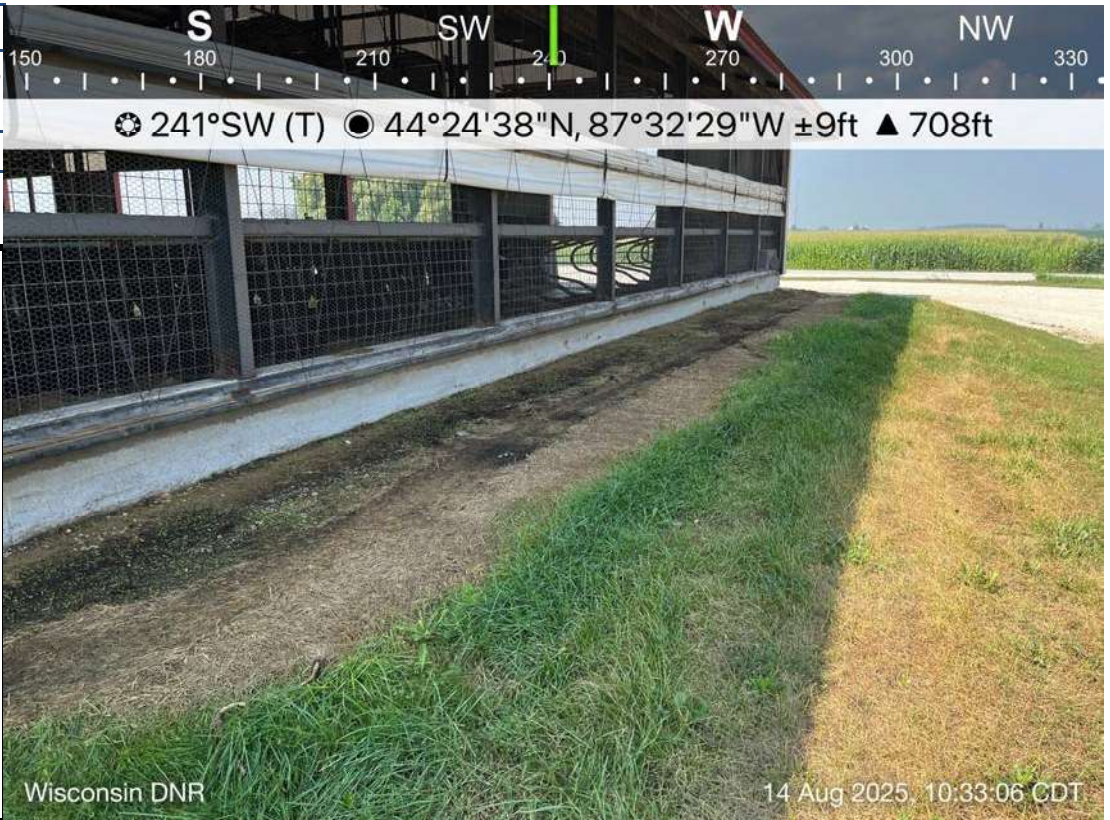
Photo #:	1982
Date/Time of Photo:	August 14, 2025 10:33 am
Photo By:	Mueller
Photo Location:	Main Site

View of the North Side of the North Freestall Barn Located on the Northeast Side of the Production Site. Minimal Bedding Leaving Barns Observed. This Photo was Taken Facing Southwest.

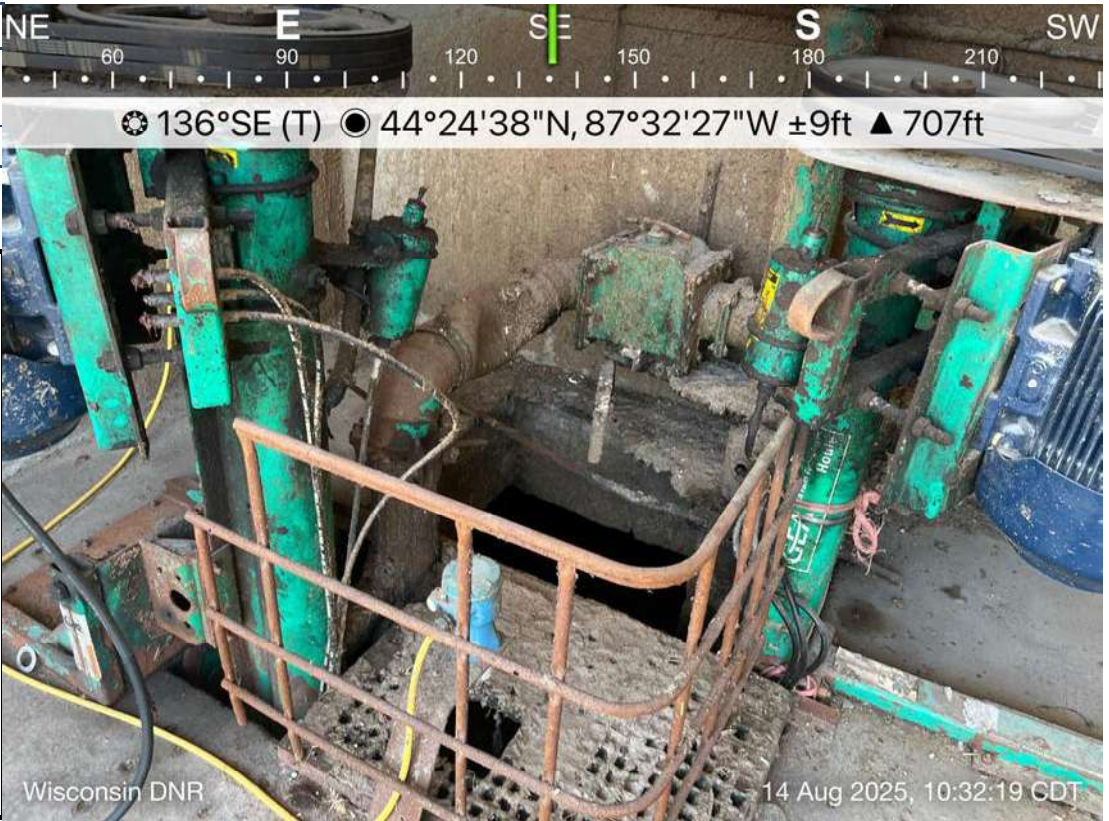
Photo #:	1984
Date/Time of Photo:	August 14, 2025 10:32 am
Photo By:	Mueller
Photo Location:	Main Site

View of the Manure Transfer System Located in the North Freestall Barn on the Northwest Side of the Production Site. This Photo was Taken Facing Southeast.

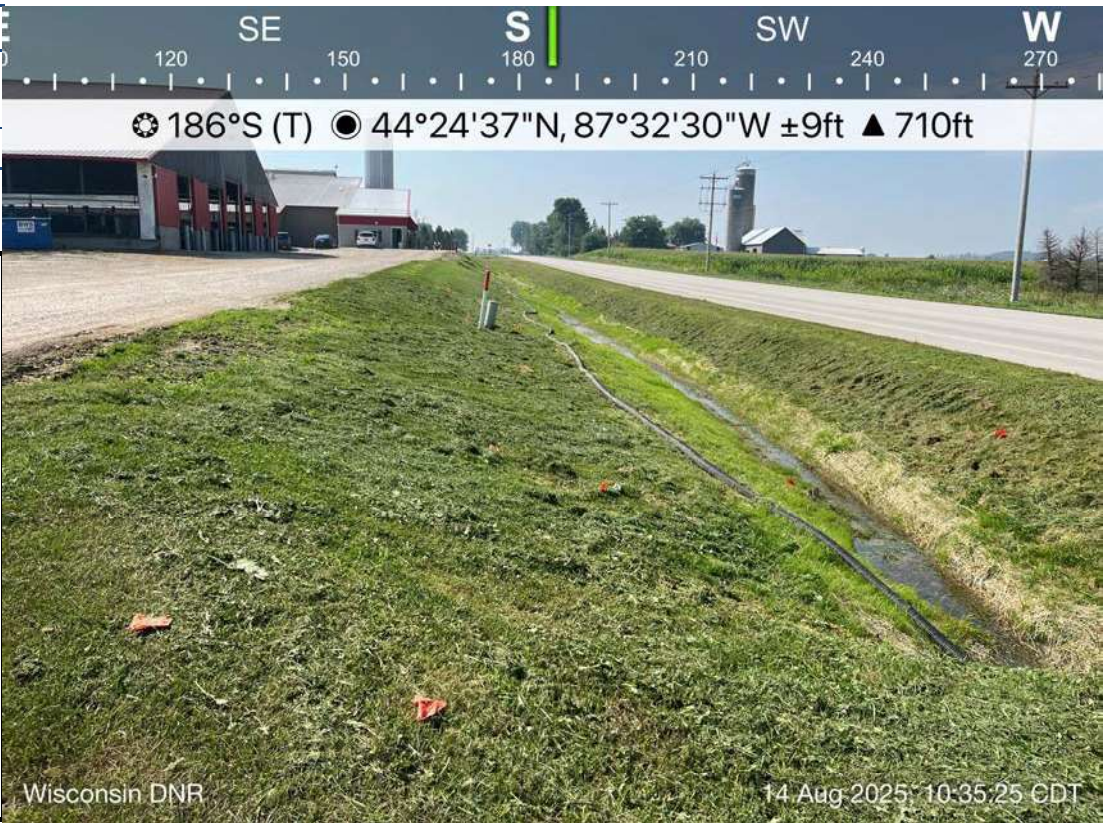
Photo #:	1997
Date/Time of Photo:	August 14, 2025 10:35 am
Photo By:	Mueller
Photo Location:	Main Site

Describe any issue(s) discovered during an inspection
7/21/25
Flume-Flush Tank ran over. The float switch failed, and the overflow pipe was plugged. Manure (effluent) ran into the surface water system and entered the Hwy 42 road ditch.

View of Restoration from a Spill a Few Weeks Prior Located on the West Side of the Production Site. This Photo was Taken Facing South.

Recommendations for repair or maintenance
The defective float switch was replaced. A second high-level float was added. The overflow pipe was jetted.
As part of the new barn project, the flush tower will be replaced with the new DNR approved flush

Corrective actions taken (immediately contact the DNR if unable to take corrective action within 30 days of identifying malfunctions, failures or other problems)
The DNR was called. The ditch was blocked with a dirt berm. A jetter truck was called in while W Dairy proceeded with vacuuming the mix of water and manure out of the ditch. Once cleaned, it was reseeded, and the dirt berm removed.

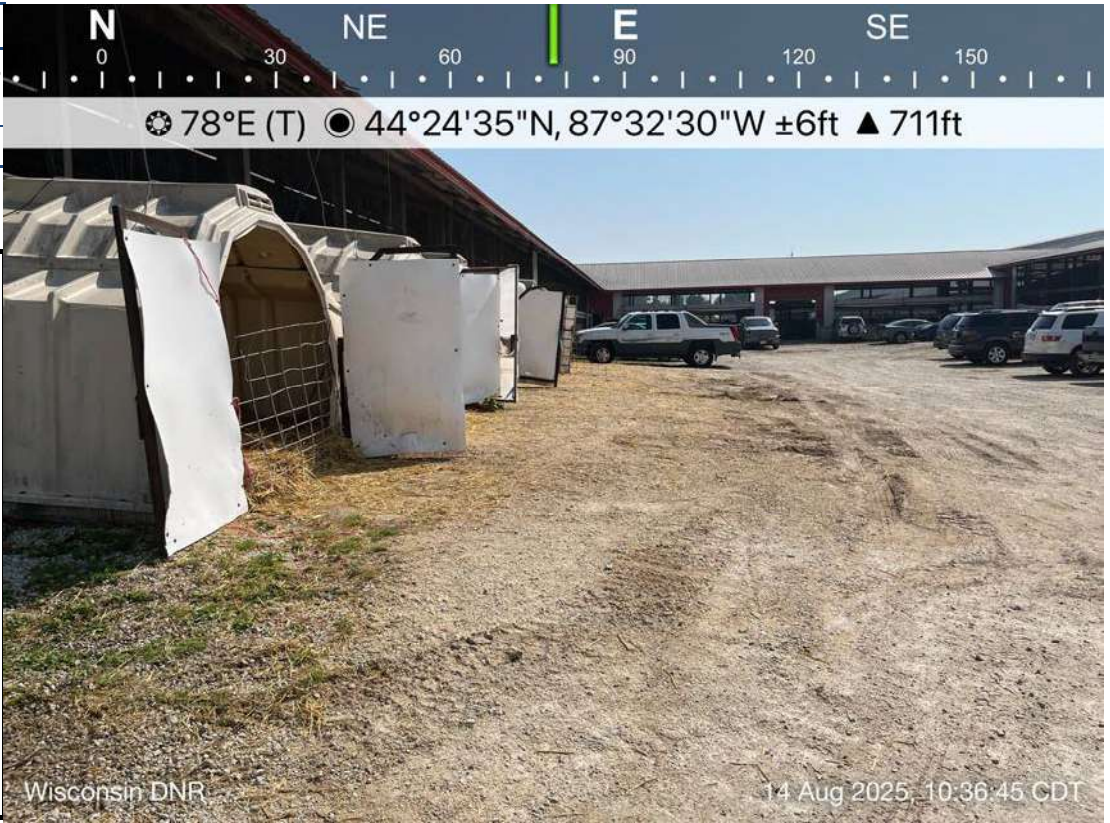
Photo #:	2006
Date/Time of Photo:	August 14, 2025 10:36 am
Photo By:	Mueller
Photo Location:	Main Site

View of the Calf Hutches Located North of the Parlor on the West Side of the Production Site. This Photo was Taken Facing East.

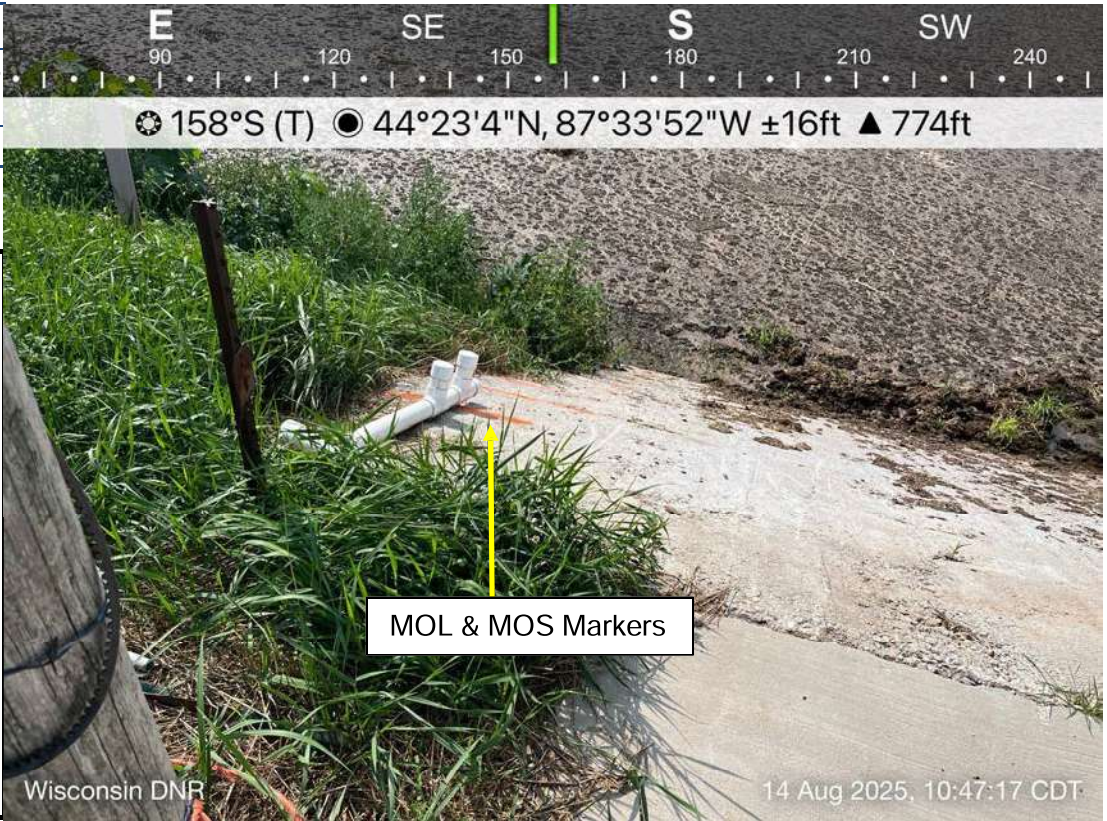
Photo #:	2018
Date/Time of Photo:	August 14, 2025 10:47 am
Photo By:	Mueller
Photo Location:	Papllham Site WSF Papllham

View of WSF Papllham Located on the West Side of the Production Site. The Yellow Arrow Represents the MOS & MOL Markers. This Photo was Taken Facing South.

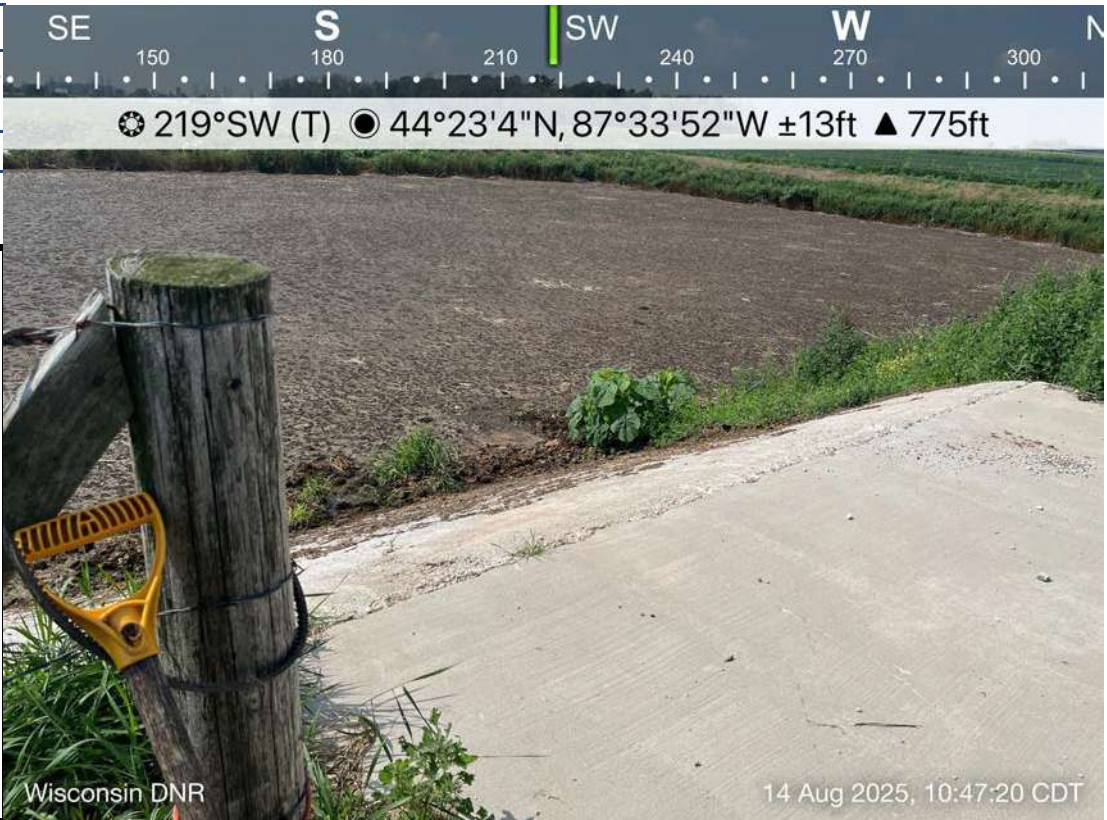
Photo #:	2019
Date/Time of Photo:	August 14, 2025 10:47 am
Photo By:	Mueller
Photo Location:	Papllham Site WSF Papllham

View of the Concrete Ramp Located on the North Side of WSF Papllham Located on the West Side of the Production Site. A Portion of Fencing to be Repaired was Observed. This Photo was Taken Facing Southwest.

- Clean out accumulated water in the Northwest corner of the feed storage area.
- Better housekeeping with feed coming out of the mangers at the Paplham Site.
- Remove vegetation around WSF Paplham.
- Repair the fence around WSF Paplham.
- Add erosion mitigation measures on the new culvert pipe at the Main Site.

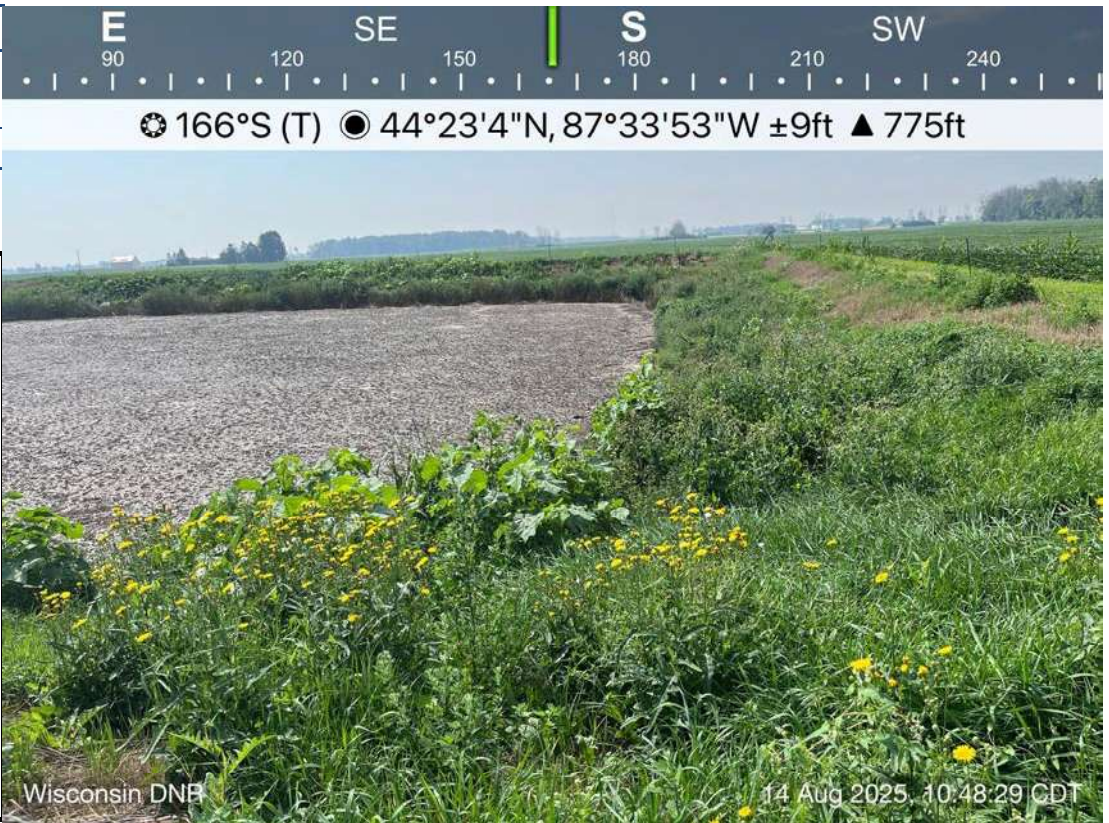
Photo #:	2023
Date/Time of Photo:	August 14, 2025 10:48 am
Photo By:	Mueller
Photo Location:	Paplhams Site WSF Paplhams

View of the West Side of WSF Paplhams Located on the West Side of the Production Site. Vegetation Around the Storage was Observed. This Photo was Taken Facing South.

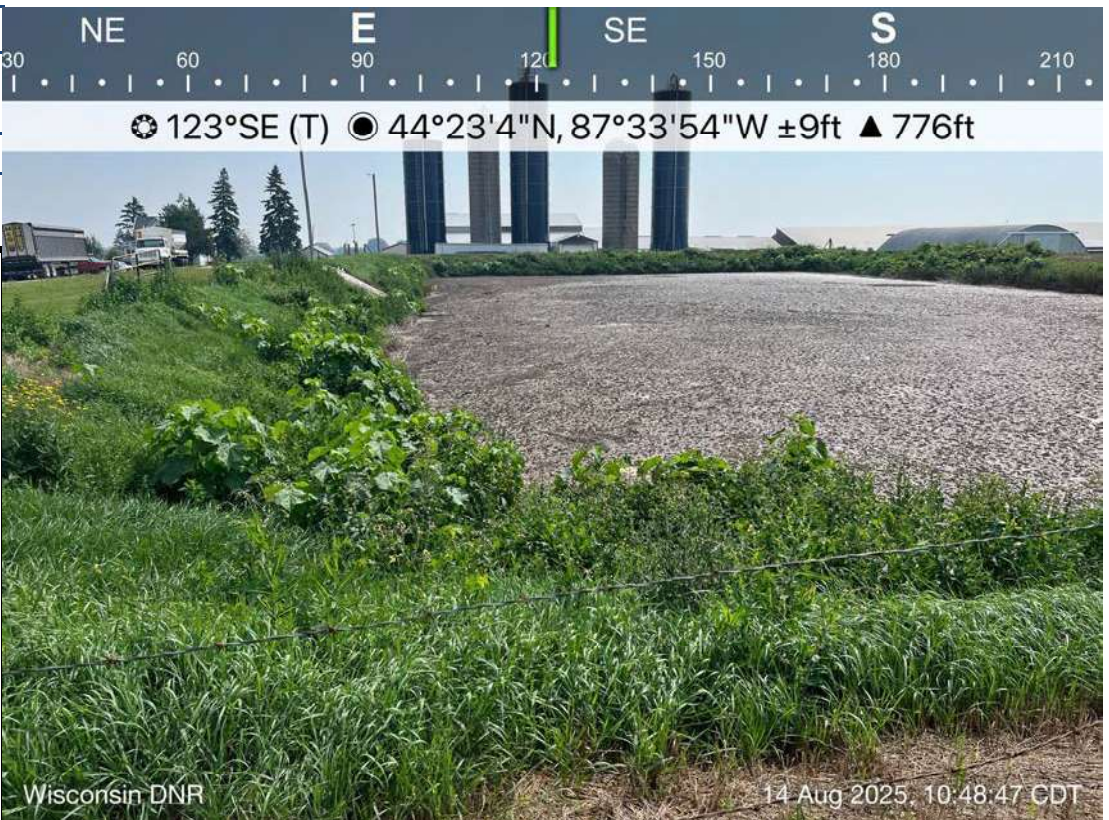
Photo #:	2019
Date/Time of Photo:	August 14, 2025 10:48 am
Photo By:	Mueller
Photo Location:	Paplhams Site WSF Paplhams

View of the Northeast Side of WSF Paplhams Located on the West Side of the Production Site. Vegetation Around the Storage was Observed. This Photo was Taken Facing Southeast.

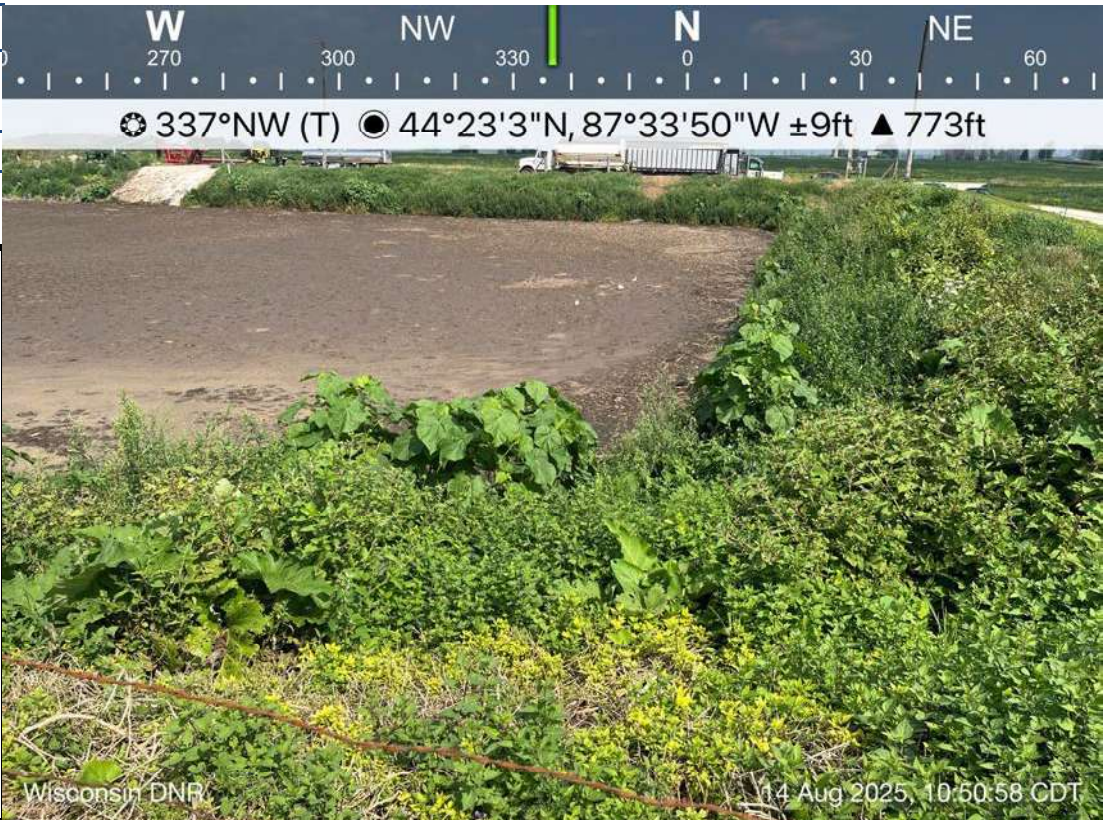
Photo #:	2019
Date/Time of Photo:	August 14, 2025 10:50 am
Photo By:	Mueller
Photo Location:	Papllham Site WSF Papllham

View of the East Side of WSF Papllham Located on the West Side of the Production Site. Vegetation Around the Storage was Observed. This Photo was Taken Facing Northwest.

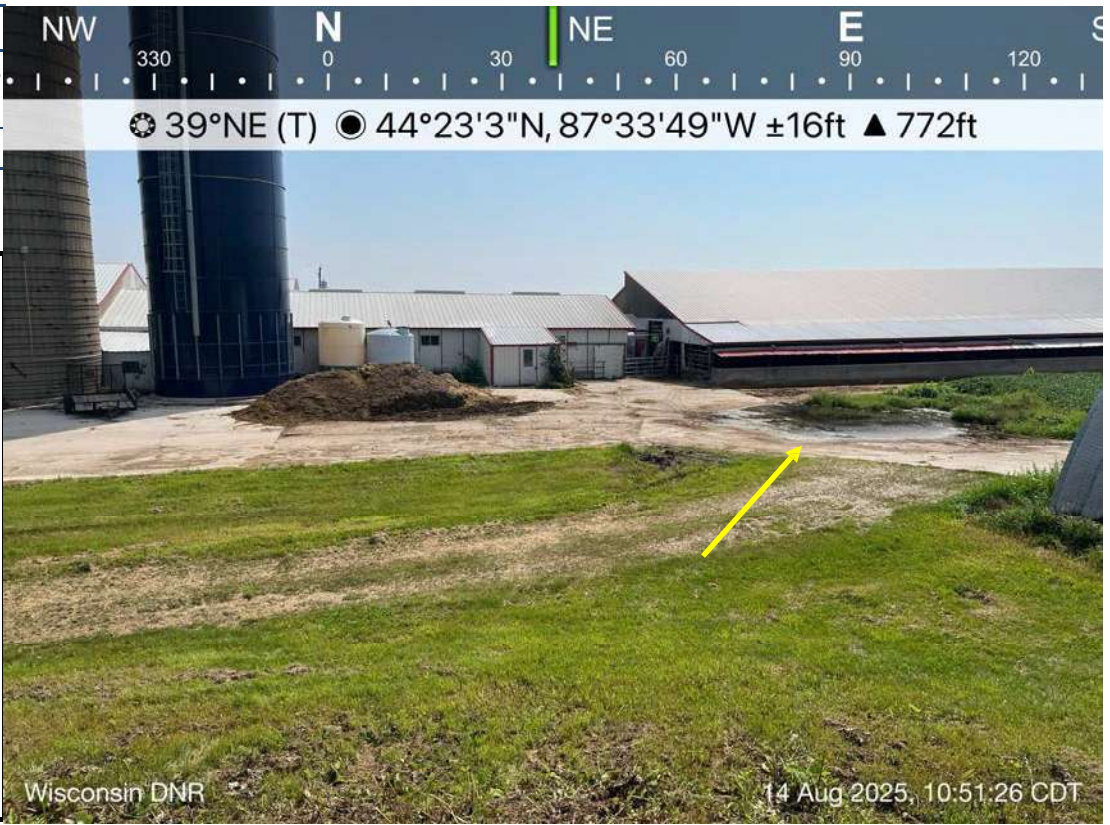
Photo #:	2018
Date/Time of Photo:	August 14, 2025 10:51 am
Photo By:	Mueller
Photo Location:	Papllham Site

Photo Description:
View of the Freestall Barn and the Accumulation of Process Wastewater Located in the Middle of the Production Site. The Yellow Arrow Represents the Accumulated Processed Wastewater. This Photo was Taken Facing Northeast.

At the Paplham Site, feed from the mangers was observed spilling over the sides during feeding, resulting in the accumulation of processed wastewater in the area. **This area of concern has since been addressed and completed. See Appendix A.**

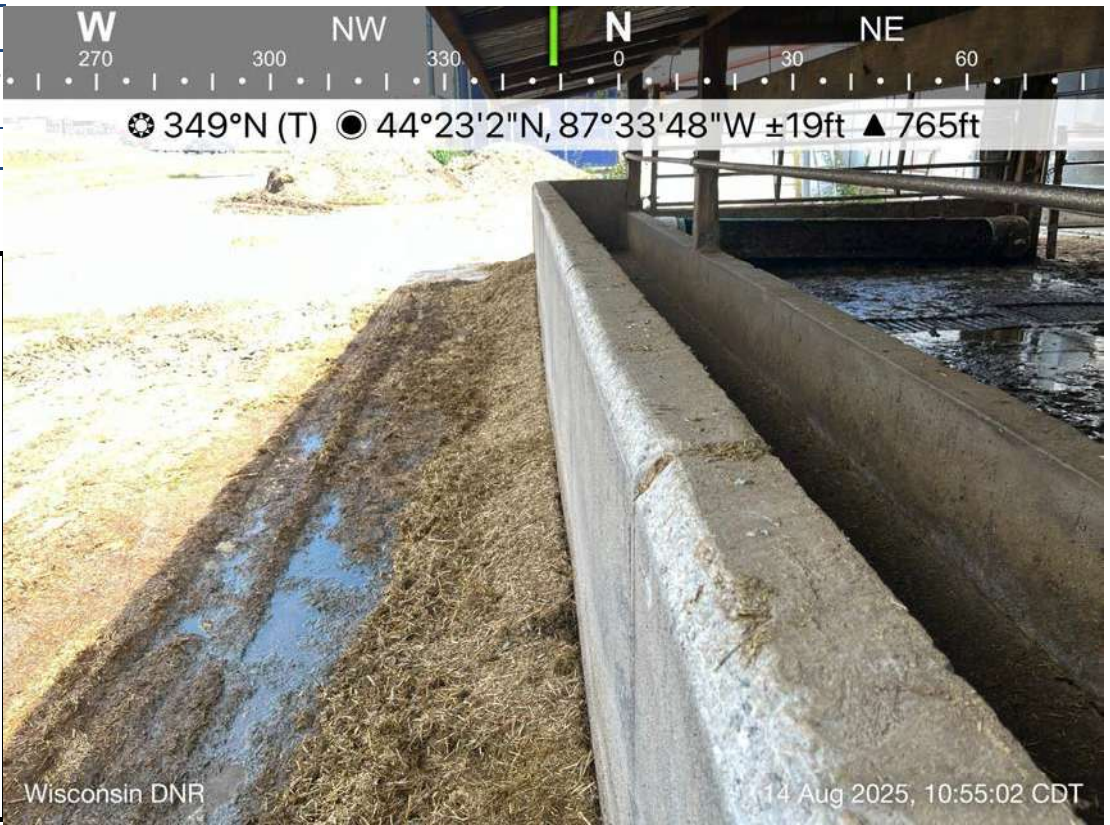
Photo #:	2018
Date/Time of Photo:	August 14, 2025 10:55 am
Photo By:	Mueller
Photo Location:	Papllham Site

View of Feed Spilled Over the Manger on the West Side of the Freestall Barn Located on the South Side of the Production Site. This Photo was Taken Facing North.

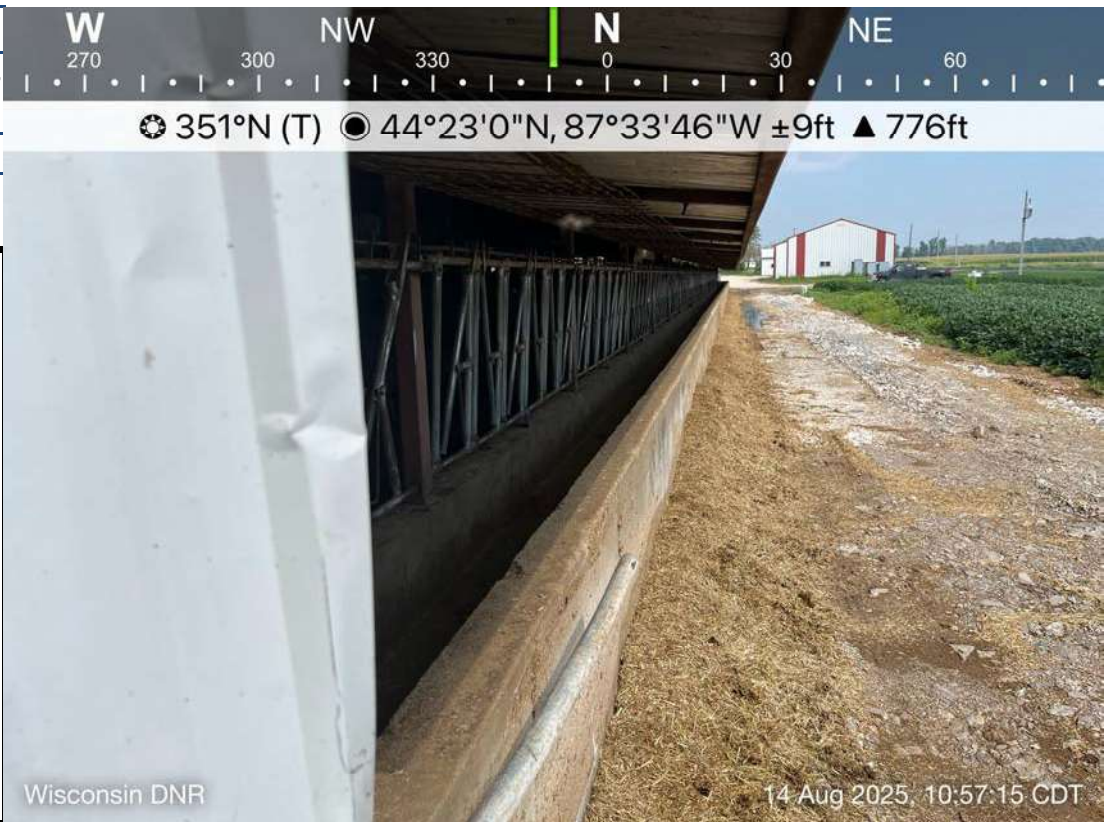
Photo #:	2019
Date/Time of Photo:	August 14, 2025 10:57 am
Photo By:	Mueller
Photo Location:	Papllham Site

View of Feed Spilled Over the Manger on the East Side of the Freestall Barn Located on the South Side of the Production Site. This Photo was Taken Facing North.

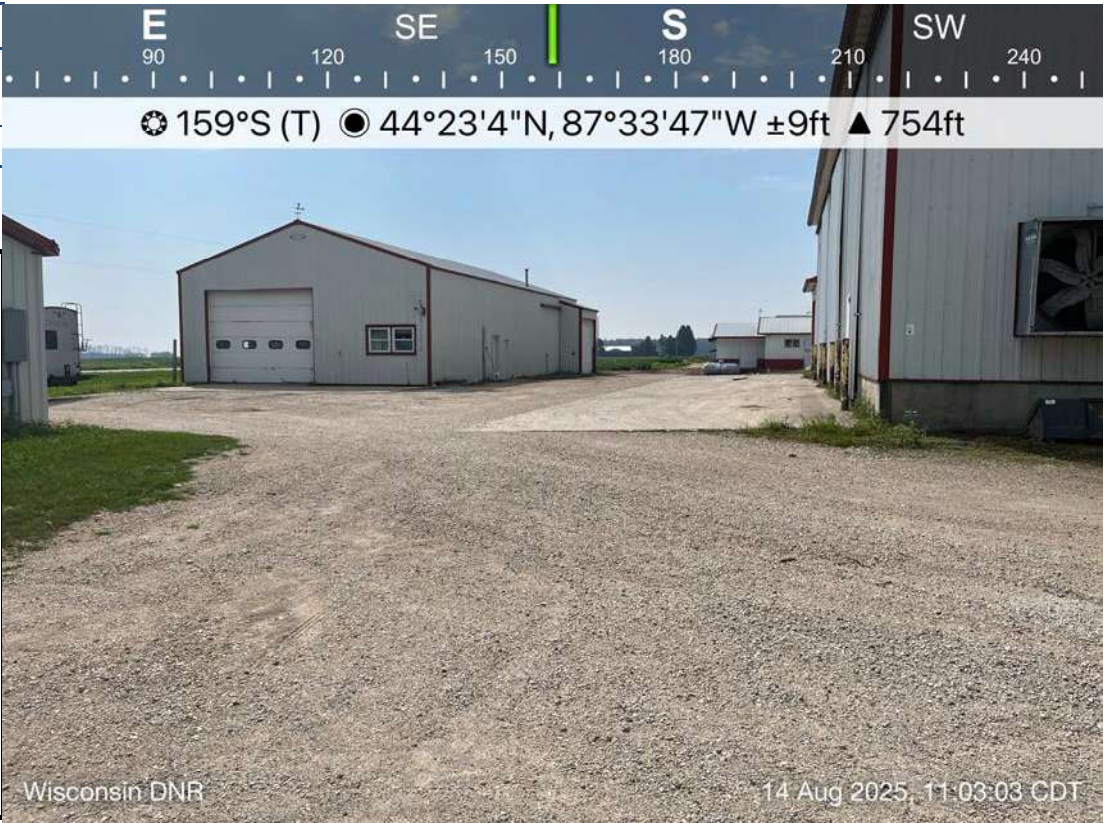
Photo #:	2018
Date/Time of Photo:	August 14, 2025 11:03 am
Photo By:	Mueller
Photo Location:	Papllham Site

View of the Outside of the Buildings Located on the East Side of the Production Site. This Photo was Taken Facing South.

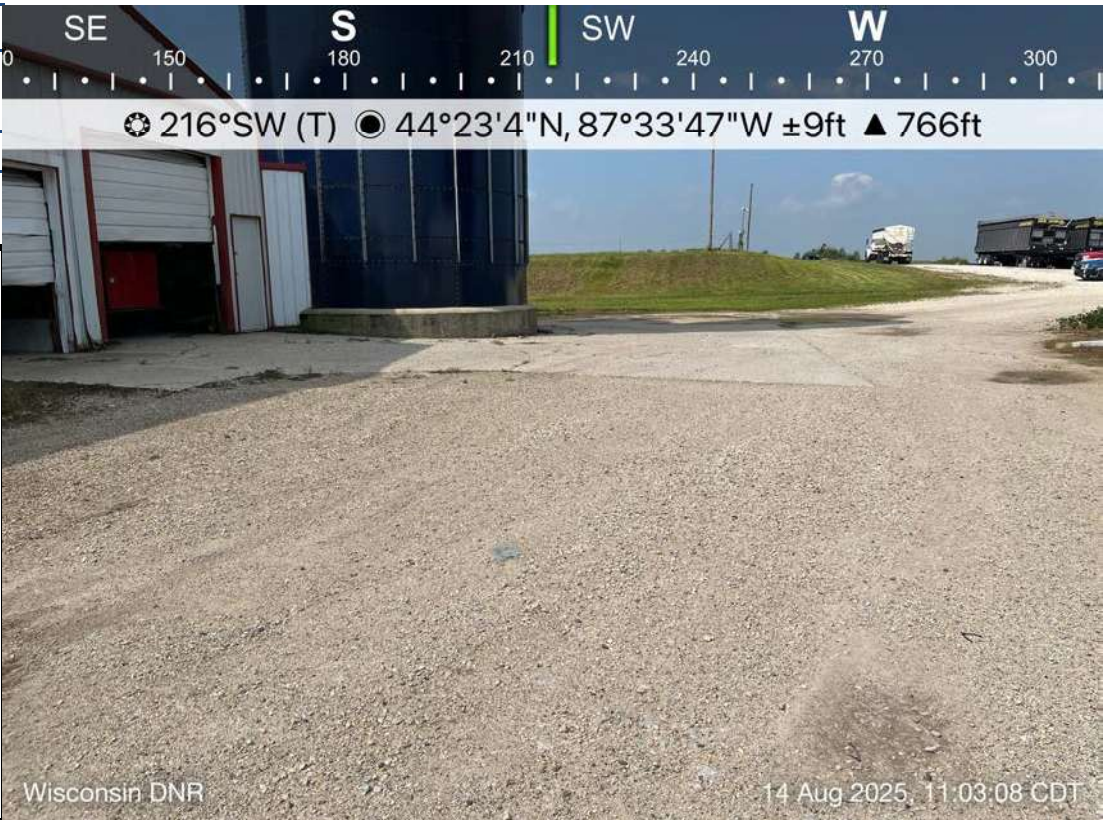
Photo #:	2019
Date/Time of Photo:	August 14, 2025 11:03 am
Photo By:	Mueller
Photo Location:	Papllham Site

View of the Outside of the Buildings and Silo Located East of WSF Papllham. This Photo was Taken Facing Southwest.
