Condition Outcomes in Wetlands Restored Using a Variety of Hydrologic Restoration Techniques: An Application of Wisconsin DNR's FQA Methodology

May 2020

Wisconsin Department of Natural Resources Bureaus of Water Quality and Waterways 101 South Webster Street Madison, WI 53703

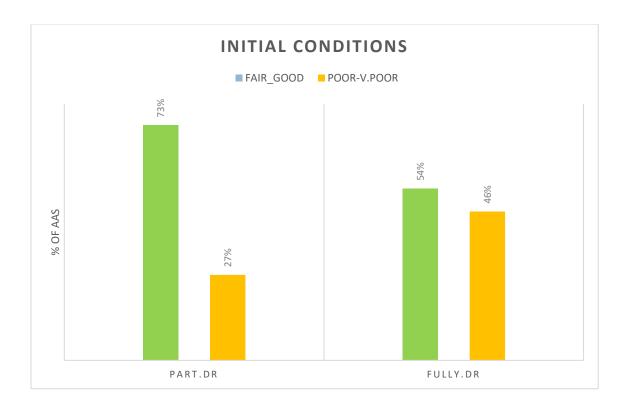
Condition results with four condition tiers reduced to two: "Fair-Good" and "Poor-Very Poor" for initial condition, maintenance, and organization type. Statistically significant differences were not found between any groups in condition outcomes.
