Wetland Mitigation Bank Prospectus

Mill Creek Wetland Mitigation Bank

City of New Berlin, Waukesha County, Wisconsin

March 18, 2025

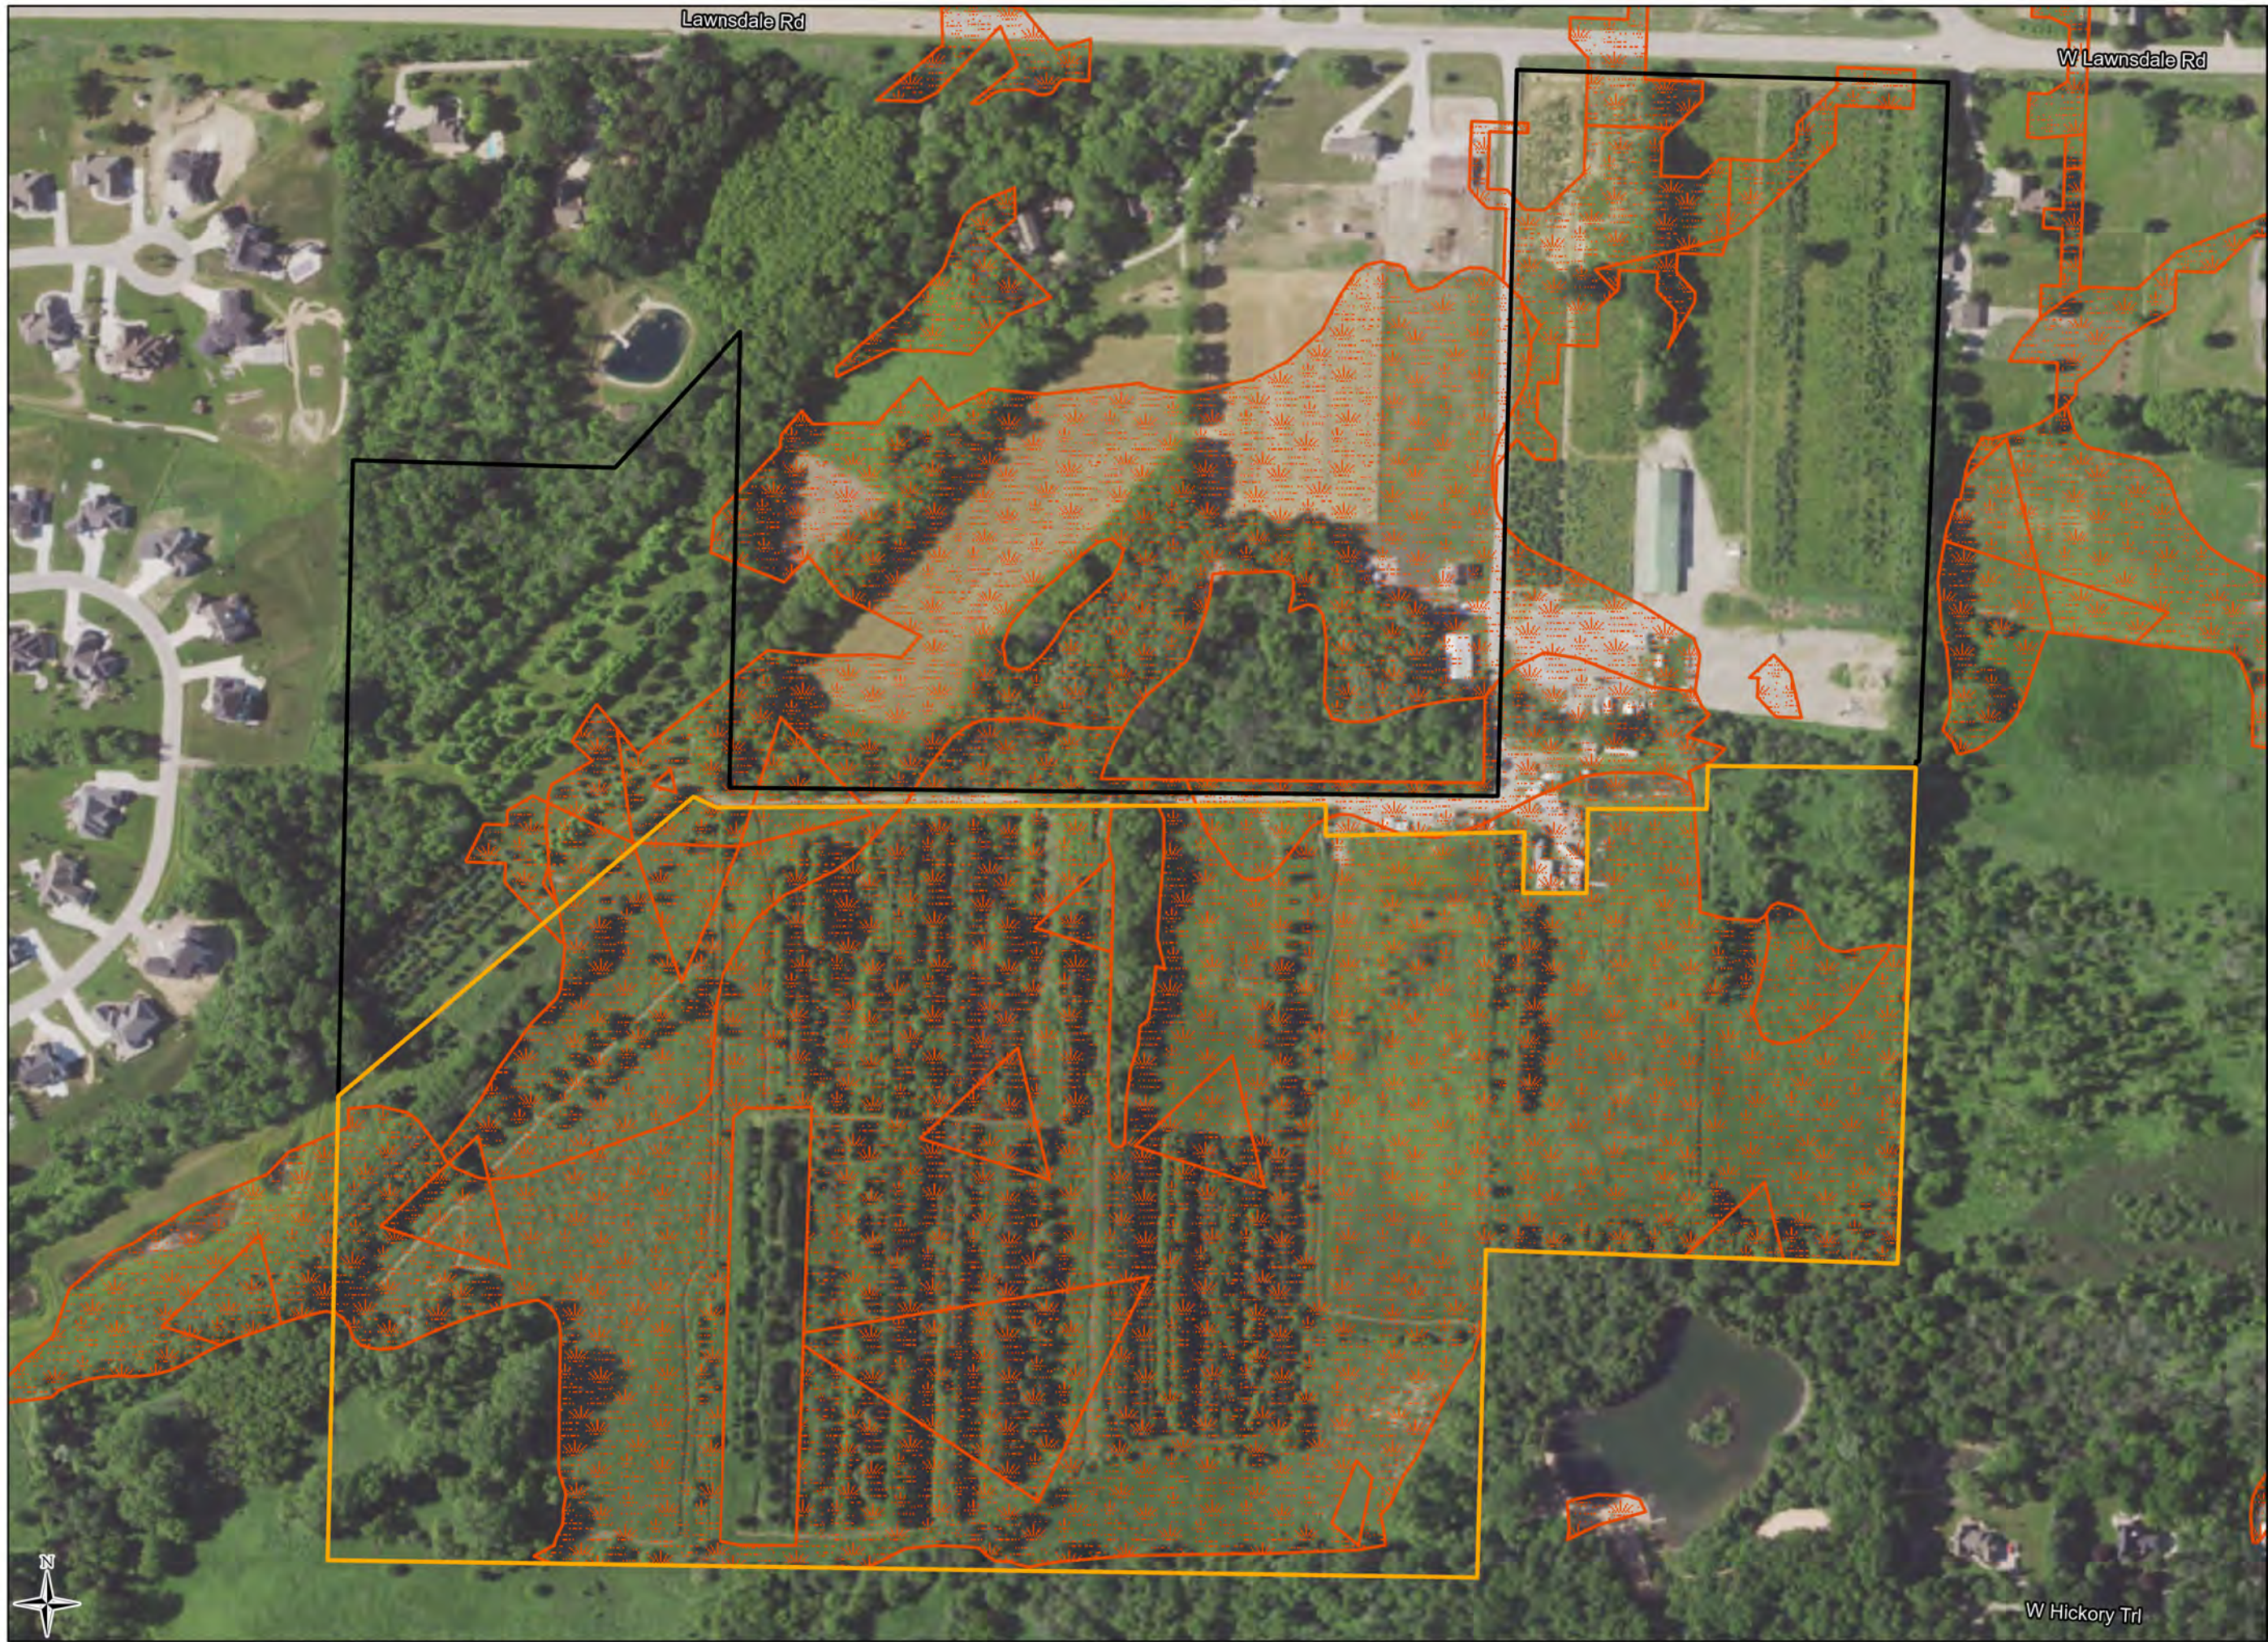
Figure 6. WDNR Potentially Restorable Wetlands

- Property Boundary (102.64 ac)
- Mitigation Project Boundary (68.17 ac)
- DNR Potentially Restorable Wetlands

- The WDNR Potentially Restorable Wetlands (PRW) layer indicates that much of the Site is suitable for wetland restoration (Appendix A, Figure 6).
- The Site is relatively flat and within a low area of the overall landscape (Appendix A, Figure 7). Hydrologic restoration will allow the organic soils to maintain a high water table and support wetland conditions.
