Little Plover River Watershed Enhancement Project – A Wetland Story

Little Plover River Watershed Enhancement Project

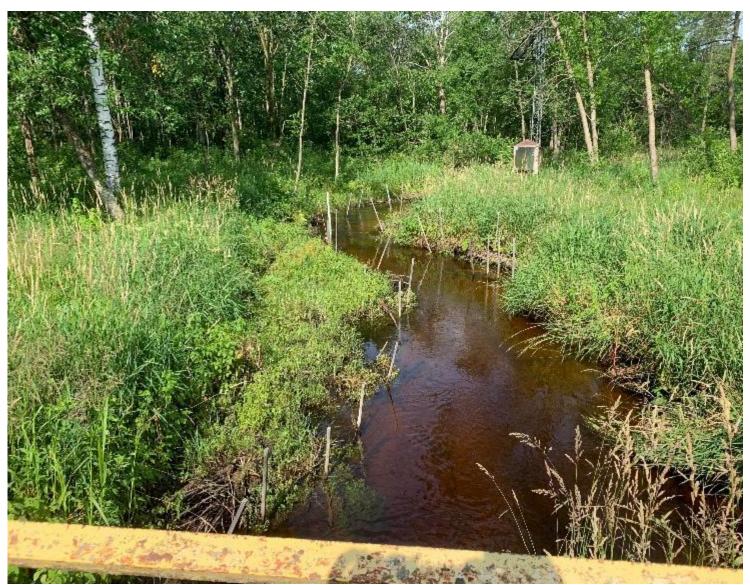
Tannins visible in creek channel during low water times - June 2021

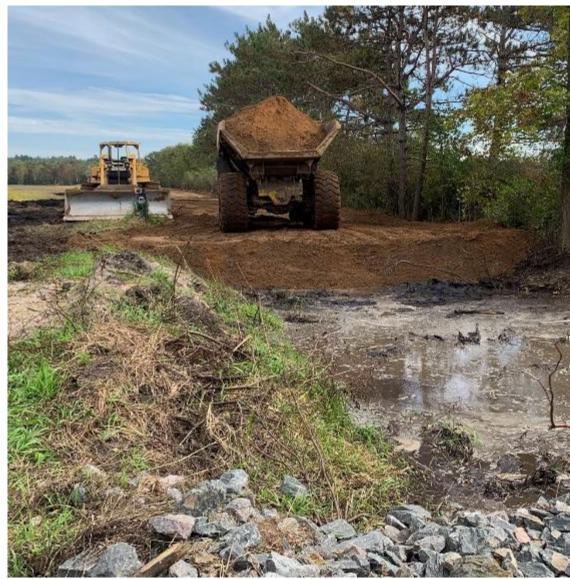
Ditch Removal

- Divert groundwater to headwater reach increased flow in upper mile of LPR
- Raise groundwater elevation – store more water
- Reduce flashiness of runoff
- Trout managers toured site during planning

- <u>Soik ditch</u> 4,150 ft filled
- <u>Feltz ditch</u> ~1,200 ft filled in 2024
- North Soik ditch ~1,000 ft filled as part of the Portage County Wetland Mitigation Bank

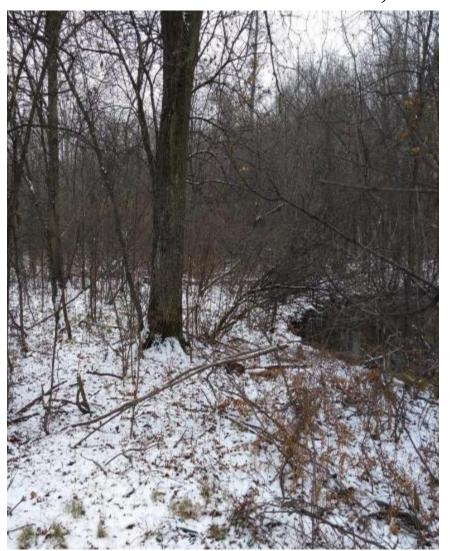
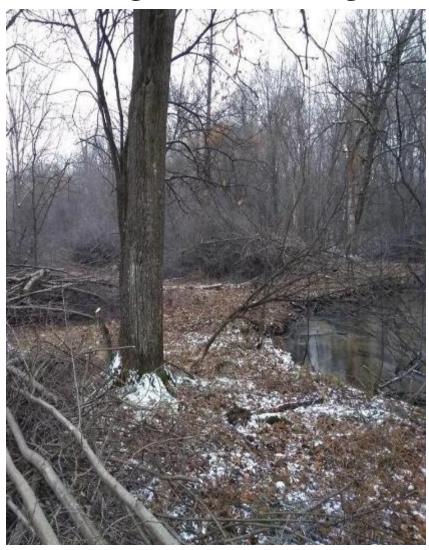
Floodplain Forest Management

Alder and buckthorn removal, hardwood thinning – increases sunlight

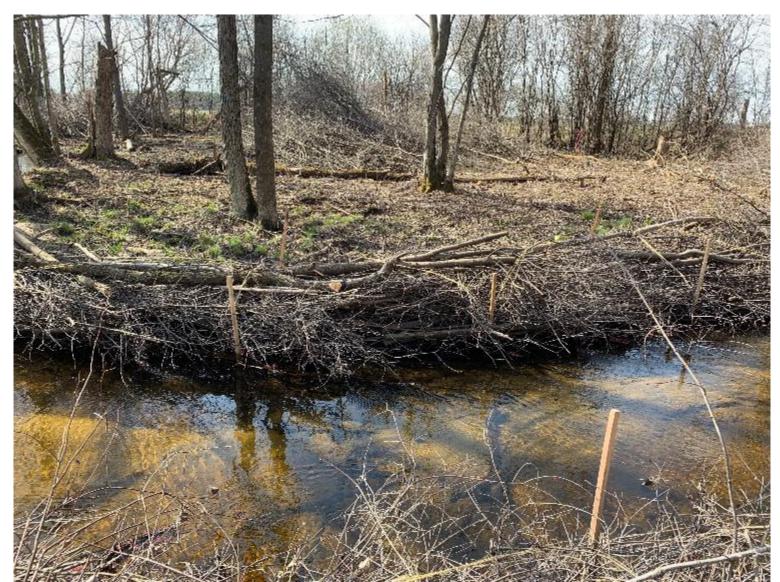
Channel Restoration - After

Brush bundles placed during volunteer workdays

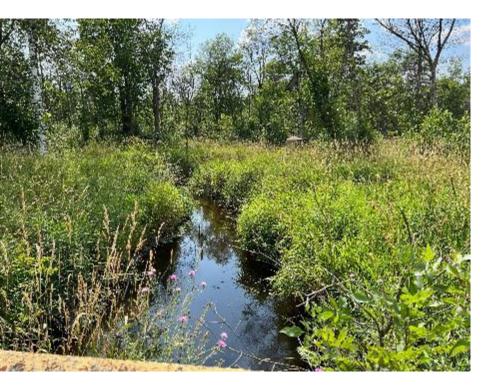
July 21, 2023 2.57 cfs

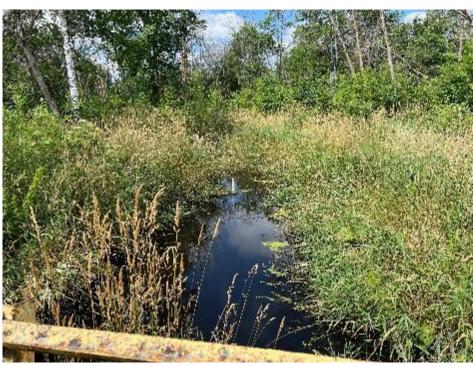
July 10, 2025 7.67 cfs
