## #22 Vilas Co Sucker Creek Culvert

Project Title Sucker Creek Bridge Replacement					Current Funded Miles 499.6/37.2	New Miles (if applicable) 0
County Vilas	Township 40 N	Range 10	Section 4	1/4 1/4 SE	1/4 NW	GPS Coordinates: Lat. _____ Long. _____

# Trail Bridge Inspection

Vilas 39

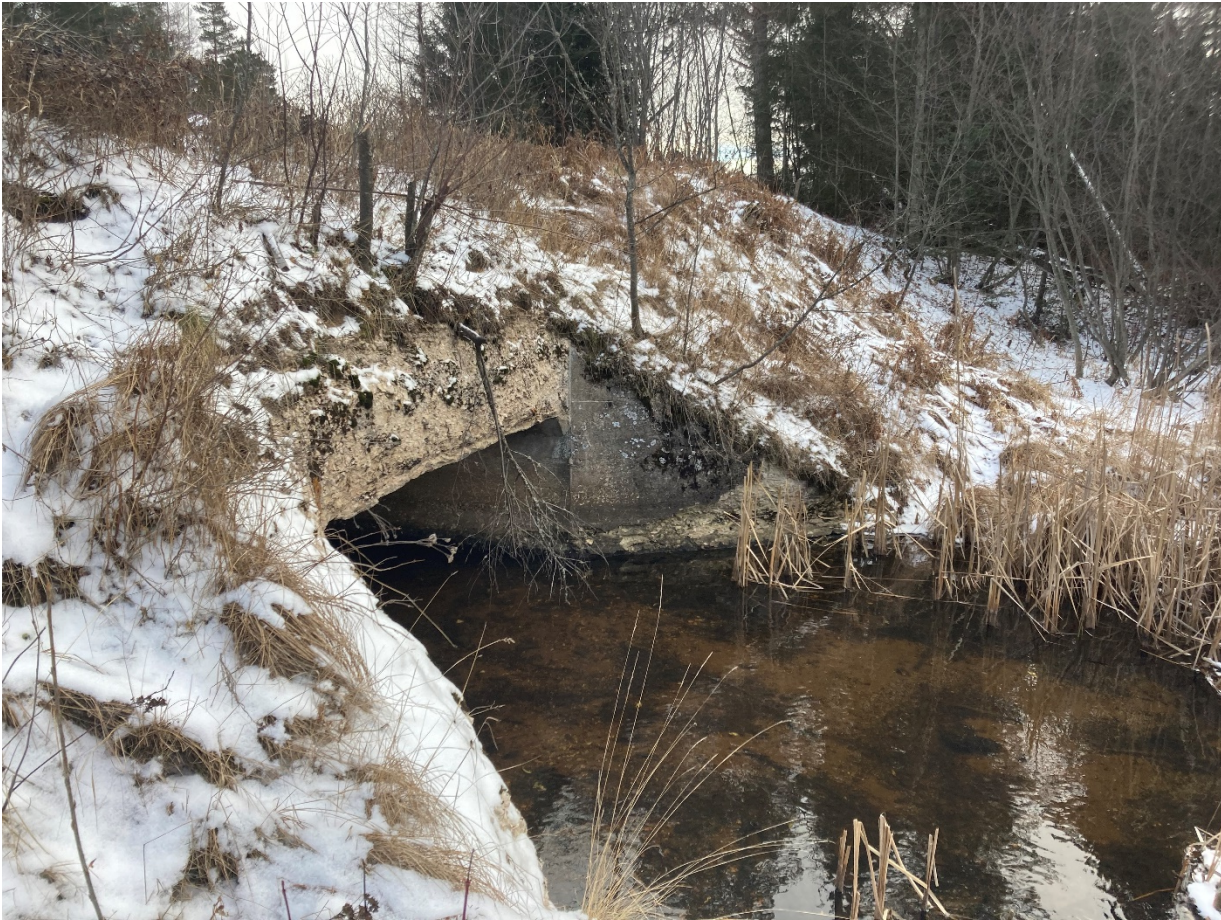
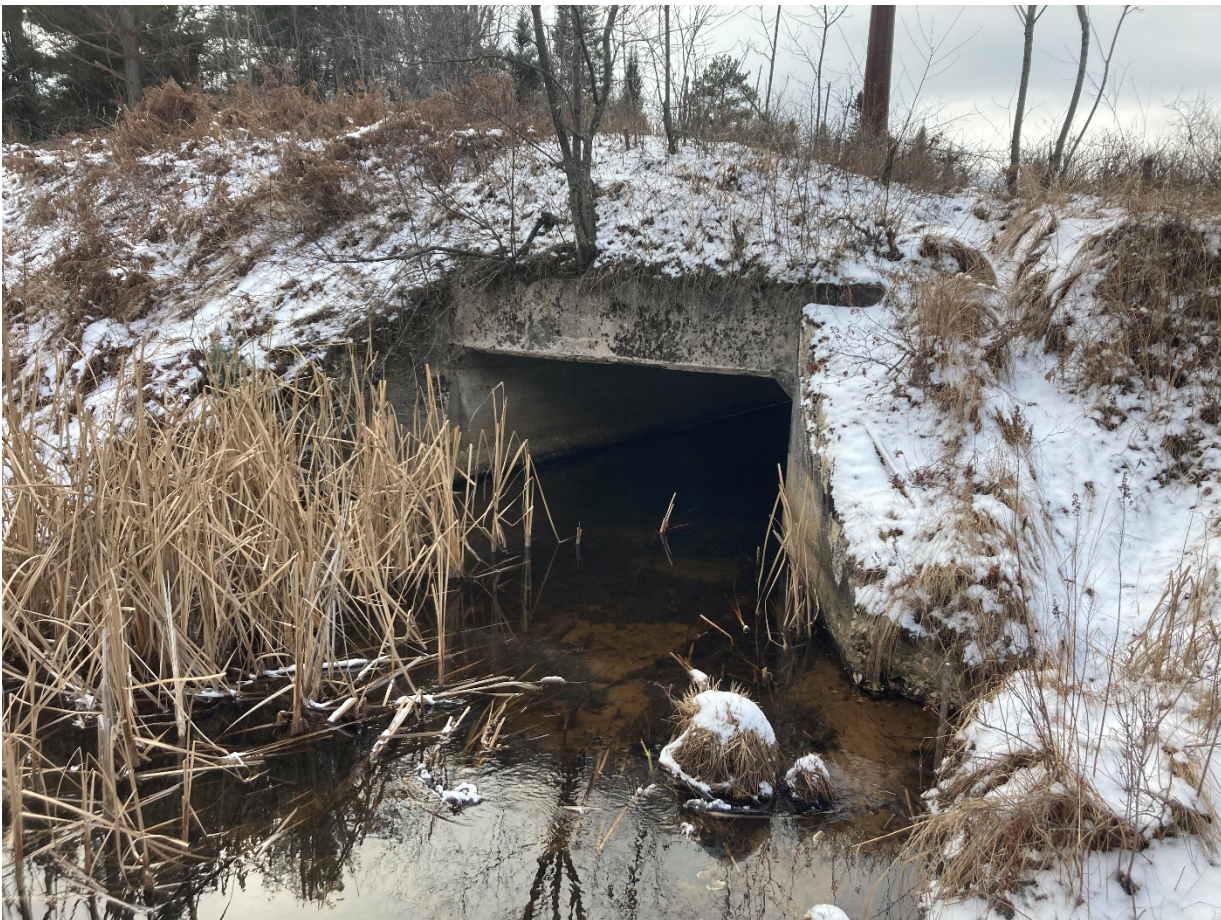
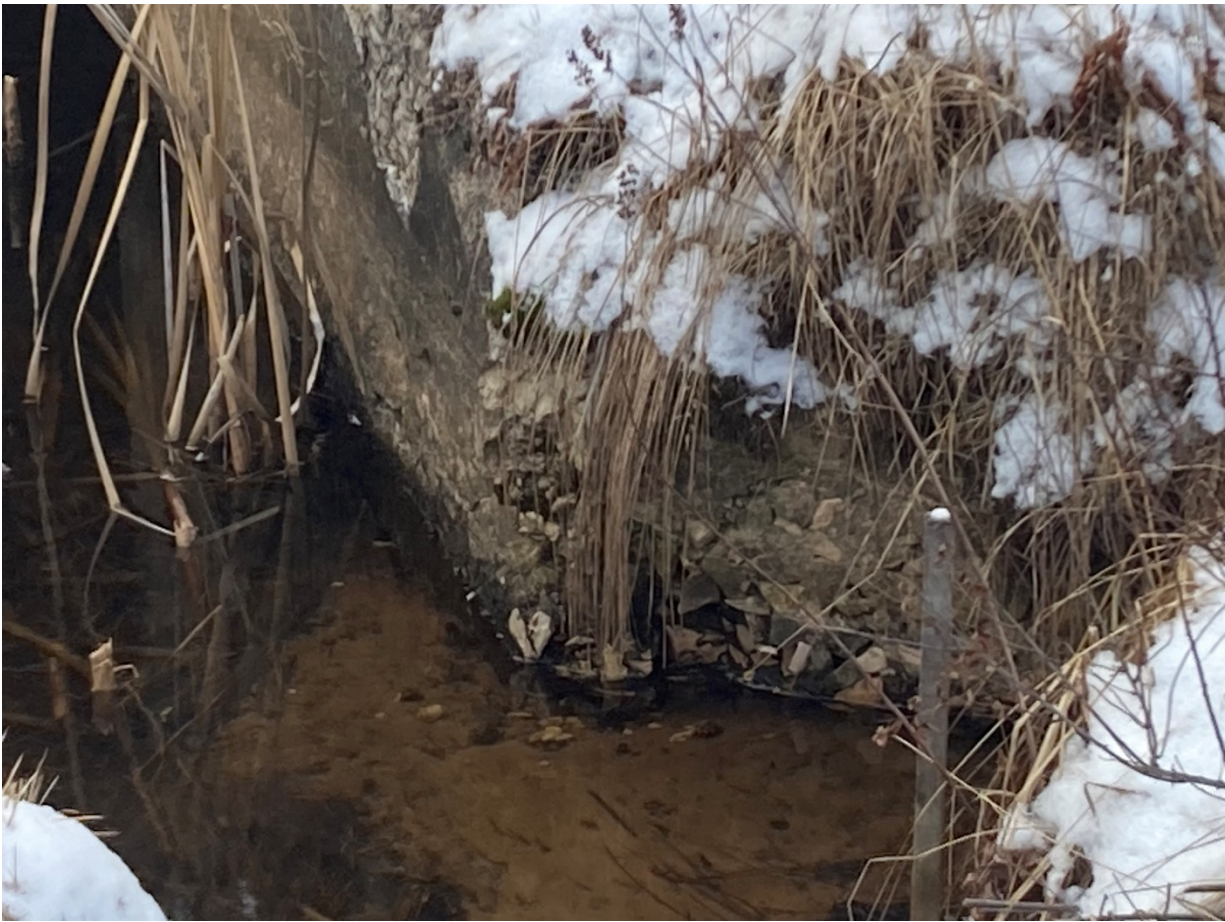
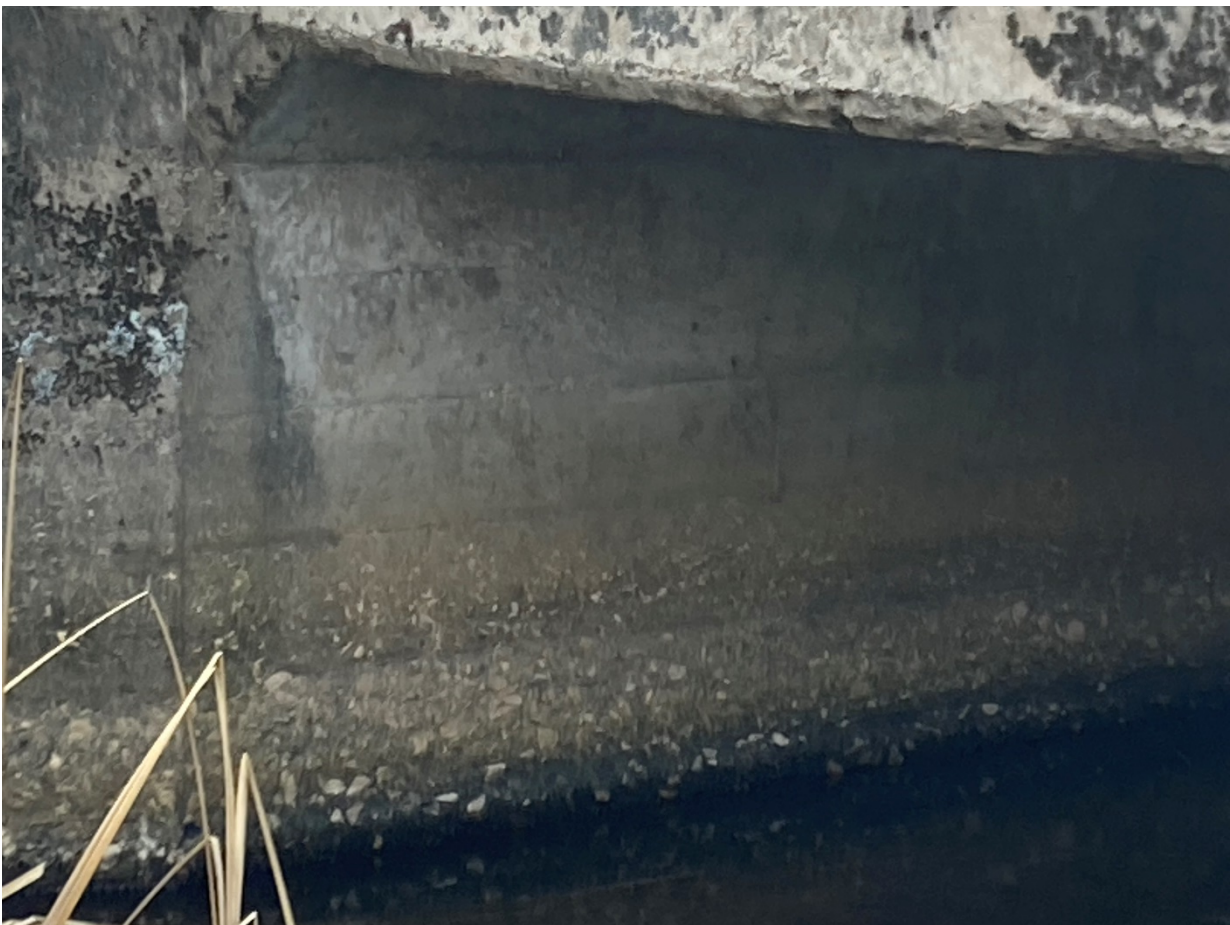
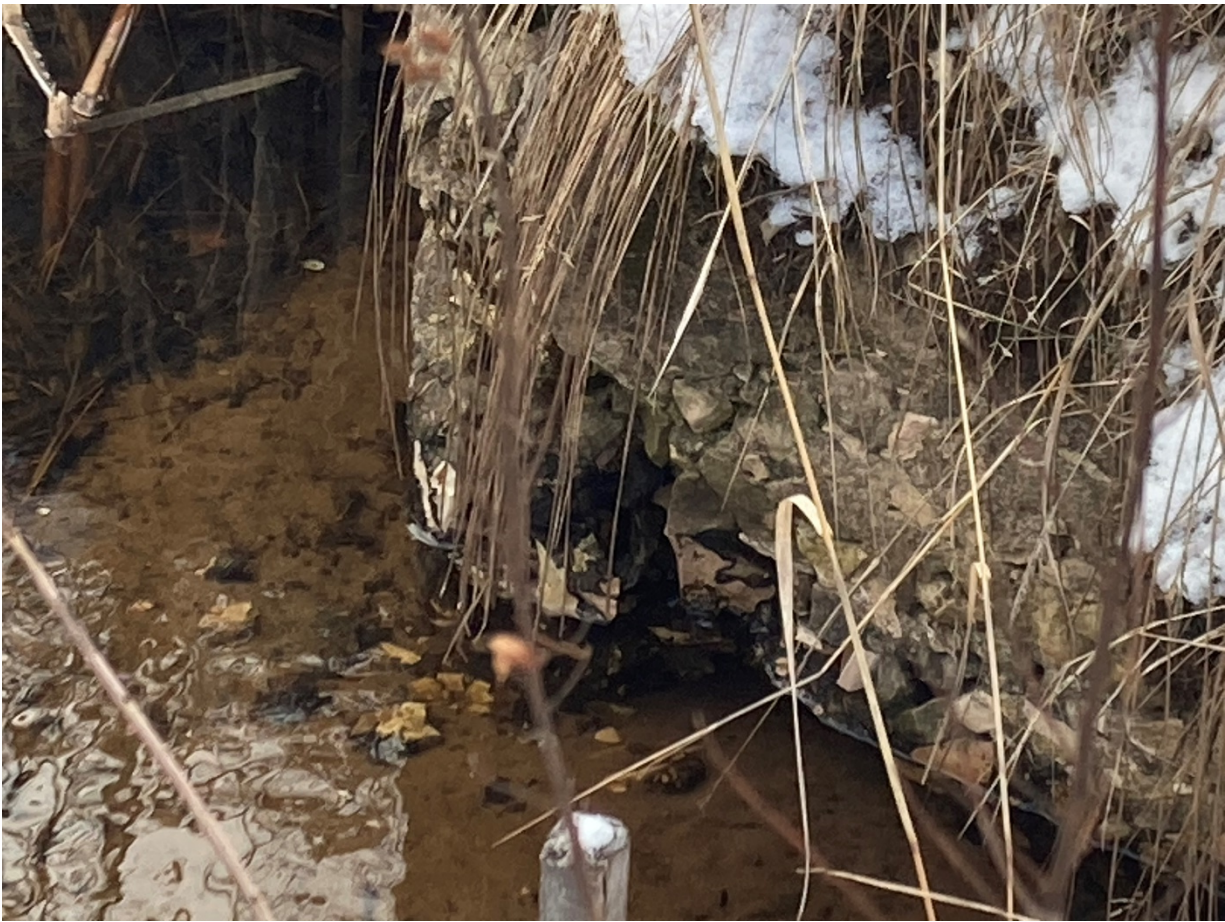
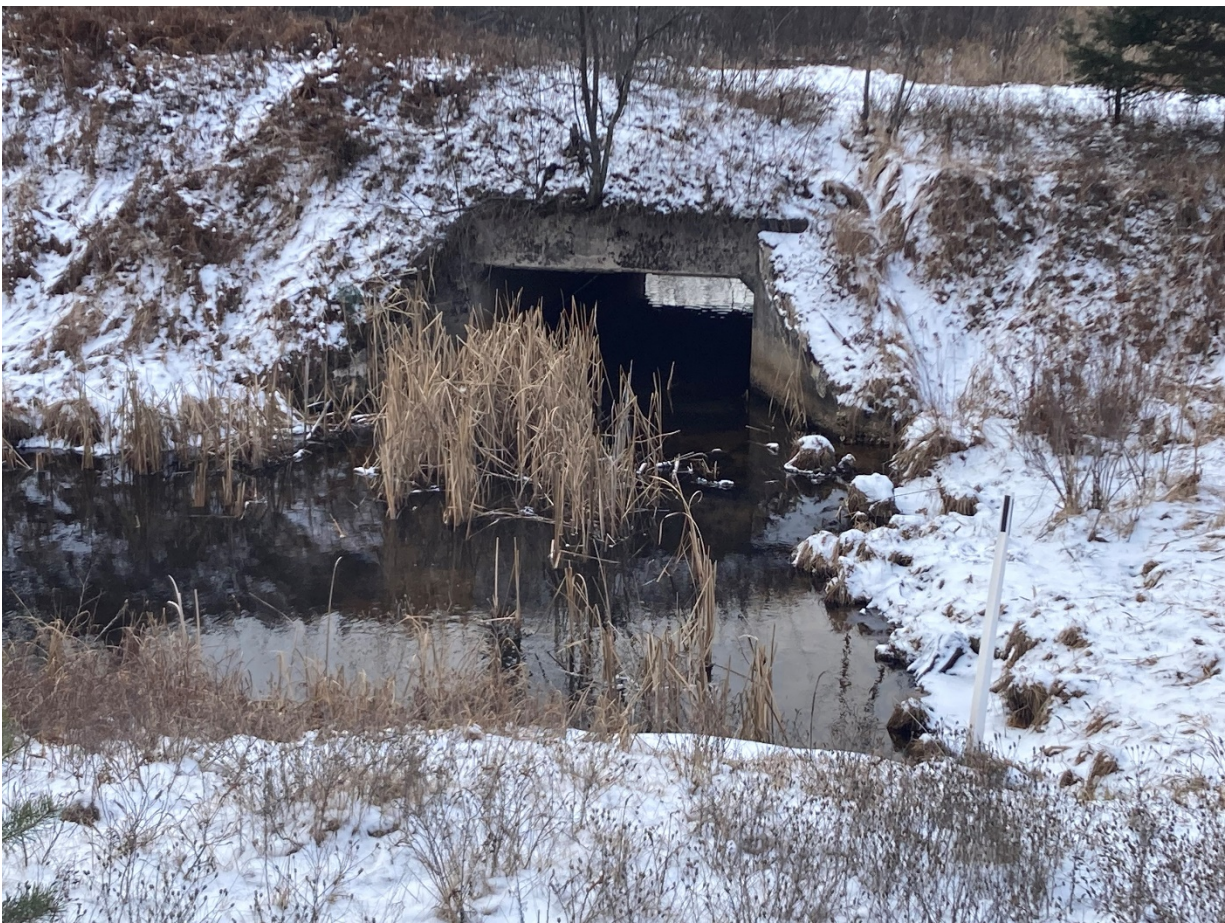
Vilas Co Sucker Creek Culvert

West end of the box culvert and wingwalls have extensive spalls. Borderline CS4, with the amount of section loss. NW wingwall is missing 1/2 of its thickness.

The box has CS2 scaling on the wetted perimeter. There is moderate spalling at the top of the east end of box. Channel has a highway culvert and low head dam immediately upstream.

Inspect on a regular schedule of 48 months.  
Monitor the spalls on the West end of the structure.  
Maintain proper drainage above the structure on the roadway.  
CUT BRUSH AROUND THE ENTIRE STRUCTURE ANNUALLY
