March 27, 2024

RE: Fall 2023 Stream C Sampling Results Summary
Reclaimed Flambeau Mine, Ladysmith, Wisconsin

This memorandum presents the activities and results from the fall 2023 Stream C monitoring.

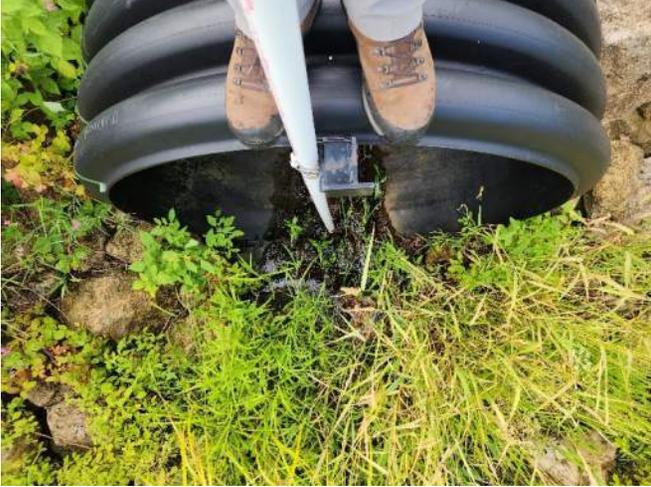
<p>Photo No. 1</p>	<p>Date: 7-28-23</p>

<p>Direction Photo Taken: North</p>			<p>Direction Photo Taken: Southwest</p>		
<p>Photo Taken By: Jim Engelhardt</p>			<p>Photo Taken By: Jim Engelhardt</p>		
<p>Description: Upstream end of culvert under Copper Park Lane.</p>			<p>Description: Downstream (west) end of culvert under Hwy 27.</p>		
<p>Photo No. 2</p>	<p>Date: 7-28-23</p>

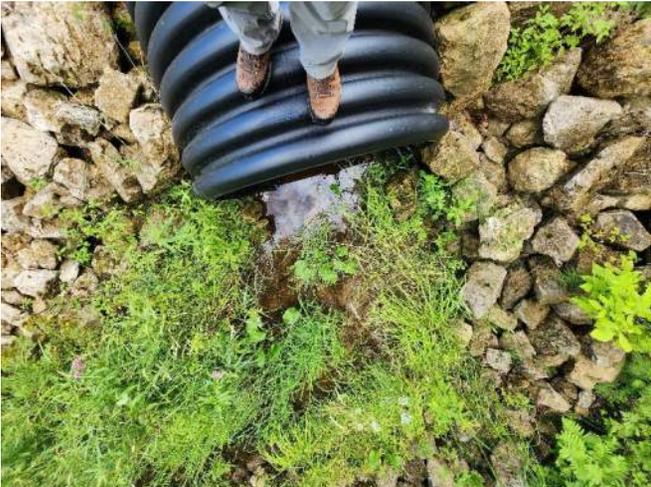
<p>Direction Photo Taken: Southwest</p>			<p>Direction Photo Taken: Northeast</p>		
<p>Photo Taken By: Jim Engelhardt</p>			<p>Photo Taken By: Jim Engelhardt</p>		
<p>Description: Downstream end of culvert under Copper Park Lane.</p>			<p>Description: Upstream (east) end of culvert under STH 27.</p>

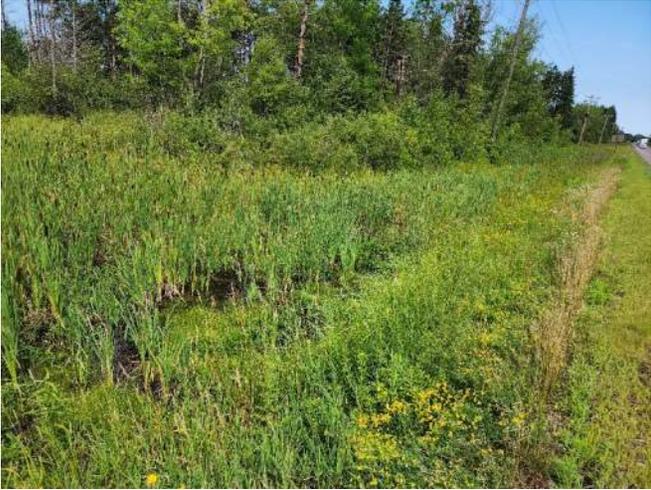
<p>Photo No. 5</p>	<p>Date: 7-28-23</p>

<p>Direction Photo Taken: North</p>			<p>Direction Photo Taken: Southwest</p>		
<p>Photo Taken By: Jim Engelhardt</p>			<p>Photo Taken By: Jim Engelhardt</p>		
<p>Description: Ditch along West side of Hwy 27 north of culvert.</p>			<p>Description: Stream C downstream of the Cooper Park Lane culvert.</p>

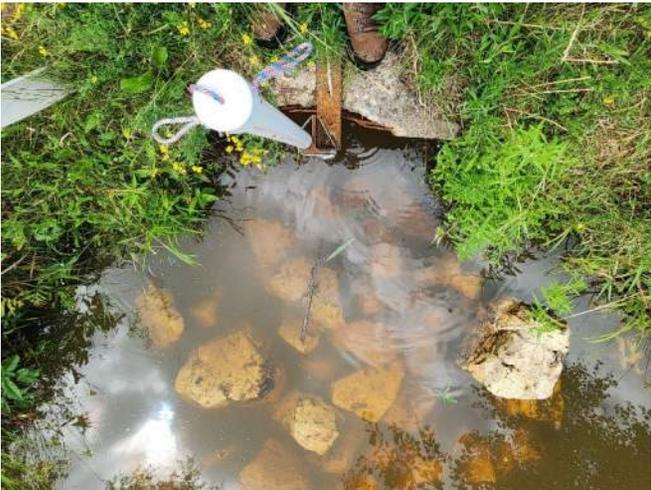
<p>Photo No. 6</p>	<p>Date: 7-28-23</p>

<p>Direction Photo Taken: East</p>			<p>Direction Photo Taken: Northeast</p>		
<p>Photo Taken By: Jim Engelhardt</p>			<p>Photo Taken By: Jim Engelhardt</p>		
<p>Description: Upstream end of culvert under Hwy 27.</p>			<p>Description: Standing water near sample point SW-NBOUT.</p>

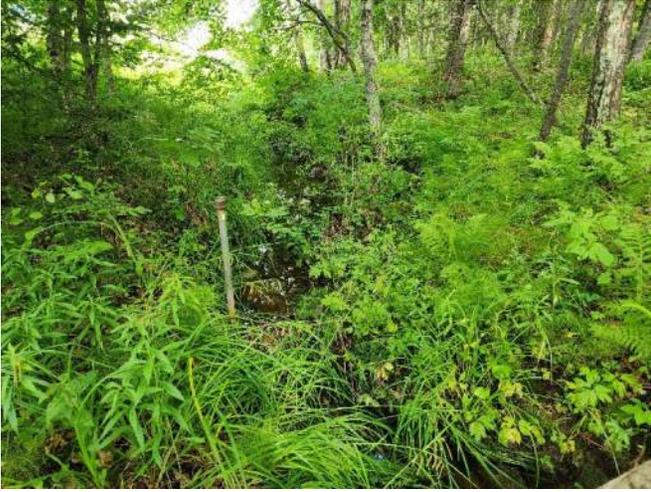
<p>Photo No. 9</p>	<p>Date: 7-28-23</p>

<p>Direction Photo Taken: East</p>			<p>Direction Photo Taken: Southwest</p>		
<p>Photo Taken By: Jim Engelhardt</p>			<p>Photo Taken By: Jim Engelhardt</p>		
<p>Description: View upstream from SW-C1.</p>			<p>Description: View downstream from SW-C1.</p>

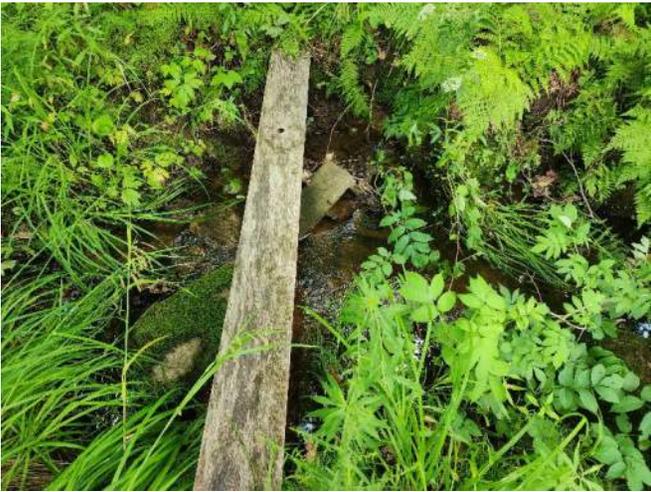
<p>Photo No. 10</p>	<p>Date: 7-28-23</p>

<p>Direction Photo Taken: South</p>			<p>Direction Photo Taken: North</p>		
<p>Photo Taken By: Jim Engelhardt</p>			<p>Photo Taken By: Jim Engelhardt</p>		
<p>Description: Flow at SW-C1.</p>			<p>Description: Flow in Steam C upstream of the Flambeau River confluence.</p>

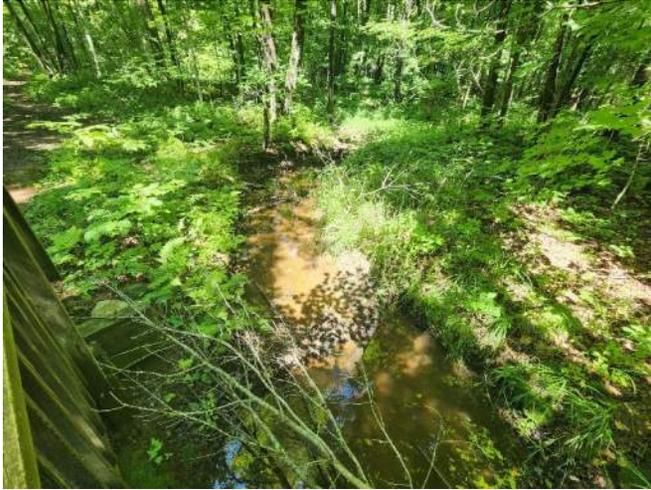
<p>Photo No. 13</p>	<p>Date: 7-20-23</p>

<p>Direction Photo Taken: South</p>			<p>Direction Photo Taken: Northeast</p>		
<p>Photo Taken By: Jim Engelhardt</p>			<p>Photo Taken By: Jim Engelhardt</p>		
<p>Description: Flow in Steam C upstream of the Flambeau River confluence.</p>			<p>Description: View downstream at SW-STM at the confluence of the Flambeau River.</p>

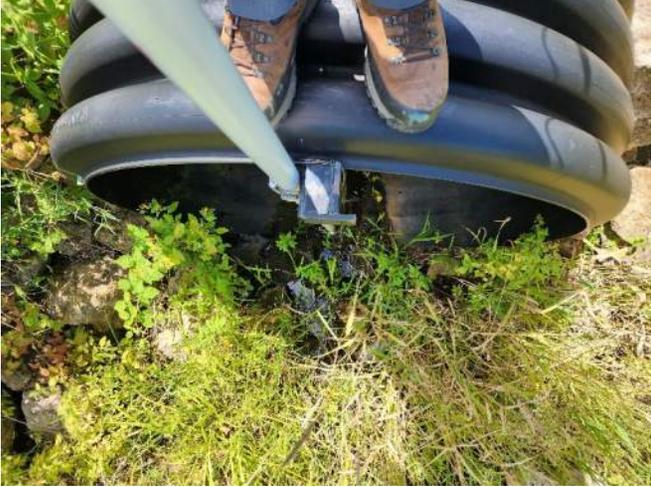
<p>Photo No. 1</p>	<p>Date: 8-15-23</p>

<p>Direction Photo Taken: North</p>			<p>Direction Photo Taken: Southwest</p>		
<p>Photo Taken By: Jim Engelhardt</p>			<p>Photo Taken By: Jim Engelhardt</p>		
<p>Description: Upstream end of culvert under Copper Park Lane.</p>			<p>Description: Downstream (west) end of culvert under Hwy 27.</p>		
<p>Photo No. 2</p>	<p>Date: 8-15-23</p>

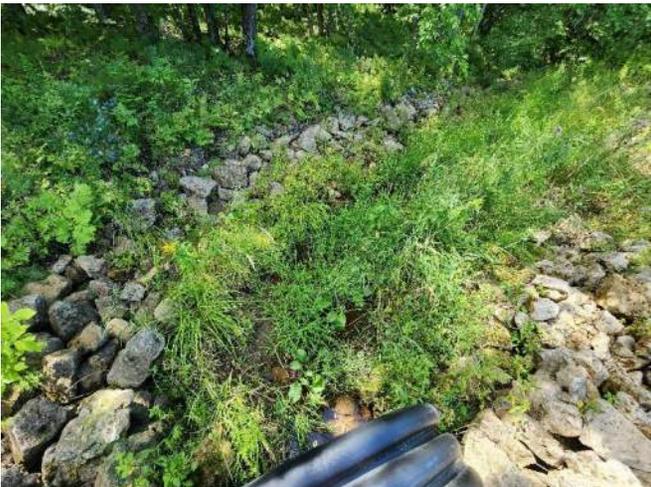
<p>Direction Photo Taken: Southwest</p>			<p>Direction Photo Taken: Northeast</p>		
<p>Photo Taken By: Jim Engelhardt</p>			<p>Photo Taken By: Jim Engelhardt</p>		
<p>Description: Downstream end of culvert under Copper Park Lane.</p>			<p>Description: Upstream (east) end of culvert under STH 27.</p>

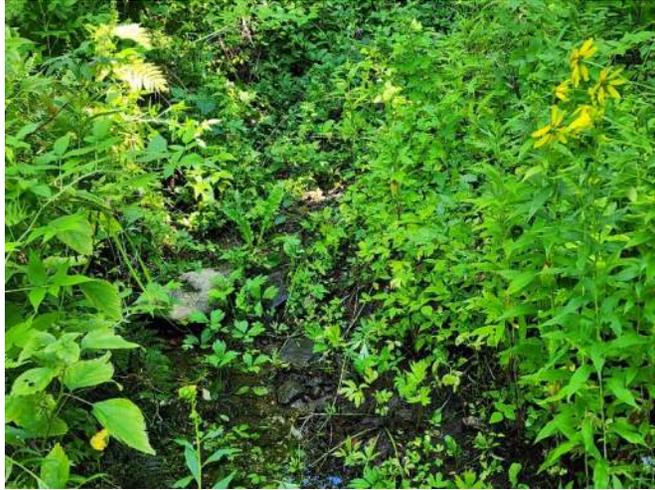
<p>Photo No. 9</p>	<p>Date: 8-15-23</p>

<p>Direction Photo Taken: West</p>			<p>Direction Photo Taken: South</p>		
<p>Photo Taken By: Jim Engelhardt</p>			<p>Photo Taken By: Jim Engelhardt</p>		
<p>Description: View upstream at SW-STM at the confluence of the Flambeau River.</p>			<p>Description: Flow in Steam C upstream of the Flambeau River confluence.</p>

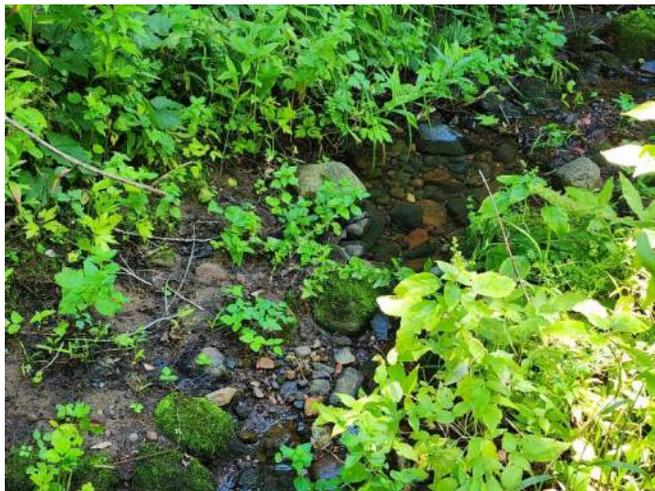
<p>Photo No. 10</p>	<p>Date: 8-15-23</p>

<p>Direction Photo Taken: Northeast</p>			<p>Direction Photo Taken: North</p>		
<p>Photo Taken By: Jim Engelhardt</p>			<p>Photo Taken By: Jim Engelhardt</p>		
<p>Description: View upstream at SW-STM at the confluence of the Flambeau River.</p>			<p>Description: Flow in Steam C upstream of the Flambeau River confluence.</p>

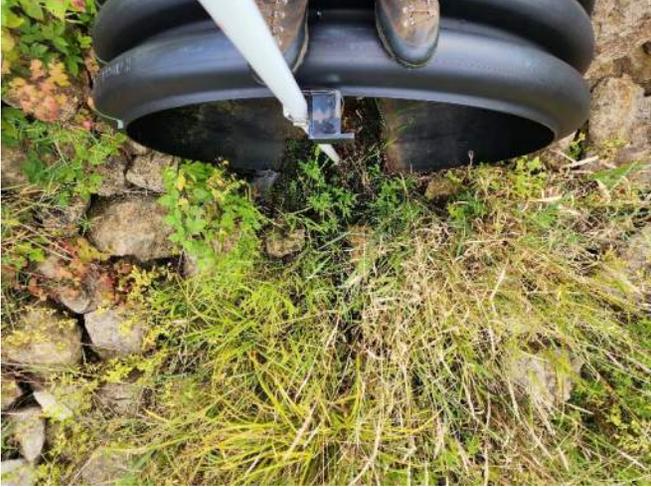
<p>Photo No. 1</p>	<p>Date: 8-29-23</p>

<p>Direction Photo Taken: North</p>			<p>Direction Photo Taken: Southwest</p>		
<p>Photo Taken By: Jim Engelhardt</p>			<p>Photo Taken By: Jim Engelhardt</p>		
<p>Description: Upstream end of culvert under Copper Park Lane.</p>			<p>Description: Downstream (west) end of culvert under Hwy 27.</p>		
<p>Photo No. 2</p>	<p>Date: 8-29-23</p>

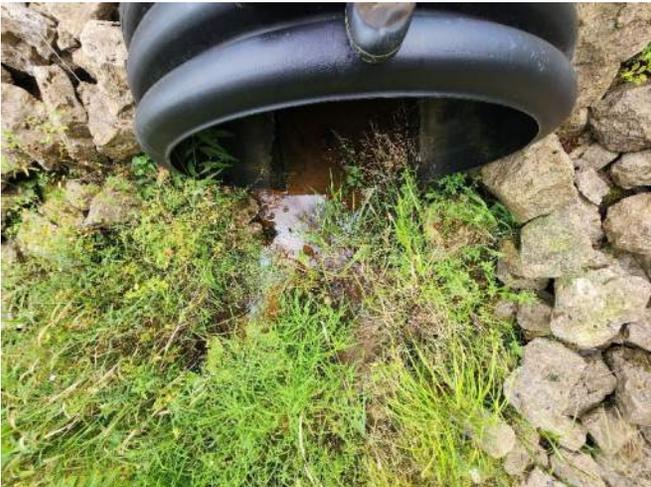
<p>Direction Photo Taken: Southwest</p>			<p>Direction Photo Taken: Northeast</p>		
<p>Photo Taken By: Jim Engelhardt</p>			<p>Photo Taken By: Jim Engelhardt</p>		
<p>Description: Downstream end of culvert under Copper Park Lane.</p>			<p>Description: Upstream (east) end of culvert under STH 27.</p>

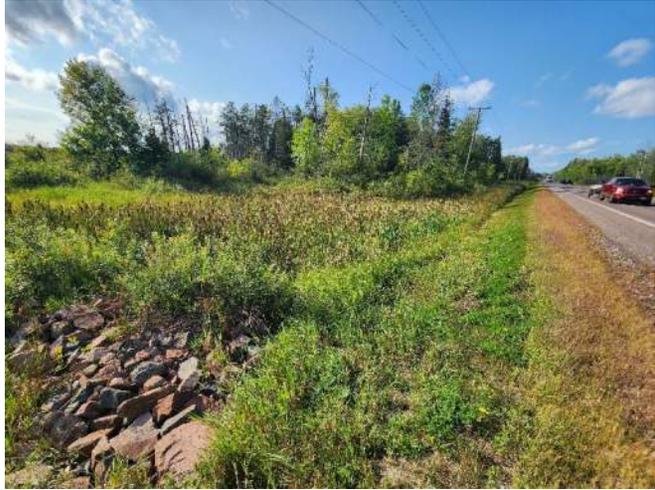
<p>Photo No. 5</p>	<p>Date: 8-29-23</p>

<p>Direction Photo Taken: North</p>		<p>Direction Photo Taken: Southwest</p>			
<p>Photo Taken By: Jim Engelhardt</p>		<p>Photo Taken By: Jim Engelhardt</p>			
<p>Description: Ditch along West side of Hwy 27 north of culvert.</p>		<p>Description: Stream C downstream of the Cooper Park Lane culvert.</p>

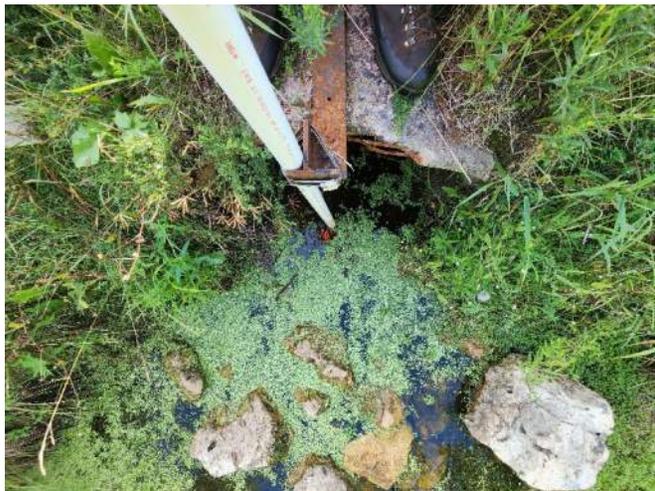
<p>Photo No. 6</p>	<p>Date: 8-29-23</p>

<p>Direction Photo Taken: East</p>		<p>Direction Photo Taken: Northeast</p>			
<p>Photo Taken By: Jim Engelhardt</p>		<p>Photo Taken By: Jim Engelhardt</p>			
<p>Description: Upstream end of culvert under Hwy 27.</p>		<p>Description: Standing water near sample point SW-NBOUT.</p>

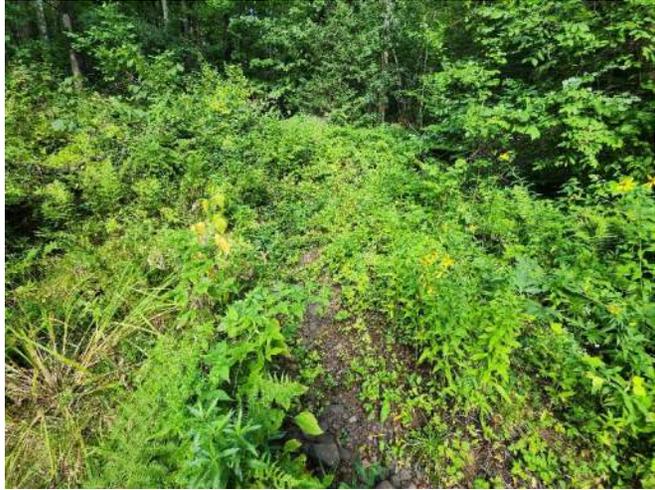
<p>Photo No. 9</p>	<p>Date: 8-29-23</p>

<p>Direction Photo Taken: West</p>			<p>Direction Photo Taken: South</p>		
<p>Photo Taken By: Jim Engelhardt</p>			<p>Photo Taken By: Jim Engelhardt</p>		
<p>Description: View upstream at SW-STM at the confluence of the Flambeau River.</p>			<p>Description: Flow in Steam C upstream of the Flambeau River confluence.</p>

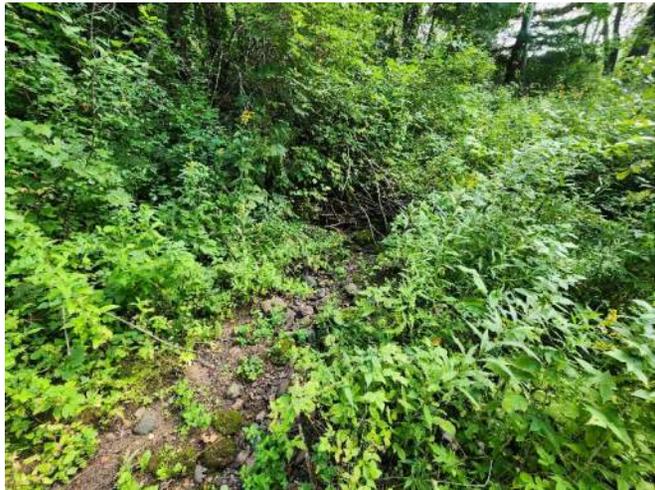
<p>Photo No. 10</p>	<p>Date: 8-29-23</p>

<p>Direction Photo Taken: Northeast</p>			<p>Direction Photo Taken: North</p>		
<p>Photo Taken By: Jim Engelhardt</p>			<p>Photo Taken By: Jim Engelhardt</p>		
<p>Description: View upstream at SW-STM at the confluence of the Flambeau River.</p>			<p>Description: Flow in Steam C upstream of the Flambeau River confluence.</p>

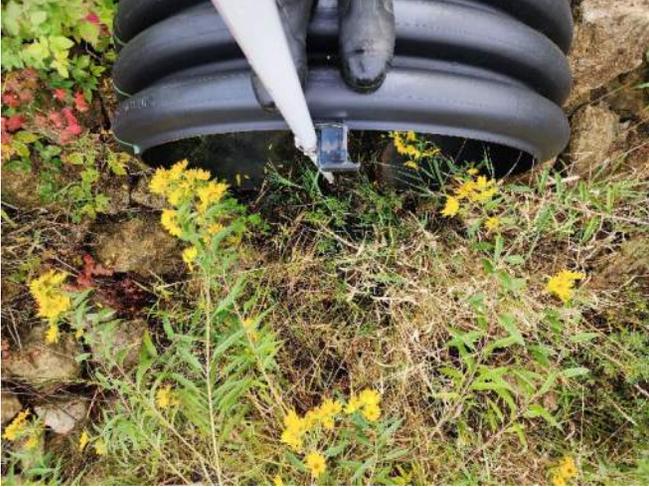
<p>Photo No. 1</p>	<p>Date: 9-15-23</p>

<p>Direction Photo Taken: North</p>		<p>Direction Photo Taken: Southwest</p>			
<p>Photo Taken By: Jim Engelhardt</p>		<p>Photo Taken By: Jim Engelhardt</p>			
<p>Description: Upstream end of culvert under Copper Park Lane.</p>		<p>Description: Downstream (west) end of culvert under Hwy 27.</p>			
<p>Photo No. 2</p>	<p>Date: 9-15-23</p>

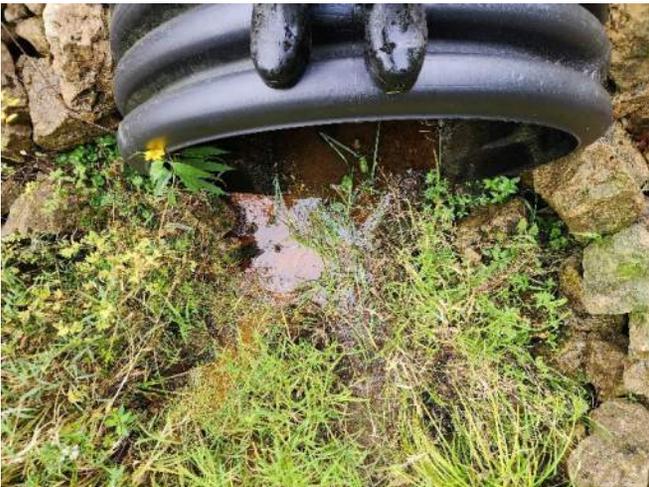
<p>Photo No. 4</p>	<p>Date: 9-15-23</p>

<p>Direction Photo Taken: Southwest</p>		<p>Direction Photo Taken: Northeast</p>			
<p>Photo Taken By: Jim Engelhardt</p>		<p>Photo Taken By: Jim Engelhardt</p>			
<p>Description: Downstream end of culvert under Copper Park Lane.</p>		<p>Description: Upstream (east) end of culvert under STH 27.</p>

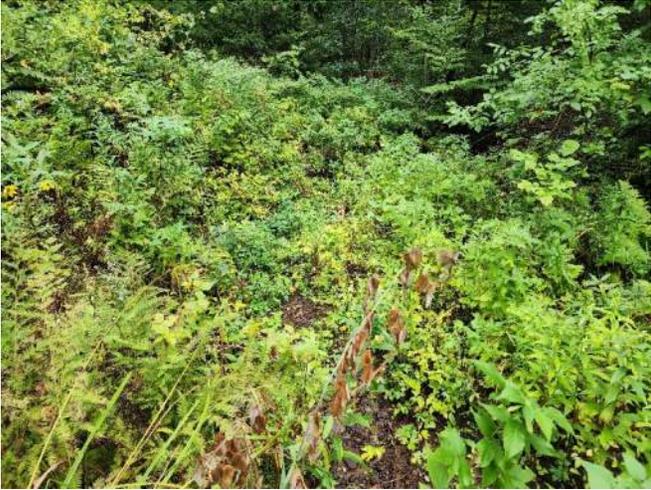
<p>Photo No. 9</p>	<p>Date: 9-15-23</p>

<p>Direction Photo Taken: West</p>			<p>Direction Photo Taken: South</p>		
<p>Photo Taken By: Jim Engelhardt</p>			<p>Photo Taken By: Jim Engelhardt</p>		
<p>Description: View upstream at SW-STM at the confluence of the Flambeau River.</p>			<p>Description: Flow in Steam C upstream of the Flambeau River confluence.</p>		
<p>Photo No. 10</p>	<p>Date: 9-15-23</p>

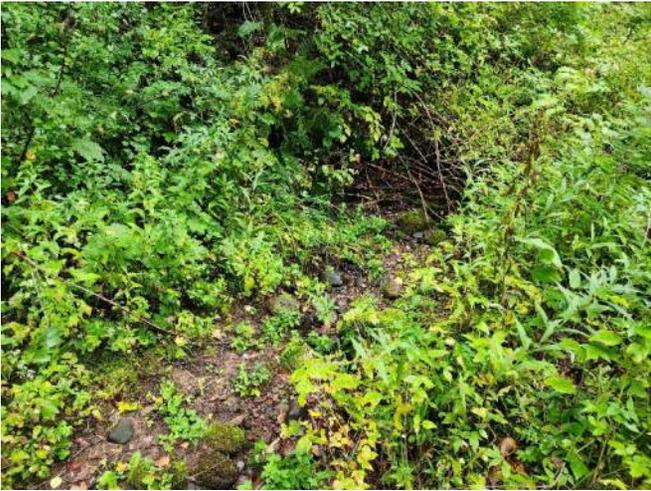
<p>Direction Photo Taken: Northeast</p>			<p>Direction Photo Taken: North</p>		
<p>Photo Taken By: Jim Engelhardt</p>			<p>Photo Taken By: Jim Engelhardt</p>		
<p>Description: View upstream at SW-STM at the confluence of the Flambeau River.</p>			<p>Description: Flow in Steam C upstream of the Flambeau River confluence.</p>

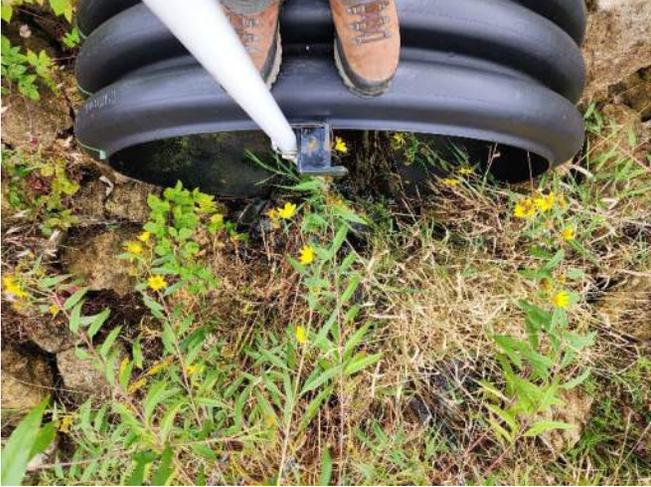
<p>Photo No. 1</p>	<p>Date: 9-25-23</p>

<p>Direction Photo Taken: North</p>			<p>Direction Photo Taken: Southwest</p>		
<p>Photo Taken By: Jim Engelhardt</p>			<p>Photo Taken By: Jim Engelhardt</p>		
<p>Description: Upstream end of culvert under Copper Park Lane.</p>			<p>Description: Downstream (west) end of culvert under Hwy 27.</p>		
<p>Photo No. 2</p>	<p>Date: 9-25-23</p>

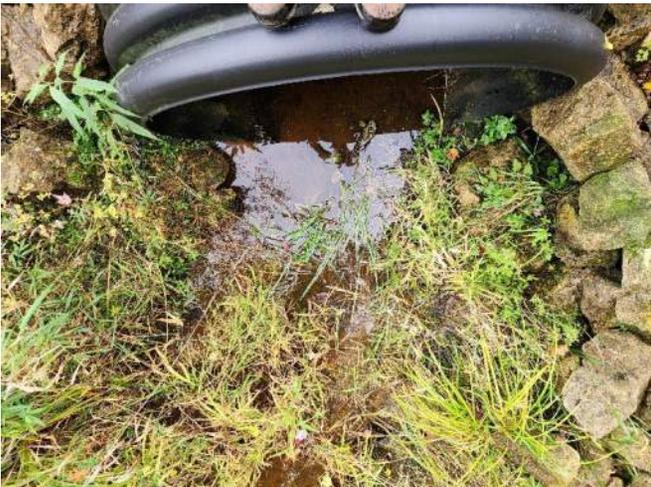
<p>Direction Photo Taken: Southwest</p>			<p>Direction Photo Taken: Northeast</p>		
<p>Photo Taken By: Jim Engelhardt</p>			<p>Photo Taken By: Jim Engelhardt</p>		
<p>Description: Downstream end of culvert under Copper Park Lane.</p>			<p>Description: Upstream (east) end of culvert under STH 27.</p>

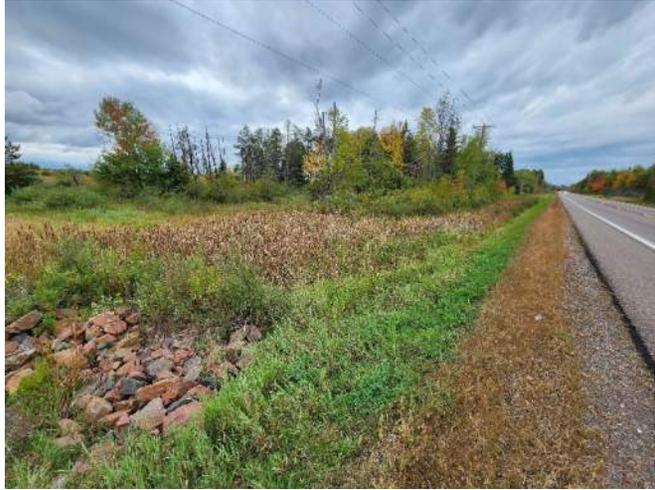
<p>Photo No. 5</p>	<p>Date: 9-25-23</p>

<p>Direction Photo Taken: North</p>		<p>Direction Photo Taken: Southwest</p>			
<p>Photo Taken By: Jim Engelhardt</p>		<p>Photo Taken By: Jim Engelhardt</p>			
<p>Description: Ditch along West side of Hwy 27 north of culvert.</p>		<p>Description: Stream C downstream of the Cooper Park Lane culvert.</p>

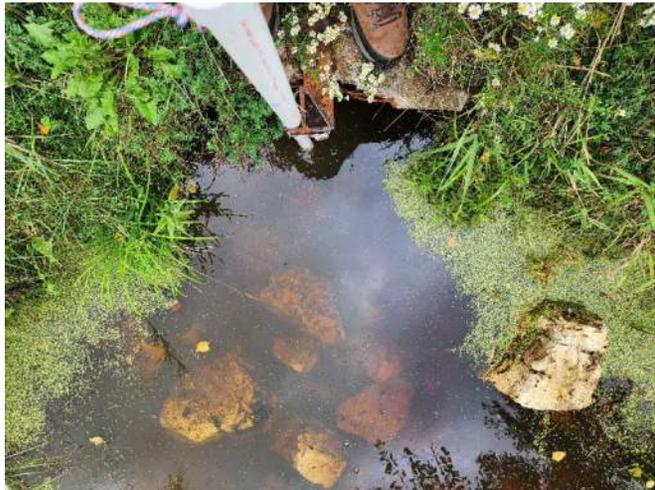
<p>Photo No. 6</p>	<p>Date: 9-25-23</p>

<p>Direction Photo Taken: East</p>		<p>Direction Photo Taken: North</p>			
<p>Photo Taken By: Jim Engelhardt</p>		<p>Photo Taken By: Jim Engelhardt</p>			
<p>Description: Upstream end of culvert under Hwy 27.</p>		<p>Description: View from upstream end of culvert under Copper Park Lane.</p>

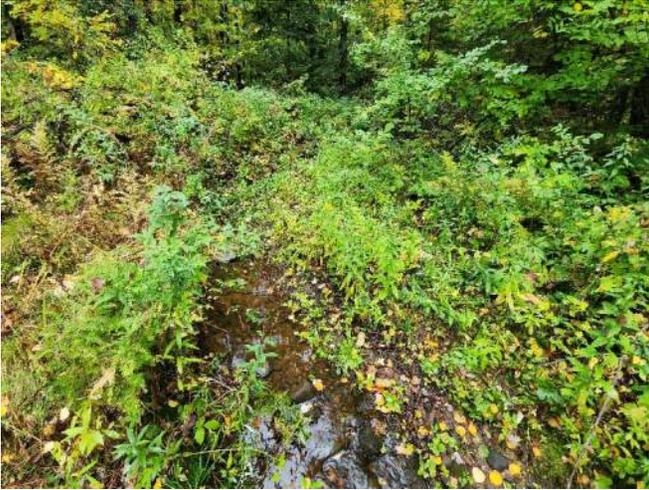
<p>Photo No. 9</p>	<p>Date: 9-25-23</p>

<p>Direction Photo Taken: West</p>			<p>Direction Photo Taken: South</p>		
<p>Photo Taken By: Jim Engelhardt</p>			<p>Photo Taken By: Jim Engelhardt</p>		
<p>Description: View upstream at SW-STM at the confluence of the Flambeau River.</p>			<p>Description: Flow in Steam C upstream of the Flambeau River confluence.</p>		
<p>Photo No. 10</p>	<p>Date: 9-25-23</p>

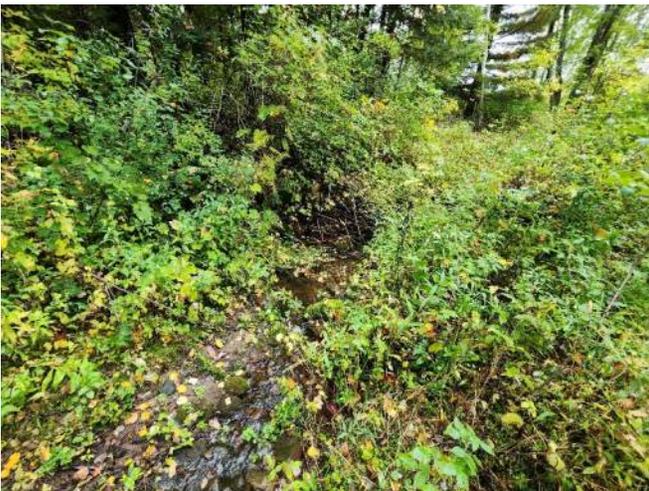
<p>Direction Photo Taken: Northeast</p>			<p>Direction Photo Taken: North</p>		
<p>Photo Taken By: Jim Engelhardt</p>			<p>Photo Taken By: Jim Engelhardt</p>		
<p>Description: View upstream at SW-STM at the confluence of the Flambeau River.</p>			<p>Description: Flow in Steam C upstream of the Flambeau River confluence.</p>

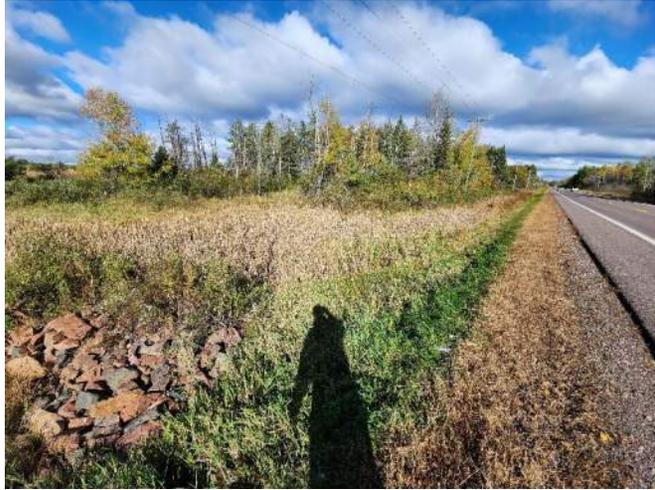
<p>Photo No. 5</p>	<p>Date: 10-14-23</p>

<p>Direction Photo Taken: North</p>		<p>Direction Photo Taken: Southwest</p>			
<p>Photo Taken By: Jim Engelhardt</p>		<p>Photo Taken By: Jim Engelhardt</p>			
<p>Description: Ditch along West side of Hwy 27 north of culvert.</p>		<p>Description: Stream C downstream of the Cooper Park Lane culvert.</p>

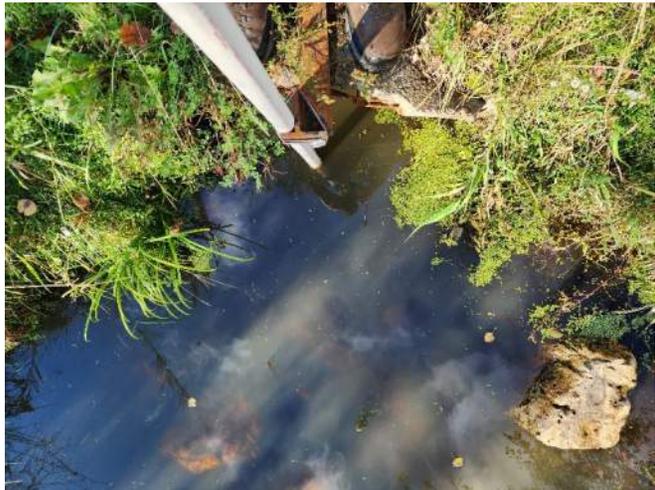
<p>Photo No. 6</p>	<p>Date: 10-14-23</p>

<p>Direction Photo Taken: East</p>		<p>Direction Photo Taken: North</p>			
<p>Photo Taken By: Jim Engelhardt</p>		<p>Photo Taken By: Jim Engelhardt</p>			
<p>Description: Upstream end of culvert under Hwy 27.</p>		<p>Description: View from upstream end of culvert under Copper Park Lane.</p>

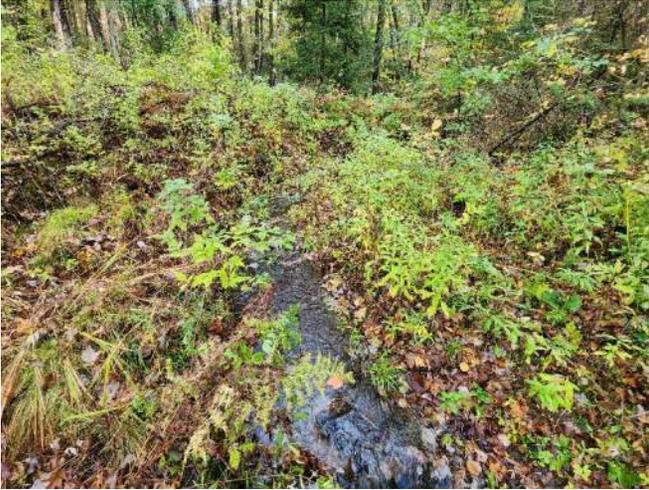
<p>Photo No. 9</p>	<p>Date: 10-14-23</p>

<p>Direction Photo Taken: West</p>			<p>Direction Photo Taken: South</p>		
<p>Photo Taken By: Jim Engelhardt</p>			<p>Photo Taken By: Jim Engelhardt</p>		
<p>Description: View upstream at SW-STM at the confluence of the Flambeau River.</p>			<p>Description: Flow in Steam C upstream of the Flambeau River confluence.</p>		
<p>Photo No. 10</p>	<p>Date: 10-14-23</p>

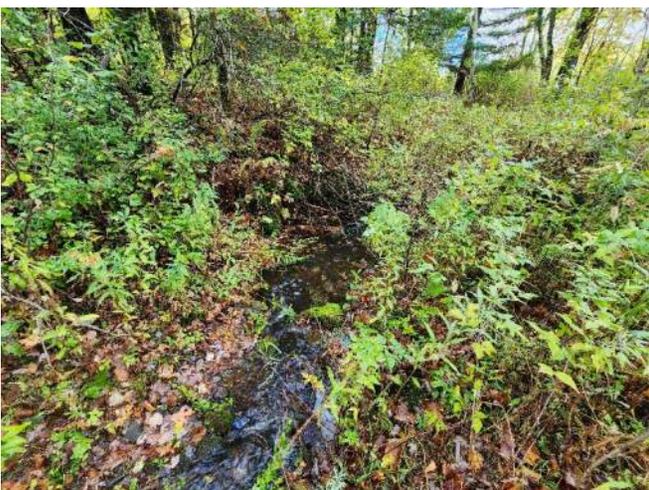
<p>Direction Photo Taken: Northeast</p>			<p>Direction Photo Taken: North</p>		
<p>Photo Taken By: Jim Engelhardt</p>			<p>Photo Taken By: Jim Engelhardt</p>		
<p>Description: View upstream at SW-STM at the confluence of the Flambeau River.</p>			<p>Description: Flow in Steam C upstream of the Flambeau River confluence.</p>
