A-14 Tri Co/Cheese Country Bridge #7

Project Title Cheese Country Trail Bridge #7 Replacement					Current Funded Miles	New Miles (if applicable)
County Lafayette	Township 04 N	Range 3	Section 31	¼ ¼ NW	¼ SW	GPS Coordinates: Lat. 42.778328 Long. -90.188072

Inspection Report for

Cheese Country Trail over Unnamed Stream

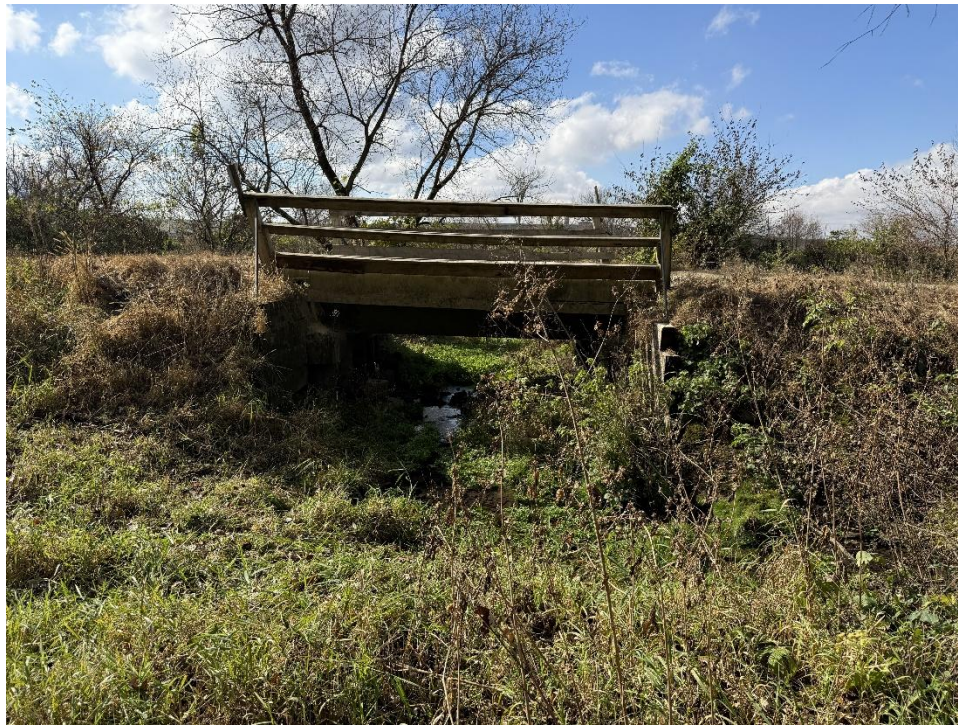
Bridge #7

- Advanced decay of timber components throughout structure. **Crushing timber beams are indicative of overload distress.**

- **Bridge should be evaluated for structural capacity posted for load at the most restrictive allowable limit.**
- Schedule for complete replacement as soon as possible.
