A-17 Lincoln Co Hilt Lake Bridge Rehab

Project Title Hilt Lake Summer ATV UTV Bridge Rehab					Current Funded Miles 47.4	New Miles (if applicable)
County Lincoln	Township 35 N	Range 8	Section 14	¼ ¼ NW	¼ SE	GPS Coordinates: Lat. 45.515 Long. -89.457

Trail Bridge Inspection

Bailey Trail Bridge

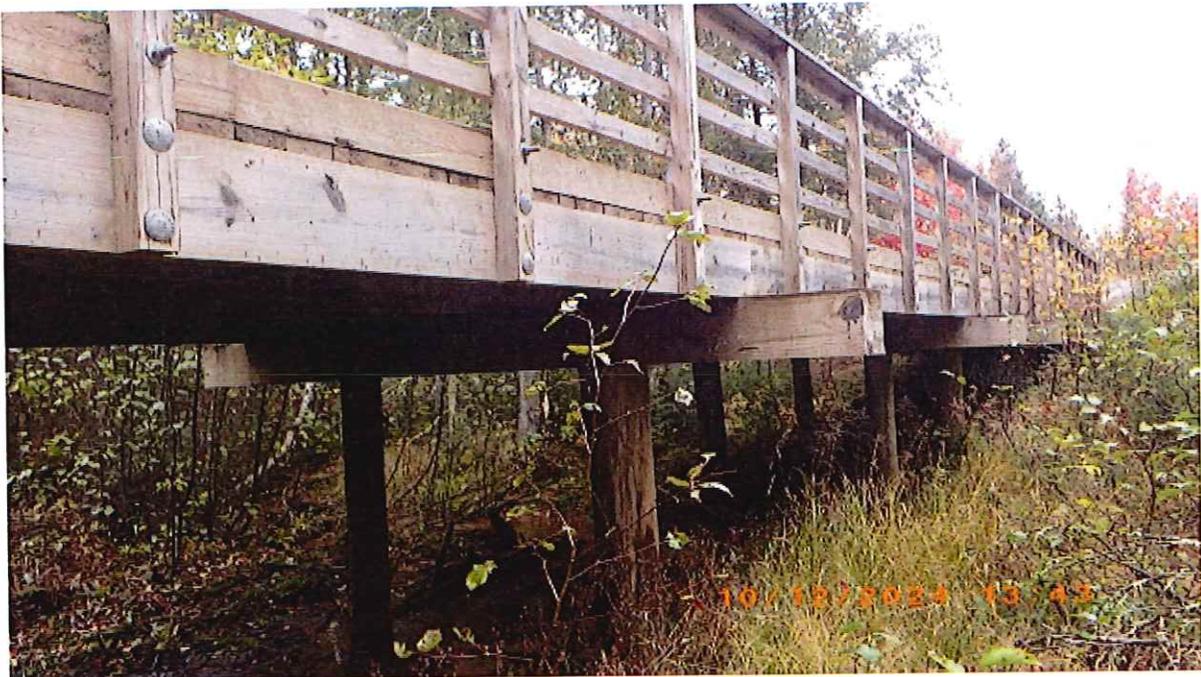
Wearing surface has CS3 wear at center and scattered sections that are CS4, completely rotten or gone. Edges are gravel covered.

Decking has widespread CS3 black / white rot. No drainage under curbs.

Stringers have widespread black mold staining, sounded solid, but will begin to rot soon, CS2.

Channel is in good condition. There is a tree over the stream downstream.

Overall Condition Poor

- Replace entire deck / wearing surface
- Highly recommend load rating superstructure before redecking. (questionable capacity for groomers by inspection)
- Clean deck
- Add scupper blocks under curbs for drainage
