**S-05 Tri-Co (North) Fish Creek Bridge 2 ORIGINAL APPLICATION**

**Motorized Recreation Grant Application**

Project Title Fish Creek Bridge #2					Current Funded Miles 61.2	New Miles (if applicable)
County Bayfield	Township N	Range O E O W	Section ¼ ¼	¼	GPS Coordinates: Lat. 46.572323 Long. -90.95305

TRI-COUNTY CORRIDOR OVER S FISH CREEK

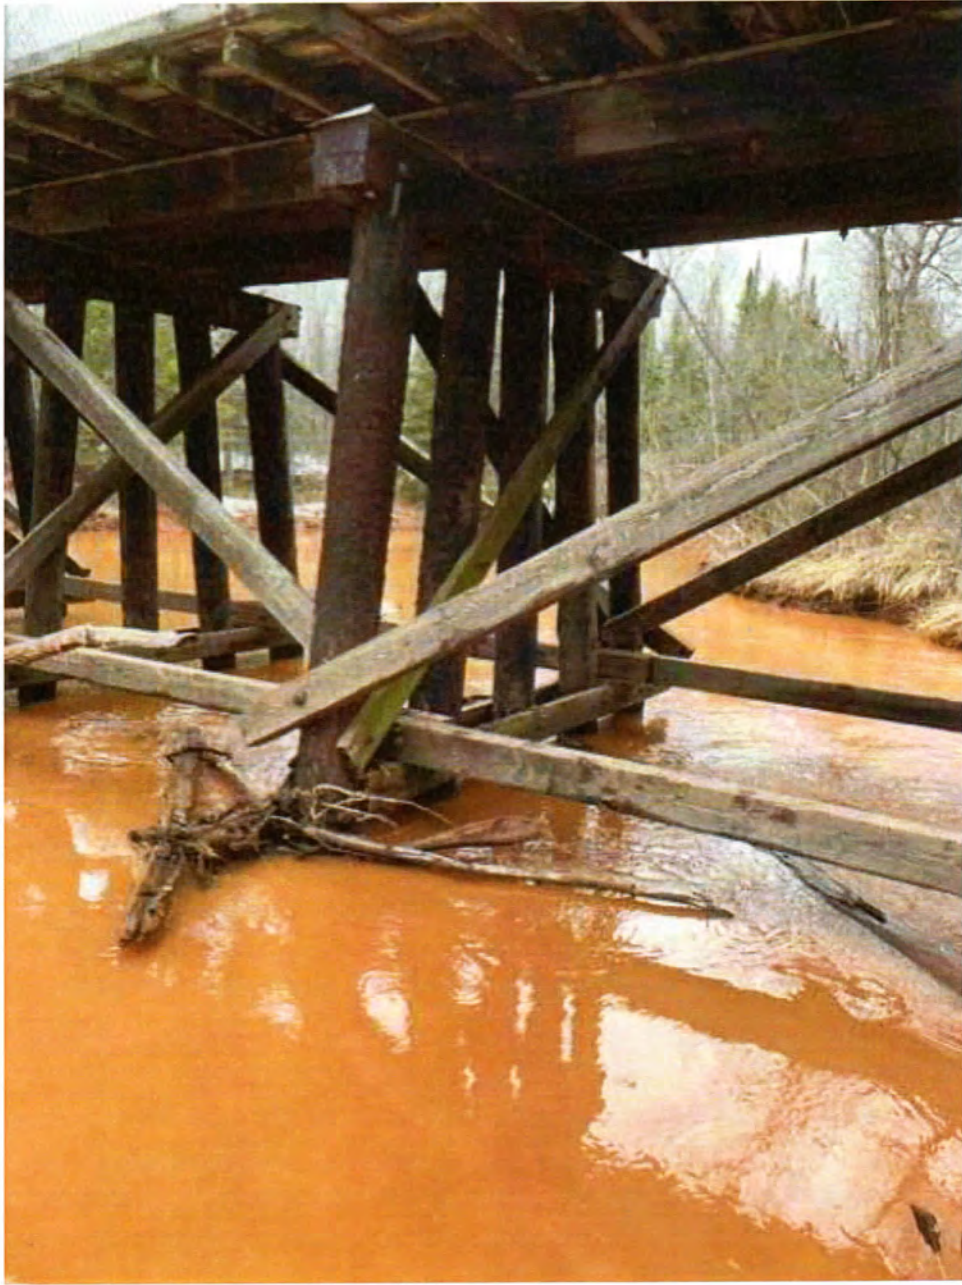
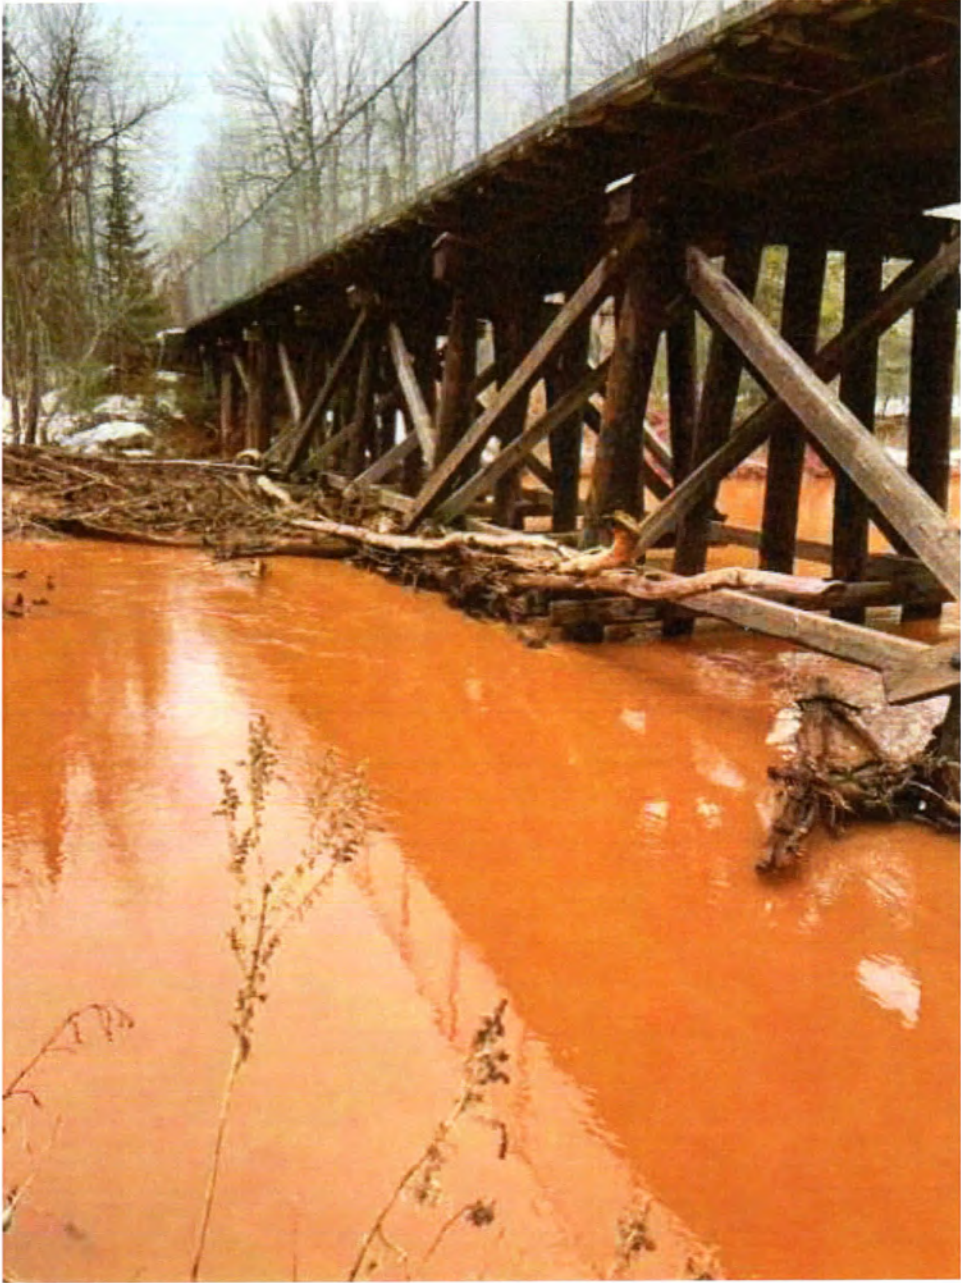
This bridge decking is loose due to deteriorated wood underneath the decking that is unsuitable to attach to. the wood below the deck is rotted and will no longer allow lag screws to attach and hold the deck boards. Many of them have come loose on one end or the other and some on both ends only held by the middle screws.

Due to pilings under the bridge, debris piles up on the up river side of the bridge causing wear on the pilings. The current pilings are worn at or below the waterline weakening them.

I have attached pictures of the bridge and debris piling up underneath it. I would need to remove some decking to get pictures of the rotten boards the decking attaches to, due to the poor condition of the sub deck I did not want to do this for fear that I would not be able to reattach the decking. If this is something that you wish us to do we will gladly do this. It was really difficult to show the poor condition in the pictures as all deck boards are missing screws and most boards are loose due to nothing solid to attach them to. My fear is a board popping up and causing damage and/or injury to a trail user.
