#### S-7 Vilas Sucker Creek Culvert

# Trail Bridge Inspection Vilas County

Bridge Name Vilas 39

Prepared By KBIS, LLC

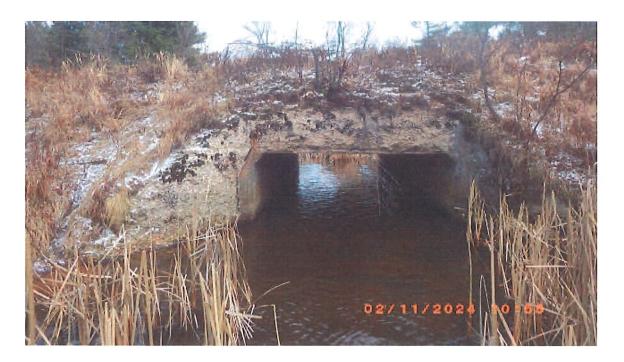
Bridge # 39

All signs have CS2 map cracking or minor damage.

West end of the box culvert and wingwalls have extensive spalls. Borderline CS4, with the amount of section loss. NW wingwall is missing 1/2 of its thickness.

The box has CS2 scaling on the wetted perimeter. There is moderate spalling at the top of the east end of box. Channel has a highway culvert and low head dam immediately upstream.

Overall Condition Poor

Inspect on a regular schedule of 48 months. Monitor the spalls on the West end of the structure. Maintain proper drainage above the structure on the roadway. CUT BRUSH AROUND THE ENTIRE STRUCTURE ANNUALLY
