S-11 Forest NST Peshtigo River Bridge

Project Title NST Peshtigo River Bridge Replacement					Current Funded Miles	New Miles (if applicable)
County Forest	Township 37 N	Range 14	<div style="display: flex; align-items: center;"> <div style="margin-right: 5px;"><input checked="" type="radio"/> E</div> <div style="margin-right: 5px;"><input type="radio"/> W</div> </div>	Section 24	1/4 1/4 1/4	GPS Coordinates: Lat. 45.68005 Long. -88.67886

Bridge Inspection Report

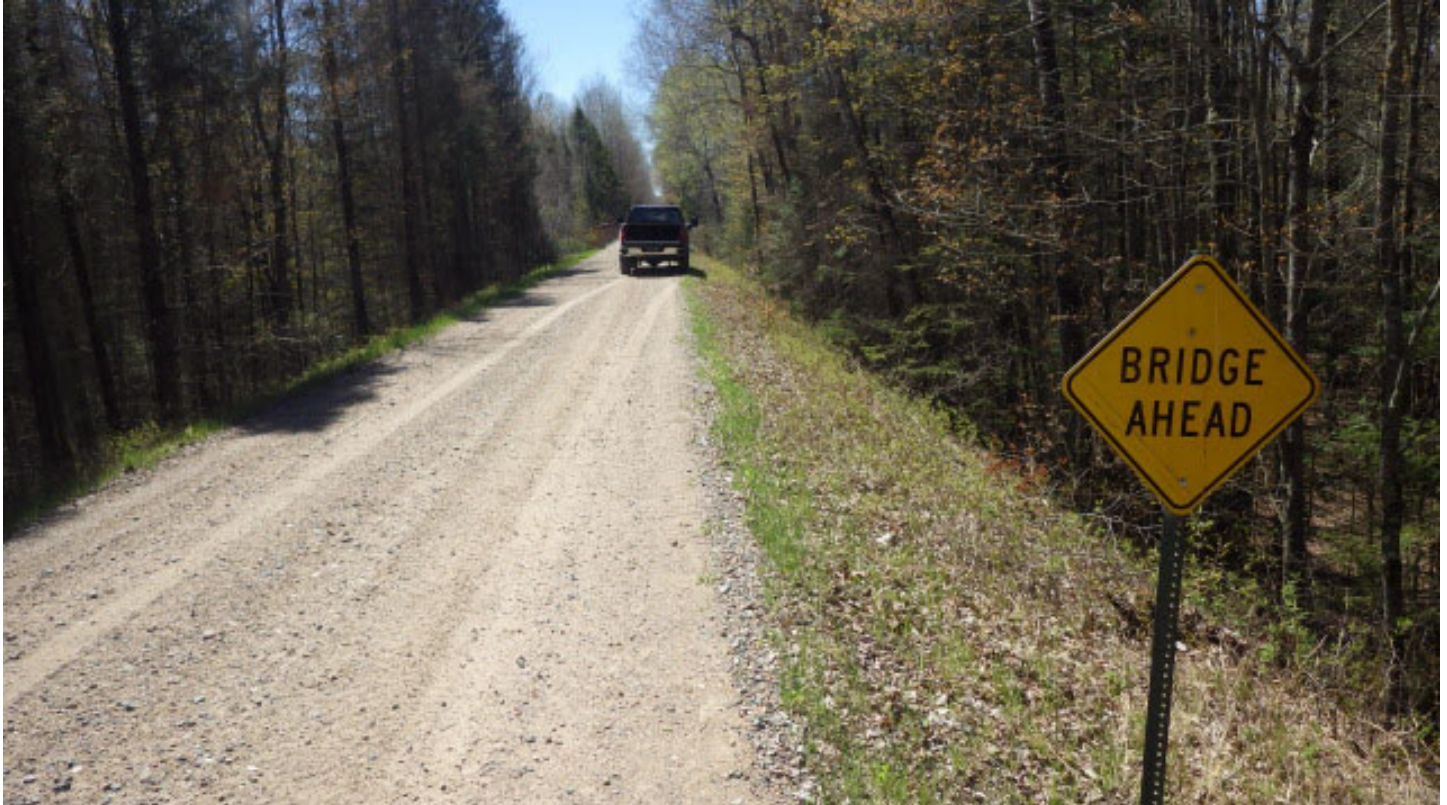
Approaches are in good condition. Object markers are in place and serviceable. Both bridge ahead signs are in place and serviceable.

North bridge ahead sign

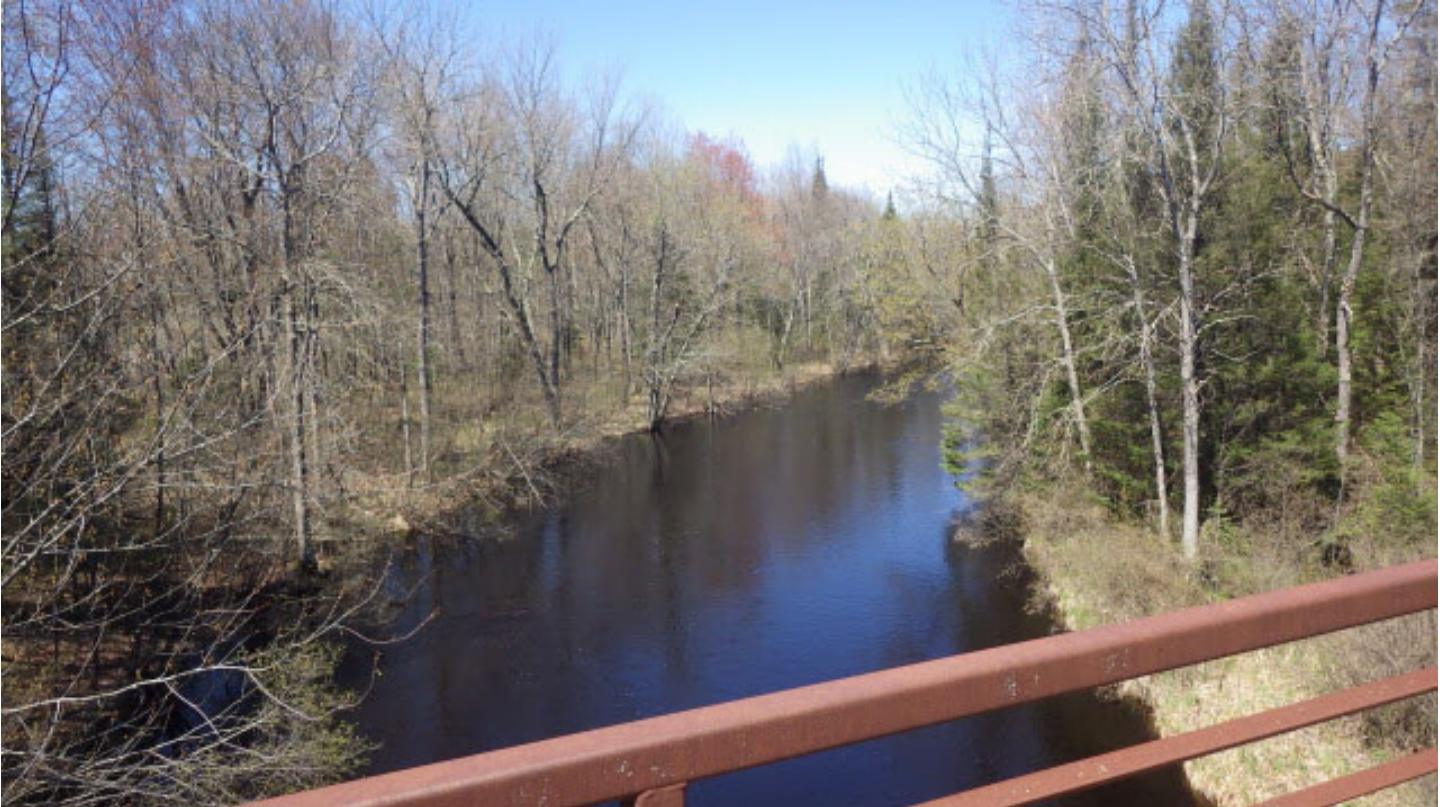
Channel is in good condition with lots of trees and brush in floodplain under bridge.

Channel looking upstream
