S-19 Tri Co/Cheese Country Bridge #35

**Motorized Recreation Grant Application**

## Inspection Report for

**Bridge #35**

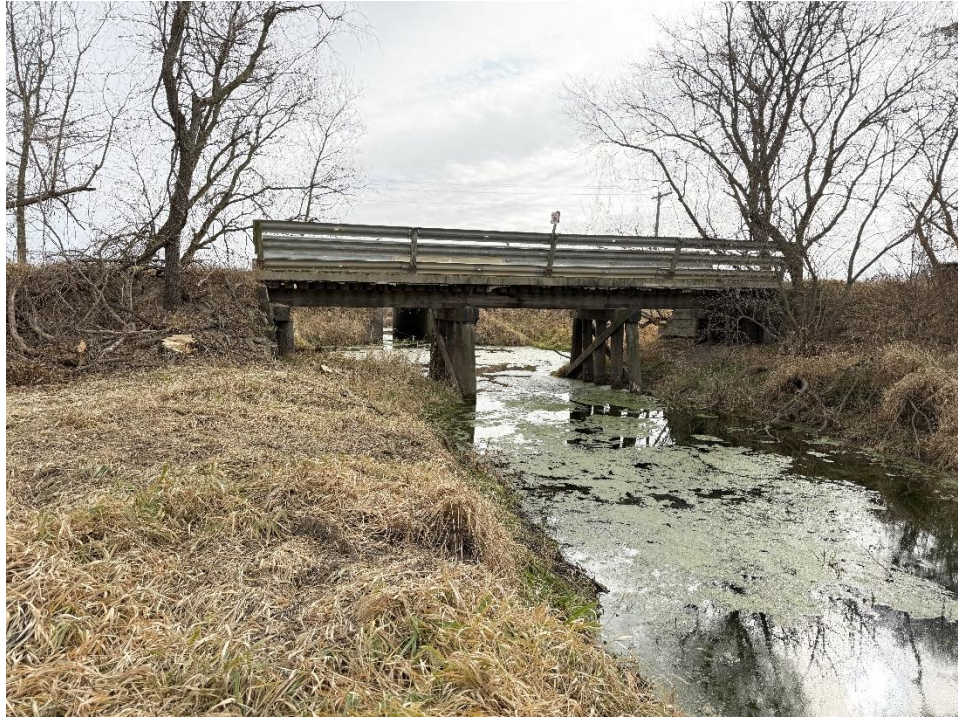
**Executive Summary****Recommended Inspection Frequency:**

- Not Applicable – **Recommend Immediate Closure.**

- The bridge has reached the end of its remaining serviceable life.
- The required efforts to repair the pier are likely not economically feasible given the condition of the bridge.

- The pile cap in the west pier is severely decayed, has split vertically across the length of the cap, separated 3", and is crushing over the adjacent piles.
