S-30 Cost Increase Request for Lynx Creek Bridge

Trail Bridge Inspection

Vilas 1

Bridge Inspection Report

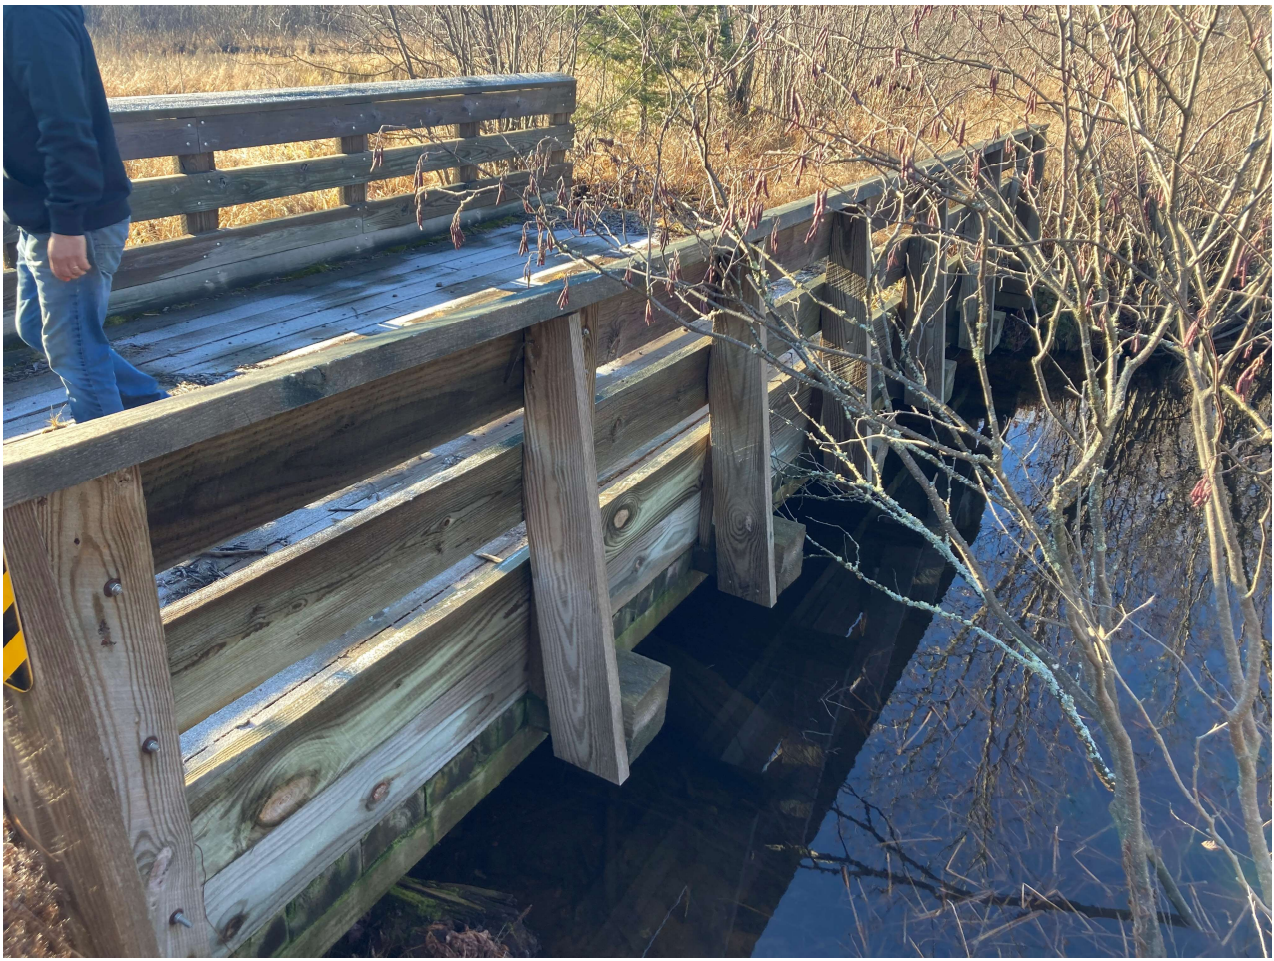
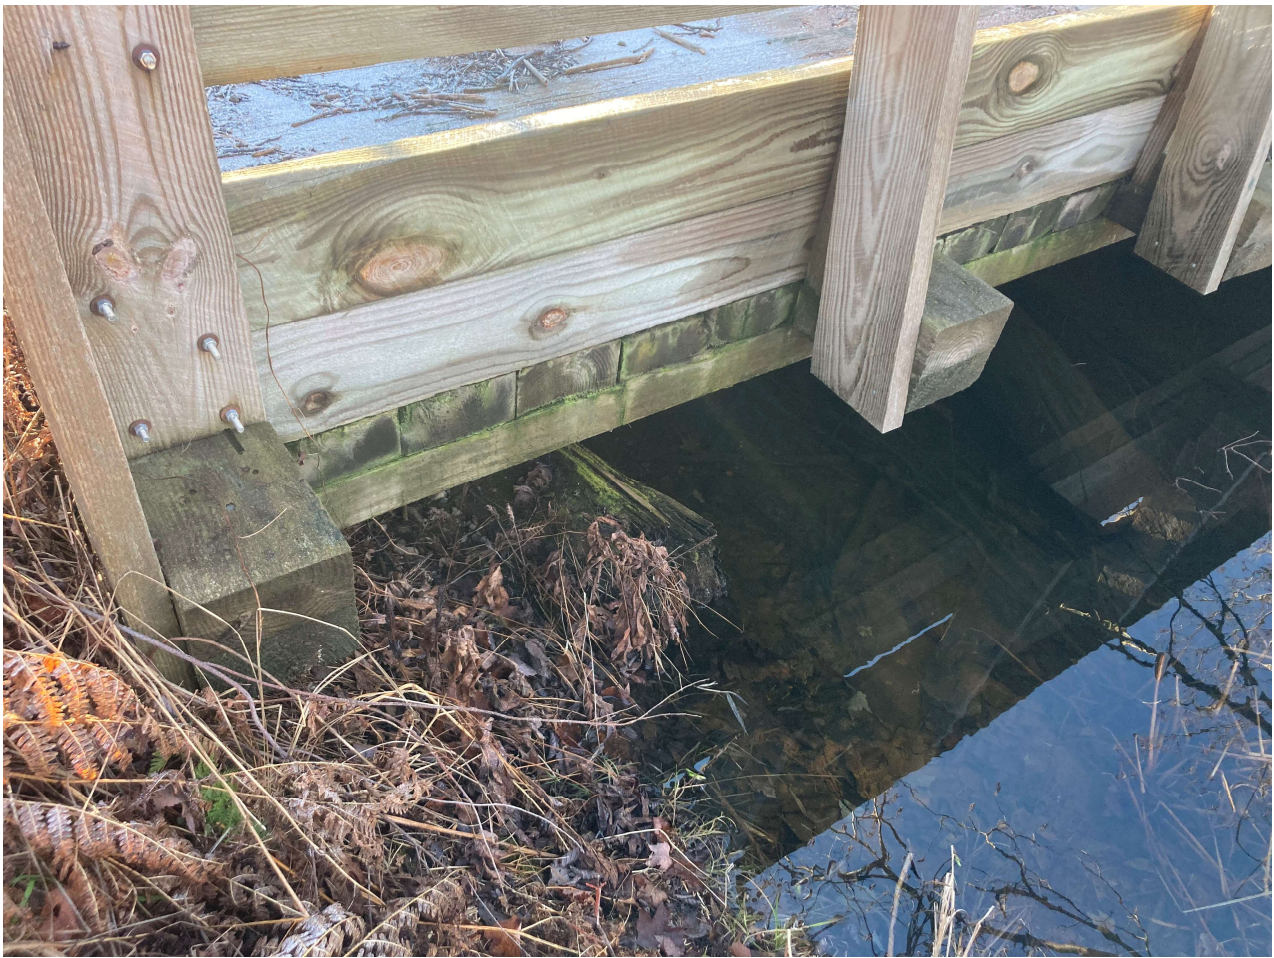
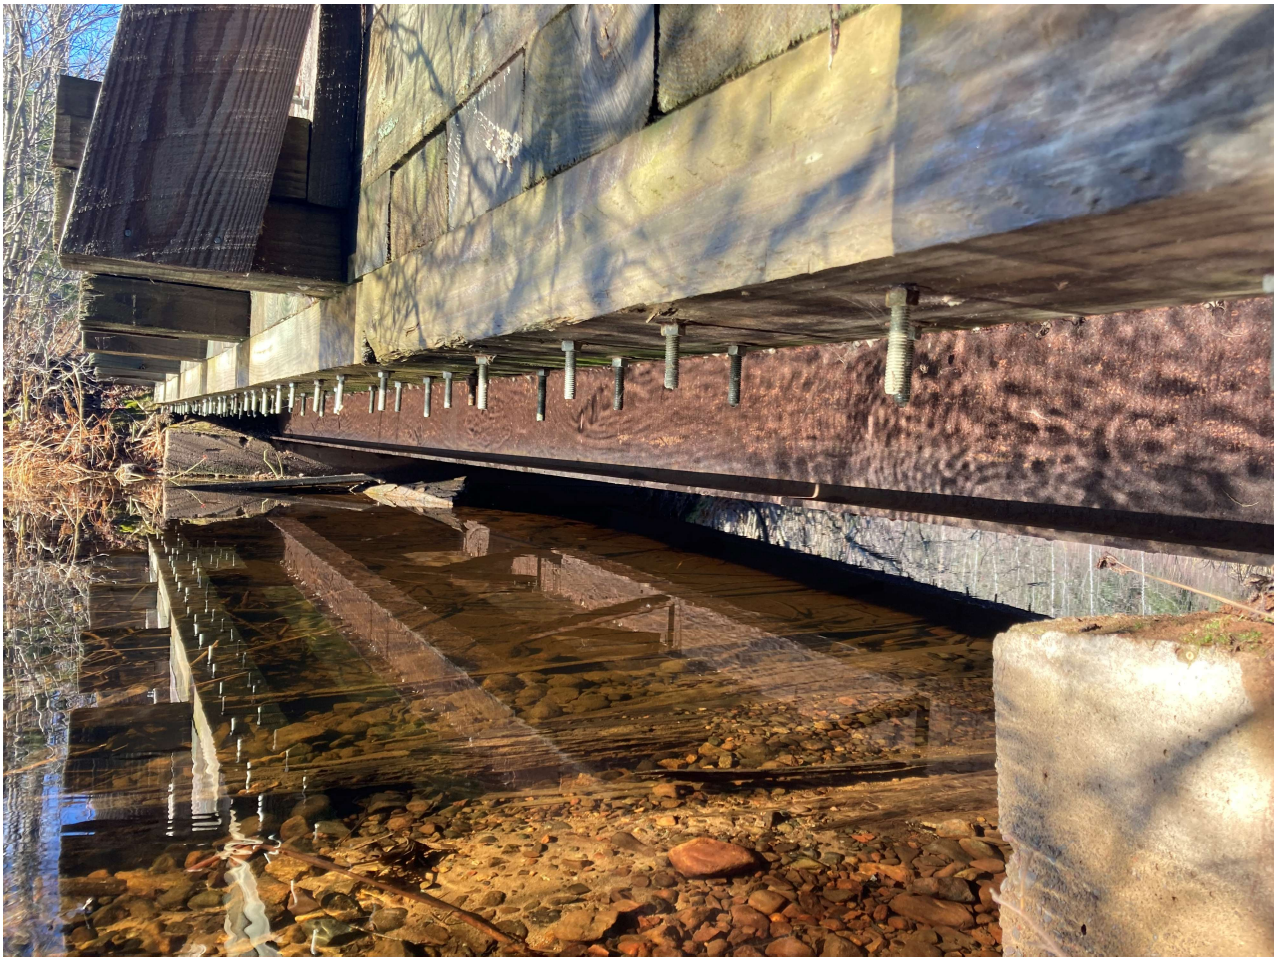
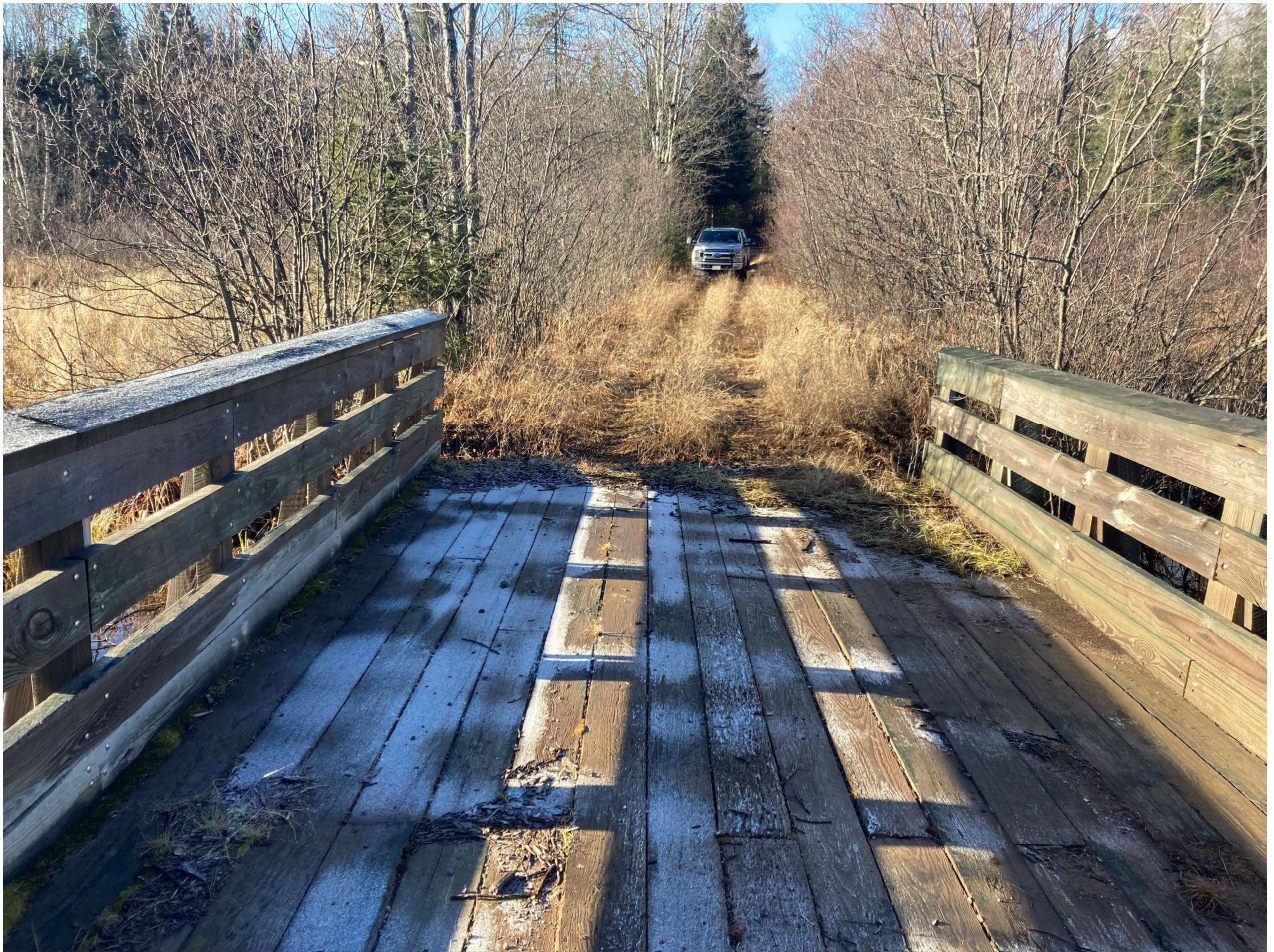
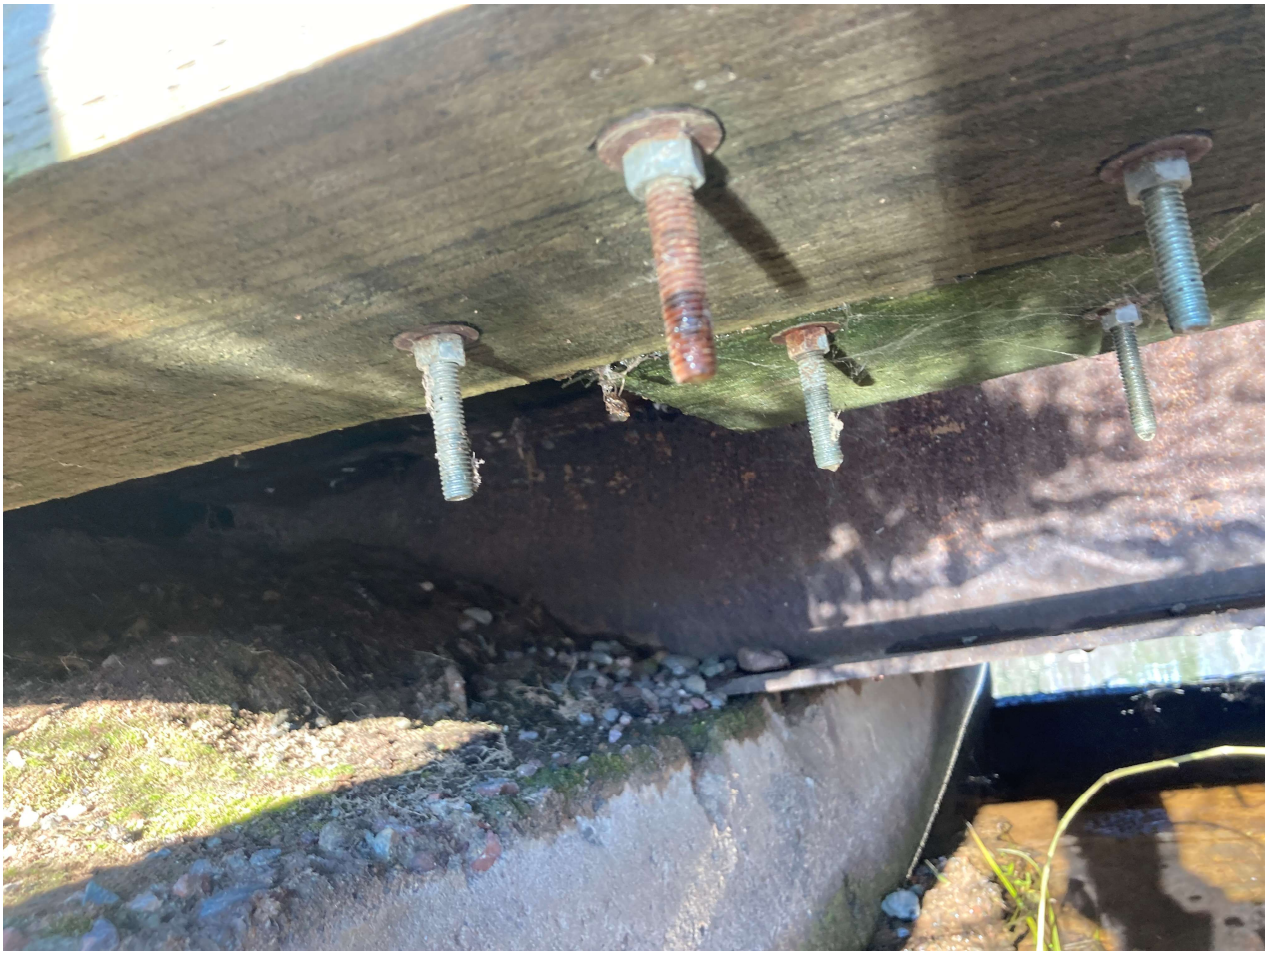
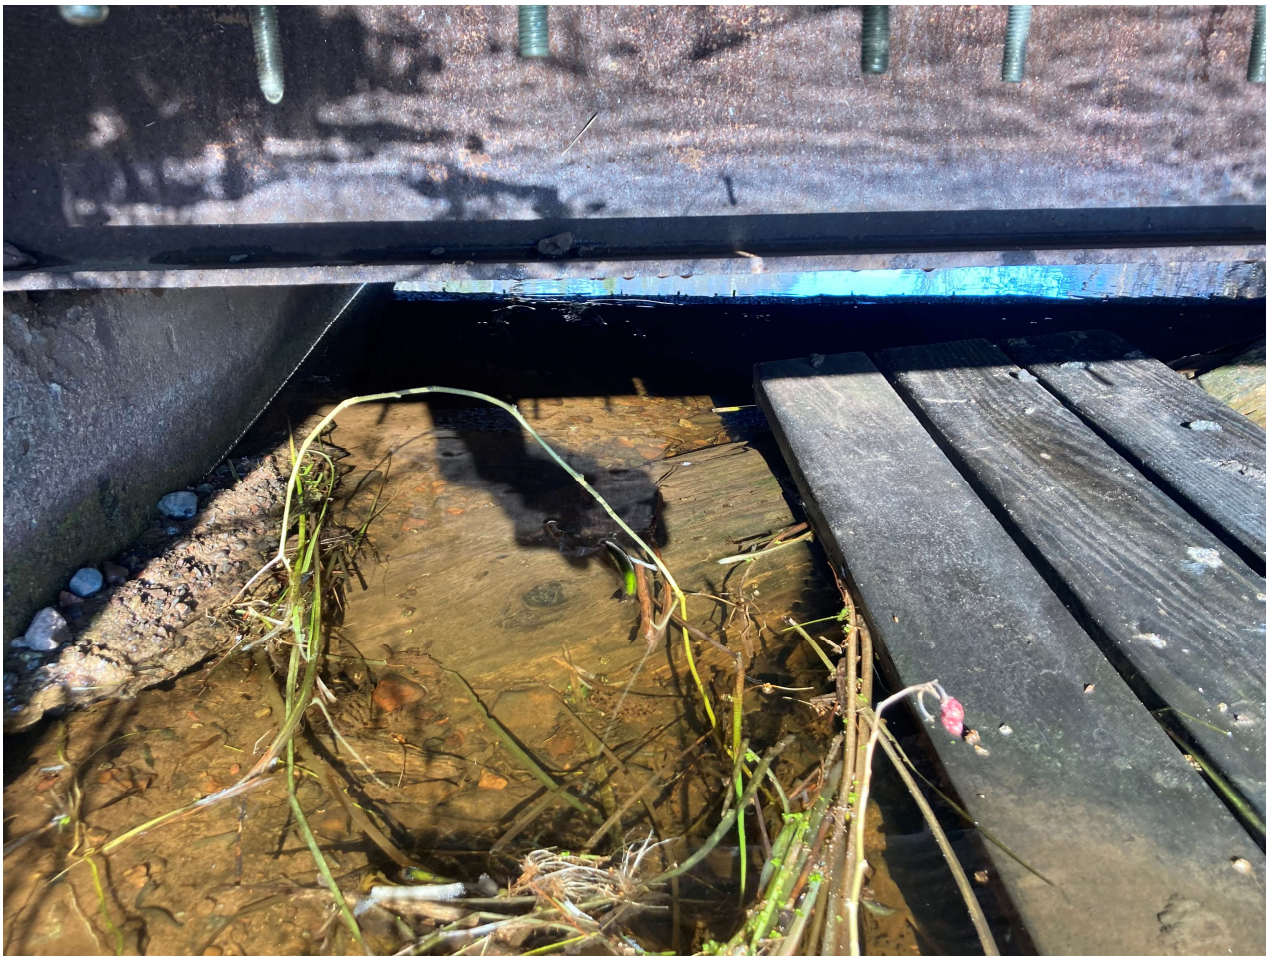
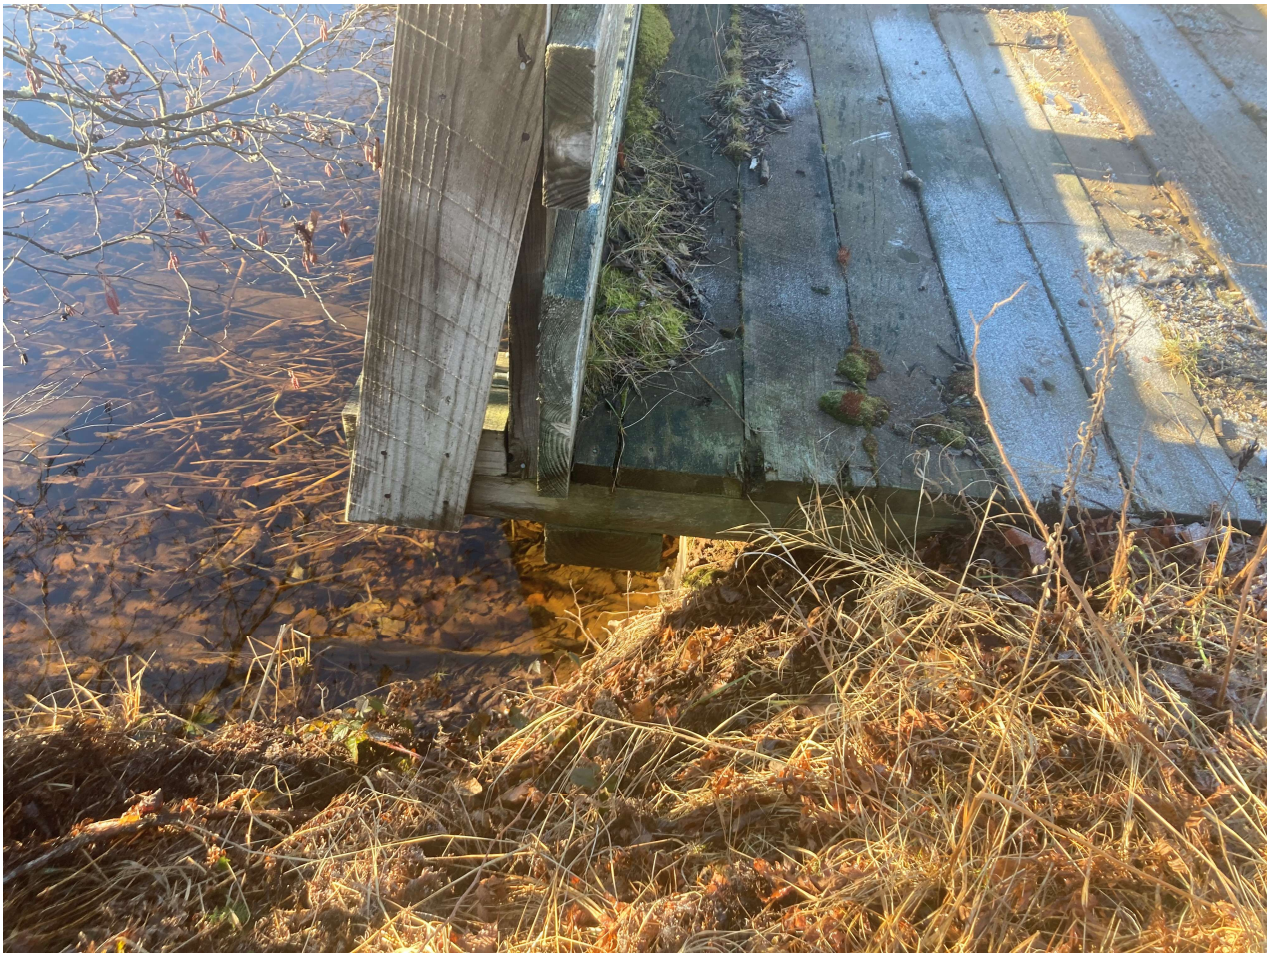
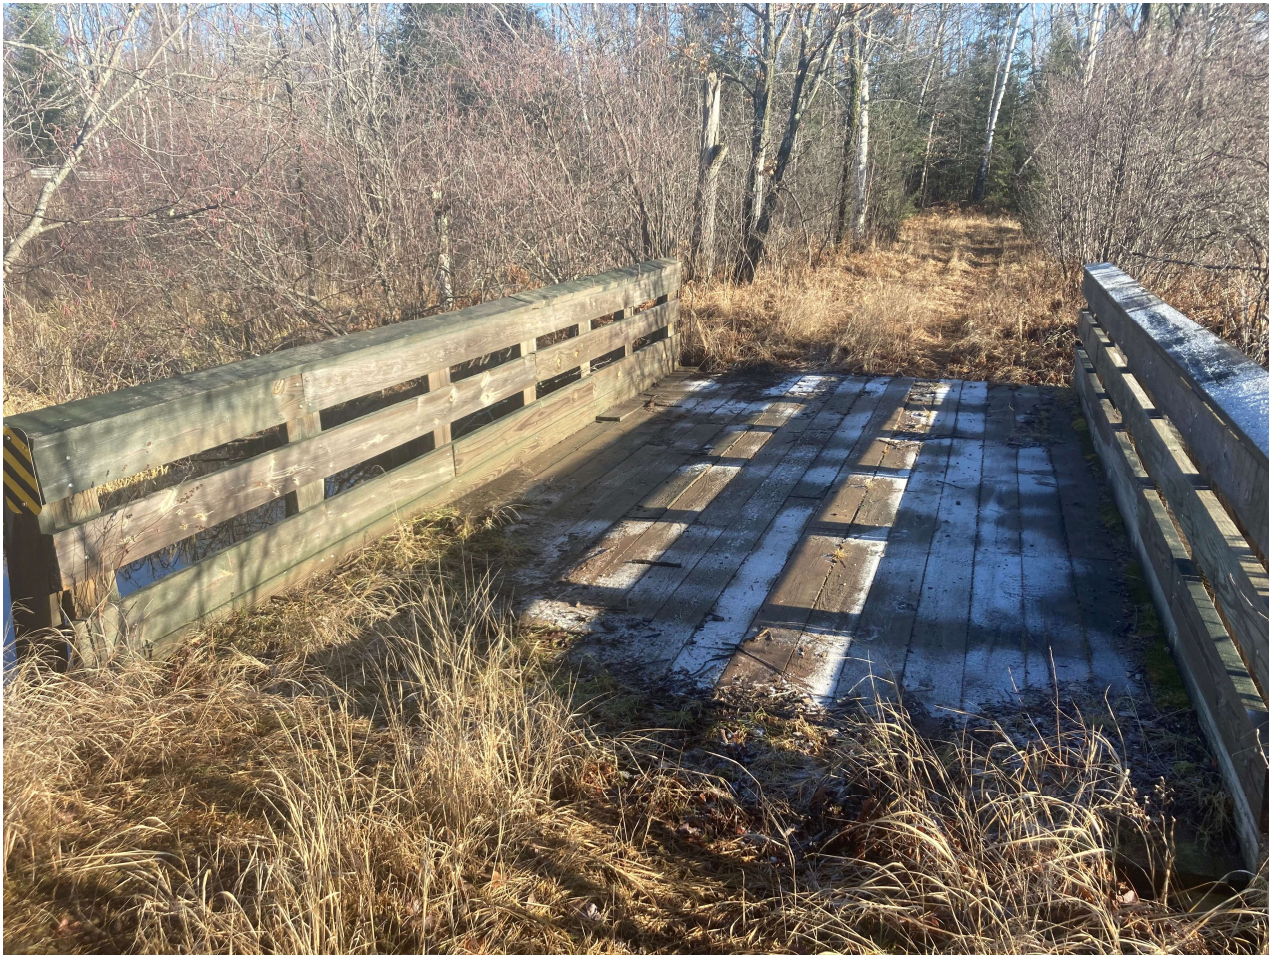
Timber wearing surface, 1 board is loose and coming up. Some areas covered in soil / vegetation. Fair.

Deck is 4"x8" transverse planks, some decay, widespread green mold on underside. Fair.

3 Steel girders, surface rust, welded splice near east 1/4 point of north girder. Fair.

Concrete footings, scaling present and moderate spalling on west footing. Large crack in east sill. East sill undermined up to 12" deep at south end. NW corner is sinking and putting a twist in the bridge. Poor condition.

Approaches have a 3' x 3' hole in SE corner, 1' x 1' hole in SW corner, approaches are 6-12" higher than bridge. Poor condition.

Object markers, All for have map cracking Fair.

1 bridge ahead sign, West missing, East Good.

Replace west bridge ahead sign.
