# **Adventures In Sub-Slab Sampling**

# Vapor intrusion sampling was conducted at two sites in the Wausau area

- A DERP site that is currently being used as a thrift store.
- VPLE site at a closed industrial facility.

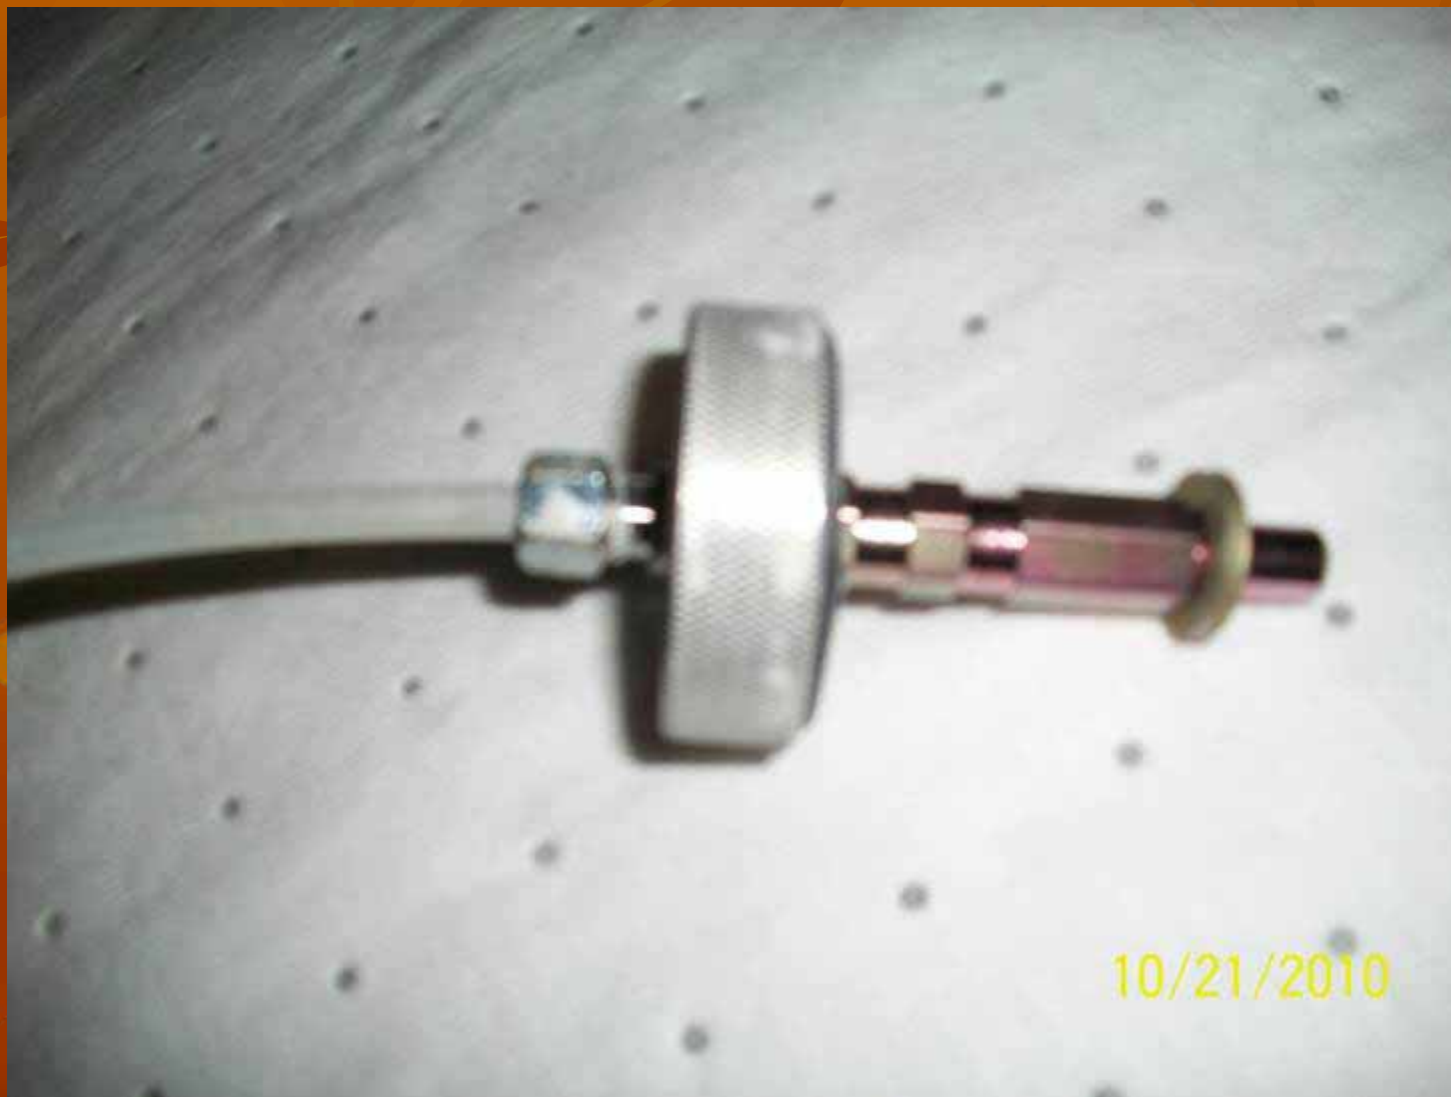
# Assembled Sample Port

# There were a number of issues at the DERP site during the second sampling event

- The ambient air registered about 10 units with the helium meter.
- The Teflon tubing registered a couple hundred units with the helium meter.
- Leak testing at the first sampling point detected helium at tens of thousands of meter units.
- Leak testing at the other sampling locations detected helium at equipment background readings.

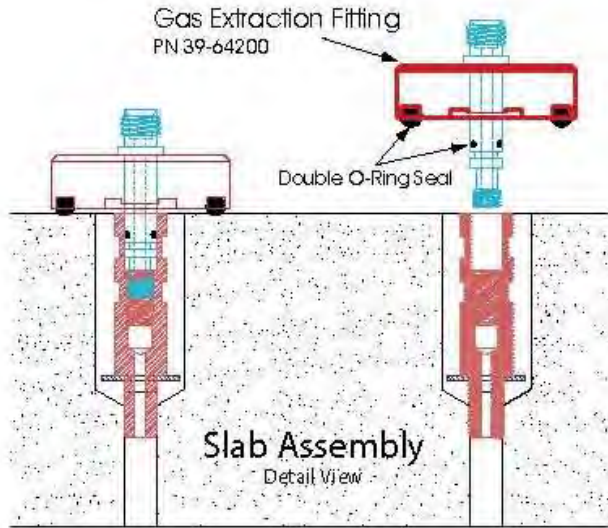
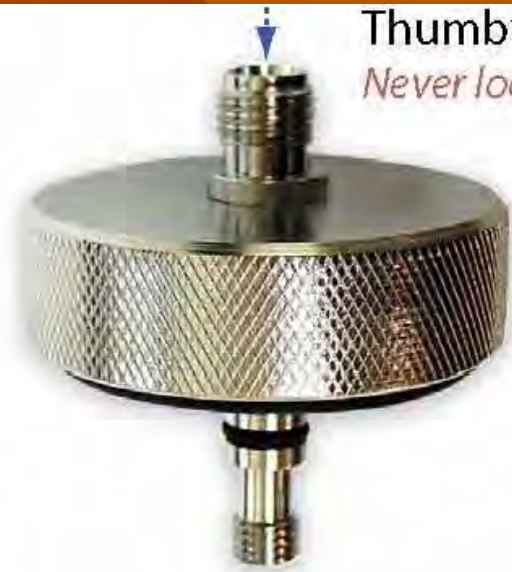
# Installed Sample Port X-section

- Foot traffic may have jarred the sample port breaking the seal between the sample port and concrete

# Sealing the thumbwheel to the floor solved the problem

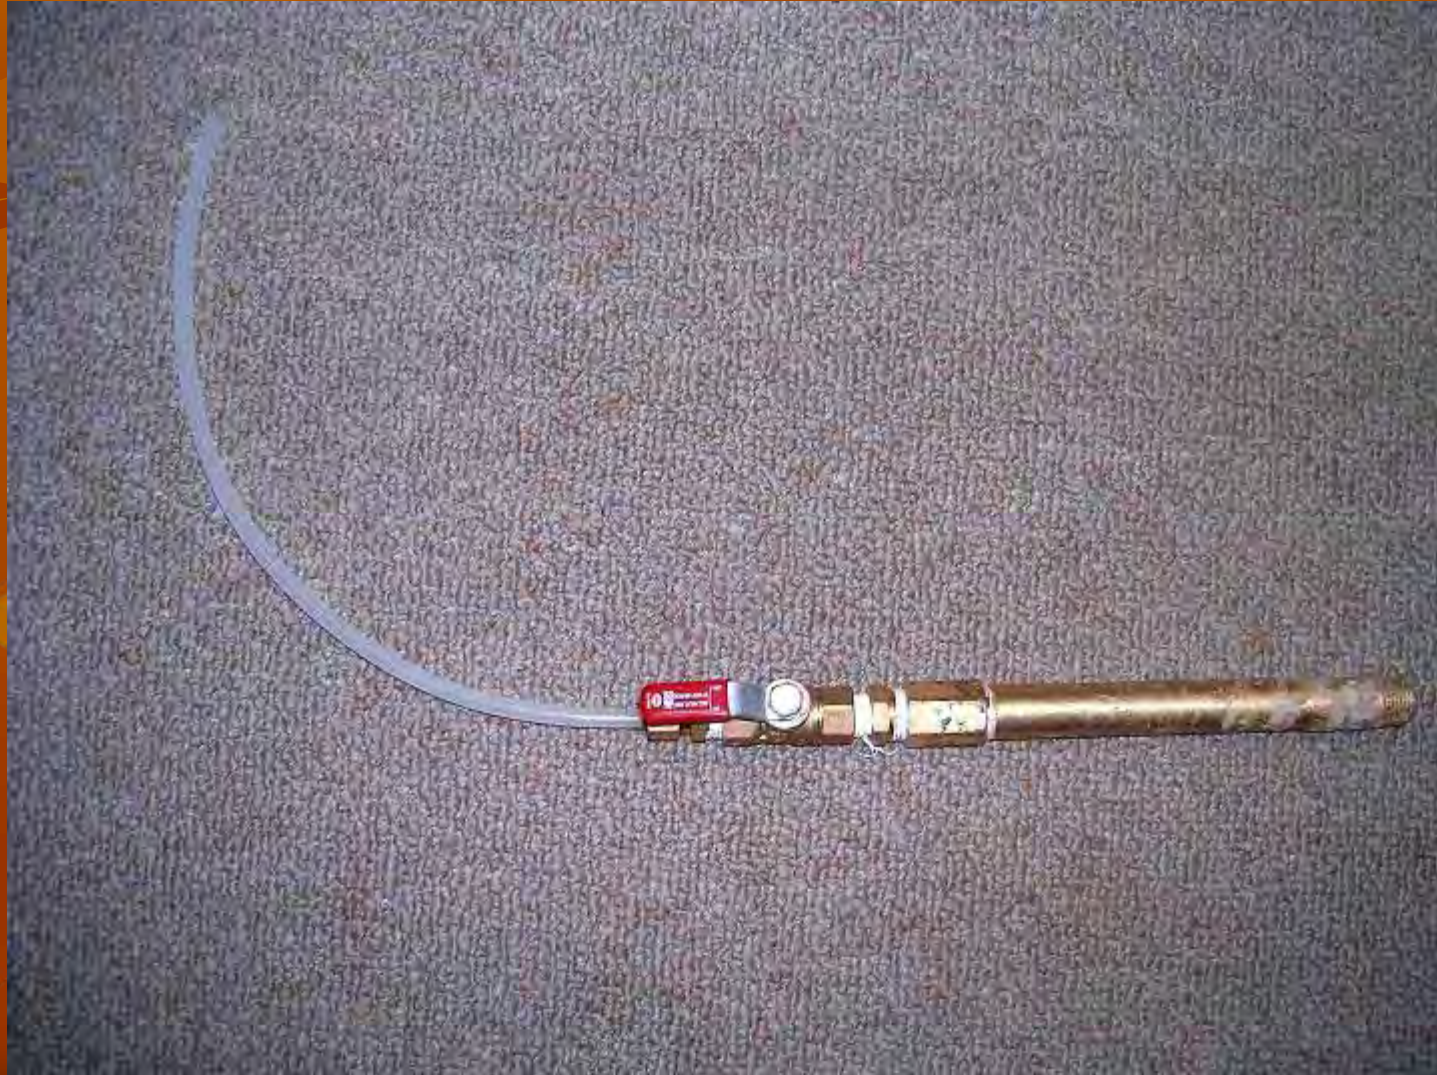
# Sample Port used at VPLE site

- Helium leak testing done at both sites.
- VPLE site used a home-made permanent sample port and sealed it with bees wax.
- DERP site used a commercially-made sample port and sealed it with concrete.
- And .....
