**Appendix 13 RCRA Feasibility Assessment (RFA) Report -
2001**

**RCRA FACILITY ASSESSMENT
MERCURY WASTE SOLUTIONS, INC.**

**Union Grove, Wisconsin
EPA ID#: WIR000000356
FID#: 252195350**

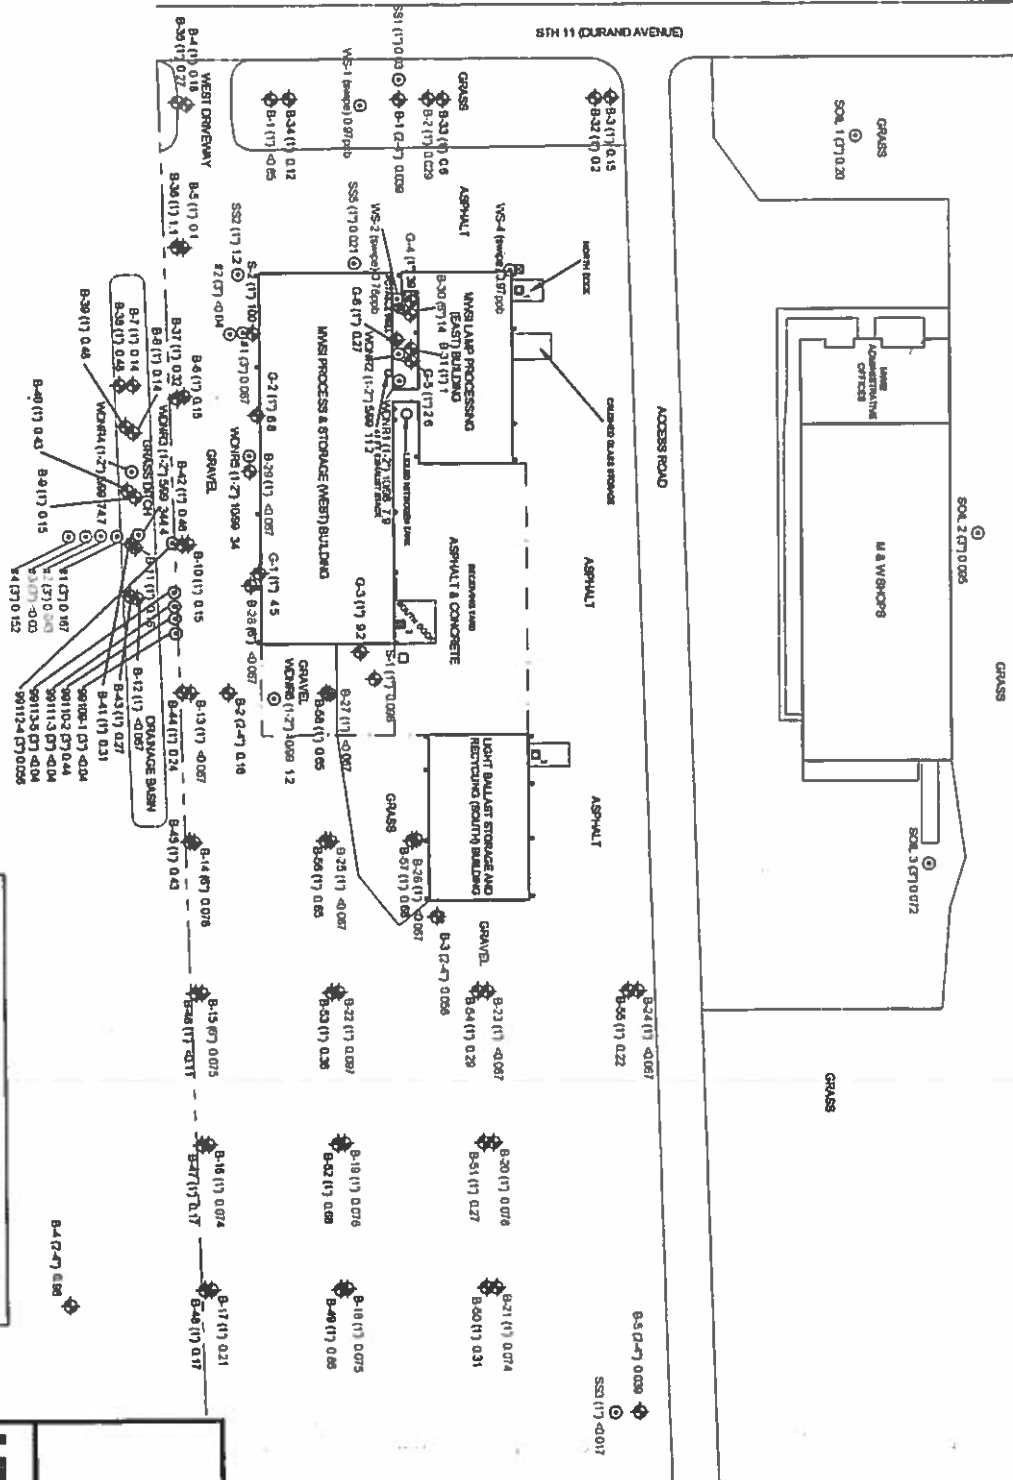
- ⊙ Soil sample (SS) or sample (MS) location with identifier, sample depth, (for SS), and mercury result for SS in parts per million (ppm) or for MS in parts per billion (ppb). Collected August 6, 1998.

OFF-SITE SAAMPLING at Systematics (-200 level west of Mercury Waste Solutions)
 ⊙ WS-3 (wrench) 1.3ppb (East door below window)
 ⊙ WS-1 (wrench) 0.07ppb (17' east of Systematics building)

Testing for potential soil contamination, a total of 58 Geoprobos were advanced across the site in October 1999 and September 2000. Soil samples were collected from approximately 1 foot bgs from target locations near points of interest (near downspouts for example) and on a grid pattern to ensure uniform site coverage. All samples were containerized and preserved as necessary and submitted to a licensed laboratory for mercury analysis. In December 2001, 13 shallow soil samples were collected from known hot spots using a shovel and submitted for laboratory analysis of mercury. Additional soil samples were collected in December 2002 and October 2003. In total, nearly 120 soil samples have been collected and analyzed for mercury. **Table 1, Appendix B** contains the laboratory results from all recent site investigations. Soil sample locations and laboratory results are depicted on **Figures 7A and 7B, Appendix A**.

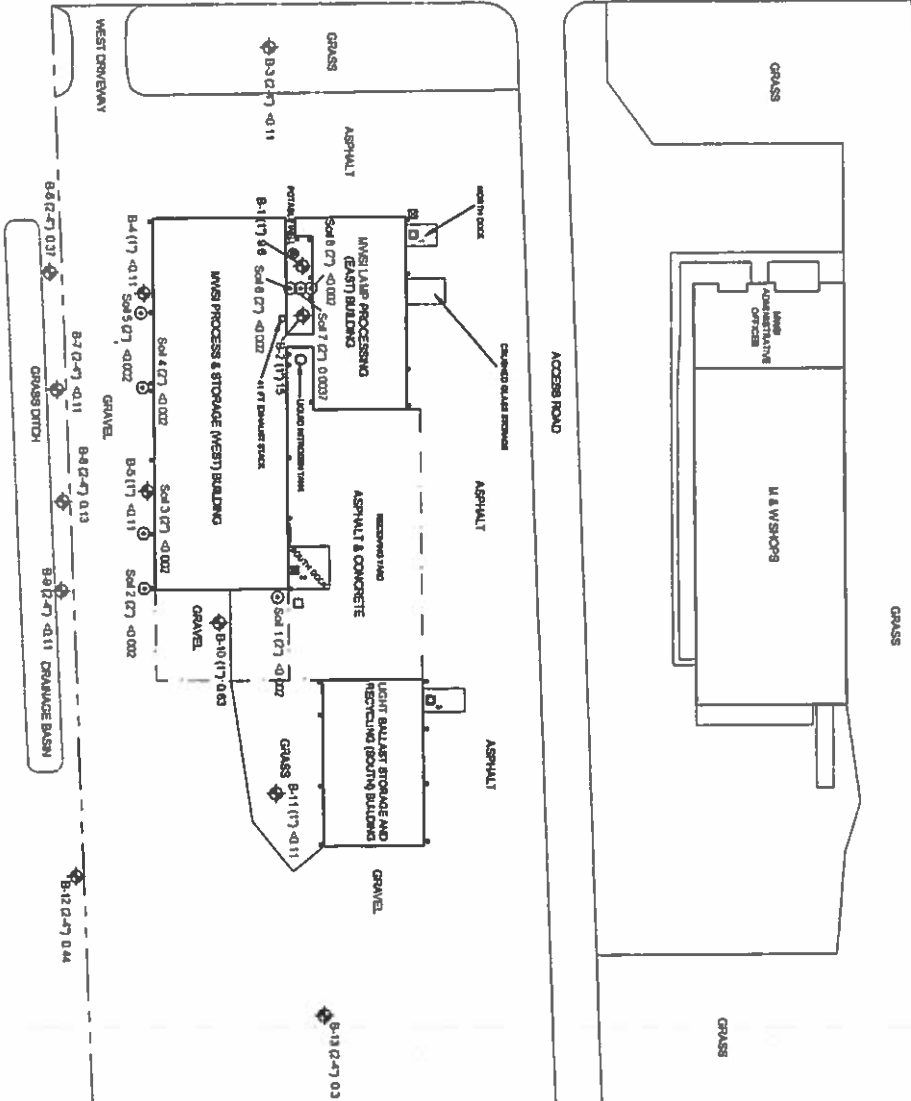
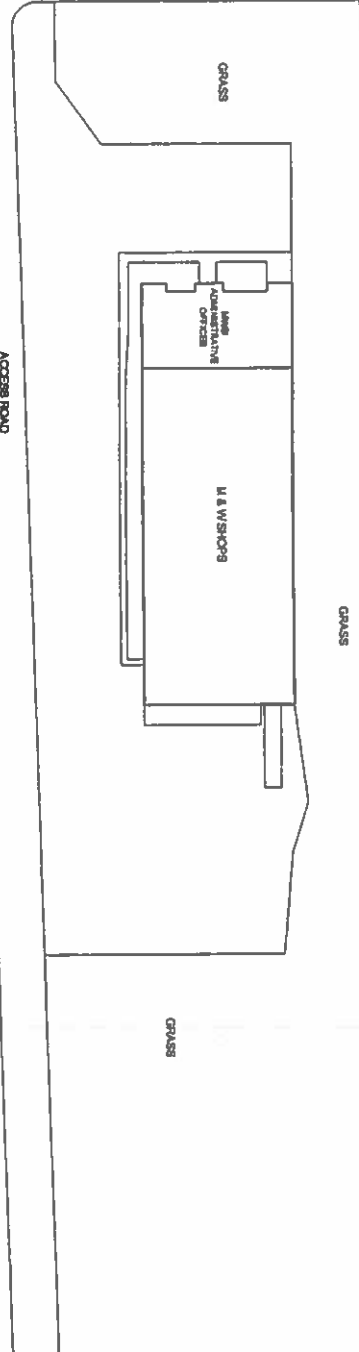
FIGURE 7B

- Approximate property line location.
- Chain link fence.
- B-2 (T) 0.11 Soil boring location with InsulIap, sample depth and mercury result in parts per million (ppm). Collected December 2001.
- B-3 (T) 0.002 Soil sample location with InsulIap, sample depth and mercury result in parts per million (ppm). Collected December 2002.
- B-20 (T) 14 Results in and are above NR 746 S1a Specific Level.
- 1 North loading dock drain - manually covered.
- 2 South loading dock drain - covered.
- 3 Ballast building dock drain - manually covered.
- Open drain (kero).
- Covered drain (kero).
- Downspout.
- All downspouts disconnected from underground storm sewer lines.

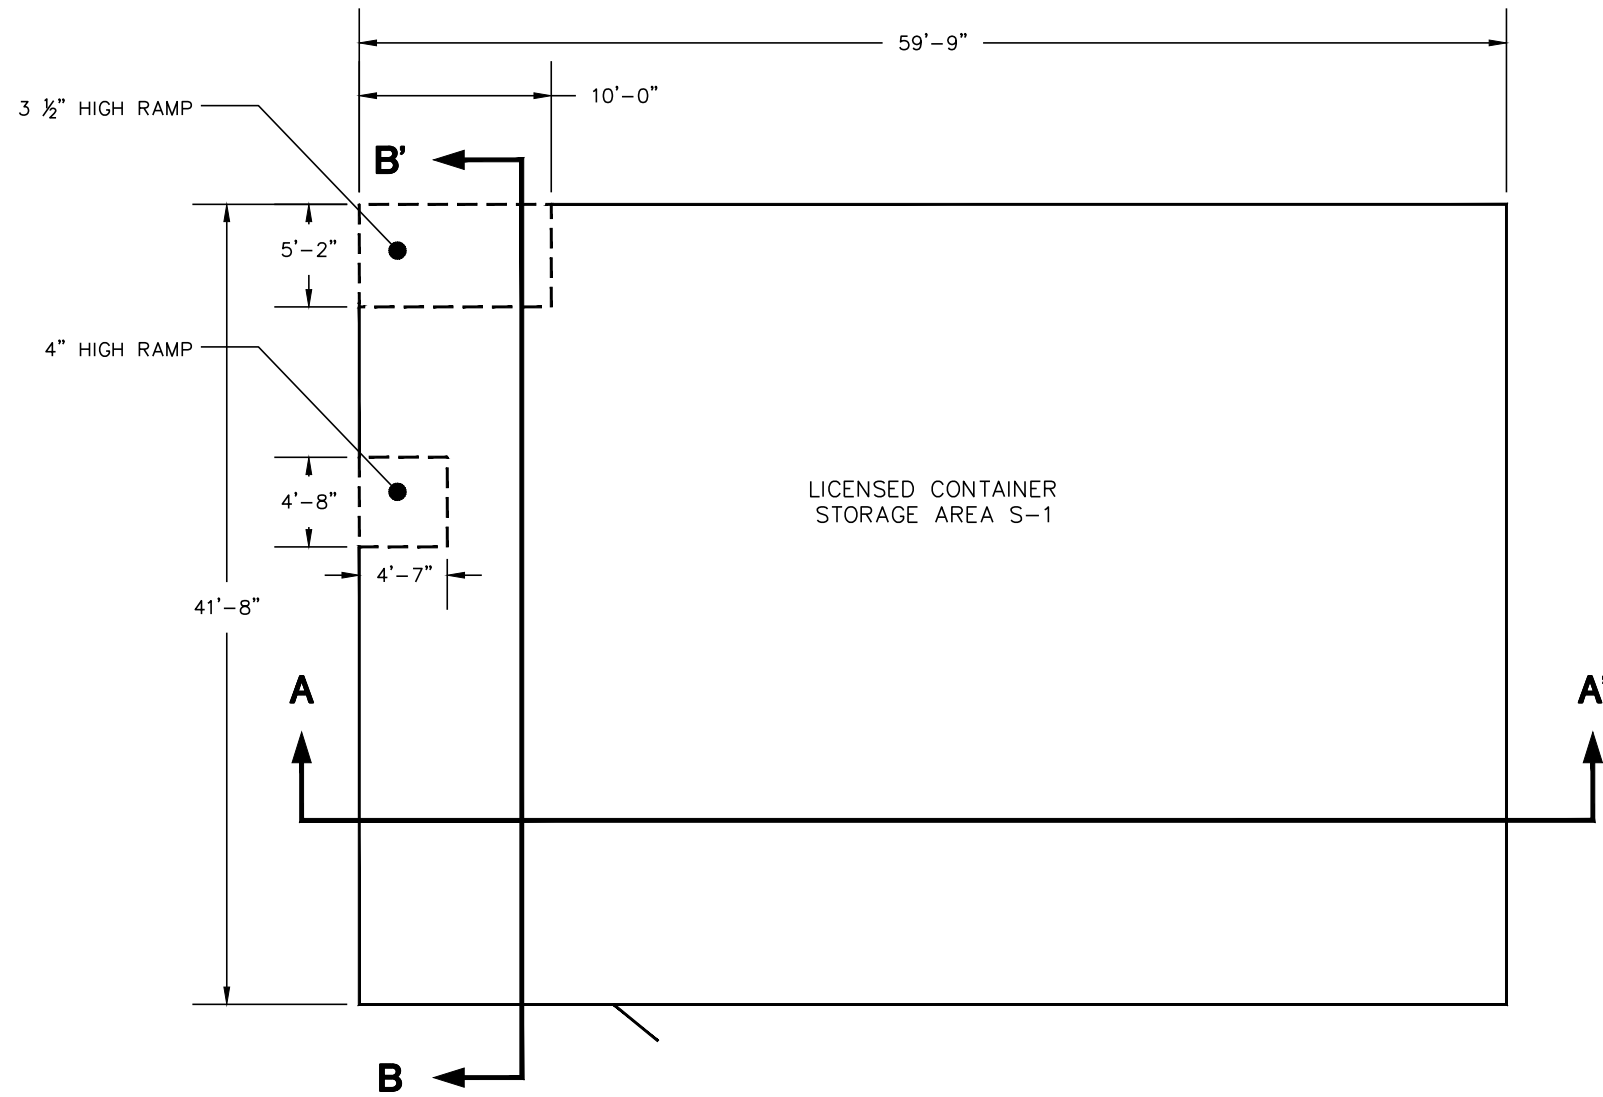
FIGURE	S-1
--------	-----

SECTION A-A'

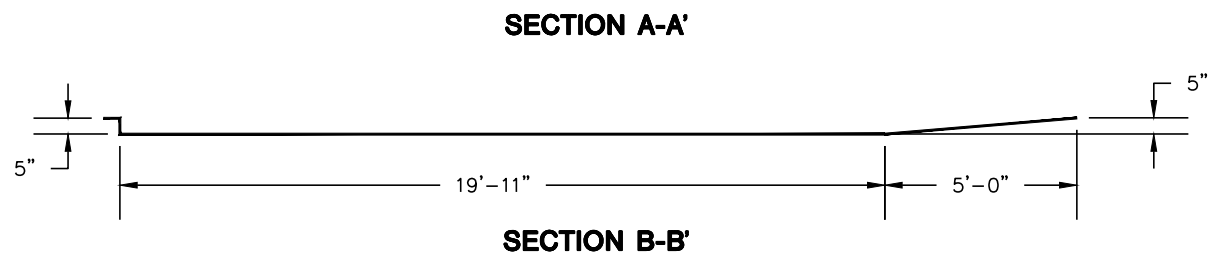
NOTE:
 DIMENSIONS BASED ON FIELD MEASUREMENTS
 COLLECTED BY SCS ENGINEERS ON
 DECEMBER 1, 2020.

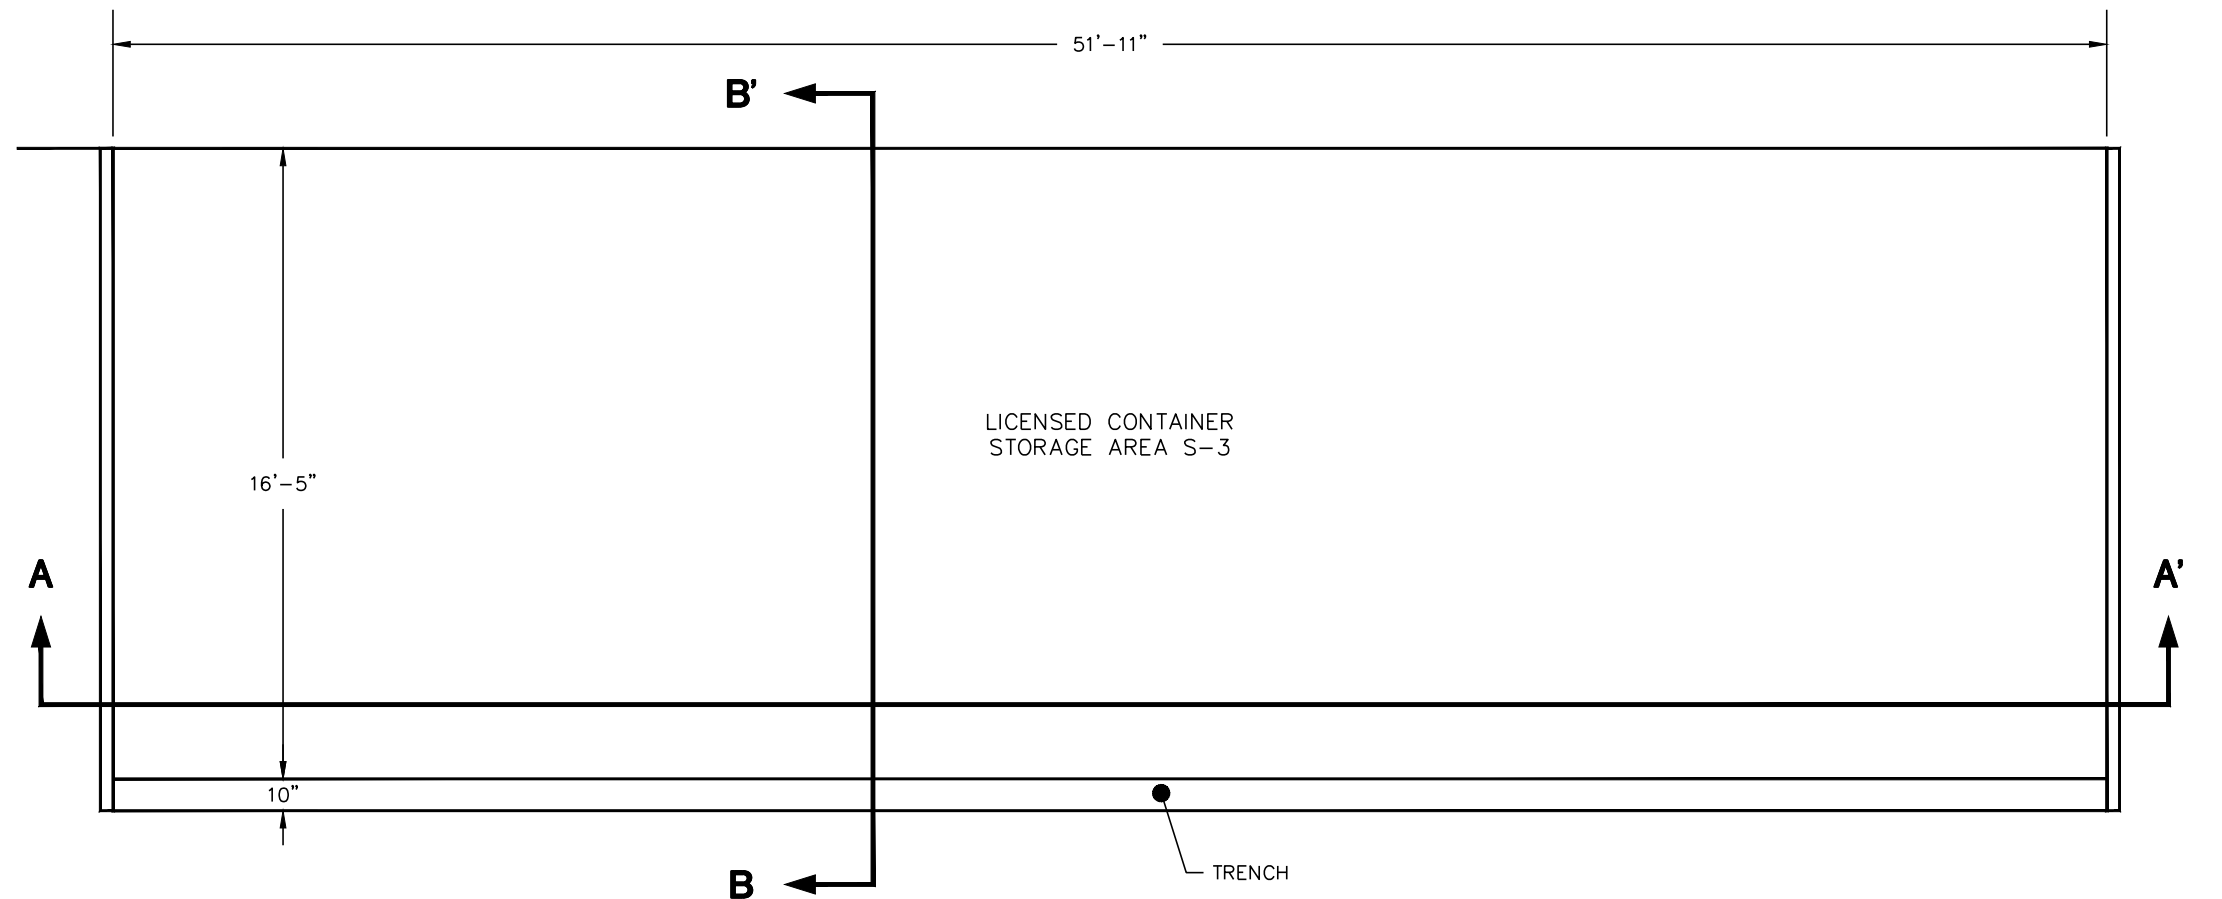
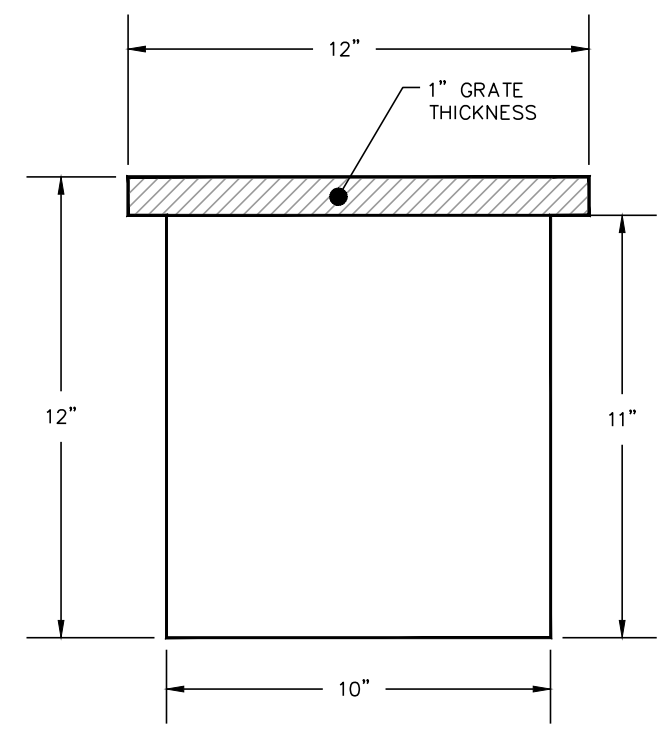
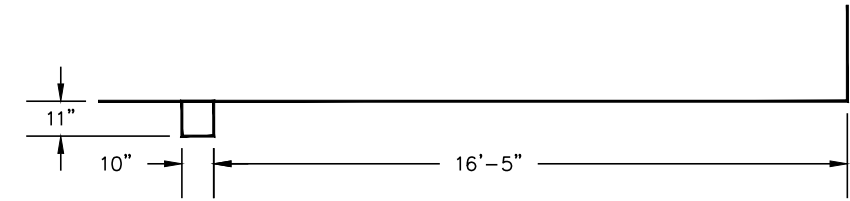
2830 DAIRY DRIVE MADISON, WI 53718-6751 PHONE: (608) 224-2830	CLIENT WM WASTE, INC.	SITE WM WASTE, INC. 21211 DURAND AVE, UNION GROVE, WI	STORAGE AREA S-3	FIGURE
DRAWN: 12/15/2020	CHECKED BY: MJT					S-3
REVISED: 12/15/2020	APPROVED BY: JMO 12/18/2020

TRENCH DETAIL

SECTION A-A'

SECTION B-B'

NOTE:
 DIMENSIONS BASED ON FIELD MEASUREMENTS
 COLLECTED BY SCS ENGINEERS ON
 DECEMBER 1, 2020.

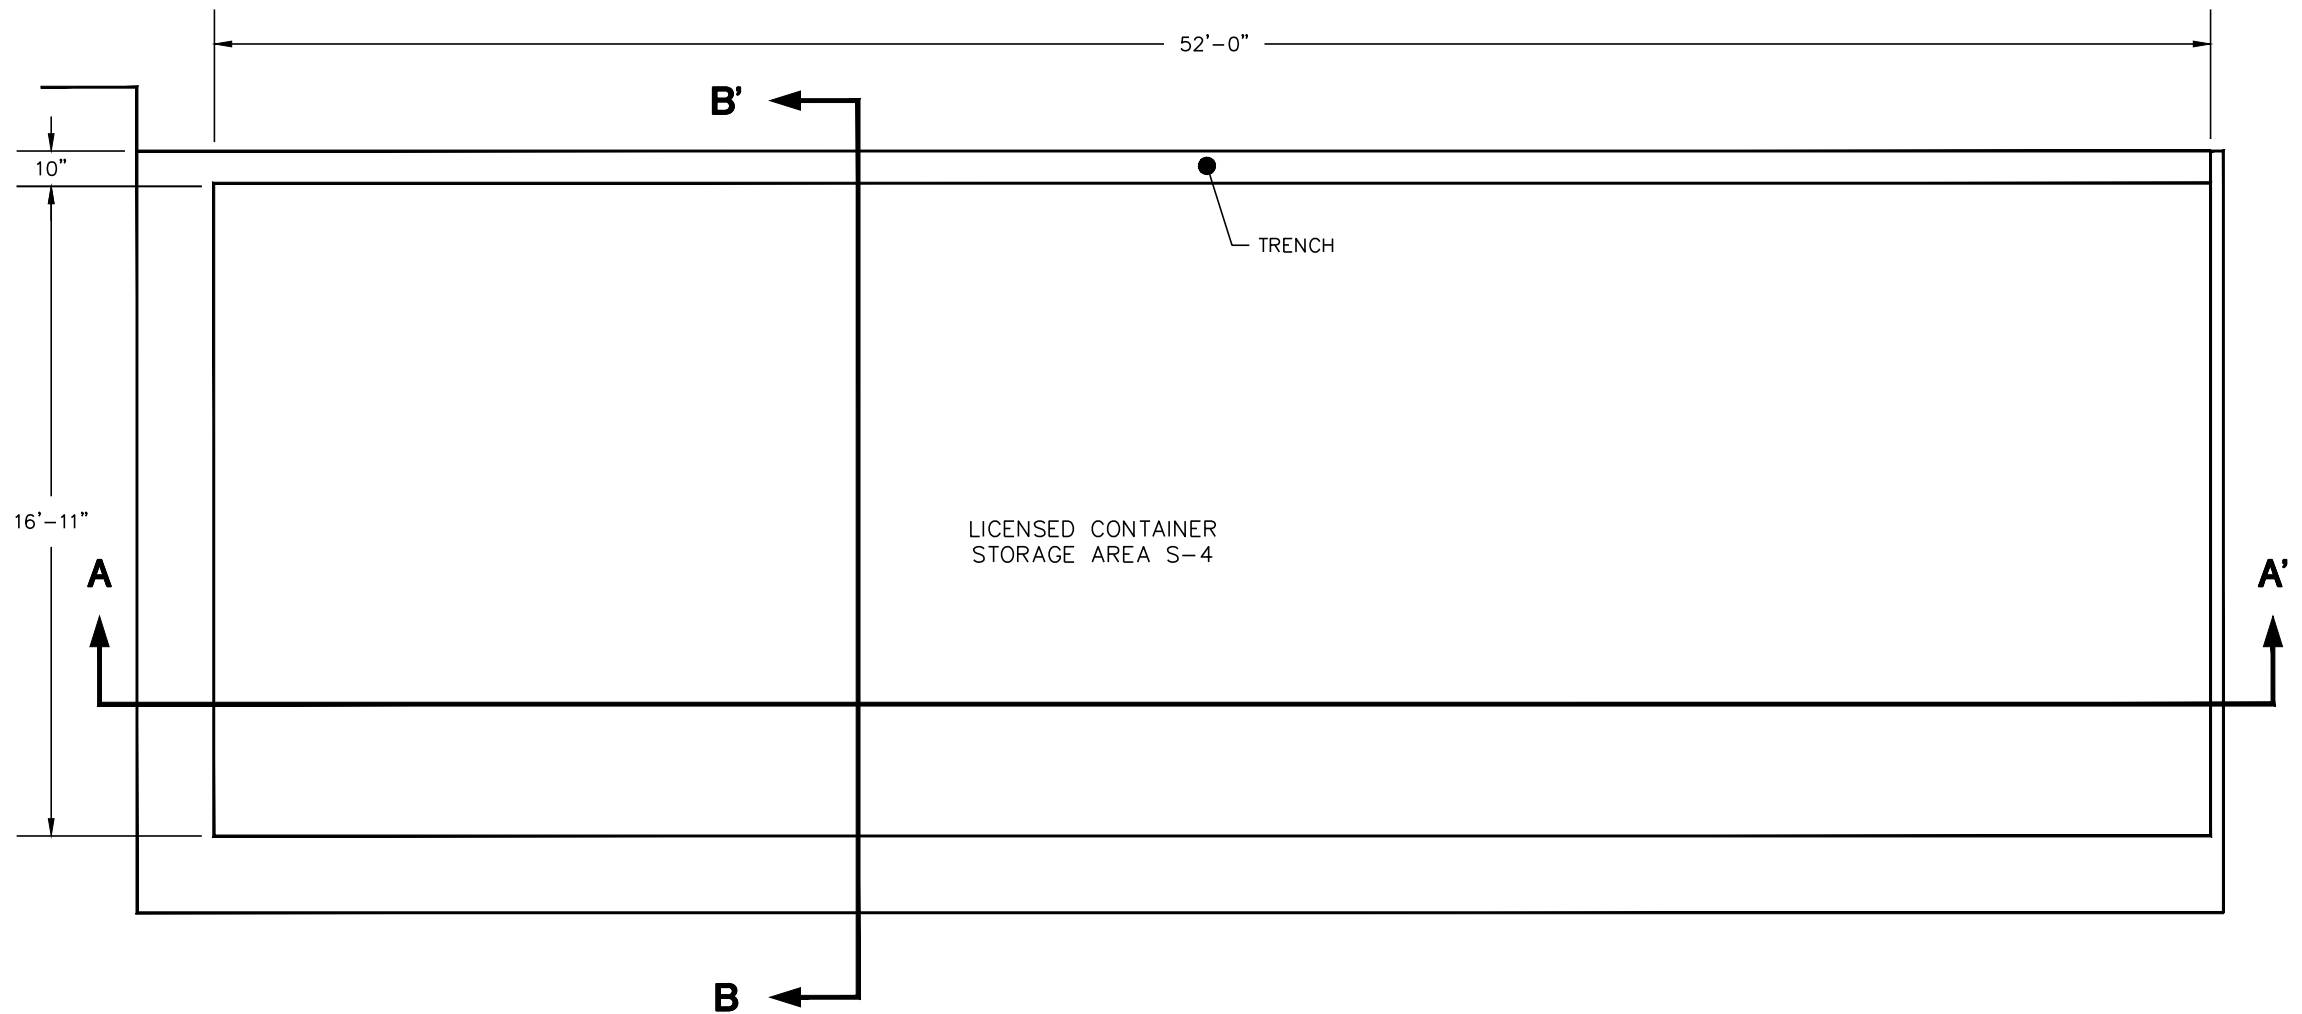
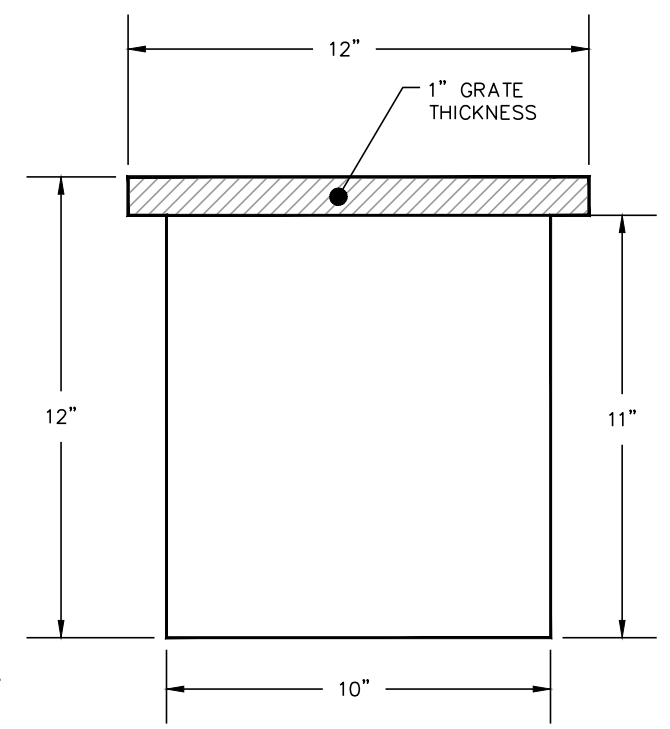
PROJECT NO. 25220201.00	DRAWN BY: JSK	<p>2830 DAIRY DRIVE MADISON, WI 53718-6751 PHONE: (608) 224-2830</p>	CLIENT WM WASTE, INC.	SITE WM WASTE, INC. 21211 DURAND AVE, UNION GROVE, WI	STORAGE AREA S-4	FIGURE
DRAWN: 12/15/2020	CHECKED BY: MJT					S-4
REVISED: 12/15/2020	APPROVED BY: JMO 12/18/2020

TRENCH DETAIL

NOTE:
DIMENSIONS BASED ON FIELD MEASUREMENTS
COLLECTED BY SCS ENGINEERS ON
DECEMBER 1, 2020.

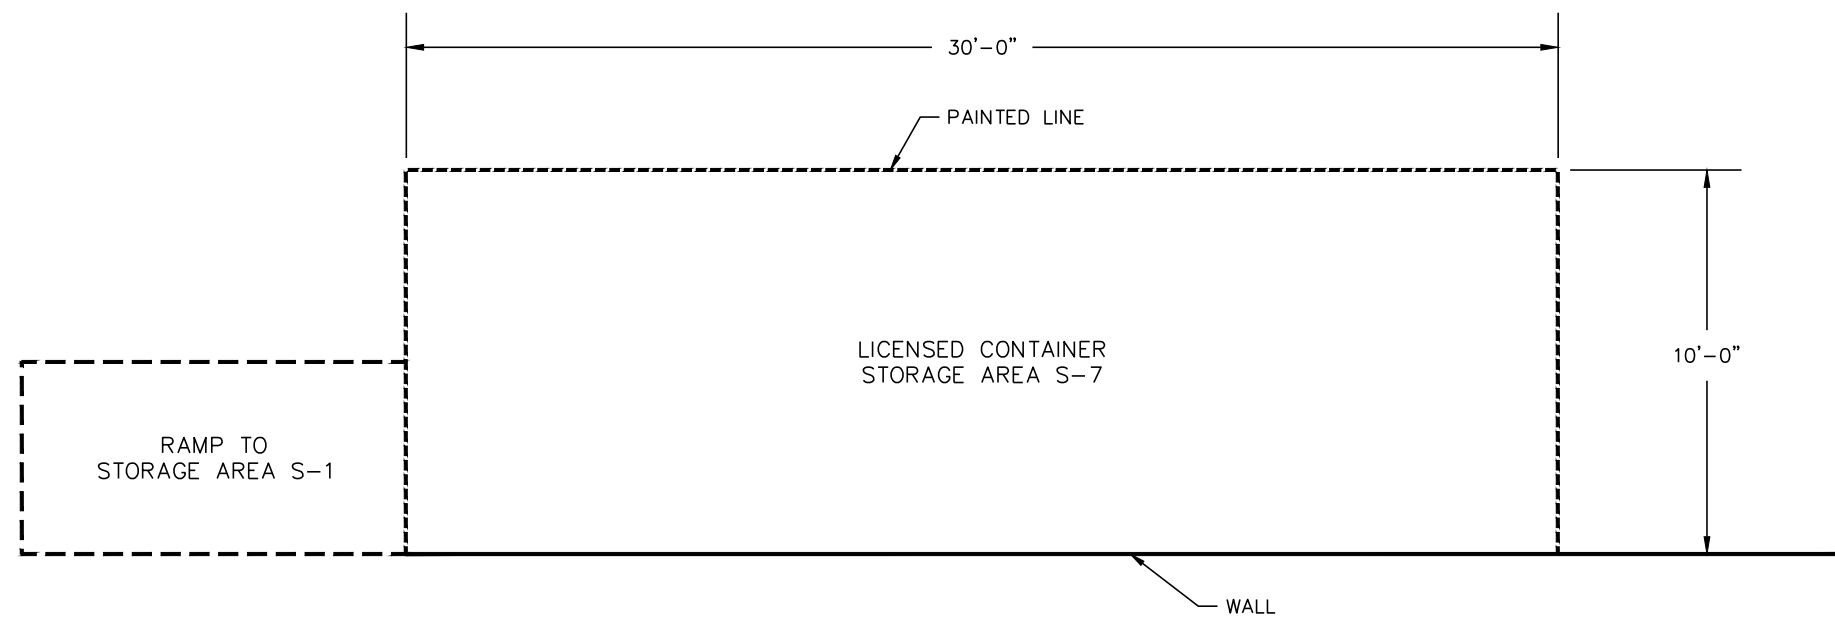
LEGEND	
	RAMP
	STORAGE AREA BOUNDARY

NOTE:
 STORAGE AREA INFORMATION BASED ON FIGURE 16-7, SHEET FPOR-10, DATED 2/24/2011 BY NIELSEN MADSEN & BARBER S.C.

NOTE:
 STORAGE AREA INFORMATION BASED ON FIGURE 16-7, SHEET FPOR-10, DATED 2/24/2011 BY NIELSEN MADSEN & BARBER S.C. EXISTING SECONDARY CONTAINMENT BASED ON FIELD MEASUREMENTS COLLECTED BY SCS ENGINEERS ON DECEMBER 1, 2020, AND DOCUMENTED IN A REPORT DATED DECEMBER 23, 2020. SCS MEASURED THE STORAGE AREA DIMENSIONS WITH A TAPE MEASURE AND A LASER DISTANCE MEASURE, AND MEASURED SLOPED AREAS WITH A LASER LEVEL.

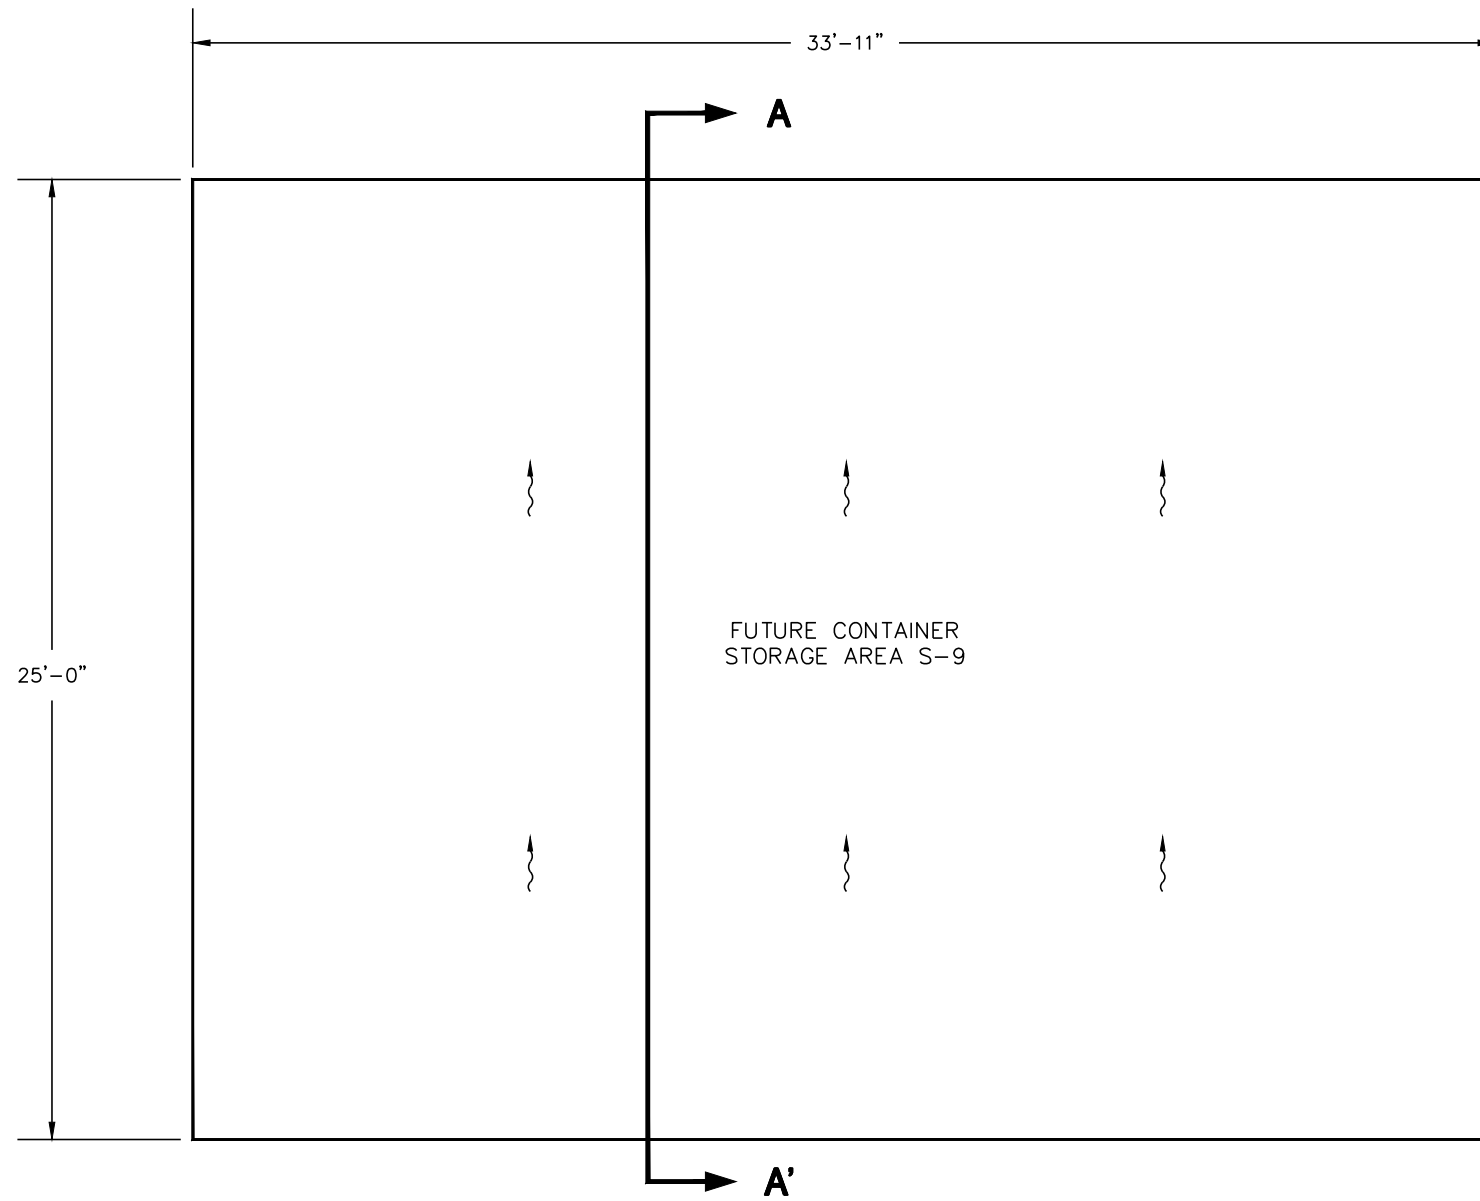
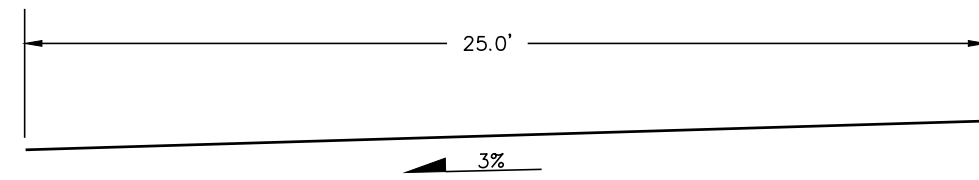
PROJECT NO.	25220201.00	DRAWN BY:	MJT		CLIENT WM WASTE, INC. 2830 DAIRY DRIVE MADISON, WI 53718-6751 PHONE: (608) 224-2830	SITE WM WASTE, INC. 21211 DURAND AVE, UNION GROVE, WI	FUTURE STORAGE AREA S-9	FIGURE
DRAWN:	12/15/2020	CHECKED BY:	MH					S-9
REVISED:	12/18/2020	APPROVED BY:	JMO 12/18/2020

SECTION A-A'

- NOTES:
1. STORAGE AREA DIMENSIONS MATCH STORAGE AREA S-12
 2. POSITIVE SLOPE TO THE WEST WAS CONFIRMED IN THE FIELD BY SCS ENGINEERS ON DECEMBER 1, 2020. SLOPE PERCENT IS APPROXIMATE, AND BASED ON RACINE COUNTY LIDAR DATA COLLECTED APRIL-MAY 2017.

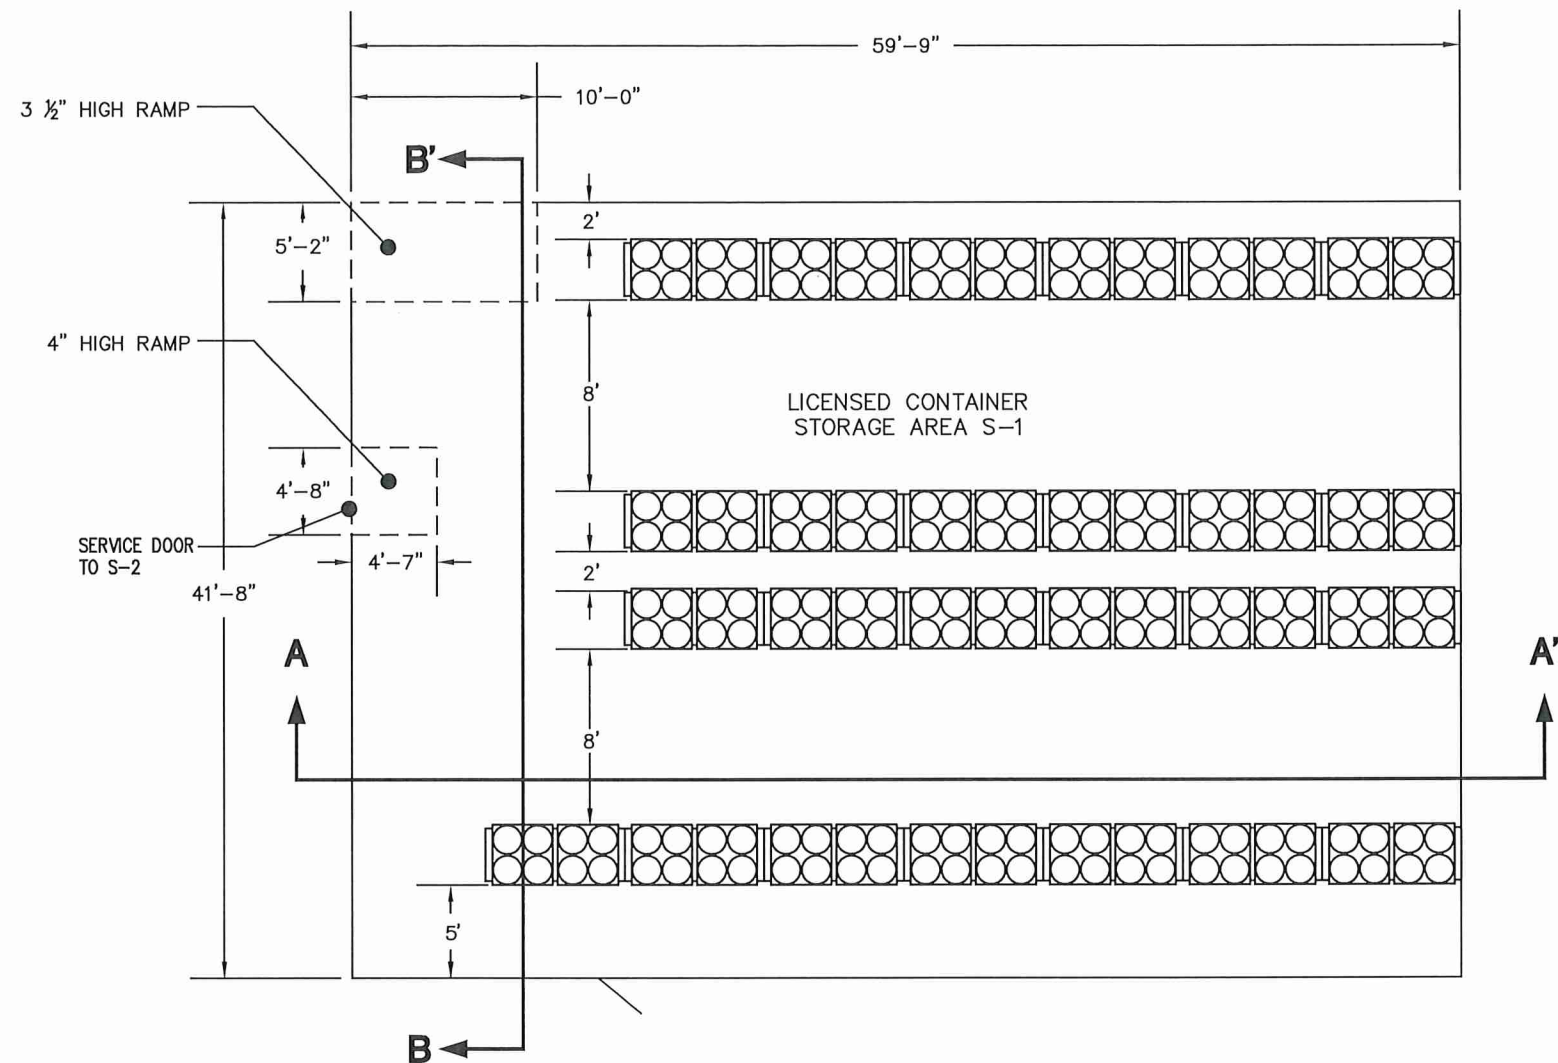
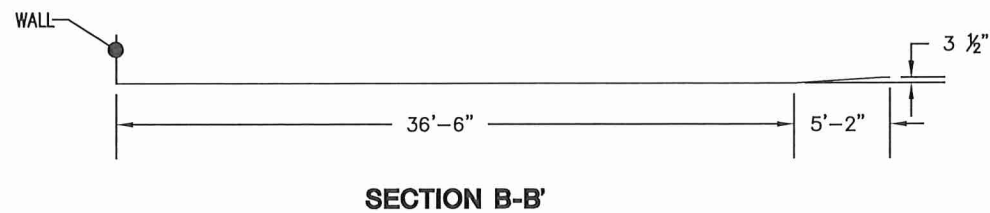
WM Waste, Inc. Union Grove, Wisconsin	
Storage Area S-1 Container Configuration	
Racine County, WI	
	Drawn: CAL/KAC-REV Checked: BDS Date: 06/14/2022 Approved: BHR Dwg. No.: WA5011-18114-42
Figure 16-1

S-1 Containment Area	
Stacking Configuration	3 - Tier Racking System
Container Type	Drum
Maximum Number of Liquid Containers	600
Largest Container (gallons)	55
Proposed Permitted Capacity (Gallons)	33,000
Required Secondary Containment Capacity (greater of 10% of total capacity or largest container)	3,300
Available Secondary Containment (gallons)	3,988
Sufficient Containment?	Yes
Proposed Upgrades	None
Proposed Containment (gallons)	3,988

NOTE:
 EXISTING SECONDARY CONTAINMENT BASED ON FIELD MEASUREMENTS COLLECTED BY SCS ENGINEERS ON DECEMBER 1, 2020, AND DOCUMENTED IN A REPORT DATED DECEMBER 23, 2020. SCS MEASURED THE STORAGE AREA DIMENSIONS WITH A TAPE MEASURE AND A LASER DISTANCE MEASURE, AND MEASURED SLOPED AREAS WITH A LASER LEVEL.

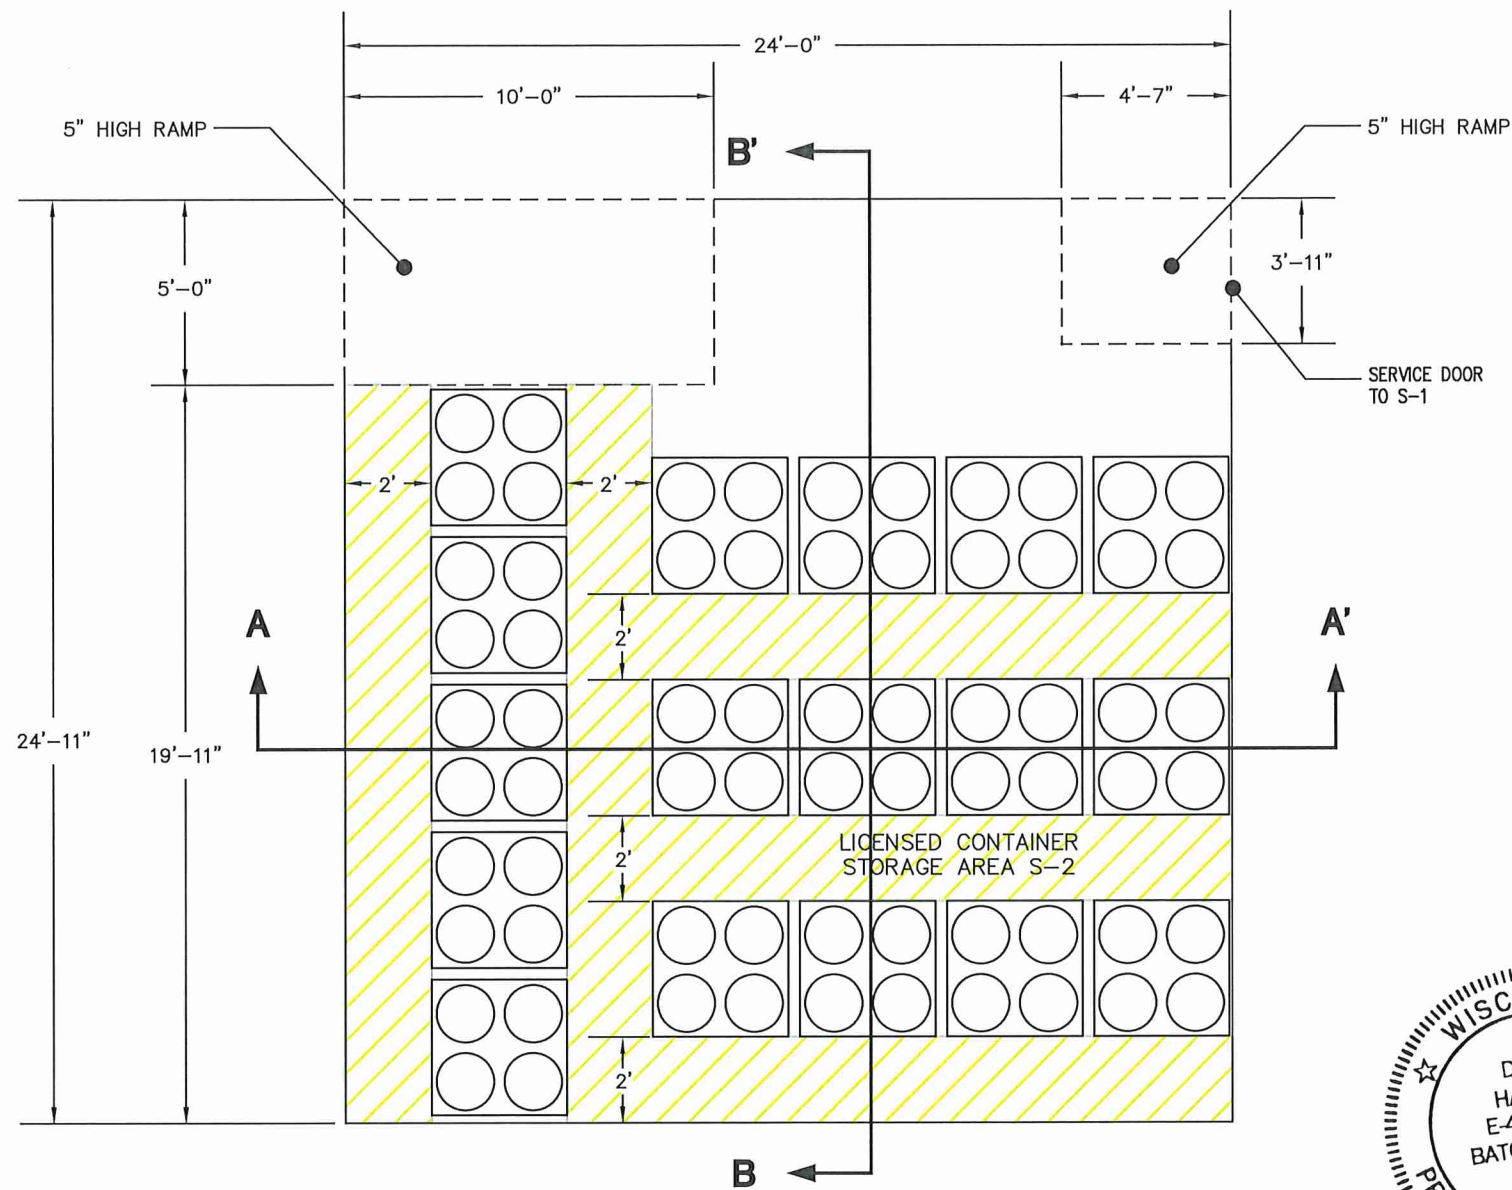
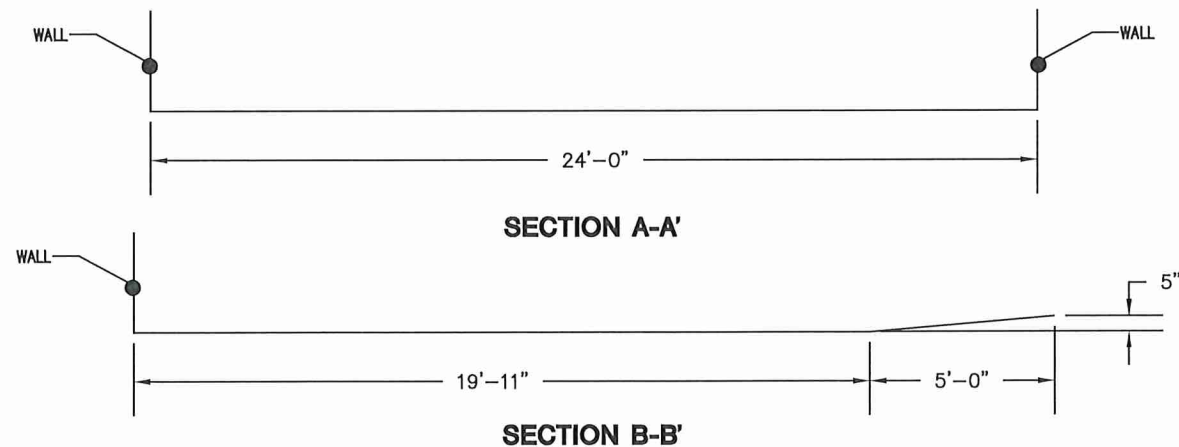
WM Waste, Inc. Union Grove, Wisconsin	
Storage Area S-2 Container Configuration	
Racine County, WI	
	Drawn: CAL Checked: BDS Date: 6/14/2022 Approved: BHR Dwg. No.: WA5011-18114-43
Figure 16-2

S-2 Containment Area	
Stacking Configuration	2-Tier Stacking
Container Type	Drum
Maximum Number of Liquid Containers (55-gallon drums or DE)	136
largest container (gallons)	55
Proposed Permitted Capacity (Gallons)	7,480
Required Secondary Containment Capacity (greater of 10% of total capacity or largest container)	748
Available Secondary Containment (gallons)	1,102
Sufficient Containment?	Yes
Proposed Upgrades	None
Proposed Containment (gallons)	1,102

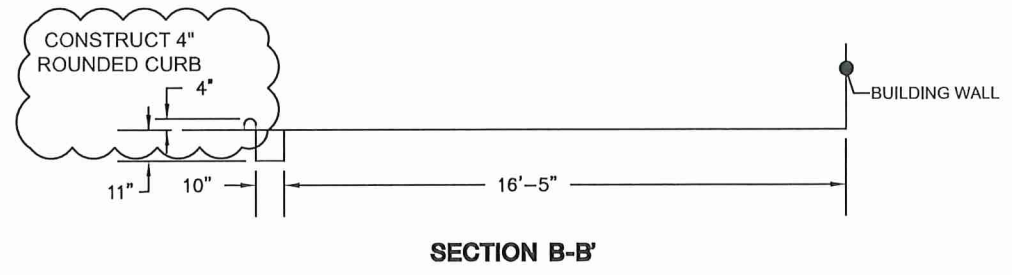
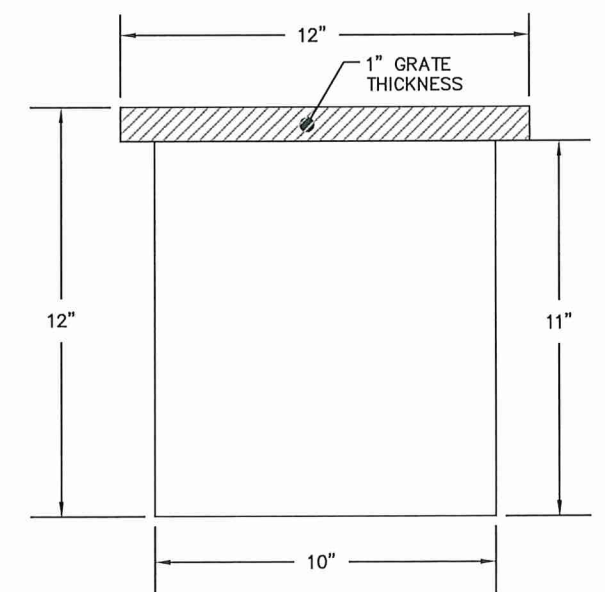
WM Waste, Inc. Union Grove, Wisconsin	
Storage Area S-3 Container Configuration	
Racine County, WI	
	Drawn: CAL Checked: BDS Date: 6/14/2022 Approved: BHR Dwg. No.: WA5011-18114-44
Figure 16-3

S-3 Containment Area	
Stacking Configuration	2-Tier Stacking
Container Type	Drum
Maximum Number of Liquid Containers (55-gallon drums or DE)	256
Largest container (gallons)	55
Proposed Permitted Capacity (Gallons)	14,080
Required Secondary Containment Capacity (greater of 10% of total capacity or largest container)	1,408
Available Secondary Containment (gallons)	297
Sufficient Containment?	No
Proposed Upgrades	Add 4 inch curbing. See details on drawing.
Proposed Containment (gallons)	1,535

NOTE:
 EXISTING SECONDARY CONTAINMENT BASED ON FIELD MEASUREMENTS COLLECTED BY SCS ENGINEERS ON DECEMBER 1, 2020, AND DOCUMENTED IN A REPORT DATED DECEMBER 23, 2020. SCS MEASURED THE STORAGE AREA DIMENSIONS WITH A TAPE MEASURE AND A LASER DISTANCE MEASURE, AND MEASURED SLOPED AREAS WITH A LASER LEVEL.

SECTION A-A'

TRENCH DETAIL

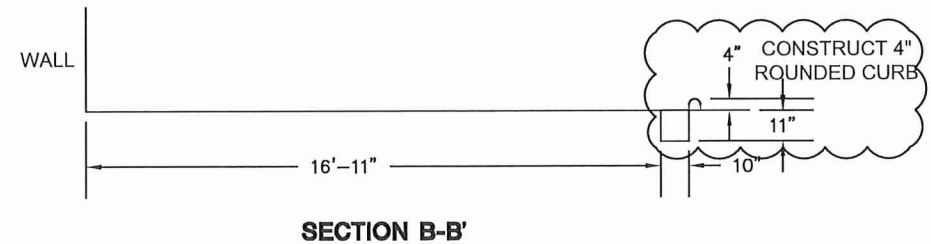
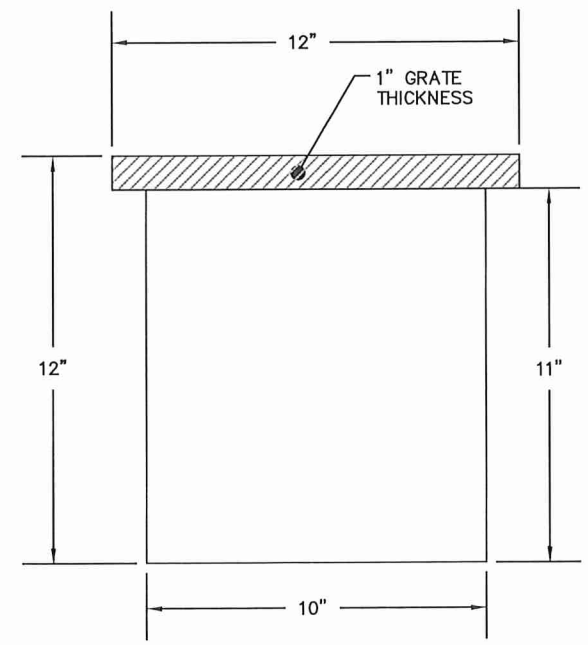
WM Waste, Inc. Union Grove, Wisconsin	
Storage Area S-4 Container Configuration	
Racine County, WI	
 	Drawn: CAL/KAC-rev Checked: BDS Date: 06/14/2022 Approved: BHR Dwg. No.: WA5011-18114-45
Figure 16-4

S-4 Containment Area	
Stacking Configuration	2-Tier Stacking
Container Type	Drum
Maximum Number of Liquid Containers (55-gallon drums or DE)	256
Largest container (gallons)	55
Proposed Permitted Capacity (Gallons)	14,080
Required Secondary Containment Capacity (greater of 10% of total capacity or largest container)	1,408
Available Secondary Containment (gallons)	297
Sufficient Containment?	No
Proposed Upgrades	Add 4 inch curbing. See details on drawing.
Proposed Containment (gallons)	1,478

SECTION A-A'

SECTION B-B'

TRENCH DETAIL

NOTE:
EXISTING SECONDARY CONTAINMENT BASED ON FIELD MEASUREMENTS COLLECTED BY SCS ENGINEERS ON DECEMBER 1, 2020, AND DOCUMENTED IN A REPORT DATED DECEMBER 23, 2020. SCS MEASURED THE STORAGE AREA DIMENSIONS WITH A TAPE MEASURE AND A LASER DISTANCE MEASURE, AND MEASURED SLOPED AREAS WITH A LASER LEVEL.
