**Appendix 13 RCRA Feasibility Assessment (RFA) Report -
2001**

**RCRA FACILITY ASSESSMENT
MERCURY WASTE SOLUTIONS, INC.**

**Union Grove, Wisconsin
EPA ID#: WIR000000356
FID#: 252195350**

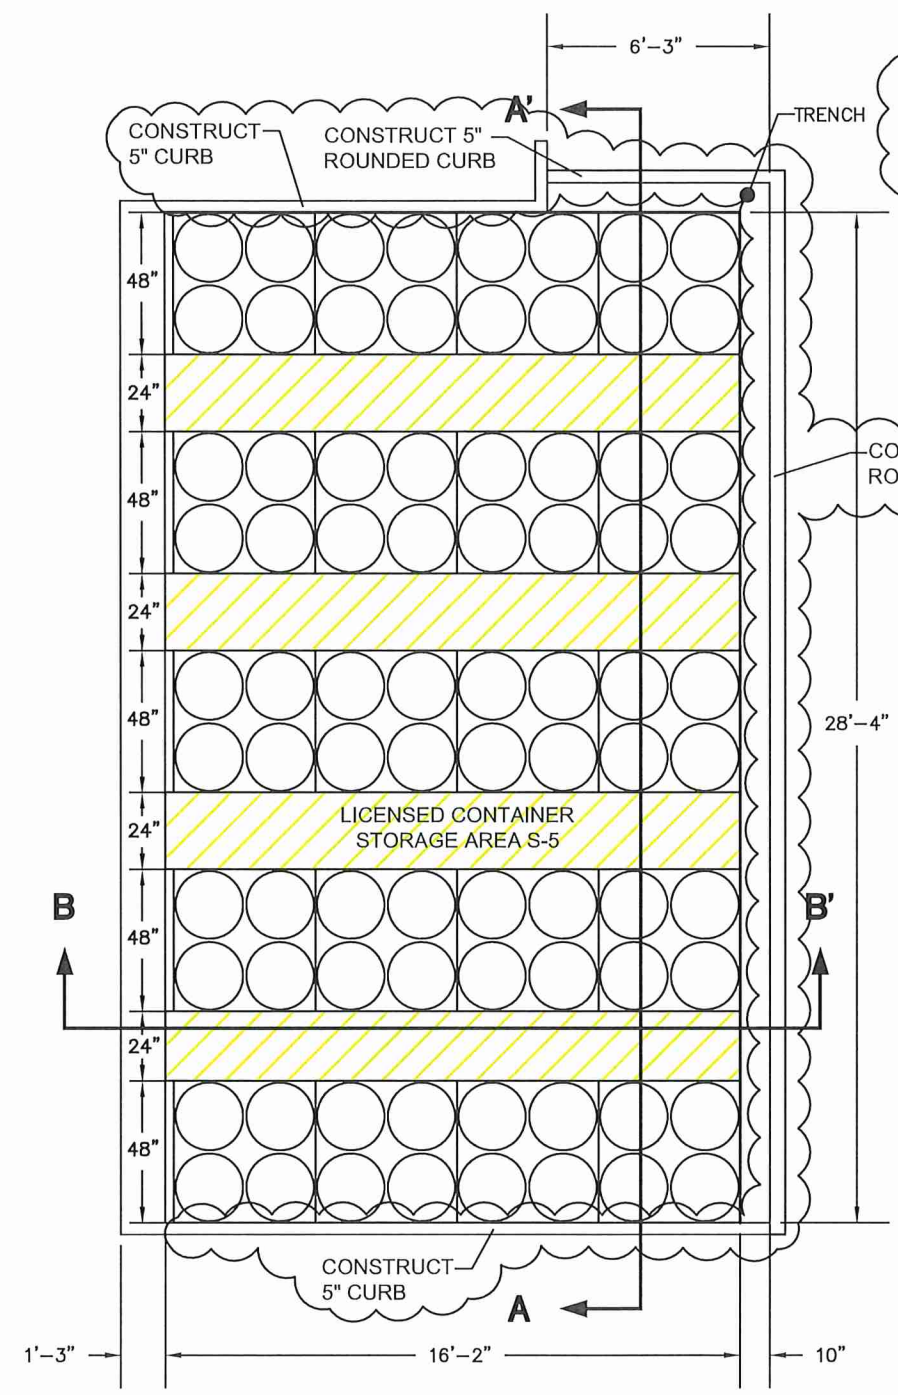
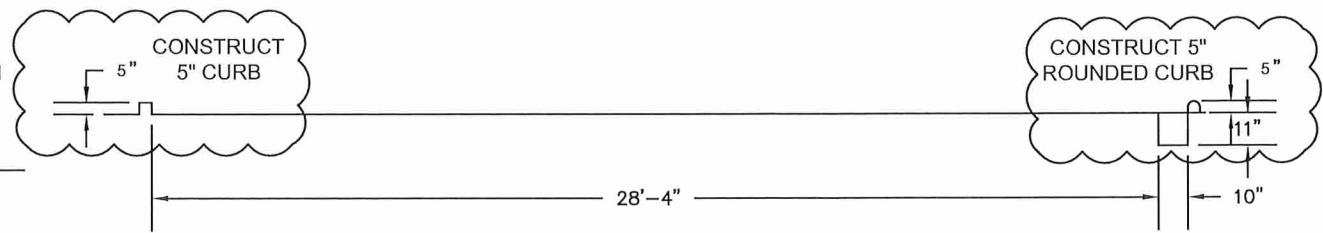
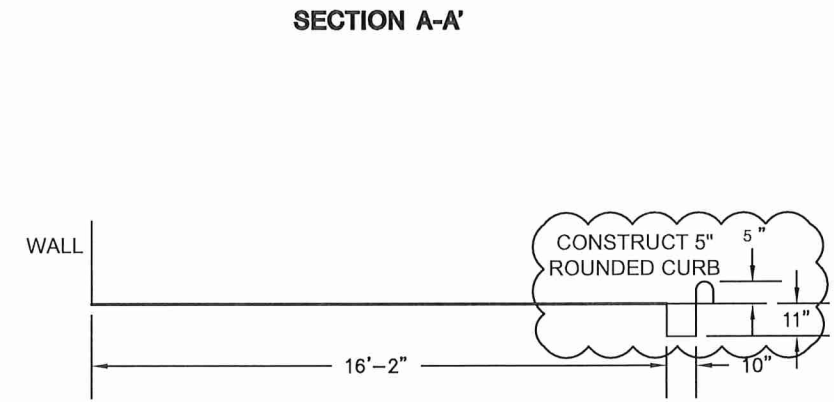
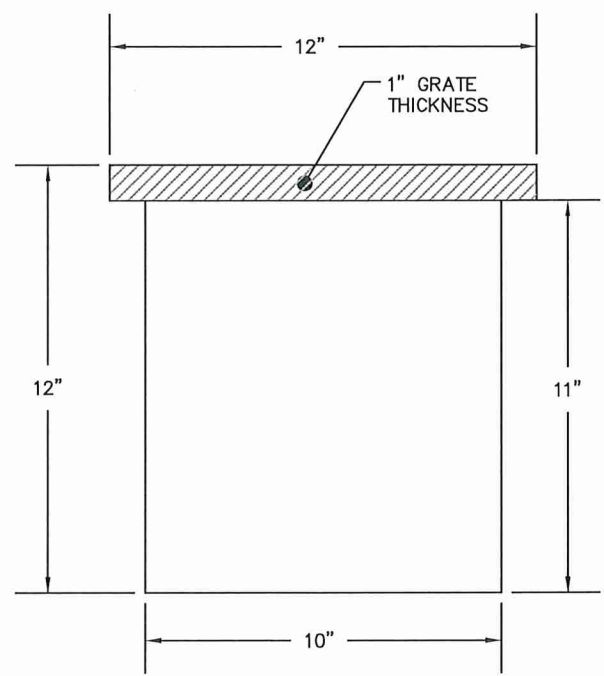
WM Waste, Inc. Union Grove, Wisconsin	
Storage Area S-5 Container Configuration	
Racine County, WI	
	Drawn: CAL/KAC-rev Checked: BDS Date: 06/03/2022 Approved: BHR Dwg. No.: WA5011-18114-46
Figure 16-5

S-5 Containment Area	
Stacking Configuration	2-Tier Stacking
Container Type	Drum
Maximum Number of Liquid Containers (55-gallon drums or DE)	160
largest container (gallons)	55
Proposed Permitted Capacity (Gallons)	8,800
Required Secondary Containment Capacity (greater of 10% of total capacity or largest container)	880
Available Secondary Containment (gallons)	198
Sufficient Containment?	No
Proposed Upgrades	Add 5 inch curbing. See details on drawing.
Proposed Containment (gallons)	942

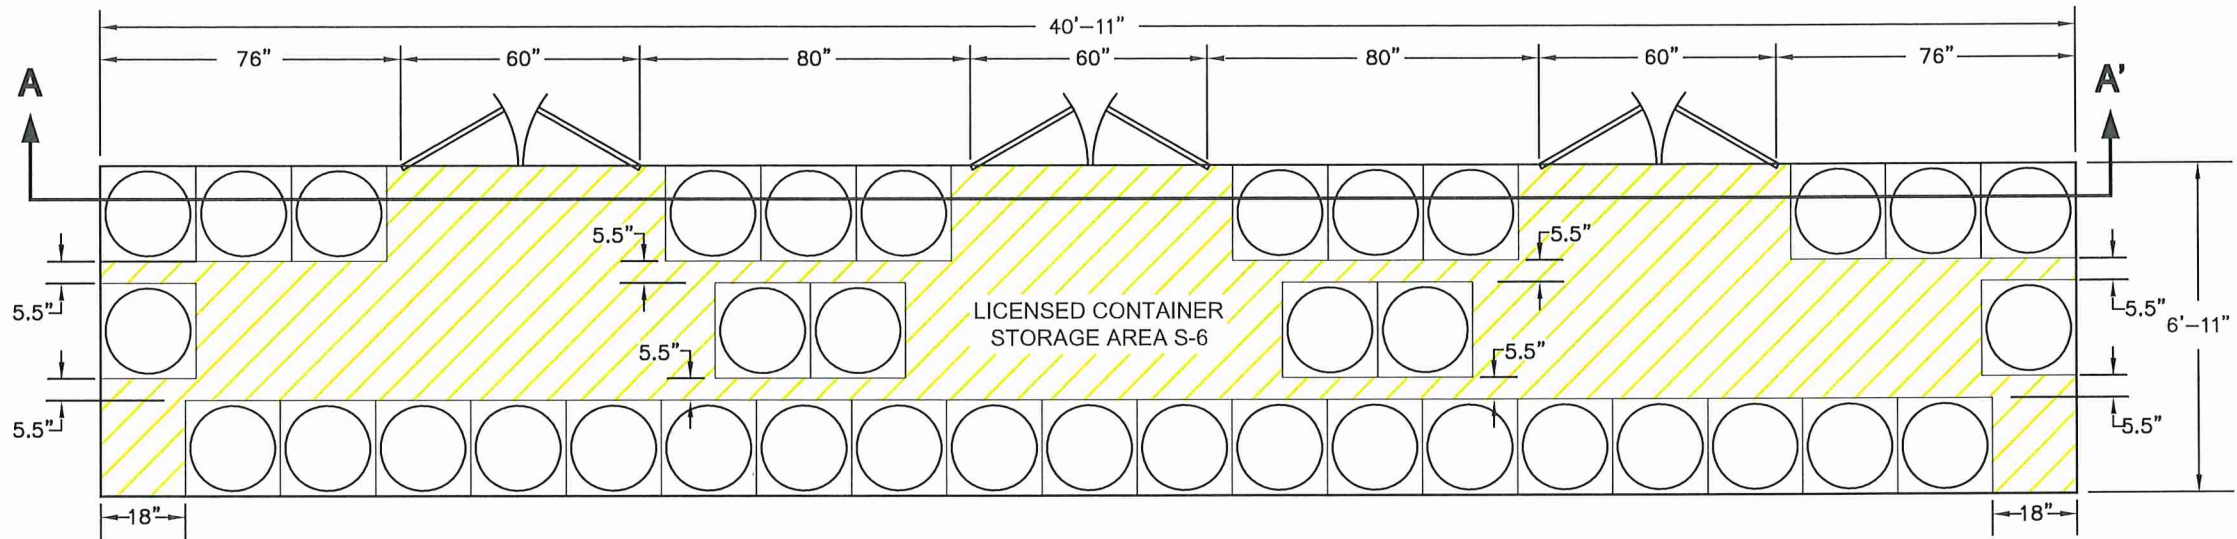
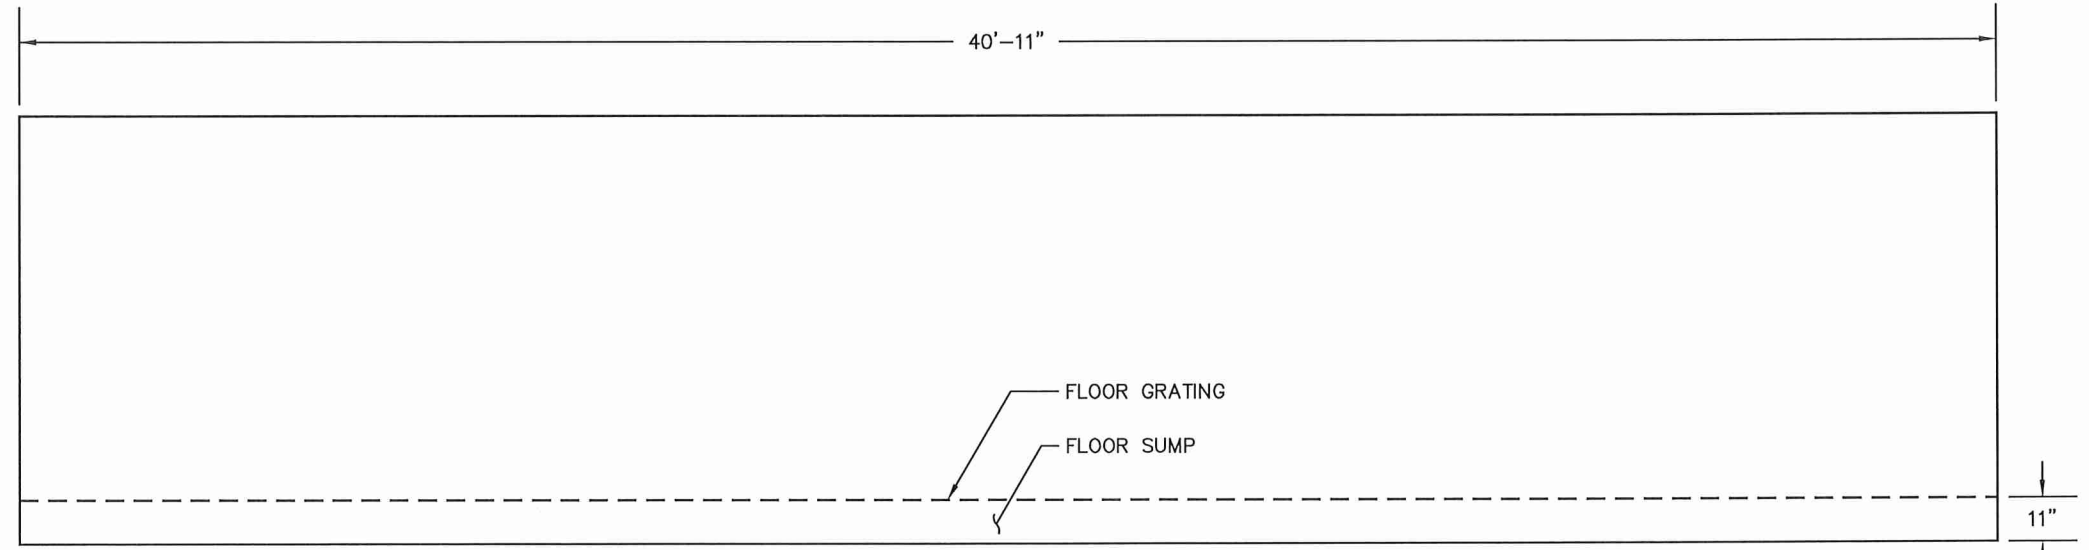
WM Waste, Inc. Union Grove, Wisconsin	
Storage Area S-6 Container Configuration	
Racine County, WI	
	Drawn: CAL/KAC-rev Checked: BDS Date: 06/14/2022 Approved: BHR Dwg. No.: WA5011-18114-47
Figure 16-6

SECTION A-A'

S-6 Containment Area	
Stacking Configuration	1-Tier Stacking
Container Type	Drum
Maximum Number of Liquid Containers (55-gallon drums or DE)	37
Largest container (gallons)	55
Proposed Permitted Capacity (Gallons)	2,035
Required Secondary Containment Capacity (greater of 10% of total capacity or largest container)	204
Available Secondary Containment (gallons)	1,941
Sufficient Containment?	Yes
Proposed Upgrades	None
Proposed Containment (gallons)	1,941

NOTE:
 EXISTING SECONDARY CONTAINMENT BASED ON FIELD MEASUREMENTS COLLECTED BY SCS ENGINEERS ON DECEMBER 1, 2020, AND DOCUMENTED IN A REPORT DATED DECEMBER 23, 2020. SCS MEASURED THE STORAGE AREA DIMENSIONS WITH A TAPE MEASURE AND A LASER DISTANCE MEASURE, AND MEASURED SLOPED AREAS WITH A LASER LEVEL.

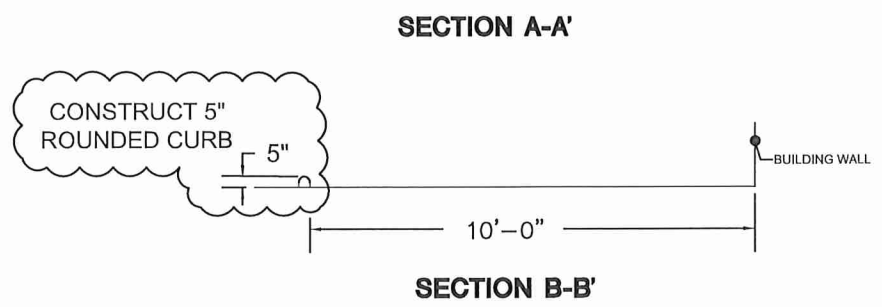
WM Waste, Inc. Union Grove, Wisconsin	
Storage Area S-7 Container Configuration	
Racine County, WI	
	Drawn: CAL/KAC-rev Date: 06/14/2022 Dwg. No.: WA5011-18114-48
Checked: BDS Approved: BHR	Figure 16-7

S-7 Containment Area	
Container Configuration	2-Tier Stacking
Container Type	Drum or Tote
Maximum Number of Liquid Containers (55-gallon drums or DE)	80
largest container (gallons)	275
Proposed Permitted Capacity (Gallons)	4,400
Required Secondary Containment Capacity (greater of 10% of total capacity or largest container)	440
Available Secondary Containment (gallons)	0
Sufficient Containment?	No
Proposed Upgrades	Add 5 inch curbing. See details on drawing.
Proposed Containment (gallons)	553

NOTE:
 STORAGE AREA INFORMATION BASED ON FIGURE 16-7, SHEET FPOR-10, DATED 2/24/2011 BY NIELSEN MADSEN & BARBER S.C. EXISTING SECONDARY CONTAINMENT BASED ON FIELD MEASUREMENTS COLLECTED BY SCS ENGINEERS ON DECEMBER 1, 2020, AND DOCUMENTED IN A REPORT DATED DECEMBER 23, 2020. SCS MEASURED THE STORAGE AREA DIMENSIONS WITH A TAPE MEASURE AND A LASER DISTANCE MEASURE, AND MEASURED SLOPED AREAS WITH A LASER LEVEL.

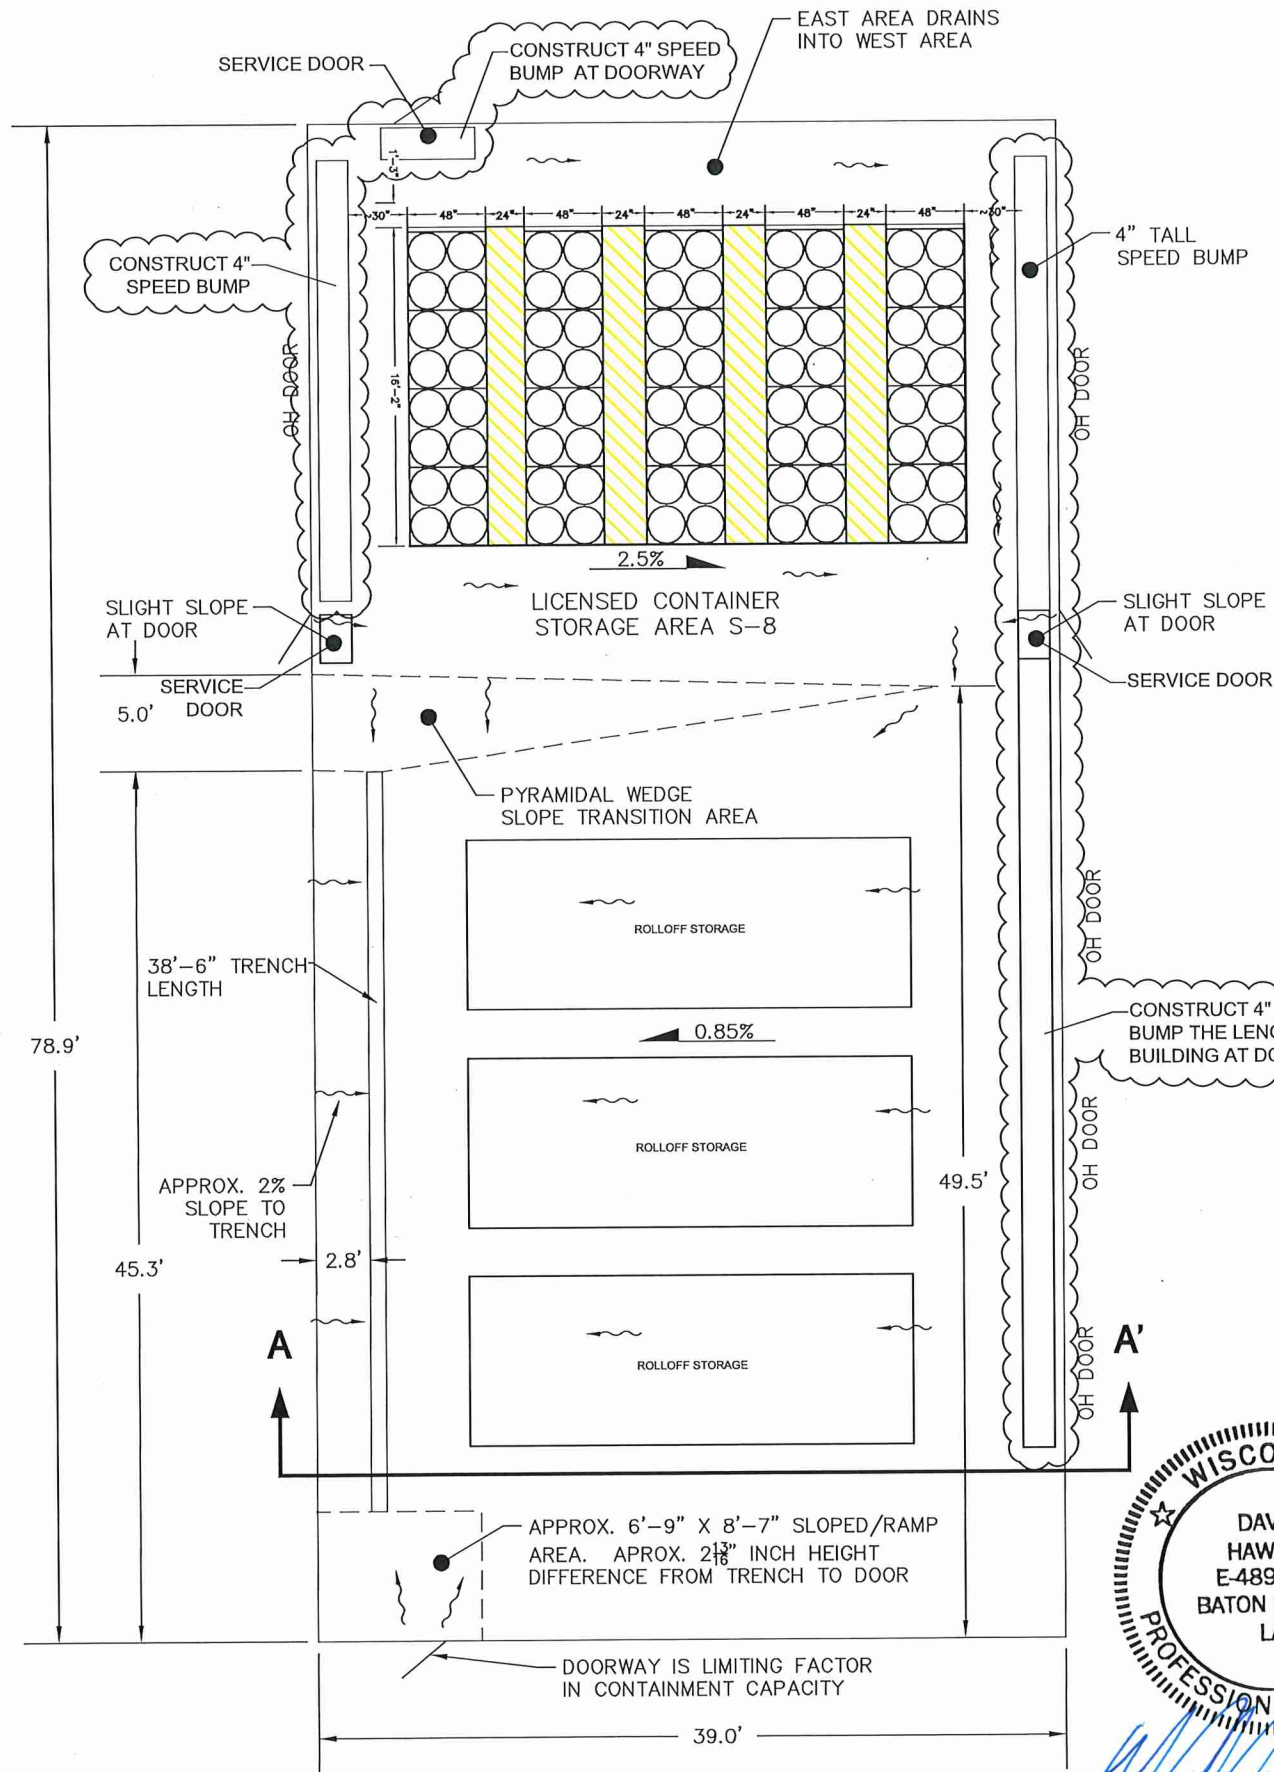
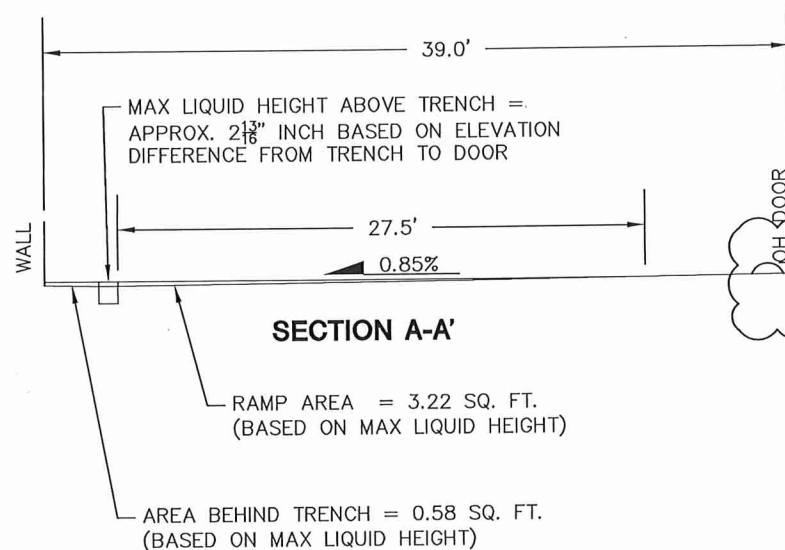
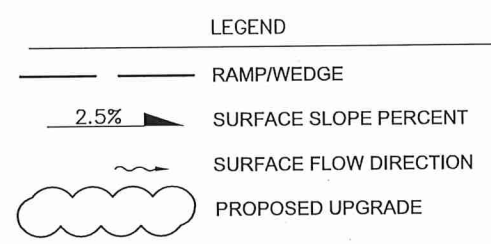
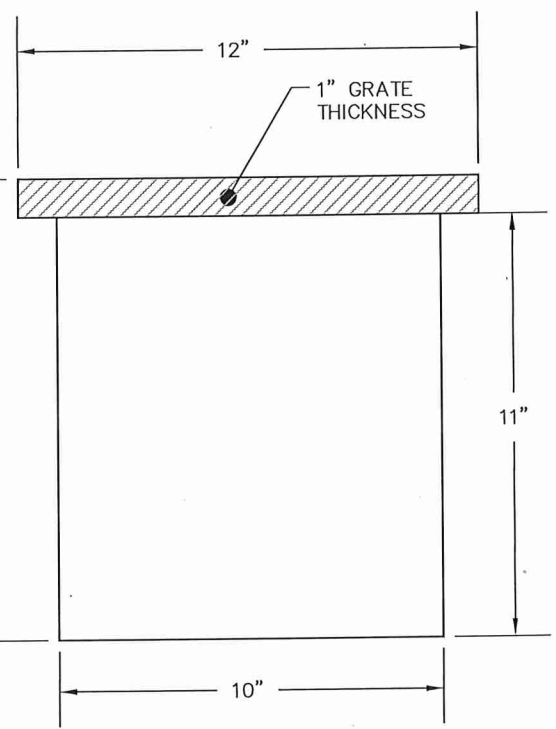
WM Waste, Inc.
 Union Grove, Wisconsin
**Storage Area S-8
 Container Configuration**
 Racine County, WI
 Drawn: CAL Checked: DWH
 Date: 1/26/2023 Approved: DWH
 Dwg. No.: WA5011-18114-49 **Figure 16-8**

S-8 Containment Area	
Container Configuration	3 Roll-Off Boxes, 2-Tier Stacking
Container Type	Roll-Off Box, Drum
Maximum Number of Liquid Containers (55-gallon drums or DE)	3 40 yd roll-off boxes, 160 Drums
largest container (gallons)	8,079
Proposed Permitted Capacity (Gallons)	33,037
Required Secondary Containment Capacity (greater of 10% of total capacity or largest container)	8,079
Available Secondary Containment (gallons)	1,545
Sufficient Containment?	No
Proposed Upgrades	Add 4 inch curbing. See details on drawing.
Proposed Containment (gallons)	8,278

NOTES:
 EXISTING SECONDARY CONTAINMENT BASED ON FIELD MEASUREMENTS COLLECTED BY SCS ENGINEERS ON DECEMBER 1, 2020, AND DOCUMENTED IN A REPORT DATED DECEMBER 23, 2020. SCS MEASURED THE STORAGE AREA DIMENSIONS WITH A TAPE MEASURE AND A LASER DISTANCE MEASURE, AND MEASURED SLOPED AREAS WITH A LASER LEVEL.
 S-8 MAY ALSO BE USED FOR COMPATIBLE HAZARDOUS WASTE DEBRIS CONSOLIDATION.

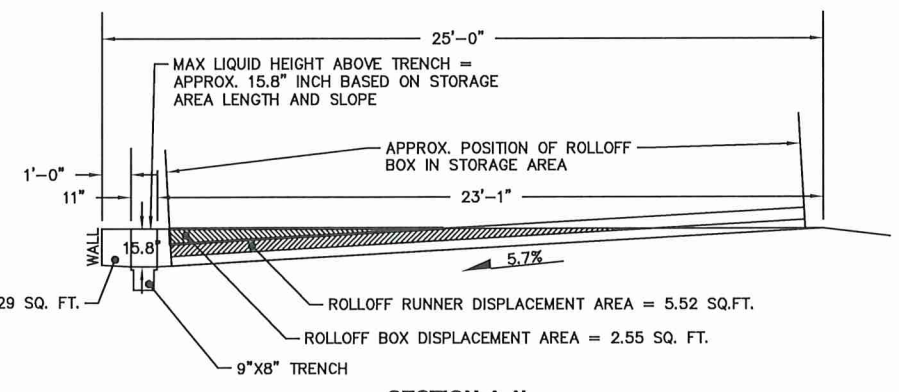
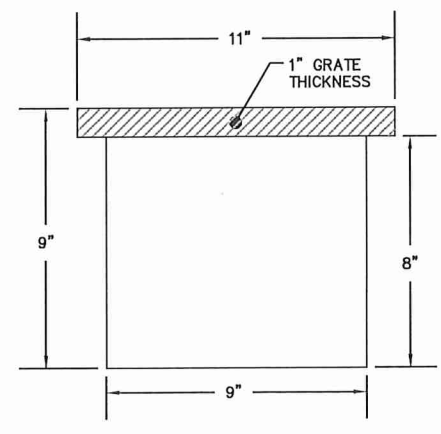
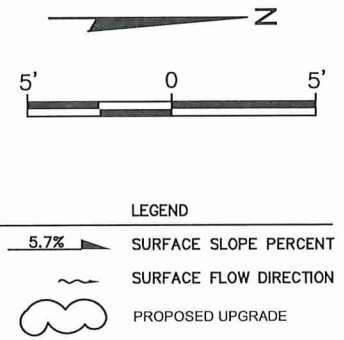
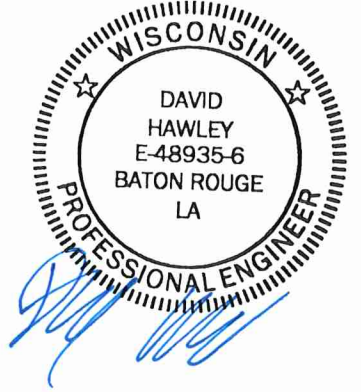
WM Waste, Inc. Union Grove, Wisconsin	
Storage Area S-12 Container Configuration	
Racine County, WI	
Drawn: CAL/KAC-rev Date: 06/14/22 Dwg. No.: WA5011-18114-50	Checked: BDS Approved: BHR Figure 16-9

S-12 Containment Area	
Container Configuration	8 Roll-Off Boxes, spaced as previously in individual units
Container Type	Roll-Off Box
Maximum Number of Liquid Containers (55-gallon drums or DE)	8 40 yd roll-off boxes
largest container (gallons)	8,079
Proposed Permitted Capacity (Gallons)	64,627
Required Secondary Containment Capacity (greater of 10% of total capacity or largest container)	8,079
Available Secondary Containment (gallons)	4,127
Sufficient Containment?	No
Proposed Upgrades	Combine S-12, -13, and -14 into one unit. Extend trench through inner walls. See details on drawing.
Proposed Containment (gallons)	11,234

NOTE:
 EXISTING SECONDARY CONTAINMENT BASED ON FIELD MEASUREMENTS COLLECTED BY SCS ENGINEERS ON DECEMBER 1, 2020, AND DOCUMENTED IN A REPORT DATED DECEMBER 23, 2020. SCS MEASURED THE STORAGE AREA DIMENSIONS WITH A TAPE MEASURE AND A LASER DISTANCE MEASURE, AND MEASURED SLOPED AREAS WITH A LASER LEVEL.

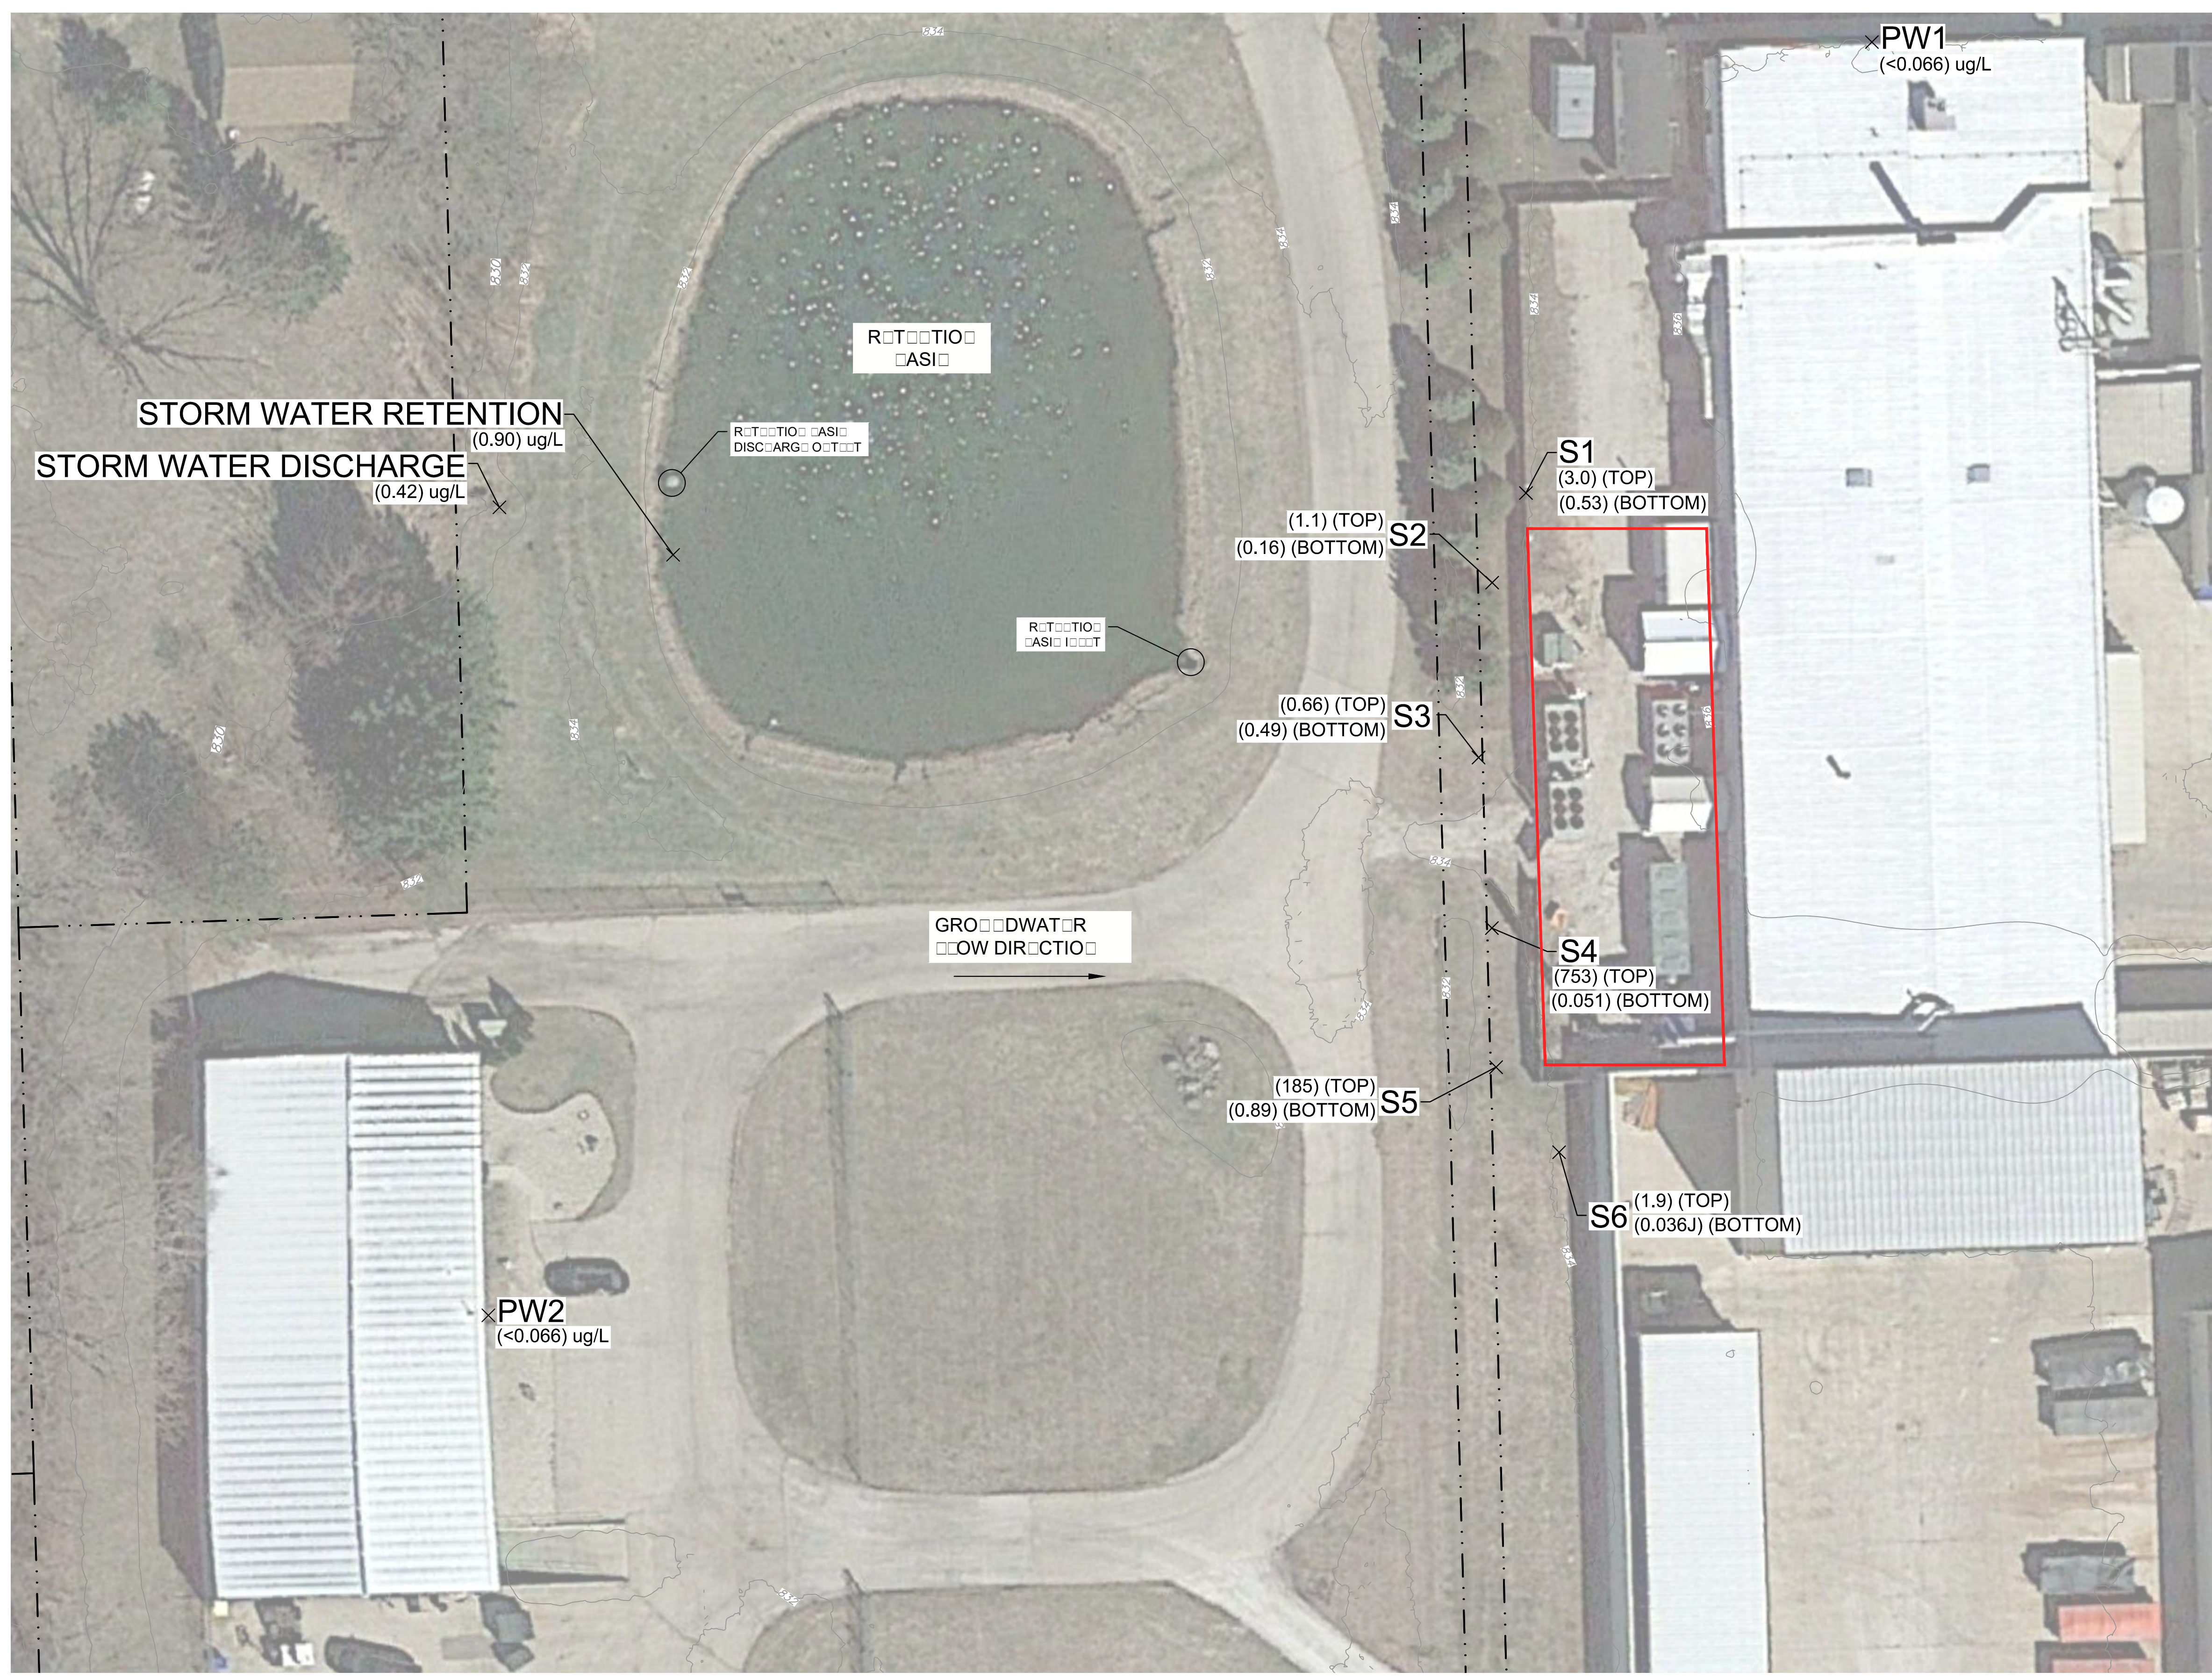
FIGURE NO.
2
 PROJECT NO.
 4221563

WM WASTE, INC.
 UNION GROVE, WISCONSIN
**2022 SITE INVESTIGATION REPORT AND
 REMEDIAL ACTION PLAN**
SITE INVESTIGATION SAMPLING LOCATIONS

soil sample was collected by using clean latex gloves. New, clean latex gloves were used for each sample. Between samples, the equipment was decontaminated. After the decontamination process, once every six to eight samples, distilled water was poured over the sampling equipment and collected in a sample container and analyzed for total mercury to confirm the efficiency of the decontamination procedures. Each soil sample location was surveyed with a GPS unit. The May 2022 soil sample locations are shown on Figure 2.

During the initial (Phase 1A) of the Investigation a total of 12 soil samples and two decontamination water samples were collected in accordance with the SIWP and analyzed in a laboratory for total mercury using United States Environmental Protection Agency (USEPA) Method 7471. The 12 samples were collected at six locations and depths described in Section 3 of this report. Figure 3 shows the sample locations and analytical results. The May 2022 analytical results are summarized on Table 2. Out of the six sample locations, laboratory results showed that the surficial soils at two locations (S4 and S5) had concentrations of total mercury above the RCL of 3.13 mg/kg. The remaining surficial soil samples were below the RCL or non-detect. Although the concentration of total mercury at S1 (3.0mg/kg) was below the RCL, it was determined that step out sampling was appropriate to provide additional confidence in the mercury concentration surrounding this area. None of the samples collected during May 2022 at a depth of one foot below the surface had total mercury detections above the RCL.

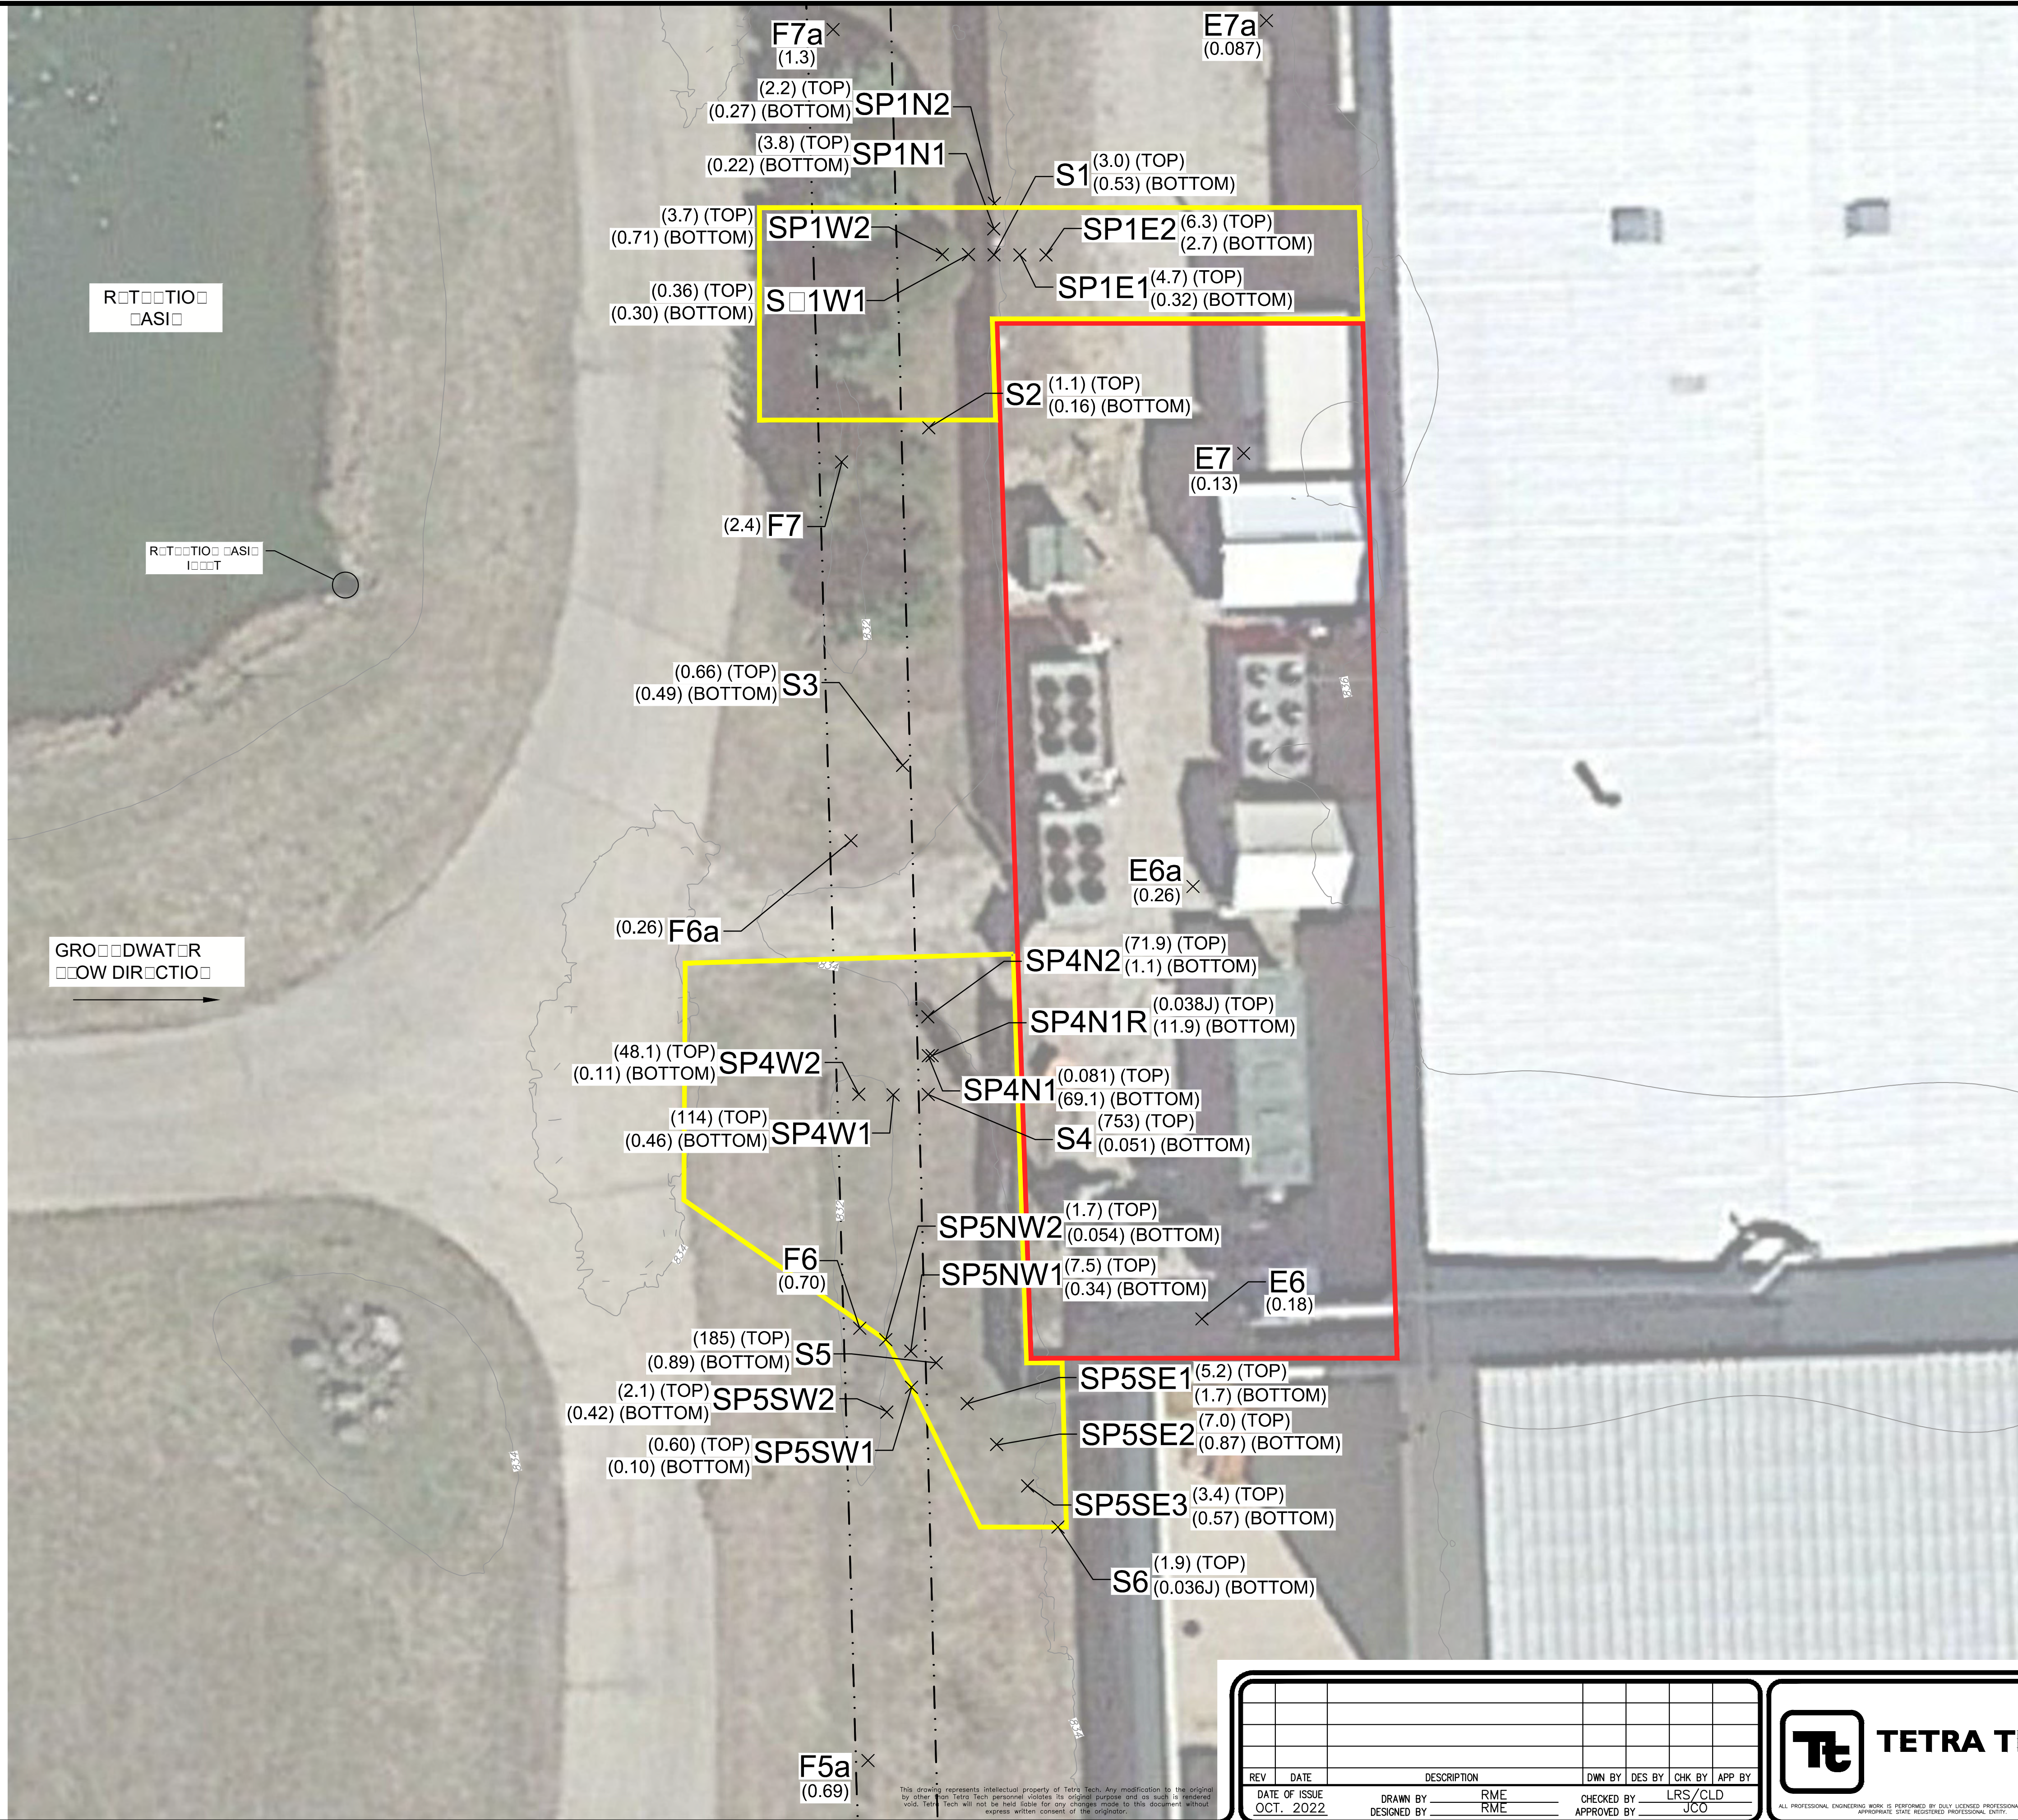
FIGURE NO.
3
 PROJECT NO.
 4221583

- RE SAMPLE LOCATION IS D O T D AS S41R LOCATED 4' TO TDD EAST O S41.
- TETRA TECH COLLECTED SOIL SAMPLES ON 8/17/2022.
- SAMPLE LOCATION WAS SROD ID TO TDD.
- TOTAL MERCURY CONCENTRATION RESULT WAS RROD ID EAC AACTICA AG ST 22, 2022.

WM WASTE, INC.
 UNION GROVE, WISCONSIN
**2022 SITE INVESTIGATION REPORT AND
 REMEDIAL ACTION PLAN**
REMEDIAL EXCAVATION AREA BOUNDARY

soil sample locations S1, S4 and S5. Figure 3 shows the step out sample locations. The rationale and plan for each of these three locations is summarized below.

The Step Out samples were collected on July 12, 2022. Due to the July 2022 results, a subsequent or confirmation sample was collected adjacent to the SP4N1 location on August 17, 2022. Step-Out soil sample locations are shown on Figure 3. Samples were collected near the surface and at a depth of one foot below the surface following the same sampling techniques as the initial samples. Additional step out samples were collected around Phase 1A sample locations S1, S4 and S5 because the total mercury concentration approached or exceeded the RCL. Each of the 34 total step out samples were collected between areas that samples exceeded the RCL and/or warranted further investigation and a known boundary delineation. Boundary delineations are further defined for each initial sample point below.

The step out samples collected around S1, S4 and S5 were performed in accordance with the SIWP. The results of step-out sampling showed surficial concentrations above the 3.13 mg/kg limit in 12 of the 17 step-out locations. One step-out location had a concentration above the 3.13 mg/kg limit one foot below the surface depth. Figures 3 shows the step sample results as they relate to the delineation boundaries and the Table 3 shows the results in tabular form.

Water quality of the samples collected from the stormwater retention pond and the two water supply wells onsite were analyzed for total mercury using USEPA Method 7470. The sample locations are shown on Figure 3. The laboratory results are summarized in Table 2 and in the laboratory reports in Attachment 2. Samples were collected in accordance with the Sample and Analysis section of the SIWP on May 24, 2022. Total mercury was not detected in either of the two onsite water supply well samples (PW-1 and PW-2). The surface water in the stormwater pond and the stormwater pond discharge had detectable concentrations of total mercury. The sample collected in the pond had a concentration of 0.90 ug/L and the sample collected from the pond discharge had a concentration of 0.42ug/L. There is not an established standard to compare surface water concentrations. Once the Remedial Action Plan is implemented for the contaminated soil, it will no longer be a potential source of contamination for the surface water at the site and concentrations should decrease.
