**Appendix 13 RCRA Feasibility Assessment (RFA) Report -
2001**

**RCRA FACILITY ASSESSMENT
MERCURY WASTE SOLUTIONS, INC.**

**Union Grove, Wisconsin
EPA ID#: WIR000000356
FID#: 252195350**

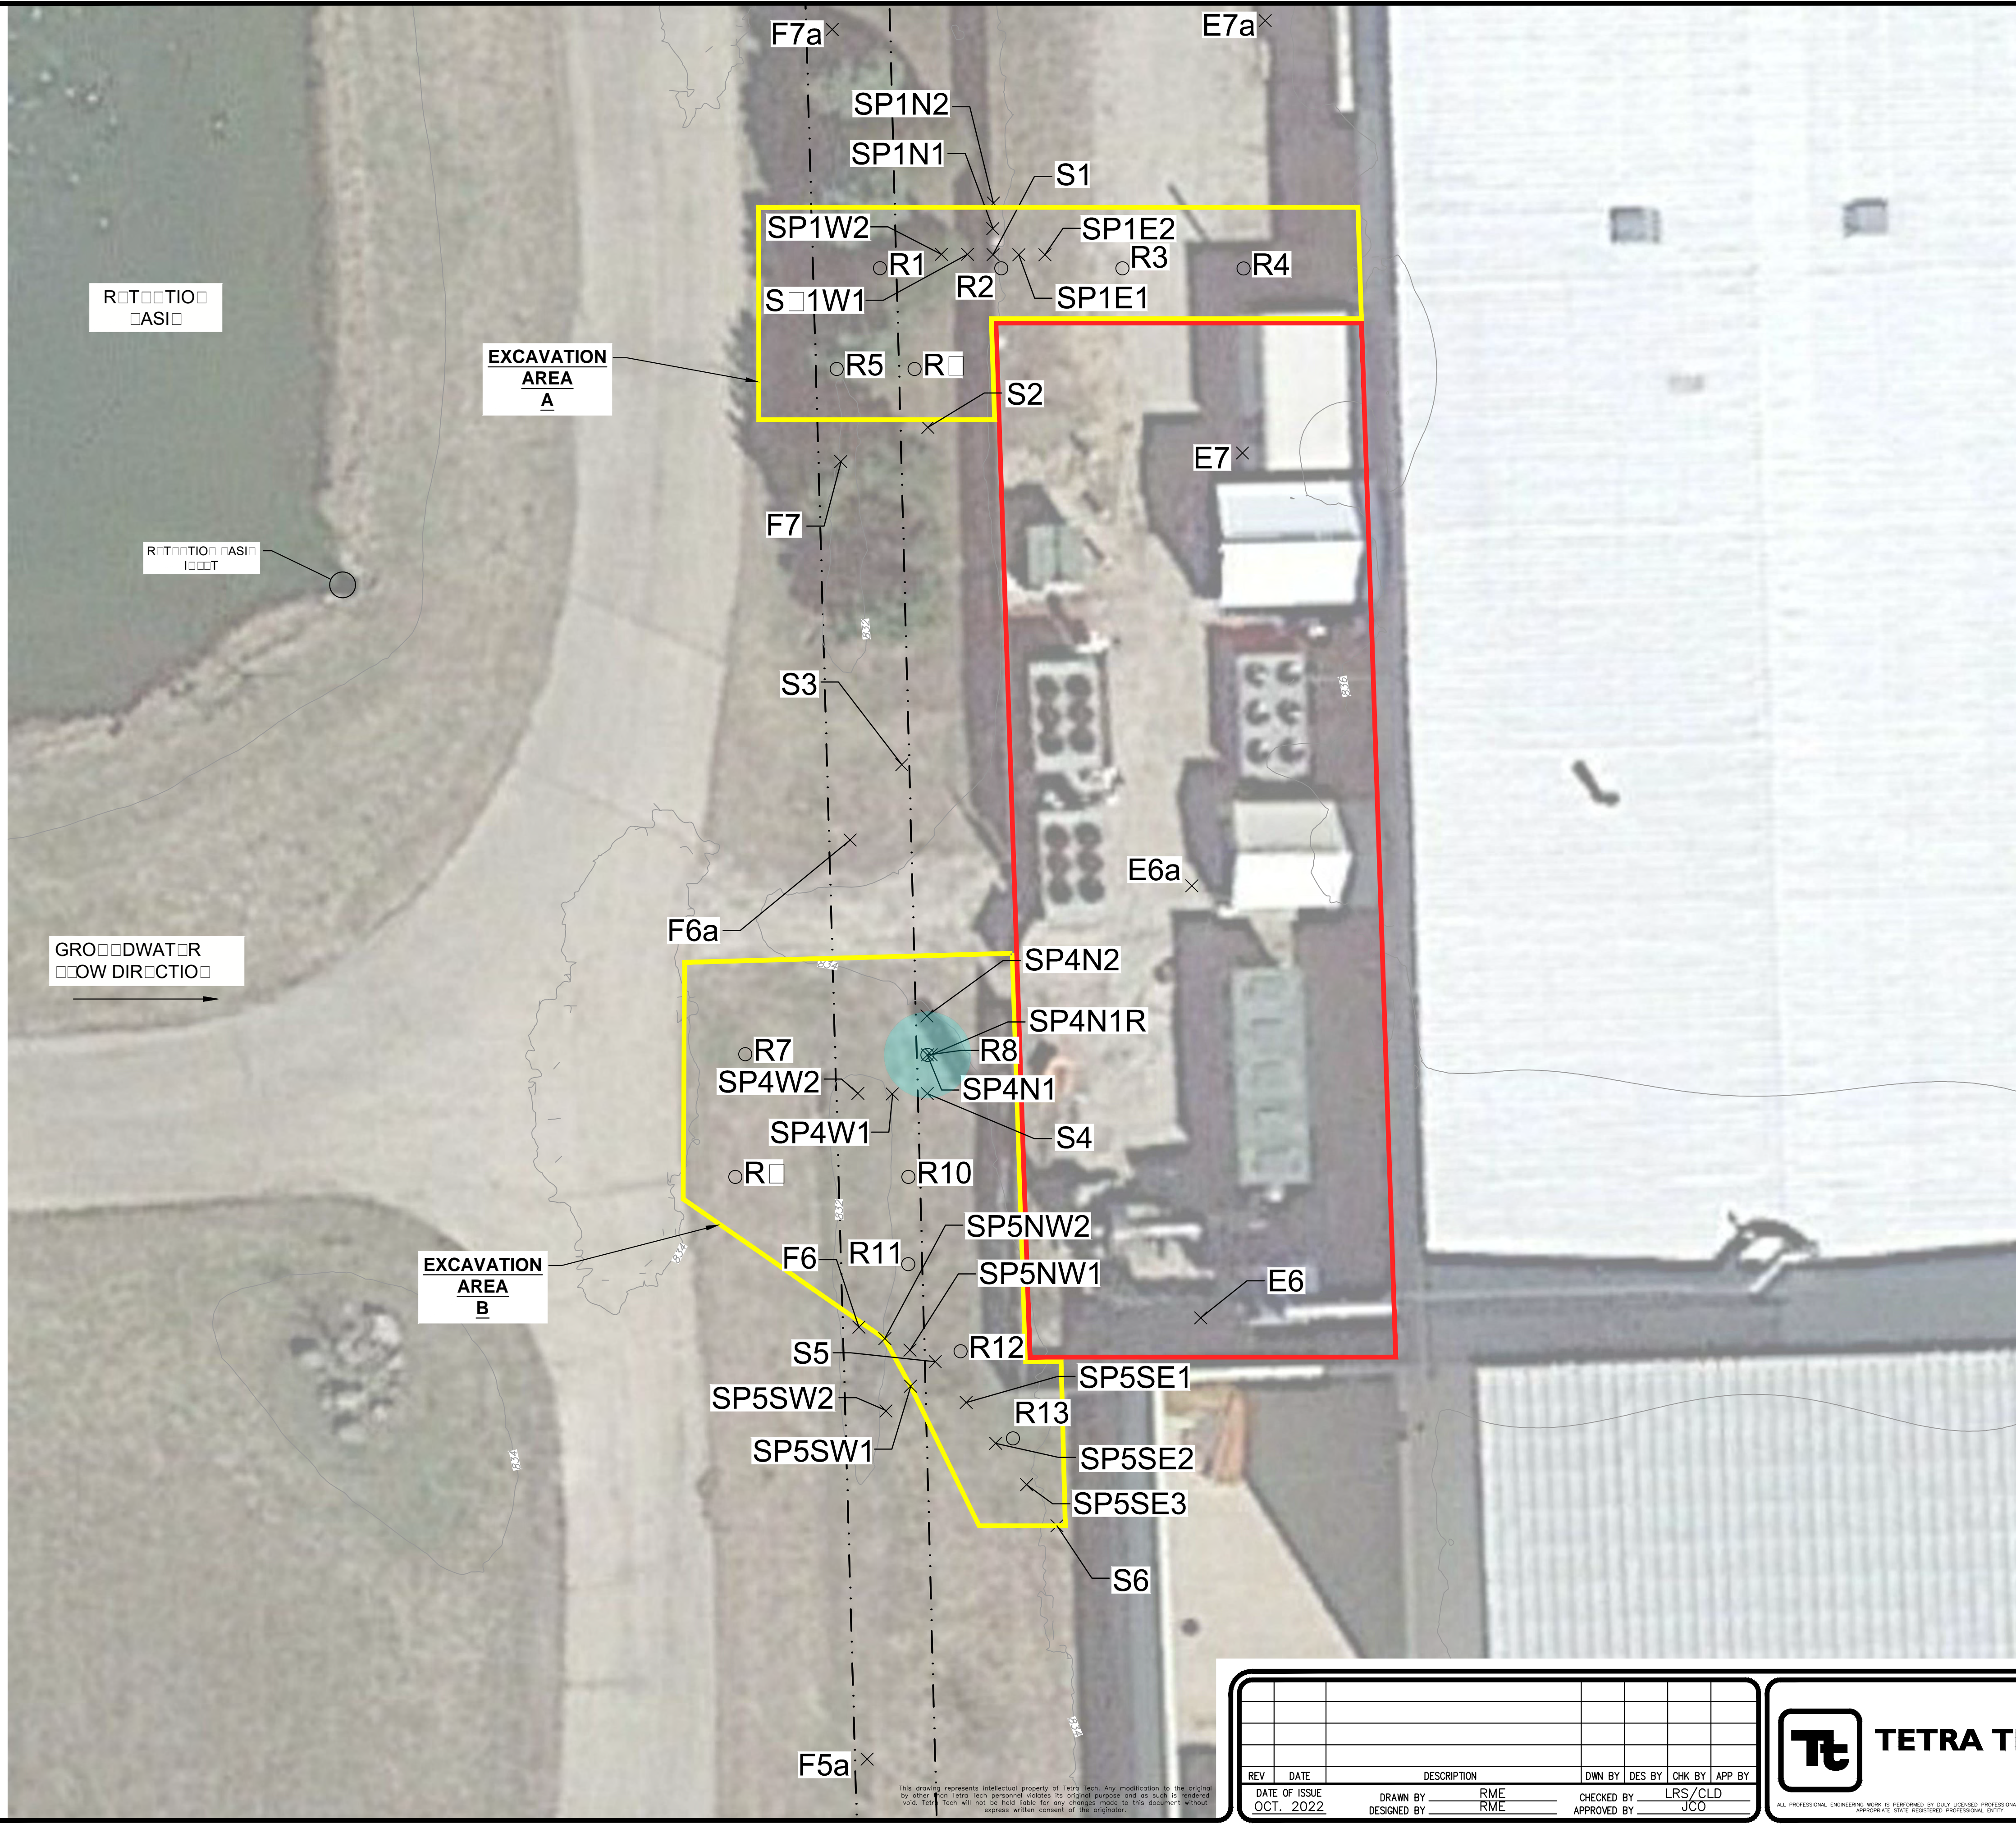
FIGURE NO.
4
 PROJECT NO.
 4221563

1. TETRA TECH WILL SURVEY INVESTIGATION COORDINATES AND CONFIRMATION SAM LOCATIONS FOLLOWING INVESTIGATION.
2. THE CROSSED INVESTIGATION AREAS AREA A AND AREA B WILL BE RELATED TO A DETAIL OF FOOT FLOW GROUND SURFACE. THE FOOT RADIUS AREAS S41 S41R WILL BE RELATED TO A DETAIL OF 1.5 FOOT FLOW GROUND SURFACE.
3. THE 2017 INVESTIGATION SURFACE IS TAKEN FROM THE WISCONSIN CARTOGRAPHIC OFFICE.

WM WASTE, INC.
 UNION GROVE, WISCONSIN
**2022 SITE INVESTIGATION REPORT AND
 REMEDIATION ACTION PLAN**
REMEDIATION CONFIRMATION SAMPLE LOCATIONS

delineated by soil sample results, the previous remediated area and the manmade features such as roads and buildings as shown on Figure 4. At the location of SP4N1 and SP4N1R, a 5-foot diameter area will be excavated to a depth of one and a half feet to account for the mercury concentration over the RCL limit of 3.13 mg/kg at the 12 inches below ground surface.

The confirmation samples will be shipped to a certified laboratory. The Area A and B excavations will stay open until confirmation sample results are received. The proposed excavation areas and confirmation sample locations are shown on Figure 4. If a confirmation sample exceeds the RCL, that area will be further excavated, and an additional confirmation sample or samples will be collected and analyzed until the concentration in the remaining soil is below the RCL. Excavation procedures will be considered complete once the soil sample results within the excavated or remediated areas are analyzed below the RCL. Upon completion of the remediation activities, the roll-off containers will be removed from site and disposed under proper chain-of-custody. The excavated areas will be backfilled with clean topsoil, general fill and/or gravel from a local supplier.
