WATER QUALITY TRADING PLAN

Waukesha County, Wisconsin

Revised: February 11, 2025

Project located in Rotary Park, Village of Menomonee Falls

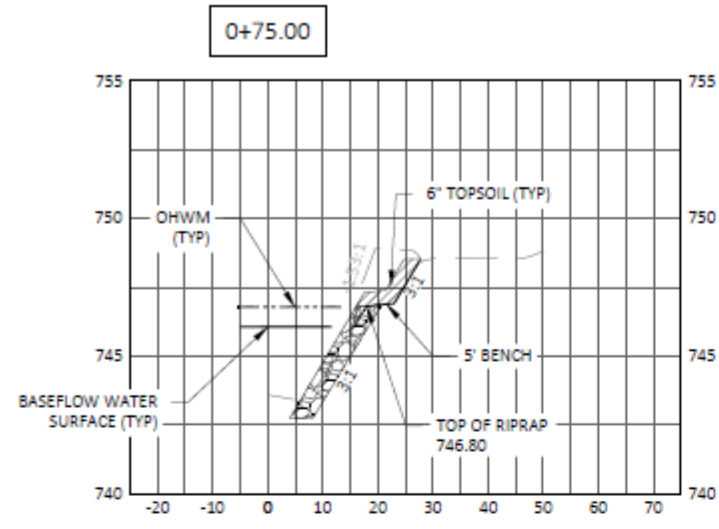
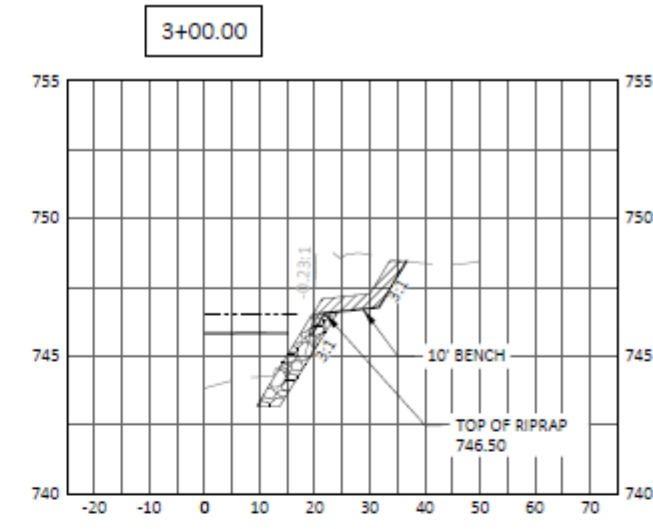
ROTARY PARK STABILIZATION:
 SECTIONS

SECTIONS
 HORIZONTAL SCALE: 1"=30'
 5X VERTICAL EXAGGERATION

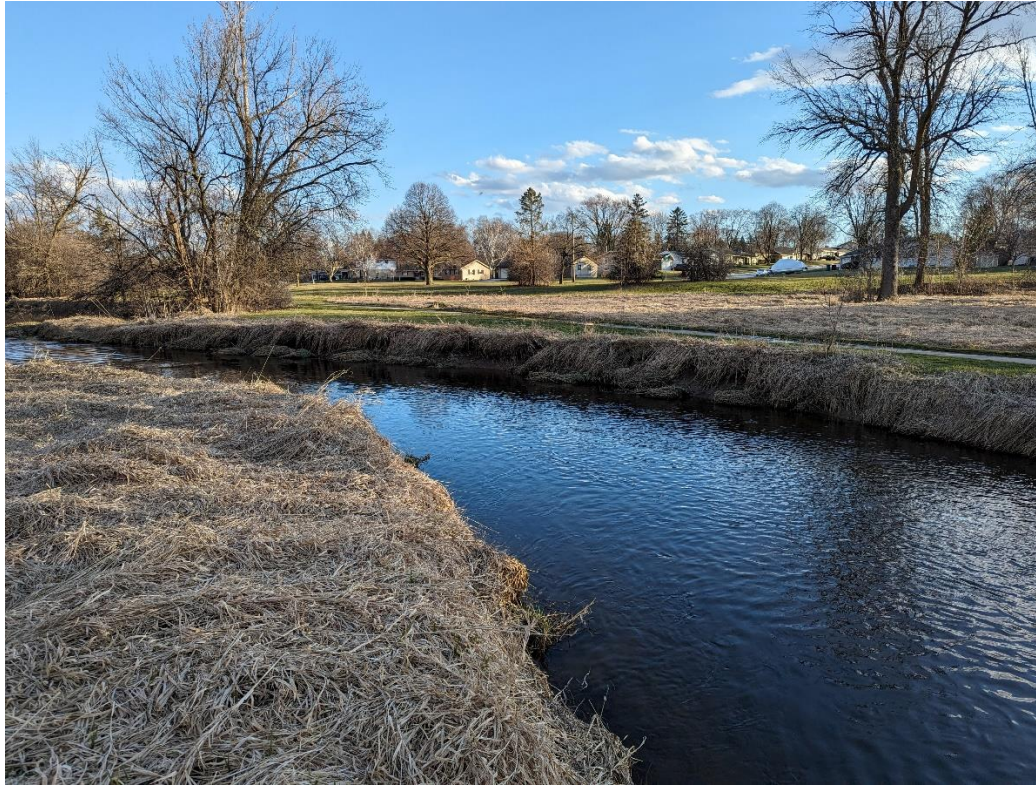
Image 1.1 – Bank on right, undercut with slumped sections in stream, covered with grass

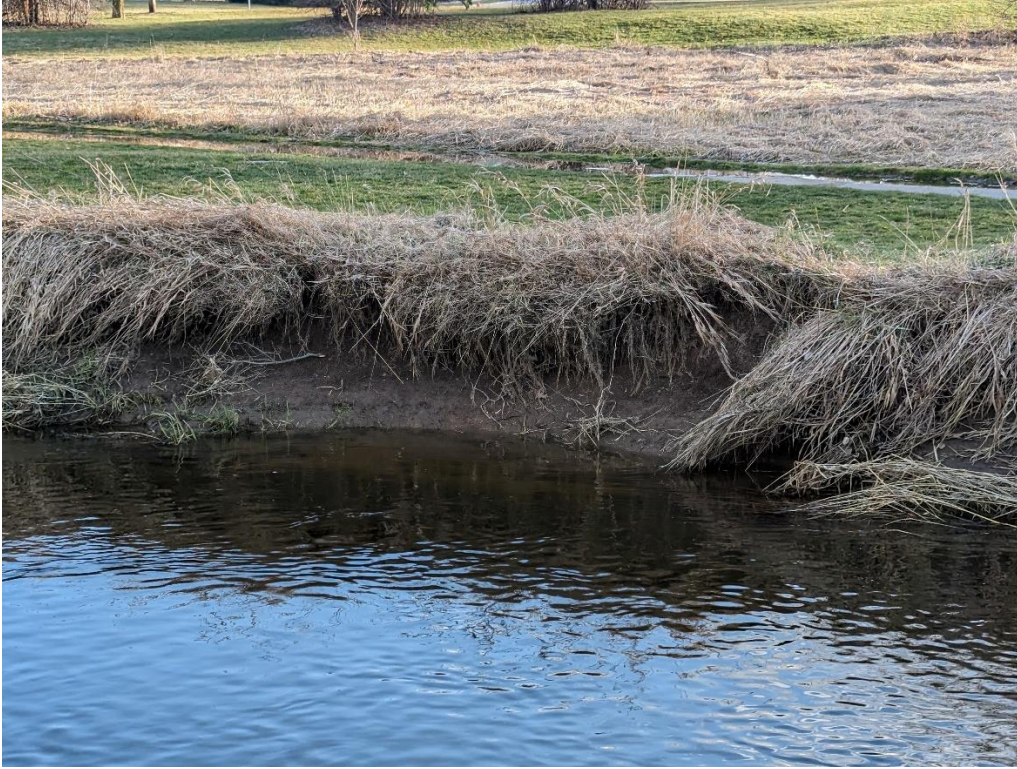
Image 1.2 – Bank undercut, covered with grass

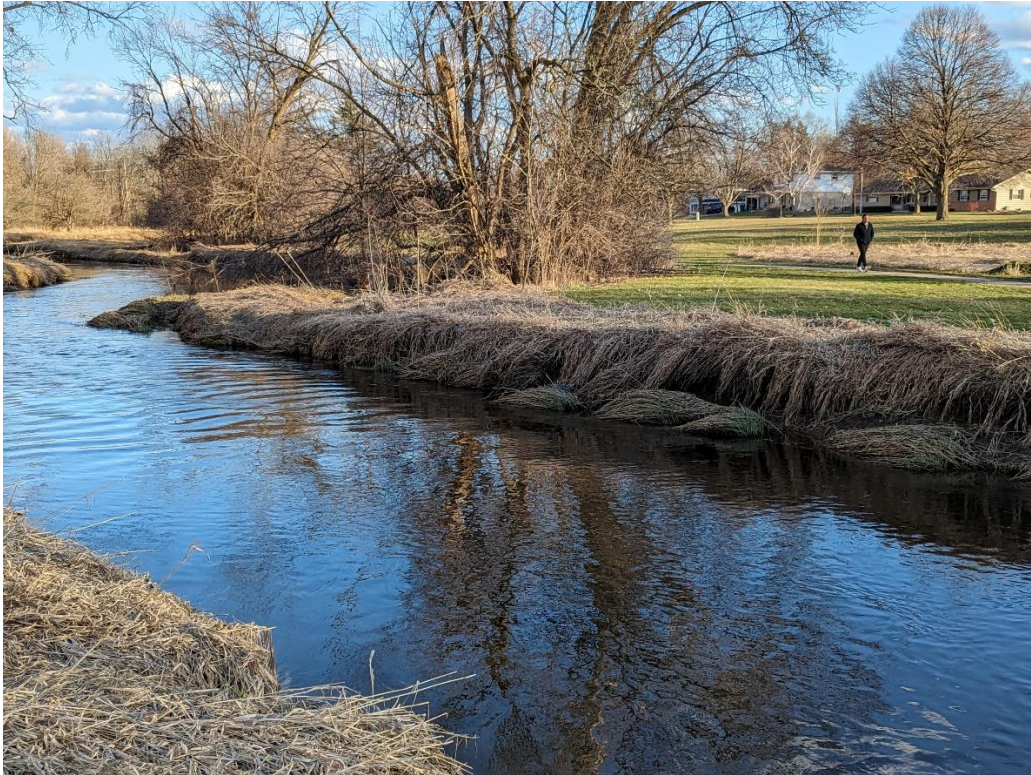
Image 1.3 – Bank on right, undercut, partly covered with grass.

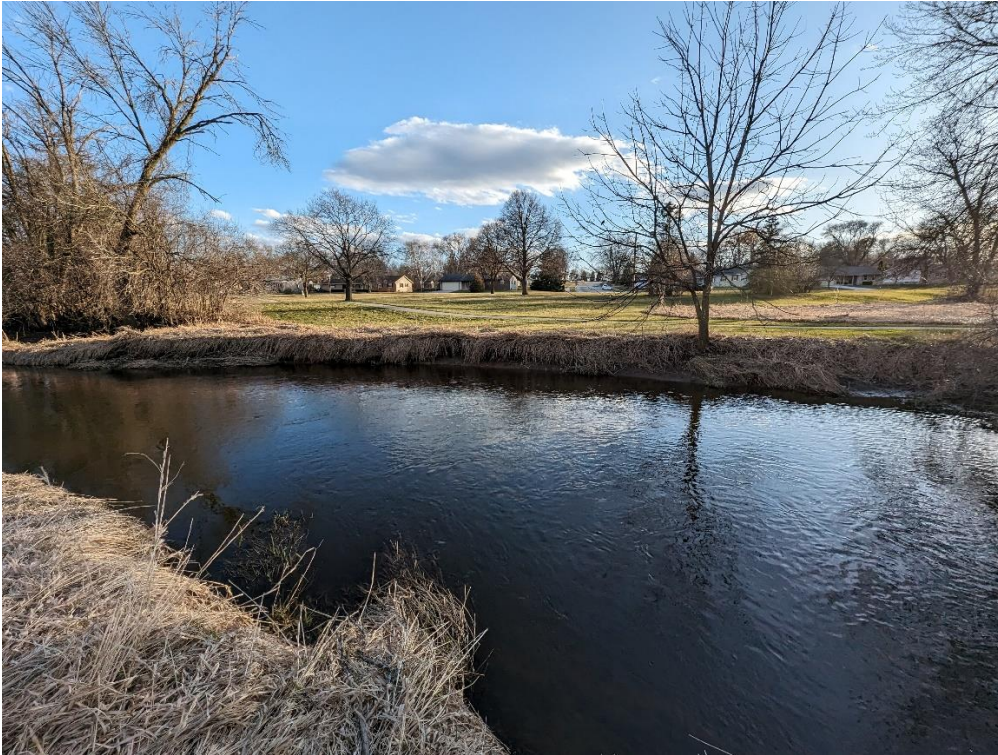
Image 2.1 – Bank, undercut with exposed roots and overgrown with grass.

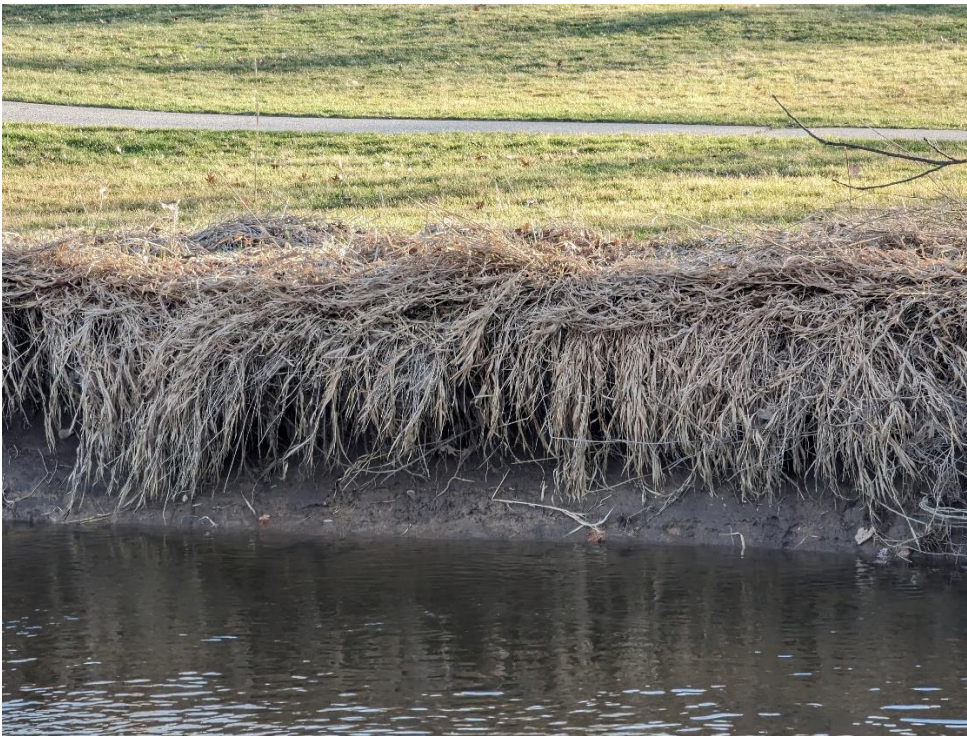
Image 2.2 – Bank, undercut, somewhat hidden due to overhanging grass.

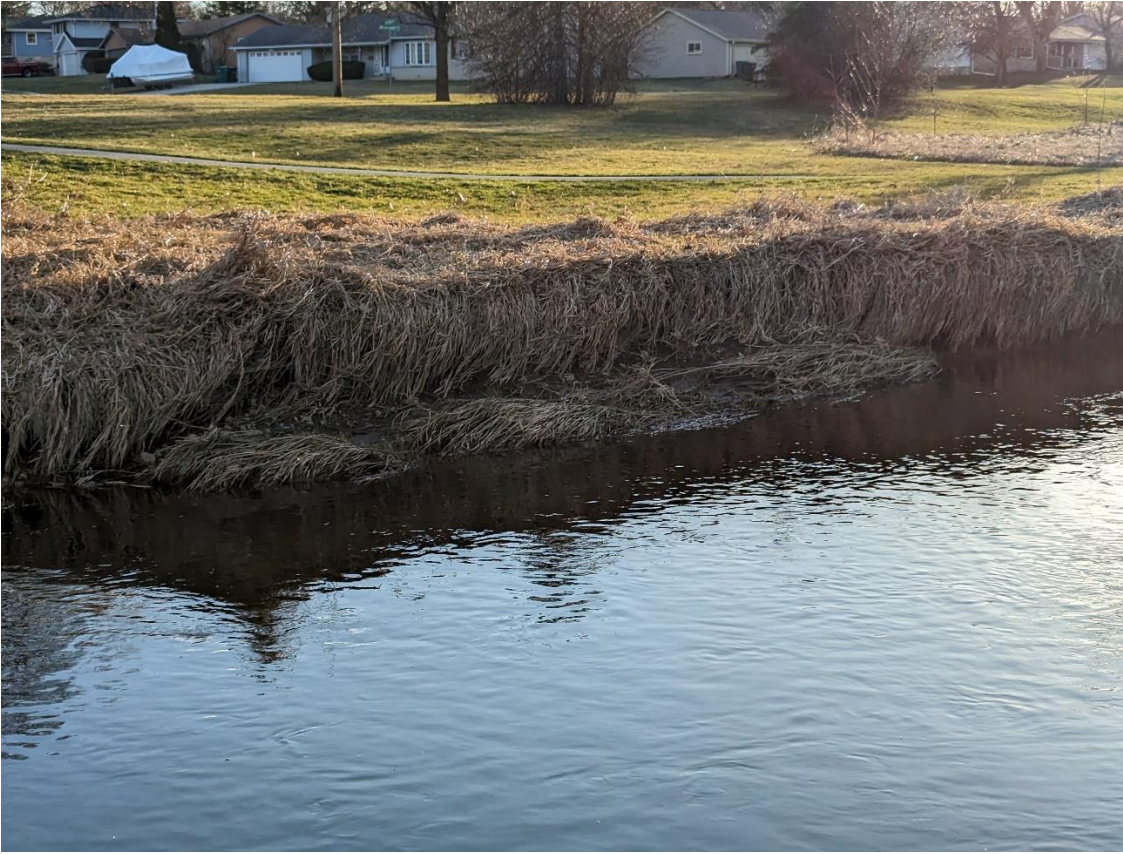
Image 2.3 – Bank, undercut, with slumped sections of soil in water.

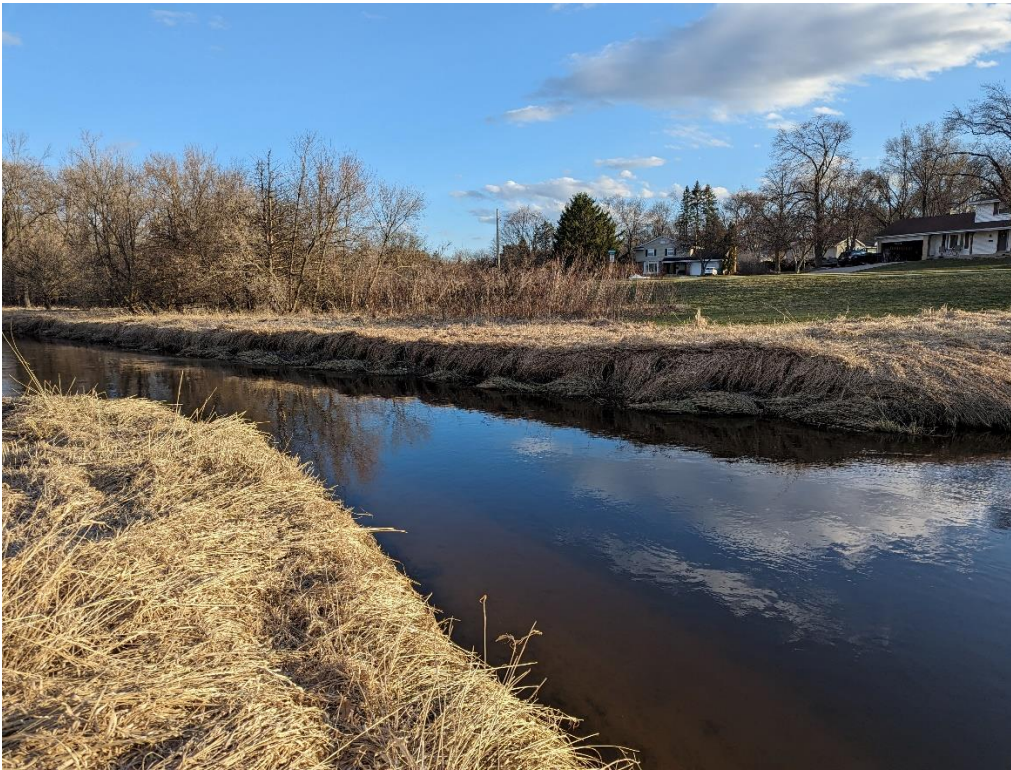
Image 3.1 – Bank, undercut with slump, covered with grass.

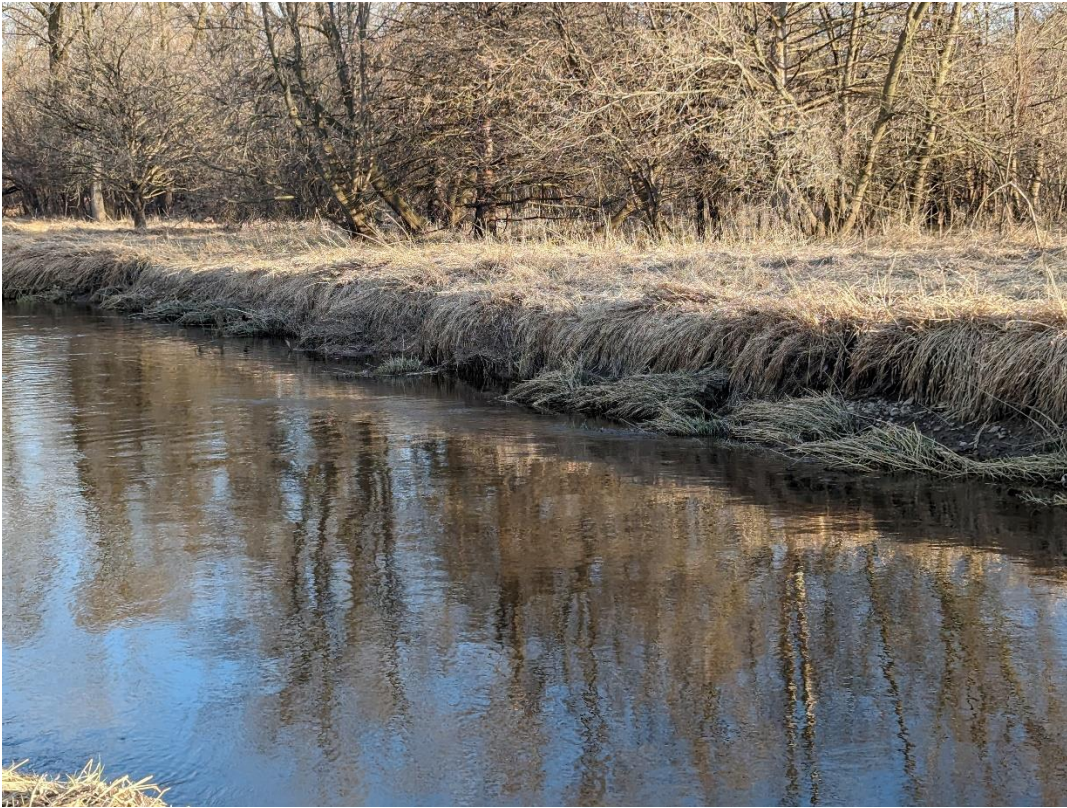
Image 3.3 – Bank on top, undercut with slumped material, covered with grass.
