S-14 Trempealeau Buffalo River Bridge

Motorized Recreation Grant Application

Bridge Inspection Report for:
Department of Land Management, Trempealeau County, WI
CTH NN & I-94 Snowmobile Bridge

CTH NN & I-94 Snowmobile Bridge

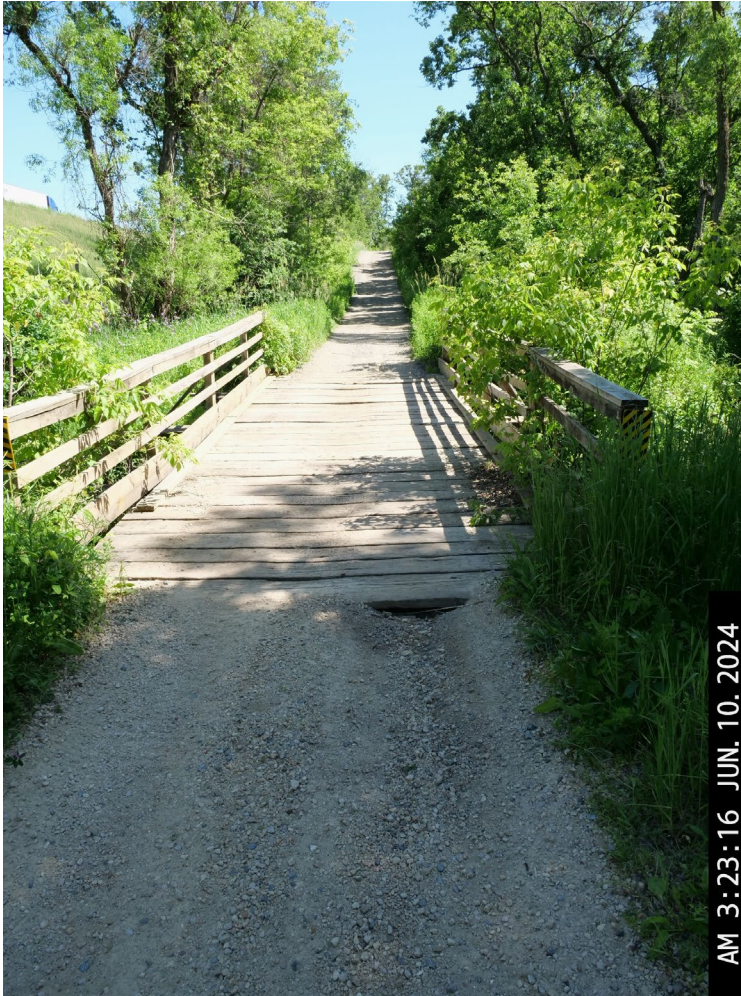
Deck: The timber decking is 31' 3" by mostly 12" boards clipped to the top flange of the steel girders. The decking is very worn with some uneven longitudinal movement of boards creating 1"+ gaps between some planks. All plank are significantly worn in the center from snowmobile track studs. Currently, one plank is broken, two have been temporarily repaired with treated 2x4s. underneath and most are significantly weakened from loss of thickness. Worst damage is on the south end of bridge. The bridge railings attached to the ends of longer deck plank are very loose with some repaired damage.

North End of Deck looking to South

Recommended maintenance is complete bridge rehabilitation consisting of removing the existing deck, installing a solid abutment around the timber pilings, riprapping the river bank underneath the bridge, cleaning and painting the steel I beams, and installing a new deck and railings.

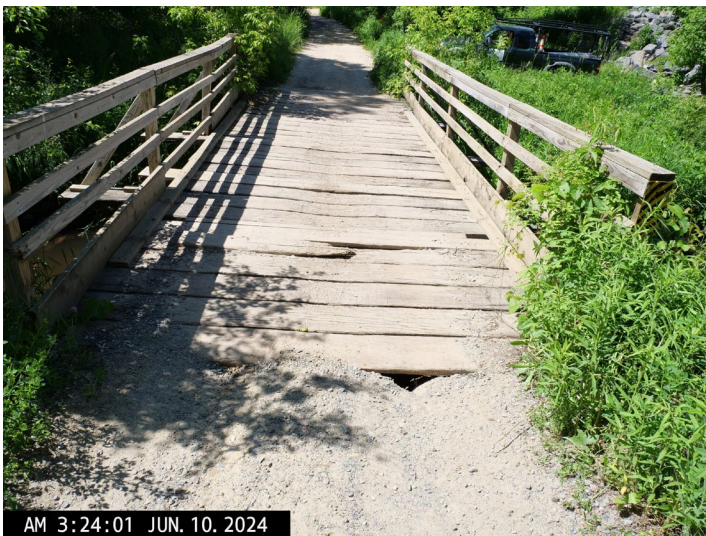
South End of Deck looking to North

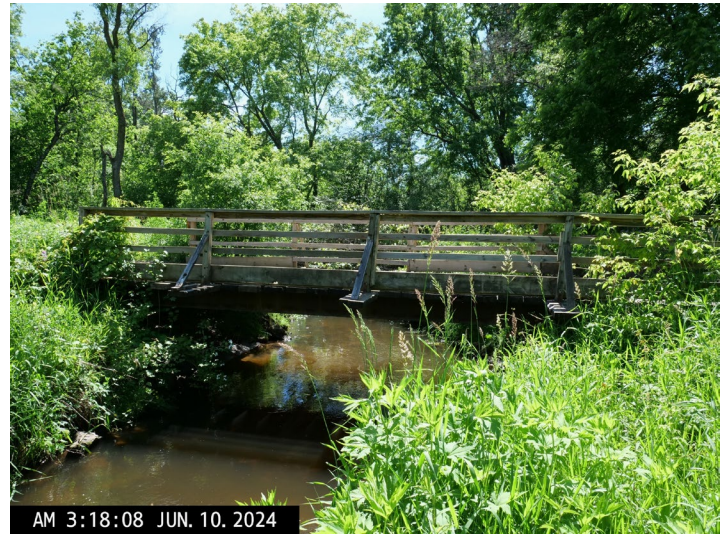
Channel: The channel makes a gentle bend through the bridge. The banks are steep underneath and around the bridge, but mostly well vegetated. Two dead trees are laying in the creek immediately upstream of the bridge and will cause issues with bridge integrity during floods if left in place.

Bridge Profile Looking Downstream to West

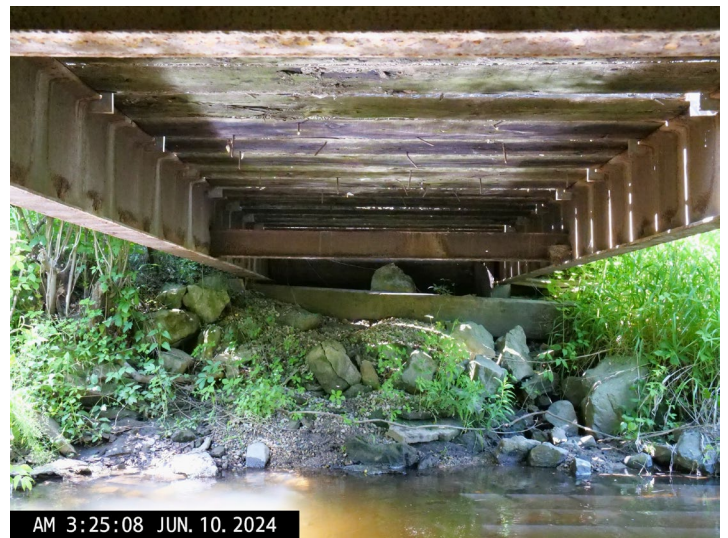
Substructure: The main substructure is four timber piling (one at each end of the I beams) with "L" notches cut in the top for the I beams to rest on. The pilings are in good shape. Since the abutments are simply the pilings supporting the I beams, there isn't a solid transition from the gravel trail to the bridge deck. The trail gravel erodes

down under the deck planks at each end of the bridge and eventually into the river during floods. A single wood plank retaining wall is located between the timber piling and the river but they aren't retaining much fill or rock located underneath the ends of the deck. One of the retaining planks is almost broke in two. There isn't enough large riprap under the bridge to protect the trail and bank during floods.

North Abutment & Retaining Wall

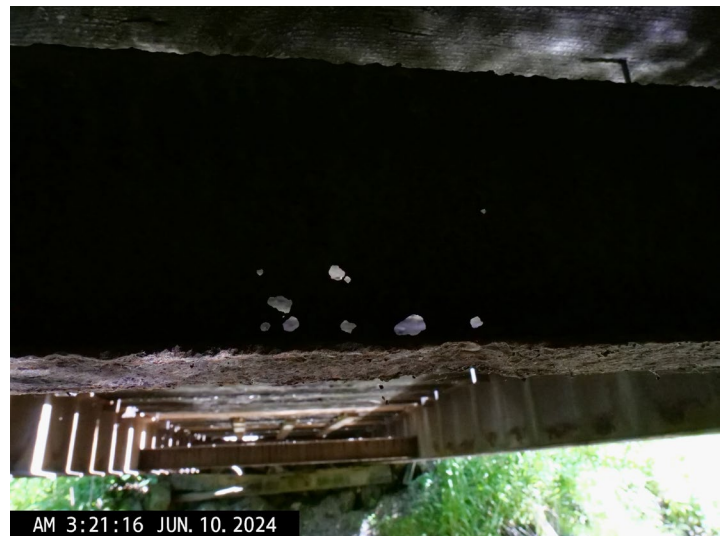
Superstructure: The steel I beams are significantly rusted with pack rusting on the top and bottom flanges and pit rusting throughout. There is no protective coating on the beams. Two steel diaphragms hold the I beams together and one diaphragm has holes completely through it.

North I Beam Diaphragm with metal section loss & Holes

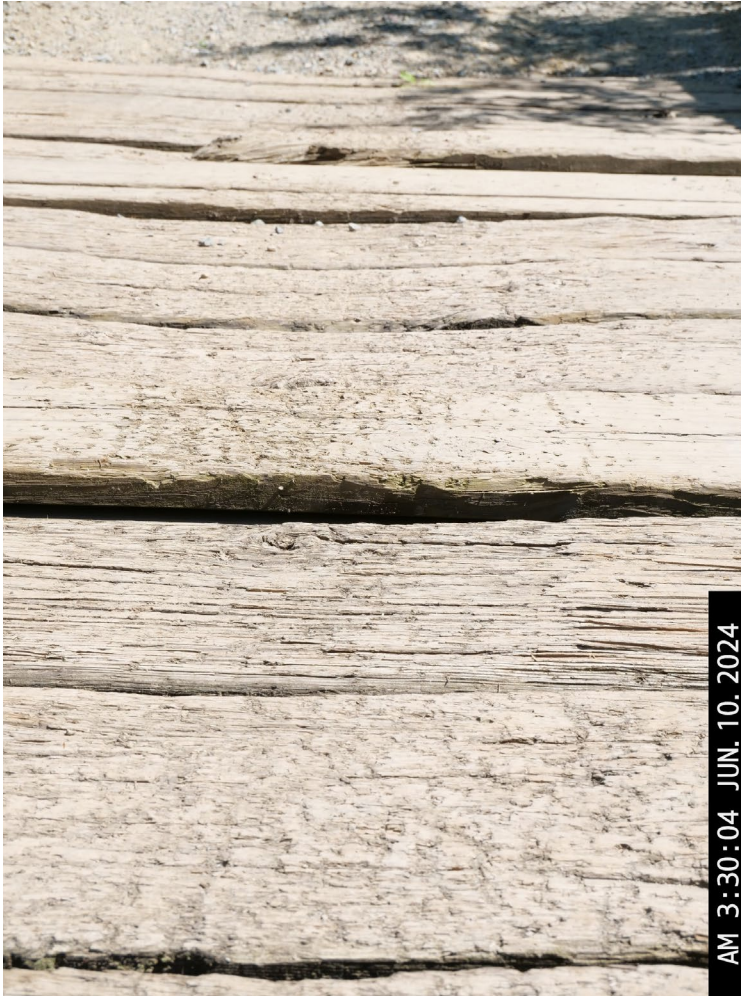
Deck Plank Wear looking to South at South end

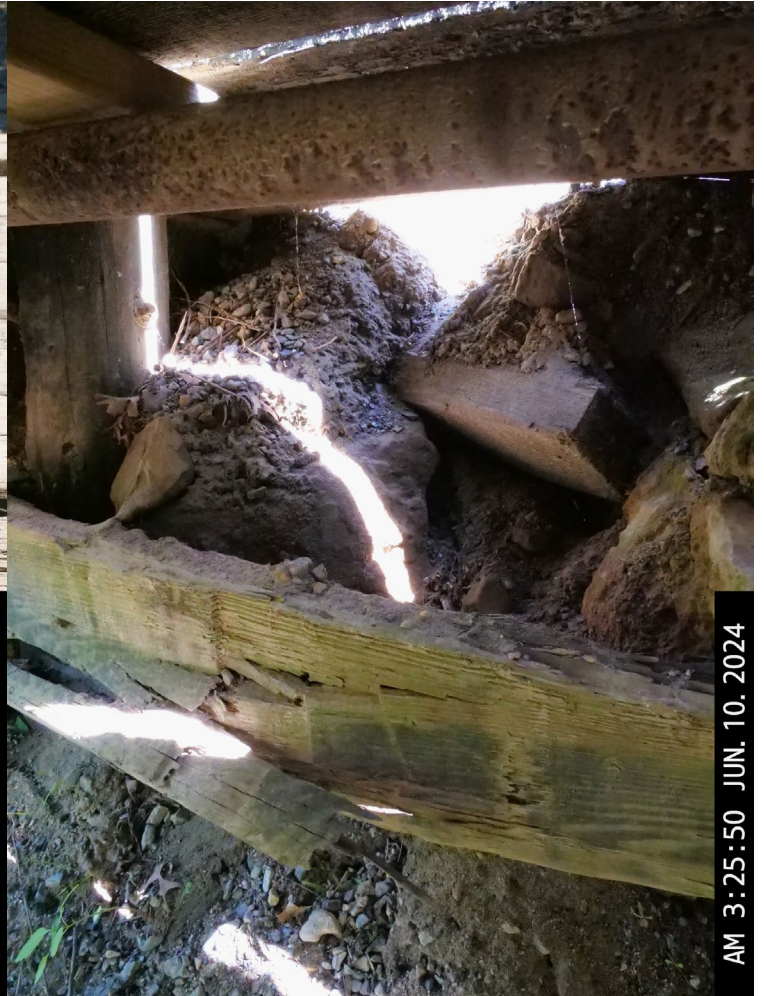
South Abutment & Retaining Wall

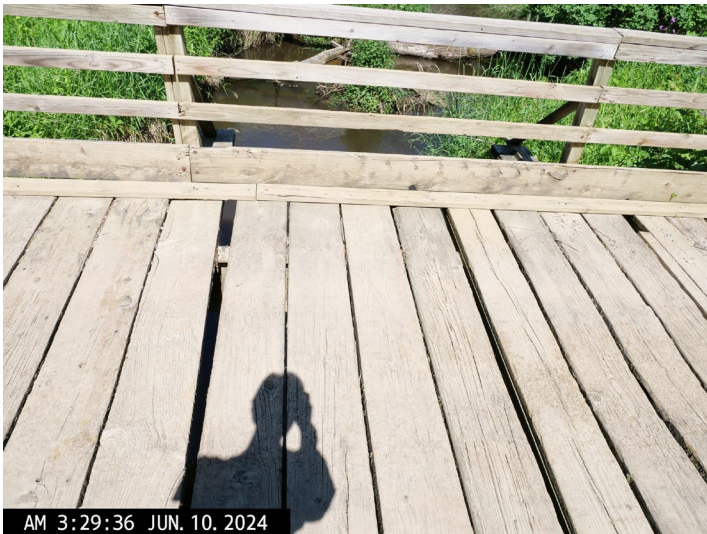
Timber Plank Gaps Looking Upstream to East

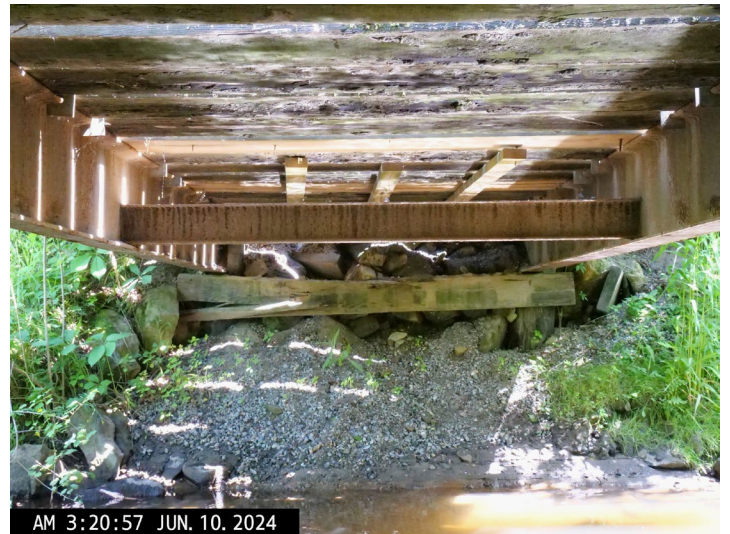
South Abutment Retaining Wall
