## Permit Fact Sheet

Permit Number	WI-0062758-04-1
Permittee Name and Address	Thistle Dairy LLC 3006 Lone Elm Rd, Van Dyne, WI 54979
Permitted Facility Name and Address	Thistle Dairy LLC 3006 Lone Elm Road Van Dyne
Permit Term	March 01, 2025 to September 30, 2027
Discharge Location	3006 Lone Elm Road, Van Dyne, WI in the SE ¼ of Section 35, T17N, R16E
Receiving Water	3006 Lone Elm Road, Van Dyne, WI in the SE ¼ of Section 35, T17N, R16E to the Upper Fox River Watershed, and groundwaters of the state
Discharge Type	Existing

On October 22, 2024, the Department of Natural Resources (department) conducted a mid-permit walkover inspection of Thistle Dairy. Results and photos are included in the enclosed report. The department has noted follow up action items on page 3 in the enclosed report.

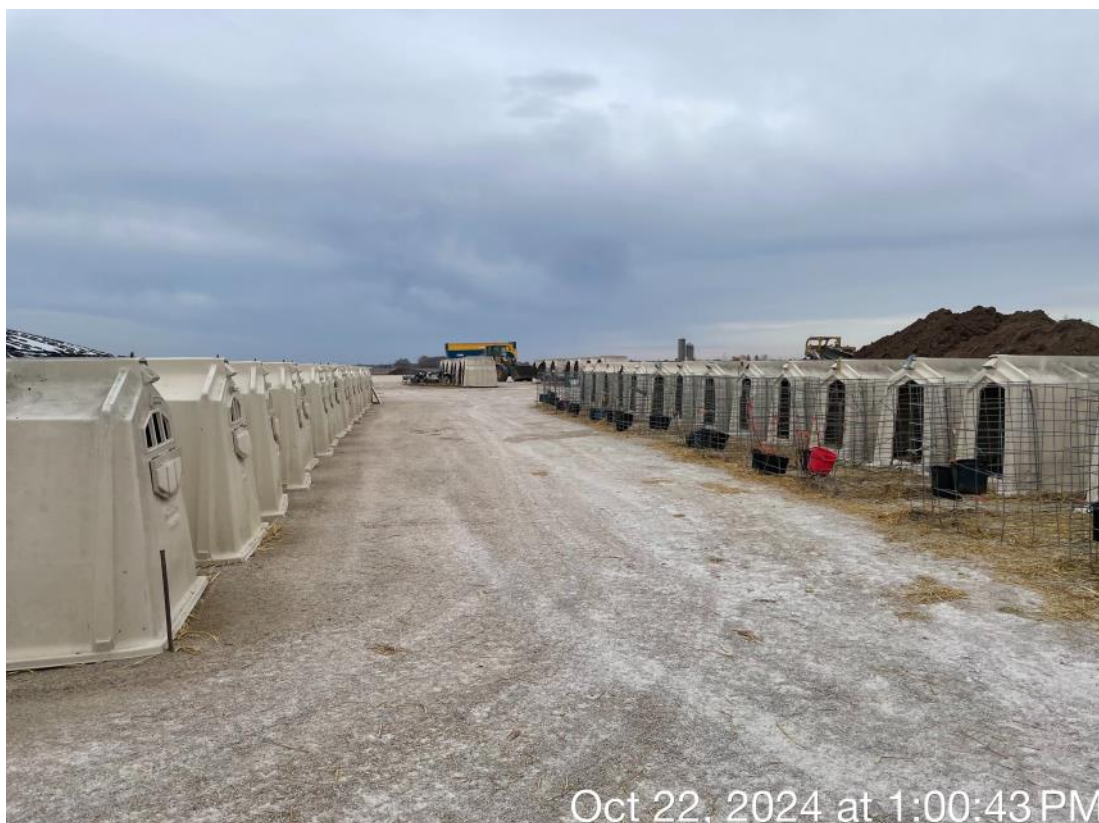
<b>Photo #:</b>	1
<b>Date/Time of Photo:</b>	10/22/2024 1300
<b>Photo By:</b>	Makayla Jacobs
<b>Photo Location:</b>	Temporary calf hutch area
<b>Photo Description:</b>  Standing at the North end looking South.

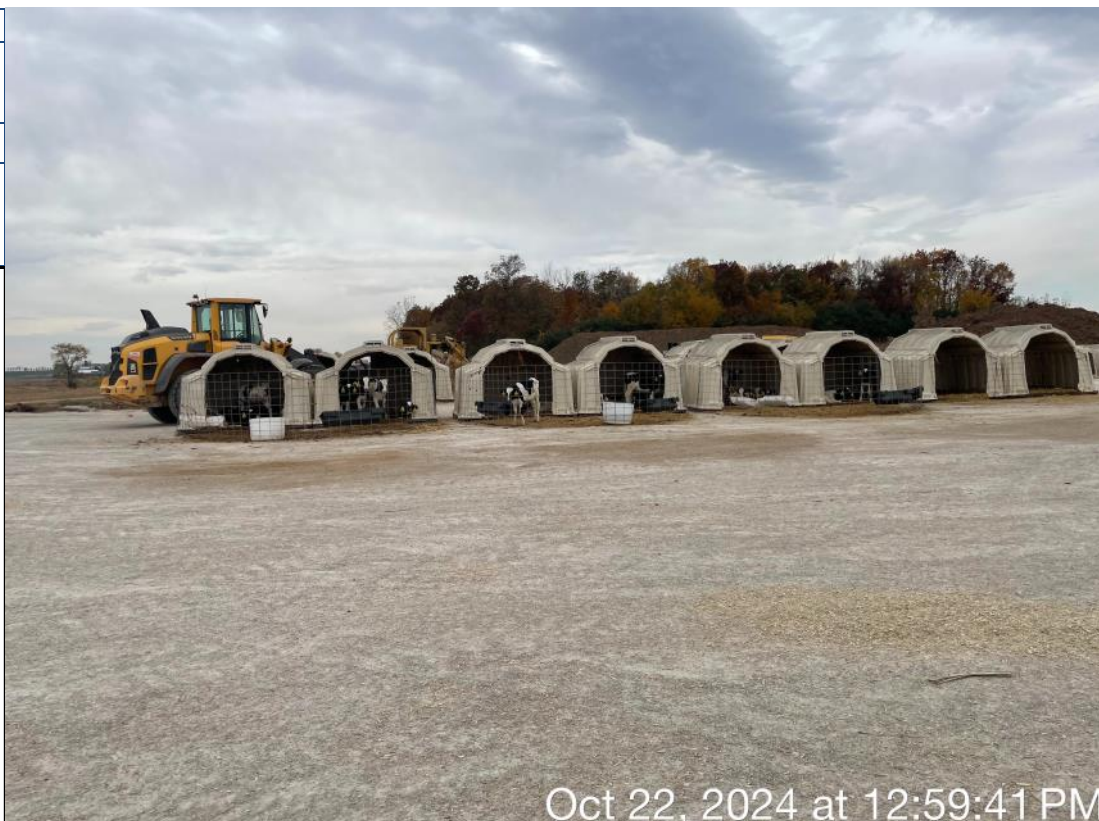
<b>Photo #:</b>	2
<b>Date/Time of Photo:</b>	10/22/2024 12:59
<b>Photo By:</b>	Makayla Jacobs
<b>Photo Location:</b>	Temporary calf hutch area
<b>Photo Description:</b>  Standing at the East side looking West.

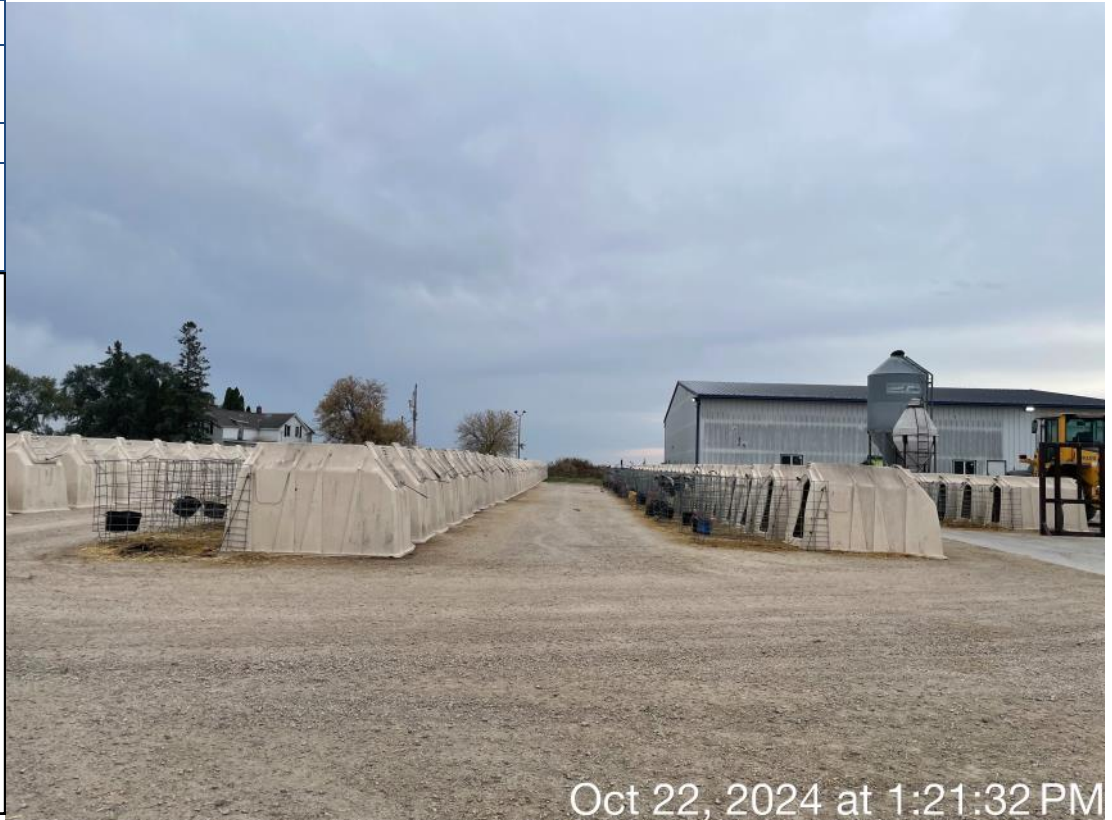
<b>Photo #:</b>	3
<b>Date/Time of Photo:</b>	10/22/2024 13:21
<b>Photo By:</b>	Makayla Jacobs
<b>Photo Location:</b>	Calf Hutch Area

Thistle Dairy utilizes one permanent calf hutch area located south of the existing feed storage area. Calves are bedded with straw on a gravel base. Runoff from this area drains north towards the feed storage area and is collected via a designated collection inlet and transferred to the feed storage runoff controls. No indications of runoff leaving the intended flow paths were observed.

Standing at the North side looking South.

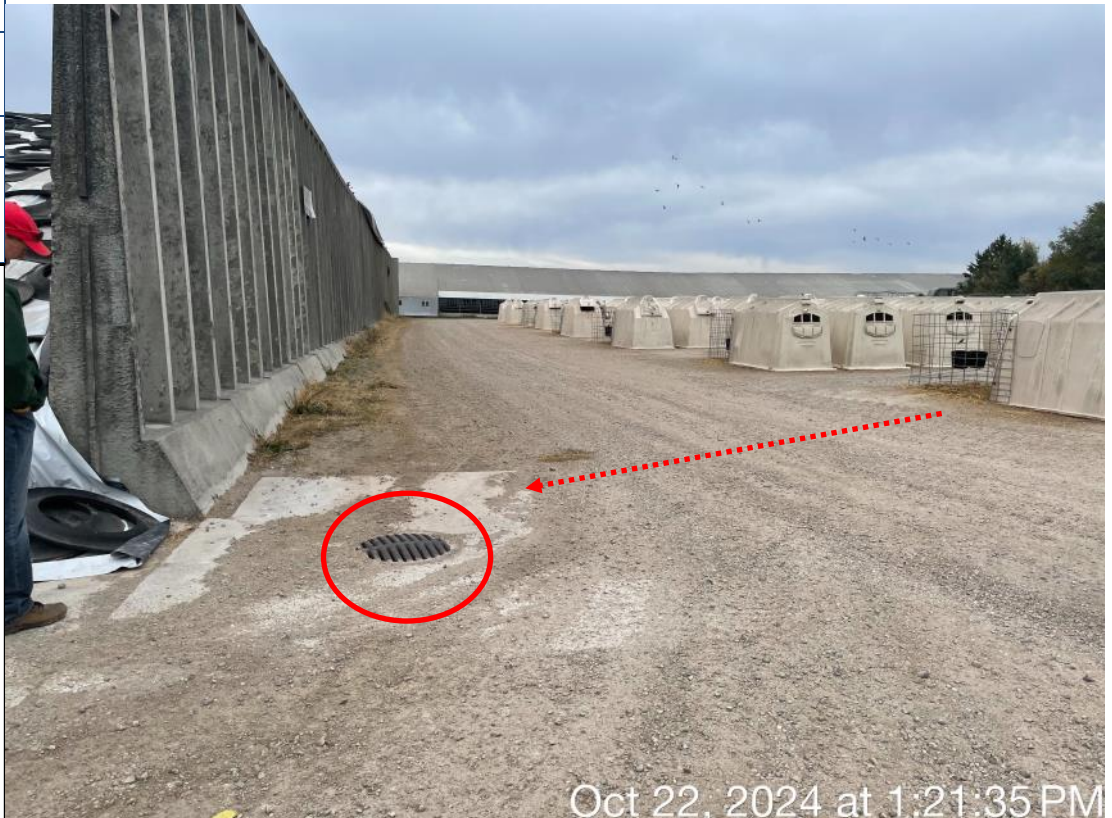
<b>Photo #:</b>	4
<b>Date/Time of Photo:</b>	10/22/2024 13:21
<b>Photo By:</b>	Makayla Jacobs
<b>Photo Location:</b>	Calf Hutch Area

Calf hutch areas appear managed to not have current or past indicators of discharges. Calf hutch runoff control systems appear well-maintained, in good repair and in compliance with permit requirements

Standing at the North side looking East. Circled in red is a collection inlet and the red arrow indicates the flow path from the calf hutch area.

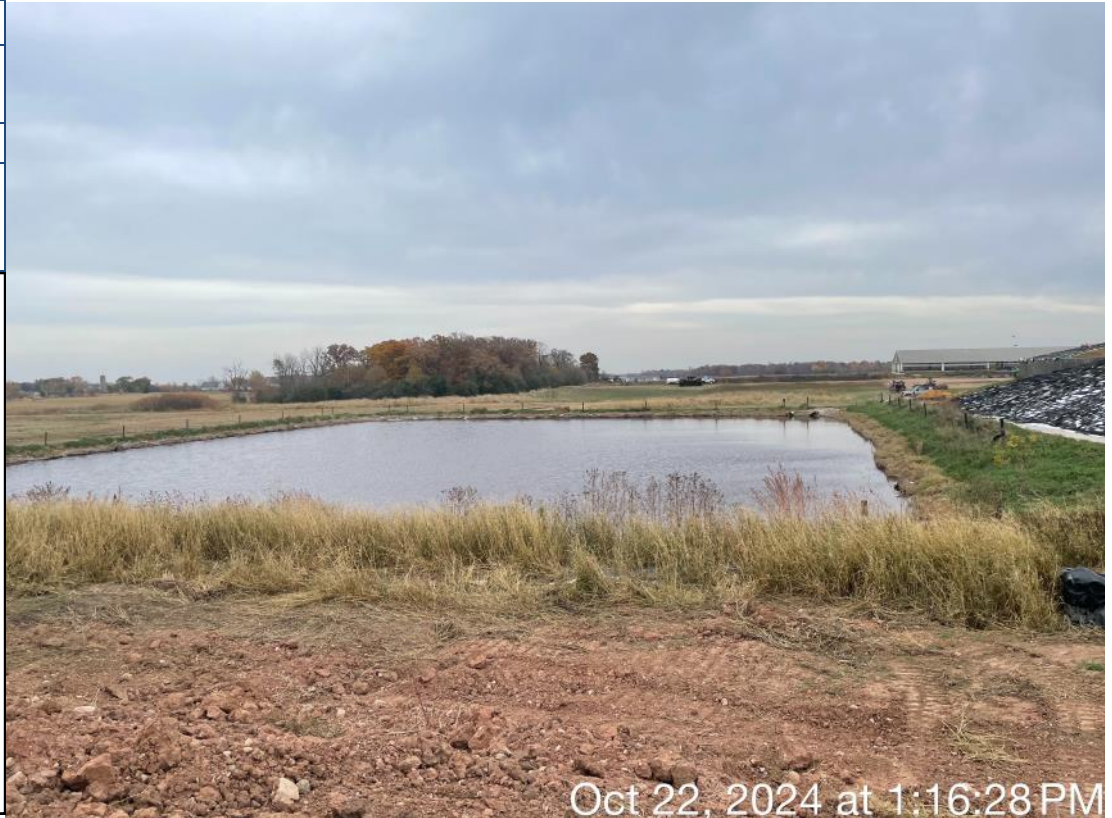
WSF 3, also called the leachate basin, is an earthen lined pit constructed in 2016 and serves as storage for the feed storage runoff collection system, including runoff from the calf hutch area. At the time of inspection, required fencing and permanent markers were in place. Woody vegetation was observed growing on the top of the storage berm, Jacobs reminded Thompson that this vegetation would need to be removed to protect the integrity of the earthen liner.

<b>Photo #:</b>	5
<b>Date/Time of Photo:</b>	10/22/2024 13:16
<b>Photo By:</b>	Makayla Jacobs
<b>Photo Location:</b>	WSF 3
<b>Photo Description:</b>  Standing at the West side of WSF 3 looking East.

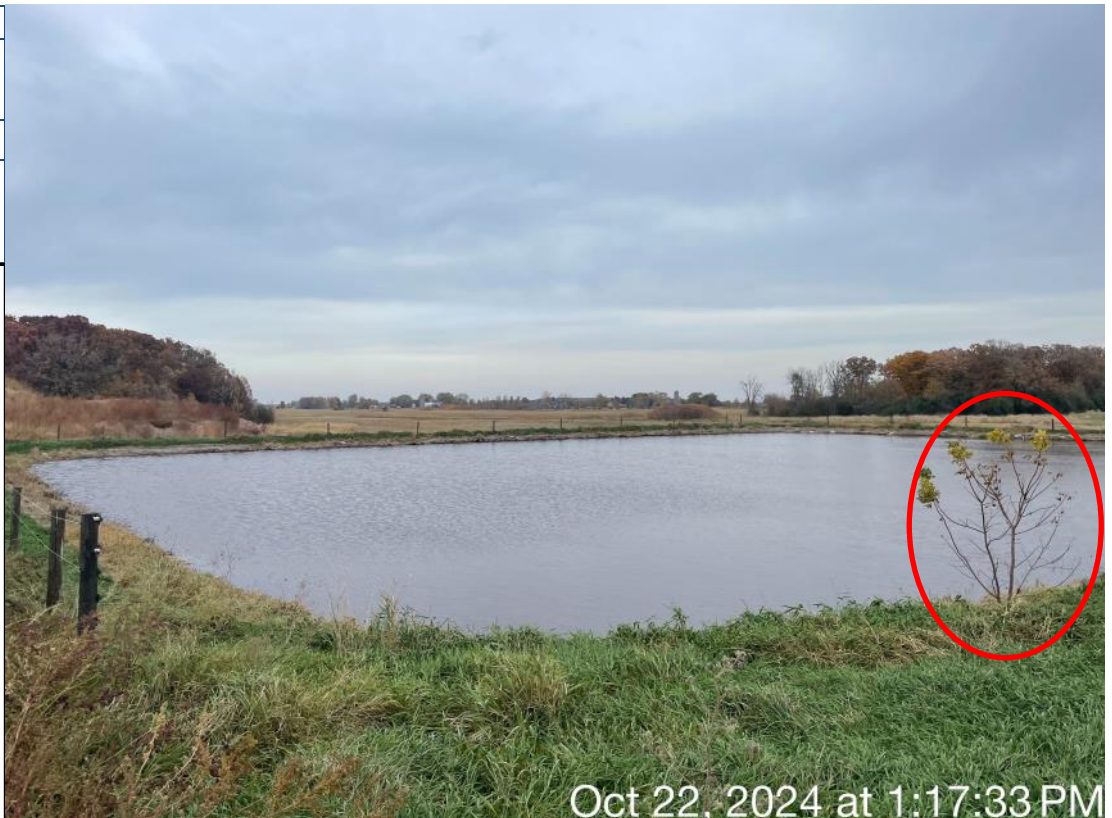
<b>Photo #:</b>	6
<b>Date/Time of Photo:</b>	10/22/2024 13:17
<b>Photo By:</b>	Makayla Jacobs
<b>Photo Location:</b>	WSF 3
<b>Photo Description:</b>  Standing at the Southwest side of WSF 3 looking Northeast. Circled in red is wooded vegetation.

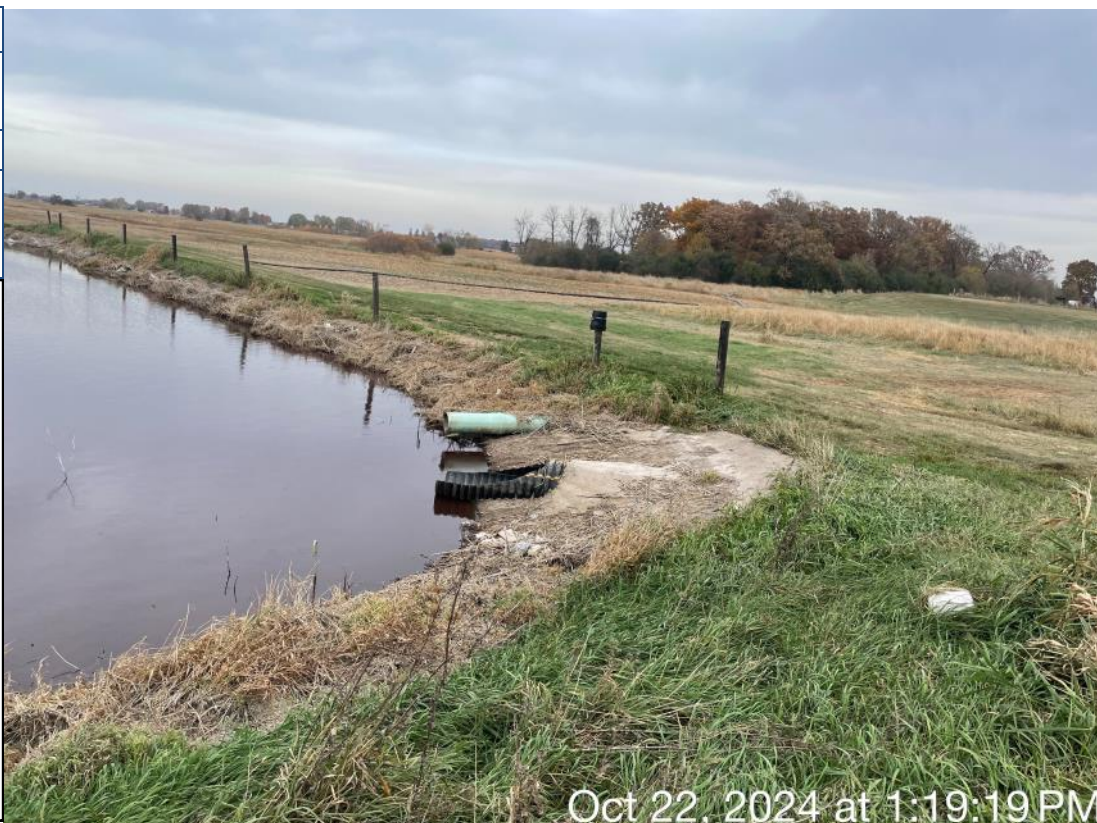
<b>Photo #:</b>	7
<b>Date/Time of Photo:</b>	10/22/2024 13:19
<b>Photo By:</b>	Makayla Jacobs
<b>Photo Location:</b>	WSF 3
<b>Photo Description:</b>  Standing on the South side of WSF 3 looking northeast. Markers are metal stakes.

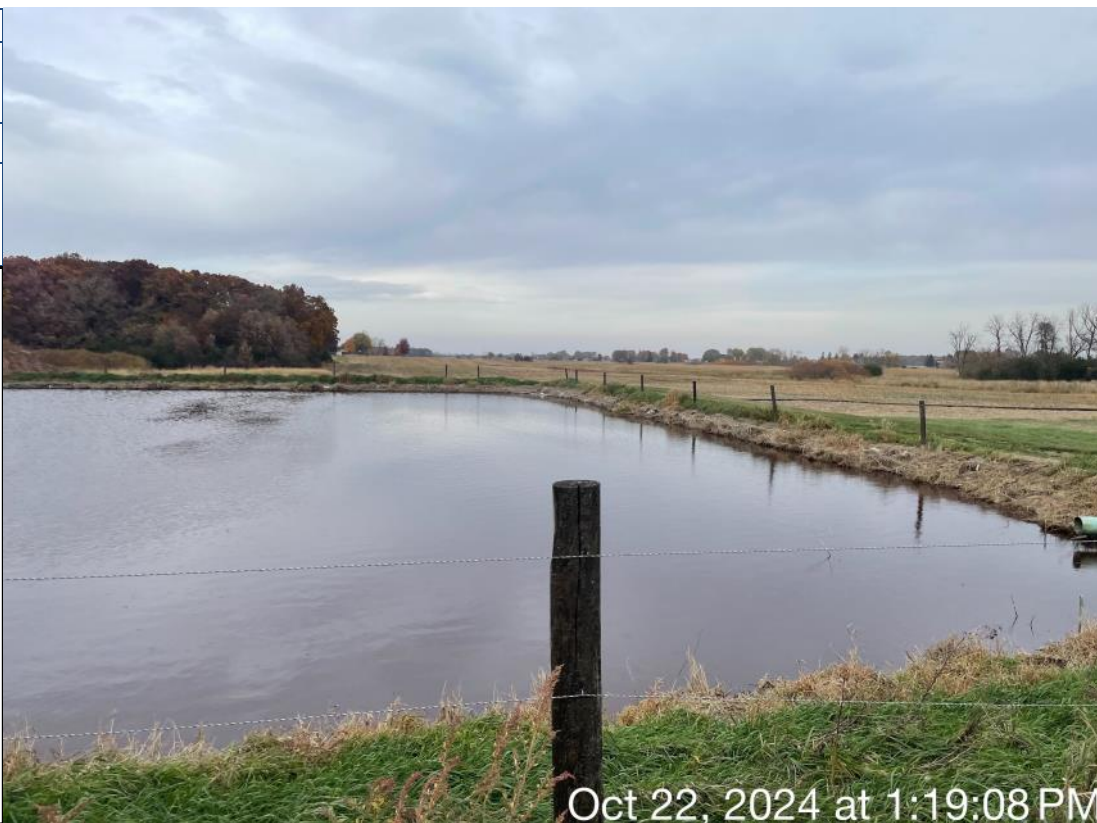
<b>Photo #:</b>	8
<b>Date/Time of Photo:</b>	10/22/2024 13:19
<b>Photo By:</b>	Makayla Jacobs
<b>Photo Location:</b>	WSF 3
<b>Photo Description:</b>  Standing on the South side looking North.

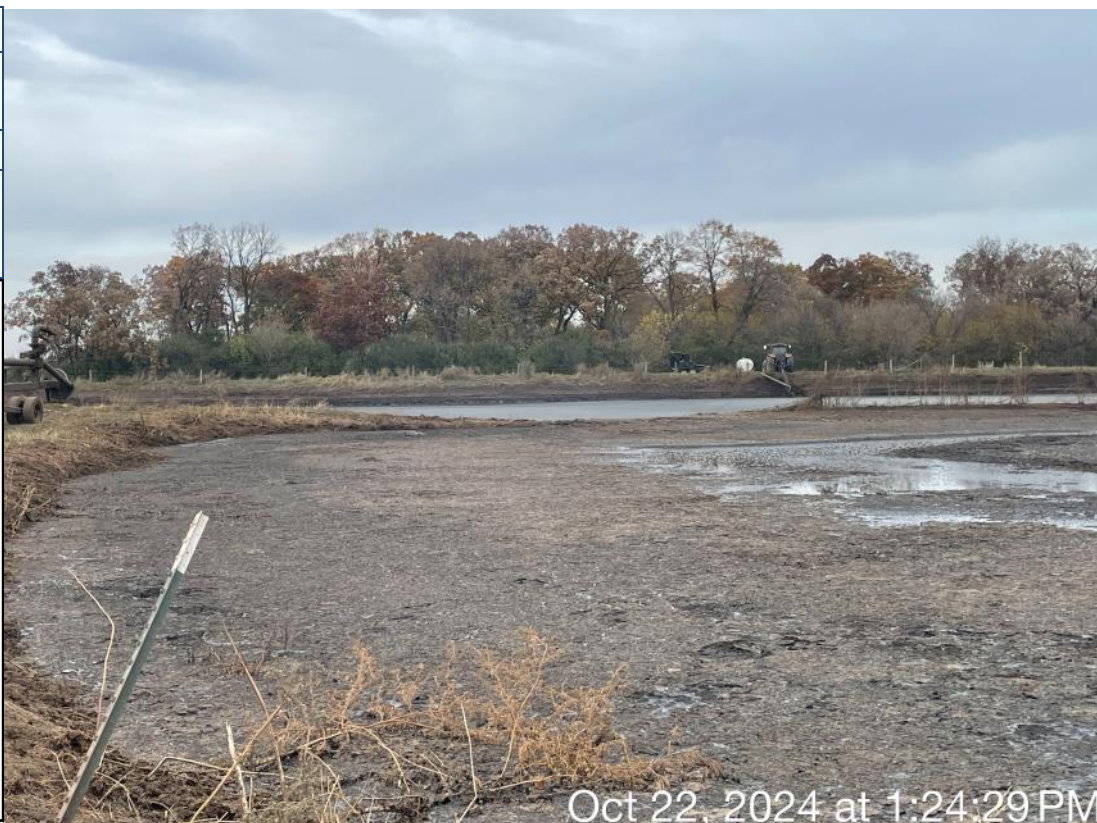
<b>Photo #:</b>	9
<b>Date/Time of Photo:</b>	10/22/2024
<b>Photo By:</b>	Makayla Jacobs
<b>Photo Location:</b>	WSF 1
<b>Photo Description:</b>  Standing on the Southwest side of WSF 1 looking North.

2- Safety fencing around WSF 1 & 2 should be replaced after hauling is completed.

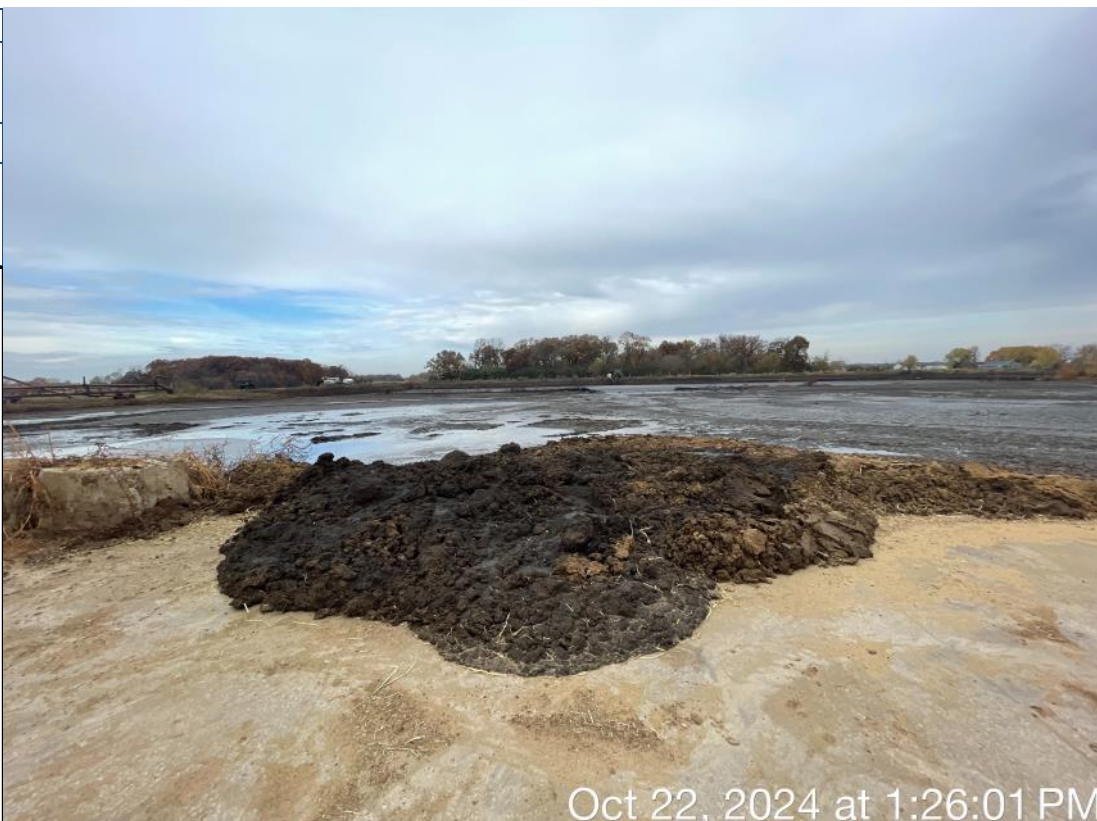
<b>Photo #:</b>	10
<b>Date/Time of Photo:</b>	10/22/2024
<b>Photo By:</b>	Makayla Jacobs
<b>Photo Location:</b>	WSF 1
<b>Photo Description:</b>  Standing on the South side of WSF 1 looking North.

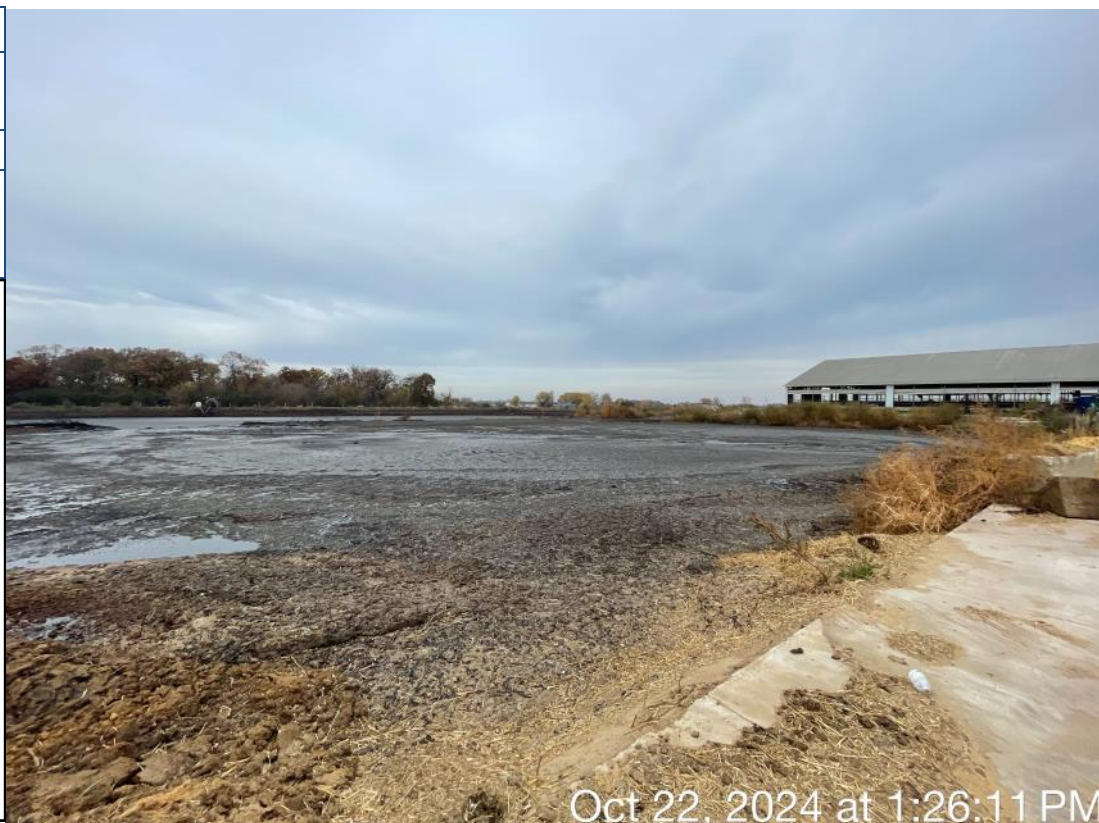
<b>Photo #:</b>	11
<b>Date/Time of Photo:</b>	10/22/2024 13:26
<b>Photo By:</b>	Makayla Jacobs
<b>Photo Location:</b>	WSF 1

Standing on the South side of WSF 1 looking Northeast.

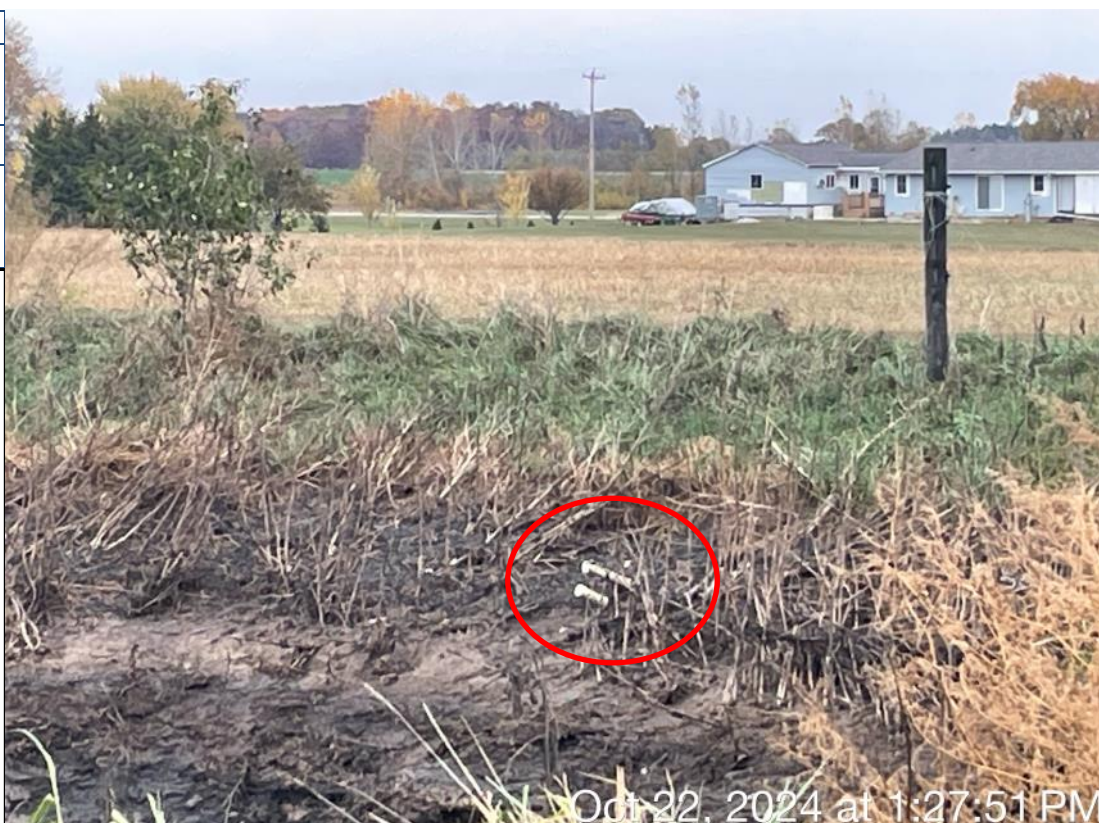
<b>Photo #:</b>	12
<b>Date/Time of Photo:</b>	10/22/2024 13:27
<b>Photo By:</b>	Makayla Jacobs
<b>Photo Location:</b>	WSF 2

Standing on the south side of WSF 2 looking Northeast.  
Circled in red are the markers.

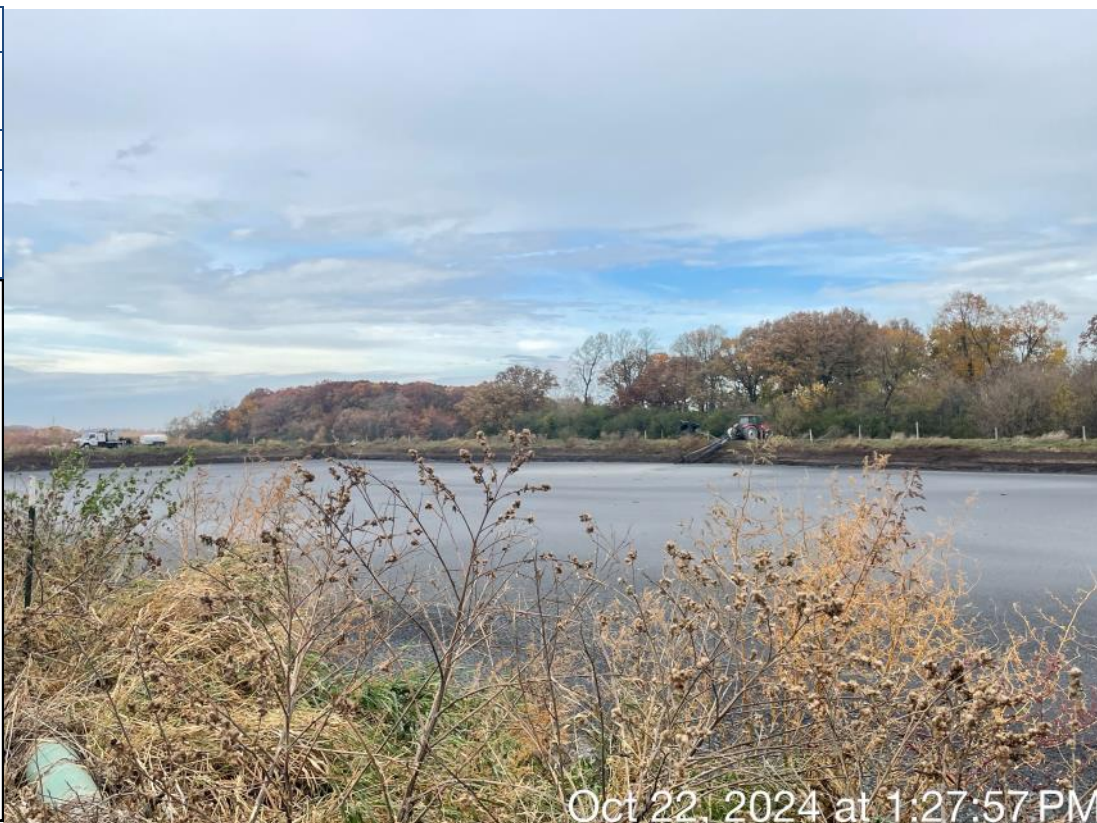
<b>Photo #:</b>	13
<b>Date/Time of Photo:</b>	10/22/2024 13:27
<b>Photo By:</b>	Makayla Jacobs
<b>Photo Location:</b>	WSF 2
<b>Photo Description:</b>  Standing on the South side of WSF 2 looking Northwest.

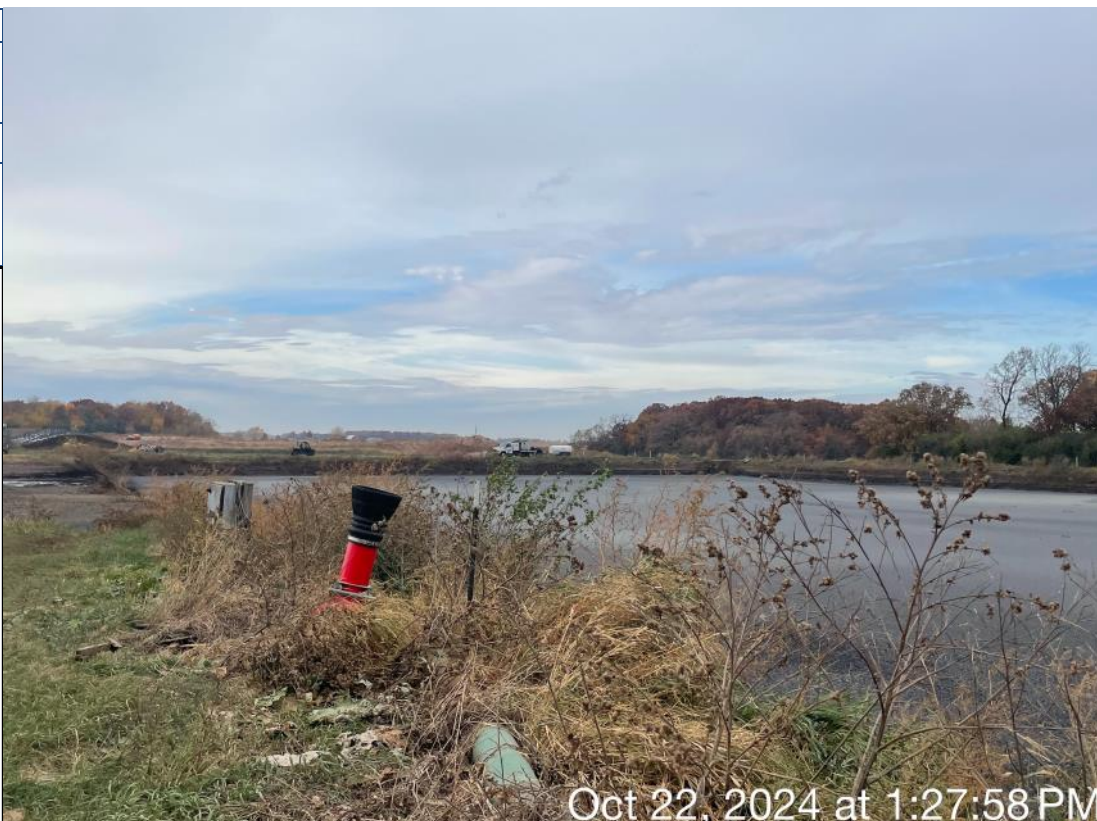
<b>Photo #:</b>	14
<b>Date/Time of Photo:</b>	10/22/2024 13:27
<b>Photo By:</b>	Makayla Jacobs
<b>Photo Location:</b>	WSF 2
<b>Photo Description:</b>  Standing on the South side looking West.

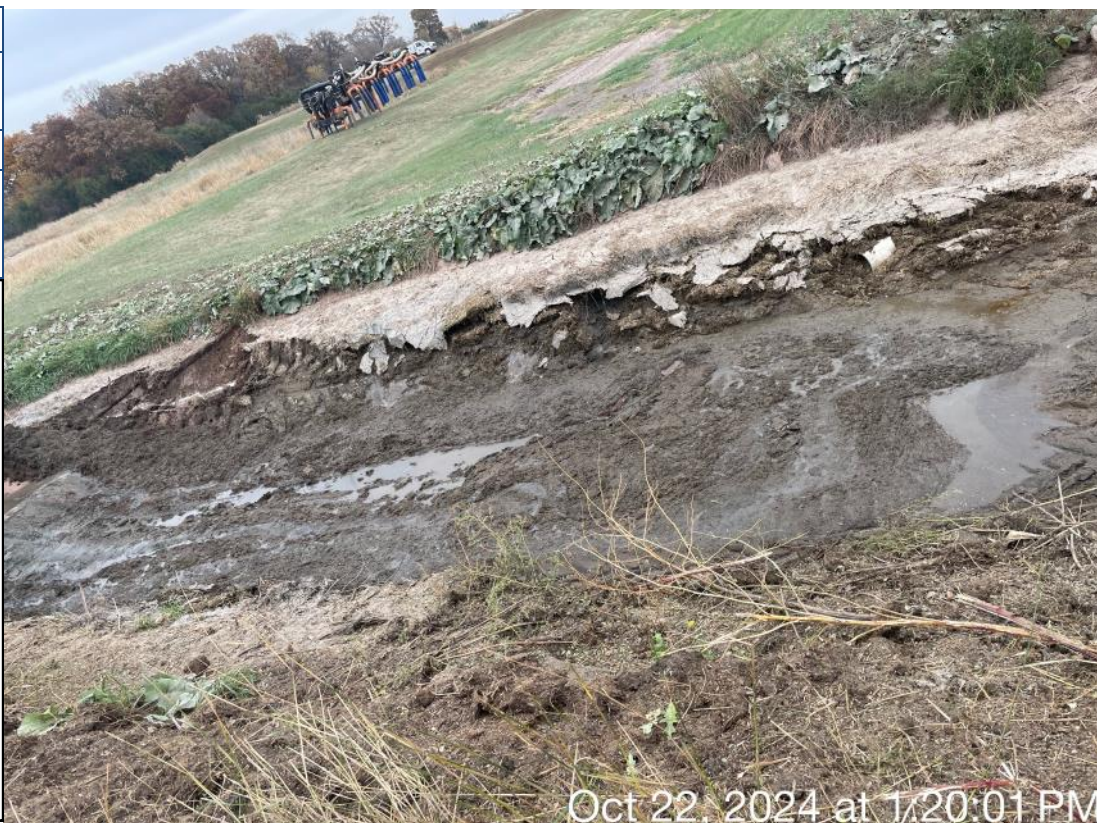
<b>Photo #:</b>	15
<b>Date/Time of Photo:</b>	10/22/2024 13:20
<b>Photo By:</b>	Makayla Jacobs
<b>Photo Location:</b>	Leachate Collection Basin

Standing on the West side of the leachate collection basin looking East. Farm was in the process of removing built up solids.

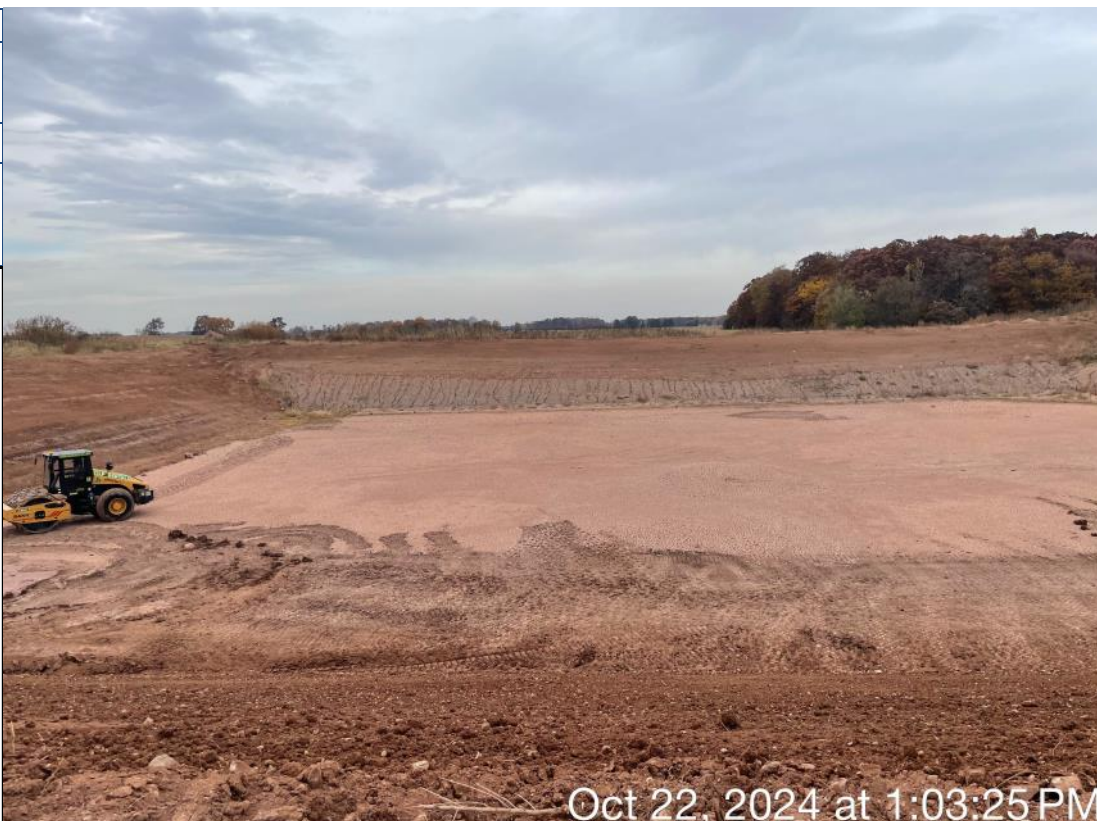
<b>Photo #:</b>	16
<b>Date/Time of Photo:</b>	10/22/2024 13:03
<b>Photo By:</b>	Makayla Jacobs
<b>Photo Location:</b>	New WSF 4

Standing on the South side of the New WSF 4 looking North. Under construction.

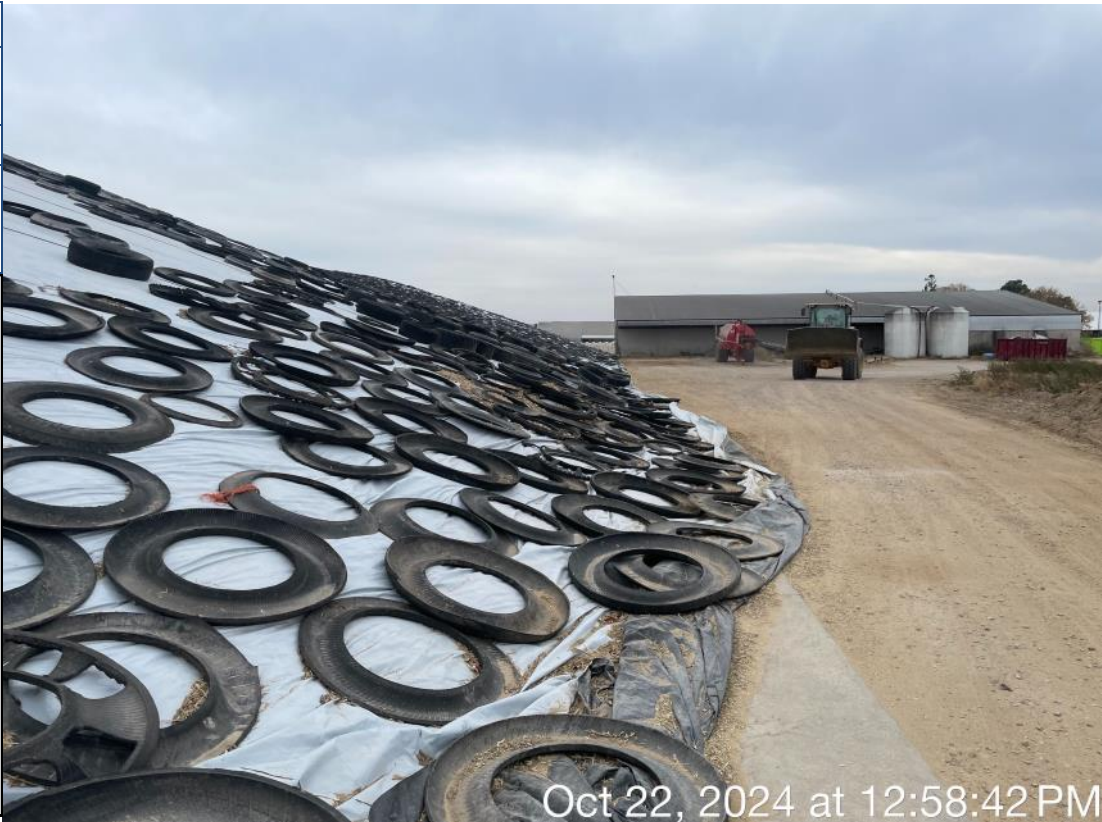
Photo #:	17
Date/Time of Photo:	10/22/2024 12:58
Photo By:	Makayla Jacobs
Photo Location:	Feed Storage pad
Photo Description:  Standing at the Southwest side of the feed storage pad looking East.

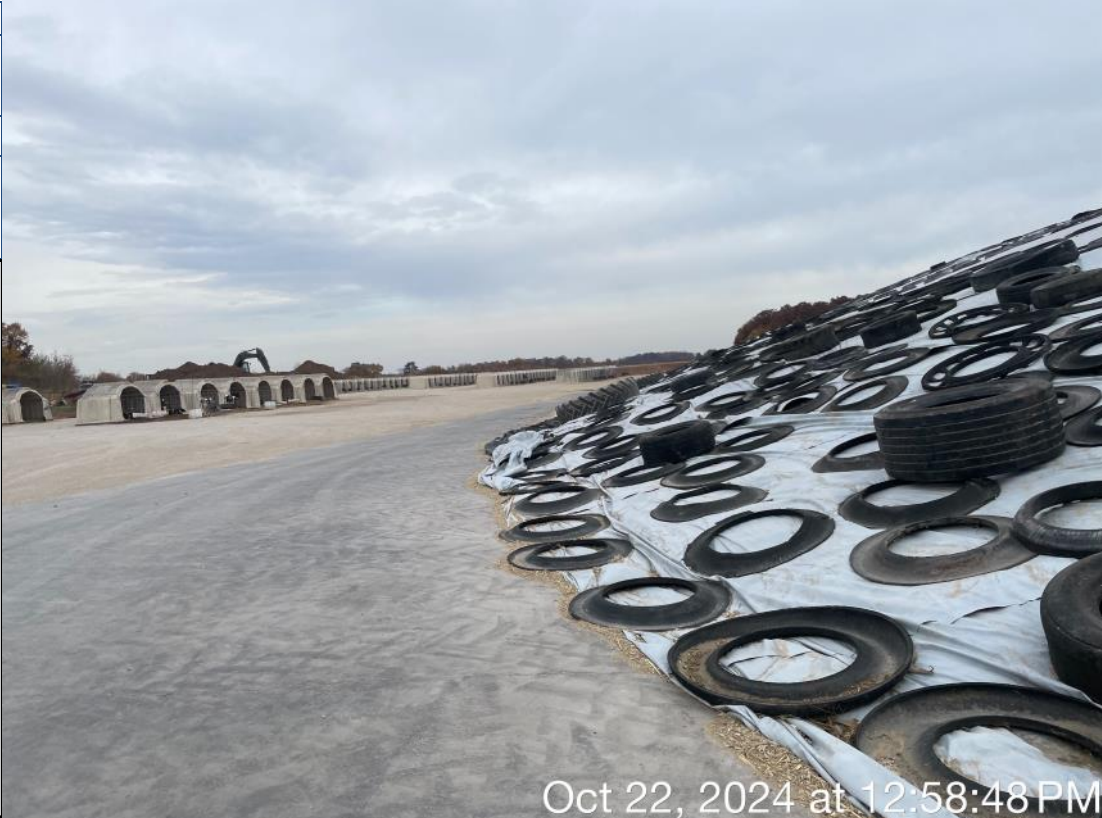
Photo #:	18
Date/Time of Photo:	10/22/2024 12:58
Photo By:	Makayla Jacobs
Photo Location:	Feed Storage Pad
Photo Description:  Standing on the Southwest side of the feed storage pad looking North.

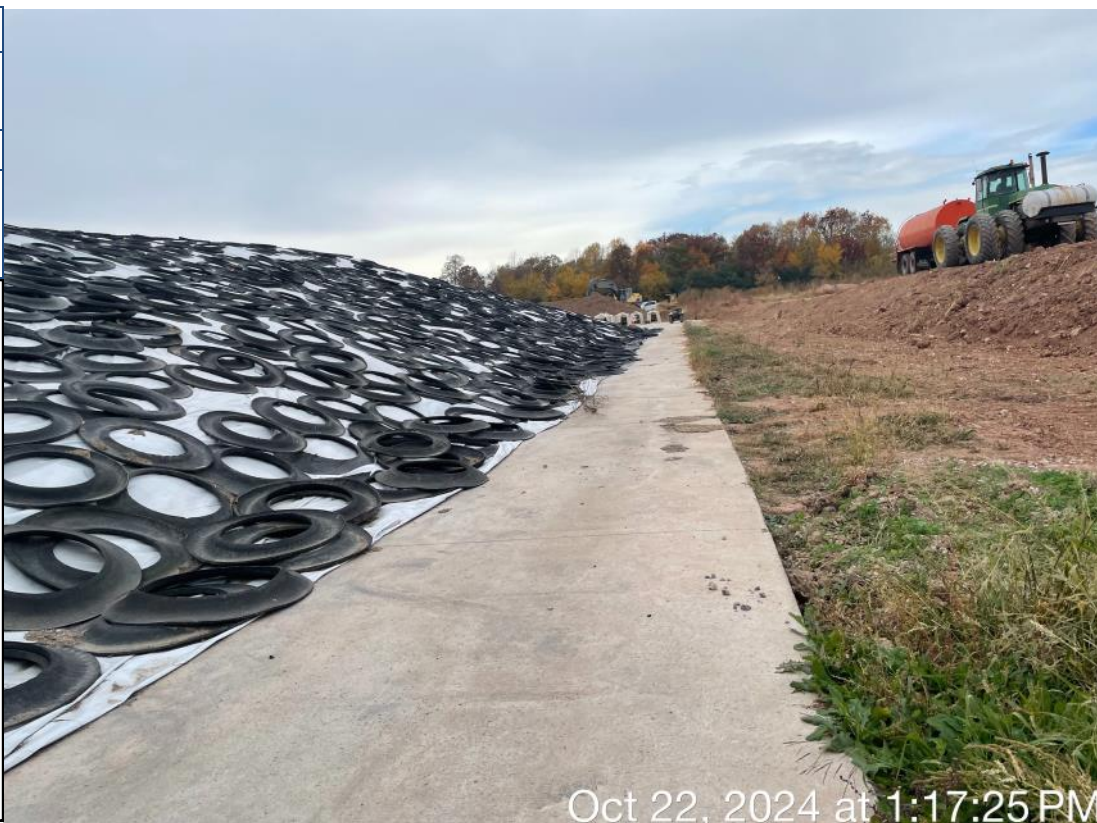
<b>Photo #:</b>	19
<b>Date/Time of Photo:</b>	10/22/2024 13:17
<b>Photo By:</b>	Makayla Jacobs
<b>Photo Location:</b>	Feed Storage pad

Standing on the North side of the feed storage pad looking West.

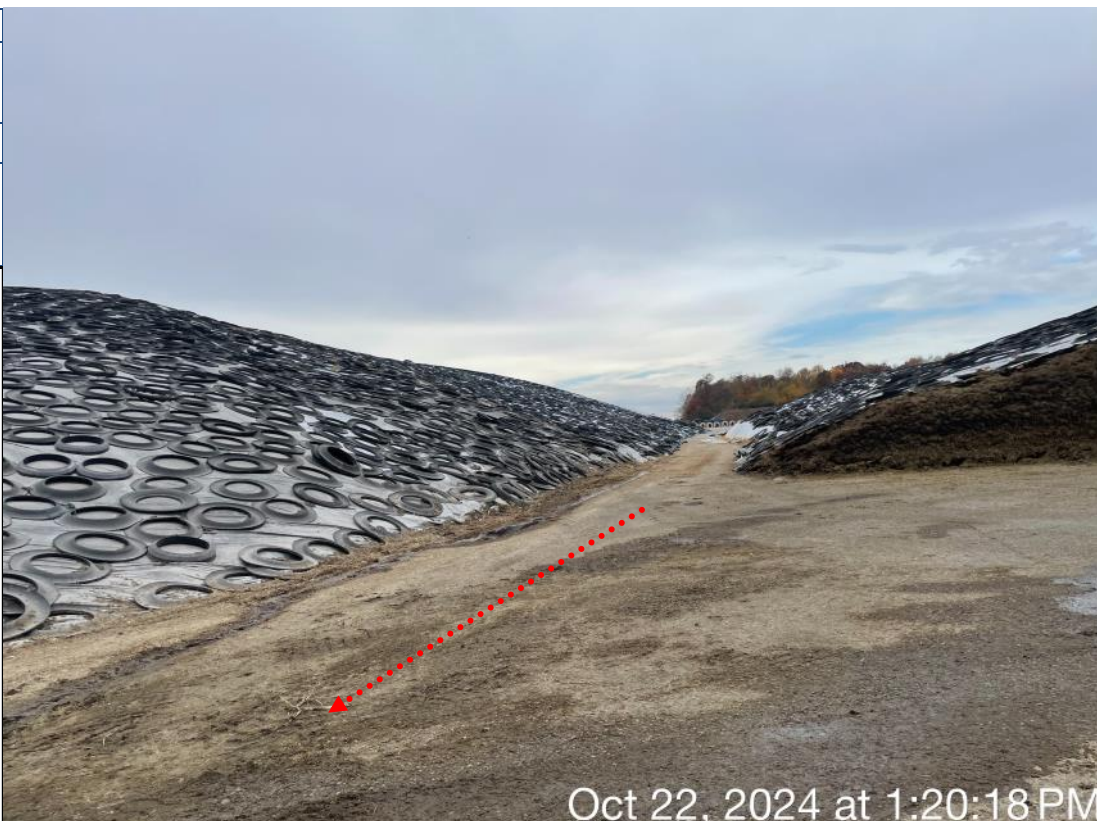
<b>Photo #:</b>	20
<b>Date/Time of Photo:</b>	10/22/2024 13:20
<b>Photo By:</b>	Makayla Jacobs
<b>Photo Location:</b>	Feed Storage pad

Feed storage areas and associated process wastewater (leachate, runoff) appear managed to not have current or past indicators of discharges. Feed storage areas and runoff control systems appear well-maintained, in good repair and in compliance with permit requirements.

Standing on the East side of the feed storage pad looking West. Red arrow indicates direction of runoff path.

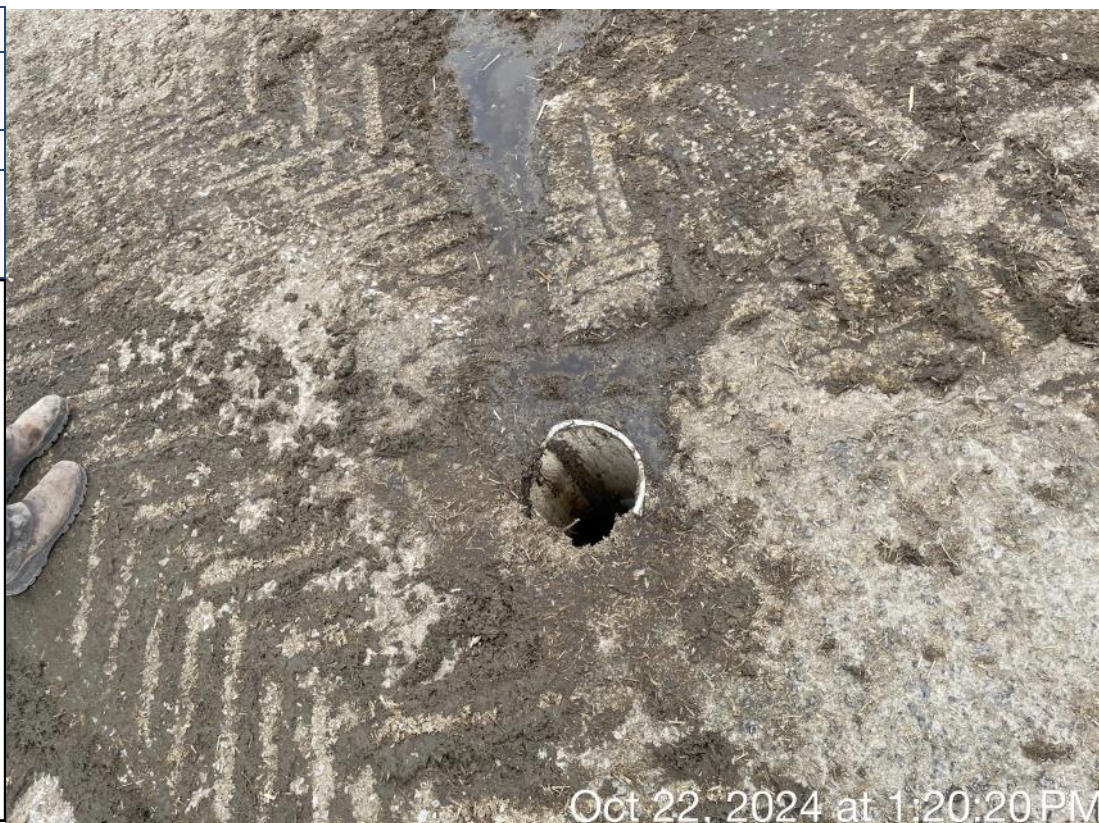
<b>Photo #:</b>	21
<b>Date/Time of Photo:</b>	10/22/2024 13:20
<b>Photo By:</b>	Makayla Jacobs
<b>Photo Location:</b>	Feed Storage pad

View of the feed storage area runoff collection inlet.

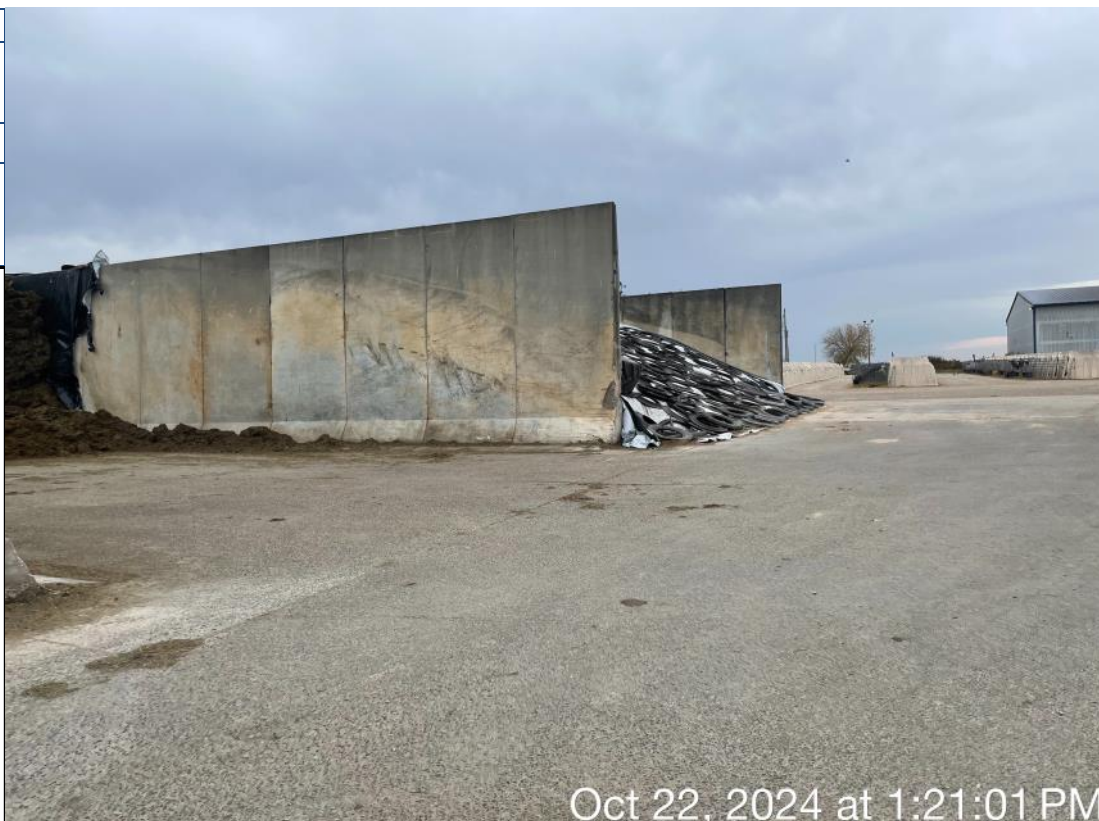
<b>Photo #:</b>	22
<b>Date/Time of Photo:</b>	10/22/2024 13:21
<b>Photo By:</b>	Makayla Jacobs
<b>Photo Location:</b>	Feed Storage pad

Standing on the West side of the Feed bunkers looking Southeast.

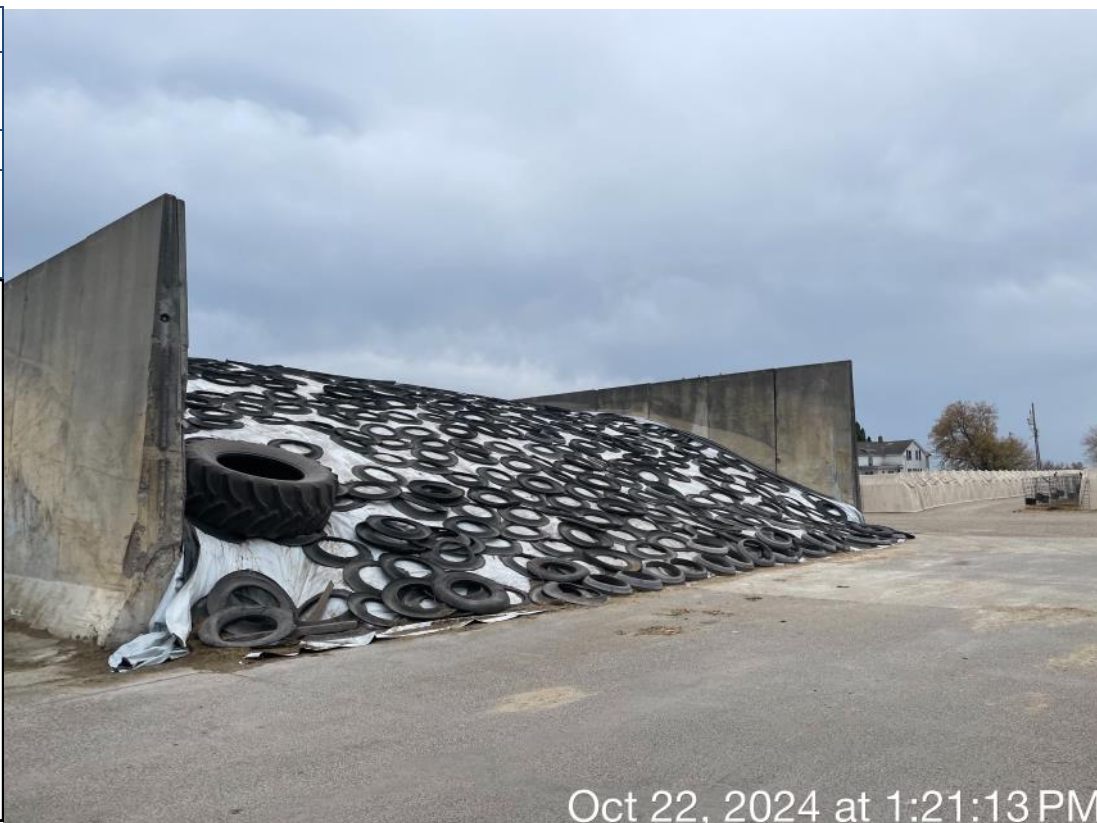
<b>Photo #:</b>	23
<b>Date/Time of Photo:</b>	10/22/2024
<b>Photo By:</b>	Makayla Jacobs
<b>Photo Location:</b>	Feed Storage pad

Standing on the West side of the feed storage bunker looking Southeast.
