## Permit Fact Sheet

Permit Number	WI-0062758-04-1
Permittee Name and Address	Thistle Dairy LLC 3006 Lone Elm Rd, Van Dyne, WI 54979
Permitted Facility Name and Address	Thistle Dairy LLC 3006 Lone Elm Road Van Dyne
Permit Term	March 01, 2025 to September 30, 2027
Discharge Location	3006 Lone Elm Road, Van Dyne, WI in the SE ¼ of Section 35, T17N, R16E
Receiving Water	3006 Lone Elm Road, Van Dyne, WI in the SE ¼ of Section 35, T17N, R16E to the Upper Fox River Watershed, and groundwaters of the state
Discharge Type	Existing

On October 22, 2024, the Department of Natural Resources (department) conducted a mid-permit walkover inspection of Thistle Dairy. Results and photos are included in the enclosed report. The department has noted follow up action items on page 3 in the enclosed report.

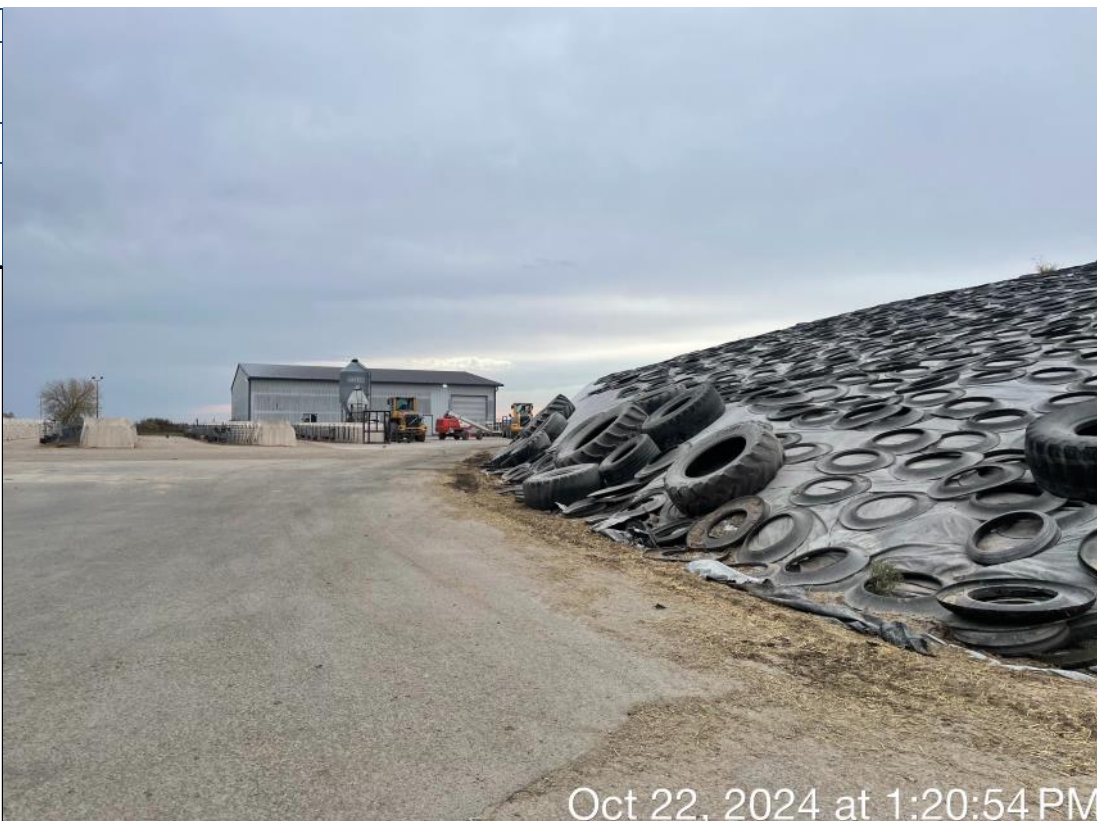
<b>Photo #:</b>	24
<b>Date/Time of Photo:</b>	10/22/2024
<b>Photo By:</b>	Makayla Jacobs
<b>Photo Location:</b>	Feed Storage pad

Standing on the East side of the feed storage pad looking South.

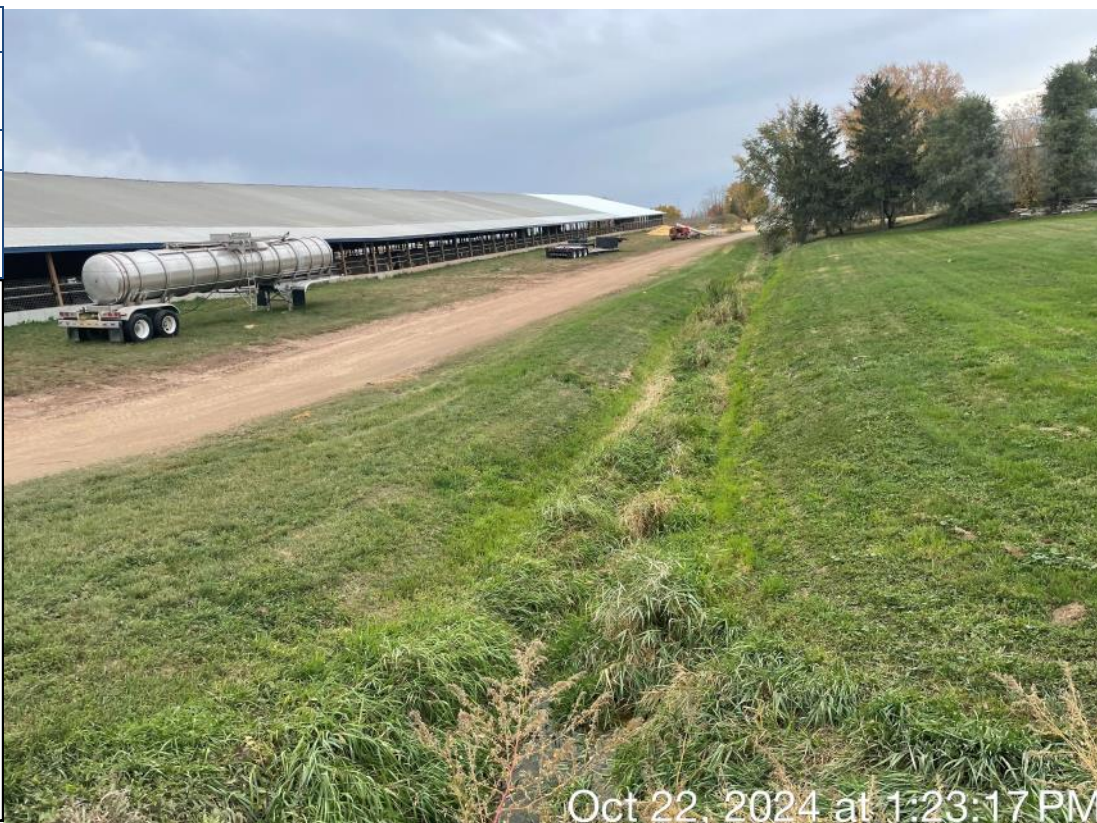
<b>Photo #:</b>	25
<b>Date/Time of Photo:</b>	10/22/2024 13:23
<b>Photo By:</b>	Makayla Jacobs
<b>Photo Location:</b>	Feed Storage pad

View of intermittent stream running through production site.

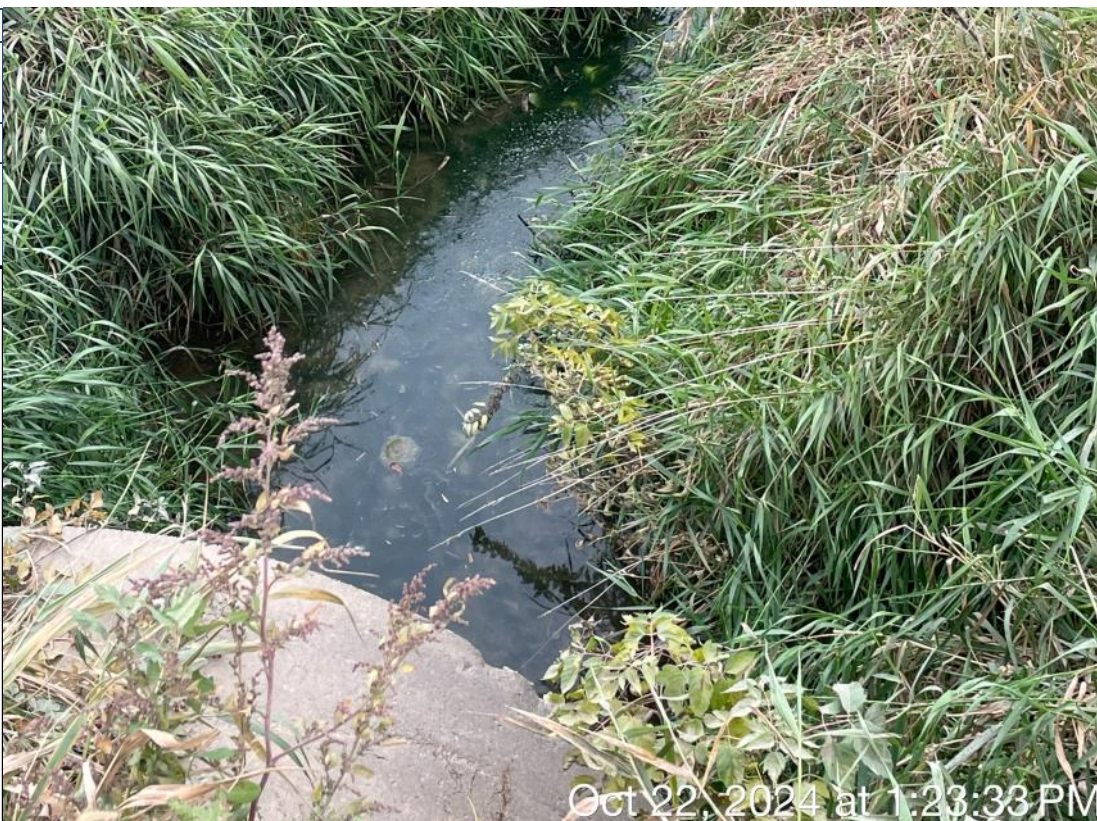
<b>Photo #:</b>	26
<b>Date/Time of Photo:</b>	10/22/2024 13:23
<b>Photo By:</b>	Makayla Jacobs
<b>Photo Location:</b>	Feed Storage pad

View of intermittent stream running through production site.
