WATER QUALITY TRADING PLAN

Waukesha County, Wisconsin

Prepared By: Waukesha County Land Resources Division

Project located in Frontier Park, Village of Butler

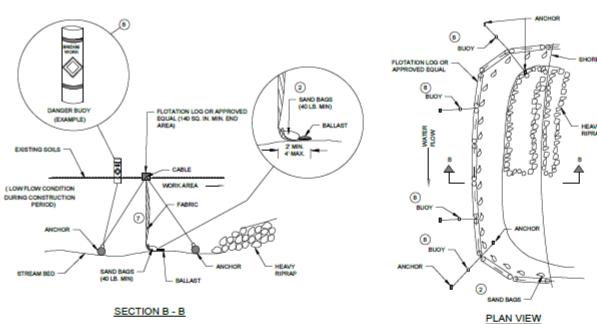
TURBIDITY BARRIER - FLOAT ALTERNATIVE CAUTION - SEE NOTE 6

- ① DRIVEN STEEL POSTS, PIPES, OR CHANNELS. LENGTH SHALL BE SUFFICIENT TO SECURELY SUPPORT BARRIER AT HIGH WATER ELEVATIONS.
- SAND BAGS TO BE USED AS ADDITIONAL BALLAST WHEN ORDERED BY THE ENGINEER TO MEET ADVERSE FIELD CONDITIONS. SPACE AS APPROPRIATE FOR SITE CONDITIONS.

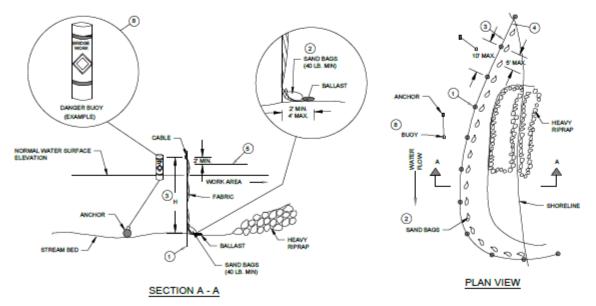
TURBIDITY BARRIER - STANDARD POST INSTALLATION

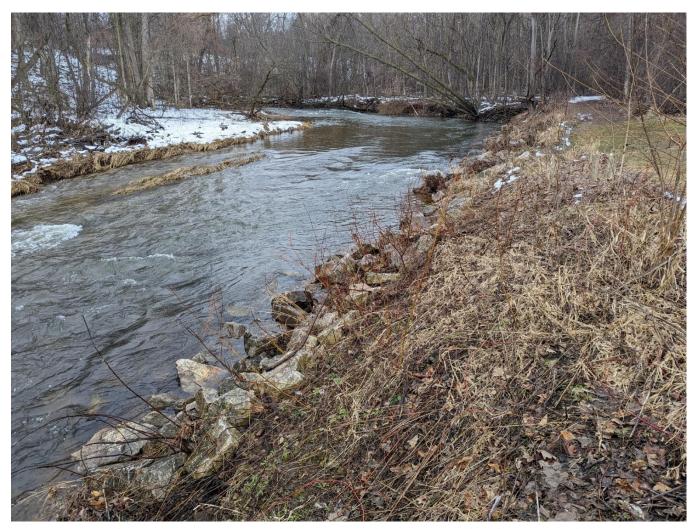
Image 1.1 – Looking southwest. Bank on top right, undercut with slumped sections in stream. Existing downstream riprap on lower right.

The streambanks have experienced significant erosion as the Menomonee River Watershed has been developed and cleared for agricultural and residential use. The banks are predominately undercut with some rills and vegetative overhang. Tree roots are readily visible throughout the reaches. Fallen trees and slumps are also visible in

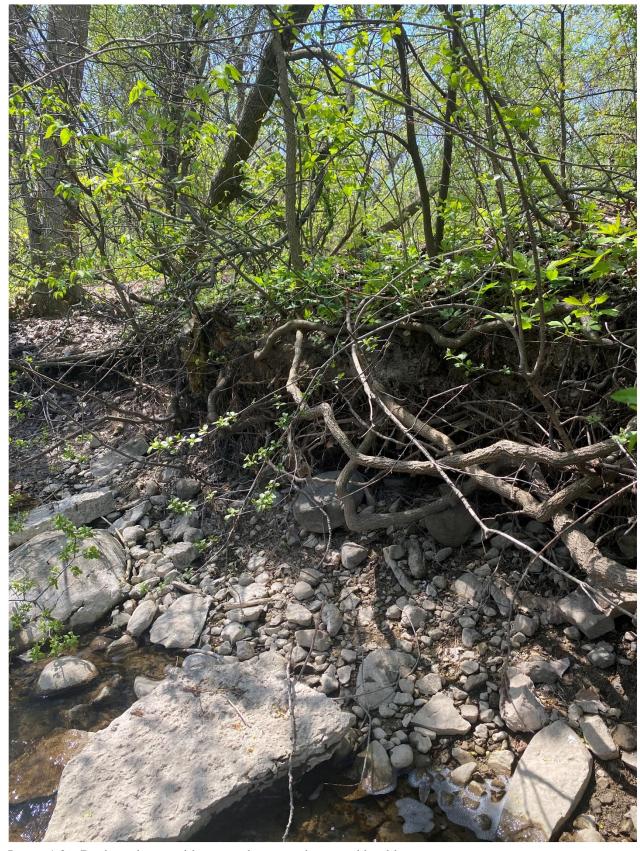
$Image \ 1.2-Bank, undercut \ with \ exposed \ roots \ and \ exposed \ boulders.$

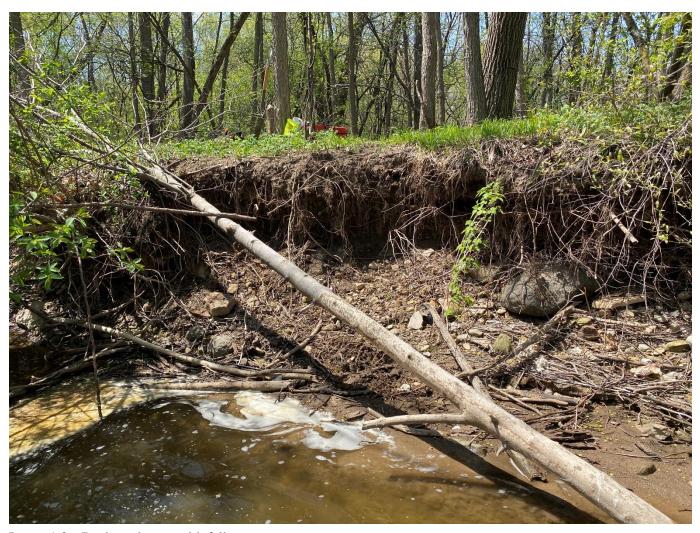
Image 1.3 – Bank, undercut, with fallen trees.

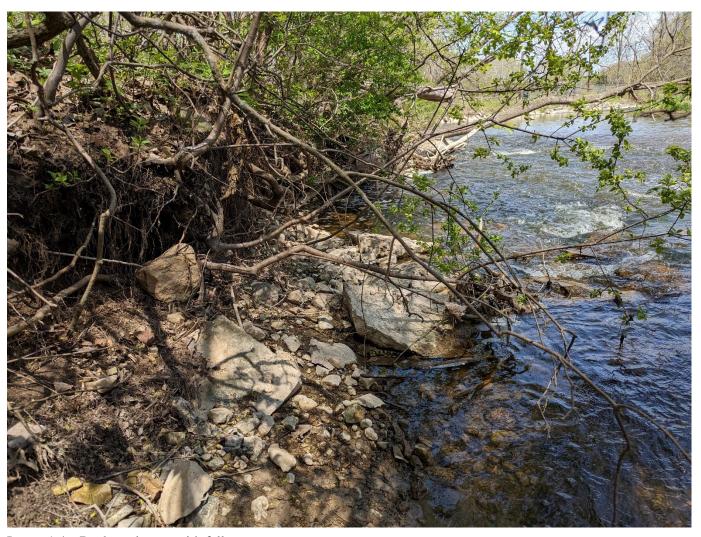
Image 1.4 – Bank, undercut, with fallen trees.
