WATER QUALITY TRADING PLAN

Waukesha County, Wisconsin

Prepared By: Waukesha County Land Resources Division Project located in South Playing Fields park, Village of Elm Grove

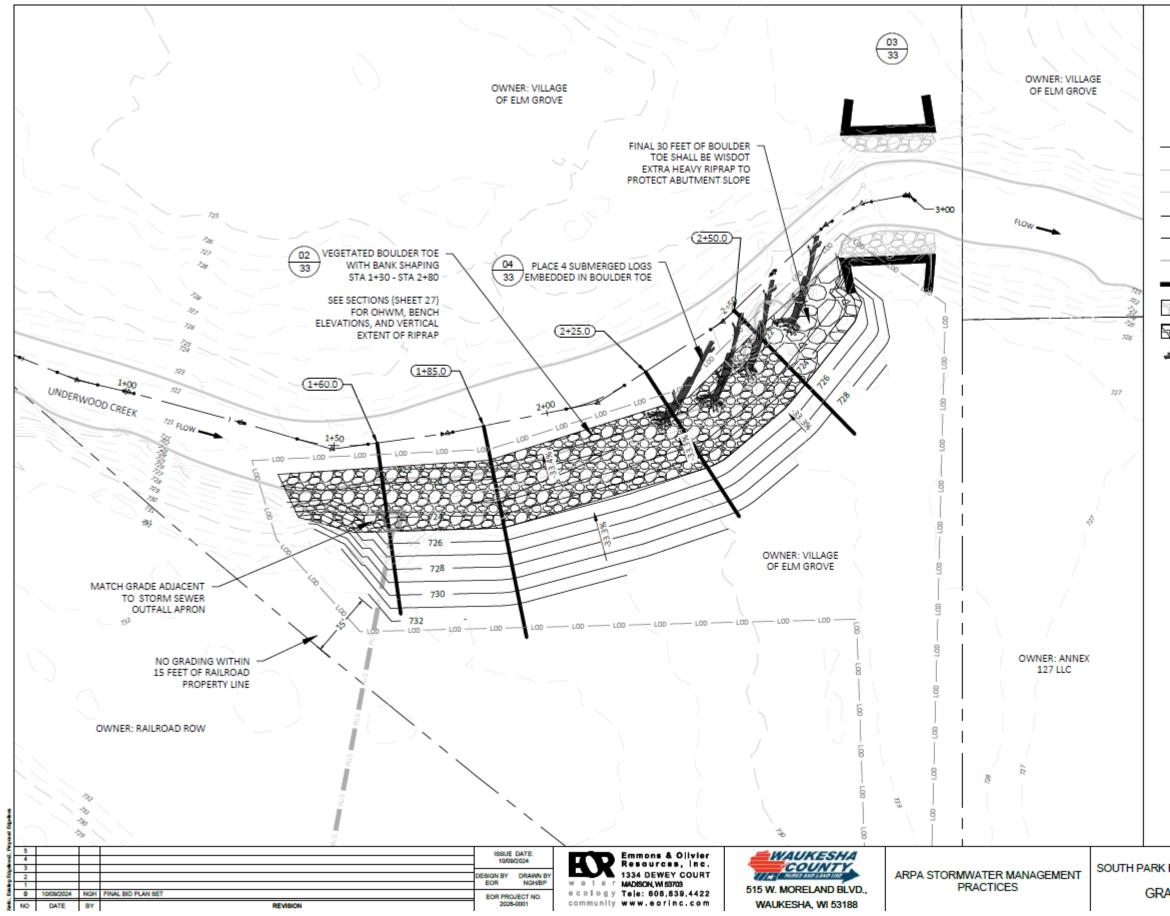
GRADING PLAN

SOUTH PARK FIELDS STABILIZATION:

Protecting the streambank in high energy locations with stone will better protect the streambank as compared to grading alone. The streambank stabilization project will occur within HUC-12 #040400030403 in order to generate TP and TSS credits. A Plan of the grading and protection implementation is provided in Attachment #5.

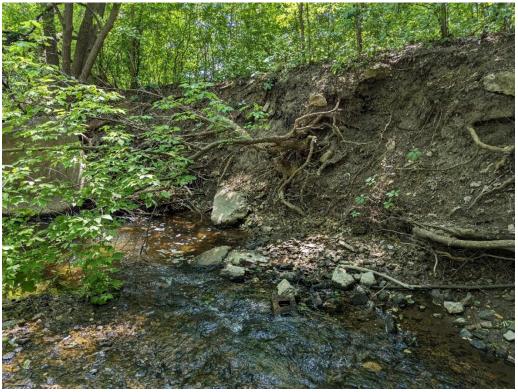
Image 2.1 – Bank, undercut with exposed roots..

The streambanks have experienced significant erosion as the Underwood Creek Watershed has been developed and cleared for agricultural and residential use. The banks are predominately undercut with some rills and vegetative overhang. Tree roots are readily visible throughout the reaches. Fallen trees and slumps are also visible in areas. Recession rates for each Reach along with documentation regarding existing condition were estimated in Attachment #6. The project area is mapped as floodplain and wetland. The project site has never been developed or cropped. The property became parkland in about 2005.

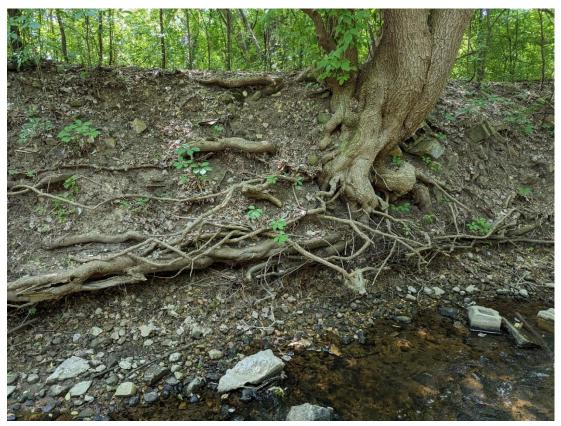
Image 2.2 – Bank, exposed roots.

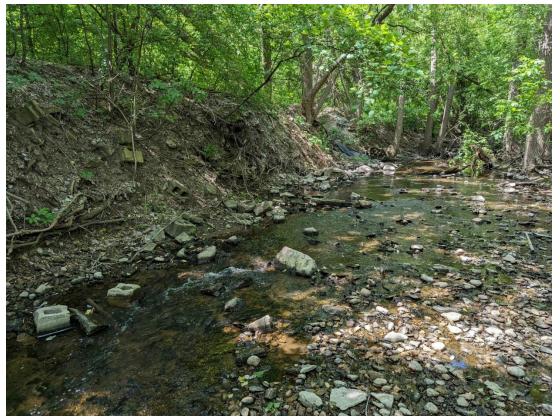
Image 2.3 – Bank with exposed roots.

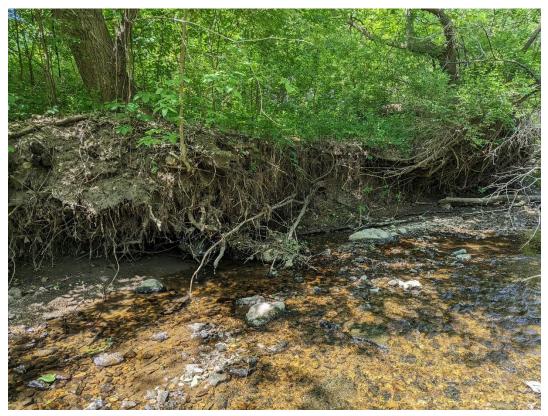
Image 2.4 – Bank, undercut

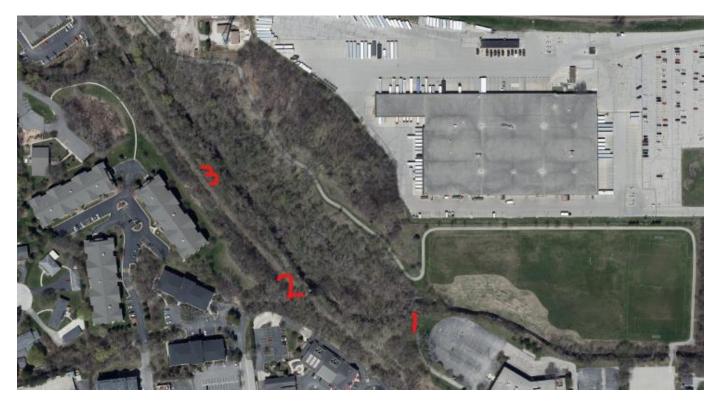
Soil - Texture Analysis

Sample #	Sample ID	Sand %	Silt %	Clay %	Texture Name	Total P %
1	Underwood Creek Elm Grove Streambank (3)	59	24	17	Sandy Loam	
2	Underwood Creek Elm Grove Streambank (3)					0.05

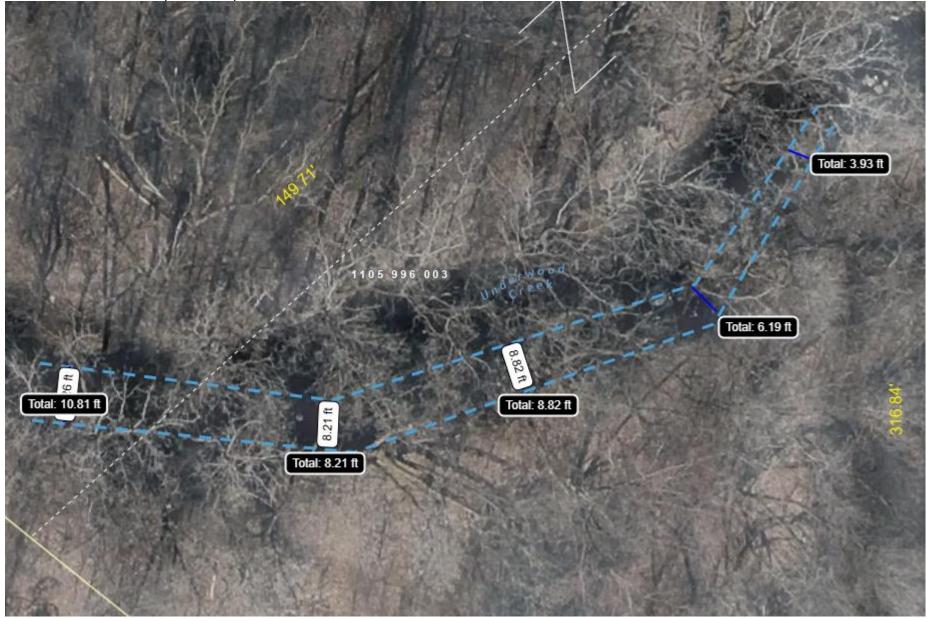
Bank Erosion Rate from air photos comparison

~	U	0	U	L	1	0				
1	Estimate of Bank Erosion Rate										
2	1995 to 20	24									
3											
4	South - me	easured fror	n air photo	comparison	1						
5	Station	Distance (f	ft)								
6	1	10.8									
7	2	8.2									
8	7	8.8									
9	8	6.2									
10	9	3.9									
11			ft/yr								
12	Average	7.6	0.26								
13	Geomean	7.2	0.25								
14											
15	Per table of	on page 4:									
16	Banks bar	e, many ex	posed roots	s, some falle	en trees, S	evere, 0.3-0	.5 ft/yr				
17											
18

An evaluation using historic air photos (south reach) and field observations (north reach) and measurements (both) has been conducted to estimate stream bank recession rate. The survey data, narrative, and photos documenting the current state of eroding stream banks is provided in Attachment #6.
