# Water Quality Trading Plan

## Village of Belmont

Lafayette County, Wisconsin

# **Belmont Water Quality Trading Plan**

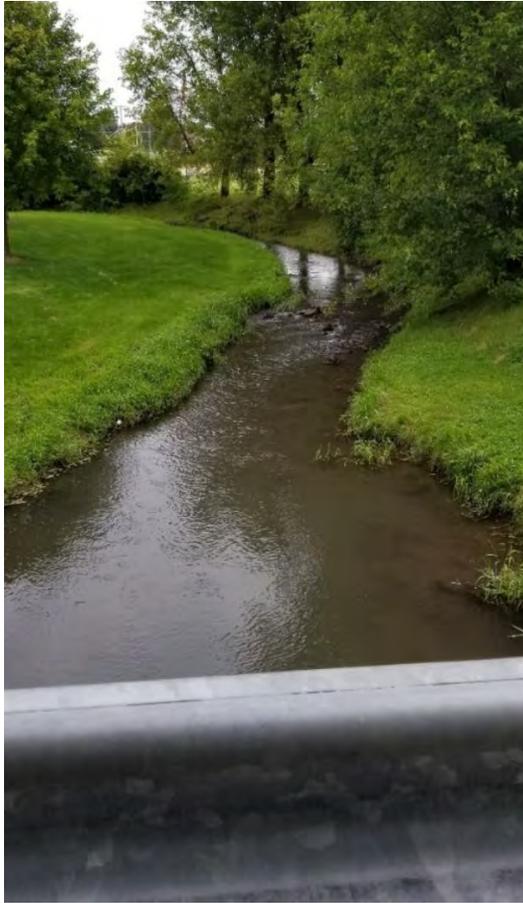
*Figure 31.5: 3E(A)/3W(A) North of WDNR Bridge*

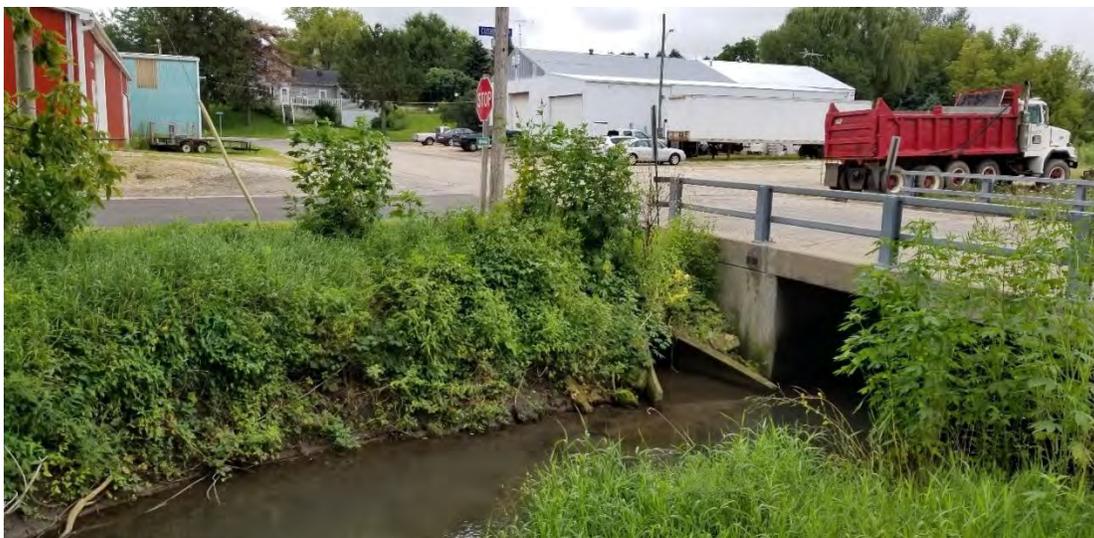
Figure 8.7: at Spring Street Bridge

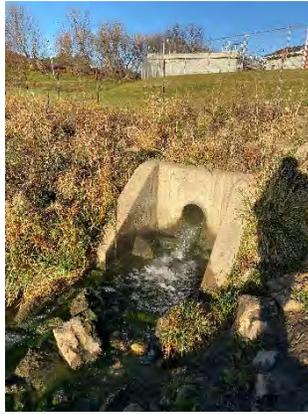
Location of Belmont wastewater treatment plant outfall.

*Figure 1.0: Sta. 0+00-0+50*

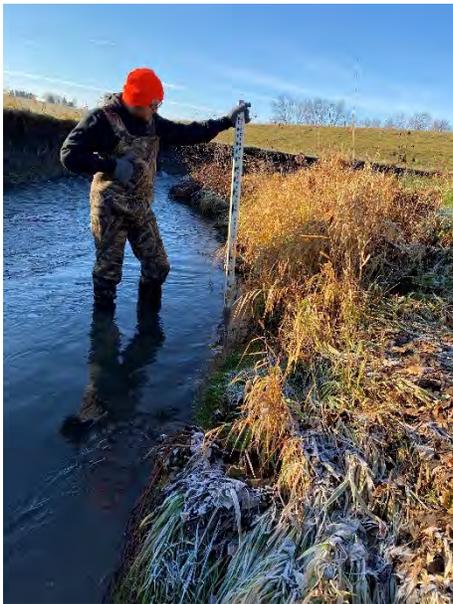
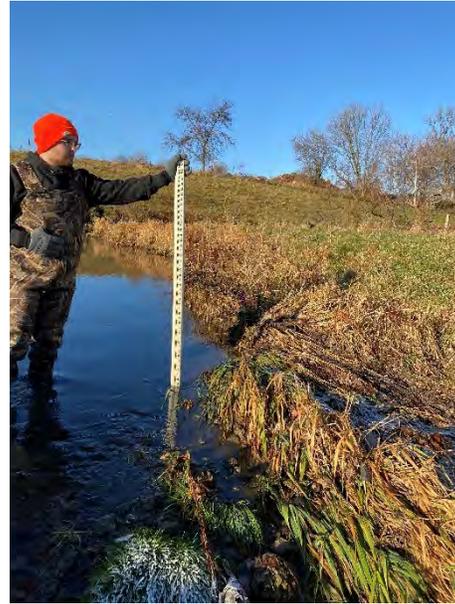
1A:

*Figure 2.0: Sta. 0+50-3+50 Slight. Vegetated banks with some bare banks.*

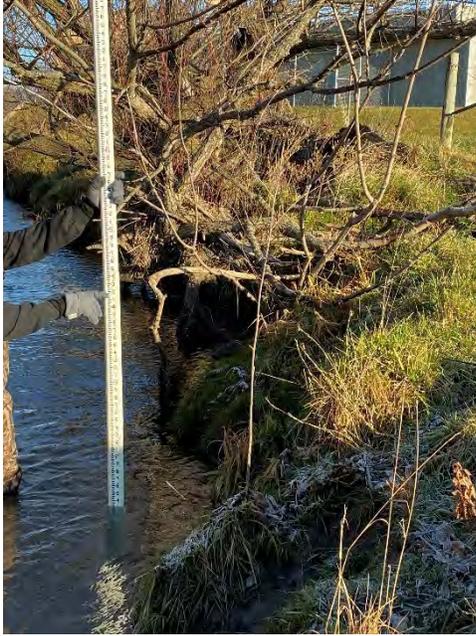
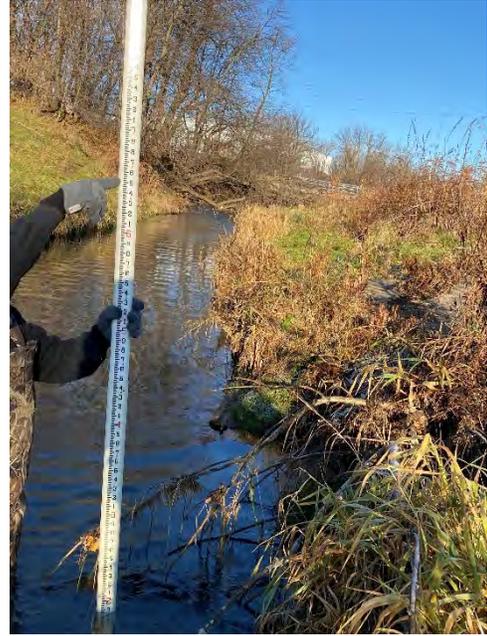
Figure 3.0: Sta. 3+50-6+00 Slight/Moderate. Exposed tree roots, bare banks, and some slumps.

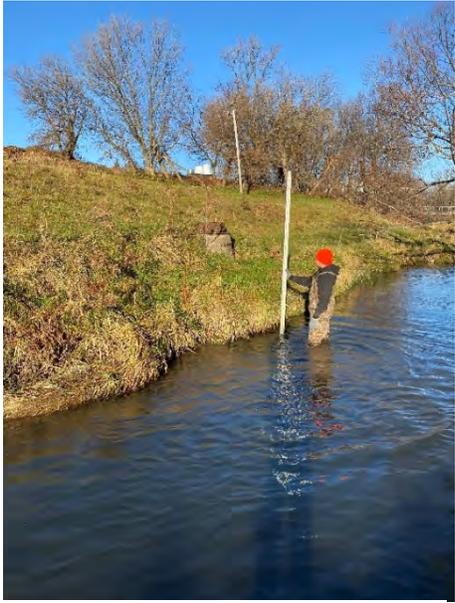
*Figure 5.0: 3+50-5+00 Slight/Moderate. Slumps and slips present.*

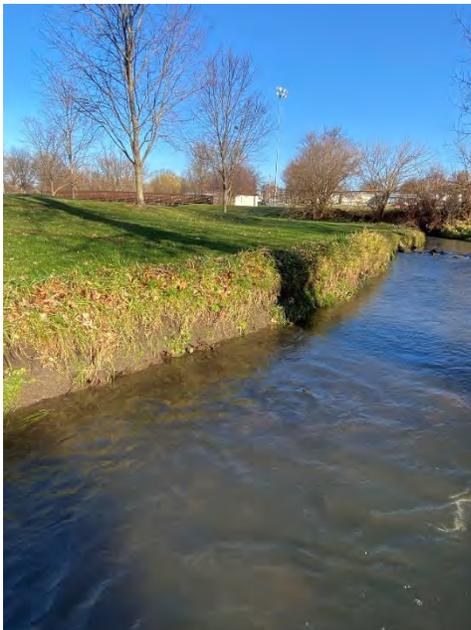
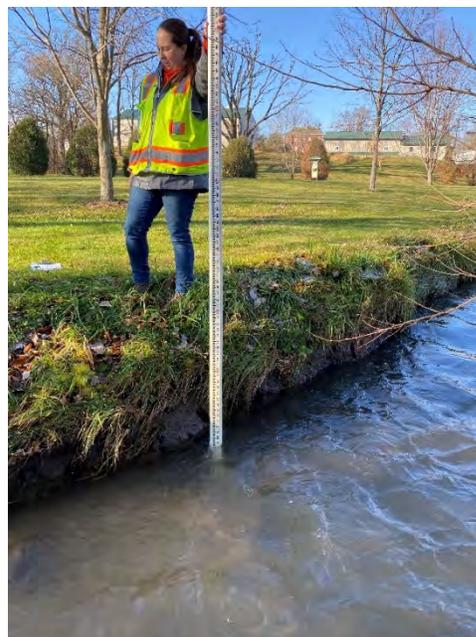
3D:

Figure 13.0: Sta. 19+00-22+00 Moderate. Bare banks, vegetative overhang and channel cross section is U-shaped.

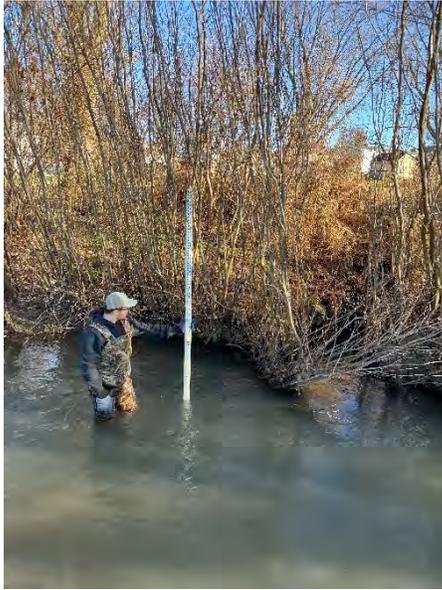
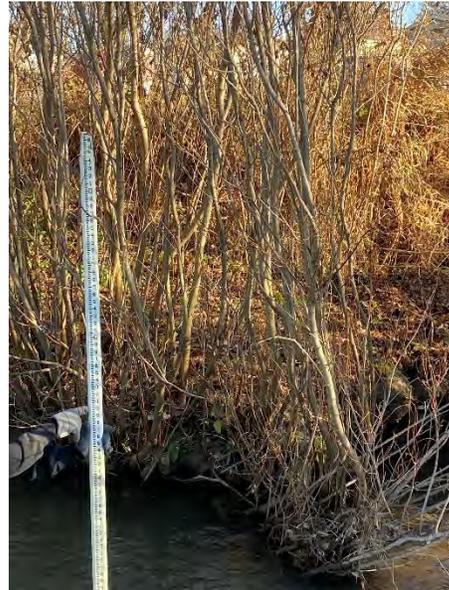
3E:

Figure 14.0: 22+00-23+50 Severe. Bare banks, exposed tree roots, with fallen trees, and channel cross-section is U-Shaped.

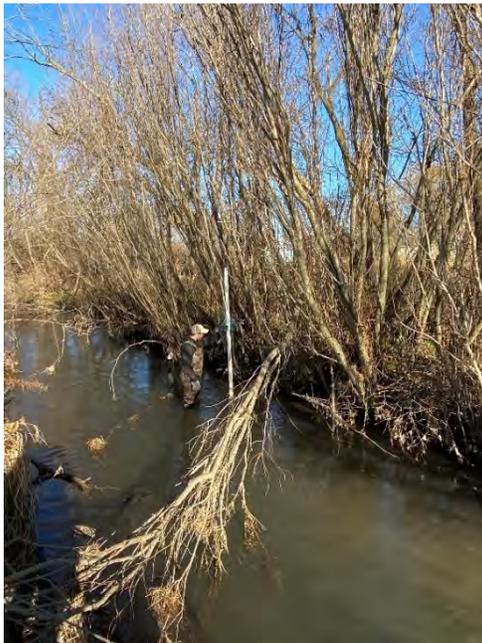
Figure 15.0: Sta. 22+00-23+50 Severe.

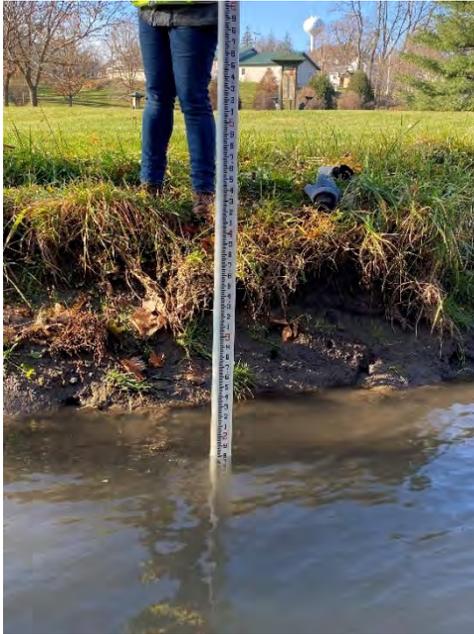
3F:

*Figure 16.0: Sta. 22+00-23+50 Moderate/Severe. Bare banks, vegetative overhang, and slumps.*

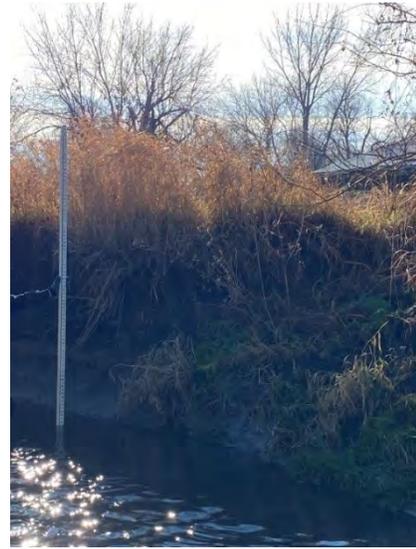
3T:

Figure 20.0: Sta. 32+25-34+22 Severe. Bare banks, vegetative overhang, slumps, and channel cross-section is U-shaped.

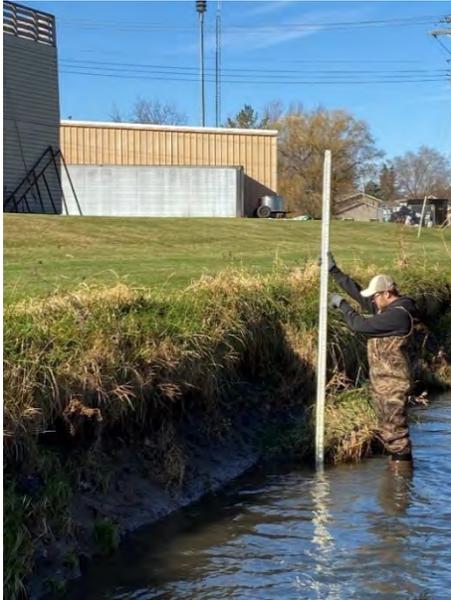
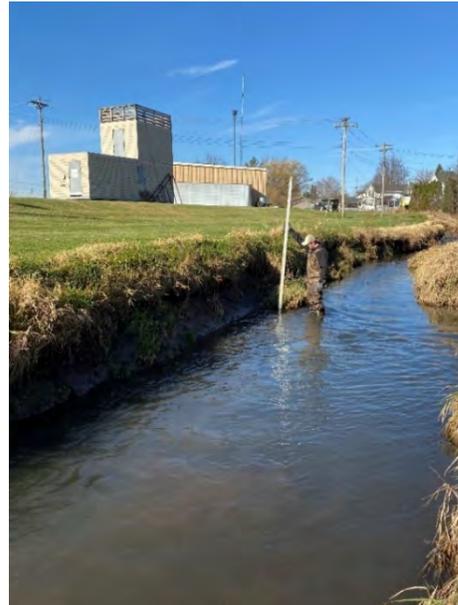
3Z:

Figure 24.0: Sta. 35+00-35+50 Severe. Bare banks, vegetative overhang, slumps, and channel cross-section U-shaped

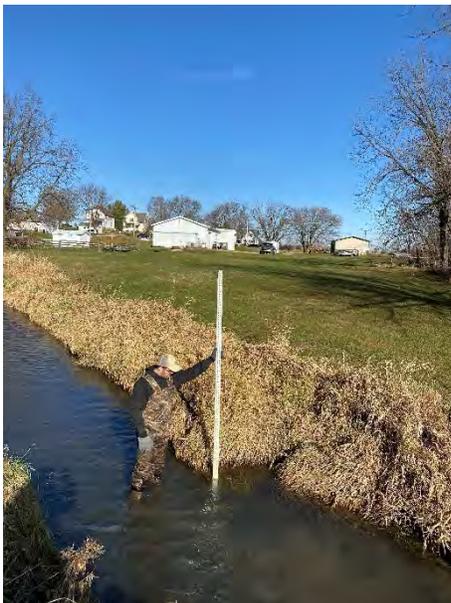
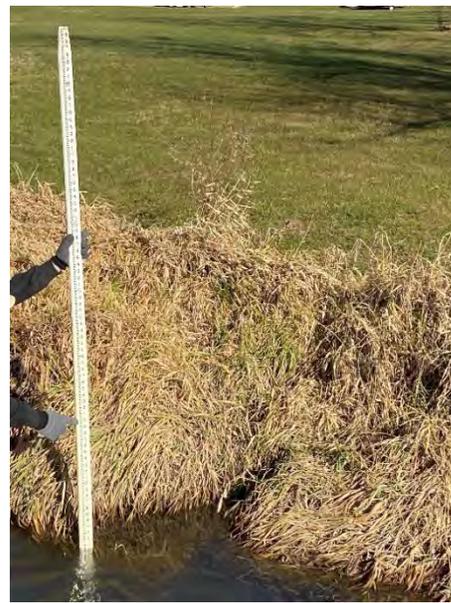
4A:

Figure 25.0: Sta. 35+50-36+00 Slight

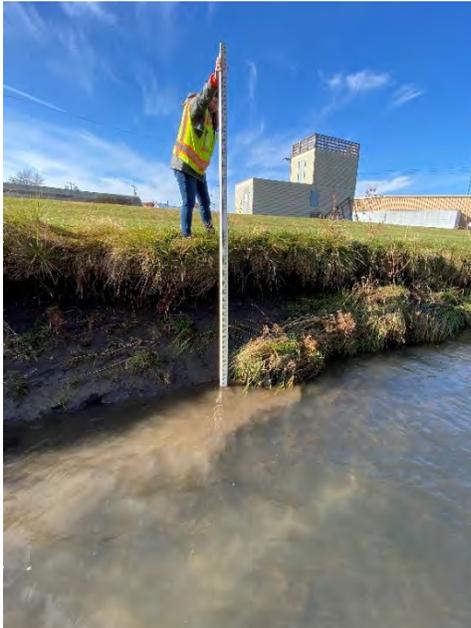
4B:

Figure 26.0: Sta. 35+50-36+00 Severe. Bank exposed, channel cross-section U-shaped, slumps/slips, and vegetative overhang.

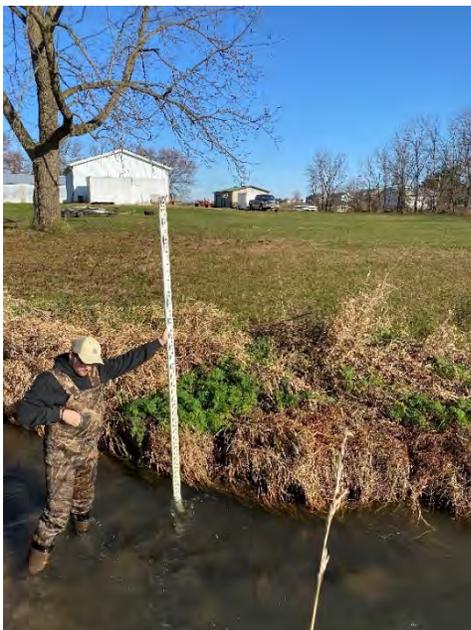
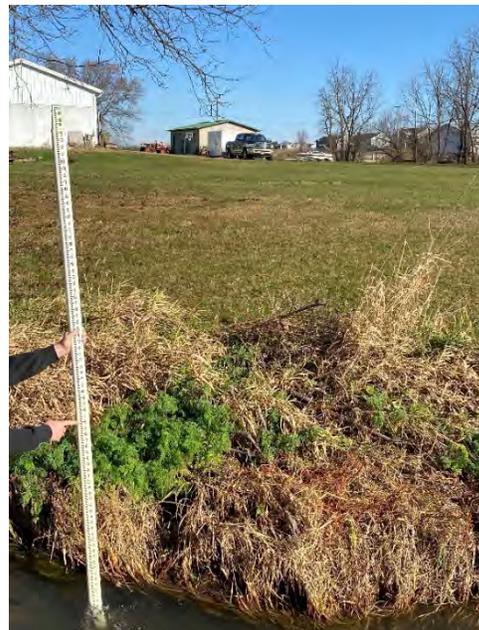
4E:

Figure 27.0: Sta. 36+50-37+50 Slight/Moderate. Some bare banks, vegetative overhang, and slumps.

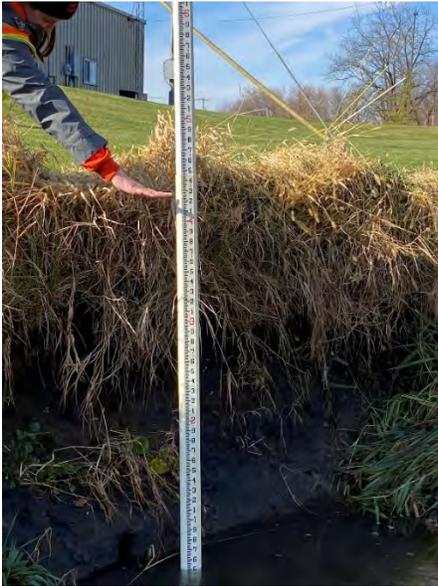
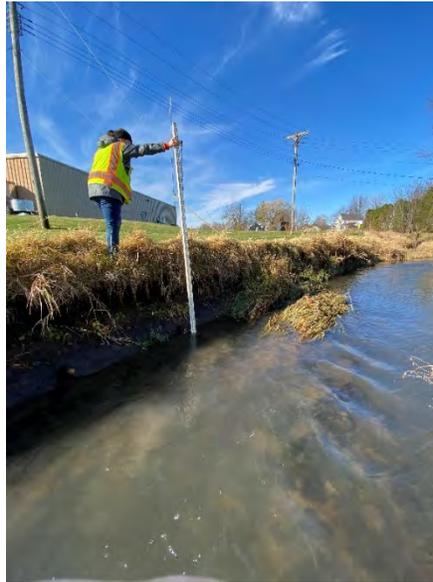
4F:

*Figure 28.0 Sta. 36+50-37+50 Severe. Bare banks, vegetative overhang, slumps, exposed roots, and channel cross-section U-Shaped.*

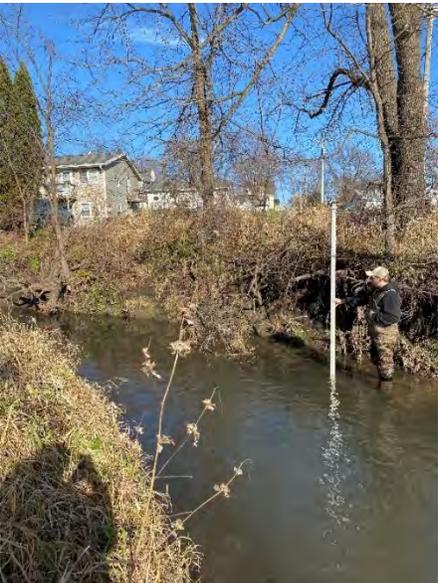
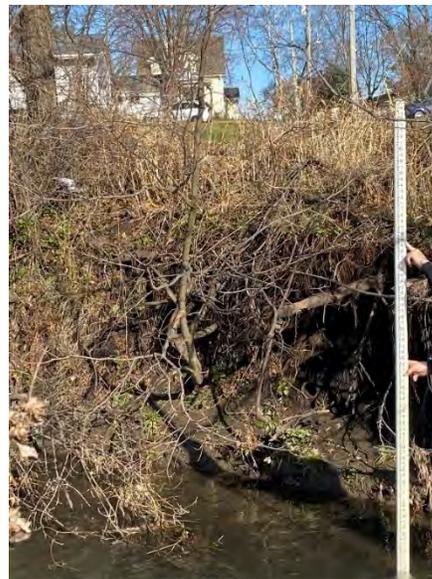
4K:

*Figure 29: Sta. 38+75-40+00 Severe. Bare banks, exposed tree roots, trees falling into stream, vegetative overhang, and channel cross-section is U-shaped*

In locations where the storm sewer culverts are suspended in the air, the bank will be reconstructed to eliminate the condition and riprap will be installed to protect the bank below the culvert. Any trees that have fallen into the stream or are on the verge of doing so will be removed along with their roots.

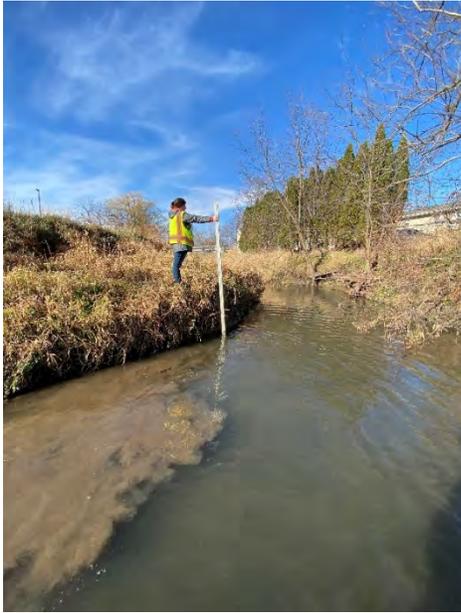
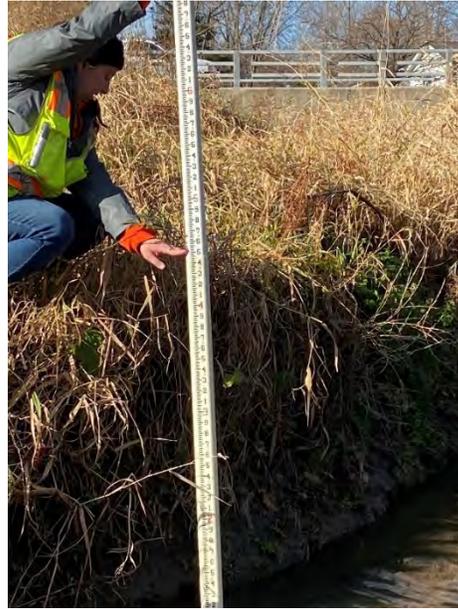
4L:

Figure 30.0: Sta. 38+75-40+00 Moderate. Bare banks, slumps, vegetative overhang, and exposed roots.

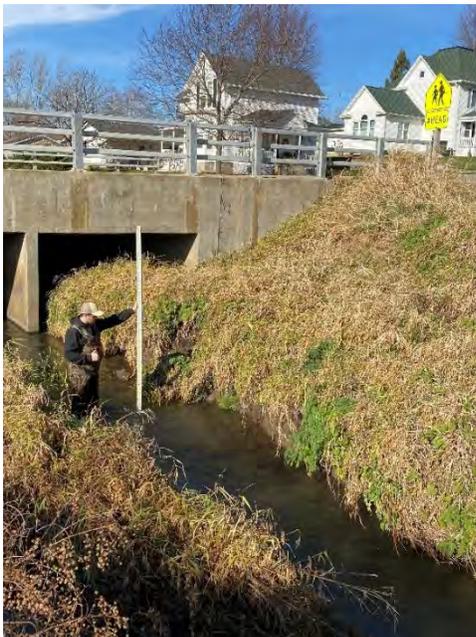
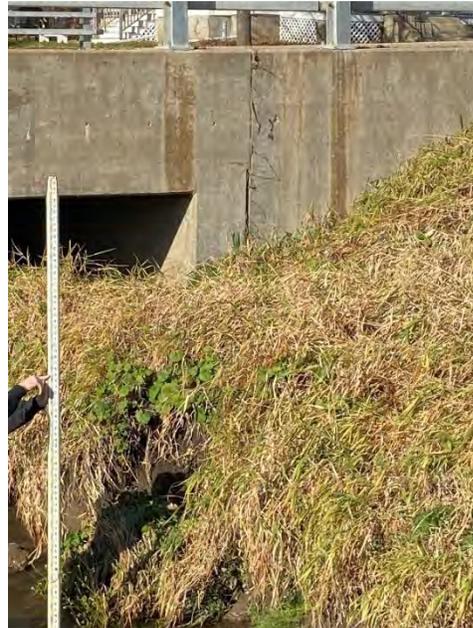
4M:

Figure 31.0: Sta. 40+00-40+25 Moderate. Slumps, vegetative overhang, and channel cross-sections U-Shaped.

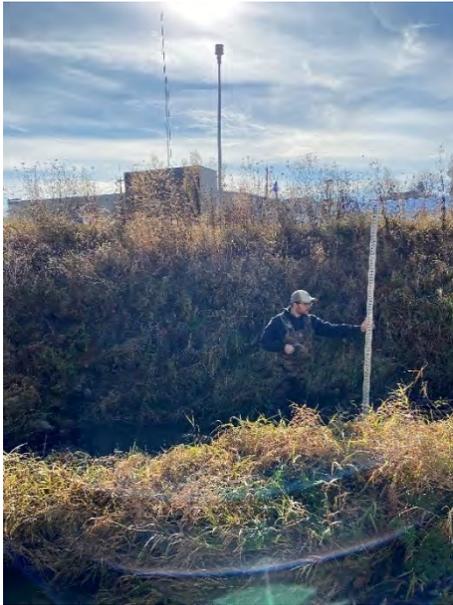
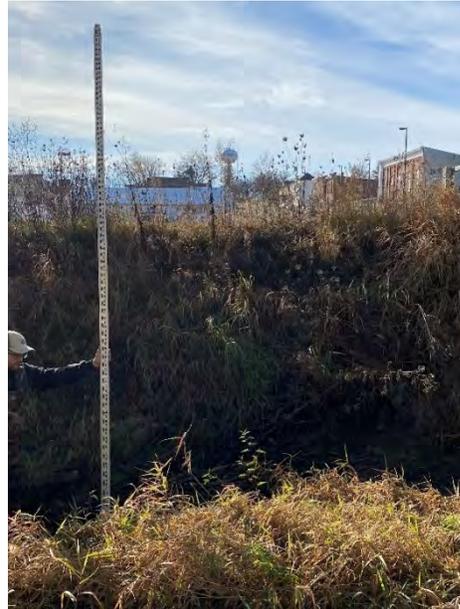
4N:

Figure 32.0: Sta. 40+00-40+25 Moderate. Slumps, vegetative overhang, and channel cross-section is U-shaped.

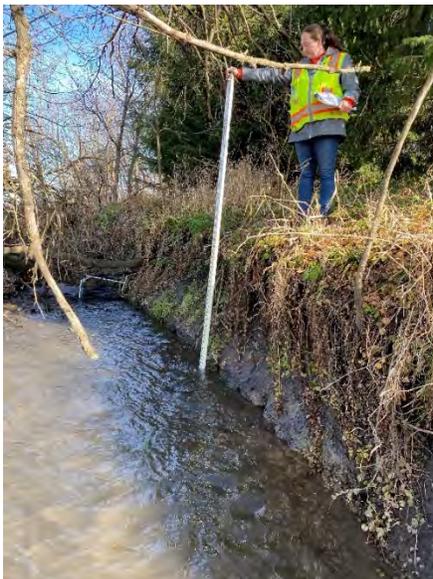
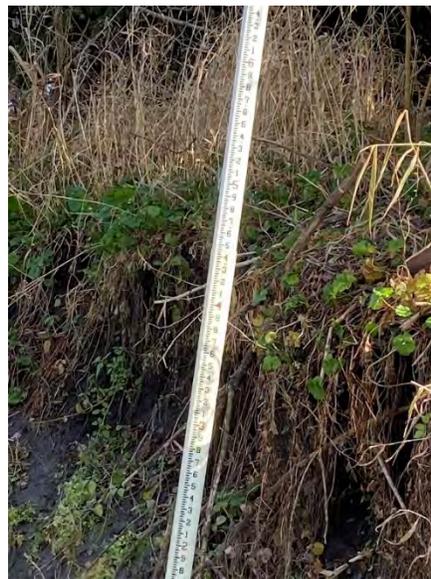
5A:

Figure 33.0: Sta. 50+00-50+20 Severe. Bare banks, exposed roots, tree falling into stream, and channel cross-section U-shaped.

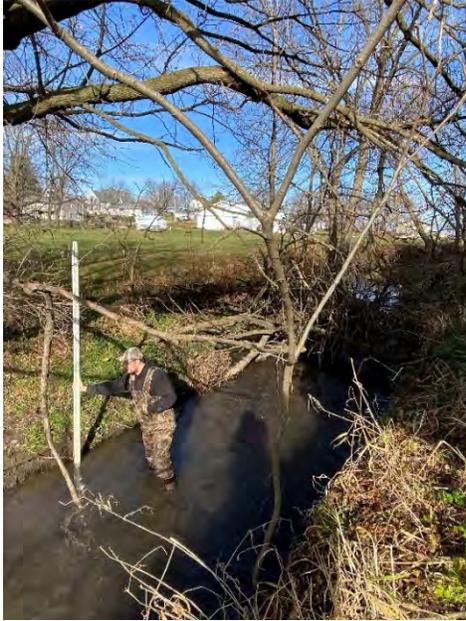
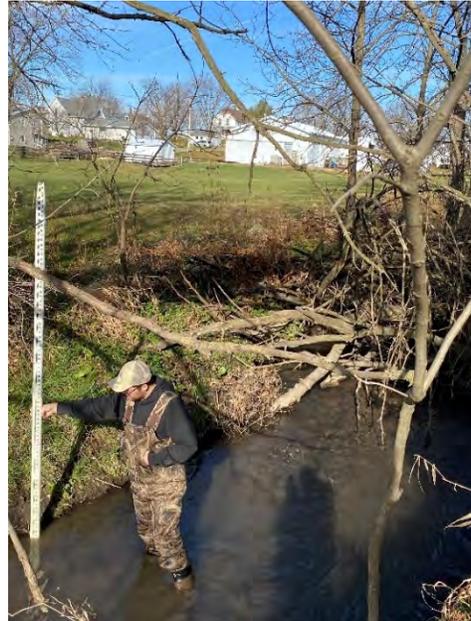
5B:

*Figure 34.0: Sta. 50+00-50+20 Moderate. Bare banks, exposed roots and trees falling into stream.*

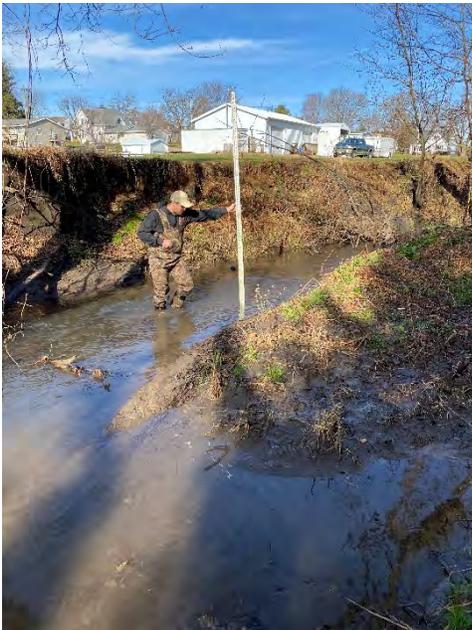
5C:

*Figure 35.0: Sta. 50+20-52+50 Slight/Moderate. Bare banks, exposed roots, trees falling into stream, and channel cross-section U-Shaped.*

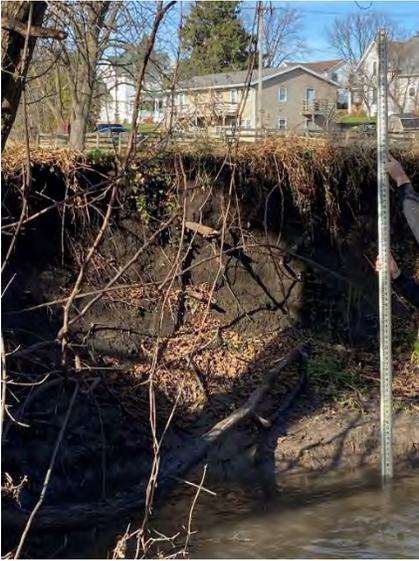
5D:

*Figure 36.0: Sta. 50+20-52+50 Severe. Bare bank and vegetative overhang.*

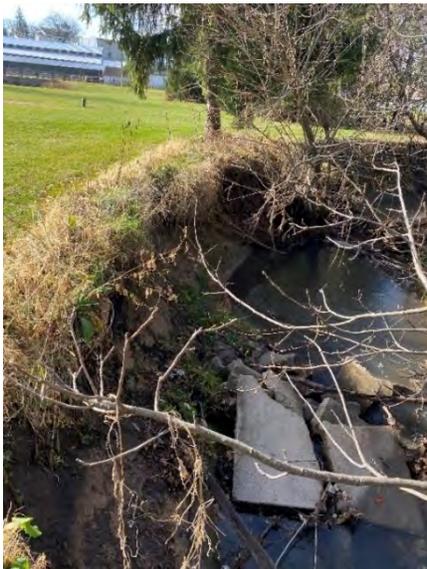
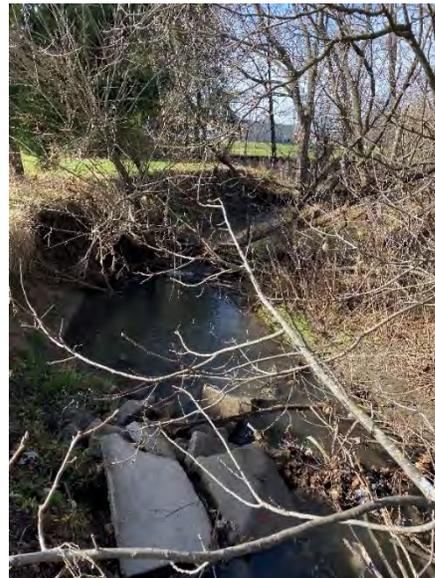
5I:

*Figure 37.0: Sta. 53+00-53+20 Severe. Bare banks, exposed roots, trees falling into stream, and channel cross-section U-shaped.*

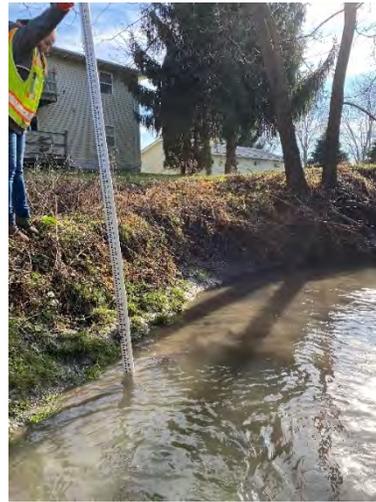
5M:

Figure 38.0: Sta. 54+50-55+50 Severe. Bare banks, exposed roots, slumps, and channel cross-section is U-shaped.

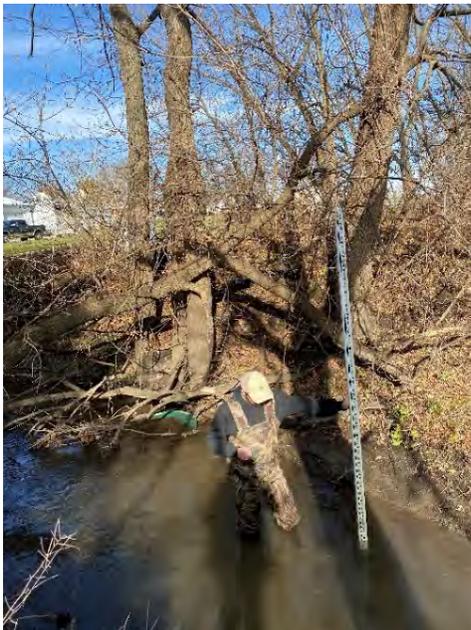
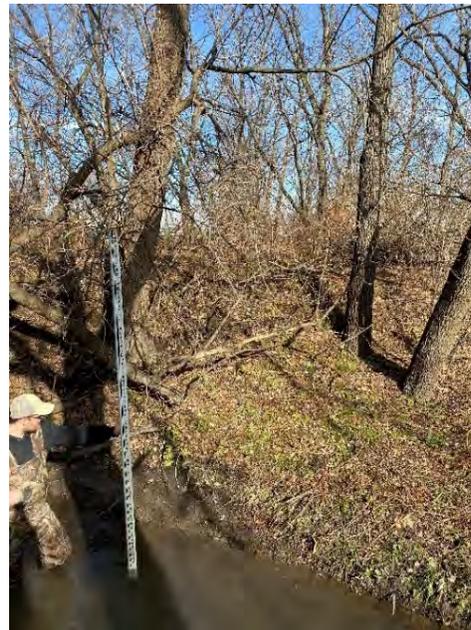
5N:

Figure 39.0: Sta. 54+50-55+50 Slight/Moderate. Bare banks, exposed roots and trees falling into stream.

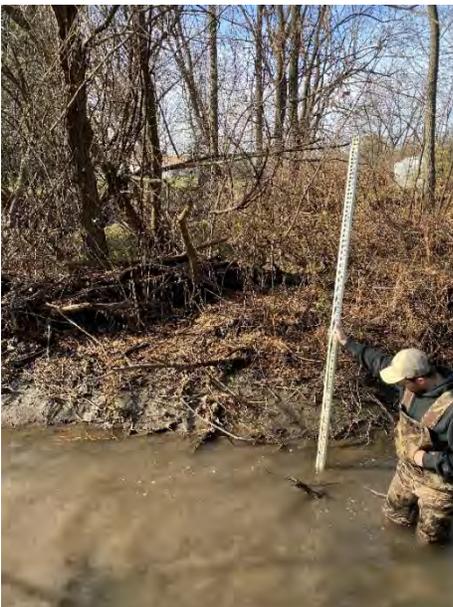
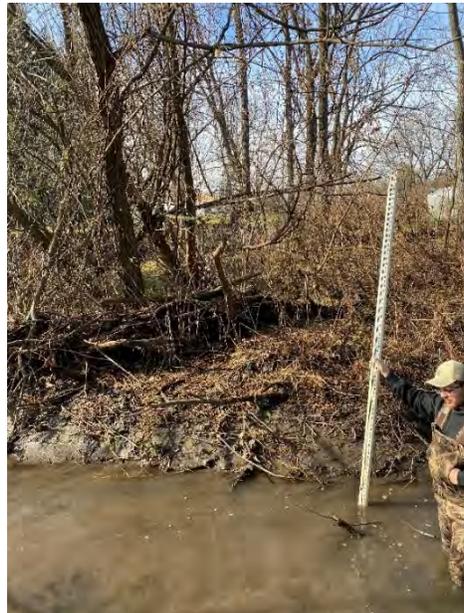
5R:

*Figure 41.0: Sta. 56+00-56+50 Slight/Moderate. Bare banks, vegetative overhang, exposed roots, and trees falling into stream.*

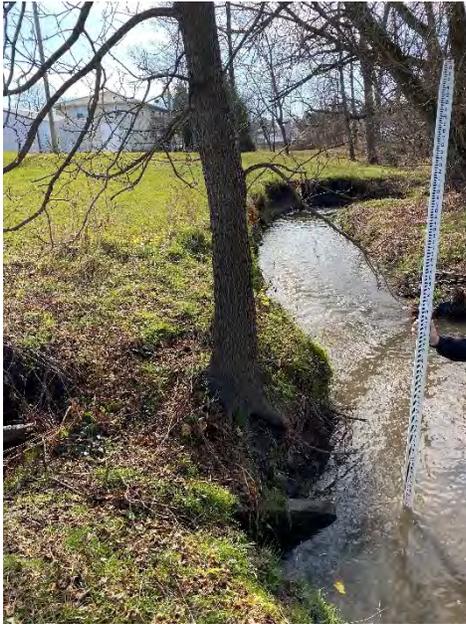
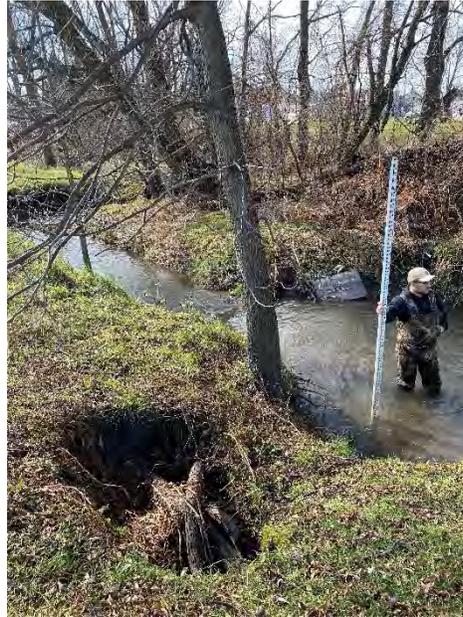
5S:

*Figure 42.0: Sta. 56+50-56+90 Moderate. Bare banks, vegetative overhang, slumps, exposed outfall, and channel cross-section is U-Shaped.*

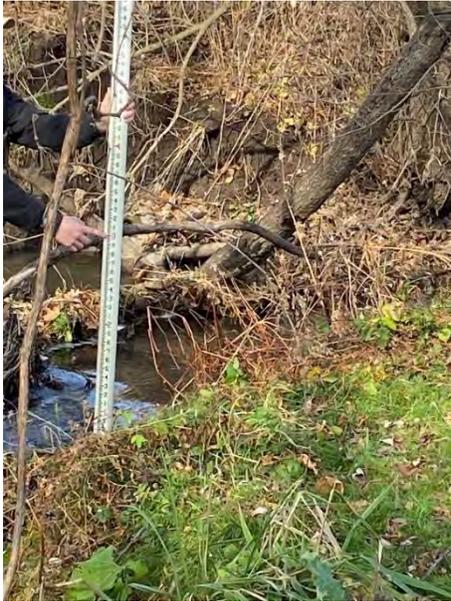
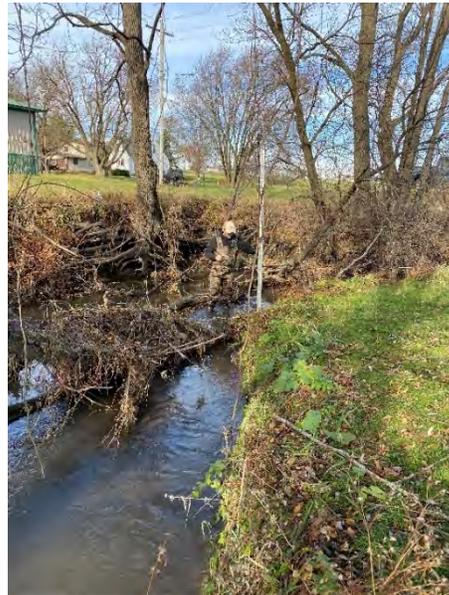
5U:

*Figure 44.0: Sta. 56+90-57+35 Moderate/Severe. Bare banks, exposed tree roots, slumps and trees falling into stream.*

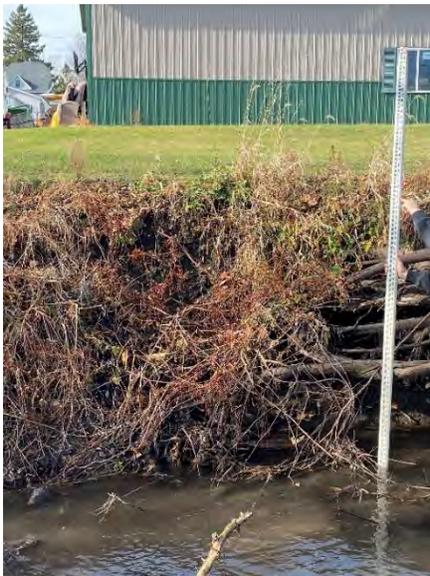
5V:

*Figure 45.0: Sta. 56+90-57+35 Moderate/Severe. Bare banks, exposed roots, slumps, and trees falling into stream.*

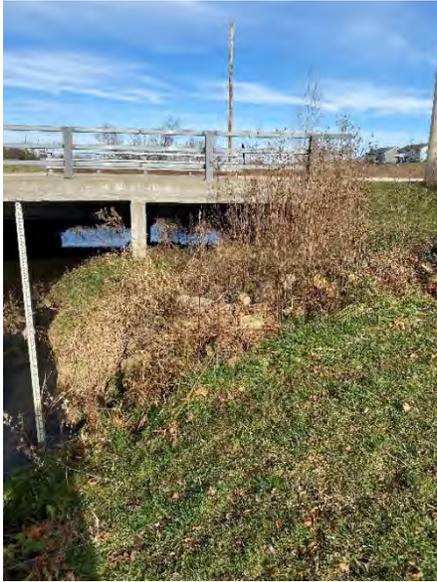
5W:

Figure 46.0: Sta. 57+35-57+75 Slight. Vegetative overhang and outfall exposed.

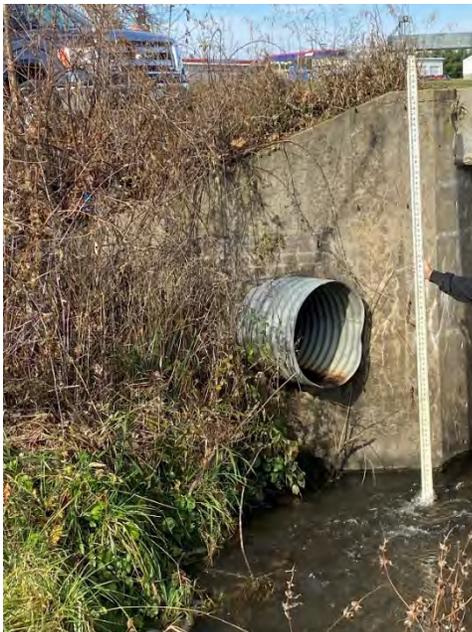
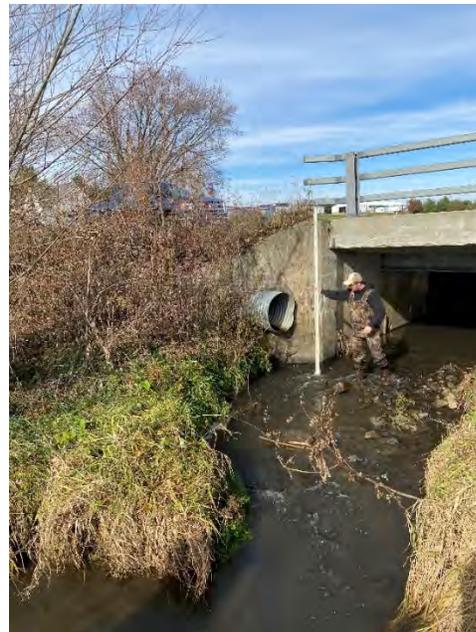
5X:

Figure 47.0 Sta. 57+75-58+00 Slight. Vegetative overhang. Culvert within bridge.
